Building and Timber Pest Inspection Report

Inspection Date: Wed, 11 Feb 2026

Property Address: 2 Tee Glade, Blacktown NSW 2148,
Australia

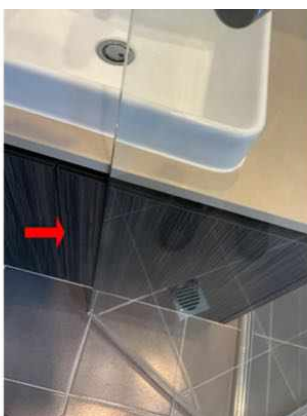
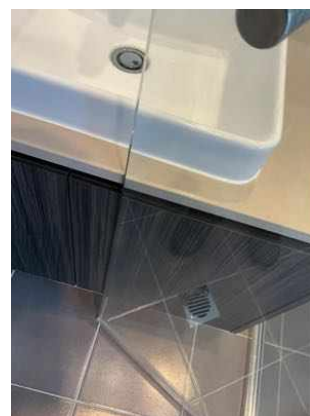
Building: Main Building
Location: Bathroom
Finding: shower screen door hitting vanity unit
Information: The shower screen door makes contact with the edge of the vanity unit when opened. This indicates inadequate clearance between the shower screen and the fixed bathroom fixture. The door's operation is impeded and presents a safety concern.

- Potential for impact damage to the vanity and shower screen.
- Increased risk of glass breakage, posing a personal injury hazard.
- Ongoing stress may lead to hardware failure or misalignment of the door.

This condition does not comply with the intent of AS 4349.1-2007, Appendix C – Significant Items, under “Defects in the condition of secondary and finishing elements,” specifically where normal use may cause failure or injury.

Engage a licensed glazier or shower screen installer to adjust or replace the screen to ensure proper clearance and safe operation. A cabinetmaker may be consulted if modification to the vanity is more feasible.

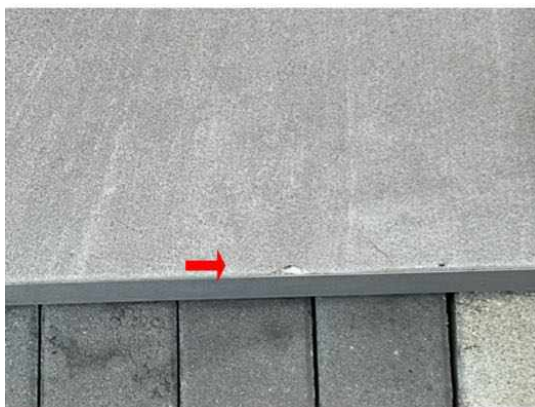
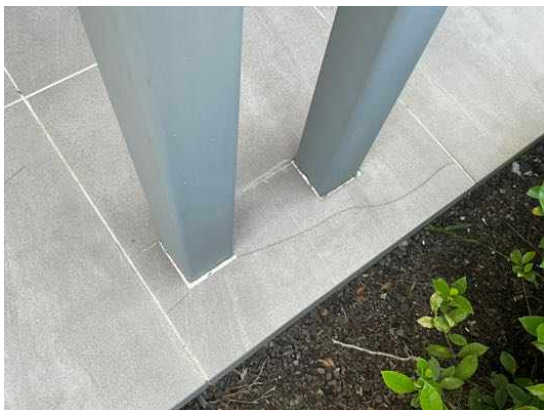
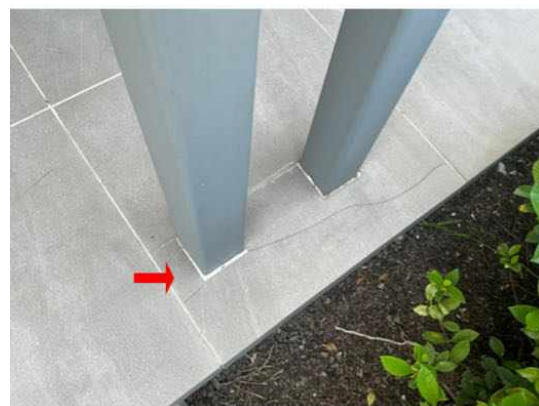
Building: Main Building
Location: Front porch
Finding: Floor Tile crack
Information: A floor tile has a visible crack on the surface.

The damaged tile presents a trip hazard, may lead to cuts if stepped on barefoot, and can allow moisture ingress into the substrate, which may cause further deterioration or loosening of adjacent tiles. It also affects the overall appearance of the floor.

A licensed tiler should be engaged to remove the damaged tile and install a matching replacement. If spare tiles are unavailable, additional remedial work may be required to blend the repair with surrounding finishes.

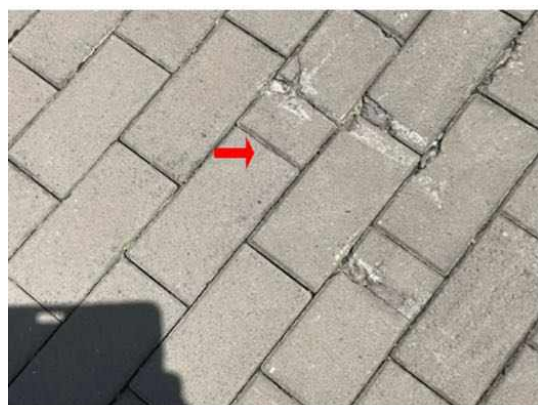
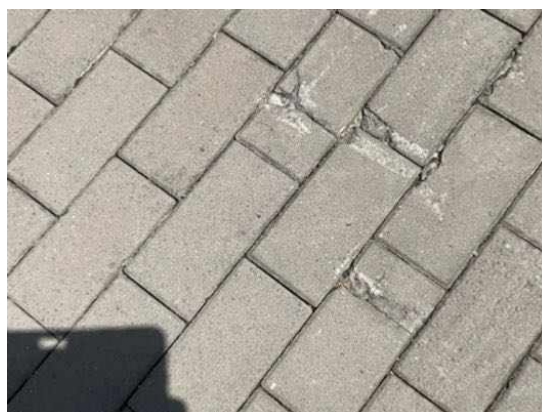
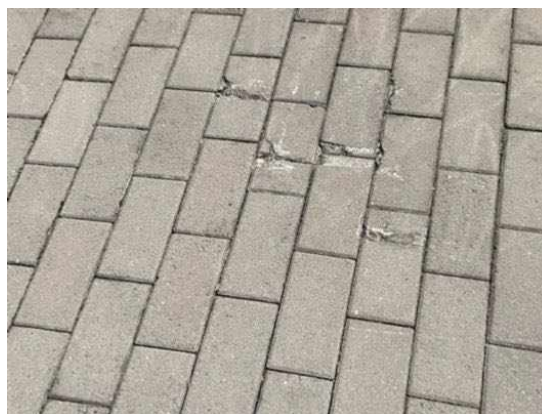
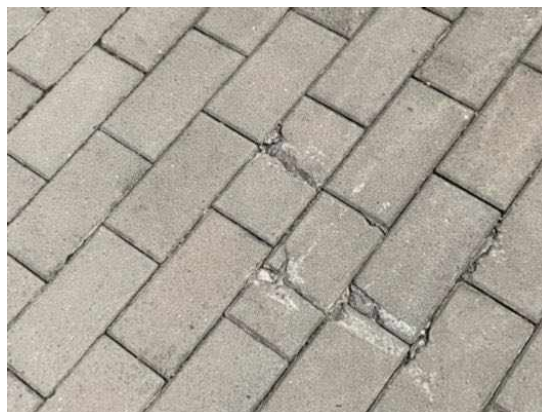
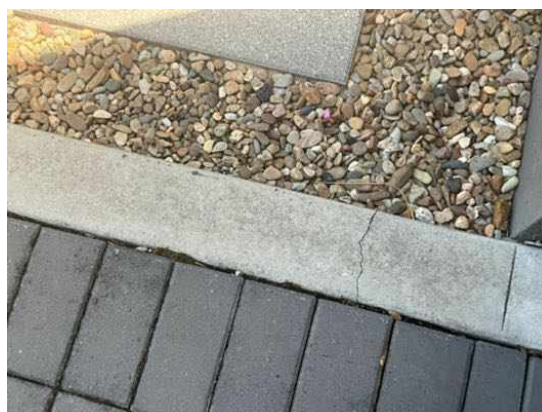
Finding 3.02

Building: Main Building
Location: Driveway
Finding: Bricks / Pavers uneven and displaced....
Information: Cracked, uneven, and displaced pavers were observed. Several pavers appear loose, misaligned, or deteriorated.

The uneven surface poses a significant trip hazard for pedestrians and may impact the usability of the driveway. Displacement and cracking can worsen over time due to vehicle traffic, poor subbase compaction, or water ingress. Wall cracking may lead to moisture entry or structural wear if left untreated.

- A qualified paving contractor should be engaged to lift, relevel, and relay the affected pavers with proper bedding and compaction.
- A licensed builder or bricklayer should repair and seal the masonry wall crack around the pipe to prevent further water ingress and deterioration.
- Drainage should also be checked to ensure water is not contributing to the issue.

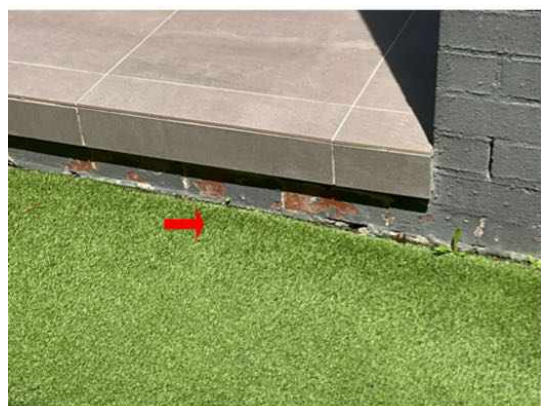
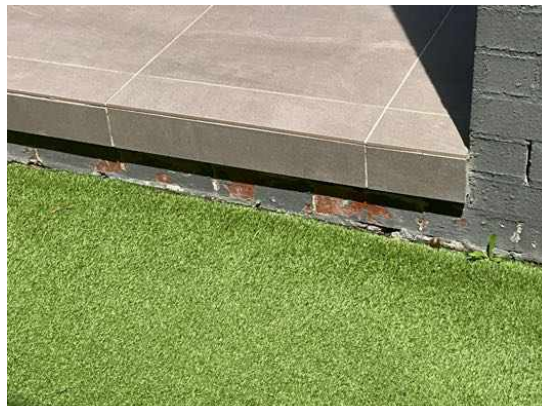
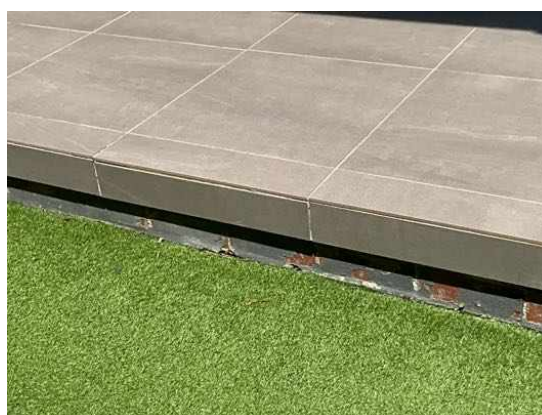
Finding 3.03

Information: Sections of the paint in this area was found to have deteriorated. Paint deteriorating is generally an indication of excessive moisture in the area that is currently hidden by the painted surface.

The presence of excessive moisture can have major implications on associated building elements if left unattended. While only seemingly minor at this stage, the damage cannot be determined due to the paint, obstructing any further inspection of the damage.

It is highly advised that the affected paint to be cleaned to allow a further, more invasive inspection by a licensed builder/painter. Failure to act on this defect may necessitate major works in the future.

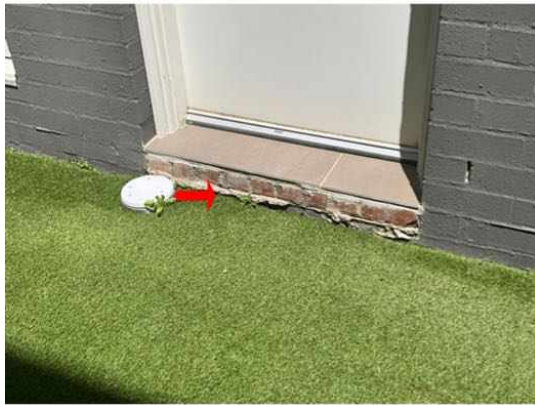
Finding 3.04

Building:	Main Building
Location:	Exterior walls - rear
Finding:	Poor workmanship
Information:	The structure exhibits signs of poor workmanship, evident in various aspects of construction and finishing.

Risk: Poor workmanship poses a range of risks, including compromised structural integrity, potential safety hazards, and a decreased lifespan of the structure. It may also lead to aesthetic and functional issues.

Resolution: A qualified contractor or construction professional should be consulted to assess and address the poor workmanship. They can implement corrective measures to ensure structural soundness, safety, and overall quality of the construction.

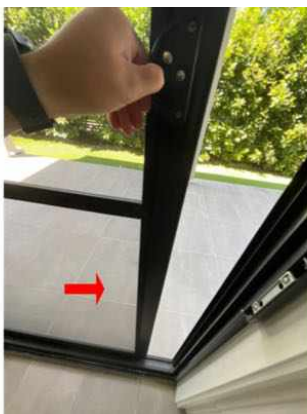
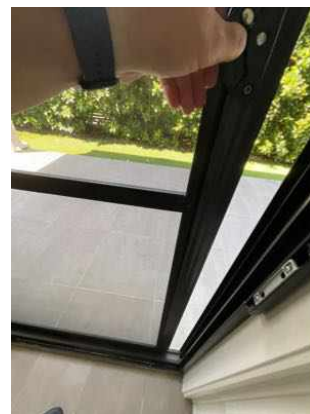
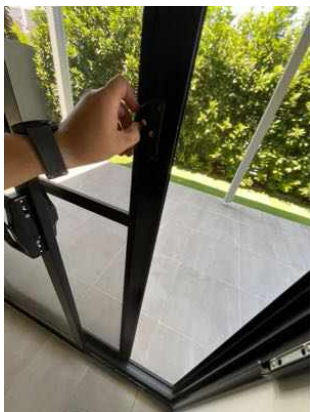
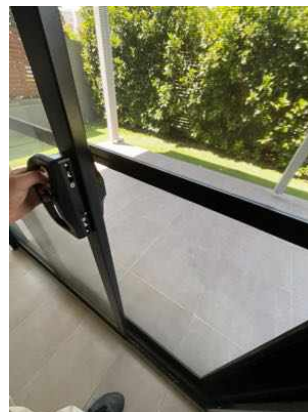
Finding 3.05

Information: The door to this area was difficult to operate at the time of inspection. This is likely due to damaged wheels which help the door to operate in a smooth fashion.

Doors provide ventilation and exits to the adjoining area and should be at a fully operational level to ensure user comfort and safety. Restricted function of the door may also pose as a potential safety hazard if required for emergency egress from the building.

Generally, factors such as general age of the building element and a lack of maintenance are the usual causes for this type of defect.

Replacement of door running hardware may be required, as well as minor repairs and cleaning. A registered builder or general handy person will be required to repair the sliding door.

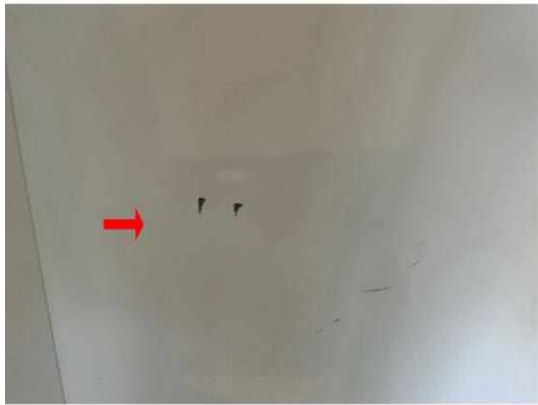
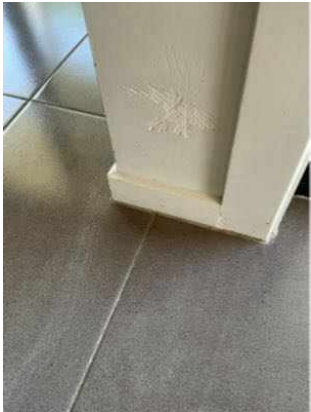
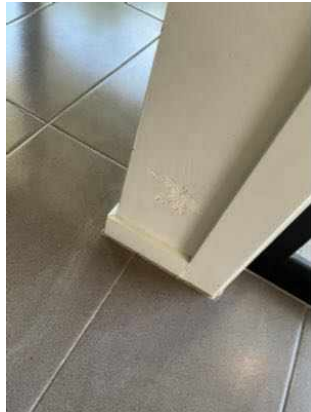
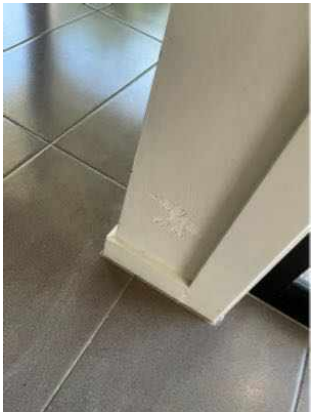
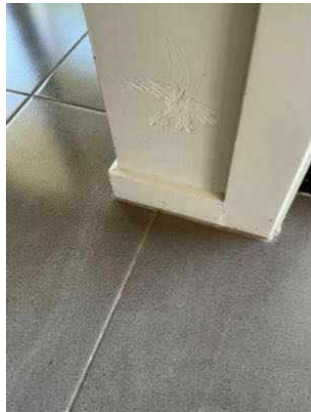
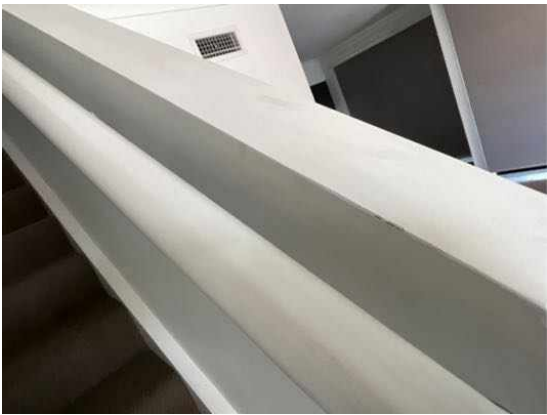
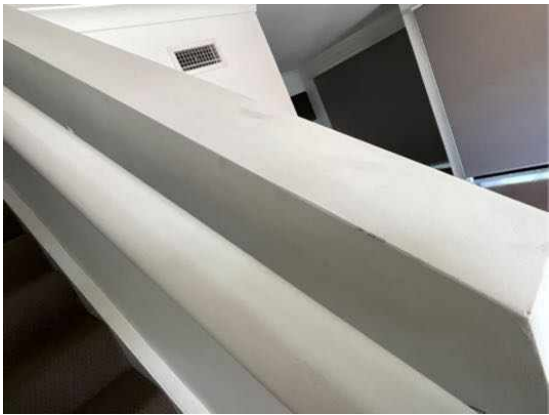
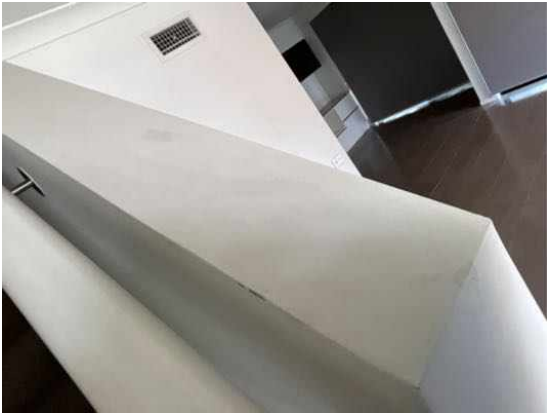
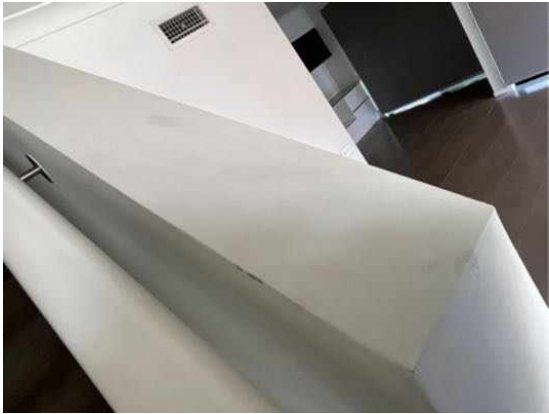
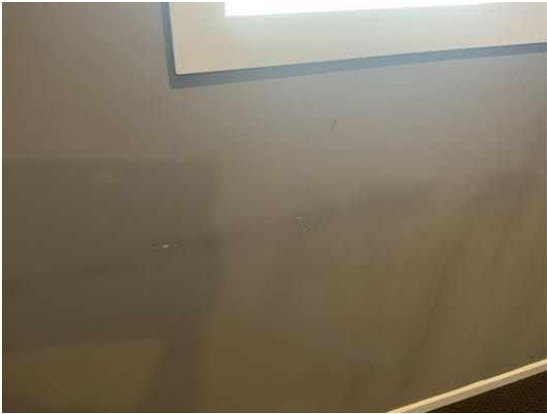
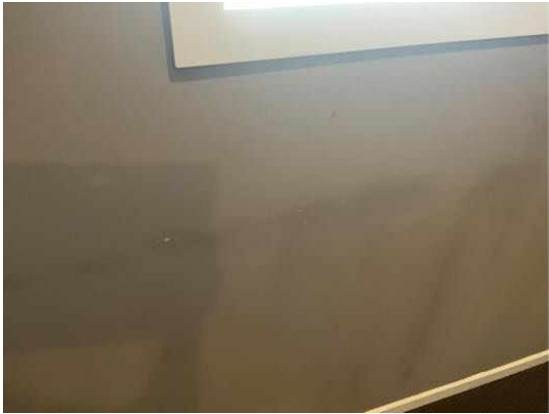
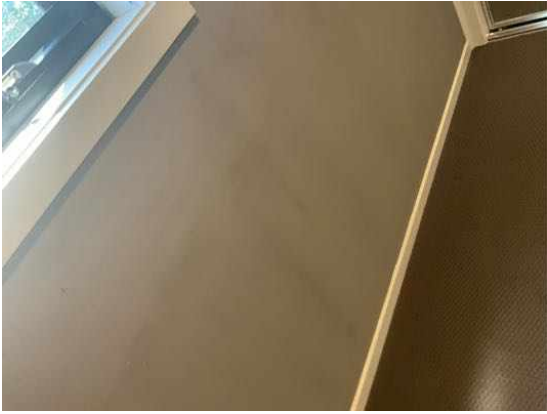
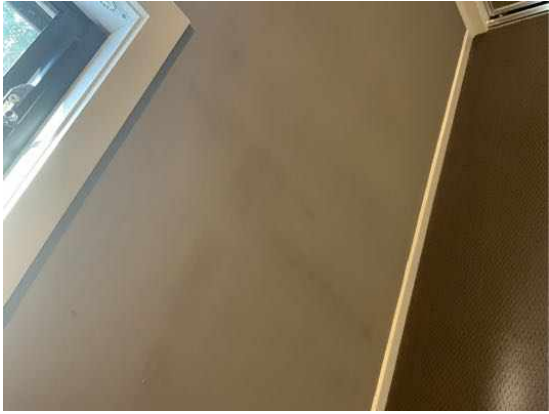
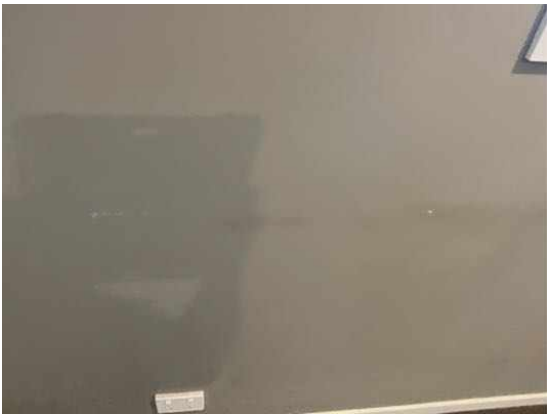
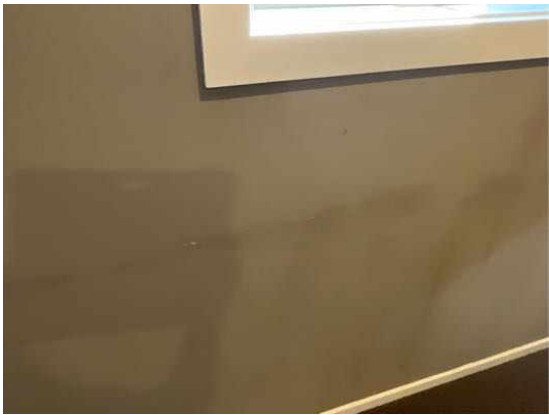
Finding 3.06

Building:	Main Building
Location:	All Areas
Finding:	Paint surface - Scratches
Information:	Scratches have been identified on the paint surface, detracting from the overall appearance and quality of the painted surface.

1. Aesthetic Degradation: Scratches mar the appearance of the painted surface, diminishing its visual appeal and potentially lowering property value.
2. Corrosion Vulnerability: Exposed areas of bare metal due to scratched paint are susceptible to corrosion, leading to structural damage and compromised durability.
3. Environmental Hazards: Scratched paint can release hazardous chemicals into the environment, posing risks to both human health and the ecosystem.

A qualified painter should address the issue promptly to repair the scratched paint. Depending on the severity of the scratches, repair options may include sanding, priming, and repainting the affected area to restore the integrity and appearance of the paint surface.

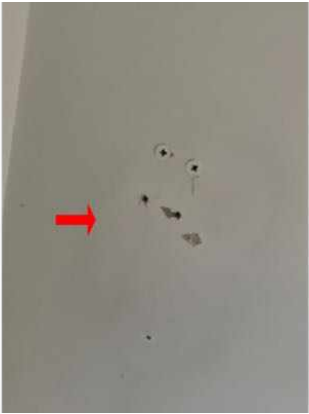
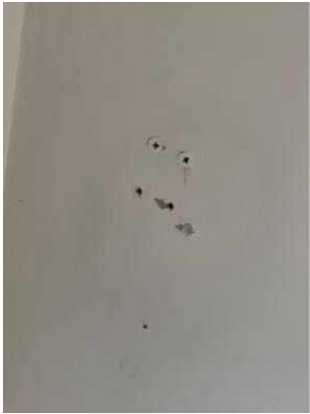
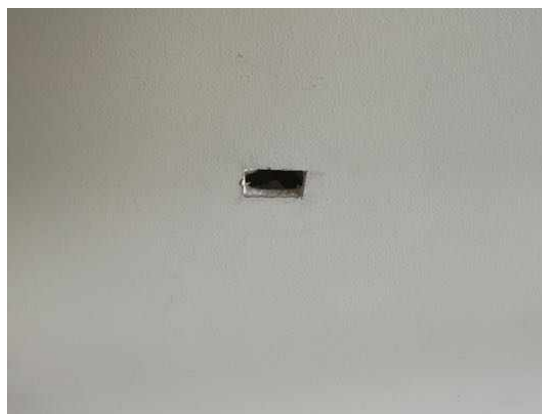
Finding 3.07

Building: Main Building
Location: All Areas
Finding: Holes in Gyprock
Information: Holes in the drywall (gyprock) has been identified, potentially compromising the structural integrity and aesthetics of the wall surface.

The hole in the drywall can allow drafts, pests, or moisture to enter the interior space, affecting insulation and potentially causing damage to the wall. It also detracts from the visual appeal of the room.

A professional drywall or plaster repair specialist can patch and repair the hole in the drywall, ensuring it is structurally sound and visually appealing once again.”

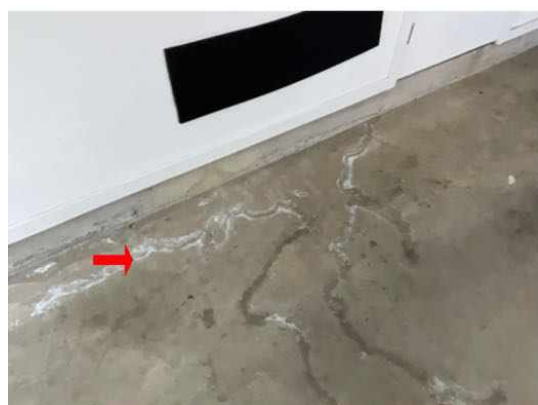
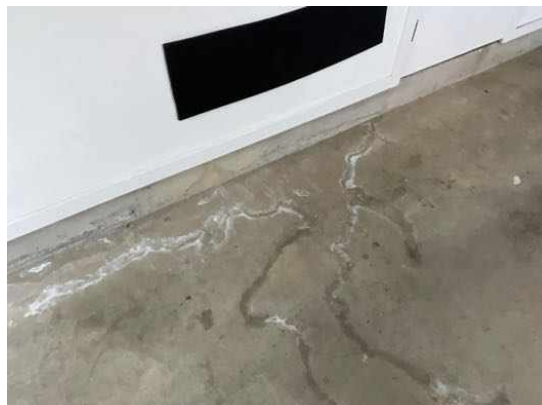
Finding 3.08

Finding: Water staining

Information: Water staining was evident in this area at the time of inspection. Water staining indicates that surfaces have been exposed to excessive moisture over time. The minerals and other elements in the water lead to staining, which may graduate to corrosion and deterioration if left unmanaged.

While mostly an appearance defect, water staining can be indicative of more serious defects, which may be currently concealed by other building elements.

Where water staining is active, a licensed plumber must be consulted to identify the cause of the staining and to provide advice on any reparation works that may be required. Replacement of any broken or damaged structures is advised.

Conversely, where water staining is old and inactive, affected building materials may be repaired or replaced at client discretion. A qualified carpenter or registered builder may be appointed to perform these works.

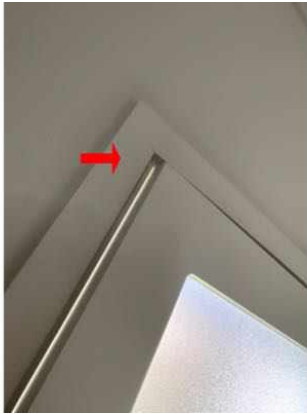
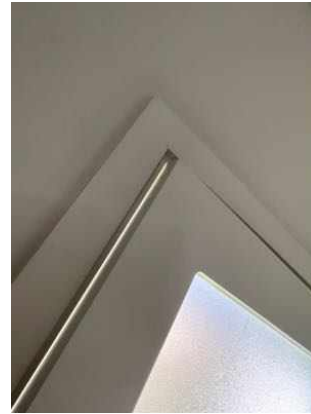
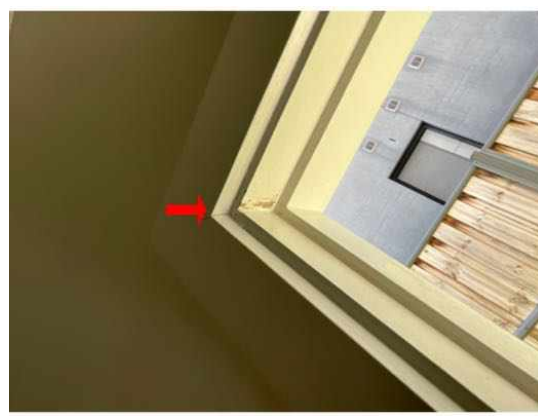
Finding 3.09

Building: Main Building
 Location: Garage
 Finding: Door - Binding/jamming
 Information: Binding and/or jamming of this door is evident during standard operation. This defect inhibits the functionality of the affected door as well as creating potential for secondary defects to associated building elements.

A door that binds to flooring or to the associated door frame may have several causes, ranging from minor defects, such as poor installation of the door or deteriorated hinges, through to major structural issues. For minor causes, a qualified carpenter or general handyperson should be appointed to perform minor rectification

works at client discretion.

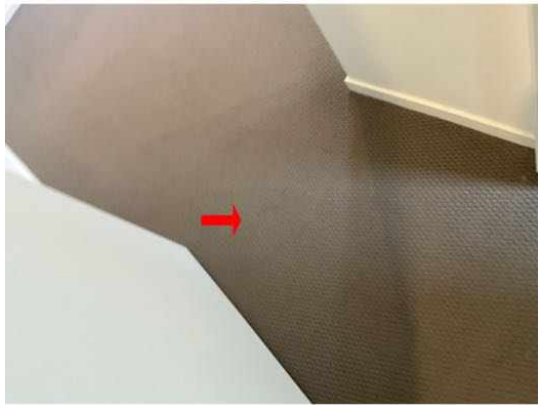
Finding 3.10

Building:	Main Building
Location:	Stairs - Internal
Finding:	Stair Tread Damaged
Information:	The stair tread shows signs of moisture damage and swelling to the laminated finish and underlying substrate. Deterioration of stair components may create a trip hazard and can worsen over time if the moisture source is not addressed.

It is recommended that the source of moisture be identified and rectified, and the damaged tread be repaired or replaced by a qualified carpenter or builder.

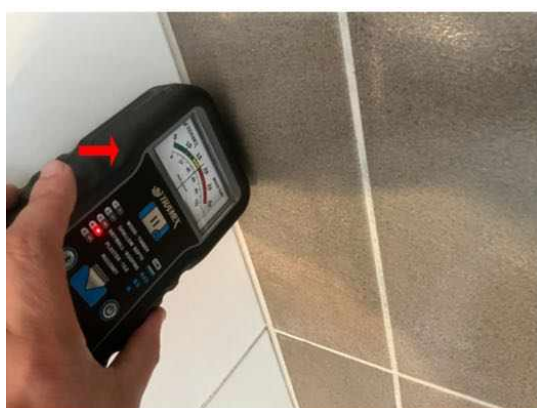
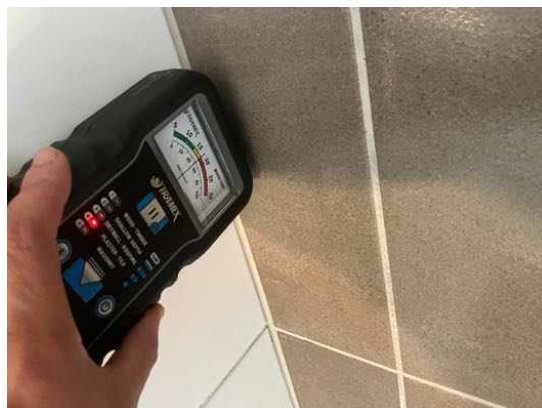
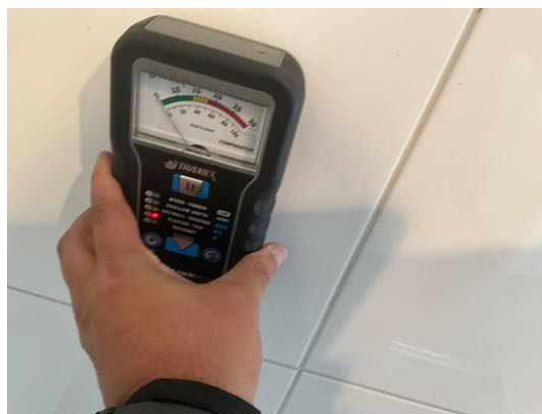
Finding 3.12

Building:	Main Building
Location:	Bathroom
Finding:	Shower - Damp
Information:	Damp is evident to the lower 300mm of wall to the shower alcove. This defect is quite common, and is suspected to have been caused by moisture permeating through the grouting in this area, which shows evidence of deterioration. Leaking pipes within the adjoining wall is also a possible cause.

Damp (or structural damp) refers to the presence of unwanted moisture in the structure of a building, either as the result of intrusion from outside, or condensation from within the structure. In the shower area, internal water leaks or other sources of excessive moisture are generally the cause of damp.

Unmanaged damp in the shower recess is likely to facilitate the formation and development of mould and fungi growth, decaying associated building materials and compromising their structural integrity. It is important to address damp conditions, as the World Health Organisation notes that excess moisture leads - on almost all indoor materials - to growth of microbes such as moulds, fungi and bacteria, which subsequently emit spores and other matter into the indoor air. Exposure to these contaminants is associated with a wide range of respiratory and other health-related problems.

Consultation with a qualified plumber or bathroom specialist is advised immediately to identify the cause of damp and to perform remedial works as required. Where excessive mould growth is present, further inspection by a specialist environmental health inspector should also be considered.

Always ensure that sealant and grout is in good condition to prevent any moisture issues occurring in the future.

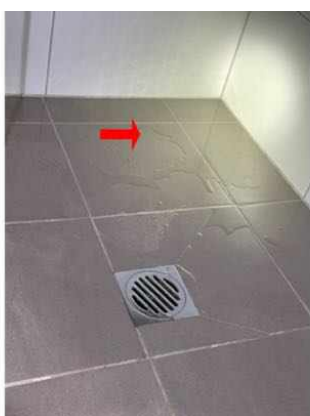
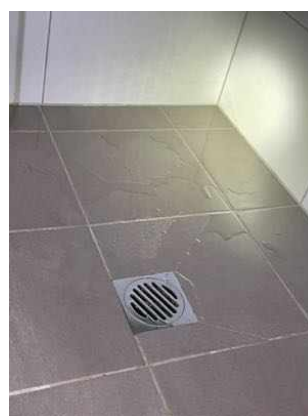
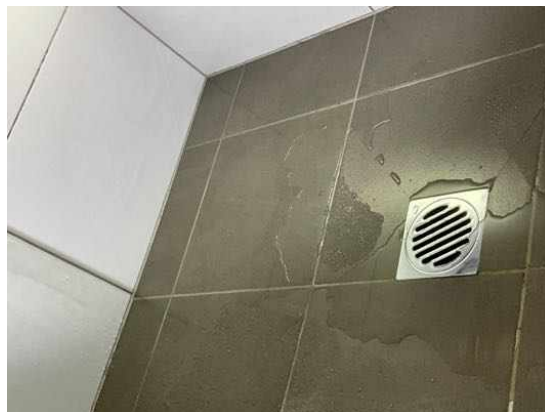
Finding 3.13

Building:	Main Building
Location:	Bathroom
Finding:	Shower base - Water pooling
Information:	Evidence of water pooling around the floor waste in the shower recess was noticed at the time of inspection. It is suspected that this excessive moisture is attributed to insufficient fall in the shower floor tiles.

This pooling is minor overall but is still considered unsatisfactory, as standard tiling practices would not permit this situation to occur. Pooling water around floor wastes can create a slip hazard in extreme cases and create conditions that are conducive to mould growth over time. Where left unmanaged, the degradation of sealant and grouting is also likely to occur, possibly necessitating further repair works.

Remedial works may involve some sections of tiling and flooring repair and replacement. A tiling contractor or bathroom specialist should be appointed to provide further advice on reparation options and to perform works as necessary.

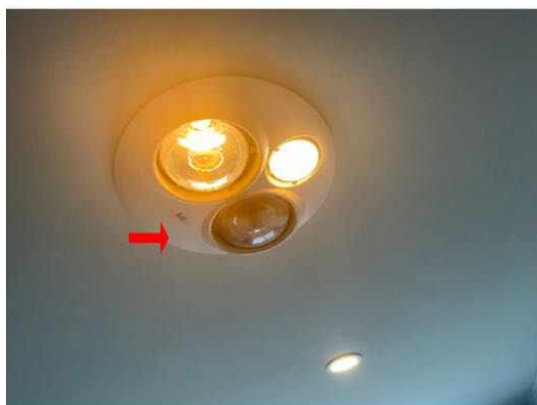
Finding 3.14

Building: Main Building
 Location: Ensuite
 Finding: Heating light in exhaust fan not working / operating
 Information: "The heating light in the exhaust fan is not operating, failing to provide the intended heating function."

A qualified electrician or HVAC technician can fix the issue by inspecting the heating element, wiring, and controls to identify and repair any faults or damages.

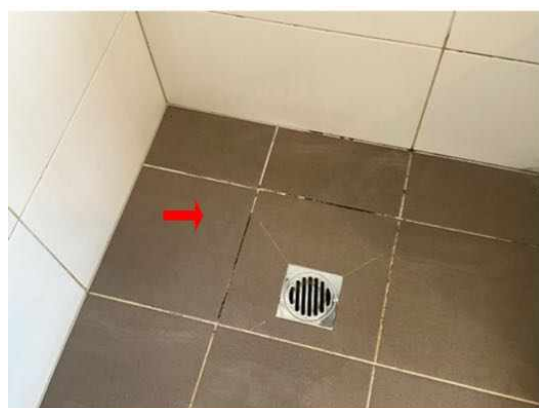
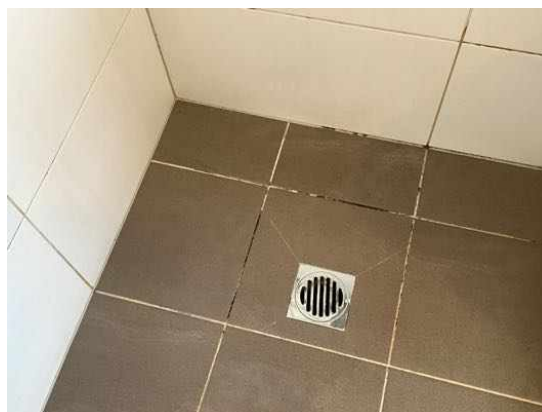
Finding 3.15

Building: Main Building
 Location: Ensuite
 Finding: Sealant and grouting - Missing or damaged
 Information: It was noted on inspection that sealant or grout is degraded to the tiled shower alcove and or other areas of the bathroom.

Different materials and floor areas move at different rates, generally causing cracking to grout or sealant at this point. A flexible sealant is required to allow for expected expansion and contraction, while keeping the joint water tight and protective of all associated building materials.

There appears to be excessive mould to the sealant and grout which will likely require scraping out and replacement.

Flexible and mould resistant materials should be applied to affected areas to prevent any subsequent water damage that is likely to occur. Regular maintenance and replacement of damage or missing or damaged sealant and grout is highly recommended to the wet areas, as this is a regular wear and tear defect. Sealant and grouting in areas that come into regular contact with water should be maintained for the long term care of your property.

A sealant specialist or tiling contractor should be appointed to complete these works as soon as possible

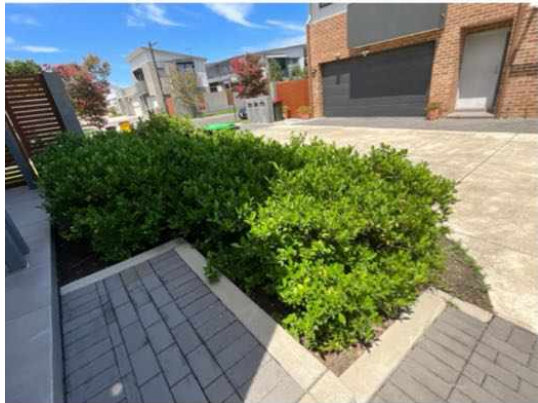
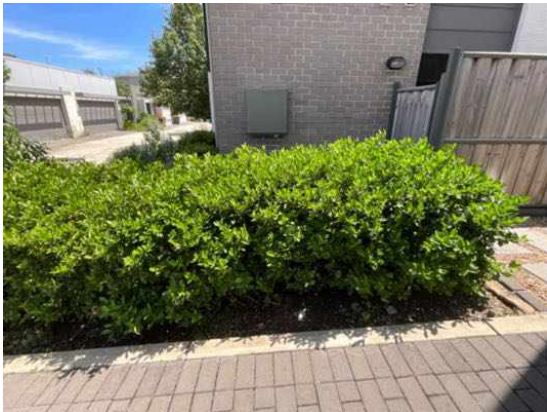
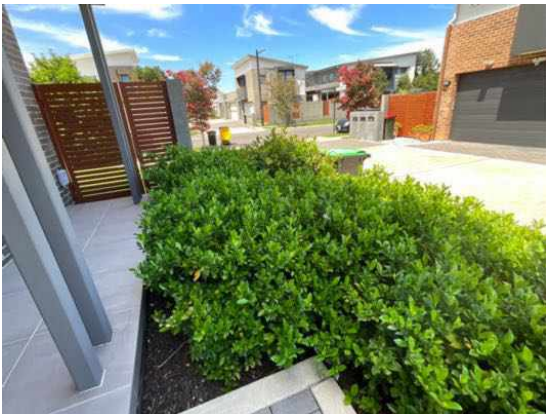
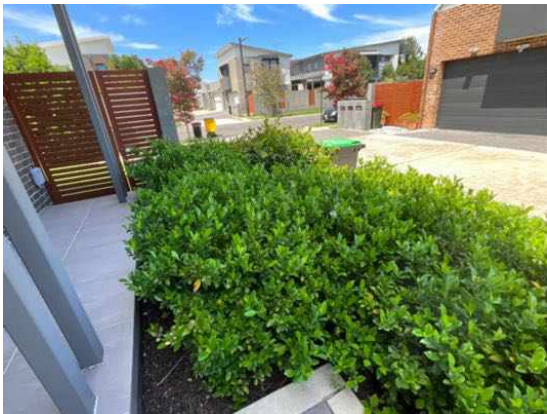
Finding 6.02

Building: Main Building
Location: All Areas
Finding: vegetation around a property can increase the risk of termite infestation
Information: The presence of vegetation around a property can increase the risk of termite infestation, as it provides a conducive environment for them. To address this, consider maintaining a clear space between the vegetation and your home. If you suspect a termite issue, it's advisable to consult with a licensed pest control professional for inspection and treatment.

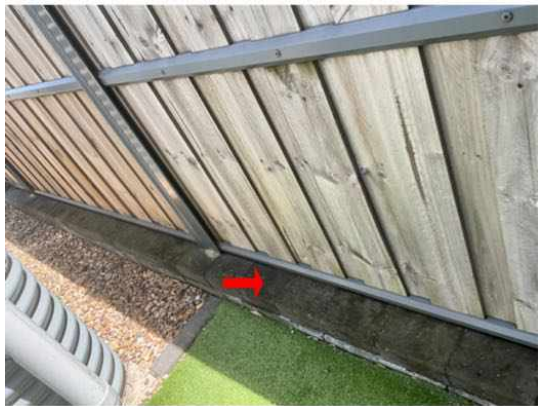
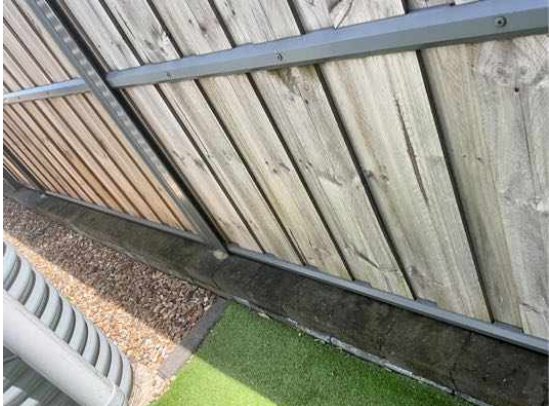
Finding 6.03

Building: Main Building
Location: All Areas
Finding: Timber on ground / conducive conditions to termite damage
Information: Timber on the ground is indeed conducive to termite damage. Termites are known to thrive in moist environments, and wood in contact with soil or moisture is more susceptible to infestation.

To prevent this, it's important to keep timber elevated and away from direct ground contact. Regular inspections and proper termite control measures are also essential to protect your wooden structures from termite damage.

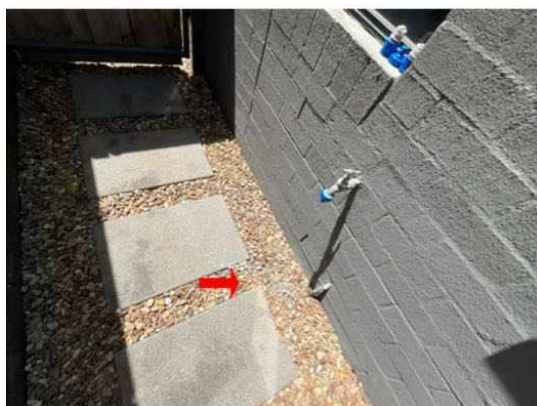
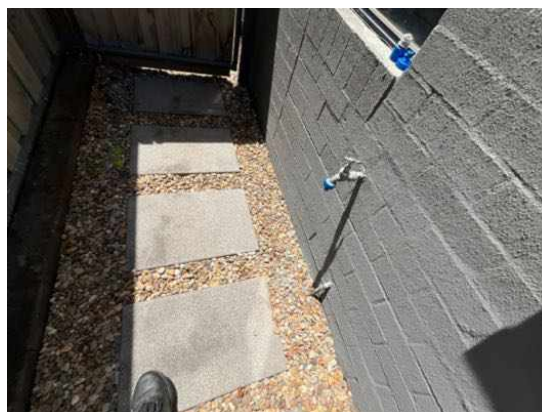
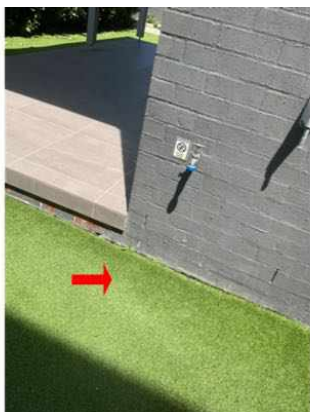
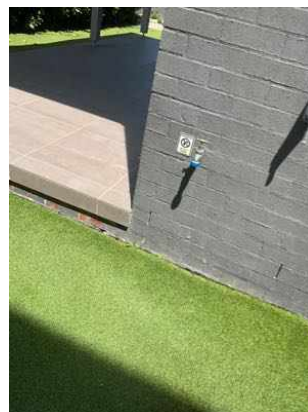
Finding 6.04

Building:	Main Building
Location:	All Areas
Finding:	No Drain under tap
Information:	There is no drain installed under the tap, leading to water accumulation and creating conducive conditions for timber pests. This defect needs immediate attention to prevent potential damage and pest infestation.

1. **Water Accumulation:** Without proper drainage, water can accumulate around the base of the tap, leading to persistent dampness in the surrounding area.
2. **Timber Pest Infestation:** The damp environment created by standing water is highly conducive to timber pests, such as termites and wood borers, which thrive in moist conditions and can cause significant damage to wooden structures.
3. **Structural Damage:** Prolonged exposure to moisture can lead to wood rot and deterioration of structural timber, compromising the integrity of the building.
4. **Health Hazards:** Persistent dampness can also promote mold and mildew growth, posing health risks to occupants.
5. **Aesthetic Damage:** Water stains and damage to finishes and materials around the tap area can detract from the appearance of the building and lead to costly repairs.

A licensed plumber or a qualified building contractor can address this defect by:

1. **Assessment:** Evaluating the area to determine the best approach for installing a proper drainage system under the tap.
2. **Installation:** Installing a drain that effectively channels water away from the base of the tap, preventing water accumulation and dampness.
3. **Repair and Prevention:** Inspecting and repairing any existing water damage and implementing measures to prevent future water accumulation and pest infestations.

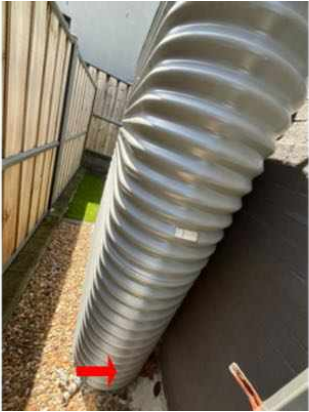
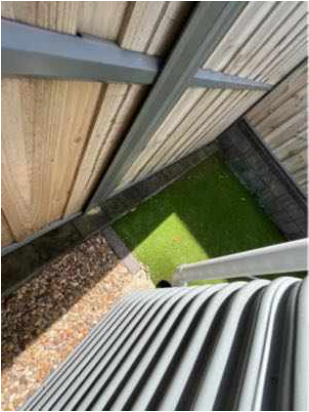
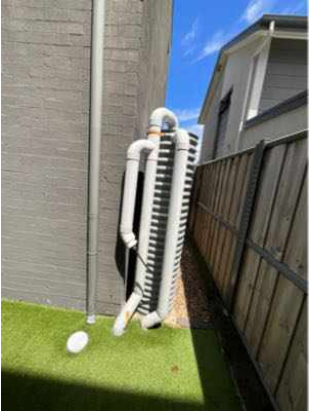
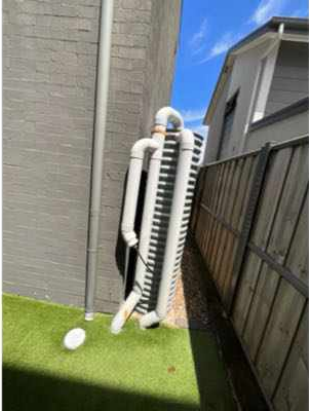
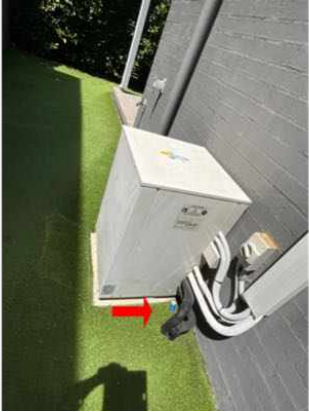
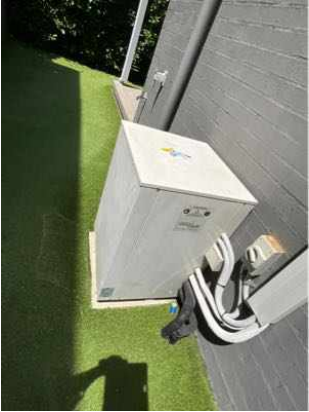
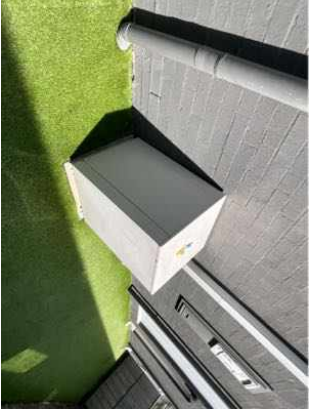
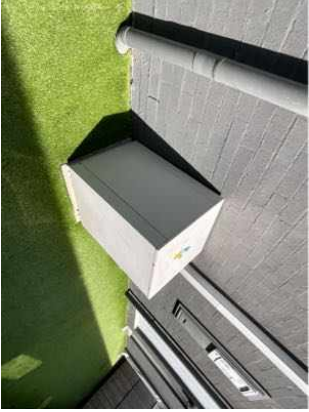
Finding 6.05

Building:	Main Building
Location:	All Areas
Finding:	Bridging or Obstruction Conducive environment for Termites
Information:	Bridging of termite barriers occurs when termites bridge (usually by building a mud tunnel) a termite barrier or inspection inspection zone or where termites have a passage, allowing them to bridge the barrier.

Where bridging has occurred full inspection is prevented and termites may enter a property in a concealed or undetected manner.

Recommended moving obstructions away from the external walls for further and future inspections.

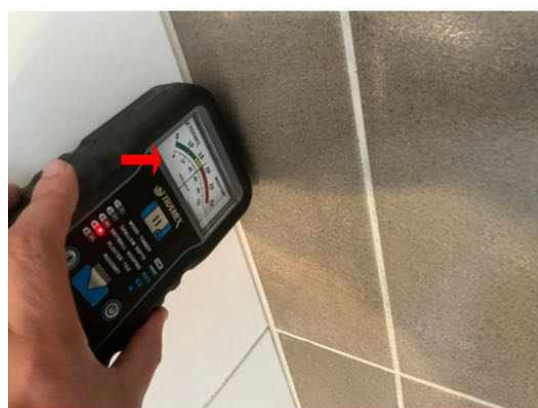
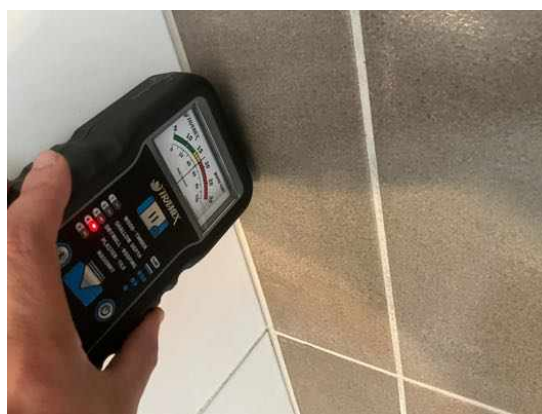
Finding 6.06

Building:	Main Building
Location:	Bathroom
Finding:	Excessive moisture - Conducive to Timber pest
Information:	Excessive moisture can attract termites and produce conditions that promote fungal growth and wood decay.

Excessive moisture is generally caused by deteriorated inadequate or missing roof drainage leaking plumbing pipes or fixtures poorly plumbed HWS overflows or condenser units and poor site drainage.

Prior to any remedial works being performed a qualified plumber should be appointed to further inspect the property and to identify the cause of the excessive moisture. Works to remove affected building elements may then be necessary and should be performed by an appropriate tradesperson.

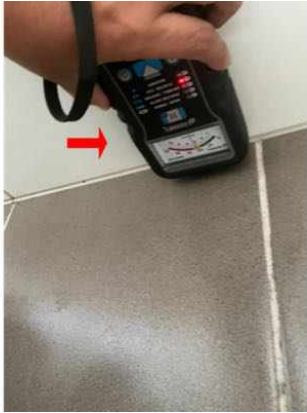
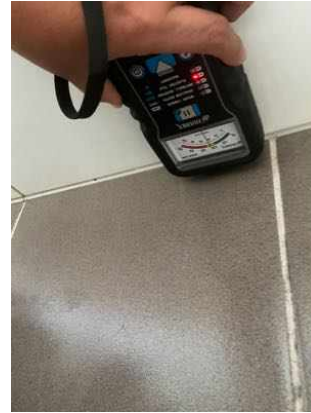
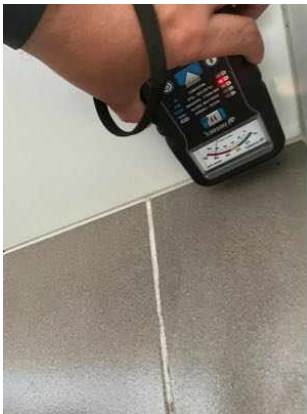
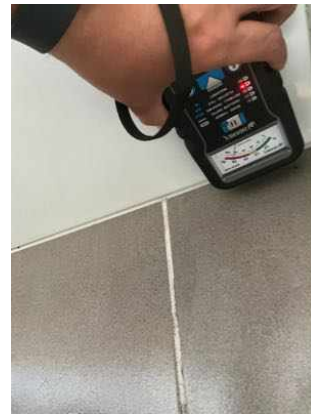
Finding 6.07

Building:	Main Building
Location:	Ensuite
Finding:	Excessive moisture - Conducive to Timber pest
Information:	Excessive moisture can attract termites and produce conditions that promote fungal growth and wood decay.

Excessive moisture is generally caused by deteriorated inadequate or missing roof drainage leaking plumbing pipes or fixtures poorly plumbed HWS overflows or condenser units and poor site drainage.

Prior to any remedial works being performed a qualified plumber should be appointed to further inspect the property and to identify the cause of the excessive moisture. Works to remove affected building elements may then be necessary and should be performed by an appropriate tradesperson.

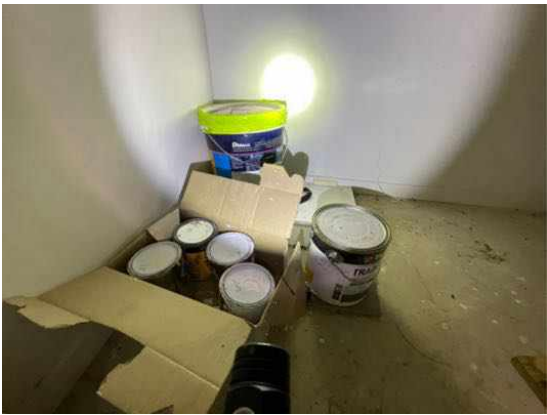
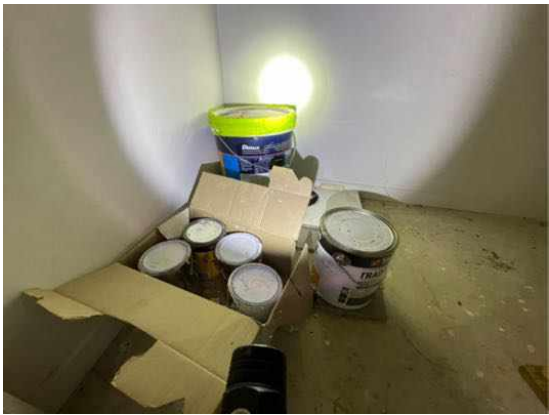
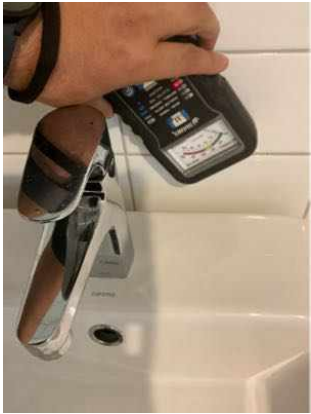
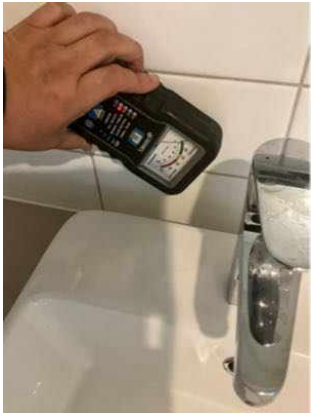
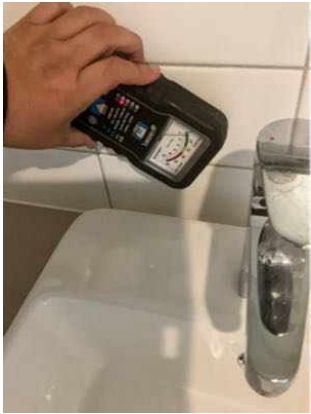
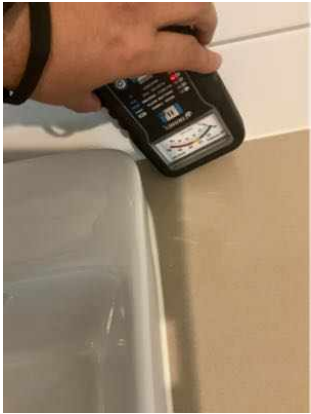
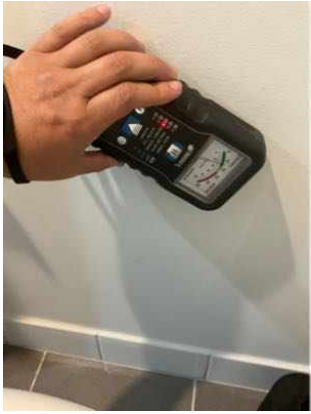
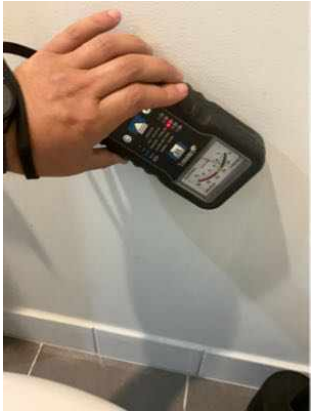
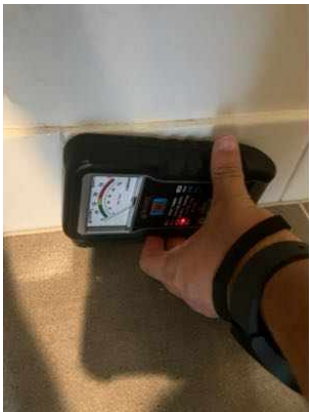
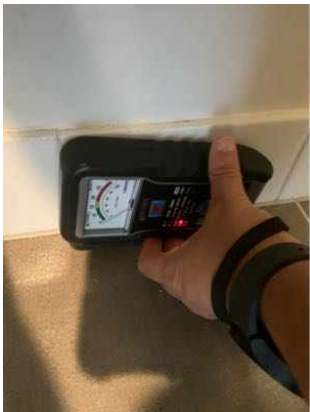
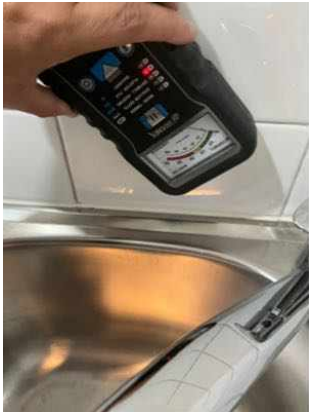
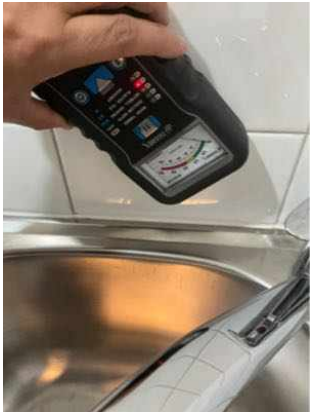
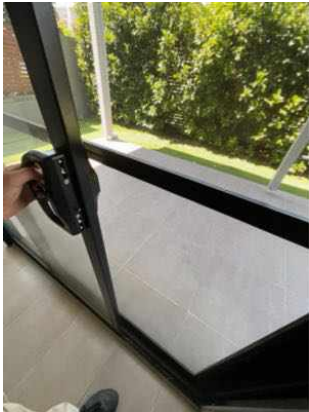
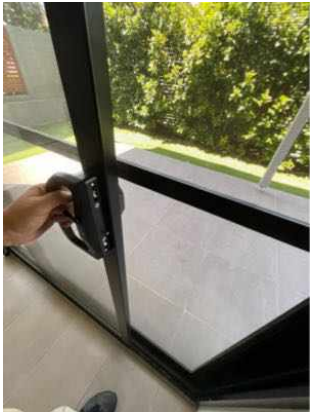
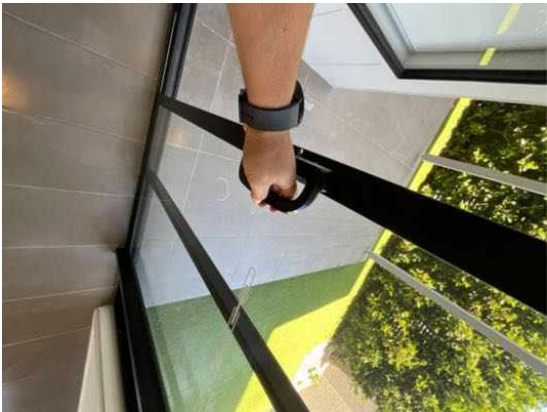
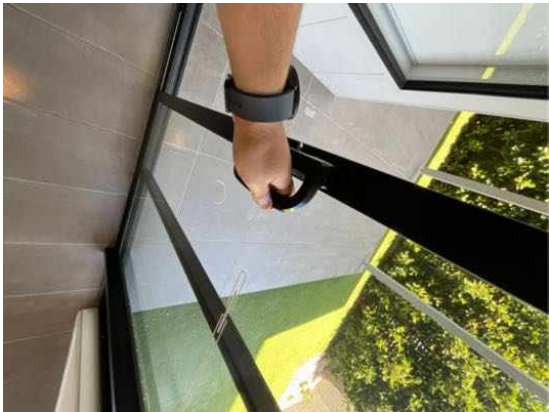
Building: Main Building
Location: All External Areas
Finding: Additional Photos - Obstructions and Limitations
Information: These photographs are an indication of the obstructions and limitations which impeded full inspection of the property at the time of inspection. These obstructions can hide an array of defects and should be removed to allow full inspection to be carried out. A re-inspection is recommended once the areas are made accessible.

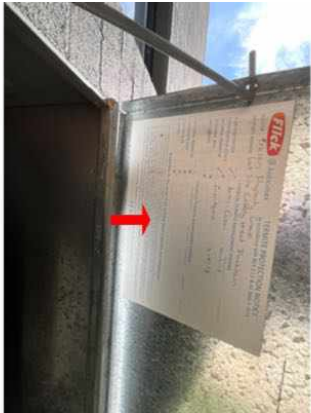
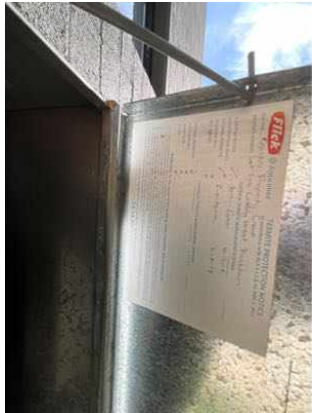
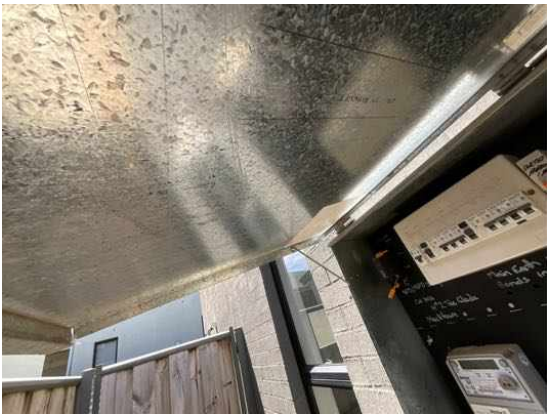
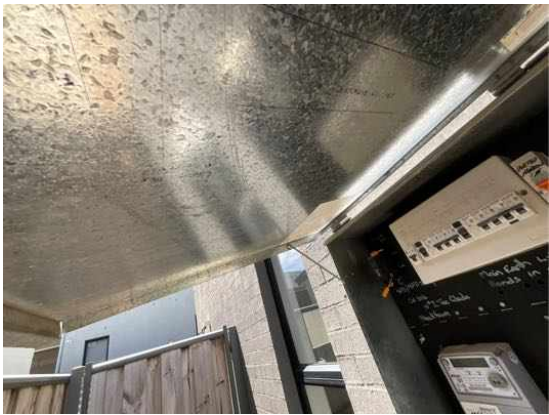
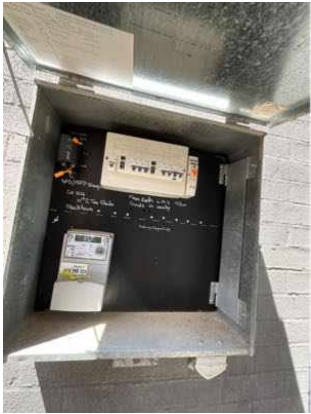
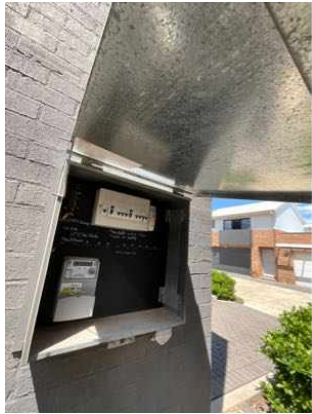
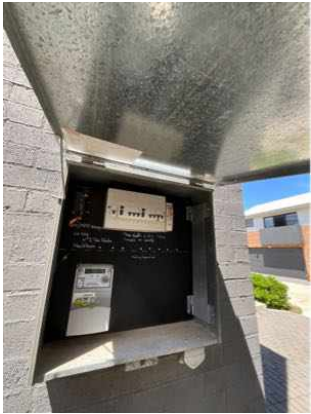
Building: Main Building
 Location: Exterior walls - left side
 Finding: Evidence of Termite Management System - Durable notice / Legible Sticker - seek further information
 Information: The application of a pre & post-construction chemical termite barrier is highly recommended for all properties. Such barriers are highly effective in preventing termite attack on any timber building elements throughout the property.

A durable notice placed in the switchboard unit to indicate termite barriers at the time of inspection.

Client must seek further information from the vendor or real estate agent if the conditions of termite management systems were maintained as per the label or seek advise from licensed pest controller.
