Building and Timber Pest Inspection Report

Inspection Date: Tue, 24 Feb 2026

Property Address: 2N Derby St, Walcher and 1E Fitzroy St,
Walcher

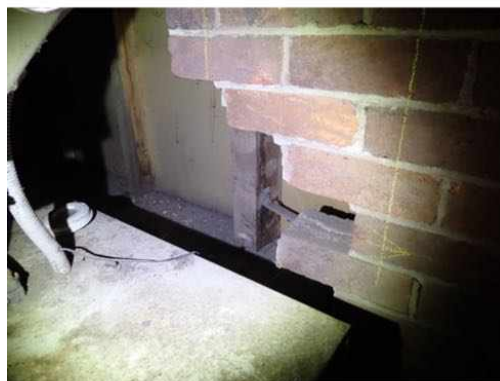
Finding 2.07

Building:	Main Building
Location:	Rear/side of single story building
Finding:	Brickwork Knocked Out Poorly to Accommodate Air Conditioning Unit
Information:	Brickwork has been poorly cut and removed to accommodate the installation of an air conditioning unit. The opening appears roughly formed and inadequately finished, which may affect the structural integrity, weatherproofing and overall appearance of the wall. In simple terms, bricks have been knocked out roughly to fit the air conditioner, and the work looks untidy. This type of alteration, if not properly supported or sealed, may allow moisture ingress or ongoing cracking around the opening. It is recommended that a qualified builder or bricklayer assess the

modification and carry out appropriate rectification works, including proper support, flashing and sealing as required. Rectification can be undertaken at the owner's discretion.

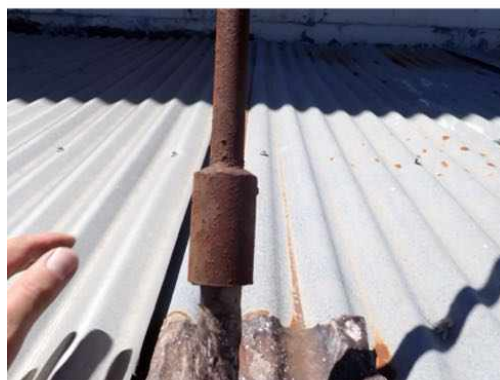
Finding 2.08

Building: Main Building
 Location: Front awning
 Finding: Corrosion to Front Awning Support – Engineering Consultation Recommended
 Information: Corrosion was identified to the front awning support structure. The rust observed is more than minor surface corrosion but no immediate failure was noted at the time of inspection. In simple terms, all the metal supports at the front awning are noticeably rusted. This condition is commonly associated with prolonged weather exposure and deterioration of protective coatings. If left unaddressed, corrosion may continue and potentially affect the long-term durability of the support. It is recommended that a qualified builder or metal fabricator assess the extent of deterioration and carry out repairs or treatment as required. Consultation with a structural engineer is recommended to confirm the structural adequacy of the support if concerns remain. Rectification can be undertaken at the owner's discretion to prevent further deterioration.

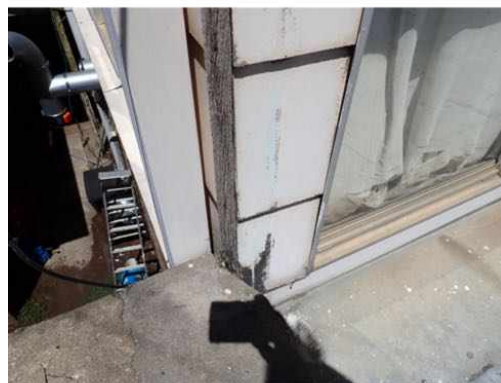
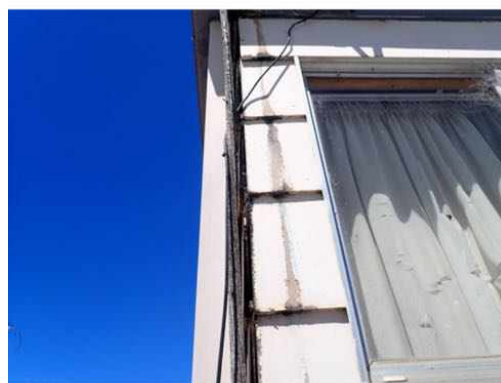
Finding 2.09

Building: Main Building
Location: Second story external cladding
Finding: Wood Rot to Timber Trims and Deterioration to Weatherboard Cladding
Information: Wood rot was identified to sections of the external timber trims, along with deterioration to areas of the weatherboard cladding. The timber shows signs of decay and breakdown consistent with age and weather exposure. In simple terms, parts of the external timber trims and cladding are rotting and wearing out. This is a common defect in buildings of this age due to ongoing exposure to the elements and maintenance requirements. If left unaddressed, deterioration may progress and allow moisture ingress into wall cavities. It is recommended that a qualified carpenter remove and replace affected timber components as required and that the external surfaces be properly prepared and re-coated to maintain protection. A licensed timber pest controller should also be consulted where decay is present to assess for any associated termite risk. Rectification can be undertaken at the owner's discretion to prevent further deterioration.

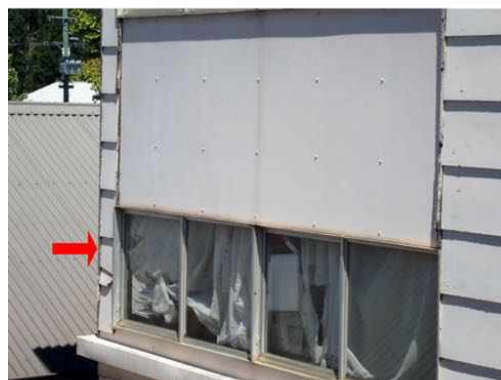
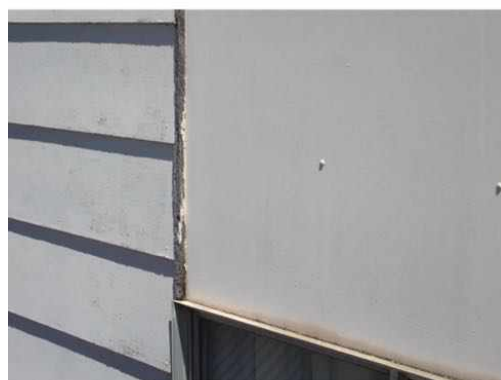
Finding 2.10

Building:	Main Building
Location:	Second story windows
Finding:	Second-Storey External Windows in Deteriorated Condition
Information:	<p>The second-storey external windows were found to be in deteriorated condition. Defects observed include age-related wear, breakdown of protective coatings and general deterioration of window components. In simple terms, the upstairs outside windows are run down and showing their age. This is a common condition in buildings of this age due to prolonged weather exposure and maintenance requirements. Access limitations typical of second-storey windows may restrict detailed inspection of all elements. If left unaddressed, deterioration may progress and affect operation, weatherproofing and durability. It is recommended that a qualified carpenter or window specialist assess the affected windows and carry out repairs, re-coating or replacement as required. Rectification can be undertaken at the owner's discretion to prevent further deterioration.</p>

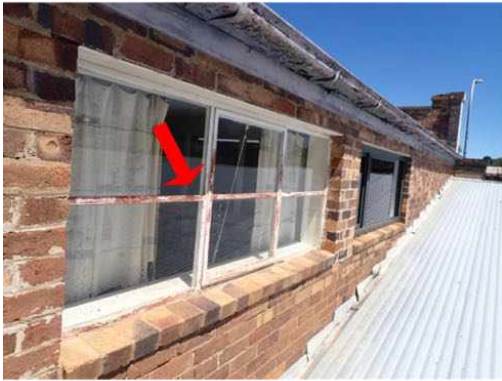
Finding 2.11

Building:	Main Building
Location:	Second story roof
Finding:	Second-Storey Roof Cladding and Plumbing in Poor, Rust-Affected Condition
Information:	The second-storey roof cladding and associated plumbing components were found to be in poor, rust-affected condition. Defects observed include corrosion, age-related deterioration and general wear consistent with prolonged weather exposure. In simple terms, the upstairs roof sheeting and plumbing are significantly rusted and run down. This is a common condition in buildings of this age. If left unaddressed, continued corrosion may lead to water ingress, ineffective stormwater discharge and further structural damage. It is recommended that a licensed roofing contractor and/or licensed plumber assess the affected areas and carry out repairs or replacement as required. Rectification can be undertaken at the owner's discretion to prevent further deterioration.

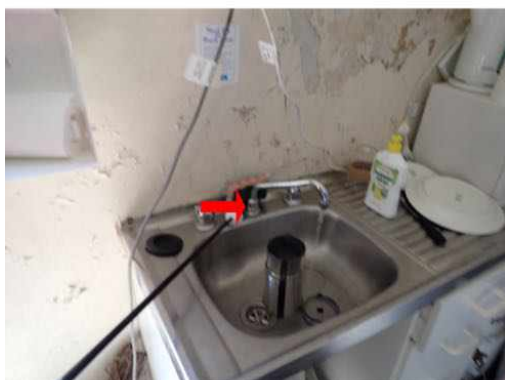
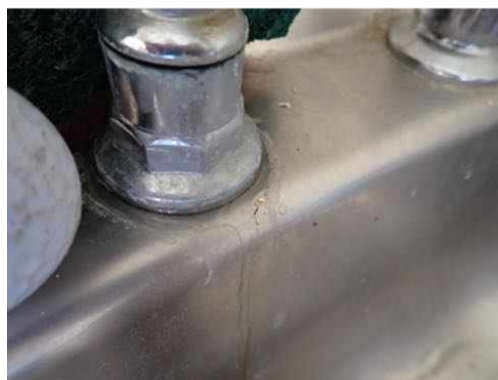
Finding 3.01

Building:	Main Building
Location:	Kitchen area rear single story building
Finding:	Minor leak in Kitchen Tap and Average Condition Kitchen – Rear Single-Storey Building
Information:	The kitchen tap within the rear single-storey building was observed to have a minor leaking at the time of inspection. Continued leakage may result in water wastage and potential moisture-related damage to surrounding cabinetry or fixtures. It is

The kitchen overall was found to be functional but in average condition, with general wear and age-related deterioration noted. In simple terms, the kitchen works but is older and shows signs of use. This is common for a building of this age. Upgrades or refurbishment can be undertaken at the owner's discretion depending on desired standard and future plans for the building.

recommended that a licensed plumber repair or replace the tap and check associated fittings for leaks.

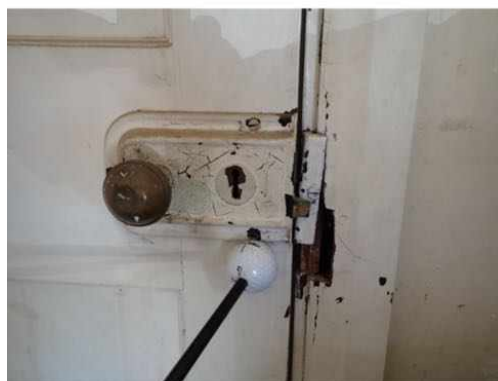
Finding 3.02

Building:	Main Building
Location:	Kitchen area rear single story building
Finding:	Door Hardware to Kitchen Area in Poor Condition
Information:	The door hardware to the kitchen area, although operational at the time of inspection, was found to be in poor condition. Components show signs of wear, age-related deterioration and possible loosening. In simple terms, the door handles and fittings work but are worn and run down. This condition is commonly associated with age and regular use. If left unaddressed, hardware may fail or become difficult to operate. It is recommended that a qualified handyman or carpenter repair or replace the affected hardware as required. Rectification can be undertaken at the owner's discretion.

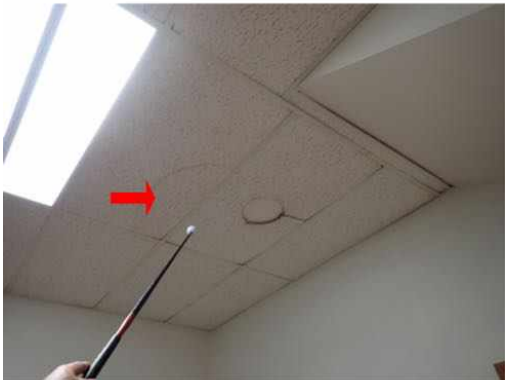
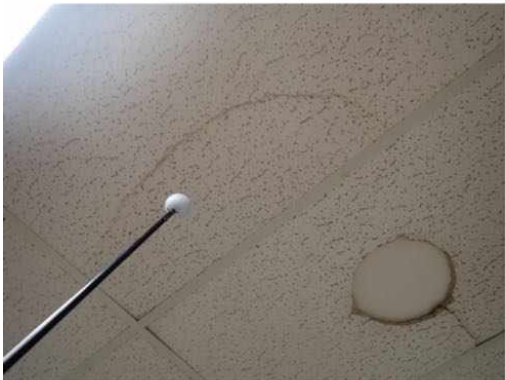
Finding 3.03

Building: Main Building
Location: Findex tenancy
Finding: Water-Stained Ceiling Tiles to Findex Tenancy
Information: Several water-stained ceiling tiles were identified within the Findex tenancy at the time of inspection. The staining indicates past or possible moisture ingress; however, no active leaks were observed to the accessible areas during the inspection. In simple terms, some ceiling tiles show water marks from previous moisture. This condition is commonly associated with roof leaks, plumbing leaks or condensation events. It is recommended that a qualified contractor investigate the source of the staining to confirm whether the issue is historical or ongoing, and replace affected ceiling tiles as required. Further action can be undertaken at the owner or tenant's discretion depending on lease arrangements.

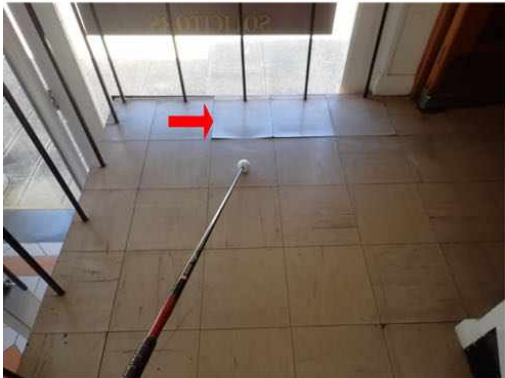
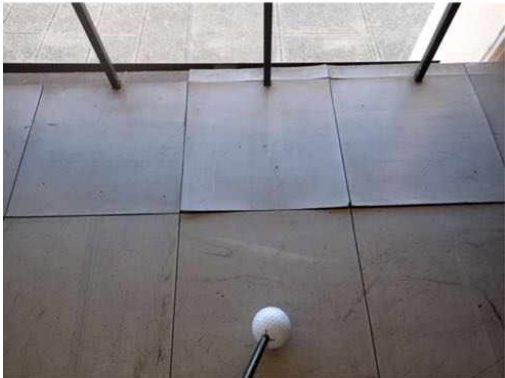
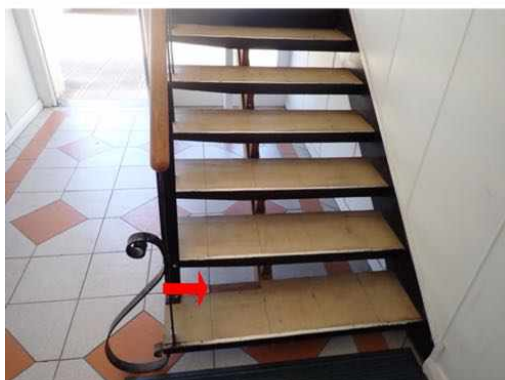
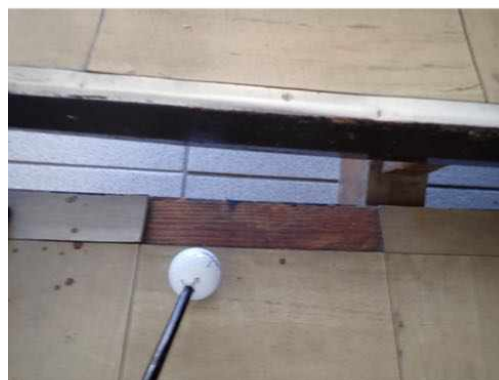
Finding 3.04

Finding: Age-Related Deterioration to Vinyl Floor Tiles

Information: Age-related deterioration was identified to sections of the vinyl floor tiles. The flooring shows signs of wear, surface scuffing and minor breakdown consistent with long-term use. In simple terms, the vinyl flooring is worn and showing its age. This condition is common in buildings of this age and with regular foot traffic. While generally cosmetic at this stage, continued wear may lead to lifting or further surface damage over time. It is recommended that a suitably qualified flooring contractor assess and repair or replace affected sections as required to prevent further deterioration. Rectification can be undertaken at the owner's discretion.

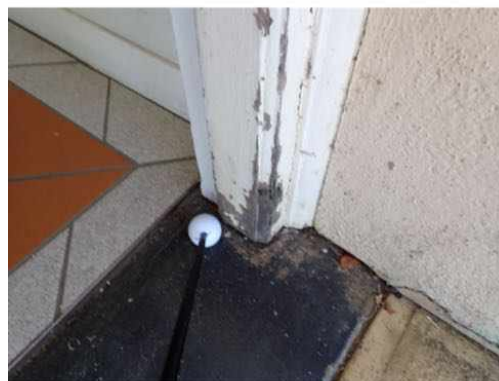
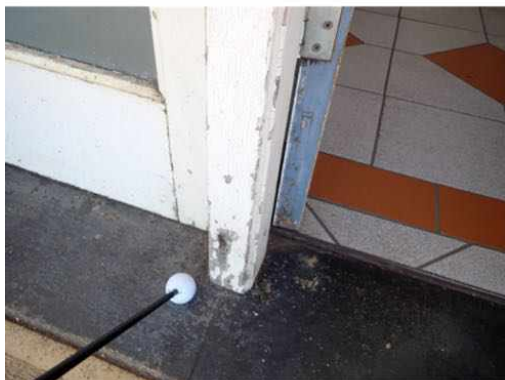
Finding 3.05

Building:	Main Building
Location:	External foyer entry
Finding:	Timber Door and Window Framing to External Foyer Entry Weathered Condition
Information:	The timber door and window framing to the external foyer entry were found to be in weathered condition. The timber shows signs of age-related wear and exposure to the elements. In simple terms, the timber around the entry door and windows is worn and weathered. This is a common condition due to ongoing sun and weather exposure. If left unmaintained, the timber may deteriorate further and become susceptible to decay. It is recommended that a qualified carpenter repair any damaged sections as required and that a qualified painter prepare and re-coat the timber to provide adequate protection. Maintenance can be undertaken at the owner's discretion to prevent further deterioration.

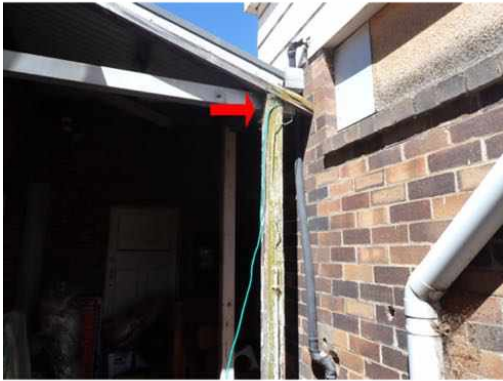
Finding 7.01

Building:	Main Building
Location:	Rear/side veranda.
Finding:	Wood Rot/Deterioration to Side/Rear Veranda Post and Surrounding Framing
Information:	Wood rot and deterioration were identified to the side/rear veranda post and the framing around the base of the post. The timber shows signs of decay consistent with prolonged moisture exposure and age-related wear. In simple terms, the timber post and surrounding frame at the veranda are rotting. This condition is commonly associated with weather exposure. If left unaddressed, deterioration may worsen and affect the structural stability of the veranda support. It is recommended that a qualified carpenter or builder remove and replace the affected timber components and ensure the area is adequately sealed and protected from moisture. A licensed timber pest controller should also be consulted to assess for any associated termite risk. Rectification should be undertaken to prevent further structural deterioration and can be arranged at the owner's discretion.

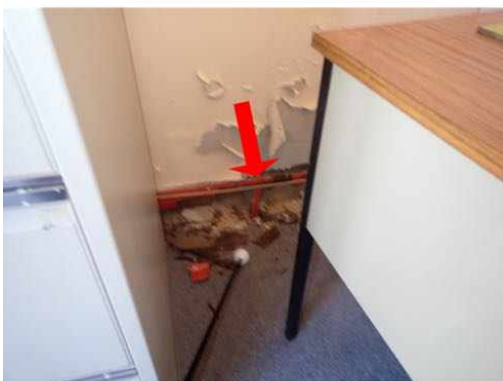
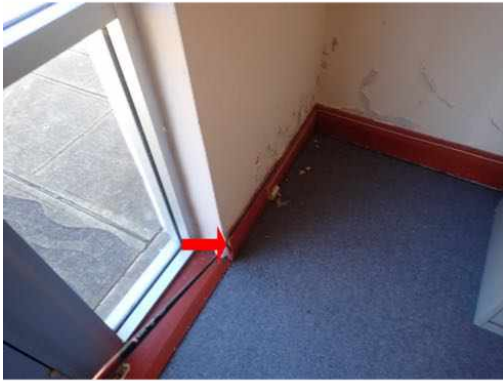
Finding 7.02

Building:	Main Building
Location:	Single story building
Finding:	Wood Rot and Damage to Skirting Board – Single-Storey Building (Room with Glass Door)
Information:	<p>Wood rot and associated damage were identified to the skirting board within the single-storey building, specifically in the room containing the glass door. The timber shows signs of decay consistent with moisture exposure and age-related deterioration. In simple terms, the skirting board in that room is rotting and damaged. This condition is commonly caused by moisture ingress, condensation or prolonged contact with damp surfaces. If left unaddressed, deterioration may progress and affect adjoining wall linings. It is recommended that a qualified carpenter remove and replace the affected skirting board and investigate the source of moisture if applicable. A licensed timber pest controller should also be consulted to assess for any associated termite risk. Rectification can be undertaken at the owner's discretion to prevent further deterioration.</p>

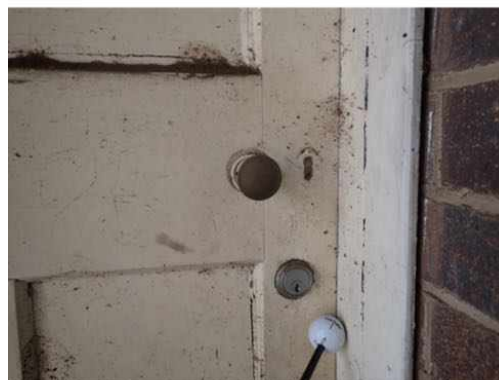
Building:	Main Building
Location:	Rear/side of single story building
Finding:	Side Timber Doors Locked at Time of Inspection – Fair Condition for Age
Information:	The side timber doors were locked at the time of inspection and internal faces/operation could not be fully assessed. Based on external visual observations only, the doors appear to be in fair condition consistent with their age. In simple terms, the side timber doors were locked so they couldn't be properly checked, but from what could be seen they look reasonable for their age. This is a common limitation where access is restricted. It is recommended that the doors be fully inspected once access is available to confirm condition and operation. Further assessment can be undertaken at the owner's discretion.

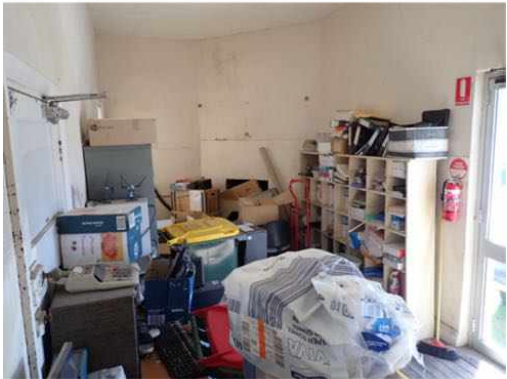
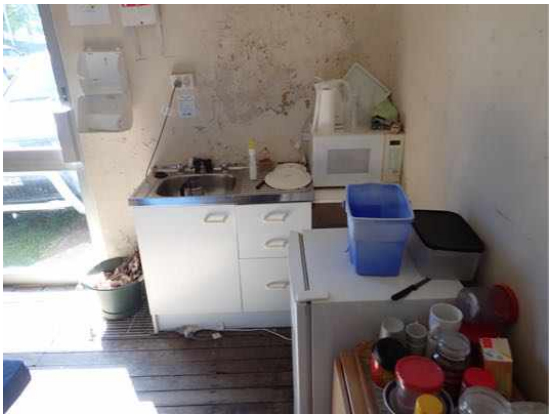
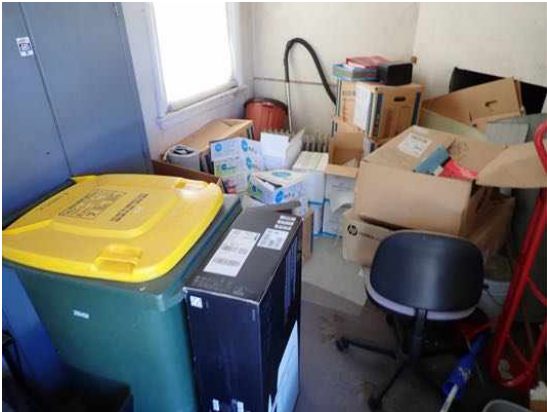
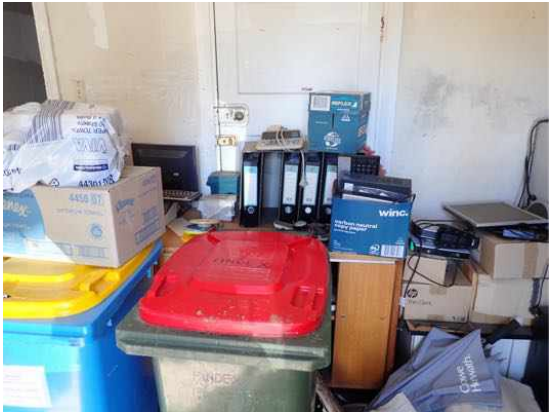
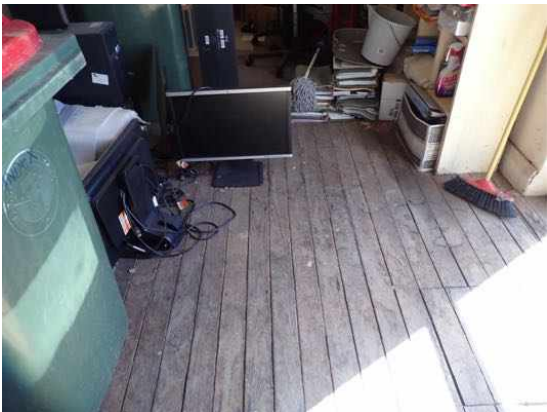
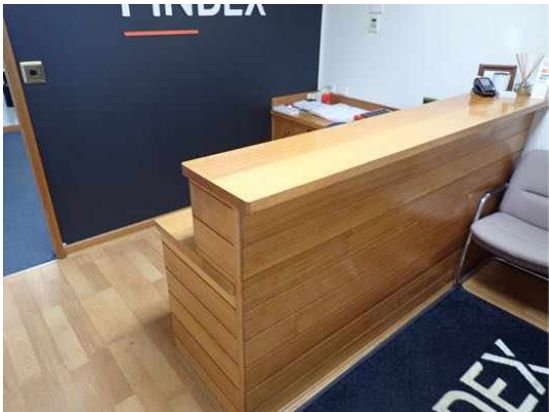
Building:	Main Building
Location:	All Areas
Finding:	Additional Photos - Obstructions and Limitations
Information:	These photographs are an indication of the obstructions and limitations which impeded full inspection of the area at the time of inspection. These obstructions can hide an array of defects and should be removed to allow full inspection to be carried out. A re-inspection is recommended once the areas are made accessible.
