# Building and Timber Pest Inspection Report

Inspection Date: Tue, 10 Feb 2026

Property Address: 549 Sanders Rd, Lavington NSW 2641,  
Australia

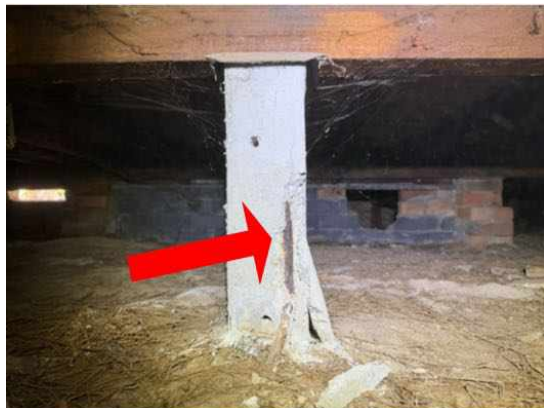
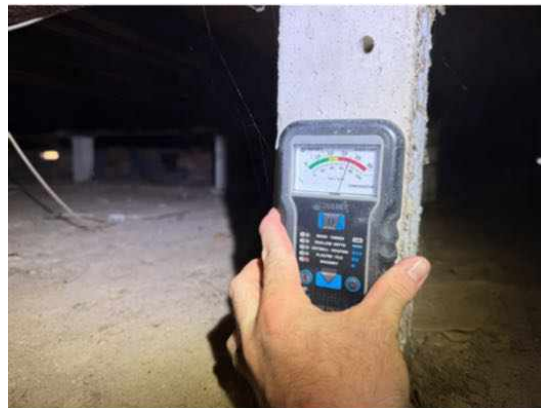
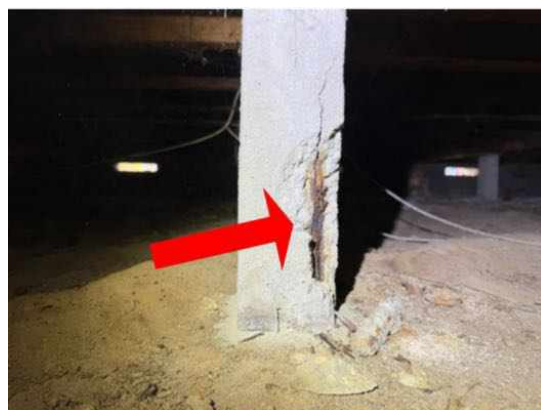
Building: Main Building  
 Location: Subfloor piers, & brickwork  
 Finding: Brickwork & Concrete Piers - Deterioration (Fretting) & Concrete Cancer  
 Information: Deterioration (fretting), was evident in some areas of the brickwork in the subfloor. Concrete cancer (rust of steel reinforcements inside a concrete structure) was also noted to some concrete piers & has caused cracking. Evidence of high moisture was

also noted in these areas.

If neglected, further deterioration is likely to occur overtime. Recommend consulting with a structural engineer, in the short term to provide further advice and specify any required remedial works.

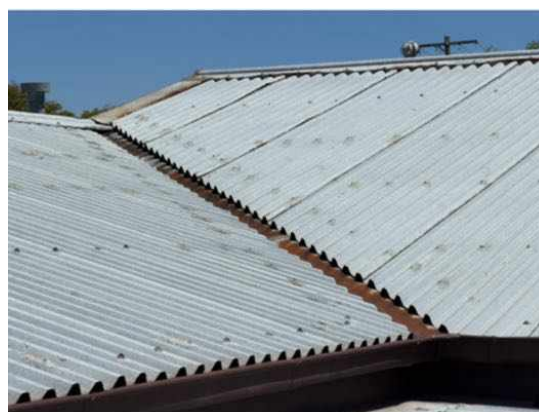
Building:	Main Building
Location:	Roof Plumbing
Finding:	Roof plumbing & sheeting - Rusted & Loose / Disconnected
Information:	It appears that the roof plumbing including but not limited to the gutters, down-pipes and areas of the roof sheeting have areas of rust and corrosion. The shed gutter was found to be sagging and the down-pipe disconnected.

Rusted roof plumbing could eventually develop holes and leaks overtime that can affect other building elements if neglected. Recommend engaging a licensed roof plumber in the short term, to provide further advice & remedial works where necessary.

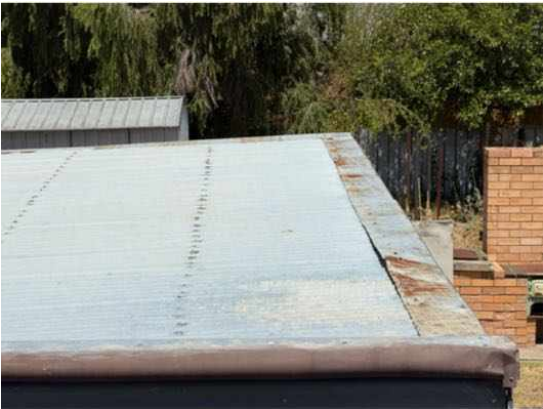
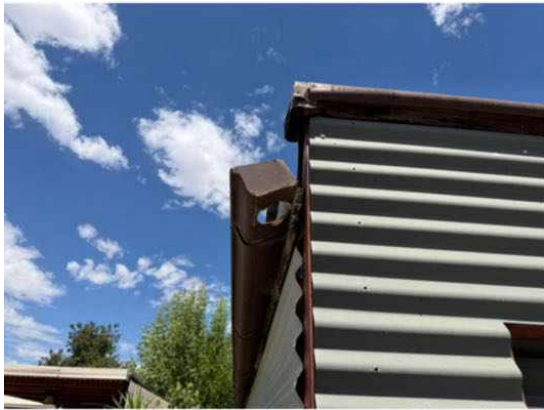
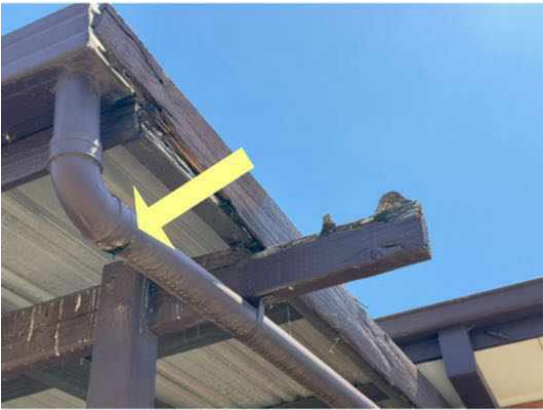
Finding 3.04

Building: Main Building  
 Location: Gutters  
 Finding: Debris in Gutters  
 Information: It appears that there is some debris in the gutters. Accumulation of debris can lead to blockages of the gutters & water overflows, if neglected.

Recommend engaging a general handyman to remove all debris from the gutters promptly to prevent overflows & blockages.

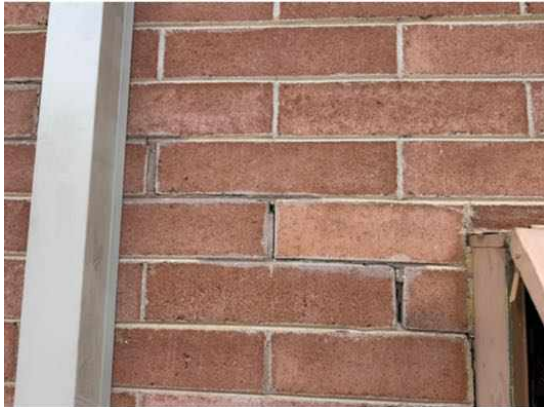
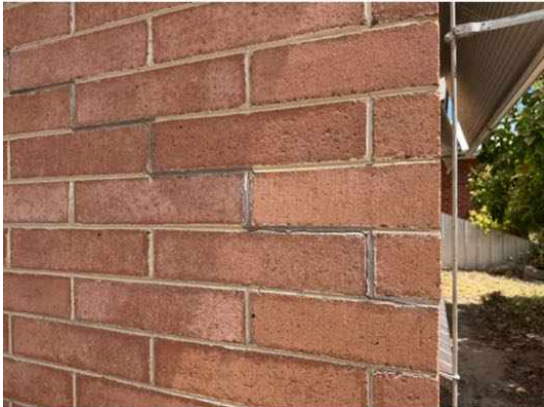
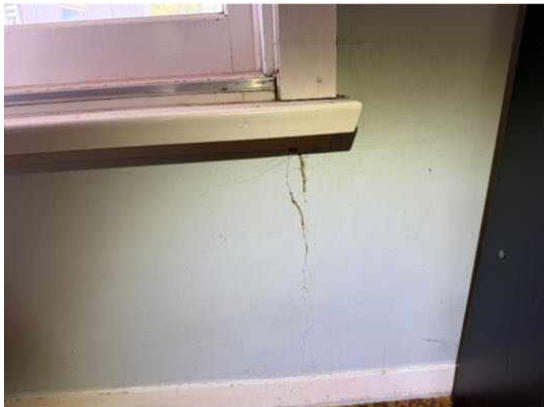
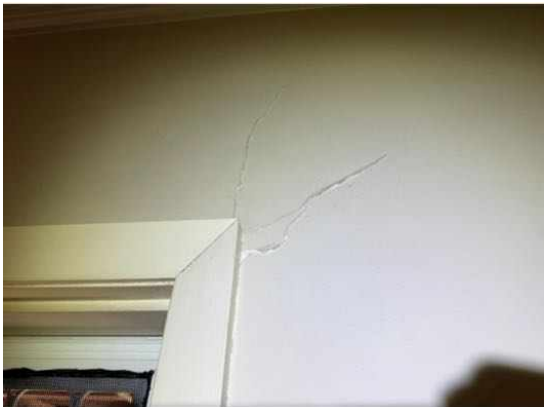
Building: Main Building  
 Location: External Brickwork, Internal wall linings  
 Finding: Cracking - External & Internal  
 Information: Cracking was identified to some areas of the brickwork and internal wall / ceiling linings at the time of inspection. Cracking has a variety of possible causes, however, the most common is movement of adjacent footings and/or expansion / contraction of building materials.

Cracking is a relatively common defect, and is most likely to occur adjacent to windows, doors and other openings.

The client should monitor the cracking. Should the cracking lengthen, widen or become more numerous, the client should consult with a structural engineer promptly to provide further advice.

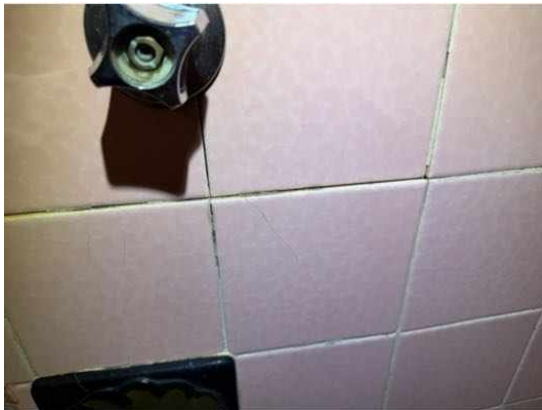
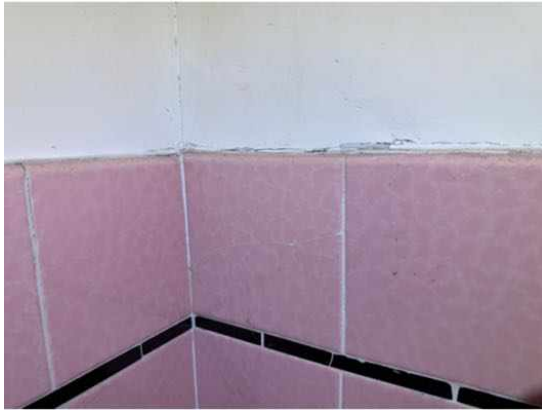
Building: Main Building  
 Location: Bathroom  
 Finding: Sealant / grouting - deteriorated or missing & Cracked & Loose Tiles  
 Information: It appears that the sealant and grout has deteriorated in the bathroom. Areas of cracked and loose tiles were also noted, which can allow for moisture ingress behind the tiles, if neglected.

Sealant and grouting in areas that come into regular contact with water should be maintained for the long term care of your property.

Recommend engaging a licensed tiling contractor in the short term, to provide remedial works where necessary.

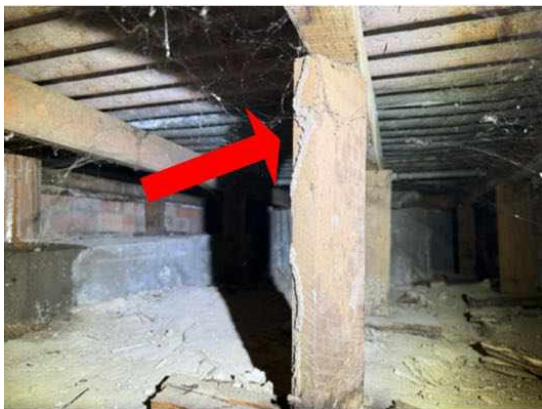
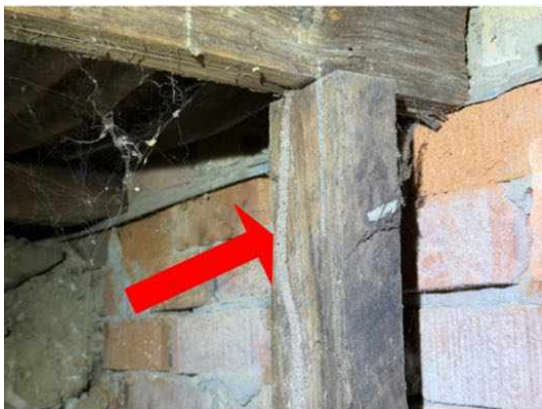
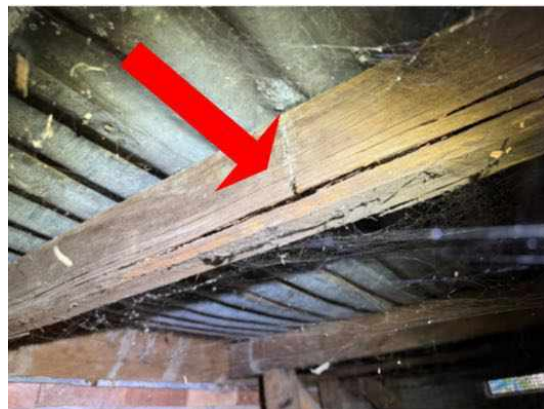
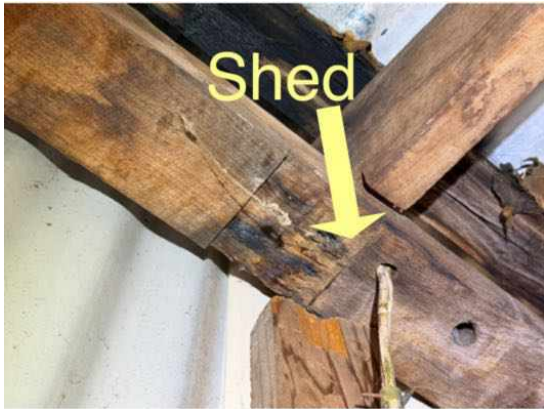
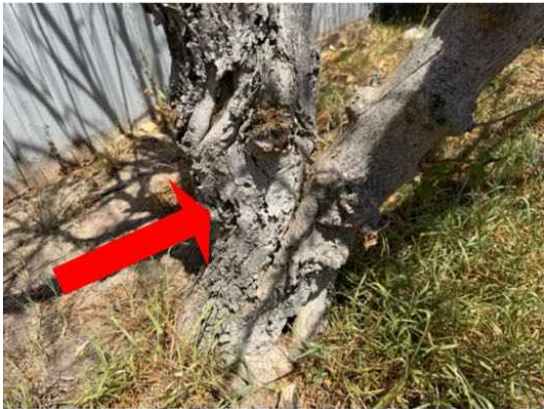
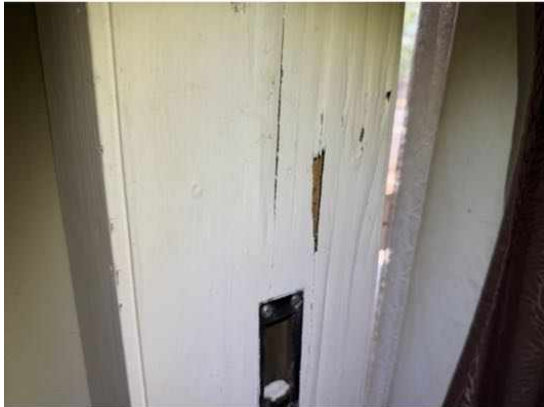
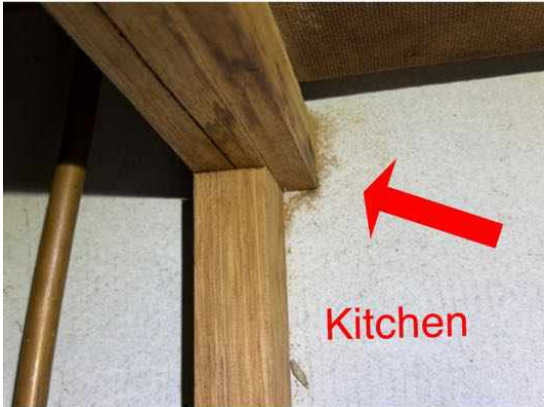
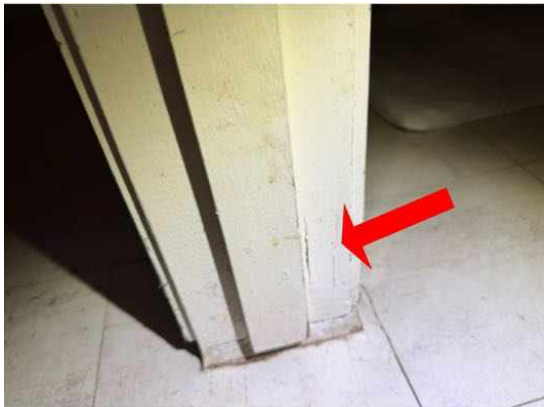
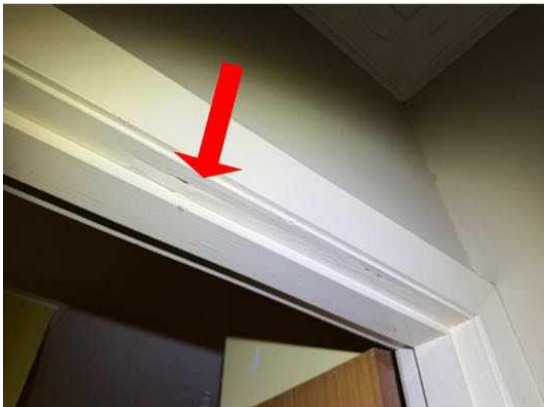
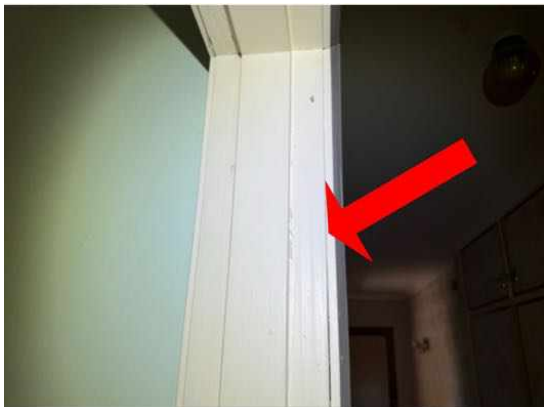
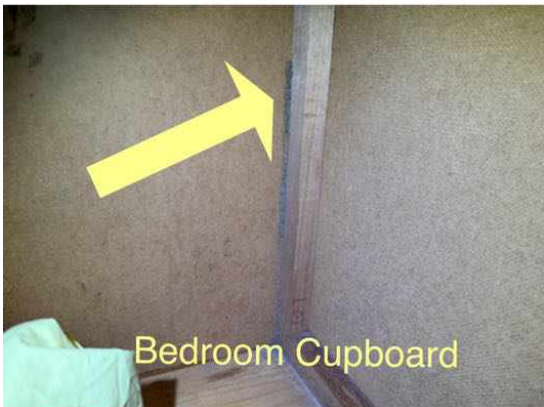
Building:	Main Building
Location:	Subfloor, Door frames, Kitchen & Bedroom Cupboards
Finding:	Evidence of termite workings & damage
Information:	Although no live termite activity was identified at the time of inspection, previous termite damage & workings were identified at, but not limited to, areas throughout the subfloor, rear trees, shed framing, beneath kitchen sink, bedroom cupboards and several door frames throughout the building.

The client should engage a licensed pest controller promptly, to provide further advice regarding installation of a termite treatment. A more invasive inspection, conducted by a licensed tradesperson, is also advised to identify the extent of the damage. 6 monthly ongoing termite inspections, conducted by a qualified termite inspector, are also recommended

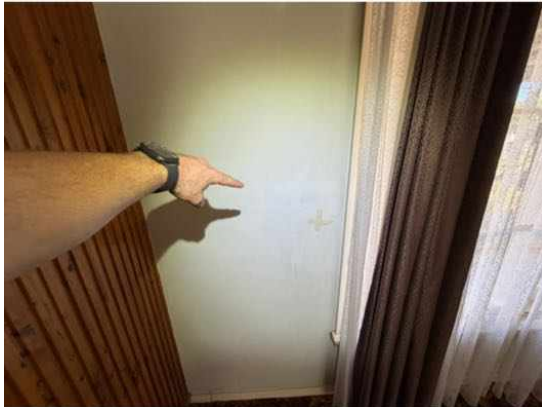
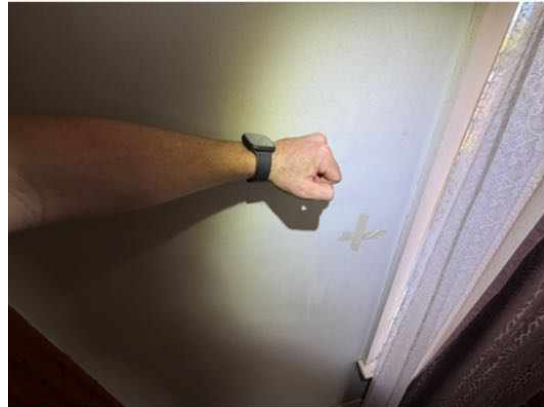
Building:	Main Building
Location:	Bedroom, Lounge
Finding:	Audible Indications of Potential Termite Damage
Information:	It appears areas of audible droppings in the wall cavities were identified at, but not limited to the lounge room & bedroom walls. This may be an indicator of potential termite damage in the wall cavity. Therefore, a more invasive inspection conducted by a licensed tradesperson is recommended to confirm, and identify the extent of the damage.

Should termite damage be confirmed, a registered builder should then be engaged to replace any affected building materials.

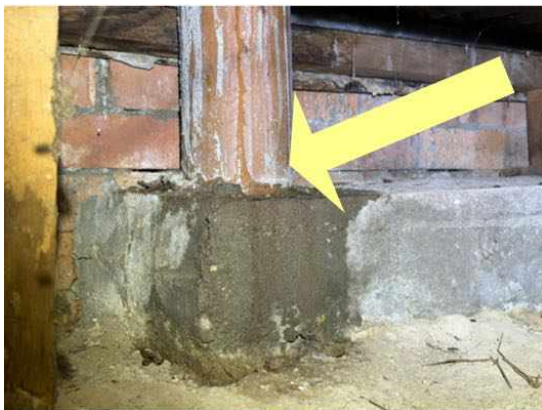
### Finding 6.03

Building:	Main Building
Location:	Subfloor beneath bathroom
Finding:	Plumbing - Leaking
Information:	It appears that the plumbing beneath the bathroom in the subfloor was leaking at the time of inspection. Causes of this defect include but are not limited to, damaged plumbing fittings and fixtures or insufficient sealants.

Areas of leaking creates an environment conducive to termite activity and water damage to surrounding materials, if neglected. Recommend engaging a licensed plumber promptly, to provide remedial works where necessary.

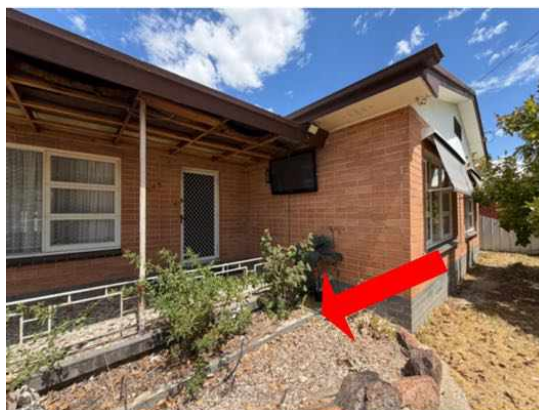
**Finding 6.04**

Building: Main Building  
Location: All external areas  
Finding: Potential Water pooling - against property  
Information: It appears that there are potential areas around the perimeter of the property that could be susceptible to water pooling.

Where insufficient drainage of taps, hot water system & aircon overflows, and garden beds against the house are present, water pooling is likely to occur, and can create areas conducive to timber pests and potential damage to the subfloor structure overtime, if neglected.

Recommend consulting with a licensed plumber in the short term to further assess and provide remedial advice.

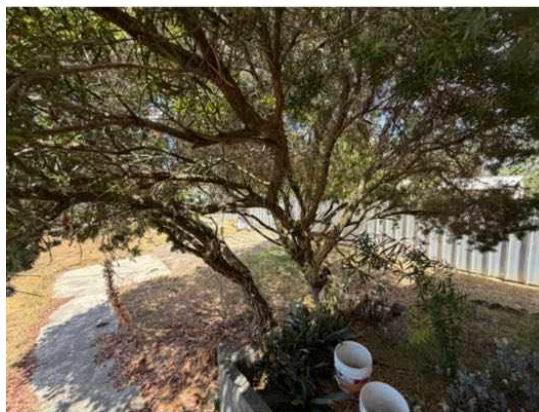
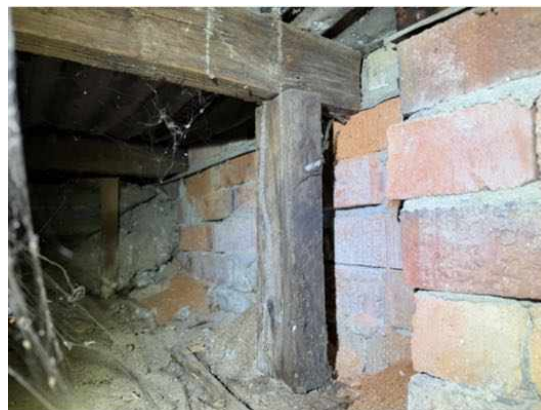
### Finding 6.05

Building:	Main Building
Location:	All External Areas
Finding:	Timber in direct ground contact & trees - conducive to termites
Information:	Where timber materials are in direct contact with the ground and consequently moisture, they become conducive to termite activity. The timber debris in the subfloor, landscaping timbers, shed framing, and trees surrounding the building create an environment conducive to termite infestation.

Where feasible, any timbers in direct contact with the ground should be removed and any trees in close proximity to the building should be removed or test drilled (inspected) at least annually to reduce the risk of termite infestation & detect any early signs of termite activity.

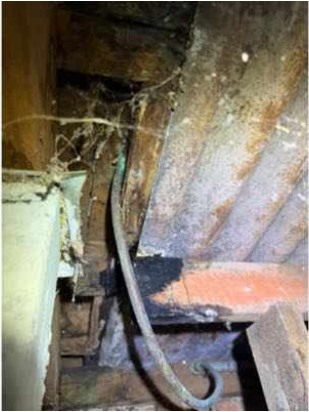
### Finding 7.01

Building:	Main Building
Location:	Subfloor beneath bathroom, Shed Framing, Fascia's, Verandah Framing
Finding:	Fungal decay & weathering
Information:	Areas of fungal decay (wood rot) were identified at but not limited to the subfloor timber's beneath the bathroom, fascias, verandah framing and shed framing.

For areas of fungal decay, the client can engage a licensed carpenter at their discretion to replace affected materials. For areas of general weathering, it is advised the client engage a licensed painter to apply protective sealant or coating to areas of weathered external timbers.

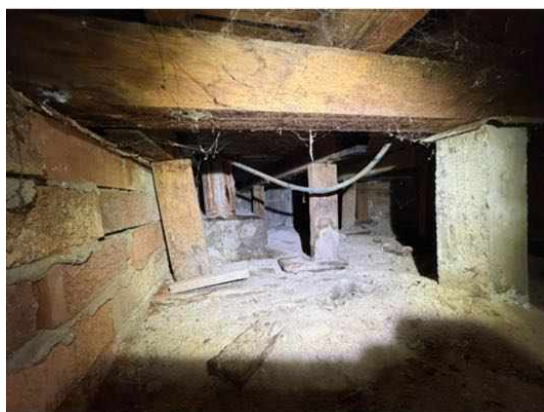
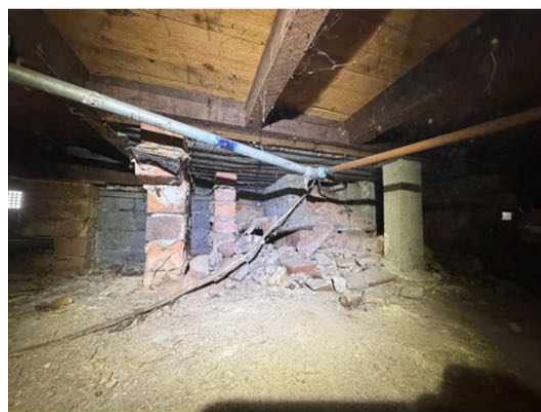
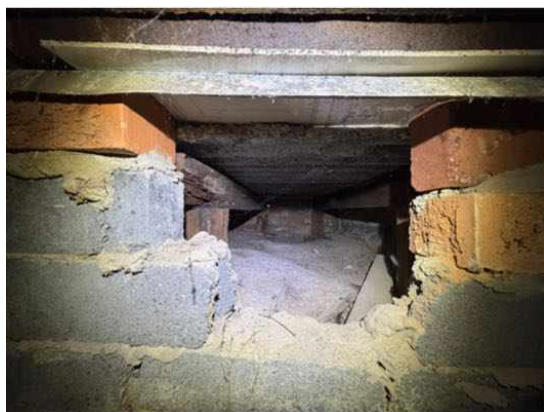
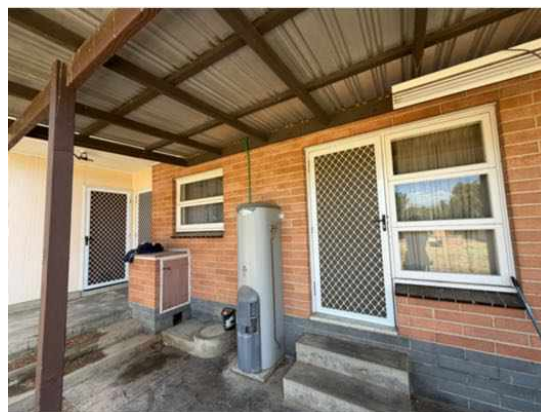
Building: Main Building  
Location: All Areas  
Finding: Additional Photos - Obstructions and Limitations  
Information: These photographs are an indication of the obstructions and limitations which impeded full inspection of the property at the time of inspection. These obstructions can hide an array of defects and should be removed to allow full inspection to be carried out. A re-inspection is recommended once the areas are made accessible.

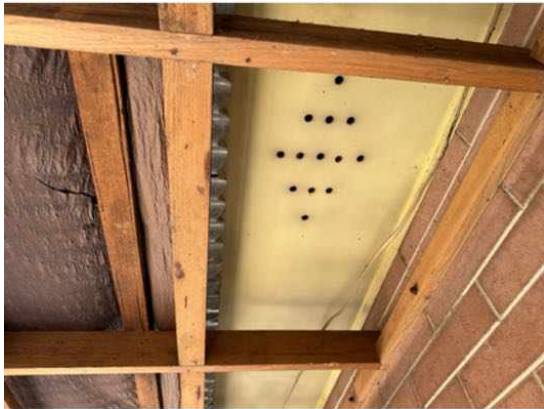
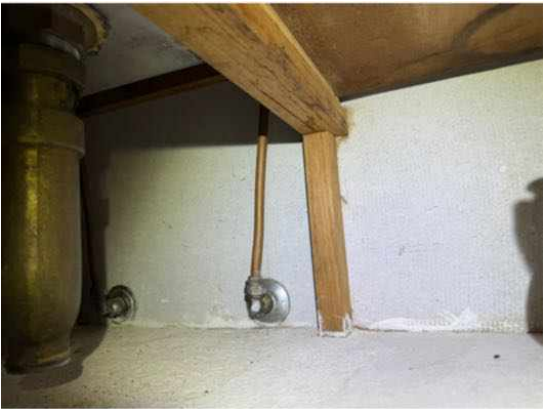
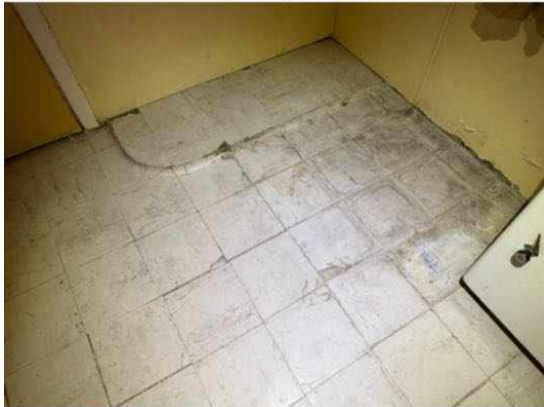
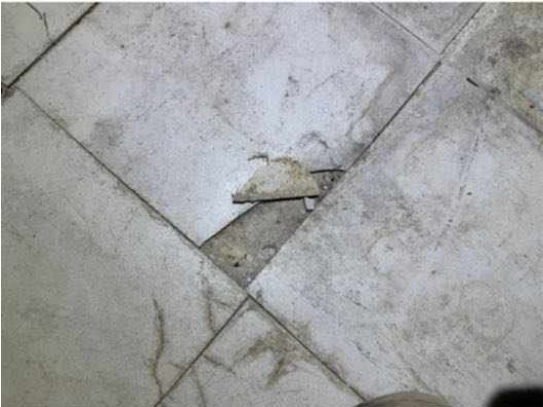
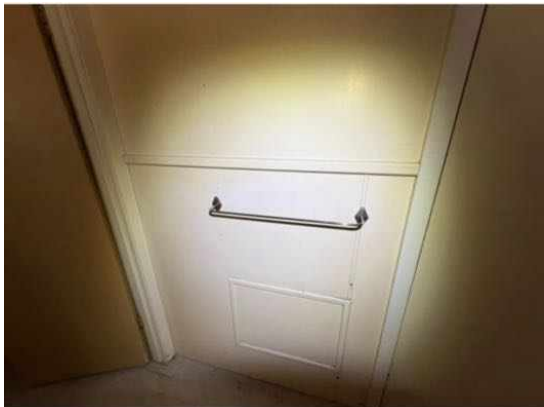
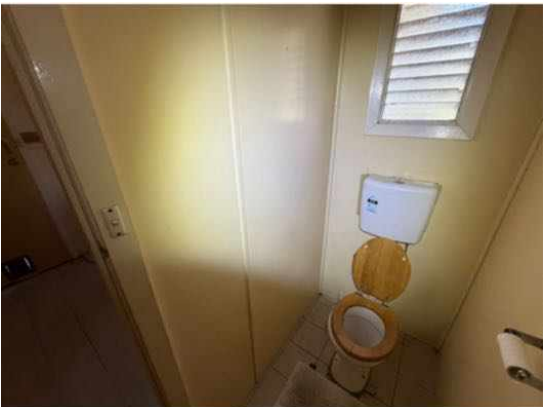
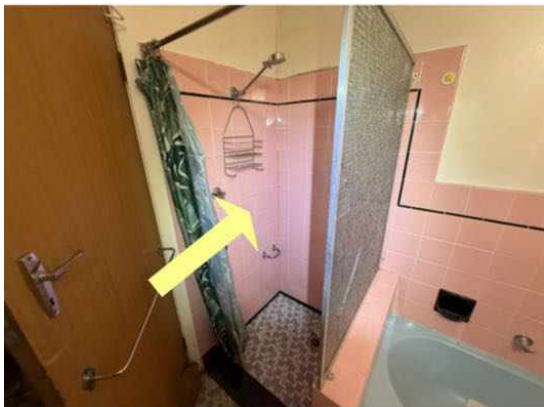
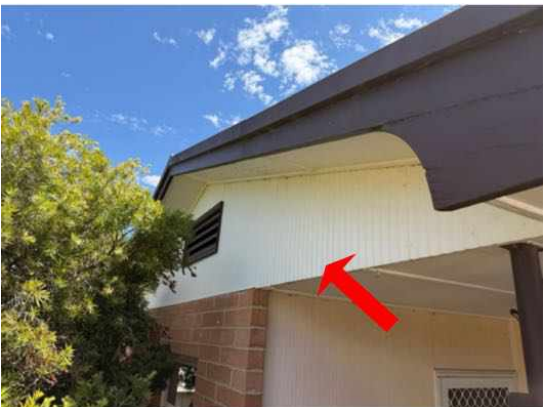
- several suspected ACM (asbestos) materials were identified throughout the building. Recommend that the client consider a separate asbestos inspection and condition order including taking of samples to confirm.
- several areas of the roof plumbing & roof sheeting were found to be rusted & deteriorated. Recommend consulting with a licensed roofing contractor and/or roof plumber to provide remedial works.
- Debris present in guttering. Recommend handyman or client to remove all debris to avoid overflows.

Building:	Main Building
Location:	Eaves, Soffit Linings, Bathroom, Laundry, Toilet & Kitchen Wall Linings, Vinyl Plank Flooring, Gable Cladding
Finding:	Asbestos - Suspected ACM Identified on Site
Information:	This suspected defect is highlighted as a caution only as reporting on asbestos is outside the scope of this report. It is suspected that there is some potential ACM (Asbestos containing materials) present throughout the building. The vinyl floor tiles in the laundry, which may be an ACM were also found to be broken and in a potentially hazardous state.

It is advised that the client consider a separate Asbestos Inspection and Condition Audit, which can include the taking of samples for definitive confirmation of the presence of Asbestos, carried out by a licensed Asbestos Inspector.

In the interim, the client is advised to act with caution around the area, due to the suspected presence of Asbestos.

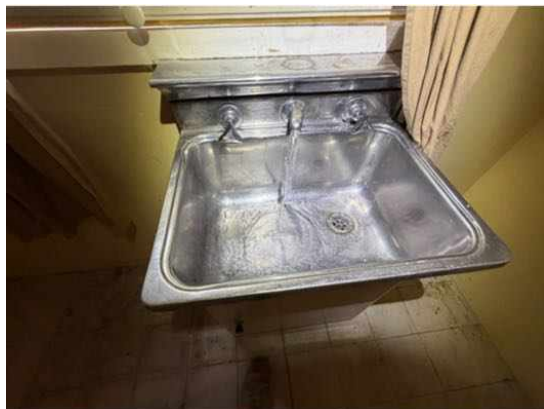
Building:	Main Building
Location:	Hot Water Taps
Finding:	Hot Water - Not Operating
Information:	It appears that the hot water was not operating at the time of inspection. The client can engage a licensed plumber at their discretion, to provide further advice and remedial works where necessary, to ensure that the hot water system is operating as intended

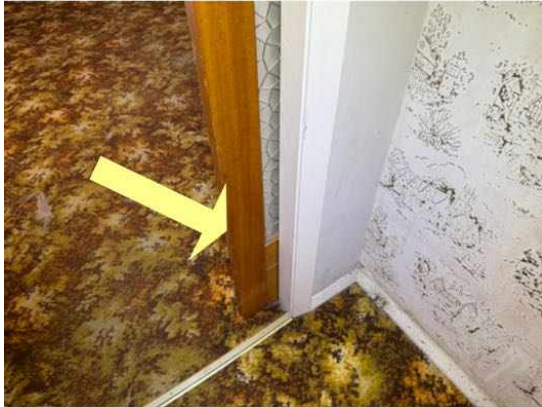
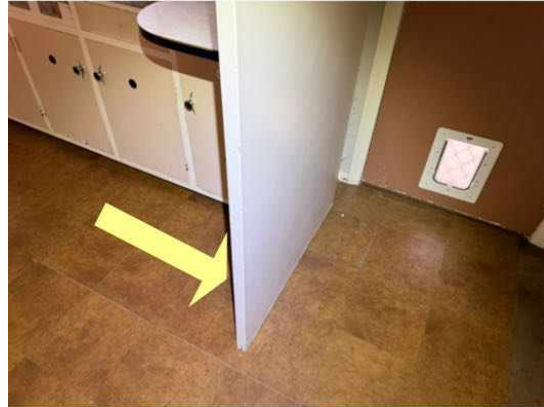
Finding: Sliding Doors - Stiff to slide

Information: It is noted for the clients information that some sliding doors were found to be stiff to slide at the time of inspection. The client can engage a general handyman, at their discretion to provide maintenance works where necessary.
