Building and Timber Pest Inspection Report

Inspection Date: Fri, 20 Feb 2026

Property Address: 3 St Albans Rd, Kingsgrove NSW 2208,
Australia

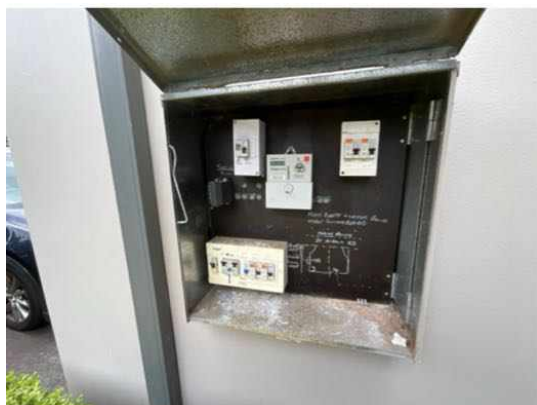
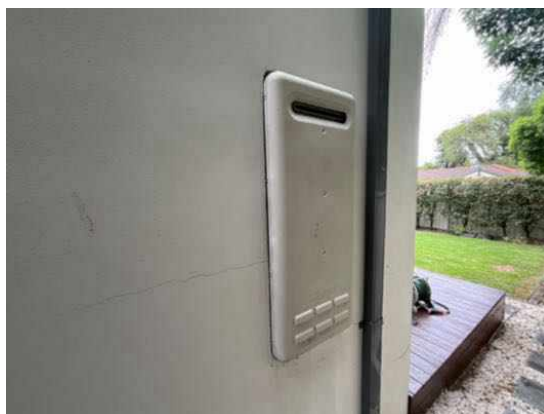
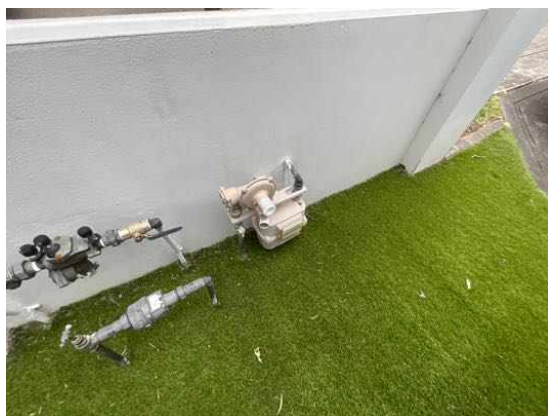
Building: Main Building
Location: All Areas
Finding: Photos Added
Information: Additional photos are provided for your general reference.

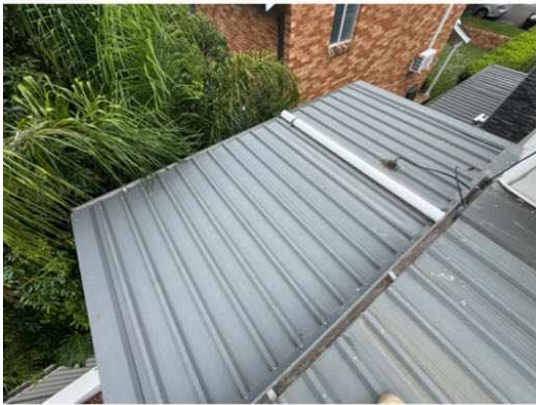
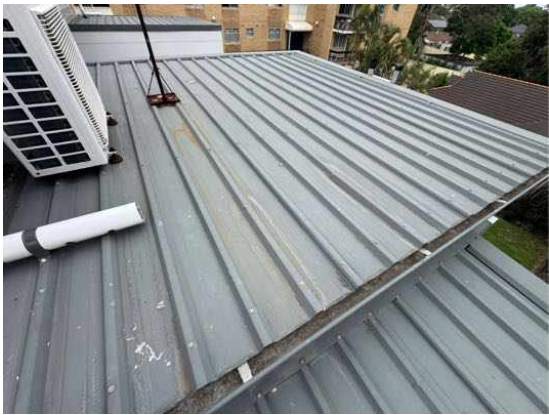
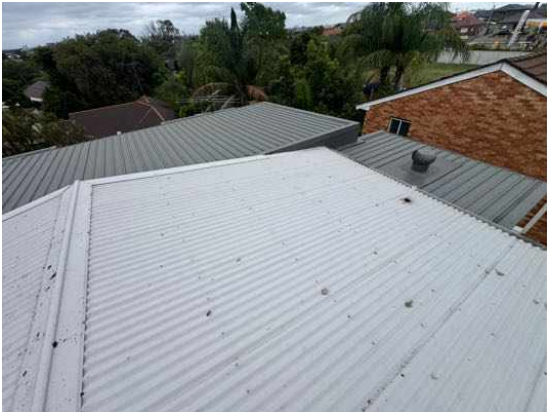
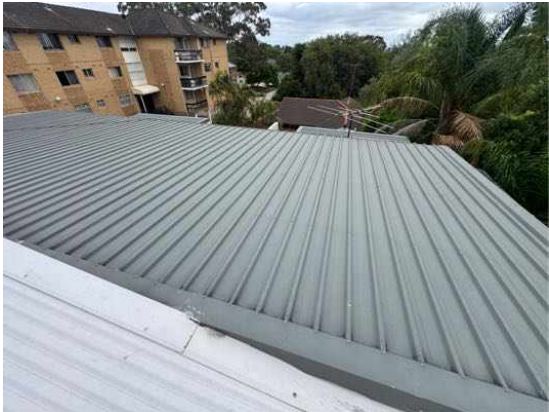
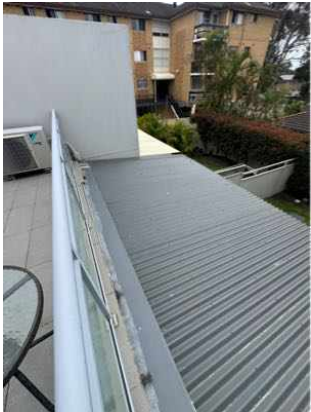
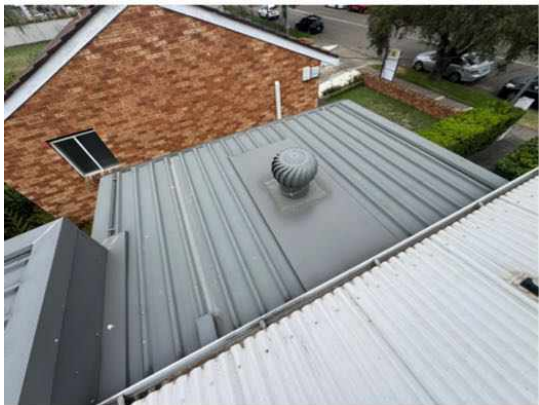
Building: Main Building
Location: Roof Exterior
Finding: Photos Added
Information: Additional photos are provided for your general reference.
