Building and Timber Pest Inspection Report

Inspection Date: Mon, 2 Mar 2026

Property Address: 33 Edward St, Corowa NSW 2646, Australia

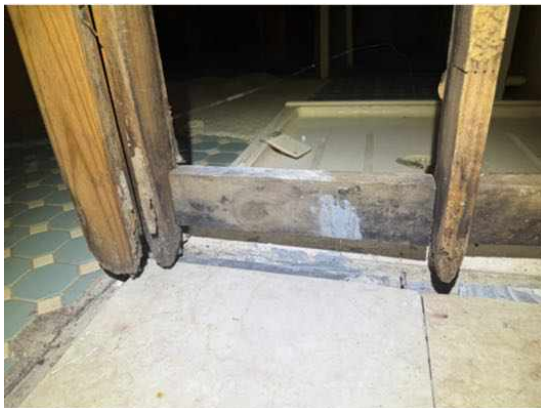
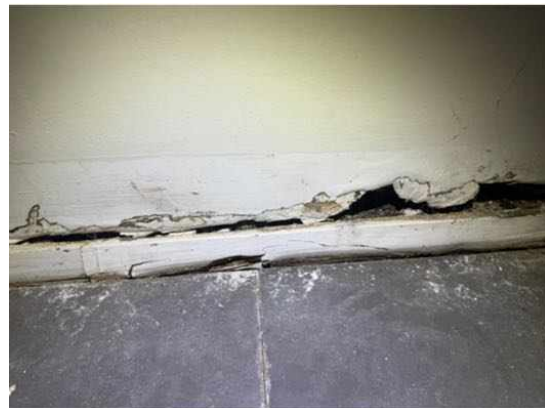
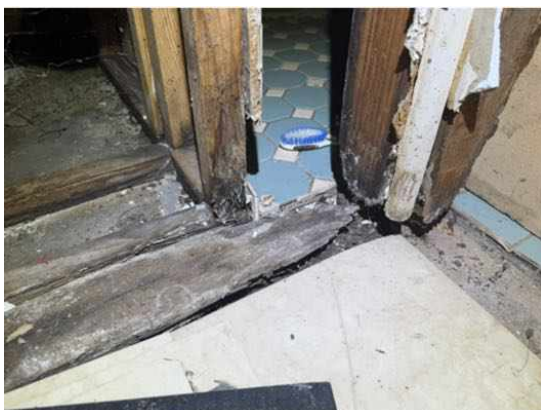
Building: Main Building
Location: Bathroom, Bedroom & Toilet Framing
Finding: Decayed & Unsupported Framing
Information: It was found that the framing at, but not limited to the bathroom, toilet and bedroom wall framing have been affected by fungal decay (wood rot) and areas of the framing are unsupported. This has likely been caused by a previous shower leak.

A registered builder is required promptly, to replace any affected structural materials, to avoid the development of secondary building defects.

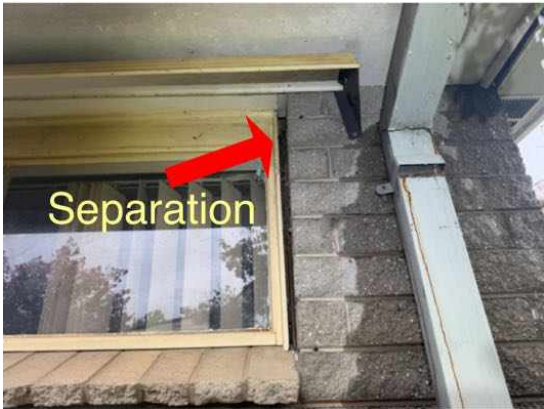
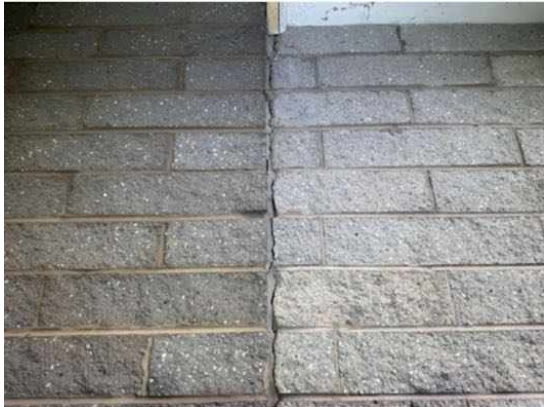
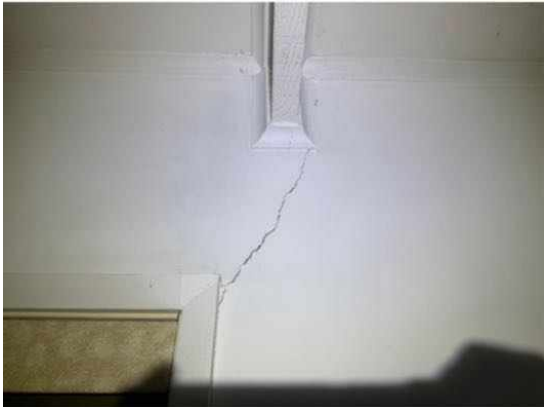
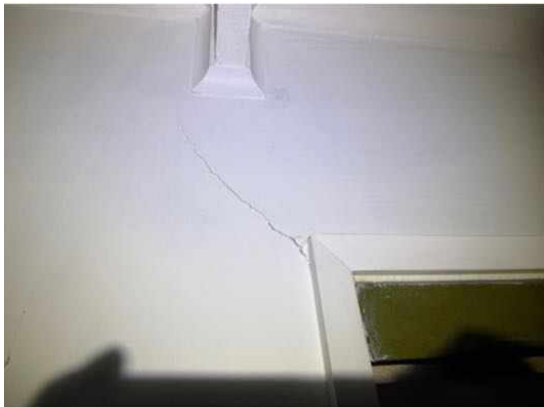
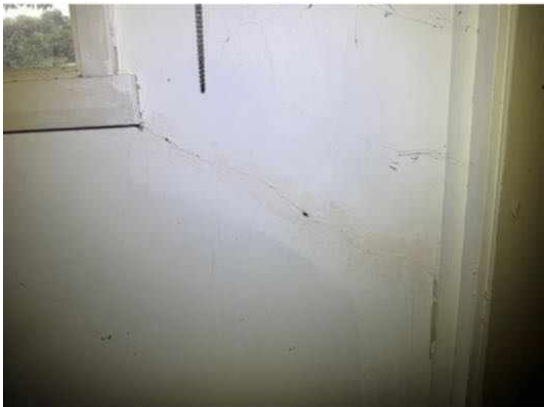
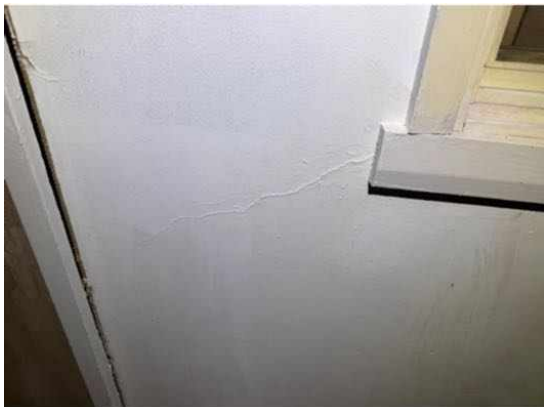
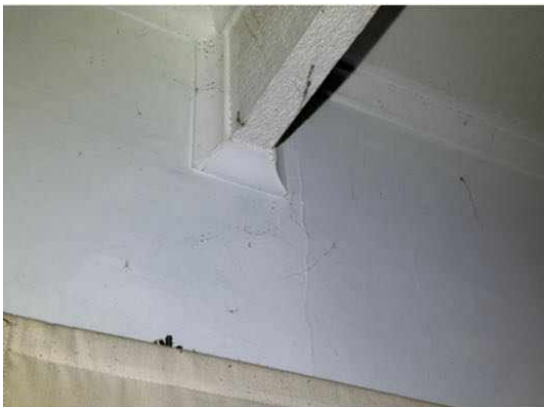
Building:	Main Building
Location:	All External Areas
Finding:	Brickwork & Plaster - Cracking, Movement
Information:	Cracking was identified to areas of the brickwork & plaster at the time of inspection. Gaps between the window frames and brickwork was also identified, indicating movement. Cracking has a variety of possible causes. However, the most common is movement of adjacent footings.

It is advised that the client consult with a structural engineer in the short term, to provide further advice regarding areas of cracking and movement. In the interim, these areas should be monitored to identify any further movement.

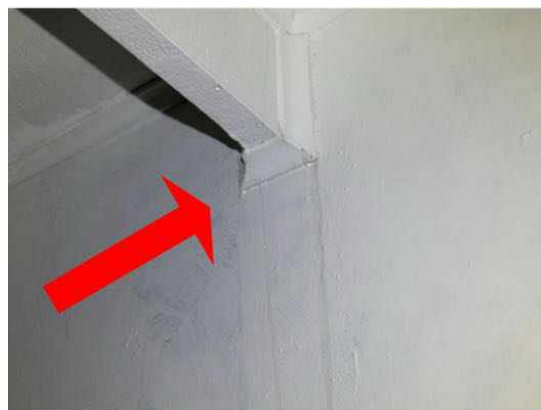
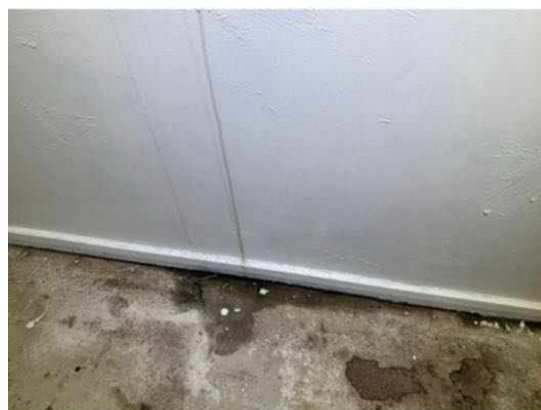
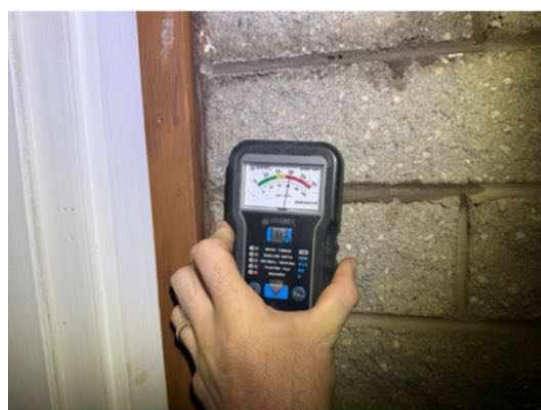
Finding 3.03

Building: Main Building
Location: Bedrooms, Lounge Room, Extension Wall, Rear Eave
Finding: Walls & Floor - Leaking & High Moisture
Information: High moisture and areas of leaking were identified at, but not limited to bedroom walls, lounge room & bedroom slab, extension wall, and rear eaves. Potential causes of leaking include damaged plumbing fittings and fixtures, or deterioration of the roof plumbing.

This creates an environment conducive to termite activity, and water damage to surrounding materials.

Recommend engaging a licensed roof plumber and/or roofing contractor promptly to provide remedial works.

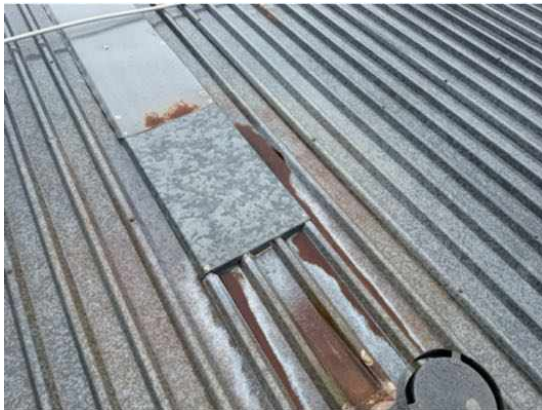
Finding 3.04

Building:	Main Building
Location:	Roof Exterior
Finding:	Roof Exterior & Flashings - Weathered, Rust & Loose
Information:	The roof exterior was found to be in a weathered condition at the time of inspection evidenced by loose screws, weathered/deteriorated flashings, and areas of rust. While weathering of the roof exterior is consistent with the age of the property, remedial works are required.

Where left unmanaged, deteriorating and damaged roof sheeting and plumbing is likely to lead to secondary defects, including water leaks.

A licensed roofing contractor should be engaged promptly, to provide further advice and remedial work's where necessary.

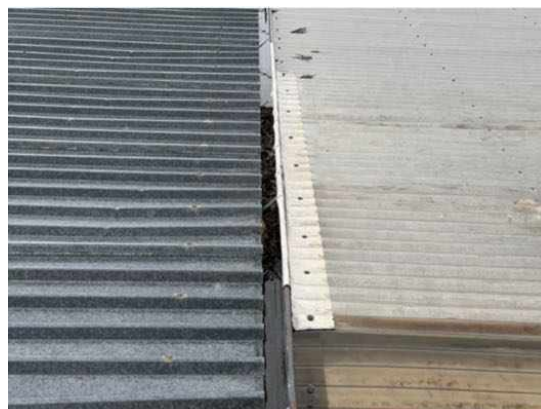
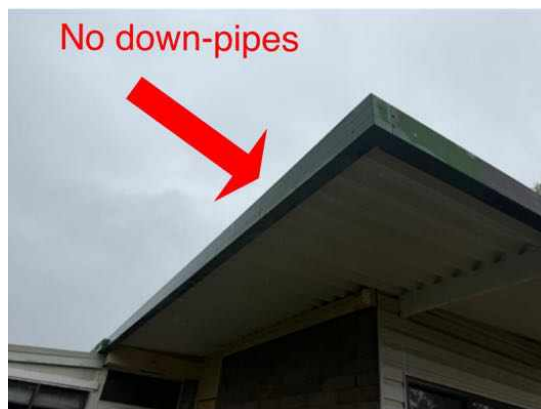
Finding 3.05

Building:	Main Building
Location:	Guttering
Finding:	Roof Plumbing - Insufficient & Debris/Water pooling
Information:	Water pooling and debris were noted in sections of the guttering at the time of inspection, likely due to sagging or blockages. It appears there is also insufficient roof plumbing installed. Water pooling can lead to deterioration of the roof plumbing over time, if neglected.

A licensed roof plumber should be engaged in the short term, to provide further advice & remedial works to ensure adequate roof drainage is achieved. All debris should be cleared promptly to ensure proper drainage and prevent overflows.

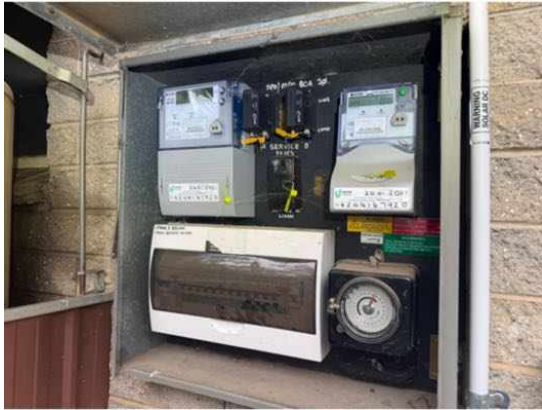
Building:	Main Building
Location:	Switchboard
Finding:	Termite Management System - no evidence of a chemical installation
Information:	The application of a termite barrier is strongly recommended, as it appears no termite management system has been installed, with no evidence or durable notice to suggest works taking place. Generally, a durable notice is placed in the meter box to

Such barriers are highly effective in preventing termite attack on the building and therefore should be installed.

Recommend seeking further advice from a licensed pest controller.

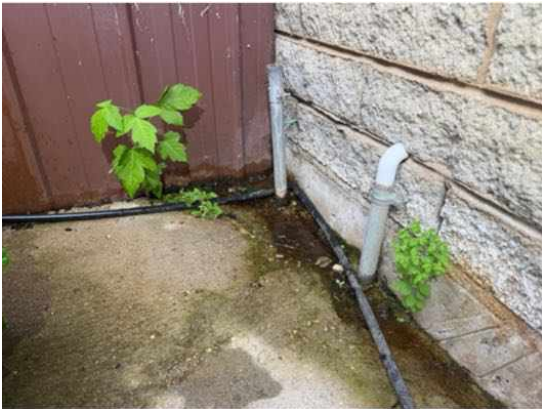
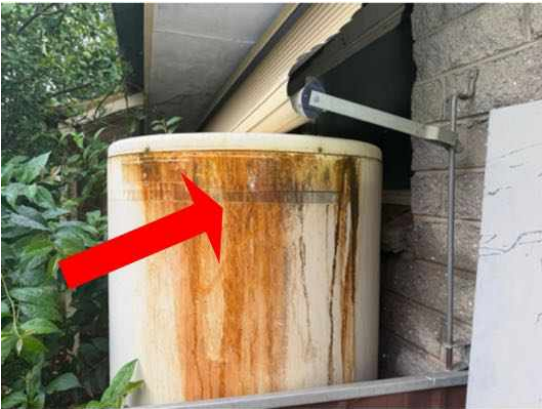
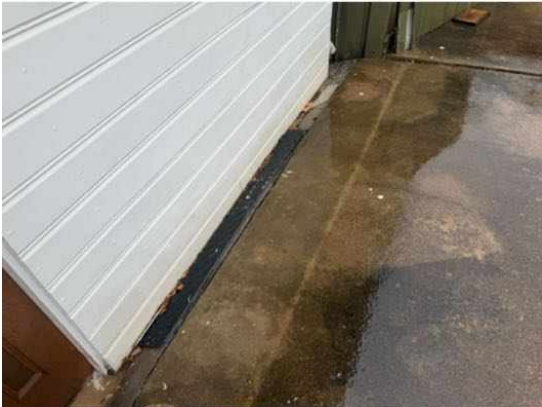
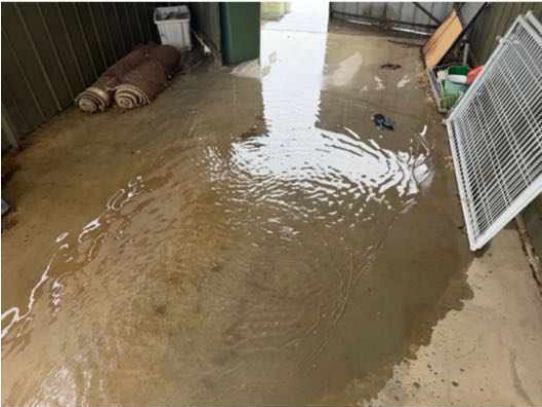
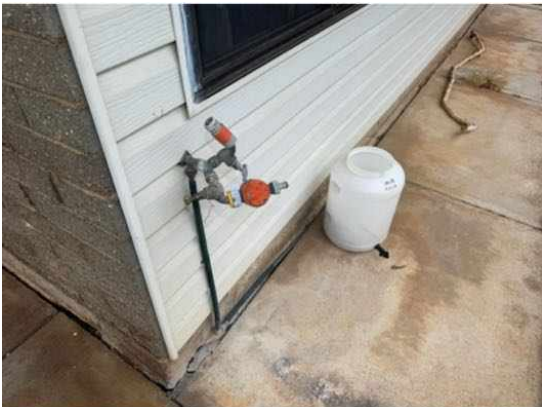
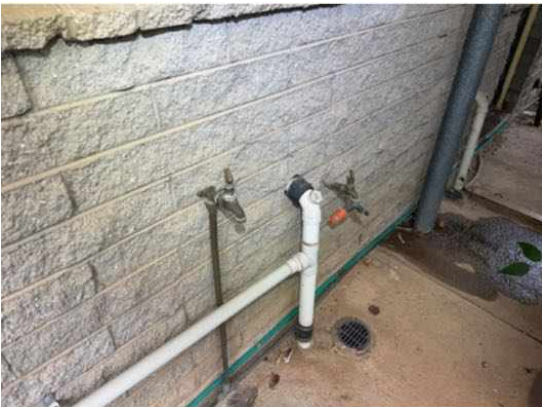
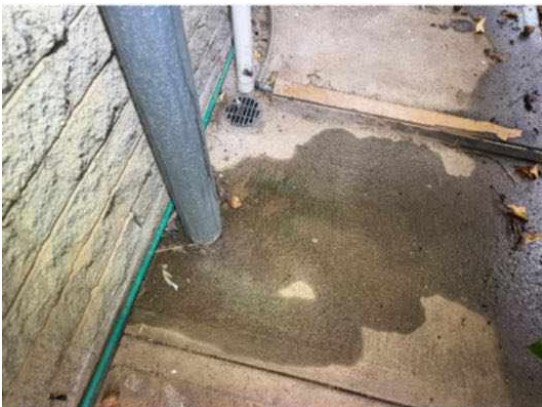
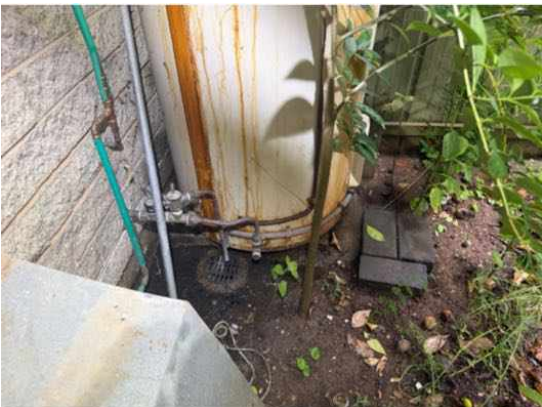
Finding 6.02

Building:	Main Building
Location:	All external areas, Roof Plumbing
Finding:	Water pooling against property & Leaking Roof Plumbing
Information:	Potential areas of water pooling around the perimeter of the property were identified. Leaking gutters, tanks and down-pipes were also noted.

Where insufficient drainage of taps, hot water system & aircon overflows, and garden beds against the house are present, water pooling is likely to occur, and can create areas conducive to timber pests & water damage to surrounding materials.

Recommend consulting with a licensed plumber and/or landscaping contractor promptly, to provide further advice & remedial works.

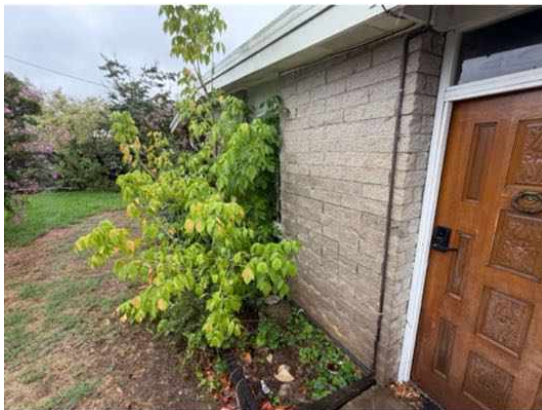
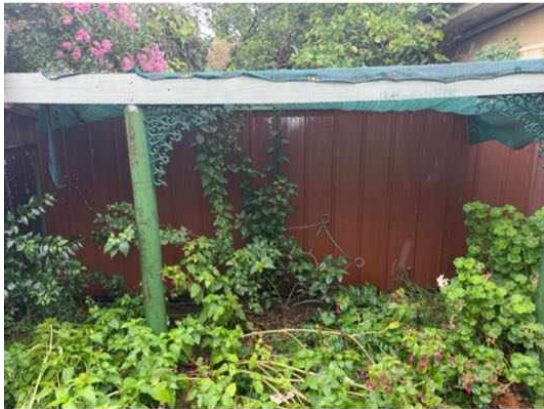
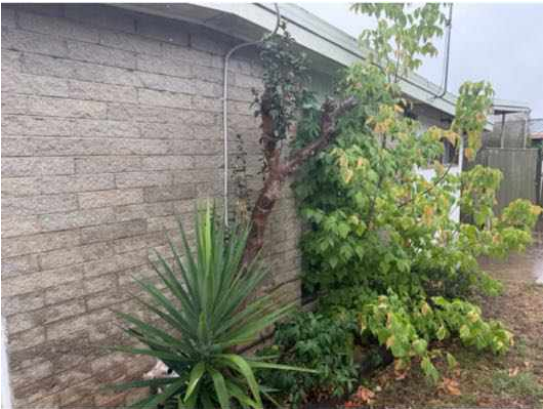
Finding 6.03

Building:	Main Building
Location:	All External Areas
Finding:	Timber in direct ground contact & trees - conducive to termites
Information:	Where timber materials are in direct contact with the ground and consequently moisture, they become conducive to termite activity. The tree stumps, landscaping timbers, and trees surrounding the building create an environment conducive to termite infestation.

Where feasible, any timbers in direct contact with the ground should be removed and any trees in close proximity to the building should be removed or test drilled (inspected) at least annually to reduce the risk of termite infestation & detect any early signs of termite activity.

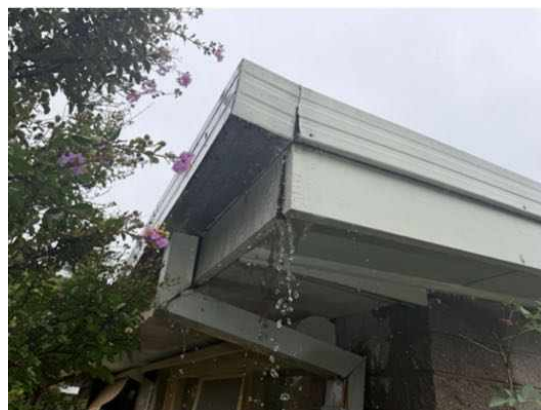
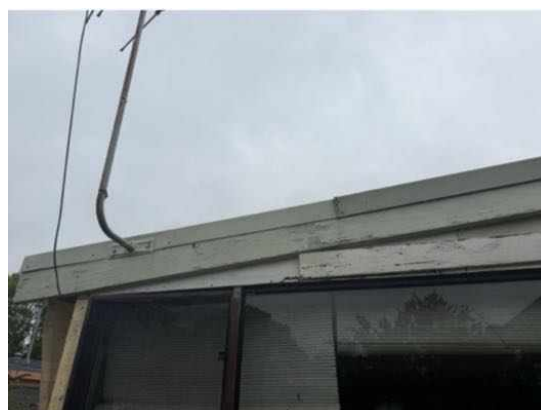
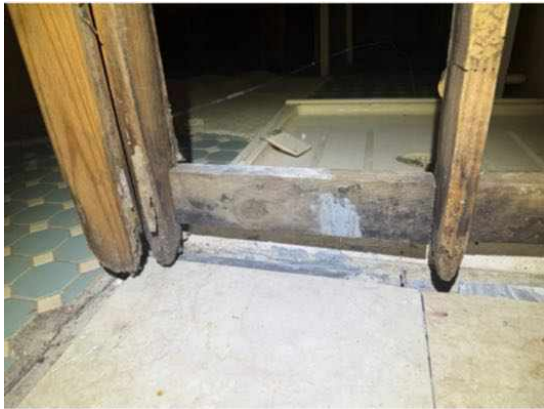
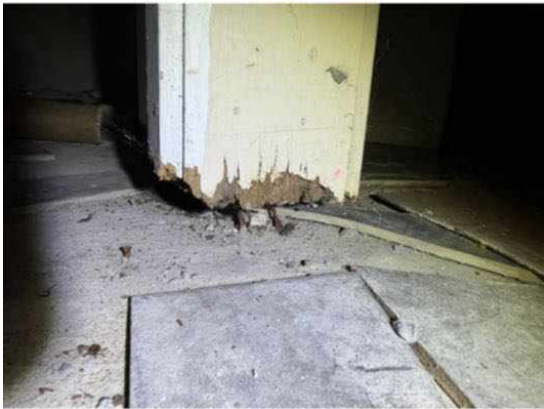
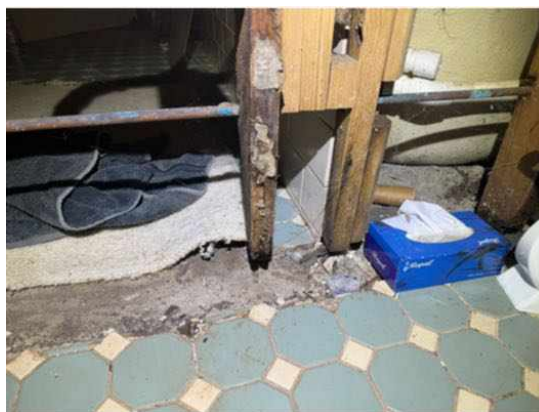
Finding 7.01

Building:	Main Building
Location:	Fascias, Carport Framing, Bathroom & Wall Framing, Skirting, Kitchen Kick board
Finding:	Fungal decay & weathering
Information:	Areas of fungal decay (wood rot) & weathering were identified at but not limited to the fascias, carport framing, bathroom & wall framing, skirting and kitchen kick board.

For areas where structural timbers are affected by wood rot (bathroom, bedroom and toilet framing) a registered builder should be engaged promptly to replace affected materials where necessary.

For areas where fungal decay is superficial, the client can engage a licensed carpenter at their discretion to replace affected materials.

For areas of general weathering, it is advised the client engage a licensed painter to apply protective sealant or coating to areas of weathered external timbers.

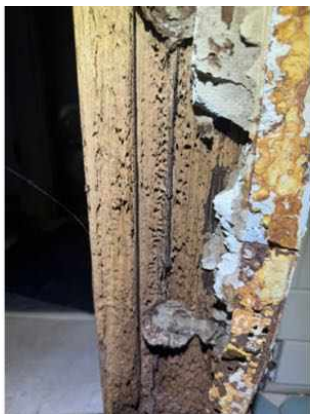
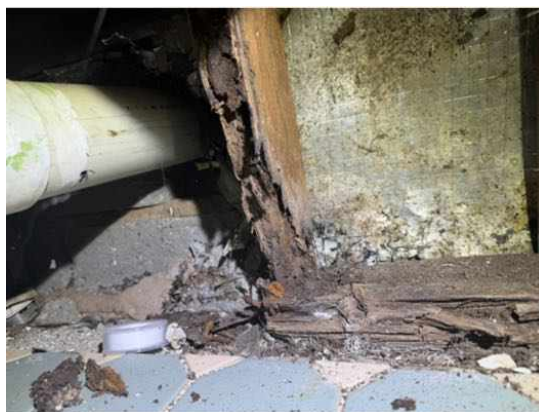
Finding 8.01

Building: Main Building
Location: Bathroom & Toilet Framing
Finding: Evidence of wood borer damage identified
Information: Evidence of previous Lyctus Borer (powder-post beetle) damage was identified at but not limited to, the bathroom & toilet framing.

As no live wood borer activity was identified treatment is not required.

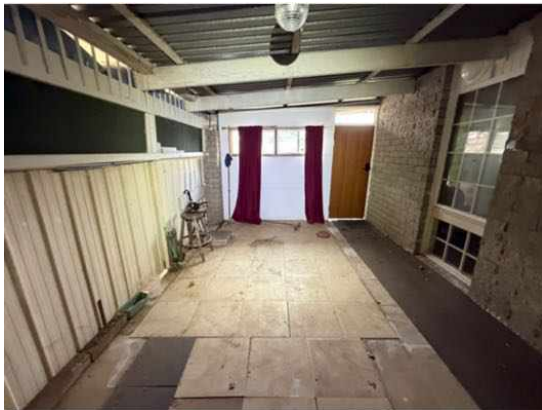
Building: Main Building
Location: All Areas
Finding: Additional Photos - Obstructions and Limitations
Information: These photographs are an indication of the obstructions and limitations which impeded full inspection of the property at the time of inspection. These obstructions can hide an array of defects and should be removed to allow full inspection to be carried out. A re-inspection is recommended once the areas are made accessible.

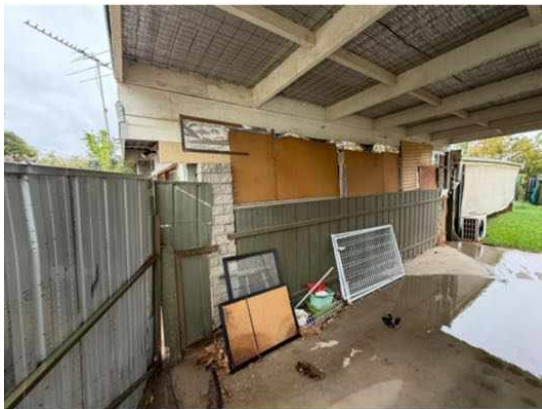
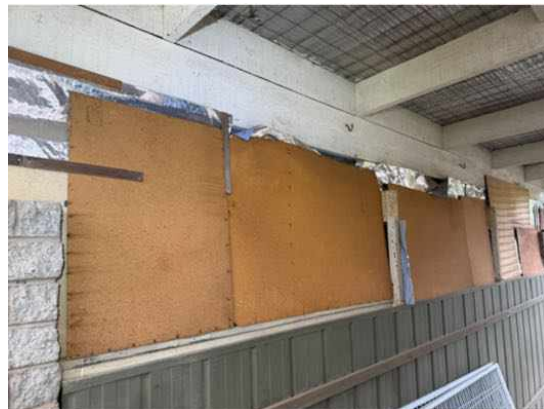
Building:	Main Building
Location:	Carport/Extension Room
Finding:	Carport - Not Sealed / Cladded sufficiently
Information:	It was noted that the wall of the carport/extension room was not sufficiently sealed / cladded with the appropriate building materials. The client can engage a registered builder at their discretion to provide remedial works where necessary to install the relevant building materials.
