Building Inspection Report

Inspection Date: Fri, 16 Jan 2026

Property Address: 505/11-13 Clifton St, Blacktown NSW 2148,
Australia

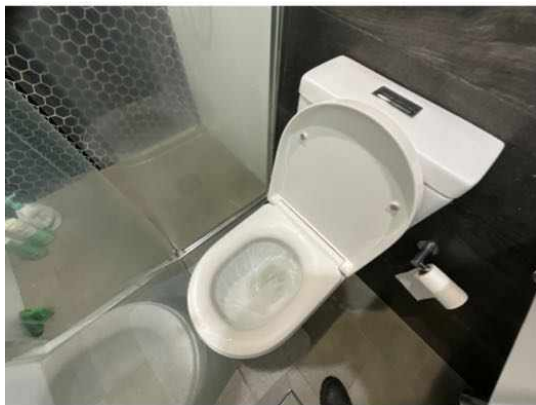
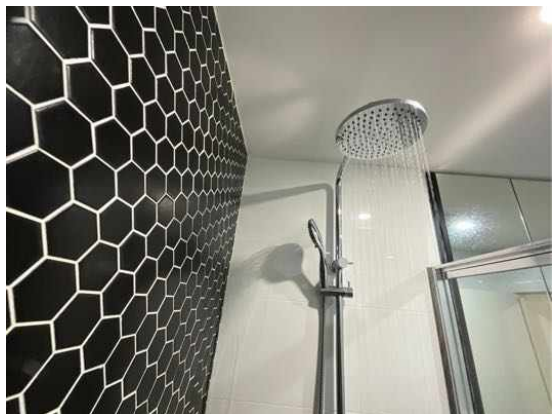
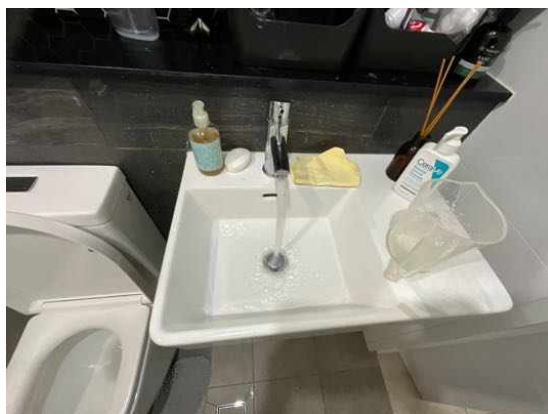
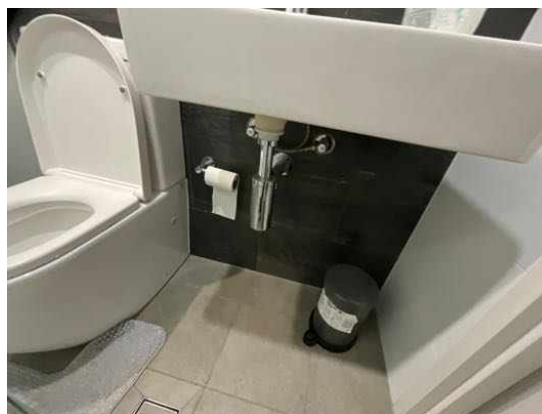
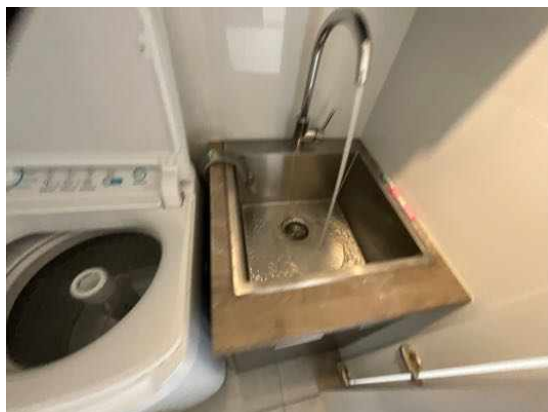
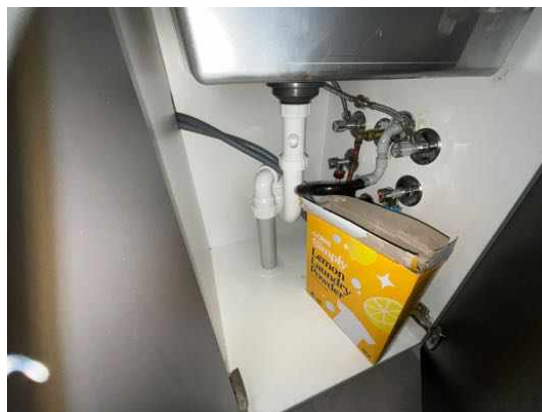
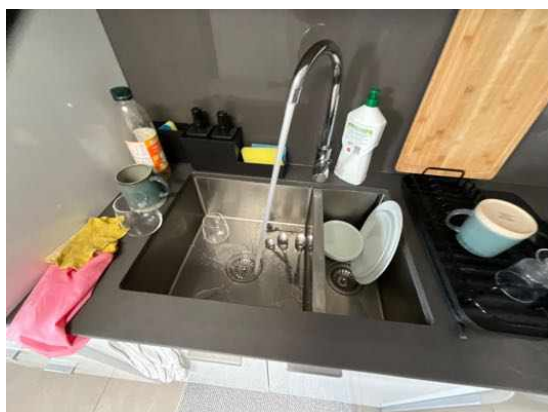
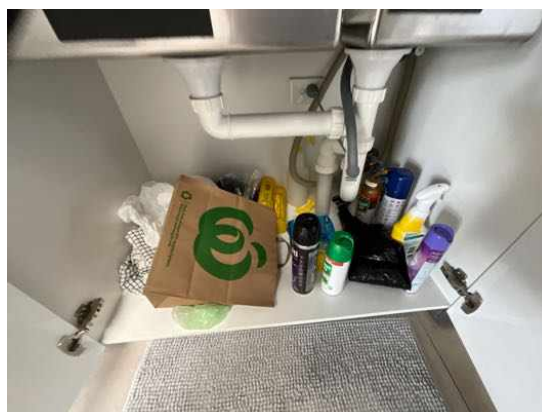
Building: Main Building
Location: All Wet Areas
Finding: Additional Photos
Information:

Additional photos are provided for your general reference.

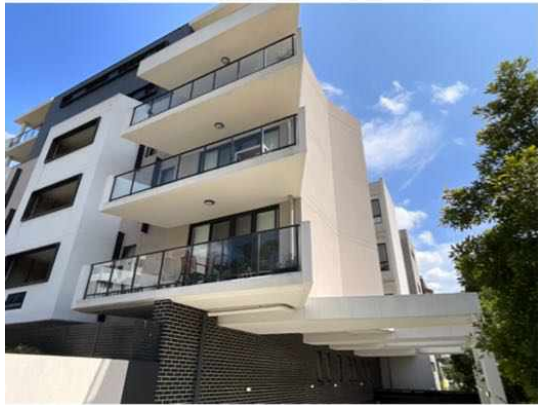
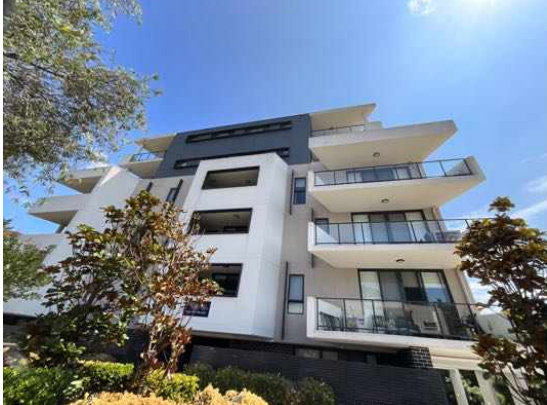
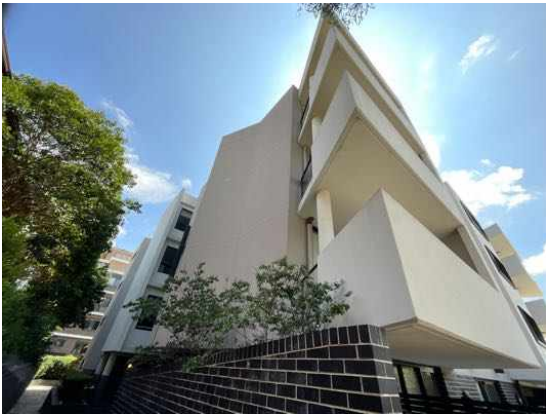
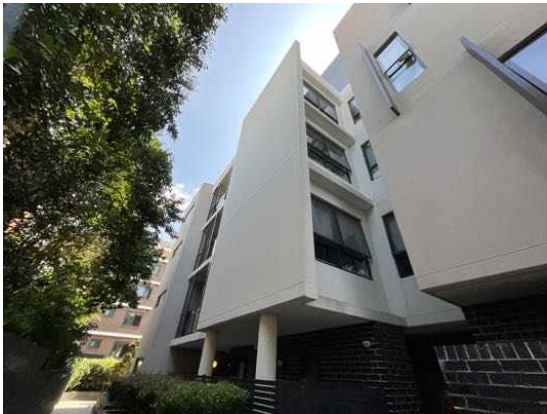
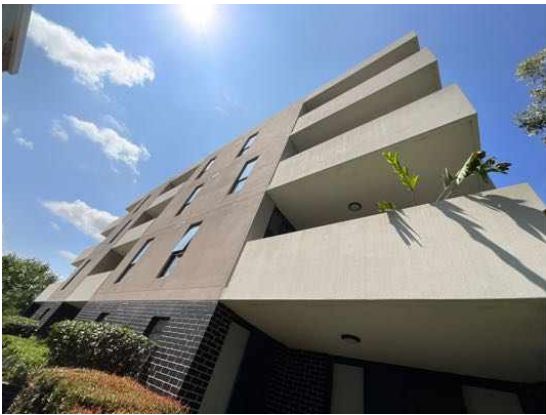
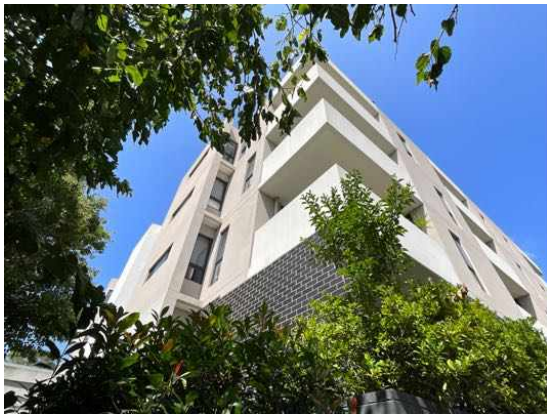
Building: Main Building
Location: Exterior
Finding: Additional Photos
Information:

Additional photos are provided for your general reference.
