Building and Timber Pest Inspection Report

Inspection Date: Thu, 2 Apr 2026

Property Address: 26 Dorchester Cres, Carrum Downs VIC
3201, Australia

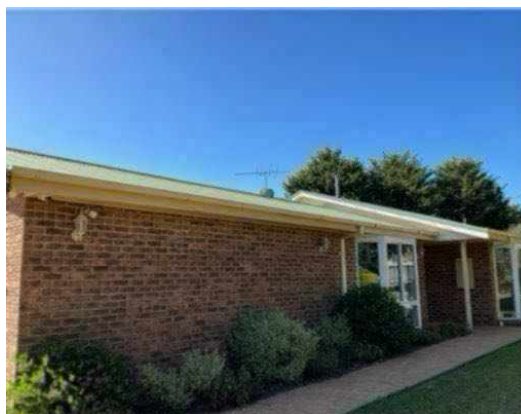
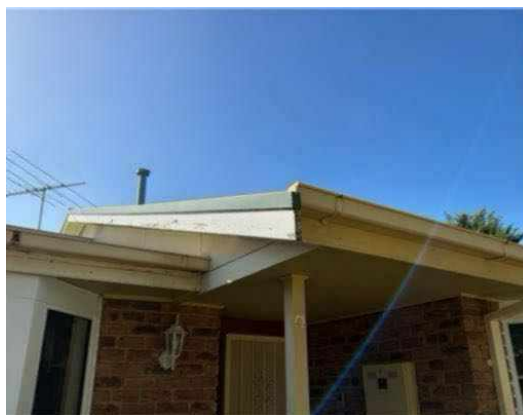
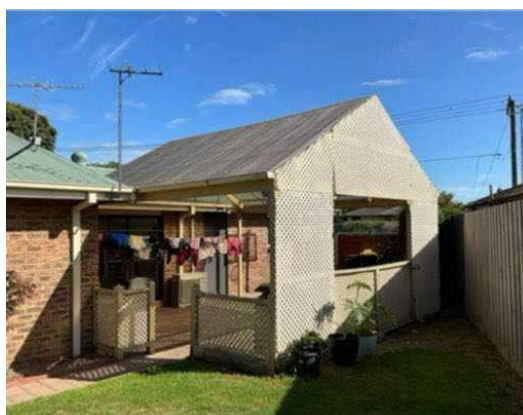
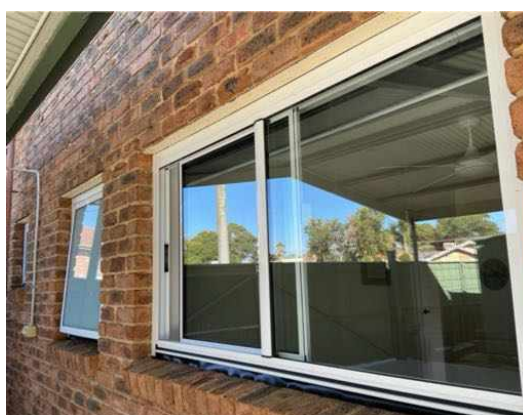
Building:	Main Building
Location:	Various parts of the building
Finding:	External painting deteriorated
Information:	Much of the external paintwork has been neglected and requires attention to prepare and re-paint.

Whilst incomplete or missing paint finish is generally an appearance defect, it can also lead to the development of secondary building defects over time. Incomplete areas of paint finish expose the area to moisture, potentially accelerating the deterioration of underlying building materials.

Degraded paint finishes should be sanded back, filled, leveled and painted, as applicable. Where inadequate or missing paint protection has led to the deterioration of the associated building element, repair and/or replacement of this building element may be required.

A painting contractor should be appointed as soon as possible to perform necessary works to aid the appearance of the affected area and to ensure the area is protected against further deterioration. Alternatively, the homeowner following manufacturer instructions may perform these works.

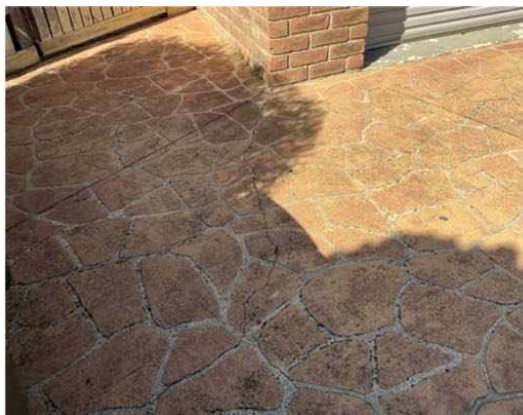
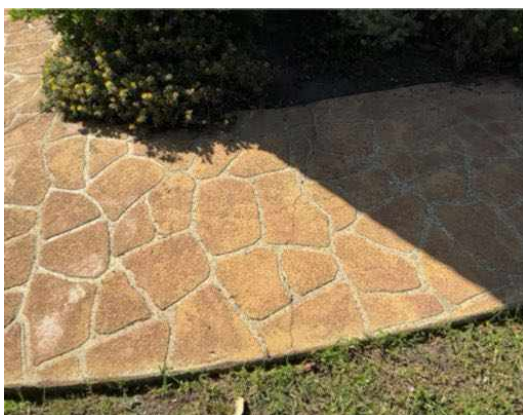
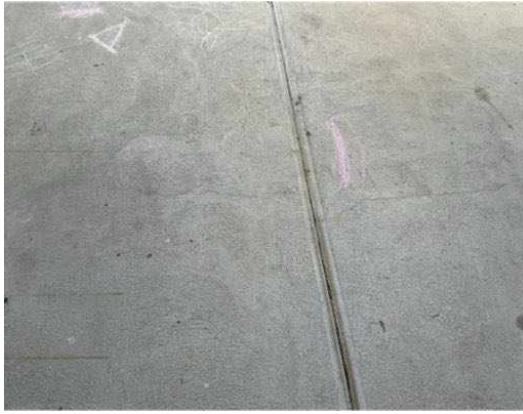
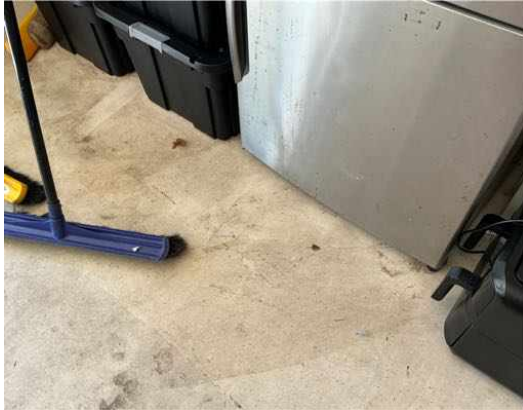
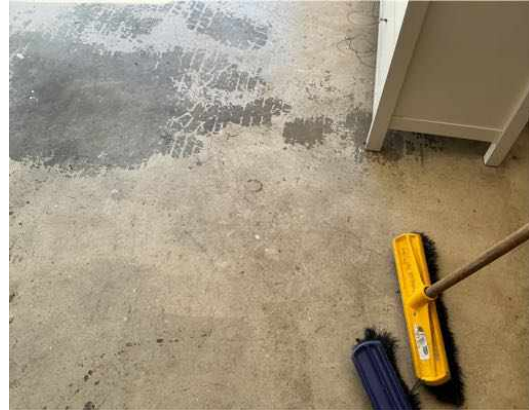
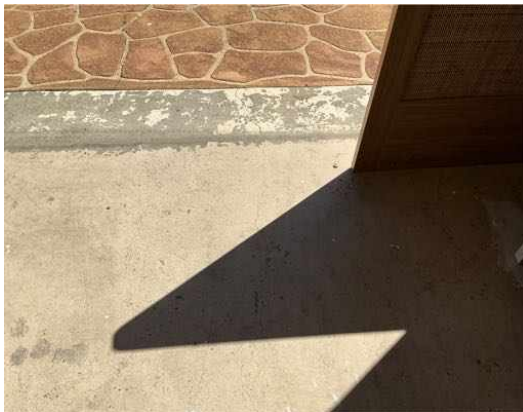
Finding 3.02

Building: Main Building
Location: Driveway and pathway
Finding: Driveway/pathway Cracking
Information: Cracks were identified in the driveway and pathways concrete paving. Although cracks are quite noticeable, they are often only considered to be an appearance defect, and usually do not indicate any structural damage.

Generally the cause of the cracks in existing concrete paving such as driveways and pathways is indicative of the expansion and contraction of the concrete. Such causes are generally due to environmental factors, such as moisture levels, weather conditions, root systems of nearby trees or the soil types on which they are laid.

Cracks may also be due to poor original installation of the concrete. Factors such as poor compaction of the sub surface and/or inadequate reinforcing of the slab may create cracking and other secondary defects.

Monitoring of all cracking should be conducted frequently. Always contact a building inspector should cracks widen, lengthen, or become more numerous.

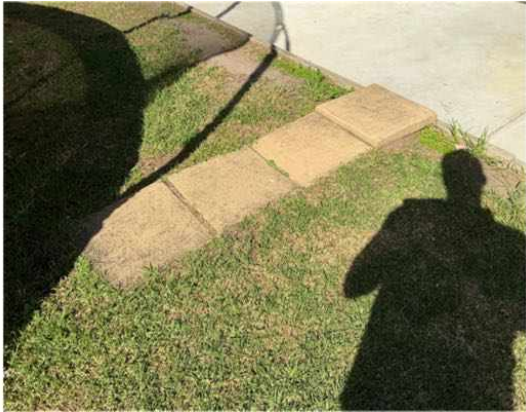
Finding 3.03

Building: Main Building
 Location: Rear pathway
 Finding: Paving - loose/uneven
 Information: Sections of the external paved area are loose/uneven, creating a potential trip hazard. It appears as though the area has been subject to rough installation, or that paving sections have lifted due to movements in the foundation of the property.

Where paving creates a trip hazard, personal injury may ensue if due caution is not taken by all persons within this area.

Re-paving of the area is required as soon as possible to remedy this situation. Further

consultation with a specialist paver is advised.

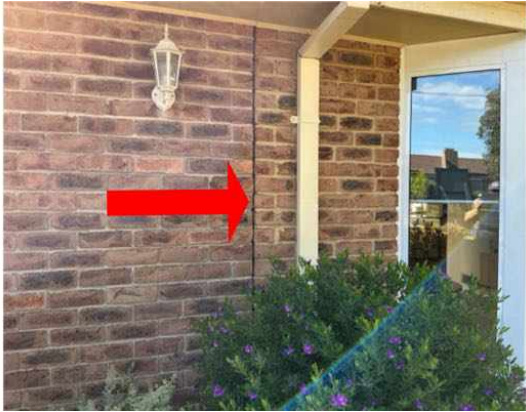
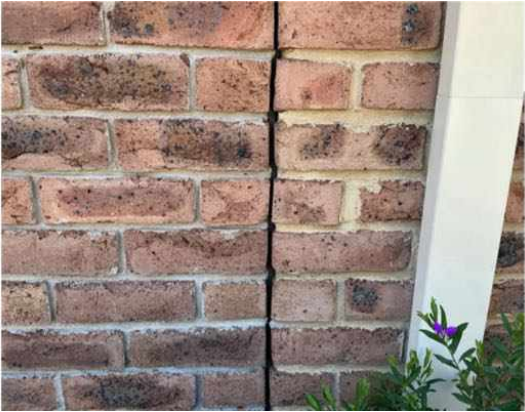
Finding 3.04

Building: Main Building
Location: Exterior walls
Finding: A few gaps to the exterior walls/windows
Information: A few gaps were noticed to some of the exterior walls/windows to the building. These gaps can let in water, drafts, and pests. Overtime moisture ingress may cause damage to internal walls, mould growth, or structural issues. Gaps also reduce the energy efficiency of the property. Recommend engaging a caulker to seal gaps with an exterior grade flexible sealant that is UV and weather resistant to reduce the risk of pest/water penetration to the building as soon as possible.

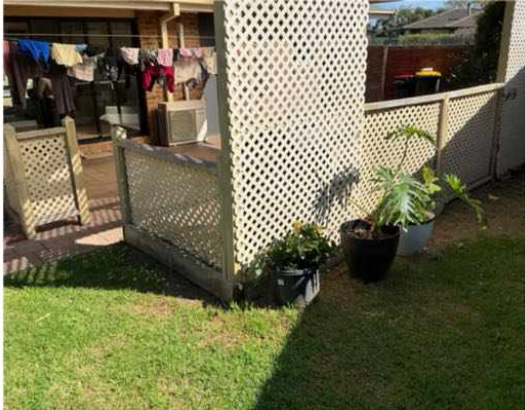
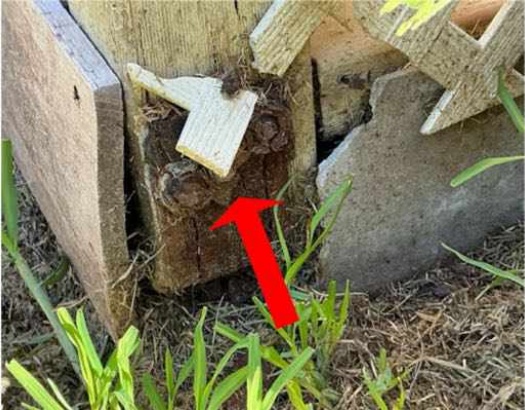
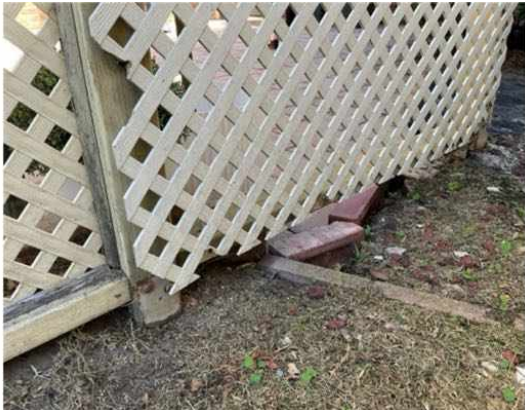
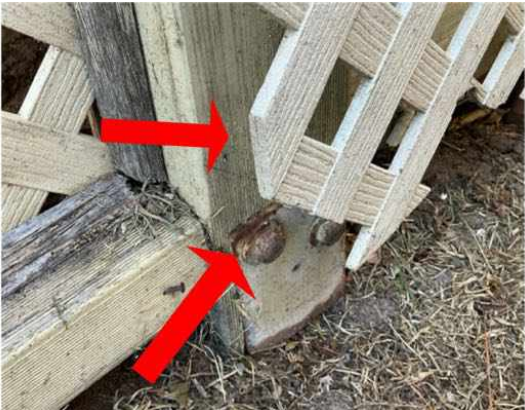
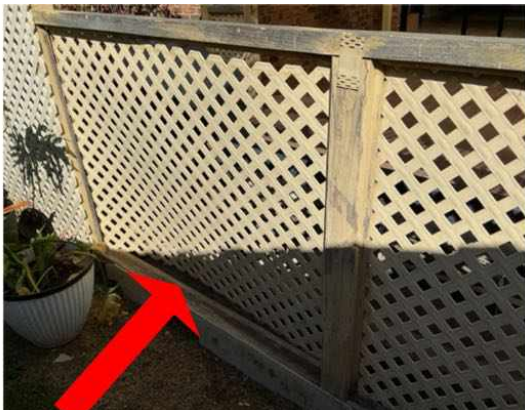
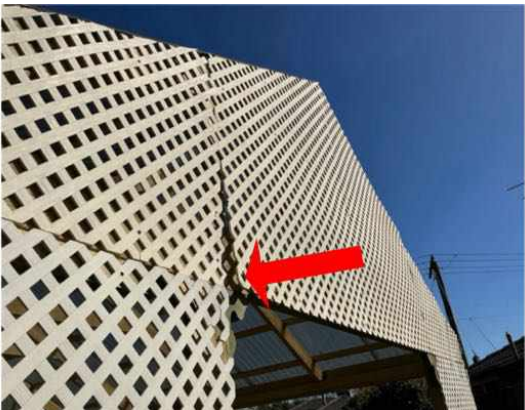
Finding 3.05

Building: Main Building
Location: Yard - Back
Finding: Patio fixings rusted and cladding deteriorated
Information: During inspection of the patio it was noted that some of the fixings are rusted and parts of the cladding is deteriorated. Recommend engaging a carpenter to replace rusted fixings and repair parts of the cladding that is deteriorated to reduce the risk of further deterioration as soon as possible.

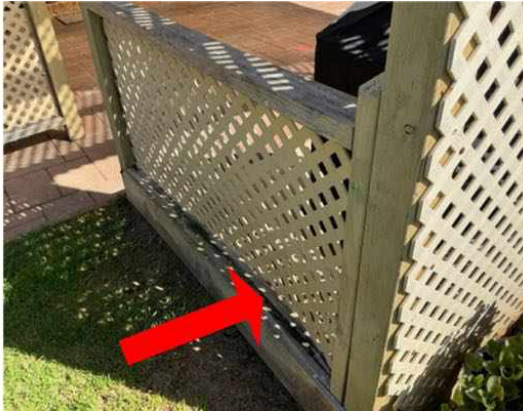
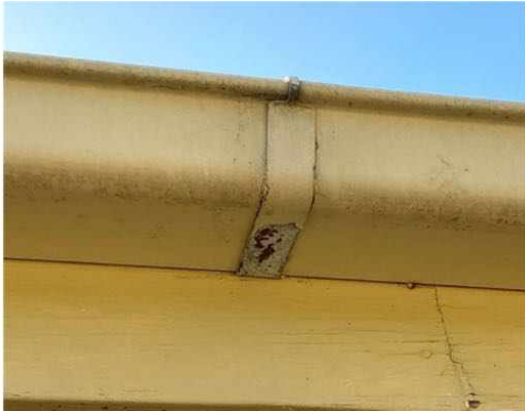
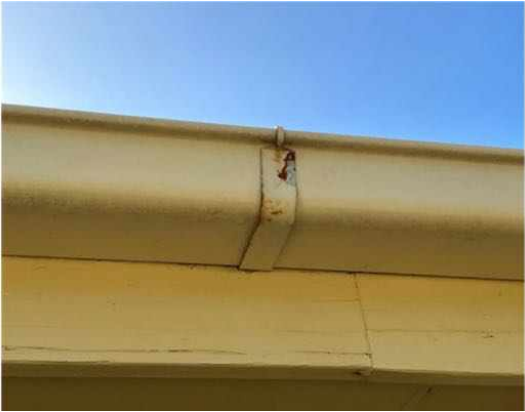
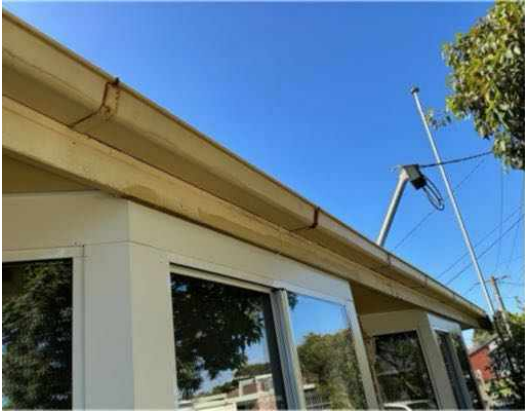
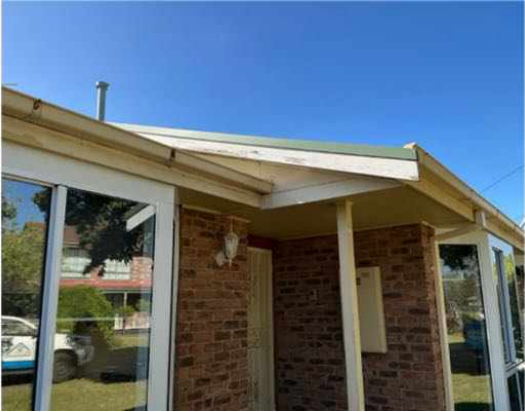
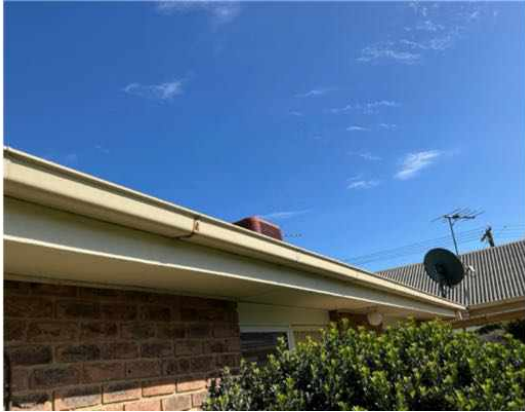
Finding 3.06

Building:	Main Building
Location:	Roof Exterior
Finding:	Gutters clips Rusted or corroded
Information:	The gutter clips to the roof shows evidence of rusting and corrosion, which is likely to have developed as a result of excessive exposure to moisture and or inadequate coatings.

As surface rust provides no protection to the underlying iron, the deteriorating condition is likely to worsen if not addressed in the short-term future.

Where possible, the use of galvanized (treated) metals or aluminium coated metals aid in rust prevention, as does regular general maintenance. Rust formation can be controlled with coatings, such as paint, that isolate the iron from the environment.

Rusting and corrosion should be managed by ideally removing or limiting the affected surface from exposure to moisture.

A licensed plumber may be appointed to replace any building elements that have been severely affected by rust or water damage.

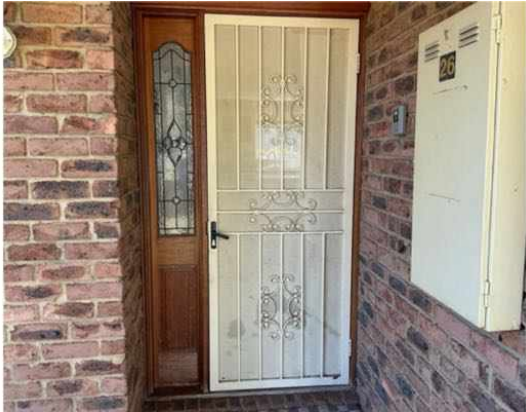
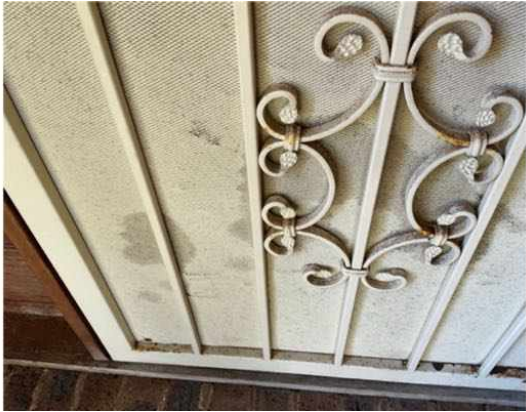
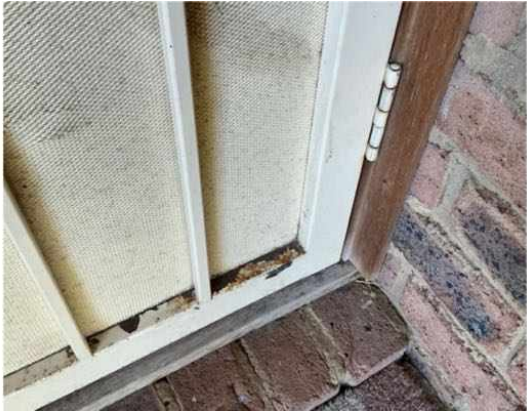
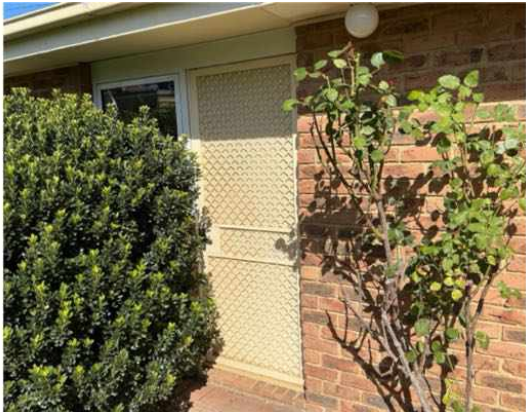
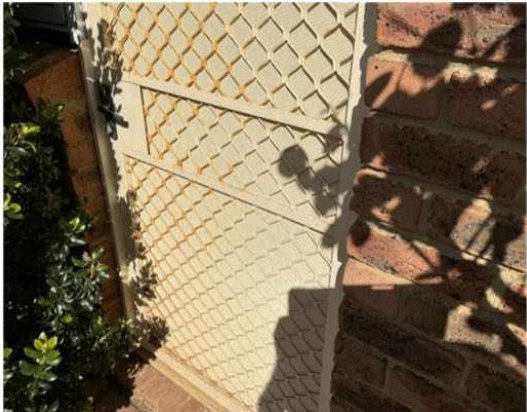
Finding 3.08

Building:	Main Building
Location:	Security doors
Finding:	Security door -Deteriorating/rust

Information: The front and rear security doors have deteriorated/rusted due to deterioration of the paint work overtime.Recommend engaging a carpenter/painter to repair or replace to reduce the risk of further damage at the owners discretion. Whilst incomplete or missing paint finish is generally an appearance defect, it can also lead to the development of secondary building defects over time. Incomplete areas of paint finish expose the area to moisture, potentially accelerating the deterioration of underlying building materials.

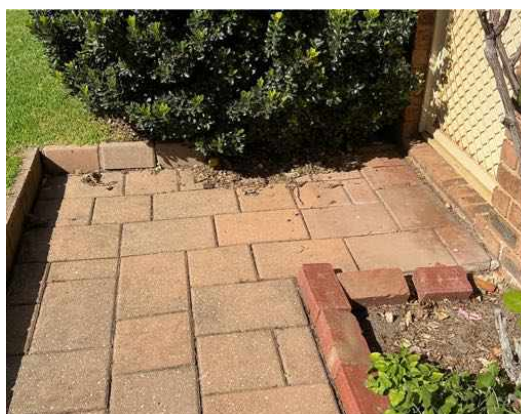
Finding 3.10

Building: Main Building
 Location: Yard - Back
 Finding: Deteriorating/loose garden edging
 Information: The garden edging in the rear yard has deteriorated and is coming loose due to poor installation. Recommend engaging a landscaper to repair/replace to reduce the risk of further deterioration as soon as possible.

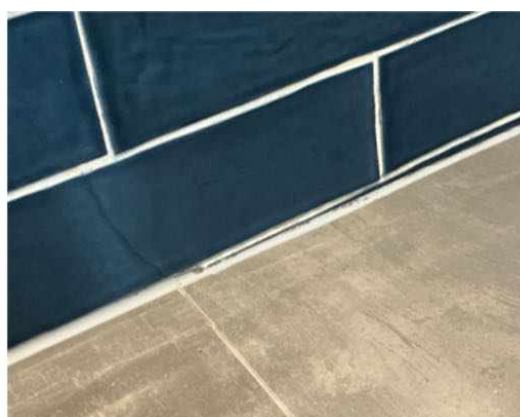
Finding 3.11

Building: Main Building
 Location: Bathroom
 Finding: Bathroom Sealant and grouting - Missing or damaged
 Information: It was noted on inspection that sealant or grout is degraded to the tiled shower alcove and or other areas of the bathroom.

Different materials and floor areas move at different rates, generally causing cracking

Flexible and mould resistant materials should be applied to affected areas to prevent any subsequent water damage that is likely to occur. Regular maintenance and replacement of damage or missing or damaged sealant and grout is highly recommended to the wet areas, as this is a regular wear and tear defect. Sealant and grouting in areas that come into regular contact with water should be maintained for the long term care of your property.

A sealant specialist or tiling contractor should be appointed to complete these works as soon as possible

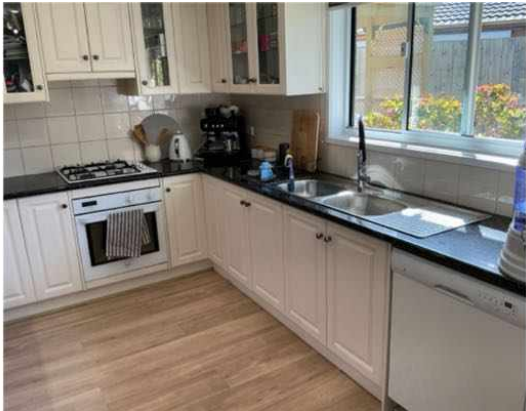
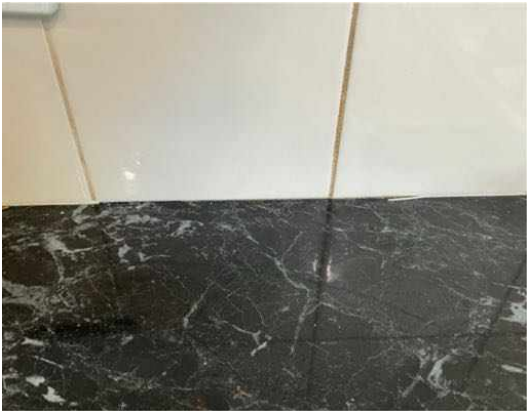
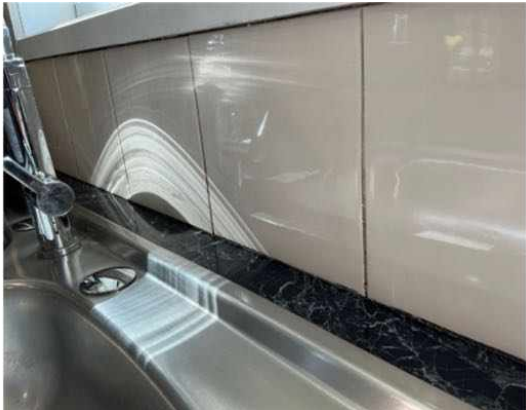
Building:	Main Building
Location:	Kitchen
Finding:	Kitchen Sealant and grouting - Missing or damaged
Information:	It was noted on inspection that sealant or grout is degraded to the kitchen splash back and or other areas of the kitchen.

Different materials and floor areas move at different rates, generally causing cracking to grout or sealant at this point. A flexible sealant is required to allow for expected expansion and contraction, while keeping the joint water tight and protective of all associated building materials.

There appears to be excessive mould to the sealant and grout which will likely require scraping out and replacement.

Flexible and mould resistant materials should be applied to affected areas to prevent any subsequent water damage that is likely to occur. Regular maintenance and replacement of damage or missing or damaged sealant and grout is highly recommended to the wet areas, as this is a regular wear and tear defect. Sealant and grouting in areas that come into regular contact with water should be maintained for

the long term care of your property.

A sealant specialist or tiling contractor should be appointed to complete these works as soon as possible

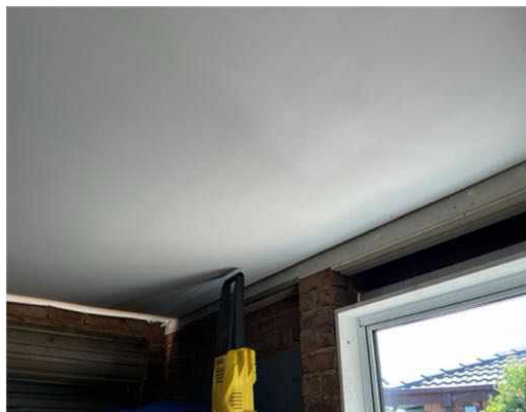
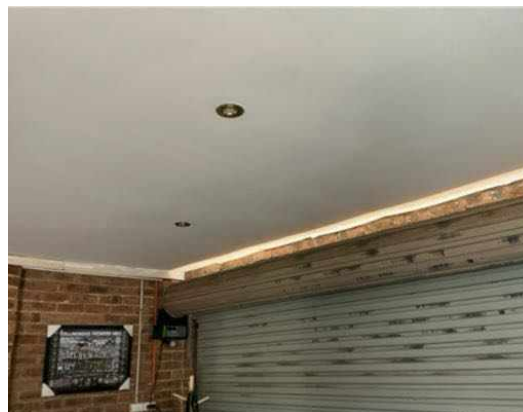
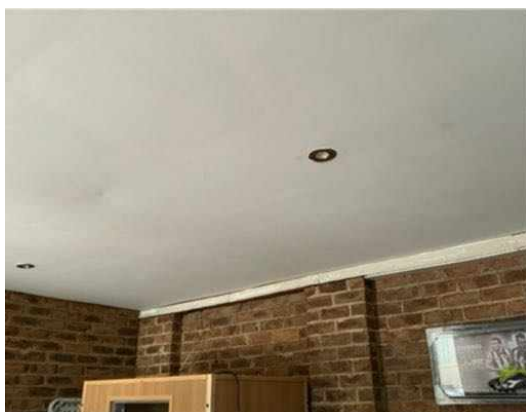
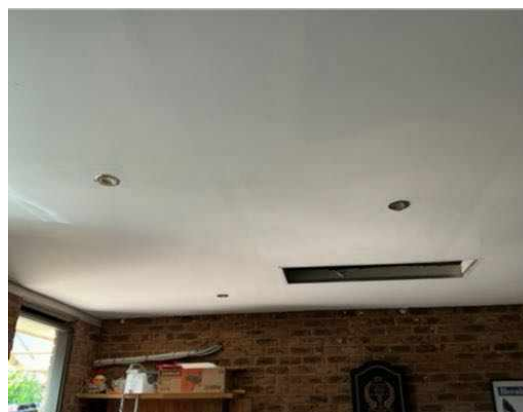
Finding 3.14

Building:	Main Building
Location:	Garage
Finding:	Garage plaster work unfinished
Information:	During inspection of the garage it was noticed that there is no cornices fitted and the manhole is unfinished. Recommend engaging a plasterer/painter to rectify to finish off.

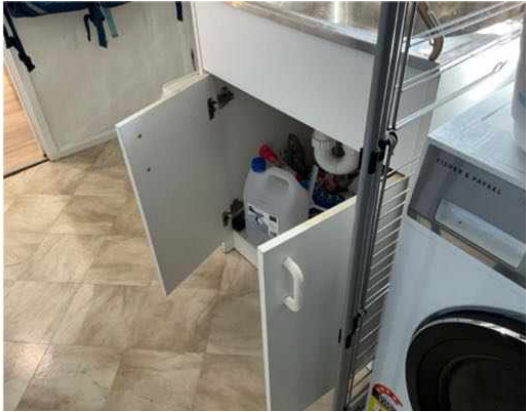
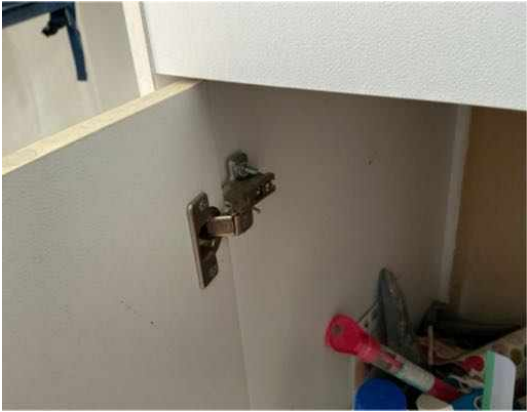
Finding 3.15

Building:	Main Building
Location:	Laundry
Finding:	Cabinets need adjument
Information:	On inspection it was noticed that the laundry cabinets do not shut correctly and require maintenance or adjustment. Recommend engaging a cabinet maker to adjust/maintain to reduce the risk of further deterioration at the owners discretion.

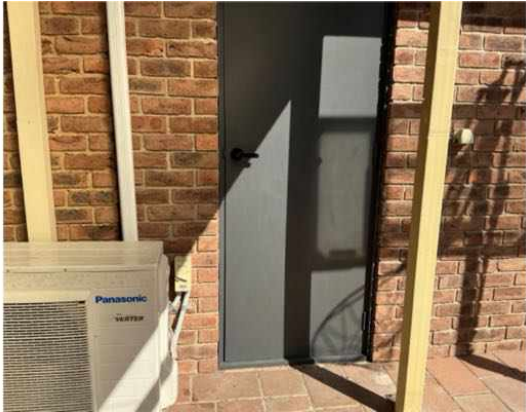
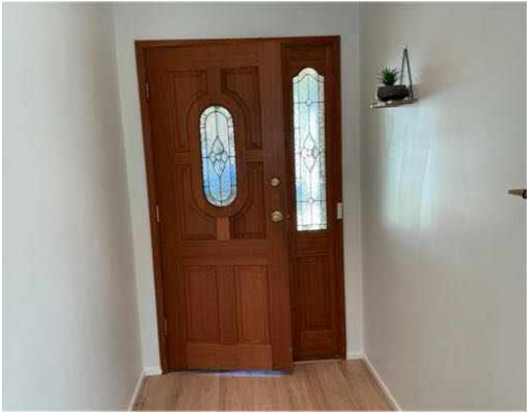
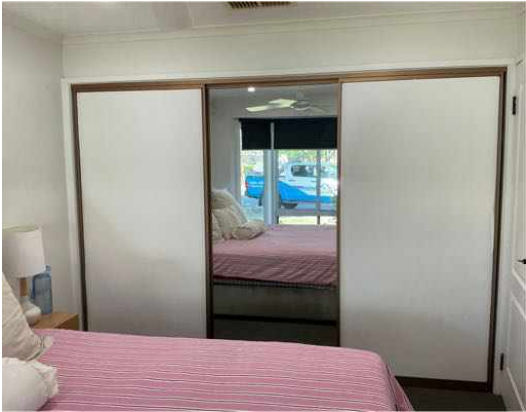
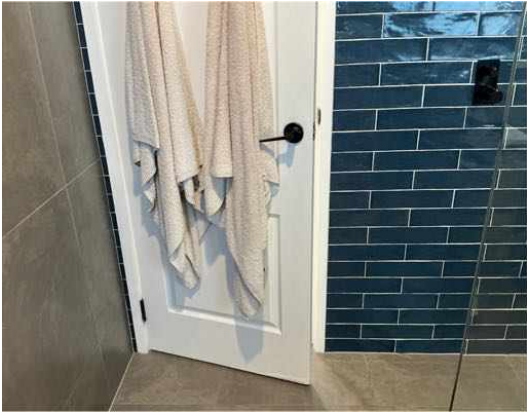
Finding 3.16

Building: Main Building
 Location: Various parts of the building
 Finding: Doors required maintenance
 Information: Some of the doors to the building require some maintenance to make them operate more smoothly. This can happen overtime with deterioration or lack of maintenance. Recommend engaging a carpenter to repair/maintain doors at the owners discretion.

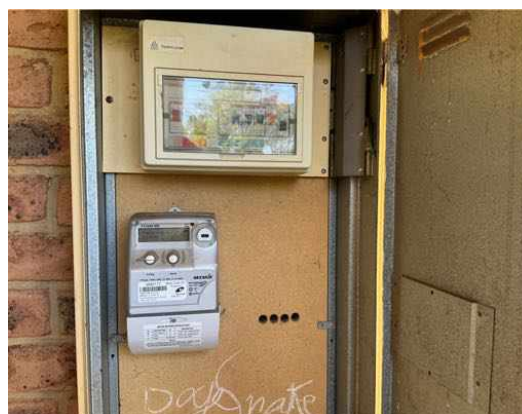
Building:	Main Building
Location:	All External Areas
Finding:	No Termite Management System - no evidence of a chemical installation
Information:	The application of a post-construction chemical termite barrier is highly recommended for all properties, particularly if live termite activity has been found on the site previously. Such barriers are highly effective in preventing termite attack on any timber building elements throughout the property.

A durable notice should be placed in the switchboard unit to indicate current termite barriers. At the time of inspection, it appeared as though no termite management system has been installed, with no evidence to suggest preventative works taking place.

The client may consider gaining further advice from a pest controller as to the costs and procedures involved with this application. It is recommended that obtaining such advice be a short-term priority.

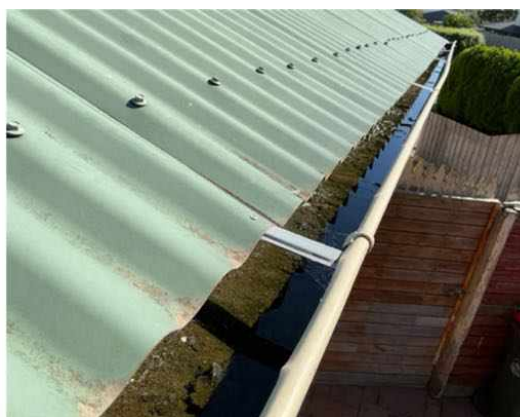
Finding 6.02

Building:	Main Building
Location:	Roof Exterior
Finding:	Gutters - Water pooling
Information:	Water was found to be pooling in sections of the rear roof and patio roof guttering. This creates excessive moisture which can attract termites. This is generally a

secondary defect caused by blocked or partially blocked gutters or if the gutters do not have enough fall to the down pipes. Such blockages and subsequent water pooling are likely to lead to rust and water damage to associated structures if left unattended.

Any areas of guttering that shows evidence of water pooling should be checked for partial or full blockages and any secondary damage that may have occurred as a result. Depending on the extent of the damage, building elements may require repair and/or replacement to ensure adequate roof drainage and function of exterior plumbing system.

A roofing plumber should be appointed as soon as possible to rectify this issue. It is highly advised that all gutters be maintained on a frequent basis to ensure the condition of roof plumbing.

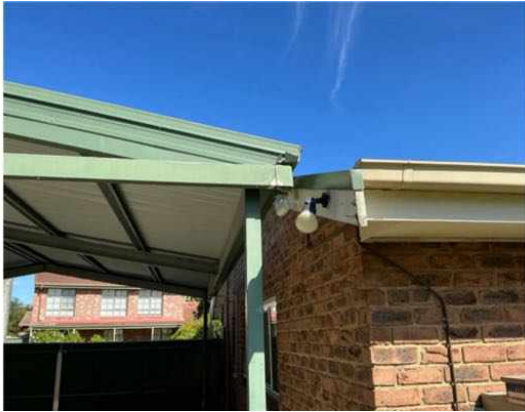
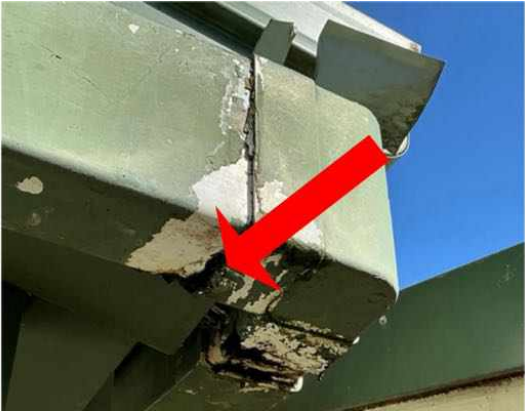
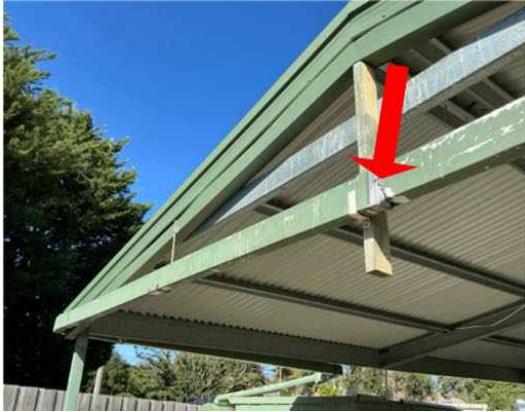
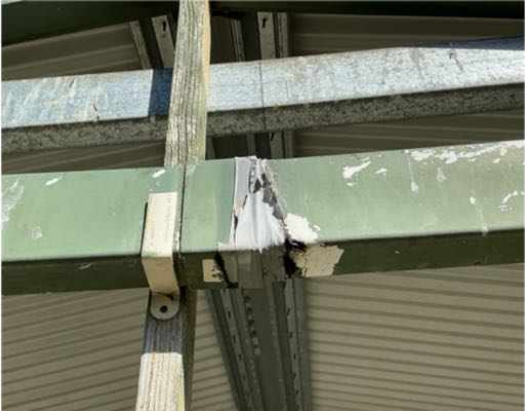
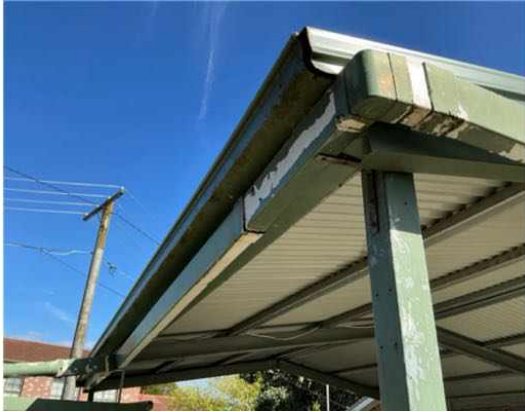
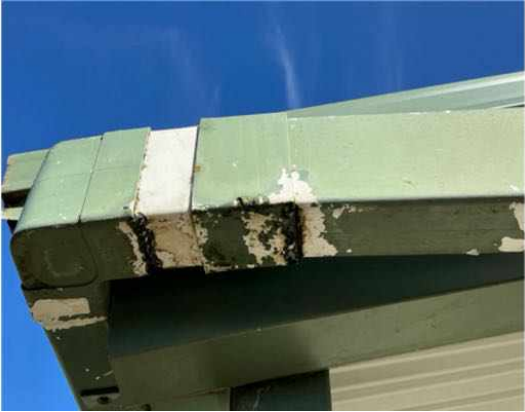
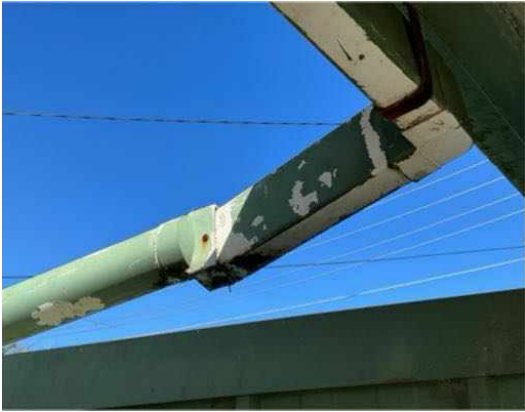
Building:	Main Building
Location:	Carport
Finding:	Leaking down pipes
Information:	The down pipes to the carport are leaking due to deterioration overtime or impact damage. This disconnection negatively impacts the functional capacity of the roof plumbing.

Where roof plumbing doesn't drain adequately, the area at the base perimeter can become excessively damp, potentially creating an environment that is susceptible to rust and corrosion of surrounding building elements, as well as attracting termites and other pests.

It is highly recommended that a plumber be appointed to further inspect the area and to install adequate drainage equipment where necessary.

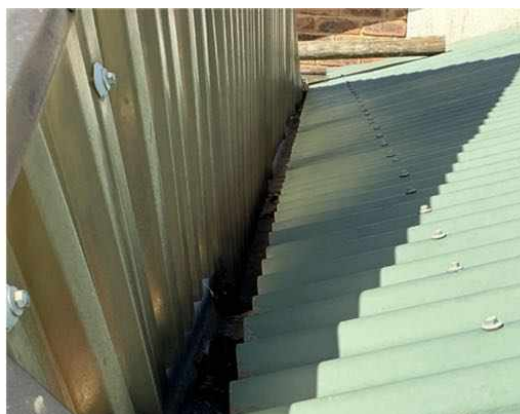
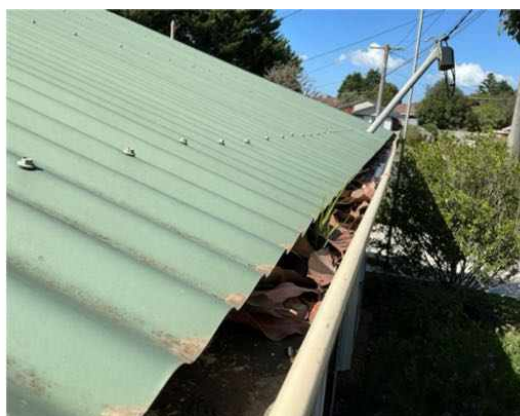
Finding 6.05

Building: Main Building
Location: Roof Exterior
Finding: Gutters -Partially Blocked with debris
Information: It was noticed on inspection that some of the gutters were partially blocked with debris. Roof plumbing structures, such as guttering and downpipes, should be free of all debris to prevent blockages. Blockages of the guttering and downpipes will lead to pooling and accumulated water overflows, which is likely to subsequently flood eaves and exterior walls.

Blocked gutters are likely to lead to high levels of moisture in the affected areas. Such moisture will not only cause rust and decay of the associated building materials, but can also provide conditions that are conducive to termite and timber pest activity. Blockages in gutters should therefore be removed immediately to ensure dry conditions are maintained.

Consult a Licensed Plumber for further specific advice on remedial works that may be required. In the interim, it is highly advised that blocked gutters be removed by the homeowner or a general handyperson as a matter of urgency.

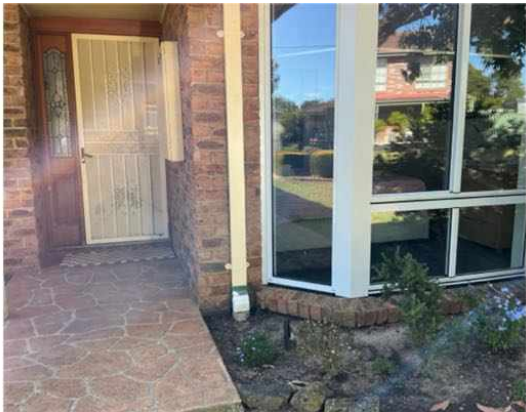
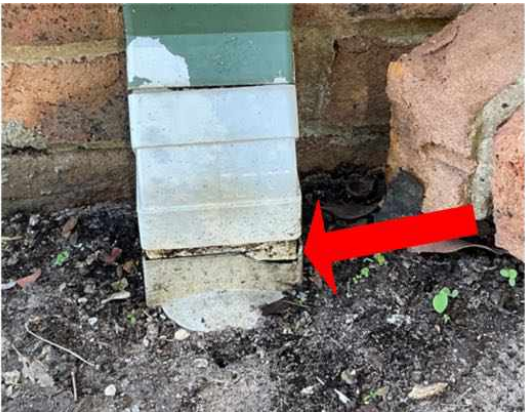
Finding 6.06

Building: Main Building
 Location: Exterior walls - front
 Finding: Damaged down pipe
 Information: The down pipe near the entrance of the building is damaged due to deterioration overtime or impact damage. This disconnection negatively impacts the functional capacity of the roof plumbing.

Where roof plumbing doesn't drain adequately, the area at the base perimeter can become excessively damp, potentially creating an environment that is susceptible to rust and corrosion of surrounding building elements, as well as attracting termites and other pests.

It is highly recommended that a plumber be appointed to further inspect the area and to install adequate drainage equipment where necessary.

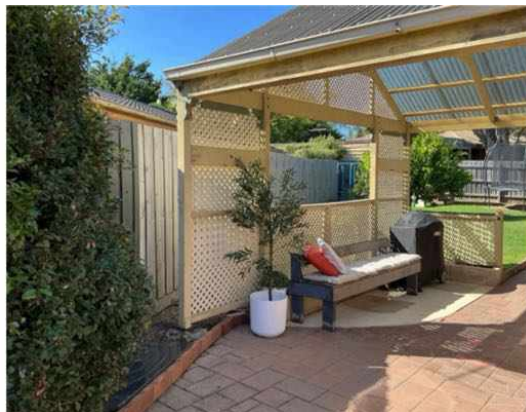
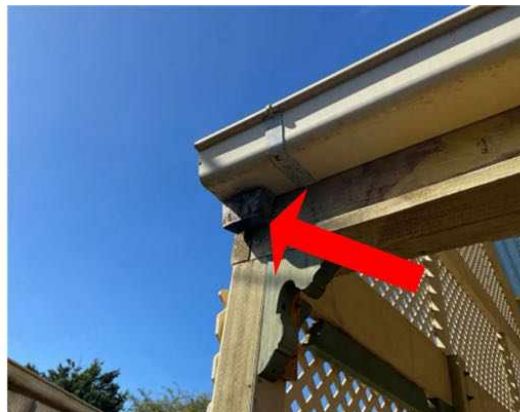
Finding 6.07

Building: Main Building
 Location: Yard - Back
 Finding: No down pipe installed
 Information: No down pipes installed to parts of the patio roof. Where plumbing doesn't drain

adequately, the area at the apse perimeter can become excessively damp, potentially creating an environment that is susceptible to rust and corrosion of surrounding building elements as well as attracting termites and other pests. Recommend engaging a plumber to install down pipes to reduce the risk of footing movement and other moisture related issues as soon as possible.

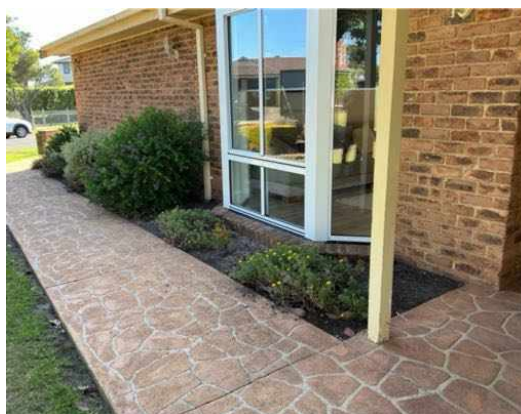
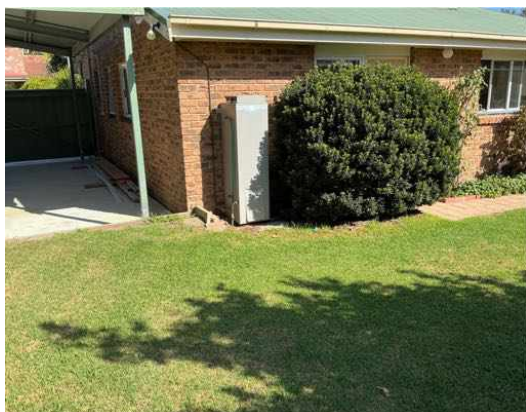
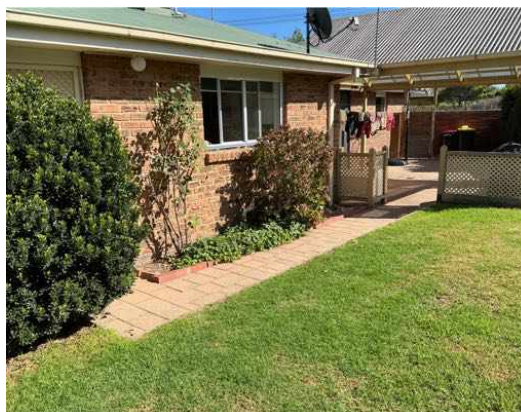
Finding 6.08

Building:	Main Building
Location:	Yards
Finding:	Site drainage - poor/inadequate
Information:	The site drainage to parts of the yards was found to be inadequate at the time of inspection. Where drainage doesn't drain adequately, the area at the base perimeter can become excessively damp, potentially creating an environment that is susceptible to rust and corrosion of surrounding building elements as well as attracting termites and other pests.

It is important that water does not lie against the base of walls; surrounding paths and ground levels should be sloped to drain water away from walls. Downpipes should not discharge stormwater onto lower walls or plinths. Stormwater should be carried away by large, regularly cleaned drains. Ground levels may need to be lowered to expose a buried DPC.

Where site drainage is inadequate, installation of an Agricultural (Aggie) Drain may be required. A qualified plumber should be appointed to further inspect the property and perform any remedial works as necessary. Water damage and secondary defects are likely to occur if left unmanaged.

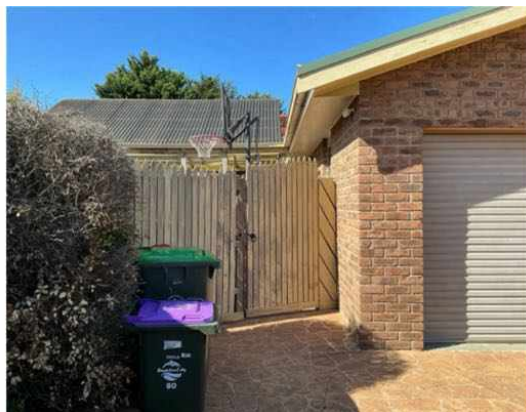
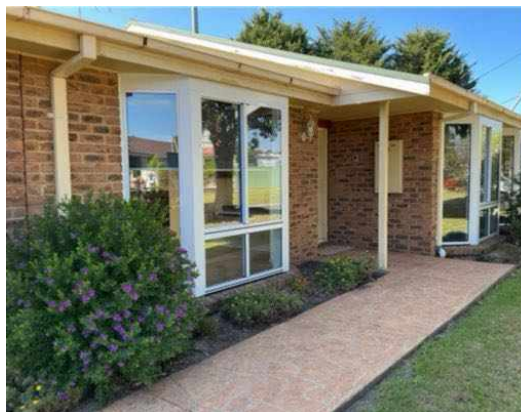
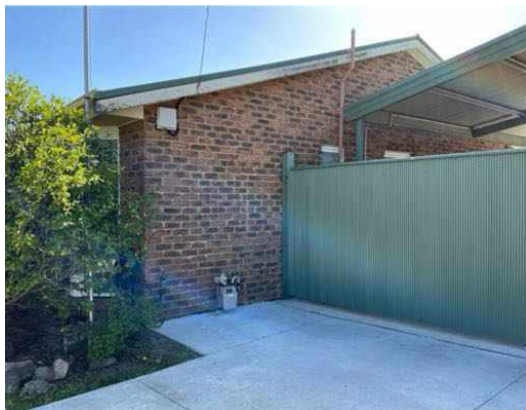
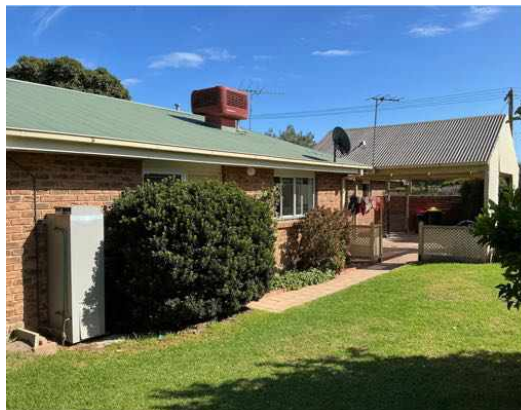
Finding 6.09

Building:	Main Building
Location:	Various parts of the building
Finding:	Bridging attachments to buildings
Information:	Bridging occurs when items against a building provide a concealed entry point for termites into the building or by passing around a termite management system.

Where any part of an attachment to a building is not isolated and is not provided with a clear gap of not less than 25mm from building, bridging occurs. Attachments to buildings such as hot water services, downpipes, verandahs, decks, steps, fences, service conduits and the like provide the opportunity for concealed entry.

Building attachments of this nature need to be frequently inspected for termite activity by a qualified inspector.

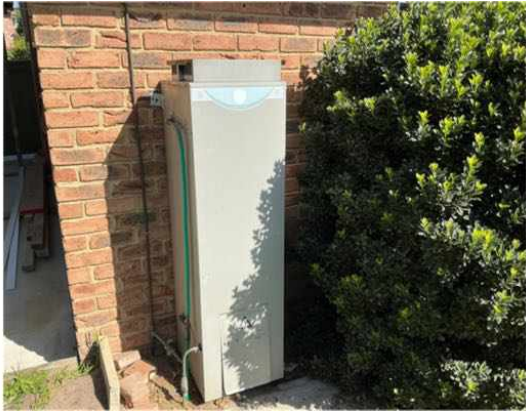
Finding 6.10

Building:	Main Building
Location:	Yard - Back
Finding:	HWS Overflow - Not Connected
Information:	The Hot Water System (HWS) overflow was found to be disconnected from storm water drainage and is creating excessive moisture in the surrounding area.

These damp conditions can lead to secondary defects such as rot, rust or corrosion of associated building elements, the formation of fungal decay, or even the creation of potential slip hazards. When coupled with poor site drainage, pooling of water may also attract termite activity to this area.

It is highly recommended that a licensed plumber be appointed to connect the HWS overflow in order to prevent such an environment from being created. These minor works should be carried out as soon as possible.

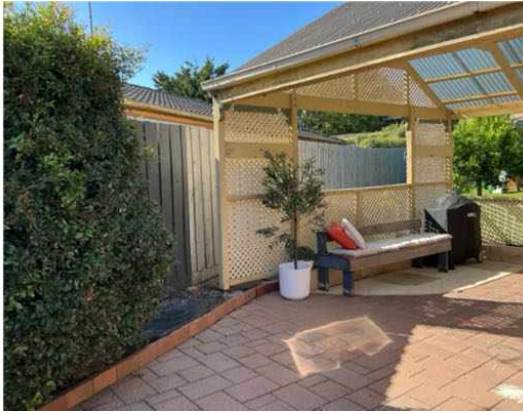
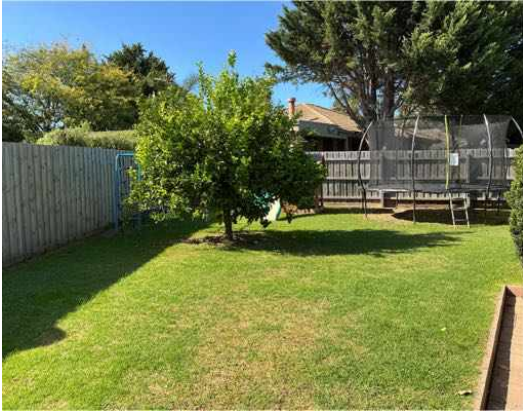
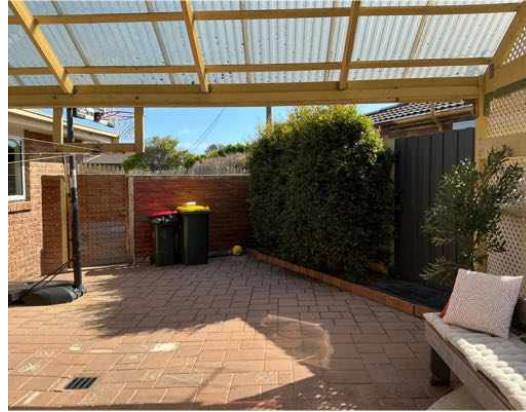
Finding 6.11

Building: Main Building
Location: Various parts of the building
Finding: In ground contact
Information: Any timbers in direct ground contact provide opportunity for concealed termite entry and are likely to be subject to premature rot and decay as the soil retains moisture or damp conditions against the timbers.

Remove untreated timber that is in direct contact with external grounds. Consider replacement with more durable materials i.e. treated timber or non timber elements. Frequent pest inspections are advised to readily identify any termite activity in these areas.

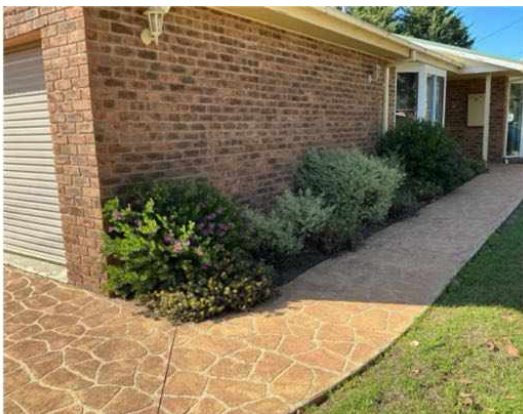
Finding 6.12

Finding: Garden Beds Conditions Conducive to Termites

Information: Garden beds were found to be evident in close proximity to the building. Garden beds immediately adjacent to the perimeter of the building block the visual inspection of these areas, providing a concealed termite entry point.

These garden beds can include untreated timber, and with a combination of moisture from watering hosing can make conditions conducive to termite activity and termite ingress.

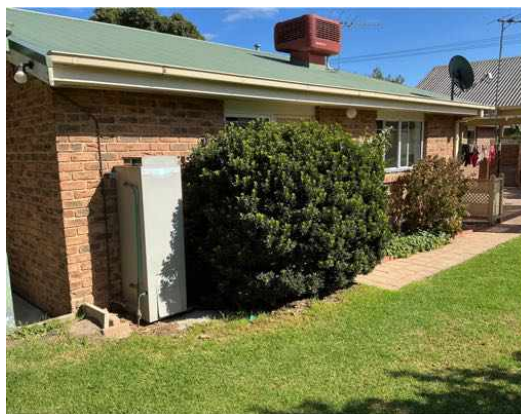
Finding 6.13

Building:	Main Building
Location:	Yard - Back
Finding:	Air conditioning unit overflow -Not plumbed for drainage
Information:	The overflow to the air conditioning unit is not plumbed or connected to suitable drainage, which has resulted in the surrounding area becoming excessively damp. These damp conditions can lead to secondary defects such as rot, rust or corrosion of associated building elements, the formation of fungal decay, or even the creation of potential slip hazards. When coupled with poor site drainage, pooling of water may also attract termite activity to this area. It is highly recommended that a qualified plumber be appointed to install adequate drainage to the overflow. These works will ensure that the area remains dry and free of any secondary defects.

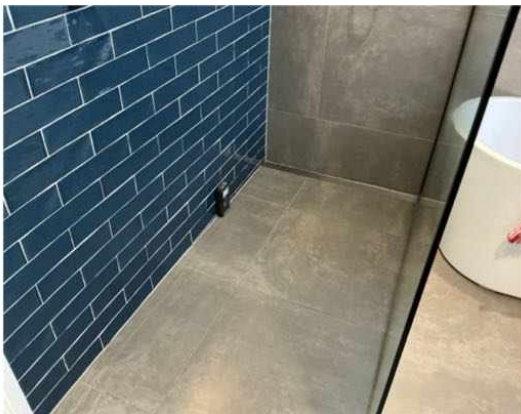
Building:	Main Building
Location:	Bathroom
Finding:	Shower - Damp
Information:	Damp is evident to parts of the bathroom shower alcove found using using a moisture meter. This defect is quite common, and is suspected to have been caused by moisture permeating through the grouting in this area, which shows evidence of

deterioration creating moist conditions. Leaking pipes within the adjoining wall is also a possible cause. Excessive moisture can attract termites.

Damp (or structural damp) refers to the presence of unwanted moisture in the structure of a building, either as the result of intrusion from outside, or condensation from within the structure. In the shower area, internal water leaks or other sources of excessive moisture are generally the cause of damp.

Unmanaged damp in the shower recess is likely to facilitate the formation and development of mould and fungi growth, decaying associated building materials and compromising their structural integrity. It is important to address damp conditions, as the World Health Organisation notes that excess moisture leads - on almost all indoor materials - to growth of microbes such as moulds, fungi and bacteria, which subsequently emit spores and other matter into the indoor air. Exposure to these contaminants is associated with a wide range of respiratory and other health-related problems.

Consultation with a qualified plumber or bathroom specialist is advised immediately to identify the cause of damp and to perform remedial works as required. Where excessive mould growth is present, further inspection by a specialist environmental health inspector should also be considered.

Always ensure that sealant and grout is in good condition to prevent any moisture issues occurring in the future.

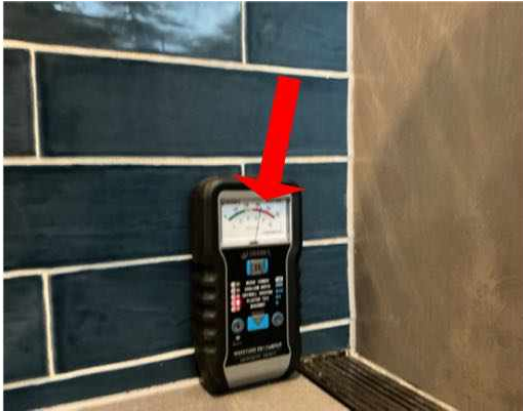
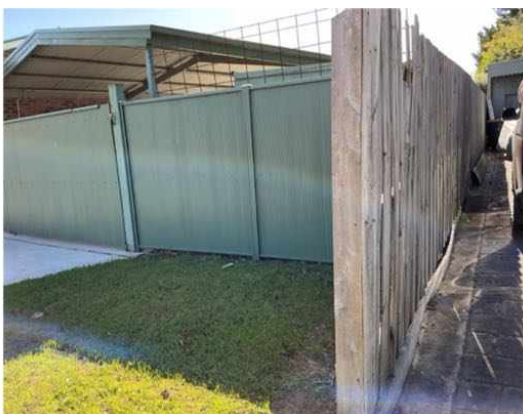
Finding 7.01

Finding: Fencing - wood rot-fungal decay

Information: It was noted at the time of inspection that sections of the fencing to the property have deteriorated and have fungal decay/wood rot present. Typically fencing deteriorates due to age and or wear, rot and or rust which is generally expected for a structure of this age, due to prolonged exposure to weather conditions. Sometimes inadequate installation or maintenance can be to blame.

If left unattended, it is likely that further damage will occur. It is suspected that repair of several elements of the fencing may be required however replacement may be a consideration of the client also.

A licensed fencing contractor should be appointed to provide further advice and perform rectification works as necessary.
