Building and Timber Pest Inspection Report

Inspection Date: Thu, 2 Apr 2026

Property Address: 26 Dorchester Cres, Carrum Downs VIC
3201, Australia

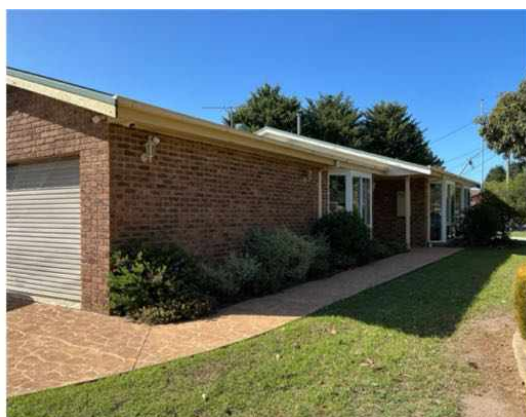
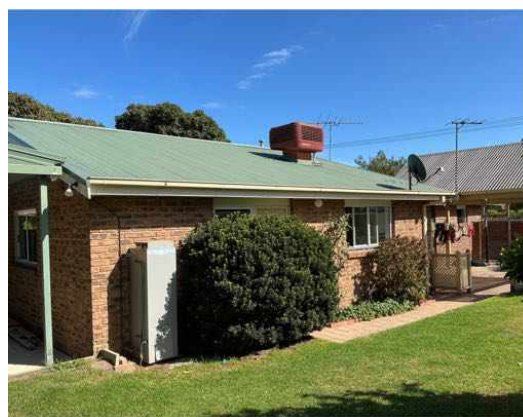
Building:	Main Building
Location:	All External Areas
Finding:	Additional Photos - Obstructions and Limitations
Information:	These photographs are an indication of the obstructions and limitations which impeded full inspection of the property at the time of inspection. These obstructions can hide an array of defects and should be removed to allow full inspection to be carried out. A re-inspection is recommended once the areas are made accessible.

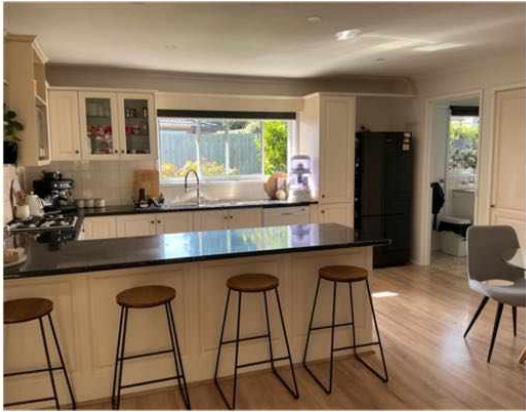
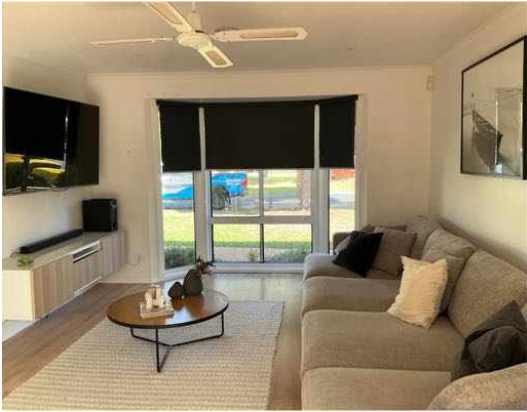
Building:	Main Building
Location:	All Internal Areas
Finding:	Additional Photos - Obstructions and Limitations
Information:	These photographs are an indication of the obstructions and limitations which impeded full inspection of the property at the time of inspection. These obstructions can hide an array of defects and should be removed to allow full inspection to be carried out. A re-inspection is recommended once the areas are made accessible.

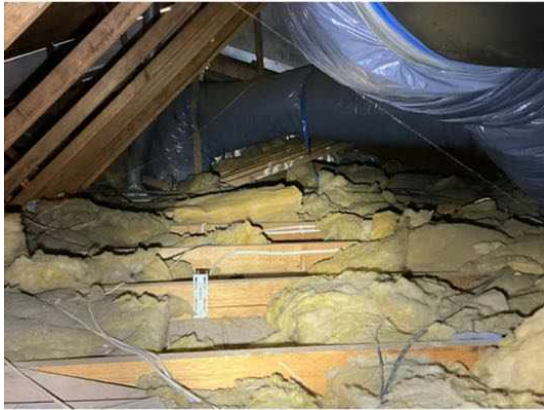
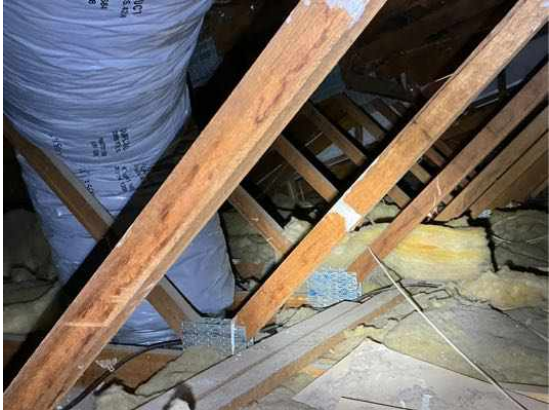
Building: Main Building
Location: Roof Void
Finding: Obstructions and Limitations -roof cavity
Information: These photographs are an indication of the obstructions and limitations which impeded full inspection of the roof cavity at the time of inspection. These obstructions can hide an array of defects and should be removed to allow full inspection to be carried out. A re-inspection is recommended once the areas are made accessible.
