Building and Timber Pest Inspection Report VR

Inspection Date: Thu, 2 Apr 2026

Property Address: 15 Abelia Ave, Yamba NSW 2464, Australia

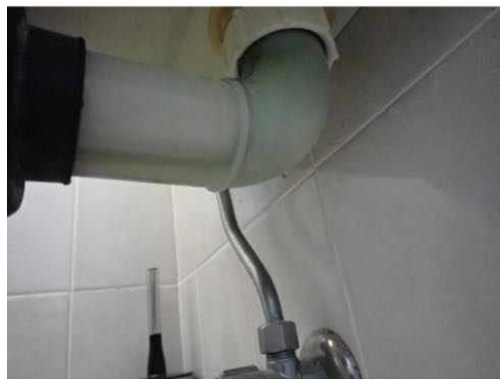
Building:	Main Building
Location:	Toilet (WC)
Finding:	Minor Leak to Toilet Cistern During Flushing

Information: A minor leak was identified to the toilet cistern during flushing. The leak is likely associated with worn internal components such as the inlet valve, outlet seal, or flush mechanism. Continued leakage may lead to unnecessary water wastage and potential deterioration to surrounding building materials over time. It is recommended that a licensed plumber inspect, repair, or replace the defective components as required. Repairs should be undertaken at the owner’s discretion.

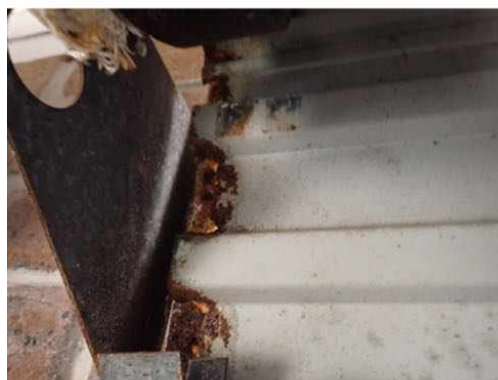
Finding 3.07

Building:	Main Building
Location:	Garage
Finding:	Surface Rust To Garage Roller Door Edges
Information:	Surface rust has been identified to the edges of the garage roller doors. This is typically associated with age-related deterioration, exposure to moisture, or breakdown of protective coatings and is a common defect with garage roller doors of this age. If left untreated, rust may progress and lead to further corrosion and deterioration of the metal components. It is recommended that a painter, metal fabricator, or suitably experienced handyman treat the affected areas, remove corrosion, and apply appropriate protective coatings. Repairs can be carried out at the owner's discretion.

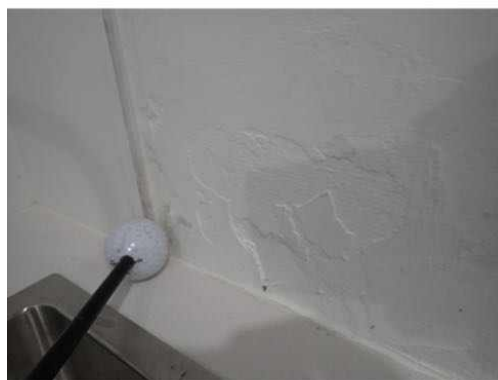
Finding 3.08

Building:	Main Building
Location:	Laundry
Finding:	Missing Tiles To Laundry Splashback
Information:	Tiles are missing to the laundry splashback area. This may be due to previous removal, damage, or incomplete installation works. The absence of tiles can expose underlying wall materials to moisture ingress, potentially leading to deterioration over time. It is recommended that a tiler or suitably experienced handyman replace the missing tiles and ensure appropriate sealing to prevent moisture penetration. Repairs can be carried out at the owner's discretion.
