Building and Timber Pest Inspection Report

Inspection Date: Thu, 22 Jan 2026

Property Address: 1064 S Arm Rd, South Arm NSW 2460, Australia

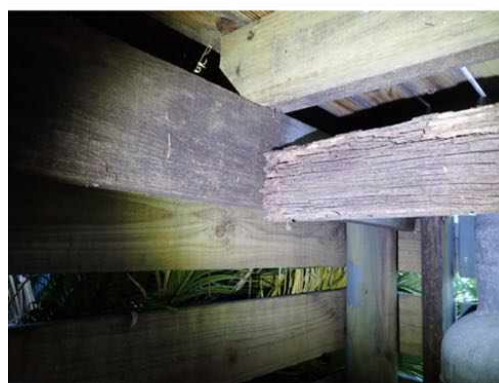
Finding 1.01

Building:	Main Building
Location:	Subfloor
Finding:	External – Gas Regulator Timber Mount Age Related Damage
Information:	Age related damage was identified to the timber that the gas regulator is fixed to. Maintenance or replacement of the affected timber is recommended to ensure adequate support to the installation. Repairs can be carried out by a suitably qualified carpenter, with a licensed gas plumber engaged if the regulator requires adjustment or removal.

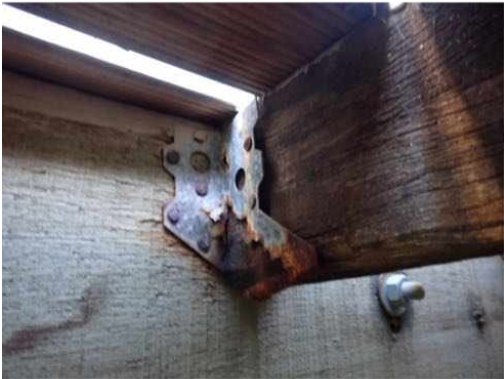
Finding 2.02

Building:	Main Building
Location:	Subfloor
Finding:	External – Deck Framing Joist Hangers
Information:	Rusted joist hangers were identified to the deck framing. This is a common age-related condition and maintenance or replacement of affected fixings is recommended to maintain structural support. Repairs can be carried out by a suitably qualified carpenter or builder.

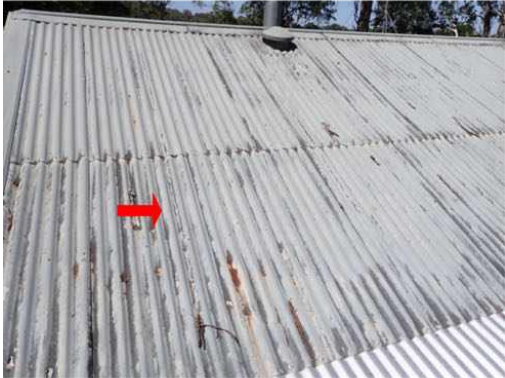
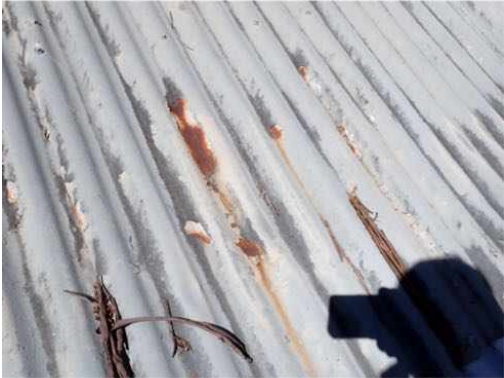
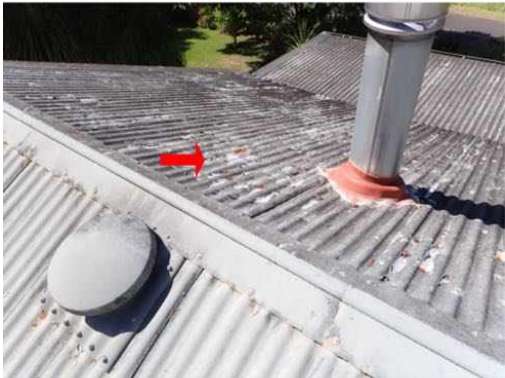
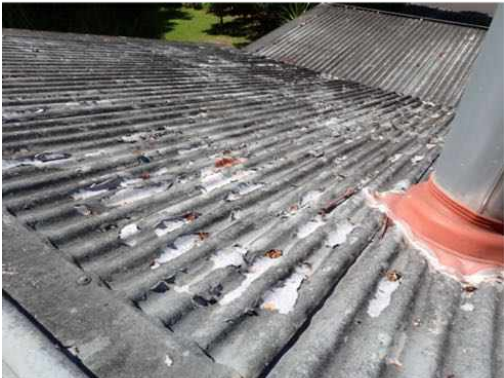
Finding 2.03

Building: Main Building
Location: Roof Exterior
Finding: Roof – Cladding Poor Condition.
Information:

The roof cladding was found to be in poor condition, with defects including flaking paint, surface rust, impact-related damage, rusted fixings, and evidence of sheet patchwork add ons. This condition is consistent with age-related deterioration and ongoing maintenance or further works may be required to maintain weatherproofing. Further assessment and repairs can be carried out by a suitably qualified roofing contractor or builder.

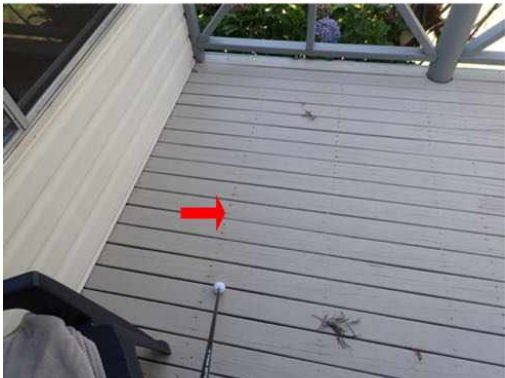
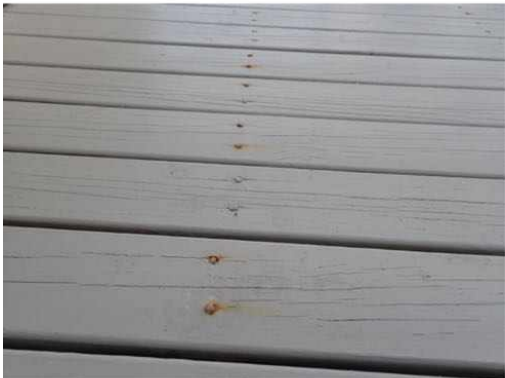
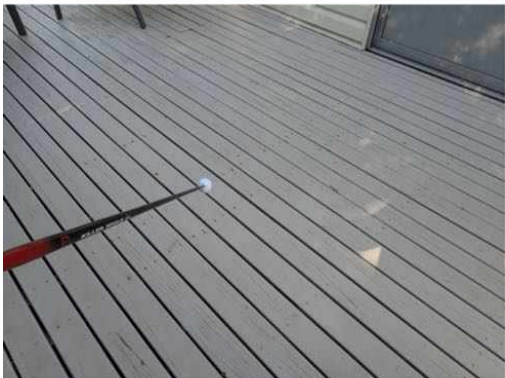
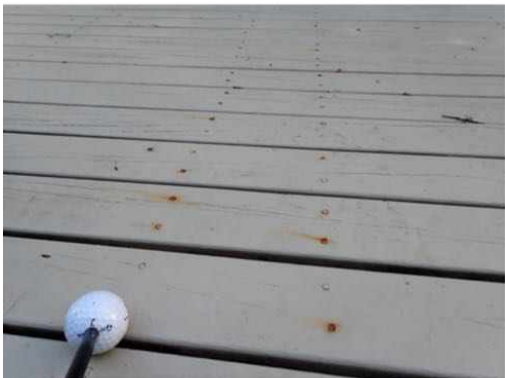
Finding 3.04

Building: Main Building
 Location: Decked areas
 Finding: External – Timber Decking Fixings
 Information: Rusted decking fixings were identified to the timber decking boards at multiple locations. This is a common age-related condition and may reduce the long-term effectiveness of the fixings. Replacement of affected fixings as part of routine maintenance is recommended. Repairs can be carried out by a suitably qualified carpenter or handyman.

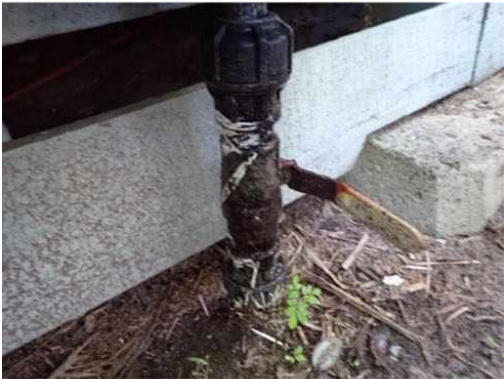
Finding 3.06

Building: Main Building
Location: Left hand side of building
Finding: Plumbing – Leaks
Information: Minor leaks in the plumbing were identified at this location. Maintenance and repairs are recommended to prevent ongoing moisture-related issues. Repairs can be carried out by a suitably qualified plumber

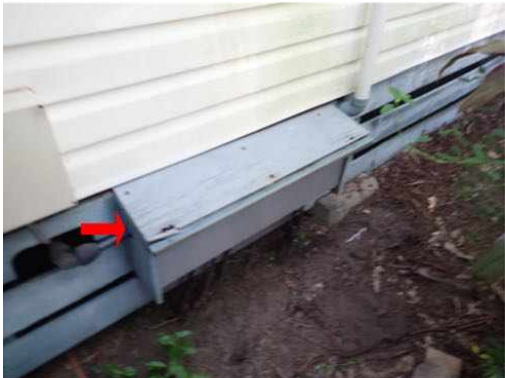
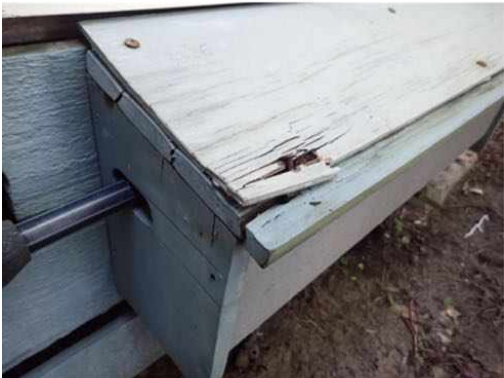
Finding 3.07

Building: Main Building
Location: Left hand side of building
Finding: Plumbing – Timber Cover
Information: Wood rot was identified to the plumbing timber cover at this location. Ongoing maintenance or replacement of the affected timber is recommended to prevent further deterioration. Repairs can be carried out by a suitably qualified carpenter or handyman.

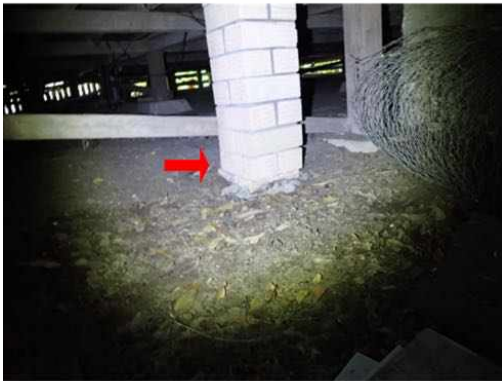
Finding 3.08

Building:	Main Building
Location:	Subfloor
Finding:	Subfloor – Brick Pier Alignment
Information:	A damaged brick pier was identified to be out of alignment at the base. While this appears localised, maintenance and rectification are recommended to ensure continued support and stability. Repairs can be carried out by a suitably qualified bricklayer or builder.

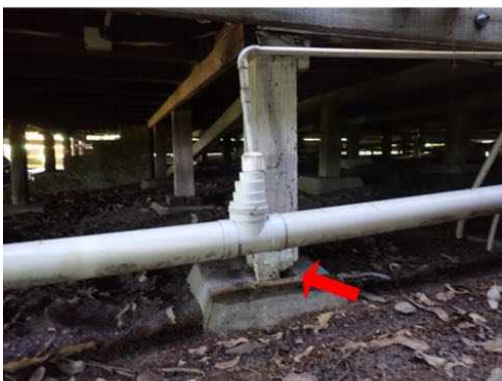
Finding 3.09

Building:	Main Building
Location:	Subfloor
Finding:	Subfloor – Timber Stumps
Information:	Although the majority of the timber stumps were found to be in good condition, several stumps were identified to be out of plumb and/or exhibit minor wood rot. This is a common defect with a building of this age and appears localised in nature. Repairs can be carried out as deemed necessary by a suitably qualified builder or carpenter.

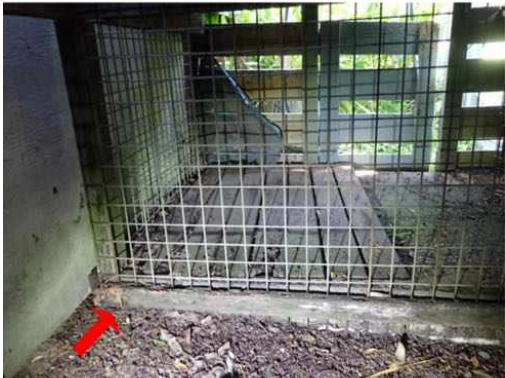
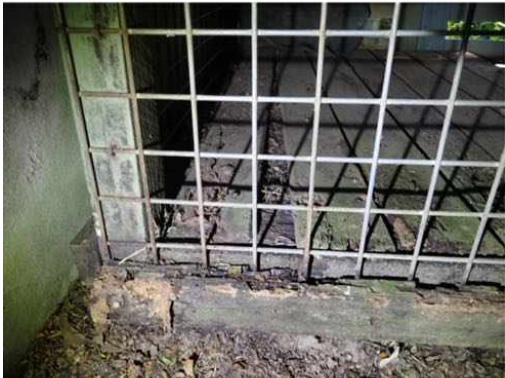
Finding 6.02

Building: Main Building
Location: Subfloor
Finding: Wood rot — old pet inclosure
Information: Wood rot was identified to what appeared to be an old pet enclosure. This appears to be age-related deterioration, removal of the affected timber is recommended as required to prevent conditions that are conducive to termite attack. Works can be carried out by a suitably qualified carpenter or handyman.

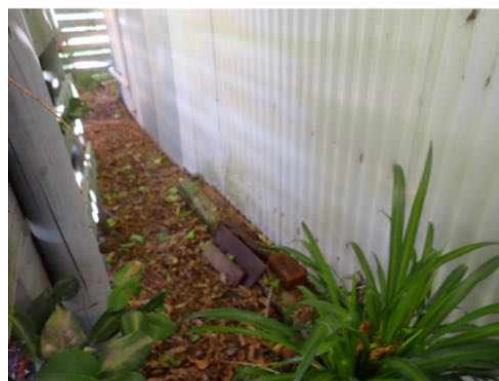
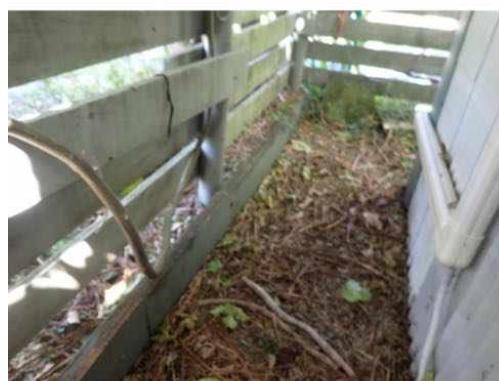
Finding 6.03

Building:	Shed
Location:	Perimeter of shed/granny flat
Finding:	Subfloor / Exterior – Conditions Conducive to Timber Pest Activity
Information:	Conditions conducive to timber pest attack were identified around the lower perimeter of the building. This is a common condition and improving ground clearances and ongoing maintenance is recommended to reduce risk. Works can be carried out by a suitably qualified carpenter, with advice from a licensed timber pest technician if required.

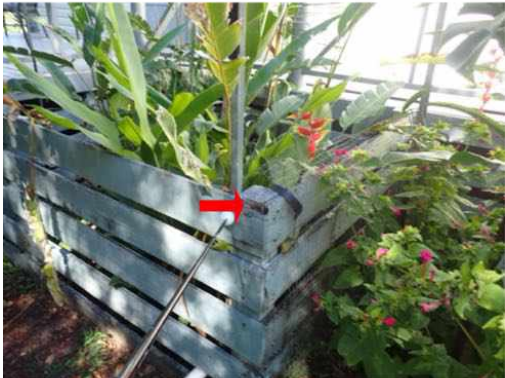
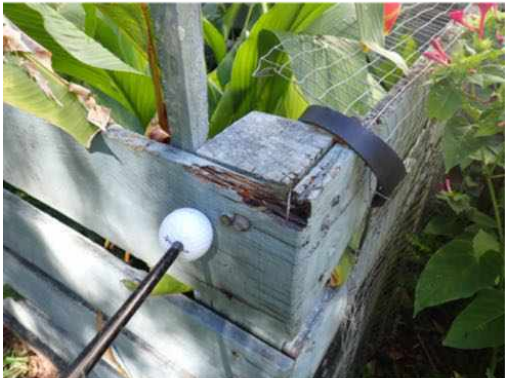
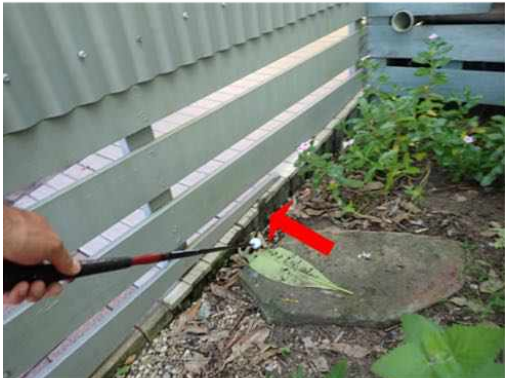
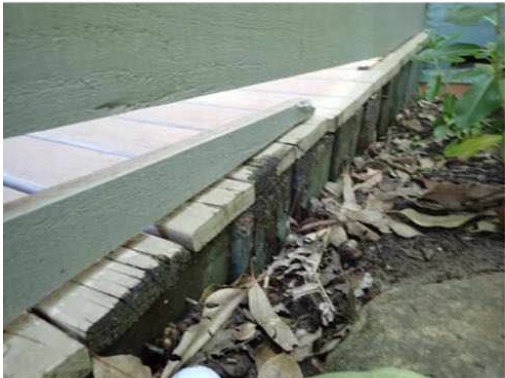
Finding 7.03

Building: Main Building
Location: Decking and perimeter of building
Finding: External – Timber Screening
Information: Wood rot was identified to timber screening at several locations. This is a common age-related condition and maintenance or replacement of affected sections is recommended to prevent further deterioration. Repairs can be carried out by a suitably qualified carpenter or handyman.

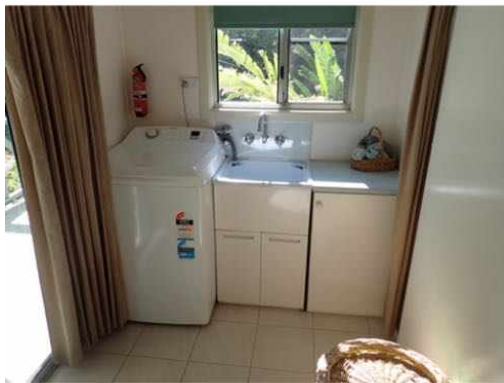
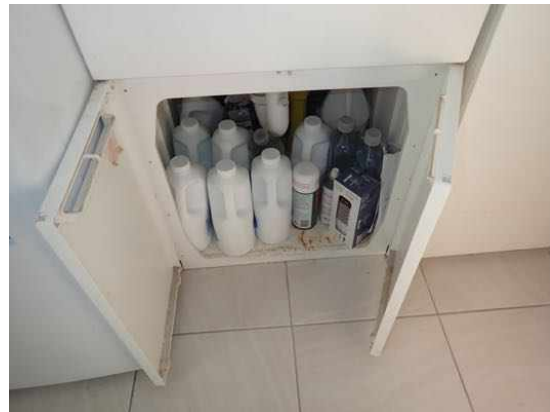
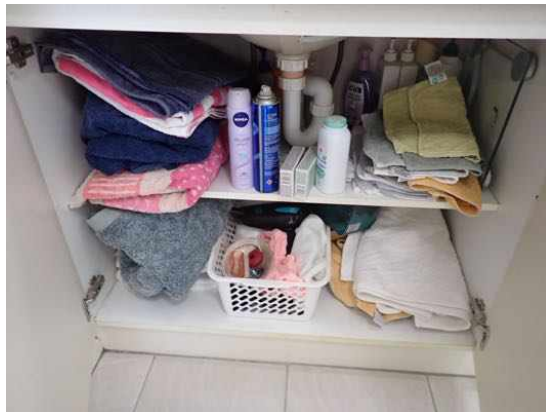
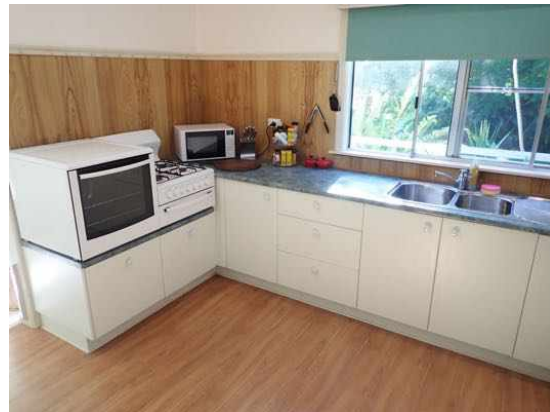
Noted Item

Building: Main Building
Location: All Areas
Finding: Additional Photos - Obstructions and Limitations
Information: These photographs are an indication of the obstructions and limitations which impeded full inspection of the area at the time of inspection. These obstructions can hide an array of defects and should be removed to allow full inspection to be carried out. A re-inspection is recommended once the areas are made accessible.

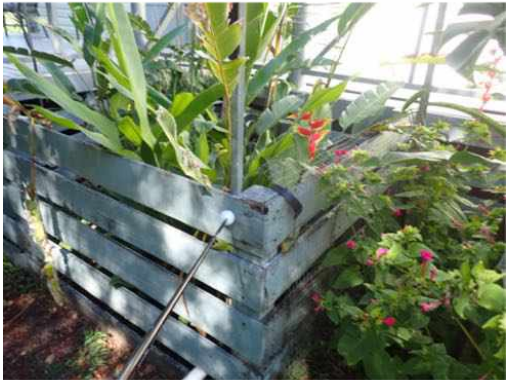
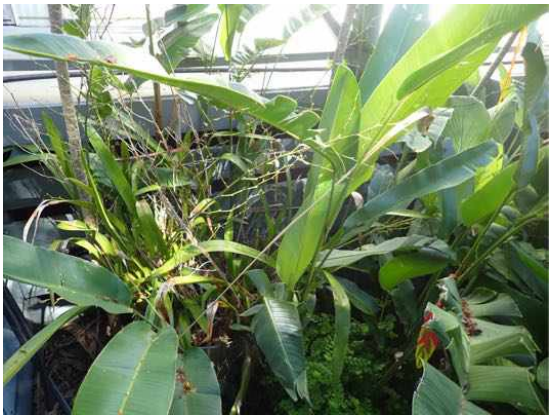
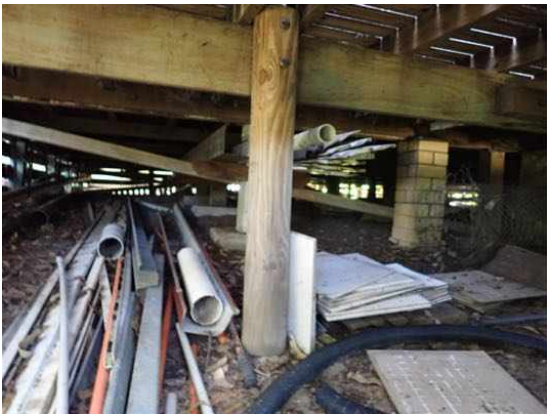
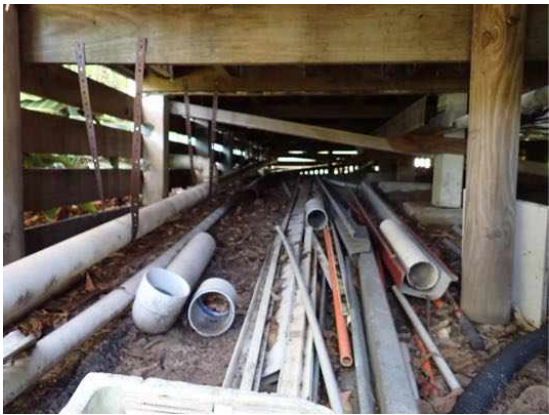
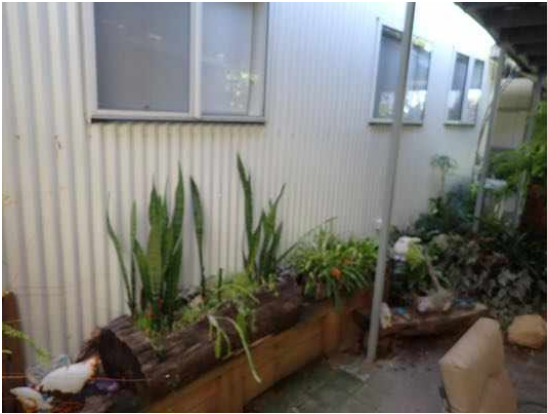
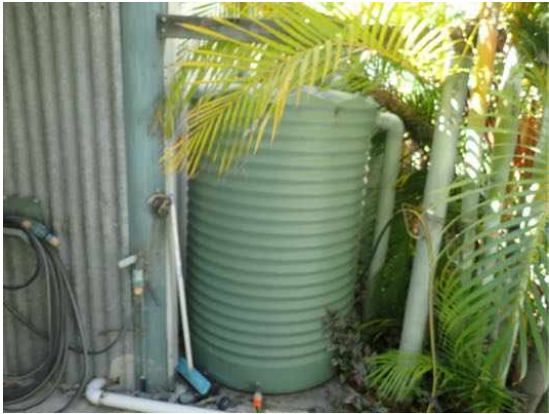
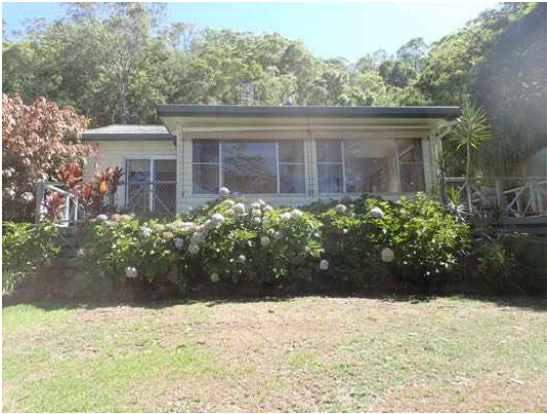
Building: Main Building
 Location: All Areas
 Finding: Additional Photos - Obstructions and Limitations
 Information: These photographs are an indication of the obstructions and limitations which impeded full inspection of the area at the time of inspection. These obstructions can hide an array of defects and should be removed to allow full inspection to be carried out. A re-inspection is recommended once the areas are made accessible.
