Building and Timber Pest Inspection Report

Inspection Date: Mon, 16 Mar 2026

Property Address: 14 Cut Glade, Blacktown NSW 2148,
Australia

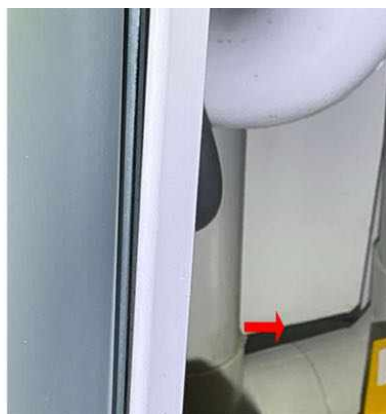
Building: Main Building
Location: All Internal Areas - Laundry
Finding: Painted surface - Bubbling
Information: Sections of paint in this area was found to have bubbled and deteriorated. Paint bubbling is generally an indication of excessive moisture in the area, that is currently hidden by the painted surface.

The presence of excessive moisture can have major implications on associated building elements if left unattended. While only seemingly minor at this stage, the damage cannot be determined due to the paint obstructing any further inspection of the damage.

It is highly advised that the affected paint be cleaned to allow a further, more invasive inspection by a licensed plumber. Failure to act on this defect may necessitate major works in the future.

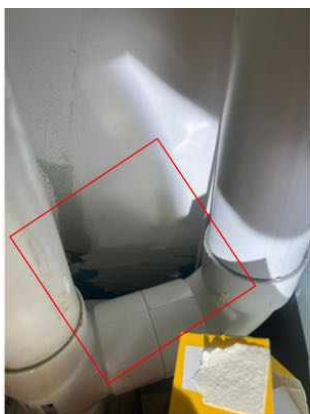
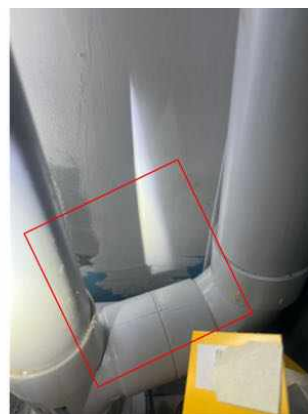
Finding 3.02

Building:	Main Building
Location:	Bathroom, Laundry
Finding:	Elevated Moisture Bathroom (No visible deterioration noted)
Information:	Elevated moisture levels were detected to tiled surfaces in bathroom/shower areas. Persistent moisture ingress can lead to concealed damage, including timber rot and mould growth.

Elevated moisture readings in tiled wet areas can occur from normal shower use, age/deterioration of waterproofing membranes, plumbing leaks or moisture absorption through grout lines. While no damage was visible, elevated readings may indicate moisture retention behind tiles, which can be a conducive condition for future deterioration if not monitored.

Monitor the area over time for signs of drumming, efflorescence, tile movement, or grout deterioration. Recommend a licensed waterproofing specialist to perform further investigation (e.g., pressure testing, membrane assessment).

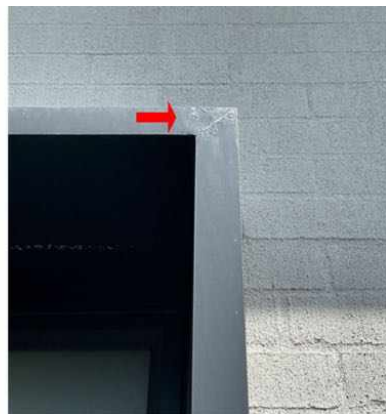
Finding 3.09

Building:	Main Building
Location:	All External Areas
Finding:	Eave Trim Separation
Information:	The external timber trim at the eaves corner displays a visible separation crack, likely due to minor building movement or timber shrinkage over time. While not structurally significant on its own, the gap may allow moisture ingress and should be sealed with a flexible exterior-grade sealant to prevent further deterioration.

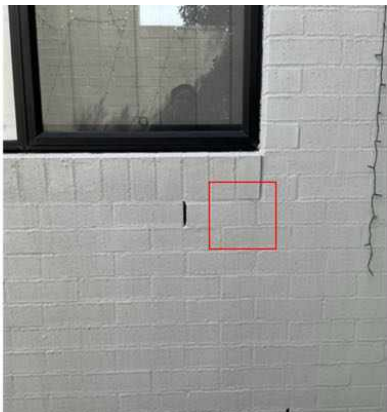
Finding: Brickwork - Cracking [Fine] to some areas

Information: Although fine cracks are quite noticeable, they are often only considered to be an appearance defect and usually do not indicate any structural damage. Generally, the cause of a fine crack is indicative of a separation between brickwork and mortar throughout the structure, but single bricks may also show cracks of this nature.

Cracking of this nature can generally be repaired with minor filling and should be conducted by a qualified bricklayer.

Always contact a building inspector should cracks widen lengthen or become more numerous.

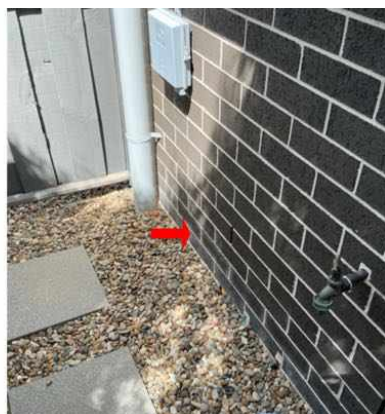
Finding 6.04

Building:	Main Building
Location:	All External Areas
Finding:	In ground contact - Timber
Information:	Any timbers in direct ground contact provide opportunity for concealed termite entry and are likely to be subject to premature rot and decay as the soil retains moisture or damp conditions against the timbers.

Remove untreated timber that is in direct contact with external grounds. Consider replacement with more durable materials i.e. treated timber or non timber elements. Frequent pest inspections are advised to readily identify any termite activity in these areas.

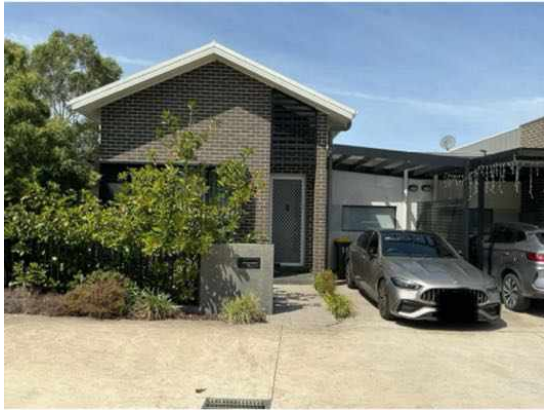
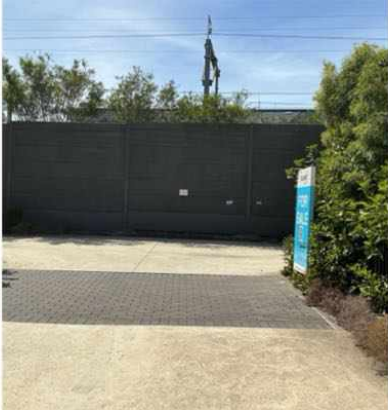
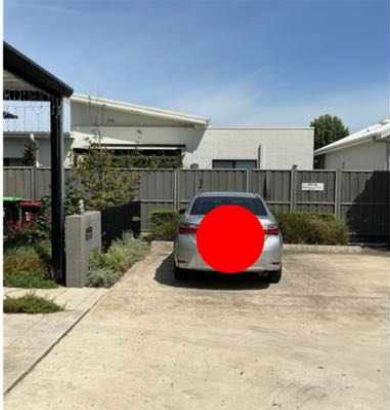
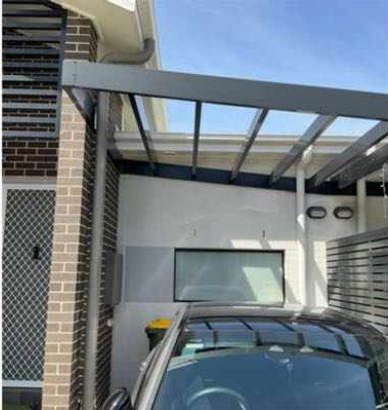
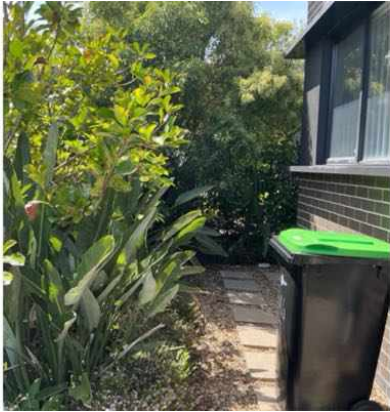
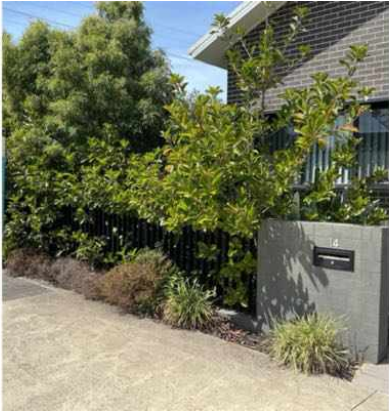
Building: Main Building
Location: All External Areas
Finding: Additional Photos - Obstructions and Limitations
Information: These photographs are an indication of the obstructions and limitations which impeded full inspection of the property at the time of inspection. These obstructions can hide an array of defects and should be removed to allow full inspection to be carried out. A re-inspection is recommended once the areas are made accessible.

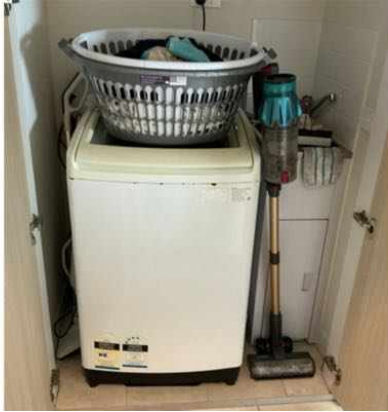
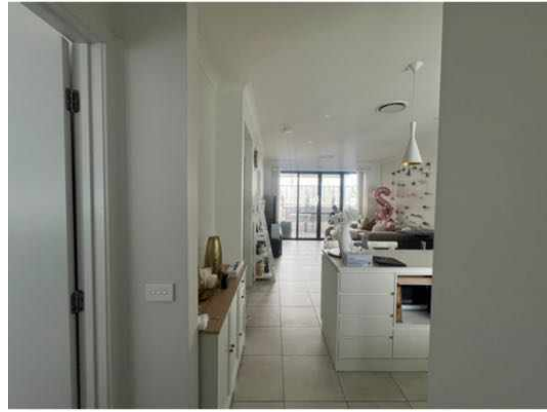
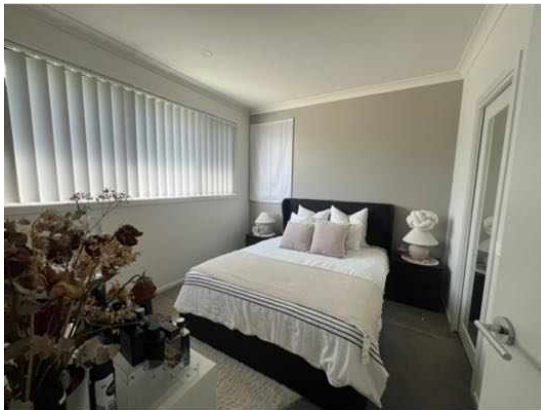
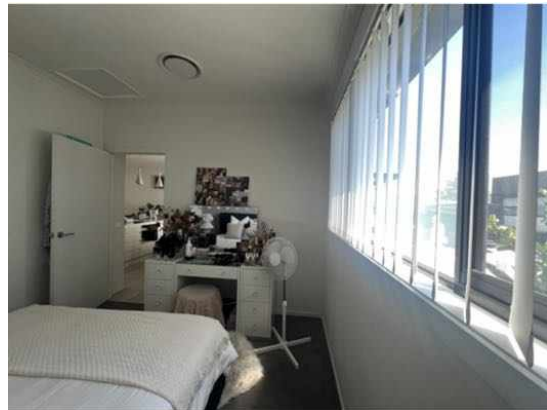
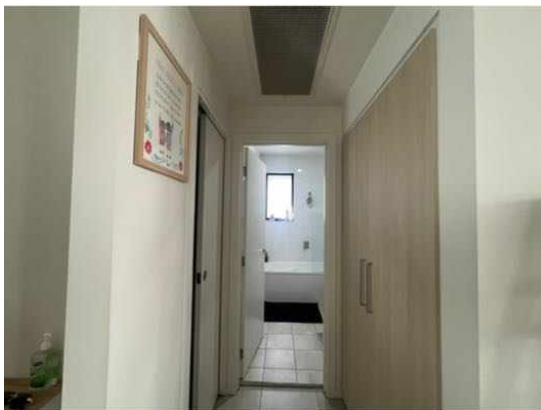
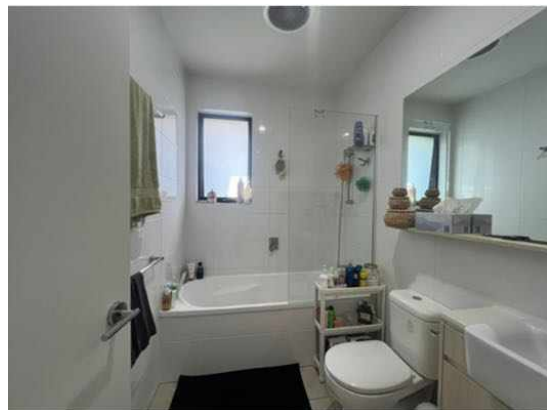
Building: Main Building
Location: All Internal Areas
Finding: Additional Photos - Obstructions and Limitations
Information: These photographs are an indication of the obstructions and limitations which impeded full inspection of the property at the time of inspection. These obstructions can hide an array of defects and should be removed to allow full inspection to be carried out. A re-inspection is recommended once the areas are made accessible.

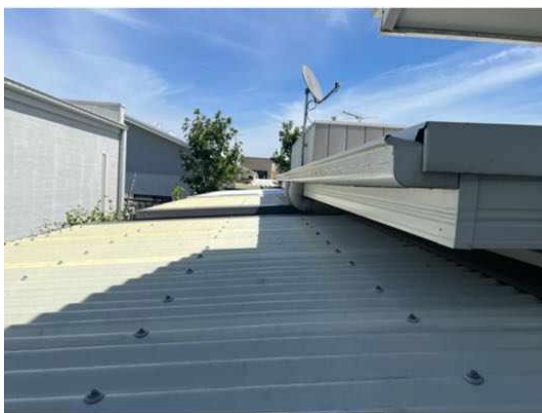
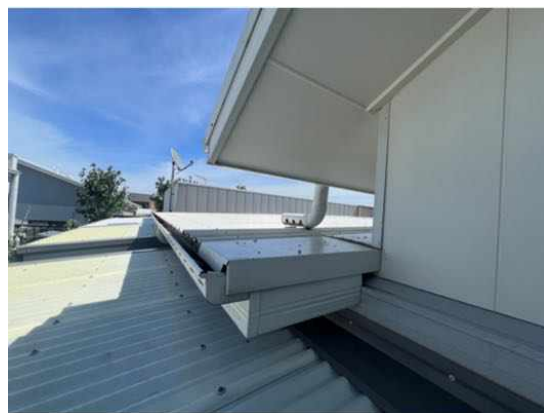
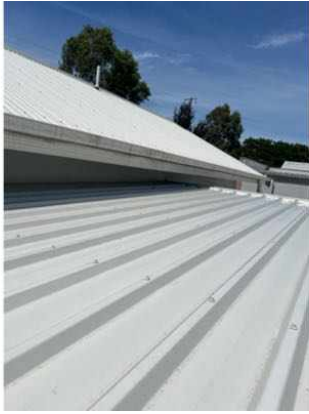
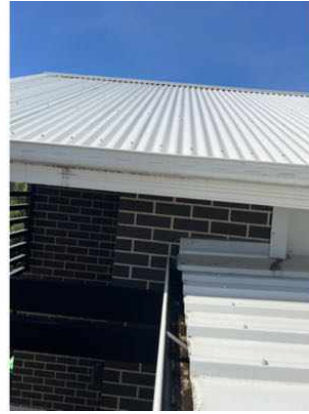
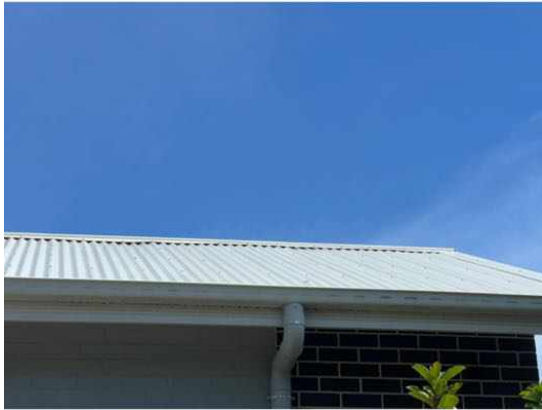
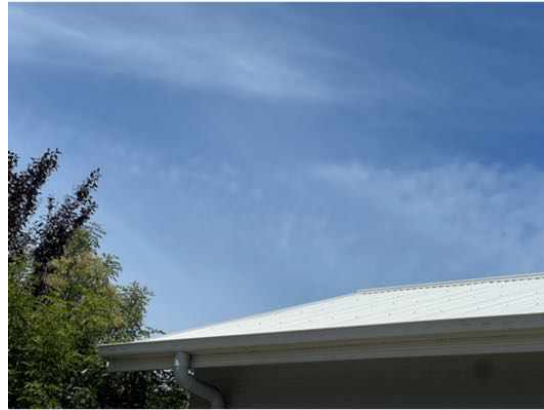
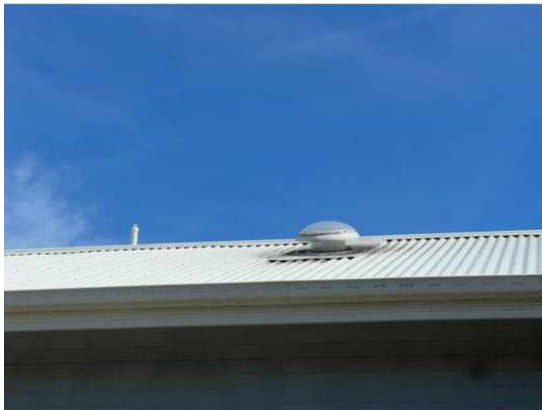
Building: Main Building
 Location: Roof Exterior
 Finding: Additional Photos - Obstructions and Limitations
 Information: These photographs are an indication of the obstructions and limitations which impeded full inspection of the property at the time of inspection. These obstructions can hide an array of defects and should be removed to allow full inspection to be carried out. A re-inspection is recommended once the areas are made accessible.

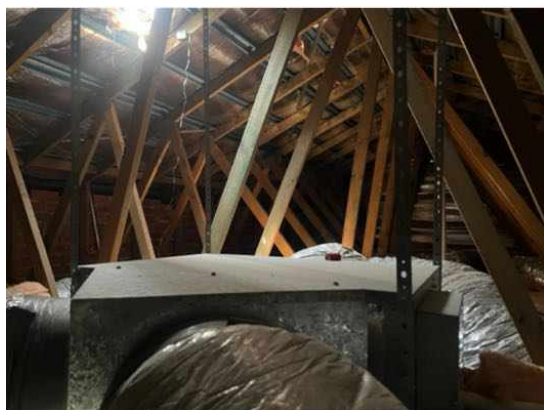
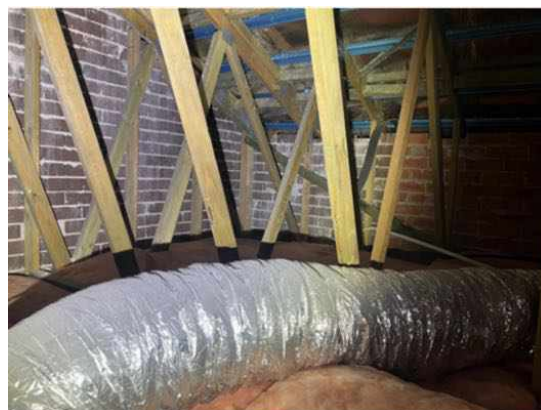
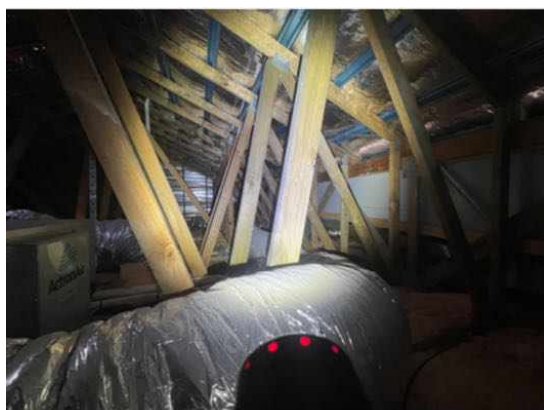
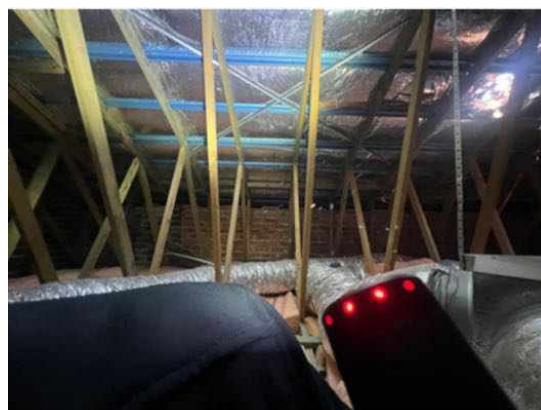
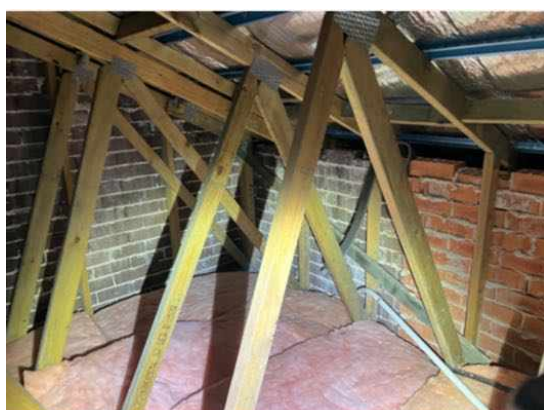
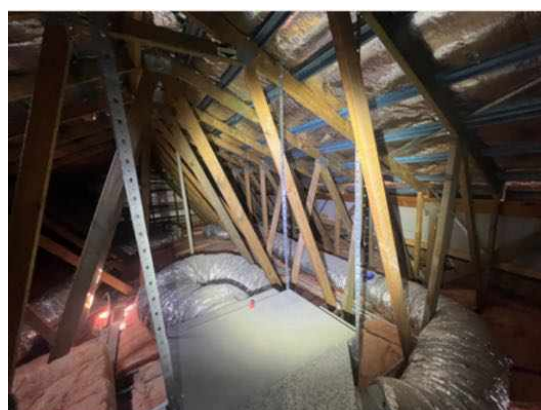
Building:	Main Building
Location:	Roof Void
Finding:	Additional Photos - Obstructions and Limitations
Information:	These photographs are an indication of the obstructions and limitations which impeded full inspection of the property at the time of inspection. These obstructions can hide an array of defects and should be removed to allow full inspection to be carried out. A re-inspection is recommended once the areas are made accessible.

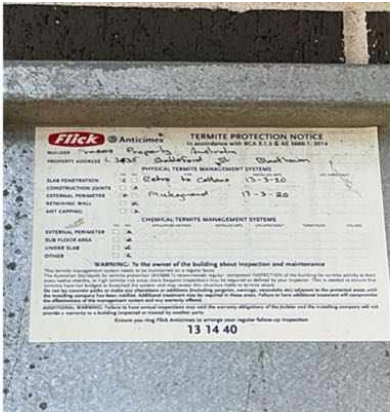
The following items were noted as - Evidence of a previous termite management program

Where a Termite Management System has been identified you should refer to the type of barrier date of installation warranty conditions and any documentation provided by a builder or past owner. Consult the company who installed the barrier to confirm whether the system is still under warranty.

Most chemical termite management systems expire and require replenishment and all physical systems are primarily designed to prevent concealed entry.
