Building and Timber Pest Inspection Report

Inspection Date: Fri, 6 Feb 2026

Property Address: 72 Cottesloe Dr, Robina QLD 4226,
Australia

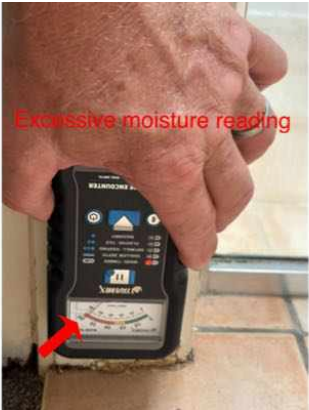
Moisture damage was found to the bottom of the timber door frames to the bathroom and to the hallway. Excessive moisture readings were recorded at the base of the timber door frame for the door into the bathroom. This appears to have had previous repairs carried out to it.

Excessive moisture reading

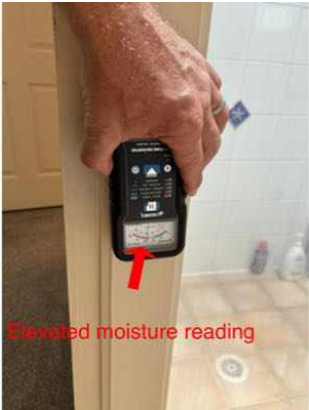
Information: At the time of the inspection, it was noted that there was evidence of moisture damage around the shower area of the family bathroom. Elevated moisture readings were recorded on the tiled shower wall and the wall on the bedroom side of the shower. The grout in the shower was not in a good condition and sealant has been applied to at least one grout line.

Elevated moisture reading

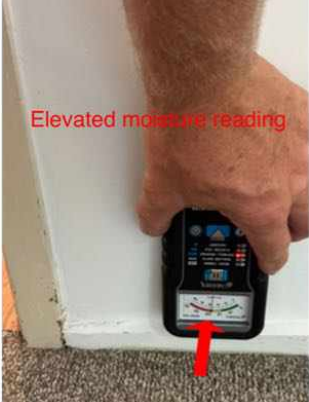
Elevated moisture reading

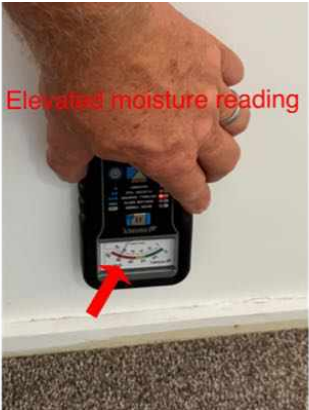
Elevated moisture reading

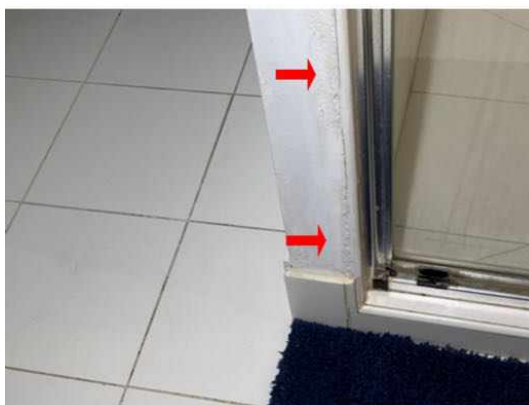
Building:	Main Building
Location:	Ensuite
Finding:	Ensuite - moisture damage
Information:	At the time of the inspection, it was noted that there was evidence of moisture damage to the wall next to the shower in the ensuite. Moisture readings were inconclusive due to the metal corner beads under the plaster which give false excessive moisture readings. It appears that the shower screen may be leaking.

A bathroom specialist should be engaged to assess the shower area in the ensuite and provide a solution for this issue. This should be done as a short term priority.

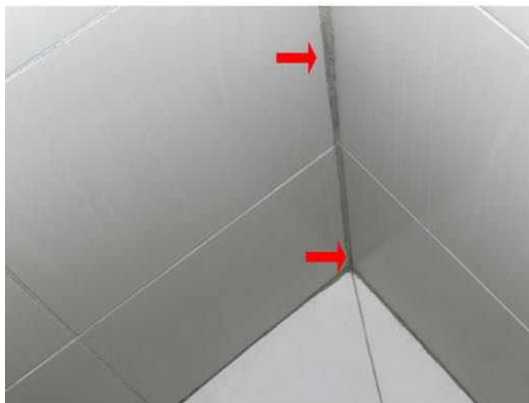
Building:	Main Building
Location:	Ensuite
Finding:	Ensuite - sealant deteriorating
Information:	At the time of the inspection it was noticed that the sealant in shower of the ensuite was deteriorating.

Sealant is used in tiled areas to prevent moisture from entering the wall cavity and causing damage to the building elements. A moist environment in the wall cavity may also be a conducive condition for termite activity.

If it is not addressed, damage to building elements will occur and would require invasive works to rectify any damage.

A building maintenance professional or sealant applicator should be appointed to replace all sealant as a matter of urgency.

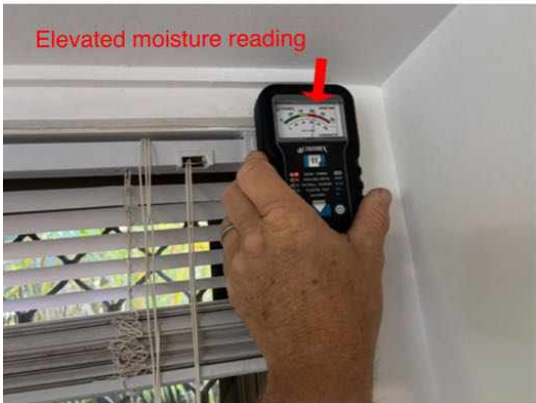
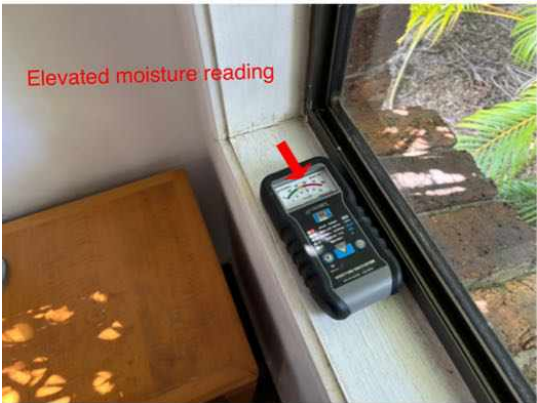
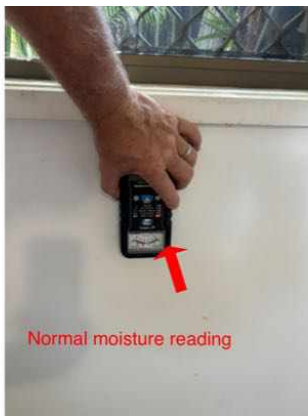
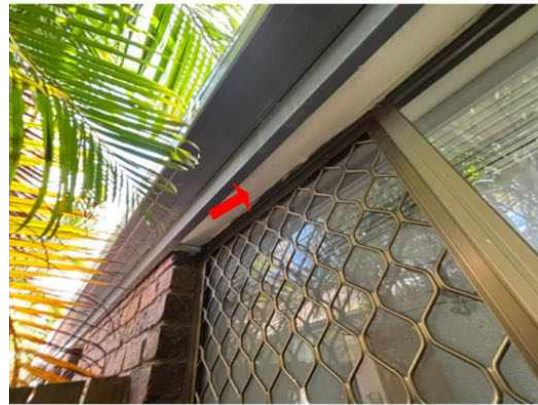
Finding 3.03

Building:	Main Building
Location:	Bedroom 4
Finding:	Window frame - Water stained
Information:	At the time of the inspection, it was noted that there was evidence of water staining to the top of the window frame in bedroom 4(back right corner). Moisture damage was found on the window sill of this window. Elevated moisture readings were recorded on the timber window frame.

Water staining indicates that surfaces have been exposed to excessive moisture over time. The minerals and other elements in the water lead to staining, which may graduate to corrosion and deterioration if left unmanaged.

While mostly an appearance defect, water staining can be indicative of more serious defects, which may be currently concealed by interior ceilings.

Where water staining is active, a licensed plumber must be consulted to identify the cause of the staining and to provide advice on any reparation works that may be required. Replacement of any damaged structures is advised.

Conversely, where water staining is old and inactive, affected building materials may be repaired or replaced at client discretion.

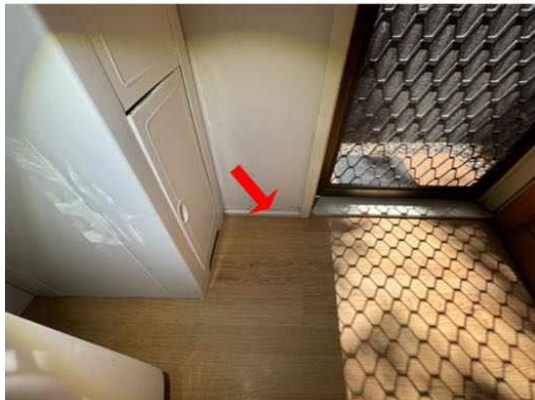
Finding 3.04

Finding: Laundry - evidence of moisture damage

Information: At the time of the inspection, it was noted that there was evidence of moisture damage to a lower section of the exterior wall in the laundry. This may be due to the external laundry door having no weather seals to it. Elevated moisture readings were recorded in this area.

Again, this part of the dwelling has little to no eaves on the exterior and as such, blocked gutters could overflow back into the building. The gutters were clear when inspected.

A building maintenance professional could be engaged to install weather seals to the external laundry door and repair the moisture damage. This can be done at the clients discretion.

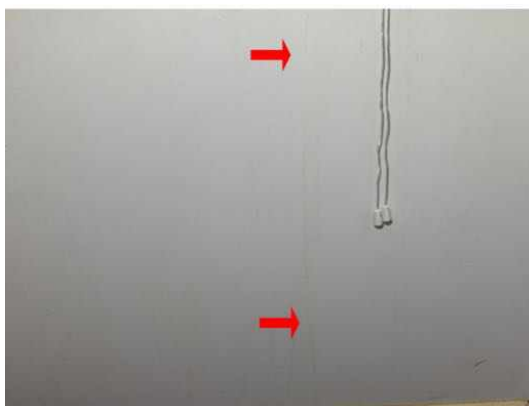
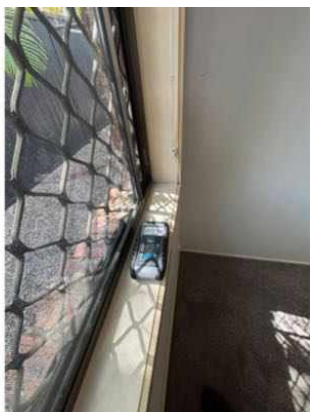
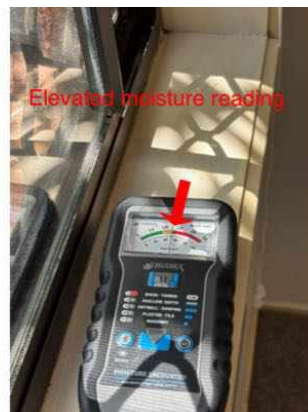
Finding 3.05

Finding: Bedroom 3 - water stain

Information: At the time of the inspection, it was noted that there was a water stain to the wall under the window in bedroom 3. Elevated moisture readings were recorded on the window sill but only in front of the opening side of the window. It is suspected that moisture has entered the room through the open window. Again, this part of the dwelling has little to no eaves and as a result the window is not protected from weather.

A building maintenance professional or painting contractor could be engaged to carry out the necessary repairs to this area. This can be done at the clients discretion.

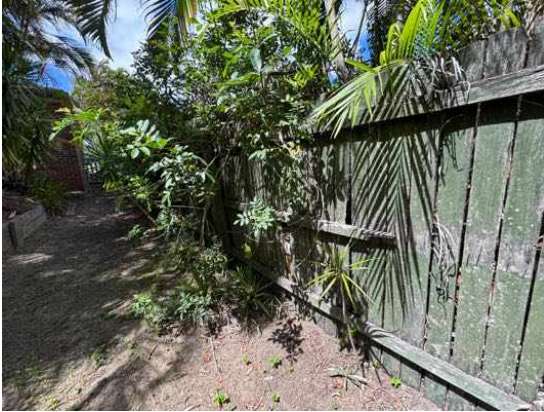
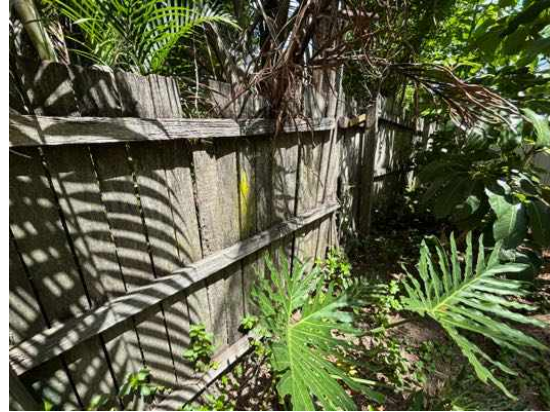
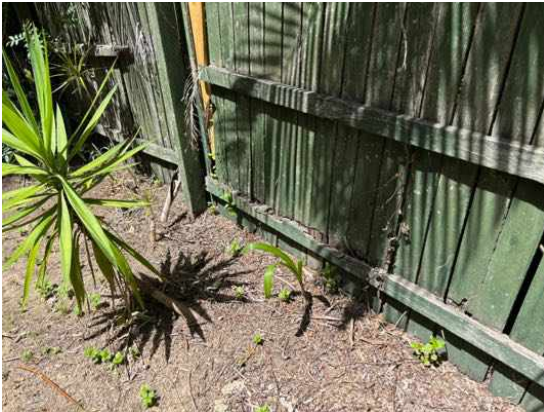
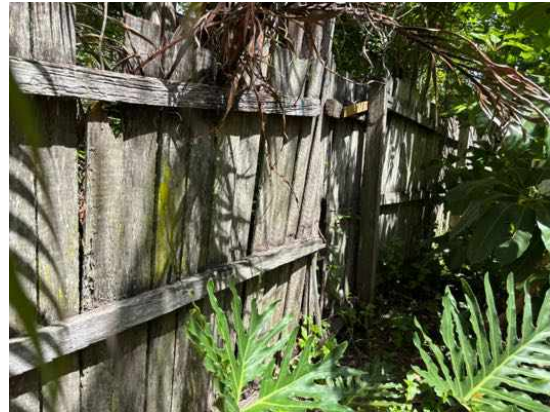
Building: Main Building
Location: Boundary fence
Finding: Boundary fence- deteriorating
Information: At the time of the inspection, it was noted that the left hand side timber boundary fence was deteriorating. This will be due to the age of the materials and general weathering. The fence is currently upright however there is movement to some sections when pressure is applied to them.

A fencing contractor should be engaged to assess the fences and provide a solution to rectify this issue. This can be done at the clients discretion.

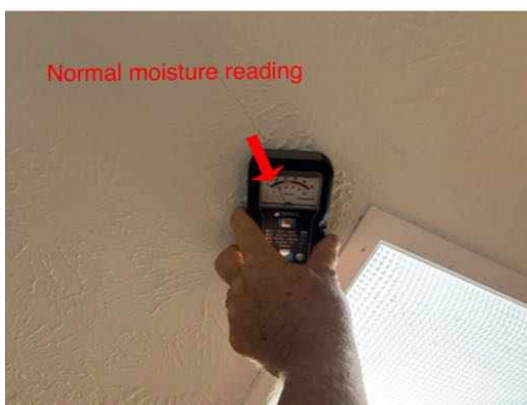
Finding: Kitchen - ceiling lining cracking

Information: At the time of the inspection, it was noted that there was minor cracking to the ceiling lining around the skylight in the kitchen area. This appears to be general wear and tear and movement of the associated building materials. Normal moisture readings were recorded around the skylights.

The functionality of the ceiling lining is not affected at present. A plasterer could be engaged to repair the cracks. This can be done at the clients discretion.

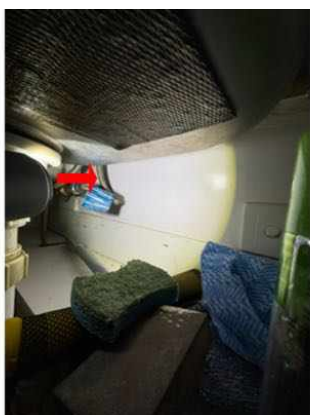
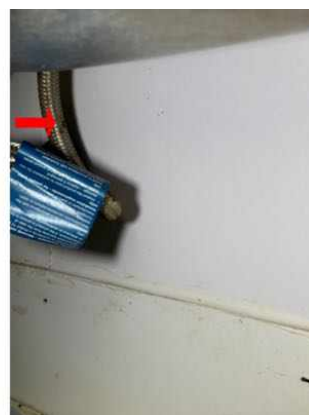
Finding 3.11

Building:	Main Building
Location:	Kitchen
Finding:	Kitchen - flexible hose has signs of rust
Information:	At the time of the inspection, it was noted that a flexible hose to the kitchen mixer had signs of rusting. This may be due to the age of the hose. Flexible hoses typically have a 5 - 10 year lifespan. It is recommended that they be changed if they have signs of bulging, fraying, kinking or rust.

A licensed plumber should be engaged to replace both the flexible hoses to the kitchen mixer. This should be done as a matter of urgency.

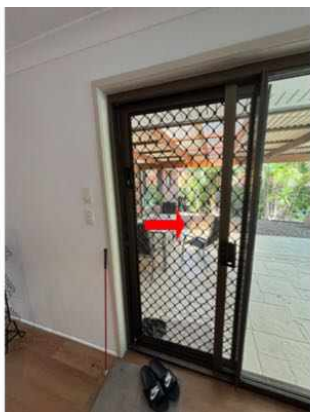
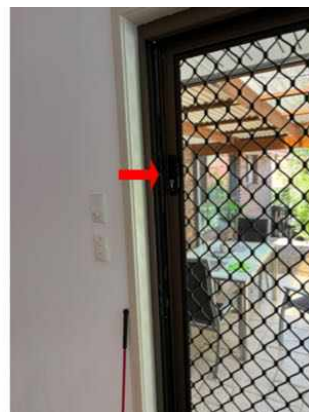
Finding 3.12

Building:	Main Building
Location:	Lounge
Finding:	Lounge - screen door not latching
Information:	At the time of the inspection, it was noted that the screen door in the lounge was stiff to operate and did not latch during normal operation, it could not be locked.

A screen door specialist should be engaged to carry out the necessary repairs to restore functionality to this screen door. This can be done at the clients discretion.

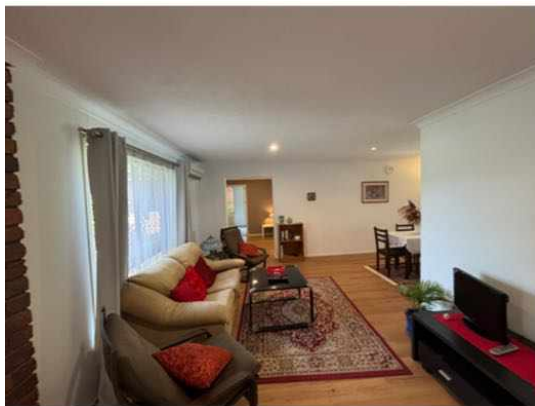
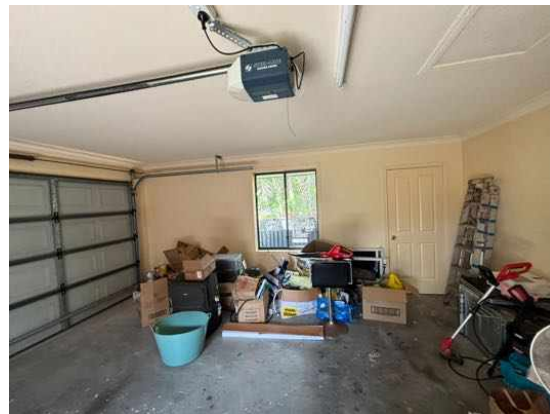
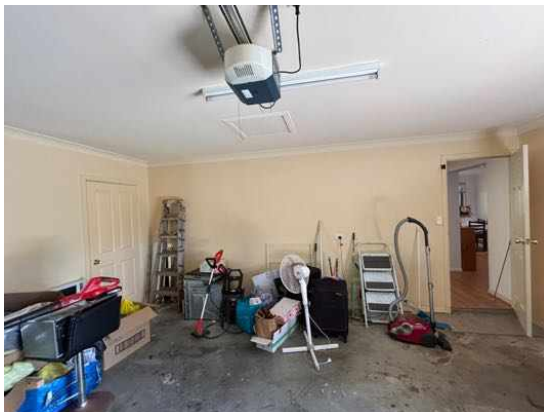
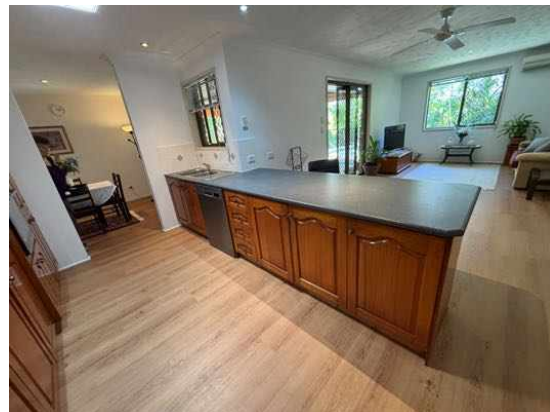
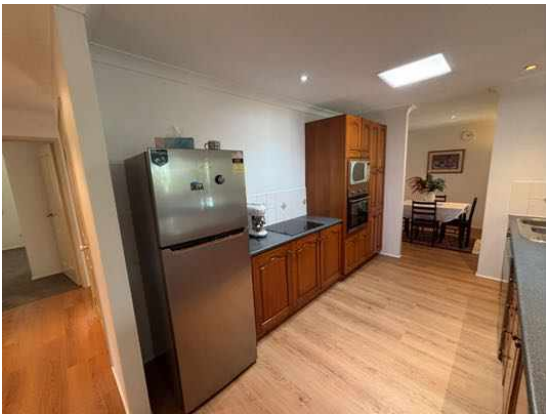
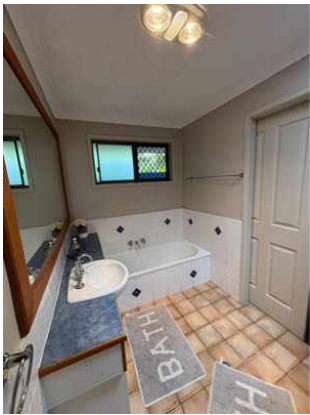
Building: Main Building
Location: All Internal Areas
Finding: Obstructions and Limitations - Internal areas
Information: These photographs are an indication of the obstructions and limitations which impeded full inspection of the property of the internal areas at the time of inspection. These obstructions can hide an array of defects and should be removed to allow full inspection to be carried out. A re-inspection is recommended once the areas are made accessible.

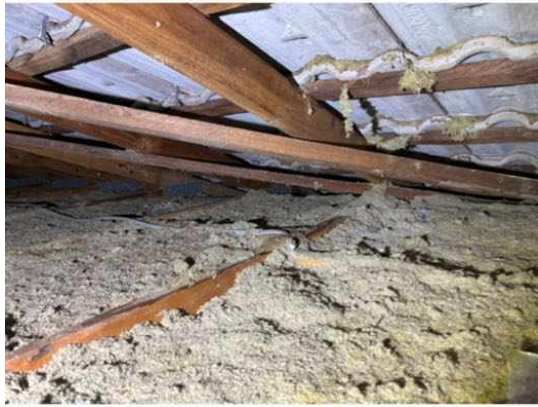
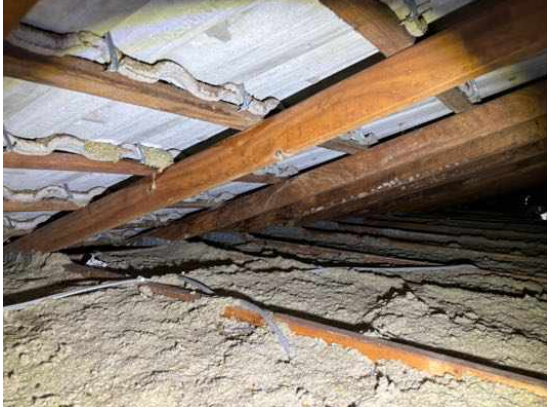
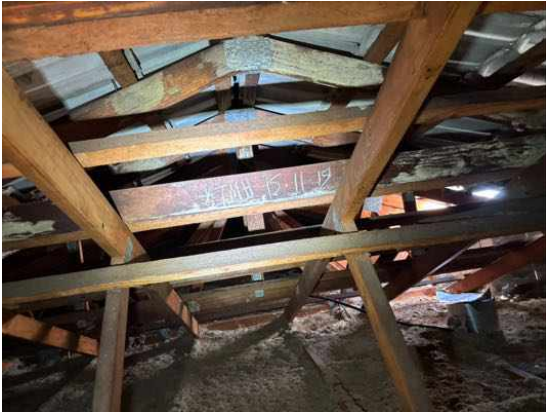
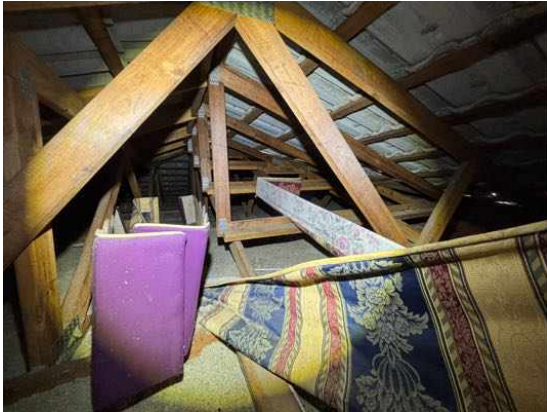
Building: Main Building
Location: Roof Void
Finding: Obstructions and Limitations - Roof cavity
Information: These photographs are an indication of the obstructions and limitations which impeded full inspection of the property of the roof cavity

at the time of inspection. These obstructions can hide an array of defects and should be removed to allow full inspection to be carried out. A re-inspection is recommended once the areas are made accessible.
