# Building and Timber Pest Inspection Report

Inspection Date: Mon, 19 Jan 2026

Property Address: 504/16 Flack Ave, Hillsdale NSW 2036,  
Australia

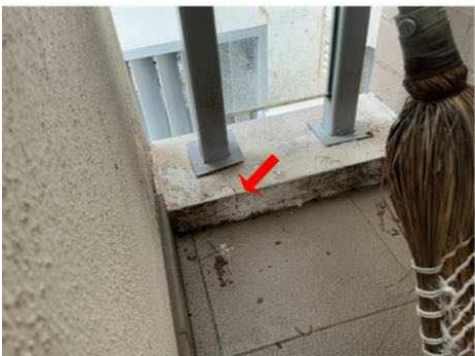
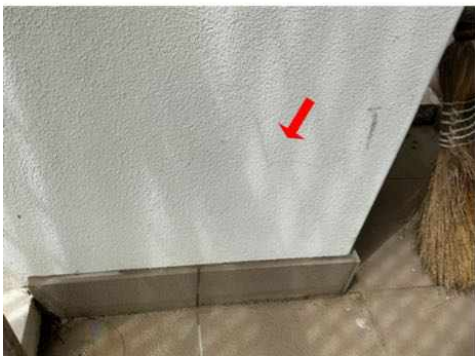
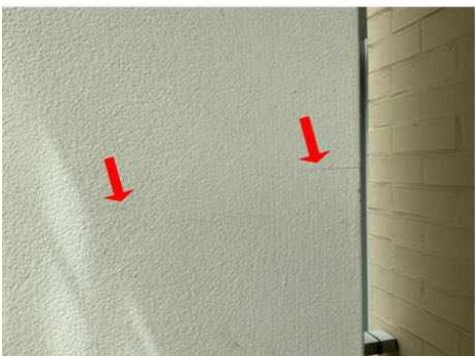
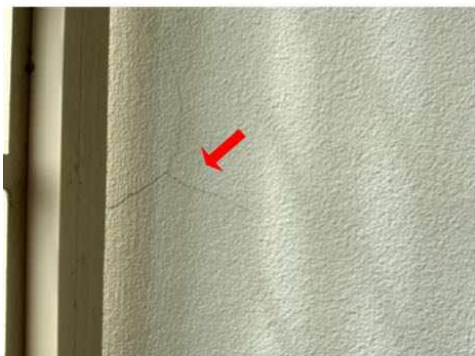
Building: Main Building  
Location: Balconies  
Finding: Cracks to external render - Category 1  
Information: It has been observed that cracking to internal rendered surfaces has occurred. The degree of damage falls within Category 1, described as fine cracks that do not need repair and which are less than 1.0mm in width limit.

Damage of this category is not considered a defect for rectification. Always contact your building inspector should cracks widen, lengthen, or become more numerous.

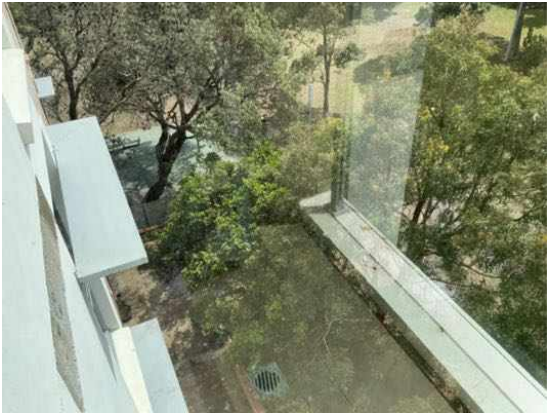
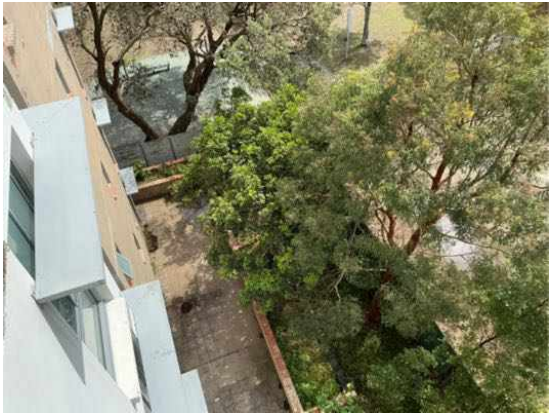
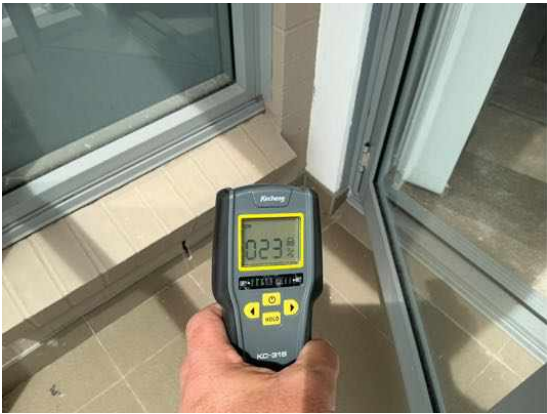
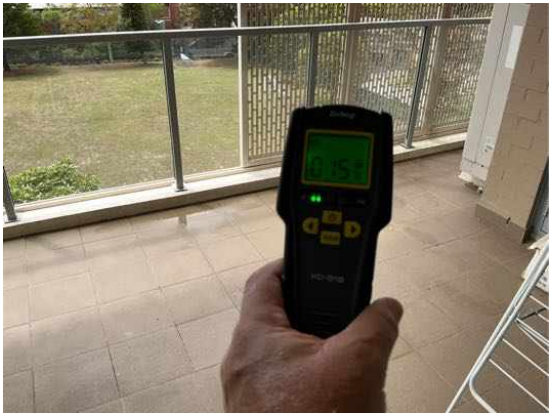
Building:	Main Building
Location:	All Areas
Finding:	Termite Management System - no evidence of a chemical installation
Information:	The application of a post-construction chemical termite barrier is highly recommended for all properties, particularly if live termite activity has been found on the site previously. Such barriers are highly effective in preventing termite attack on any timber building elements throughout the property.

Regular inspections every 6-12 months- or advised by the termite management system installer.

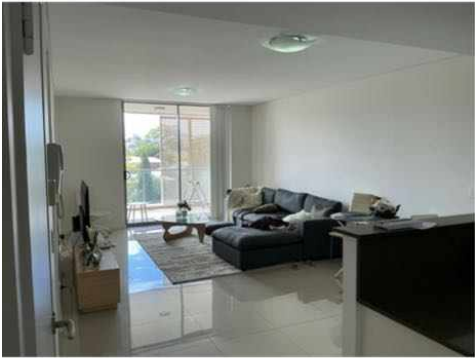
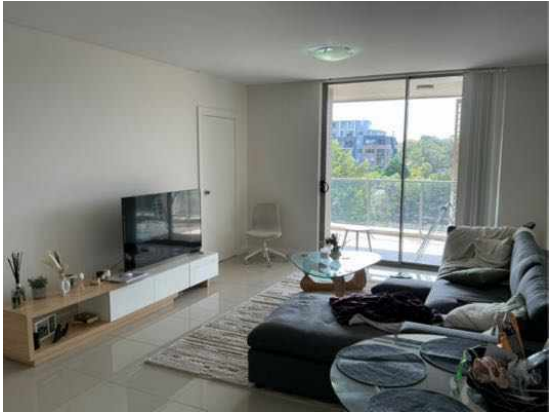
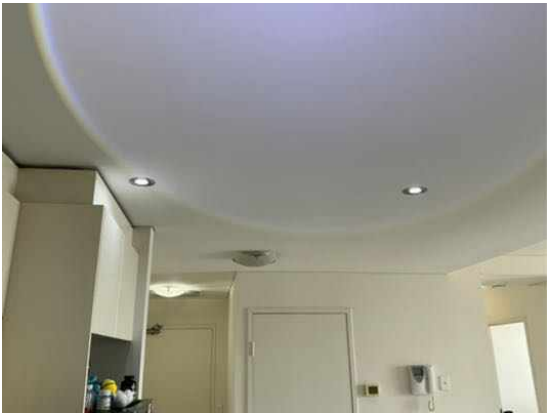
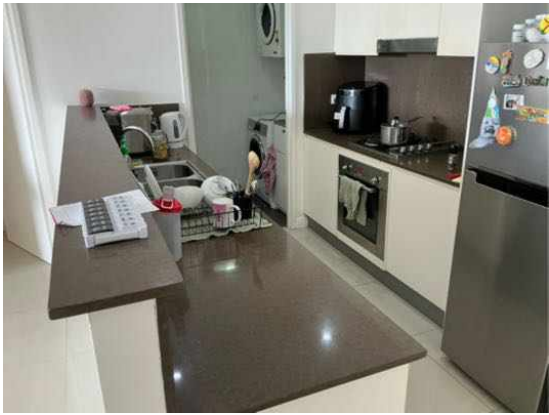
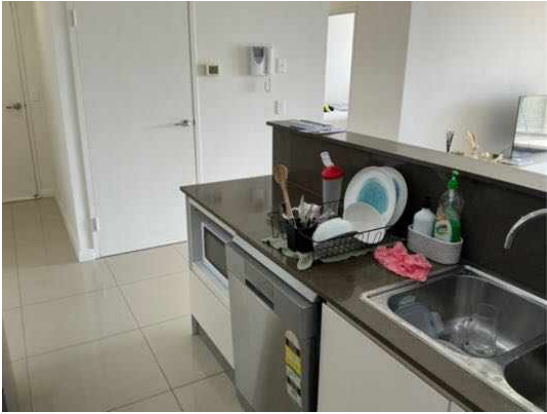
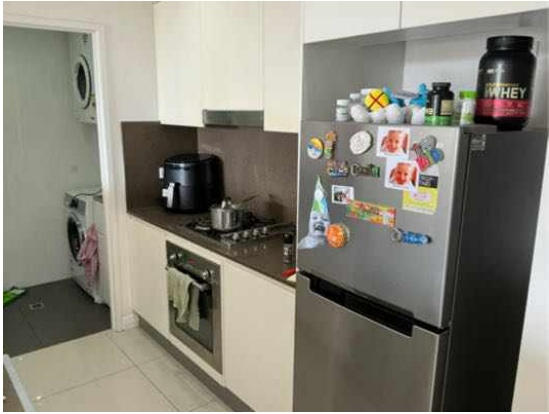
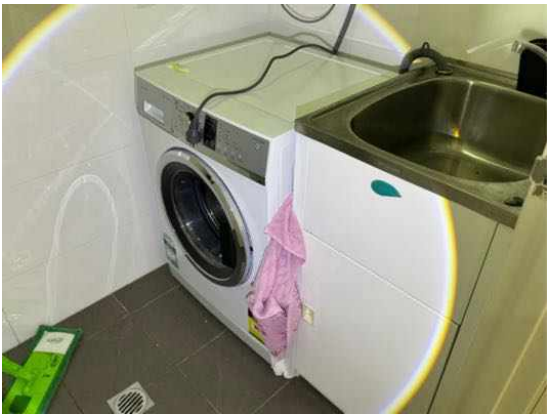
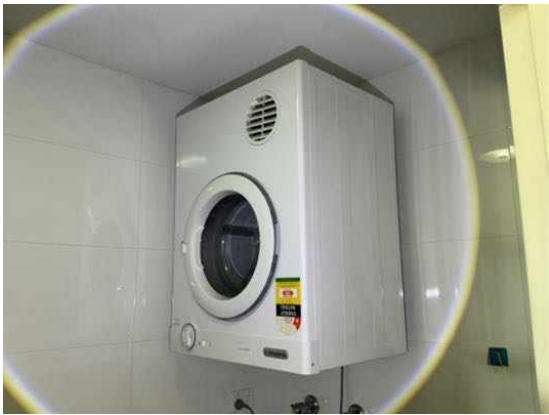
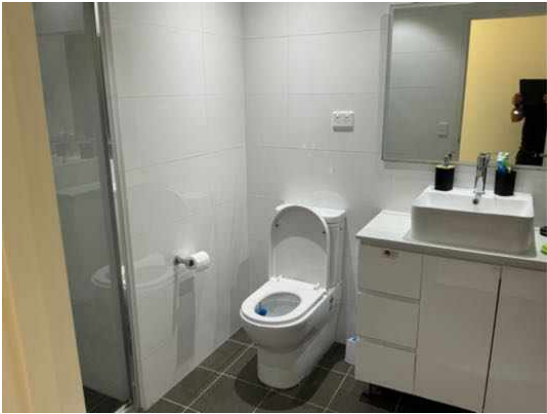
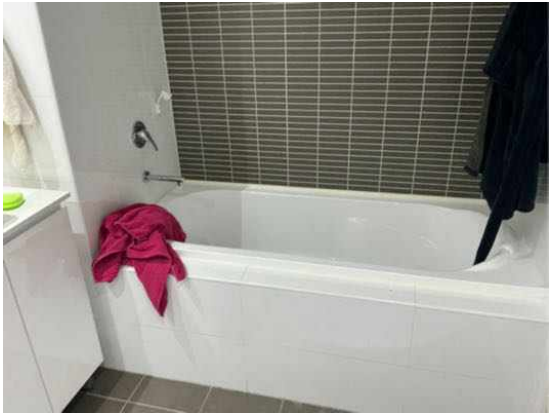
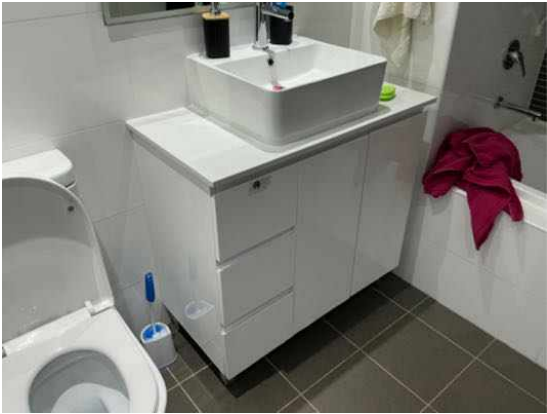
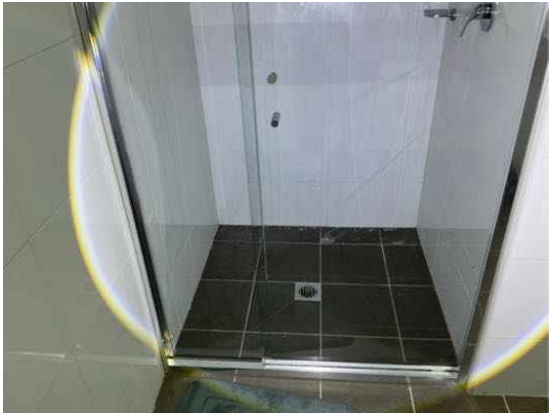
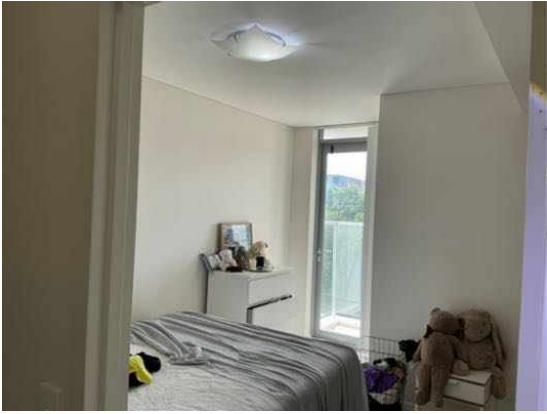
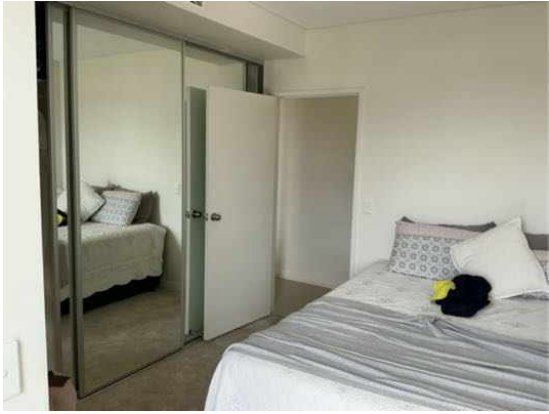
Building: Main Building  
 Location: All Areas  
 Finding: Additional Photos - Obstructions and Limitations  
 Information: These photographs are an indication of the obstructions and limitations which impeded full inspection of the property at the time of inspection. These obstructions

can hide an array of defects and should be removed to allow full inspection to be carried out. A re-inspection is recommended once the areas are made accessible.

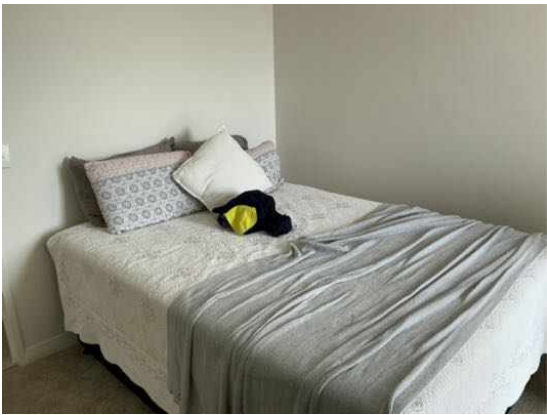
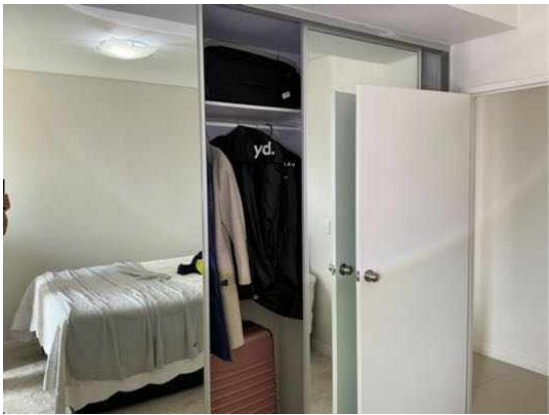
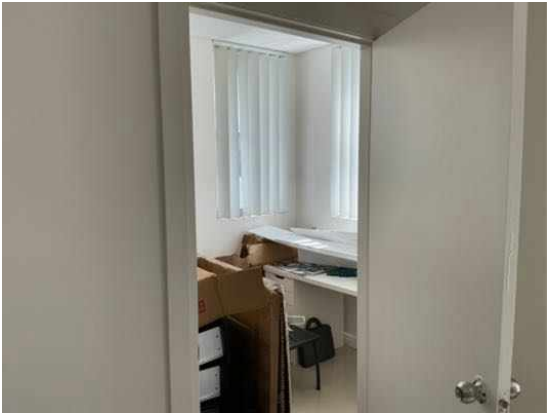
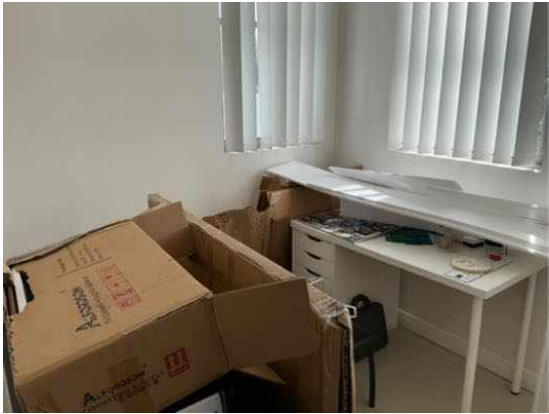
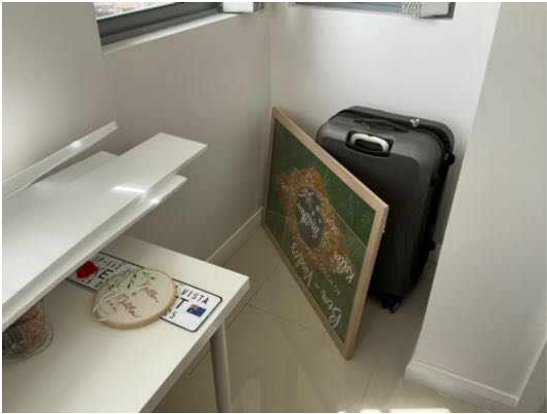
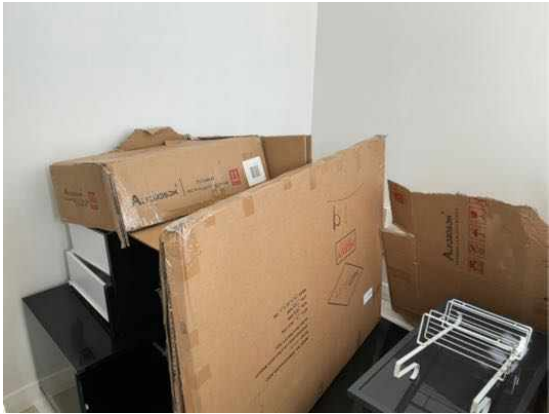
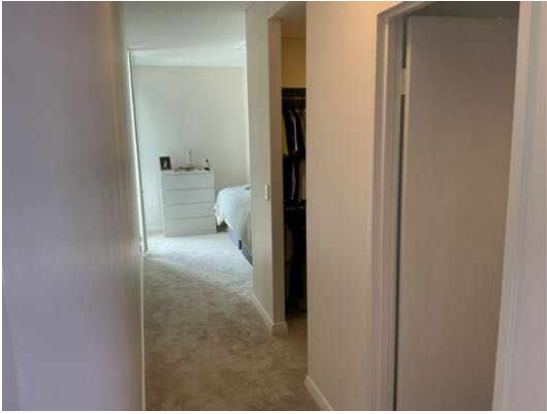
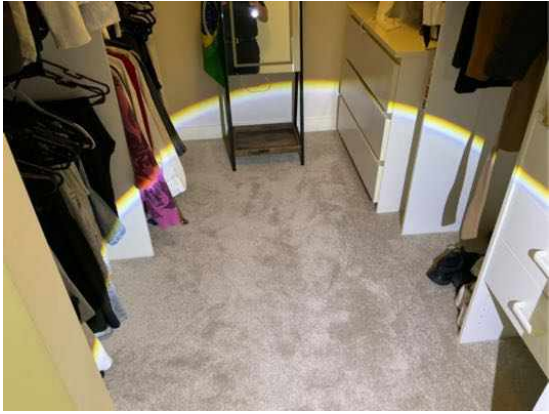
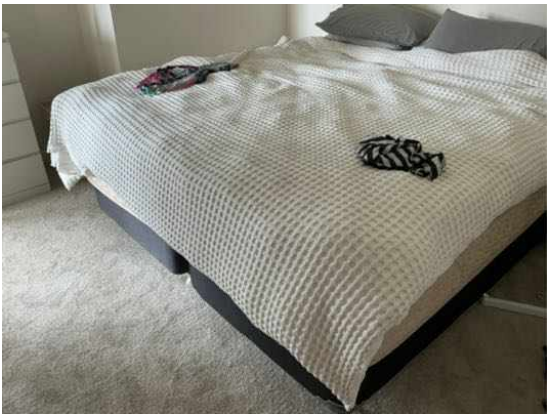
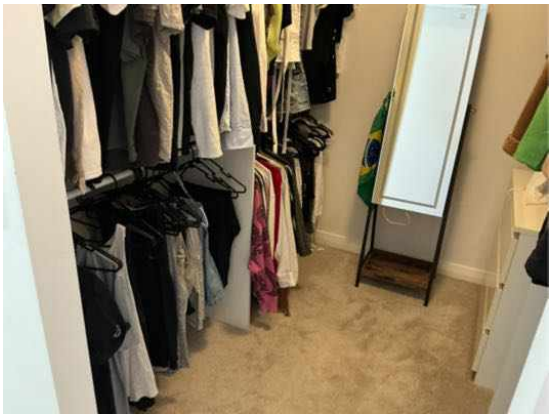
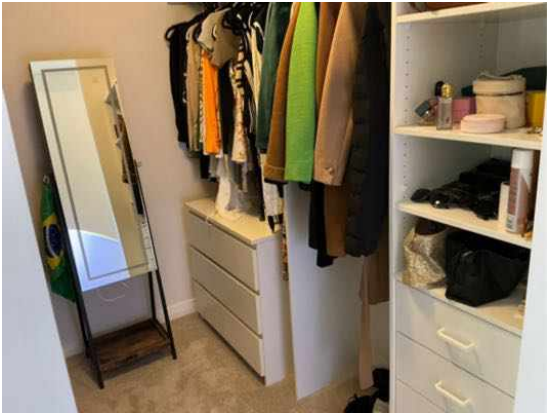
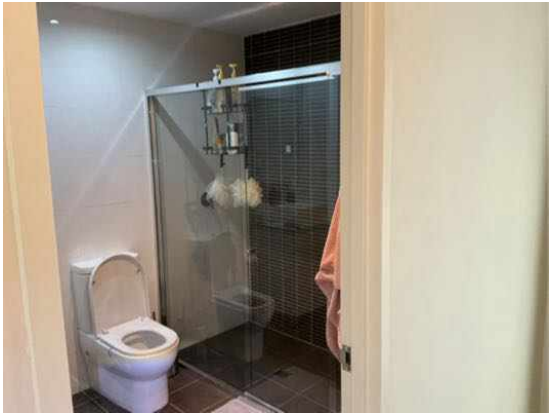
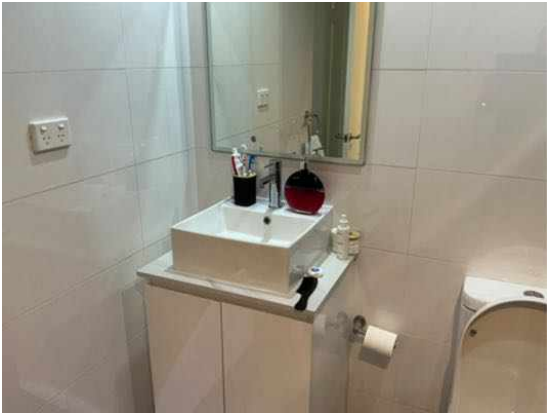
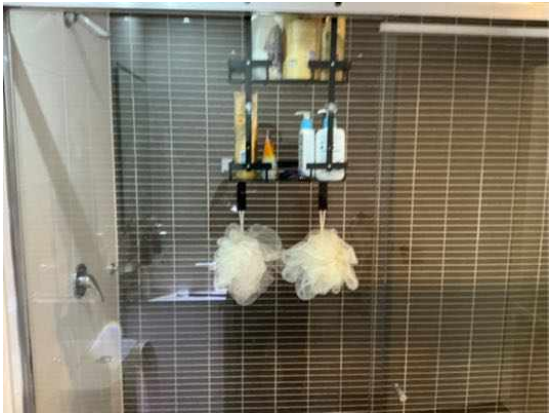
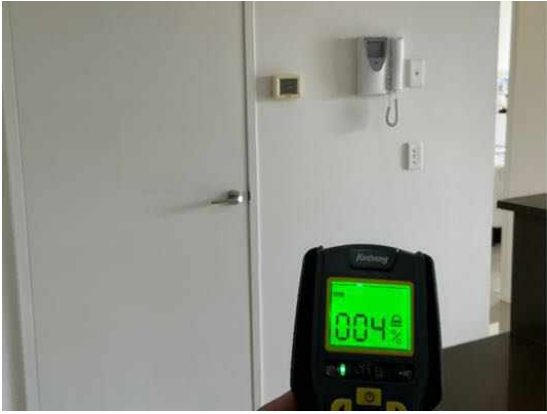
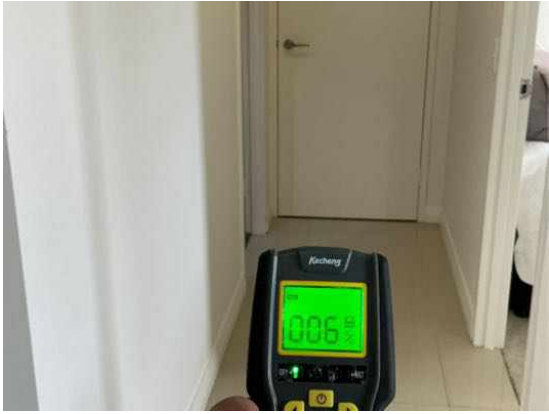
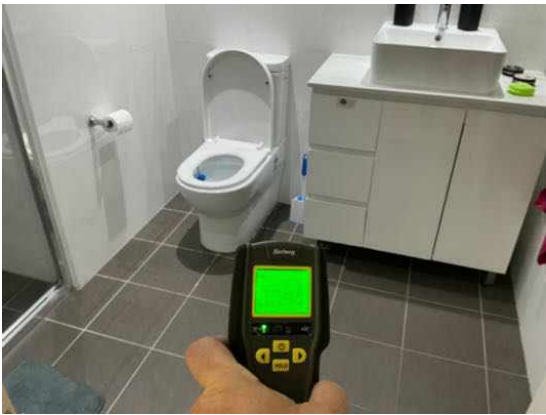
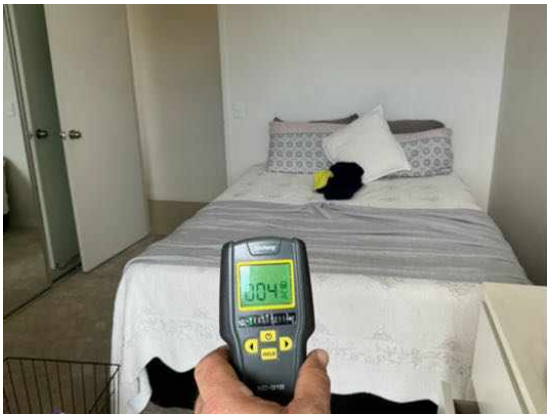
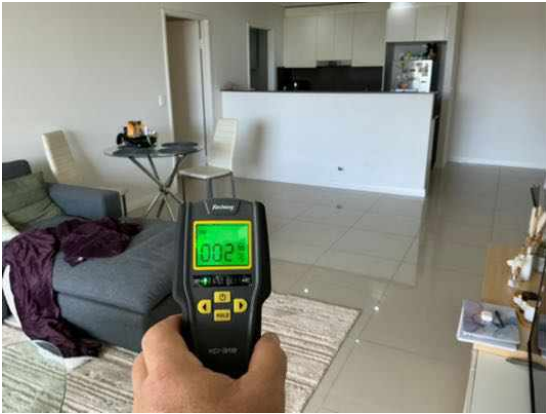
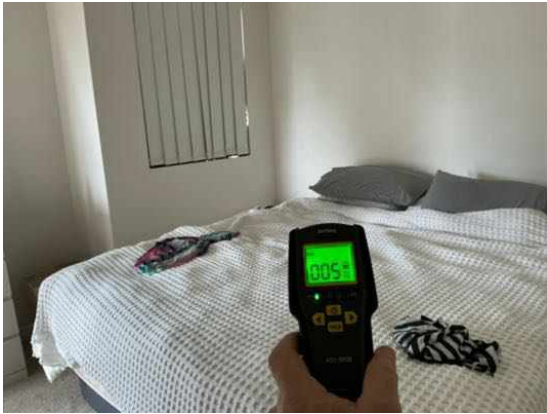
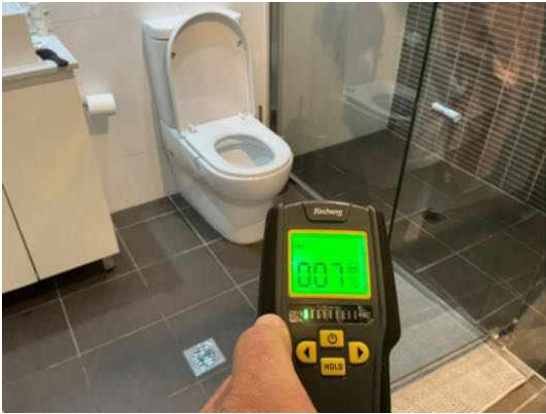
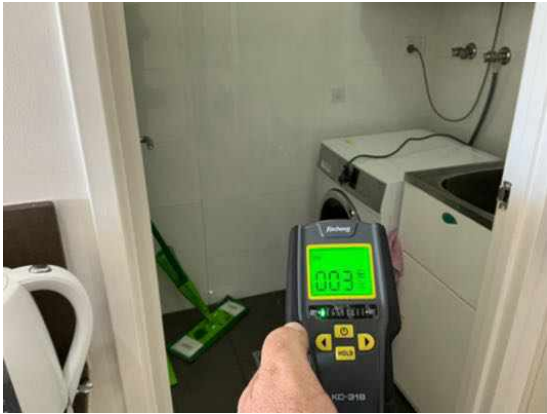
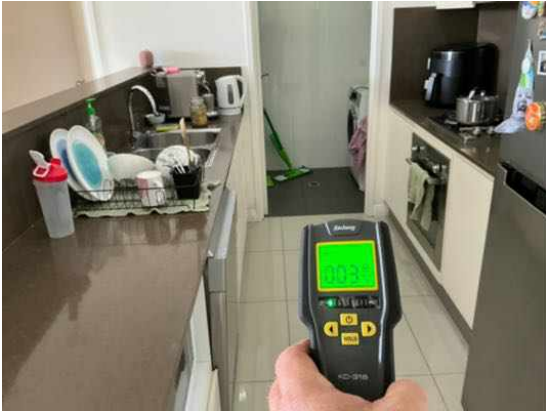
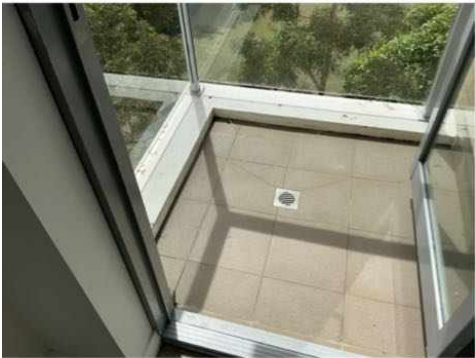
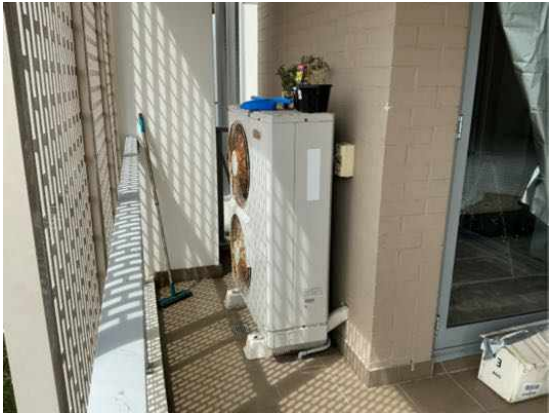
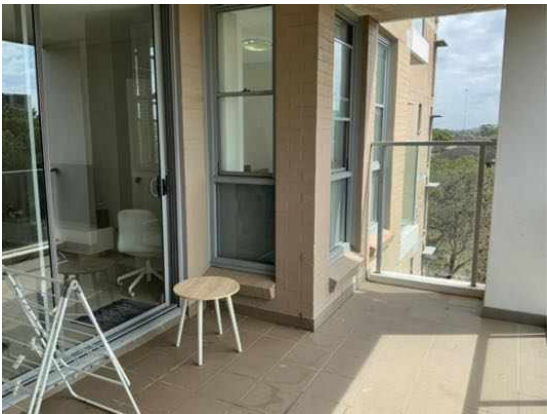
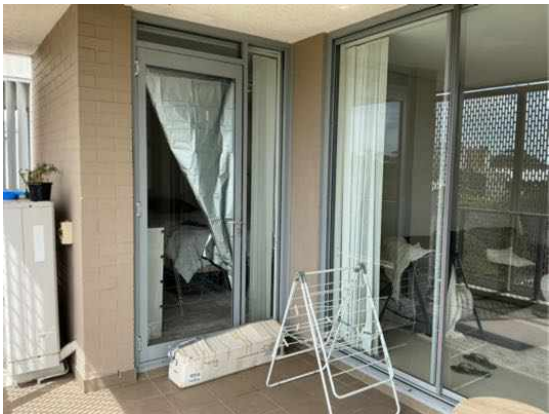
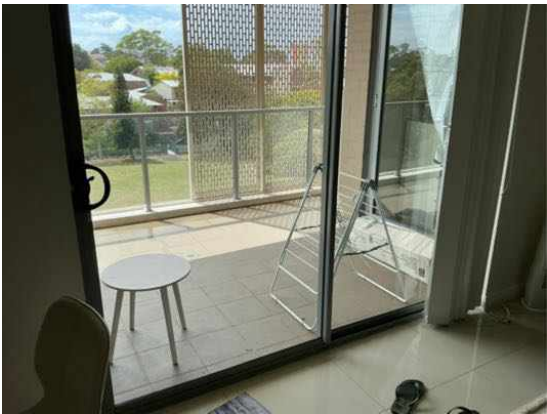
Building: Main Building  
Location: All Areas  
Finding: Additional Photos - Obstructions and Limitations  
Information: These photographs are an indication of the obstructions and limitations which impeded full inspection of the property at the time of inspection. These obstructions can hide an array of defects and should be removed to allow full inspection to be carried out. A re-inspection is recommended once the areas are made accessible.
