Building Inspection Report

Inspection Date: Wed, 1 Apr 2026

Property Address: 54 Ohallorans Rd, Lara VIC 3212, Australia

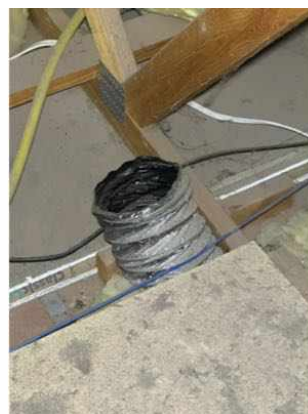
Defects 1.01

Contemporary requirements for mechanical kitchen ventilation systems specify that ducted rangehoods must discharge directly to the external atmosphere. Venting into the roof void introduces airborne grease particles, cooking odours, and moisture-laden air into an enclosed space, which may result in long-term deterioration of insulation materials, framing components, and roof elements.

- Accumulation of grease and moisture within the roof void
- Potential mould or condensation-related damage to insulation and framing
- Non-compliance with current NCC requirements for mechanical exhaust systems
- Possible reduction in indoor air quality and ventilation performance

While this installation may have been permissible under older standards, it is not compliant with current construction and health expectations. Rectification is advised to prevent further impact to the roof space and to meet modern regulatory requirements.

- A licensed plumber or mechanical ventilation specialist should be engaged to modify the ductwork and install a compliant termination to the external atmosphere
- The roof cavity should be inspected for signs of moisture damage or grease build-up resulting from prolonged internal discharge
- Any insulation affected by grease or moisture contamination should be replaced

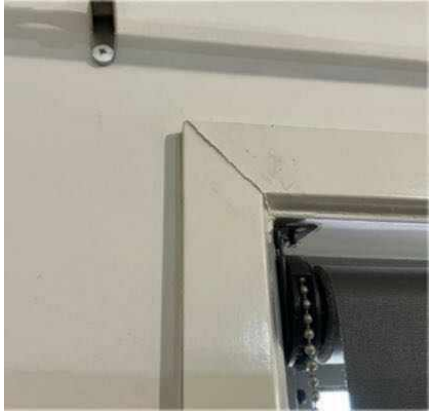
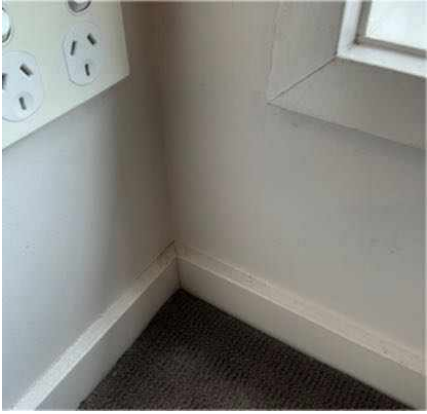
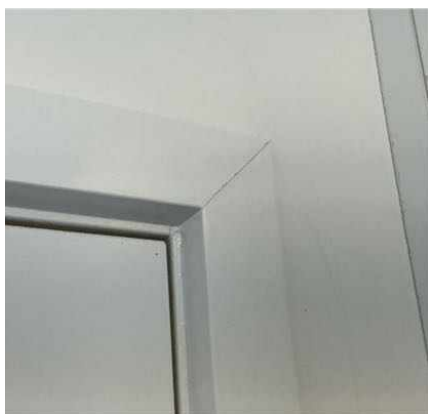
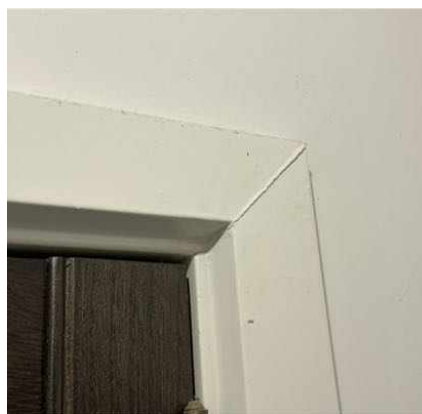
Defects 3.01

Building:	Main Building
Location:	All Internal Areas
Finding:	Cracking to Painted Architraves and Skirting Boards
Information:	Cracks were observed opening up in various sections of the painted architraves and skirting boards. These cracks may be associated with minor building movement, timber shrinkage, or inadequate surface preparation prior to painting.

- Aesthetic presentation is compromised by visible cracking.
- Potential ongoing movement may lead to further deterioration or require repeated maintenance.
- May indicate underlying workmanship or preparation issues.

This condition is not uncommon following recent painting, particularly in timber joinery, and is typically considered a maintenance item unless associated with significant structural movement.

- Engage a qualified painter or builder to assess the extent of cracking and undertake necessary repairs, which may include filling, sanding, and repainting affected areas.
- Monitor for any signs of worsening or recurring movement over time.

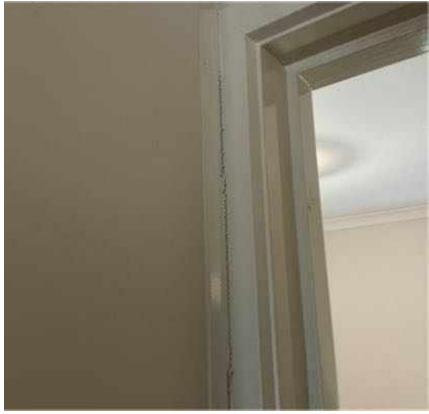
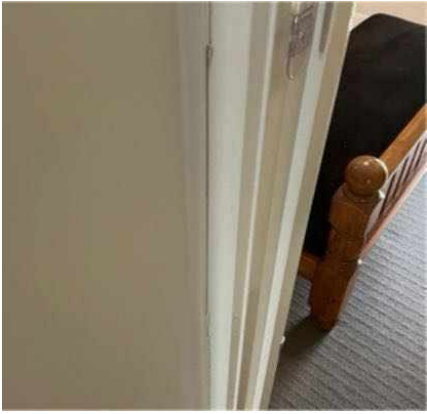
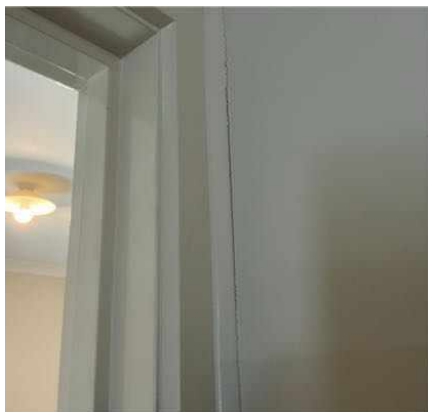
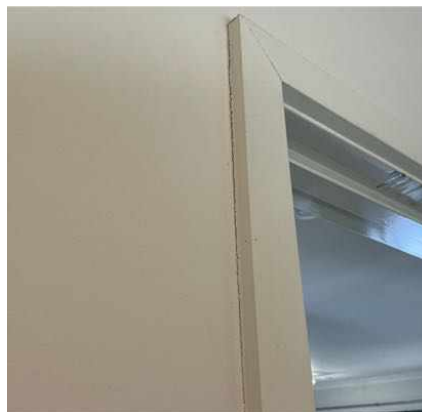
Defects 3.02

Building:	Main Building
Location:	All Internal Areas
Finding:	Cracking Between Architrave and Wall Junction
Information:	During the inspection, cracking and separation were observed between the architrave and the adjoining wall surface. This condition is commonly caused by normal building movement, minor frame shrinkage, or seasonal expansion and contraction of materials. In some cases, movement may also be influenced by additional loads from attached fittings such as blinds or curtain brackets.

- Cracking detracts from the appearance of internal finishes.
- Minor separation may continue with seasonal changes or building movement.
- Unsealed gaps can collect dust or allow minor moisture staining over time.

The condition appears cosmetic and is typical of normal building movement. It can be readily repaired through routine maintenance and repainting.

- Inspect the affected areas and refix or reinforce the architrave where movement is evident.
- Recaulk or fill the junction using a flexible sealant suitable for painted surfaces, then sand and repaint.
- Ensure that any attached fittings are adequately supported to reduce future stress on trim components.

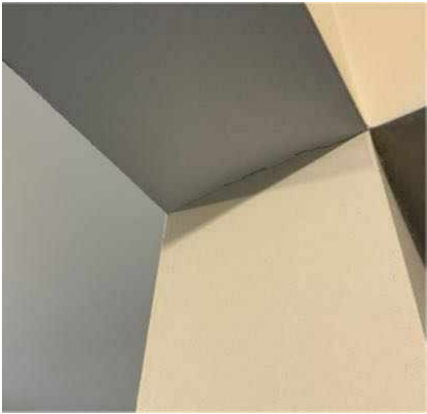
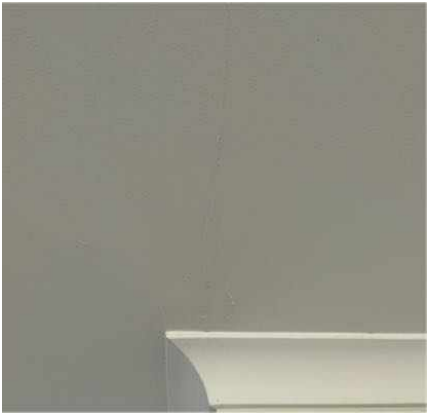
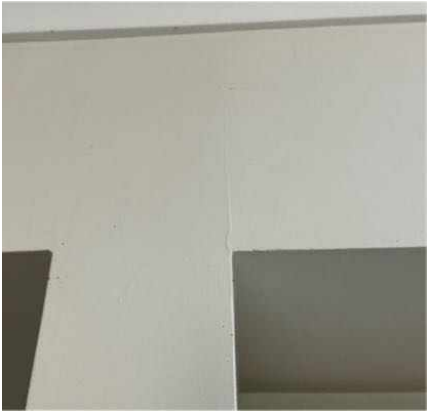
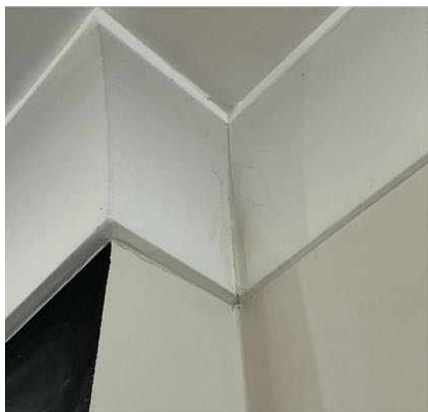
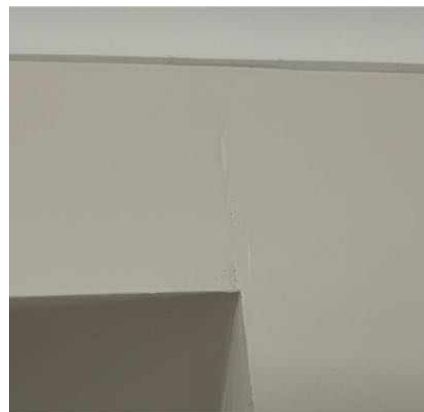
Defects 3.03

Building:	Main Building
Location:	All Internal Areas
Finding:	Cracking to Internal Wall Linings
Information:	Cracking was observed to internal wall linings during the inspection. These types of cracks are generally considered common and are typically the result of natural building movement, age-related wear, thermal expansion and contraction, or minor installation-related issues in plasterboard or supporting framing members.

The cracking noted is typical of minor building movement and does not currently present as structural. Regular monitoring and cosmetic repair will assist in preserving the internal presentation and allow early intervention if future issues arise.

- Engage a qualified plasterer to repair cracks and consider installing expansion joints if necessary to accommodate ongoing building movement.
- Arrange for repainting by a qualified painter following any plaster repairs.
- Monitor cracks over time for signs of progression (e.g. widening, lengthening, or new cracks forming).
- If deterioration continues or operational issues with doors/windows arise, seek further assessment from a building inspector or structural engineer.

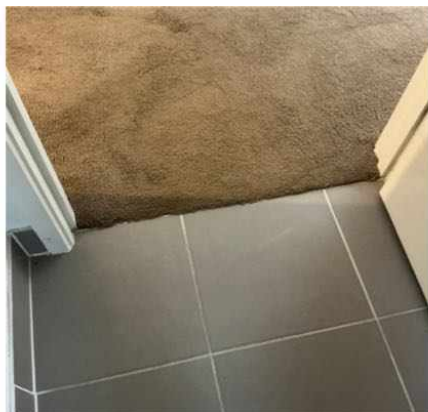
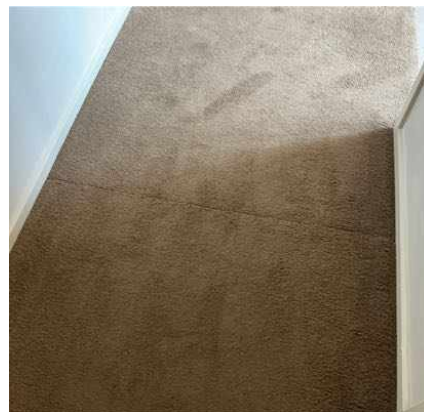
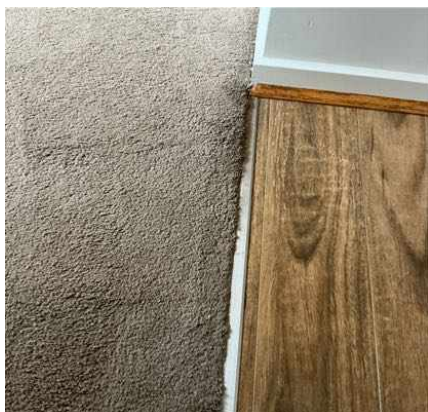
Defects 3.04

Building:	Main Building
Location:	Internal Areas
Finding:	Early Wear to Carpeted Flooring
Information:	During the inspection, the carpet in areas was observed to be showing early signs of wear. This includes visible flattening of the pile, localised tracking along the main traffic path, and minor surface irregularities. These conditions are commonly associated with regular foot traffic, furniture movement, and general use over time, particularly in high-use circulation areas.

- Progressive wear may lead to further deterioration of the carpet fibres, reducing overall service life.
- Worn areas can detract from the cosmetic presentation of internal spaces.
- If deterioration continues, localised repairs may become impractical, requiring partial or full replacement.

The observed carpet wear appears consistent with normal use and is not unusual for trafficked areas. Ongoing maintenance and monitoring will assist in managing presentation and extending the remaining lifespan of the flooring.

- Continue routine cleaning and maintenance to slow further wear, including professional carpet cleaning as required.
- Consider the use of runners or protective mats in high-traffic areas to reduce ongoing deterioration.
- If wear becomes more pronounced or unacceptable, seek advice from a flooring specialist regarding repair or replacement options.

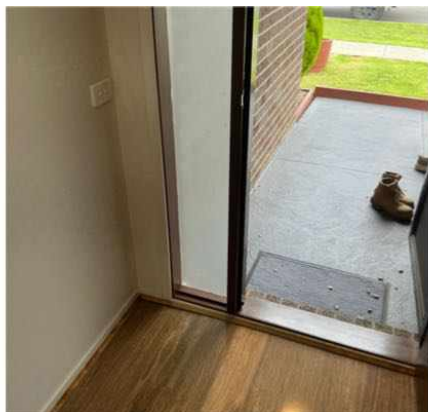
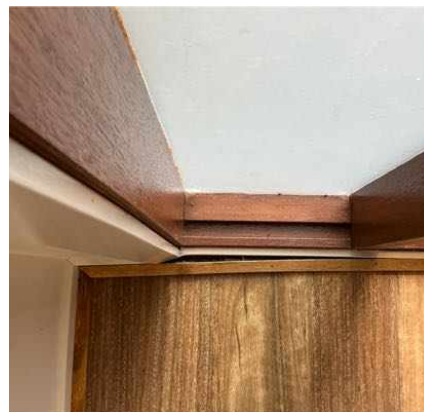
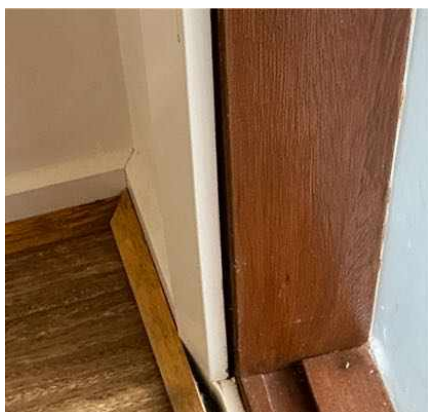
Defects 3.05

Building:	Main Building
Location:	Entry
Finding:	Door Frame Movement and Misalignment at External Door
Information:	At the time of inspection, the door frame at the external doorway appears to have moved outward, as evidenced by the misalignment between the architrave and the floating floor trim. Gaps are visible at the junctions, and the finishes do not align as intended. This condition may be due to inadequate fixing of the door frame, however this was not verified at the time of inspection.

- Movement of the door frame may continue if fixing is inadequate.
- Gaps at junctions can allow air, moisture, and pests to enter.
- Misalignment may affect door operation and sealing performance.

The door frame shows signs of movement and misalignment. Further assessment and rectification are recommended to ensure proper fixing and performance.

- Realign and refit affected trims and architraves to achieve a consistent finish.
- Seal gaps as required to prevent air and moisture ingress.

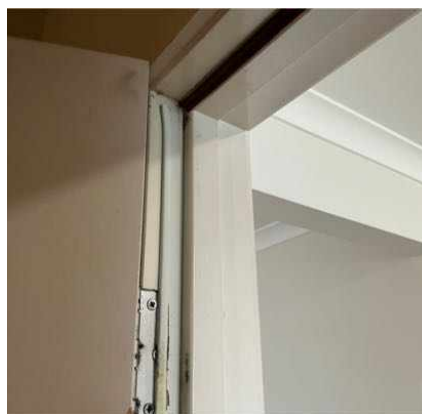
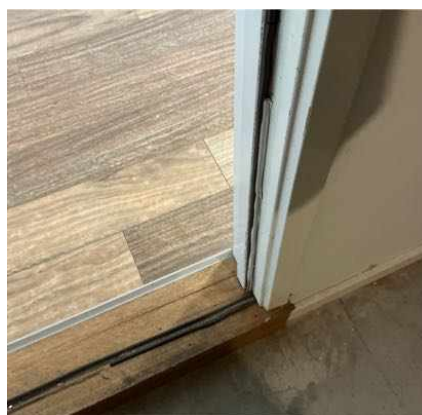
Defects 3.07

Building:	Main Building
Location:	Garage Access
Finding:	Deteriorated and Missing External Door Seals
Information:	During inspection, several external door seals were found to be deteriorated and no longer providing effective sealing, while other openings were observed with seals completely missing. The deterioration appears consistent with age, ongoing wear, and weather exposure. Missing seals leave visible gaps between the door leaf and frame threshold.

The absence or failure of seals compromises the door's intended function of restricting air, moisture, and pest ingress.

- Allows wind, dust, and moisture to enter the dwelling
- Reduces thermal efficiency and may increase heating/cooling costs
- Creates potential pathways for insects or vermin through unsealed gaps
- May contribute to drafts, discomfort, or internal condensation under certain weather conditions

Restoring effective sealing to external doors will improve comfort, reduce energy loss, and minimise moisture or pest ingress risks.

- Install new seals to openings where seals are missing
- Replace deteriorated seals with suitable weather-resistant products
- Check frames for alignment during seal installation to ensure proper contact
- Implement periodic maintenance inspections of external openings to sustain weather-tightness

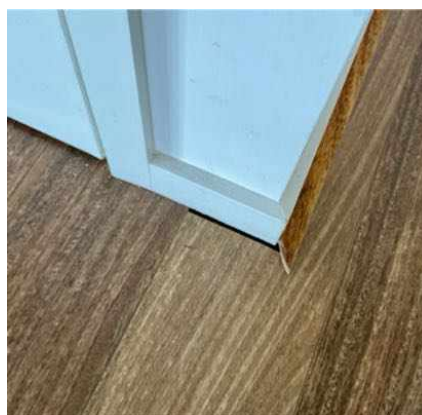
Defects 3.08

Building: Main Building
 Location: Kitchen
 Finding: Missing Floating Floor Trims
 Information: At the time of inspection, floating floor trims were observed to be missing in one or more areas at floor junctions. This has resulted in exposed flooring edges and an incomplete finish. The absence of trims does not meet acceptable standards of workmanship and leaves the flooring installation vulnerable to movement and edge damage during normal use.

- Exposed flooring edges are prone to damage and deterioration.
- Increased likelihood of floor movement or separation at junctions.
- Potential trip hazard where level transitions are not properly finished.
- Overall finish and durability of the flooring installation is reduced.

The current condition reflects an incomplete flooring installation. Rectification is recommended to provide a complete, durable, and serviceable finish.

- Engage a qualified flooring contractor to supply and install all missing trims.
- Ensure trims are securely fixed and neatly finished at all floor junctions.
- Confirm all exposed flooring edges are adequately protected.

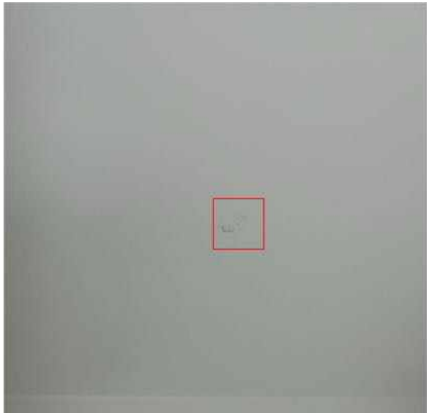
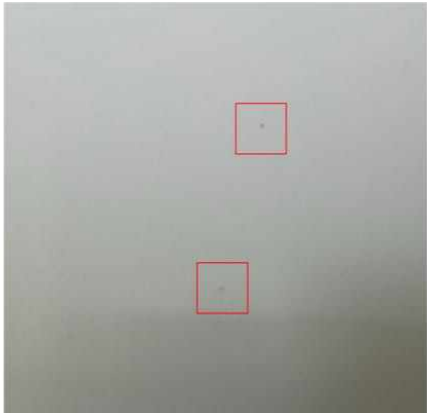
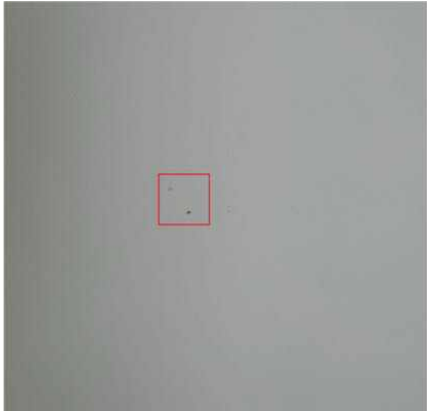
Defects 3.09

Building: Main Building
 Location: Living Room
 Finding: Historic Water Damage to Ceiling Linings
 Information: During the inspection, areas of the ceiling linings displayed visible staining, patchiness,

and surface irregularities consistent with historic moisture exposure. The affected areas appear dry at the time of inspection, and no active dripping or moisture ingress was observed. However, the exact source and extent of the previous moisture event could not be confirmed. The condition suggests prior water penetration or prolonged humidity exposure, which has affected the ceiling lining finishes.

- Historic water exposure may have reduced the long-term durability and integrity of the ceiling linings.
- There is potential for concealed damage to framing or insulation above the affected ceiling areas.
- Previous leaks may recur if the original source has not been permanently rectified.
- Cosmetic deterioration affects the overall presentation of the internal finishes.

In summary, the ceiling linings show evidence of historic water damage. While no active moisture was observed at the time of inspection, the underlying cause has not been confirmed, and further investigation and ongoing monitoring are recommended to ensure no continuing or future moisture issues are present.

- Monitor the affected ceiling areas during rainfall and high-humidity conditions for any signs of active moisture.
- Engage a licensed builder or plumber to investigate possible sources of historic water ingress, including roof coverings, flashings, gutters, or plumbing services.
- If no active moisture is present, engage a qualified tradesperson to repair, prepare, and repaint the affected ceiling linings.
- If further moisture activity is detected, undertake immediate investigation and rectification to prevent further damage.

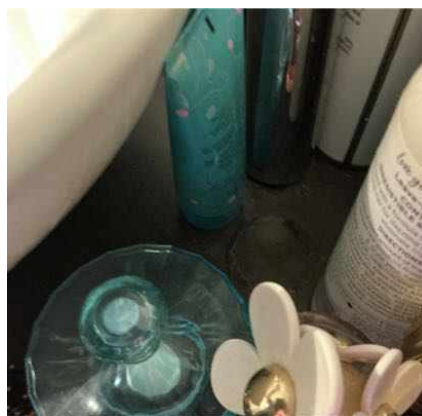
Defects 3.10

Building:	Main Building
Location:	Ensuite
Finding:	Loose Basin Mixer Tap
Information:	At the time of inspection, the basin mixer tap was found to be loose at its base where it connects to the countertop. The fitting does not sit firmly in place, indicating that the securing components beneath the benchtop may not have been adequately tightened or installed. Fixtures should be securely fixed to prevent movement during normal use.

- Movement of the tap can place stress on plumbing connections over time.
- Potential for minor water ingress at the base if not properly sealed.
- Ongoing use may worsen the looseness and affect functionality.

The mixer tap is not adequately secured and should be rectified to ensure it is stable and performs as intended.

- Engage a licensed plumber to secure the mixer tap correctly.
- Ensure the base is properly sealed to maintain water resistance.
- Check for any associated leaks or movement in connected pipework.

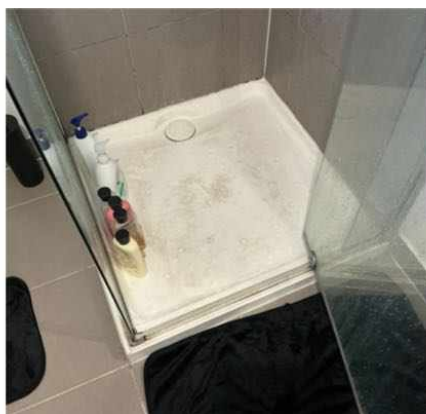
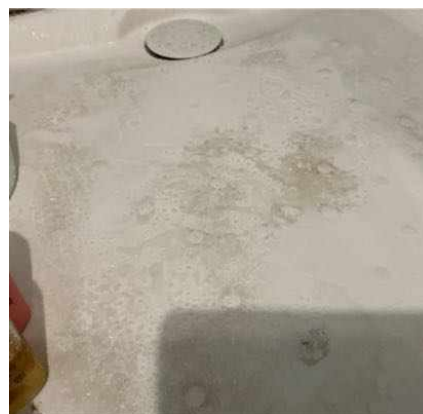
Defects 3.11

Building:	Main Building
Location:	Ensuite
Finding:	Shower Base – Deterioration and Surface Staining
Information:	At the time of inspection, the shower base exhibited visible surface deterioration and staining, particularly across the central area. The finish appears worn and discoloured, with evidence of ongoing water exposure and material breakdown. The condition

suggests the surface has degraded over time and may no longer be performing as intended.

- Deteriorated surfaces may allow water to sit rather than drain effectively.
- Surface breakdown can lead to hygiene concerns and ongoing staining.
- Potential for water to track into junctions and surrounding materials over time.
- Indicates general wear and possible age-related decline of the shower base.

The shower base shows signs of deterioration and wear and will require attention to maintain functionality and prevent potential water-related issues.

- Engage a suitable contractor to assess the condition of the shower base.
- Repair, resurface, or replace the base as required depending on condition.
- Ensure all junctions and seals are checked and maintained during any works.
- Monitor for any signs of leakage or further deterioration.

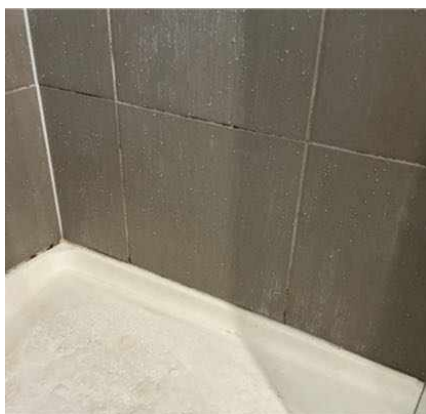
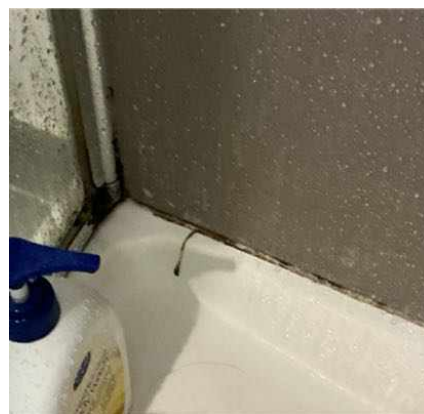
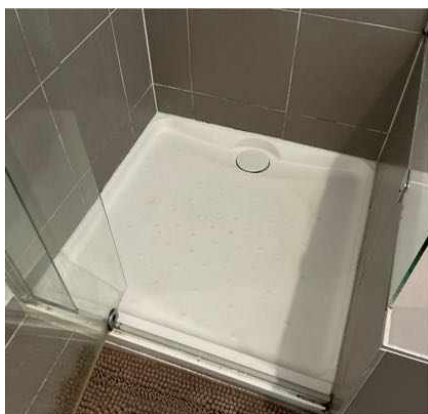
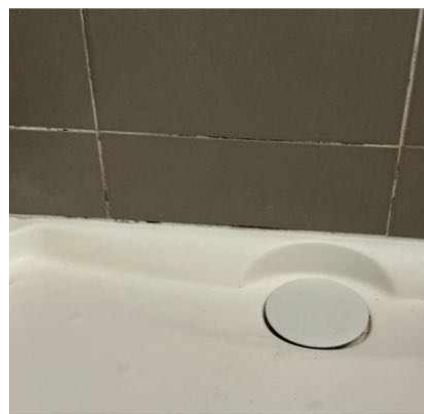
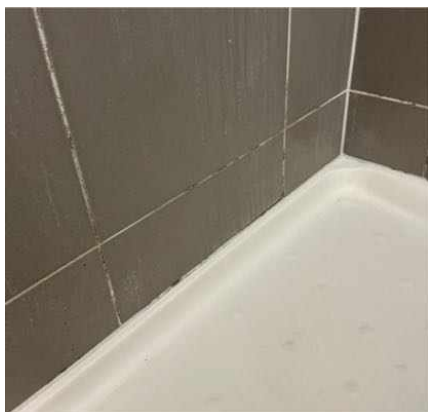
Defects 3.12

Building:	Main Building
Location:	Ensuite & Bathroom
Finding:	Mould Growth on Shower Junction Caulking
Information:	Minor mould growth was observed on the silicone caulking at the wall-to-floor junction within the shower recess. The sealant appears intact, but the presence of mould indicates moisture retention along the junction.

In summary, the mould growth appears superficial at this stage, but cleaning and improved ventilation are recommended to maintain hygiene and prevent recurrence.

- Clean the affected silicone using a suitable mould-removal product designed for wet areas.
- Improve ventilation within the bathroom where possible to assist with drying after use.
- If mould staining persists, consider replacing the silicone with a mould-resistant sanitary-grade product in accordance with AS 3740:2021 Waterproofing of domestic wet areas.

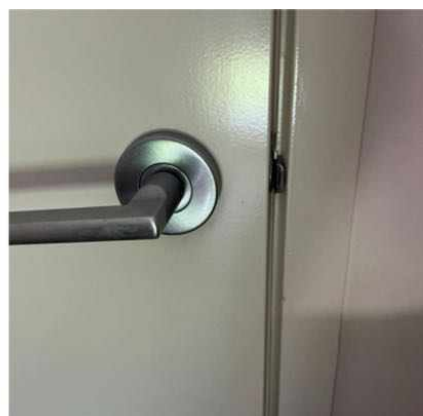
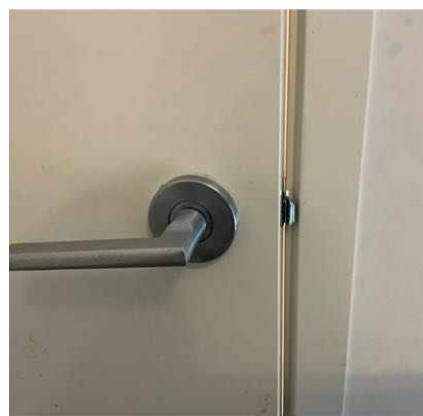
Defects 3.13

This condition is considered maintenance-related and can typically be resolved through minor repairs. Prompt action will restore functionality and prevent further wear to door components.

- Engage a qualified carpenter or handyman to:
- Realign or reposition striker plates as needed
- Tighten or replace worn hinge hardware
- Plane or sand door edges where minor swelling or warping is present
- Monitor humidity in high-moisture areas to prevent ongoing movement
- Repaint or seal affected door edges to minimise moisture ingress

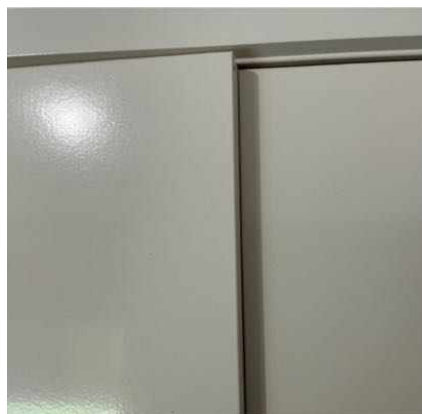
Defects 3.15

Building:	Main Building
Location:	Bedroom 4
Finding:	Internal Binding Robe Doors
Information:	During the inspection, it was found that one or more internal robe doors throughout the property were observed to be binding against each other during opening and closing. This issue affects the functionality of the doors and may lead to progressive

Correcting this issue will restore proper functionality and prevent long-term deterioration of cupboard door systems.

- Engage a qualified carpenter or handyman to assess all affected robe doors.
- Adjust hinges, realign doors, or plane down contact points as needed to ensure smooth operation.
- Inspect hardware for wear or looseness and replace if necessary.
- Continue to monitor door performance and perform routine maintenance such as hinge tightening and lubrication.

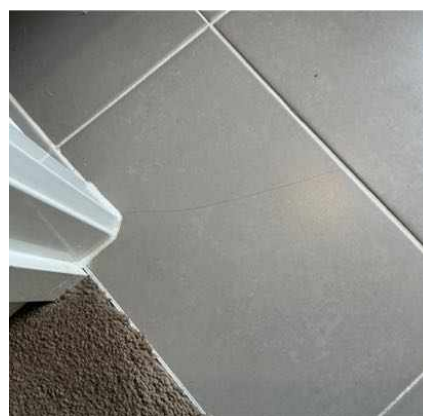
Defects 3.16

Building: Main Building
 Location: Laundry
 Finding: Cracked Floor Tiles - Non Structural
 Information: Cracks were observed in the floor tiles across multiple areas of the home. These appear to be the result of minor settlement in the floor structure or natural expansion and contraction of materials over time. The cracking is localised and does not appear to indicate any structural concern at this stage.

Cracked tiles are a relatively common occurrence and typically considered a maintenance or cosmetic issue unless accompanied by other signs of structural movement.

- Engage a tiling contractor or qualified handyman to assess and replace affected tiles as required.
- If cracking becomes more extensive, consult a registered builder or building inspector for further evaluation.

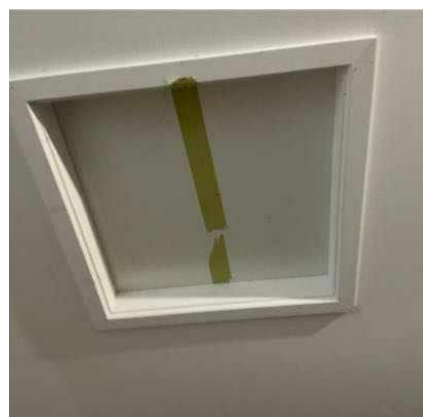
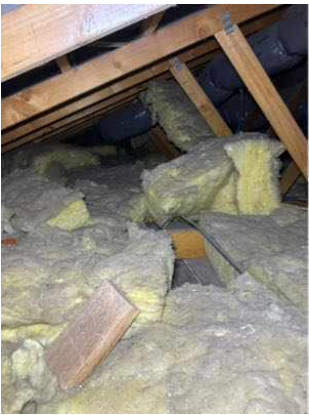
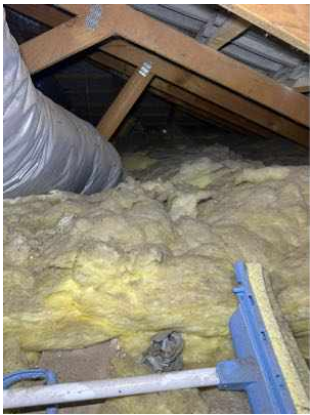
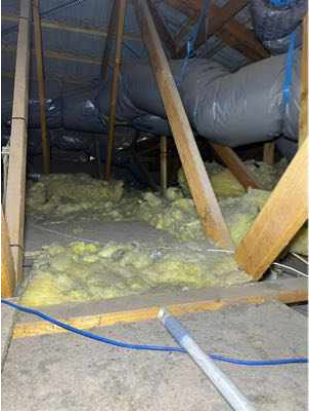
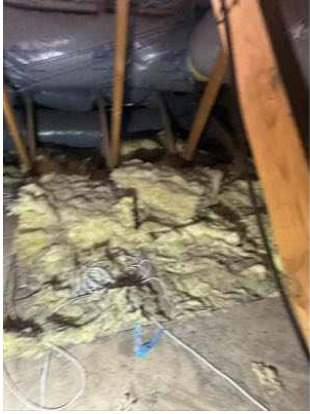
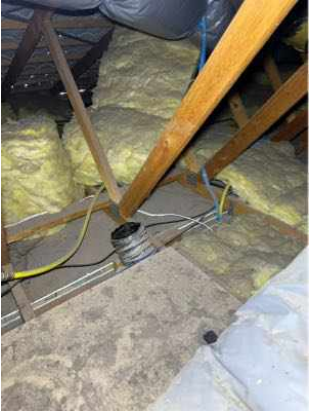
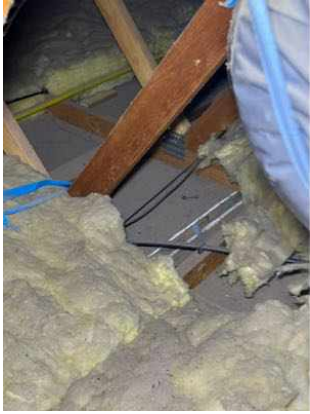
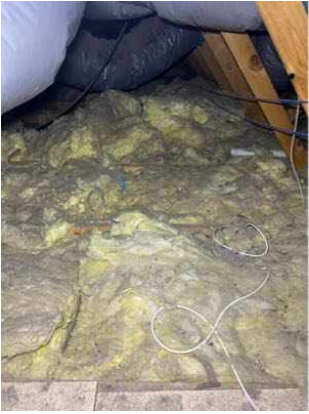
Defects 3.17

Information: At the time of inspection, ceiling insulation batts were observed to be disturbed and inadequately reinstated in one or more areas. This has resulted in gaps, displacement, and compression of the insulation material, affecting the continuity of the thermal barrier. The current condition reduces the effectiveness of the insulation and does not reflect acceptable installation standards.

The current condition reflects inadequate installation of ceiling insulation in one or more areas. Rectification is recommended to restore thermal performance and ensure a consistent and effective insulation layer.

- Engage a suitable contractor to reinstate insulation in affected areas.
- Ensure batts are correctly positioned, uncompressed, and provide full coverage.
- Confirm no gaps or voids are present within the insulation layer.

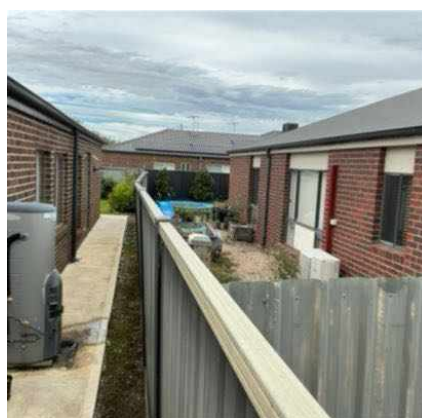
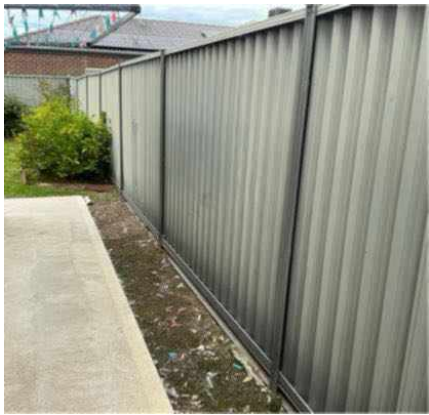
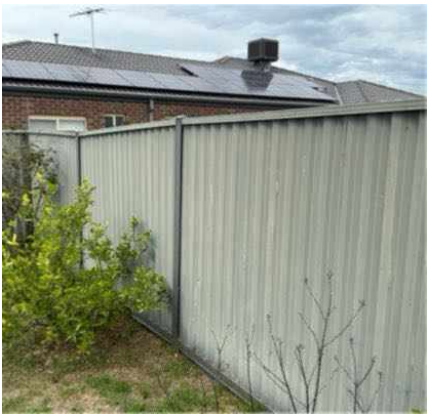
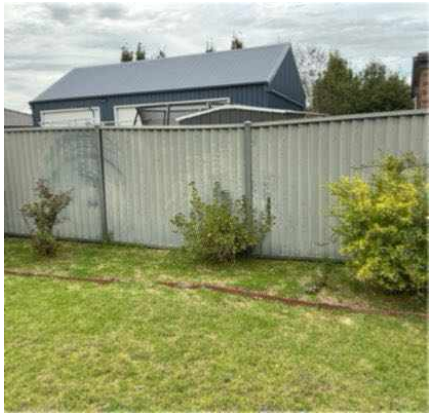
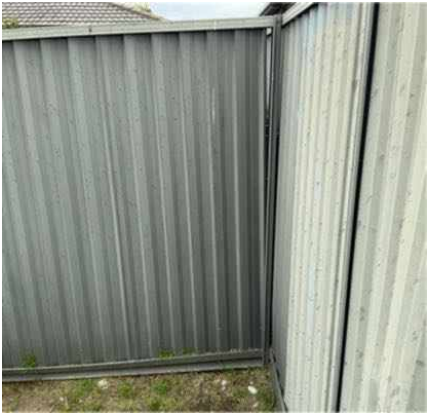
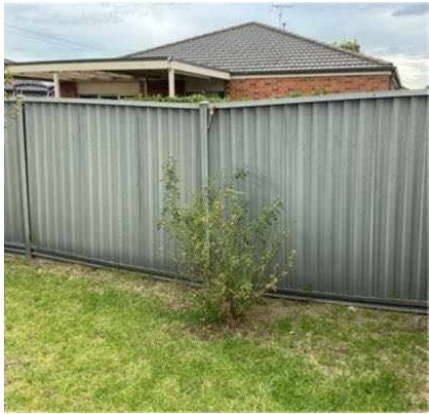
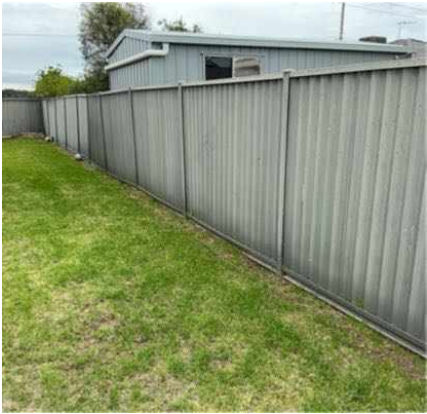
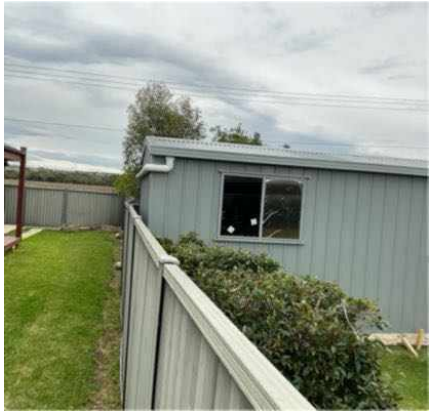
Defects 3.18

Building: Main Building
Location: All External Areas
Finding: Colourbond Boundary Fence – Movement, Fading and Corner Separation
Information: At the time of inspection, the Colourbond boundary fencing was observed to be in a deteriorated condition with visible fading to panels, waviness along the fence line, and sections of settlement. Movement has resulted in misalignment of panels, with a noticeable gap present at a corner junction where the fence sections no longer meet correctly.

- Gaps at fence junctions may allow entry of pests and reduce boundary security.
- Ongoing movement can place stress on posts and fixings, leading to further deterioration.
- Waviness and misalignment indicate loss of stability in sections of the fence.
- Faded panels reduce the overall aesthetic appearance of the property.

The fence shows signs of movement and deterioration and requires rectification to restore alignment, function, and overall presentation.

- Re-align and re-support affected fence sections, particularly at the corner junction.
- Inspect posts and footings for movement and rectify as required.
- Backfill and compact surrounding soil to reduce further settlement.
- Consider panel replacement or repainting if improved appearance is desired.

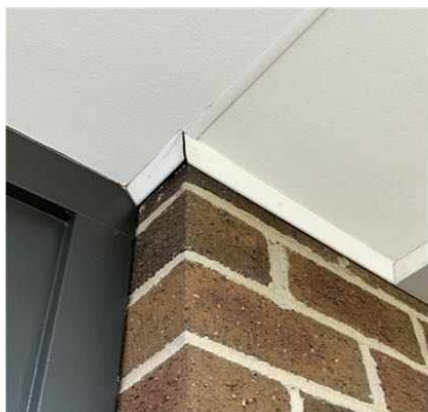
Defects 3.19

Building:	Main Building
Location:	Eave
Finding:	Cracking and Separation of Timber Quad Moldings at Eaves
Information:	During the inspection, cracking and separation was noted at the mitre joints of timber quad moldings installed around the eaves in multiple locations. This condition is common in aging properties and is typically associated with natural movement and environmental exposure over time.

- Cosmetic deterioration of external timber finishes.
- Potential for moisture ingress if gaps are left untreated, leading to timber decay.
- May require ongoing monitoring as the building continues to age and move.

The separation observed is consistent with typical age-related wear and environmental exposure, and is considered a maintenance item rather than a structural concern. Prompt attention will help prevent moisture-related deterioration and preserve the external appearance of the property.

- Engage a qualified carpenter or handyman to:
- Reattach and secure any loose quad moldings.
- Fill visible gaps at mitre joints with a flexible, weather-resistant exterior filler.
- Repaint affected areas with a high-quality, weatherproof coating to protect from further weathering.
- Monitor repaired areas as part of routine exterior maintenance, particularly following seasonal changes or heavy rain events.

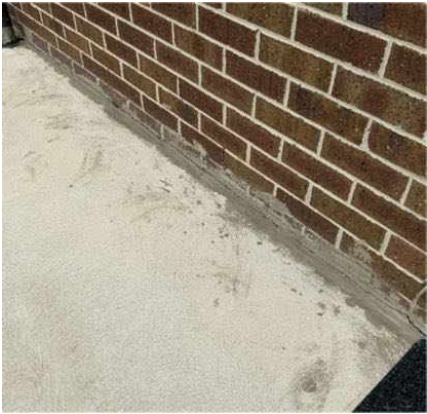
Defects 3.20

Building:	Main Building
Location:	Rear
Finding:	Concrete Apron – Evidence of Movement and Patch Repairs
Information:	At the time of inspection, the concrete apron along the rear of the dwelling displayed signs of movement, including separation at the junction between the slab and brickwork. There is evidence of patching or infill material applied along this junction, indicating prior attempts to address the gap. The surface finish also shows variations consistent with previous repair works.

- Movement of the concrete apron may allow water to collect or track toward the dwelling.
- Gaps at the slab-to-wall junction can permit moisture ingress at the base of the external wall.
- Previous patch repairs may be temporary and could reopen with further movement.
- Ongoing movement may indicate underlying ground settlement or moisture-related soil changes.

The observed movement and prior repairs indicate the apron has experienced settlement and should be monitored and maintained to minimise the risk of moisture-related issues.

- Monitor the affected area for further movement or widening of gaps over time.
- Engage a suitable contractor if movement continues to assess and rectify the cause.
- Seal the junction appropriately to reduce the risk of water ingress.
- Ensure surface drainage directs water away from the dwelling.

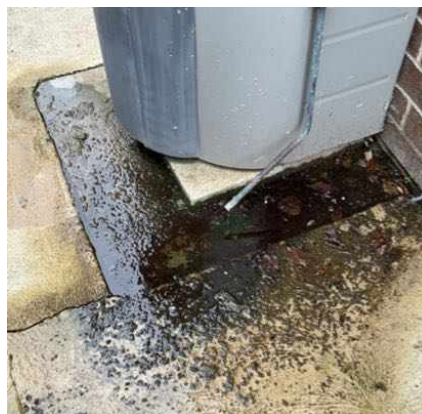
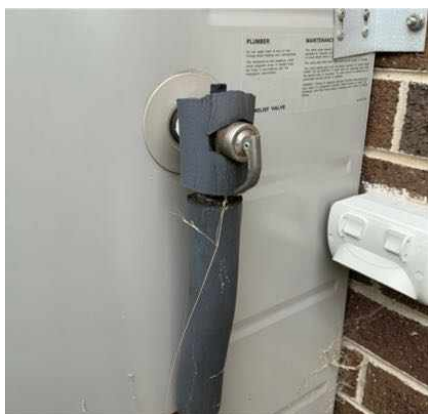
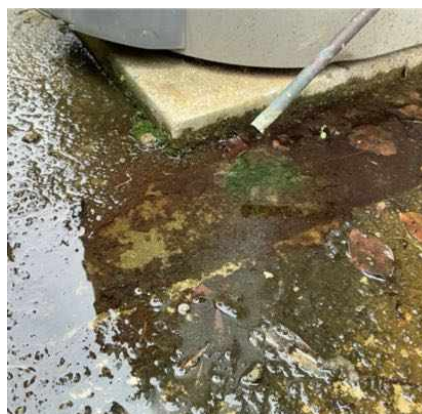
Defects 3.21

Building: Main Building
Location: Right-hand Side
Finding: Hot Water System – Continuous Discharge from Relief Valve
Information: At the time of inspection, the hot water system was observed to be discharging water continuously from the pressure/temperature relief valve. This has resulted in ongoing water pooling at the base of the unit and surrounding concrete area. The discharge pipe appears to terminate directly onto the ground without appropriate drainage, contributing to surface saturation and staining.

- Continuous discharge may indicate a faulty relief valve or excessive system pressure.
- Ongoing moisture at the base can contribute to deterioration of adjacent building elements and slab edge conditions.
- Pooling water may create slip hazards and promote algae or mould growth.
- Improper discharge location may lead to unnecessary water wastage and localised ground saturation.

The hot water system is not operating as intended and requires further investigation and rectification to prevent ongoing water discharge and associated issues.

- Engage a licensed plumber to assess the hot water system and relief valve operation.
- Repair or replace the valve if found to be defective.
- Ensure discharge is correctly directed to an appropriate drainage point in accordance with plumbing requirements.
- Monitor the area following rectification to confirm the issue has been resolved.

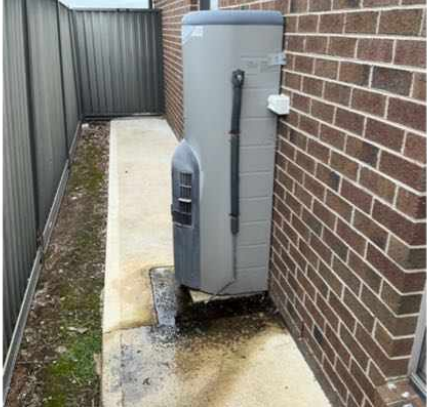
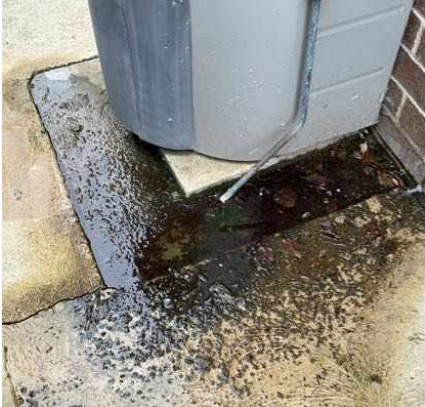
Defects 3.22

Building:	Main Building
Location:	Right-hand Side
Finding:	Uncontrolled Discharge from Hot Water System Overflow Pipe
Information:	The hot water system overflow pipe is currently discharging directly onto the surrounding ground without connection to a suitable drainage system. This condition results in persistent dampness near the dwelling, which poses a risk to both the structural elements and long-term durability of the property.

- **Foundation and Subfloor Impact:** Excessive moisture near the footings or stumps may cause differential movement, subsidence, or footing instability.
- **Moisture-Related Damage:** Damp conditions can contribute to fungal decay in timber, corrosion of metal elements, and deterioration of adjacent building materials.
- **Termite Risk:** Consistently damp soil near the building perimeter creates an attractive environment for termite activity.
- **Drainage Deficiency:** Uncontrolled overflow highlights a lack of adequate site drainage and may result in localised water pooling or slip hazards.

Rectifying the overflow discharge is essential to protect the property from moisture-related issues and ensure compliance with accepted plumbing and site drainage practices.

- Engage a licensed plumber to connect the hot water system overflow pipe to a compliant and appropriately directed drainage point.
- Improve surface water management around the discharge area to ensure water is diverted away from the foundation or subfloor.
- Monitor the area for signs of recurring dampness, erosion, or pooling, and implement remedial action where required.
- Consider installing gravel, a splash pad, or hardstand surface to reduce moisture

retention at the discharge point.

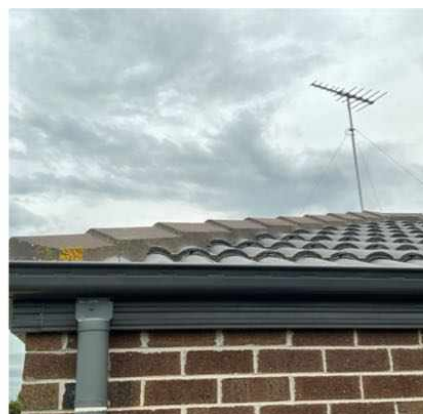
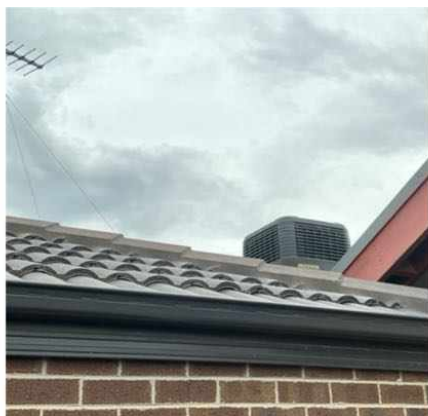
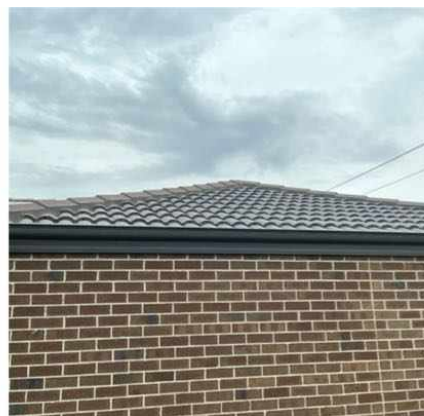
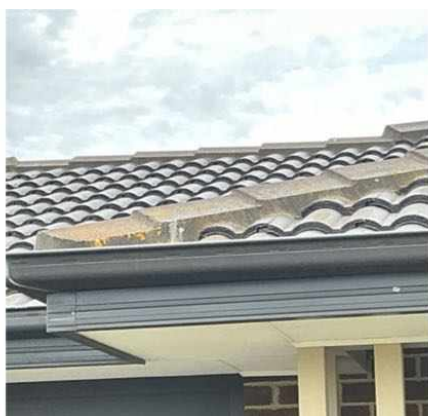
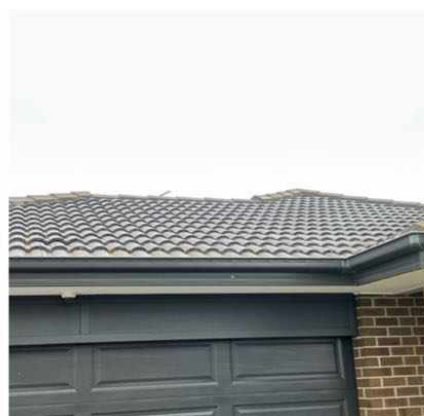
Building: Main Building
Location: Roof Exterior
Finding: Roof Covering – General Condition
Information: At the time of inspection, the roof covering appears to be in generally serviceable condition. Roof tiles were observed to be intact and adequately laid, with no significant displacement or widespread damage noted. Minor weathering and lichen growth were visible to sections of the ridge capping, which is typical for the age and exposure of the roof. No obvious signs of active leaks or immediate defects were identified from the areas viewed.

- Minor biological growth and weathering are common and typically do not impact immediate performance.
- Ongoing exposure may lead to gradual deterioration of ridge mortar over time.
- Routine maintenance will be required to preserve long-term performance.

The roof covering is currently performing its intended function and is considered to be in serviceable condition, with only routine maintenance required.

- Undertake periodic roof inspections and maintenance.
- Clean and treat lichen growth as required to prolong the life of roof components.
- Monitor ridge capping and mortar for any signs of cracking or deterioration.

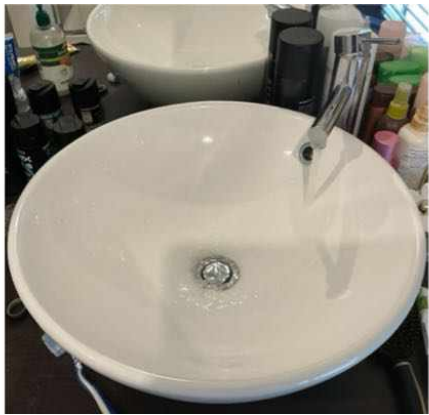
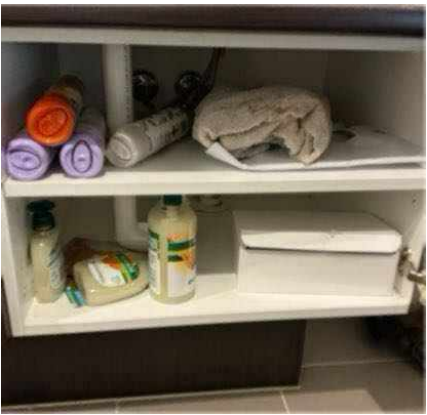
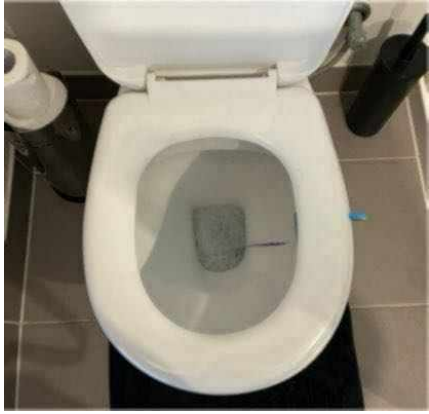
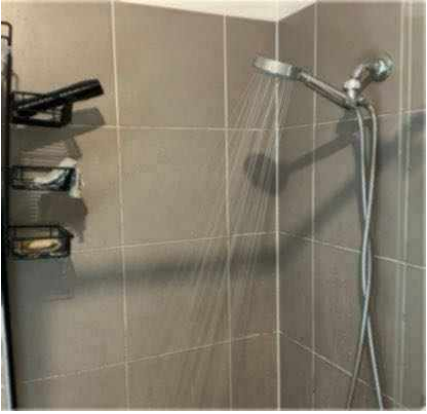
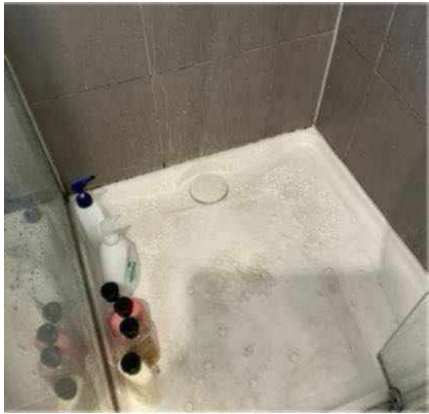
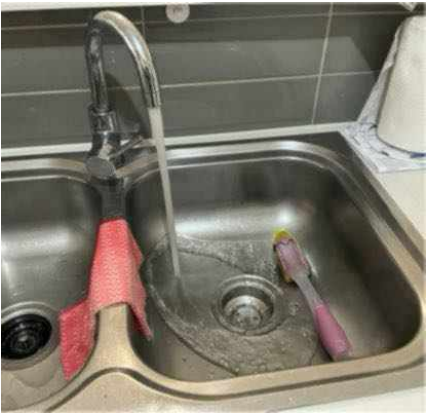
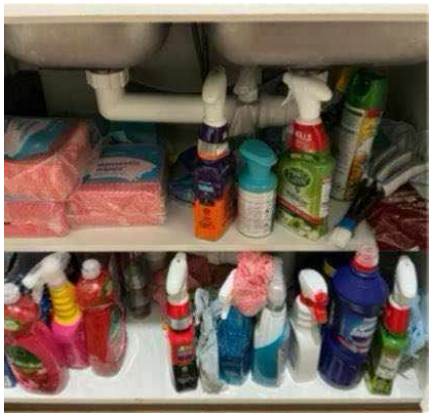
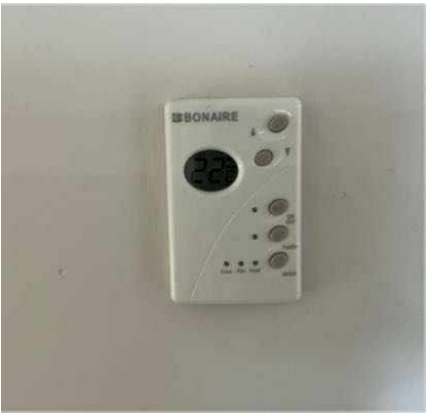
Building:	Main Building
Location:	All Internal Areas
Finding:	Plumbing Fixtures – Operational Check
Information:	Accessible plumbing fixtures were operated at the time of inspection to check for basic operation. Sinks, vanities, showers and toilets were turned on and tested for water flow, drainage and any visible leaks during operation. Fixtures generally appeared to run and drain at the time of testing, and no significant leaks were observed at accessible areas.

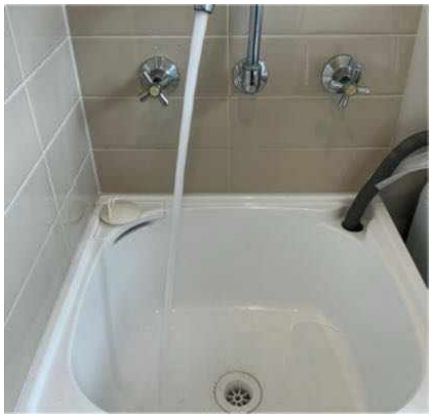
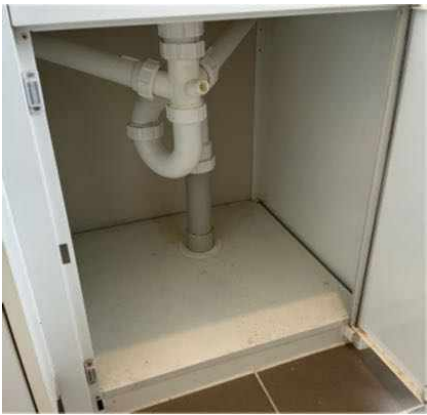
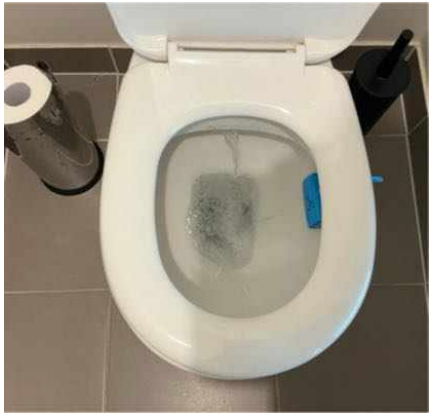
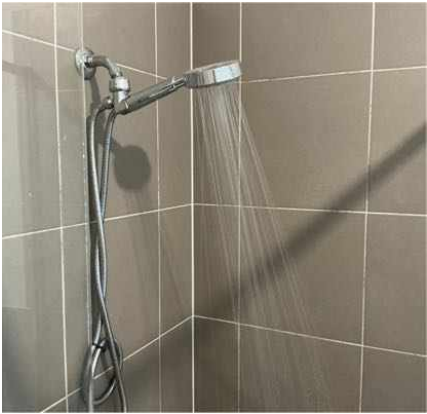
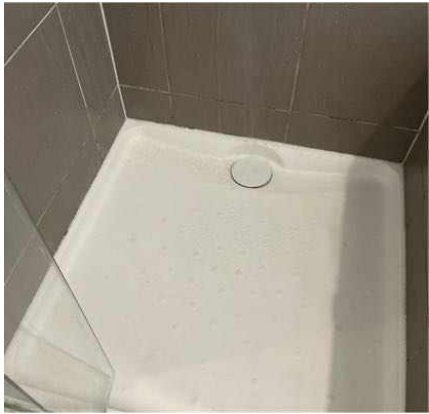
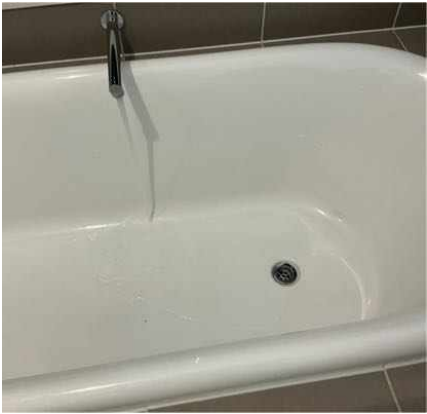
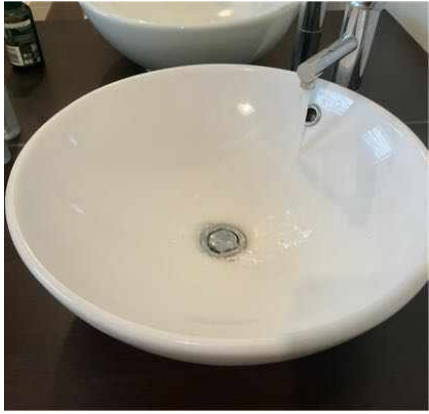
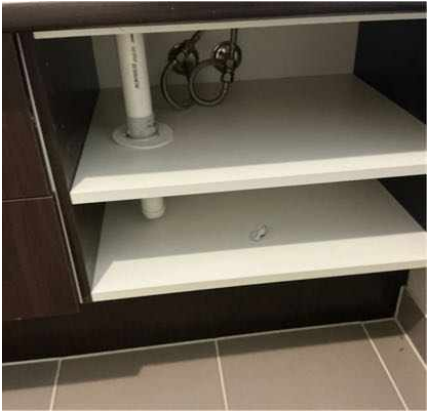
This check is limited to a visual and operational assessment only and does not include pressure testing, dismantling of fixtures, or inspection of concealed plumbing components. Conditions such as concealed leaks, slow drainage, intermittent faults, or issues within hidden pipework may not be evident during a limited inspection.
