Building Inspection Report

Inspection Date: Wed, 1 Apr 2026

Property Address: 54 Ohallorans Rd, Lara VIC 3212, Australia

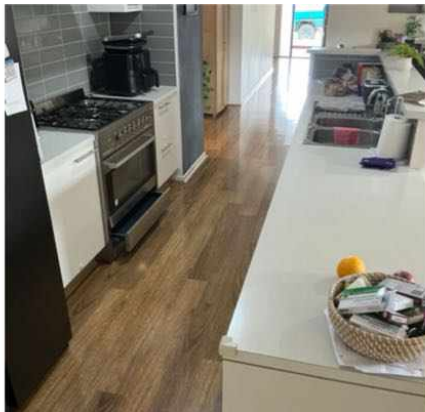
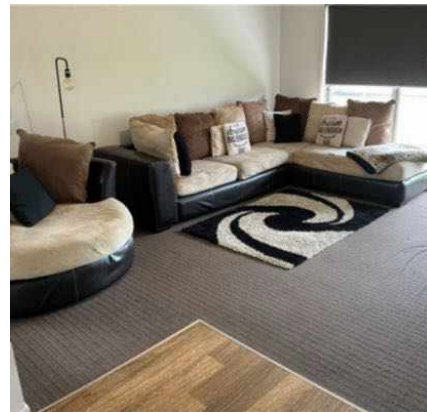
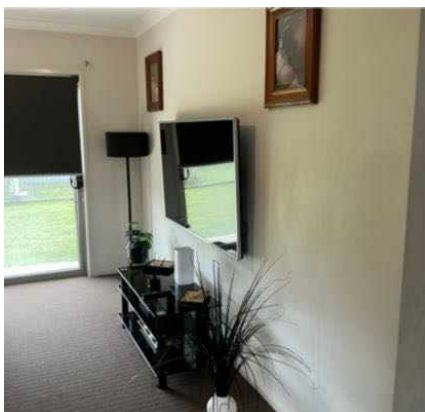
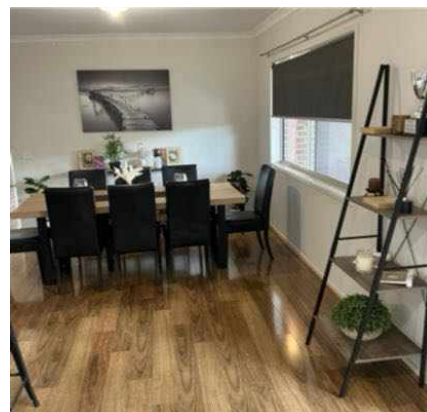
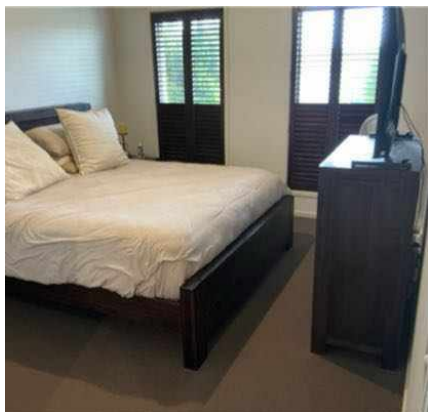
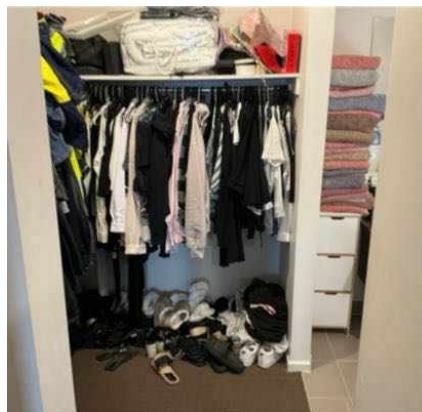
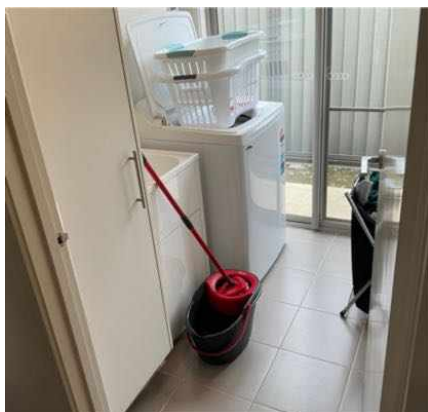
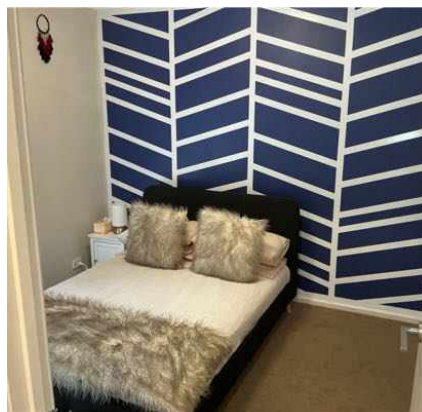
Building: Main Building
Location: All Internal Areas
Finding: Internal Inspection Limitations – Obstructed Areas
Information: Several internal areas of the dwelling were obstructed by stored items, furniture, appliances, and general household belongings at the time of inspection. These obstructions restricted inspection access, prevented visibility of key building elements, and limited the ability to assess these areas in accordance with AS 4349.1-2007.

These photographs are provided as evidence of the obstructions and the resulting inspection limitations. It must be acknowledged that concealed conditions behind or beneath such obstructions cannot be assessed, and defects may exist in these areas that were not visible at the time of inspection.

If these obstructions are removed, a re-inspection is strongly recommended to allow full access and a complete assessment of the concealed building elements.

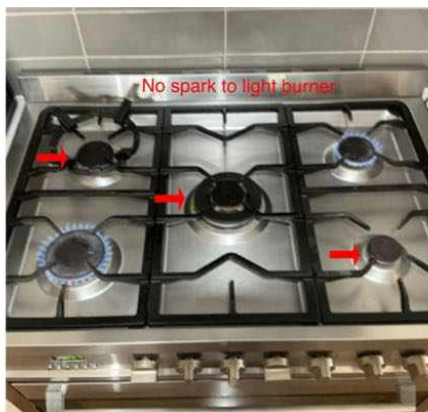
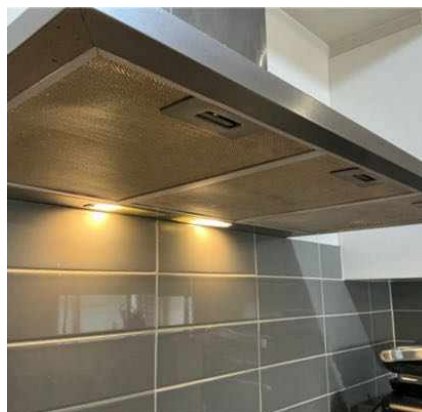
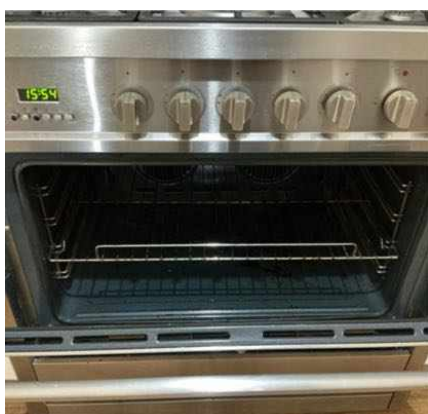
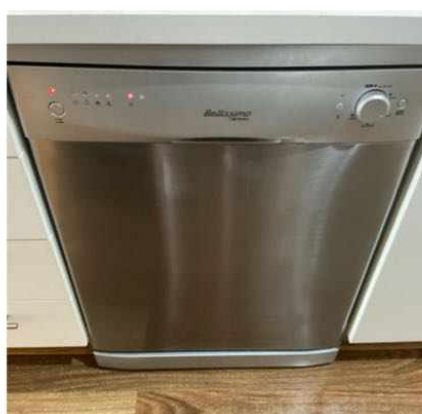
Building: Main Building
 Location: All Internal Areas
 Finding: Condition of Installed Appliances - Operational
 Information: At the time of inspection, the installed appliances—including the oven, cooktop, rangehood, and dishwasher—were checked for basic operational function. All appliances powered on and responded as expected to standard user inputs, indicating they are in working condition.

- Appliances appear to be functioning as intended at the time of inspection.
- No obvious signs of damage, malfunction, or missing components were observed.

While appliances were operational during the inspection, it should be noted that a full performance test was not conducted, and future performance or safety compliance cannot be guaranteed.

- Engage a licensed electrician or appliance technician to conduct a safety check of all appliances, particularly if installation dates, service history, or compliance documentation are unknown.

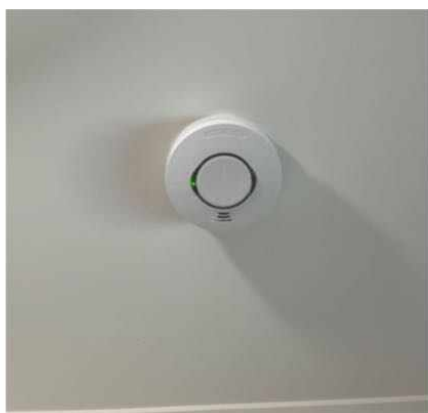
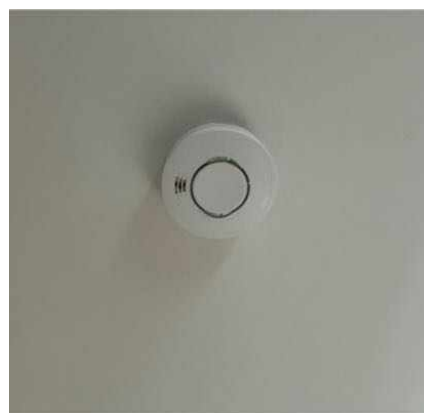
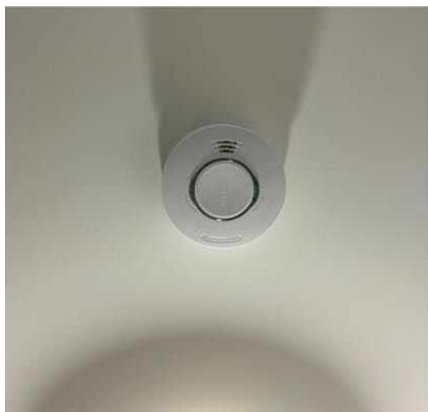
Building:	Main Building
Location:	All Internal Areas
Finding:	Smoke Detector Compliance Not Assessed
Information:	The inspection and reporting on the presence, function, and compliance of smoke detectors—whether battery-operated or hard-wired—fall outside the formal scope of this pre-purchase building inspection. However, general observations regarding smoke alarm coverage or deficiencies are noted for the client's awareness.

This report does not verify the number, condition, location, or legal compliance of smoke detection systems. Clients are strongly advised to confirm fire safety measures prior to occupancy through a specialist inspection.

- Following settlement, the client should engage a licensed electrician or fire safety professional to:
 - Inspect all existing smoke detectors for compliance, functionality, and correct placement.
 - Install new or additional units where necessary, ensuring compliance with AS 3786 and state-based legislation.
- For optimal fire safety, ensure smoke detectors are:
 - Interconnected where required.
 - Positioned in all sleeping areas and paths of travel as per current regulations.
 - Maintained according to manufacturer instructions and replaced every 10 years.
 - Tested monthly, with annual battery replacement where applicable.

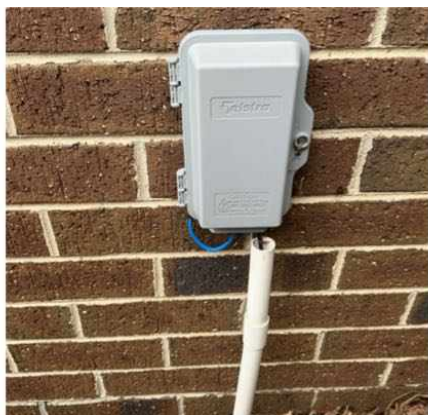
Building:	Main Building
Location:	Right-hand Side Front
Finding:	Fibre/NBN Connection Equipment Installed
Information:	At the time of inspection, a fibre internet connection enclosure was observed mounted to the internal wall. The unit appears to contain a fibre termination device and associated cabling, with power connected and indicator lights illuminated. Adjacent data outlets and a power point were also present. This indicates that fibre/NBN infrastructure is installed to the dwelling; however, confirmation of active service availability requires inquiry with the relevant service provider.

The fibre connection equipment was visually sighted, but functionality and connection status were not tested as part of this inspection.

- Confirm service availability and status with the internet provider of choice prior to occupation.
- Engage a licensed technician if relocation, modification, or additional data outlets are required.
- Maintain adequate ventilation/clearance around the enclosure to prevent overheating of equipment.

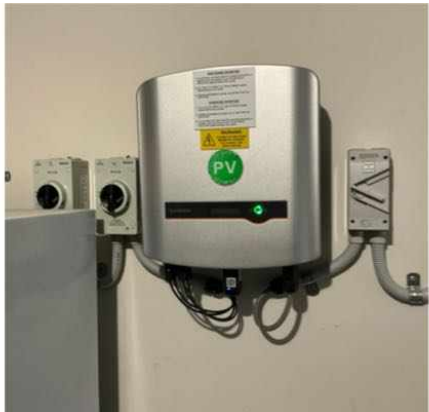
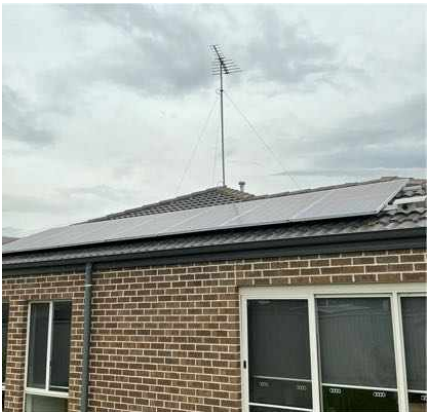
Building:	Main Building
Location:	Garage & Rear Roof
Finding:	Photovoltaic (PV) Solar Panel System – Limitations and Considerations
Information:	A rooftop PV solar panel system was present at the time of inspection. While the installation appeared intact from a visual standpoint, no assessment was made regarding its electrical compliance, inverter performance, or energy output. The inspection of solar power systems is outside the scope of a standard building inspection.

- Panels, wiring, isolators, and inverters may degrade over time or fail without regular servicing.
- Safety risks such as arc faults, exposed wiring, or non-compliant isolators may go unnoticed without a licensed electrical inspection.
- Lack of documentation, service records, or labelling can complicate future upgrades, insurance claims, or system troubleshooting.

As the inspection of solar power systems is beyond the scope of this report, no assurance is provided regarding the operational status or safety compliance of the
