Building and Timber Pest Inspection Report

Inspection Date: Wed, 25 Mar 2026

Property Address: 31 Pedder St, Marsden QLD 4132, Australia

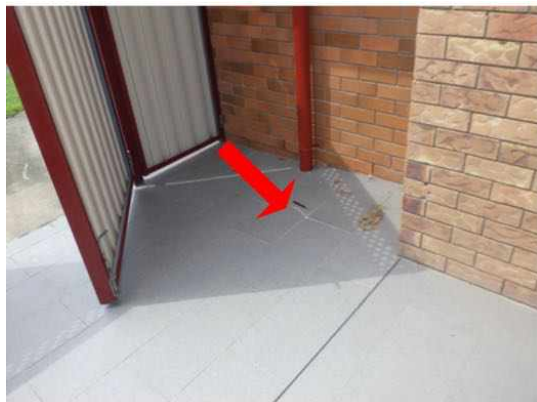
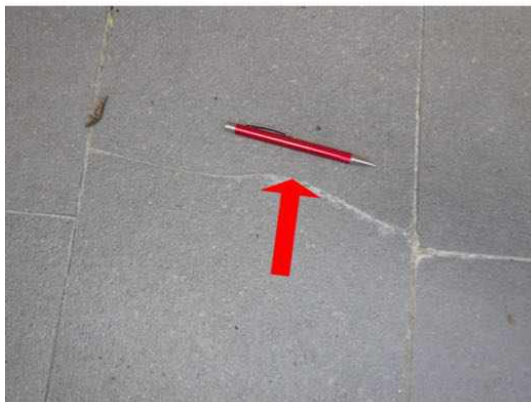
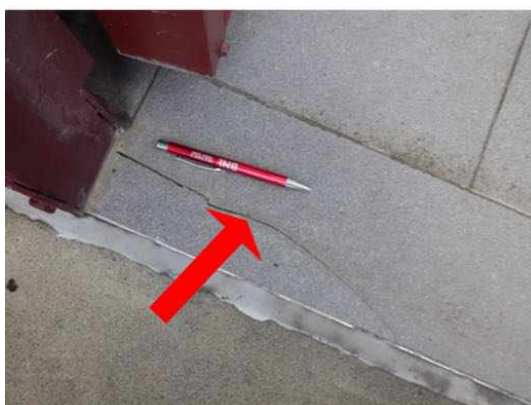
Building: Main Building
Location: External Areas > Ground Level
Finding: Tile - Cracked
Information: Cracked tiles to external paved areas were identified at the time of inspection. Such defects are generally caused by impact. Cracked or broken tiled areas may also be a direct result of poor workmanship during the construction process.

A tiling contractor could be appointed to perform repair works at the clients discretion.

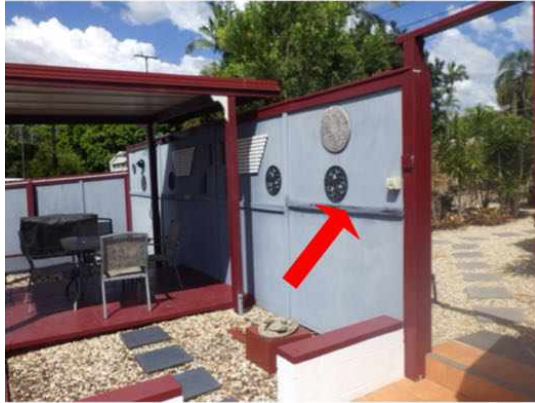
Finding 3.02

Building:	Main Building
Location:	External Areas > Existing
Finding:	Wood rot
Information:	The timber facing boards to the external fence/screens at the rear of the property show evidence of wood rot (as per example photos). Wood rot, also known as Fungal Decay, occurs when timbers and other cellulose building materials are exposed to damp conditions on an ongoing basis. This could be the result of exposure to weathering over a prolonged period of time, or the attraction of excessive moisture from other abutting building materials.

A qualified carpenter or general handyman may be required to replace the affected building materials.

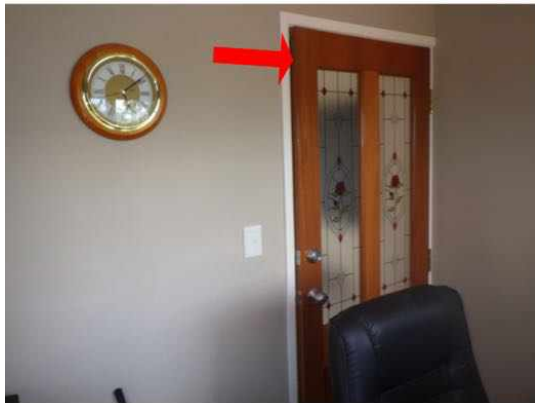
Finding 3.03

Building: Main Building
 Location: Study > Front
 Finding: Door - Binding/Jamming
 Information: Binding of the study door on the door frame was evident during standard operation.

A door that binds to the associated door frame or sill may have several causes, such as poor installation of the door or deteriorated hinges.

A qualified carpenter or general handyperson could be appointed to perform minor rectification works at client discretion.

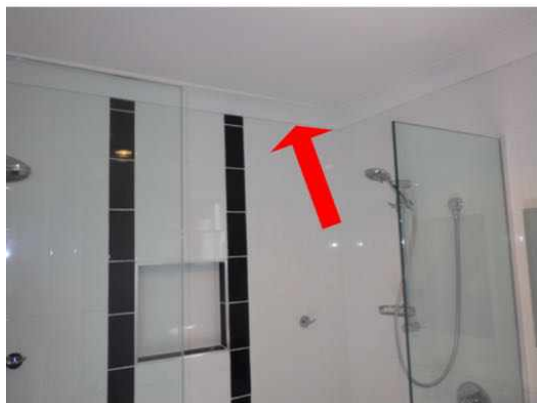
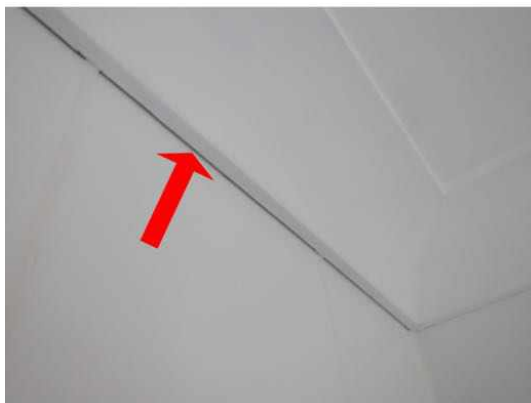
Information: It was noted that the ceiling cornice in the ensuite showing signs of minor separation from the ceiling linings and cracking.

This is a common defect caused through normal movement of homes.

You should monitor the cornice for any further signs of deterioration .

A qualified painter or general handyman could be engaged to undertake minor repair work at the clients discretion.

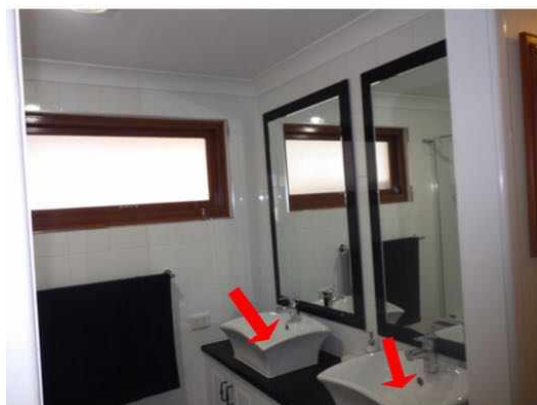
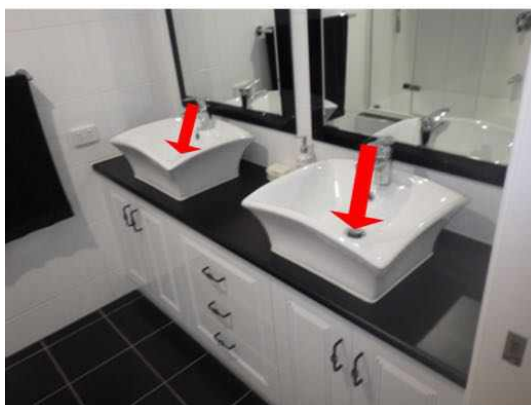
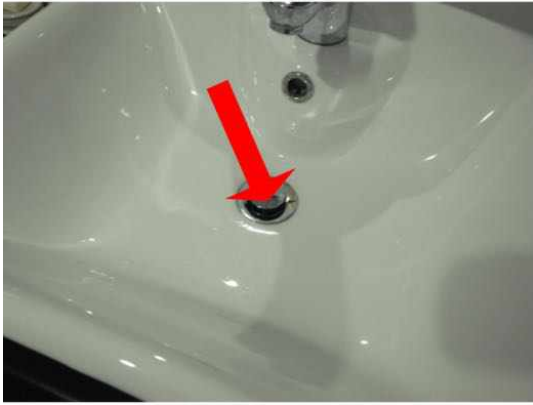
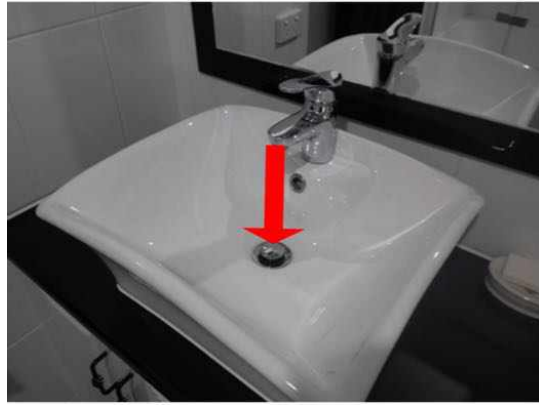
Finding 3.06

Information: The bathroom basin pop up waste's were stiff to operate at the time of inspection. It is advised that maintenance is carried out on the waste's so as they function as intended.

A handyman could be appointed to perform any remedial works where required.

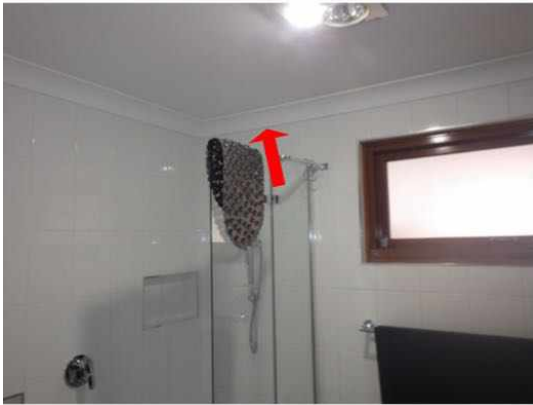
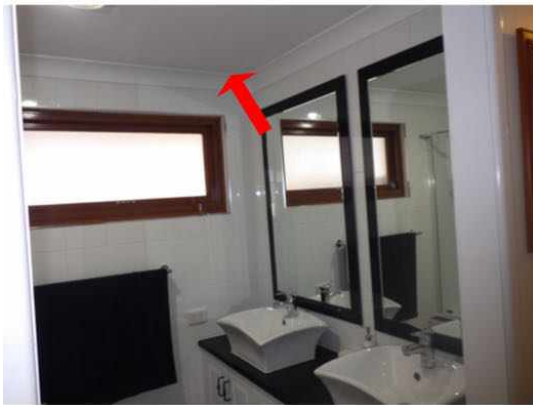
Finding 3.07

Building: Main Building
Location: Bathroom > Existing
Finding: Cornice Movement
Information: It was noted that the ceiling cornice in the bathroom is showing signs of minor separation from the ceiling linings and cracking.

This is a common defect caused through normal movement of homes.

A licensed painter or general handyman could be engaged to undertake minor repair work.

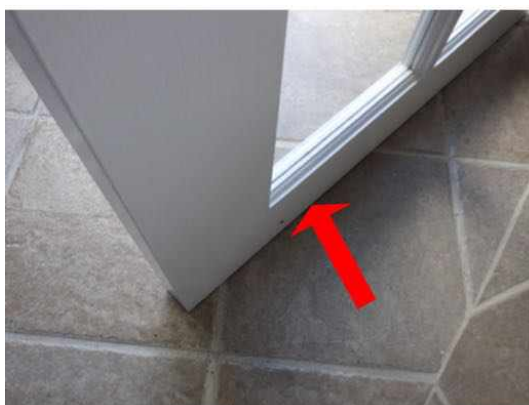
Finding 3.08

Building: Out Building
 Location: Cabana > Front
 Finding: Door Rubbing
 Information: It was noted that the bottom edge of the left side Cabana door is rubbing on the floor tiles making the door stiff to open and close at the time of inspection.

This is noted as a minor defect that you need to be aware of.

A licensed carpenter or general handyman could be engaged to ease the door at the clients discretion.

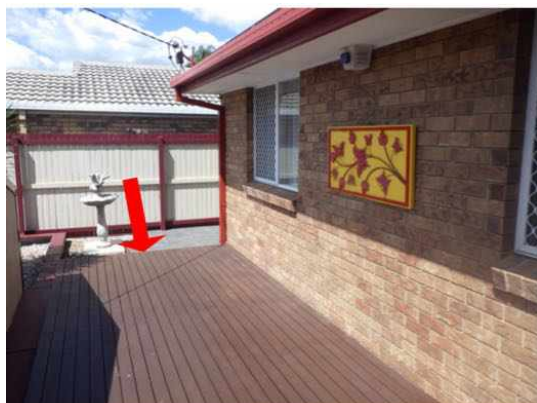
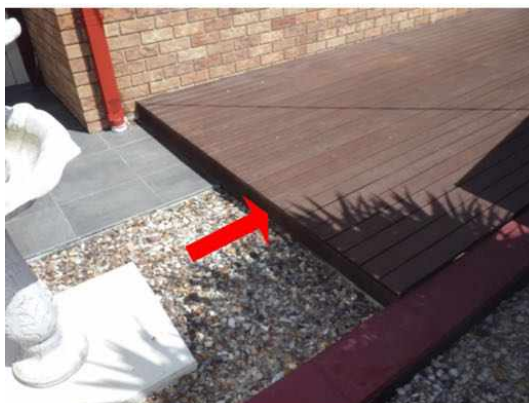
Finding 6.02

Building:	Main Building
Location:	Deck > Ground Level
Finding:	Deck - In ground contact
Information:	At the time of inspection it was noted the timber deck area to the front left side of the property is in direct contact with the finished ground level.

Any timbers in direct ground contact provide opportunity for concealed termite entry and are likely to be subject to premature rot and decay as the soil retains moisture or damp conditions against the timbers.

Remove untreated timber that is in direct contact with external grounds. Consider replacement with more durable materials i.e. treated timber or non timber elements.

Frequent pest inspections are advised to readily identify any termite activity in these areas.

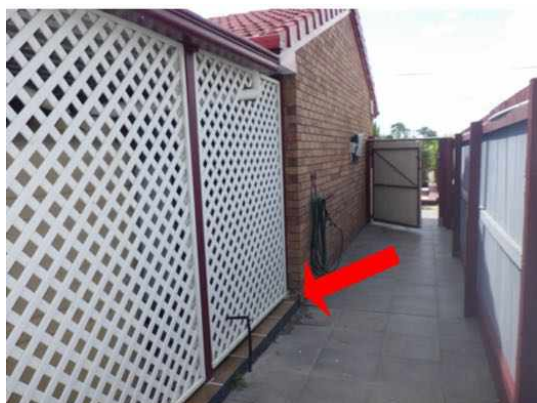
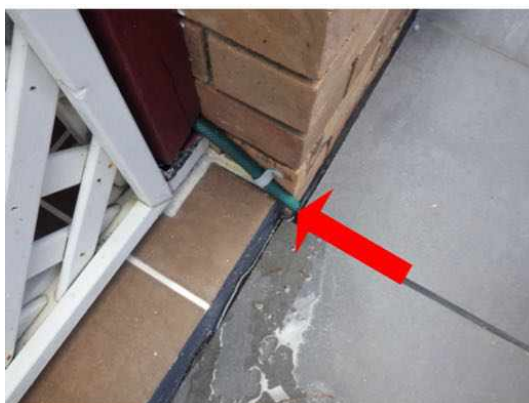
Finding 6.03

Building: Main Building
 Location: Exterior walls - left side > Rear Left
 Finding: Overflow - Not plumbed for drainage
 Information: The hot water system overflow is not plumbed or connected to suitable drainage, which can result in the surrounding area becoming excessively damp. These damp conditions can lead to secondary defects such as rot, rust or corrosion of associated building elements, the formation of fungal decay, or even the creation of potential slip hazards. When coupled with poor site drainage, pooling of water may also attract termite activity to this area. It is highly recommended that a qualified plumber be appointed to install adequate drainage to the overflow. These works will ensure that the area remains dry and free of any secondary defects.

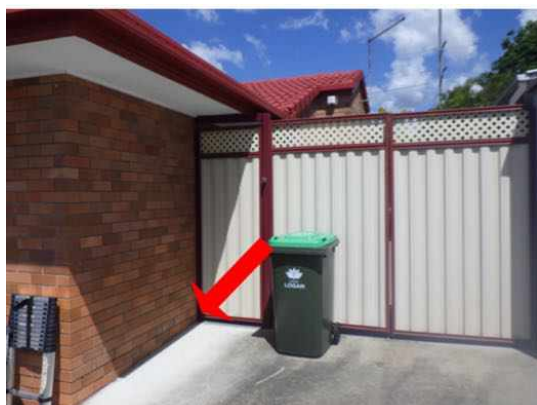
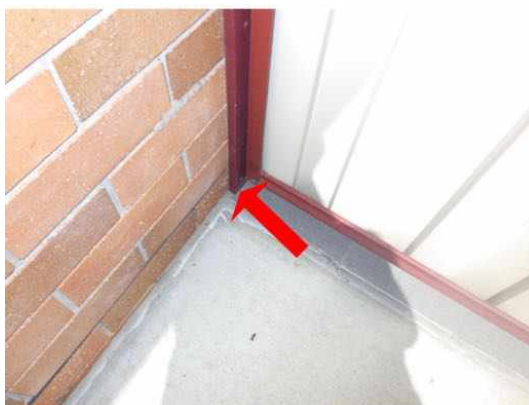
Finding 6.04

Building: Main Building
 Location: Exterior walls - right side > Front Right
 Finding: In ground contact

Any timbers in direct ground contact provide opportunity for concealed termite entry and are likely to be subject to premature rot and decay as the ground retains moisture or damp conditions against the timbers.

Ideally these types of timber members would be clear of the ground area by a minimum of 50mm to provide a clear inspection zone.

Frequent pest inspections are advised to readily identify any termite activity in these areas.

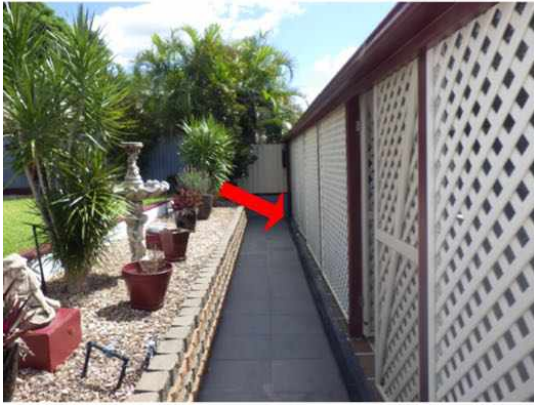
Finding 6.05

Where roof plumbing doesn't drain as required, the area at the base perimeter can become excessively damp, potentially creating an environment that is susceptible to flooding and rust or corrosion of surrounding building elements, as well as attracting termites and other pests.

It is recommended that a licensed plumber be appointed to further inspect and to extend the down pipe to the properties stormwater line as necessary.

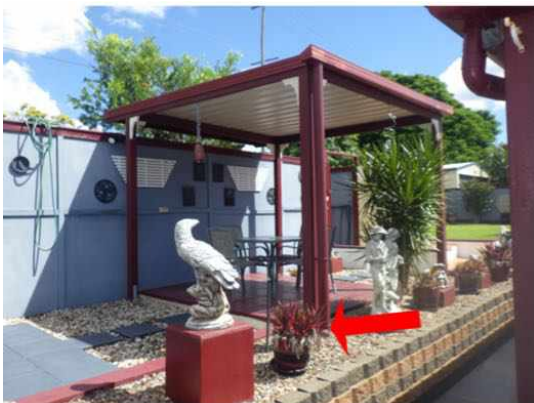
Finding 6.06

Building:	Out Building
Location:	Pergola > Front Left
Finding:	Stormwater downpipe
Information:	The down pipe to the pergola roof area at the rear of the property is not connected to the stormwater drainage on the site. This disconnection negatively impacts the functional capacity of the downpipe and the surrounding ground area.

Where roof plumbing doesn't drain as required, the area at the base perimeter can become excessively damp, potentially creating an environment that is susceptible to flooding and rust or corrosion of surrounding building elements, as well as attracting termites and other pests.

It is recommended that a licensed plumber be appointed to further inspect and to extend the down pipe to the properties stormwater line as necessary.

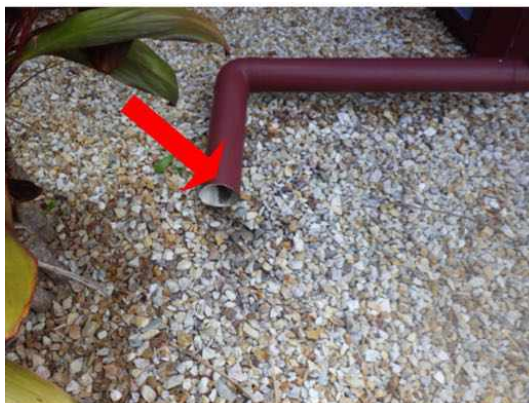
Finding 6.07

Building:	Out Building
Location:	Cabana > Rear Left
Finding:	Stormwater downpipe
Information:	The down pipe to the Cabana roof area at the rear of the property is not connected to

Where roof plumbing doesn't drain as required, the area at the base perimeter can become excessively damp, potentially creating an environment that is susceptible to flooding and rust or corrosion of surrounding building elements, as well as attracting termites and other pests.

It is recommended that a licensed plumber be appointed to further inspect and to extend the down pipes to the properties stormwater line as necessary.

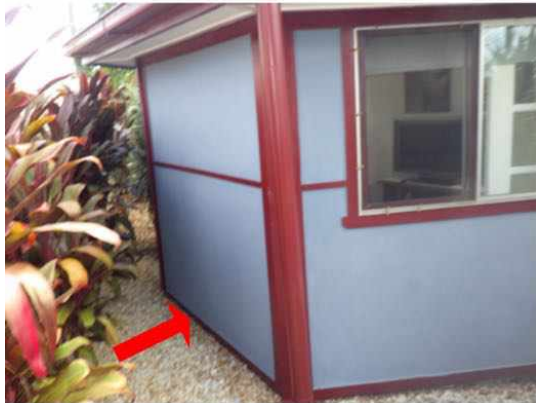
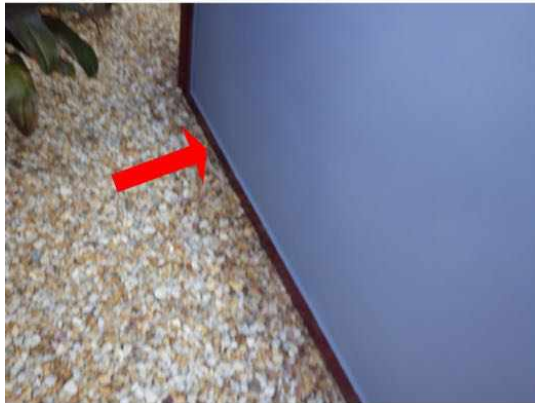
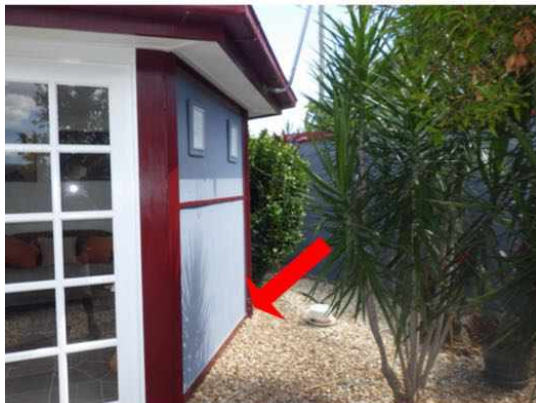
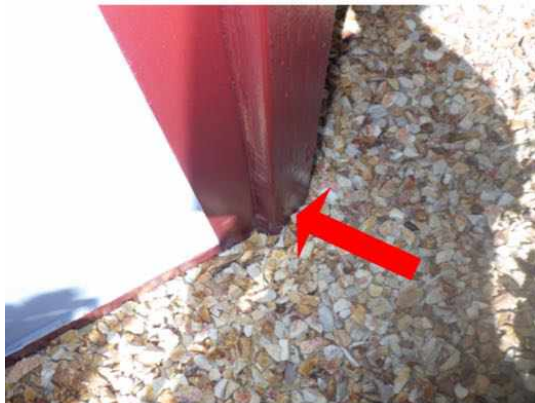
Finding 6.08

Building:	Out Building
Location:	Cabana > Ground Level
Finding:	In ground contact
Information:	At the time of inspection it was observed the Cabana area exterior wall cladding and timber trims are in direct contact it's the finished ground surface.

Any building materials or timbers in direct ground contact provide opportunity for concealed termite entry and are likely to be subject to premature rot and decay as the ground retains moisture or damp conditions against the timbers.

Ideally these types of construction materials or timber members would be clear of the ground area by a minimum of 50mm to provide a clear inspection zone.

Frequent pest inspections are advised to readily identify any termite activity in these areas.

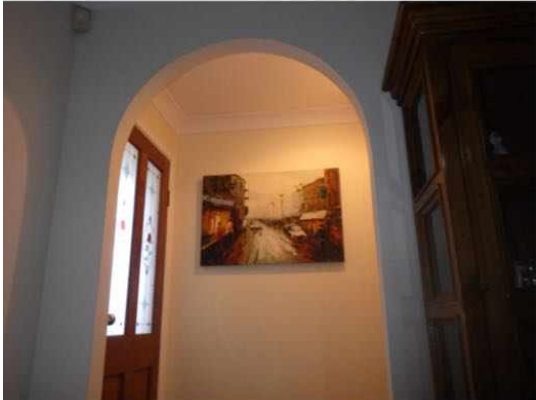
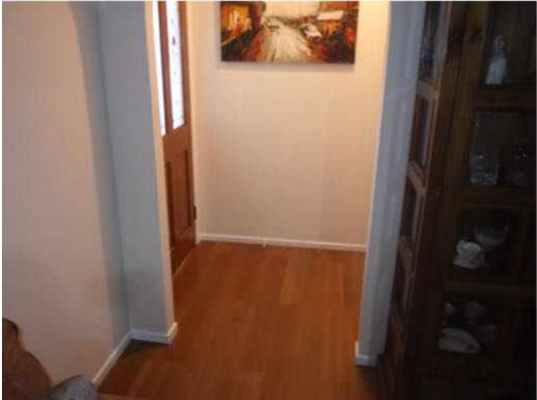
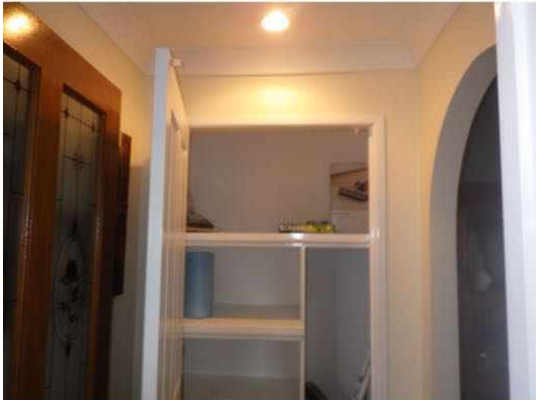
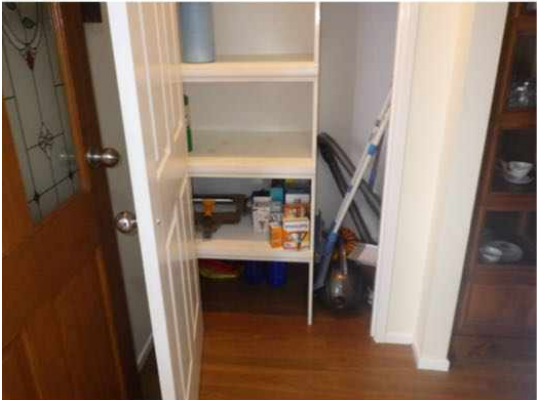
Building: Main Building
Location: Niche/Cupboard > Existing

Finding: No obvious defect
Information: No obvious defects found at the time of inspection.

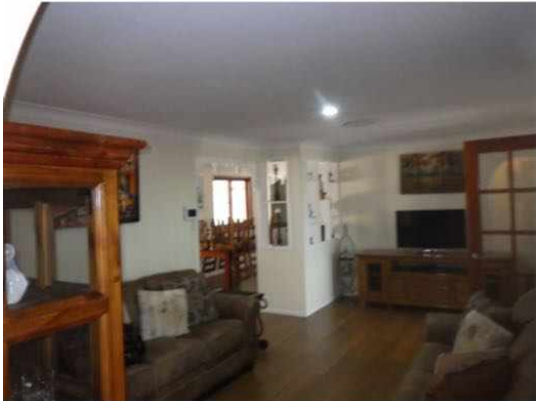
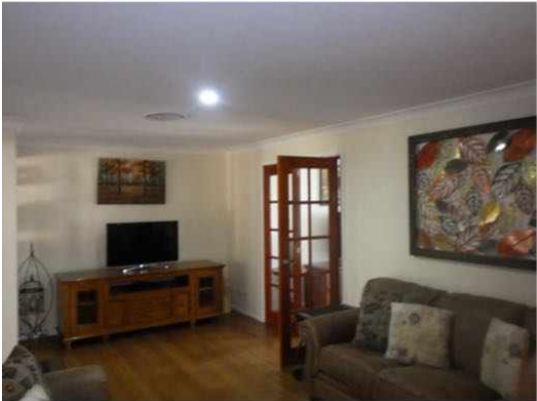
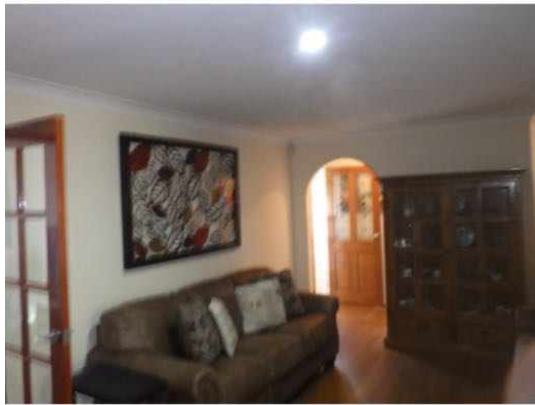
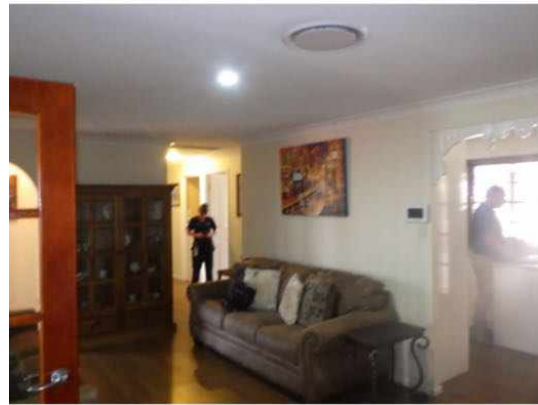
Building: Main Building
Location: Living Room > Existing
Finding: No obvious defect
Information: No obvious defects found at the time of inspection.

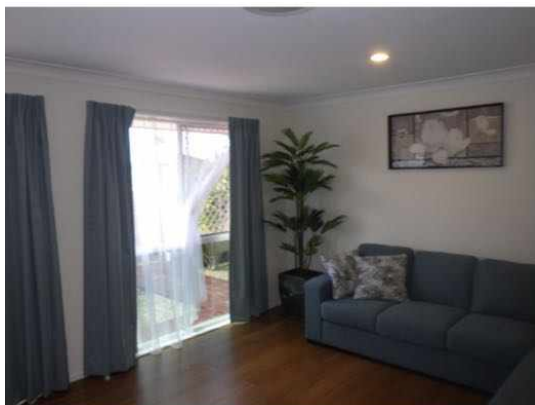
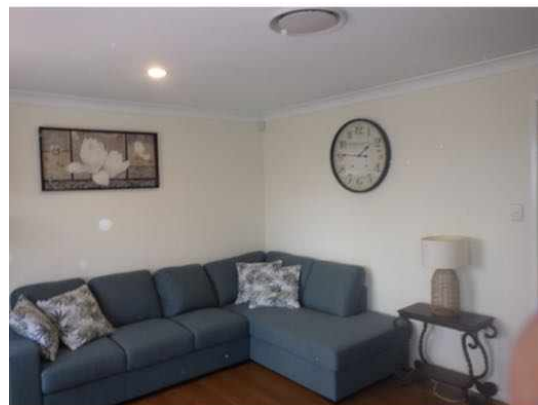
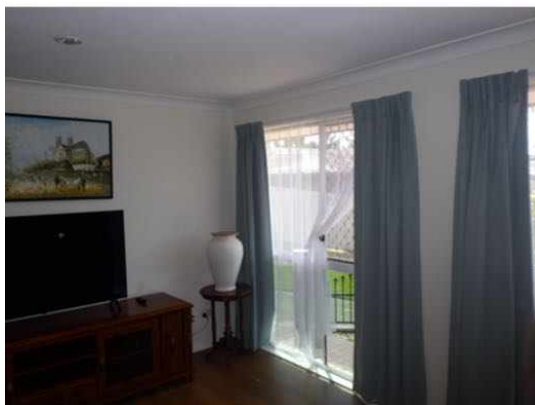
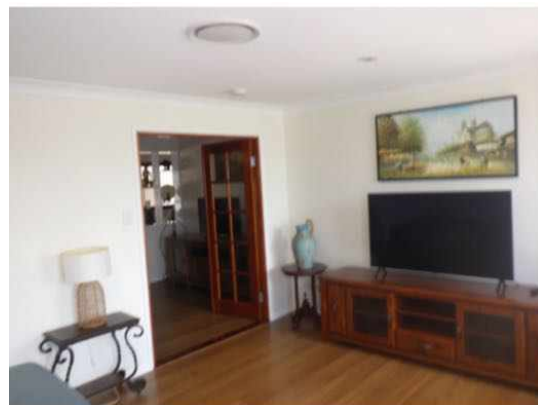
Building: Main Building
Location: Lounge Room > Existing
Finding: No obvious defect
Information: No obvious defects found at the time of inspection.

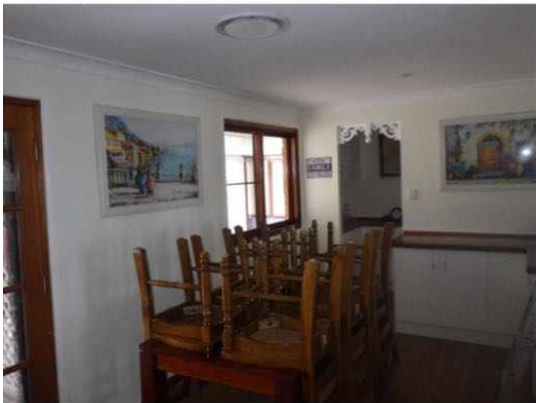
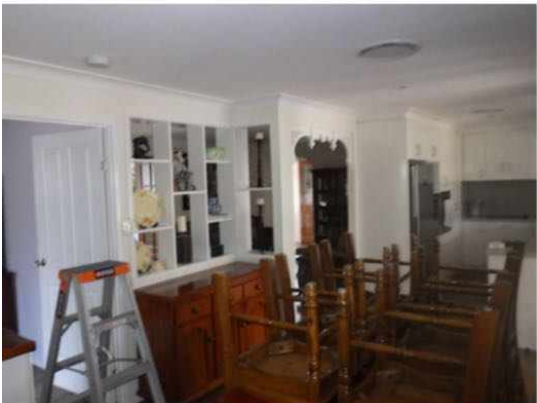
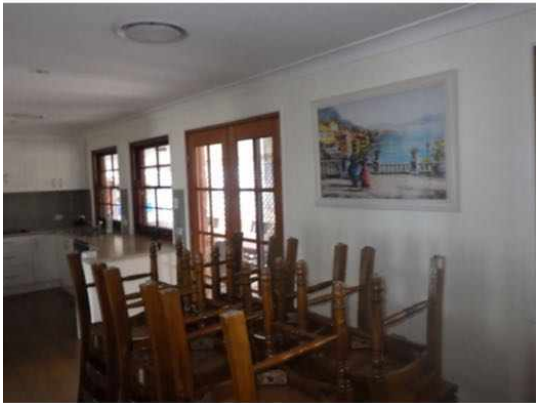
Building: Main Building
Location: Dining Room > Existing
Finding: No obvious defect

Information: No obvious defects found at the time of inspection.

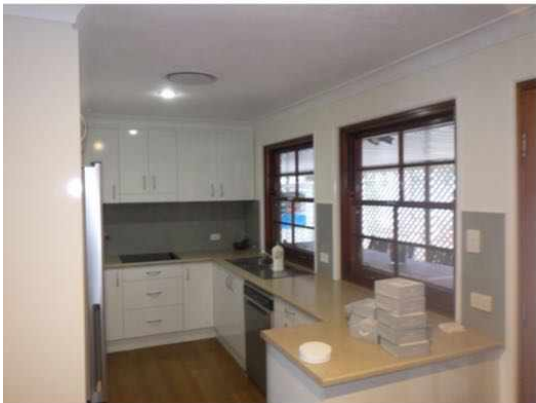
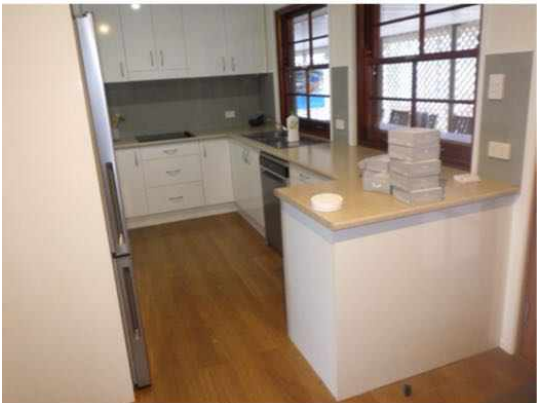
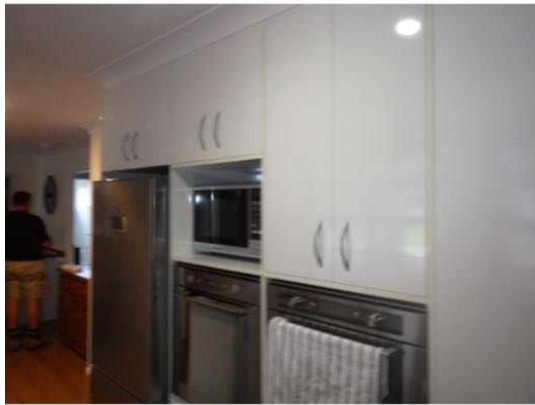
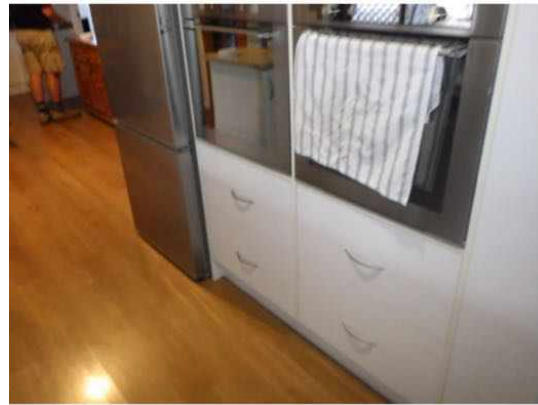
Building: Main Building
Location: Kitchen > Existing
Finding: No obvious defect
Information: No obvious defects found at the time of inspection.

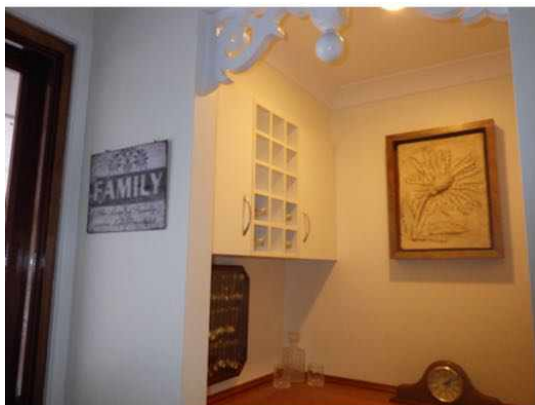
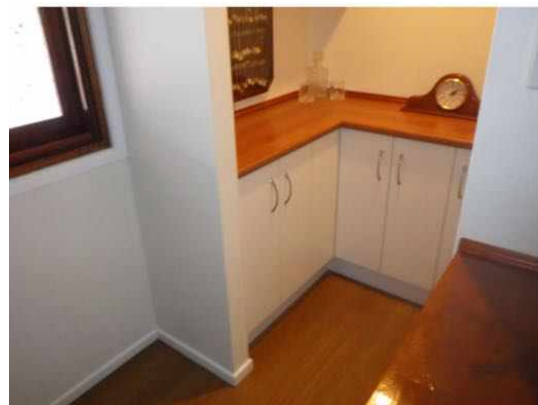
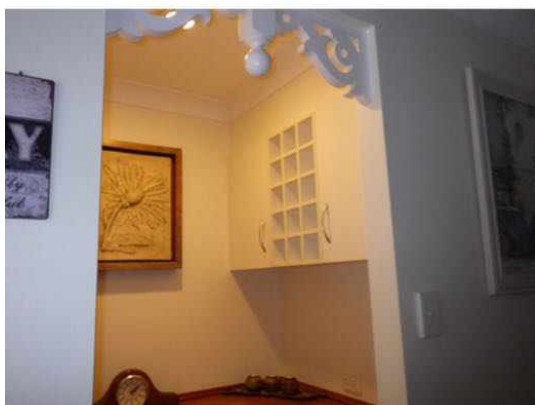
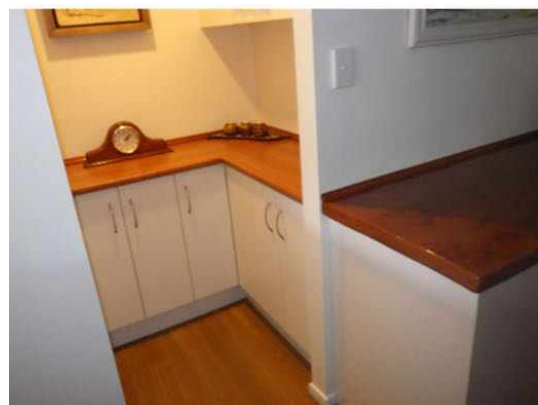
Building: Main Building
Location: Dry Bar > Existing
Finding: No obvious defect
Information: No obvious defects found at the time of inspection.

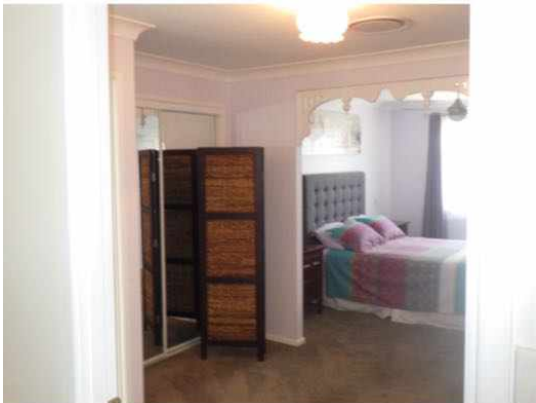
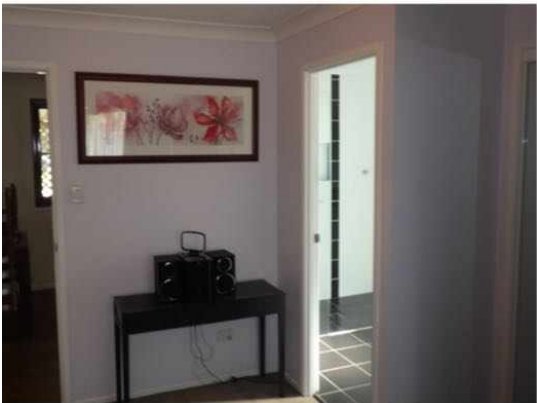
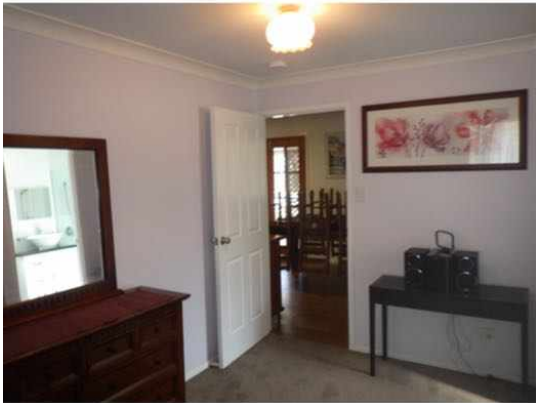
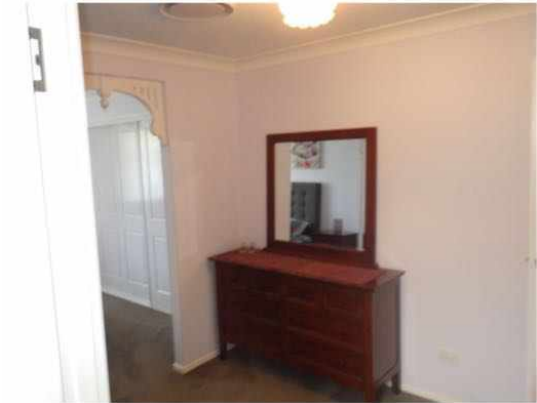
Building: Main Building
Location: Sitting Room > Existing
Finding: No obvious defect

Information: No obvious defects found at the time of inspection.

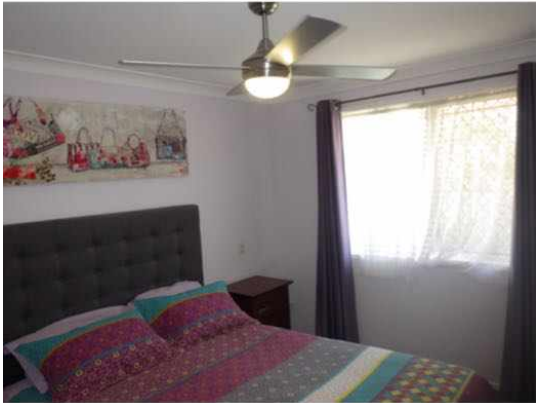
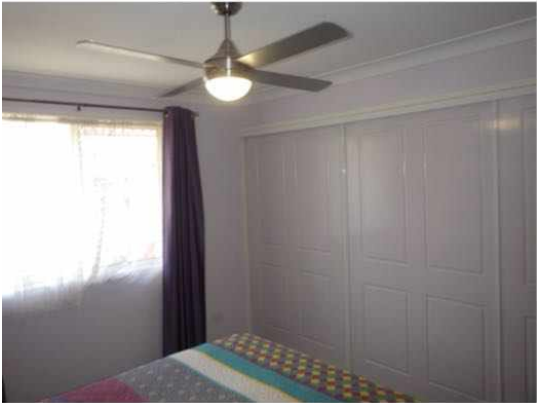
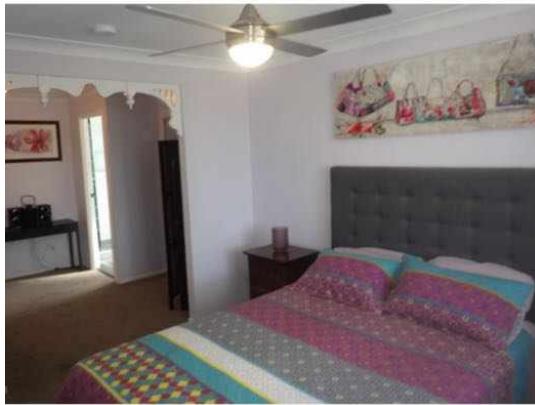
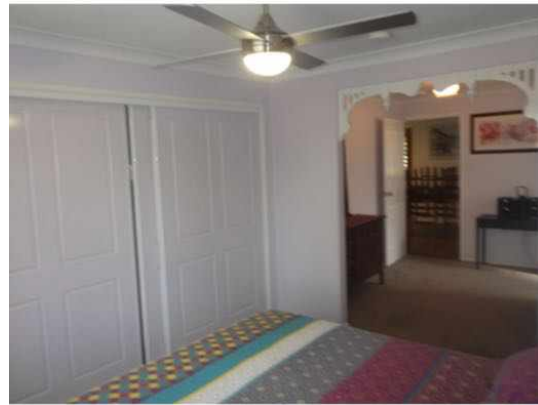
Building: Main Building
Location: Bedroom - Master > Existing
Finding: Additional Photos
Information: Additional photos are provided for your general reference

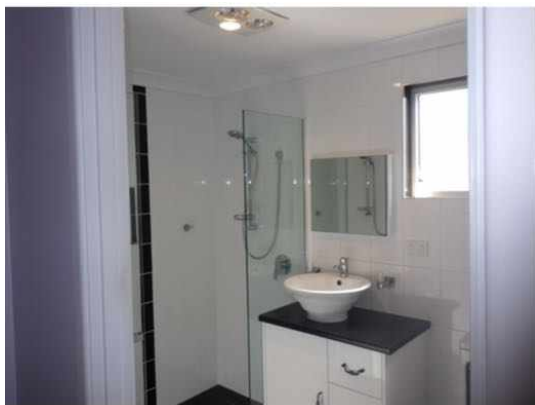
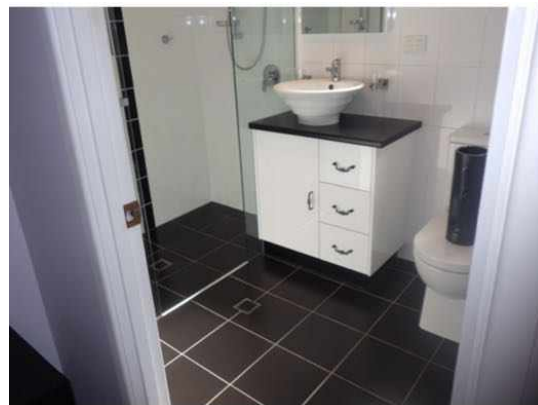
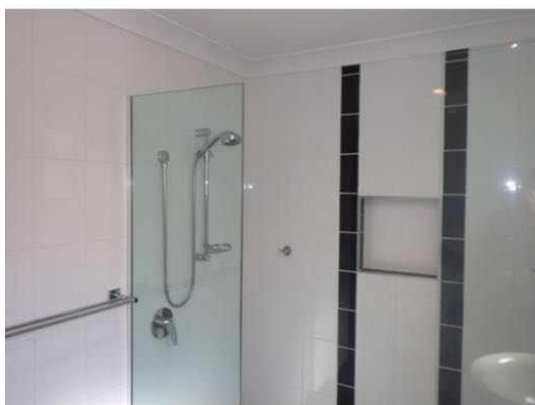
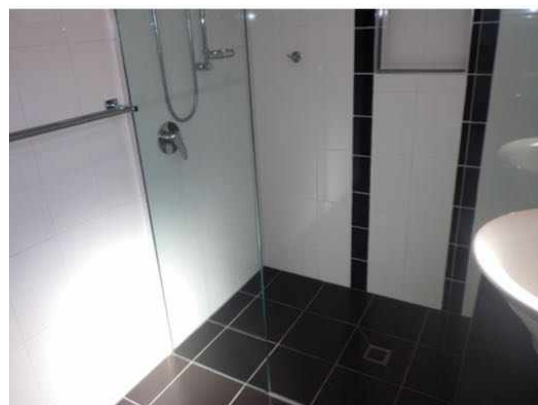
Building: Main Building
Location: Ensuite > Existing
Finding: Additional Photos
Information: Additional photos are provided for your general reference

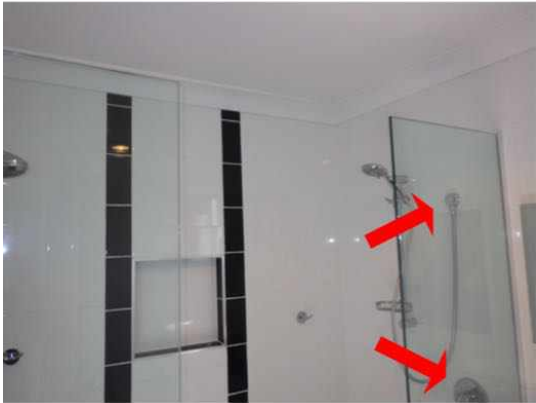
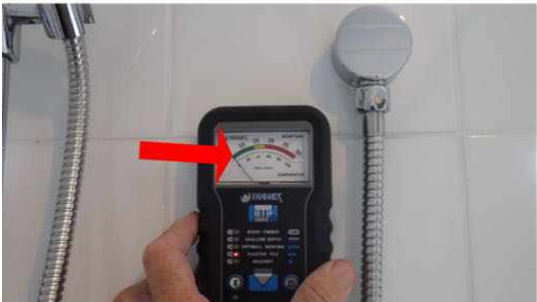
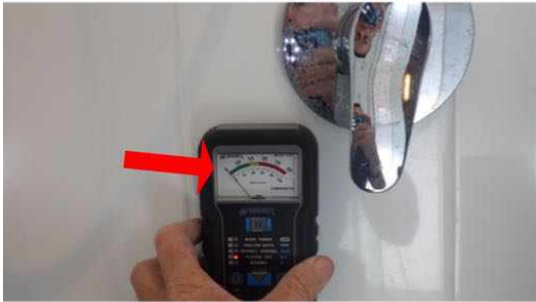
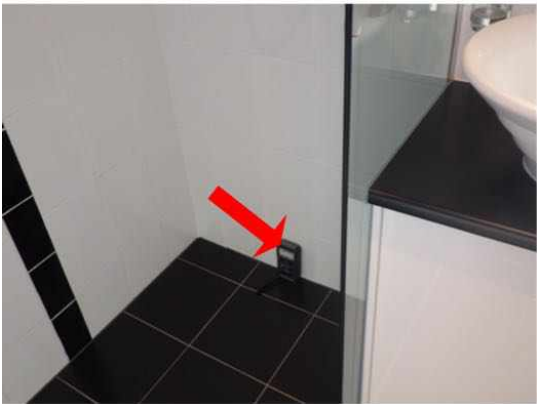
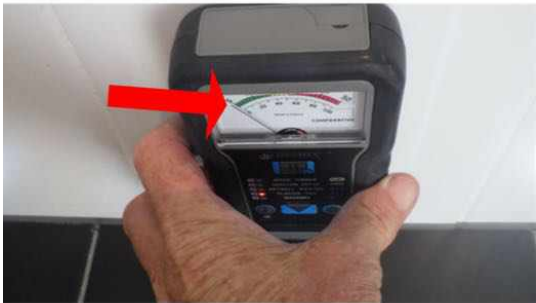
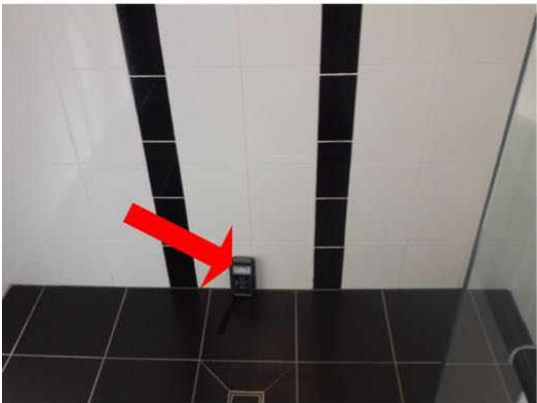
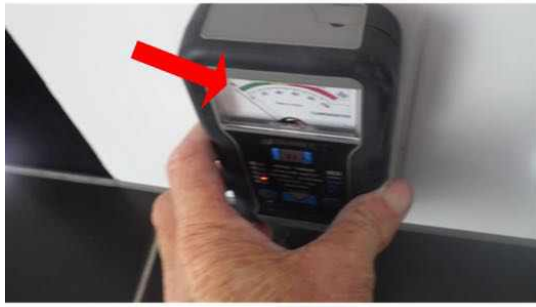
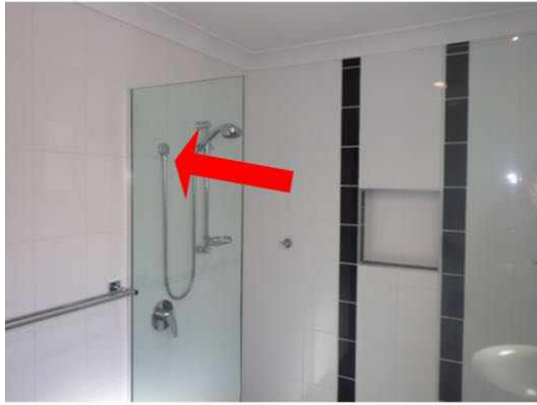
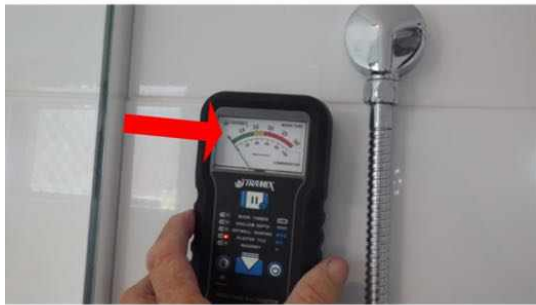
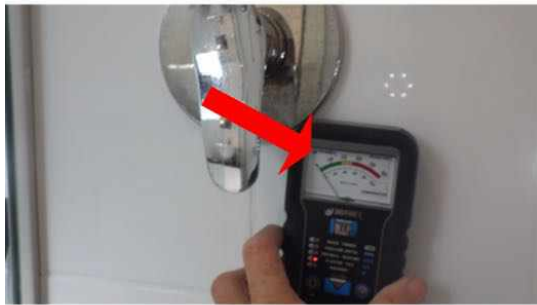
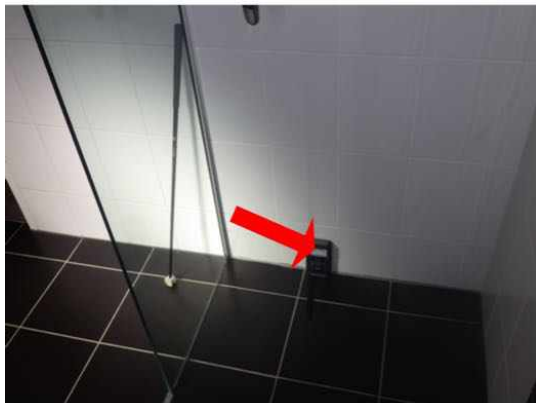
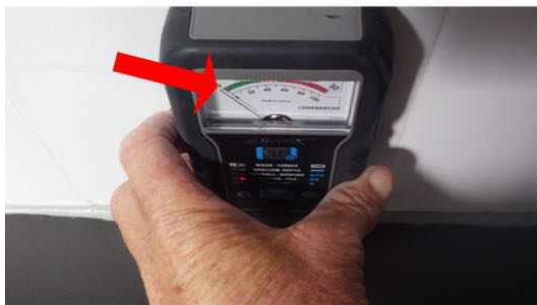
Building: Main Building
Location: Ensuite > Centre Left
Finding: Moisture Level Readings

Information: At the time of inspection the ensuite shower cubicle areas checked with the Tramex Moisture Meter returned low - normal moisture level readings.

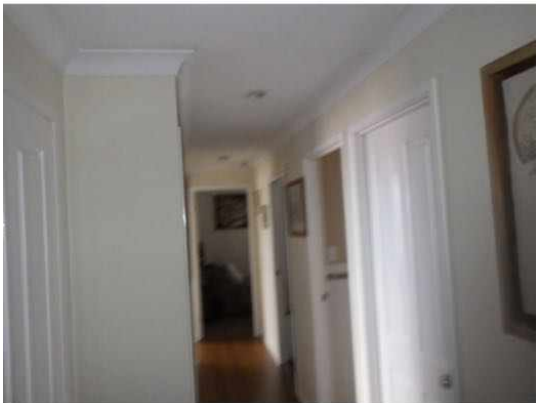
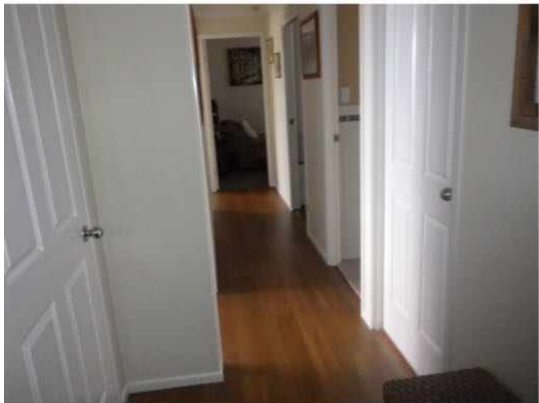
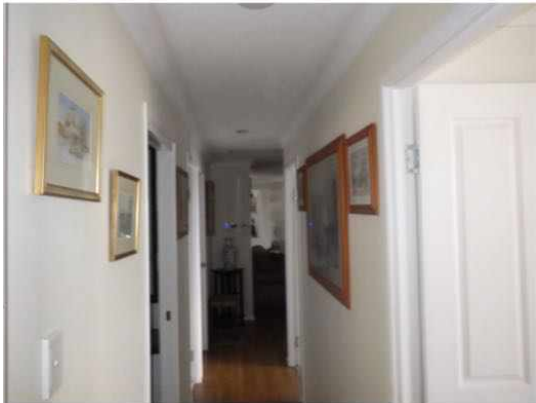
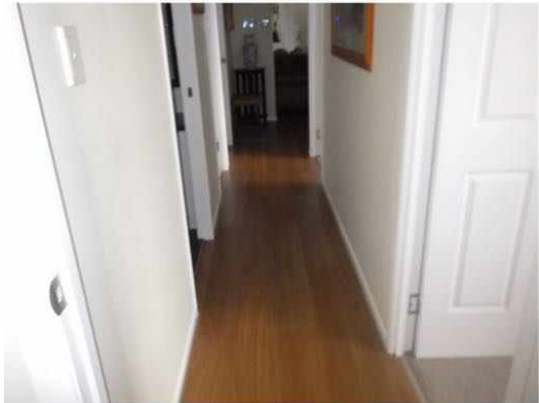
Building: Main Building
Location: Hallway > Existing
Finding: No obvious defect
Information: No obvious defects found at the time of inspection.

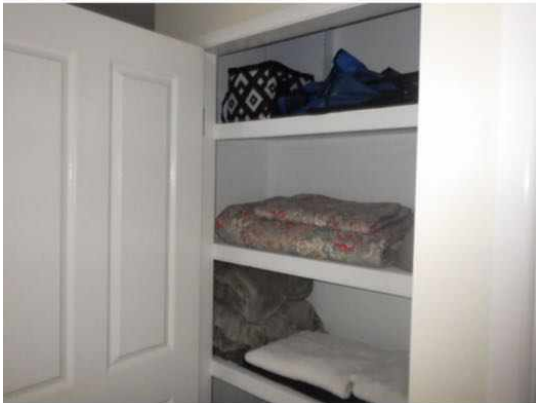
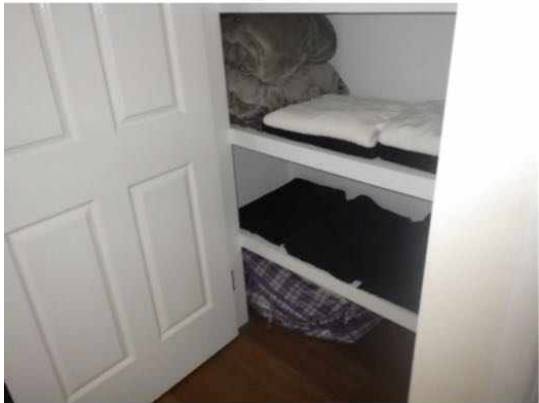
Building: Main Building
 Location: Linen Cupboard > Existing
 Finding: No obvious defect
 Information: No obvious defects found at the time of inspection.

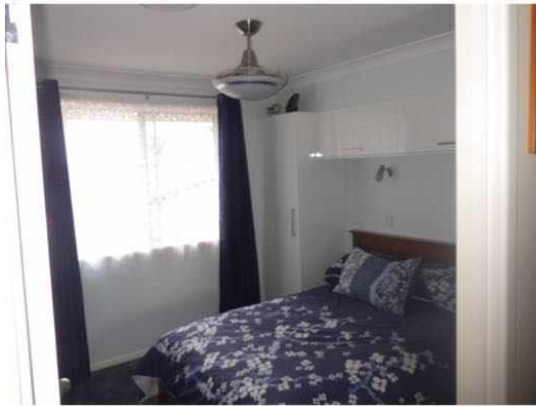
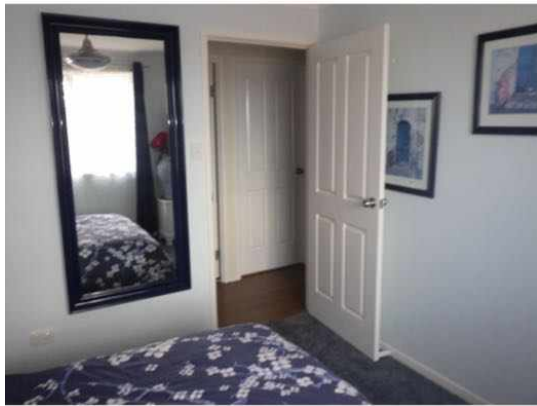
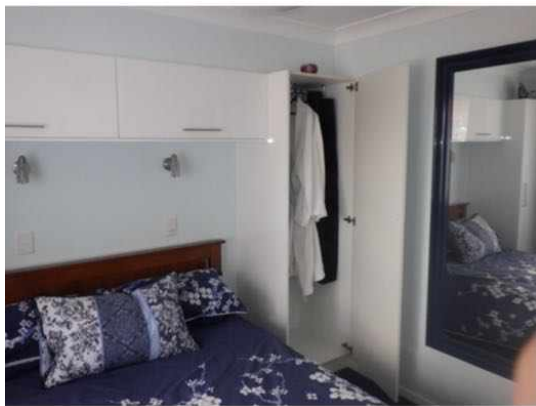
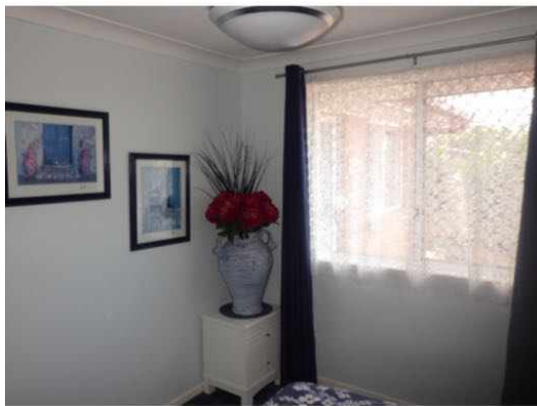
Building: Main Building
 Location: Bedroom 2 > Existing
 Finding: No obvious defect

Information: No obvious defects found at the time of inspection.

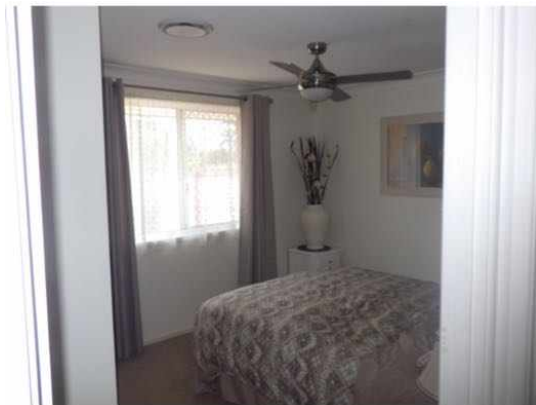
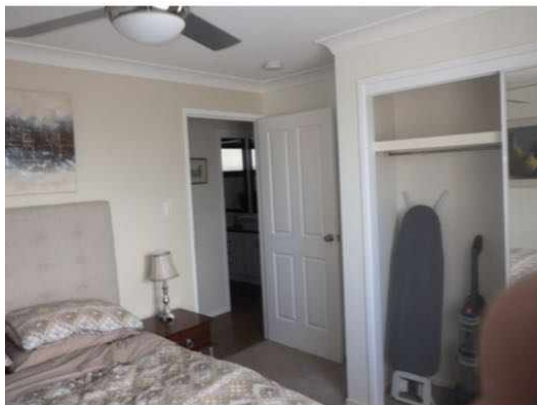
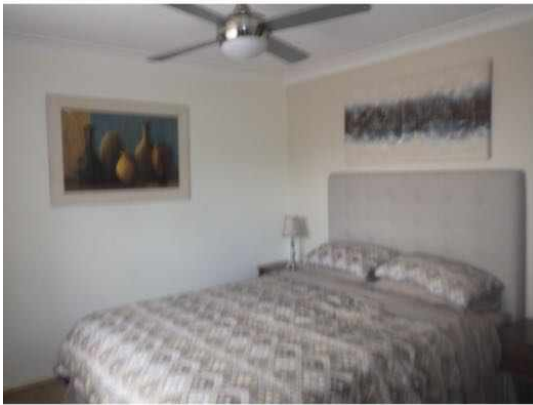
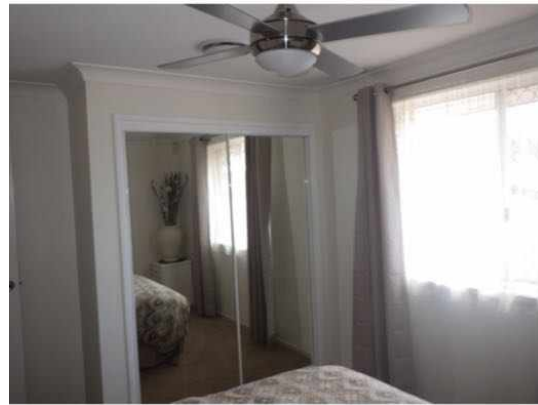
Building: Main Building
Location: Bedroom 3 > Existing
Finding: No obvious defect
Information: No obvious defects found at the time of inspection.

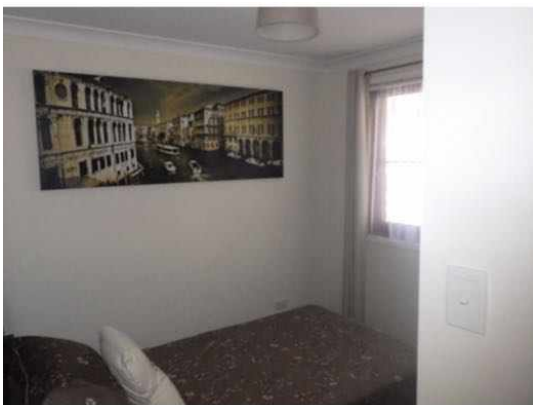
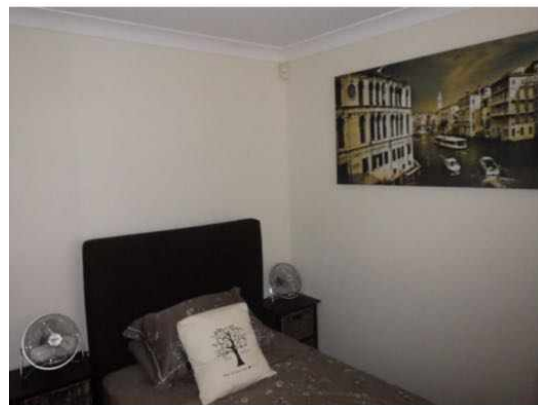
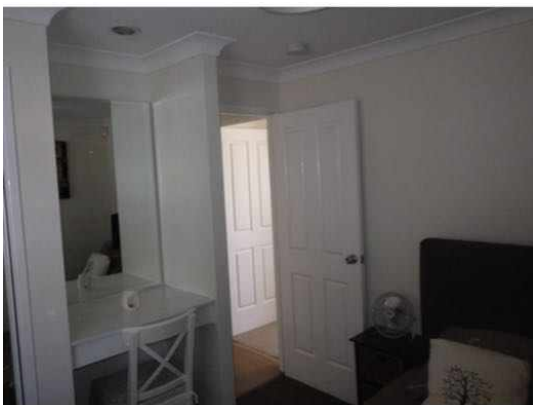
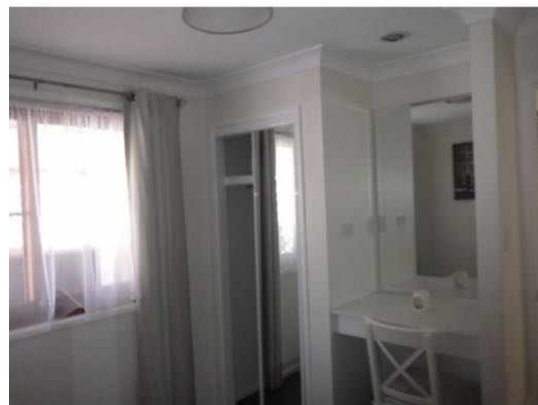
Building: Main Building
Location: Bedroom 4 > Existing
Finding: No obvious defect
Information: No obvious defects found at the time of inspection.
