Building and Timber Pest Inspection Report

Inspection Date: Wed, 25 Mar 2026

Property Address: 31 Pedder St, Marsden QLD 4132, Australia

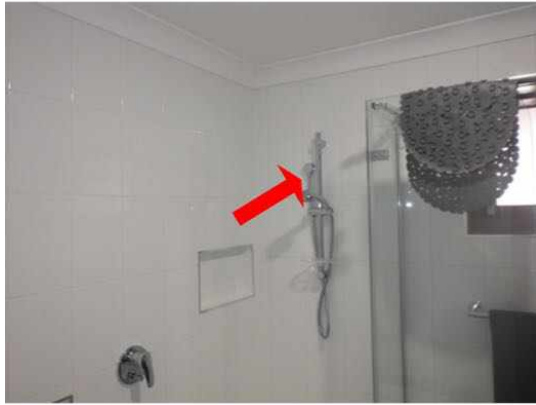
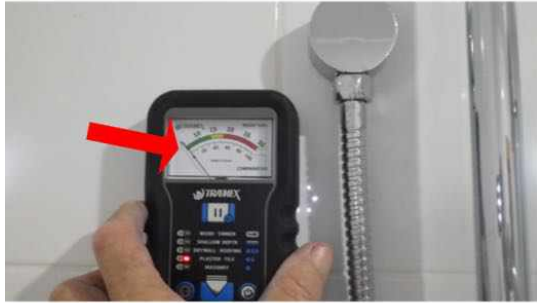
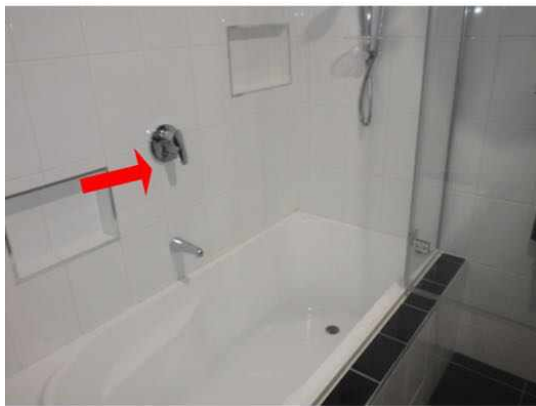
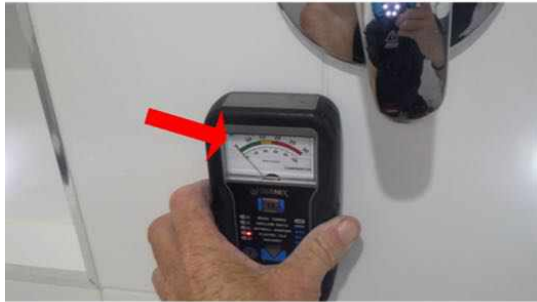
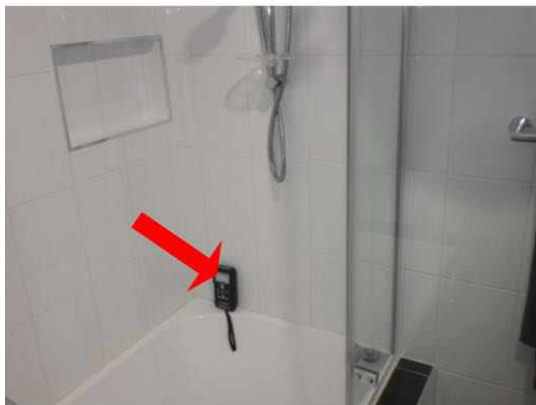
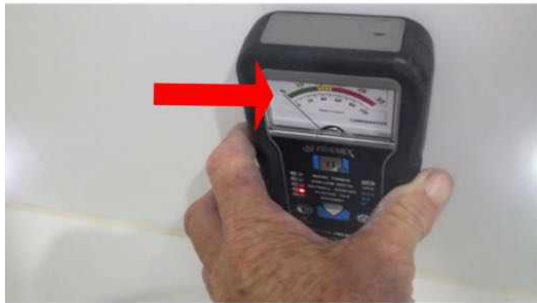
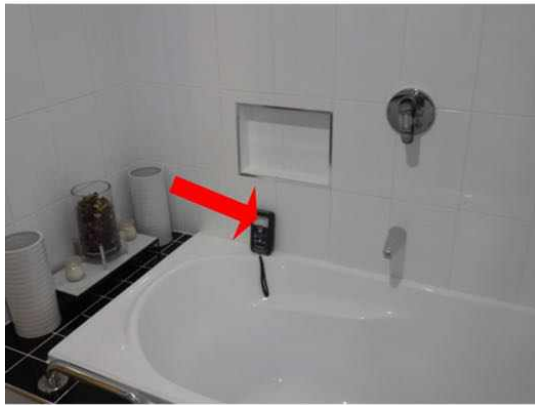
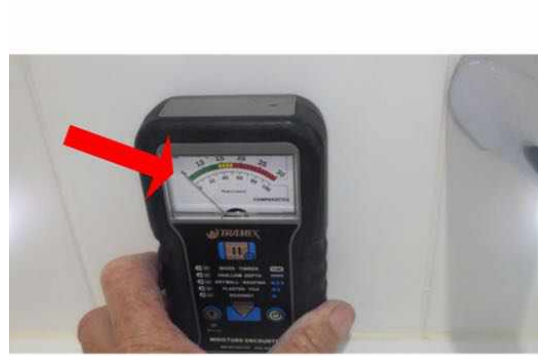
Building: Main Building
Location: Bathroom > Centre Left
Finding: Moisture Level Readings

Information: At the time of inspection the bathroom shower cubicle areas checked with the Tramex Moisture Meter returned low - normal moisture level readings.

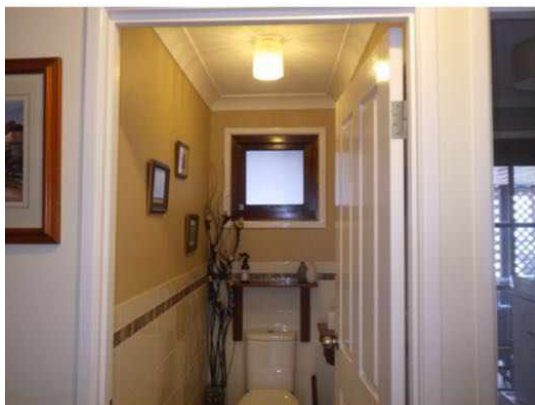
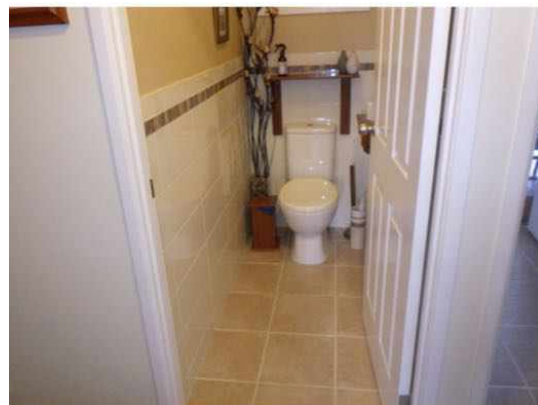
Building: Main Building
Location: Toilet (WC) > Existing
Finding: No obvious defect
Information: No obvious defects found at the time of inspection.

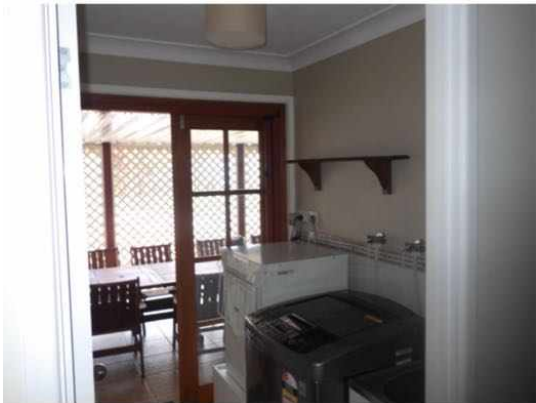
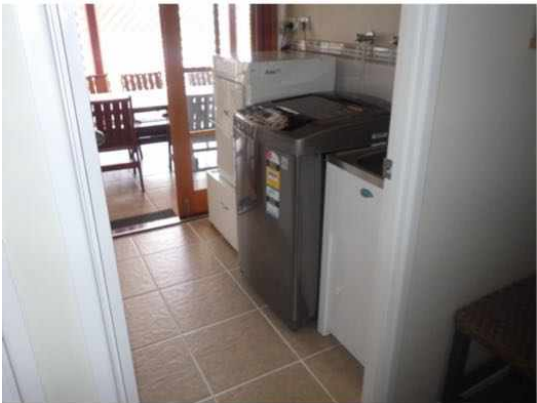
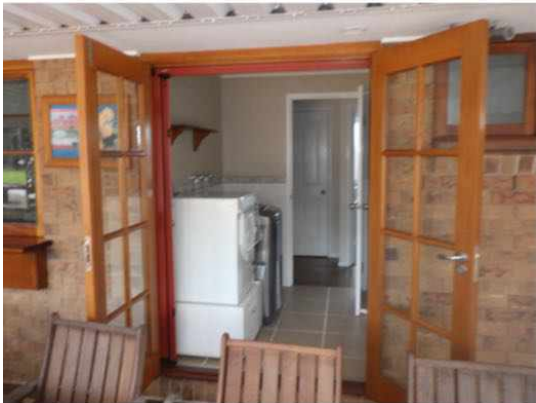
Building: Main Building
Location: Laundry > Existing
Finding: No obvious defect
Information: No obvious defects found at the time of inspection.

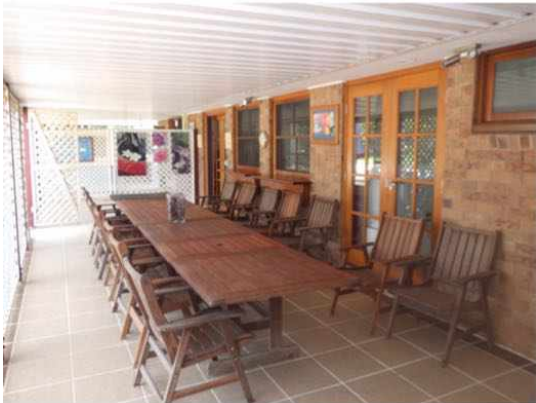
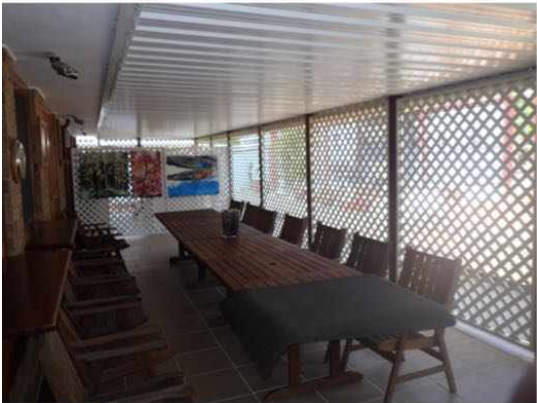
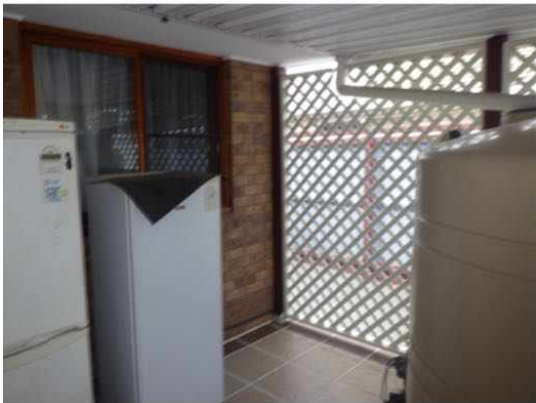
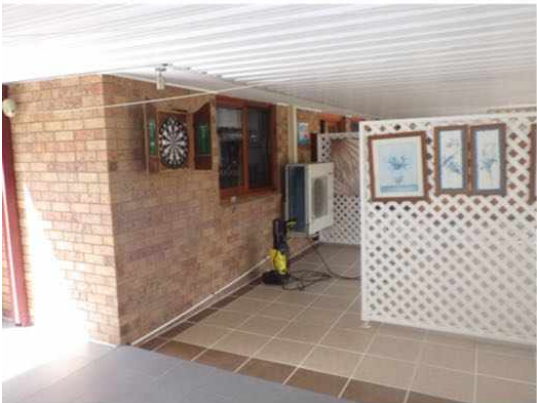
Building: Main Building
Location: Alfresco > Existing
Finding: No obvious defect
Information: No obvious defects found at the time of inspection.

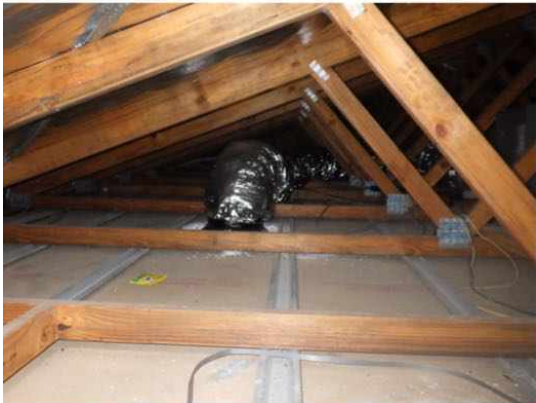
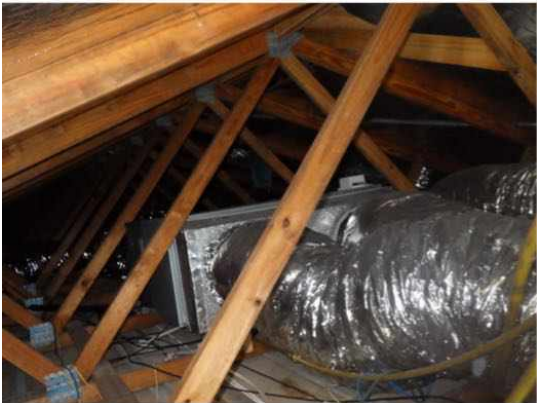
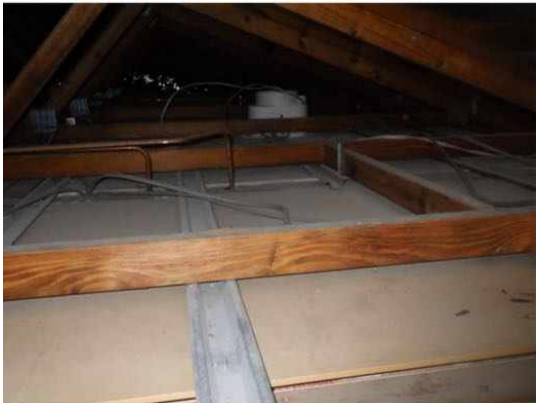
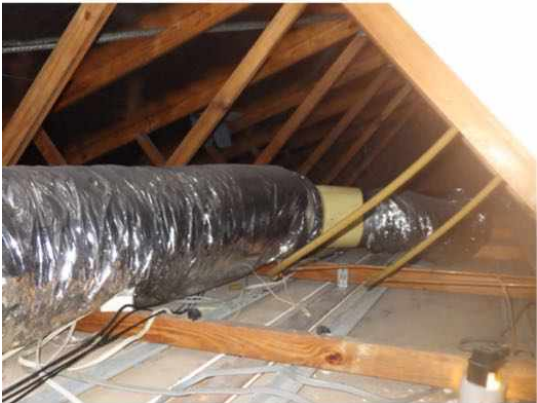
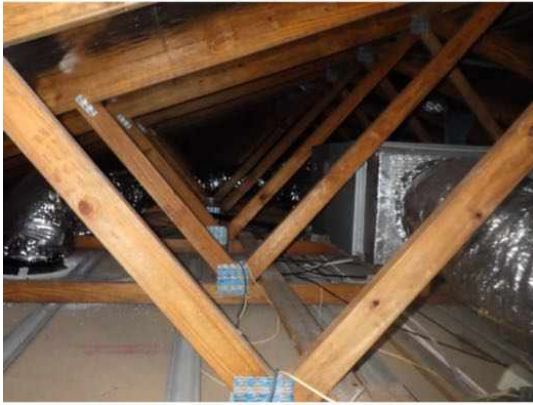
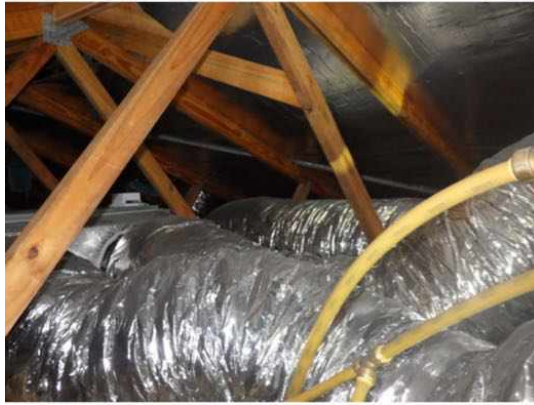
Building: Main Building
Location: Attic > Existing
Finding: Additional Photos
Information: Additional photos are provided for your general reference

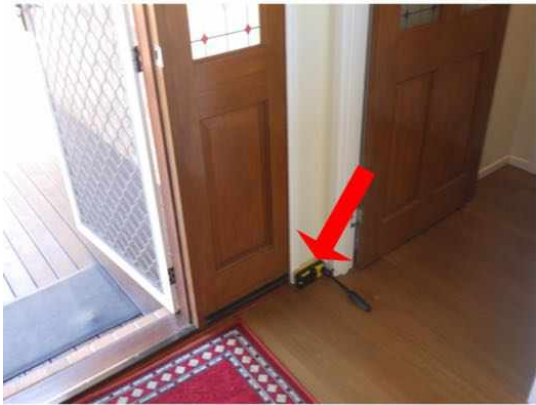
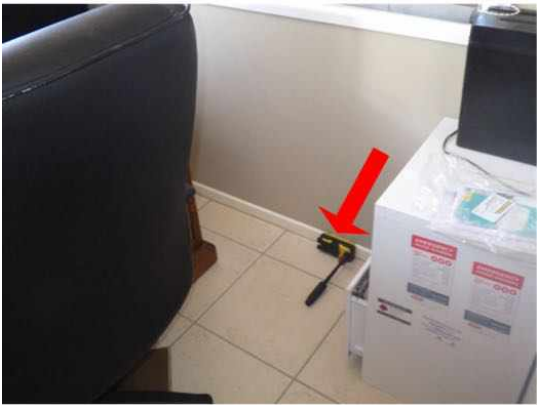
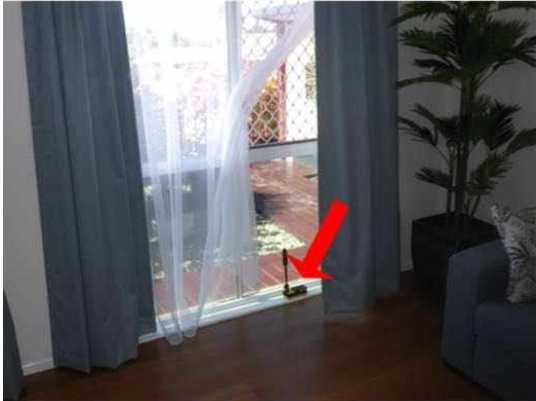
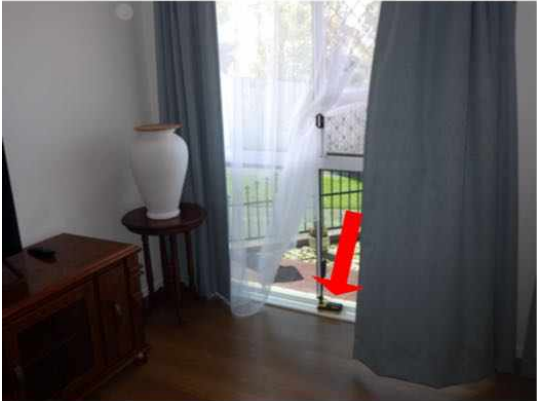
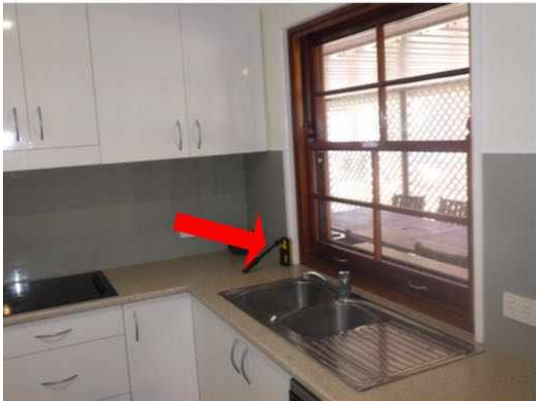
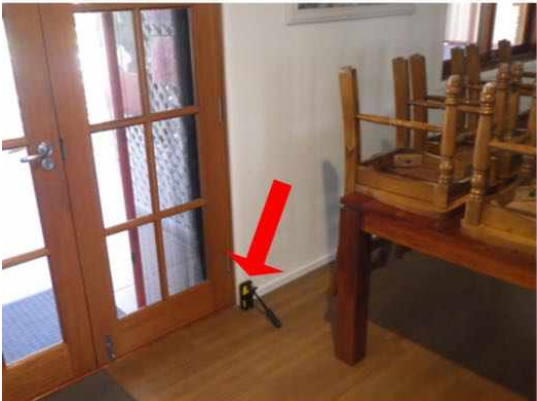
Building: Main Building
 Location: Internal Areas > Existing
 Finding: Termitracker
 Information: The termitracker itracker was positioned randomly to internal wall, timber skirting and window frame areas checking for signs of termite activity.

No activity was recorded at the time of inspection.

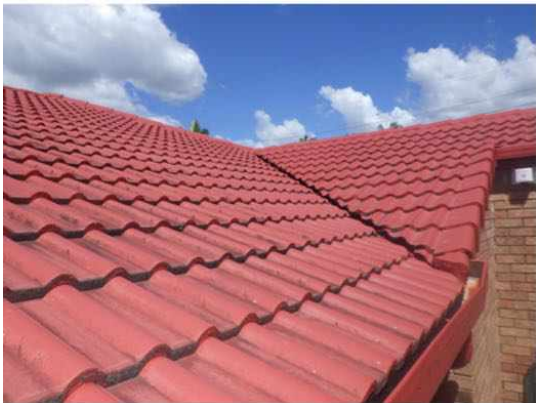
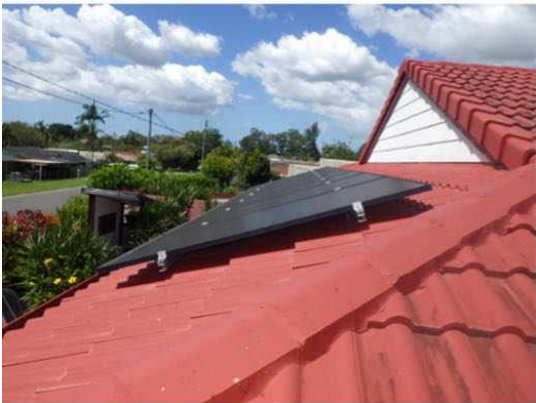
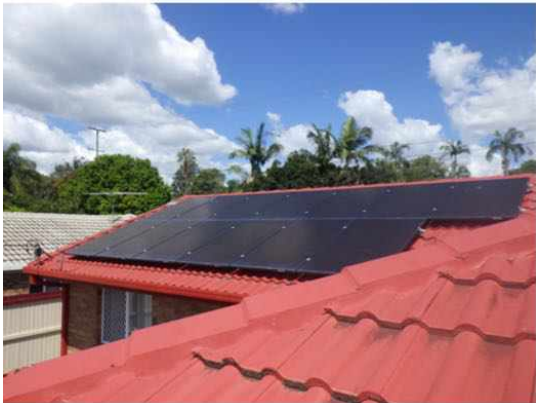
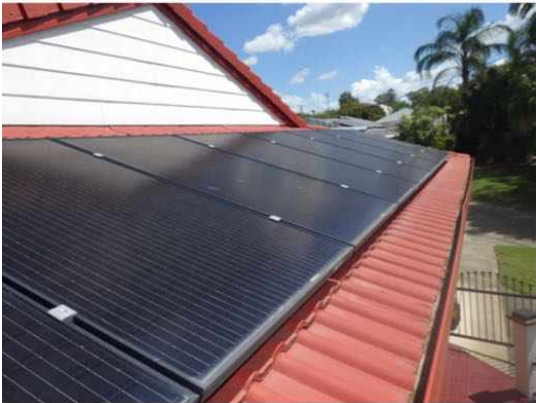
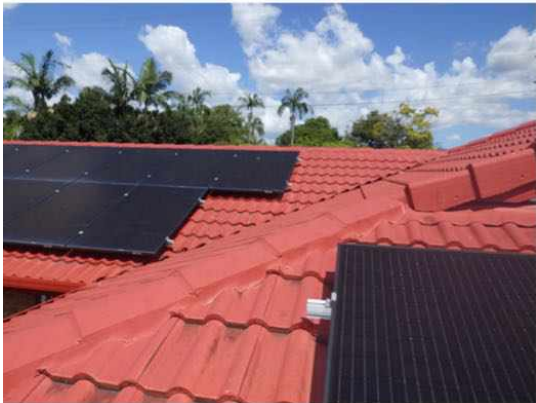
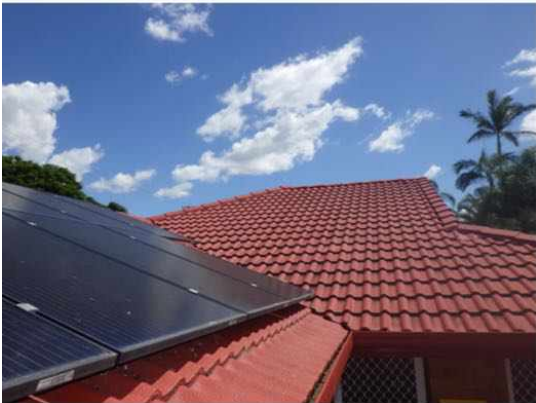
Building: Main Building
Location: Roof Exterior > Existing
Finding: Additional Photos
Information: Additional photos are provided for your general reference

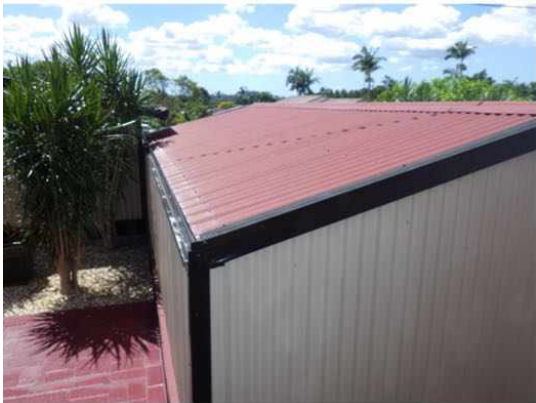
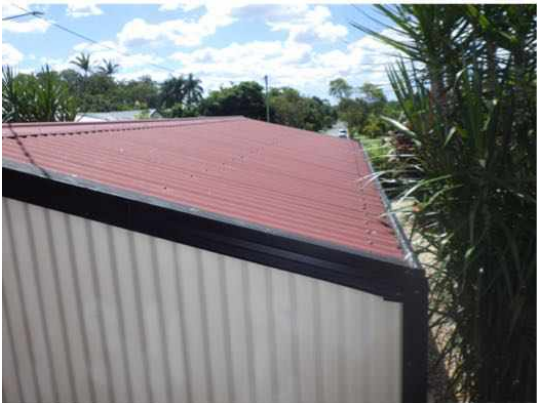
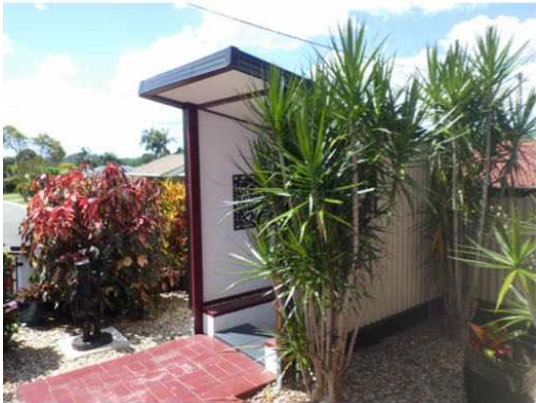
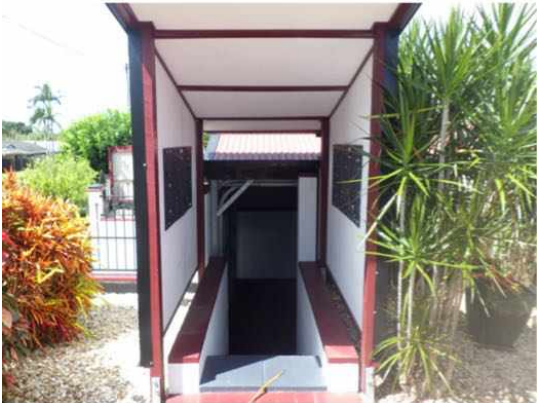
Building: Garage
Location: External Areas > Existing
Finding: No obvious defect
Information: No obvious defects found at the time of inspection.

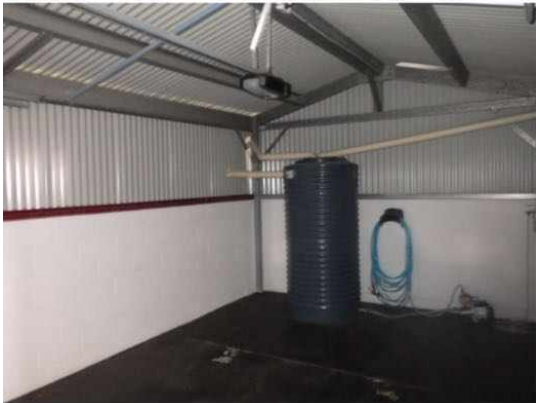
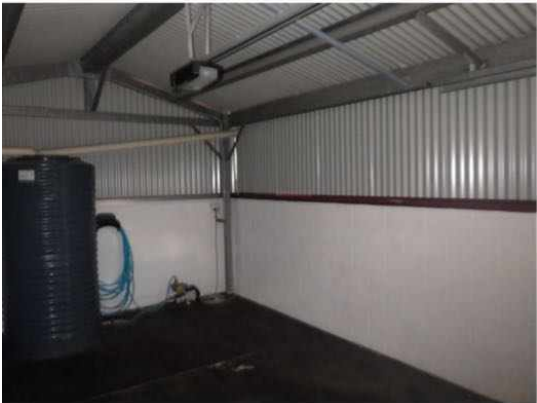
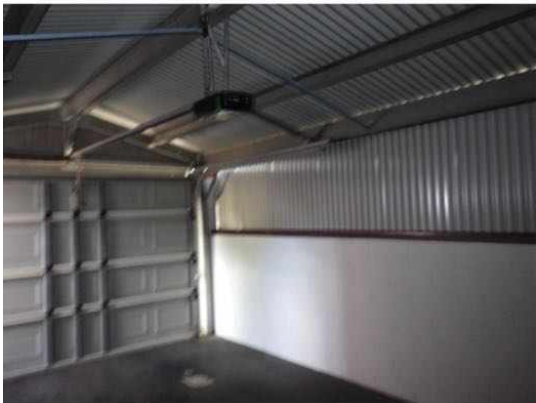
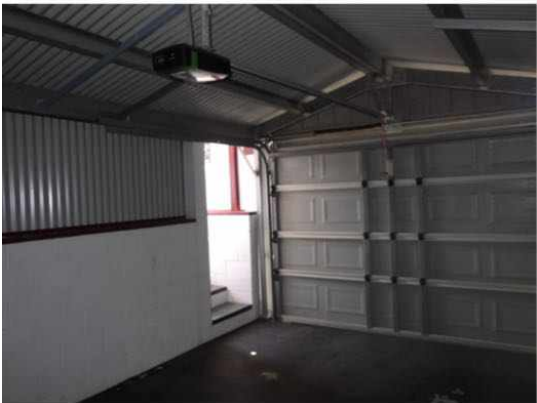
Building: Garage
Location: Internal Areas > Existing
Finding: No obvious defect
Information: No obvious defects found at the time of inspection.

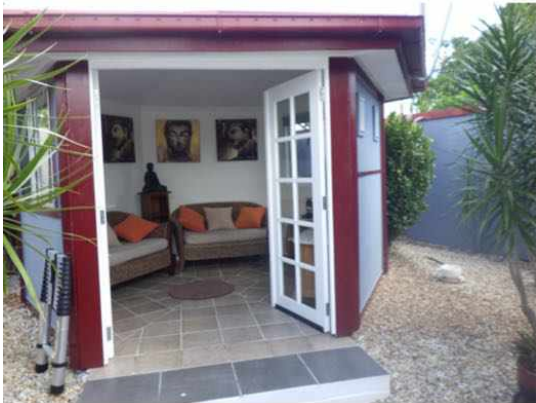
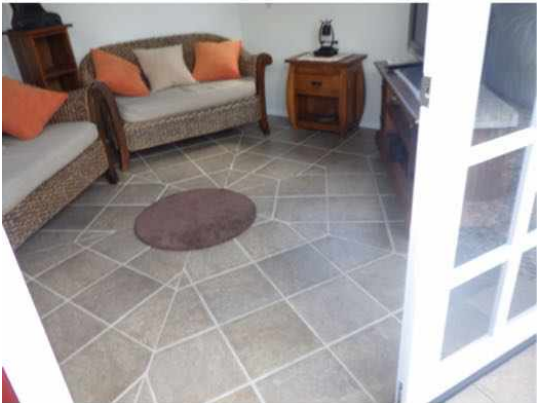
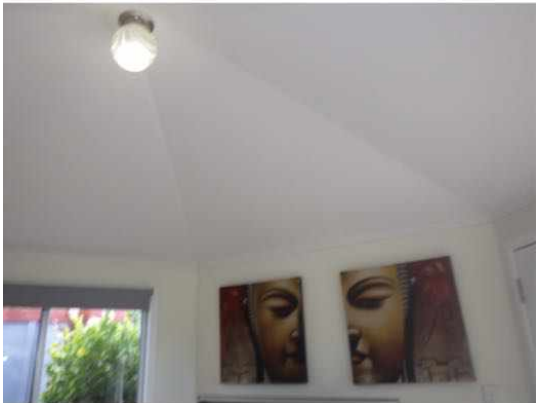
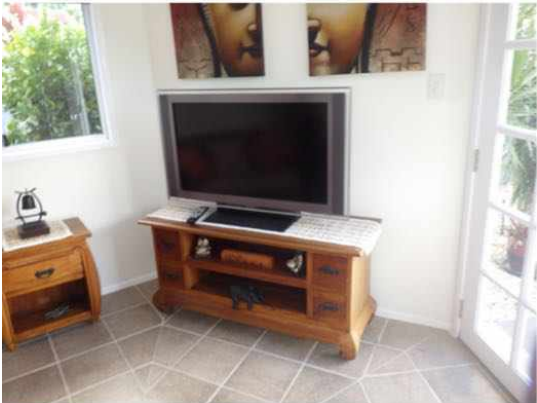
Building: Out Building
 Location: Cabana > Existing
 Finding: Additional Photos
 Information: Additional photos are provided for your general reference

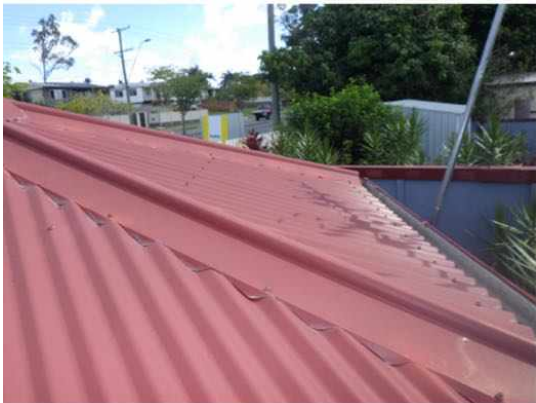
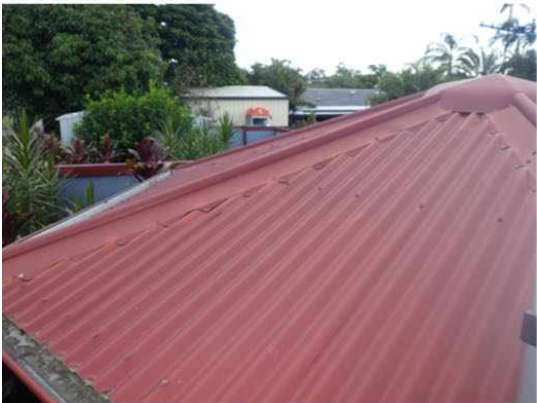
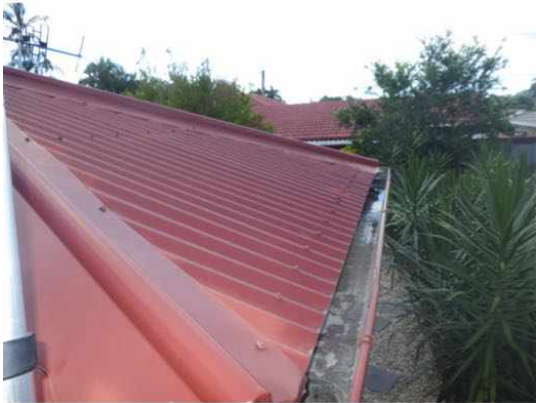
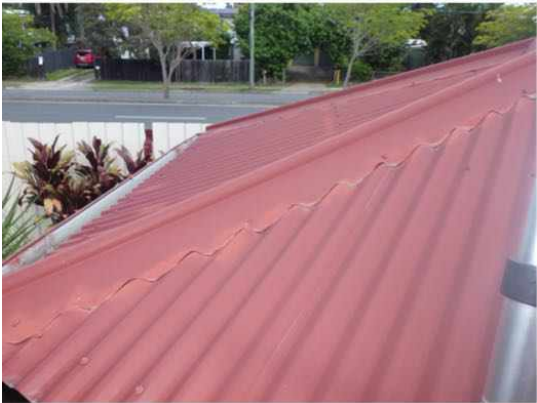
Building: Out Building
 Location: Cabana > Existing
 Finding: Additional Photos

Information: Additional photos are provided for your general reference

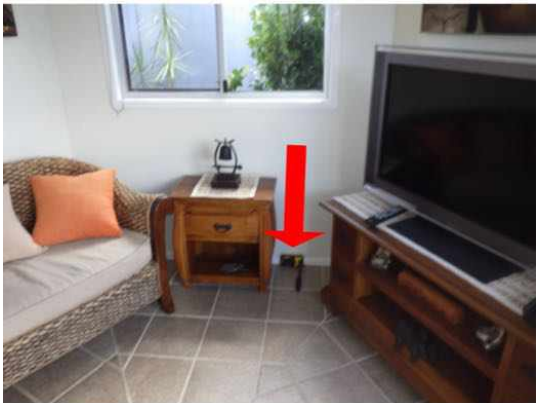
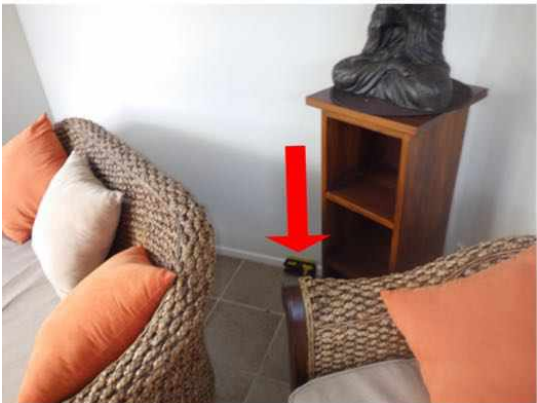
Building: Out Building
Location: Cabana > Existing
Finding: Termitracker
Information: The termitracker itracker was positioned randomly to the Cabana internal wall and timber skirting areas checking for signs of termite activity.

No activity was recorded at the time of inspection.

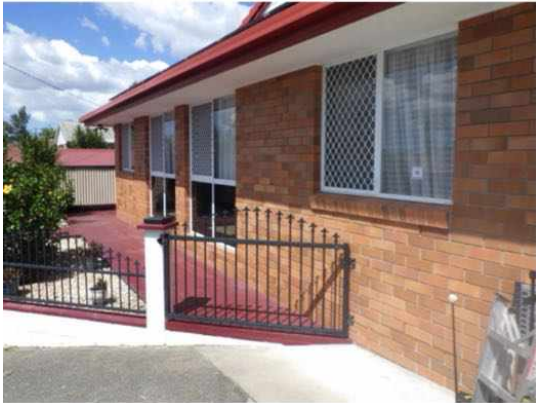
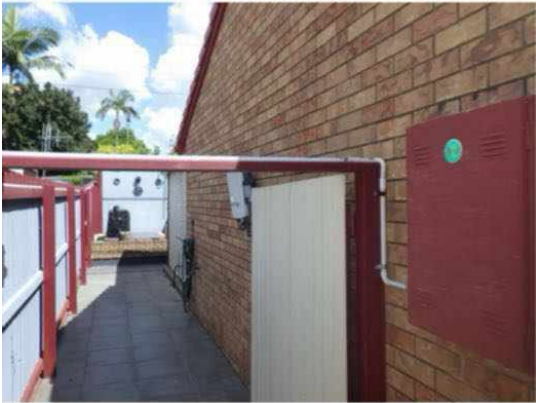
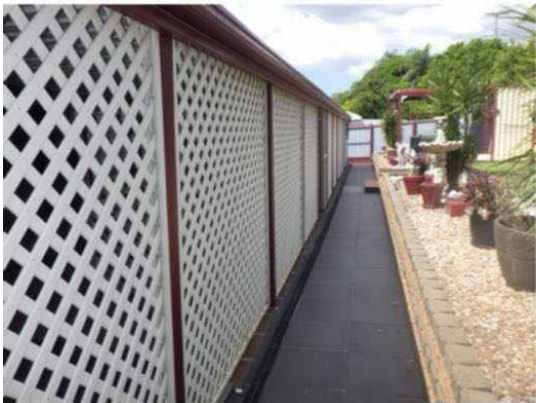
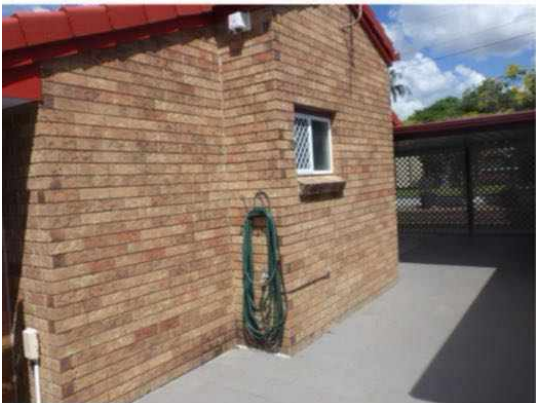
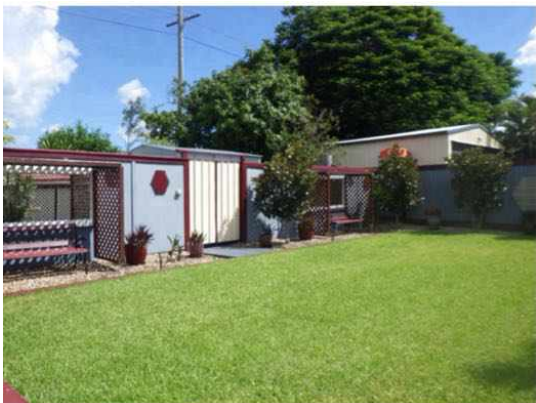
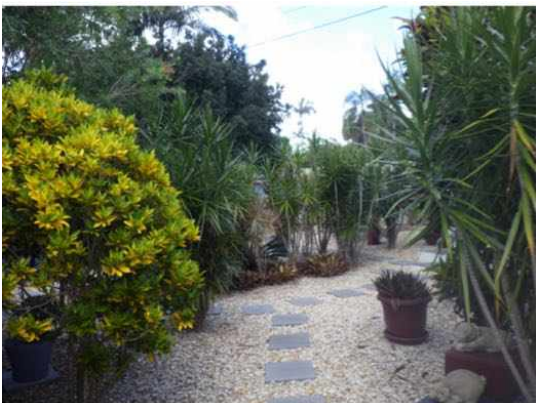
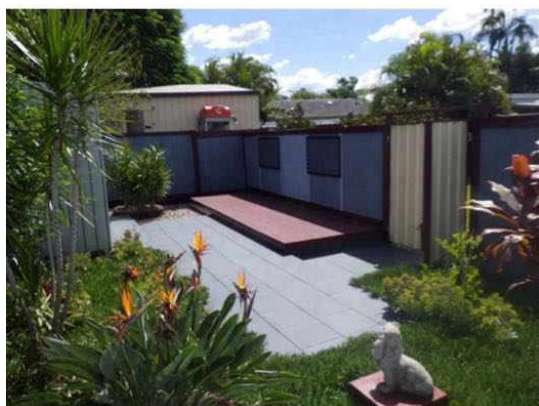
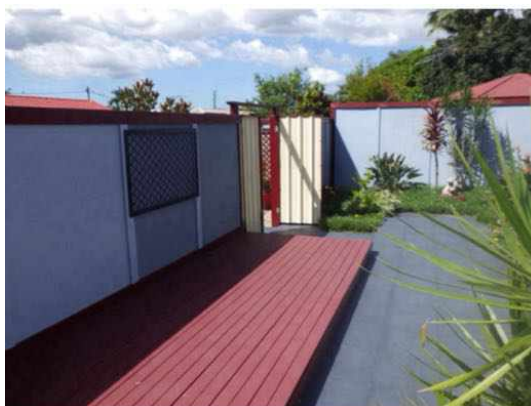
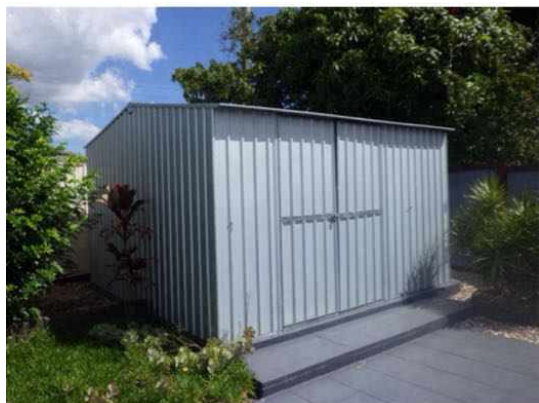
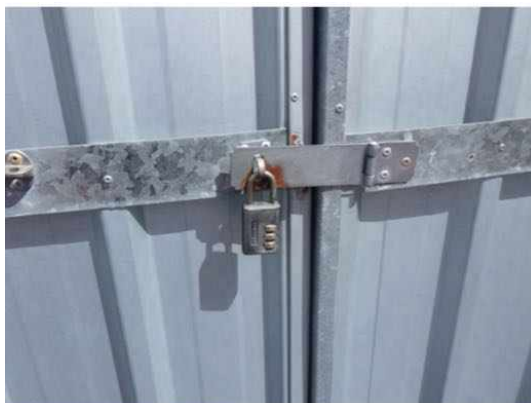
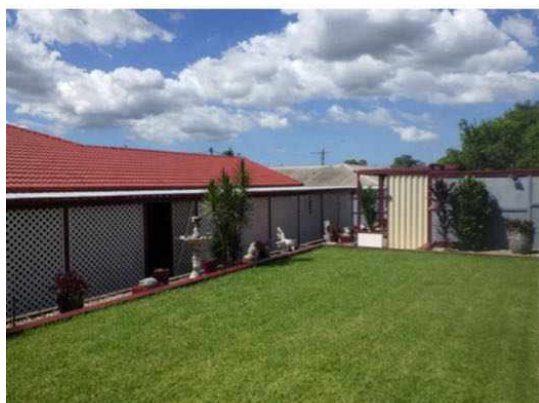
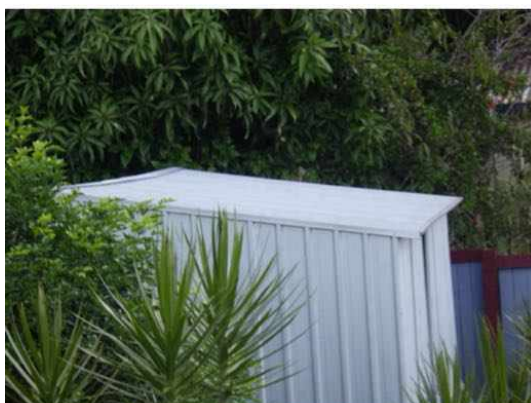
Building: Main Building
Location: External Areas > Existing
Finding: Additional Photos
Information: Additional photos are provided for your general reference

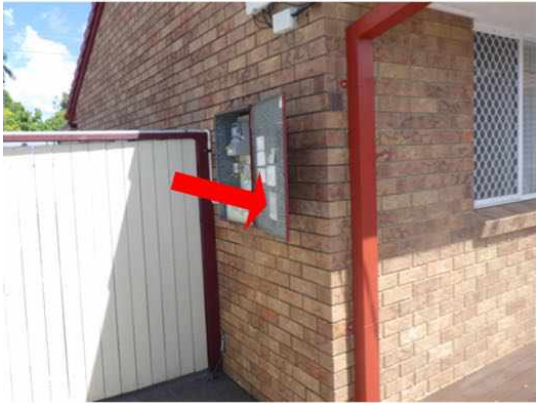
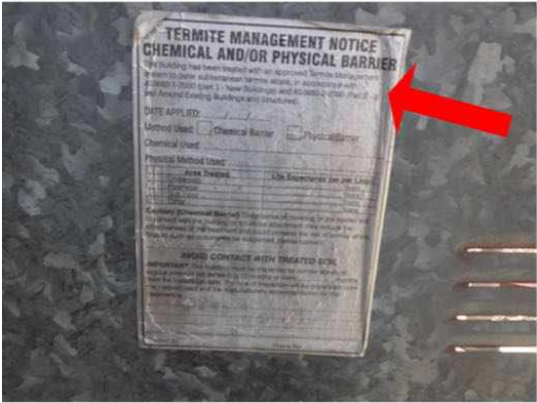
In this instance evidence of a previously installed chemical barrier durable notice was observed inside the electrical meter box (dated 4.11.2008?). This system requires replenishment and regular annual inspections.

No evidence of regular or annual inspections was found.

A further chemical treatment of the property is highly recommended.
