Building and Timber Pest Inspection Report

Inspection Date: Wed, 25 Feb 2026

Property Address: 2 Wilgah St, St Kilda East VIC 3183,
Australia

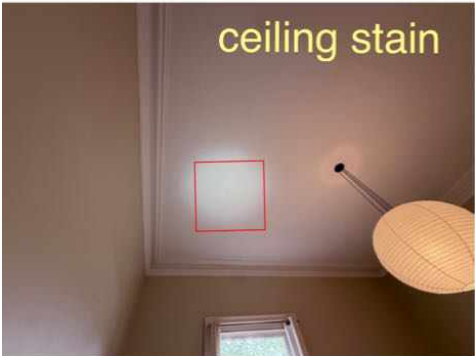
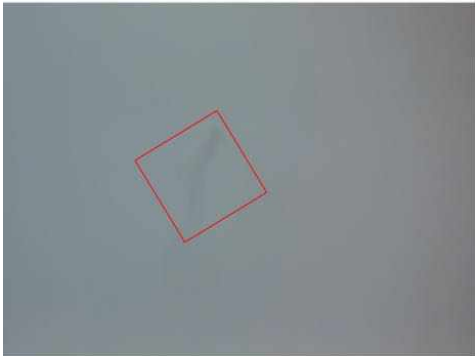
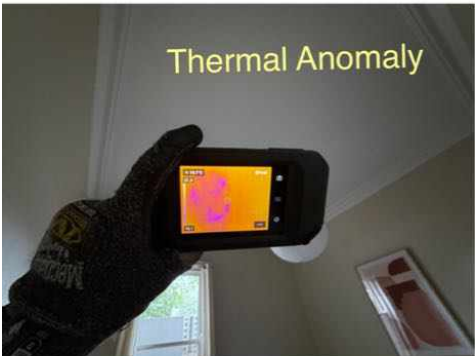
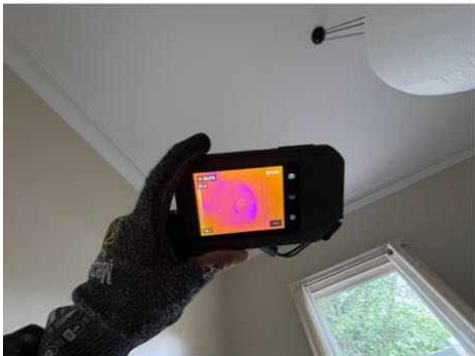
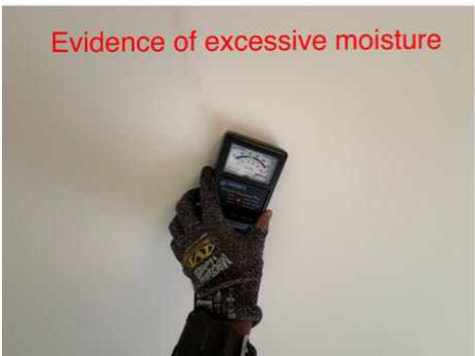
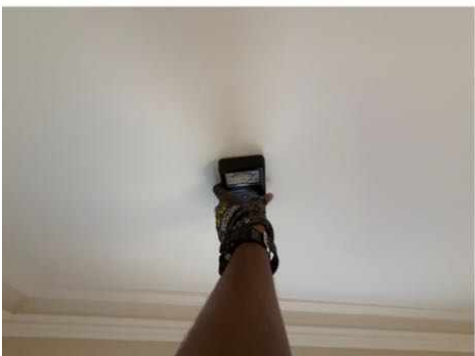
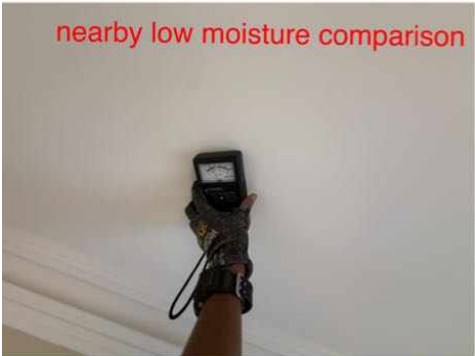
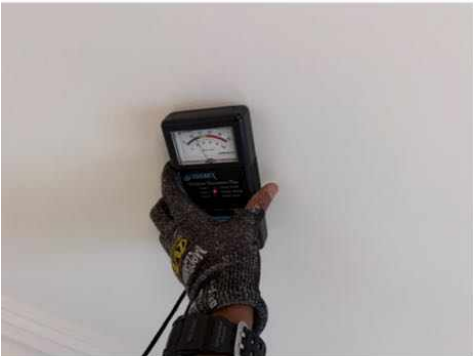
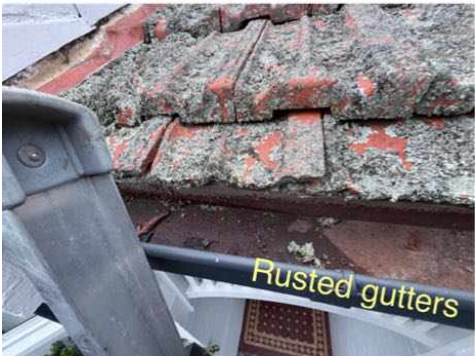
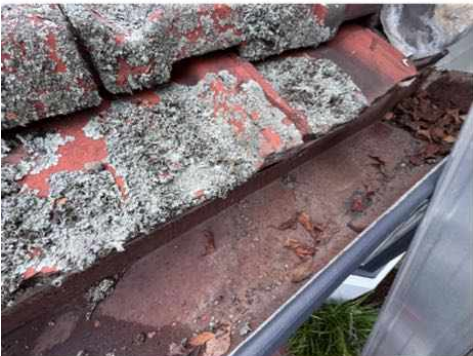
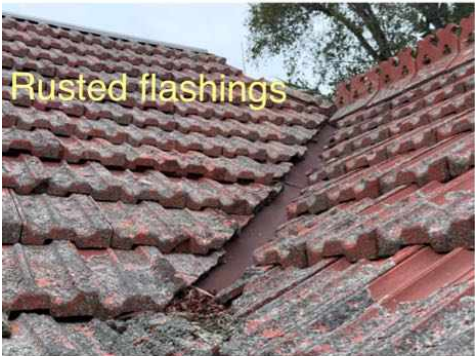
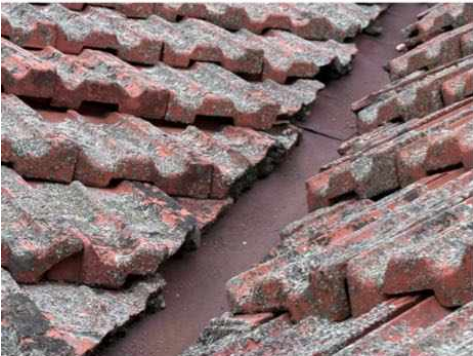
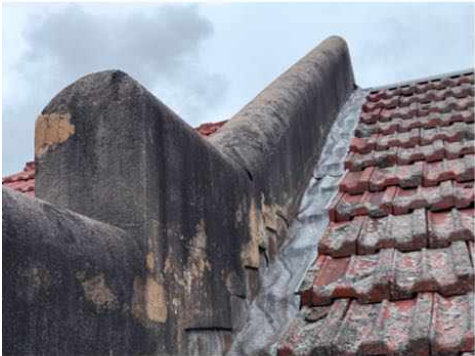
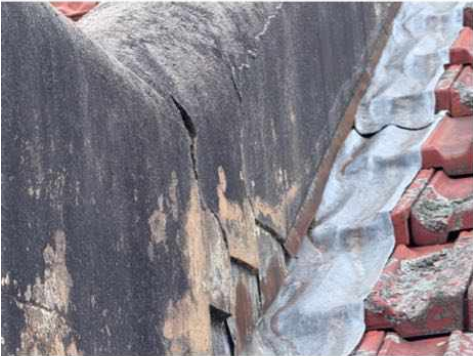
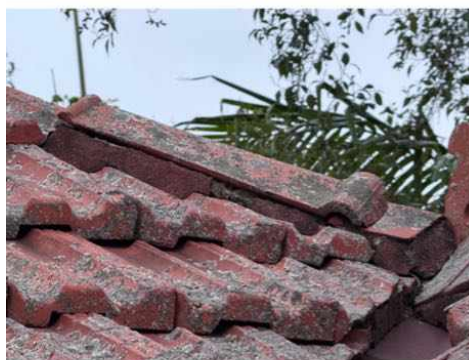
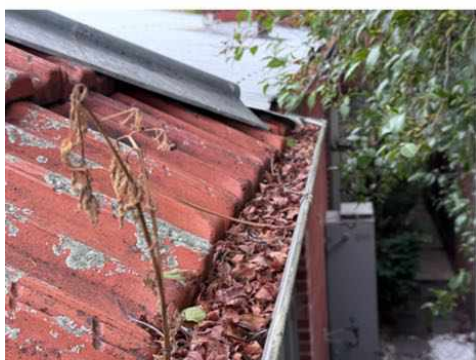
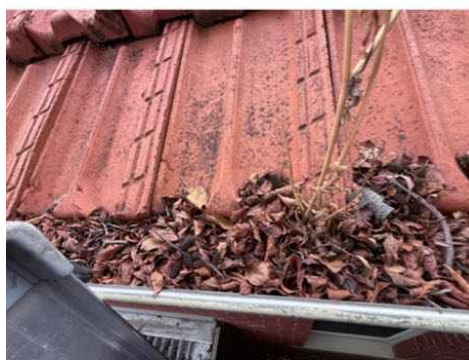
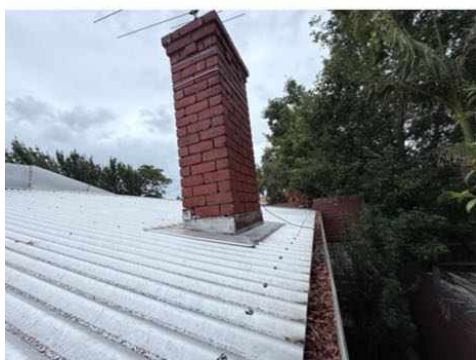
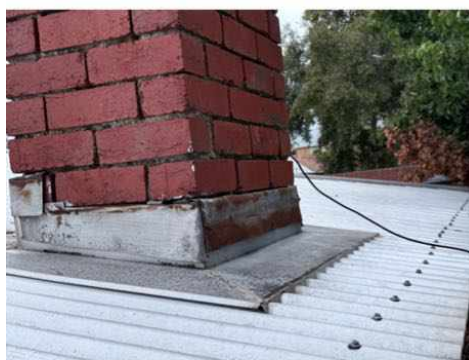
Building:	Main Building
Location:	Bedroom 2 & Roof exterior.
Finding:	Water ingress & Associated Roofing issues.
Information:	<p>Water staining and damage were identified to the ceiling/wall area within Bedroom 2. This was confirmed visually (physical staining), instrument tested (elevated moisture readings recorded via moisture meter), and supported by thermal imaging, which showed abnormal temperature patterns consistent with retained moisture within the lining/cavity. Although the exact entry point could not be verified because no direct roof-void access was available above this area at the time of inspection, the findings are consistent with active or intermittent water ingress and should be treated as a major defect due to the risk of ongoing deterioration (plaster breakdown, mould growth, timber decay/rot to concealed framing, and progressive internal damage).</p>

The most likely contributing factors were observed at the roof level. While the roof covering itself did not present as catastrophic, it displayed multiple defects that materially increase the likelihood of leaks, including rusted valley flashings (with evidence of prior patch repairs), deteriorated/cracked mortar to ridge/hip bedding and pointing, and blocked/contaminated gutters with debris that can cause overflow and backflow beneath tiles during rainfall. Collectively, these conditions reduce the roof's weatherproofing reliability and provide plausible leak pathways consistent with the internal moisture findings. Urgent investigation and rectification by a qualified roofing contractor is recommended, including leak tracing (ideally during/after rainfall), clearance of gutters, and targeted repairs/replacement to valley flashings and defective mortar areas, followed by reinstatement/repair of affected internal linings once the moisture source is confirmed resolved.

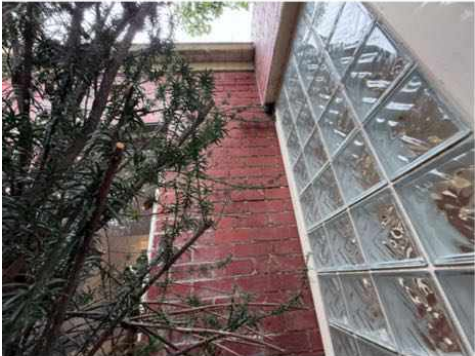
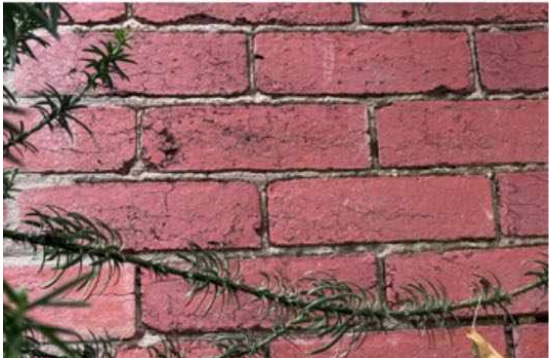
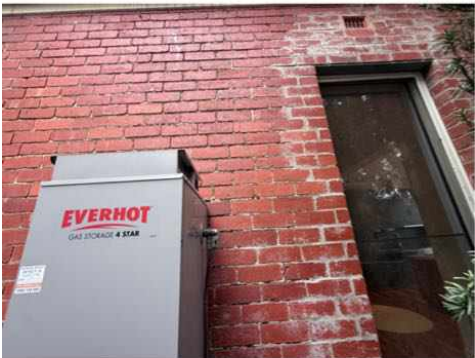
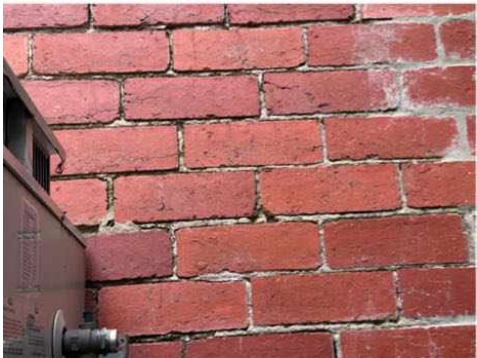
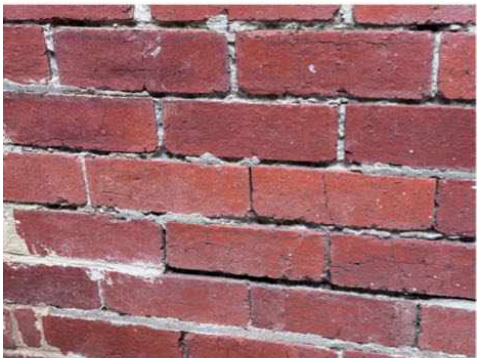
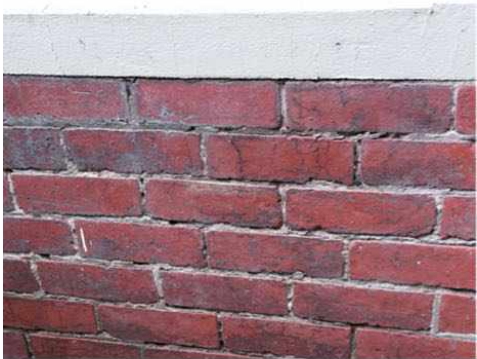
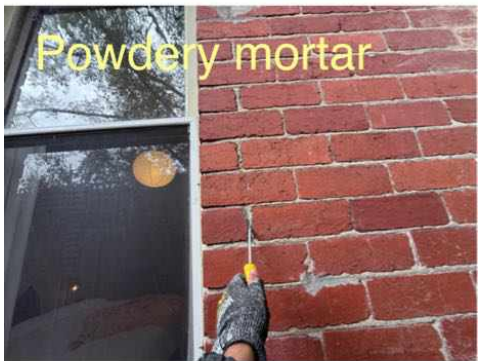
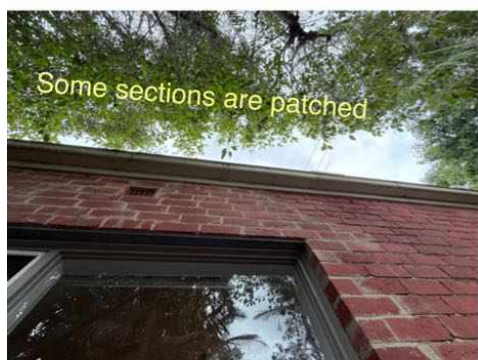
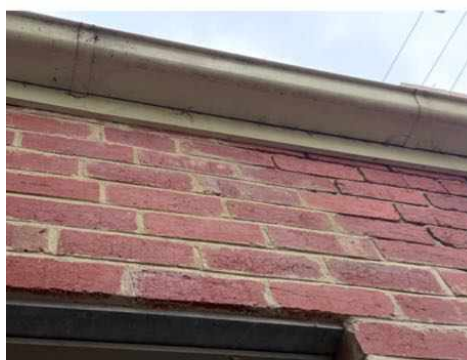
Finding 3.01

Building:	Main Building
Location:	Exterior walls - right side
Finding:	Mortar Deterioration (Moderately Significant)
Information:	The external brickwork mortar joints display age-related deterioration, with multiple sections observed to be loose, powdery, eroded and locally recessed beyond typical weathering tolerances. This condition is consistent with long-term exposure and natural binder breakdown; however, the inconsistent joint hardness and variable finish

may also indicate substandard mortar mix ratios or workmanship in certain areas. Localised patch repairs are evident but appear limited in extent and do not comprehensively address the broader deterioration. Progressive mortar loss can increase moisture penetration, reduce lateral bond between bricks, and accelerate brick arris fretting over time.

Consultation with a qualified bricklayer is recommended to assess the extent of joint degradation and determine whether staged or full elevation repointing is required in the medium term to restore overall integrity and durability of the masonry.

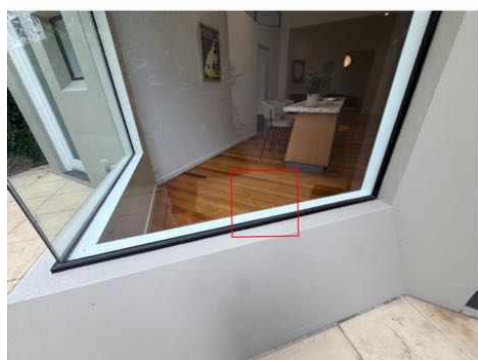
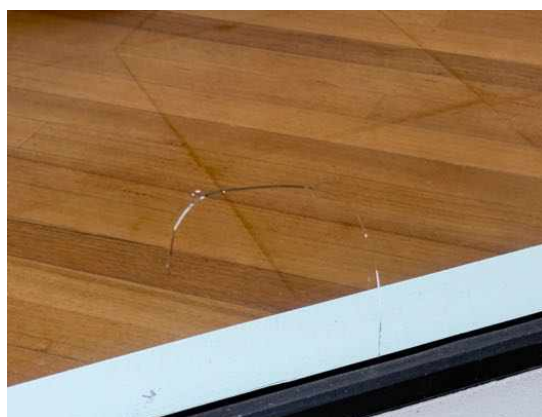
Finding 3.02

Building:	Main Building
Location:	Exterior walls - rear
Finding:	Cracked Glazing Panel
Information:	A crack was observed to the lower section of the fixed glass panel adjacent to the living/kitchen area. The crack appears localised and no immediate failure of the pane was noted at the time of inspection. While currently intact, cracked glazing can progressively weaken and may be susceptible to further spreading due to thermal movement, impact, or structural vibration.

It is recommended that the glazing be monitored in the short term and if necessary be assessed by a qualified glazier, with replacement undertaken as required to maintain safety and integrity of the window system.

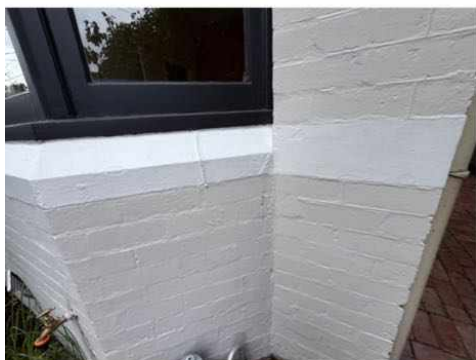
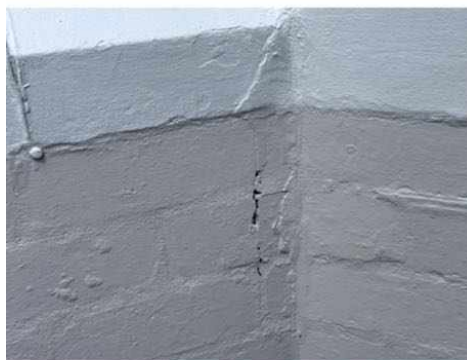
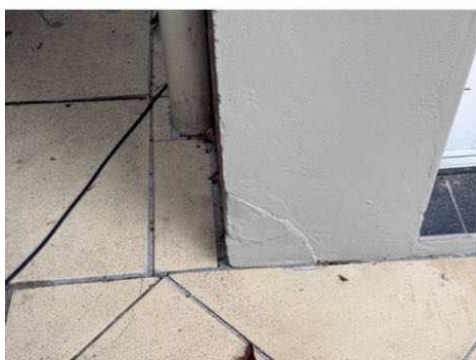
Finding 3.03

Building:	Main Building
Location:	Some external Areas
Finding:	Brickwork - Cracking [Fine]
Information:	Although fine cracks are quite noticeable, they are often only considered to be an appearance defect and usually do not indicate any structural damage. Generally, the cause of a fine crack is indicative of a separation between brickwork and mortar

throughout the structure, but single bricks may also show cracks of this nature.

Cracking of this nature can generally be repaired with minor filling and should be conducted by a qualified bricklayer.

Always contact a building inspector should cracks widen lengthen or become more numerous.

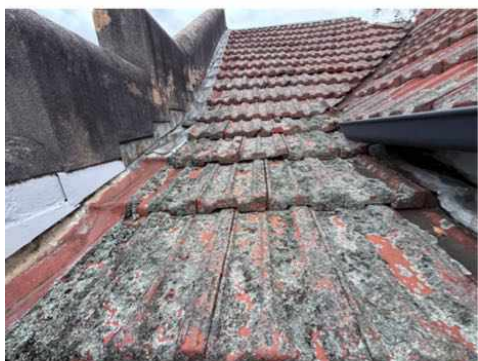
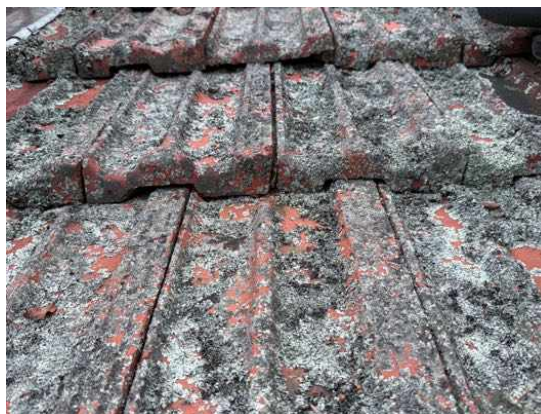
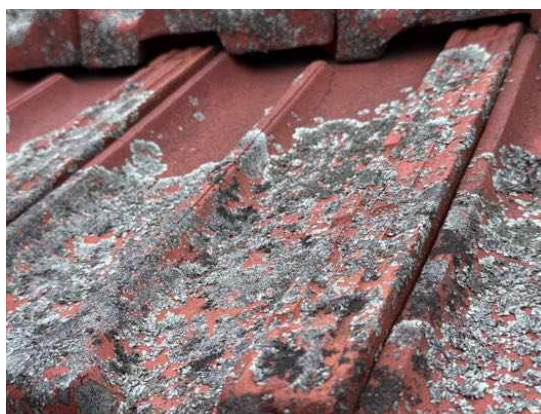
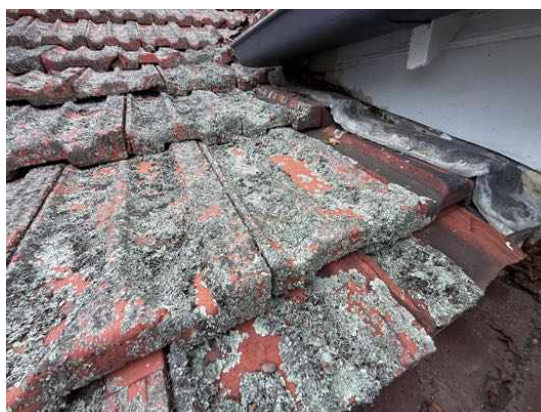
Finding 3.04

Building:	Main Building
Location:	Roof Exterior
Finding:	Roof Tiles Covered with Moss and Lichen Growth
Information:	The roof tiles are observed to be covered with moss and lichen. This biological growth can retain moisture against the tile surface, potentially accelerating tile degradation, loosening of fixings, and increasing the risk of water ingress over time.

At clients discretion roof tiles can be cleaned using a low-pressure wash or a suitable biocide treatment to remove the moss and lichen without damaging the tiles. Following cleaning, a roof inspection should be carried out to assess for any cracked, dislodged, or deteriorated tiles, with necessary repairs or replacements undertaken. Preventive maintenance such as improving roof ventilation and trimming overhanging branches can also help reduce regrowth.

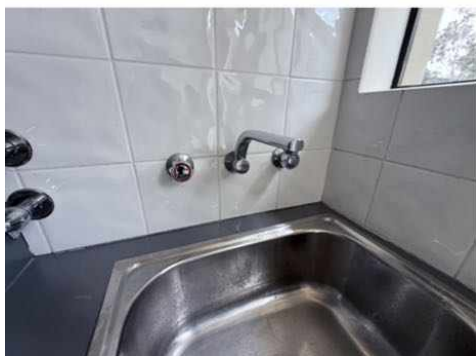
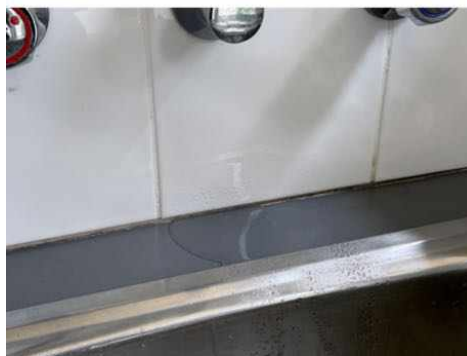
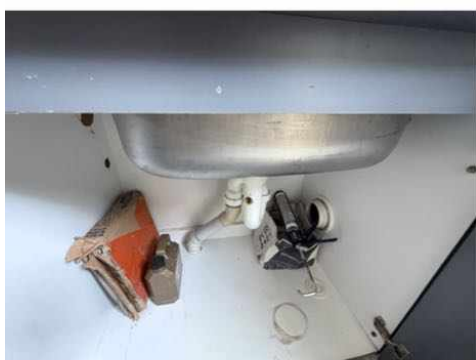
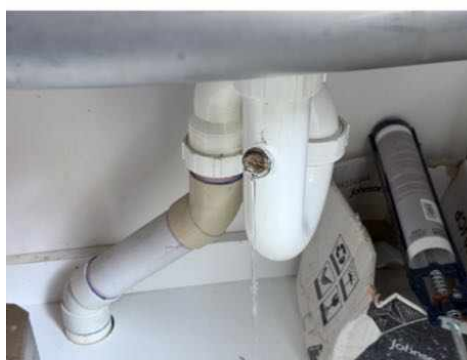
Building:	Main Building
Location:	Laundry
Finding:	Missing Cap Below Laundry Tap
Information:	The plumbing beneath the laundry sink is missing a cap/plug on one of the outlet connections of the waste pipe. When the tap is turned on, water escapes directly from the uncapped opening, leaking into the cabinet area below. This can cause water damage and swelling to the cabinet base panel.

This condition is classified as a defect as it allows uncontrolled water discharge, leading to deterioration of joinery materials, potential mould growth, and further water-

related damage if left untreated. Immediate rectification is recommended by sealing the opening with an appropriate cap or connection piece to prevent further leakage and damage.

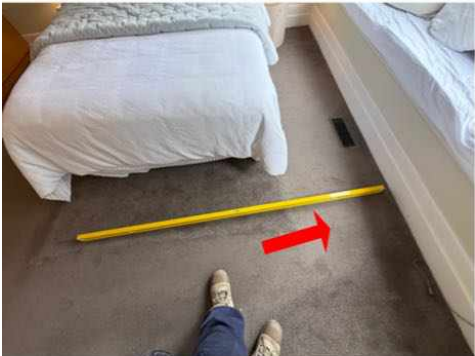
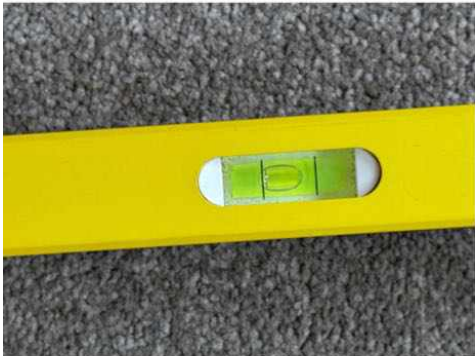
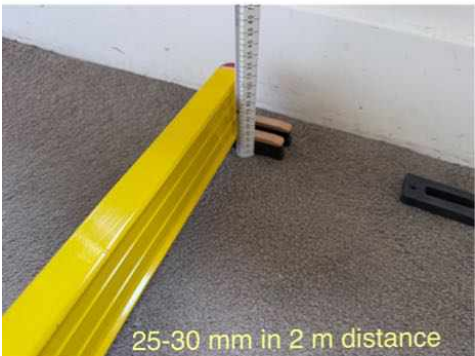
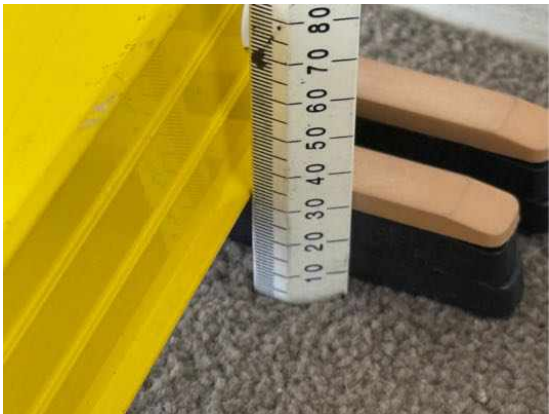
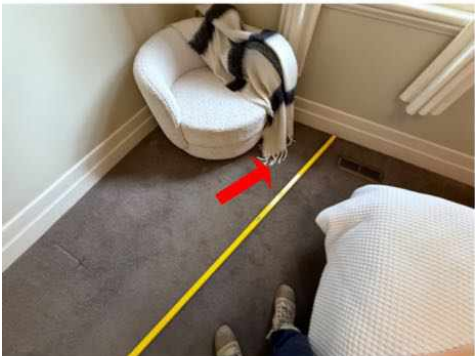
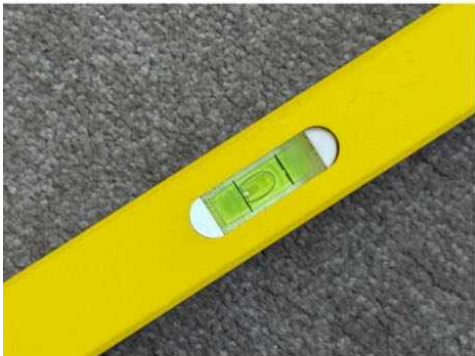
Finding 3.06

Building:	Main Building
Location:	Some Internal Areas
Finding:	Subsidence- moderately significant
Information:	It is suspected that the subfloor structure might have been affected by movement of the foundations, often referred to as sinking or subsidence.

General subsidence is usually initiated by changes in soil moisture content. The most critical factor is identifying the specific causes, and identifying if this is a recurring or ongoing problem, or one that has been resolved by previous works in the past. The max documented deviation was around 25-30 mm in 2 m distance.

Subsidence can have complex and varying causes, which will influence the required remedial works. If secondary defects like door binding, cracks around the cornices, or gaps between walls & flooring are evident. It will be advised to begin by consulting a structural engineer to determine the required scope of works. This generally includes some form of underpinning, as well as addressing the underlying cause.

A Registered Builder specialising in re-stumping would then generally carry out works

as advised by an Engineer.

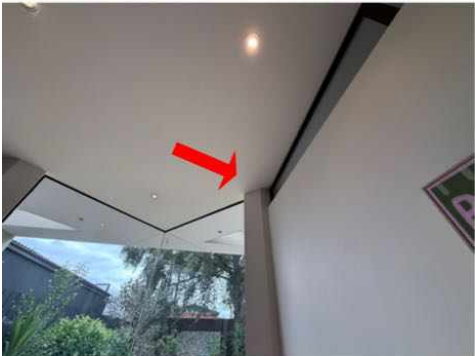
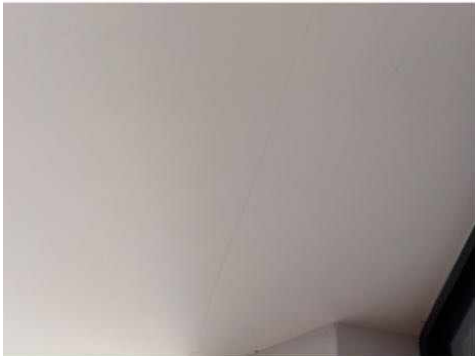
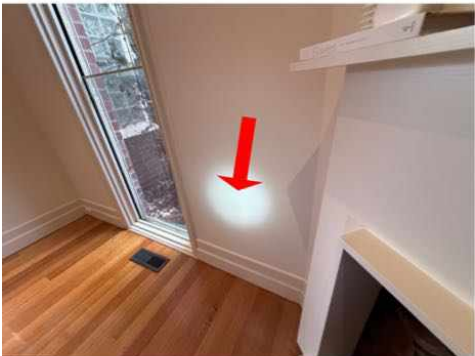
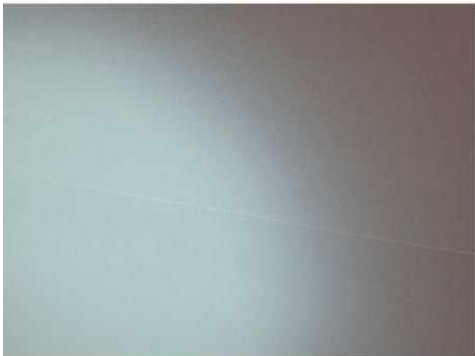
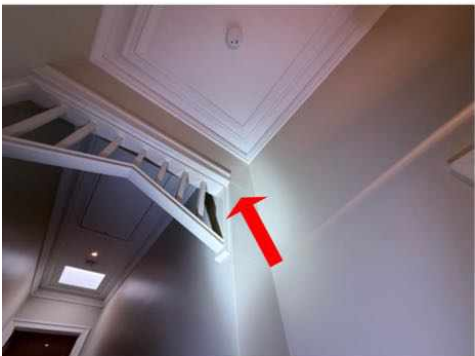
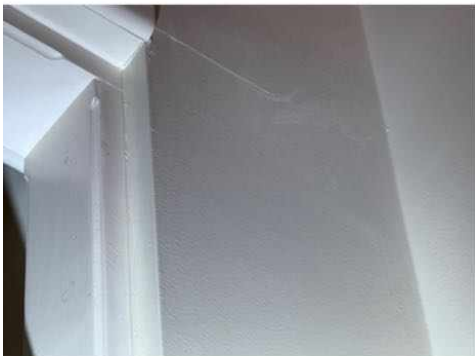
Finding 3.07

Building:	Main Building
Location:	Some Internal Areas
Finding:	Cracking - Damage Category 1 - Fine (up to 1mm)
Information:	Although fine cracks are quite noticeable, they are often only considered to be an appearance defect, and usually do not indicate any structural damage. Generally, the cause of a fine crack is indicative of a separation between building materials and finishes (e.g. paint, plaster, etc.) along joins.

Cracking of this nature can generally be repaired with minor sanding, filling and/or repainting. Such works should be performed by a qualified painter or a general handyman.

Monitoring of all cracking should be conducted frequently. Always contact a building inspector should cracks widen, lengthen, or become more numerous.

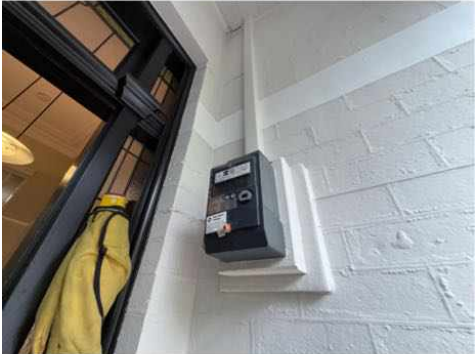
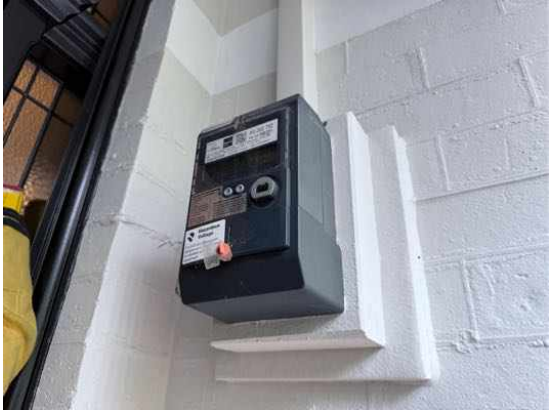
Building:	Main Building
Location:	Meter Box
Finding:	Termite Management System - no evidence of a chemical installation
Information:	The application of a post-construction chemical termite barrier is highly recommended for all properties, particularly if live termite activity has been found on the site previously. Such barriers are highly effective in preventing termite attack on any timber building elements throughout the property.

system has been installed, with no evidence to suggest preventative works taking place.

The client may consider gaining further advice from a pest controller as to the costs and procedures involved with this application. It is recommended that obtaining such advice be a short-term priority.

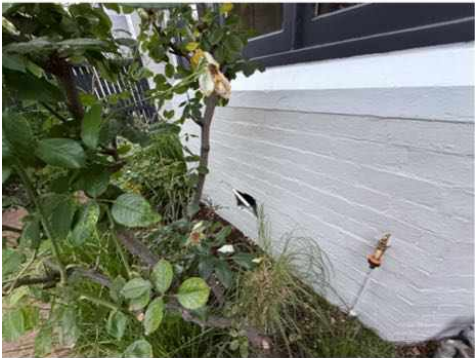
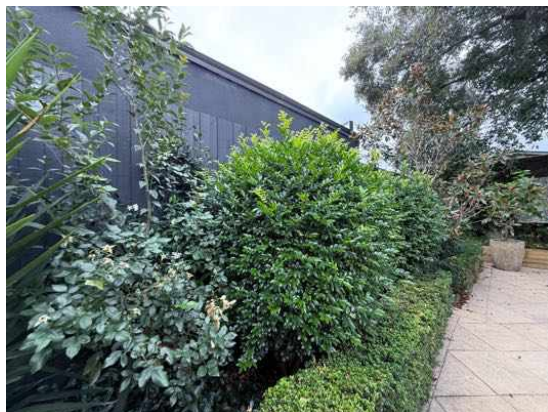
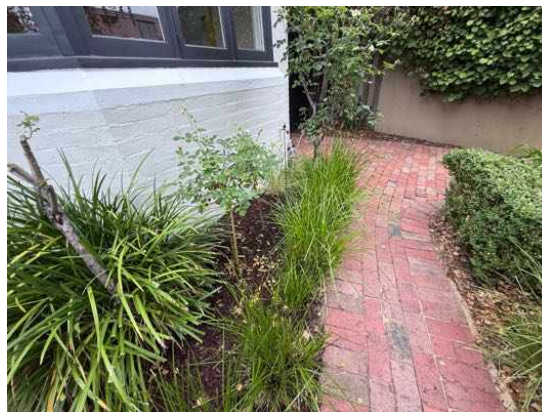
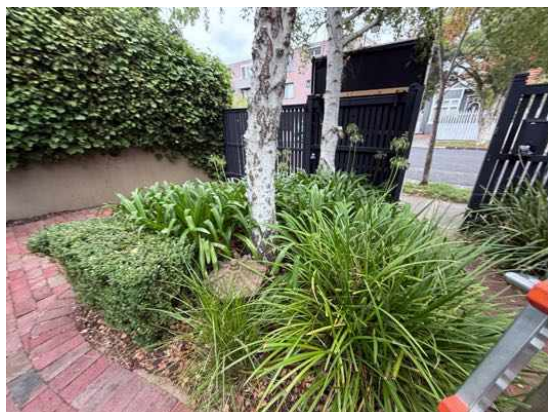
Finding 6.02

Building: Main Building
Location: All External Areas
Finding: Garden Bed/ Mulch - Conditions Conducive to Termites
Information: Mulch were found around the property. These areas can include untreated timber, and with a combination of moisture from watering hosing can make conditions conducive to termite activity and termite ingress.

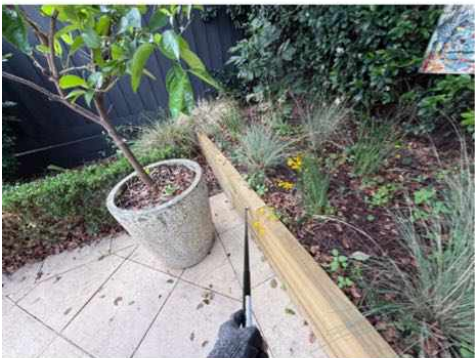
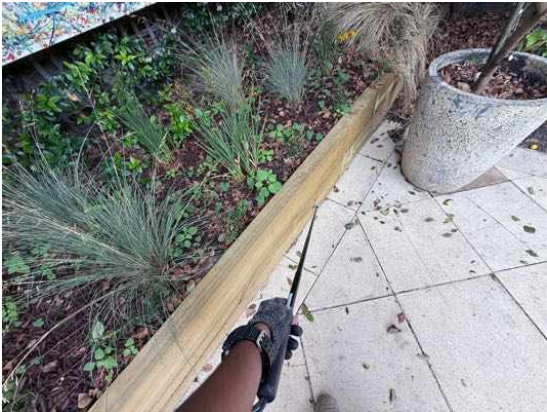
Finding 6.03

Building:	Main Building
Location:	All External Areas
Finding:	In ground contact
Information:	Any timbers in direct ground contact provide opportunity for concealed termite entry and are likely to be subject to premature rot and decay as the soil retains moisture or damp conditions against the timbers.

Remove untreated timber that is in direct contact with external grounds. Consider replacement with more durable materials i.e. treated timber or non timber elements. Frequent pest inspections are advised to readily identify any termite activity in these areas.

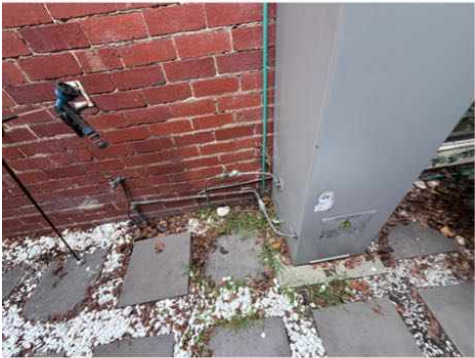
Finding 6.04

Building: Main Building
Location: Exterior walls - right side
Finding: Hot water relief valve not connected to drainage.
Information: Hot water relief valve is discharged inappropriately. Because of which, base perimeter can become excessively damp, potentially creating an environment that is susceptible to rust and corrosion of surrounding building elements, as well as attracting termites and other pests.

It is highly recommended that a plumber be appointed to install adequate drainage equipment where necessary.

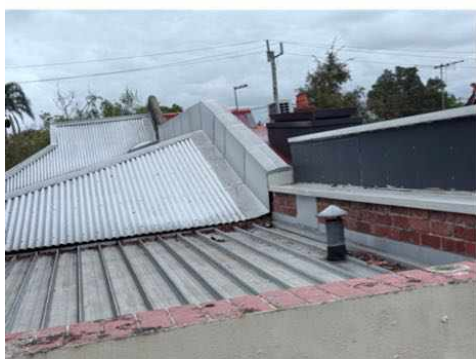
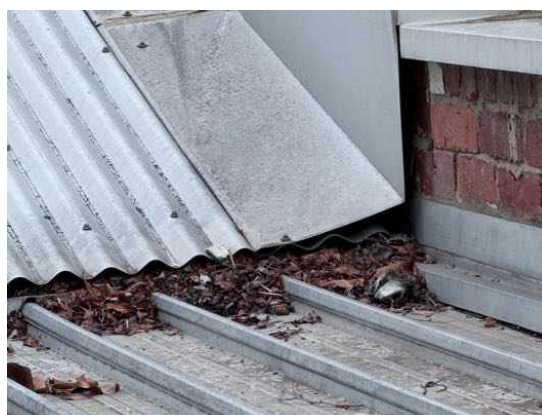
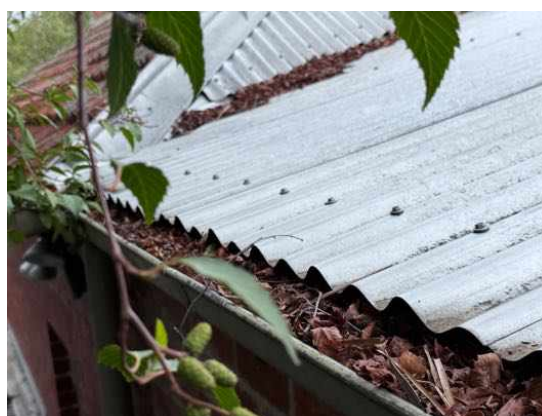
Finding 6.05

Blocked gutters are likely to lead to high levels of moisture in the affected areas. Such moisture will not only cause rust and decay of the associated building materials, but can also provide conditions that are conducive to termite and timber pest activity. Blockages in gutters should therefore be removed immediately to ensure dry conditions are maintained.

Consult a Licensed Plumber for further specific advice on remedial works that may be required. In the interim, it is highly advised that blocked gutters be removed by the homeowner or a general handyperson as a matter of urgency.

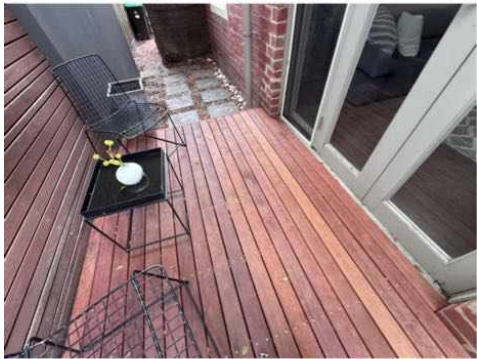
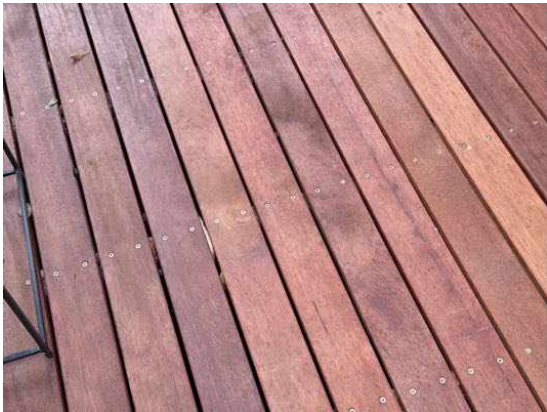
Finding 6.06

Building: Main Building
 Location: Exterior walls - right side
 Finding: Timber deck- High conducive condition.
 Information: We are unable to inspect under the timber deck if its in close proximity to the ground.

Where we are unable to inspect timber structures, decks and subfloor areas the risk of undetected termite activity is rated as extremely High.

We strongly recommend the purchaser prioritise a termite treatment by a Licensed Pest Controller to protect and maintain the asset as it is a timber structure.

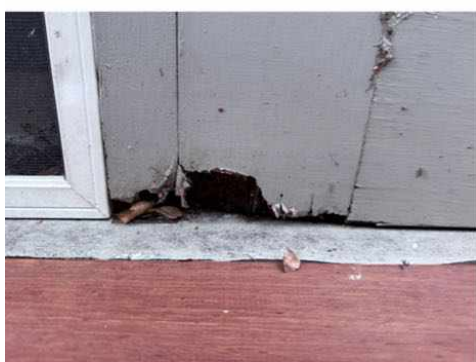
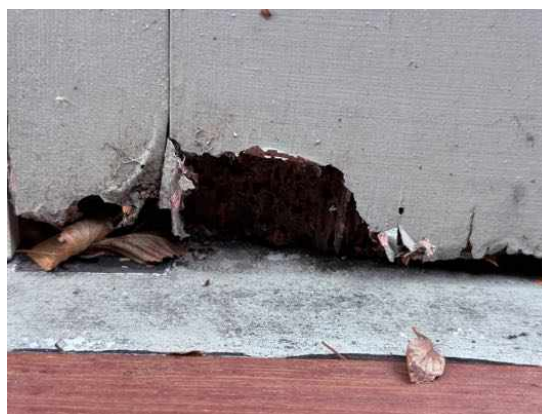
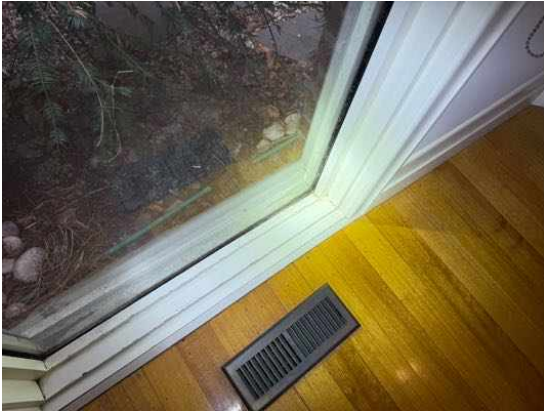
Finding 7.01

Building:	Main Building
Location:	Exterior walls - right side
Finding:	Wood rot
Information:	These building elements shows evidence of wood rot. Wood rot, also known as Fungal Decay, occurs when timbers and other cellulose building materials are exposed to damp conditions on an ongoing basis. This could be the result of exposure to weathering over a prolonged period of time, or the attraction of excessive moisture from other abutting building materials. Contributing factors also include poor air ventilation in the area.

Wood rot is often associated with general damp problems and is evidenced by a 'musty' smell or mould and mildew occurring on surfaces. If left unmanaged, damp conditions can lead to further health problems and the decay of timbers will continue. This also creates a huge conducive condition for termites.

Early intervention and regular maintenance, particularly of exterior timbers, will prolong the useful life of these building elements. Prior to any works being performed, the cause of the moisture that has created the visible wood rot should be identified and addressed in a suitable manner. Replacement of affected timbers may then be a necessary step in protecting surrounding building elements from such deterioration.

A qualified plumber may be appointed to assess the cause of excessive moisture and to provide advice on any remedial works as required. A qualified carpenter or registered builder may also be required to replace affected building materials.

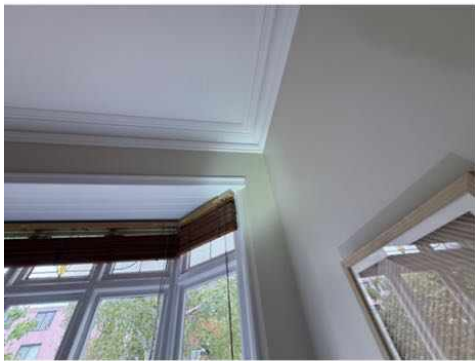
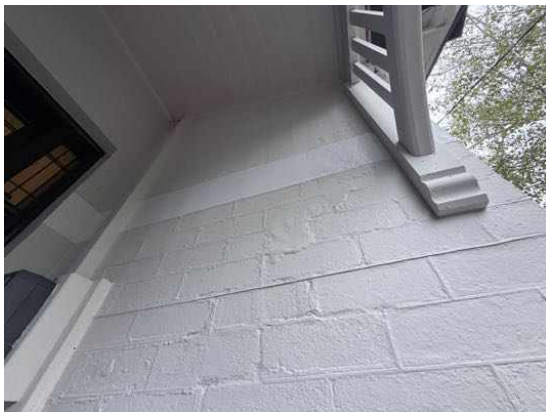
Building: Main Building
 Location: All Areas
 Finding: Evidence of recent renovations.
 Information: Whenever a property is refurbished, majority of the defects if present could get obscured beneath the revamped work. The same can be said for this property as well. Some fine cracks are filled over, walls have been painted etc. It is difficult to pinpoint on any particular defects present below such layers.

Once the property is occupied, all areas should be monitored for a period of 12-24 months to lookout for any arising defects. If staining or cracking is noticed extensively in that period, always consult your building inspector.
