Building and Timber Pest Inspection Report

Inspection Date: Wed, 25 Feb 2026

Property Address: 2 Wilgah St, St Kilda East VIC 3183,
Australia

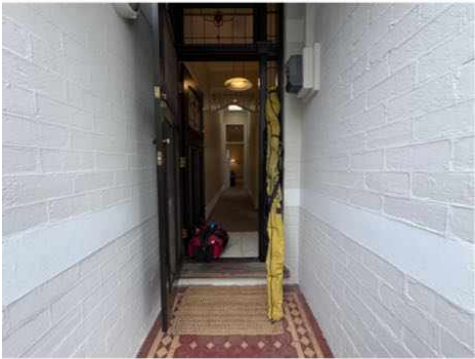
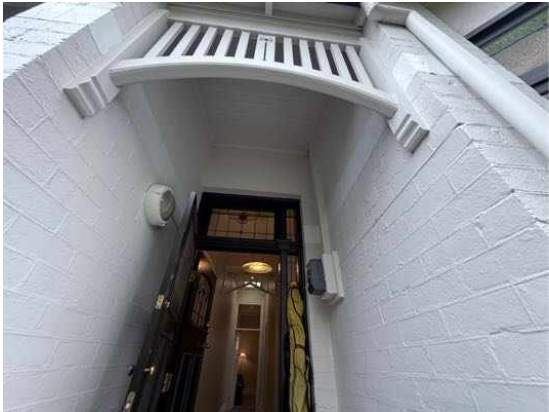
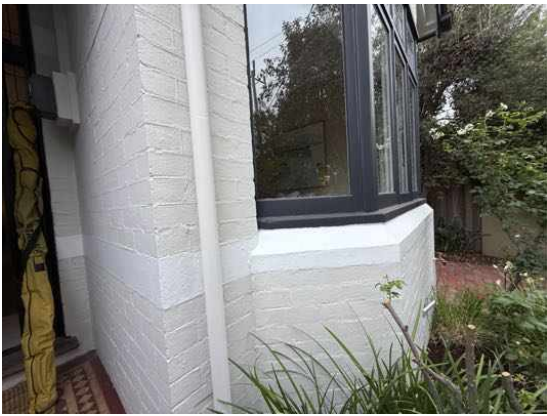
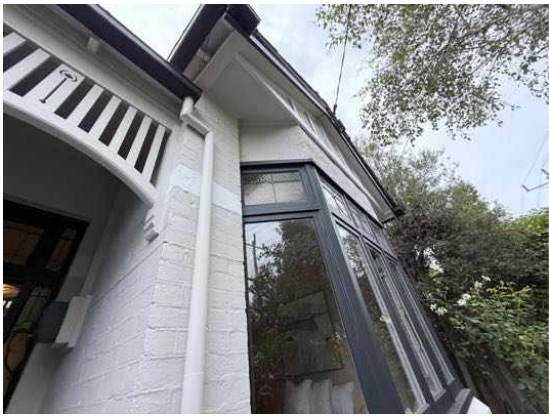
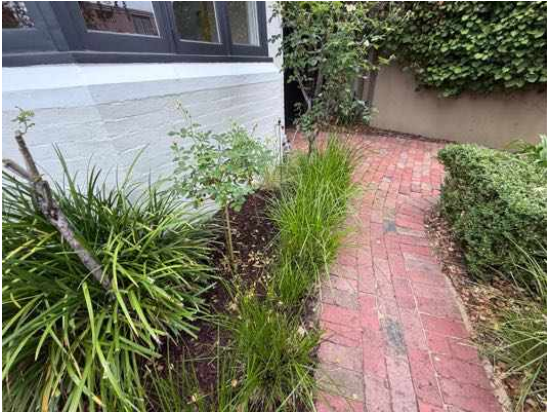
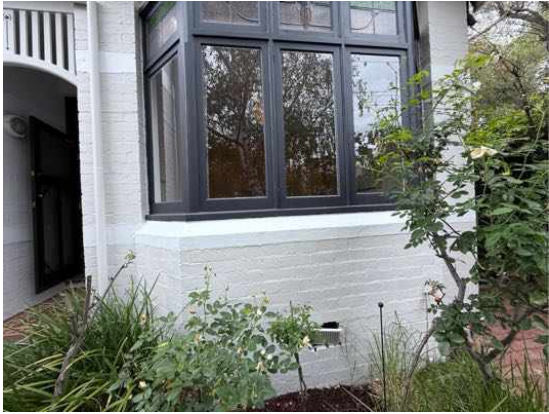
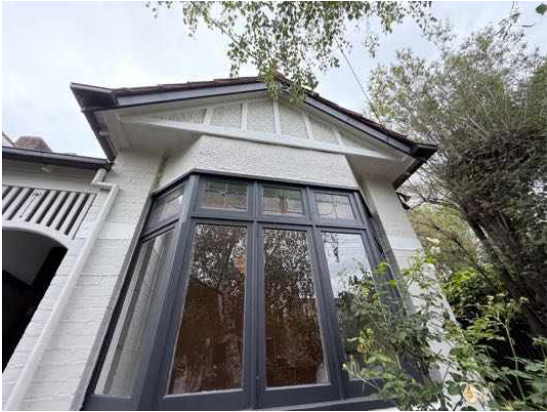
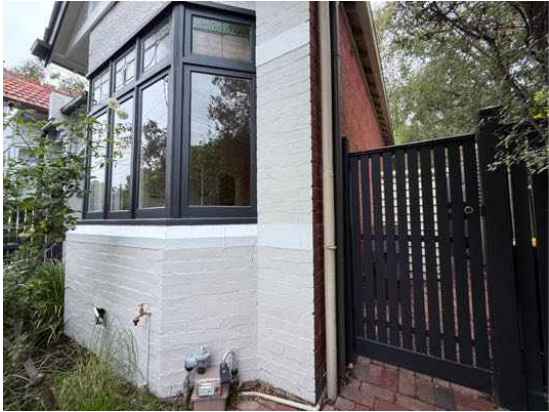
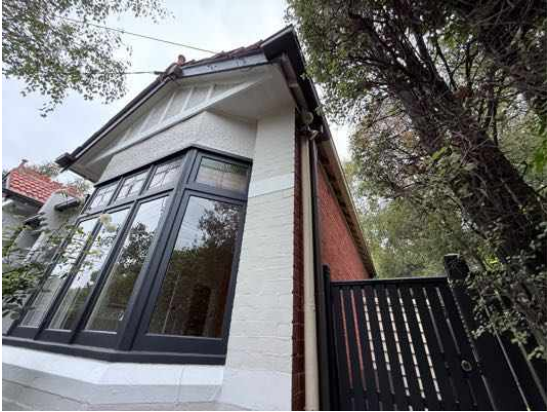
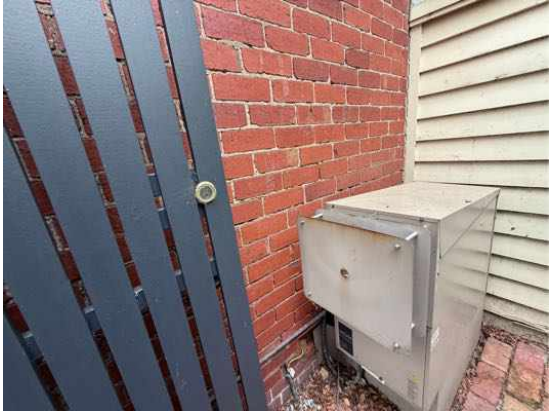
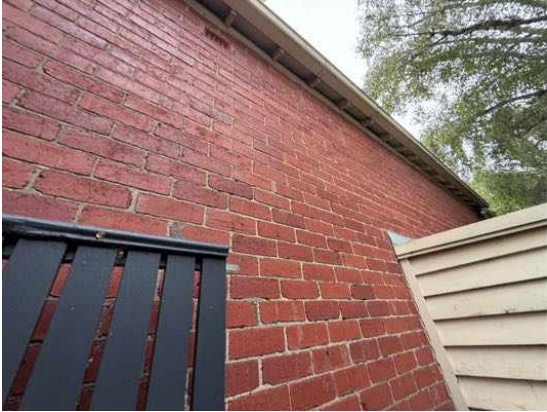
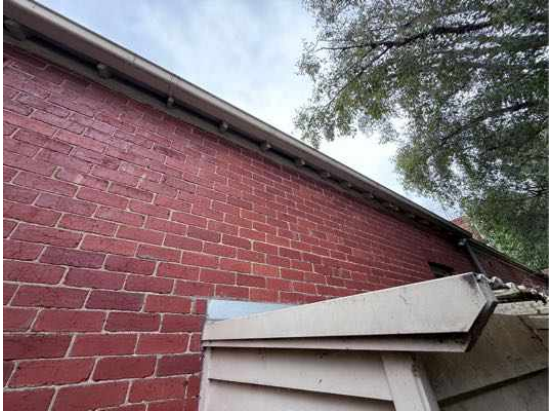
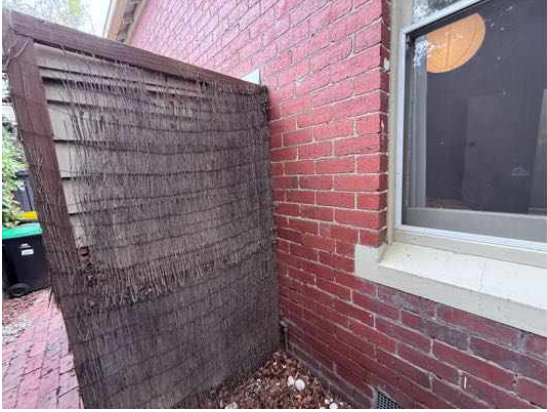
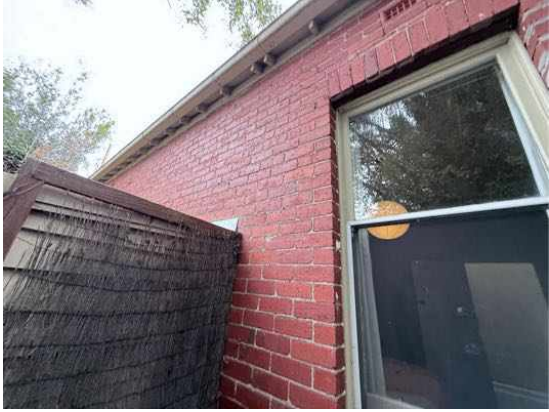
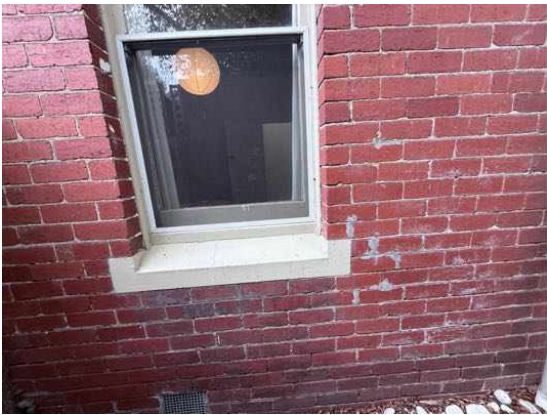
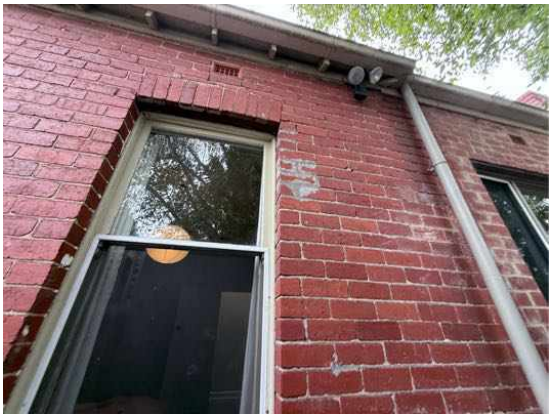
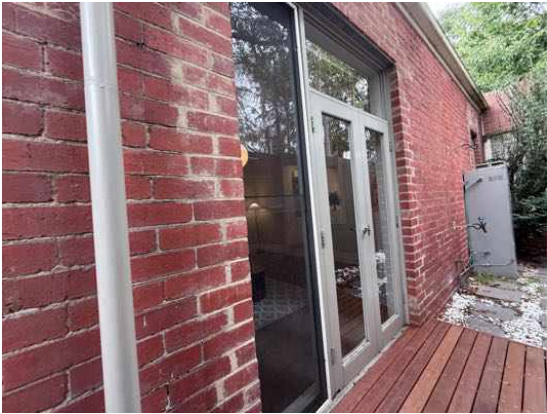
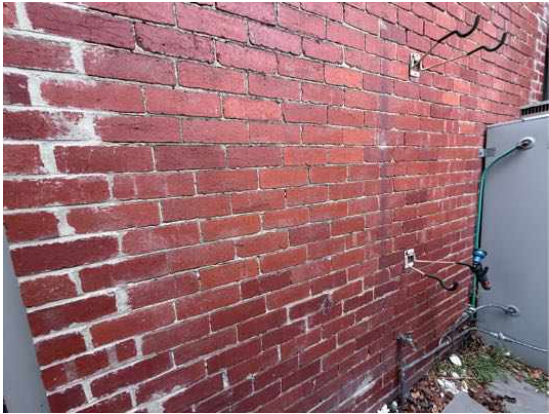
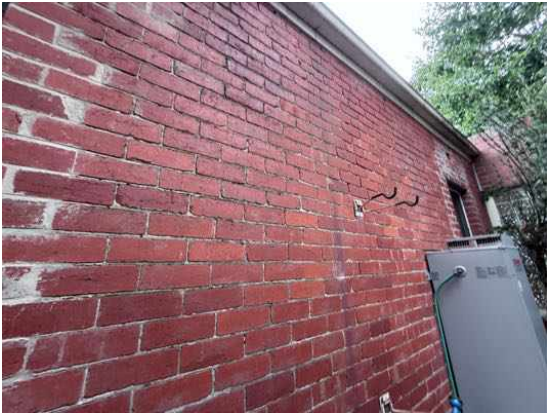
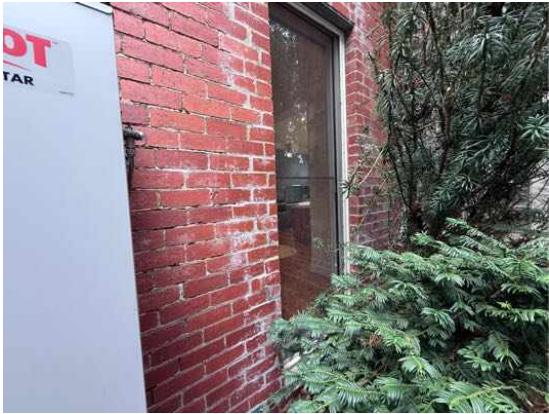
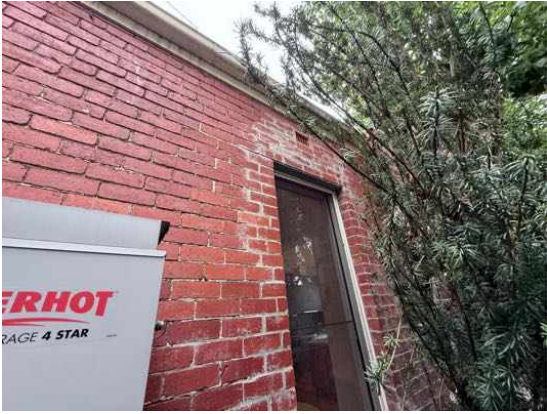
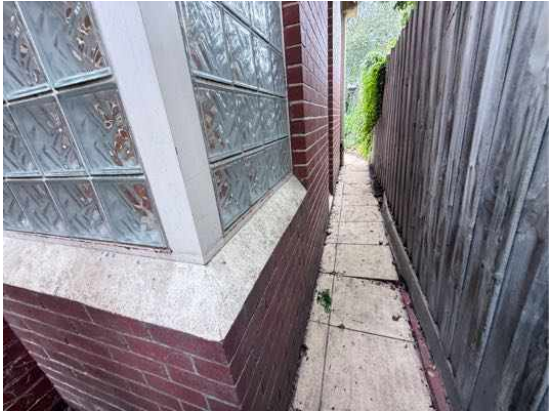
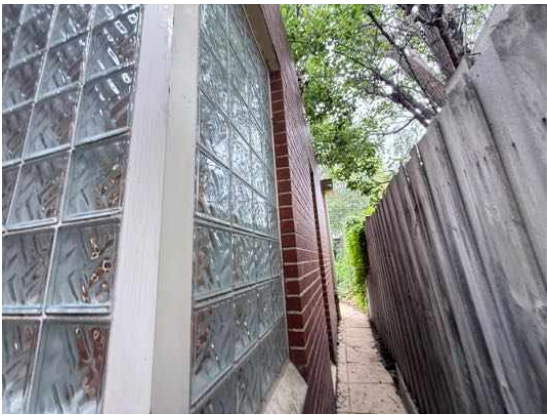
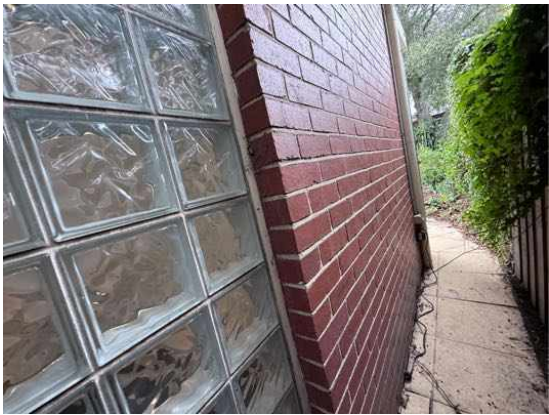
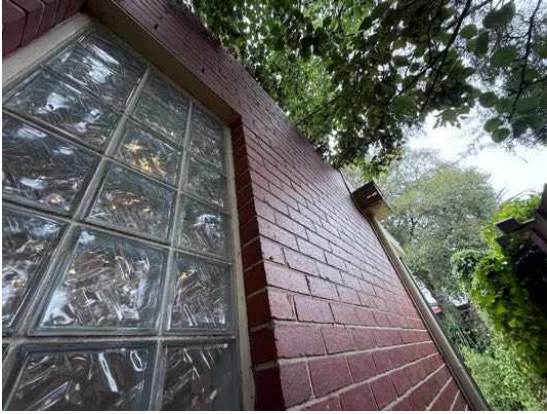
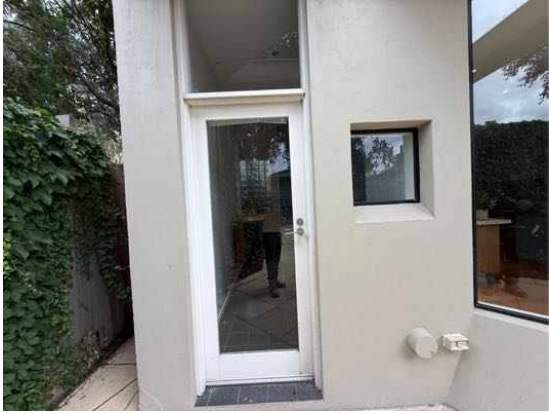
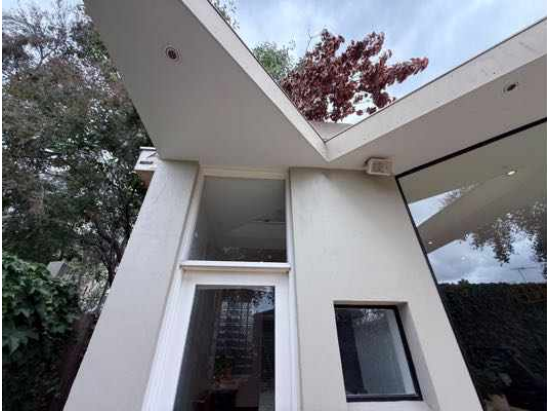
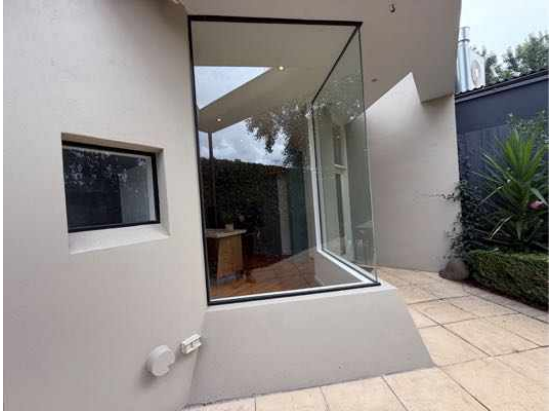
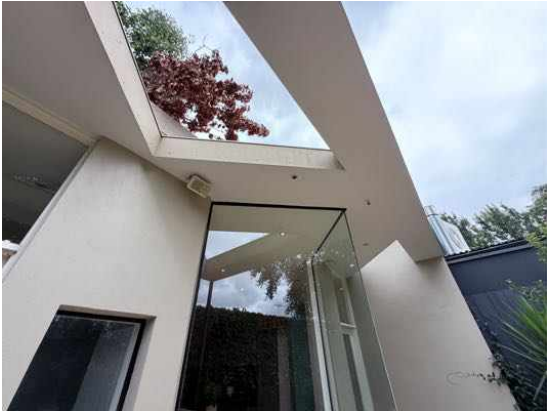
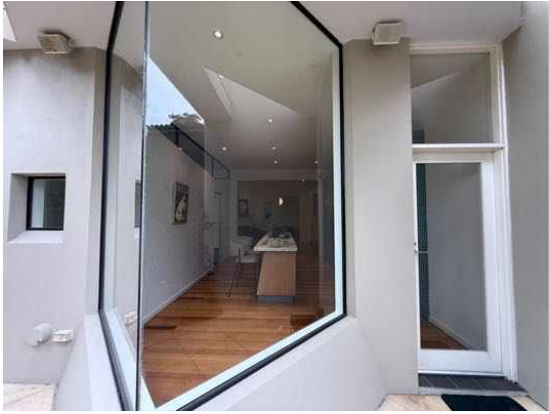
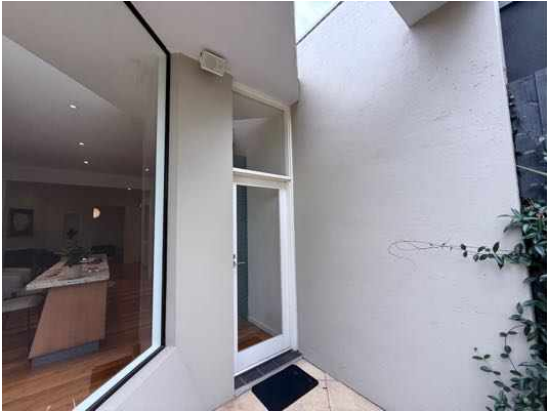
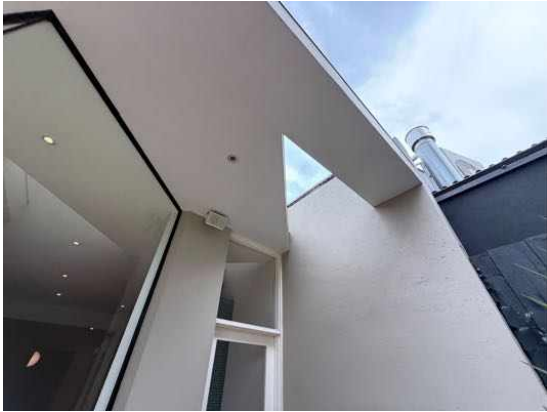
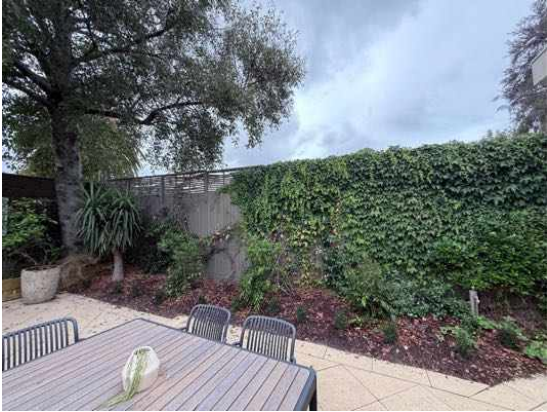
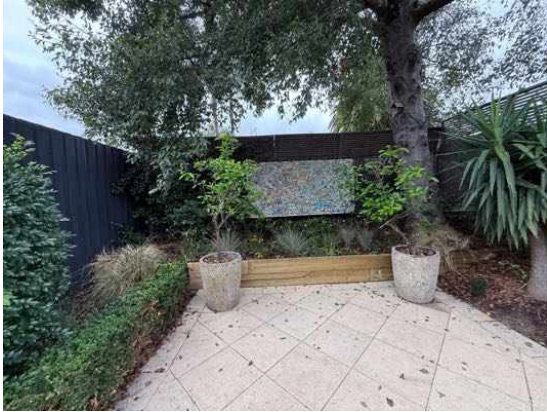
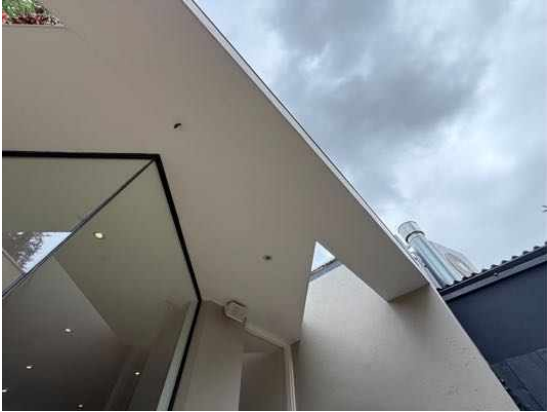
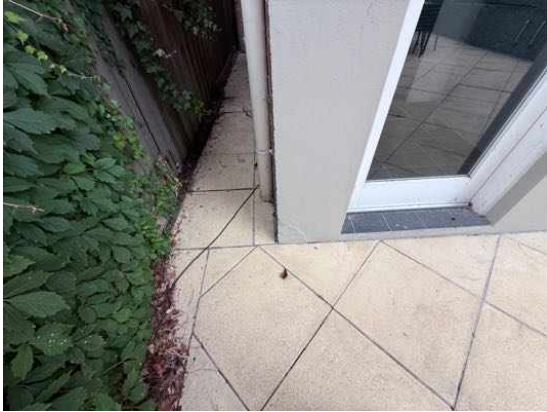
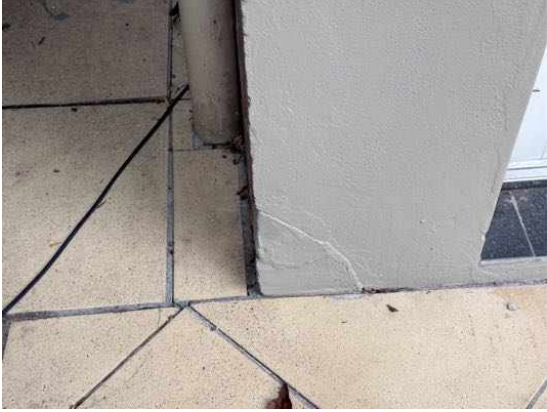
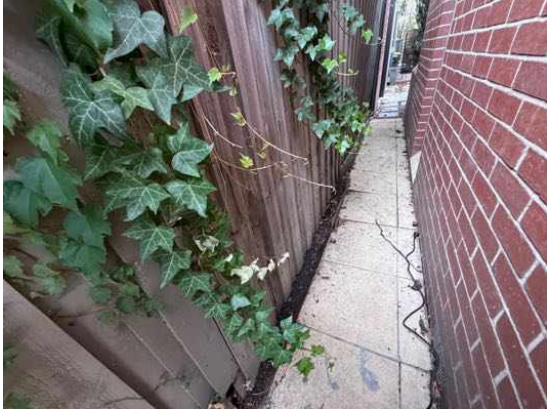
Building: Main Building
 Location: All Areas
 Finding: Additional photos & Obstruction/Limitations.
 Information: Additional photos for general documentation. May have some minor maintenance items not listed in the defects section.

Furthermore, some photographs are an indication of the obstructions and limitations which impeded full inspection of the property at the time of inspection. These obstructions can hide an array of defects and should be removed to allow full

inspection to be carried out. A re-inspection is recommended once the areas are made accessible.
