Building and Timber Pest Inspection Report

Inspection Date: Wed, 1 Apr 2026

Property Address: 13 Kean Ave, Sanctuary Point NSW 2540, Australia

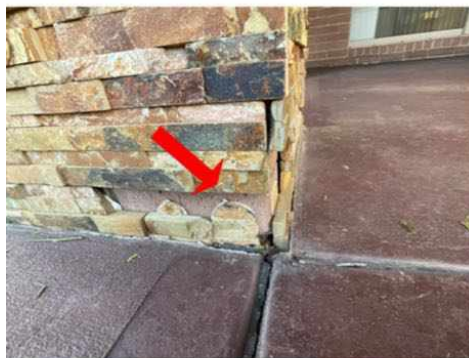
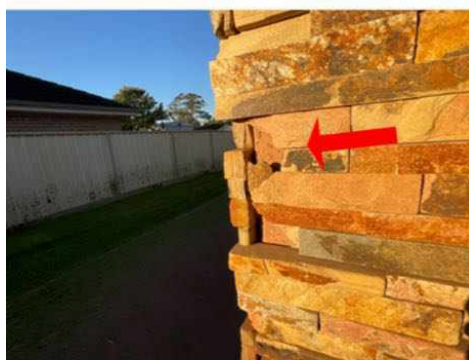
Building: Building 1
Location: Exterior front walls and rear pillar
Finding: Cladding damaged
Information: Evidence of damage was identified to the left side rear and front cladding that has minor damage. This cladding is only decorative and weatherproof cladding and sarking should be installed underneath. A carpenter would be the trade responsible for rectification of this wall areas.

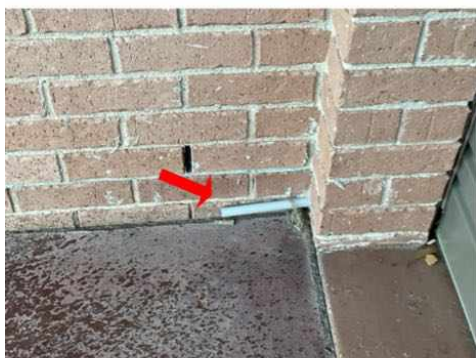
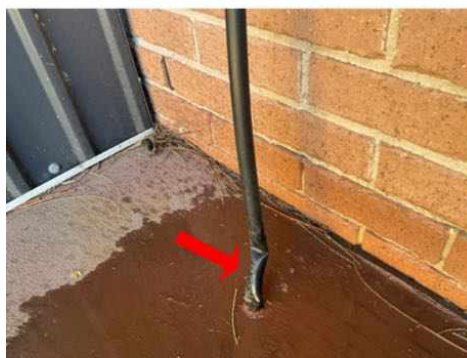
Building: Building 1
 Location: Walls at rear
 Finding: Site drainage - Inadequate
 Information: The site drainage in these areas was found to be inadequate at the time of inspection, creating potential for subsequent water damage to associated building elements.

The air conditioner and hot water system overflows run against the house walls and water tank overflow and black irrigation pipe show minor damage.

disgorge stormwater onto lower walls or plinths. Stormwater should be carried away by large, regularly cleaned drains. Ground levels may need to be lowered to expose a buried DPC.

Where site drainage is inadequate, installation of an Agricultural (Aggie) Drain may be required. A qualified plumber should be appointed to further inspect the property and perform any remedial works as necessary. Secondary defects are likely to occur if left unmanaged.

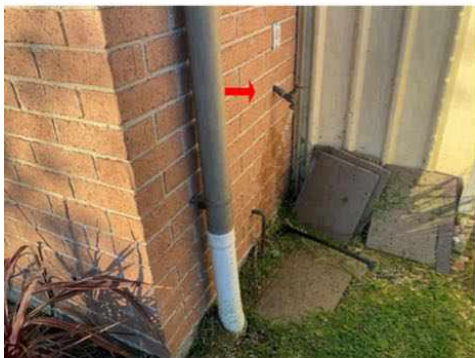
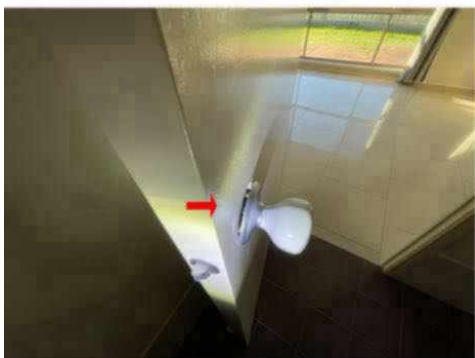
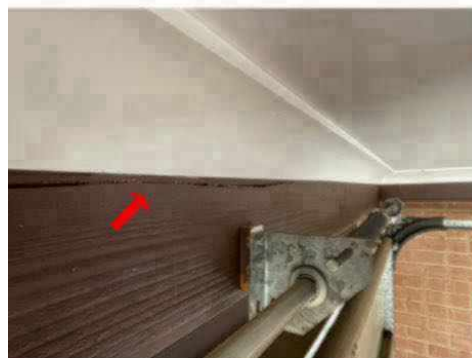
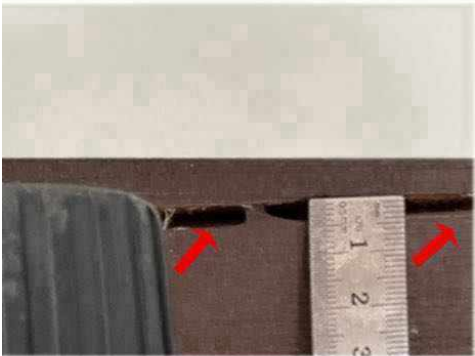
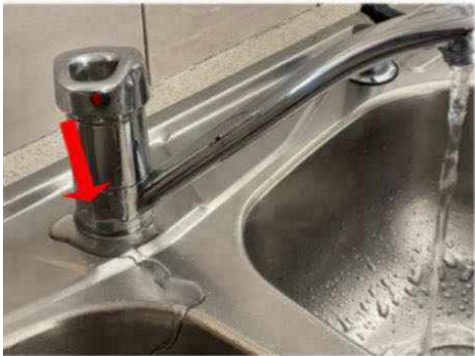
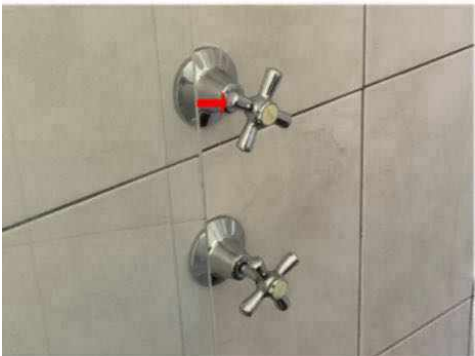
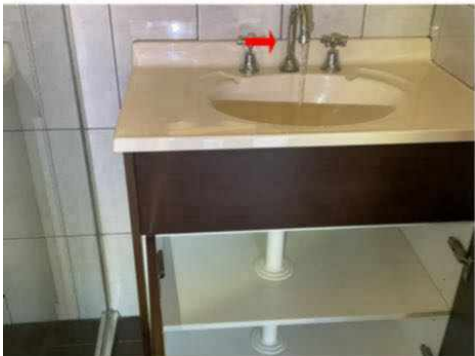
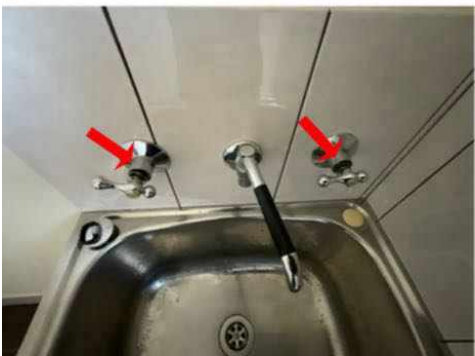
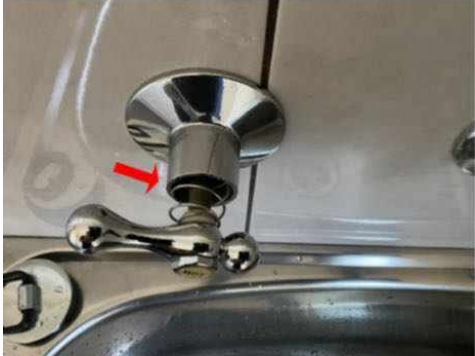
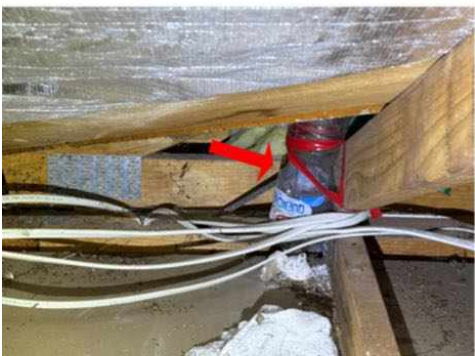
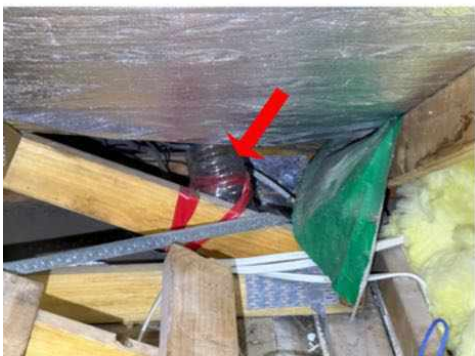
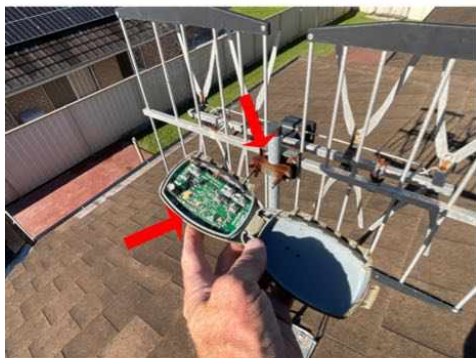
Finding 3.05

Building:	Building 1
Location:	Pictured external areas
Finding:	Building elements - Loose or Damaged
Information:	Evidence of minor missing or damaged areas was identified at the time of the inspection. These include - <ol style="list-style-type: none"> 1. The front yard two right side taps are impact damaged and bent but functioning normally. 2. The front door handle inside mechanism and ensuite handle is loose requiring adjustment. 3. A 3-4 mm split 920mm long at the top of the south garage door beam was found.

4. The kitchen tap leaked into the sink, the ensuite hot tap and vanity spout are loose, the laundry tap covers are missing, all requiring repair in the near future by a licensed plumber.

5. A few popped ceiling nails were found from very minor ceiling movement in the entry and front bedroom. No sagging or water damage was evident. A bottle was found taped to a roof trusses above the kitchen indicating there may be a very small leak. This bottle was empty. As no rain has fallen for days and no ceiling staining was evident, it appears there is no current leak. This area was only accessible from over 1 metres away for inspection. Numerous moisture readings were undertaken in ten nearby kitchen walls with no moisture found.

6. The roof aerial has minor damage and broken parts requiring an aerial technician for repair.

It is recommended to monitor this split annually and if it widens, to consult a structural engineer.

A carpenter would be the trade responsible for rectification of these areas when convenient.

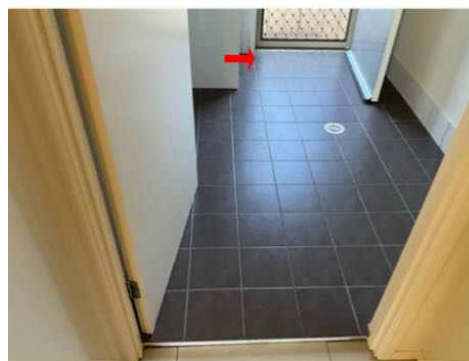
Finding 3.06

Finding: Tiles cracked

Information: A few cracked tiles were evident in these pictured areas at the time of inspection. It is suspected that this cracking has occurred as a result of minor settlement or impact damage. Cracked tiles throughout the household detract from the overall appearance of the affected areas. In wet areas of kitchens and bathrooms, it can lead to water damage of adjoining walls and floors.

Replacement of cracked tiles is recommended as soon as possible. A tiling contractor may be appointed to perform these works. Where cracks become more numerous, contact a licensed building inspector for further investigation.

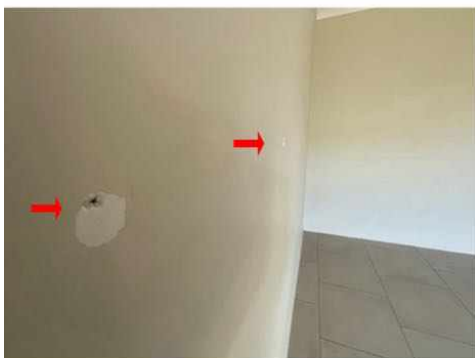
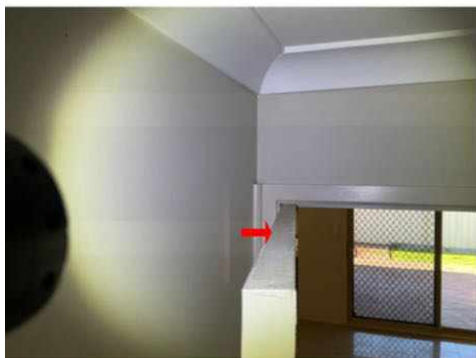
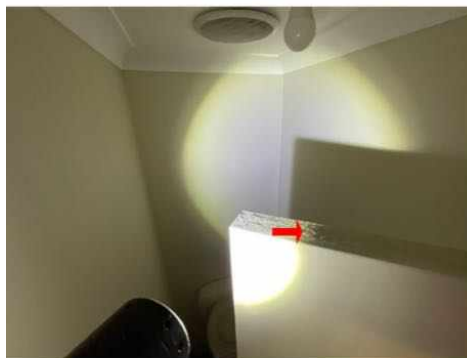
Finding 3.07

Building: Building 1
 Location: Pictured areas
 Finding: Paint missing or damaged
 Information: The paint finish in some areas of the house was found to be missing or damaged. Damaged painting is generally classified as an appearance defect. However, the appearance may also be indicative of poor surface preparation and substandard workmanship. Damaged paint finishes in areas exposed to moisture,

e.g. external areas or wet areas, could lead to deterioration of underlying building materials. Damaged paint finishes should be sanded back, filled, leveled and repainted, as applicable.

A painting contractor should be appointed as soon as possible to perform necessary works to aid the appearance of the affected area and to ensure that the area is protected against further deterioration. Alternatively, the homeowner following manufacturer instructions may be able to provide this service.

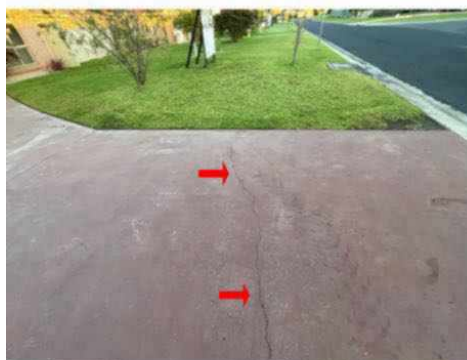
Finding 3.08

Building:	Building 1
Location:	Driveway & garage
Finding:	Crack in concrete slabs - Category 1
Information:	Small cracks coded as Category 1 was identified in these pictured slabs. These are common. A Category 1 crack is described as a fine but noticeable crack, with the slab at an otherwise reasonable level. To be considered Category 1, the approximate width of the crack is less than 1.0mm, or a less than 10mm change in offset when a 3m straight edge is placed over the defect.

Category 1 cracks should be monitored for a period of 12 months. At the end of the monitoring period, identified cracks that are rated greater than Category 2 are considered defects, and require rectification.

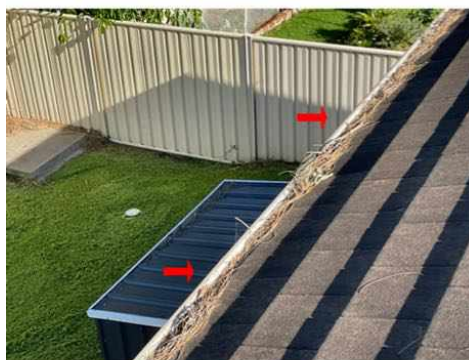
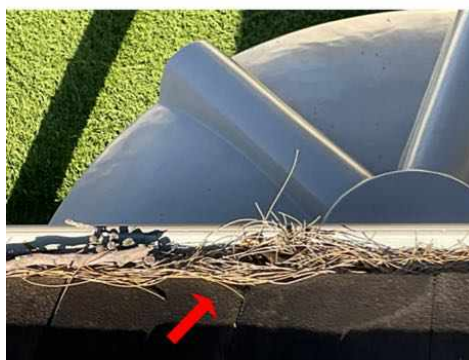
Finding 3.09

Building:	Building 1
Location:	Roof exterior
Finding:	Gutters - Full and blocked
Information:	The guttering on around the roof was found to be blocked at the time of the inspection. Roof plumbing structures, such as guttering and downpipes, should be free of all debris to prevent blockages. Blockages of the guttering and downpipes will lead to pooling and accumulated water overflows, which is likely to subsequently flood eaves and exterior walls.

Blocked gutters are likely to lead to high levels of moisture in the affected areas. Such moisture will not only cause rust and decay of the associated building materials, but can also provide conditions that are conducive to termite and timber pest activity. Blockages in gutters should therefore be removed immediately to ensure dry conditions are maintained.

It is highly advised that gutters be cleaned by the homeowner or a general handyperson as a matter of urgency.

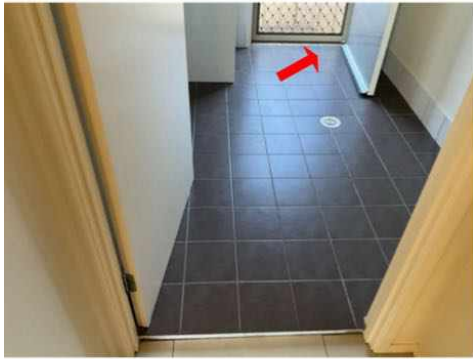
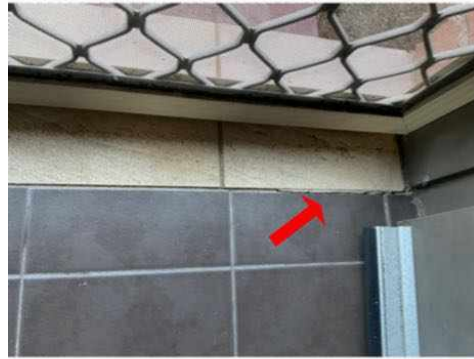
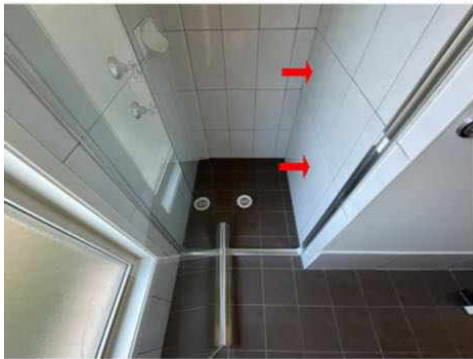
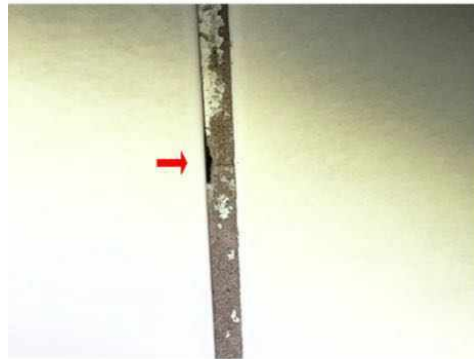
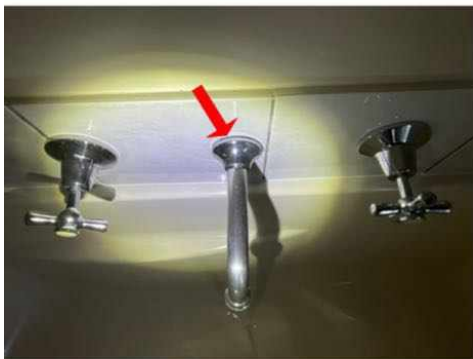
Finding 3.10

Building:	Building 1
Location:	Bathroom and laundry
Finding:	Sealant and grouting - Missing or damaged
Information:	It was noted on inspection that sealant or grout is degraded to these pictured areas.

Different materials and floor areas move at different rates, generally causing cracking to grout or sealant at this point. A flexible sealant is required to allow for expected expansion and contraction, while keeping the joint water tight and protective of all associated building materials.

Flexible and mould resistant materials should be applied to affected areas to prevent any subsequent water damage that is likely to occur. Regular maintenance and replacement of damage or missing or damaged sealant and grout is highly recommended to the wet areas, as this is a regular wear and tear defect. Sealant and grouting in areas that come into regular contact with water should be maintained for the long term care of your property.

A sealant specialist or tiling contractor should be appointed to complete these works as soon as possible

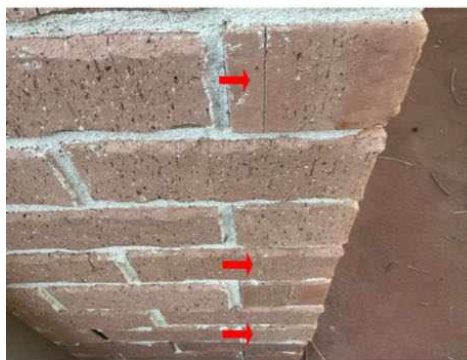
Finding 3.11

Building:	Building 1
Location:	Exterior wall
Finding:	Step cracking to brickwork (minor)
Information:	Step cracking (hairline under 0.5mm) was identified to the brickwork in this area at the time of inspection. Step cracking, which is similar to other forms of cracking, has a variety of possible causes. However, the most common is the subsidence of adjacent footings.

Step cracking is a relatively common defect, and is most likely to occur adjacent to windows, doors and other openings. Mortar failure in the gaps between affected bricks indicates the stresses and tensions affecting the wall.

Where step cracking is extensive or severe, the client is advised to consult a structural engineer. This minor step cracking can be used as a warning sign to address factors causing stress to the wall, which can include the effect of surrounding trees, water leaks, soil erosion, or even the presence of reactive soils in the surrounding area.

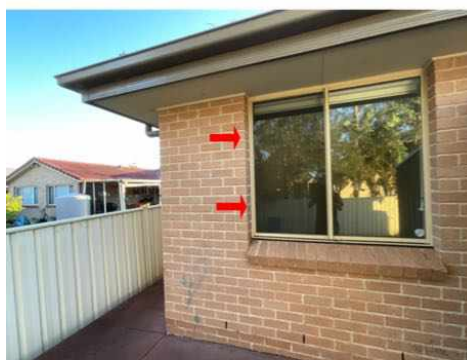
Building:	Building 1
Location:	Some window areas
Finding:	Sealant (external) - missing and attractive to termites
Information:	It was noted on inspection that areas of external sealant was missing to small areas of the external walls. A flexible sealant or flashing is required to protect the associated building materials from rainwater ingress. Any moisture ingress into the property is very attractive to termites. Flexible sealants or flashing should be applied to these affected areas to prevent termite activity.

A sealant specialist or skilled handy person should be appointed to complete these works as soon as possible.

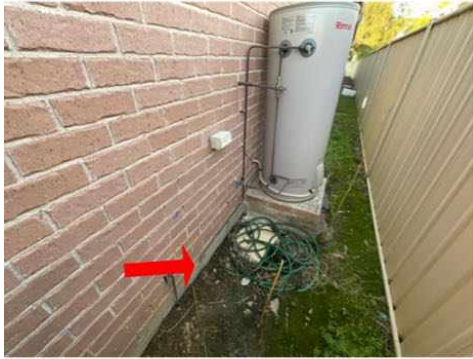
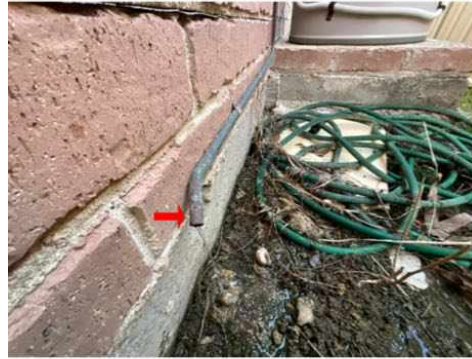
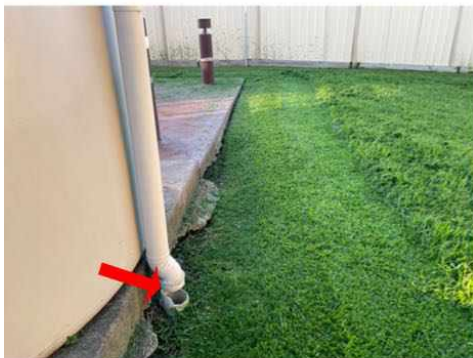
Finding 6.04

Building:	Building 1
Location:	Pictured external wall areas
Finding:	Overflows - Not plumbed for drainage or damaged
Information:	The pictured overflow pipes are not plumbed or connected to suitable drainage, which has resulted in the surrounding area becoming excessively damp.

These damp conditions can lead to secondary defects such as rot, rust or corrosion of associated building elements, the formation of fungal decay, or even the creation of potential slip hazards. When coupled with poor site drainage, pooling of water may also attract termite activity to this area. It is highly recommended that a qualified plumber be appointed to install adequate drainage to these areas. These works will ensure that the area remains dry and free of any secondary defects.

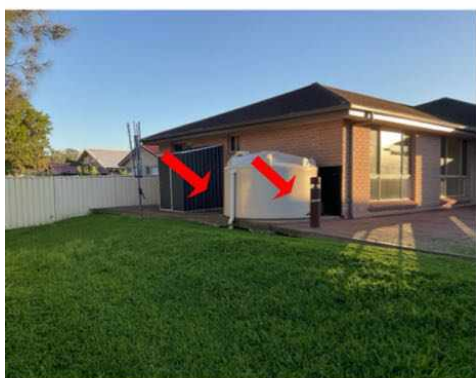
Building: Building 1
Location: All External Areas
Finding: Additional Photos - Obstructions and Limitations of EXTERNAL AREAS
Information: These photographs are an indication of the obstructions and limitations which impeded full inspection of external areas at the time of inspection. These obstructions can hide an array of defects and should be removed to allow full inspection to be carried out. A re-inspection is recommended once the areas are made accessible.

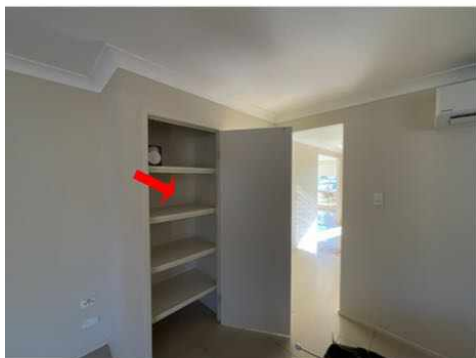
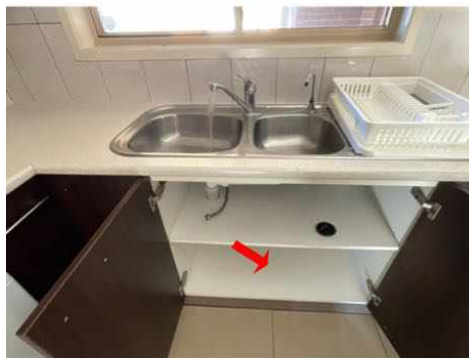
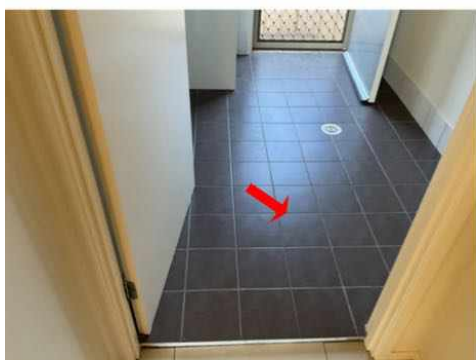
Building: Building 1
Location: All Internal Areas
Finding: Additional Photos - Obstructions and Limitations of INTERNAL AREAS
Information: These photographs are an indication of the obstructions and limitations which impeded full inspection of Internal areas at the time of inspection. These obstructions can hide an array of defects and should be removed to allow full inspection to be carried out. A re-inspection is recommended once the areas are made accessible.

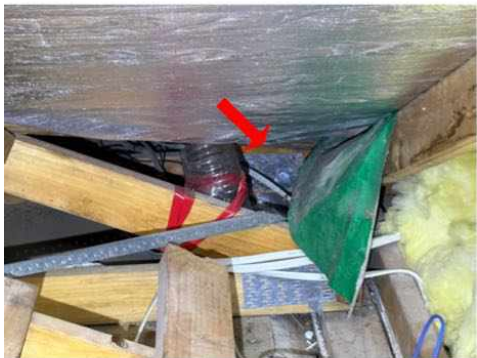
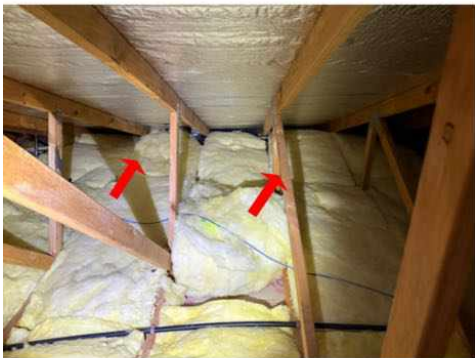
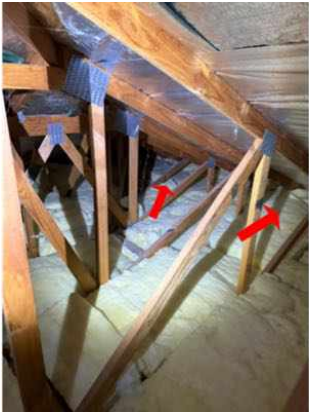
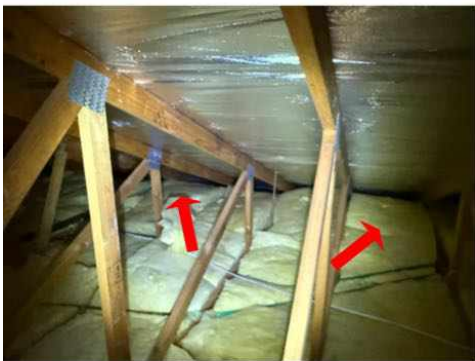
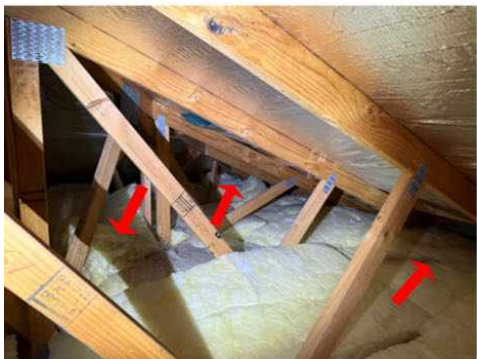
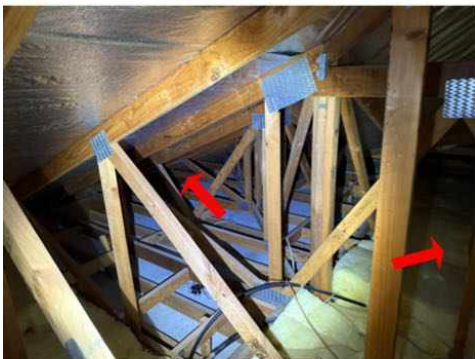
Building:	Building 1
Location:	All Roof cavity areas
Finding:	Additional Photos - Obstructions and Limitations of the ROOF CAVITY
Information:	<p>These photographs are an indication of the obstructions and limitations which impeded full inspection of roof cavity areas at the time of inspection. These obstructions can hide an array of defects and should be removed to allow full inspection to be carried out if applicable. A re-inspection is recommended once the areas are made accessible.</p> <p>The inspection was also limited to areas with an allowable crawl space of 600mm x 600mm, in particular towards the external walls where the roof line diminishes, these areas were not accessible.</p>

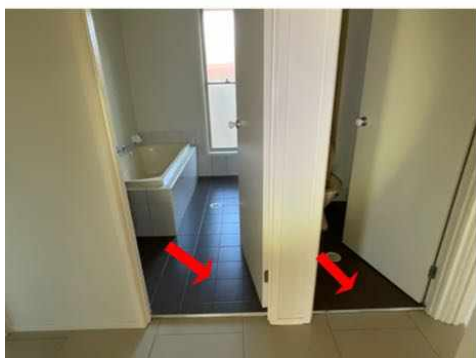
- Membrane used and Manufacturers Specifications. - The Installer and Installation Certification.

With older property's where this information is unavailable all wet areas should be monitored. If any leaks, water staining, peeling or bubbling of the paint become evident to any adjacent walls or ceilings below a licensed builder or waterproofing specialist is recommended to investigate further.
