Building and Timber Pest Inspection Report

Inspection Date: Thu, 5 Feb 2026

Property Address: 8 Burton Ave, Chester Hill NSW 2162,
Australia

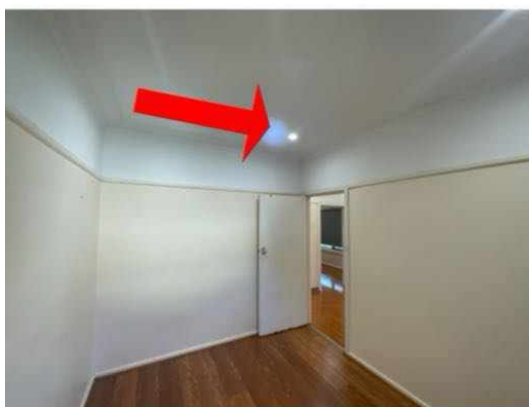
Building: Main Building
 Location: Bedroom
 Finding: Ceiling - Water damaged
 Information: Water damage to the ceiling lining is generally an indication of excessive moisture being present in the roof void, usually via a leak to the roof covering.

Where water damage is evident to the ceiling, the primary requirement is to identify and rectify the source of the leak. A roofing plumber should be appointed as soon as possible to identify the leak and perform rectification works as necessary, ensuring the water damage is restricted. Invasive inspection is highly recommended.

Once the leak is repaired, consultation with relevant tradespeople, including plasterers and painters, is advised. Rectification works may include replacement of ceiling lining or minor repainting, depending on the extent of the damage.

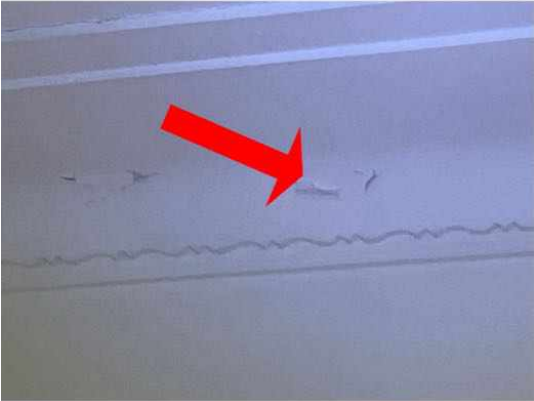
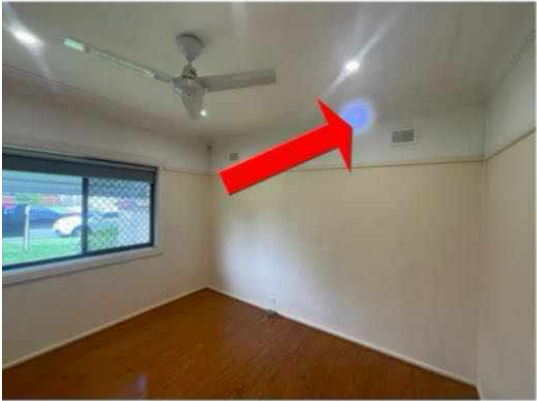
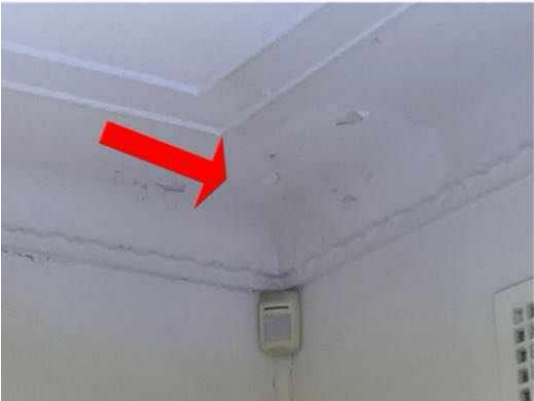
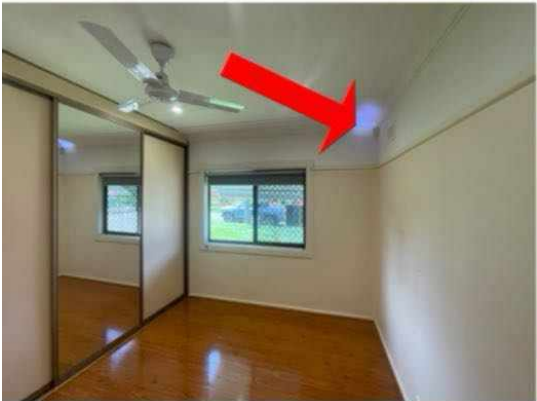
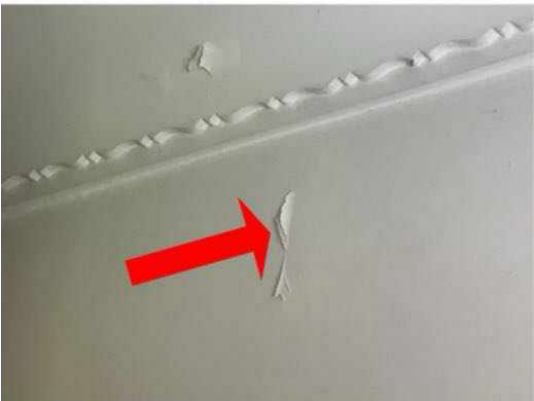
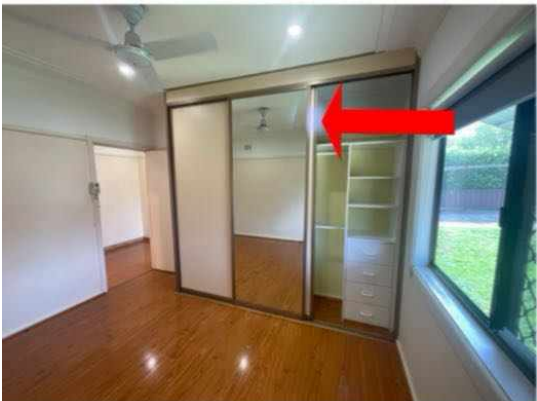
Finding 2.02

Building: Main Building
 Location: All Internal Areas
 Finding: Painted surface - Bubbling
 Information: Sections of paint in this area was found to have bubbled and deteriorated. Paint bubbling is generally an indication of excessive moisture in the area, that is currently hidden by the painted surface.

The presence of excessive moisture can have major implications on associated building elements if left unattended. While only seemingly minor at this stage, the damage cannot be determined due to the paint obstructing any further inspection of the damage.

It is highly advised that the affected paint be cleaned to allow a further, more invasive inspection by a licensed plumber. Failure to act on this defect may necessitate major works in the future.

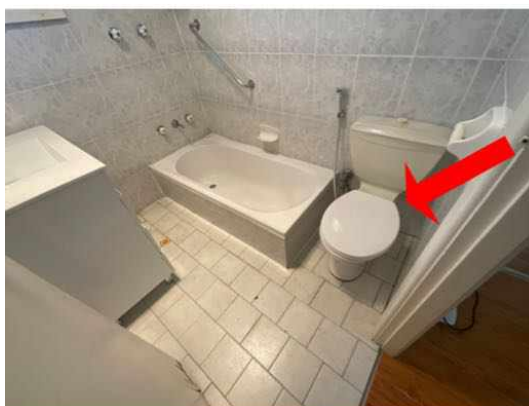
Finding 2.03

Building:	Main Building
Location:	Bathroom
Finding:	Water leak - Active
Information:	Generally, water leaks occur when a particular area of the property is not weather or water tight. As the surrounding area was found to be damp at the time of inspection, the leak is considered ongoing and hence requires urgent action.

Regardless of the location, even minor leaks that are left unmanaged can lead to serious damage of associated building elements and result in the need for replacement of building materials. Mould and other hazards such as electrical hazards may also arise if the leak is left to develop.

It is highly advised that the cause of the leak be identified and resolved immediately by a licensed plumber to prevent any further damage. Depending on the extent of the damage previously sustained, repair and/or replacement of any affected building materials may be required.

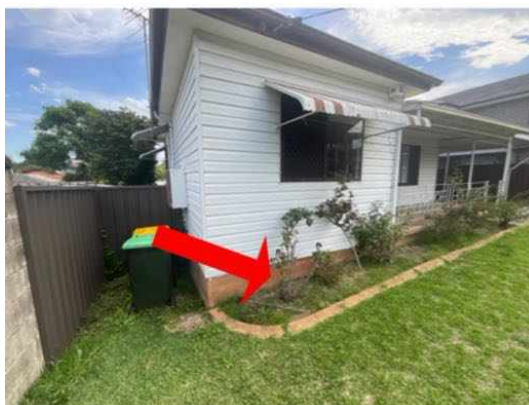
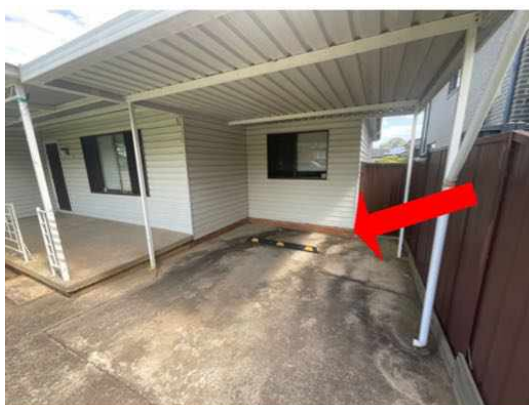
Finding 3.01

Building:	Main Building
Location:	Exterior walls
Finding:	Brickwork - Cracking [Fine]
Information:	Although fine cracks are quite noticeable, they are often only considered to be an appearance defect and usually do not indicate any structural damage. Generally, the cause of a fine crack is indicative of a separation between brickwork and mortar throughout the structure, but single bricks may also show cracks of this nature.

Cracking of this nature can generally be repaired with minor filling and should be conducted by a qualified bricklayer.

Always contact a building inspector should cracks widen lengthen or become more

numerous.

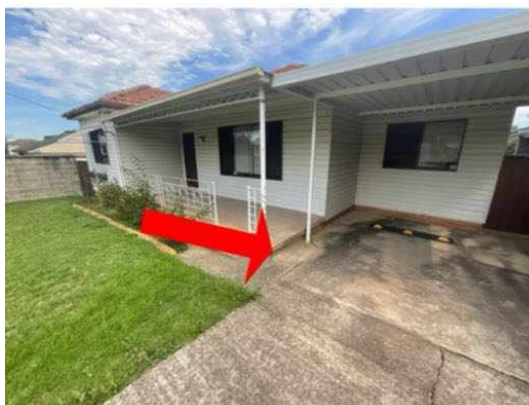
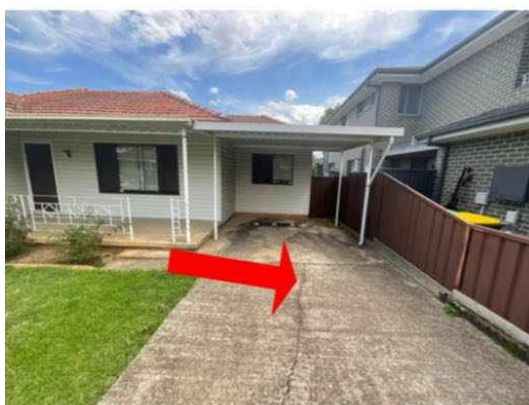
Finding 3.02

Building:	Main Building
Location:	All Internal Areas
Finding:	Cracking - External Concrete Paving Damage Category 1 - Fine (less than 2mm)
Information:	Fine cracks were identified in external concrete paving. Although fine cracks are quite noticeable, they are often only considered to be an appearance defect, and usually do not indicate any structural damage. To be considered a Category 1 or fine crack, the crack is found to be less than 2mm in width.

Generally the cause of a hairline crack in existing concrete paving such as driveways and pathways is indicative of the expansion and contraction of the concrete. Such causes are generally due to environmental factors, such as moisture levels, weather conditions, root systems of nearby trees or the soil types on which they are laid.

Fine cracks may also be due to poor original installation of the concrete. Factors such as poor compaction of the sub surface and/or inadequate reinforcing of the slab may create cracking and other secondary defects.

Monitoring of all cracking should be conducted frequently. Always contact a building inspector should cracks widen, lengthen, or become more numerous.

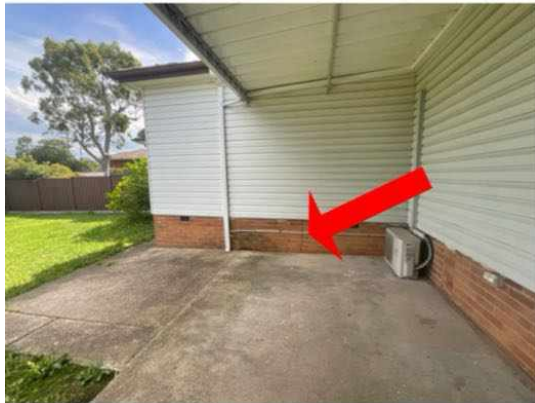
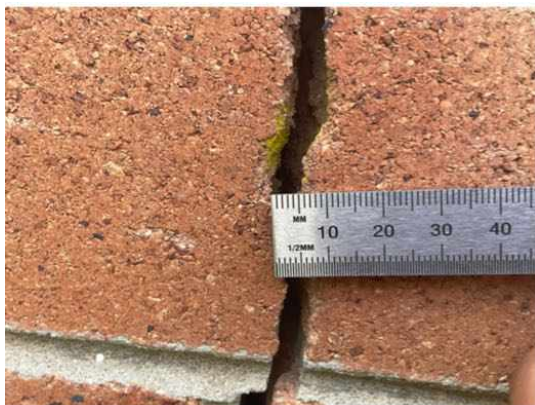
Finding 3.03

Building:	Main Building
Location:	All External Areas
Finding:	Brickwork - Cracking noticeable
Information:	There were several cracks and or crack repairs evident to external brickwork.

Noticeable cracks are a common occurrence in external brickwork and are a likely result of age expected building movement, general expansion, and/or contraction of building materials in different weather conditions. Noticeable cracks in brickwork may develop if left unattended, with potential for necessitating major remedial works or replacement of the brickwork.

It is highly advised that a qualified bricklayer be appointed to provide necessary works to cracked brickwork to prevent any further damage. Such works should be conducted as soon as possible.

Always monitor these cracks and contact a building inspector should cracks widen, lengthen, or become more numerous.

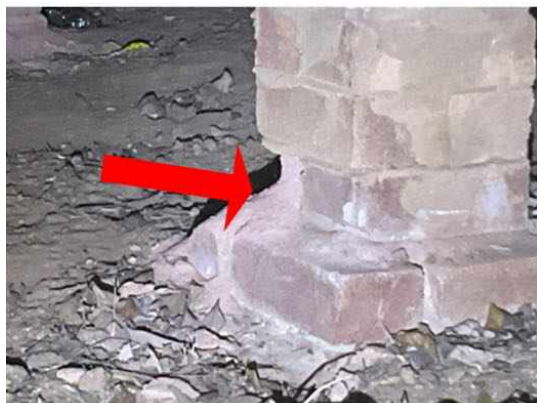
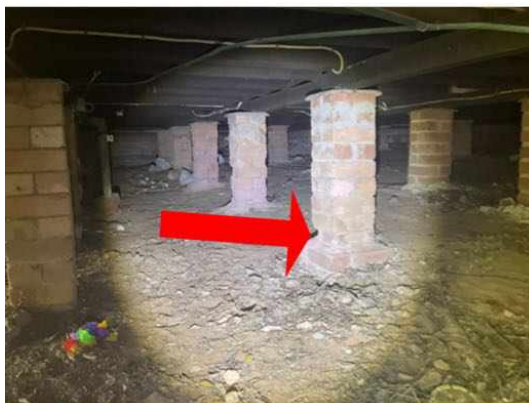
Finding 3.04

Building:	Main Building
Location:	Subfloor
Finding:	Brickwork - Deterioration
Information:	Deterioration was evident to sections of the brickwork in this area at the time of inspection. Commonly referred to as brick corrosion or erosion, the bricks are aged and likely to have been affected by a variety of factors, including weather exposure, damage, salt-based deterioration, and more.

Overtime, these factors can affect the bricks, causing them to become brittle and appear corroded or eroded. The mortar in the brickwork may also become powdery, further detracting from the structural integrity of the brickwork. If left unmanaged,

potential implications include further deterioration of the building materials, the development of secondary defects, and potential development of structural instability of the wall.

Where this degree of damage has already occurred, you should consult a Building Surveyor or Engineer to seek advice regarding the structural stability and load bearing capabilities of the wall. Such consultation is always required prior to performing any remedial works on the affected brickwork.

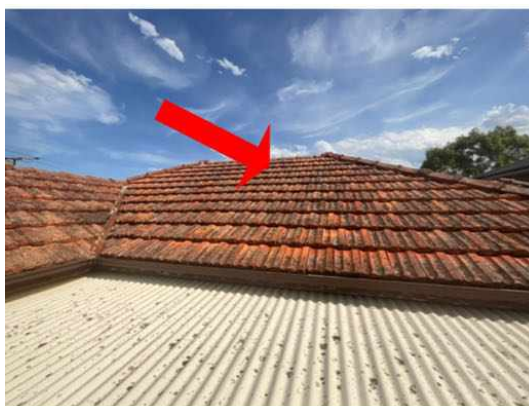
Finding 3.06

Building:	Main Building
Location:	Roof Exterior
Finding:	Roof tiles - Slippage
Information:	Upon inspection of the exterior roof covering, it was noted that numerous tiles have slipped from their original fixing. Tiles may slip over time due to a number of minor causes, including breakage of tiles, failings in the adjoining battens, or fixings that may have failed.

Roof tiles that have moved from their original position are very likely to allow water penetration into the roof void, exposing roofing structures to excessive moisture. This creates an environment that is conducive to water damage and accelerated deterioration of all associated building elements.

Replacement of loose or missing roofing tiles is recommended immediately to prevent the development of any secondary defects. A roofing restoration specialist should be appointed to complete such works as necessary.

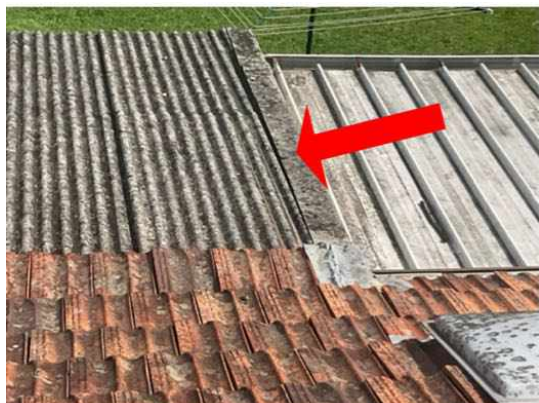
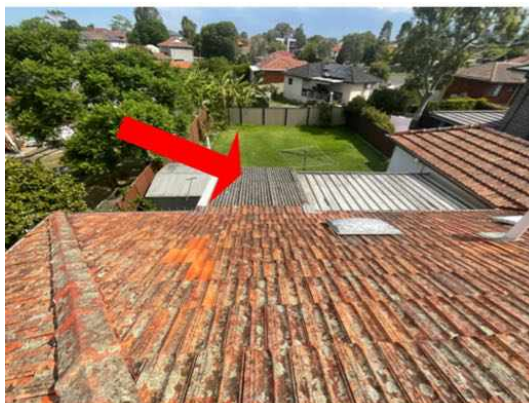
Finding 3.07

Building:	Main Building
Location:	Roof Exterior
Finding:	Asbestos - Suspected ACM Identified on Site
Information:	Reporting on Asbestos is outside the Scope of this Report. This suspected defect is highlighted as a caution only. We suspect, based on our experience in the building industry, that there is a higher risk of the identified building element containing asbestos.

As Asbestos Reporting is outside the scope of this report, we advise that you consider a separate Asbestos Inspection and Condition Audit, which can include the taking of samples for definitive confirmation of the presence of Asbestos.

In the interim, the client is advised to act with caution, especially when considering any damage to building materials general wear and tear renovations extensions demolition and general maintenance activities due to the suspected presence of Asbestos.

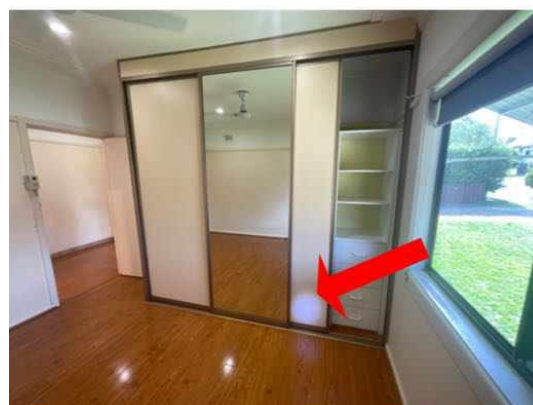
Building:	Main Building
Location:	Built In Robe
Finding:	Sliding Door - Stiff to slide
Information:	The door in this area was jammed and difficult to slide along the associated tracks at the time of the inspection. Restricted function of the affected door may pose as a potential safety hazard if required for emergency egress from the building.

Generally, factors such as general age of the building element and a lack of maintenance are the usual causes for this type of defect.

Replacement of door hardware or tracks may be required, as well as minor repairs and cleaning. A registered builder or general handy person will be required to repair the affected doors.

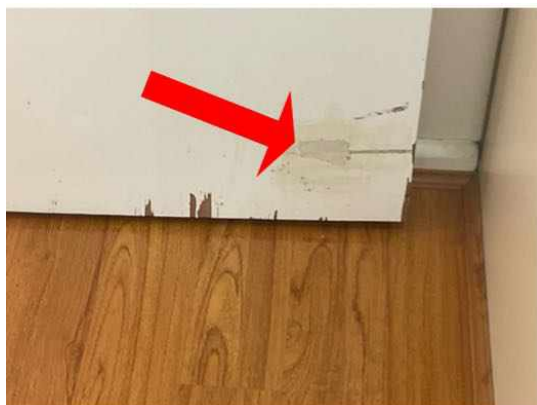
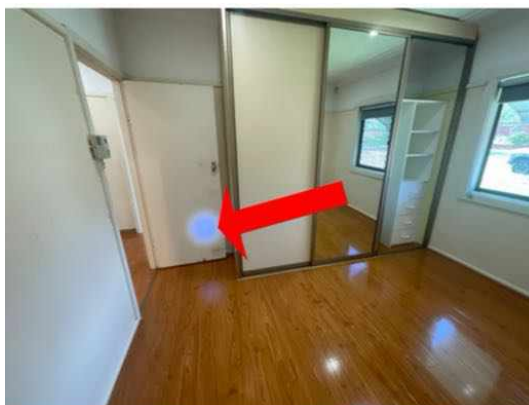
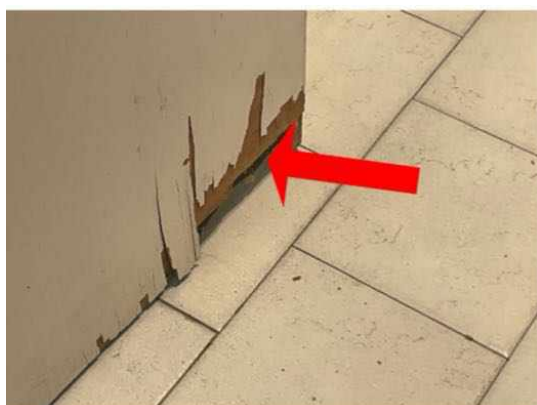
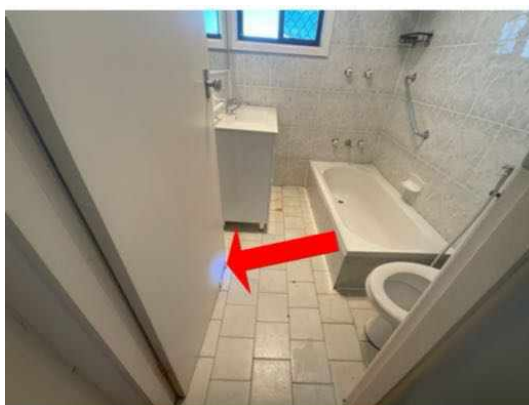
Building:	Main Building
Location:	All Internal Areas
Finding:	Door - damaged
Information:	At the time of inspection, the door in this area was found to be damaged due to the external impacts. If left unmanaged, the door is likely to deteriorate further, a

handyman or carpenter should be nominated to replace the door.

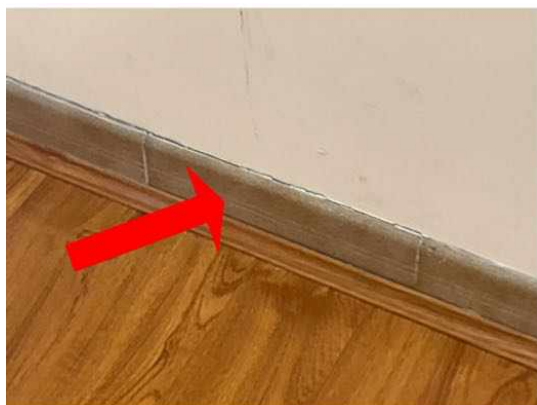
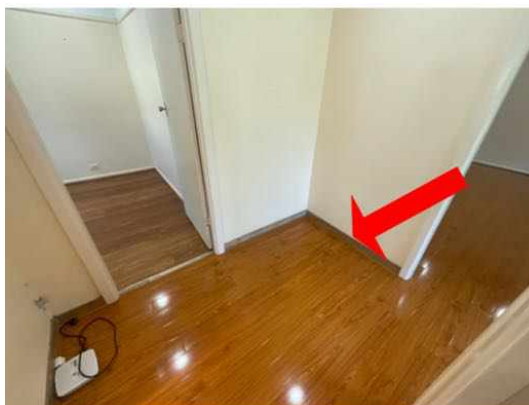
Finding 3.11

Building:	Main Building
Location:	All Internal Areas
Finding:	Tiles - Drummy
Information:	Drummy tiled areas were identified at the time of inspection. The term 'drummy' refers to tiles that have become detached from their fixing, despite otherwise being in relatively good condition. Such defects are generally caused by physical or moisture damage to the area. Drummy tiled areas may also be a direct result of poor workmanship during the construction process.

Tiled areas may swell and shrink with changes in air humidity if the area has sustained moisture damage. Any exposure to moisture is capable of causing tiled areas to become drummy and/or cracked over a prolonged period of time. Drummy tiled areas generally require removal and replacement of affected tiles, with adequate sealant and grouting.

Specialist trades are available for these types of services. A registered builder may be required to undertake works if damage is extensive or if secondary building defects have resulted. Otherwise, it is advised that a tiling contractor be appointed to perform works as necessary. Immediate action is recommended to ensure that no further

damage is sustained in the affected area.

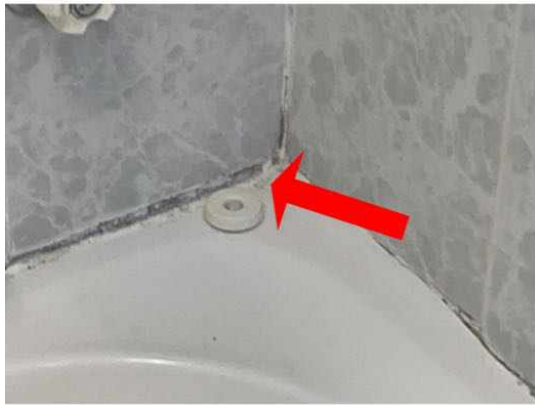
Finding 3.12

Building:	Main Building
Location:	Bathroom
Finding:	Sealant and grouting - Missing or damaged
Information:	It was noted on inspection that sealant or grout is degraded to the tiled shower alcove and or other areas of the bathroom.

Different materials and floor areas move at different rates, generally causing cracking to grout or sealant at this point. A flexible sealant is required to allow for expected expansion and contraction, while keeping the joint water tight and protective of all associated building materials.

There appears to be excessive mould to the sealant and grout which will likely require scraping out and replacement.

Flexible and mould resistant materials should be applied to affected areas to prevent any subsequent water damage that is likely to occur. Regular maintenance and replacement of damage or missing or damaged sealant and grout is highly recommended to the wet areas, as this is a regular wear and tear defect. Sealant and grouting in areas that come into regular contact with water should be maintained for the long term care of your property.

A sealant specialist or tiling contractor should be appointed to complete these works as soon as possible

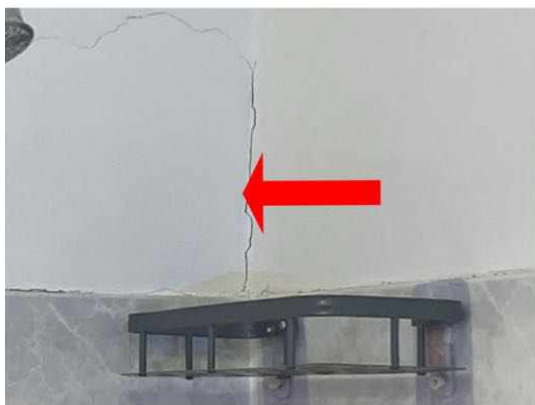
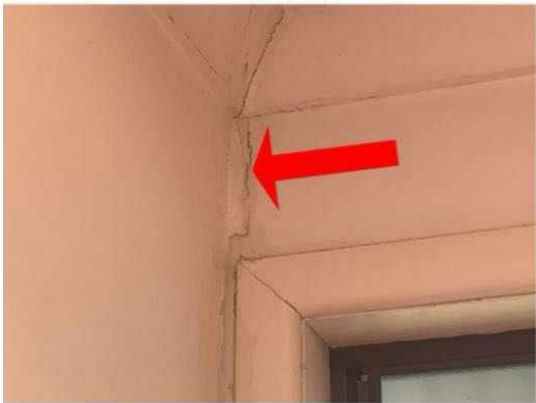
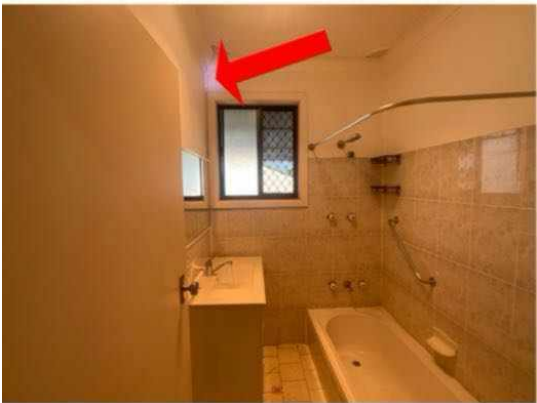
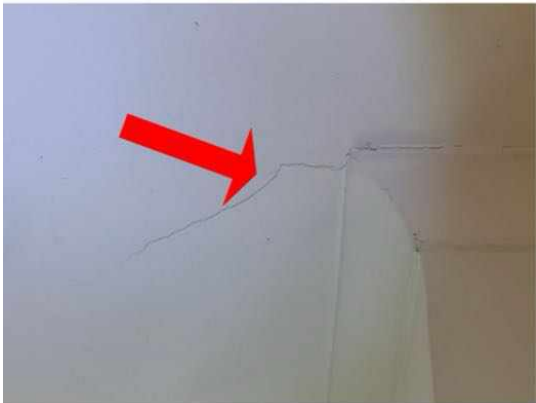
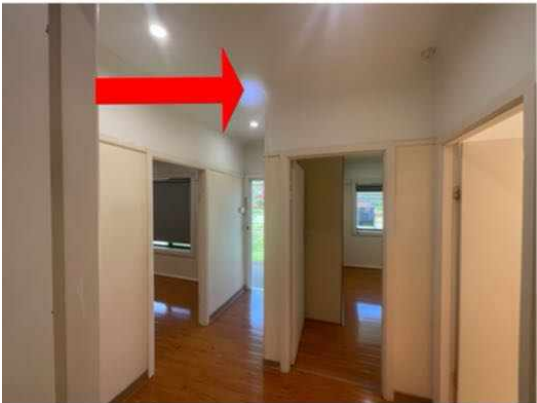
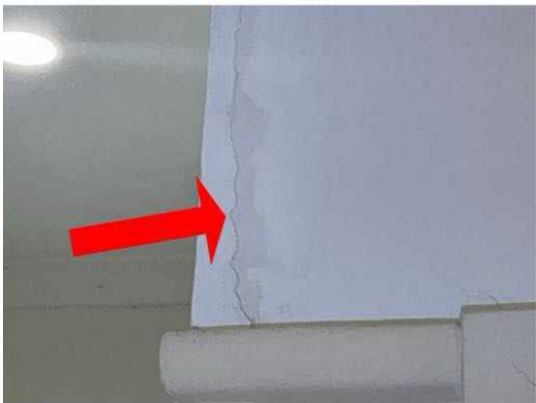
Finding 3.13

Building:	Main Building
Location:	All Internal Areas
Finding:	Cracking - Damage Category 1 - Fine (up to 1mm)
Information:	Although fine cracks are quite noticeable, they are often only considered to be an appearance defect, and usually do not indicate any structural damage. Generally, the cause of a fine crack is indicative of a separation between building materials and finishes (e.g. paint, plaster, etc.) along joins.

Cracking of this nature can generally be repaired with minor sanding, filling and/or repainting. Such works should be performed by a qualified painter or a general handyman.

Monitoring of all cracking should be conducted frequently. Always contact a building inspector should cracks widen, lengthen, or become more numerous.

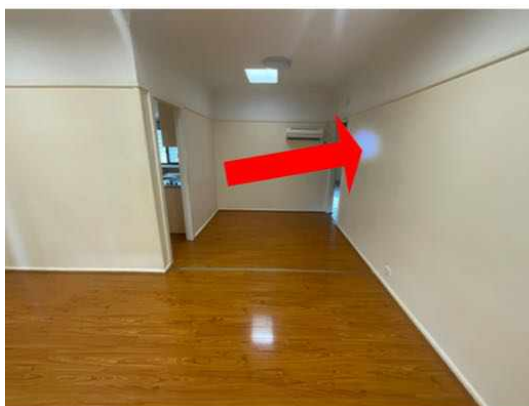
Finding 3.14

Building:	Main Building
Location:	All Areas
Finding:	Tiles - Cracked or damaged
Information:	Cracking was evident to the tiling in this area at the time of inspection. While the cracking appears to be minor, this area is frequently exposed to water, allowing potential for water penetration into adjoining sections of walls or flooring.

If left unmanaged, water penetration to these areas may lead to subsequent water damage, which is likely necessitate repair work to affected building elements.

A tiling contractor should be appointed to ensure that no further water damage occurs. The re-application of silicone and grouting throughout remaining tile work is also advised, to further protect the area against water penetration.

Where water penetration has led to water damage, appointment of a relevant tradesperson may be required to repair damaged building elements.

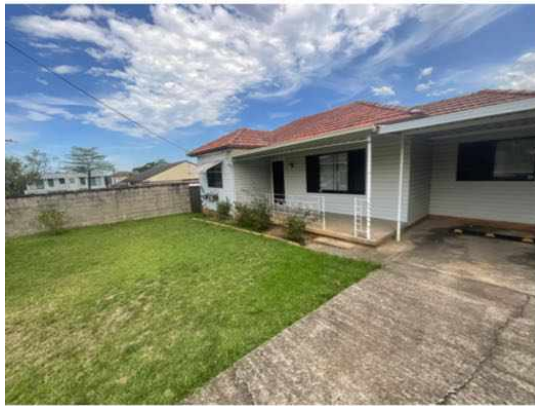
Building: Main Building
 Location: All Areas
 Finding: Garden Beds - Conditions Conducive to Termites
 Information: Garden beds were found to be evident in the garden area. These garden beds can include untreated timber, and with a combination of moisture from watering hosing

can make conditions conducive to termite activity and termite ingress.

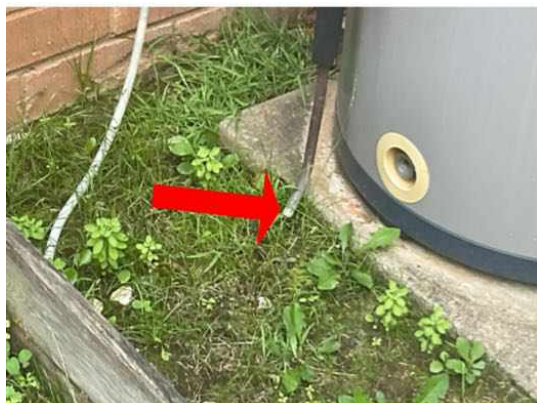
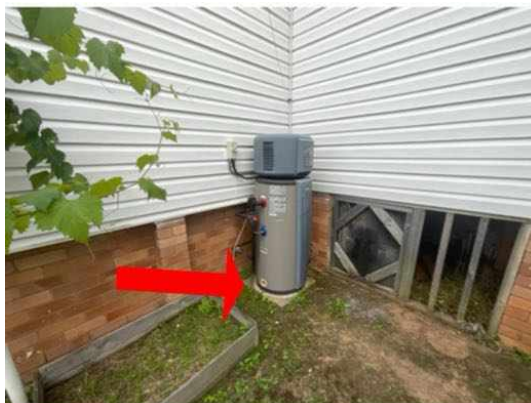
Finding 6.02

Building: Main Building
 Location: All Areas
 Finding: HWS Overflow - Not Connected
 Information: The Hot Water System (HWS) overflow was found to be disconnected from storm water drainage and is creating excessive moisture in the surrounding area.

These damp conditions can lead to secondary defects such as rot, rust or corrosion of associated building elements, the formation of fungal decay, or even the creation of

potential slip hazards. When coupled with poor site drainage, pooling of water may also attract termite activity to this area.

It is highly recommended that a licensed plumber be appointed to connect the HWS overflow in order to prevent such an environment from being created. These minor works should be carried out as soon as possible.

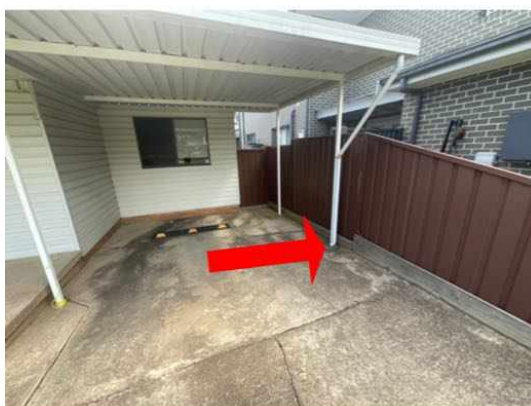
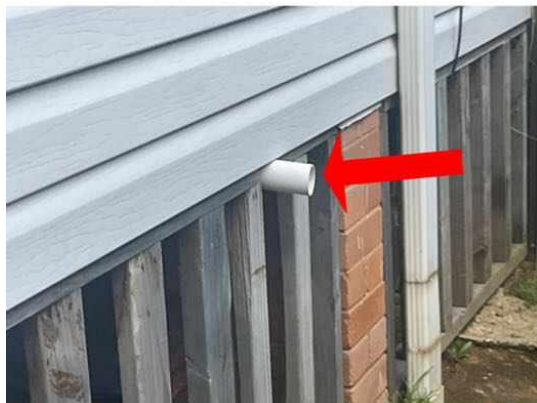
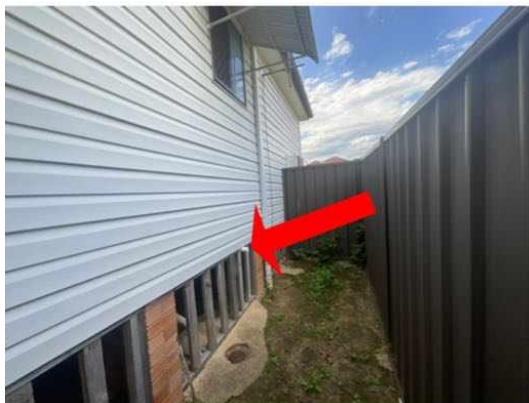
Finding 6.03

Finding: Overflow - Not plumbed for drainage

Information: The overflow is not plumbed or connected to suitable drainage, which has resulted in the surrounding area becoming excessively damp. These damp conditions can lead to secondary defects such as rot, rust or corrosion of associated building elements, the formation of fungal decay, or even the creation of potential slip hazards. When coupled with poor site drainage, pooling of water may also attract termite activity to this area. It is highly recommended that a qualified plumber be appointed to install adequate drainage to the overflow. These works will ensure that the area remains dry and free of any secondary defects.

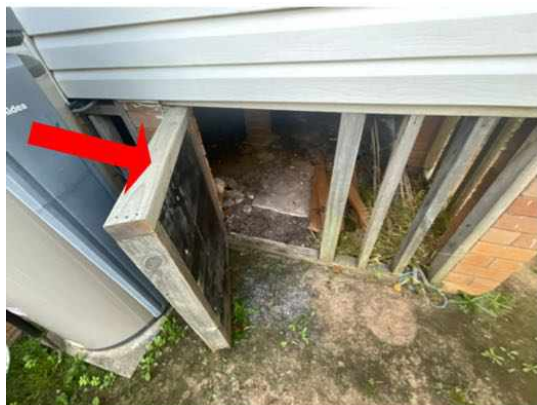
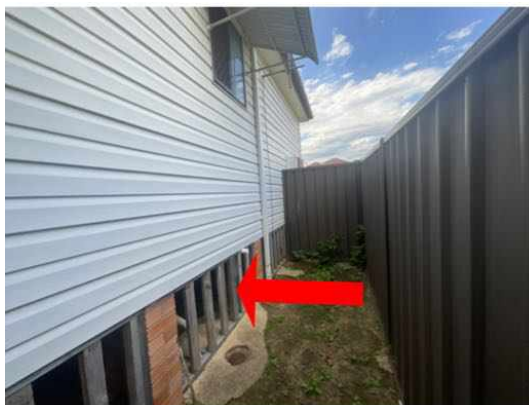
Finding 6.04

Building:	Main Building
Location:	All Areas
Finding:	Timber - exposed to weather
Information:	External timbers that are frequently exposed to harsh weather conditions require adequate protection in order to maintain their condition. Where timbers have not been painted or treated adequately, general deterioration is likely to occur at an accelerated rate.

If left unattended, replacement of these timbers is likely to be necessary in the short-term future. Adequate treatment of these timbers is required as soon as possible by a painting contractor or general handyman.

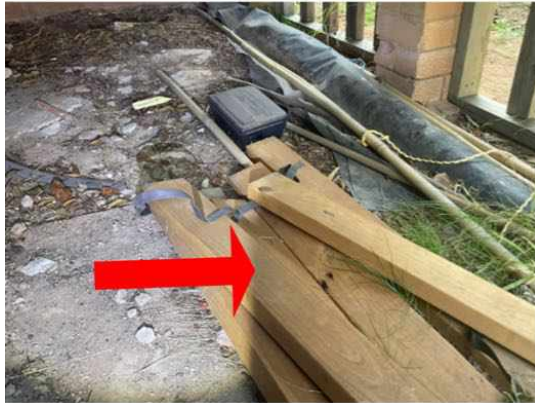
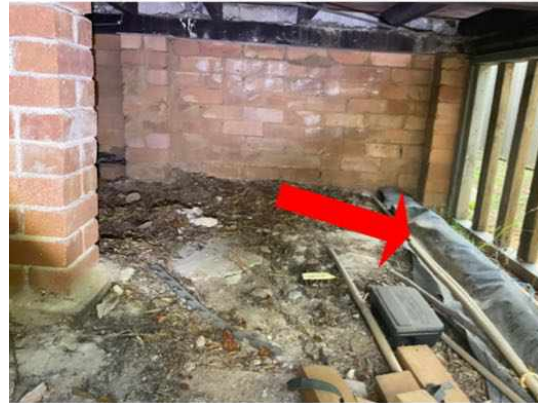
Finding 6.05

Building:	Main Building
Location:	All Areas
Finding:	In ground contact
Information:	Any timbers in direct ground contact provide opportunity for concealed termite entry and are likely to be subject to premature rot and decay as the soil retains moisture or damp conditions against the timbers.

Remove untreated timber that is in direct contact with external grounds. Consider replacement with more durable materials i.e. treated timber or non timber elements. Frequent pest inspections are advised to readily identify any termite activity in these areas.

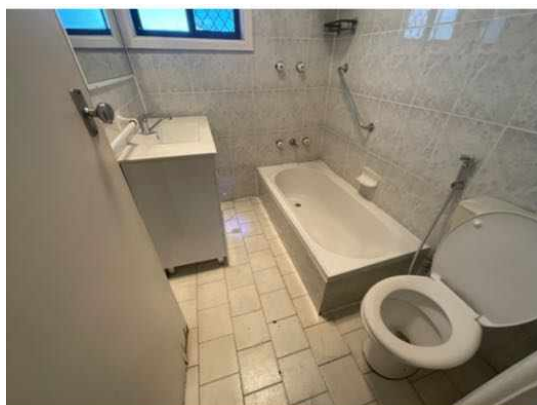
Building:	Main Building
Location:	All Areas
Finding:	Water Proofing Membranes - Information Only
Information:	Internal Water Proofing Membranes, are crucial in preventing water ingress into the property is important to know that the Membrane System used is to Australian Standards and has been installed correctly. Please refer to the original Building Documents or Maintenance Schedule for the relevant information including; - Membrane used and Manufacturers Specifications. - The Installer and Installation Certification. Especially with older property's where this information is unavailable, all wet areas should be monitored. Generally new waterproofing with a certificate may only have a guarantee of 8yrs. If any leaks, water staining, peeling or bubbling of the paint become evident to any adjacent walls or ceilings below a licensed builder or waterproofing specialist is recommended to investigate further.

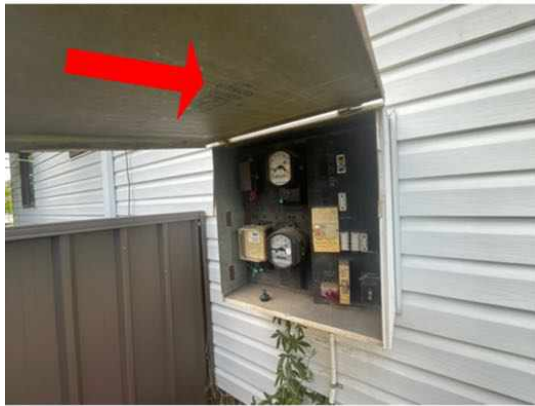
Location: All Areas
 Finding: Termite Management System - no evidence of a chemical installation
 Information: The application of a post-construction chemical termite barrier is highly recommended for all properties, particularly if live termite activity has been found on the site previously. Such barriers are highly effective in preventing termite attack on any timber building elements throughout the property.

A durable notice should be placed in the switchboard unit to indicate current termite barriers. At the time of inspection, it appeared as though no termite management system has been installed, with no evidence to suggest preventative works taking place.

The client may consider gaining further advice from a pest controller as to the costs and procedures involved with this application. It is recommended that obtaining such advice be a short-term priority.

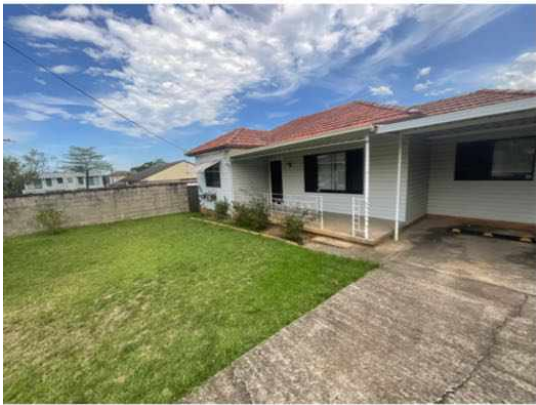
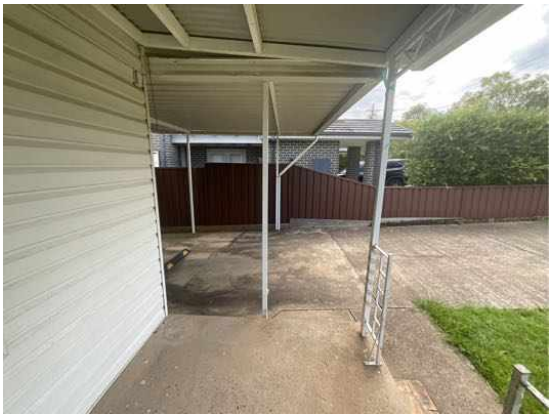
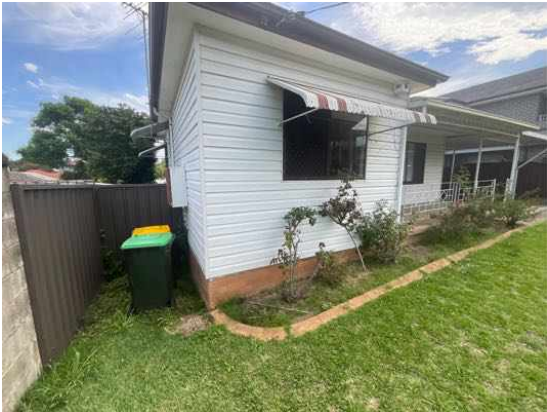
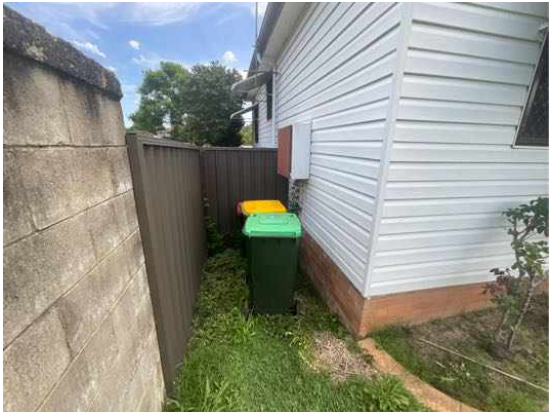
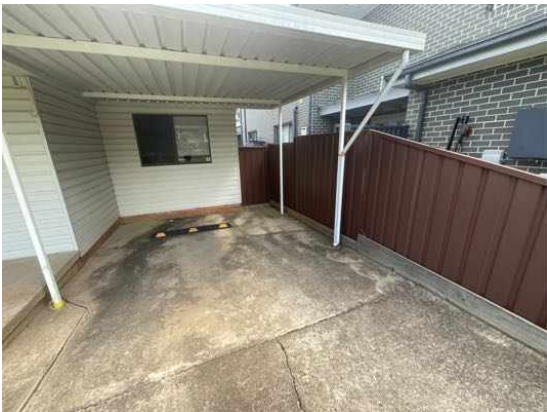
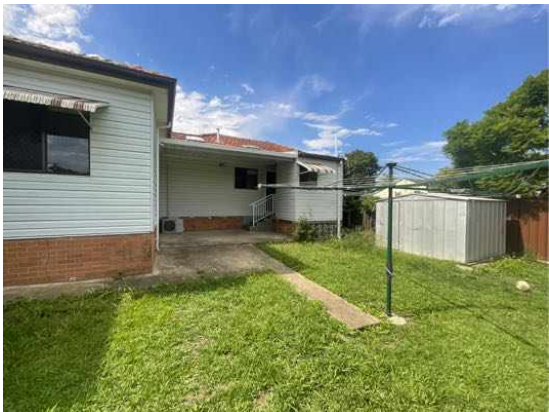
Building: Main Building
 Location: All Areas
 Finding: Additional Photos - Obstructions and Limitations
 Information: These photographs are an indication of the obstructions and limitations which impeded full inspection of the property at the time of inspection. These obstructions can hide an array of defects and should be removed to allow full inspection to be carried out. A re-inspection is recommended once the areas are made accessible.
