## Building Inspection Report

Inspection Date: Thu, 22 Jan 2026

Property Address: 18 Mawarra Ave, Capel Sound VIC 3940,  
Australia

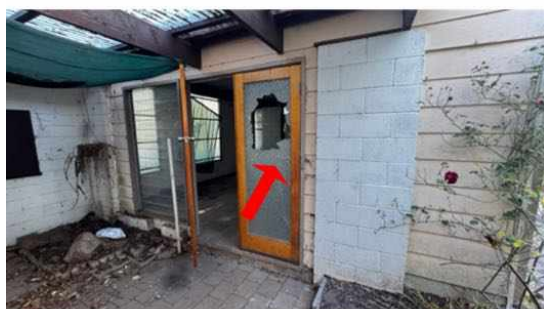
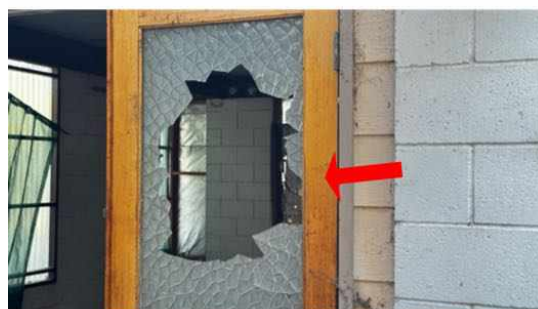
#### Defects 1.01

Building:	Main Building
Location:	All Areas >
Finding:	Safety Hazard - Glass Broken
Information:	Broken and shattered glass was observed at the time of inspection. The presence of broken glass constitutes a significant safety hazard, presenting an immediate risk of injury to occupants and visitors through cuts or lacerations.

The condition is likely due to damage, vandalism, or impact, and poses an increased risk if left unaddressed.

It is recommended that a qualified glazier be engaged as a matter of urgency to remove all broken glass, secure the affected openings, and replace damaged glazing in order to eliminate the safety risk and restore the dwelling to a safe condition.

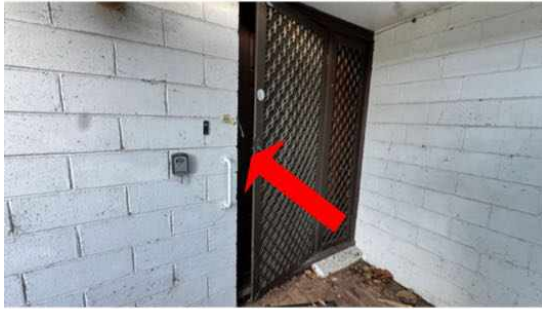
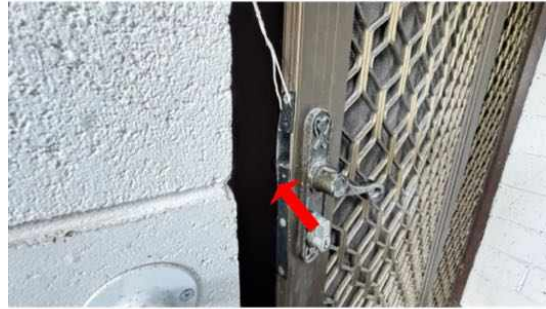
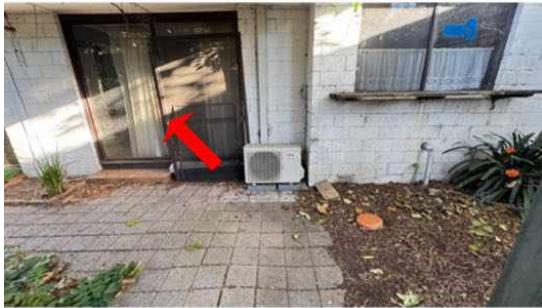
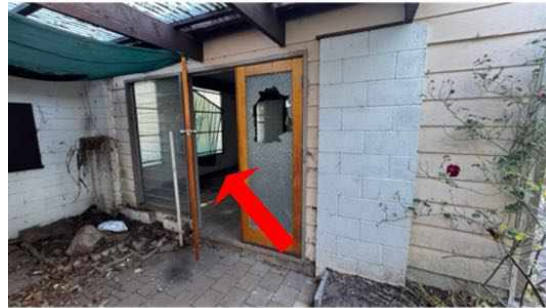
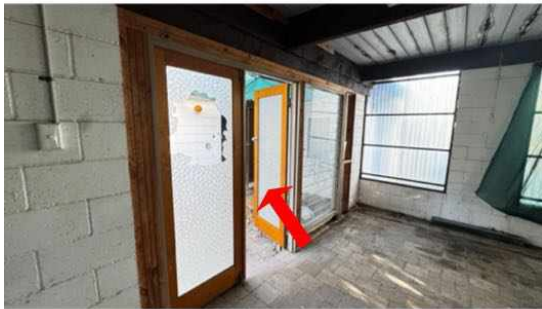
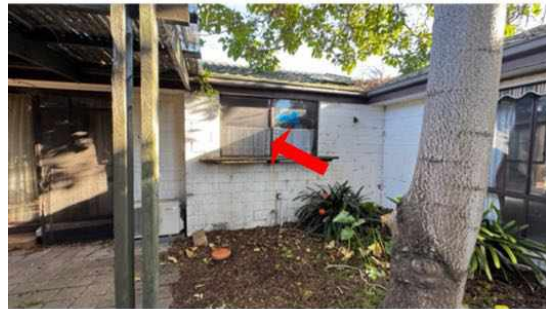
#### Defects 1.02

Building:	Main Building
Location:	All Areas >
Finding:	Safety Hazard – Property Security
Information:	The property was observed to be unsecured at the time of inspection, presenting a safety and security risk.

Unrestricted access increases the likelihood of further damage, vandalism, theft, and poses a potential risk to public safety.

It is recommended that a qualified security contractor be engaged immediately to secure the property, including boarding up openings, installing temporary fencing or security measures as required, in order to prevent further damage, reduce vandalism,

and ensure the safety of the public.

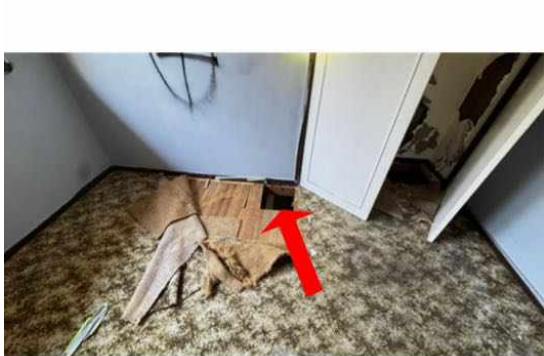
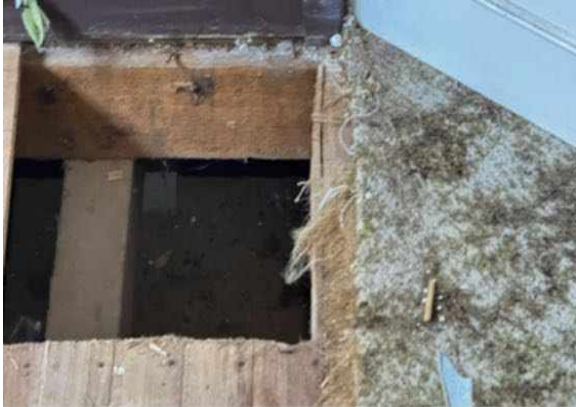
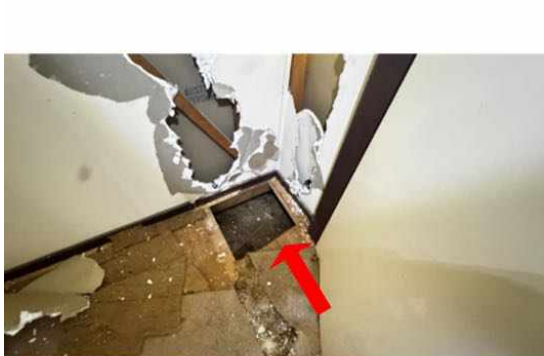
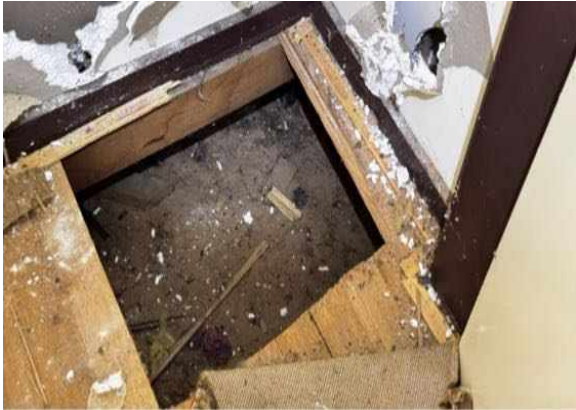
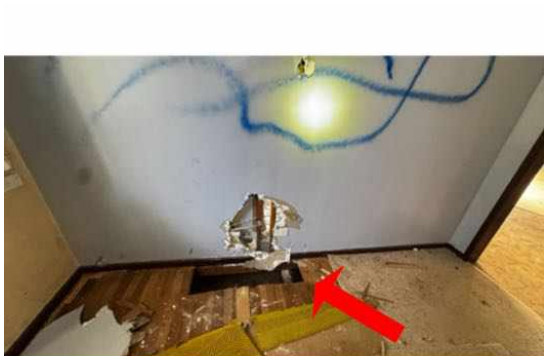
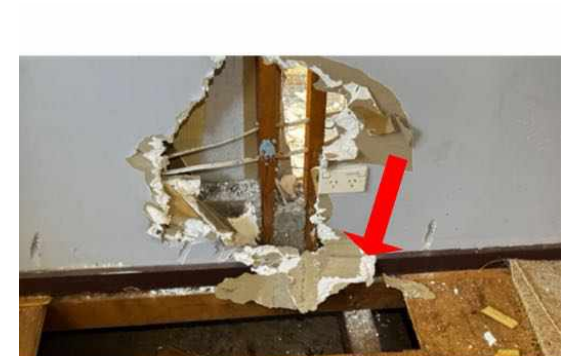
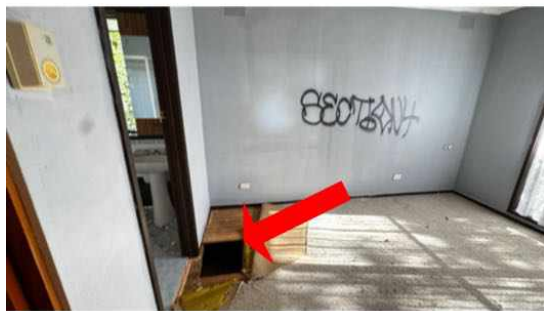
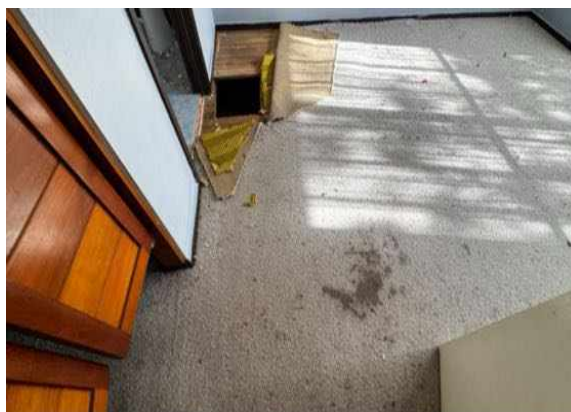
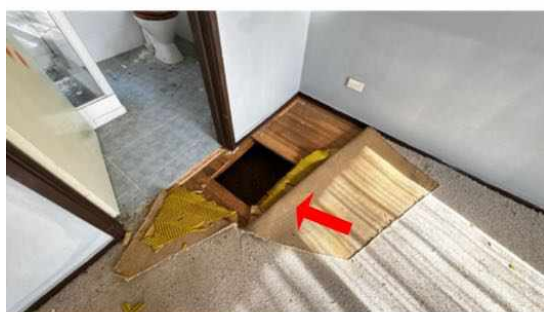
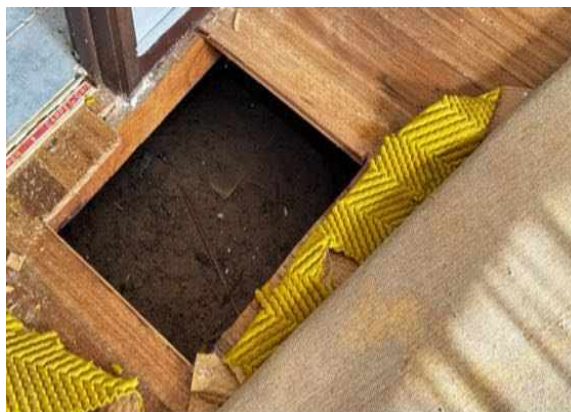
### Defects 1.03

Finding: Safety Hazard - Floors Cut Open

Information: It was observed at the time of inspection that multiple areas of internal flooring have been cut open and left exposed. These openings present a significant safety hazard, creating a risk of trips, falls, and potential injury to occupants, visitors, or trades.

The condition is likely due to incomplete works or vandalism and, if left unaddressed,

may also expose subfloor elements to further damage.

It is recommended that a registered builder or qualified contractor be engaged as a matter of urgency to make the affected areas safe, including temporarily securing or covering open floor sections and assessing the extent of damage. Permanent repairs should be undertaken as part of the broader remedial works to restore the floors to a safe and compliant condition.

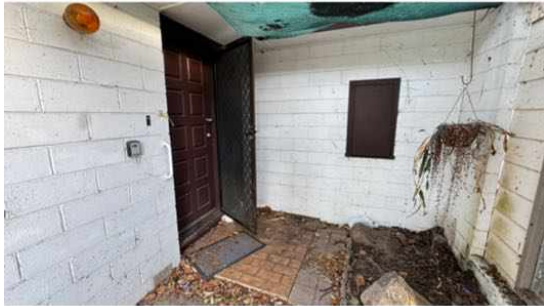
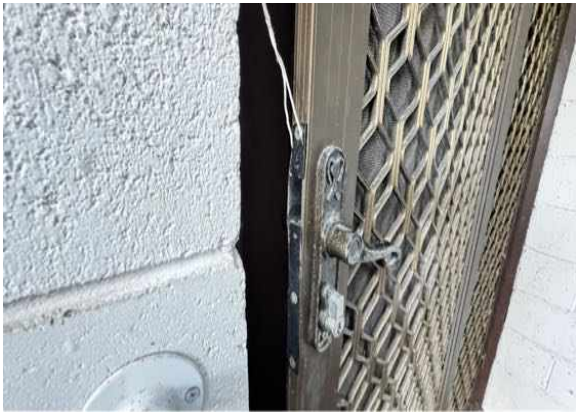
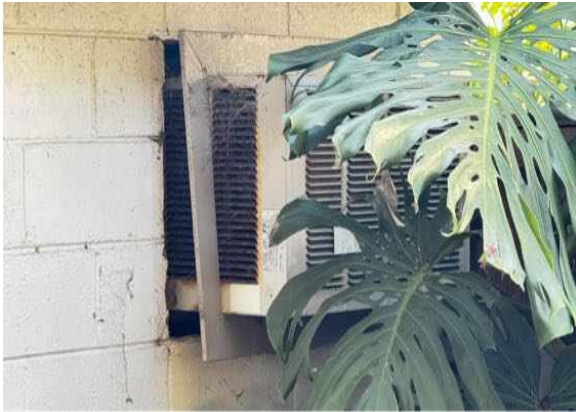
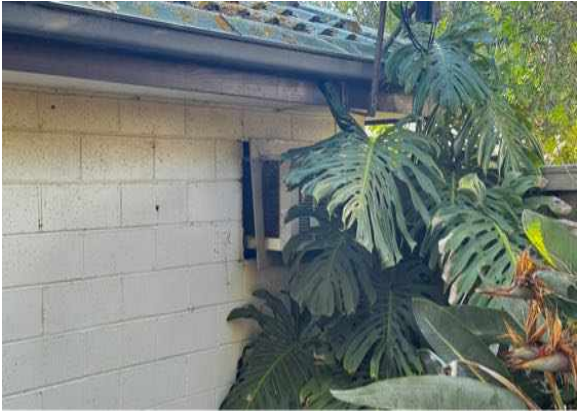
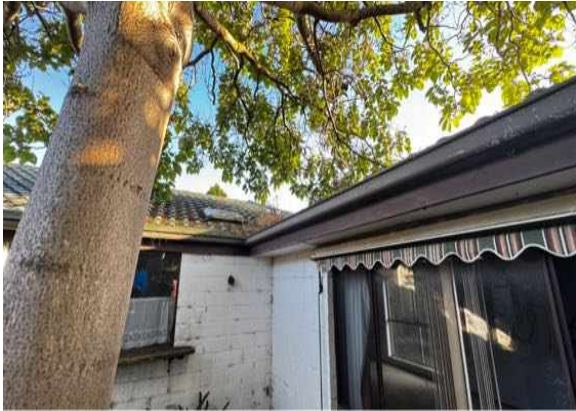
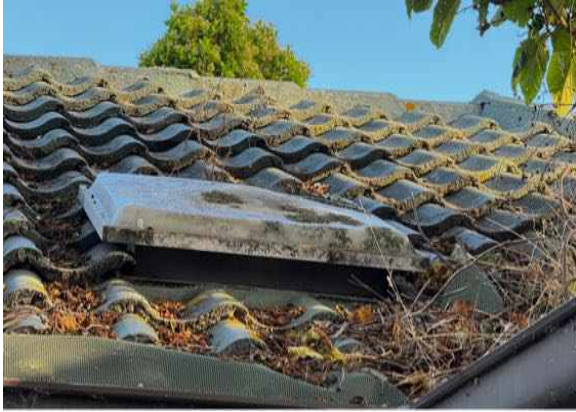
### Defects 2.01

Building:	Main Building
Location:	
Finding:	Building Elements - Damaged
Information:	The dwelling is in a severely deteriorated condition and requires a full and comprehensive renovation throughout. At the time of inspection, electrical cabling has been removed entirely, rendering the property non-functional from an electrical services perspective. The majority of hot and cold water plumbing has also been removed, leaving the dwelling without essential plumbing services. Multiple areas of internal flooring have been cut open, and plaster wall linings have been extensively vandalised and damaged.

\*\*\* It is recommended that the following suitably qualified trades and professionals be engaged immediately to conduct full invasive inspections on the property, provide expert advice for all required remedial works including but not limited to:

Security Contractor : To immediately secure the property to prevent further damage, vandalism and safety to the public.

\*All inspections and remedial works should be coordinated, and the dwelling should not be occupied until essential services, structural integrity and safety hazards have been addressed, fully reinstated and certified.

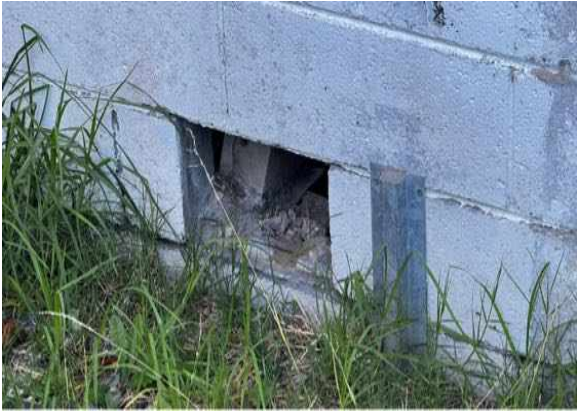
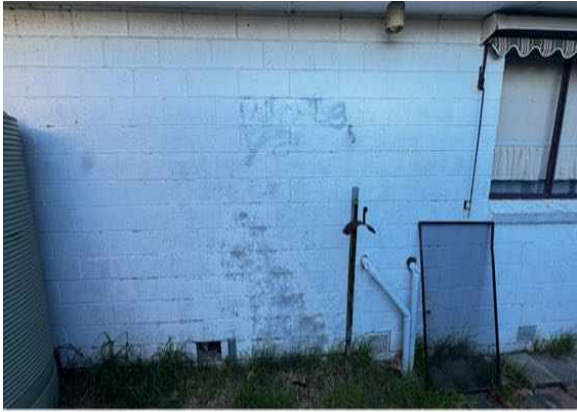
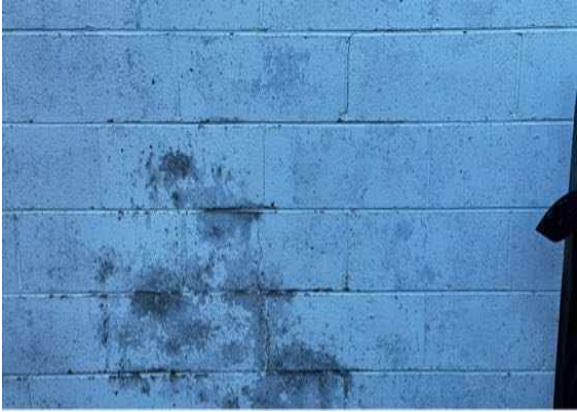
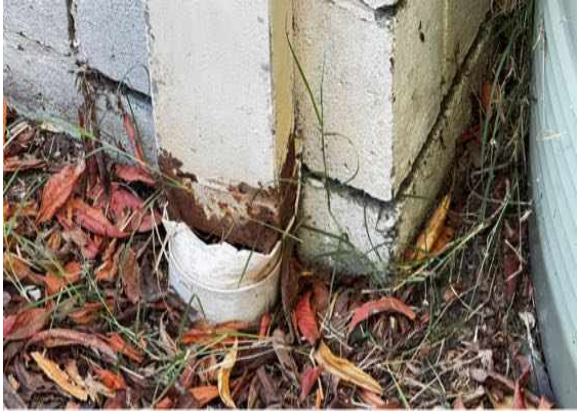
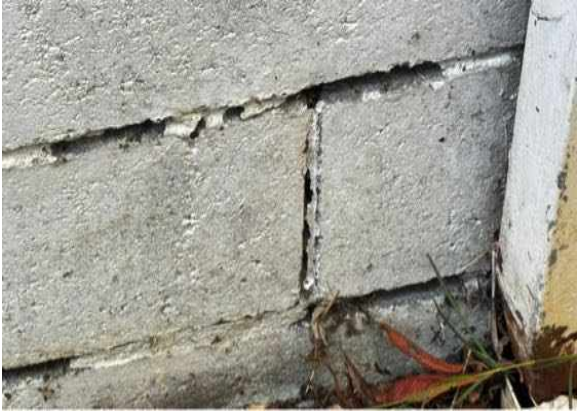
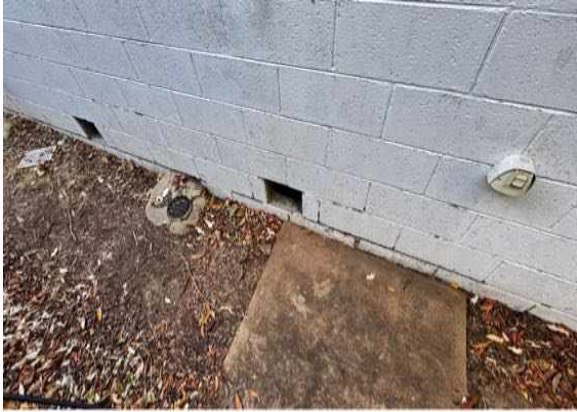
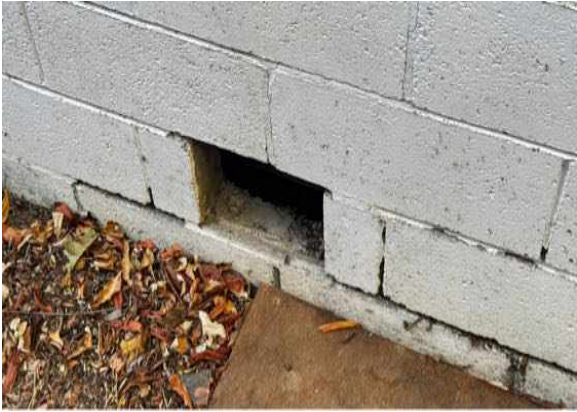
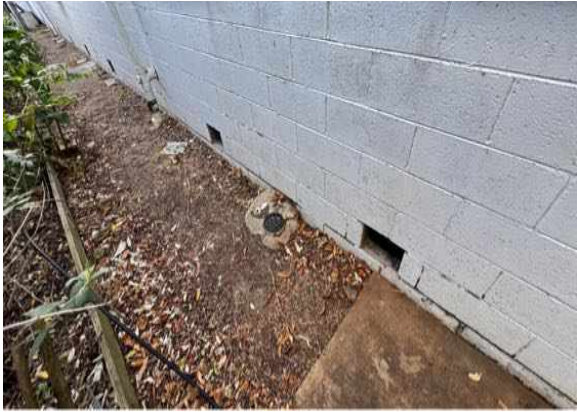
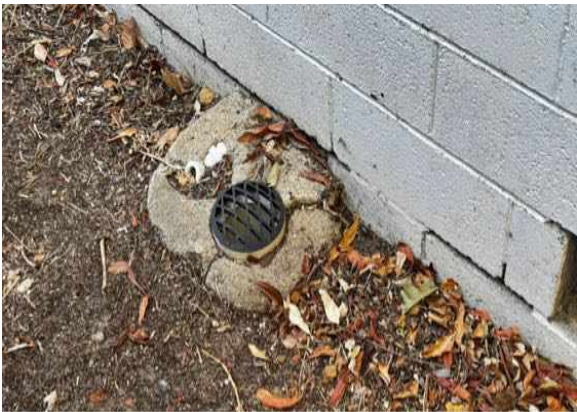
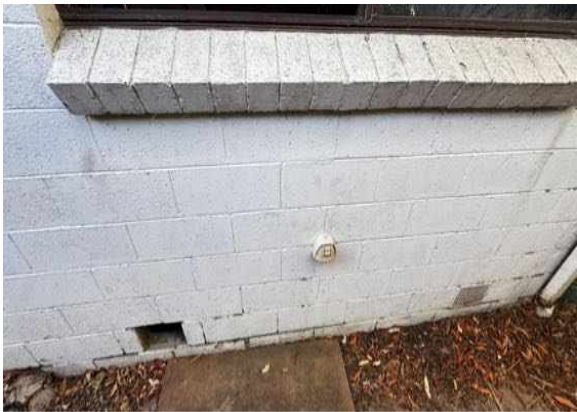
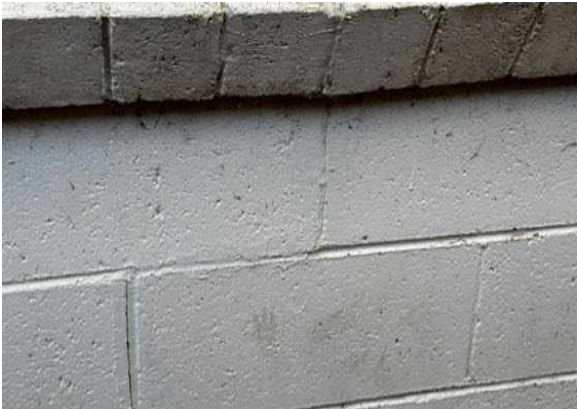
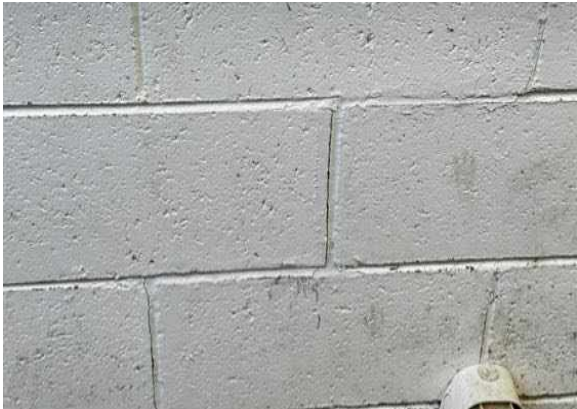
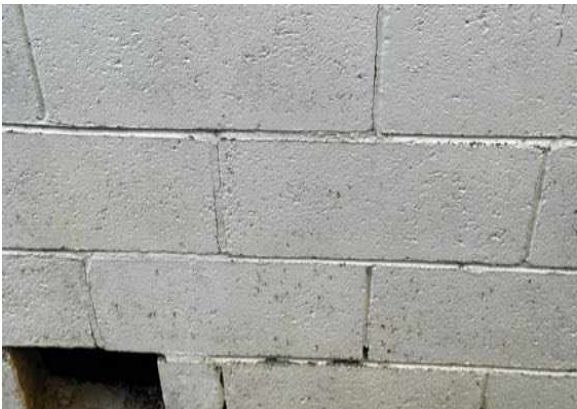
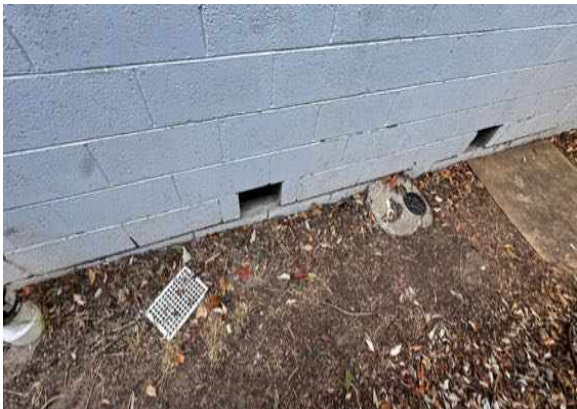
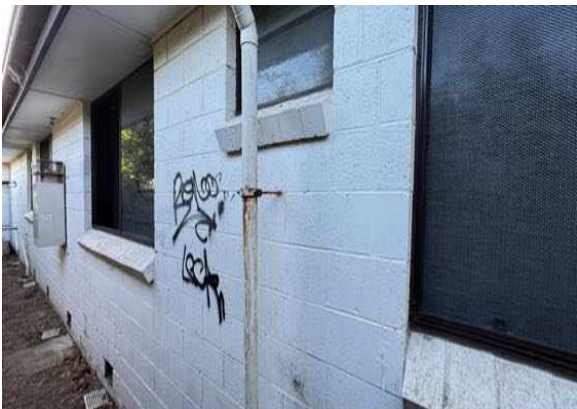
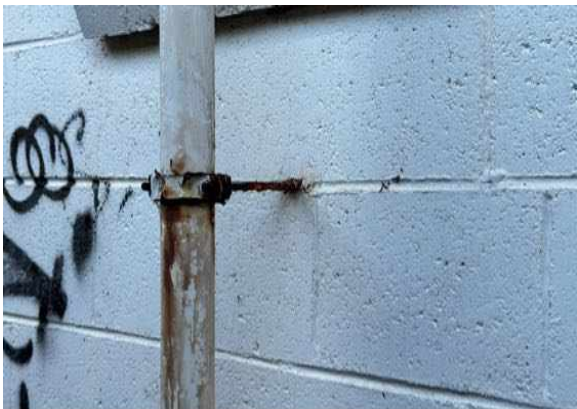
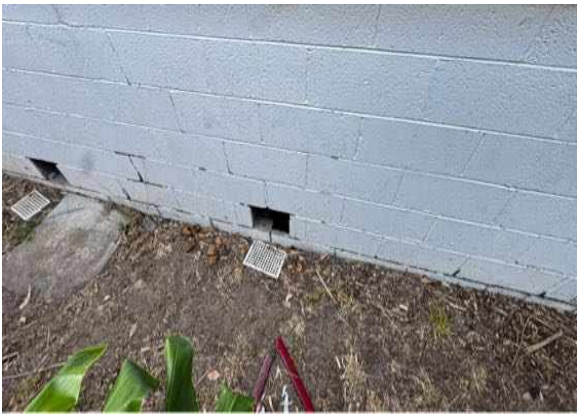
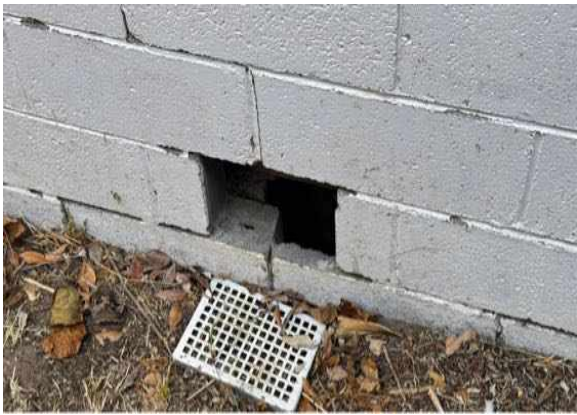
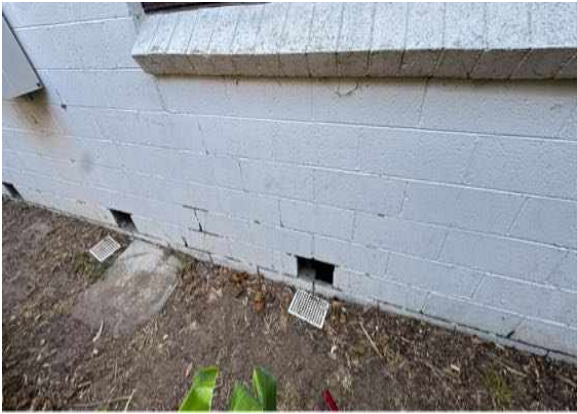
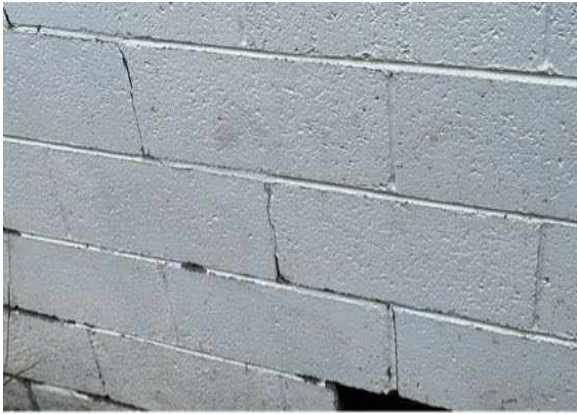
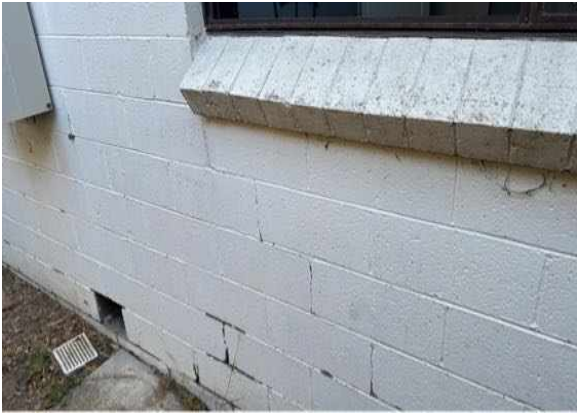
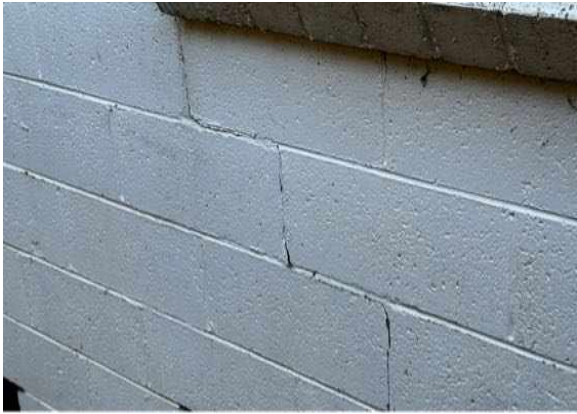
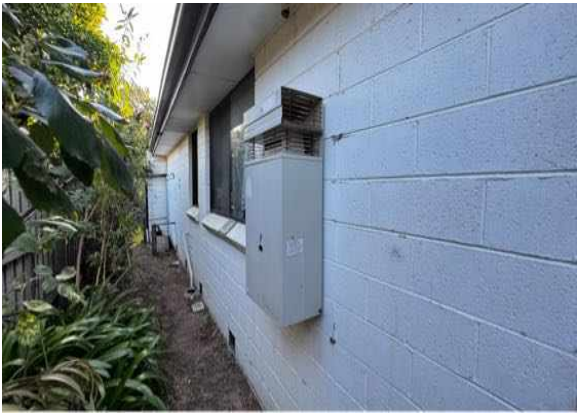
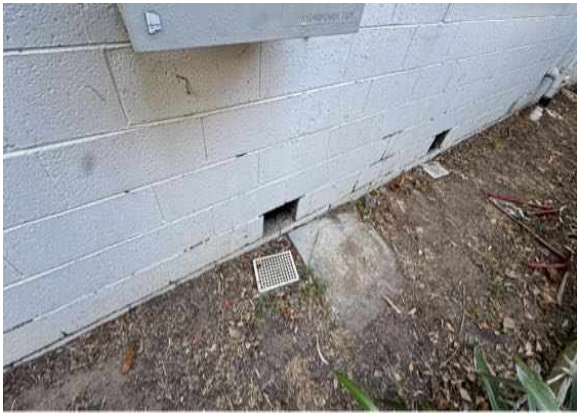
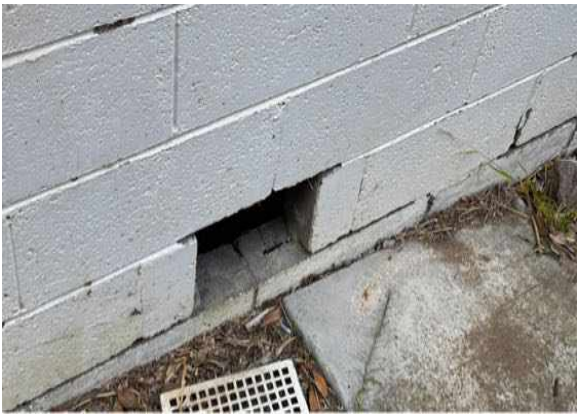
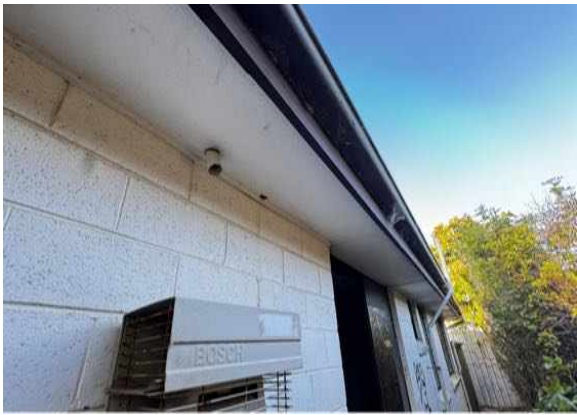
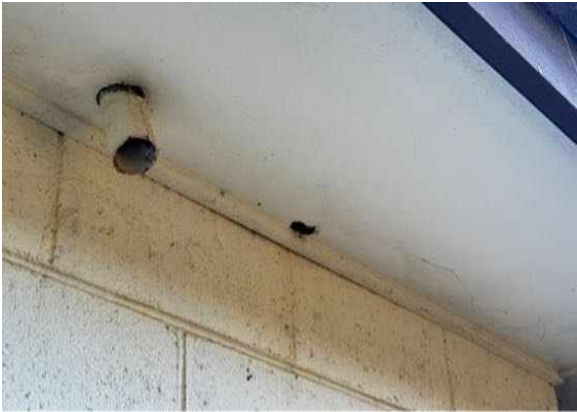
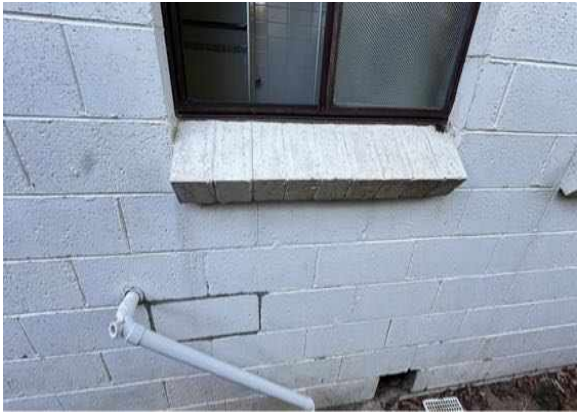
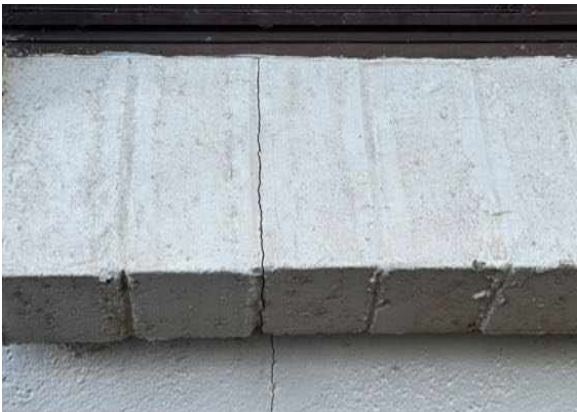
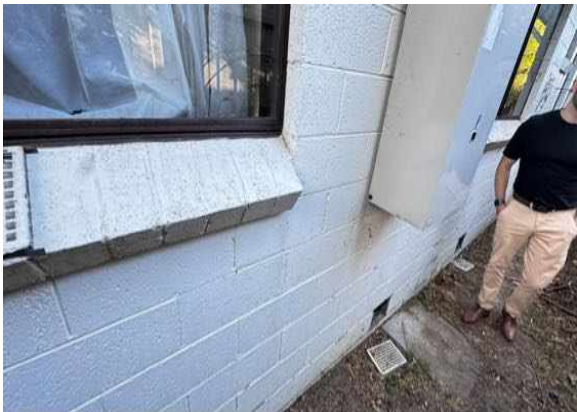
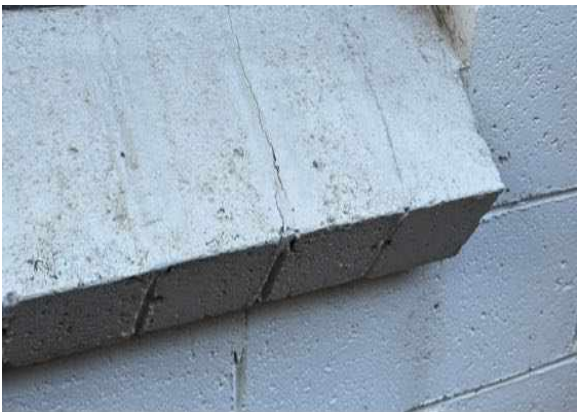
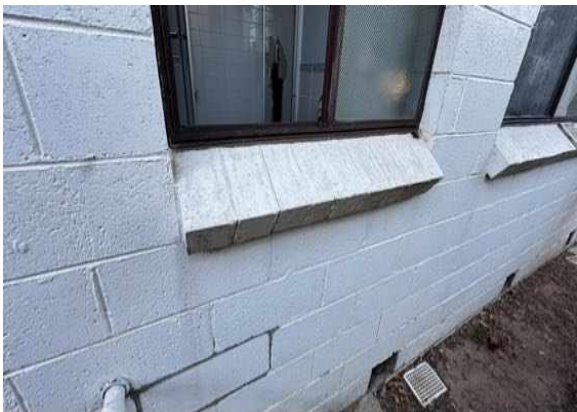
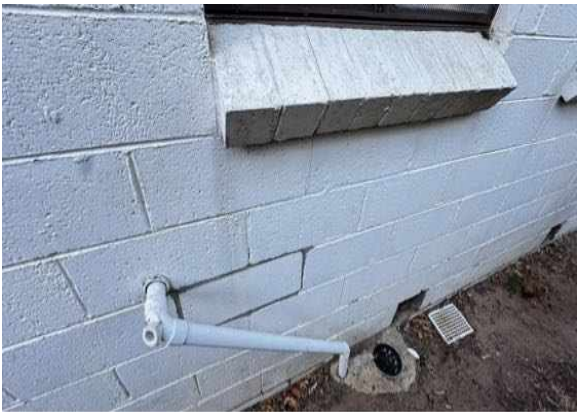
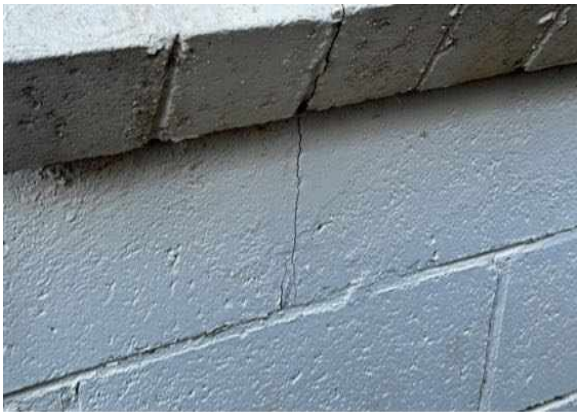
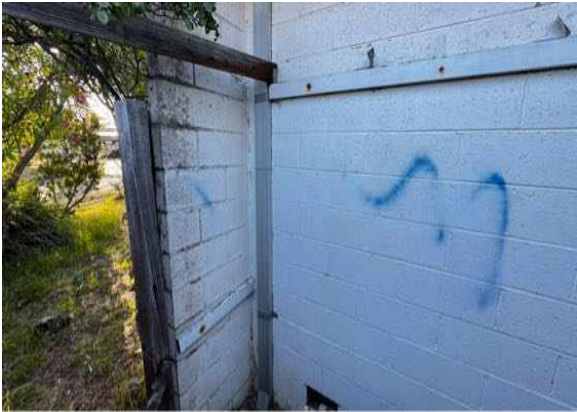
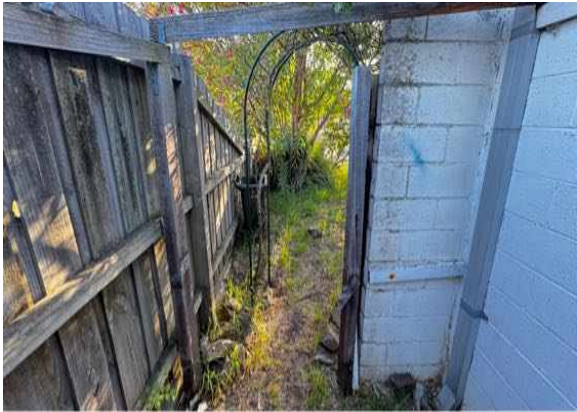
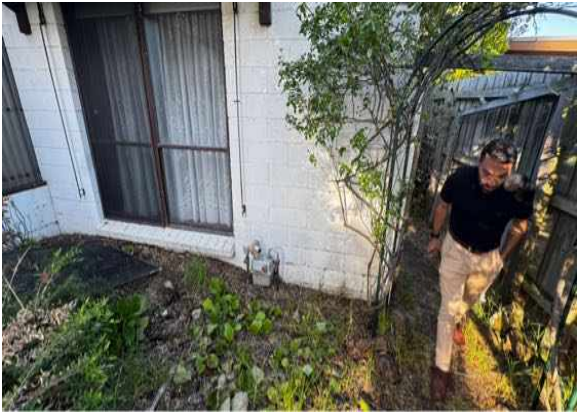
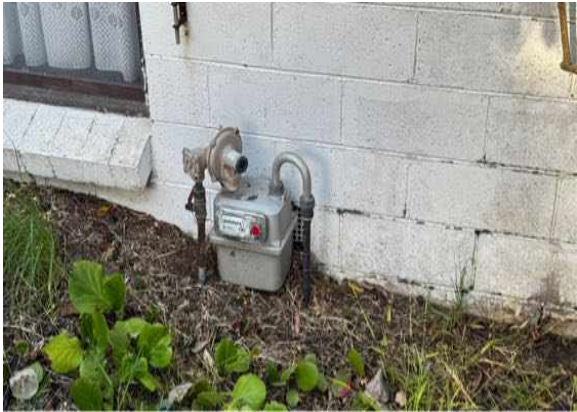
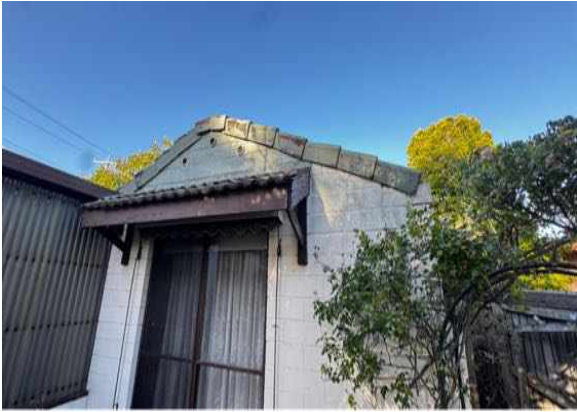
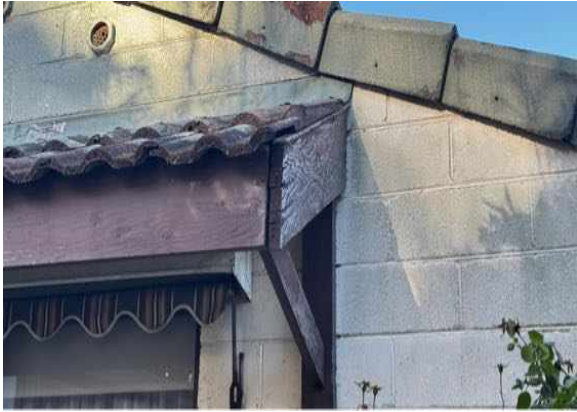
In addition, a significant number of windows are in poor condition, with broken and smashed glass evident, and most windows will require full replacement. Due to the extent of damage and removal of critical building services, the property is not habitable in its current state and will require substantial rectification works prior to occupation.
