## Building Inspection Report

Inspection Date: Thu, 22 Jan 2026

Property Address: 18 Mawarra Ave, Capel Sound VIC 3940,  
Australia

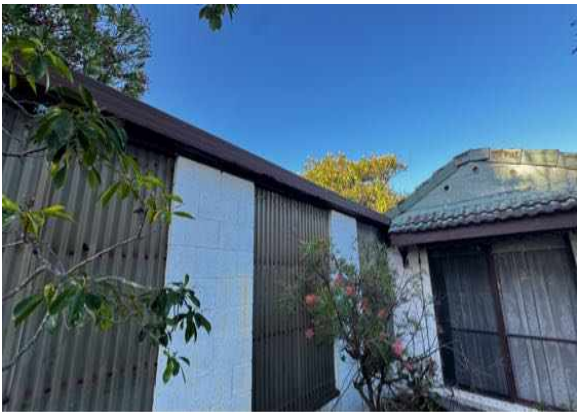
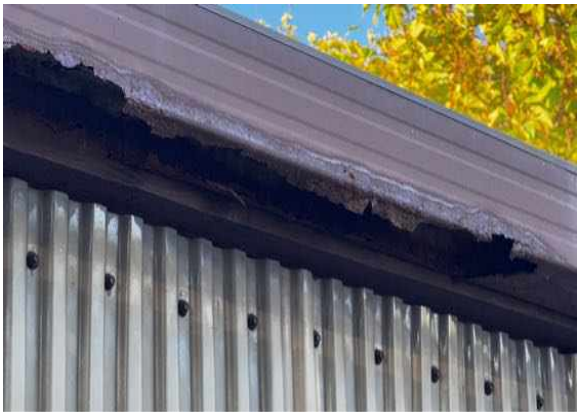
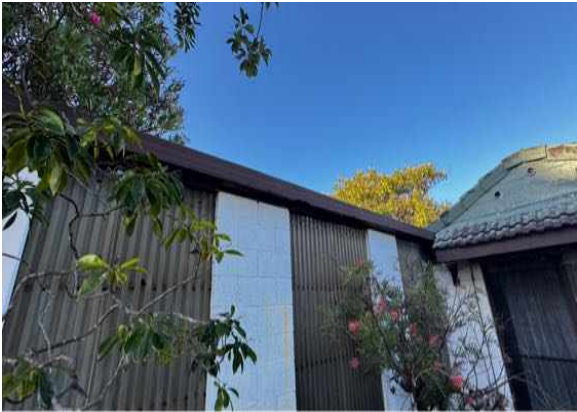
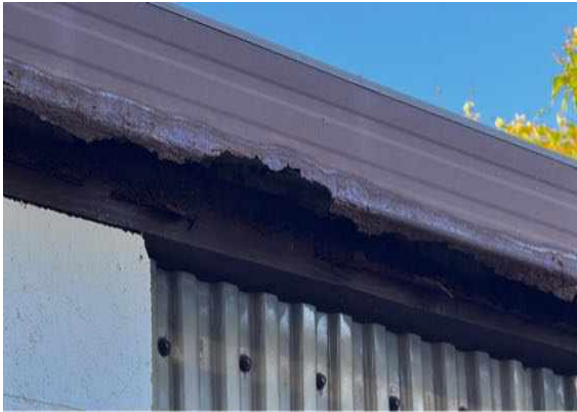
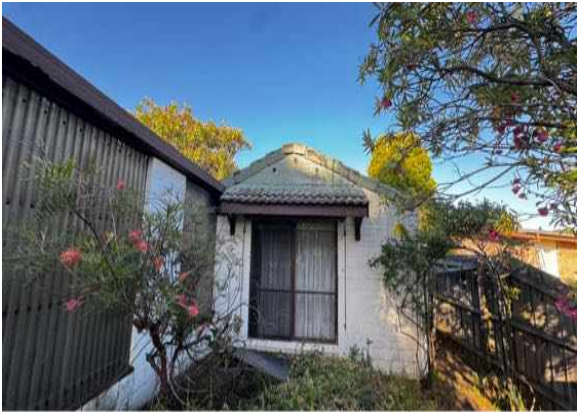
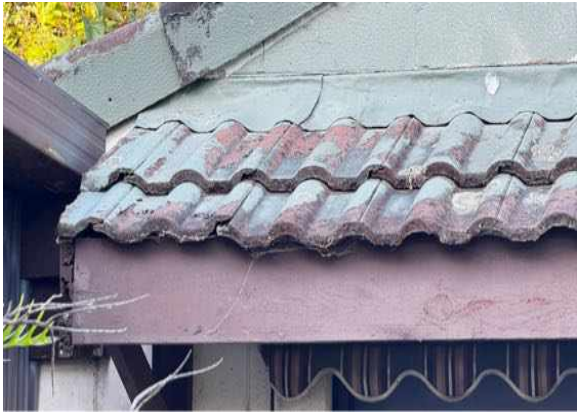
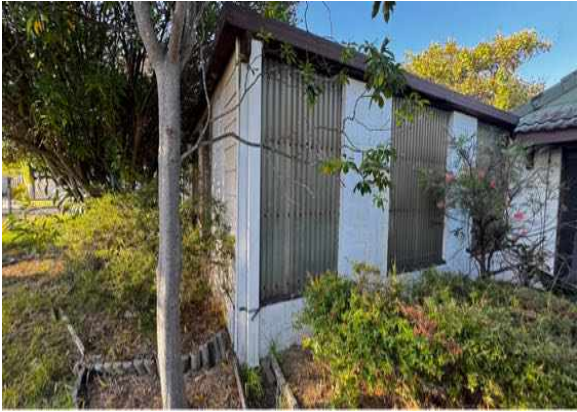
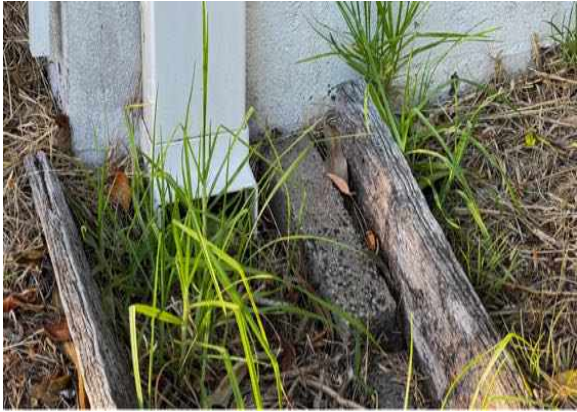
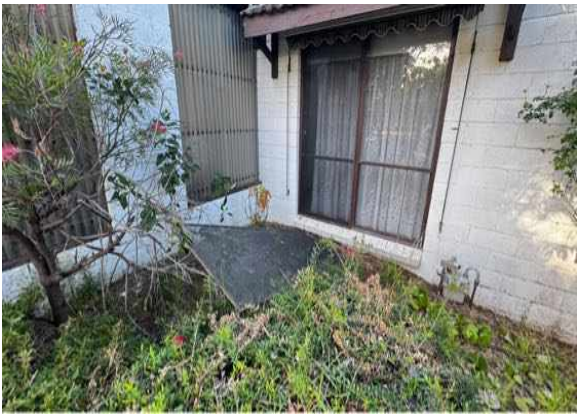
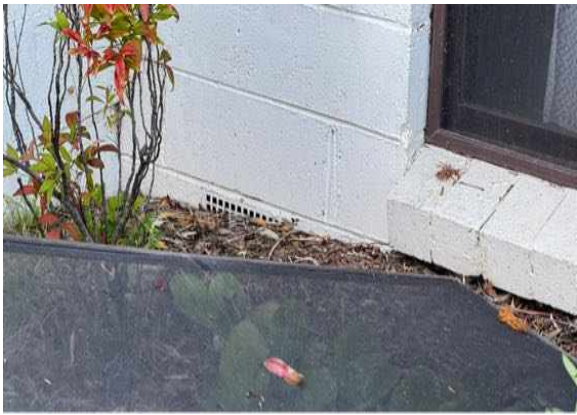
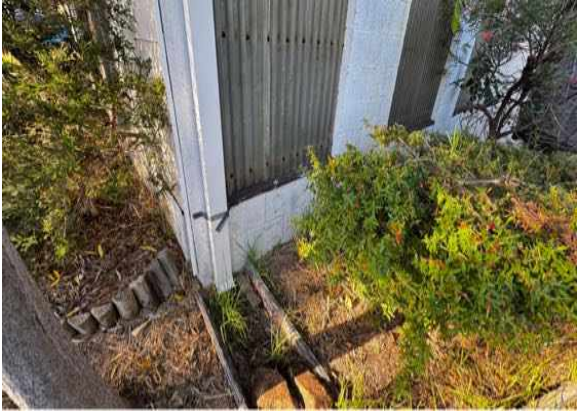
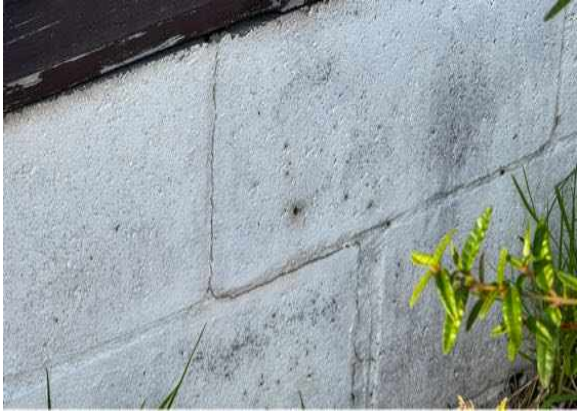
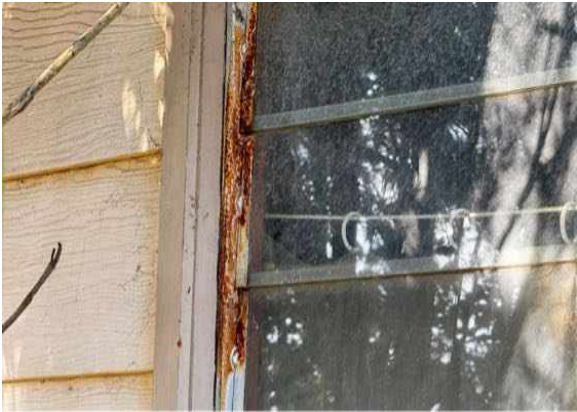
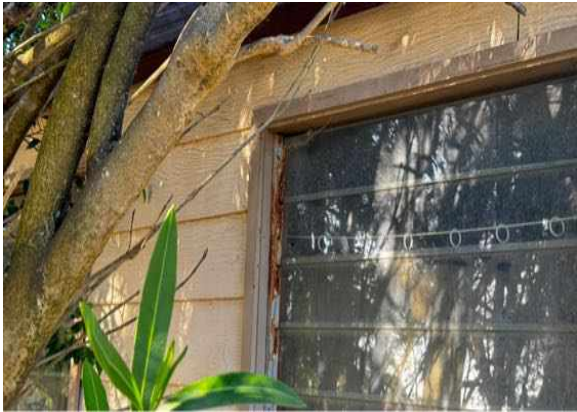
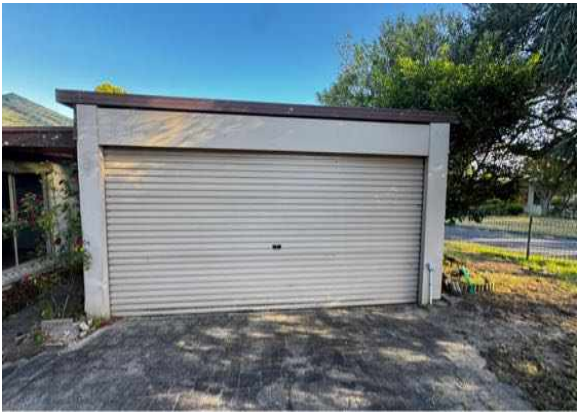
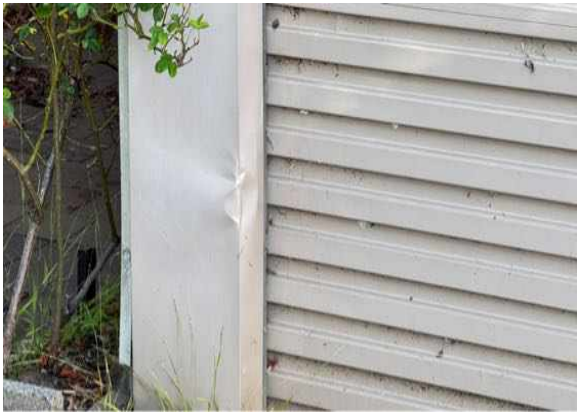
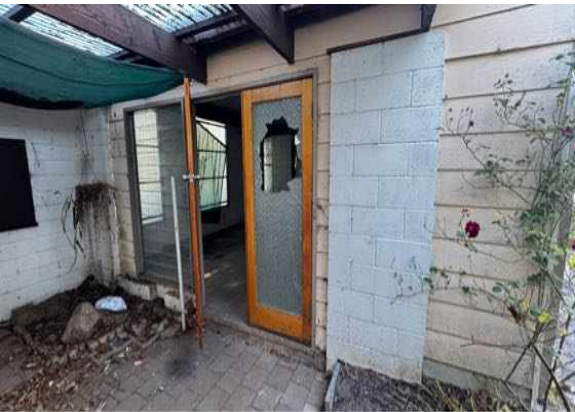
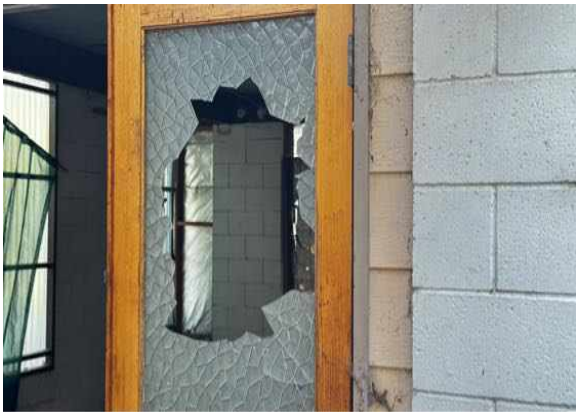
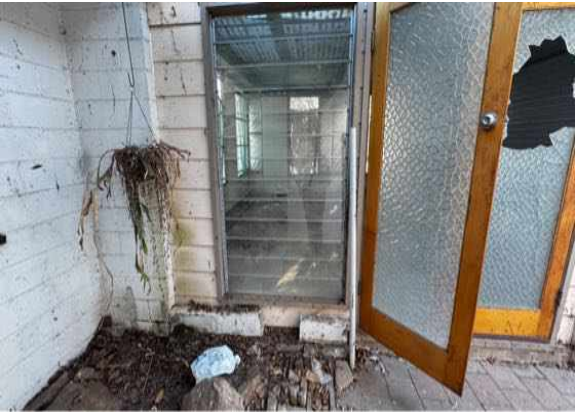
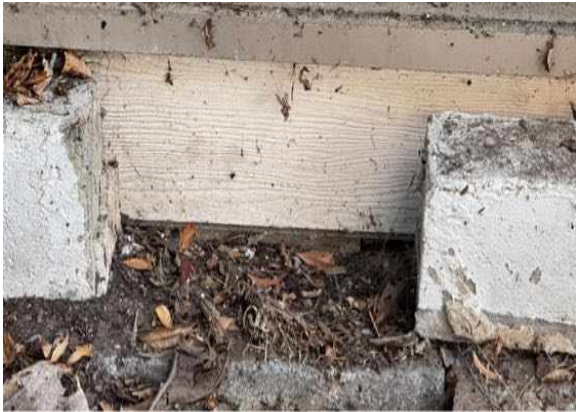
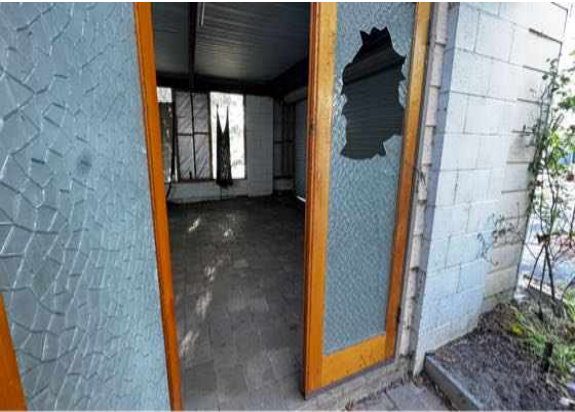
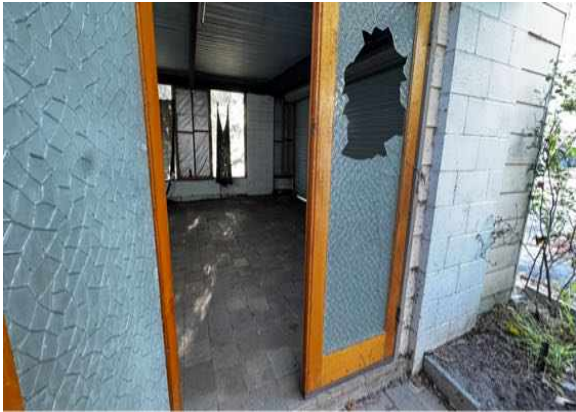
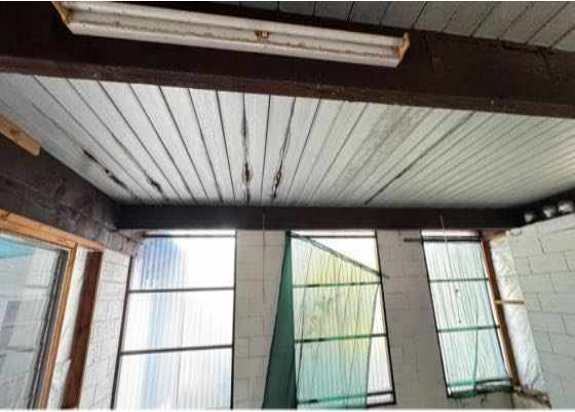
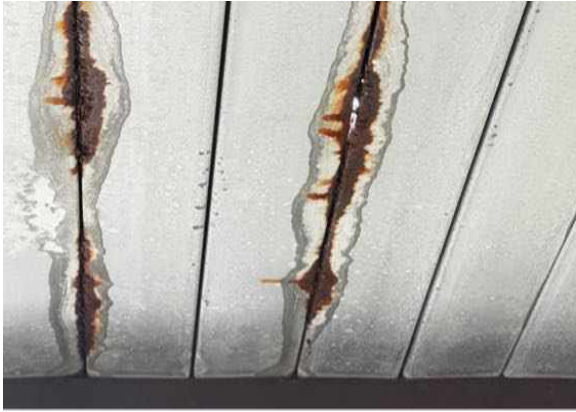
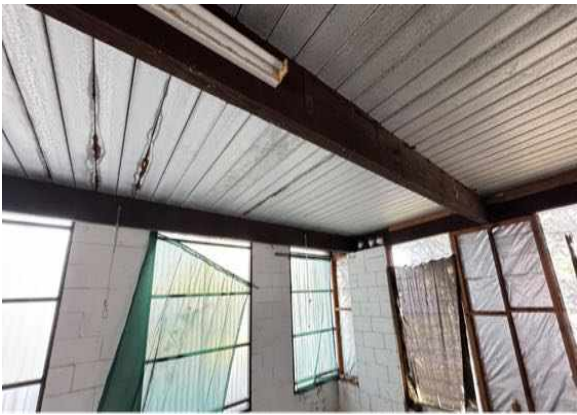
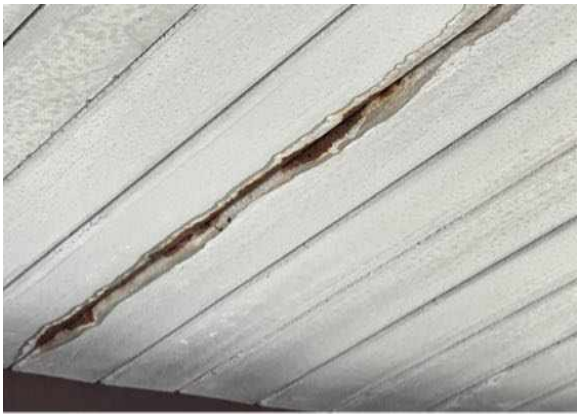
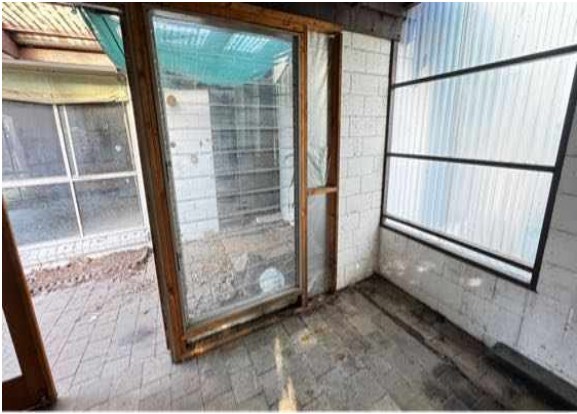
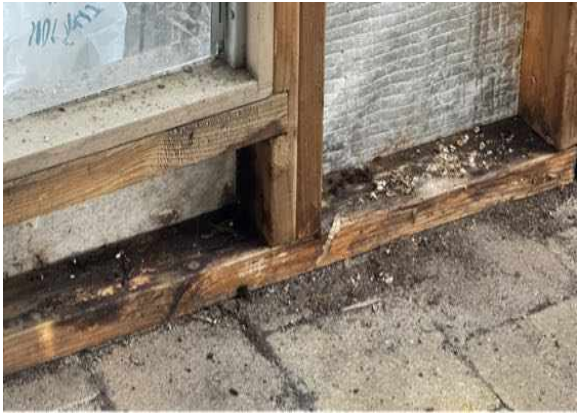
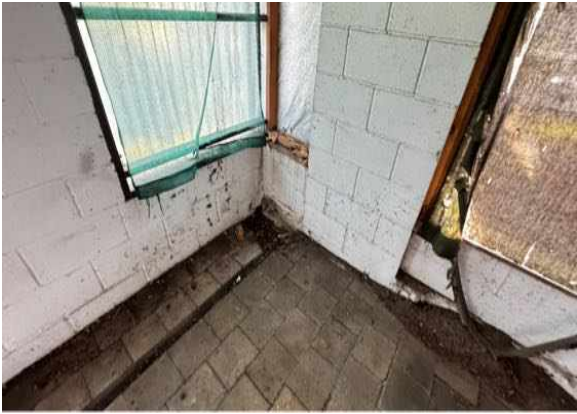
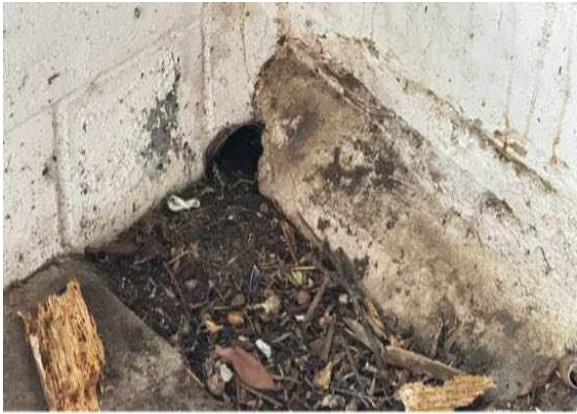
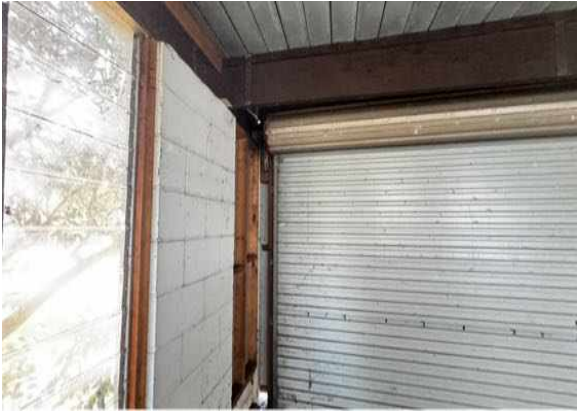
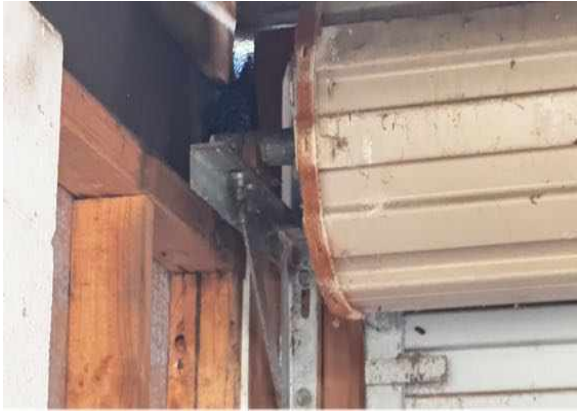
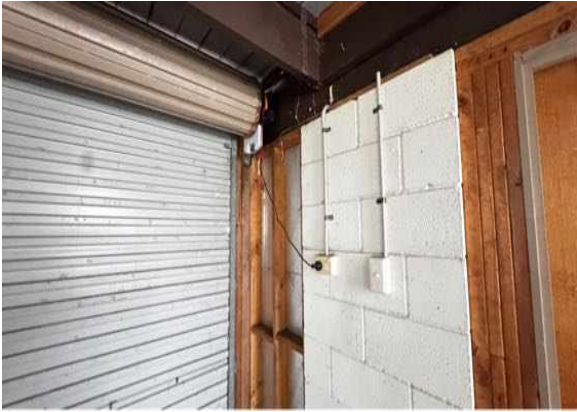
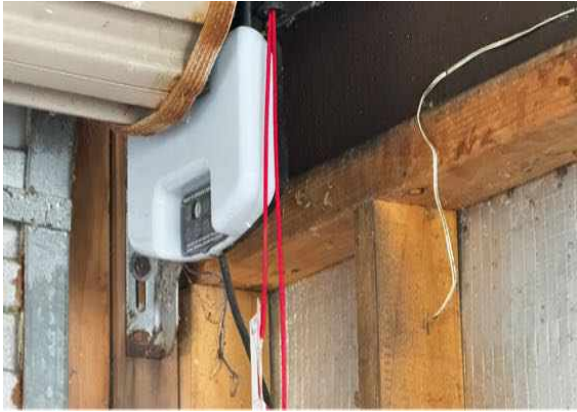
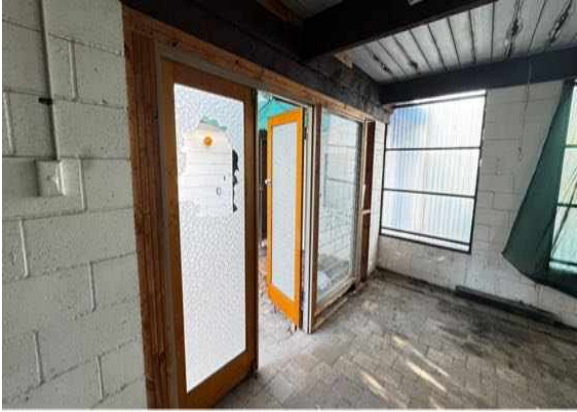
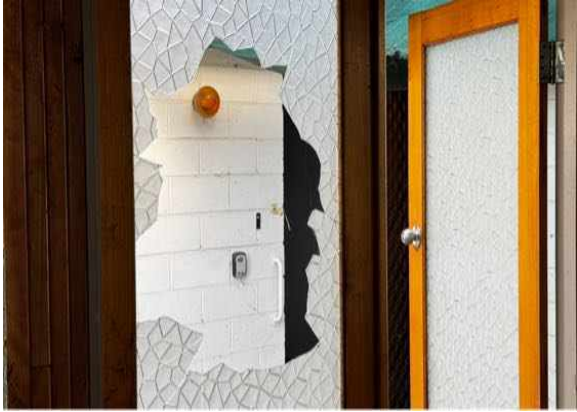
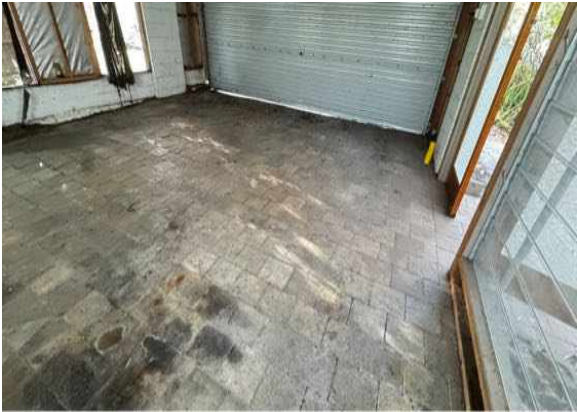
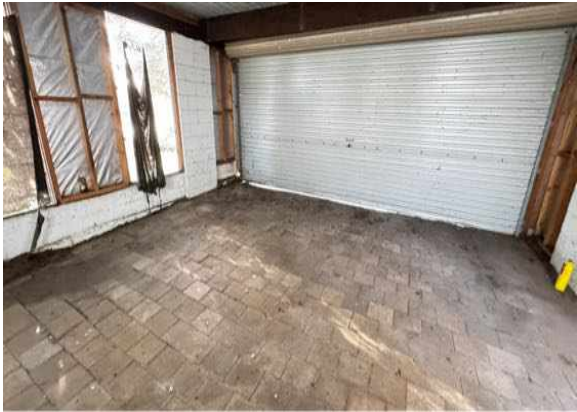
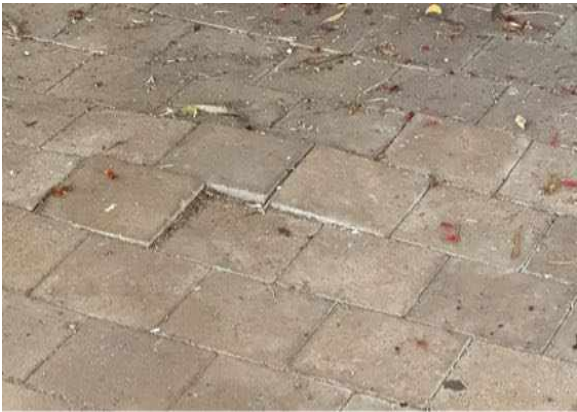
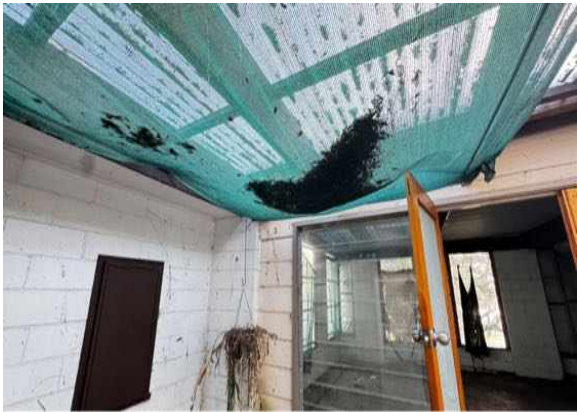
### Defects 2.01

Building:	Main Building
Location:	
Finding:	Building Elements - Damaged
Information:	The dwelling is in a severely deteriorated condition and requires a full and comprehensive renovation throughout. At the time of inspection, electrical cabling has been removed entirely, rendering the property non-functional from an electrical services perspective. The majority of hot and cold water plumbing has also been removed, leaving the dwelling without essential plumbing services. Multiple areas of internal flooring have been cut open, and plaster wall linings have been extensively vandalised and damaged.

In addition, a significant number of windows are in poor condition, with broken and smashed glass evident, and most windows will require full replacement. Due to the extent of damage and removal of critical building services, the property is not habitable in its current state and will require substantial rectification works prior to occupation.

\*\*\* It is recommended that the following suitably qualified trades and professionals be engaged immediately to conduct full invasive inspections on the property, provide expert advice for all required remedial works including but not limited to:

Licensed Plumber: To assess and replace removed or damaged hot and cold water services, drainage, and sanitary plumbing.

Roof Plumber: To inspect roof drainage systems, flashings, gutters, downpipes, and roof penetrations, and advise on required repairs or replacement.

Roof Tiler: To assess the condition of roof tiles, identify broken, displaced, or missing tiles, and provide remedial advice.

Carpenter / Flooring Contractor: To inspect damaged floor structures and provide recommendations for repair or replacement of subfloors and structural flooring.

Floor Covering Specialist: To assess internal floor finishes and provide advice for replacement of timber, laminate, vinyl, carpet, or tiled floor coverings.

Plasterer: To inspect vandalised and damaged plaster walls and ceilings and advise on repair or replacement requirements.

Cabinet Maker / Joiner: To inspect existing cabinetry and provide advice for replacement or new installation of kitchen, bathroom, and storage cabinetry.

Glazier / Window Installer: To assess and make safe broken or damaged windows and provide advice for replacement of glazing and window frames.

Security Contractor : To immediately secure the property to prevent further damage, vandalism and safety to the public.

\*All inspections and remedial works should be coordinated, and the dwelling should not be occupied until essential services, structural integrity and safety hazards have been addressed, fully reinstated and certified.

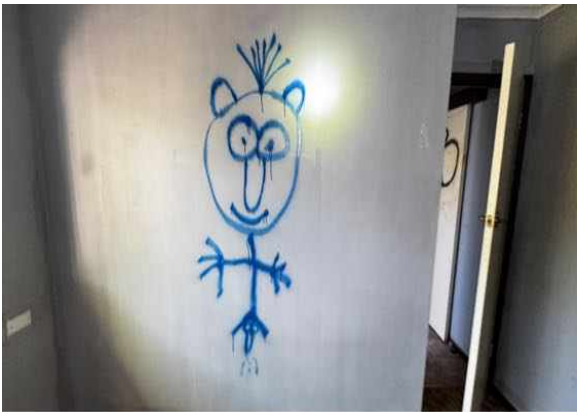
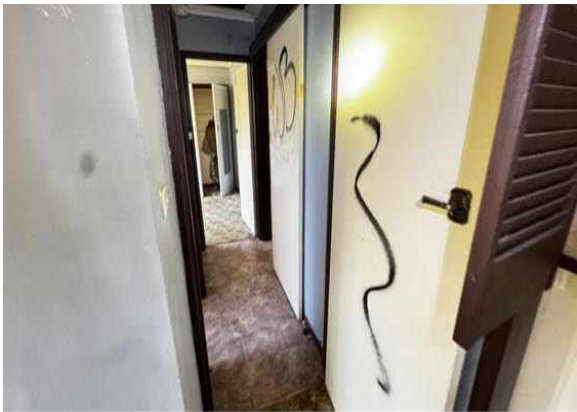
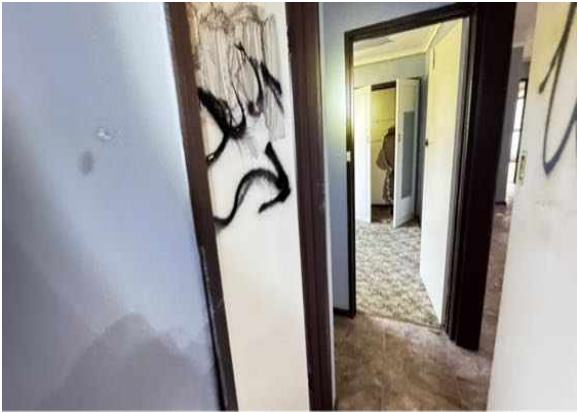
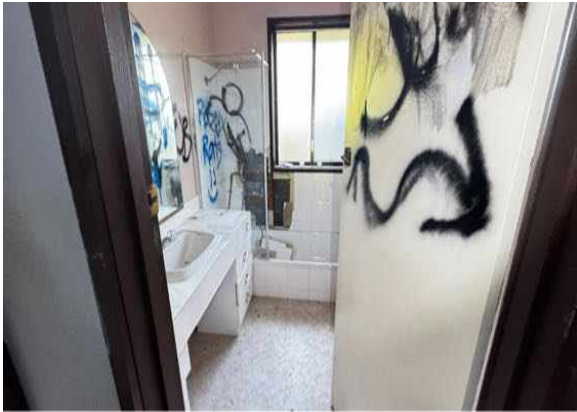
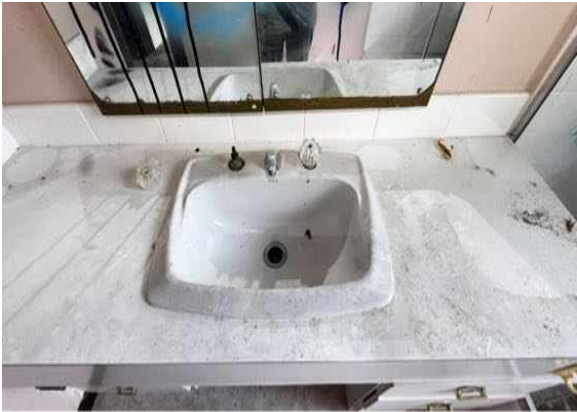
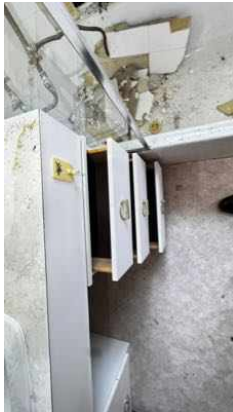
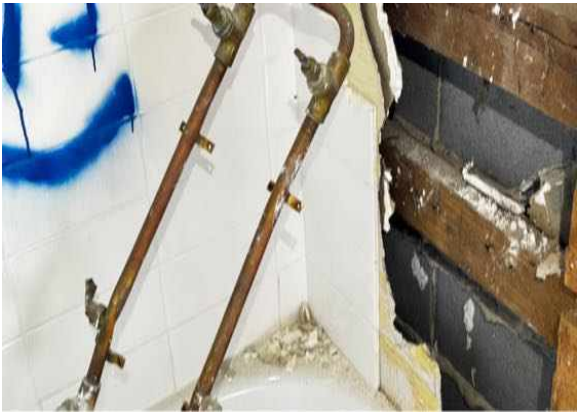
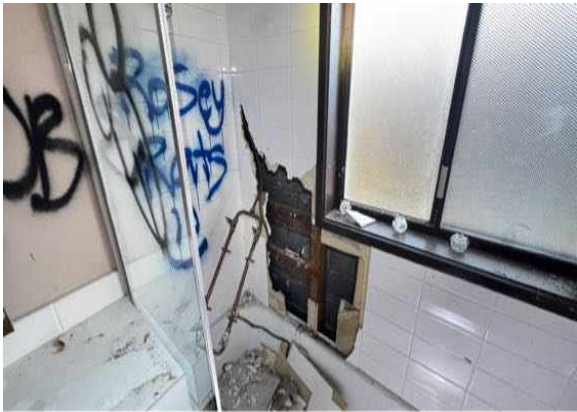
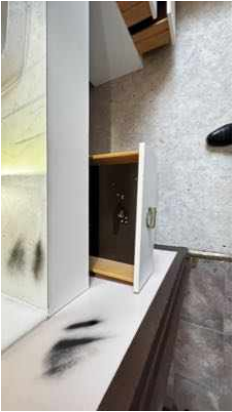
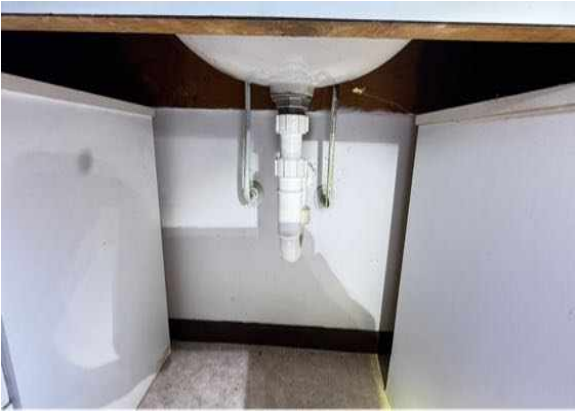
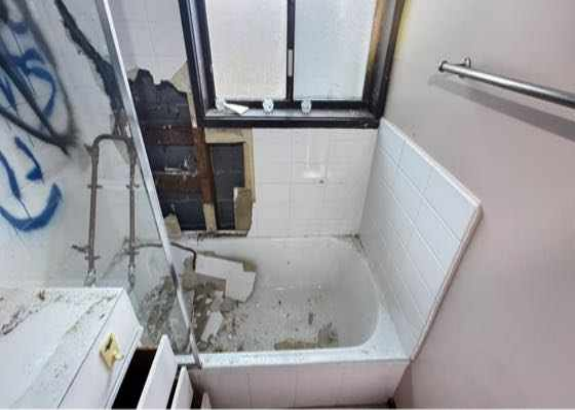
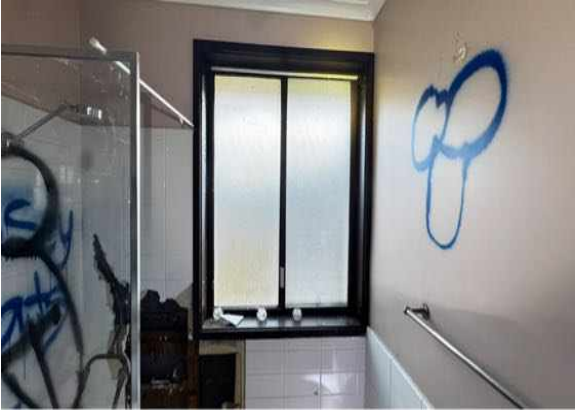
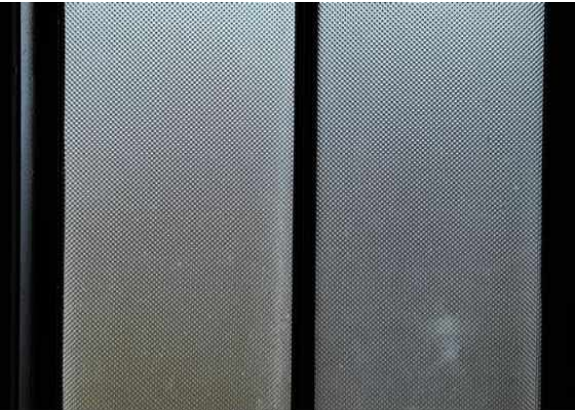
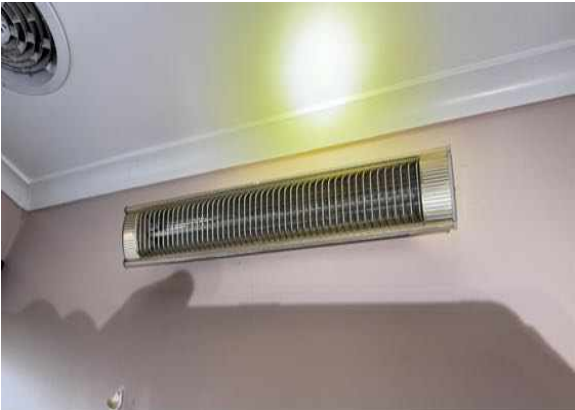
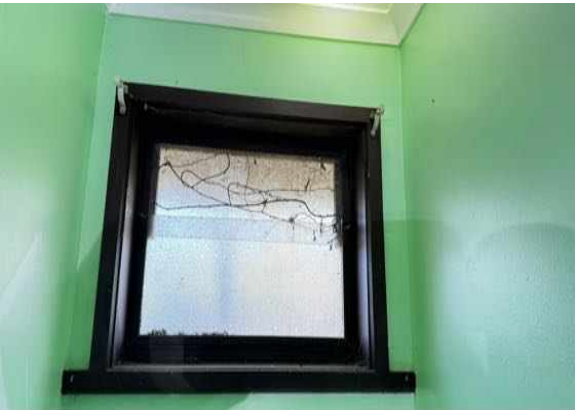
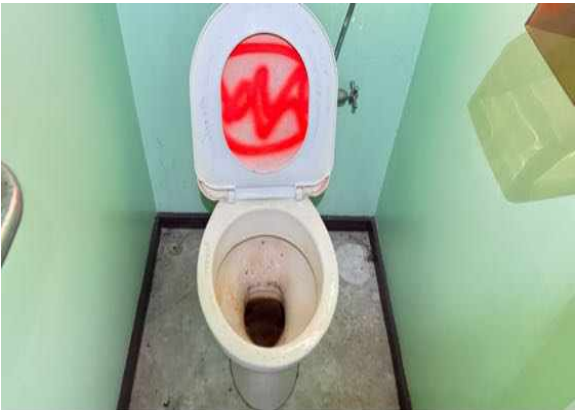
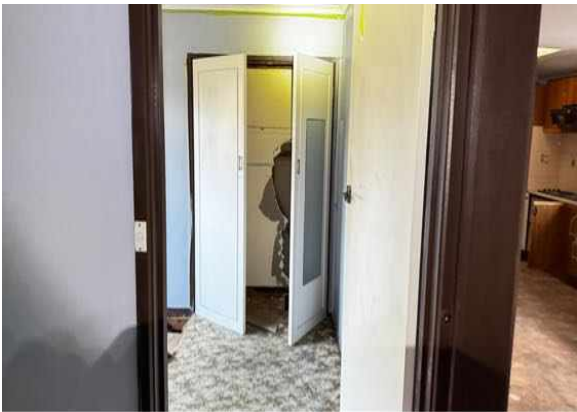
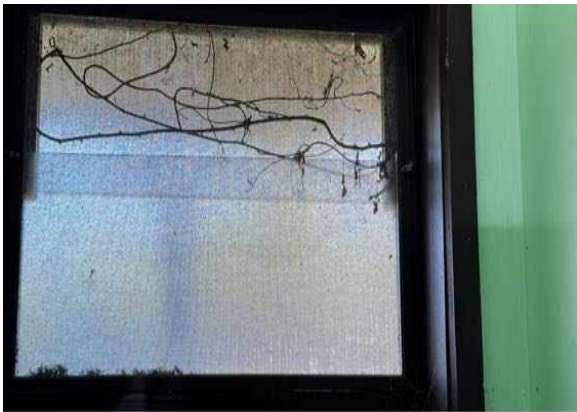
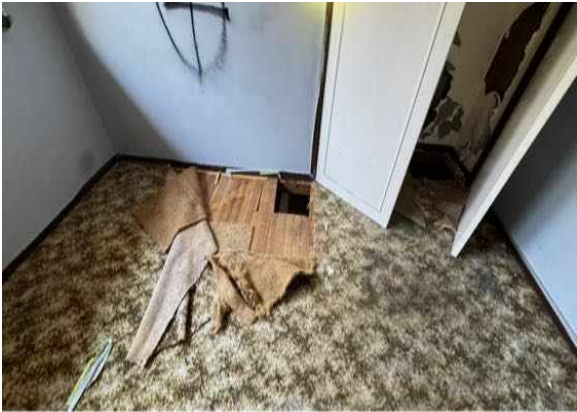
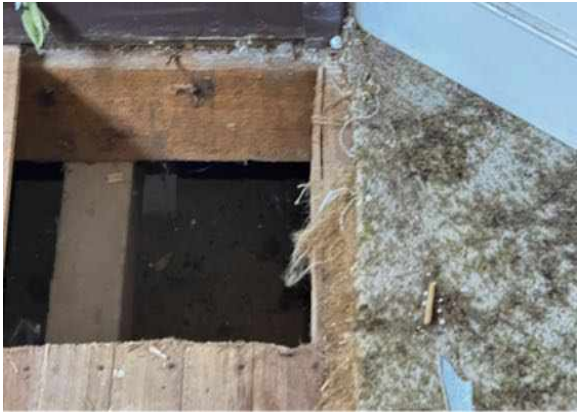
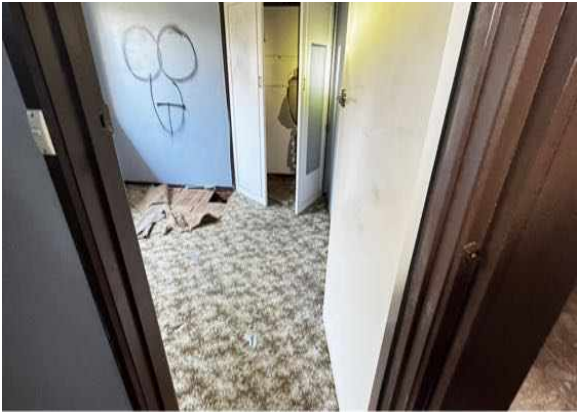
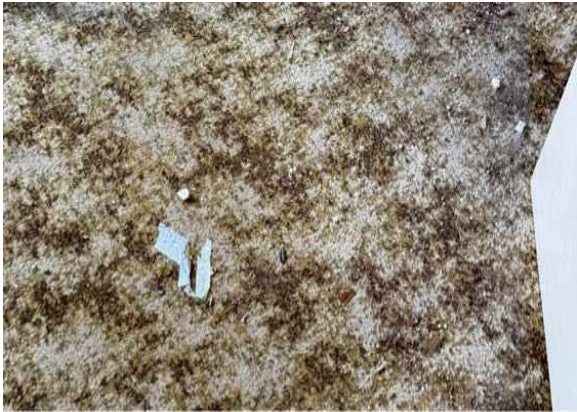
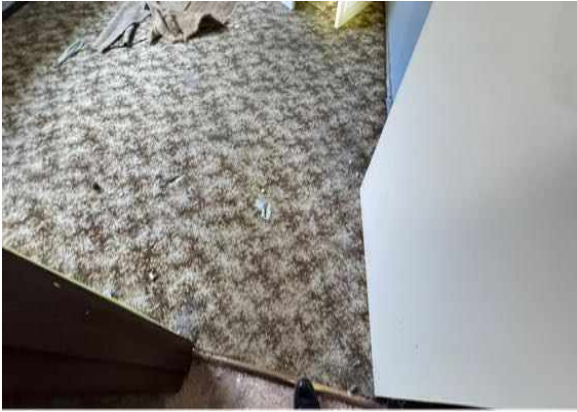
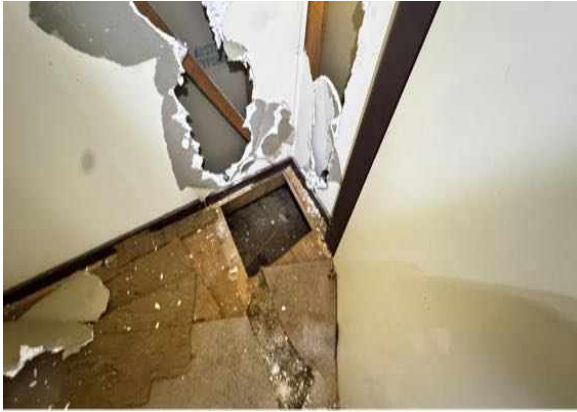
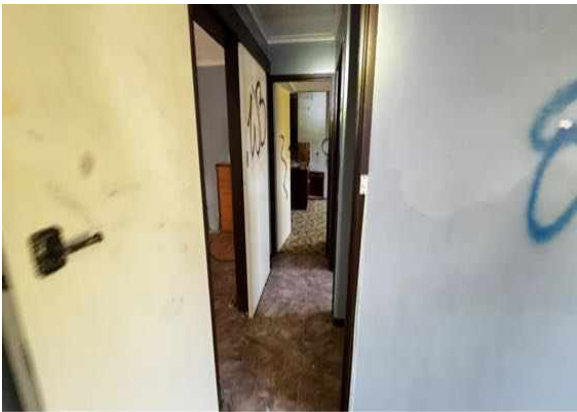
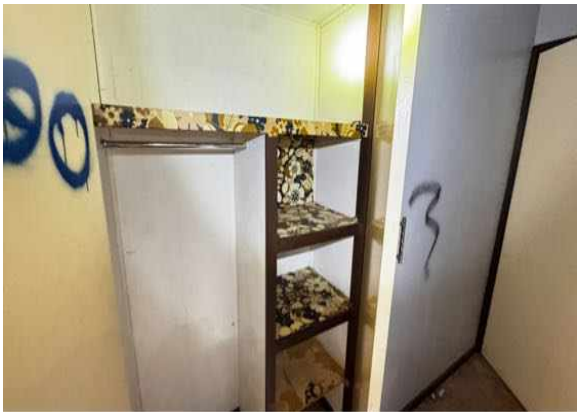
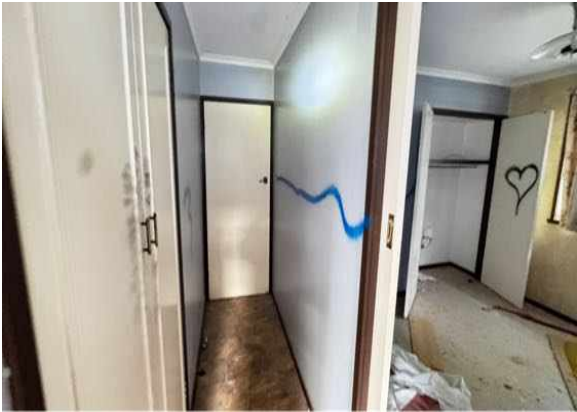
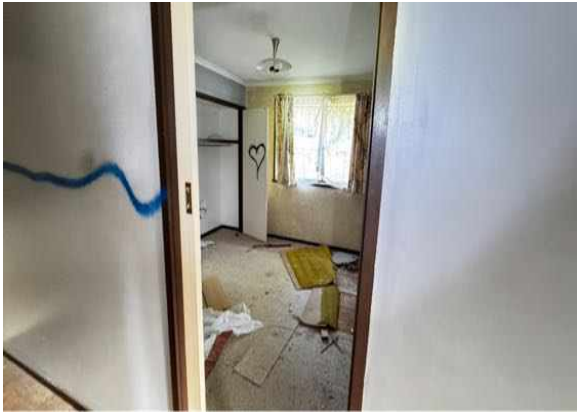
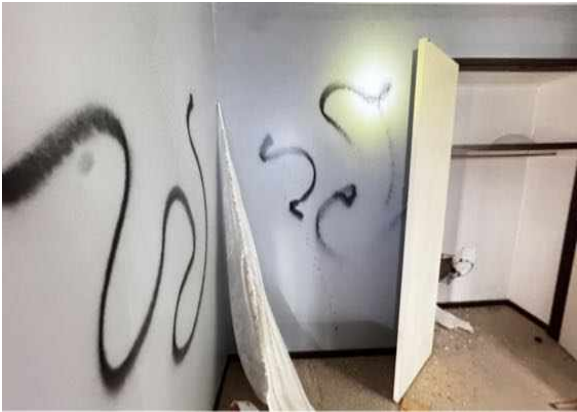
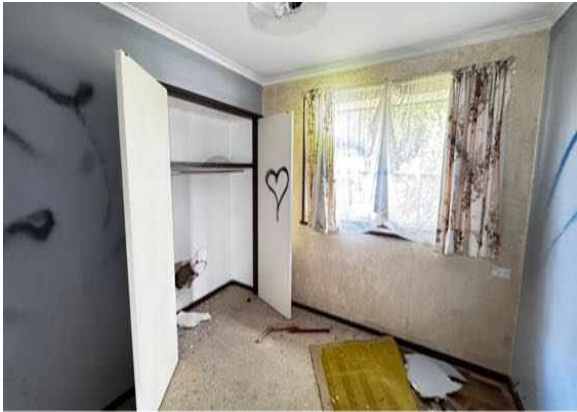
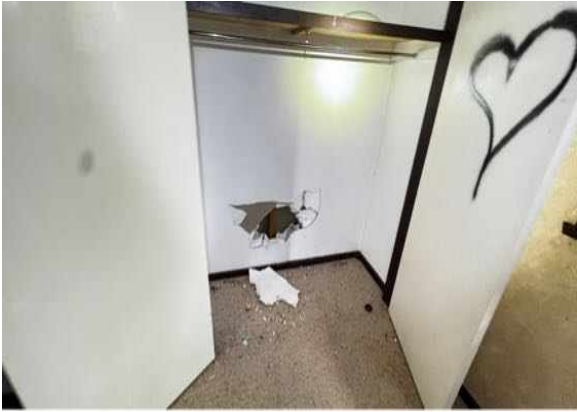
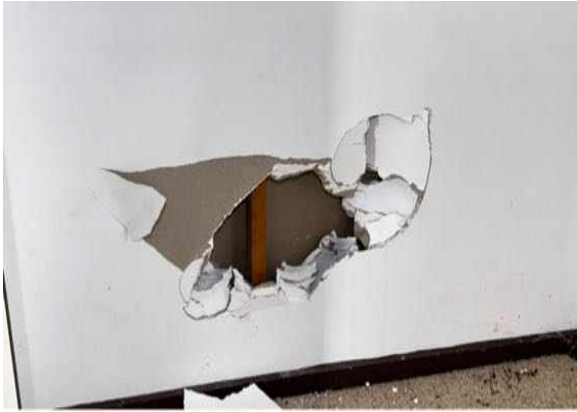
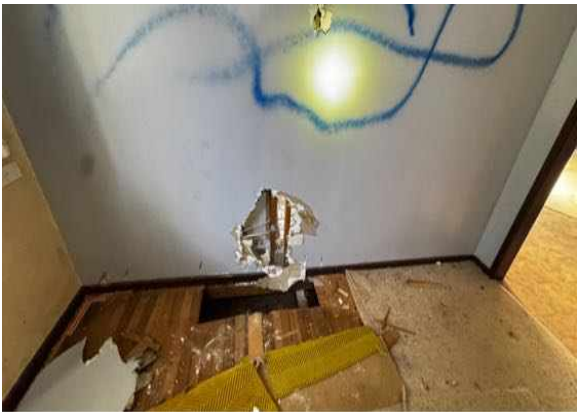
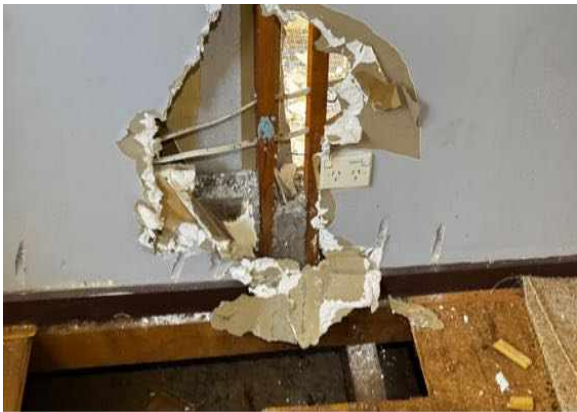
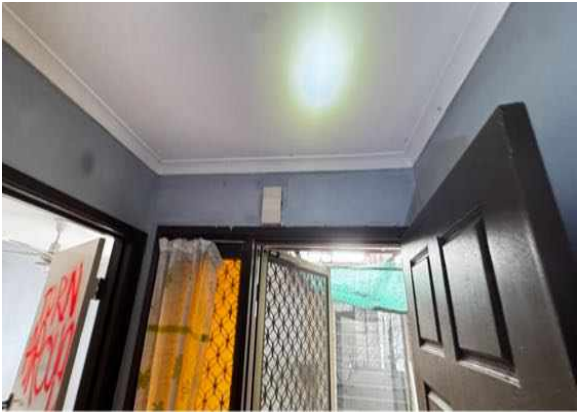
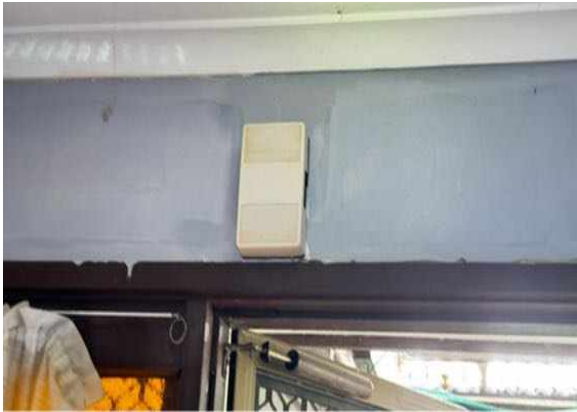
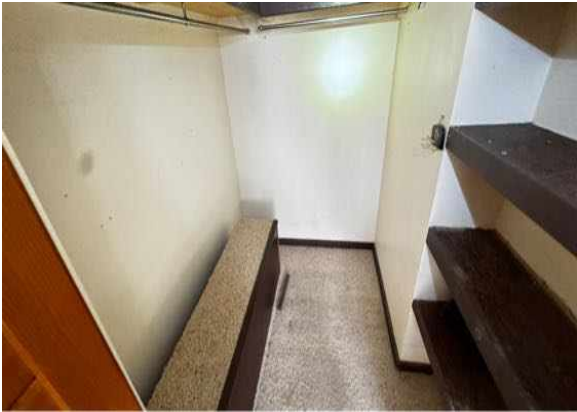
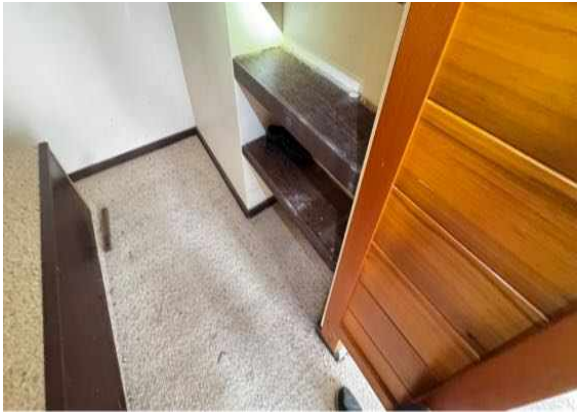
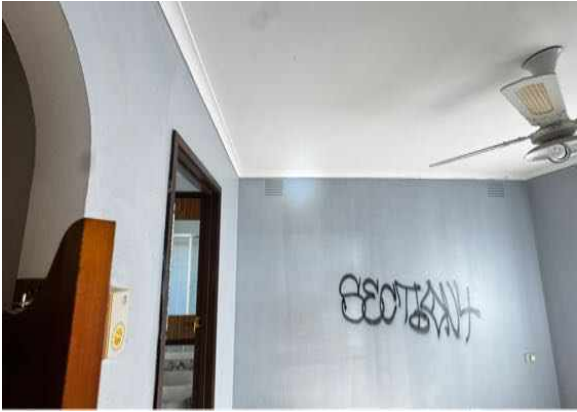
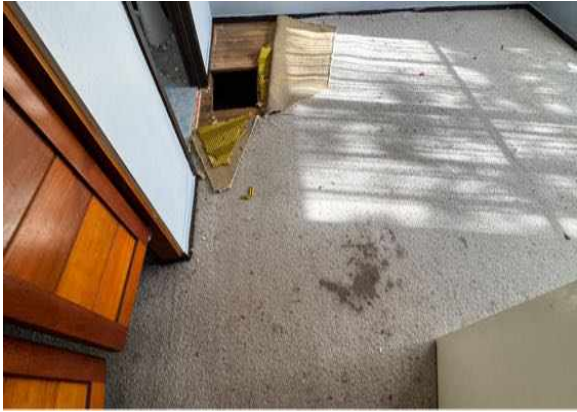
Building: Main Building  
Location: All Areas  
Finding: Walls – Major Plaster Damage Due to Vandalism  
Information: Extensive plaster damage was observed to internal walls in multiple areas of the dwelling at the time of inspection. The damage appears consistent with vandalism and includes broken, punctured, and missing sections of plaster linings.

This condition significantly detracts from the structural integrity of wall linings and the overall presentation of the dwelling. If left unaddressed, the damage may expose framing, services, or insulation, and may lead to further deterioration or safety risks.

It is recommended that a qualified plasterer or registered builder be engaged as a matter of urgency to assess the extent of damage, provide a scope of works, and carry out full replacement or repair of the affected plaster walls to restore the dwelling to a safe and acceptable condition.

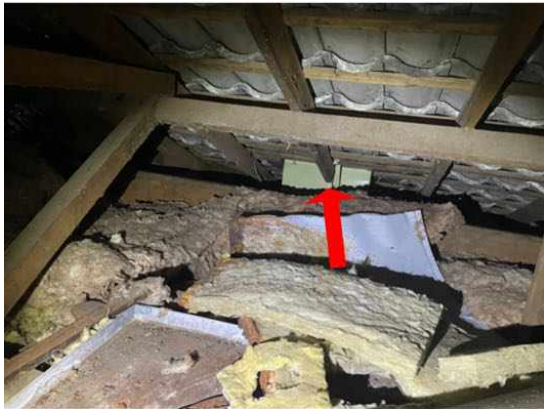
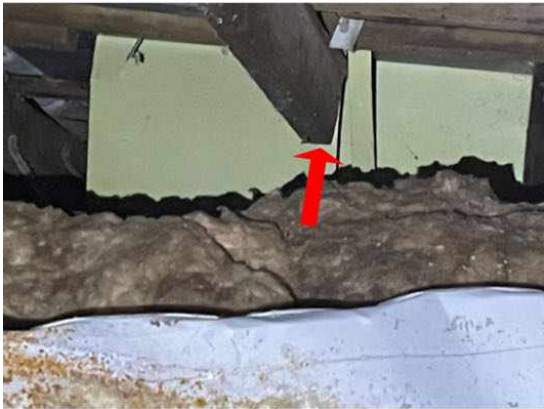
## Defects 2.02

Building:	Main Building
Location:	Roof Void >
Finding:	Roof Void - Structural Roof Framing Altered
Information:	During inspection of the roof space, structural members such as rafters, trusses, or joists were observed to have been cut or notched. The issue is present where these members have been altered, reducing their original size and strength.

This has likely occurred due to unauthorized modifications, installation of services without proper reinforcement, or poor original construction. Cutting or notching structural members can significantly reduce load-bearing capacity, compromise roof stability, and pose a serious safety hazard to occupants.

A structural engineer or registered builder is now required to inspect the roof space, assess the impact of the cut members, and undertake necessary remedial works. This may include reinforcement, replacement, or modification of affected members. Rectification should be completed immediately to ensure roof stability and occupant safety.

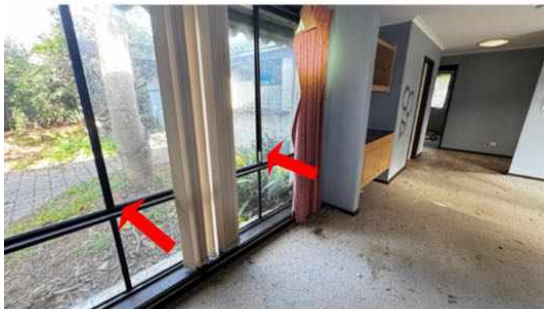
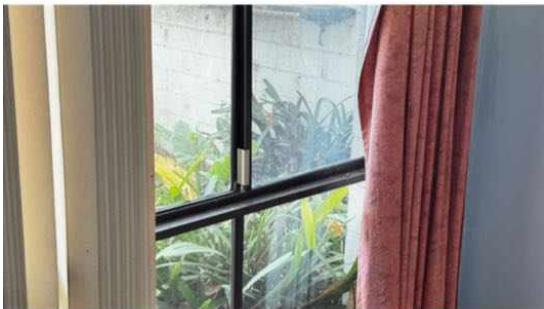
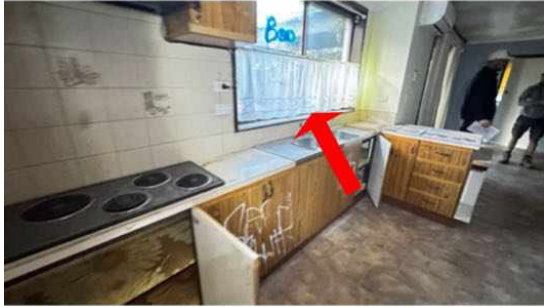
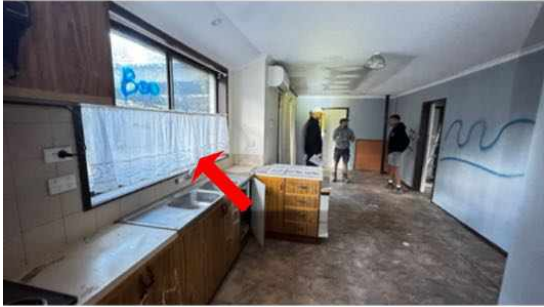
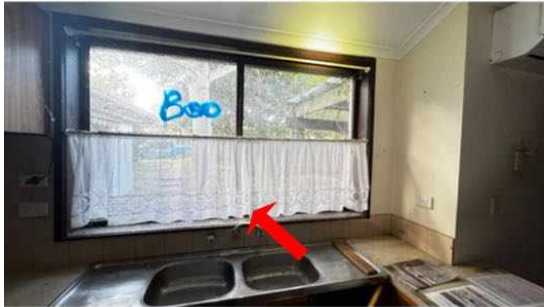
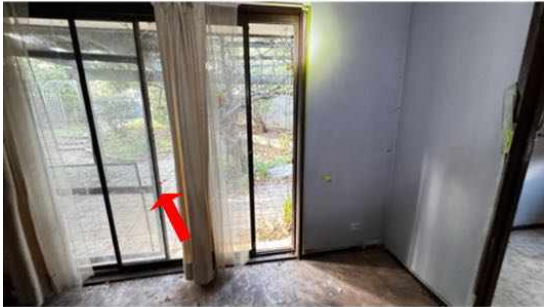
#### Defects 3.01

Building: Main Building  
Location: All Areas >  
Finding: Windows - Stiff To Open  
Information: Windows were observed to be stiff to open in this area. The stiffness can make the window difficult to operate, reduce usability, and may increase the risk of damage if force is applied.

Possible causes include misalignment, worn hardware, or buildup of debris.

It is recommended that the building owners engage a window specialist or registered builder immediately to assess the window and adjust, repair, or service it to restore smooth operation.
