## Building Inspection Report

Inspection Date: Thu, 22 Jan 2026

Property Address: 18 Mawarra Ave, Capel Sound VIC 3940,  
Australia

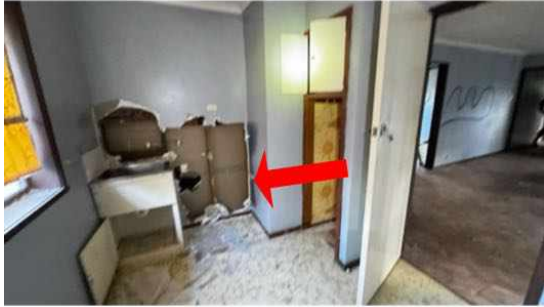
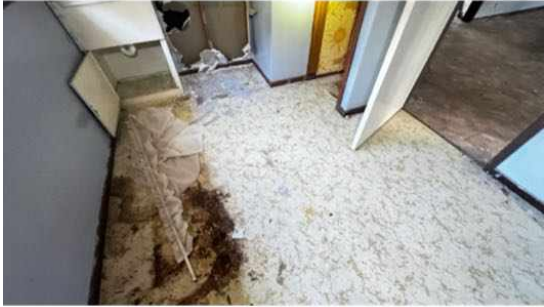
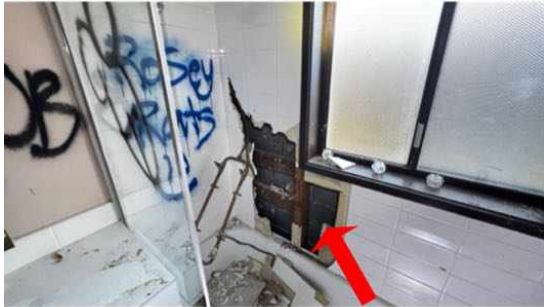
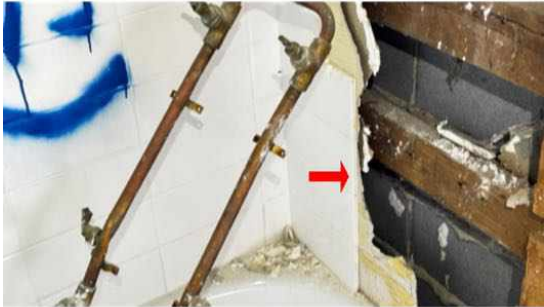
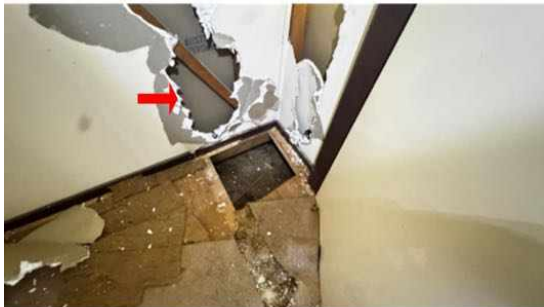
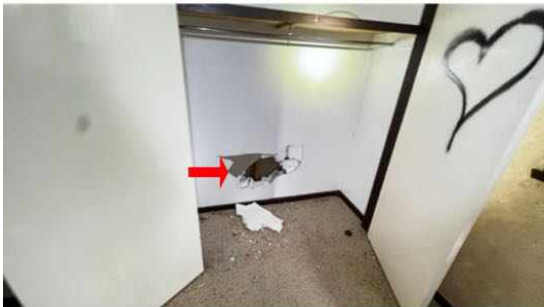
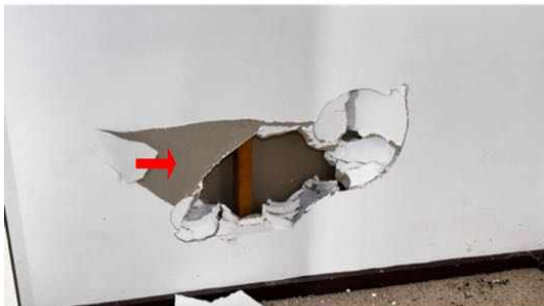
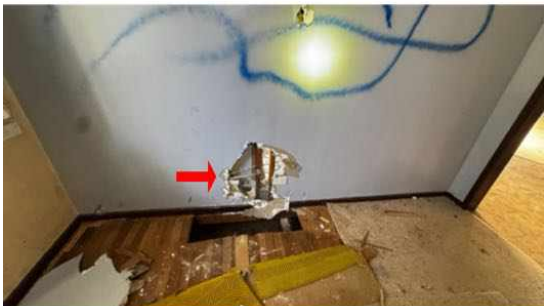
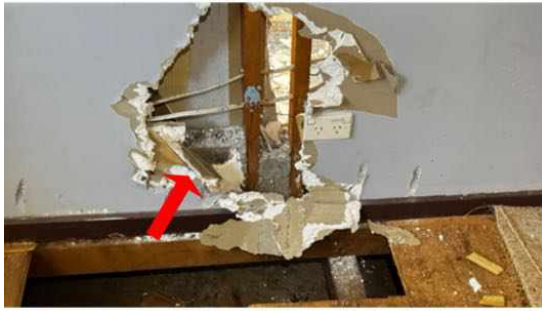
Defects 3.02

Building: Main Building  
Location: All Areas  
Finding: Walls – Major Plaster Damage Due to Vandalism  
Information: Extensive plaster damage was observed to internal walls in multiple areas of the dwelling at the time of inspection. The damage appears consistent with vandalism and includes broken, punctured, and missing sections of plaster linings.

This condition significantly detracts from the structural integrity of wall linings and the overall presentation of the dwelling. If left unaddressed, the damage may expose framing, services, or insulation, and may lead to further deterioration or safety risks.

It is recommended that a qualified plasterer or registered builder be engaged as a matter of urgency to assess the extent of damage, provide a scope of works, and carry out full replacement or repair of the affected plaster walls to restore the dwelling to a safe and acceptable condition.

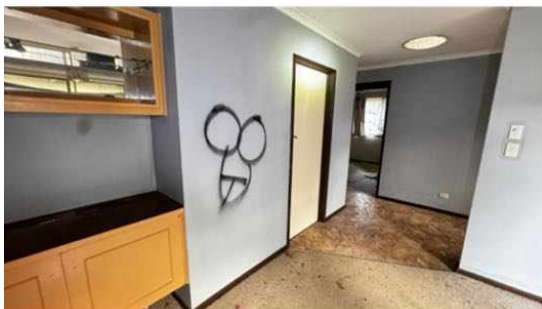
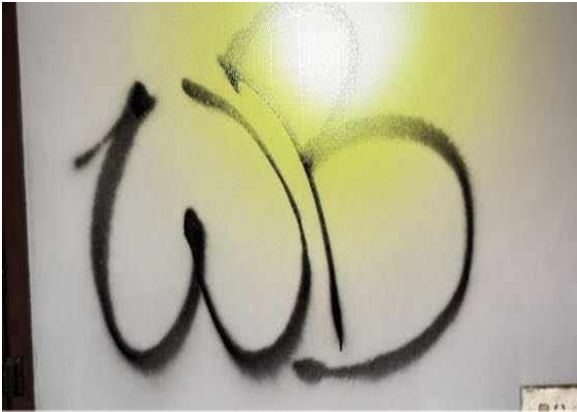
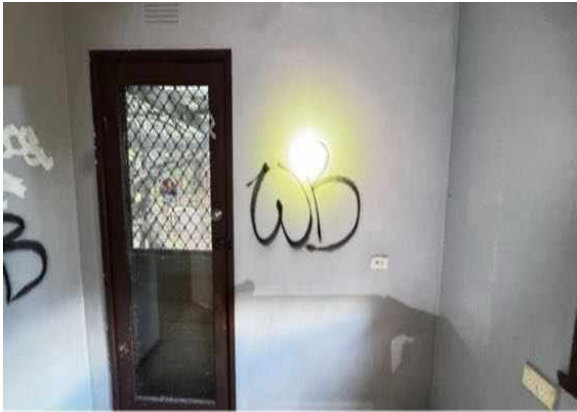
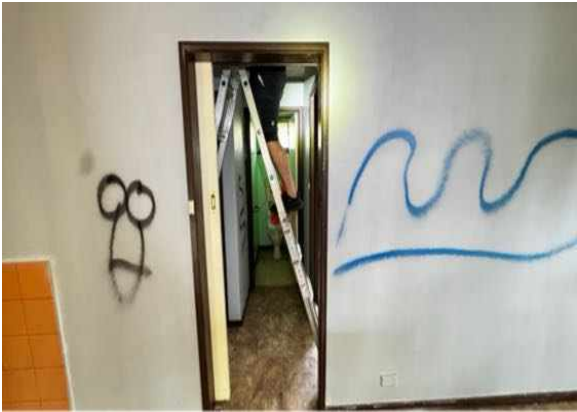
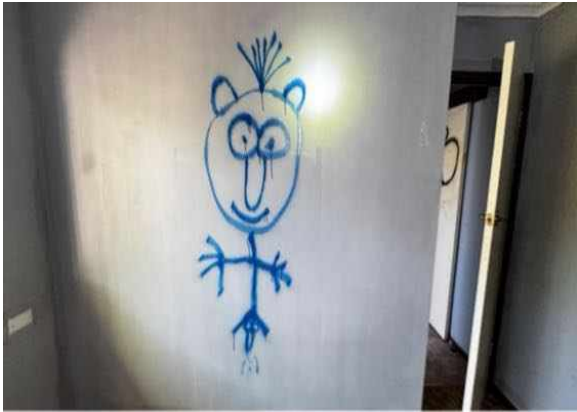
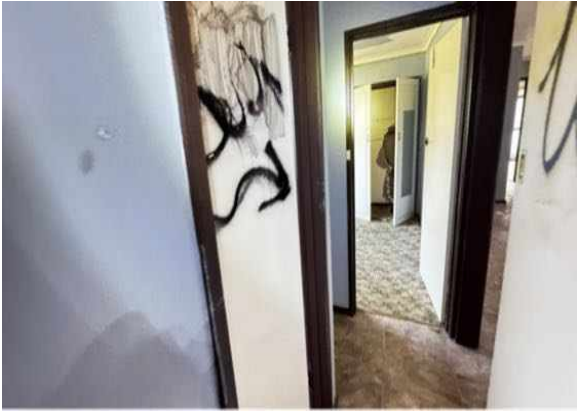
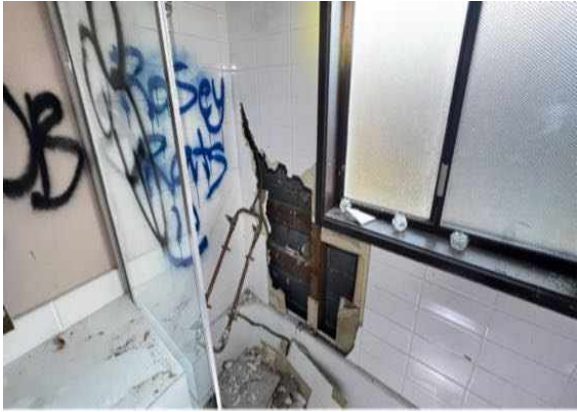
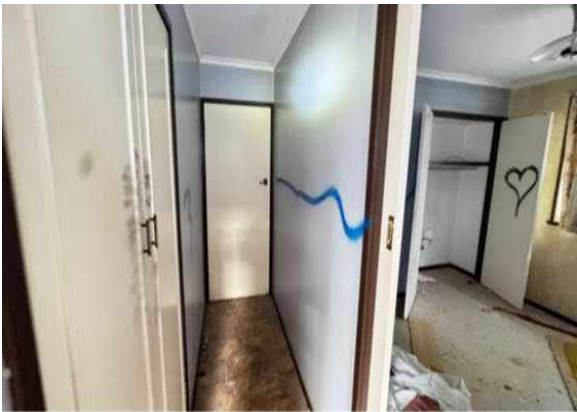
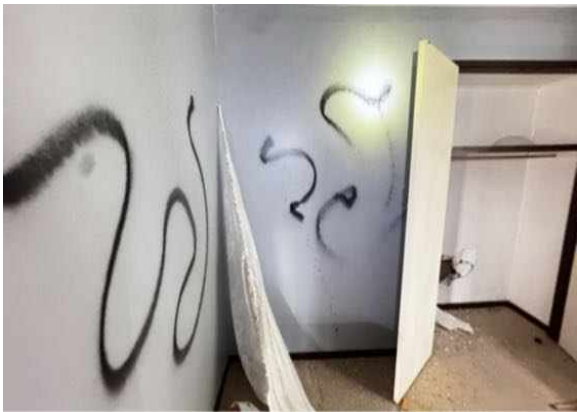
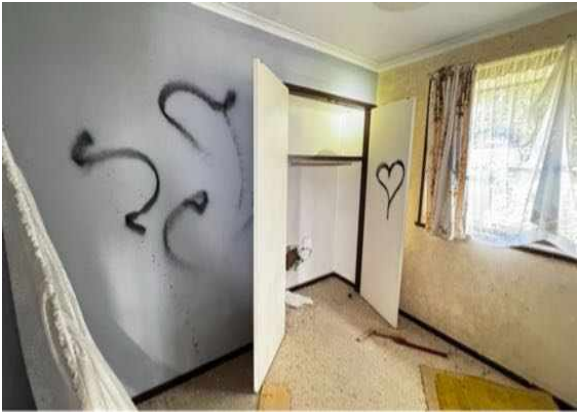
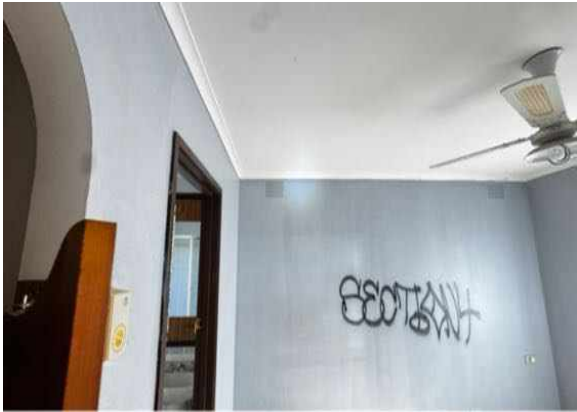
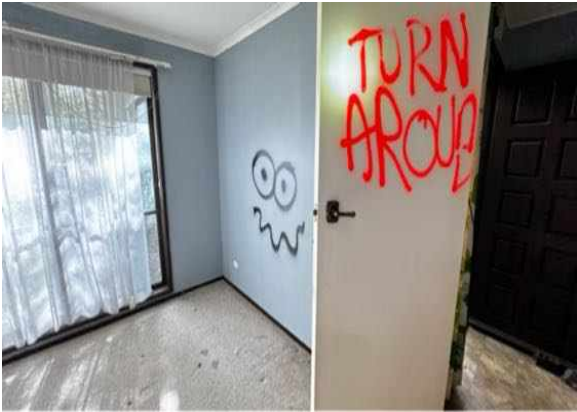
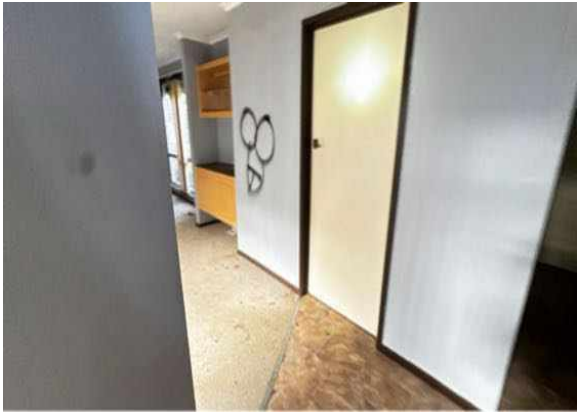
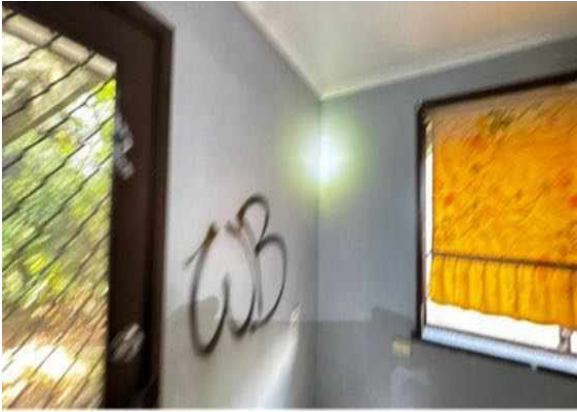
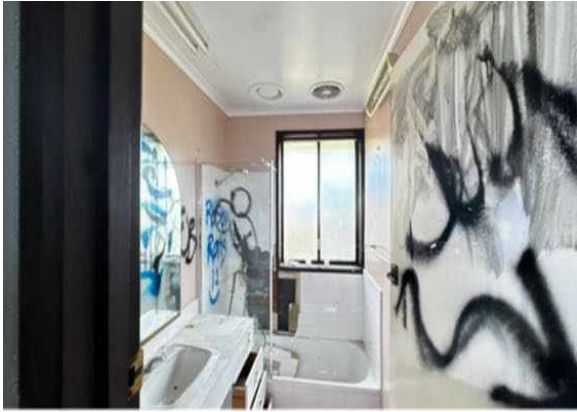
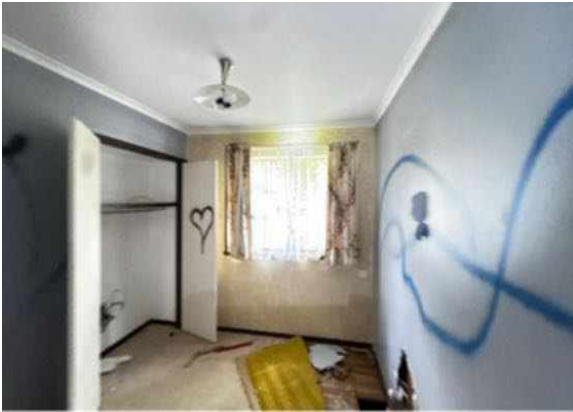
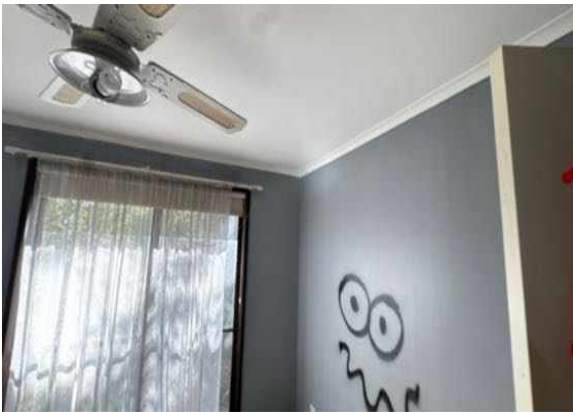
### Defects 3.03

Information: Discolouration and damage to painted wall finishes were observed in multiple areas of the dwelling at the time of inspection. The condition appears consistent with vandalism and significantly detracts from the internal presentation of the property.

The affected paint finishes may also conceal underlying damage to plaster surfaces and, if left unaddressed, may lead to further deterioration of wall linings.

It is recommended that a qualified painter or registered builder be engaged to assess the extent of the discolouration, identify any underlying substrate damage, and carry out appropriate surface preparation and repainting works once all other remedial repairs have been completed.

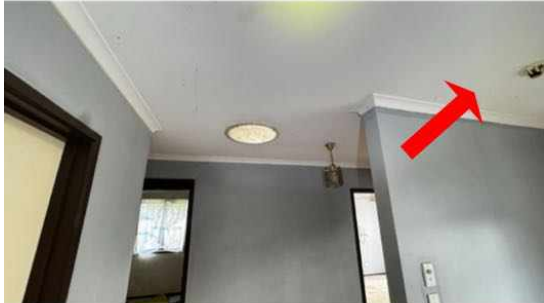
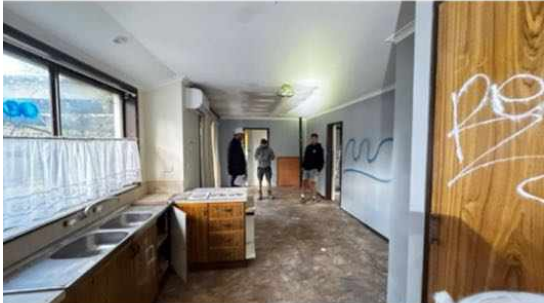
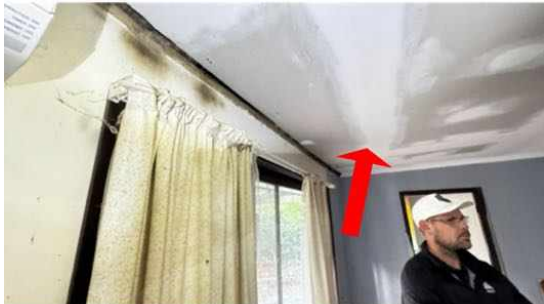
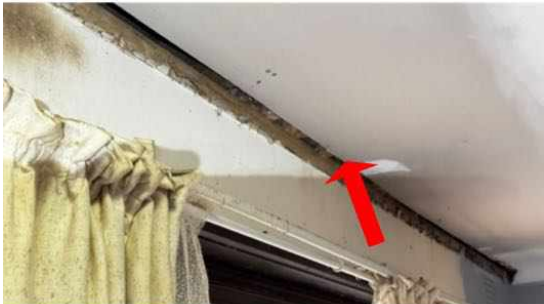
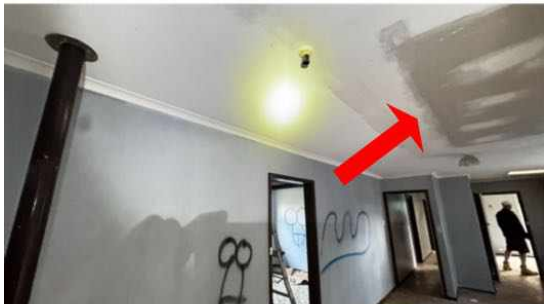
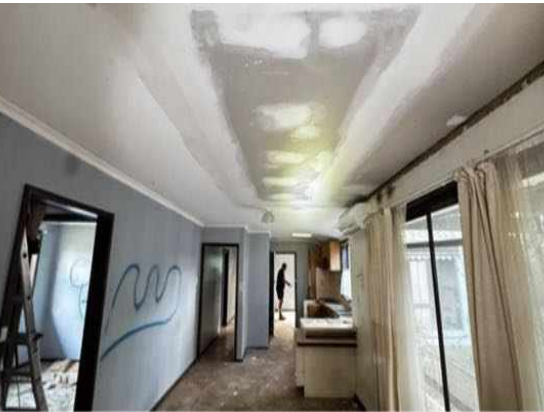
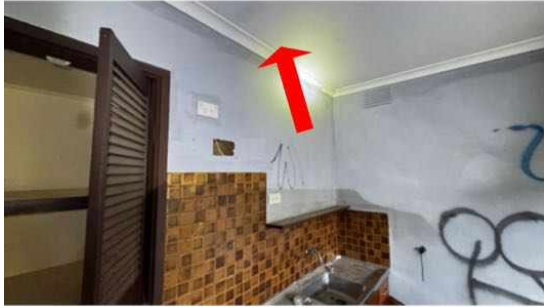
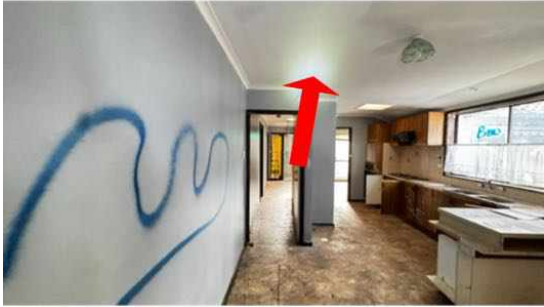
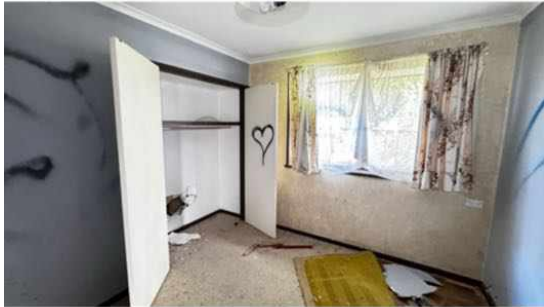
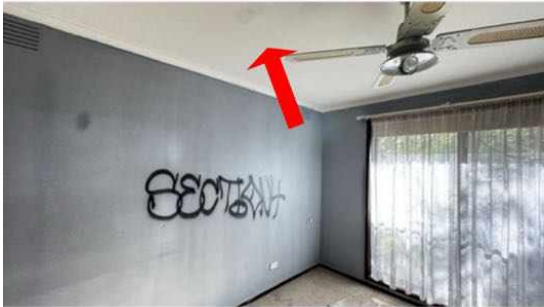
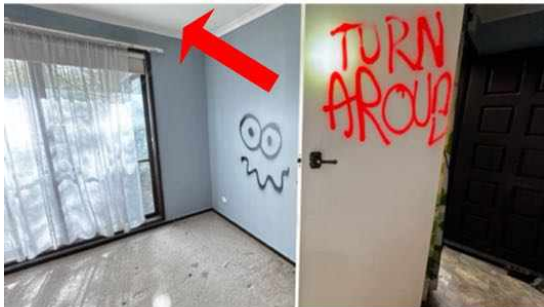
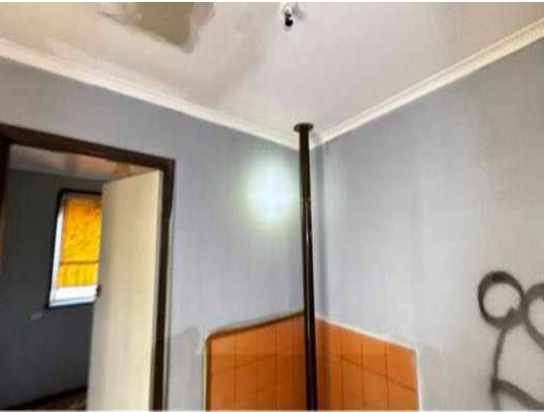
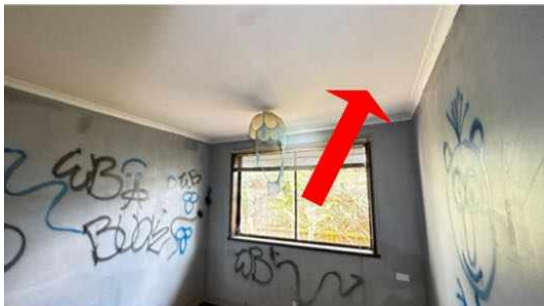
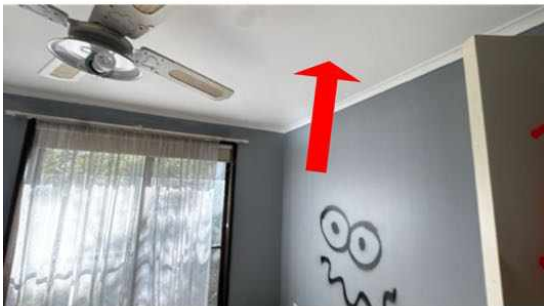
### Defects 3.04

Building: Main Building  
 Location: All Areas >  
 Finding: Ceilings - Poor Plaster Repairs  
 Information: The ceilings were inspected and poor plaster finishing was observed in this area. Uneven surfaces and general imperfections were noted, falling below acceptable workmanship standards.

These defects are likely due to inadequate sanding, poor application of joint compound, or substandard workmanship during installation. If left unaddressed, the imperfections may remain visible after painting and could contribute to future cracking or deterioration.

When practical, a qualified plasterer should be engaged to repair and refinish the affected ceiling areas. A qualified painter should then repaint the ceilings to restore a smooth, consistent finish and improve overall appearance.

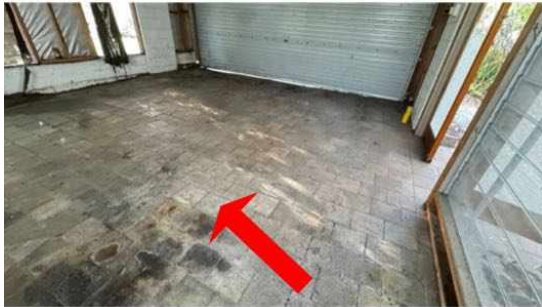
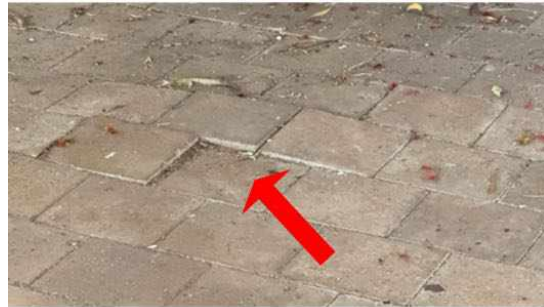
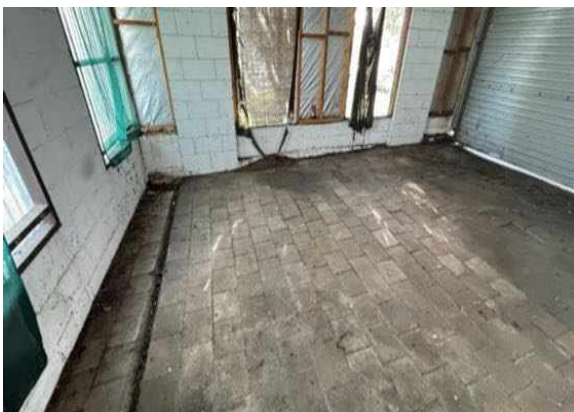
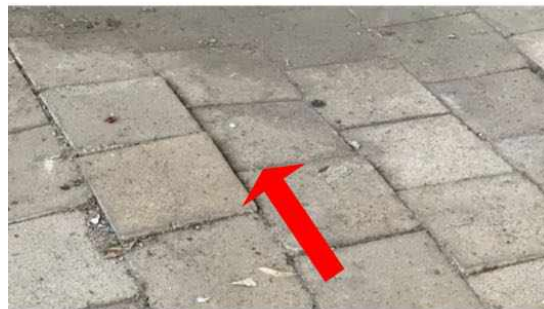
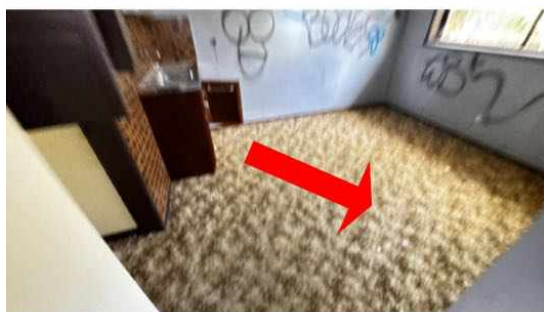
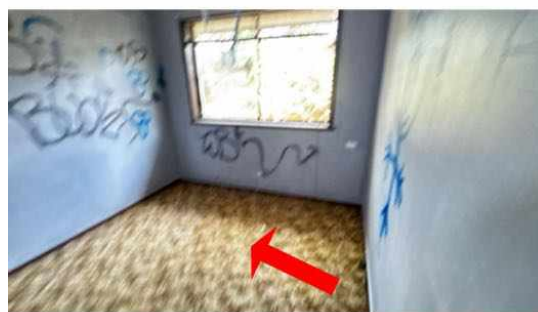
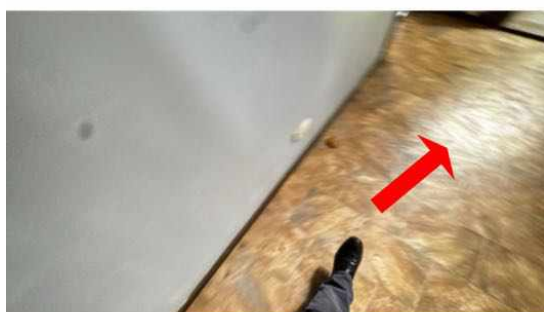
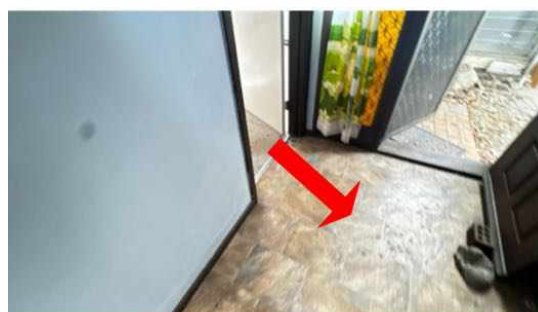
Defects 3.05

Information: A deviation in surface levels of the concrete was observed in this area, with noticeable slopes, or undulations. Deviations in floor level can affect the performance of finishes and may indicate underlying structural or foundation issues.

The deviation may be due to differential settlement of footings or foundations, improper finishing or compaction during construction.

The affected area should be monitored over time to assess whether the deviation worsens. If further movement, additional dips, or other signs of structural concern are observed, a registered builder or structural engineer should be engaged immediately to inspect and provide advice on necessary repairs. Monitoring will help ensure the ongoing condition and safety of the floor.

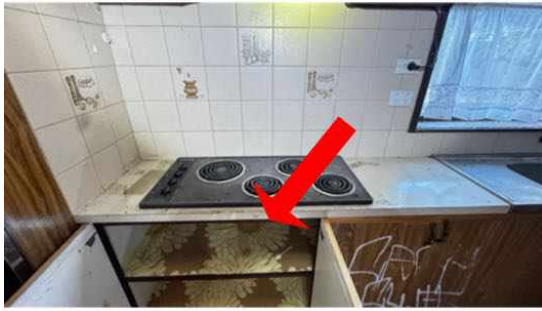
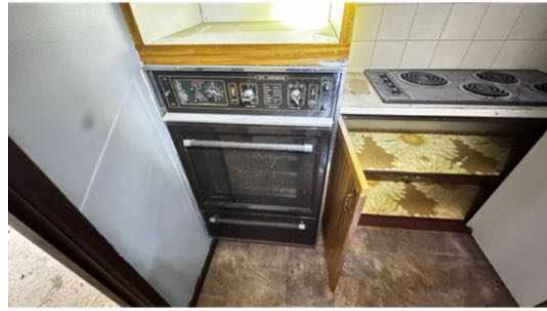
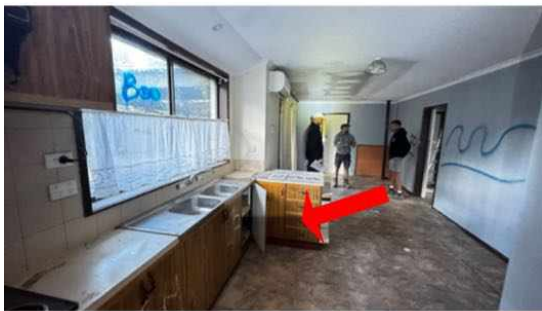
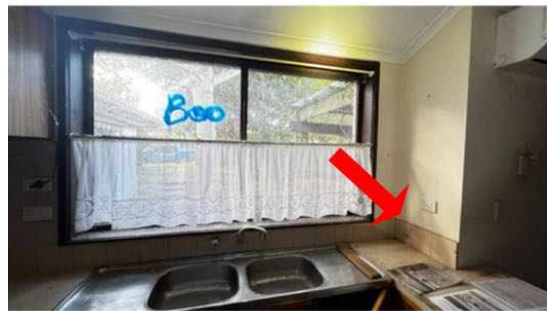
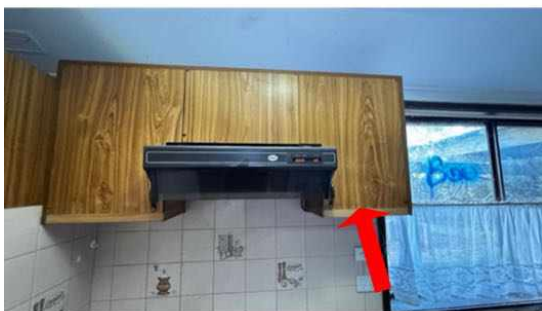
### Defects 3.06

Building:	Main Building
Location:	Kitchen >
Finding:	Kitchen - Cabinets - Damaged
Information:	The inspection identified kitchen cabinets with visible damage. Defective cabinets can compromise usability, hygiene, and, over time, may deteriorate further if exposed to moisture.

The issue may be caused by age-related material deterioration, poor installation practices or impact damage from daily use.

A licensed carpenter, joiner, or kitchen specialist should be engaged immediately to assess, repair, or replace the affected cabinets. Remedial works may include re-gluing, re-sealing, replacing damaged sections, or full replacement if structural integrity is compromised. Prompt rectification will restore functionality, prevent further deterioration, and maintain hygiene and appearance.

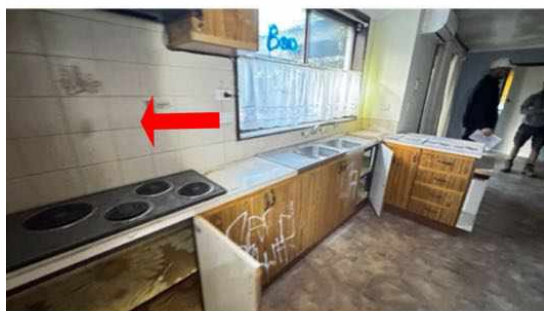
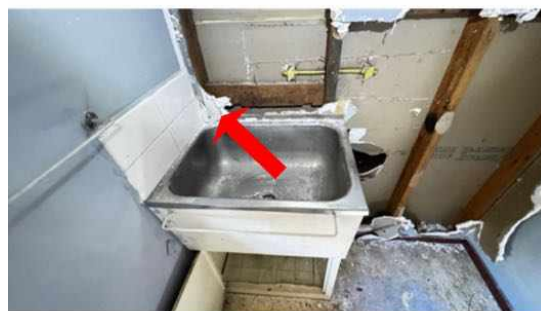
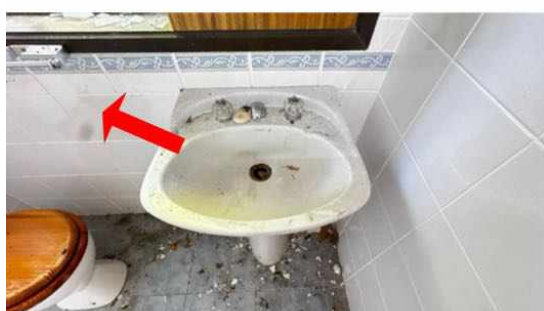
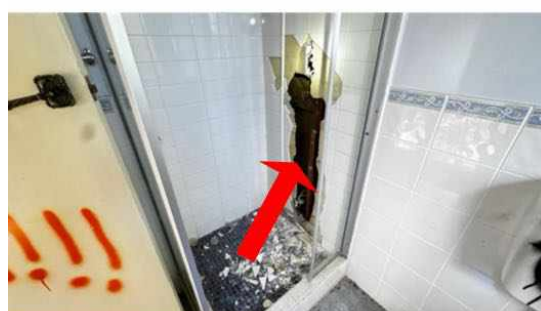
### Defects 3.07

Finding: Tiles - Cracked

Information: Cracked tiles were observed in this area. Cracked tiles can reduce durability and appearance and, if left unaddressed, may result in further detachment or damage.

This condition may be due to inadequate adhesive during installation, movement of the substrate, age-related deterioration of the tile bonding, or impact from normal use.

A qualified tiler or competent handyman should be engaged immediately to secure or replace the affected tiles. Prompt attention will restore surface integrity, maintain

hygiene, and protect the long-term appearance of the tiled area.

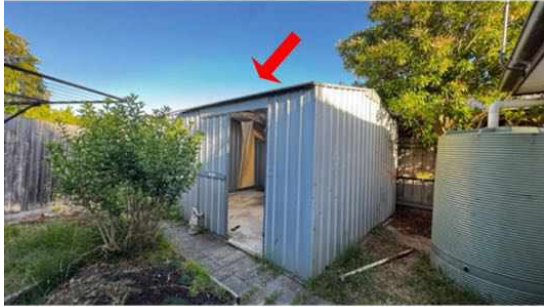
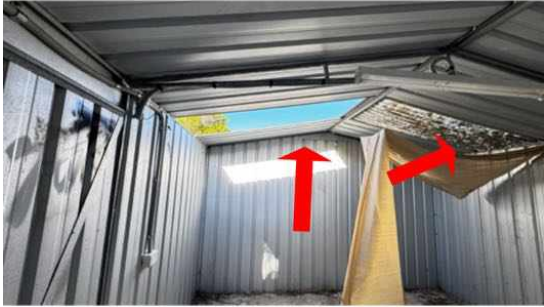
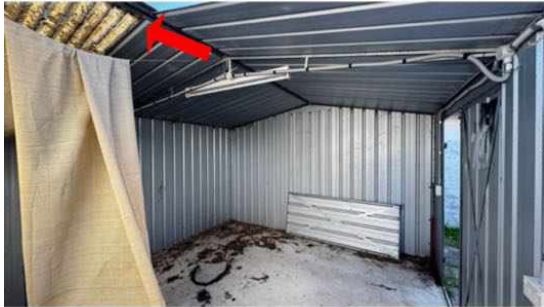
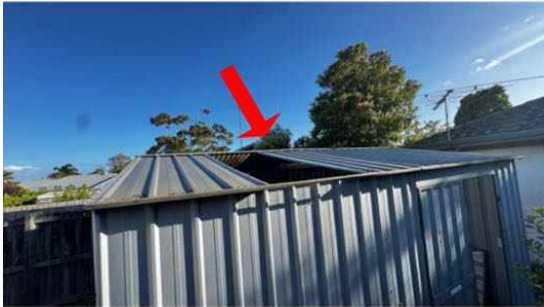
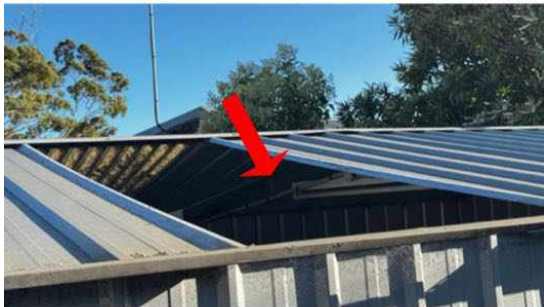
### Defects 3.08

Building: Main Building  
 Location:  
 Finding: Garden Shed - General Condition  
 Information: The garden shed was inspected visually. The shed structure shows signs of age-related deterioration, including corrosion of roofing and walls and weathered components.

The shed does not appear to compromise the primary dwelling structure but may reduce usability, weatherproofing, and amenity. This deterioration is likely due to age, exposure to weather, and a lack of regular maintenance.

When practical, a competent hand man should be engaged to repair or replace damaged, missing, or weathered components. Rectification will restore functionality, durability, and weatherproofing of the shed.

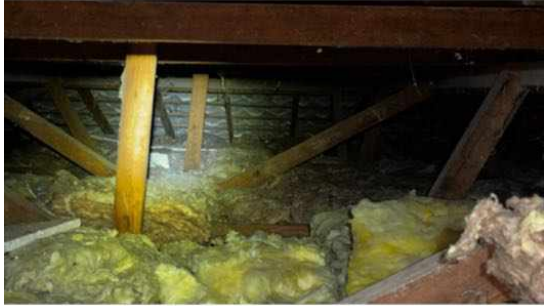
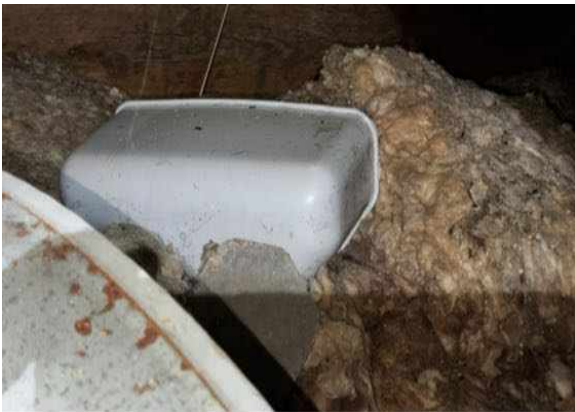
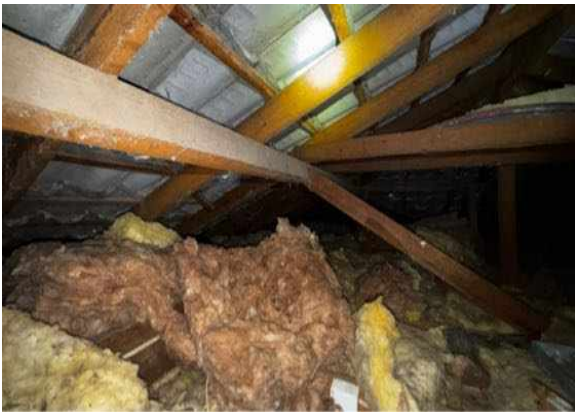
**Defects 3.09**

Building: Main Building  
 Location: Roof Void  
 Finding: Roof Void - Limited Access  
 Information: Limited access to the roof void was present due to facts including but not limited to, limited access, insulation, Air condition Unit & ducting, obstructions or placement of insulation and or sarking, for this reason complete access to the roof void was not possible.

NOTE: Unless all insulation is removed from the roof space a full inspection is never possible, timber pest or termite activity and/or damage may not be visible.

A visual inspection was carried out from accessible areas only, recommend installing another access hatch in a more accessible area for a re-inspection.

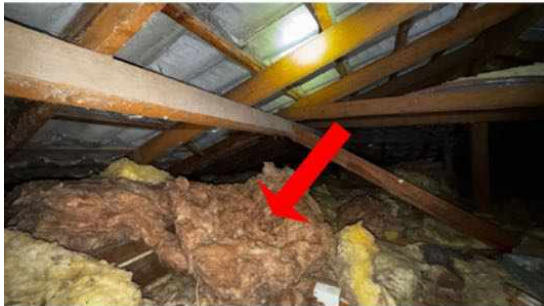
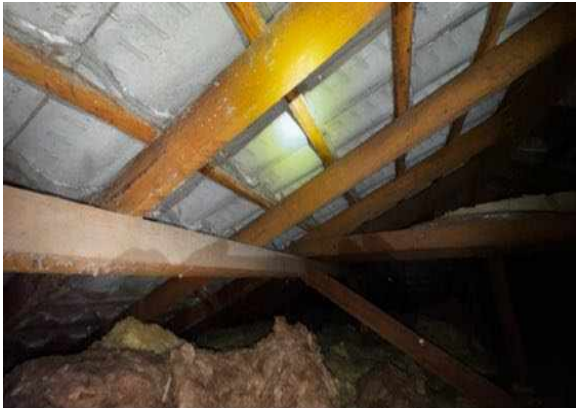
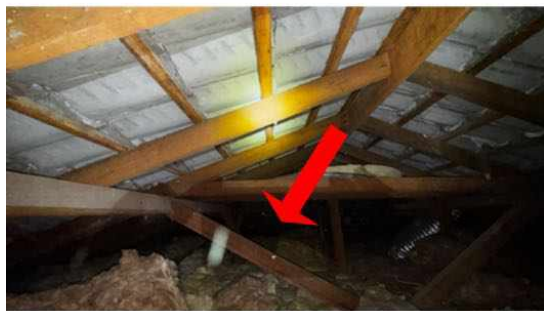
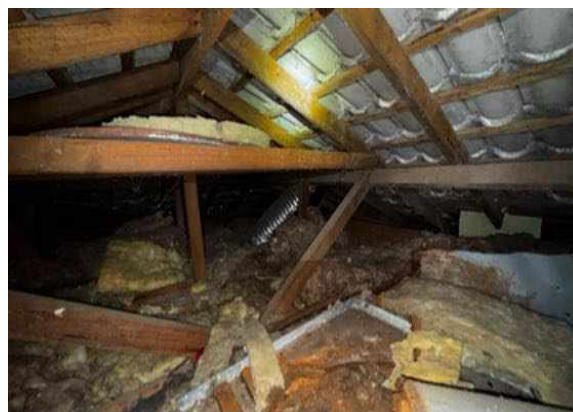
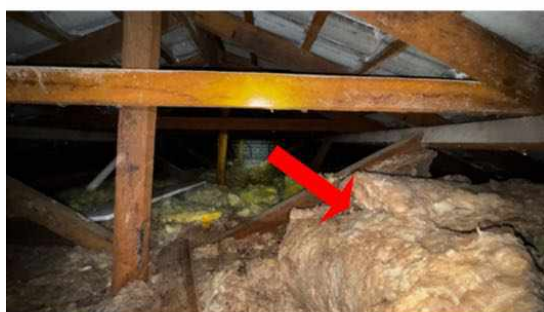
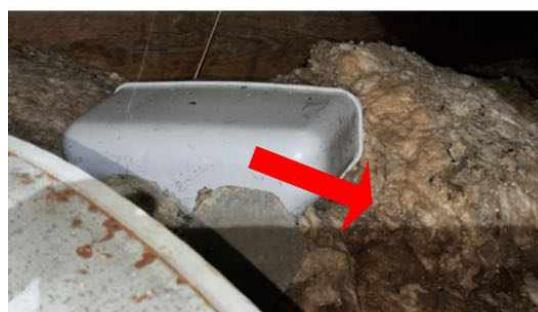
**Defects 3.10**

Building: Main Building  
Location: Roof Void >  
Finding: Roof Void - Inadequate Insulation Installation  
Information: Insulation in the roof void was found to be unevenly installed, with gaps, inconsistent coverage, and some displaced sections. This reduces its effectiveness in maintaining thermal efficiency.

The issue may result from poor workmanship during installation or movement of insulation after installation. If not corrected, the reduced insulation can increase heating and cooling costs and may create cold spots that lead to localized condensation or moisture issues.

A qualified insulation installer should be engaged promptly to assess the roof void and reposition or add insulation as needed to ensure full, even coverage without compression. Regular monitoring is recommended to maintain thermal performance.

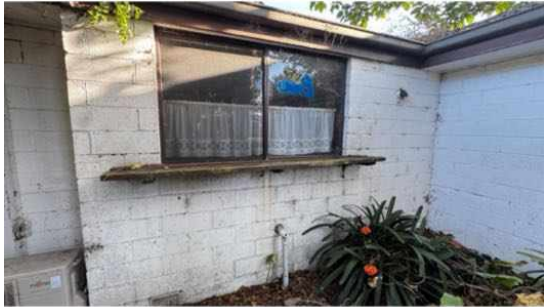
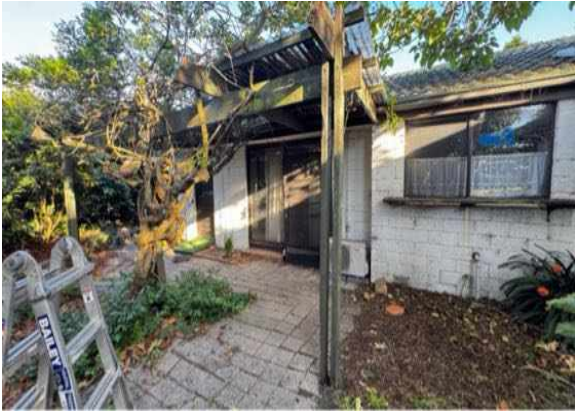
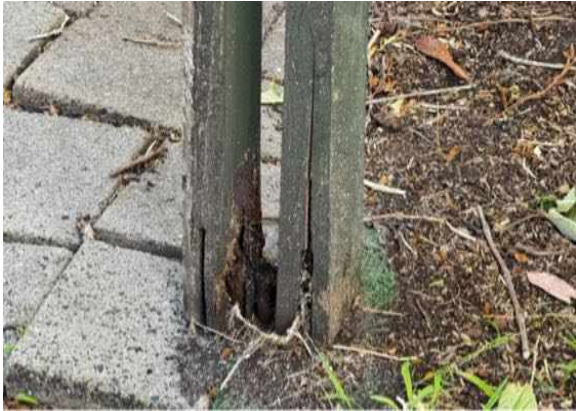
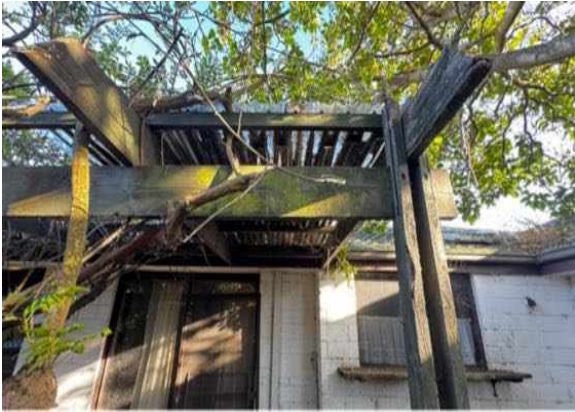
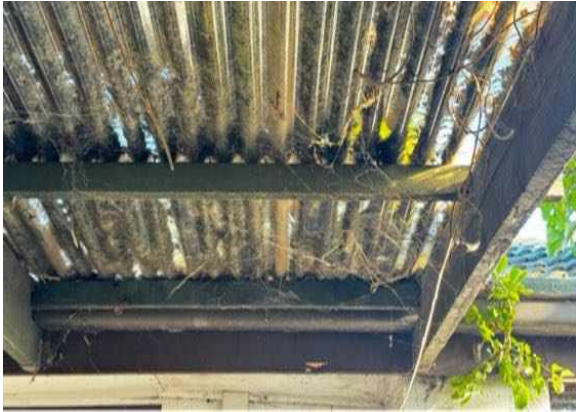
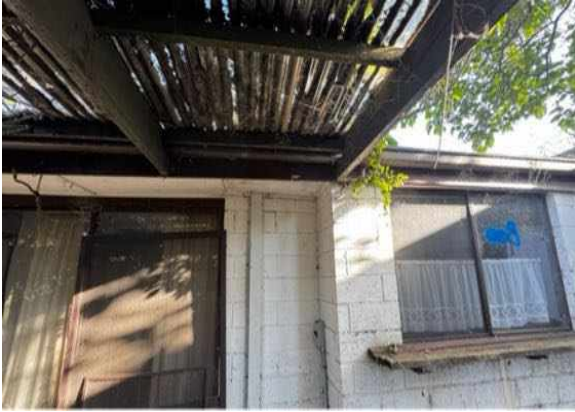
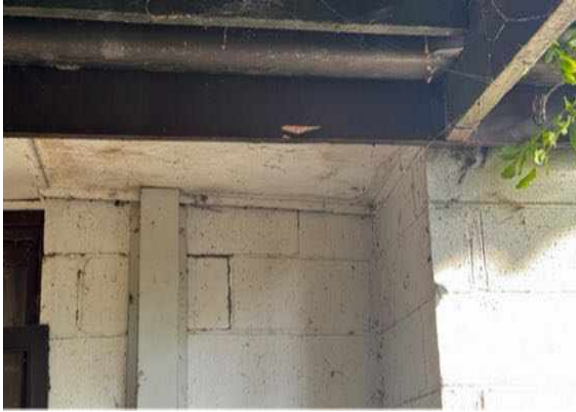
### Defects 3.11

Building:	Main Building
Location:	All External Areas
Finding:	External Timber - Timber Rot
Information:	Timber elements including wall claddings, timber rails & posts, landscaping timbers, and other external timber surfaces were inspected and show signs of rot, decay and fungal attack in these areas. Softening, discoloration, splitting, and moisture penetration indicate ongoing timber degradation.

This is likely caused by prolonged moisture exposure, inadequate protective coatings or maintenance, direct contact with soil or water, or poor detailing that traps water or limits ventilation.

If left unaddressed, the affected timber may lose structural integrity, leading to progressive decay, potential collapse of walls, decks, or landscaping features, mould growth, and reduced durability and appearance of the building exterior.

A registered builder or timber specialist should inspect the affected areas immediately to determine the extent of damage. Damaged timbers should be repaired or replaced, protective treatments applied, and drainage or detailing corrected to prevent recurrence. Ongoing monitoring and urgent remedial action are required to prevent further deterioration.
