## Building Inspection Report

Inspection Date: Thu, 22 Jan 2026

Property Address: 18 Mawarra Ave, Capel Sound VIC 3940,  
Australia

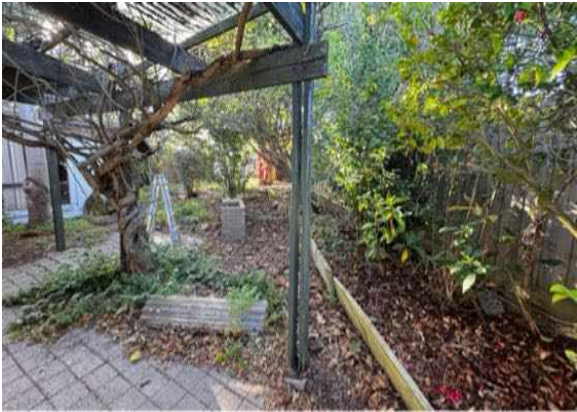
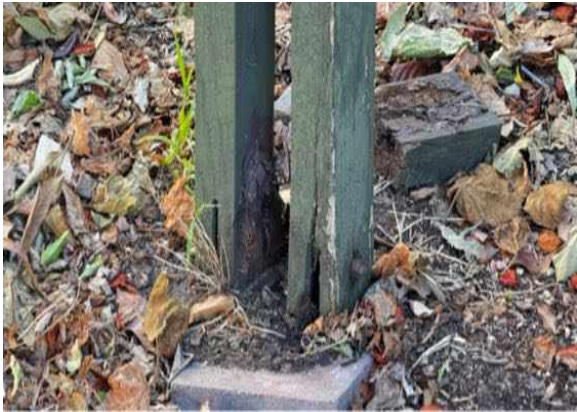
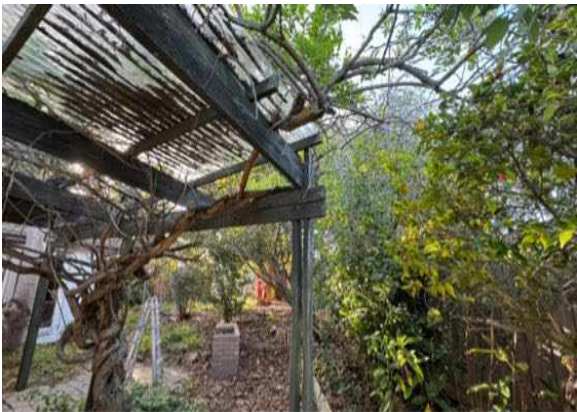
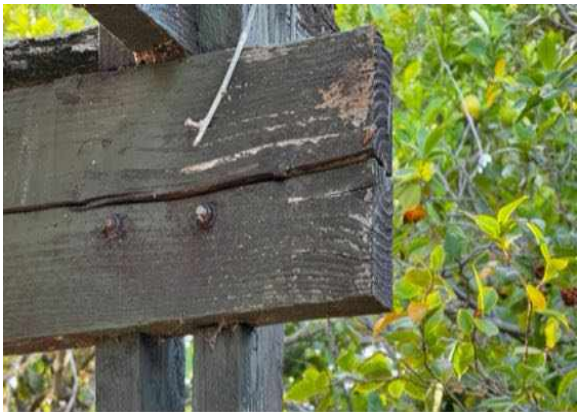
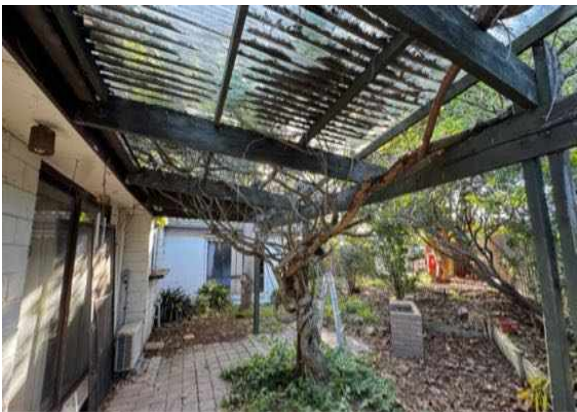
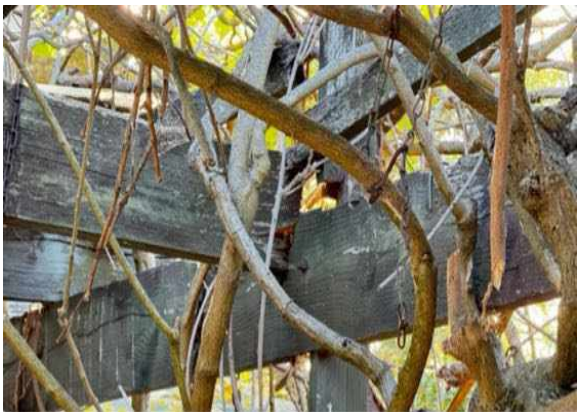
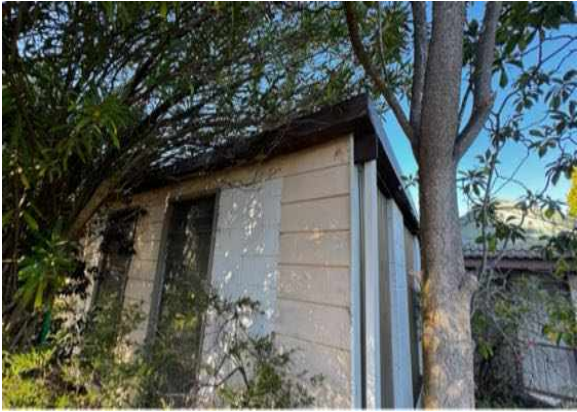
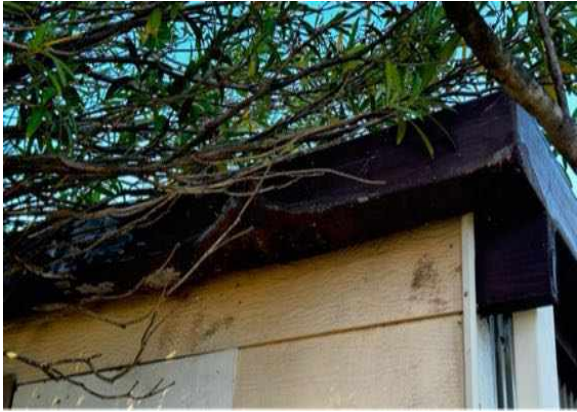
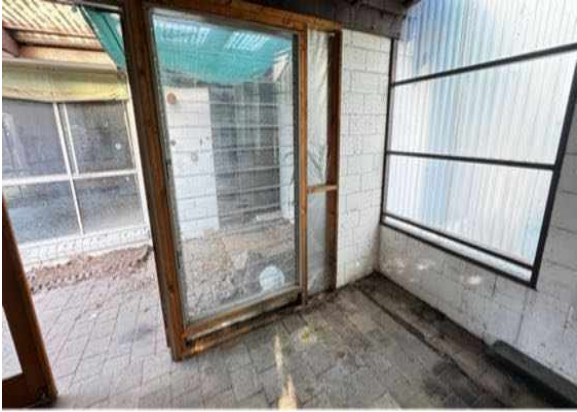
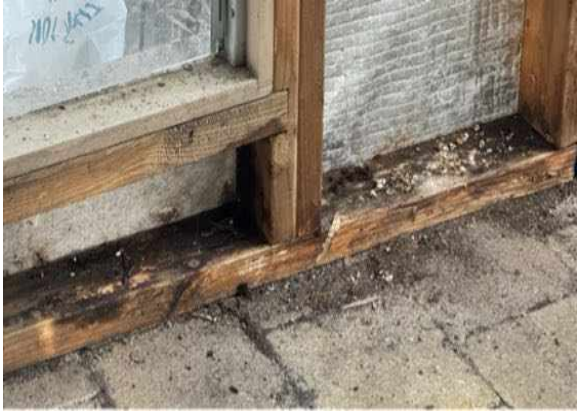
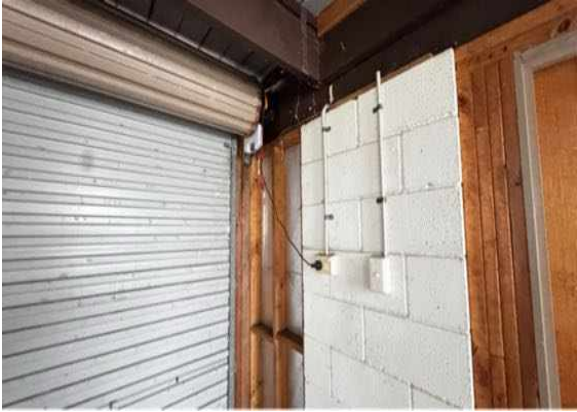
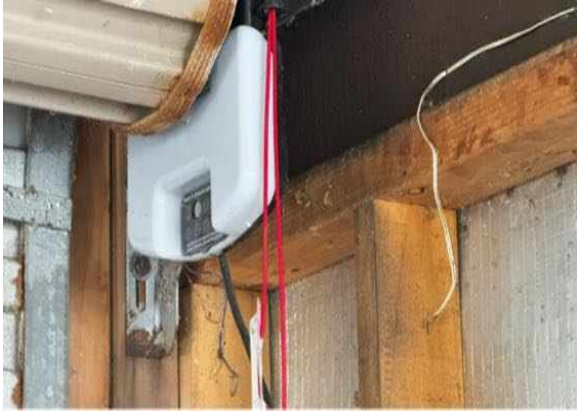
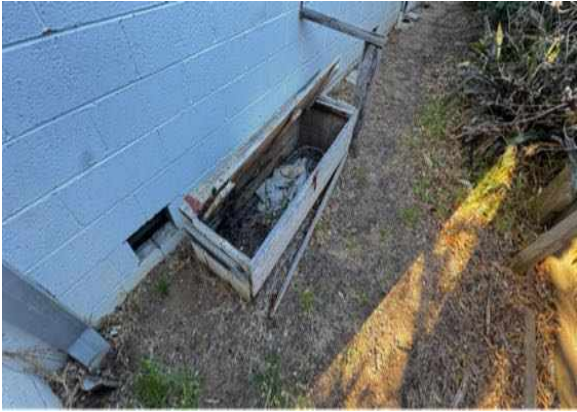
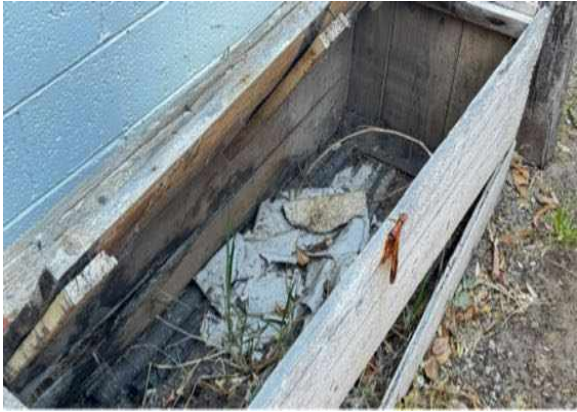
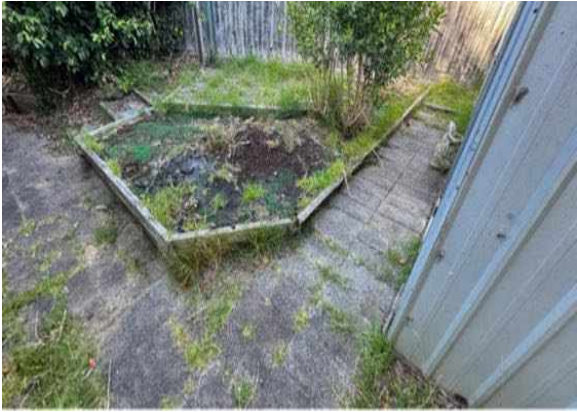
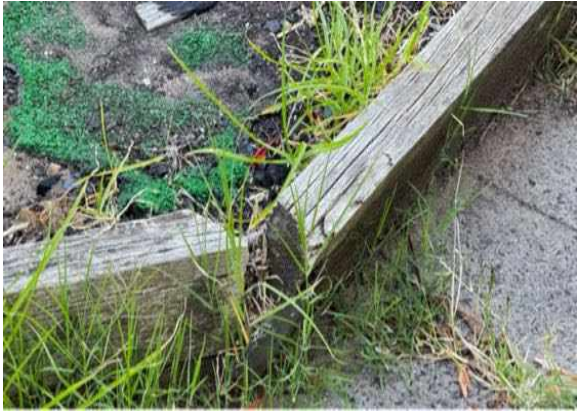
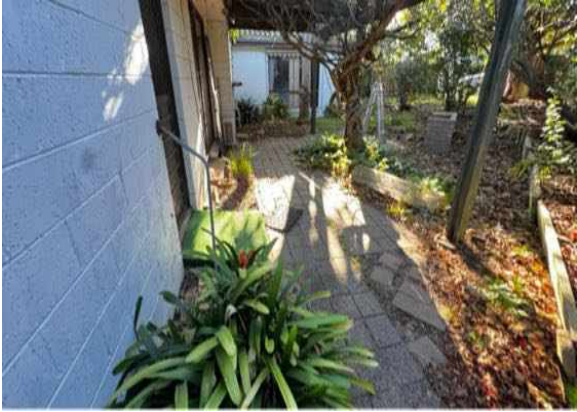
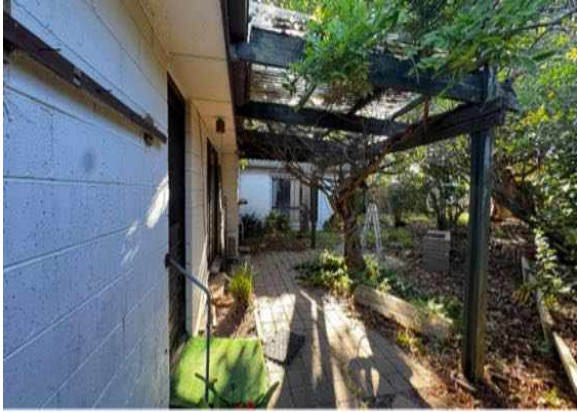
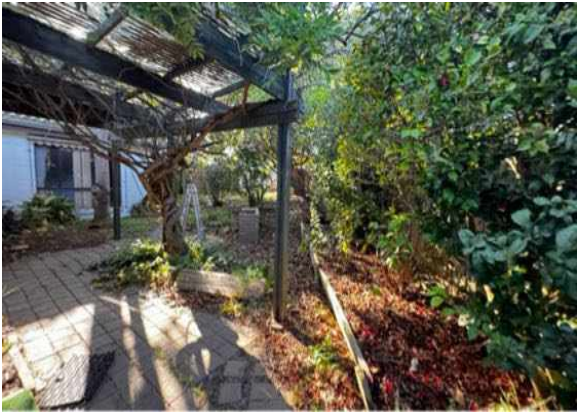
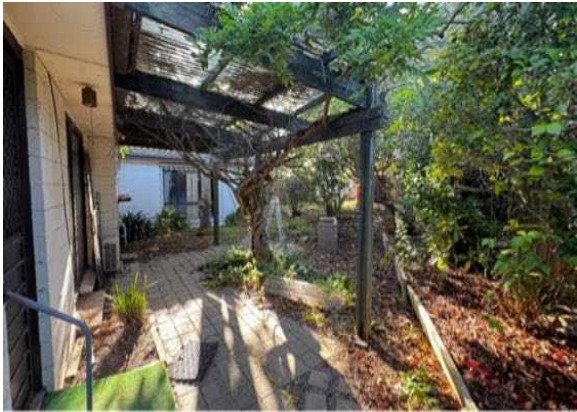
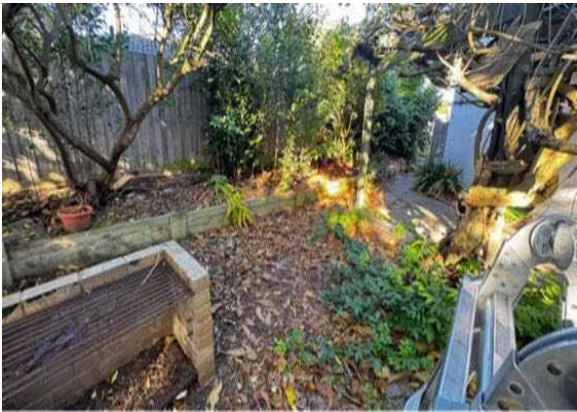
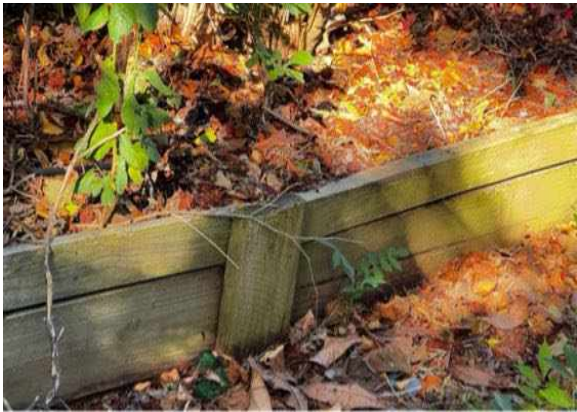
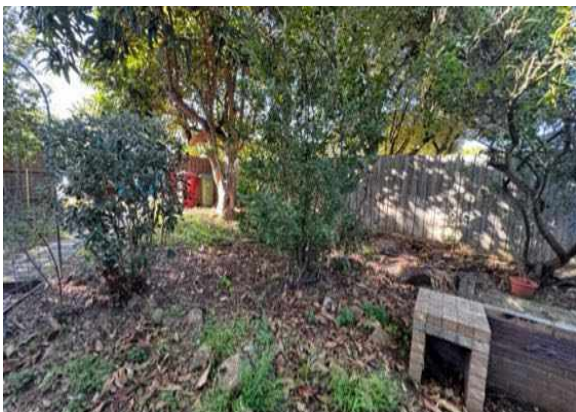
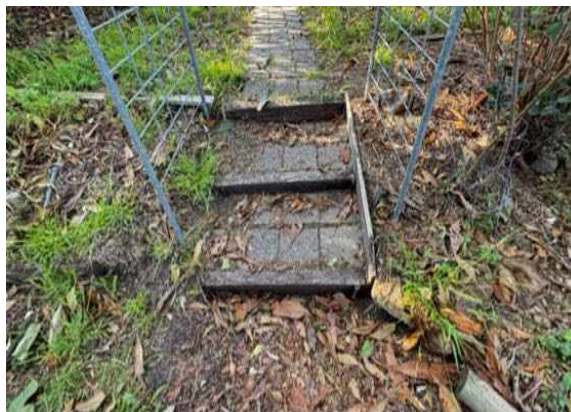
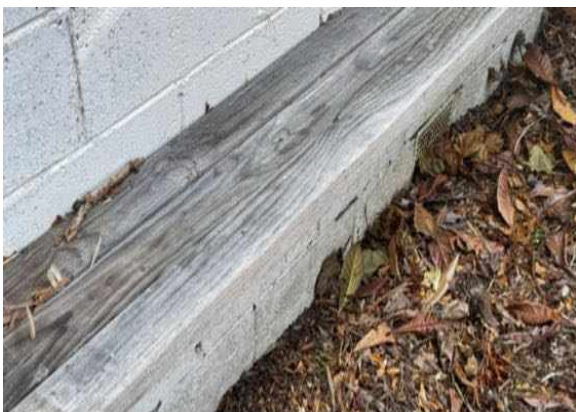
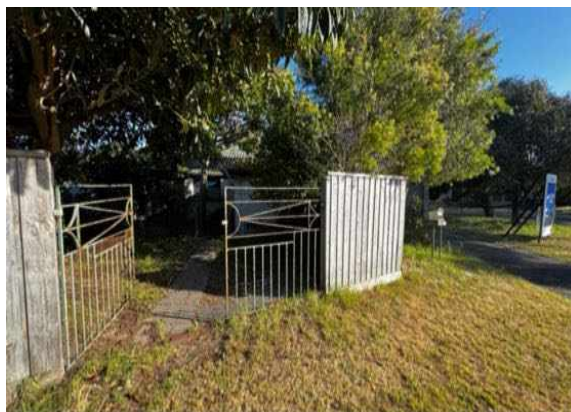
### Defects 3.11

Building:	Main Building
Location:	All External Areas
Finding:	External Timber - Timber Rot
Information:	Timber elements including wall claddings, timber rails & posts, landscaping timbers, and other external timber surfaces were inspected and show signs of rot, decay and fungal attack in these areas. Softening, discoloration, splitting, and moisture penetration indicate ongoing timber degradation.

This is likely caused by prolonged moisture exposure, inadequate protective coatings or maintenance, direct contact with soil or water, or poor detailing that traps water or limits ventilation.

If left unaddressed, the affected timber may lose structural integrity, leading to progressive decay, potential collapse of walls, decks, or landscaping features, mould growth, and reduced durability and appearance of the building exterior.

A registered builder or timber specialist should inspect the affected areas immediately to determine the extent of damage. Damaged timbers should be repaired or replaced, protective treatments applied, and drainage or detailing corrected to prevent recurrence. Ongoing monitoring and urgent remedial action are required to prevent further deterioration.

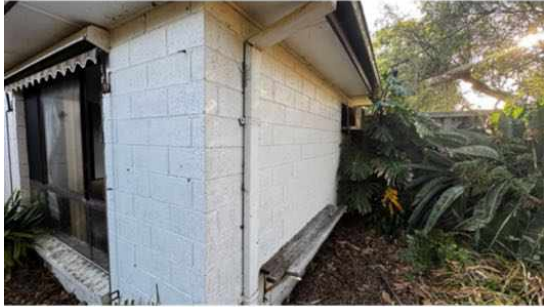
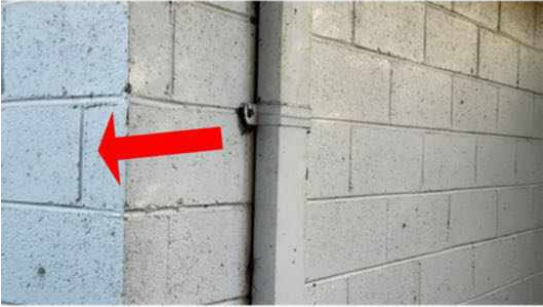
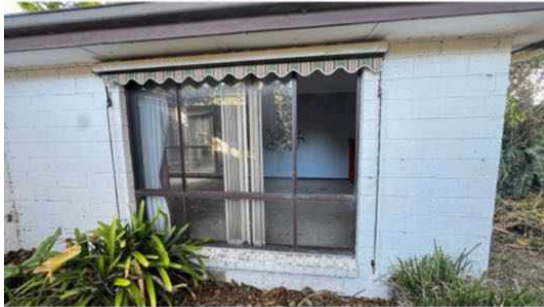
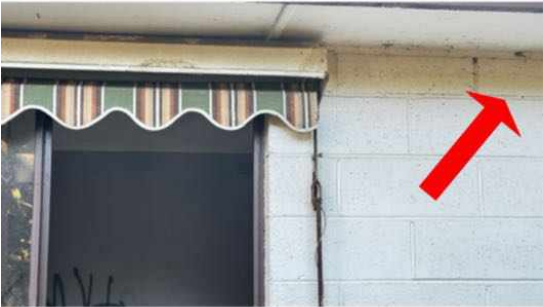
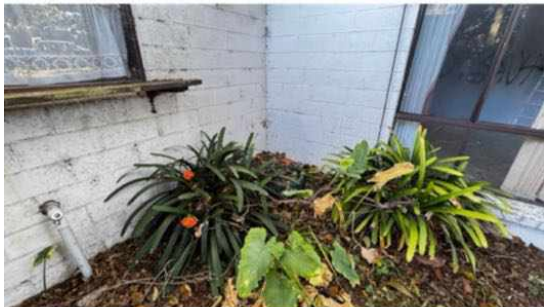
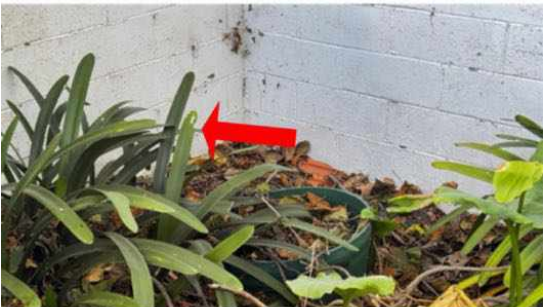
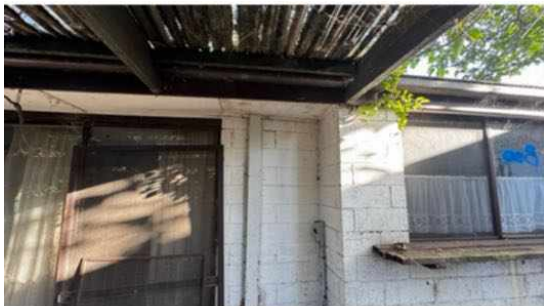
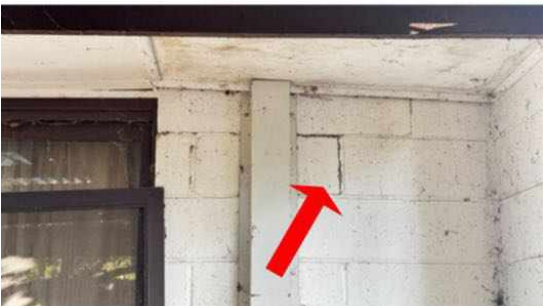
### Defects 3.12

Building:	Main Building
Location:	All External Areas >
Finding:	External Walls - Minor Cracking To Wall Claddings
Information:	Minor cracking was observed to the external walls in this area. The cracking appeared superficial and did not indicate significant structural movement; however, such cracking can allow moisture ingress if left unaddressed.

The cracking is likely due to building movement or minor settlement.

When practical, a registered builder should assess and repair the cracking, which may include sealing and repainting. The area should be monitored, and any increase in cracking or signs of movement should be further investigated immediately by a Structural Engineer.

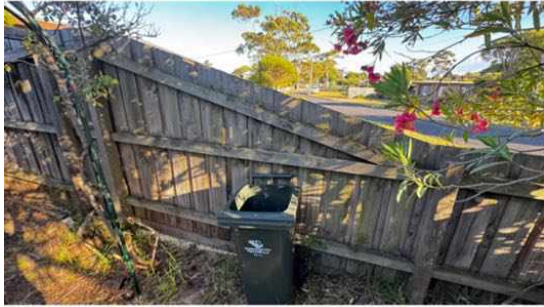
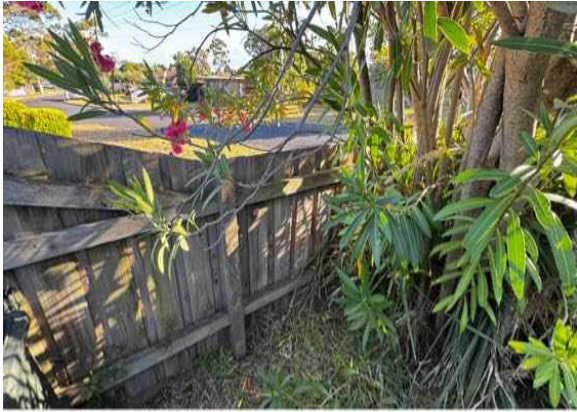
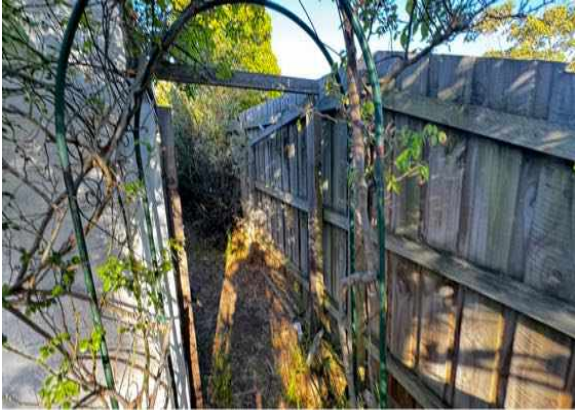
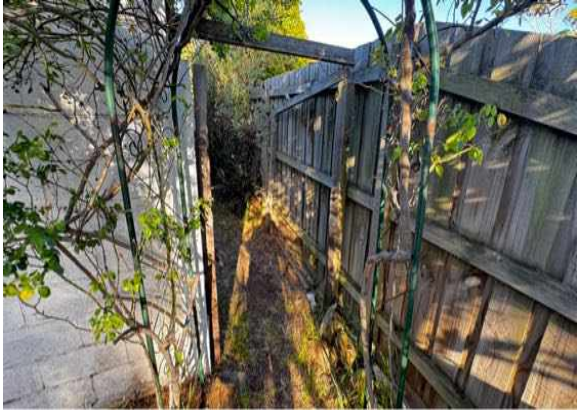
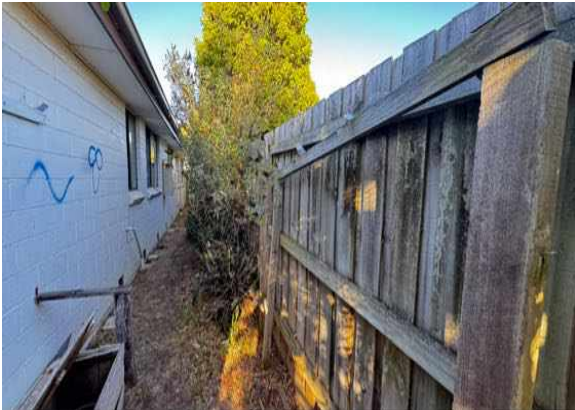
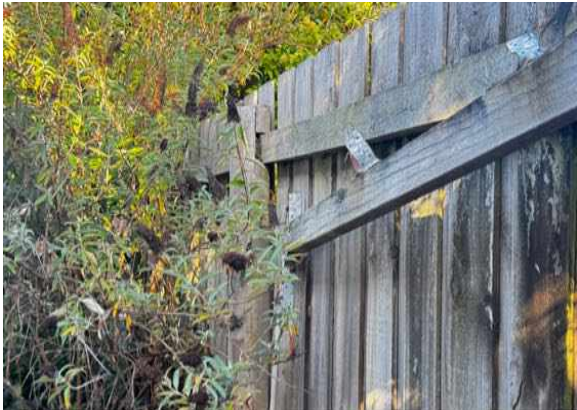
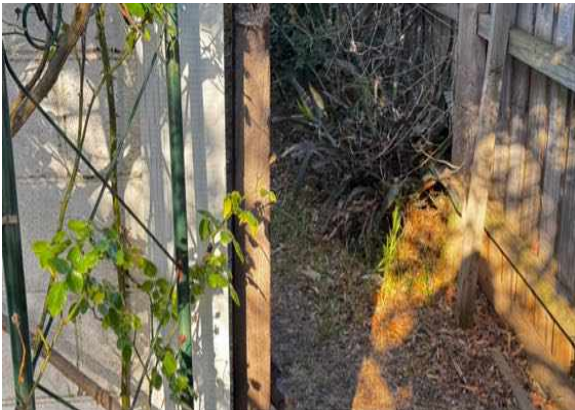
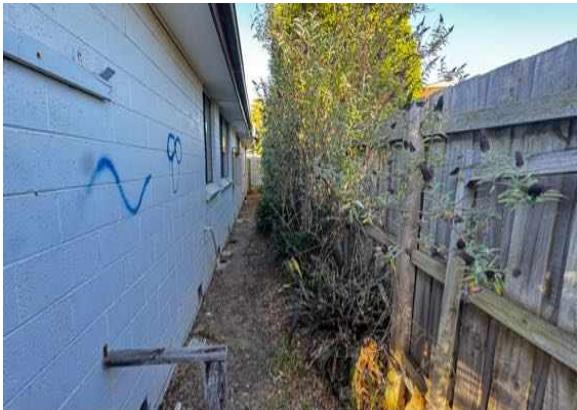
### Defects 3.13

Building:	Main Building
Location:	Fencing All Areas
Finding:	Fencing - Deteriated
Information:	Timber fencing was inspected and deterioration was observed in this area. Deteriorated fencing can compromise structural stability, reduce privacy, and may allow pest ingress or accelerated decay if left unaddressed.

Possible causes include age-related timber decay, prolonged exposure to moisture or sunlight, poor maintenance, or impact damage.

When practical, a qualified carpenter or fencing specialist should be engaged to repair or replace affected sections, and a qualified painter should be engaged to restore protective finishes. Prompt rectification will maintain structural performance, improve appearance, and extend the lifespan of the fencing.

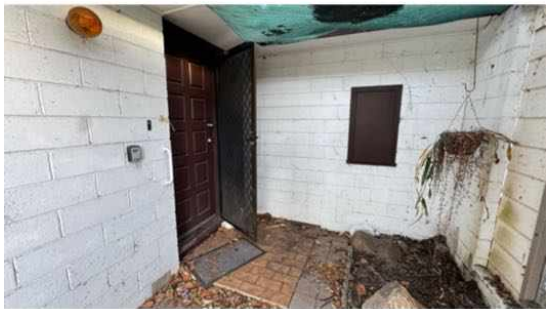
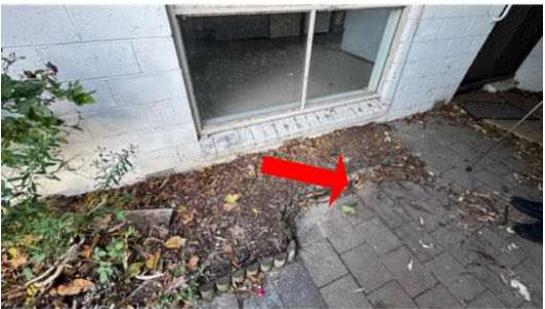
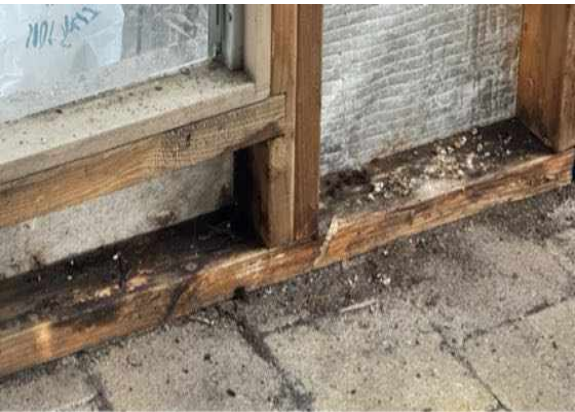
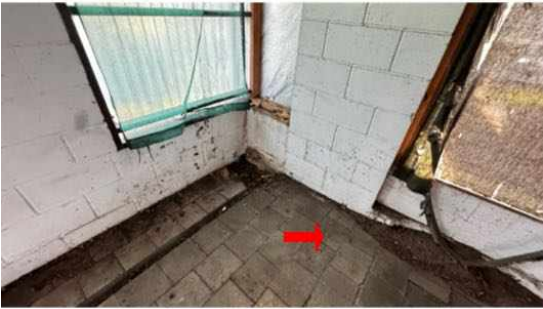
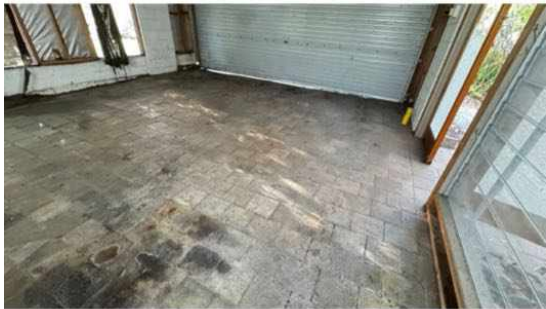
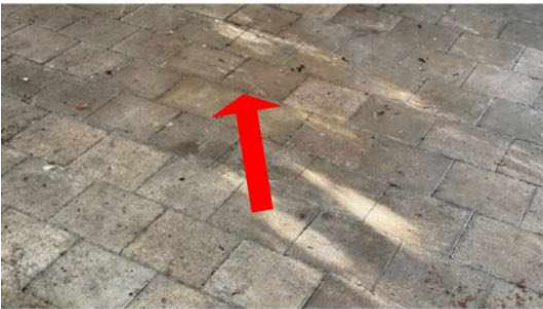
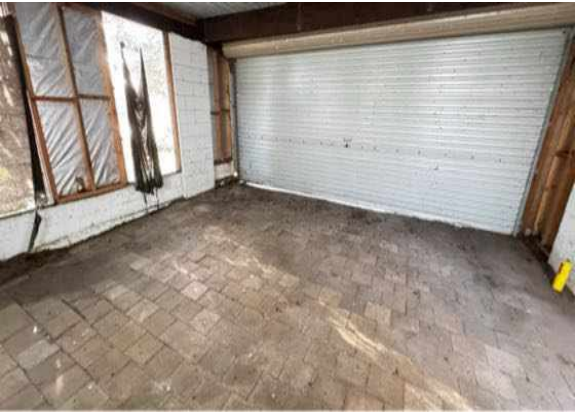
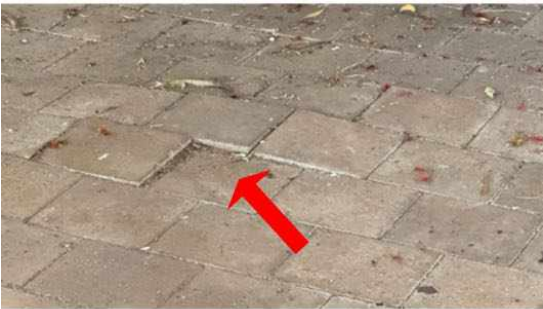
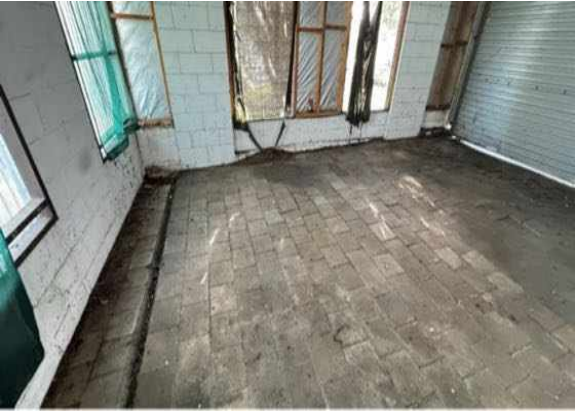
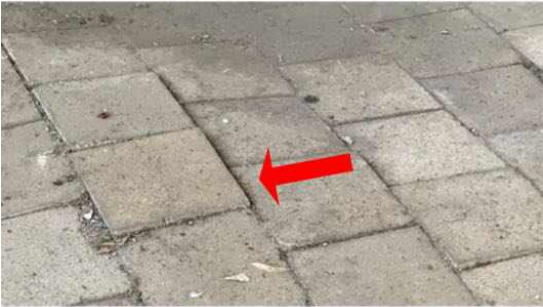
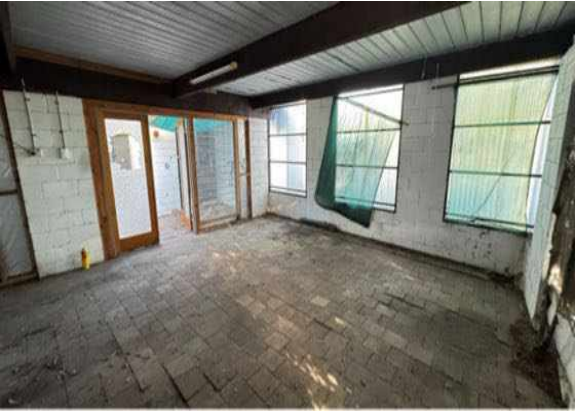
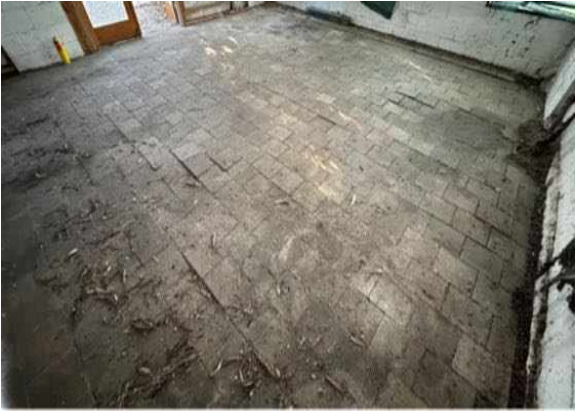
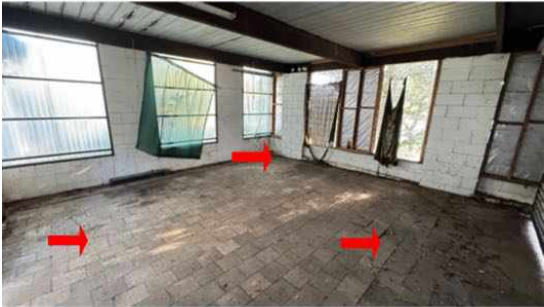
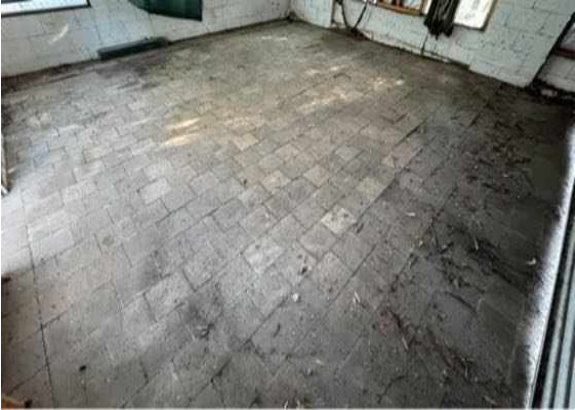
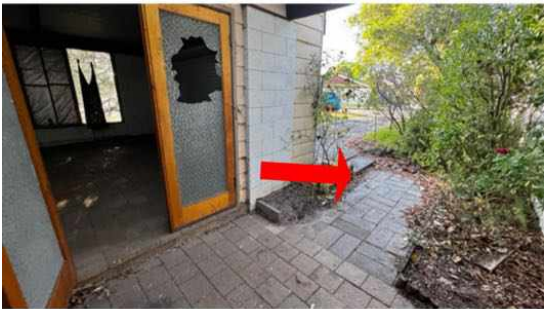
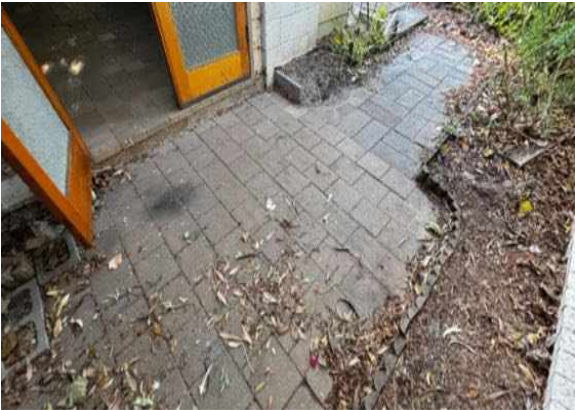
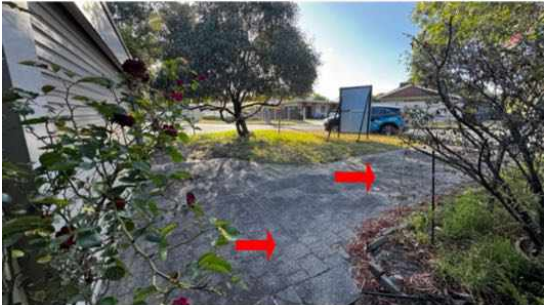
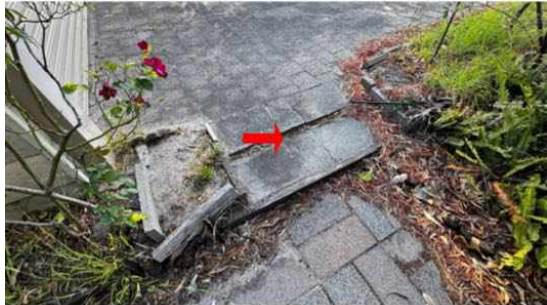
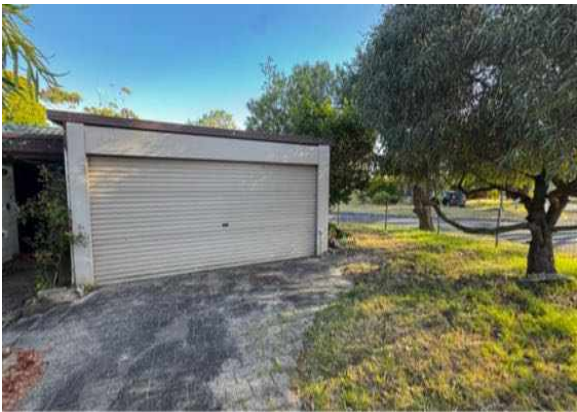
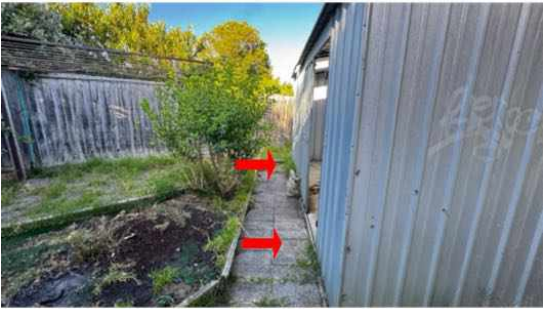
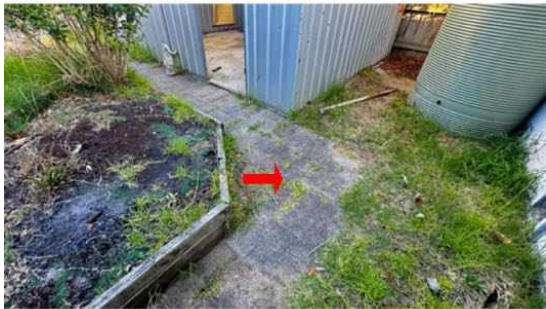
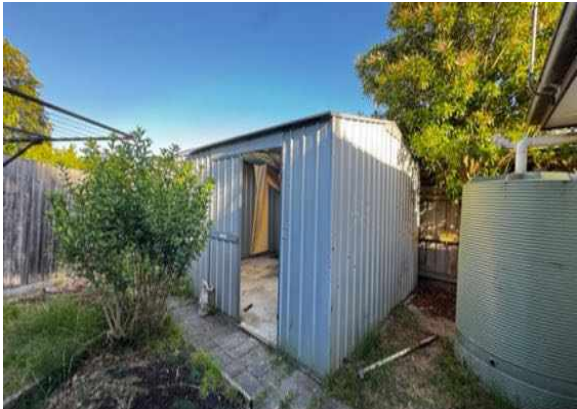
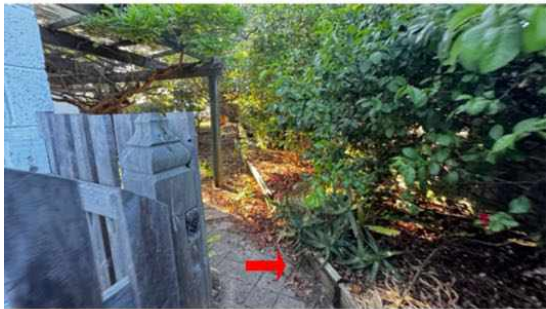
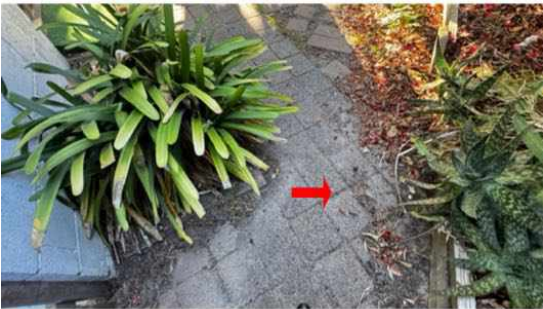
**Defects 3.14**

Building: Main Building  
Location: All External Areas >  
Finding: Paving - Minor Cracking  
Information:

The external paved areas were visually inspected. Minor cracking, uneven surfaces, and general wear were observed in this area. These defects do not currently affect structural safety but may reduce durability, appearance, and safe pedestrian access.

This may be caused by age-related deterioration of concrete, pavers, or other materials, soil movement or settlement beneath paved surfaces, tree root intrusion or erosion, or inadequate original installation or sub-base compaction.

A qualified landscaper should be engaged as soon as possible to repair or resurface sections as required. Rectification will restore even surfaces, reduce trip hazards, and improve the serviceability and appearance of the paved areas.

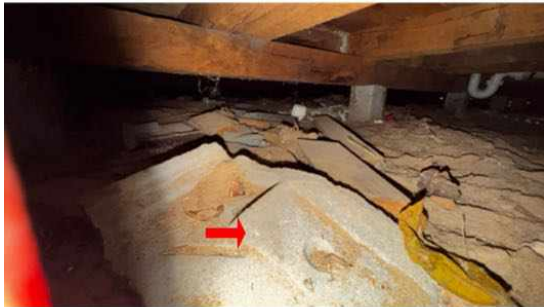
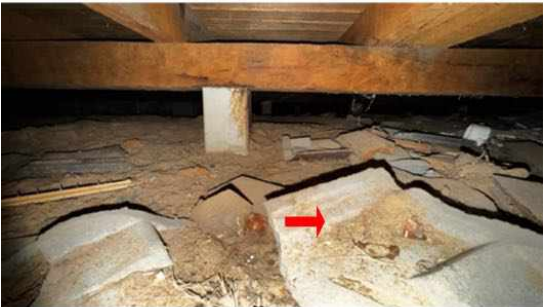
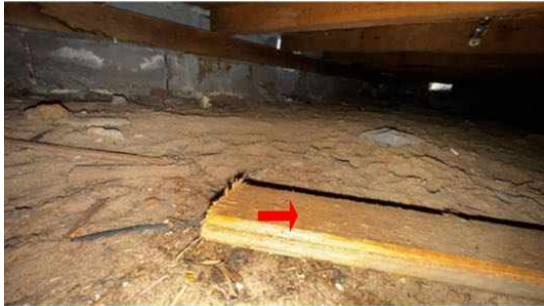
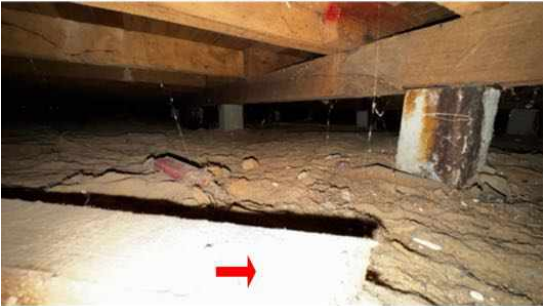
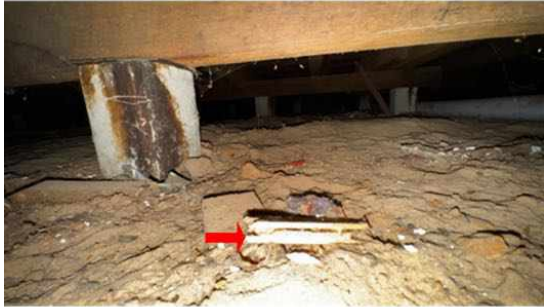
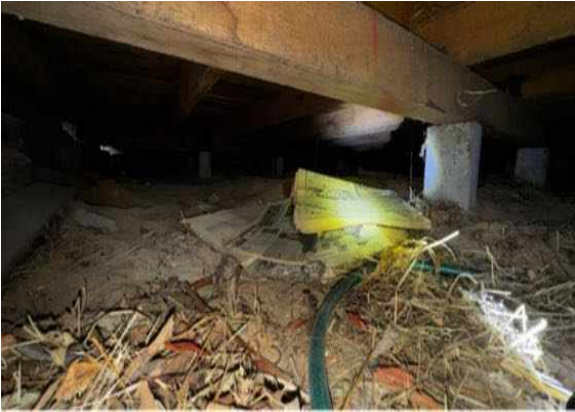
**Defects 3.15**

Building: Main Building  
 Location: Subfloor  
 Finding: Sub - Floor - Stored Items, Rubbish & Debris  
 Information: The subfloor was observed to contain stored items, rubbish, and debris. The issue is present where clutter restricts access and covers surfaces beneath the building.

This has likely occurred due to accumulation of materials over time or inadequate cleaning. Excess items can conceal defects, restrict inspections and maintenance, increase pest activity, and create fire or safety hazards.

This observation is provided for information only. When practical, a competent

handyman should be engaged to remove all rubbish and clear access to ensure safe inspection, maintenance, and ongoing monitoring of the subfloor.

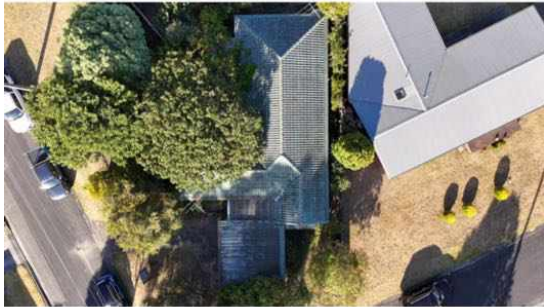
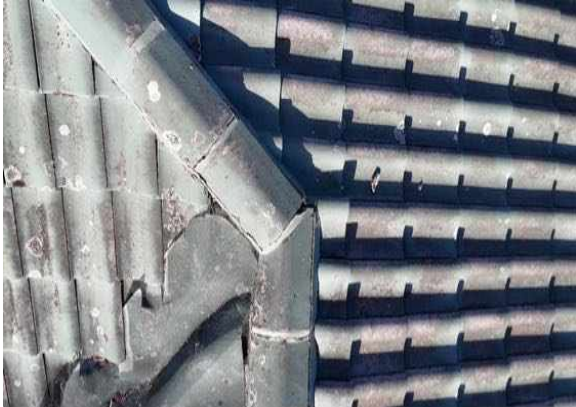
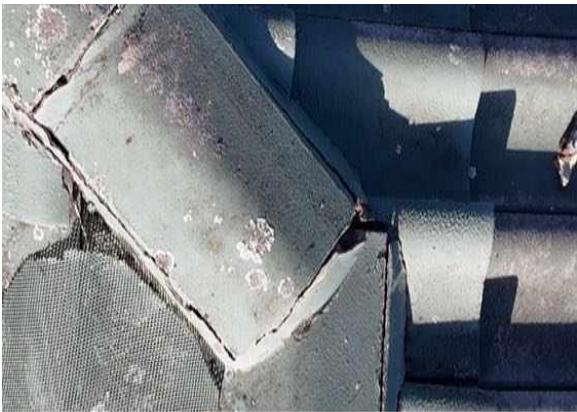
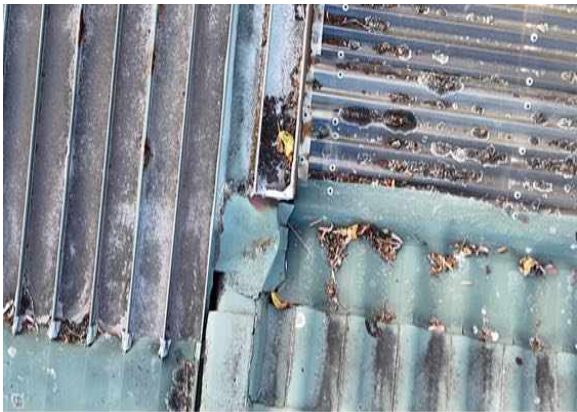
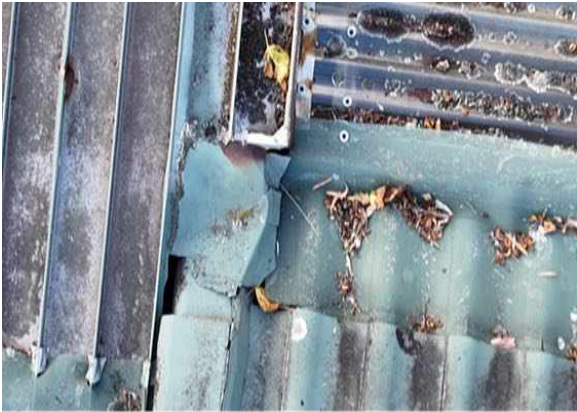
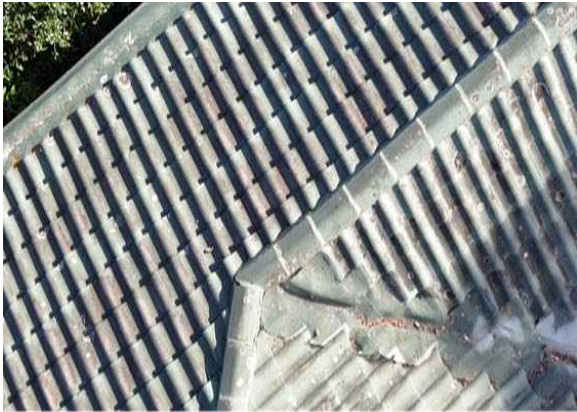
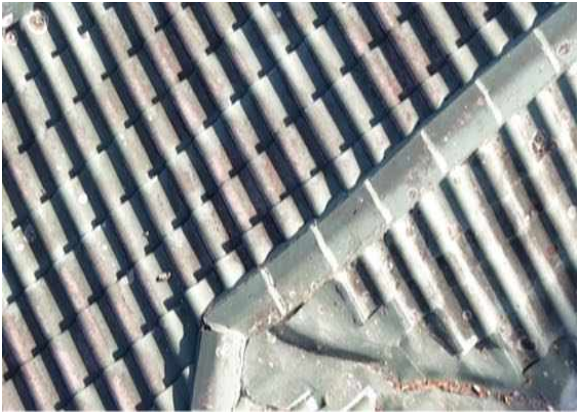
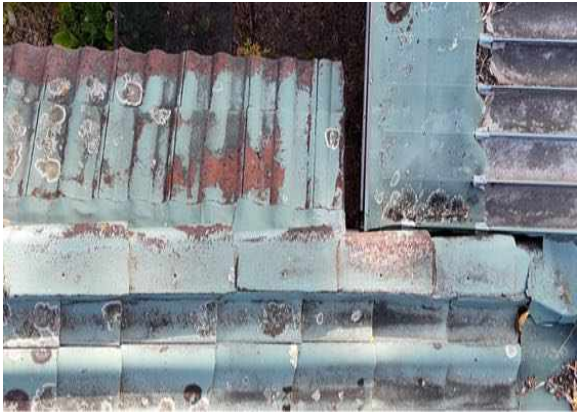
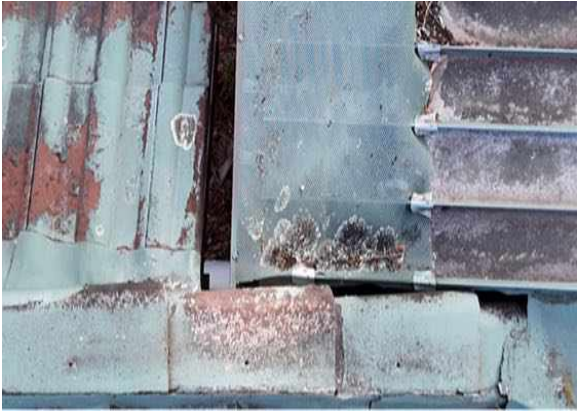
Defects 3.17

Building: Main Building  
Location: Roof Exterior  
Finding: Roof Plumbing - Roof Tiles Deteriorated  
Information: Roof tiles are weathered, deteriorated, and show moss, algae, lichen growth, and discolouration. The edges and corners of some tiles are also eroded, and the tiles are more porous and prone to water absorption.

This has likely occurred due to long-term exposure to sunlight, rain, wind, frost, and environmental conditions. These combined issues increase the risk of water penetration, leaks, damage to the roof structure, and further deterioration of surrounding tiles.

A licensed roof plumber is required to inspect and repair or replace the affected tiles in this area. This should be rectified immediately, which may include removing moss, algae, and lichen, realigning or replacing damaged tiles, treating deteriorated tiles, and ensuring the roof covering is fully watertight to prevent further damage.

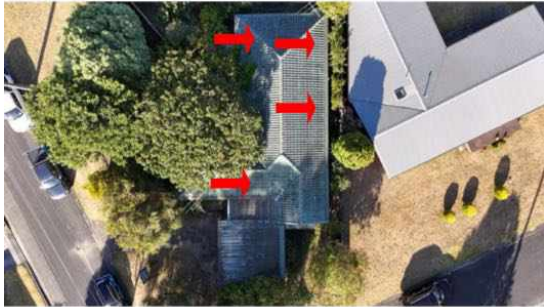
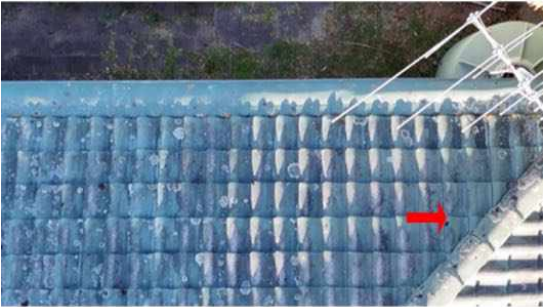
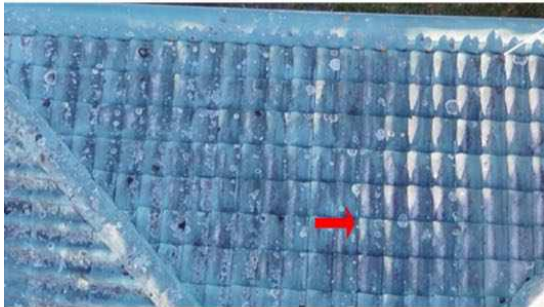
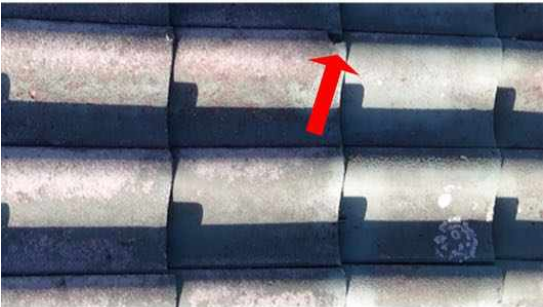
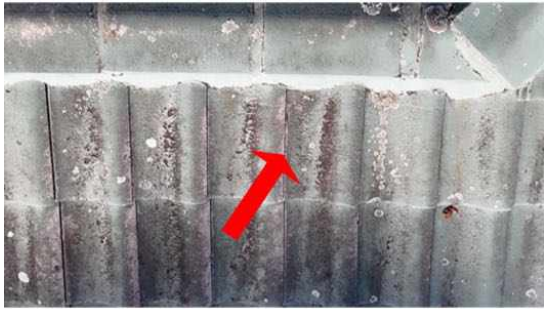
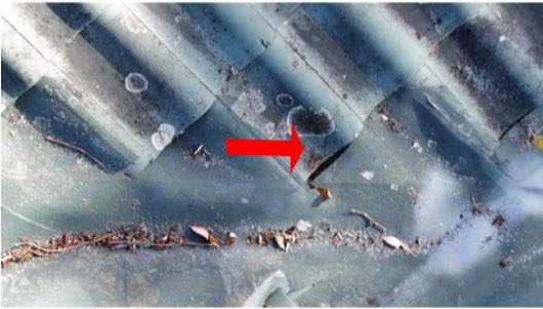
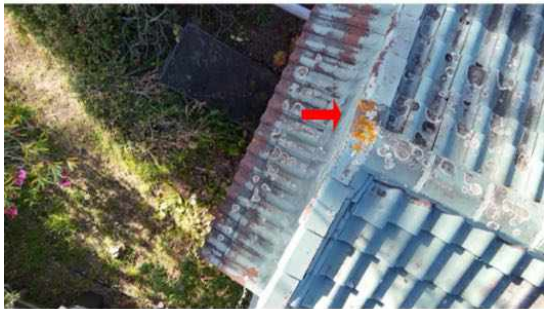
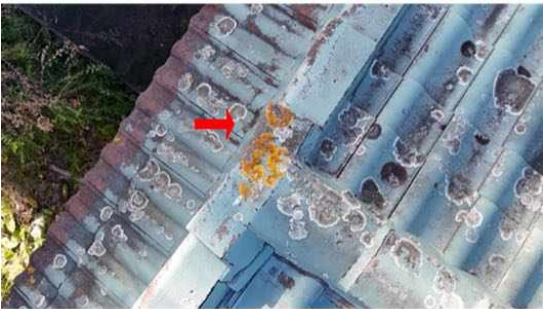
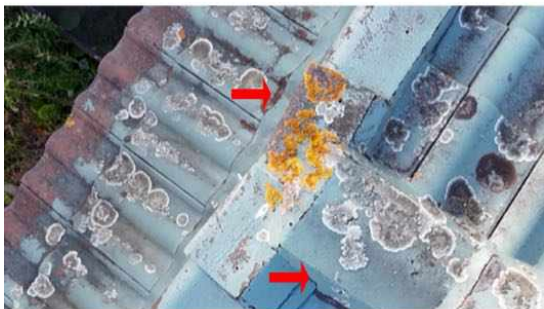
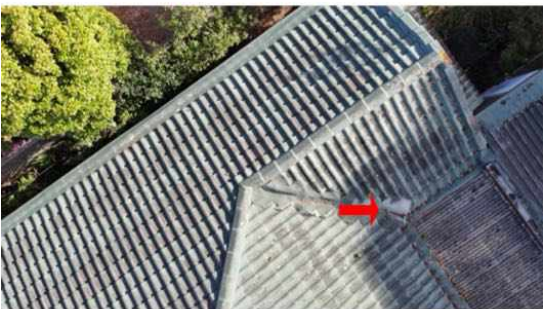
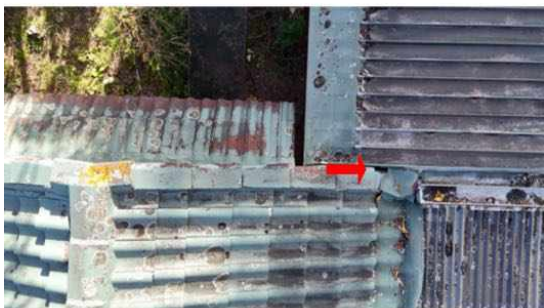
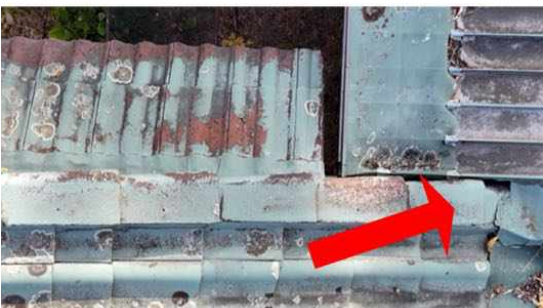
Defects 3.18

Building: Main Building  
Location: Roof Exterior  
Finding: Roof Plumbing - Gutters Blocked  
Information: Gutters in this area are blocked and not allowing water to flow freely. The issue is observed along the gutter runs where leaves, debris, or other obstructions have accumulated.

This has likely occurred due to lack of maintenance or build-up of debris over time. Blocked gutters may cause water to overflow, damage the roof, walls, or foundations, and increase the risk of erosion or water ingress.

A licensed roof plumber or competent handy man is required to inspect and clear the blocked gutters in this area. This should be rectified immediately to ensure water drains correctly and to prevent potential damage to the building.

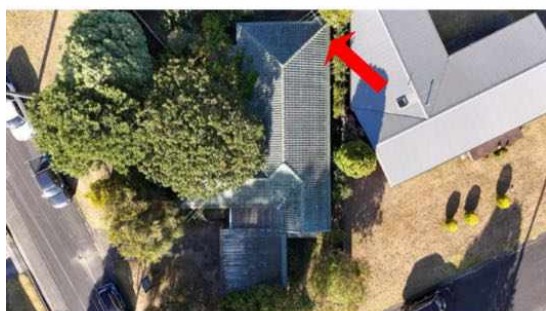
### Defects 3.19

Building: Main Building  
 Location: Roof Exterior >  
 Finding: Roof Plumbing - Downpipes Not Connected To Storm Water  
 Information: Downpipes in this area are not connected to the stormwater drainage system, allowing water to discharge directly onto surrounding ground.

This has likely occurred due to missing connections, poor installation, or design oversight. Uncontrolled water discharge may cause erosion, pooling, water ingress near the building, and potential damage to landscaping, paving, or foundations.

A licensed roof plumber is required to inspect and connect the downpipes to the

stormwater system in this area. This should be rectified immediately to ensure proper drainage and prevent potential water damage.
