## Building Inspection Report

Inspection Date: Thu, 22 Jan 2026

Property Address: 18 Mawarra Ave, Capel Sound VIC 3940,  
Australia

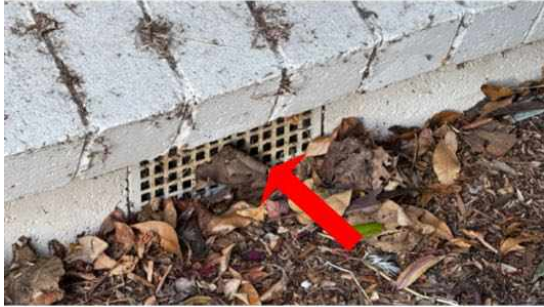
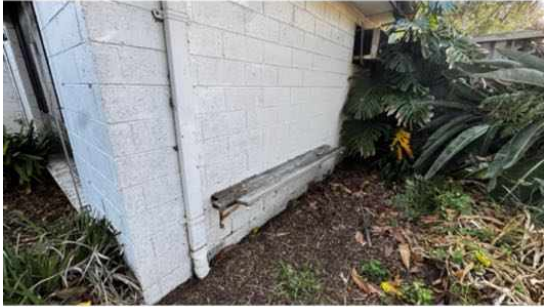
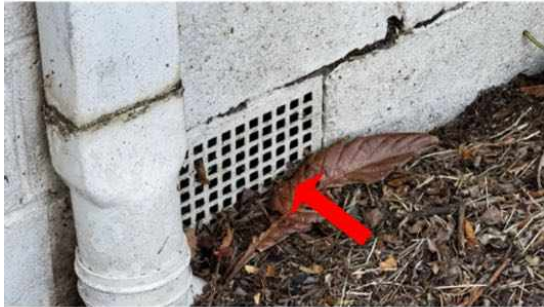
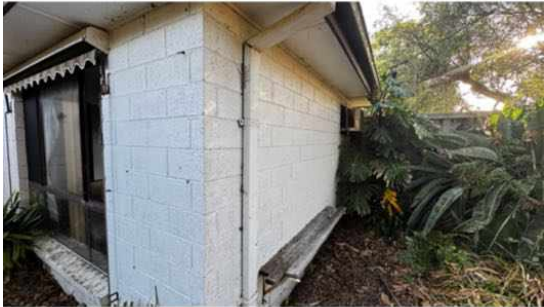
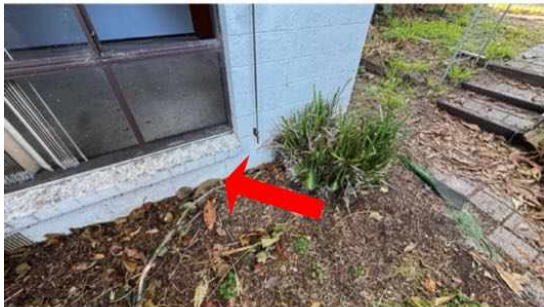
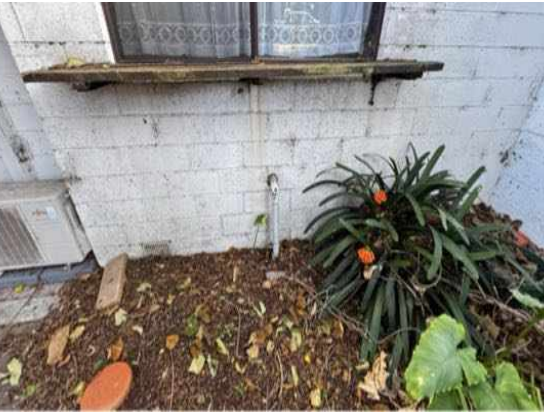
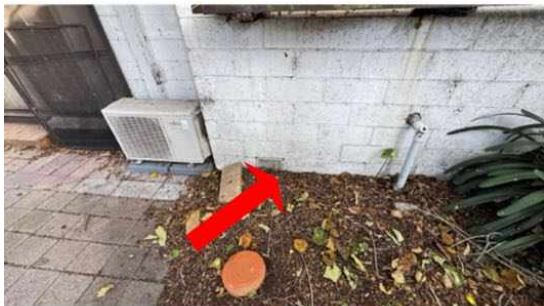
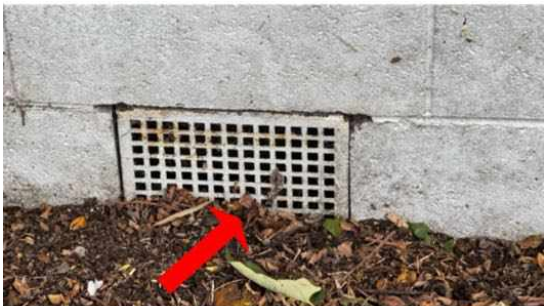
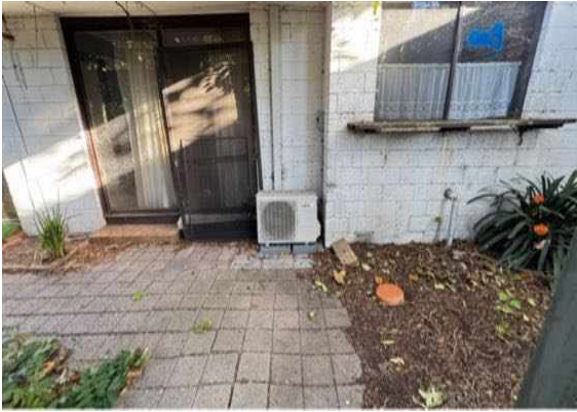
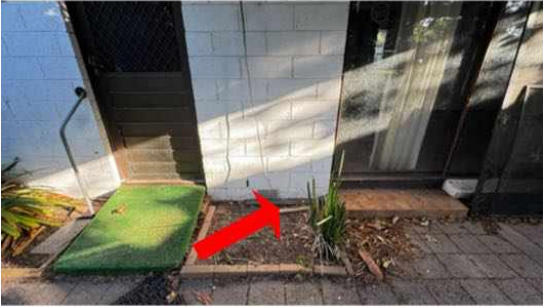
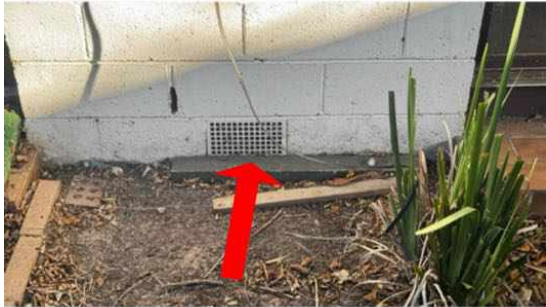
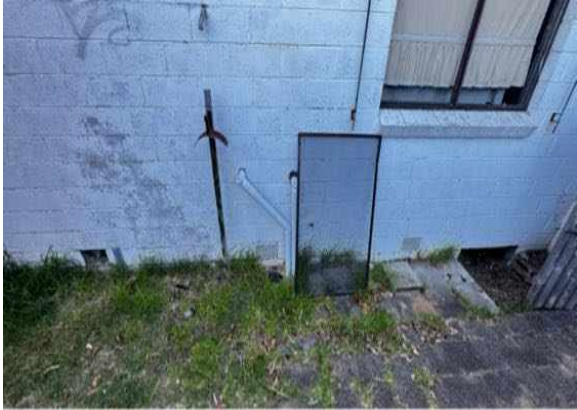
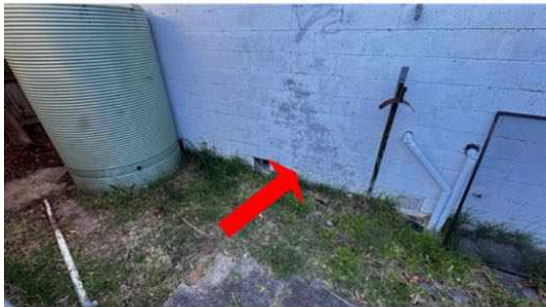
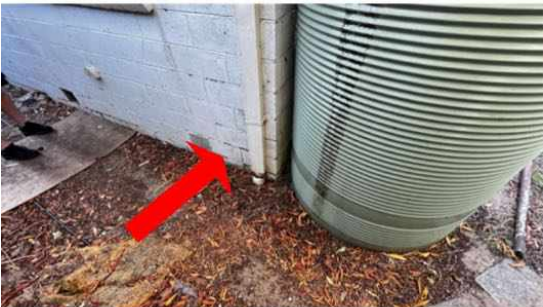
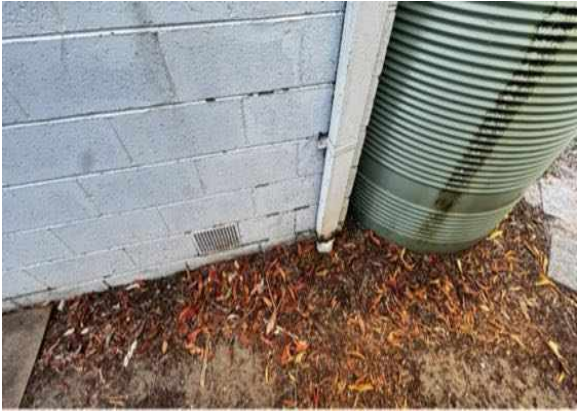
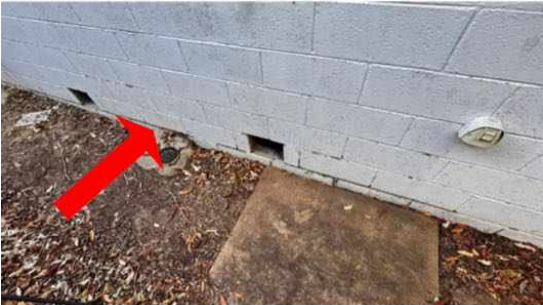
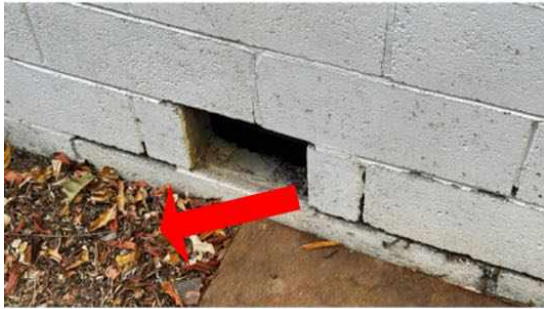
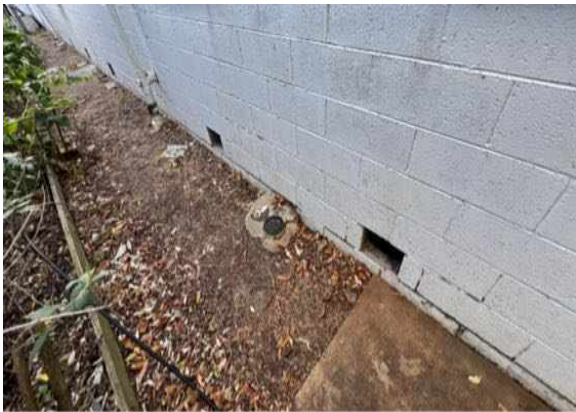
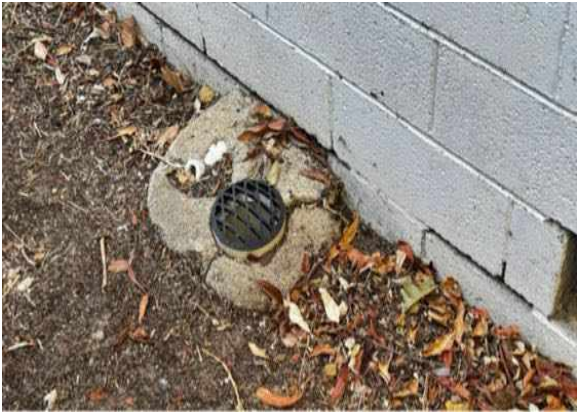
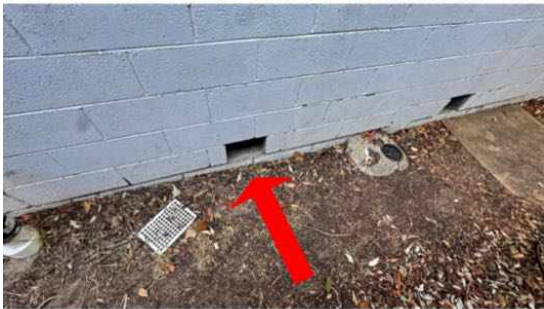
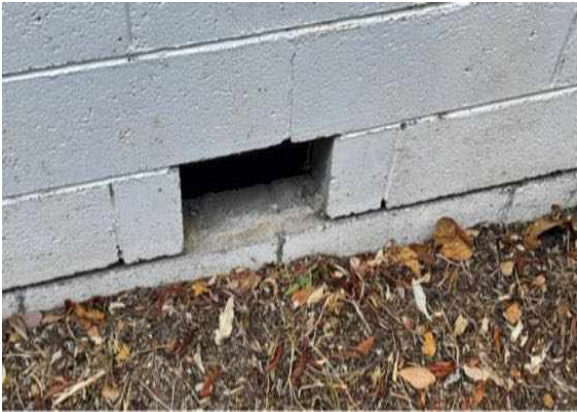
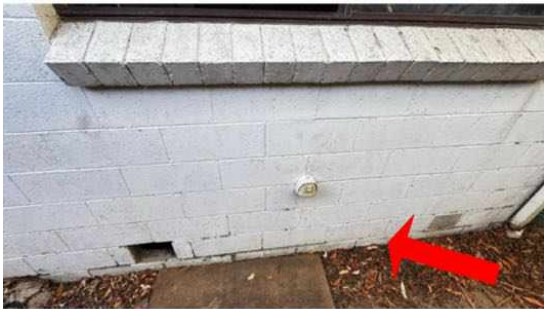
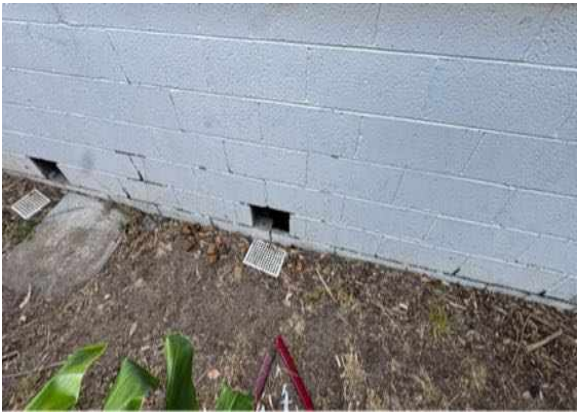
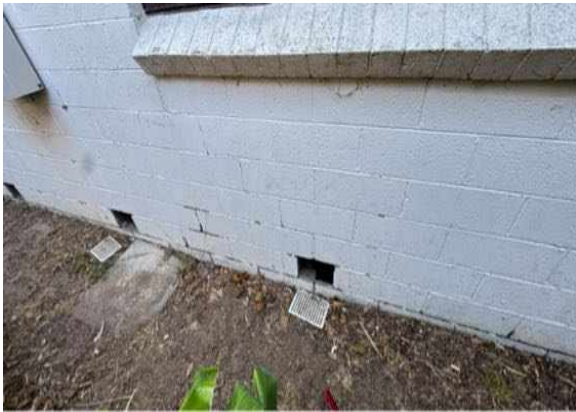
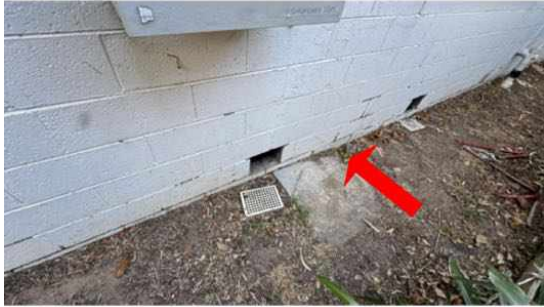
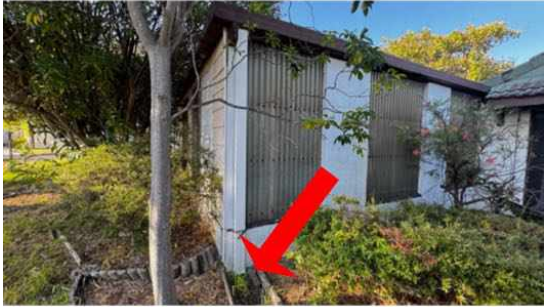
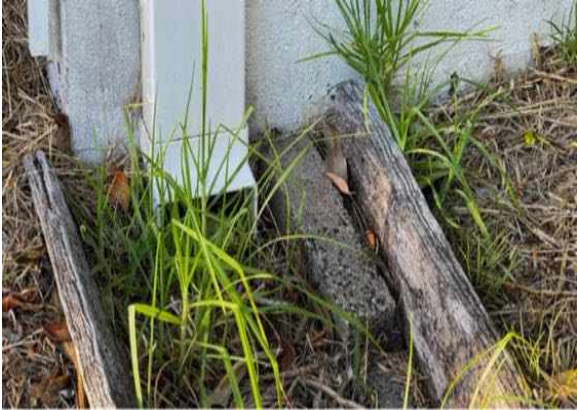
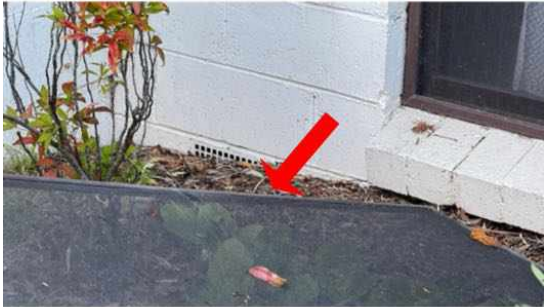
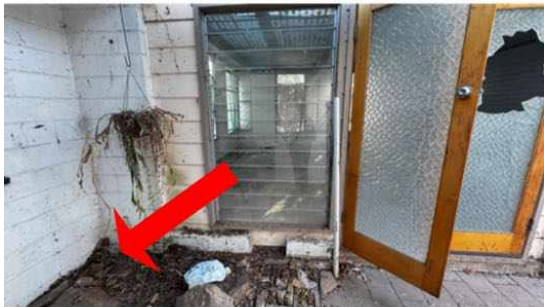
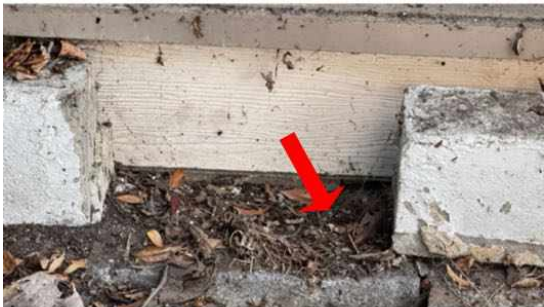
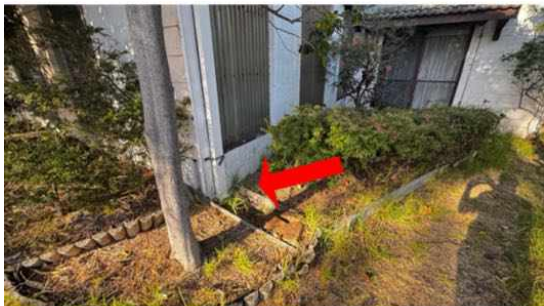
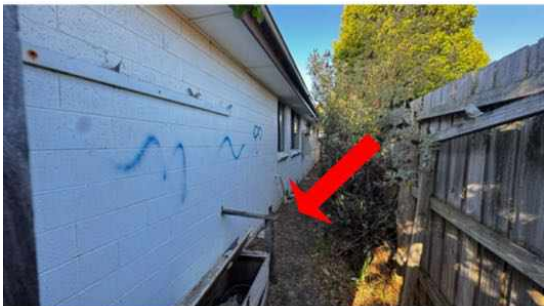
### Defects 3.20

Finding: Site Drainage - Inadequate

Information: The overall site drainage was observed to be inadequate at the time of inspection. Poor drainage can cause water to pond near external walls, increasing the risk of rising damp, foundation movement, timber decay, and deterioration of associated building elements.

Ground levels should slope away from the dwelling to direct water from walls and footings. Downpipes must be properly connected to the stormwater system and should not discharge directly onto walls, paving, or plinths. Stormwater should be directed away from the property through adequately sized and maintained drains. Where ground levels are too high and cover the damp-proof course (DPC), lowering the levels may be necessary to expose the DPC and allow effective drainage.

A licensed plumber should be engaged promptly to investigate and recommend suitable remedial works, which may include the installation of an agricultural (aggie) drain or other site drainage improvements. Immediate action is strongly recommended, as inadequate drainage can lead to progressive water damage and secondary building defects over time.

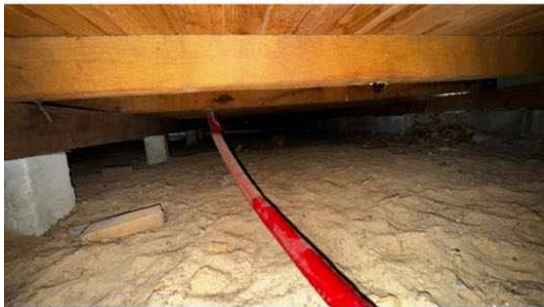
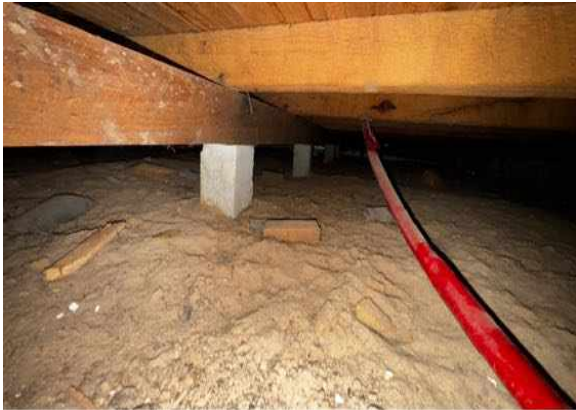
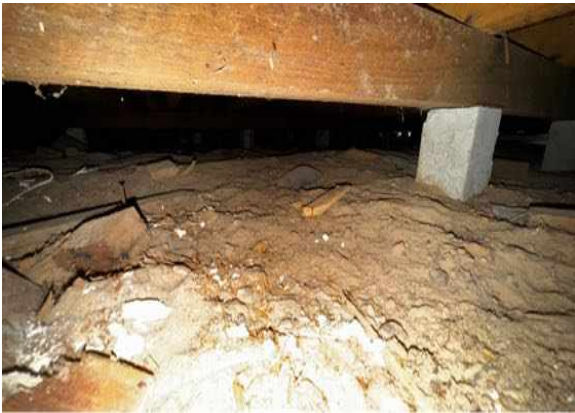
This has likely occurred due to inadequate access points. Poor access can impede inspections, maintenance, and timely identification of structural, pest, or service issues, increasing long-term repair costs and safety risks.

A registered builder is required to assess and improve subfloor access. This should be addressed as soon as possible to ensure safe entry, proper inspection, and maintenance of the subfloor.

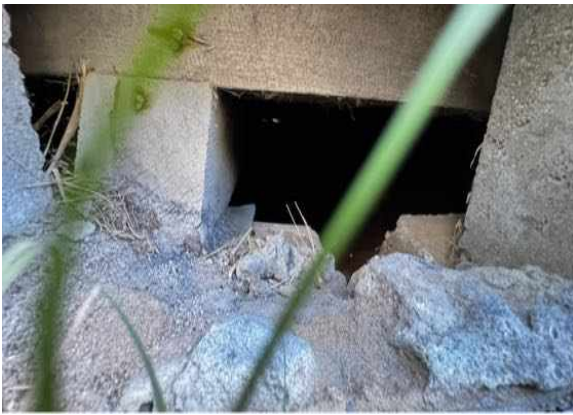
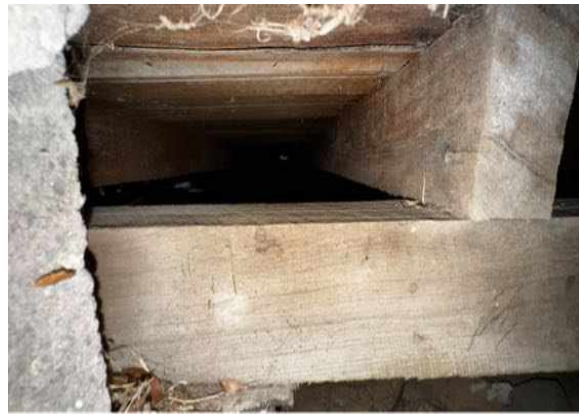
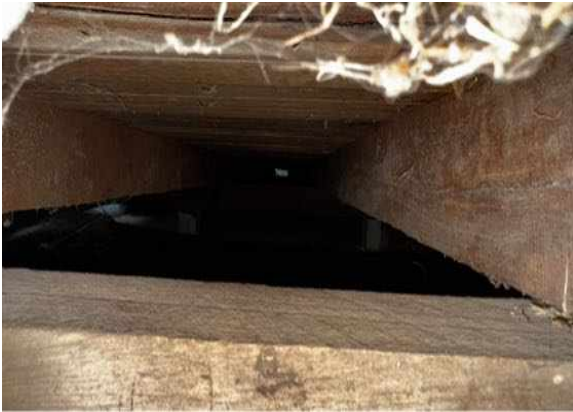
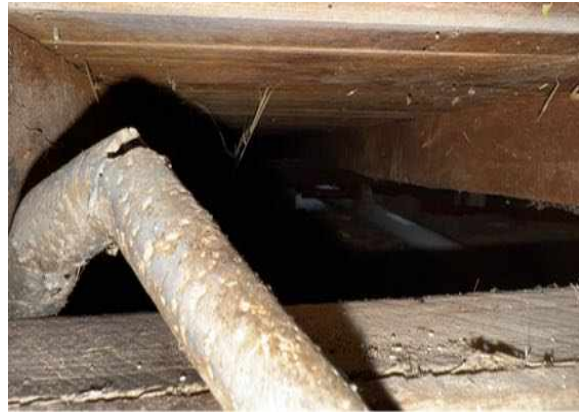
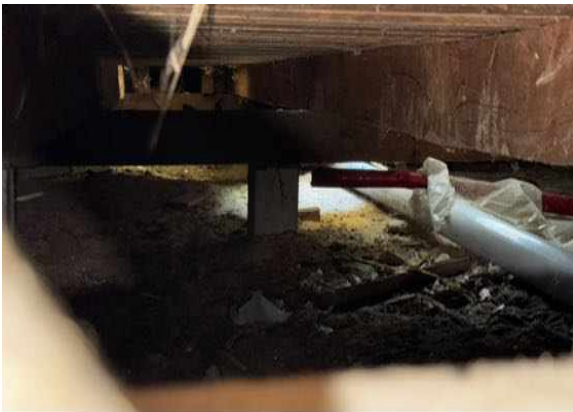
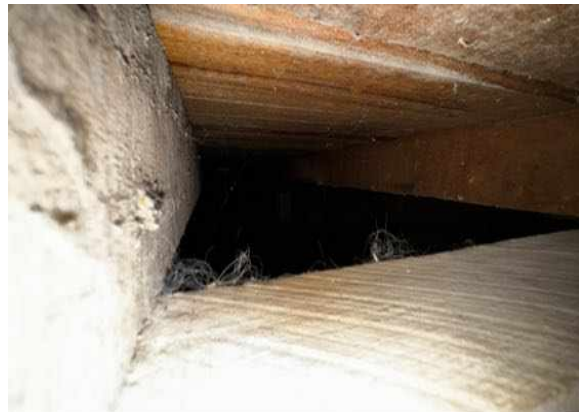
Building:	Main Building
Location:	All Areas
Finding:	Asbestos - Suspected ACM Identified On Site
Information:	Reporting on Asbestos is outside the Scope of this Report. This suspected defect is highlighted as a caution only. We suspect, based on our experience in the building industry, that there is a higher risk of the identified building element containing asbestos to areas inside and outside the property.

As Asbestos Reporting is outside the scope of this report, we STRONGLY advise that you consider a separate Asbestos Inspection and Condition Audit, which can include the taking of samples for definitive confirmation of the presence of Asbestos.

In the interim, the client is advised to act with caution not only to the areas within the report but all areas within the property, especially when considering any damage to building materials general wear and tear renovations extensions demolition and general maintenance activities due to the suspected presence of Asbestos

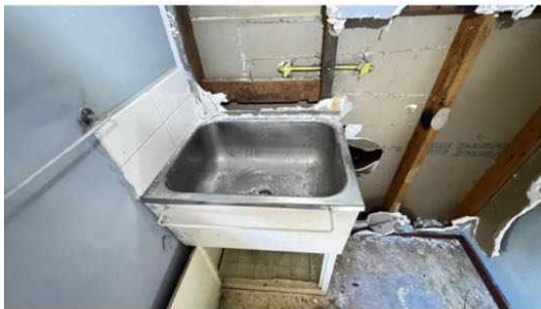
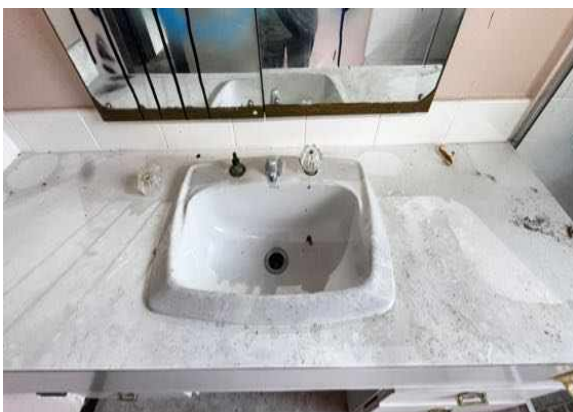
The condition is likely due to vandalism. Without reinstatement, the dwelling remains uninhabitable and non-compliant with basic service requirements.

It is recommended that a licensed plumber be engaged as a matter of urgency to inspect the plumbing system, determine the extent of removed or damaged services, and provide a scope of works and cost estimate for full reinstatement of water supply and drainage to all plumbing fixtures.

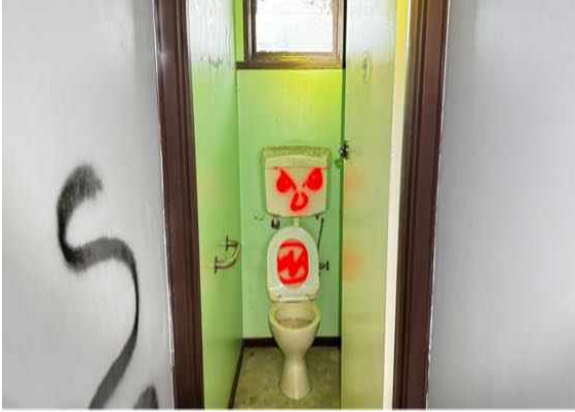
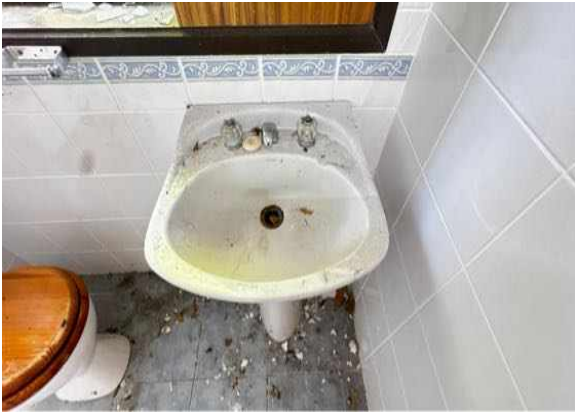
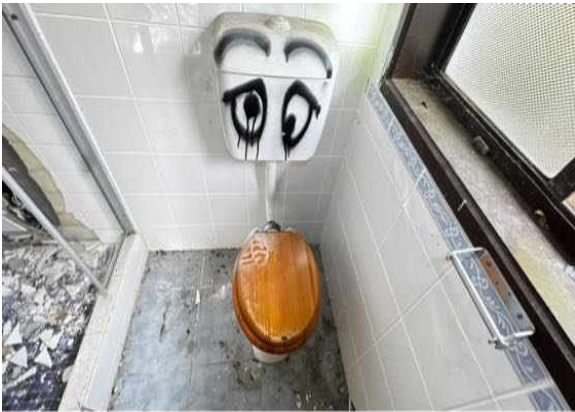
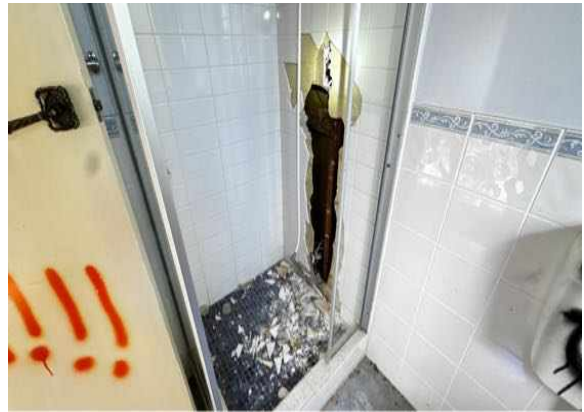
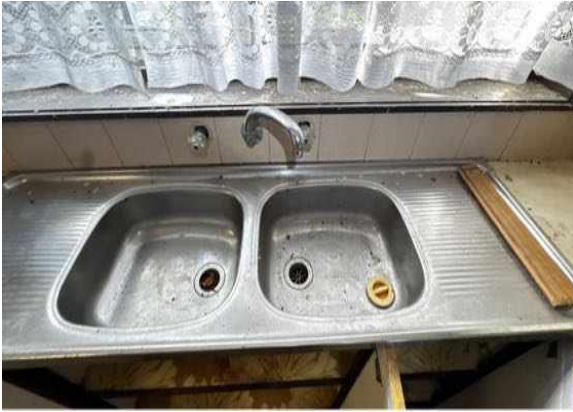
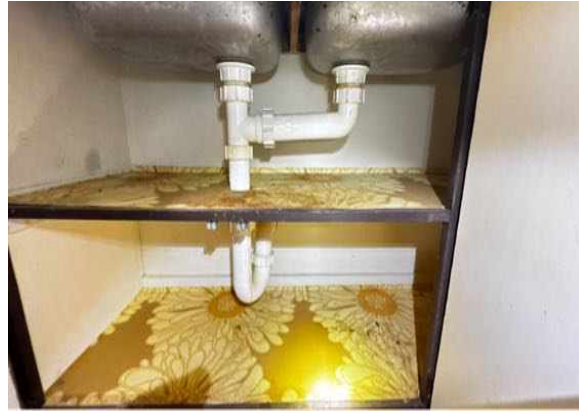
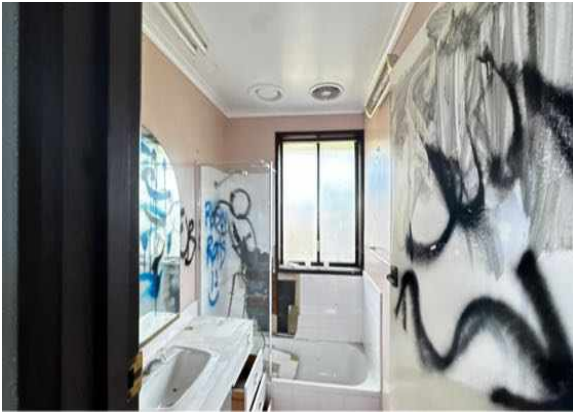
Building: Main Building  
 Location: All Internal Areas  
 Finding: No Water Supply & Drainage - Shower, Basins, Toilets, & Plumbing Fixtures  
 Information: It was observed at the time of inspection that there is no functional water supply or drainage connected to all plumbing fixtures within the dwelling, including showers, basins, and toilets. The absence of hot and cold water services and associated drainage renders these fixtures non-operational and unsuitable for use.

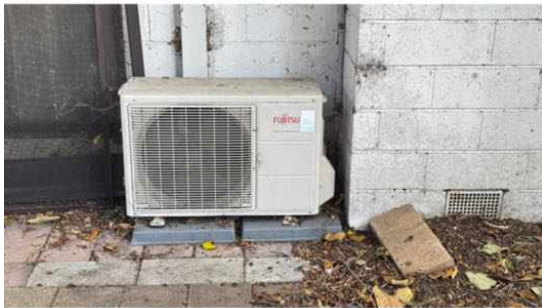
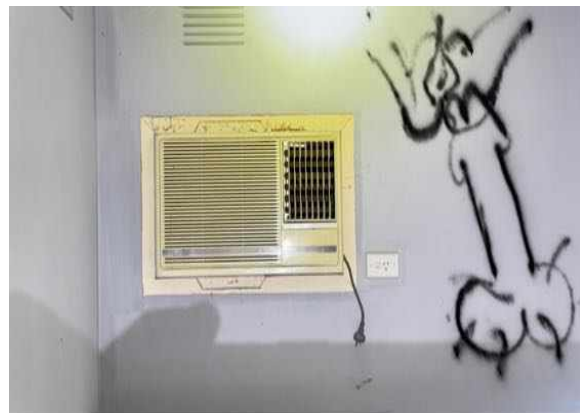
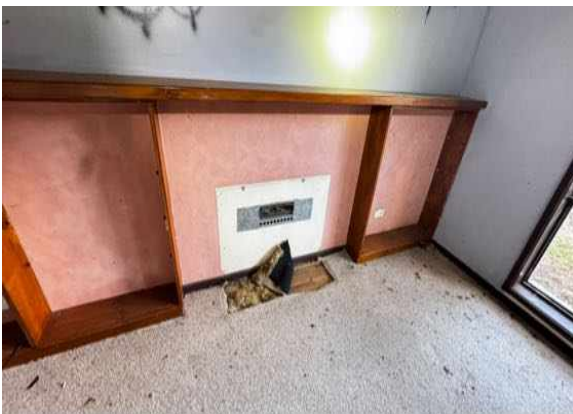
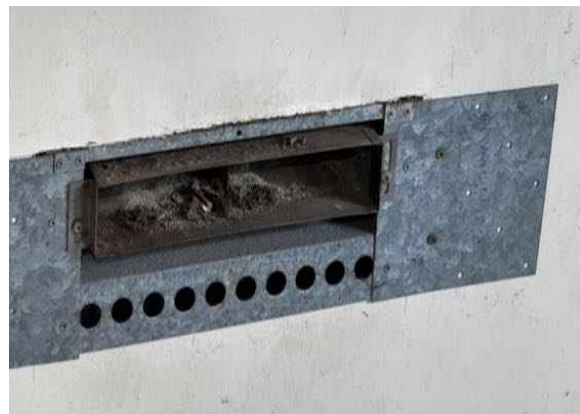
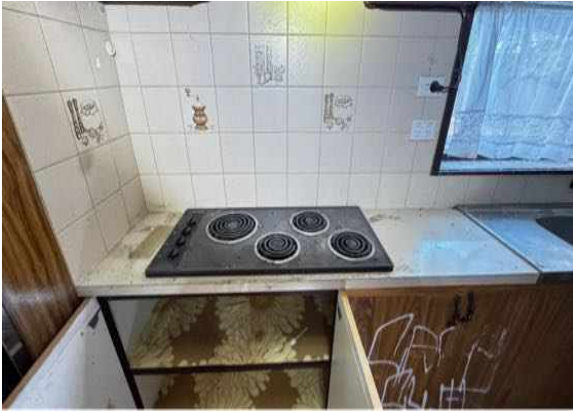
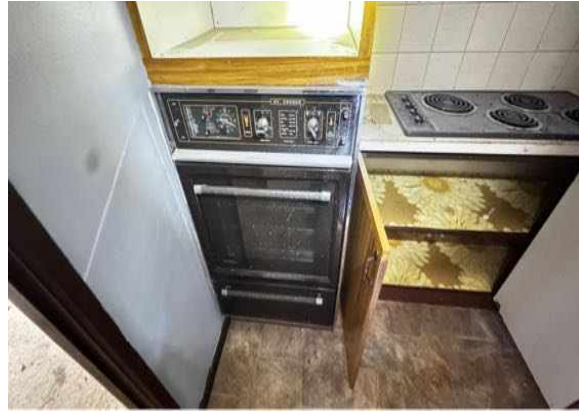
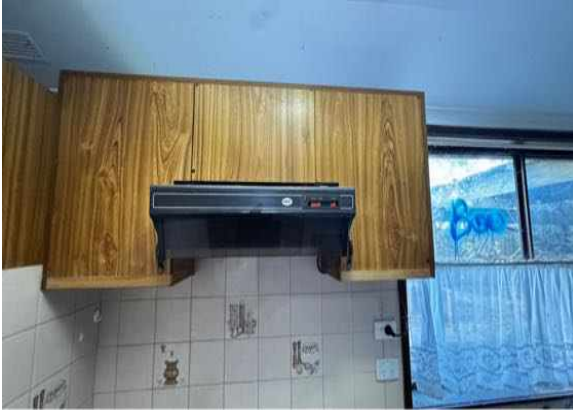
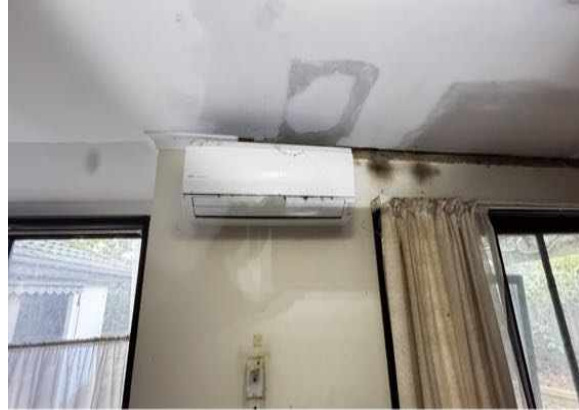
Information: The inspection did not include testing, operation, safety, or assessment of any installed or portable appliances or mechanical systems. This includes, but is not limited to, ovens, cooktops, microwaves, rangehoods, dishwashers, ducted vacuum systems, air-conditioning units, heating systems, hot water services, ceiling fans, exhaust fans, intercoms, security systems, fireplaces, and solid fuel heaters.

Appliances may be worn, damaged, or malfunctioning. Electrical or gas appliances can pose serious safety hazards if incorrectly installed or maintained.

Service, repair, or replace equipment as necessary, particularly where service history or warranty coverage is unknown.

Inspect any water, gas, or electrical connections associated with appliances to ensure safety and compliance.

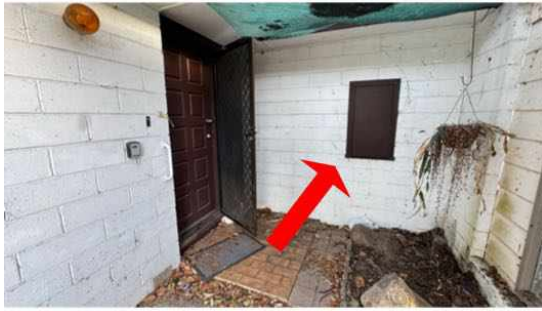
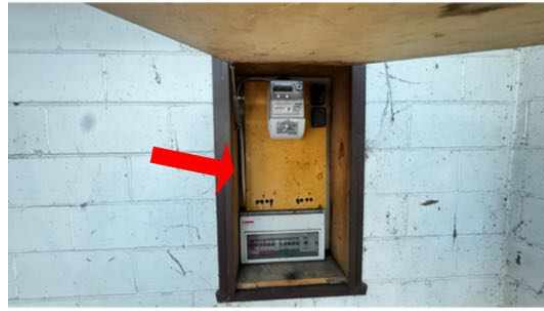
Building: Main Building  
 Location: >  
 Finding: Electrical - Switch Board Location  
 Information: For your information, the main electrical switchboard was visually inspected. No intrusive testing or detailed electrical assessment was performed as part of this inspection.

For full compliance and safety verification, a licensed electrician should be engaged to inspect the switchboard, test all circuits, and ensure all components are functioning correctly. This will help maintain electrical safety and prevent potential hazards.

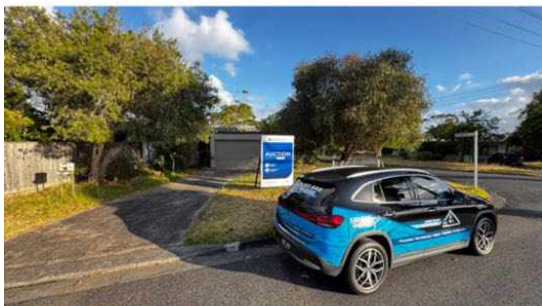
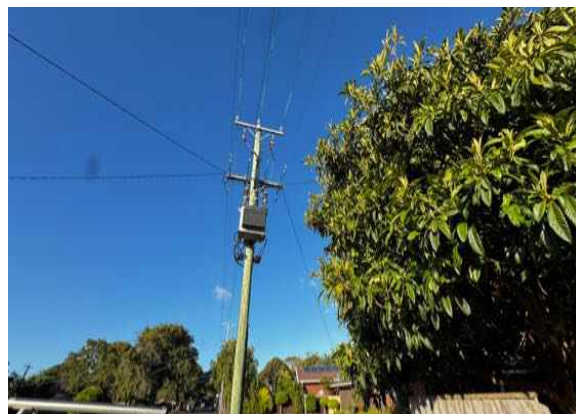
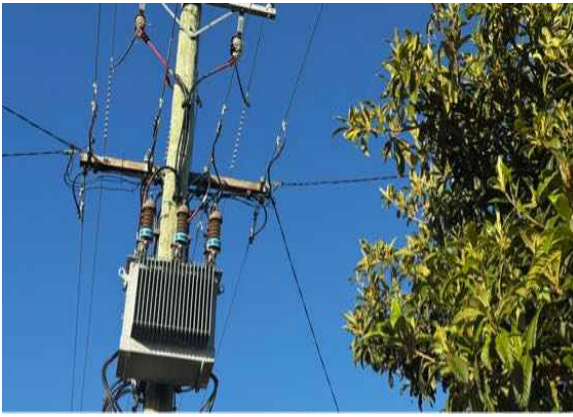
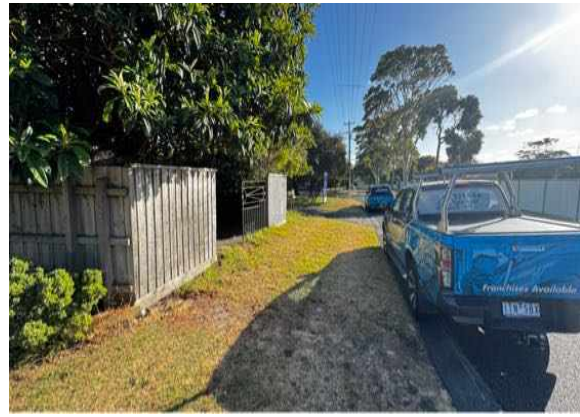
During the inspection, minor cracking, surface wear, or uneven sections were observed on footpaths or crossovers. Some accessible metal components, such as street signage or grates, showed signs of rust or deterioration. Debris accumulation and vegetation encroachment were also noted around council infrastructure. Access or visibility was limited to certain council-owned assets.

These areas should be monitored, and for detailed assessment, maintenance, or compliance verification, the relevant local council authority should be contacted immediately. Regular monitoring of adjacent council assets is recommended to ensure ongoing safety and proper maintenance.

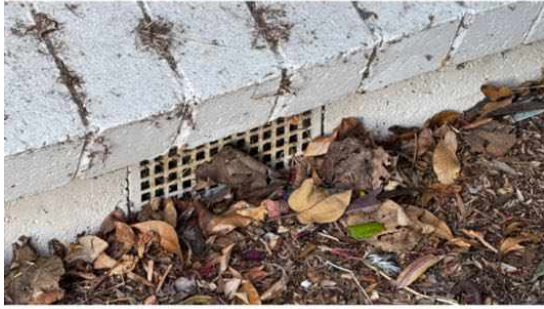
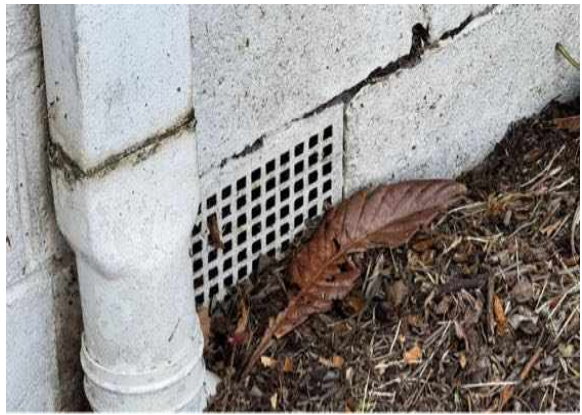
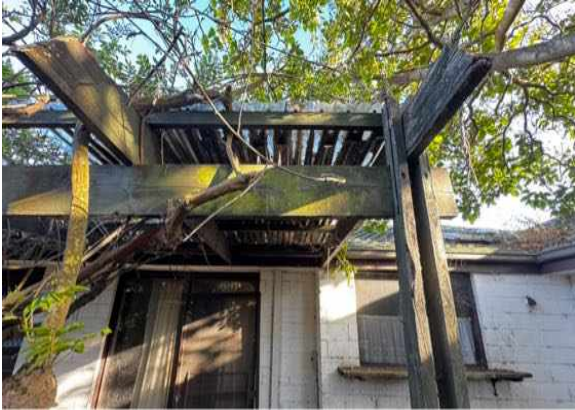
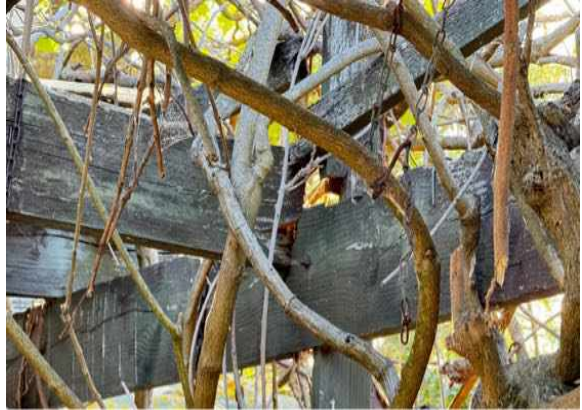
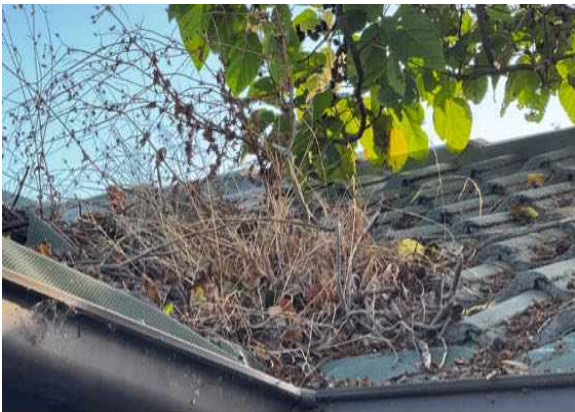
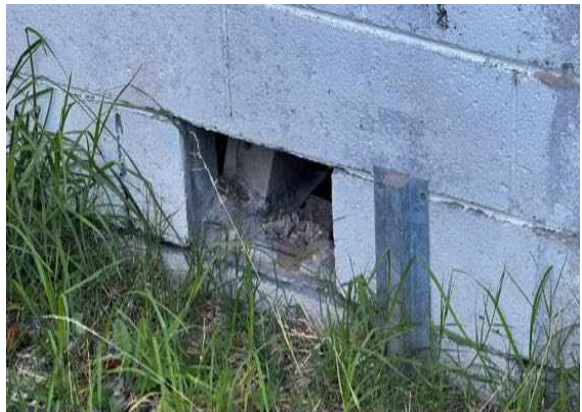
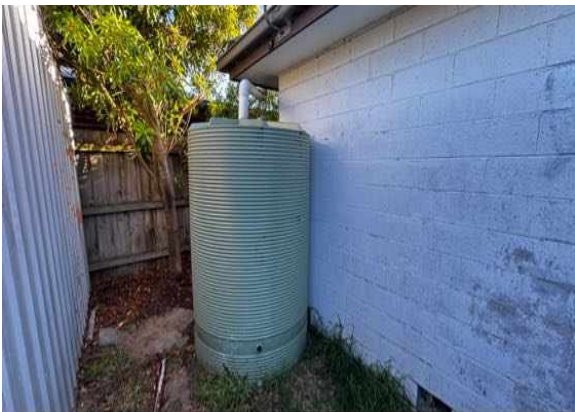
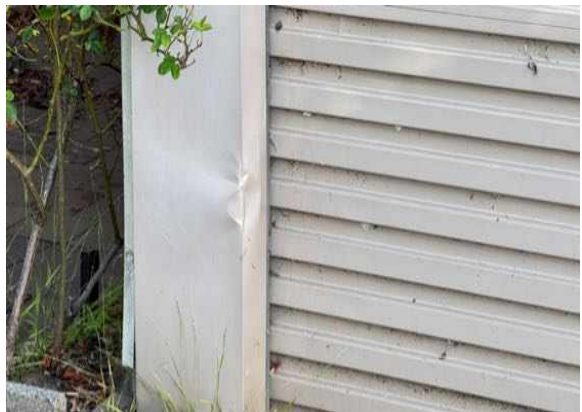
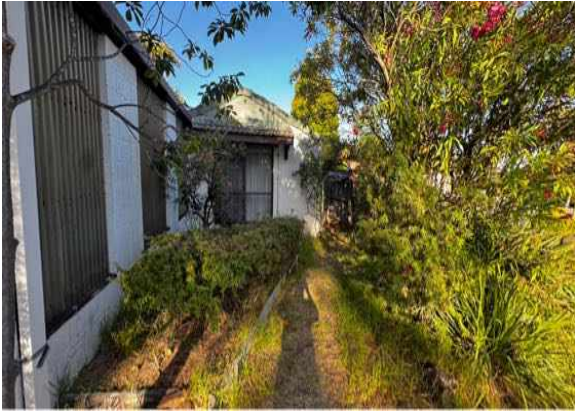
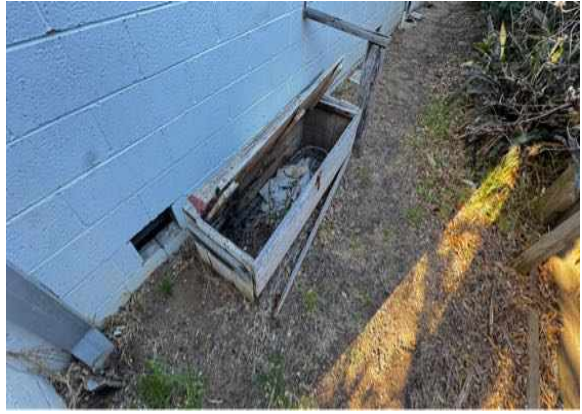
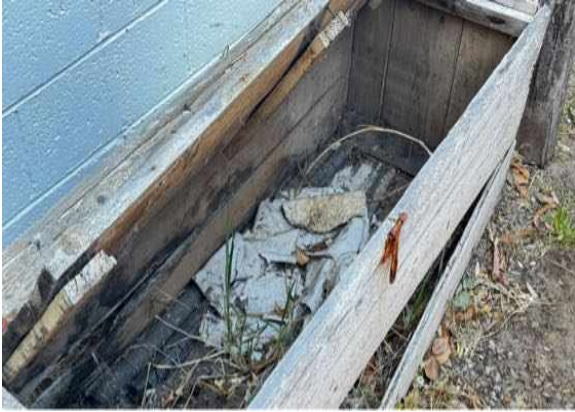
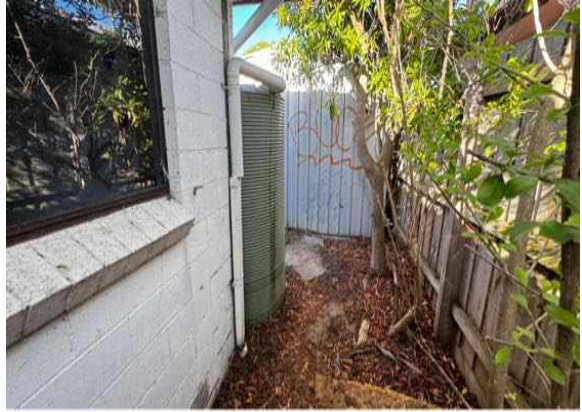
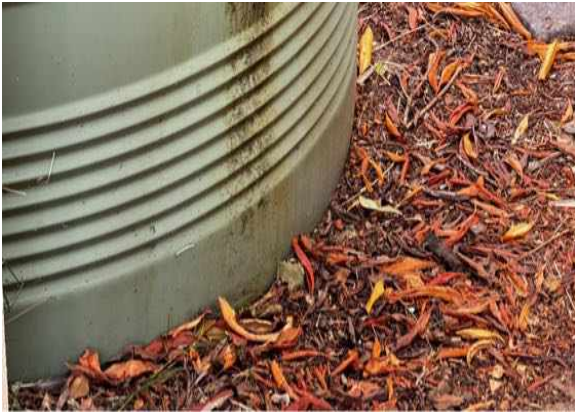
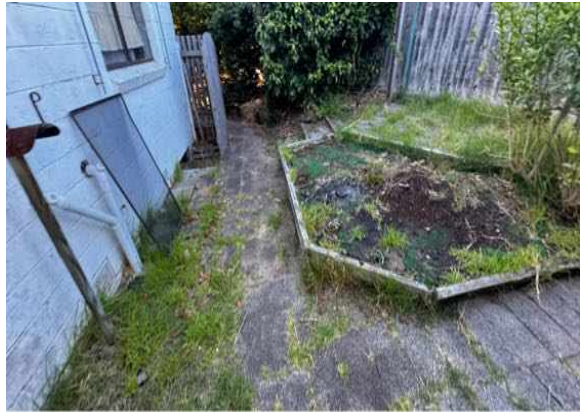
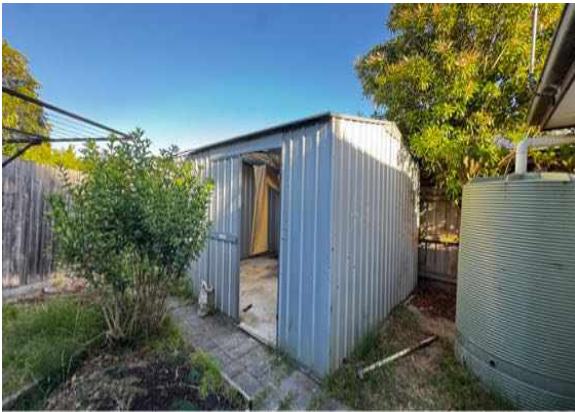
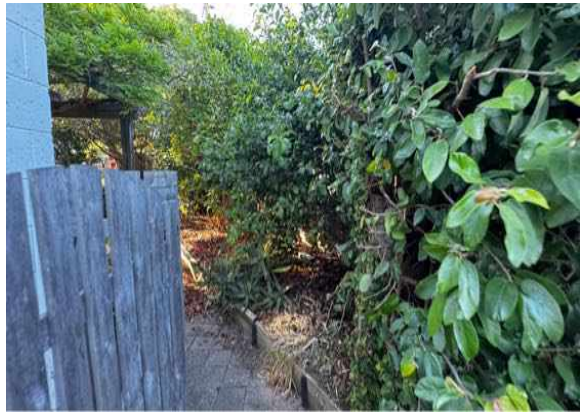
It is important to note that these restrictions can conceal a wide range of building defects, including but not limited to:

Because these areas could not be visually assessed, no comment can be made on their condition within this report.

It is strongly recommended that obstructions be removed and concealed areas made fully accessible immediately. A re-inspection should then be carried out to allow a complete assessment of the property's condition. This is particularly important prior to purchase, as defects in concealed areas can carry significant rectification costs.
