Building Inspection Report

Inspection Date: Tue, 31 Mar 2026

Property Address: 30/37 Bradley Street Glenmore Park NSW
2745

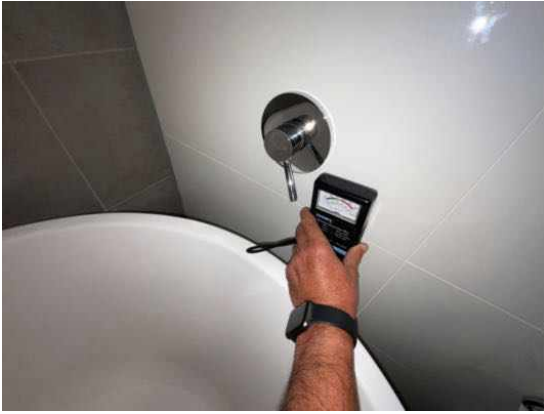
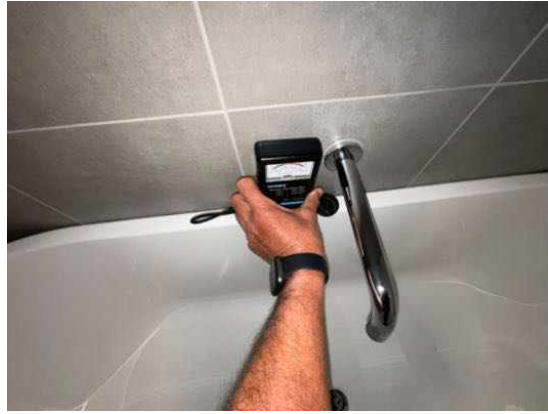
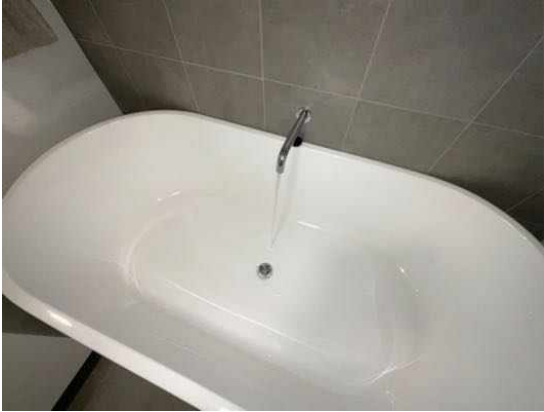
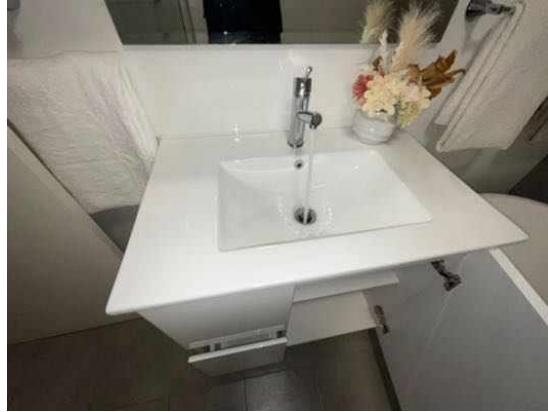
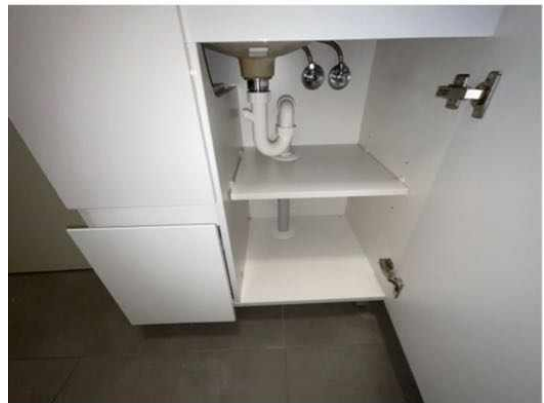
Building: Main Building
Location: Ensuite
Finding: Wet Areas - Bathroom(s) - Overall Condition & Recommendations.
Information: Overall Condition & Recommendations

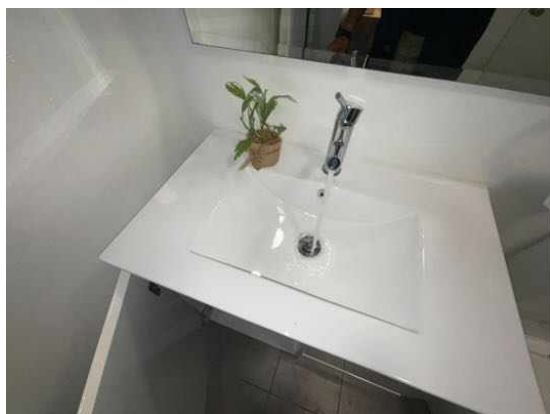
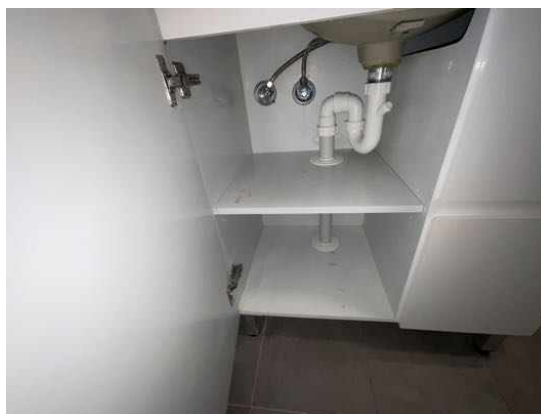
Building: Main Building
 Location: All Areas
 Finding: Water Pressure – Observation Only.
 Information: During the inspection, water pressure appeared to be within a normal operating range based on a basic functional check. However, this observation was made without the use of pressure testing equipment and does not constitute an assessment by a licensed plumber.
