Building Inspection Report

Inspection Date: Thu, 15 Jan 2026

Property Address: 2/30-32 Lydbrook Street, Westmead NSW
2145

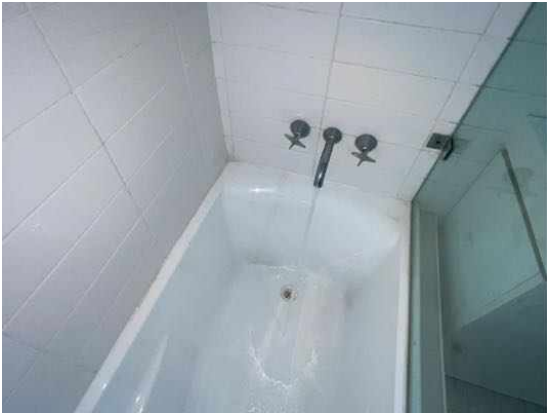
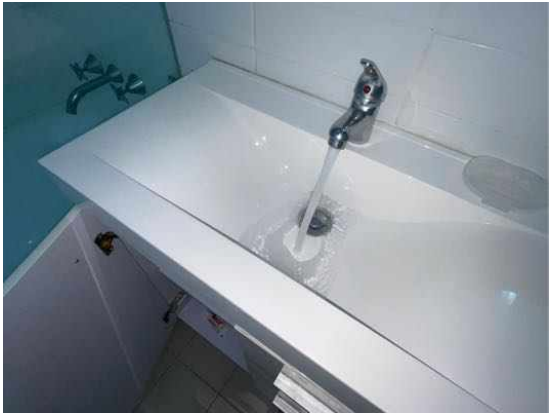
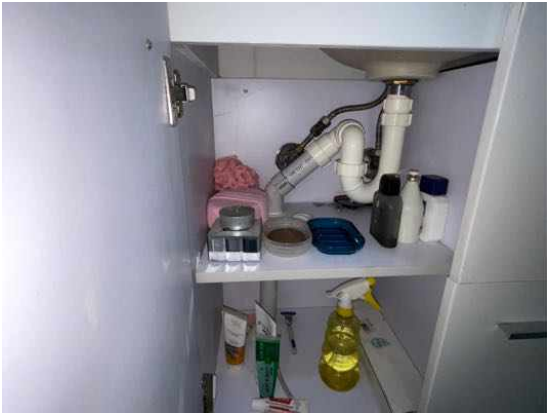
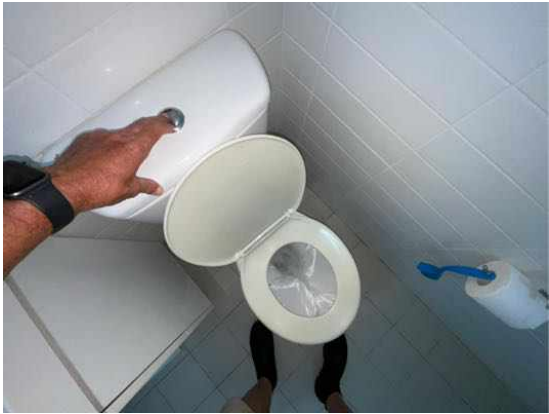
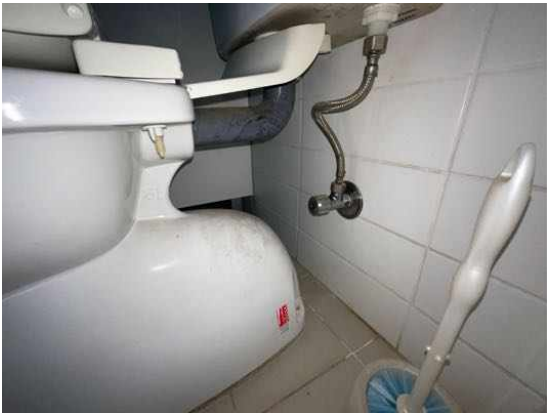
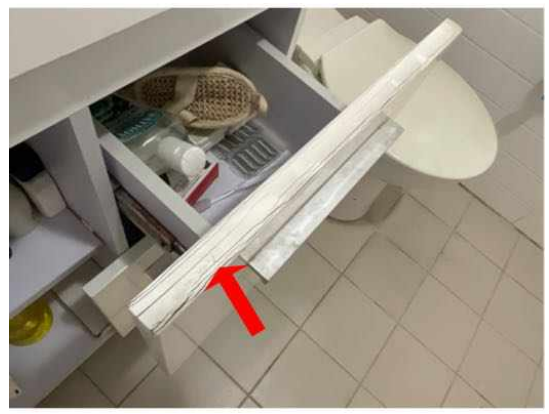
Alternatively, the assumption should be made that leakage may occur, particularly where historical or environmental conditions are conducive. The visual nature of this inspection cannot detect issues concealed behind wall/floor linings or cabinetry, and invasive investigation may be necessary to confirm the true condition of adjacent or hidden structures.

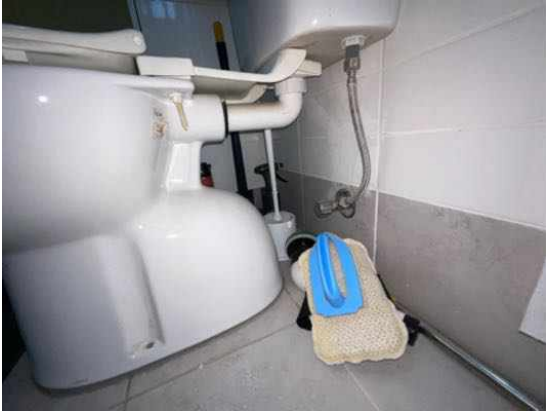
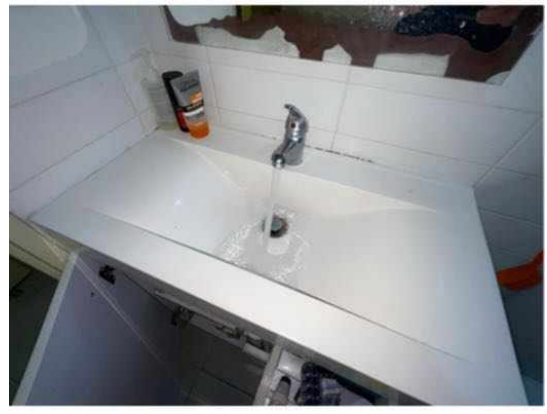
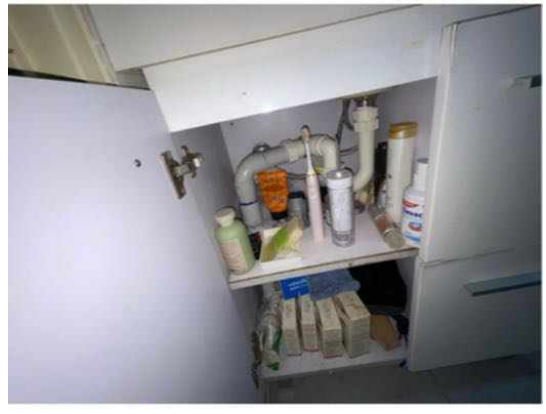
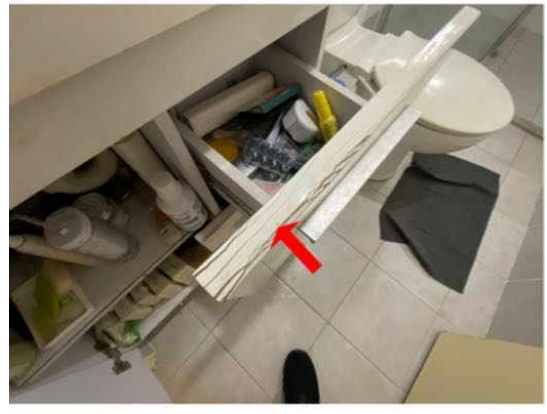
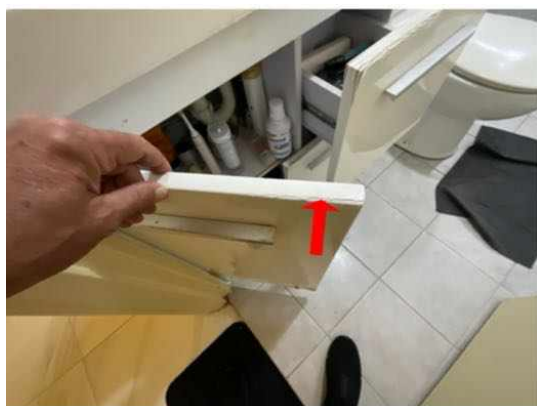
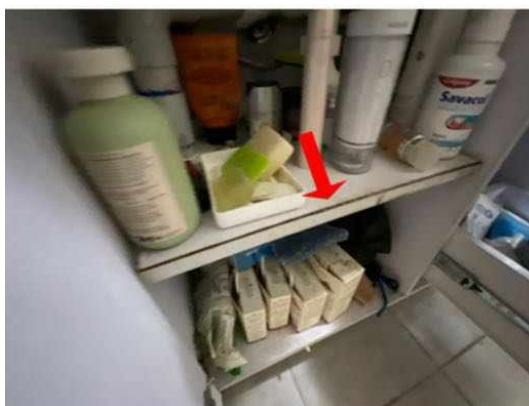
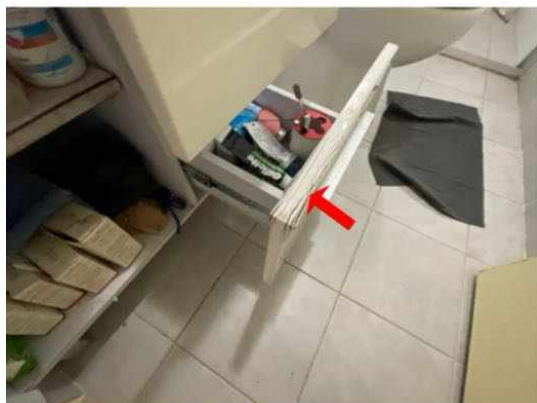
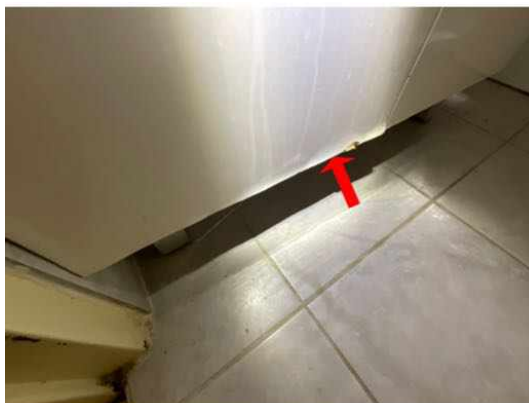
Building: Main Building
Location: Ensuite
Finding: Wet Areas - Bathroom(s) - Overall Condition & Recommendations.
Information: Overall Condition & Recommendations

Alternatively, the assumption should be made that leakage may occur, particularly where historical or environmental conditions are conducive. The visual nature of this inspection cannot detect issues concealed behind wall/floor linings or cabinetry, and invasive investigation may be necessary to confirm the true condition of adjacent or hidden structures.
