Building Inspection Report

Inspection Date: Mon, 22 Dec 2025

Property Address: 1/30 Estramina Dr, Oakdowns TAS 7019,
Australia

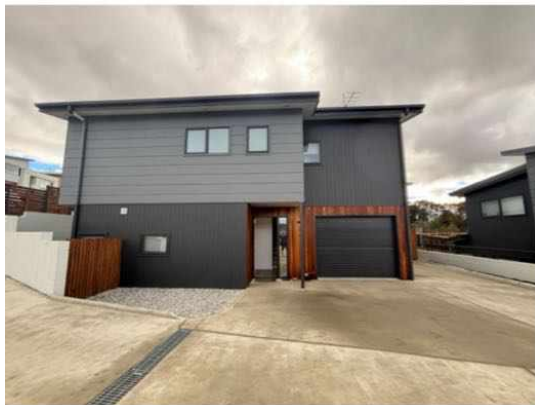
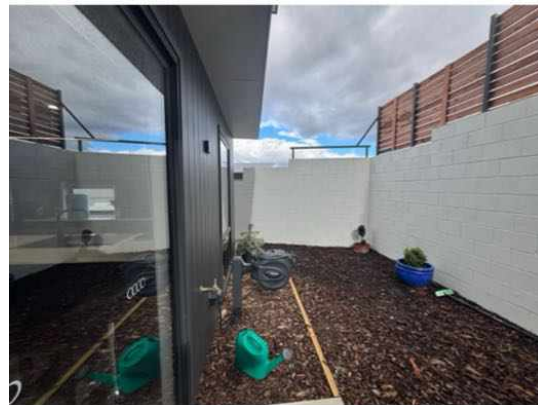
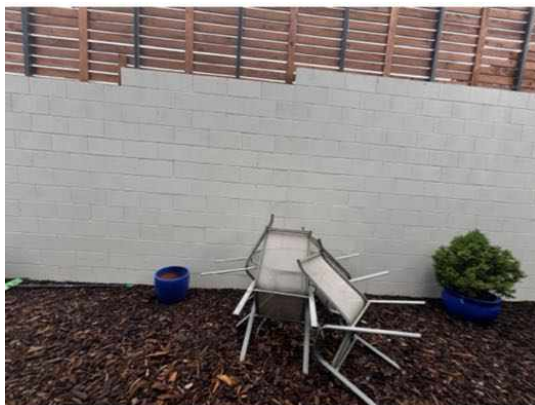
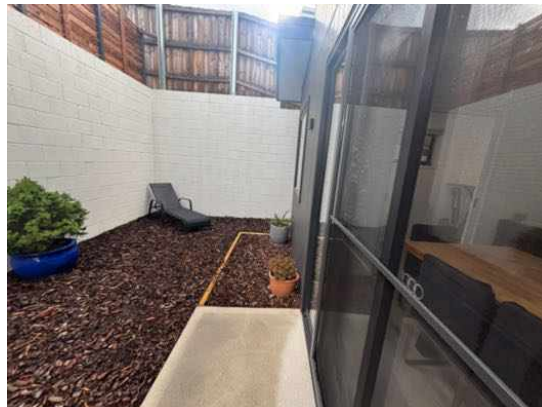
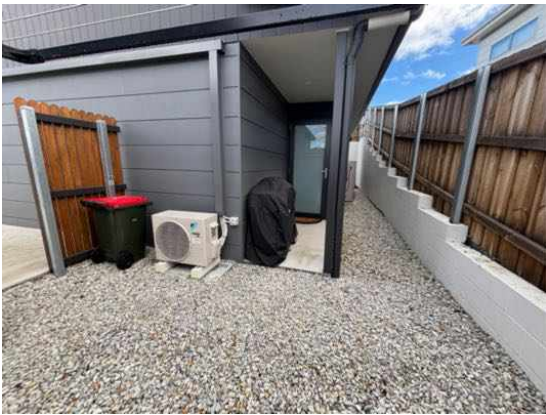
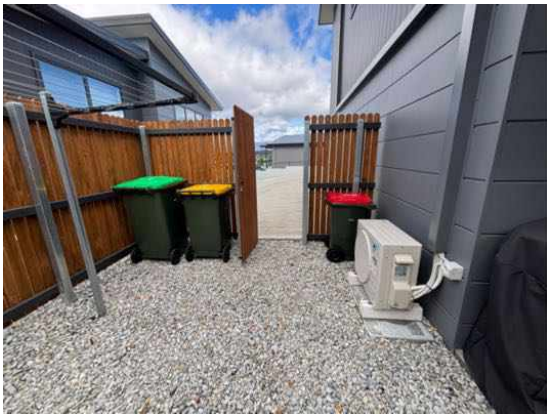
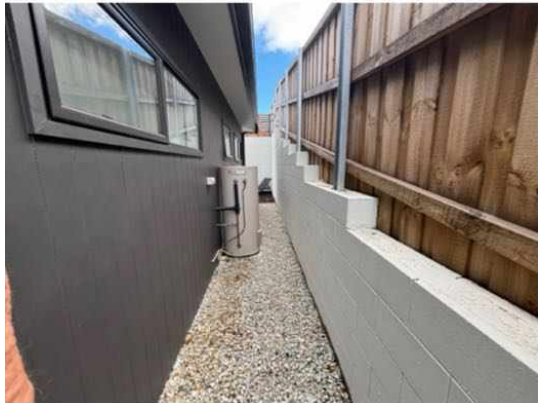
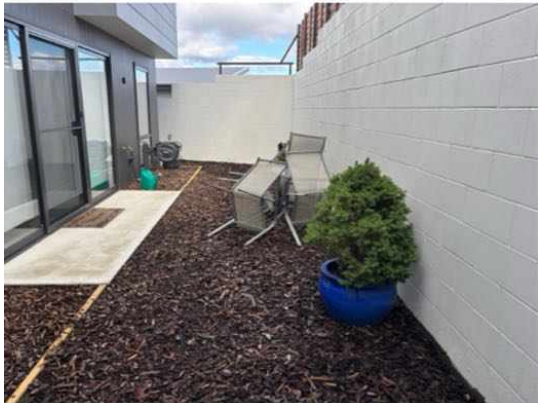
Finding: Additional Photos - Obstructions and Limitations

Information: These photographs are an indication of the obstructions and limitations which impeded full inspection of the property at the time of inspection. These obstructions can hide an array of defects and should be removed to allow full inspection to be carried out. A re-inspection is recommended once the areas are made accessible.

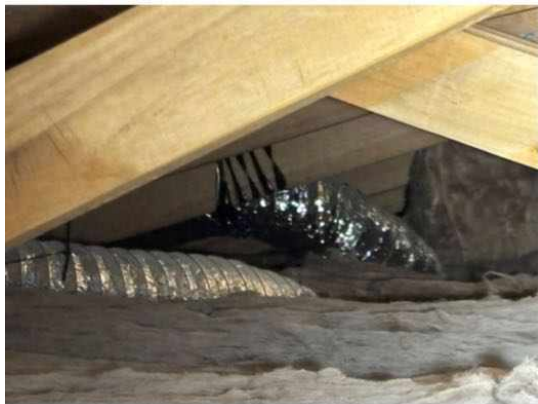
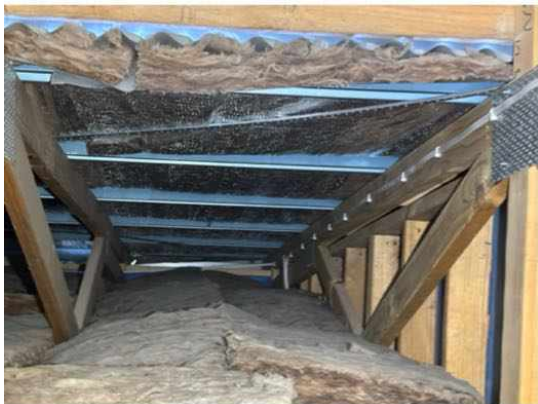
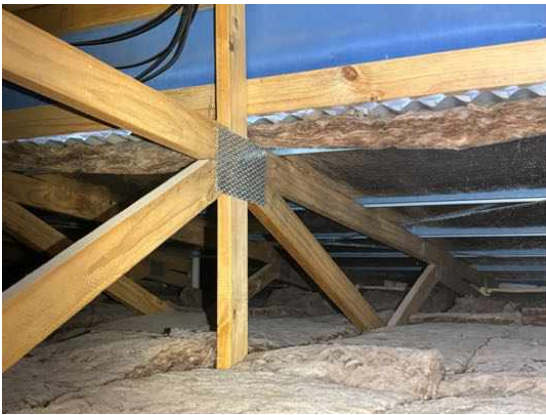
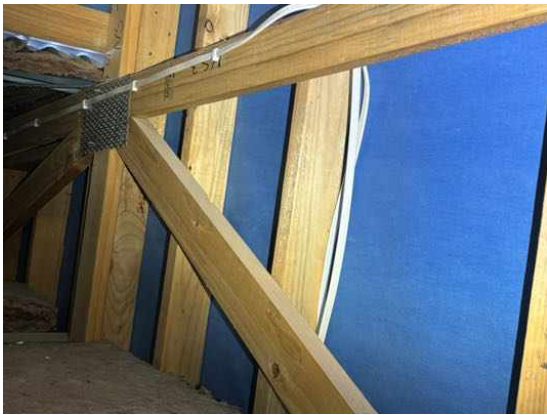
Building: Main Building
Location:
Finding: Additional Photos - Obstructions and Limitations
Information: These photographs are an indication of the obstructions and limitations which impeded full inspection of the property at the time of inspection. These obstructions can hide an array of defects and should be removed to allow full inspection to be carried out. A re-inspection is recommended once the areas are made accessible.

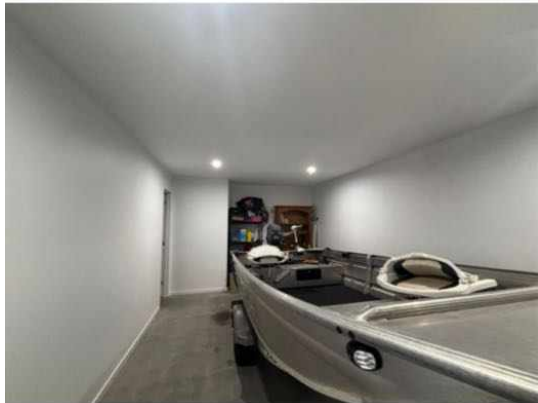
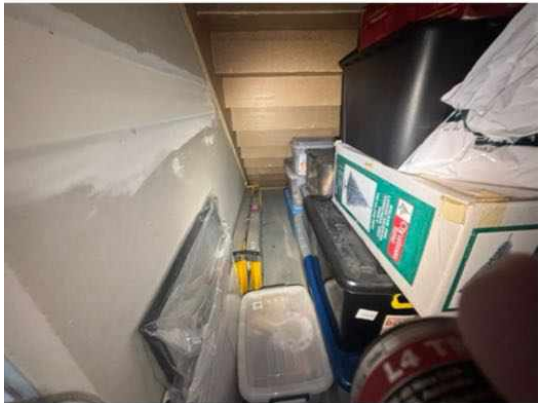
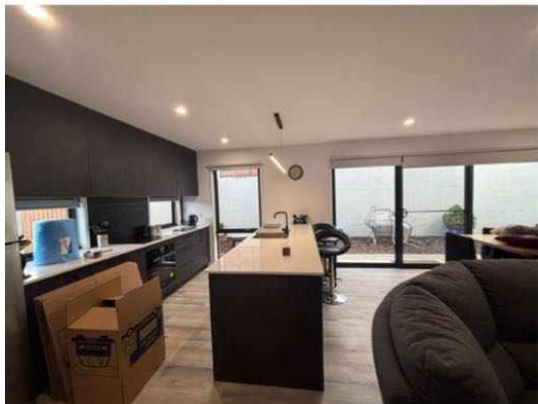
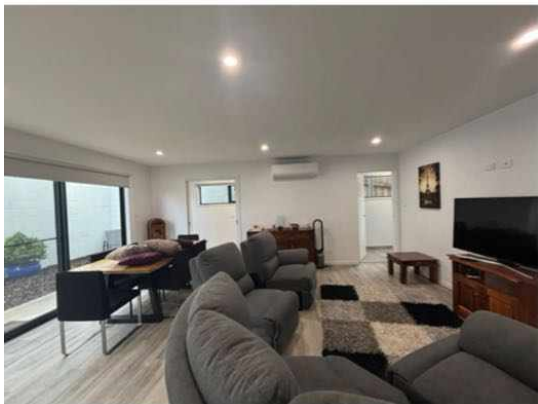
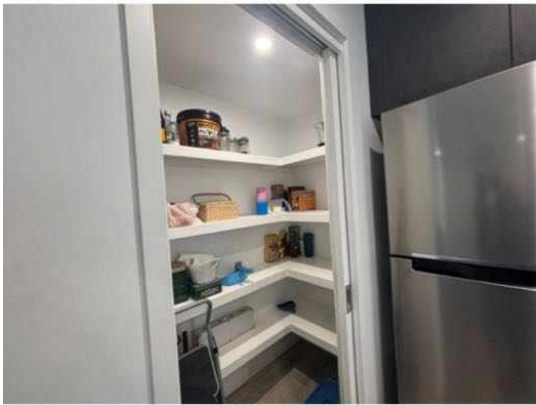
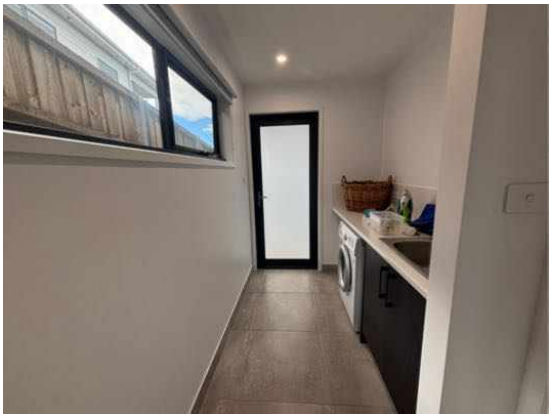
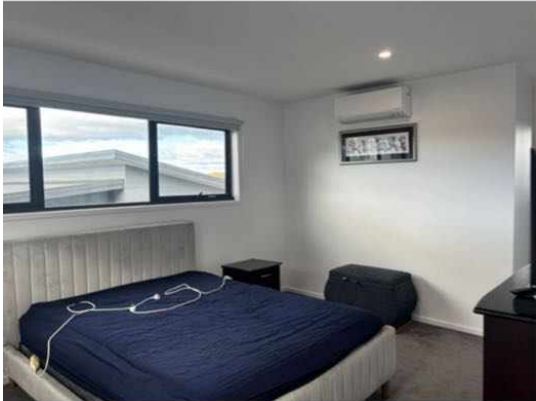
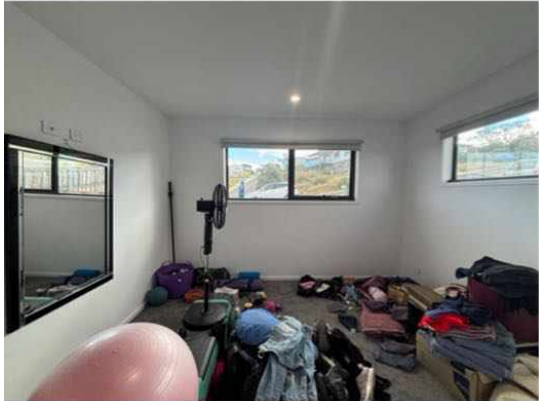
Finding: Additional Photos - Obstructions and Limitations

Information: These photographs are an indication of the obstructions and limitations which impeded full inspection of the property at the time of inspection. These obstructions can hide an array of defects and should be removed to allow full inspection to be carried out. A re-inspection is recommended once the areas are made accessible.
