Building and Timber Pest Inspection Report

Inspection Date: Fri, 6 Mar 2026

Property Address: 16 Ibex St, Earlwood NSW 2206, Australia

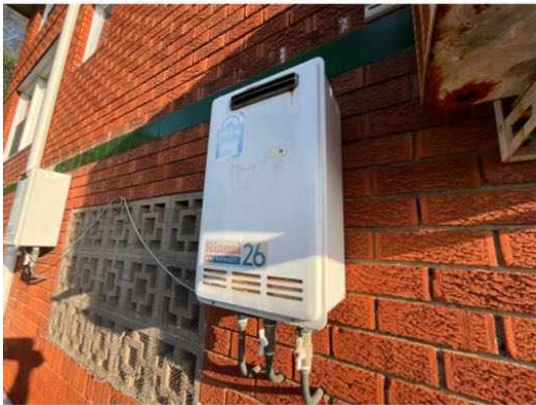
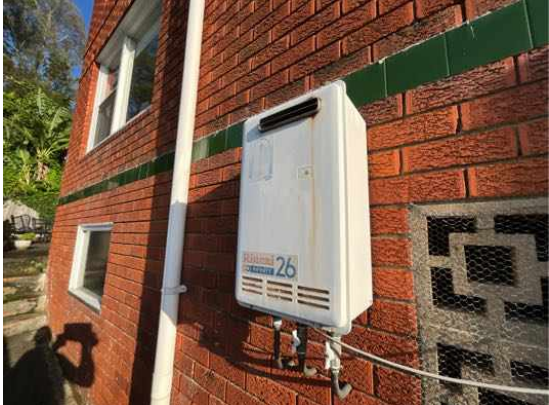
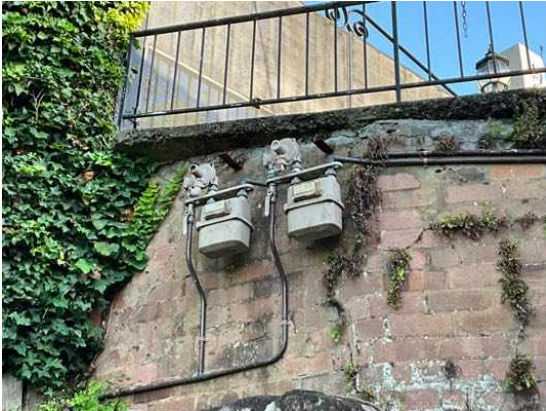
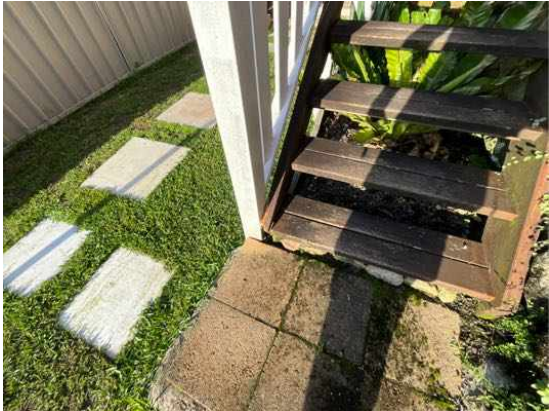
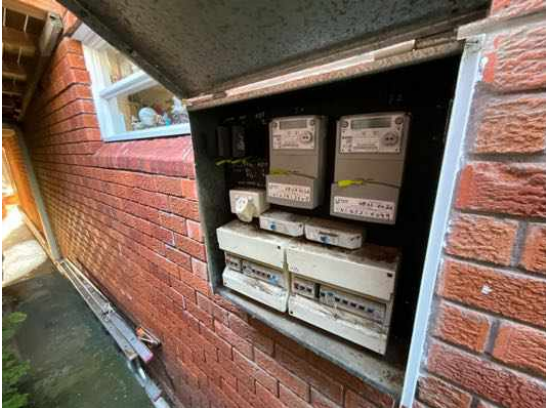
Building: Main Building
Location: All Areas
Finding: Photos Added
Information: Additional photos are provided for your general reference.

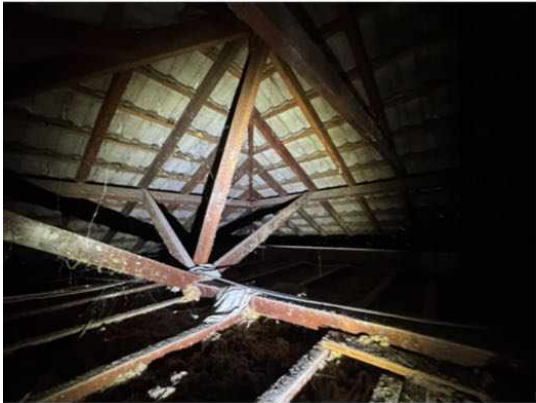
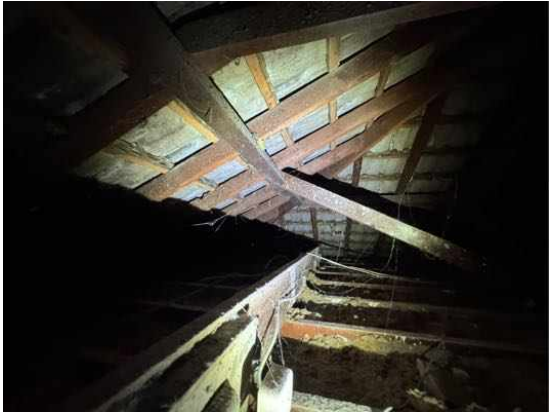
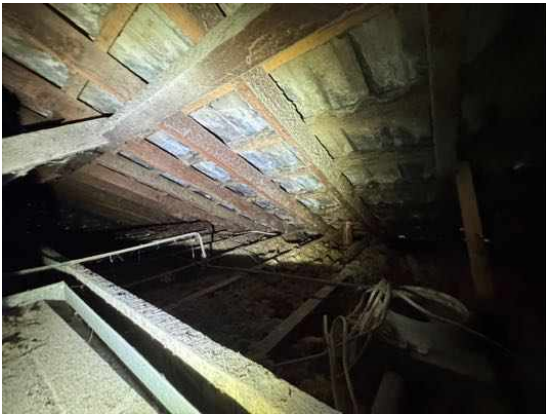
Building: Main Building
Location: Roof Void
Finding: Photos Added
Information: Additional photos are provided for your general reference.
