## Building and Timber Pest Inspection Report

Inspection Date: Wed, 21 Jan 2026

Property Address: 199 Grey St, Glen Innes NSW 2370,  
Australia

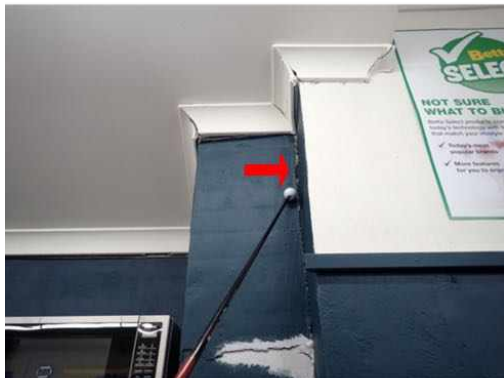
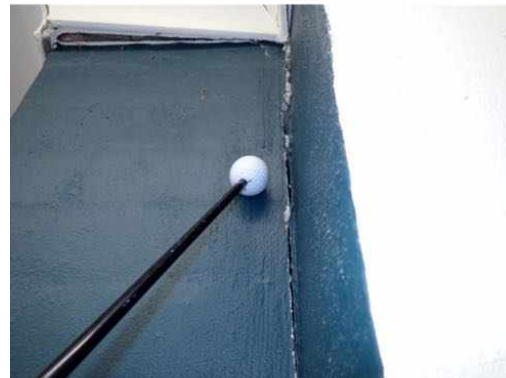
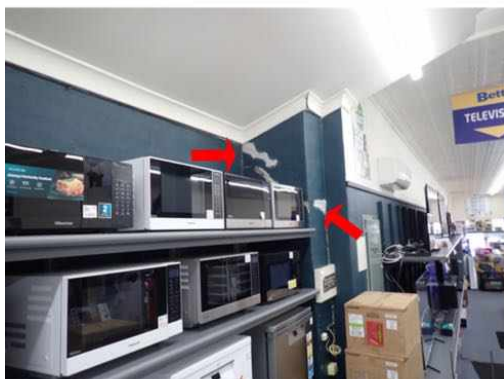
Building:	Main Building
Location:	Right hand side of show room approximately half way down
Finding:	Brickwork Wall – Structural Cracks
Information:	Brickwork Wall – Structural Cracks (Showroom Right-Hand Side)

Minor structural cracks were identified in the rendered brickwork wall approximately halfway down the showroom on the right-hand side at the time of inspection. These may be the result of building movement or age-related settlement. While not considered severe at this stage, further movement could lead to increased cracking over time. It is recommended that a suitably qualified builder or structural engineer assess and carry out repairs as deemed necessary to prevent further deterioration.

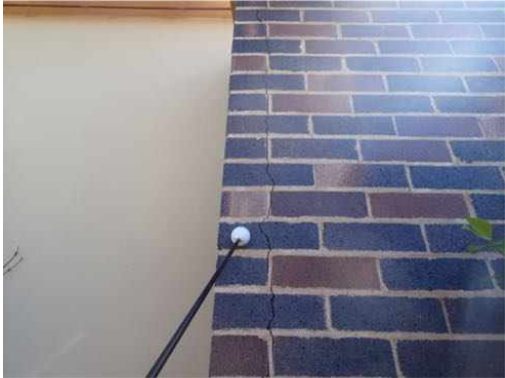
**Finding 2.04**

Building: Main Building  
Location: Right hand side of building  
Finding: Brickwork – Structural Crack Halfway Down Right-Hand Side of Building  
Information: A structural crack was identified in the brickwork approximately halfway down the right-hand side of the building at the time of inspection. This may indicate underlying movement or stress within the building structure. If left unaddressed, further deterioration and potential structural issues may occur. It is recommended that a suitably qualified structural engineer or builder assess the crack and carry out any necessary remedial works as deemed necessary.

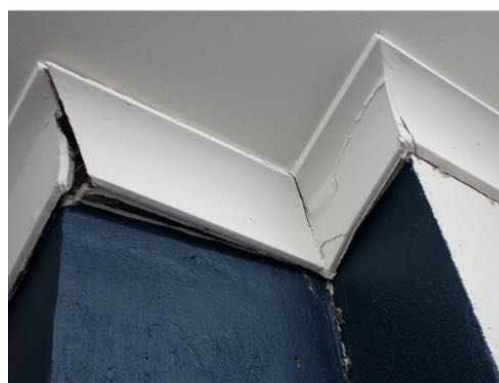
Building:	Main Building
Location:	Right hand side of show room approximately half way down
Finding:	Damaged — cornice
Information:	Cornice – damage (Showroom Right-Hand Side)

Damage was identified to the cornice at this location at the time of inspection. This may be due to general wear, minor movement, or impact damage. If left unaddressed, the condition may continue to deteriorate and affect the appearance of the area. It is recommended that a suitably qualified tradesperson repair or replace the damaged cornice as deemed necessary.

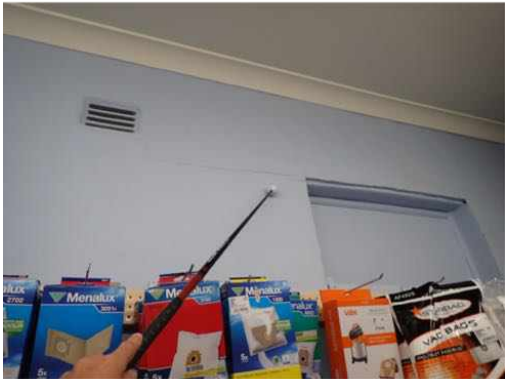
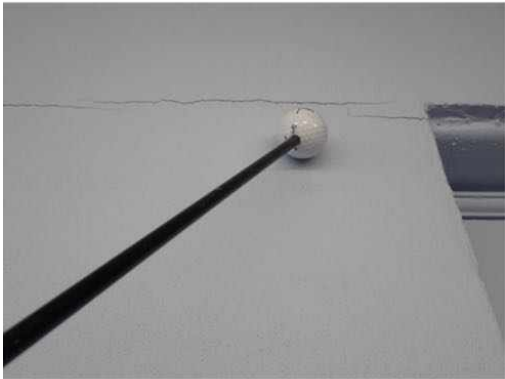
### Finding 3.04

Building:	Main Building
Location:	Rendered brick wall towards the end of the showroom
Finding:	Rendered Walls – Cracks Towards the Rear of the Showroom
Information:	Cracks were identified in the rendered walls towards the back of the showroom at the time of inspection. These may be due to building movement, age-related settlement, or thermal expansion and contraction. If left unaddressed, further deterioration may occur. It is recommended that a suitably qualified builder or tradesperson assess and carry out repairs as deemed necessary to maintain the condition of the walls.

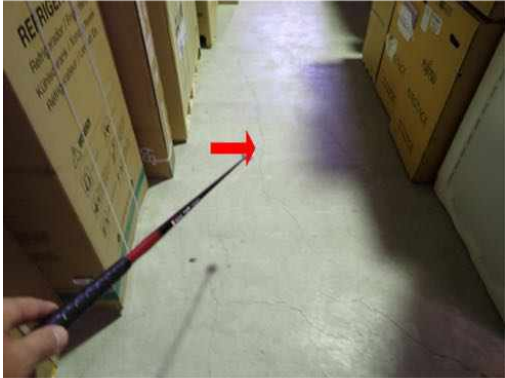
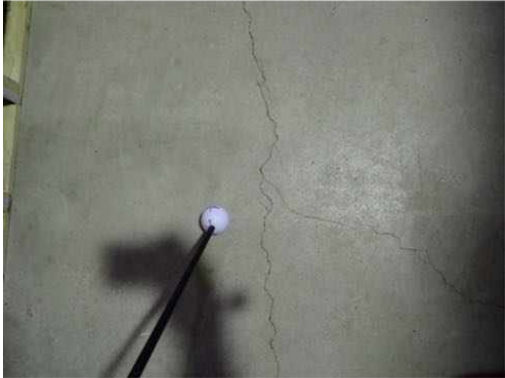
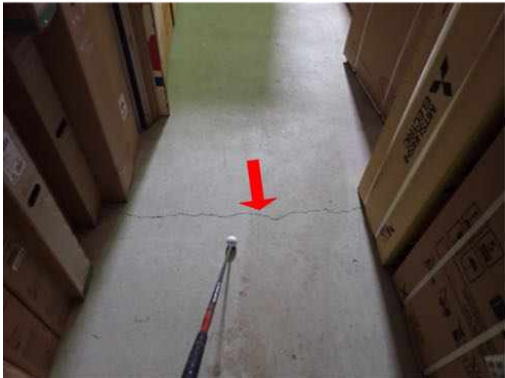
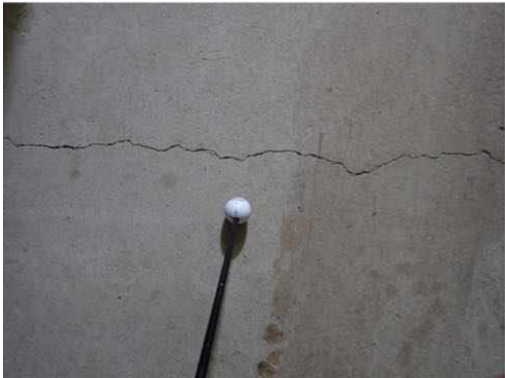
**Finding 3.05**

Building: Main Building  
Location: Warehouse floor  
Finding: Warehouse Concrete Floor – Several Minor Cracks  
Information: Several minor cracks were identified in the warehouse concrete floor at the time of inspection. These appear consistent with general shrinkage, age-related movement, or minor settlement. While not considered structurally significant, ongoing movement may lead to further deterioration if left unaddressed. It is recommended that the cracks be monitored and repaired as deemed necessary by a suitably qualified tradesperson to help prevent future damage.

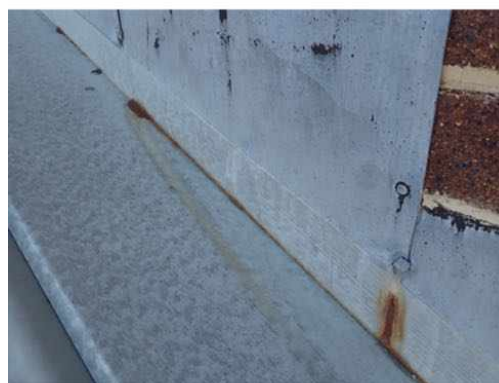
### Finding 3.09

Building:	Main Building
Location:	Roof were it meets the warehouse wall
Finding:	Brickwork / Roof Flashing – Minor Surface Rust at Warehouse Wall Junction
Information:	Minor surface rust was identified to the brickwork and roof flashing where the roof meets the warehouse brick wall at the time of inspection. This is consistent with age-related deterioration and exposure to weathering. While the rust appeared to be superficial, ongoing corrosion may occur if left unaddressed. It is recommended that a suitably qualified tradesperson clean, treat, and protect the affected areas as deemed necessary to prevent further deterioration.

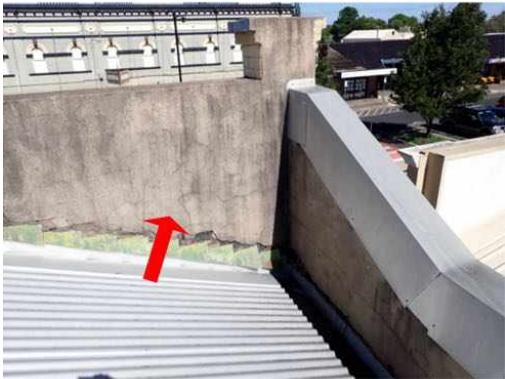
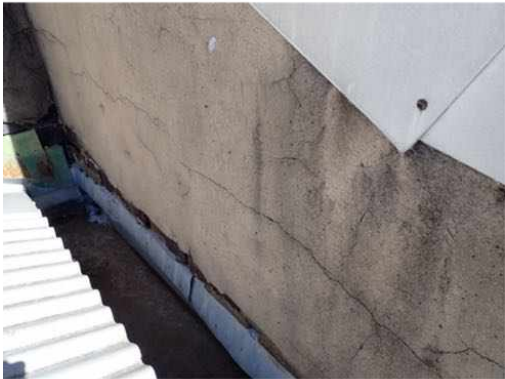
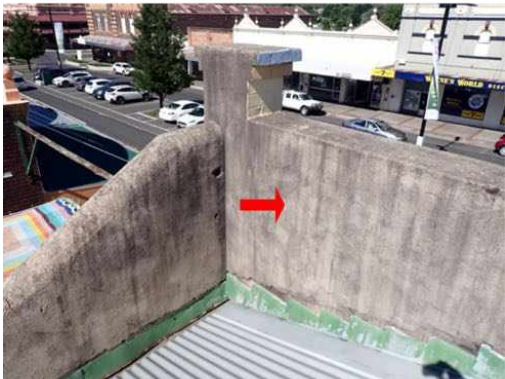
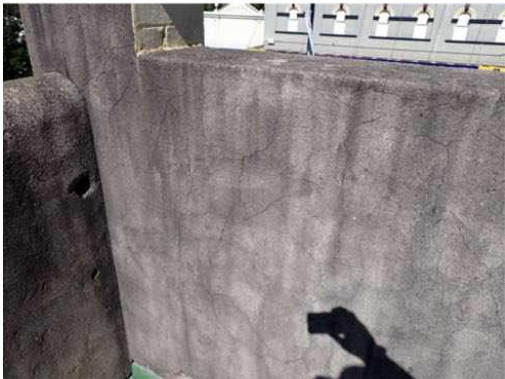
### Finding 3.10

Building:	Main Building
Location:	Back side of front parapet
Finding:	Front Parapet – Age-Related Cracks to Rear Rendered Face
Information:	Age-related cracks were identified in the rendered surface on the back side of the front parapet at the time of inspection. These appear consistent with general movement and long-term weather exposure. While not considered structurally significant at this stage, further deterioration may occur if left unaddressed. It is recommended that a suitably qualified tradesperson repair and maintain the rendered surface as deemed necessary to prevent further damage.

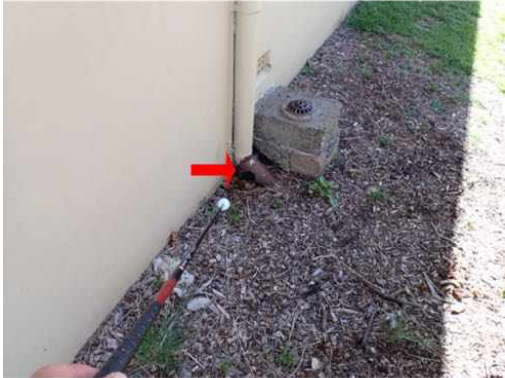
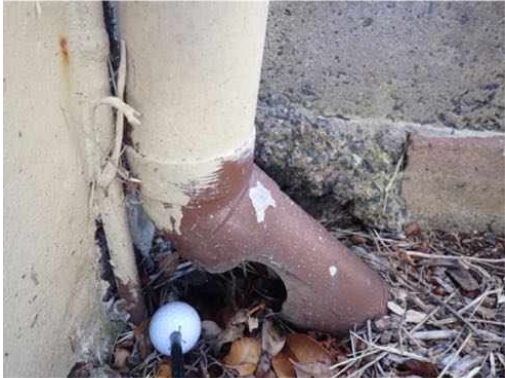
**Finding 3.11**

Building: Main Building  
Location: Right hand side of building  
Finding: Downpipe – Hole at Ground Level (Front Right-Hand Side)  
Information: A hole was identified in the downpipe at ground level on the front right-hand side of the building at the time of inspection. This may allow water to discharge at the base of the wall and cause moisture-related damage to surrounding building materials. It is recommended that a suitably qualified plumber or tradesperson repair or replace the affected section of downpipe as deemed necessary to ensure proper stormwater drainage.

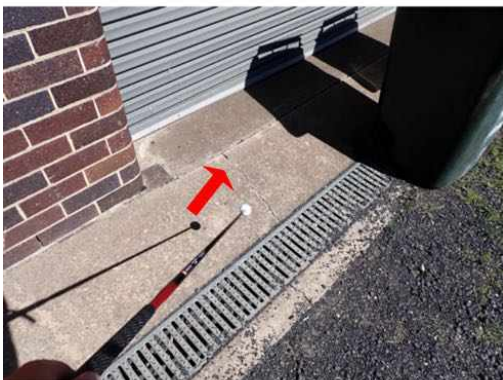
### Finding 3.13

Building:	Main Building
Location:	Rear of warehouse
Finding:	Warehouse Concrete Entry – Minor Cracks
Information:	Minor cracks were identified in the concrete entry area of the warehouse at the time of inspection. These appear consistent with general shrinkage, age-related movement, or minor settlement. While not considered structurally significant, it is recommended that the cracks be monitored and repaired as deemed necessary by a suitably qualified tradesperson to help prevent further deterioration.

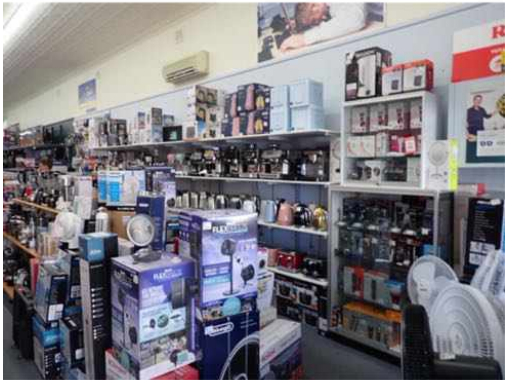
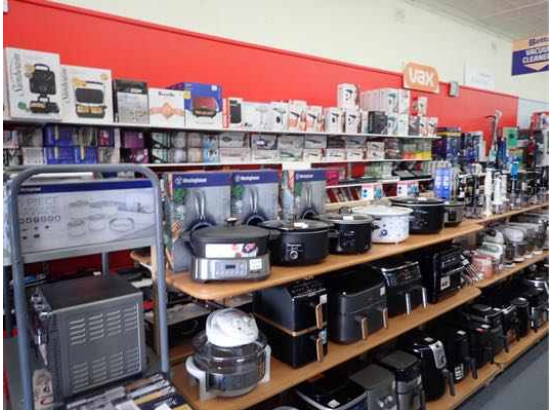
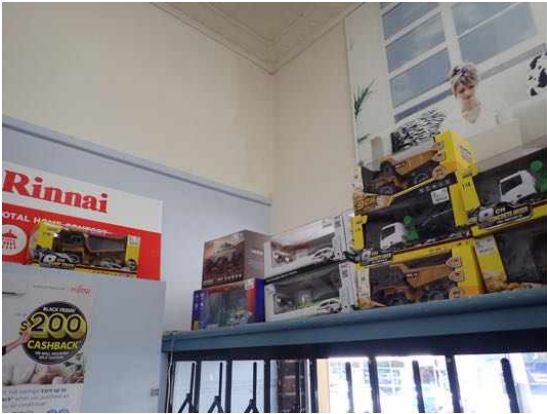
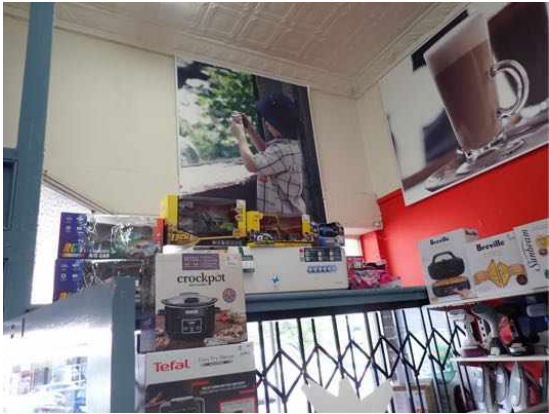
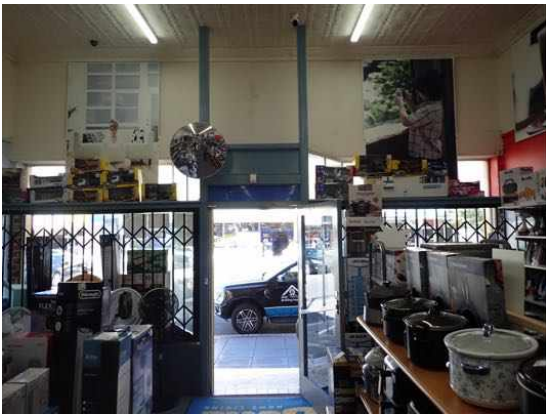
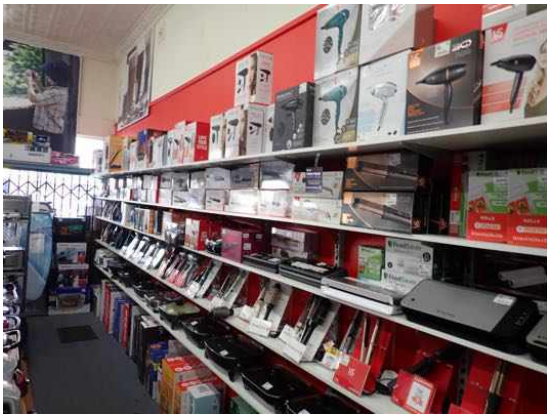
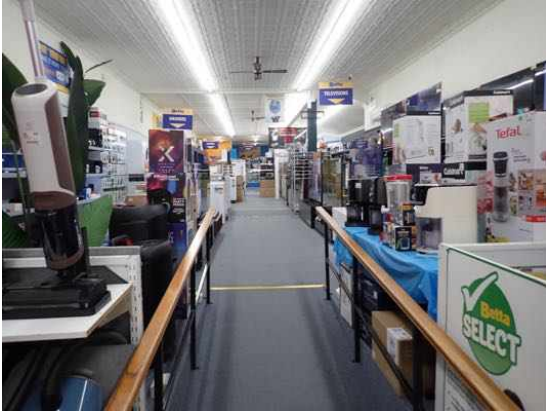
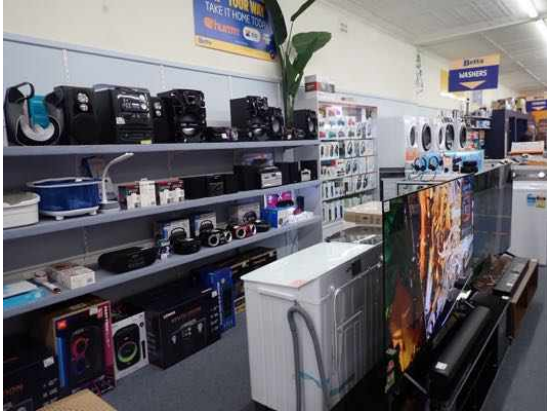
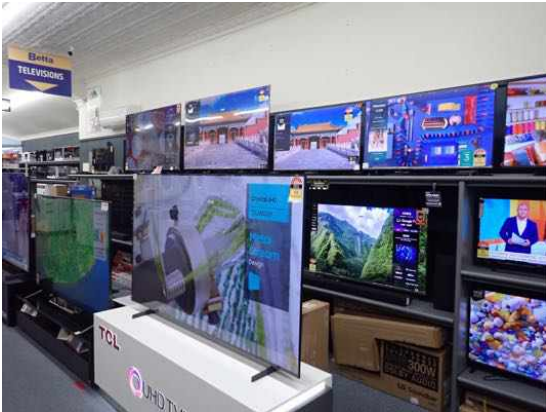
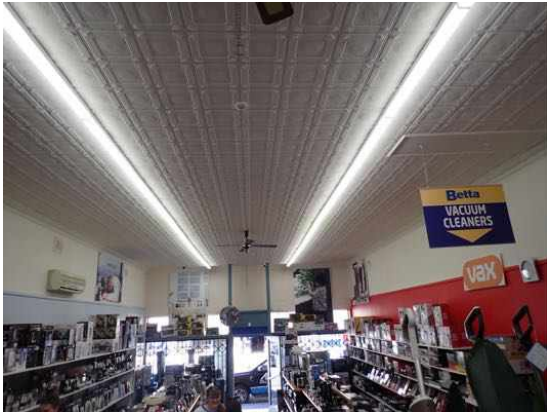
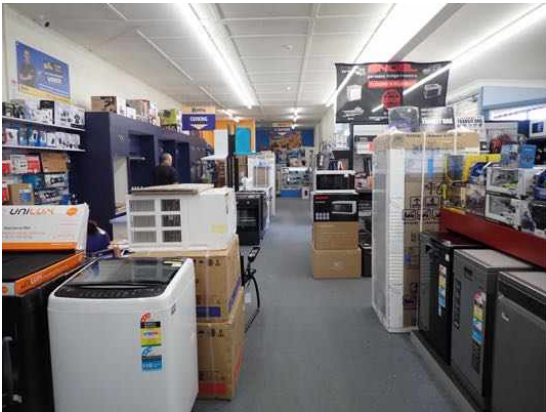
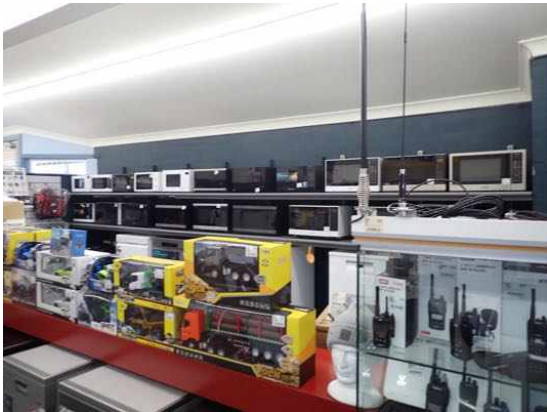
Building: Main Building  
Location: All Areas  
Finding: Additional Photos - Obstructions and Limitations  
Information: These photographs are an indication of the obstructions and limitations which impeded full inspection of the area at the time of inspection. These obstructions can hide an array of defects and should be removed to allow full inspection to be carried out. A re-inspection is recommended once the areas are made accessible.
