Building and Timber Pest Inspection Report

Inspection Date: Tue, 10 Mar 2026

Property Address: 63 Christy Dr, SCHOFIELDS, NSW, 2762,
Australia

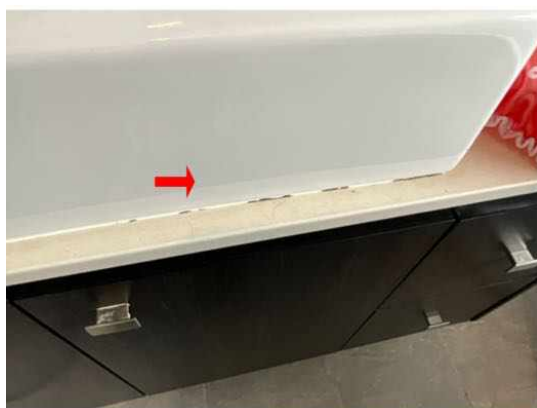
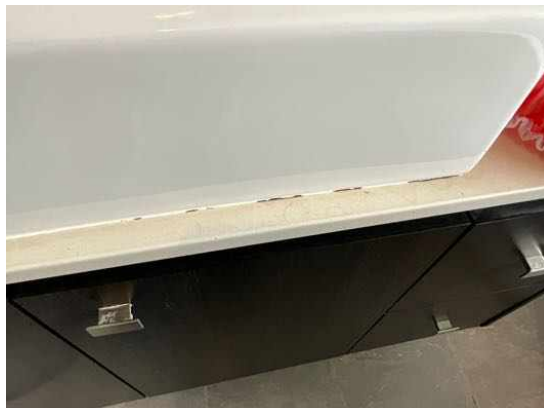
Finding 3.03

Building: Main Building
 Location: Bathroom
 Finding: Silicone Sealant - Detoriated Around Basin
 Information: The silicone seal around the basin has deteriorated, with visible gaps and discolouration noted along the edges.

Water penetration through the deteriorated seal may cause damage to surrounding surfaces, promote mould growth, and lead to deterioration of adjacent materials.

A licensed plumber or qualified handyman should remove the old sealant and reapply a sanitary-grade silicone to ensure watertight protection.

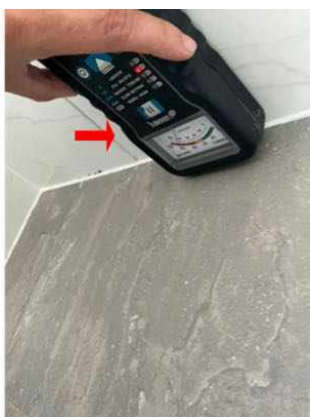
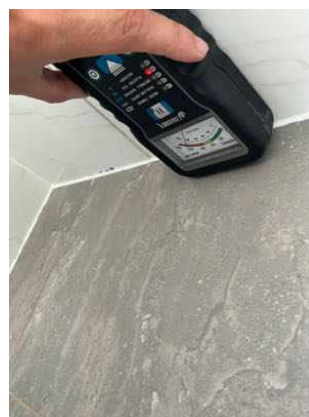
Finding 3.04

Building: Main Building
 Location: Bathroom
 Finding: Shower - Damp
 Information: Damp is evident to the lower 300mm of wall to the shower alcove. This defect is quite common, and is suspected to have been caused by moisture permeating through the

grouting in this area, which shows evidence of deterioration. Leaking pipes within the adjoining wall is also a possible cause.

Unmanaged damp in the shower recess is likely to facilitate the formation and development of mould and fungi growth, decaying associated building materials and compromising their structural integrity. It is important to address damp conditions, as the World Health Organisation notes that excess moisture leads - on almost all indoor materials - to growth of microbes such as moulds, fungi and bacteria, which subsequently emit spores and other matter into the indoor air. Exposure to these contaminants is associated with a wide range of respiratory and other health-related problems.

Consultation with a qualified plumber or bathroom specialist is advised immediately to identify the cause of damp and to perform remedial works as required. Where excessive mould growth is present, further inspection by a specialist environmental health inspector should also be considered.

Always ensure that sealant and grout is in good condition to prevent any moisture issues occurring in the future.

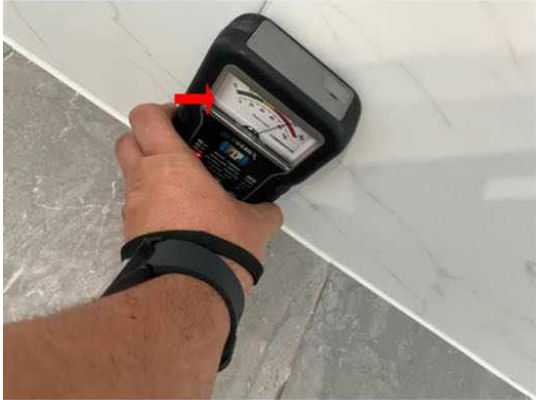
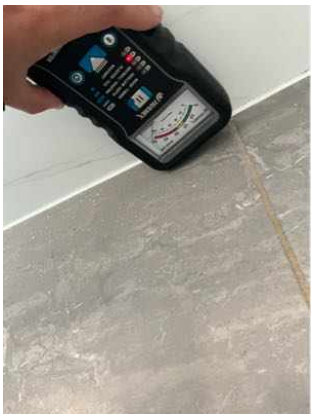
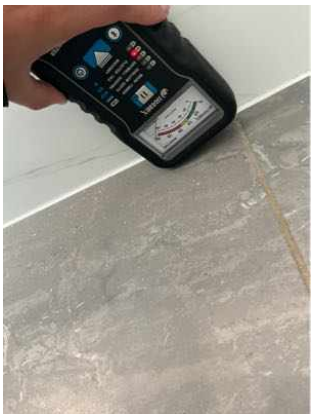
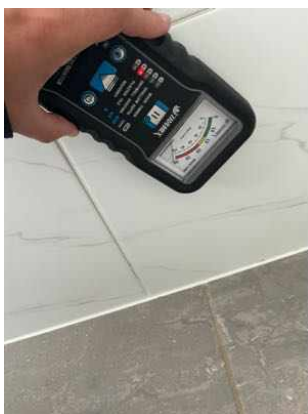
Finding 3.05

Building:	Main Building
Location:	Ensuite
Finding:	Shower - Damp
Information:	Damp is evident to the lower 300mm of wall to the shower alcove. This defect is quite common, and is suspected to have been caused by moisture permeating through the grouting in this area, which shows evidence of deterioration. Leaking pipes within the adjoining wall is also a possible cause.

Unmanaged damp in the shower recess is likely to facilitate the formation and development of mould and fungi growth, decaying associated building materials and compromising their structural integrity. It is important to address damp conditions, as the World Health Organisation notes that excess moisture leads - on almost all indoor materials - to growth of microbes such as moulds, fungi and bacteria, which subsequently emit spores and other matter into the indoor air. Exposure to these contaminants is associated with a wide range of respiratory and other health-related problems.

Consultation with a qualified plumber or bathroom specialist is advised immediately to identify the cause of damp and to perform remedial works as required. Where excessive mould growth is present, further inspection by a specialist environmental health inspector should also be considered.

Always ensure that sealant and grout is in good condition to prevent any moisture issues occurring in the future.

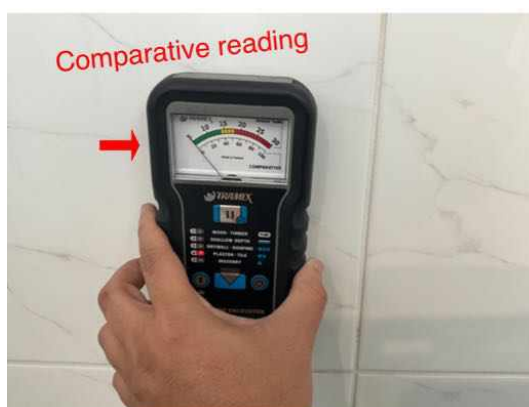
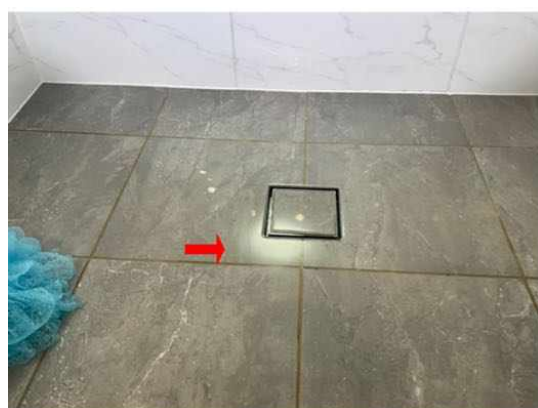
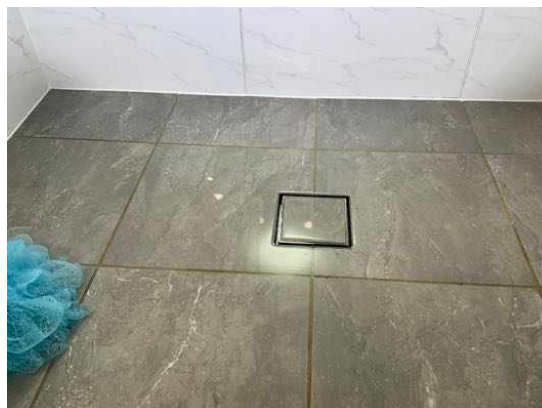
Finding 3.06

Building:	Main Building
Location:	Ensuite
Finding:	Shower base - Water pooling
Information:	Evidence of water pooling around the floor waste in the shower recess was noticed at the time of inspection. It is suspected that this excessive moisture is attributed to insufficient fall in the shower floor tiles.

This pooling is minor overall but is still considered unsatisfactory, as standard tiling practices would not permit this situation to occur. Pooling water around floor wastes can create a slip hazard in extreme cases and create conditions that are conducive to mould growth over time. Where left unmanaged, the degradation of sealant and grouting is also likely to occur, possibly necessitating further repair works.

Remedial works may involve some sections of tiling and flooring repair and replacement. A tiling contractor or bathroom specialist should be appointed to provide further advice on reparation options and to perform works as necessary.

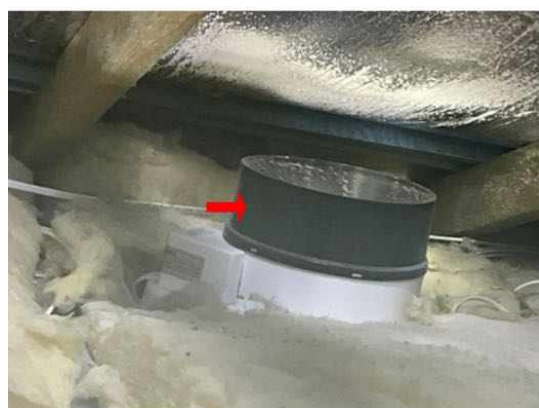
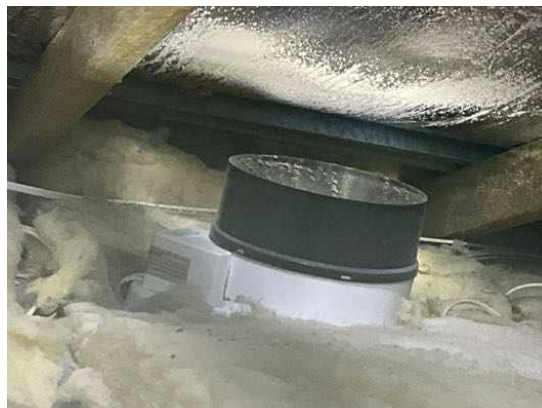
Finding 3.07

Building: Main Building
 Location: Roof Void
 Finding: Exhaust fan not vented out
 Information: The exhaust fan located within the roof void is not appropriately ducted to the external atmosphere and is currently discharging moist air directly into the roof space. This is considered a defect under AS 4349.1, as it does not meet the minimum standard of residential building performance expected under normal residential building practices.

This condition may lead to excessive condensation within the roof void, increasing the risk of mould growth, deterioration of insulation, timber decay, and overall reduced durability of building elements. It may also result in poor indoor air quality, potentially affecting occupant health.

It is recommended that the exhaust fan be modified by a licensed HVAC contractor or qualified builder, ensuring it is properly ducted to discharge externally in accordance with manufacturer specifications, the National Construction Code (NCC), and applicable Australian Standards.

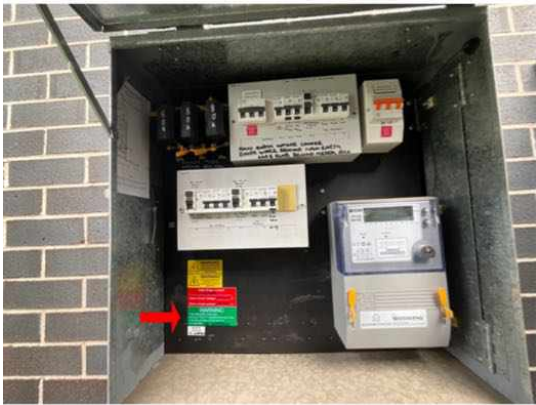
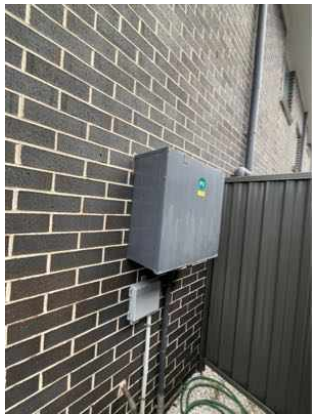
Building:	Main Building
Location:	Exterior walls - right side
Finding:	No Evidence of Termite Management System - Durable notice / Legible Sticker
Information:	The application of a pre & post-construction chemical termite barrier is highly recommended for all properties. Such barriers are highly effective in preventing termite attack on any timber building elements throughout the property.

A durable notice was not placed in the switchboard unit to indicate current termite barriers is legible at the time of inspection.

Client must seek further information from the vendor or real estate agent if the conditions of termite management systems were maintained.

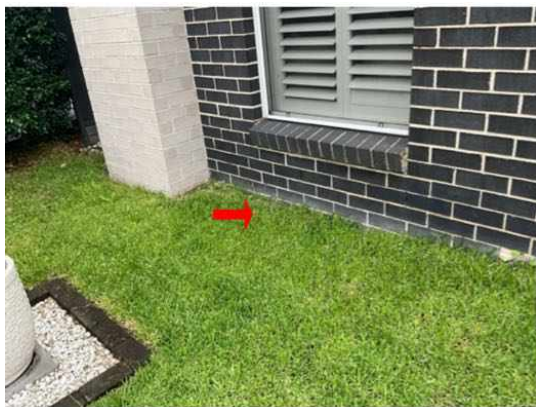
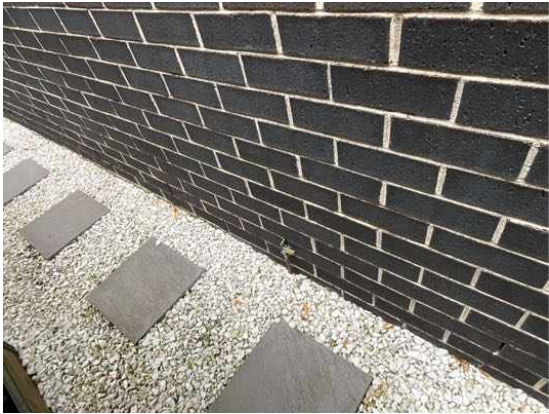
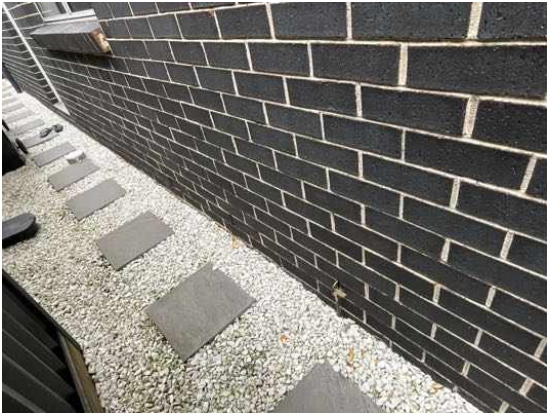
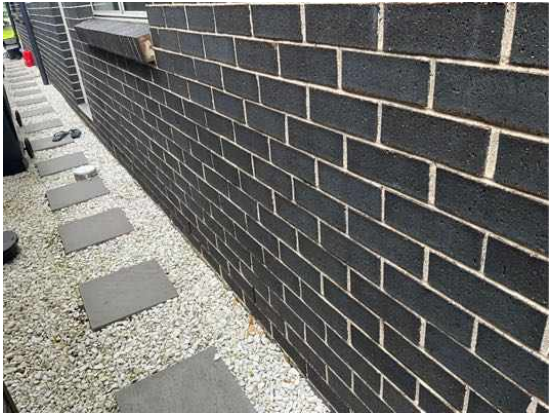
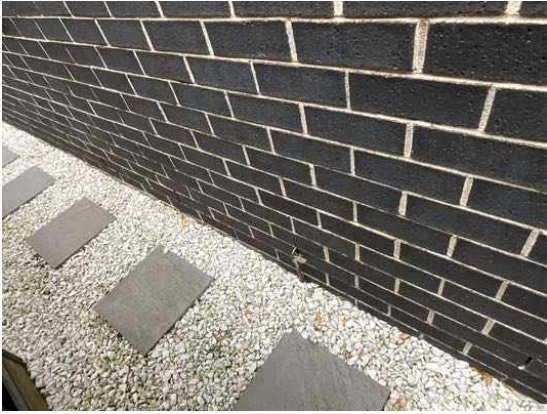
Finding 6.02

Building: Main Building
Location: All Areas
Finding: Slab Edge - Exposure
Information: An inspection zone of at least 75mm in relation to the exposed slab edge, between the bottom brick and the perimeter pavement, is required. This inspection zone should be maintained in order to force termites into the open where they can be detected more readily during regular inspections. The slab edge should not be concealed by anything that may prevent inspection of the area, including render, landscaping, soil, turf, paving, concrete cladding or other structures.

If the slab edge is not properly exposed there is a high risk of termite attack. Sometimes, in order to determine the type of slab, a suitably qualified person such as an architect or builder may be required to consult the construction plans.

Where the slab edge cannot be properly inspected, it is highly recommended that termite or timber pest inspections be carried out every 6-12 months to aid protection of the property against infestation.

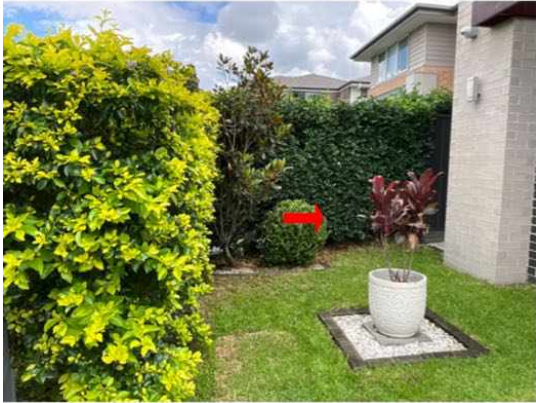
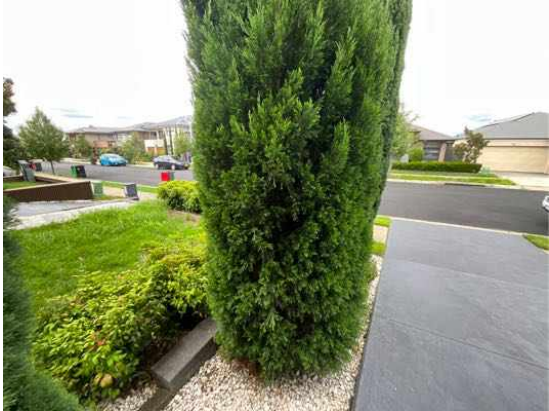
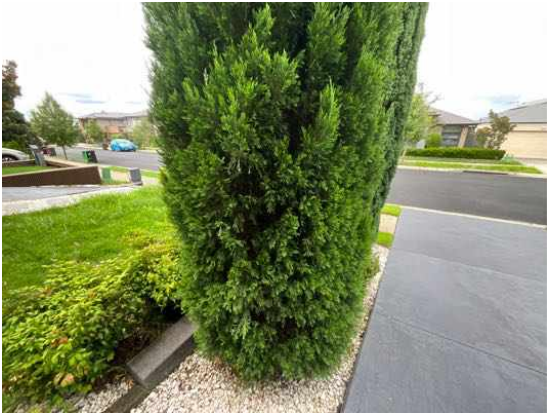
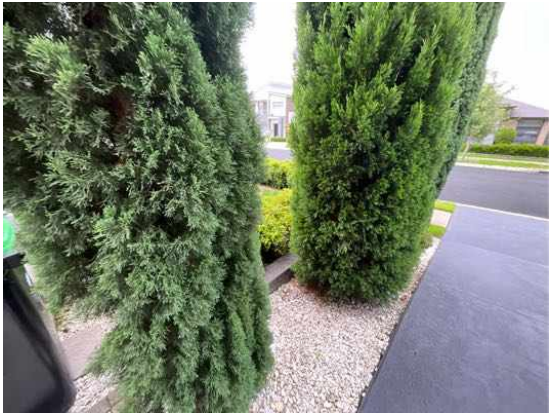
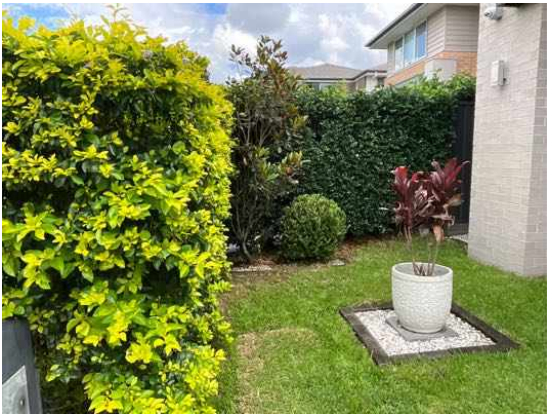
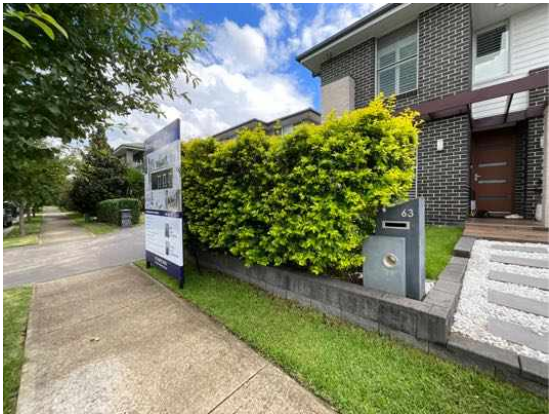
Finding 6.03

Building: Main Building
Location: All Areas
Finding: Dense vegetation around a property can increase the risk of termite infestation
Information: The presence of dense vegetation around a property can increase the risk of termite infestation, as it provides a conducive environment for them. To address this, consider maintaining a clear space between the vegetation and your home. If you suspect a termite issue, it's advisable to consult with a licensed pest control professional for inspection and treatment.

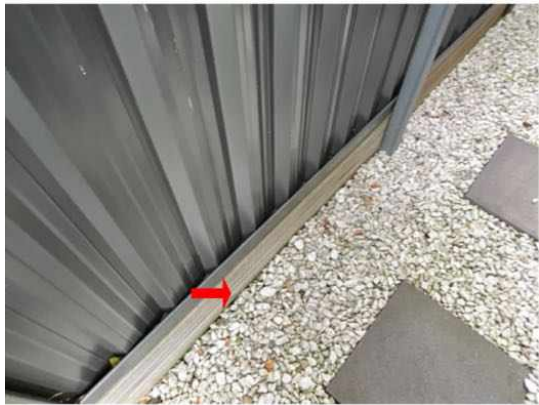
Finding 6.04

Building: Main Building
Location: All Areas
Finding: Timber on ground / conducive conditions to termite damage
Information: Timber on the ground is indeed conducive to termite damage. Termites are known to thrive in moist environments, and wood in contact with soil or moisture is more susceptible to infestation.

To prevent this, it's important to keep timber elevated and away from direct ground contact. Regular inspections and proper termite control measures are also essential to protect your wooden structures from termite damage.

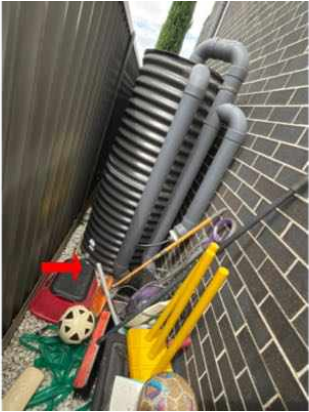
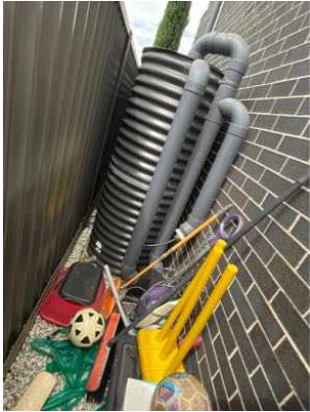
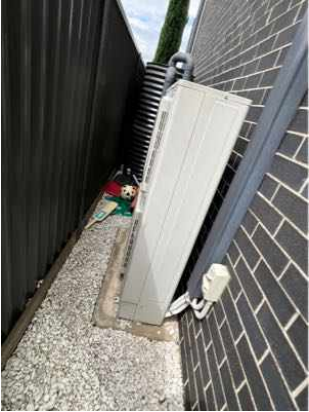
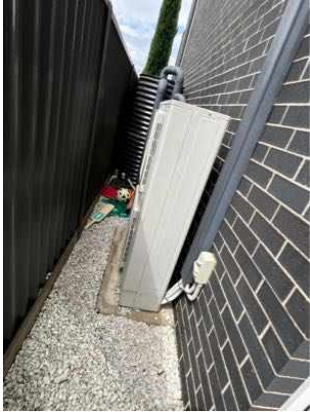
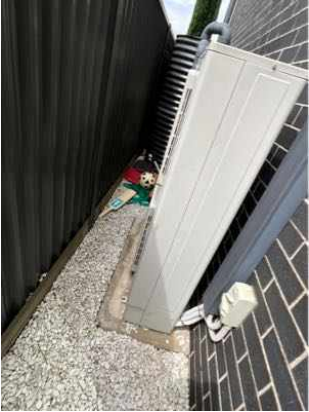
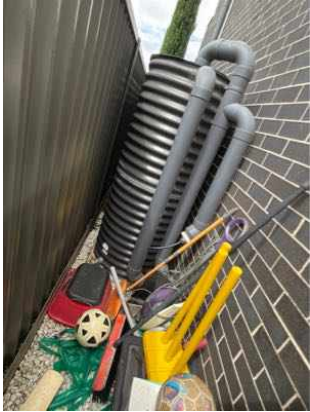
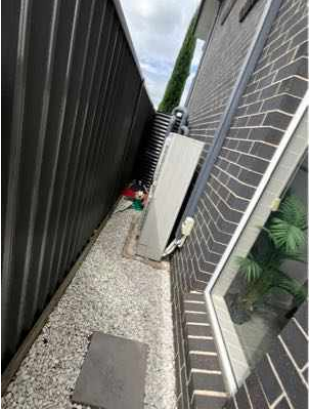
Finding 6.05

Building:	Main Building
Location:	All Areas
Finding:	Bridging or Obstruction Conducive environment for Termites
Information:	Bridging of termite barriers occurs when termites bridge (usually by building a mud tunnel) a termite barrier or inspection inspection zone or where termites have a passage, allowing them to bridge the barrier.

Where bridging has occurred full inspection is prevented and termites may enter a property in a concealed or undetected manner.

Recommended moving obstructions away from the external walls for further and future inspections.

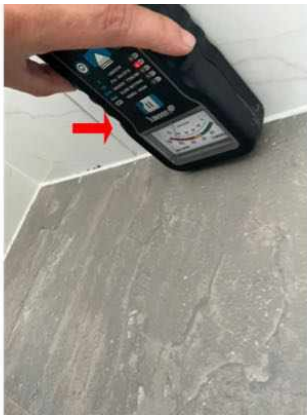
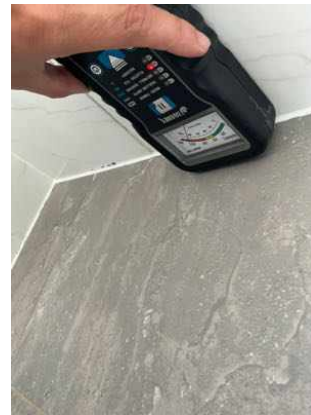
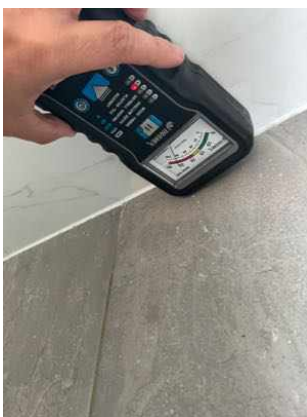
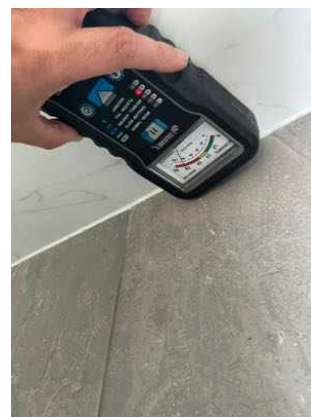
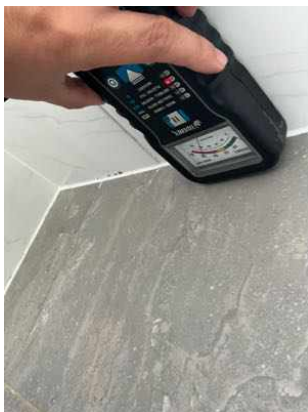
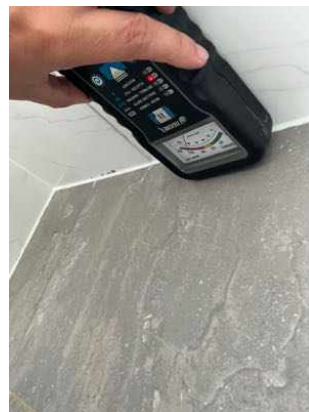
Finding 6.06

Building: Main Building
Location: Bathroom
Finding: Excessive moisture - Conducive to Timber pest
Information: Excessive moisture can attract termites and produce conditions that promote fungal growth and wood decay.

Excessive moisture is generally caused by deteriorated inadequate or missing roof drainage leaking plumbing pipes or fixtures poorly plumbed HWS overflows or condenser units and poor site drainage.

Prior to any remedial works being performed a qualified plumber should be appointed to further inspect the property and to identify the cause of the excessive moisture. Works to remove affected building elements may then be necessary and should be performed by an appropriate tradesperson.

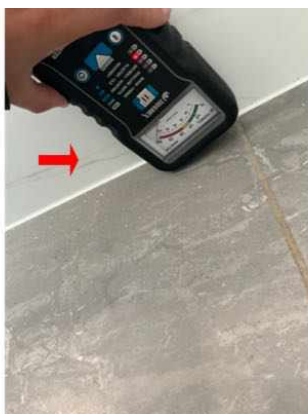
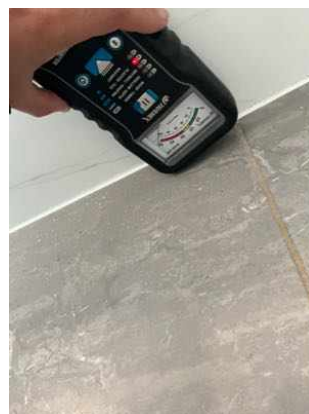
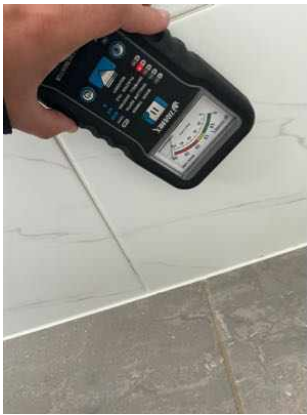
Finding 6.07

Building:	Main Building
Location:	Ensuite
Finding:	Excessive moisture - Conducive to Timber pest
Information:	Excessive moisture can attract termites and produce conditions that promote fungal growth and wood decay.

Excessive moisture is generally caused by deteriorated inadequate or missing roof drainage leaking plumbing pipes or fixtures poorly plumbed HWS overflows or condenser units and poor site drainage.

Prior to any remedial works being performed a qualified plumber should be appointed to further inspect the property and to identify the cause of the excessive moisture. Works to remove affected building elements may then be necessary and should be performed by an appropriate tradesperson.

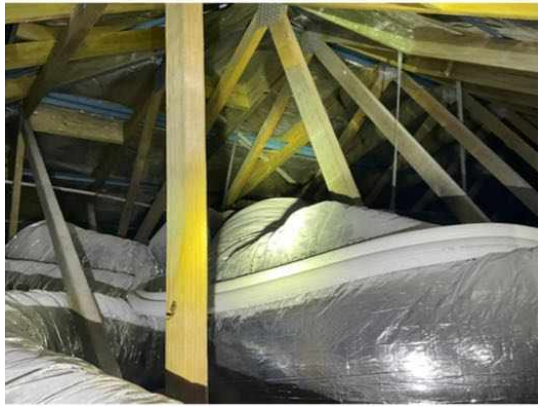
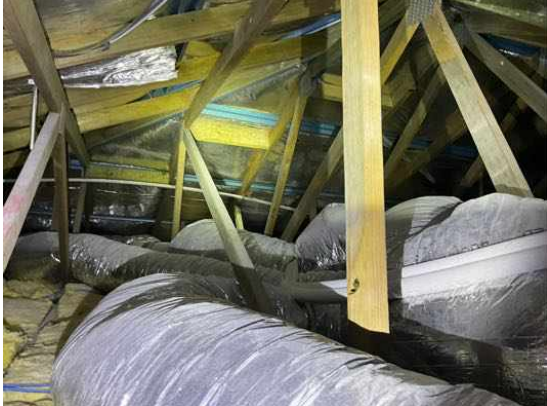
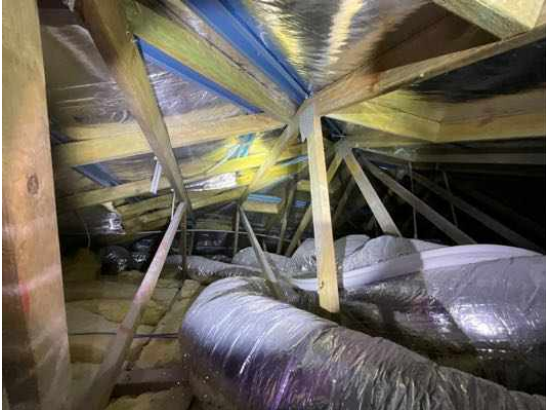
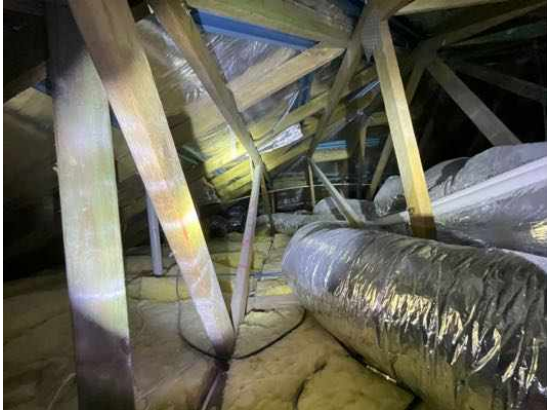
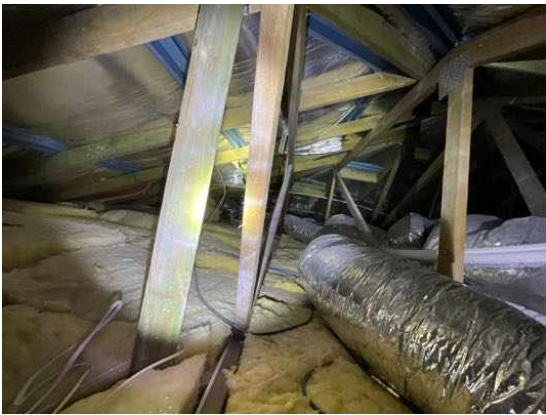
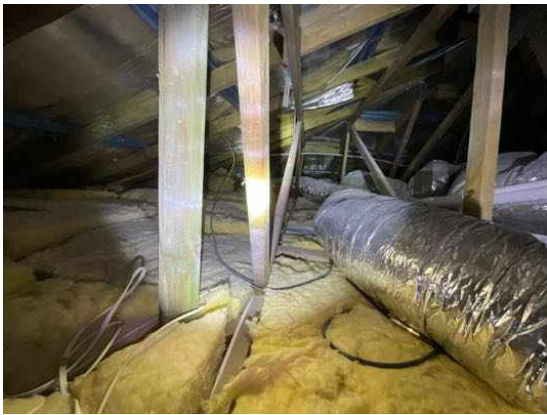
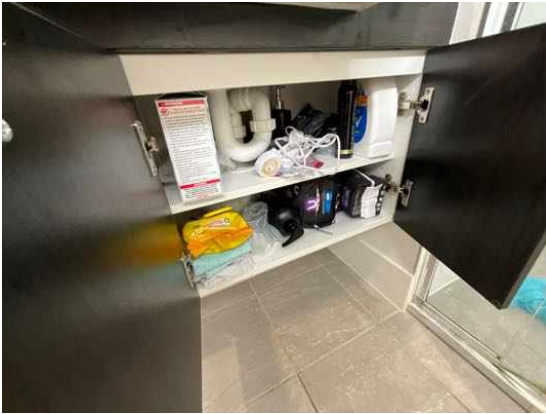
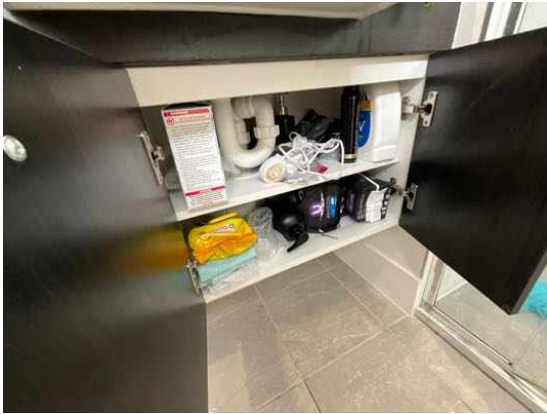
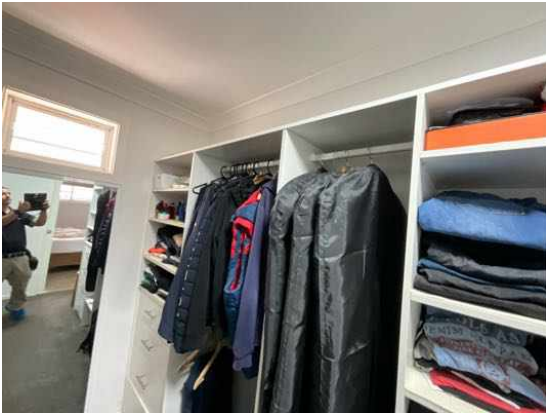
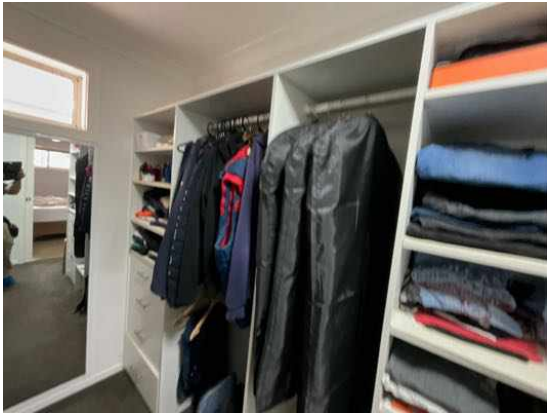
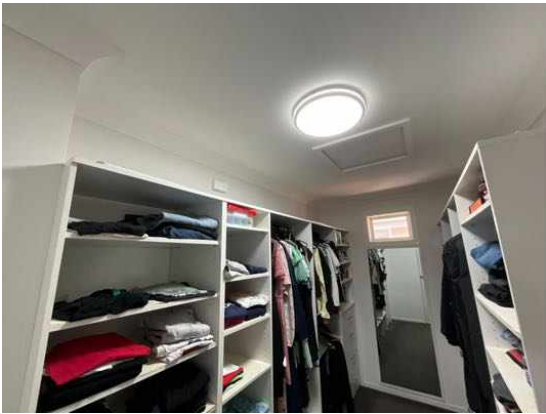
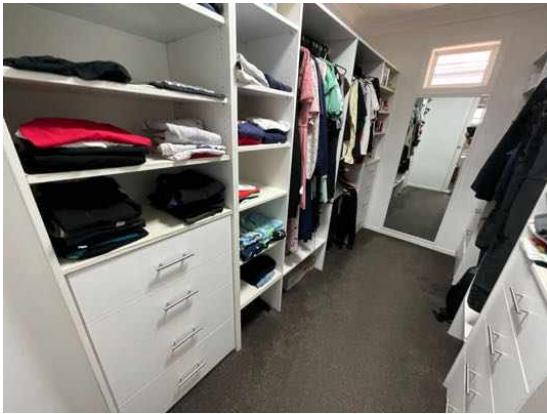
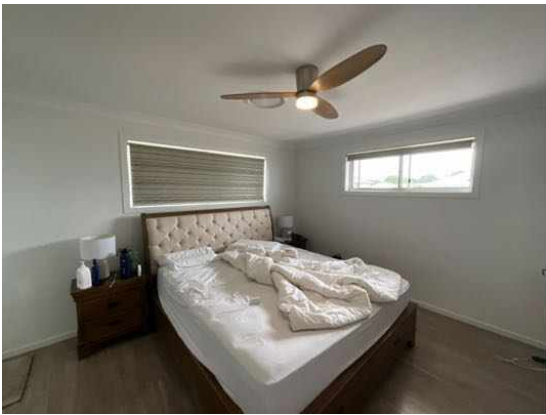
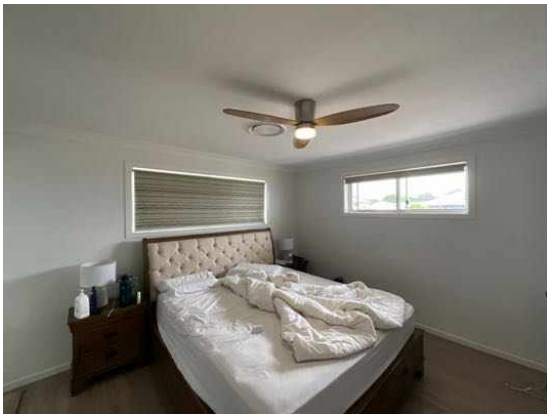
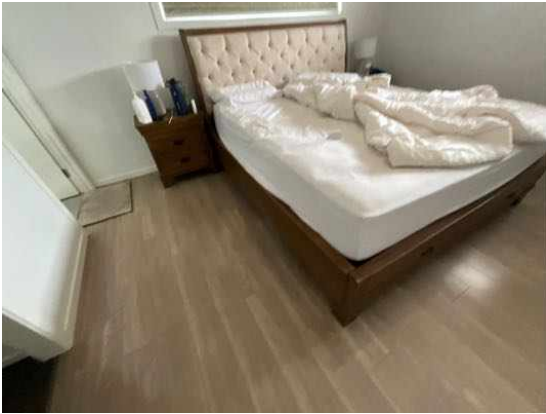
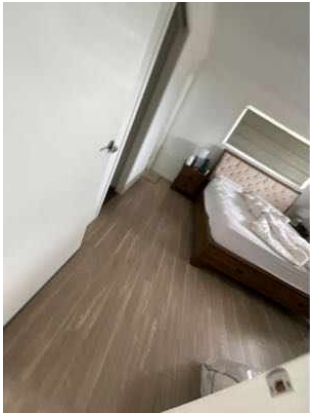
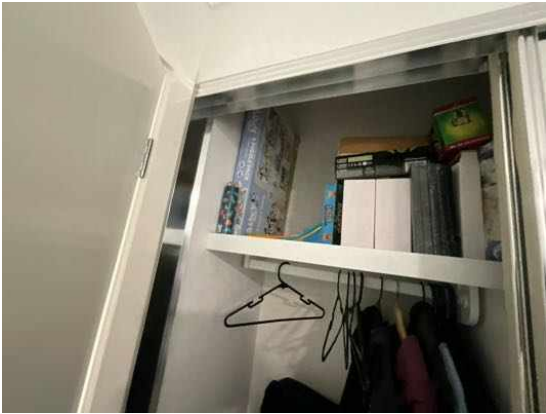
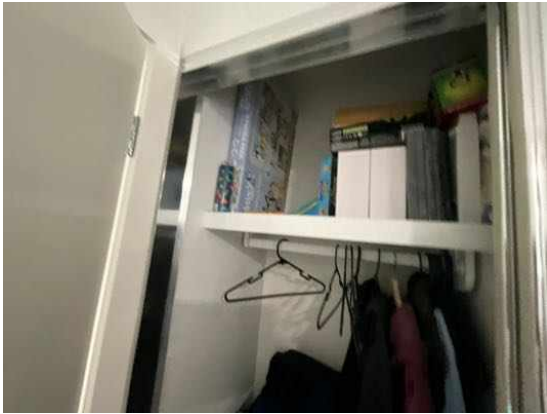
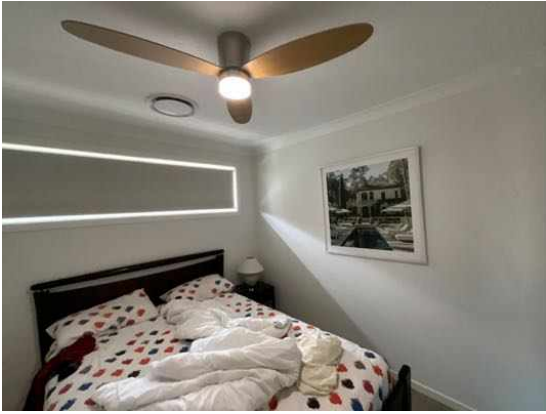
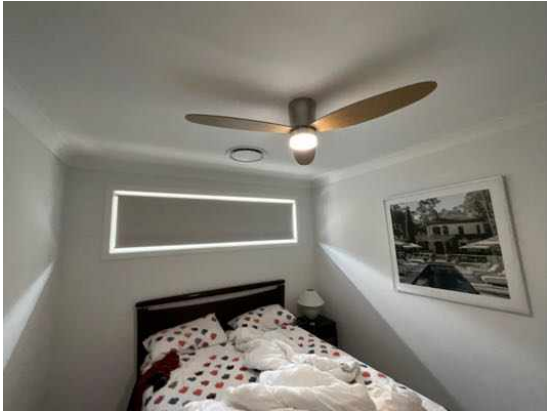
Building: Main Building
Location: All Areas
Finding: Additional Photos - Obstructions and Limitations
Information: These photographs are an indication of the obstructions and limitations which impeded full inspection of the property at the time of inspection. These obstructions can hide an array of defects and should be removed to allow full inspection to be carried out. A re-inspection is recommended once the areas are made accessible.
