Building and Timber Pest Inspection Report

Inspection Date: Tue, 10 Mar 2026

Property Address: 63 Christy Dr, SCHOFIELDS, NSW, 2762,
Australia

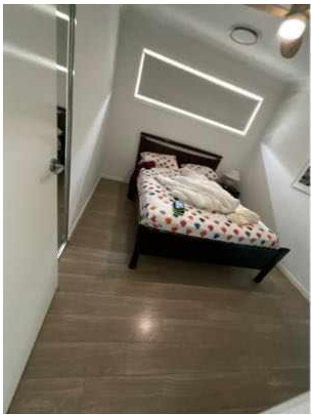
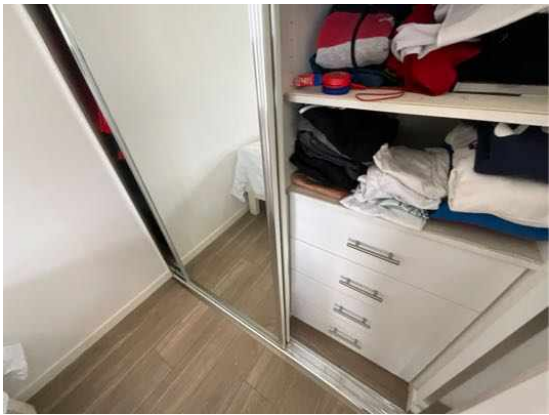
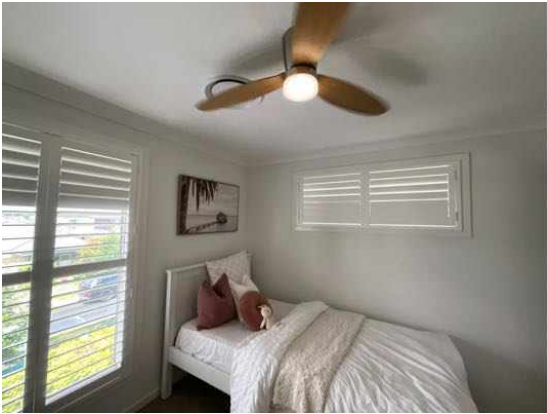
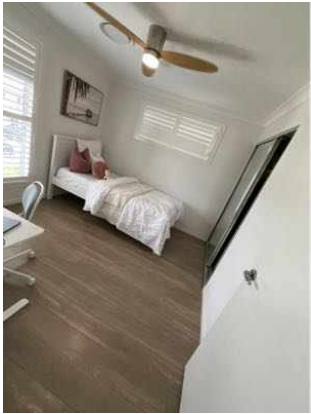
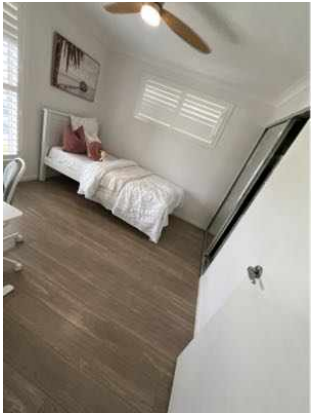
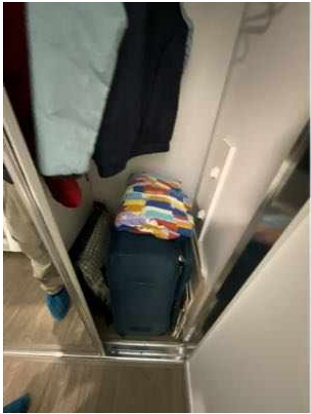
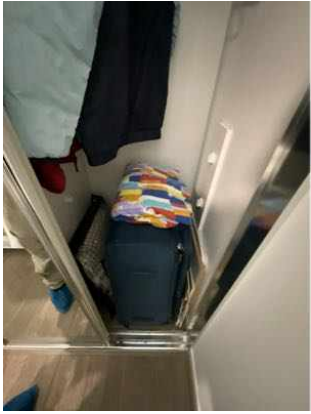
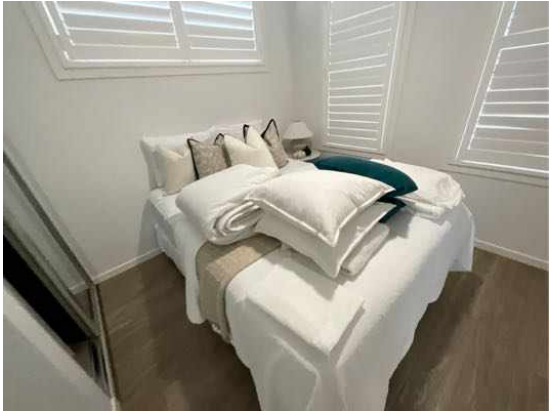
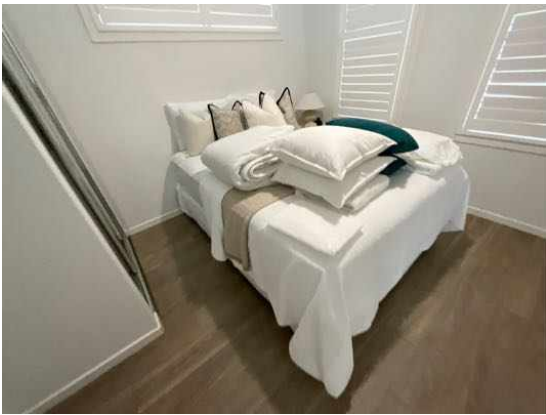
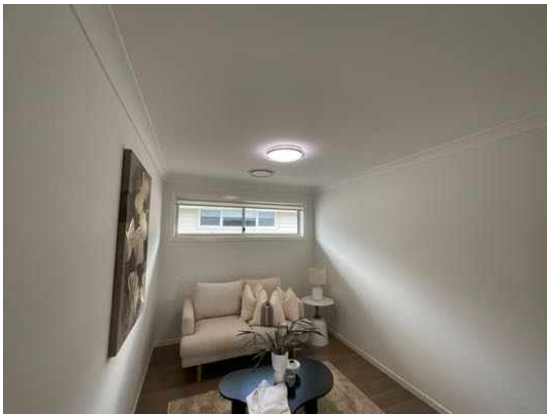
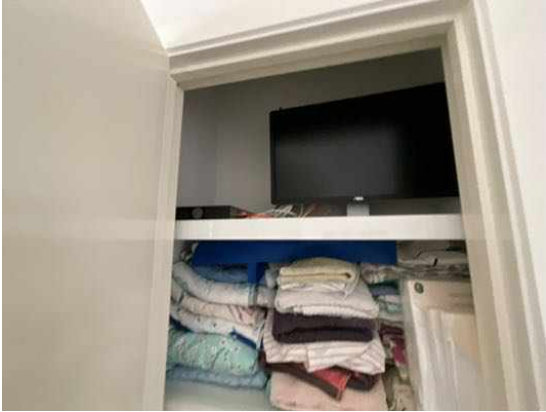
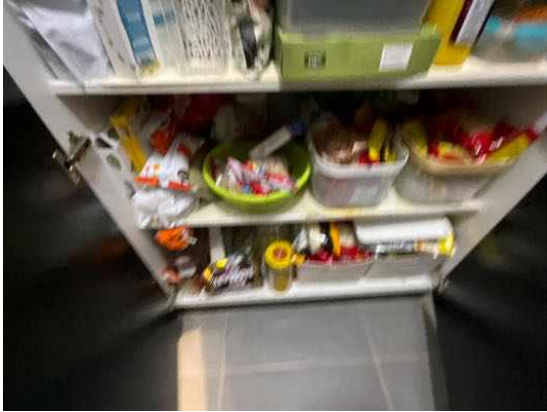
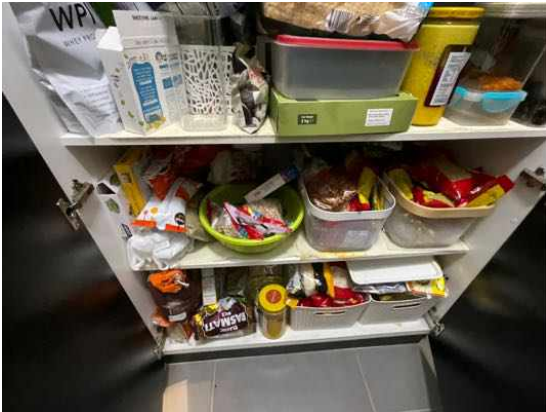
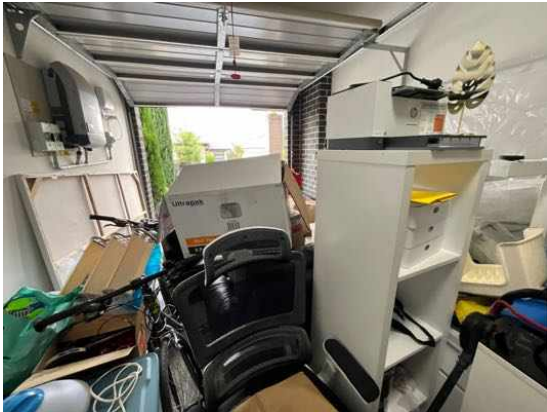
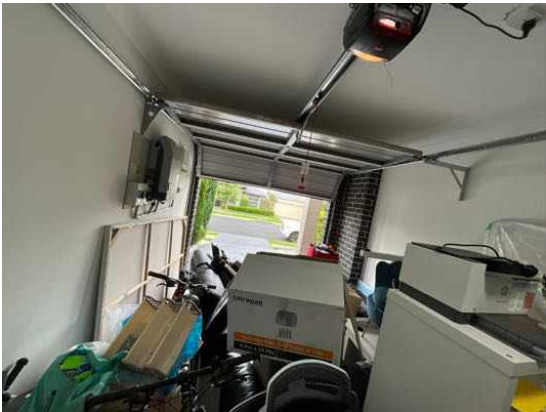
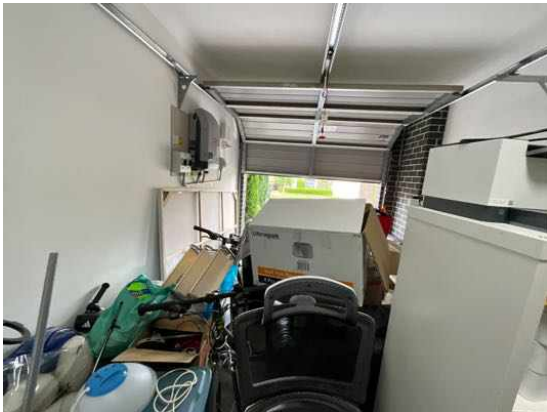
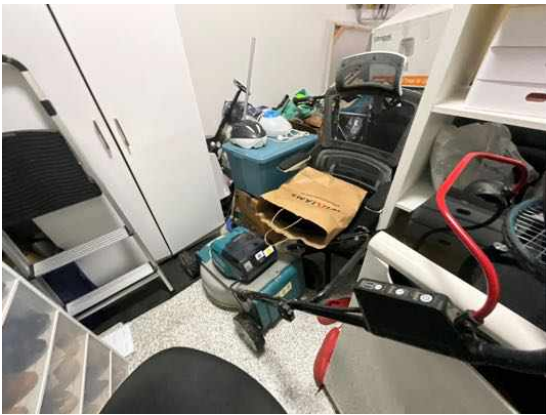
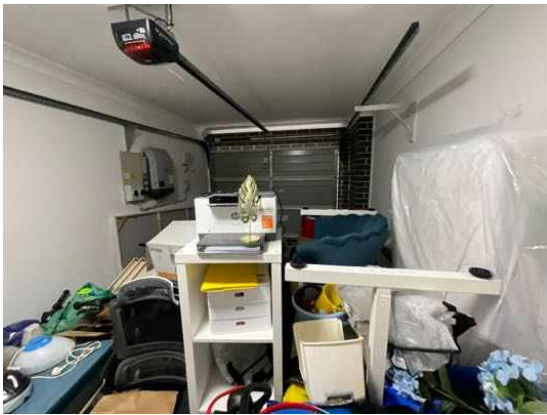
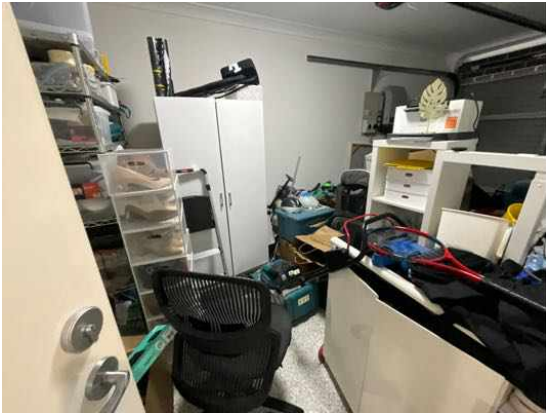
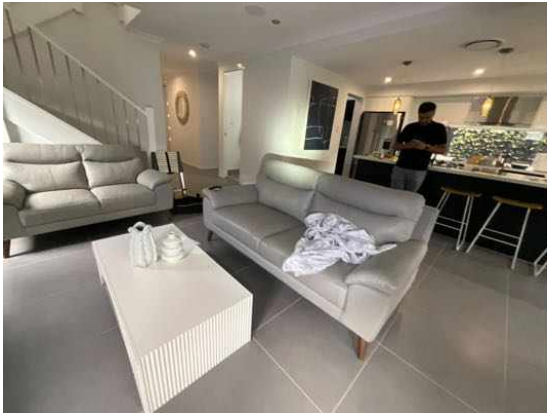
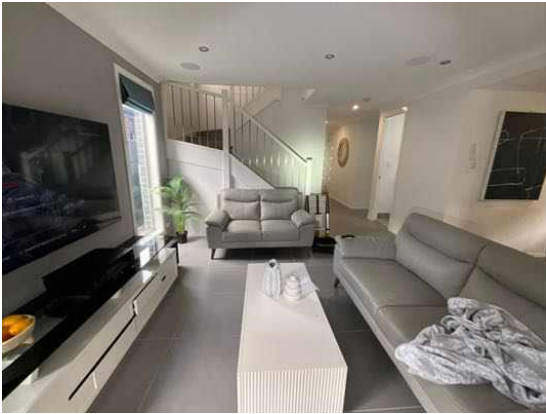
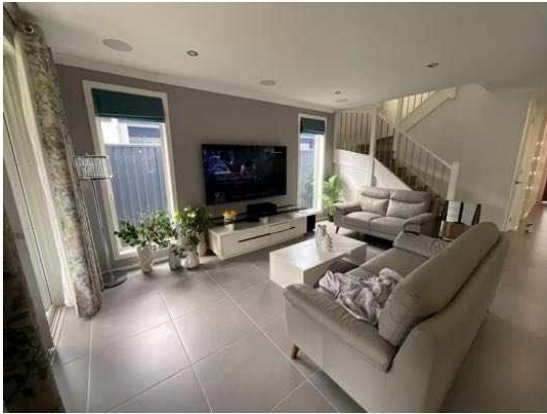
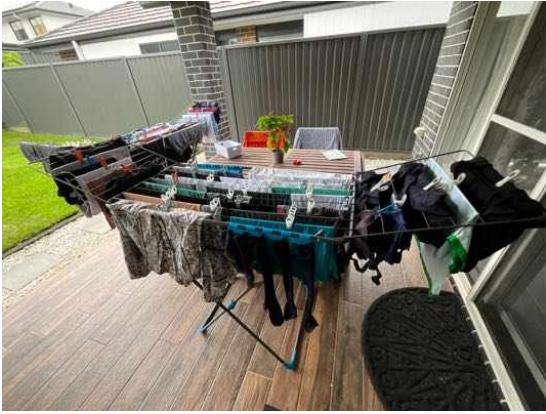
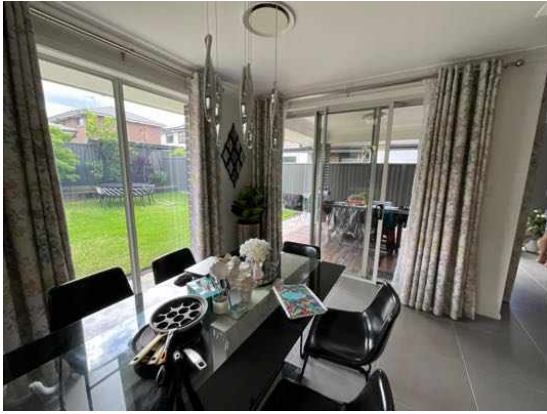
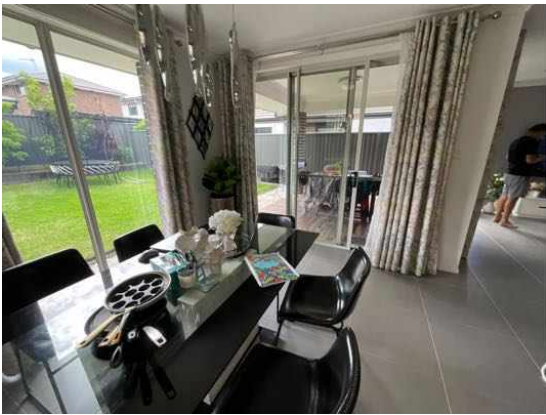
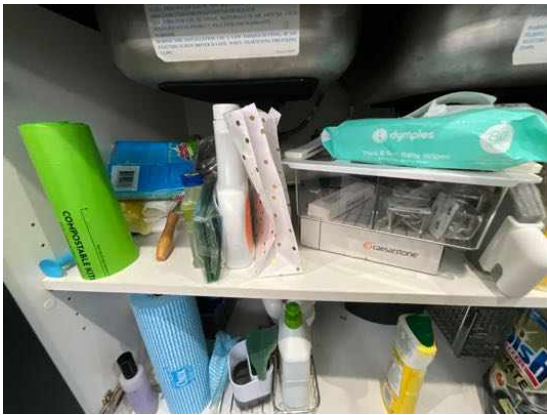
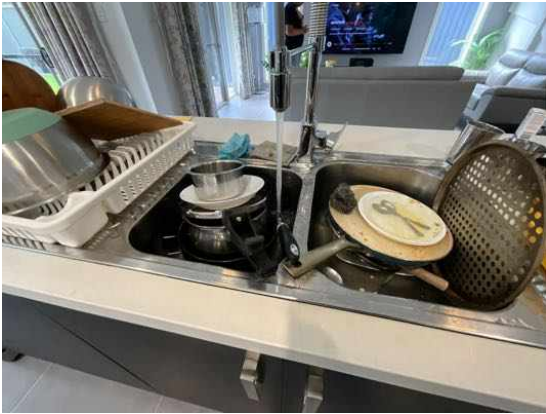
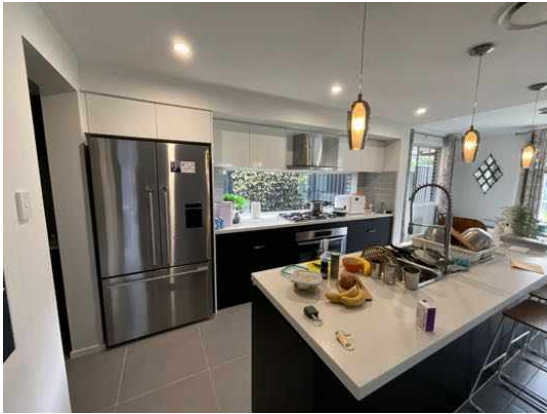
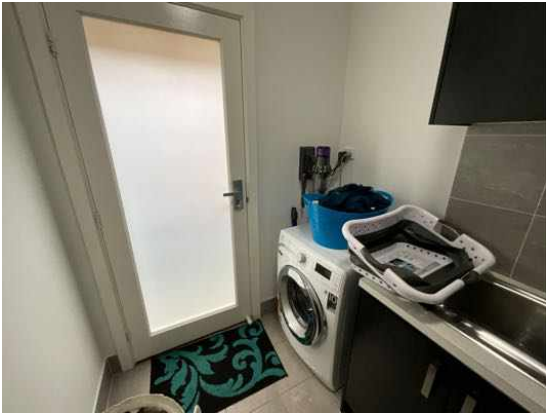
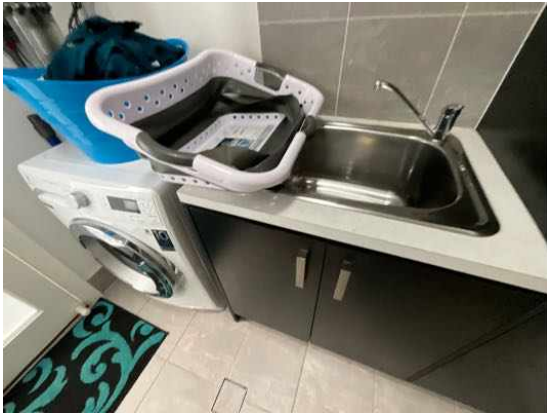
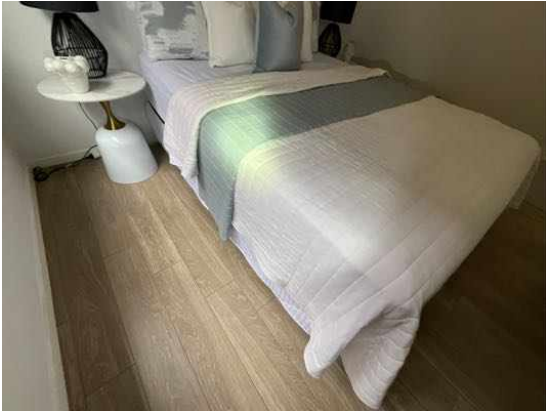
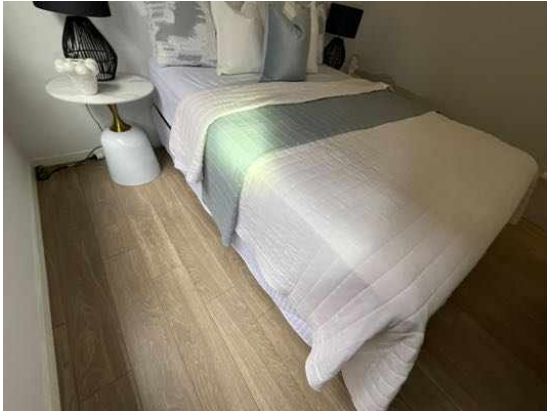
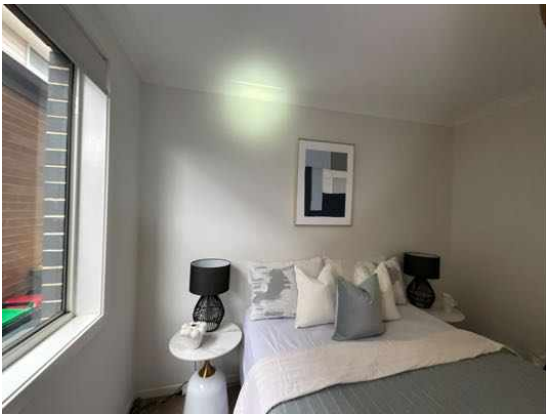
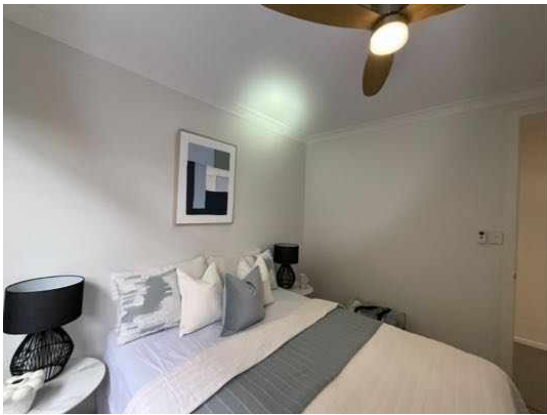
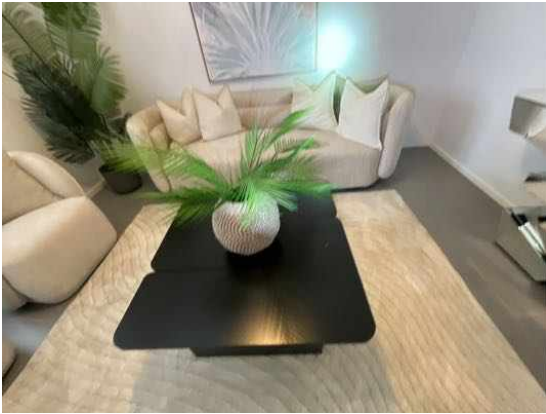
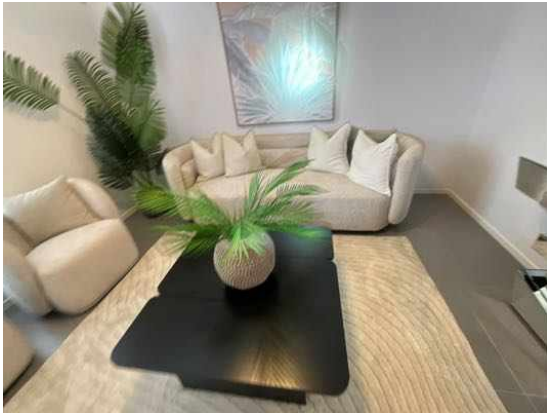
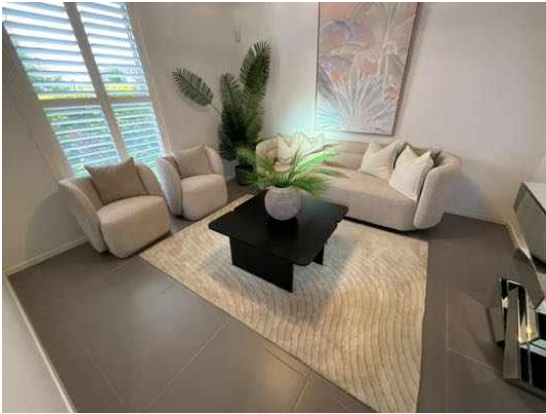
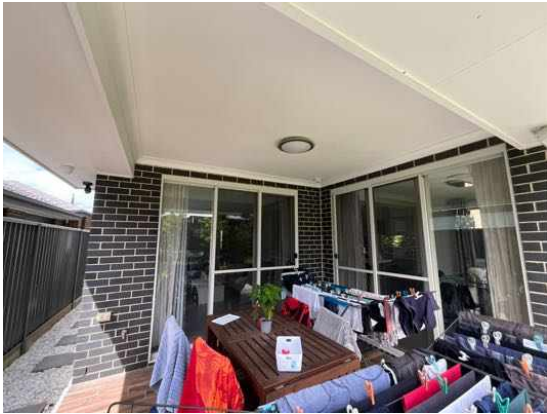
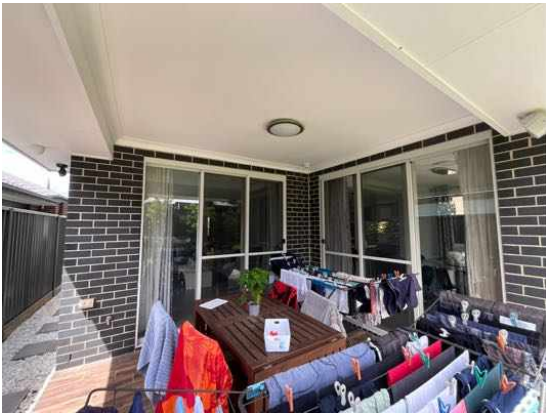
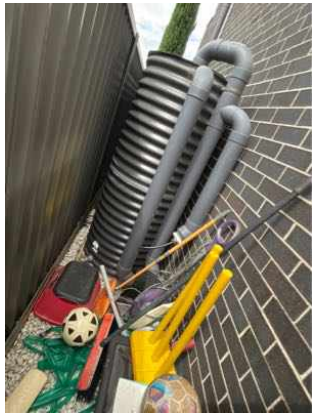
Building: Main Building
Location: All Areas
Finding: Additional Photos - Obstructions and Limitations
Information: These photographs are an indication of the obstructions and limitations which impeded full inspection of the property at the time of inspection. These obstructions can hide an array of defects and should be removed to allow full inspection to be carried out. A re-inspection is recommended once the areas are made accessible.
