Building and Timber Pest Inspection Report VR

Inspection Date: Tue, 20 Jan 2026

Property Address: 3 Gower Cl, Wetherill Park NSW 2164,
Australia

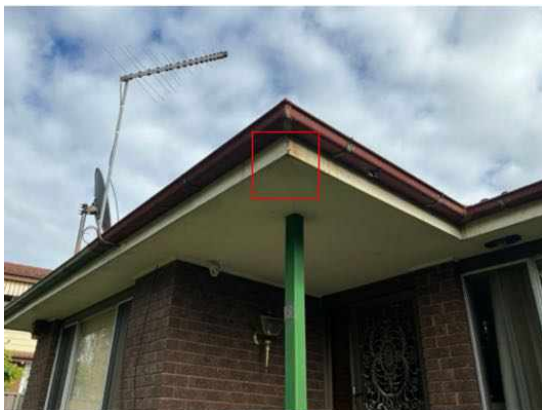
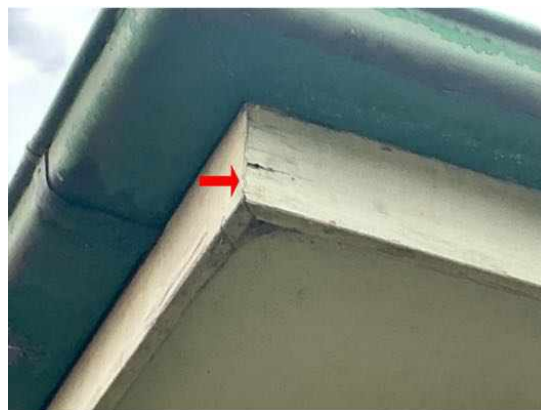
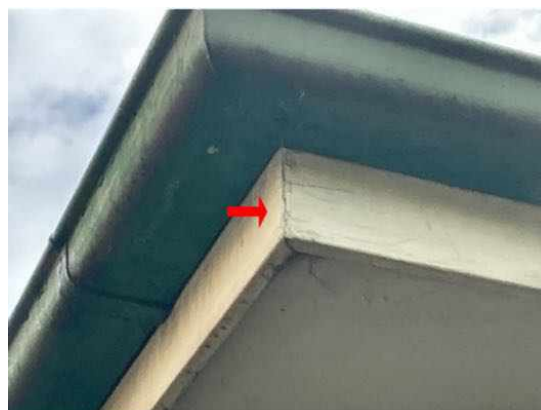
Finding 3.02

Building:	Main Building
Location:	All External Areas
Finding:	External Timber - Weathered
Information:	External timber elements around the property were observed to be showing signs of general wear and tear, including surface deterioration, fading, and early signs of weather exposure. These conditions are commonly caused by prolonged exposure to sunlight, moisture, and temperature fluctuations, which can lead to cracking, splitting, or degradation over time if not properly maintained.

It is recommended that all external timber be inspected and maintained to ensure ongoing protection. This may include sanding, sealing, or repainting affected sections. Regular maintenance will help preserve the timber's integrity, extend its lifespan, and prevent more extensive damage in the future.

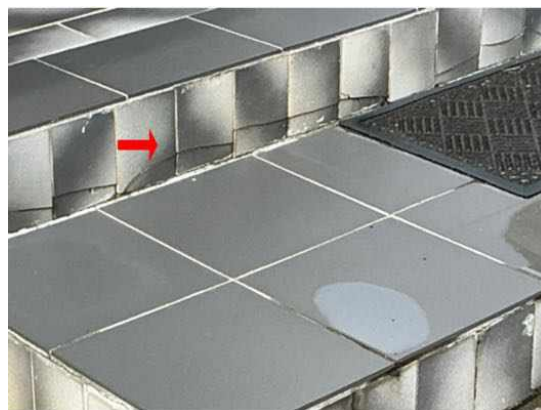
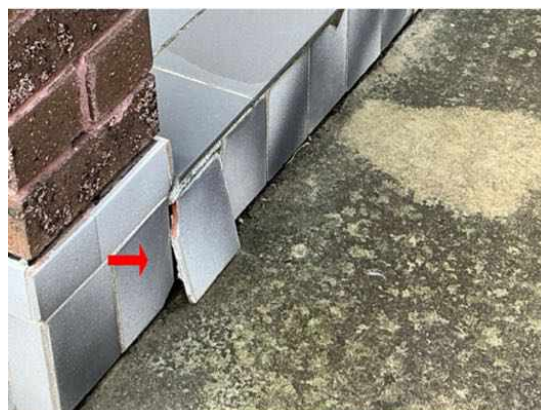
Finding 3.03

Building:	Main Building
Location:	Rear Patio
Finding:	Tiles - Cracked or damaged
Information:	Cracking was evident to the tiling in this area at the time of inspection. While the cracking appears to be minor, this area is frequently exposed to water, allowing potential for water penetration into adjoining sections of of the home.

If left unmanaged, water penetration to these areas may lead to subsequent water damage, which is likely necessitate repair work to affected building elements. This can be seen in the photos.

A tiling contractor should be appointed to ensure that no further water damage occurs. The re-application of silicone and grouting throughout remaining tile work is also advised, to further protect the area against water penetration.

Where water penetration has led to water damage, appointment of a relevant tradesperson may be required to repair damaged building elements.

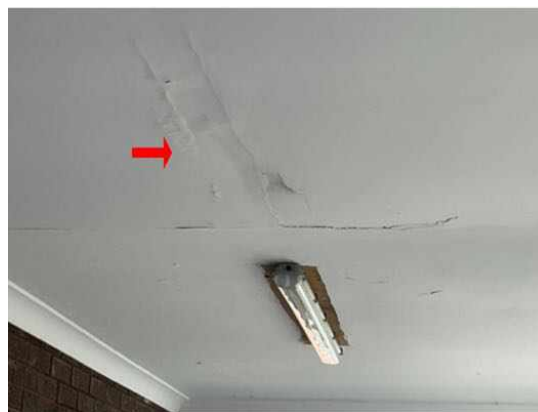
Finding 3.04

Building:	Main Building
Location:	Rear Patio
Finding:	Water staining - Ceiling Previous
Information:	Water staining was evident on parts of the ceiling at the time of inspection. Water staining indicates that surfaces have been exposed to excessive moisture over time. The minerals and other elements in the water lead to staining, which may graduate to deterioration if left unmanaged.

While mostly an appearance defect, water staining can be indicative of more serious defects, which may be currently concealed by other building elements.

Where water staining is active, a licensed plumber must be consulted to identify the cause of the staining and to provide advice on any reparation works that may be required. Replacement of any broken or damaged structures is advised.

Conversely, where water staining is old and inactive, affected building materials may be repaired or replaced at client discretion. A qualified carpenter or registered builder may be appointed to perform these works.

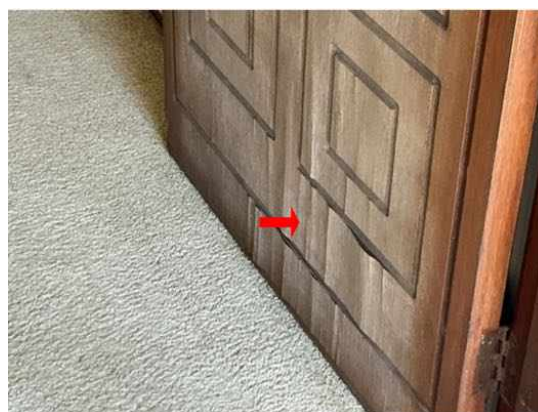
Finding 3.05

Finding: Door - Damaged Delaminating

Information: During the inspection, the entry door was observed to be in poor condition, showing extensive surface wear, swelling, and delamination of the door skin or veneer. This deterioration is likely due to age, moisture exposure, or general wear and tear over time.

Potential for further surface deterioration or structural weakening of the door panels.

A licensed carpenter or competent handyperson should be engaged to assess the affected doors and undertake repairs or replacement as required. Replacement with moisture-resistant or solid-core doors may be appropriate in higher-humidity areas to prevent recurrence.

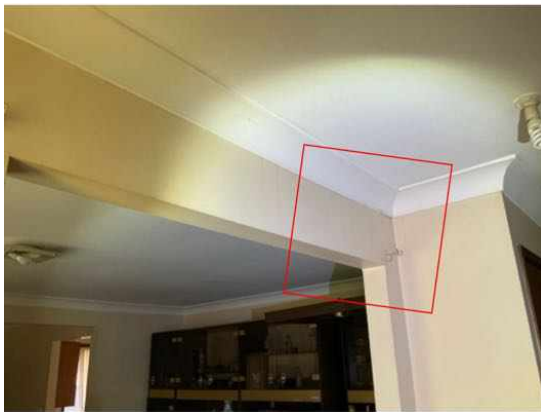
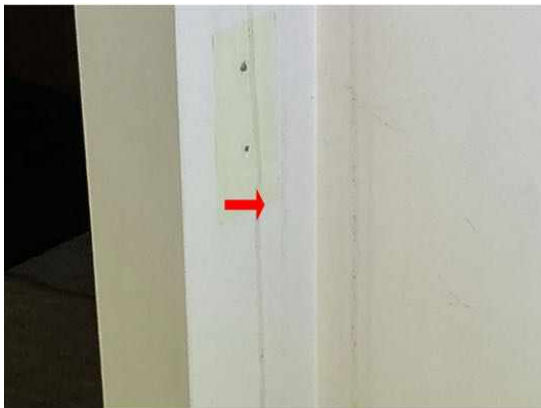
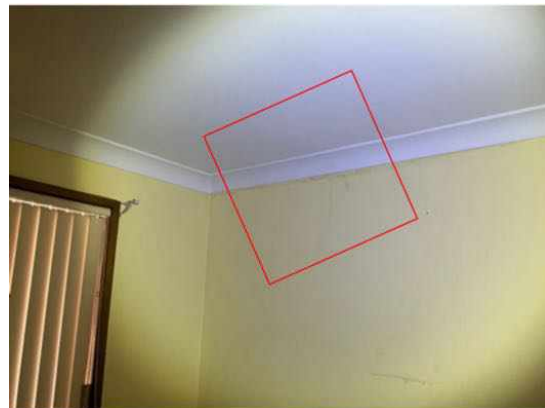
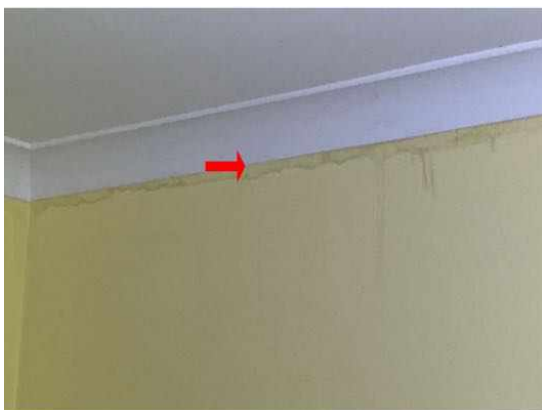
Finding 3.06

Finding: Water staining - Walls

Information: Water staining was evident on parts of the walls at the time of inspection. Water staining indicates that surfaces have been exposed to excessive moisture over time. The minerals and other elements in the water lead to staining, which may graduate to deterioration if left unmanaged.

While mostly an appearance defect, water staining can be indicative of more serious defects, which may be currently concealed by other building elements.

Where water staining is active, a licensed plumber must be consulted to identify the cause of the staining and to provide advice on any reparation works that may be required. Replacement of any broken or damaged structures is advised.

Conversely, where water staining is old and inactive, affected building materials may be repaired or replaced at client discretion. A qualified carpenter or registered builder may be appointed to perform these works.

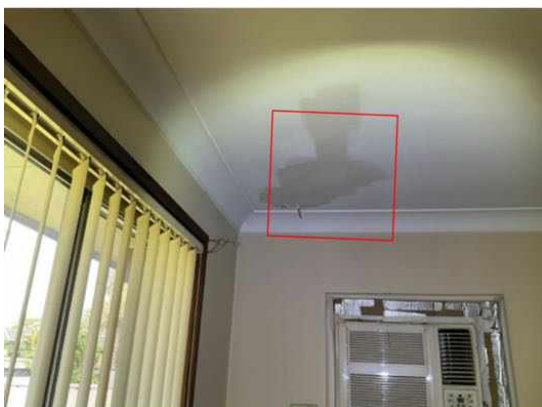
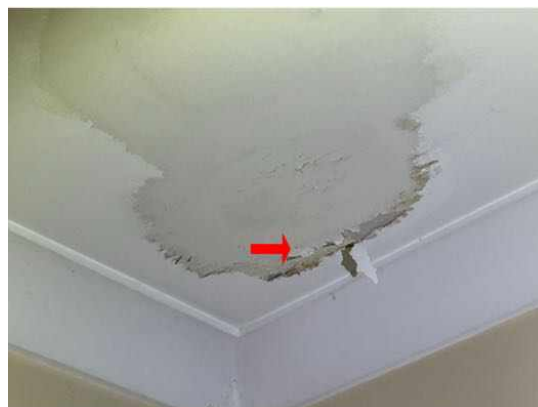
Finding 3.07

Building:	Main Building
Location:	Lounge Room
Finding:	Painted surface - Peeling
Information:	Sections of paint in this area was found to have peeled and deteriorated. Paint peeling and or bubbling is generally an indication of excessive moisture in the area, that is currently hidden by the painted surface.

The presence of excessive moisture can have major implications on associated building elements if left unattended. While only seemingly minor at this stage, the damage cannot be determined due to the paint obstructing any further inspection of the damage.

It is highly advised that the affected paint be cleaned to allow a further, more invasive inspection by a licensed plumber. Failure to act on this defect may necessitate major works in the future.

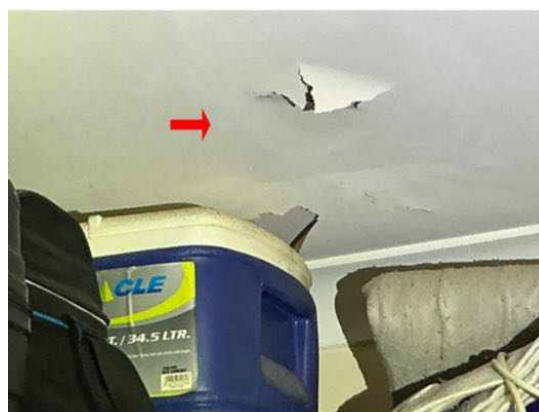
Finding 3.08

Building:	Main Building
Location:	Bedroom - Master
Finding:	Painted surface - Peeling

Information: Sections of paint in this area was found to have peeled and deteriorated. Paint peeling and or bubbling is generally an indication of excessive moisture in the area, that is currently hidden by the painted surface.

The presence of excessive moisture can have major implications on associated building elements if left unattended. While only seemingly minor at this stage, the damage cannot be determined due to the paint obstructing any further inspection of the damage.

It is highly advised that the affected paint be cleaned to allow a further, more invasive inspection by a licensed plumber. Failure to act on this defect may necessitate major works in the future.

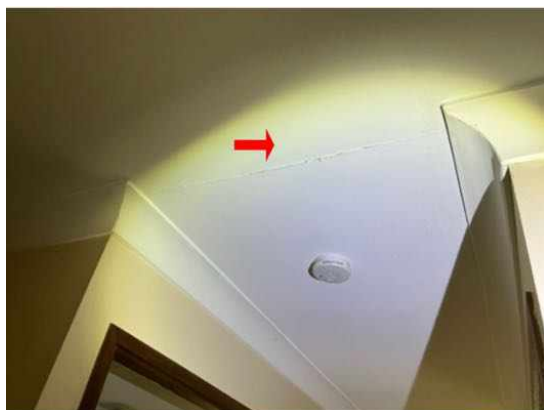
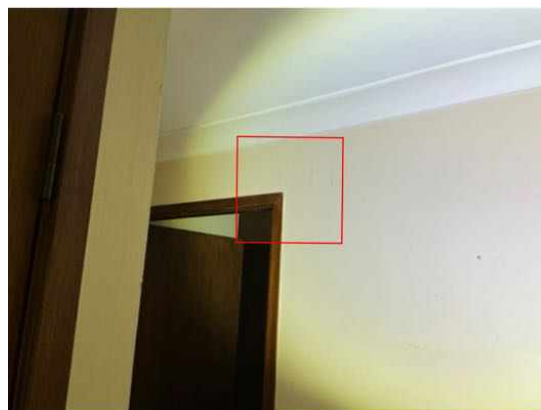
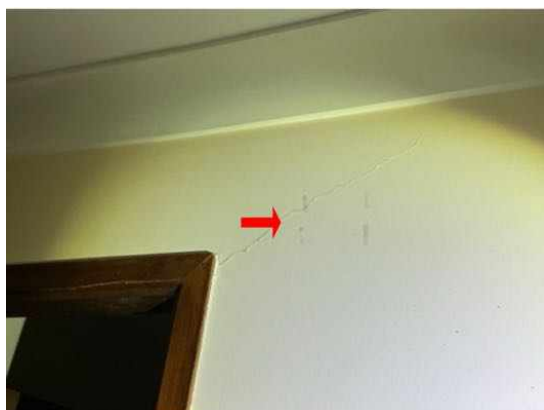
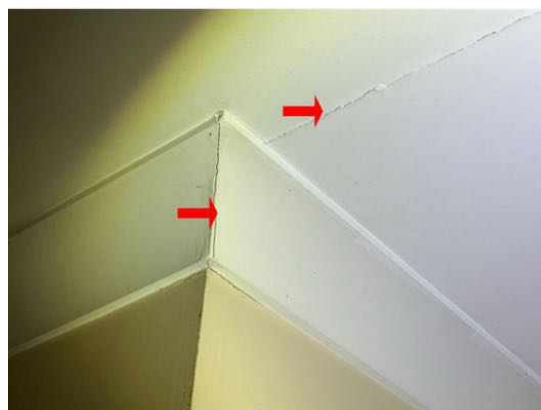
Finding 3.09

Building: Main Building
 Location: All Internal Areas
 Finding: Cracking - Plasterboard
 Information: Fine cracks in plasterboard, while occasionally noticeable, are typically regarded as cosmetic defects and do not usually signify structural damage. These cracks often result from separation between building materials and finishes (e.g., paint, plaster) along joints. In most cases, such cracks can be addressed through minor repairs such as sanding, filling, or repainting, which should be carried out by a qualified painter or general handyman.

However, regular monitoring of these cracks is essential. If any cracks show signs of widening, lengthening, or increasing in number, it is advisable to contact a building inspector for further assessment.

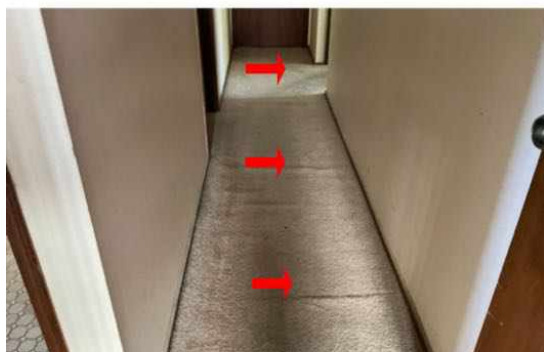
Finding 3.10

Building:	Main Building
Location:	All Internal Areas
Finding:	Floors - Squeeking/Bouncing
Information:	The internal flooring was identified as being bouncy as pictured at the time of inspection. A bouncy floor surface generally presents as a discernible change in level as they are walked across, in noisy or creaking flooring, or in consequent movement of surrounding furniture and fixtures.

Bouncy floors generally indicate that the floorboards or the subfloor structures are coming loose from the joists that they are installed on. Bouncy flooring may also be the result of gaps between flooring structures, which require packing.

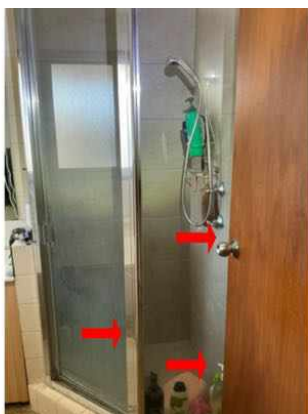
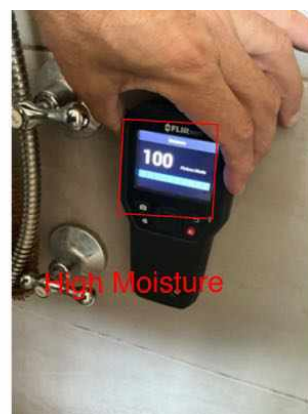
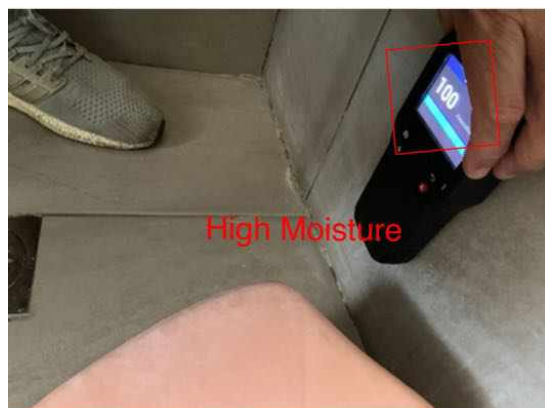
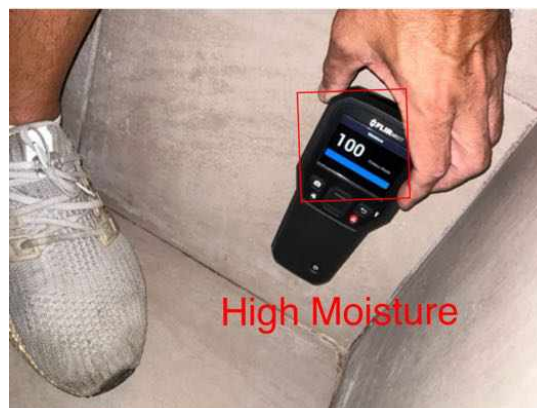
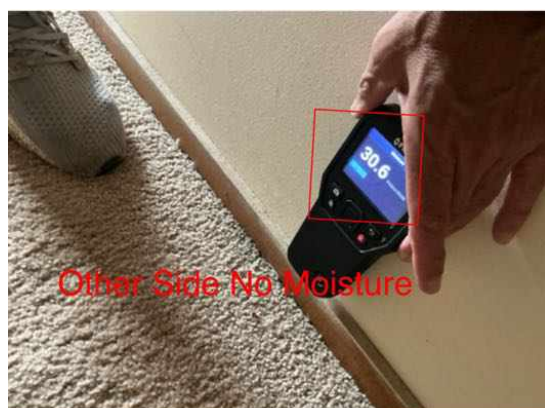
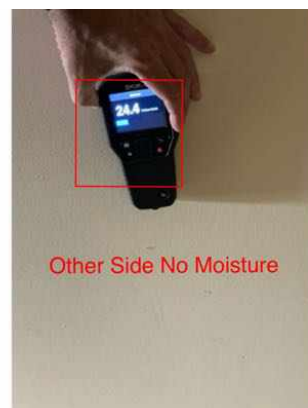
Finding 3.11

Building:	Main Building
Location:	Bathroom
Finding:	Shower damp - Monitor
Information:	Damp is evident to the lower 300mm of wall to the shower alcove. There is no high reading around the taps nor are there high readings transferring to the other side of the wall. Both sealant and grout appear in acceptable condition at present.

This defect is quite common, and is suspected to have been caused by moisture permeating or leaching through the grouting and perhaps gaps in the sealant.

Damp (or structural damp) refers to the presence of unwanted moisture in the structure of a building, either as the result of intrusion from outside, or condensation from within the structure. In the shower area, internal water leaks or other sources of excessive moisture are generally the cause of damp.

Unmanaged damp in the shower recess is likely to facilitate the formation and development of mould and fungi growth, decaying associated building materials and compromising their structural integrity. It is important to address damp conditions, as the World Health Organisation notes that excess moisture leads - on almost all indoor materials - to growth of microbes such as moulds, fungi and bacteria, which subsequently emit spores and other matter into the indoor air. Exposure to these contaminants is associated with a wide range of respiratory and other health-related problems.

Monitoring the area is advised and if any visual signs of excessive moisture appear (peeling paint, mould) then consultation with a qualified plumber or bathroom specialist would be advised to identify the cause of damp and to perform remedial works as required.

Always ensure that sealant and grout is in good condition to prevent any moisture issues occurring in the future.

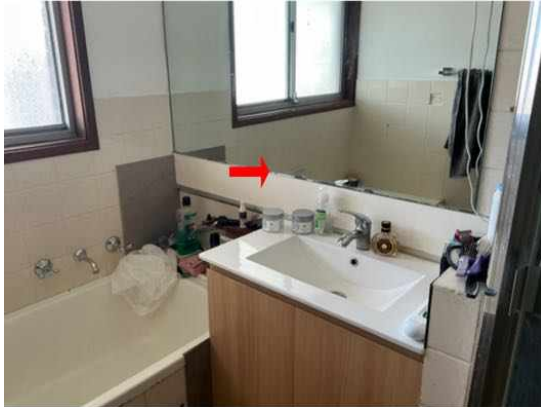
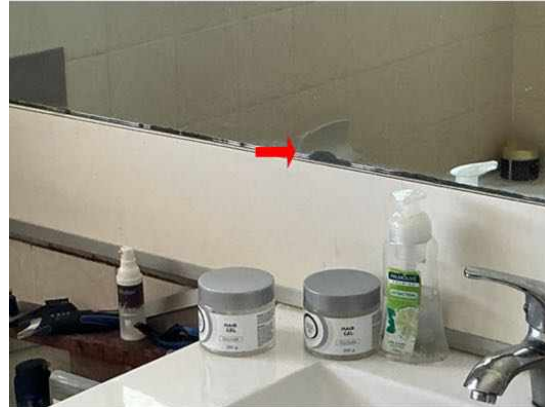
Finding 3.12

Building:	Main Building
Location:	Bathroom
Finding:	Mirror - De Silvering
Information:	The mirror inspected is showing signs of edge deterioration, with visible blackening around the perimeter. This condition is commonly caused by moisture exposure or cleaning chemicals, which can lead to the breakdown of the reflective backing over time.

It is recommended that the mirror be monitored for further deterioration and replaced if the appearance or function becomes significantly affected. Use of gentle cleaning methods and ensuring adequate ventilation may help prevent further damage.

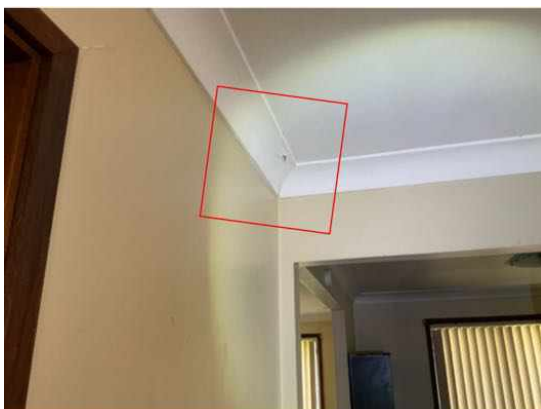
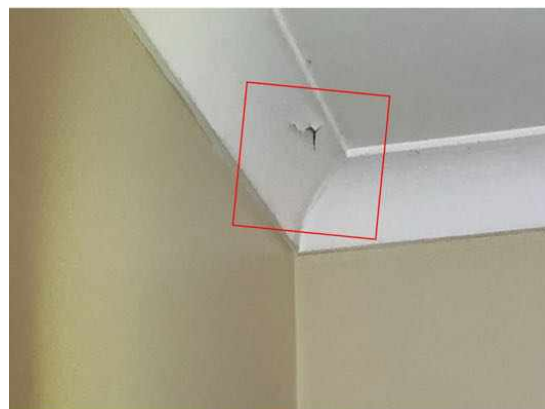
Finding 3.13

Building:	Main Building
Location:	Kitchen
Finding:	Painted surface - Peeling
Information:	Sections of paint in this area was found to have peeled and deteriorated. Paint peeling and or bubbling is generally an indication of excessive moisture in the area, that is currently hidden by the painted surface.

The presence of excessive moisture can have major implications on associated building elements if left unattended. While only seemingly minor at this stage, the damage cannot be determined due to the paint obstructing any further inspection of the damage.

It is highly advised that the affected paint be cleaned to allow a further, more invasive inspection by a licensed plumber. Failure to act on this defect may necessitate major works in the future.

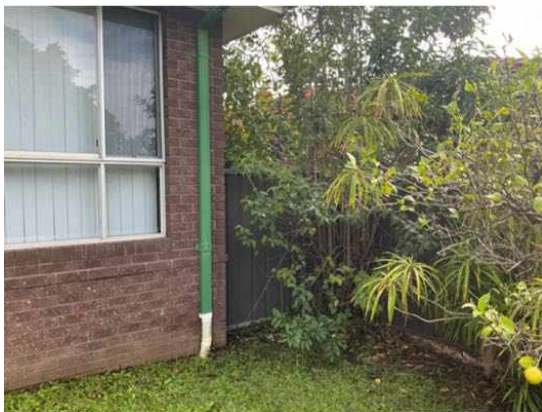
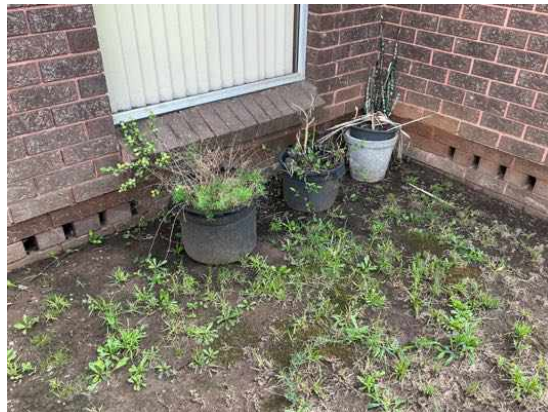
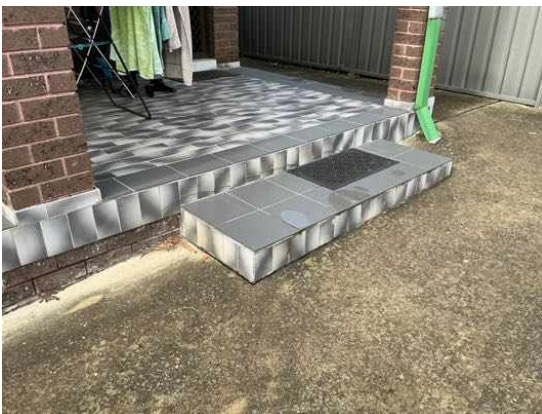
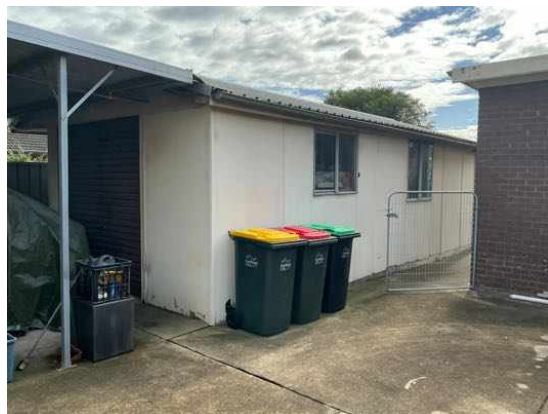
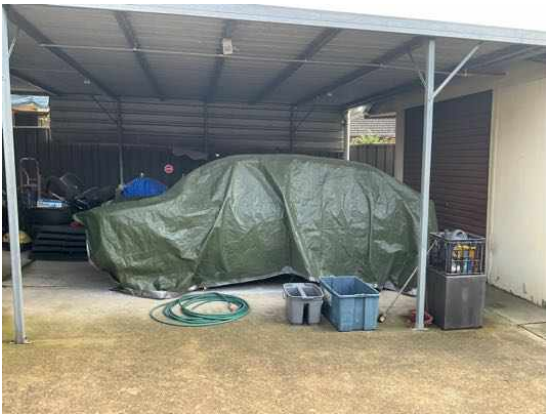
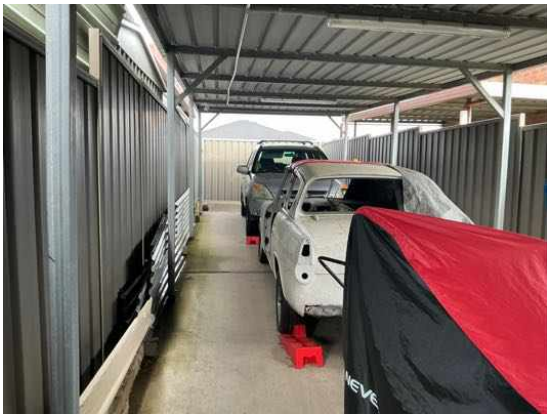
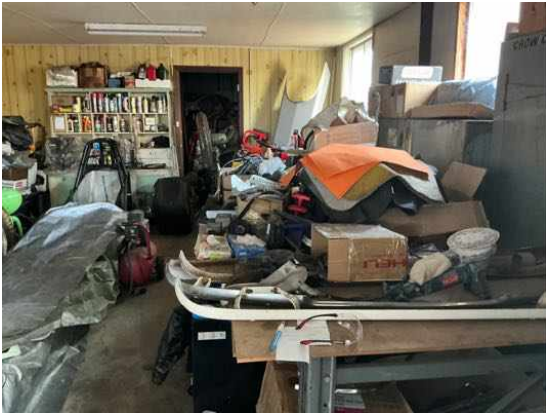
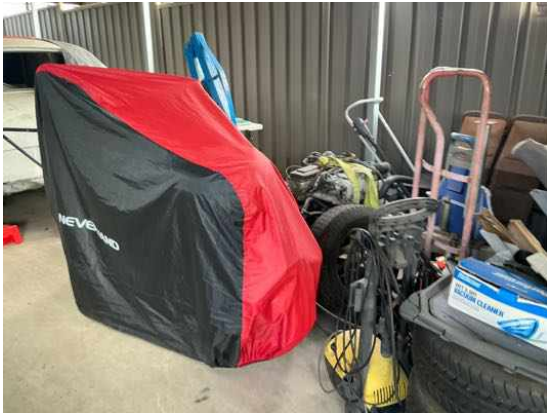
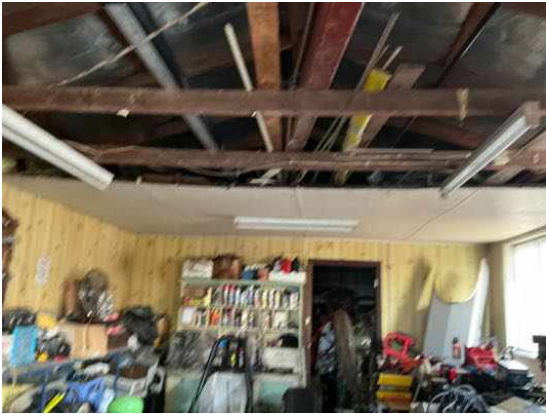
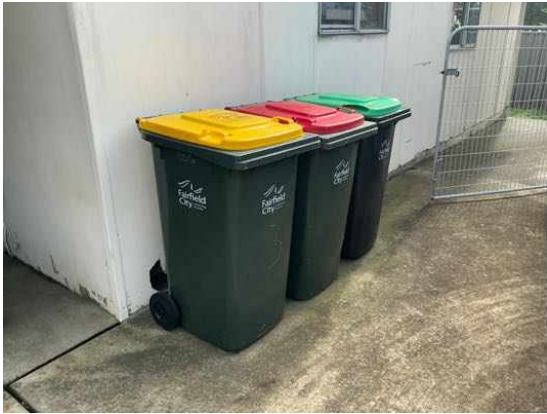
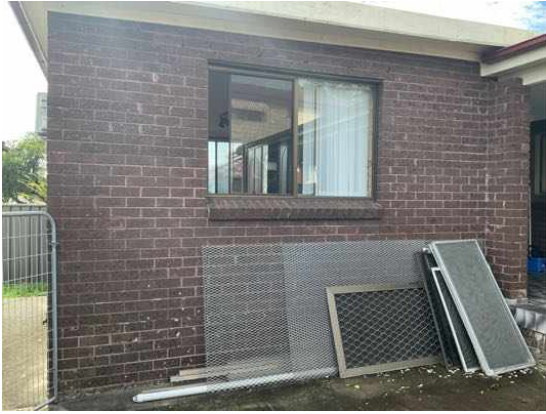
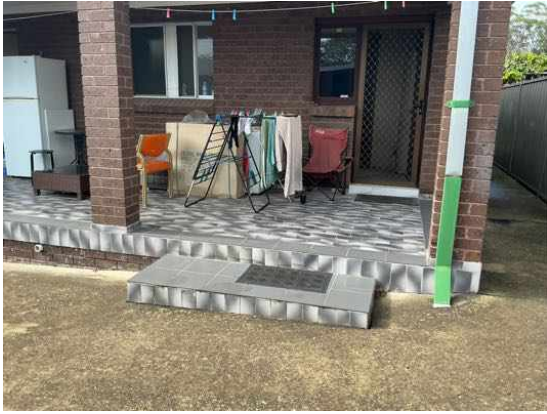
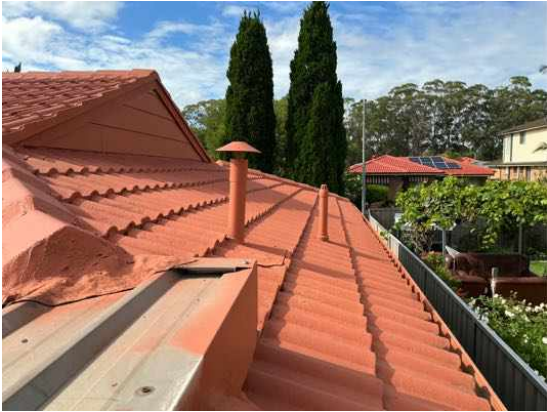
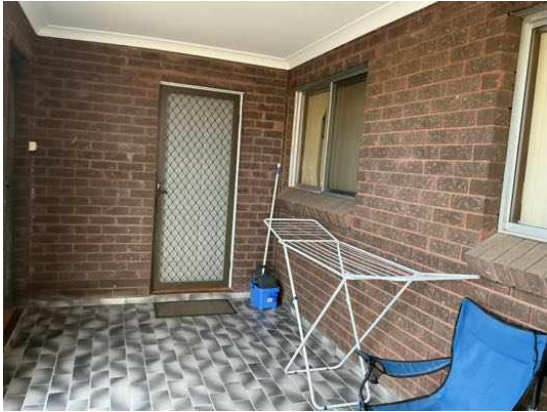
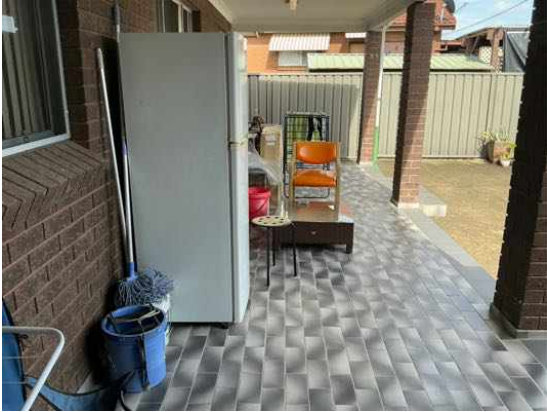
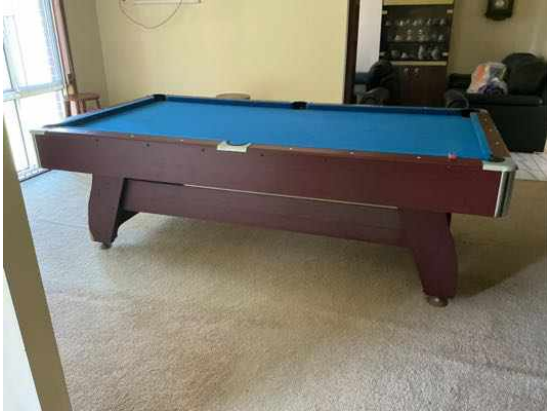
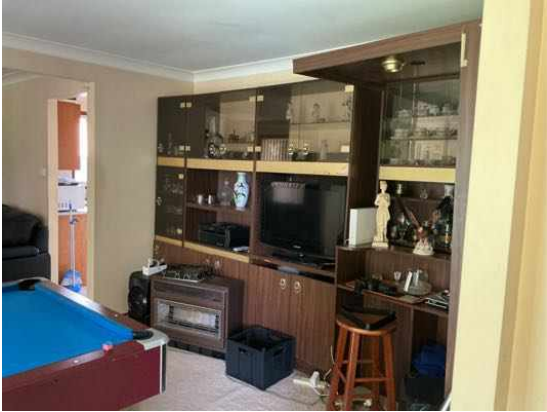
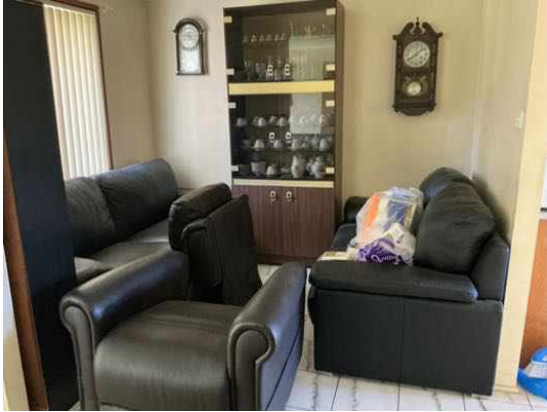
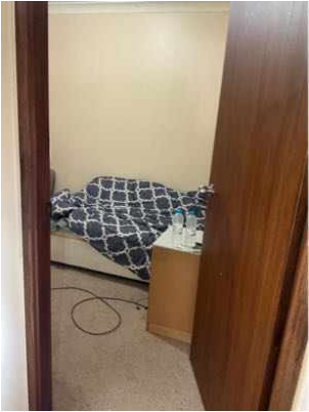
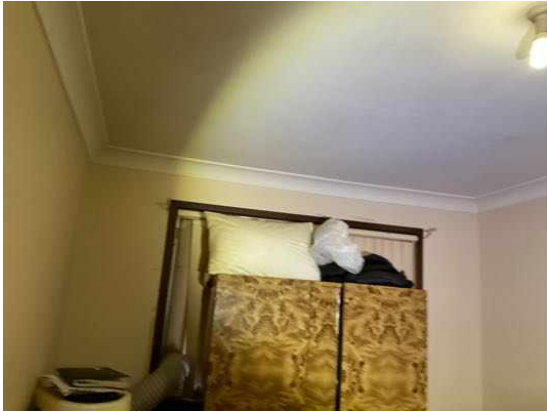
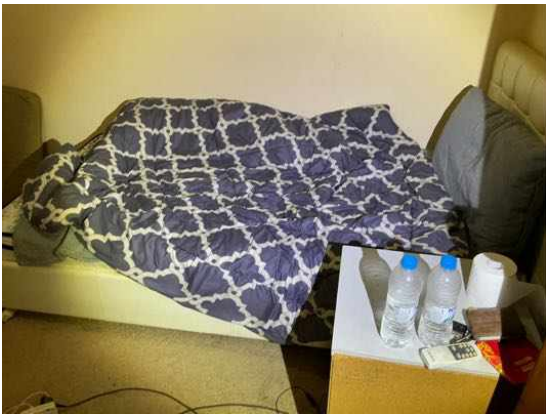
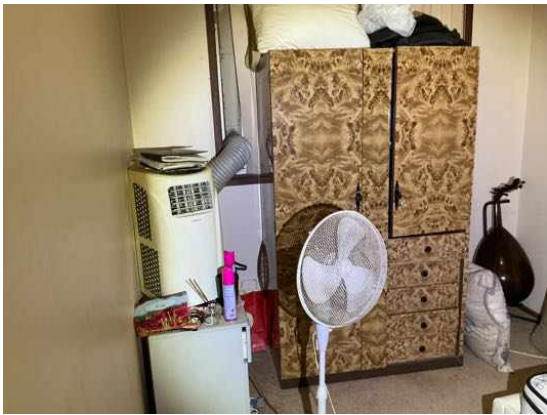
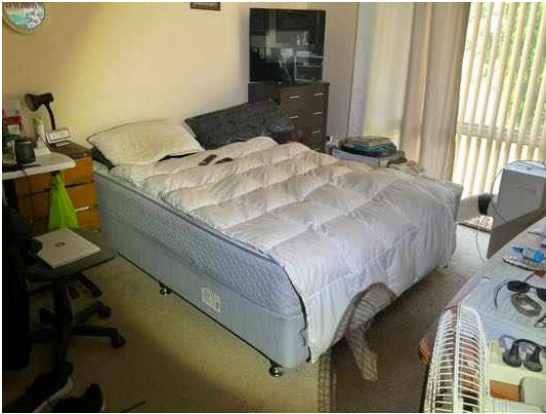
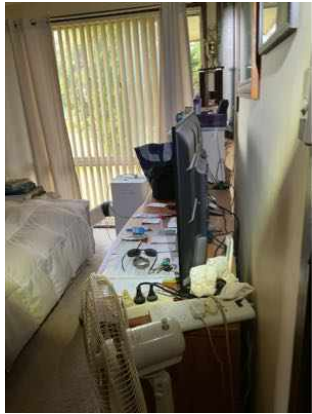
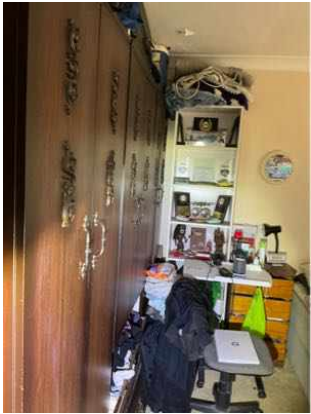
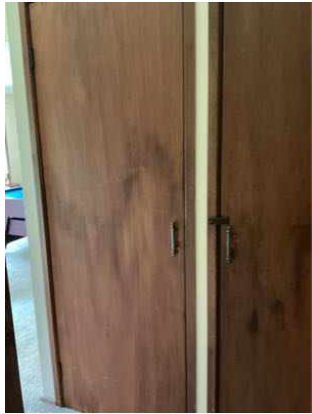
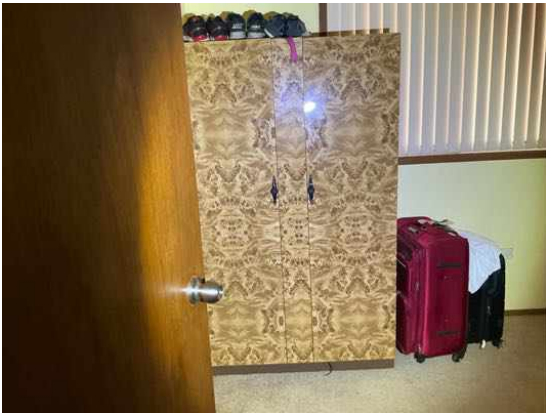
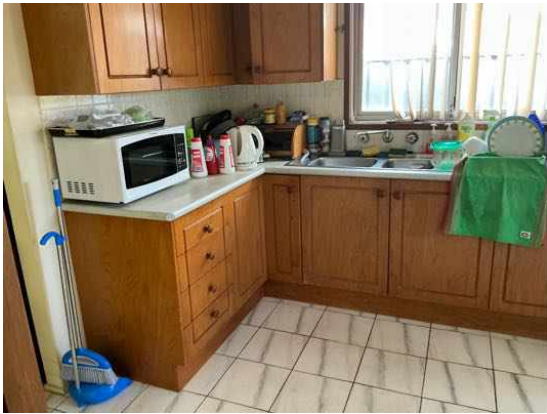
Noted Item

Building: Main Building
Location: All Areas
Finding: Additional Photos - Obstructions and Limitations
Information: These photographs are an indication of the obstructions and limitations which impeded full inspection of the property at the time of inspection. These obstructions can hide an array of defects and should be removed to allow full inspection to be carried out. A re-inspection is recommended once the areas are made accessible.

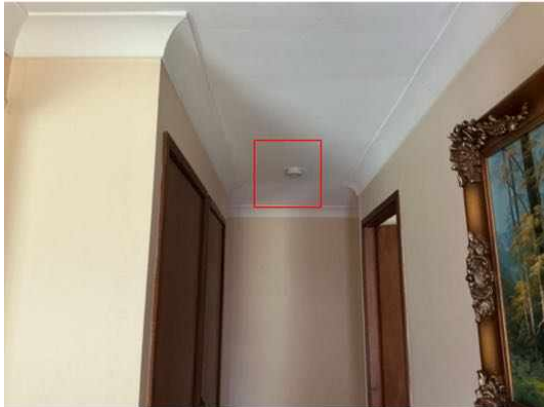
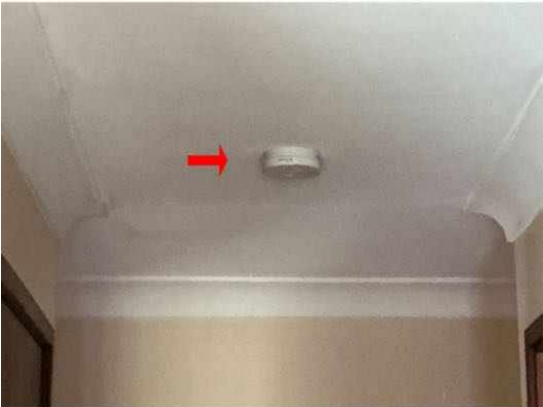
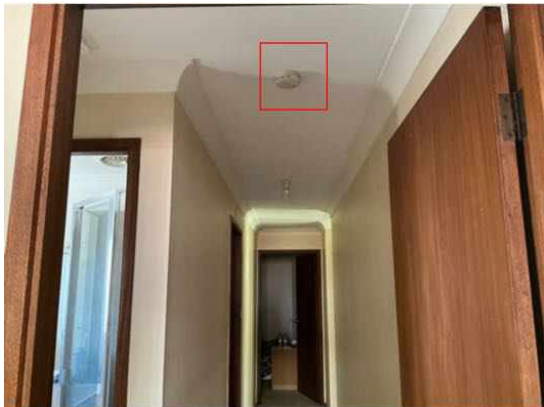
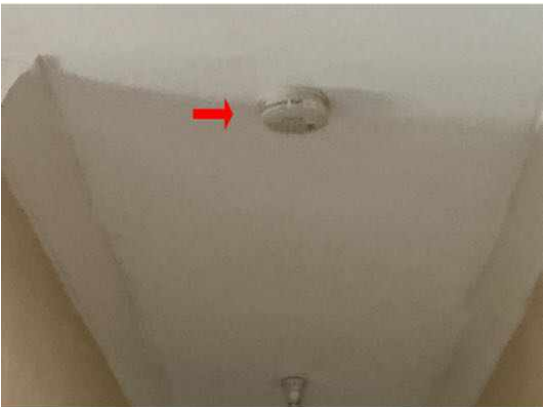
Building: Main Building
Location: All Internal Areas
Finding: Smoke Detectors and Alarms
Information: Reporting on Smoke Detectors or Alarms, including hard wired smoke detection systems and their legislative requirements, is outside the Scope of this Report.

Always ensure sufficient working and suitable smoke detectors are installed prior to occupying any building. Additionally, it is advised that all smoke detectors be tested by the homeowner on a monthly basis.

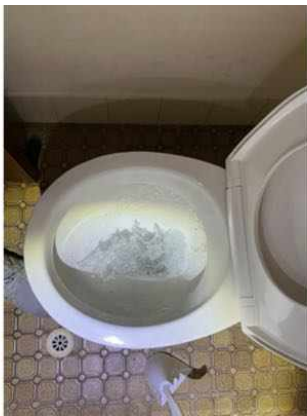
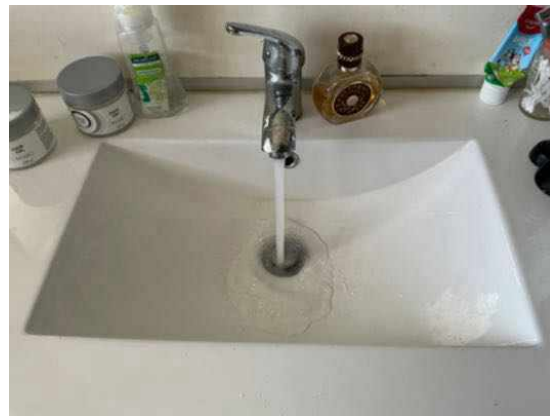
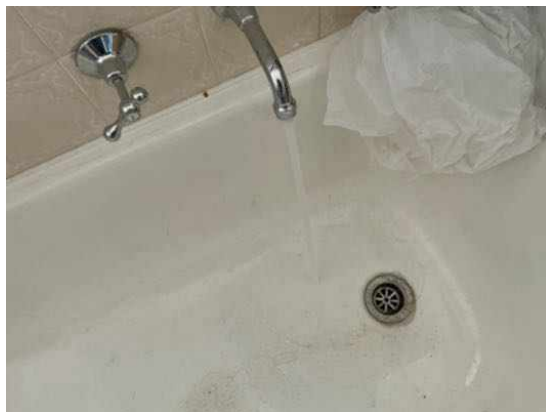
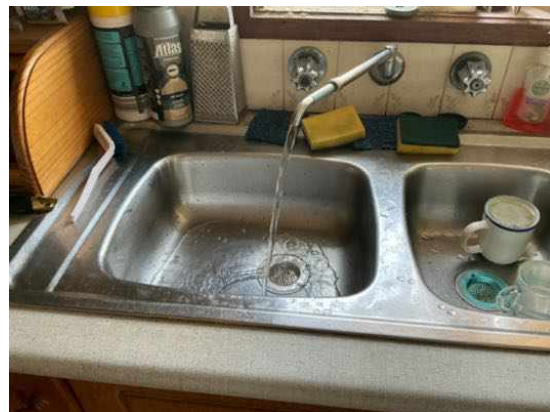
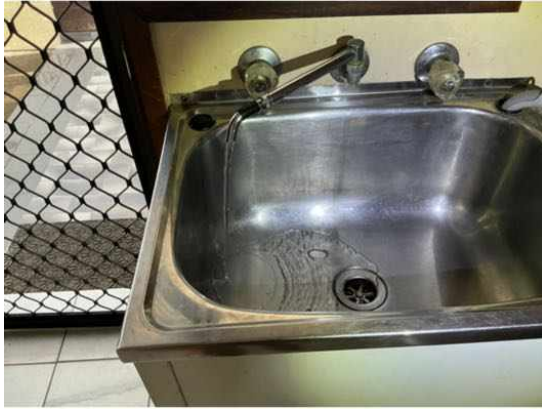
Building: Main Building
Location: All Wet Areas

Information: During the inspection, taps, draining systems and toilets were checked for both water flow and drainage efficiency, as well as inspected for any visible signs of leakage at the time of the inspection. No issues were noted in these areas, unless highlighted in a separate, no immediate remedial work appears to be necessary for these items. Any relevant photo's Documenting these inspections may be found in the additional photo section for reference.

However, it is important to note that while a thorough inspection of cupboards and cabinetry was conducted the presence of instructions such as stored items or fixtures may have limited full visibility of potential water damage or hidden defects. These obstructions can conceal underlying issues that may not be immediately visible during the initial inspection. Furthermore, conditions can change after the inspection has been carried out and defects or damage could be revealed once obstructions are removed or as time progresses.

Given this, it is strongly recommended that a reinspection be conducted after all obstructions have been removed from the cupboards to allow for a full thorough assessment of these areas. This will ensure that any concealed damage or defects are identified and addressed in a timely manner. Regular maintenance and monitoring of plumbing and drainage systems are also advised to insure long-term functionality and to prevent future problems from arising.

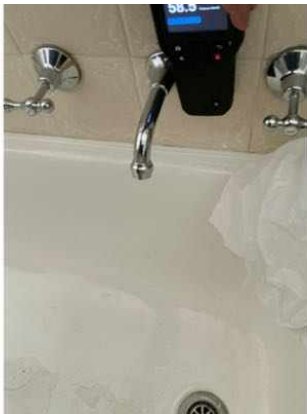
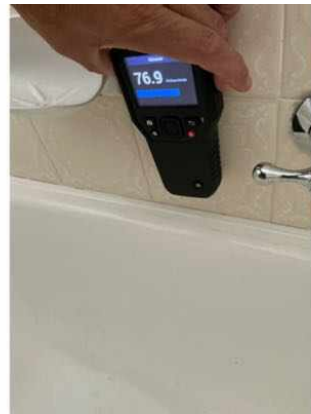
Building: Main Building
Location: All Internal Areas
Finding: Photos added Moisture Readings - Wet Areas
Information: Additional photos are provided for your general reference.

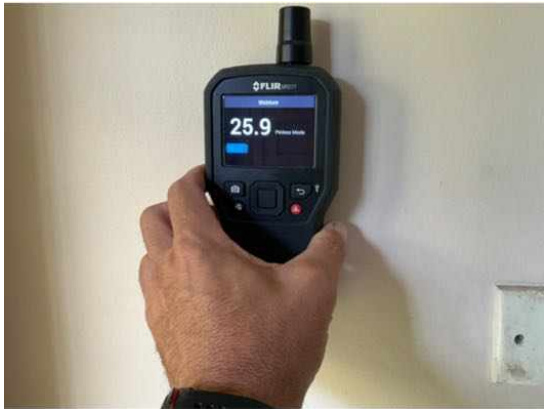
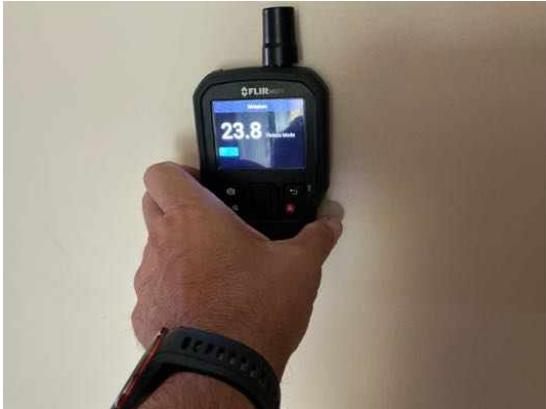
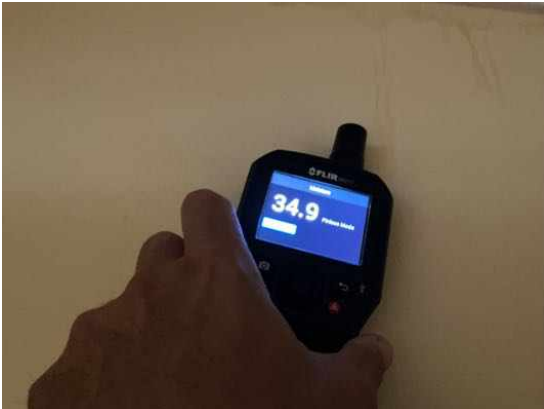
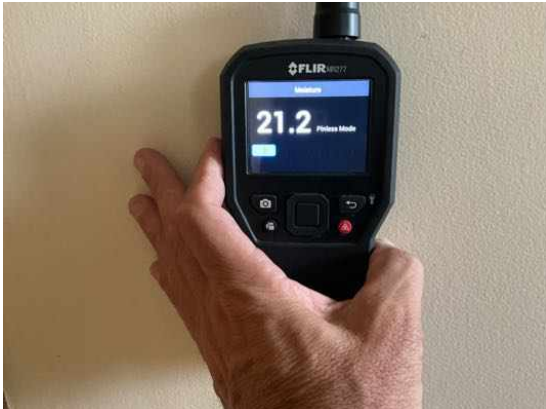
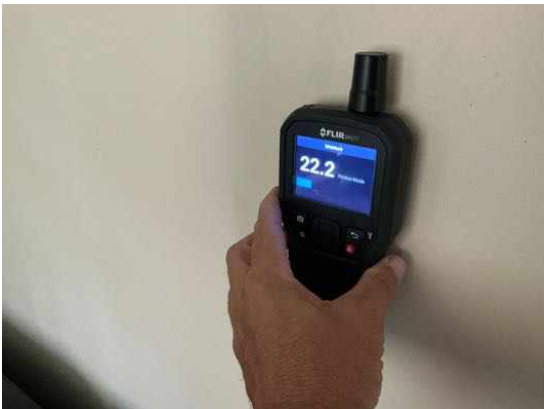
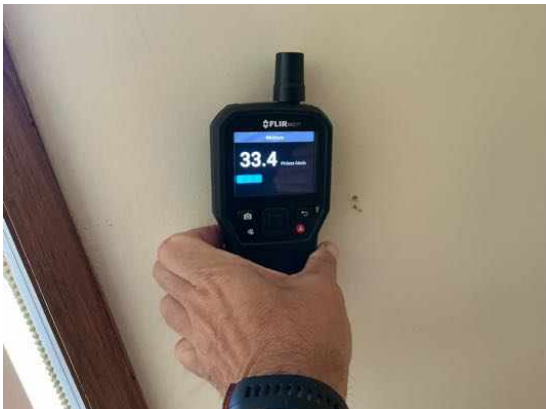
Building: Main Building
Location: All Internal Areas
Finding: Photos added Moisture Readings - Other Areas
Information: Additional photos are provided for your general reference.

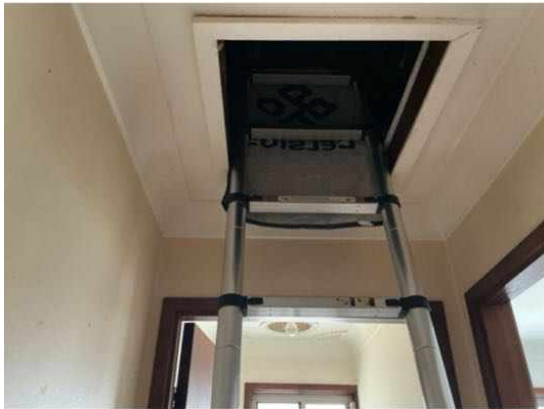
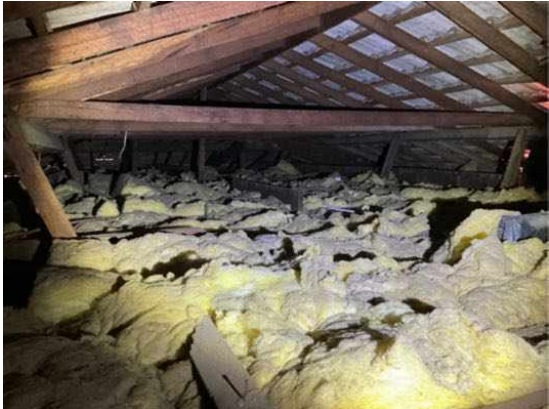
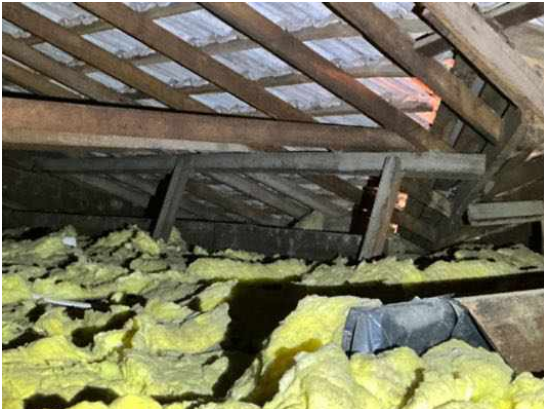
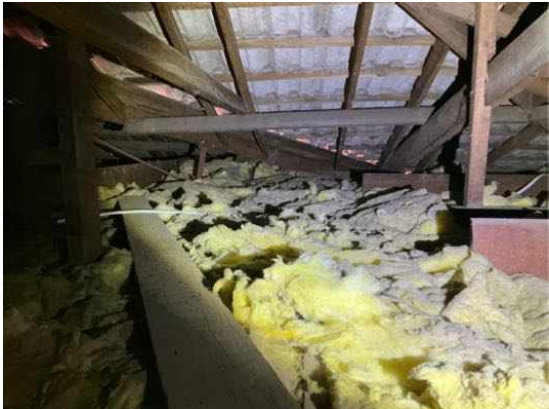
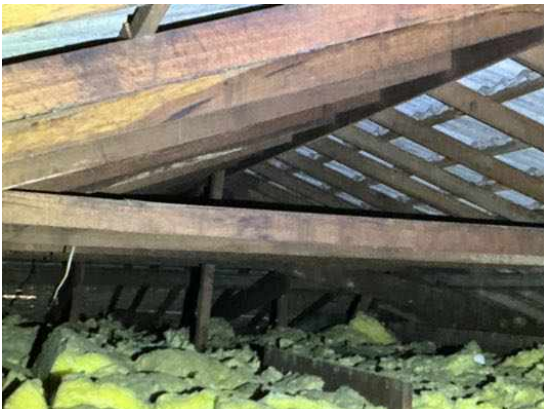
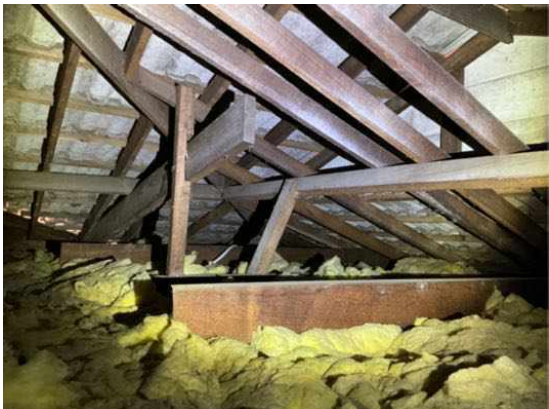
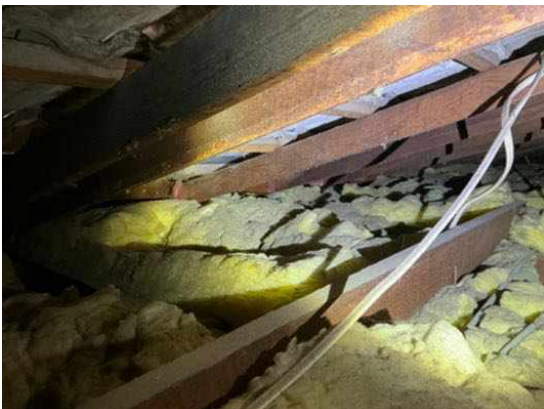
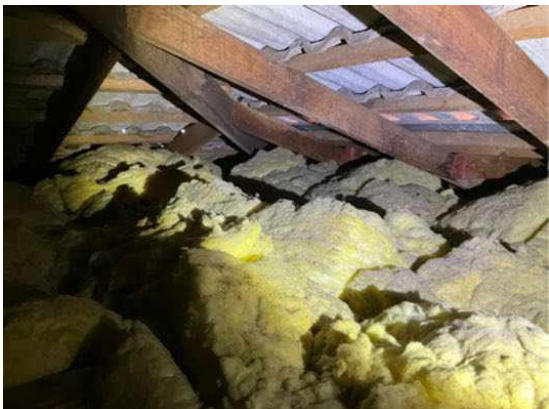
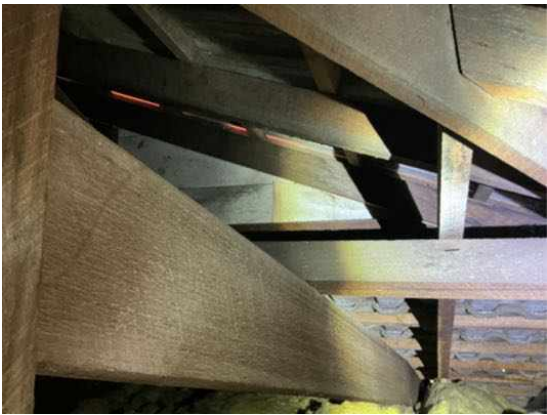
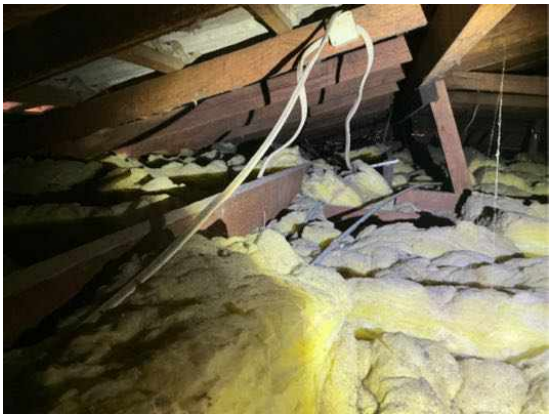
Building: Main Building
Location: Roof Void
Finding: Additional Photos Roof Void
Information: Additional photos are provided of the general roof void for your general reference at the time of inspection.

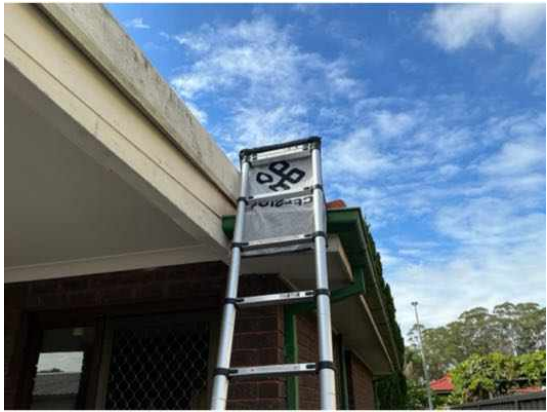
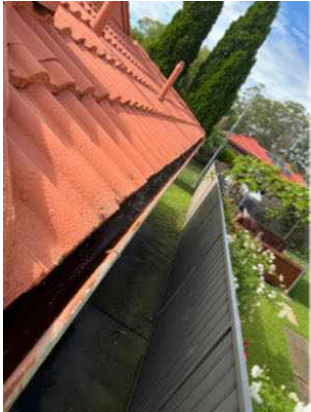
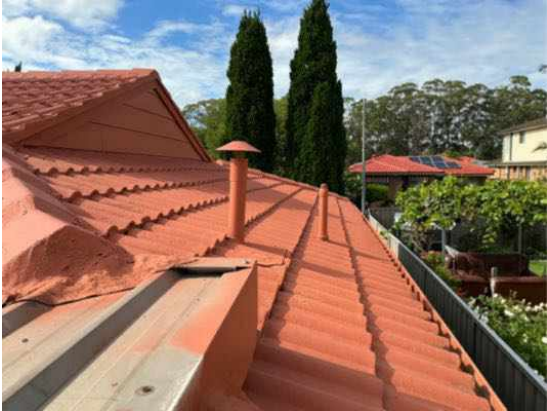
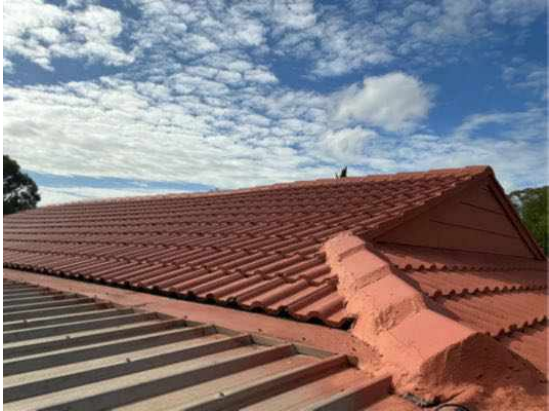
Building: Main Building
Location: Roof Exterior
Finding: Additional Photos Roof
Information: Additional photos are provided of the general roof for your general reference at the time of inspection.
