Building and Timber Pest Inspection Report VR

Inspection Date: Tue, 20 Jan 2026

Property Address: 3 Gower Cl, Wetherill Park NSW 2164,
Australia

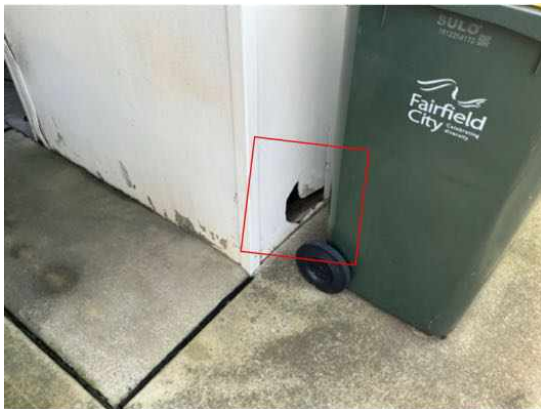
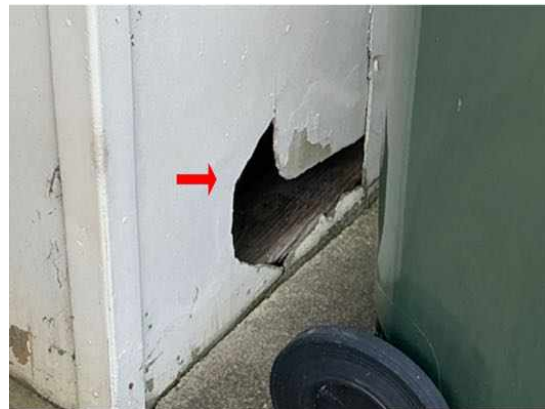
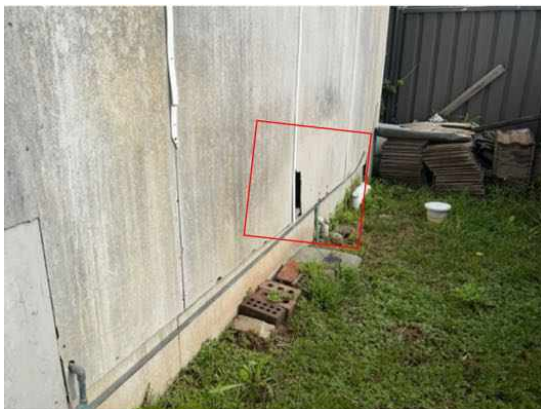
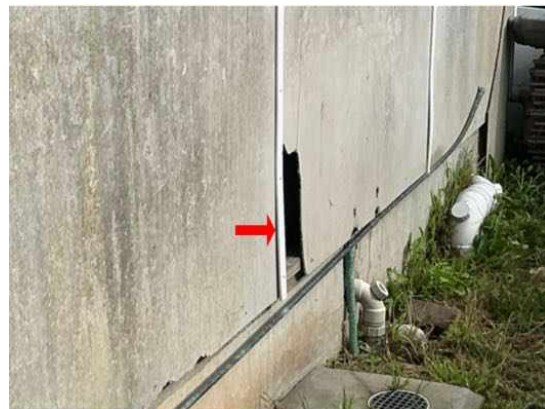
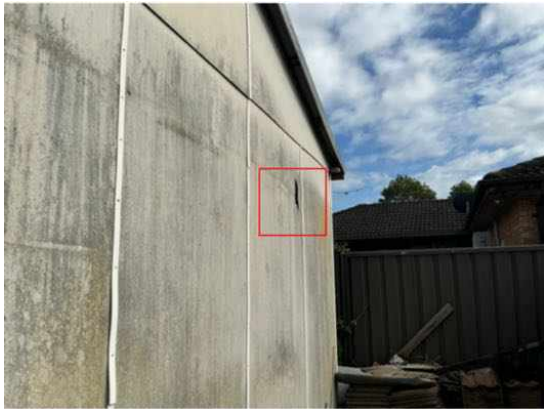
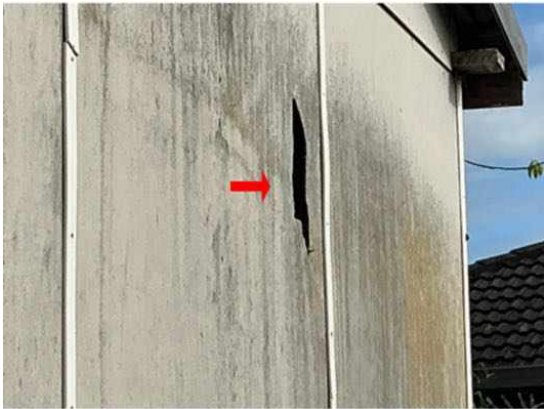
Building: Main Building
Location: Garage
Finding: Asbestos - Suspected
Information: Reporting on Asbestos is outside the Scope of this Report. This suspected defect is highlighted as a caution only. We suspect, based on our experience in the building industry, that there is a higher risk of this property containing asbestos.

As Asbestos Reporting is outside the scope of this report, we advise that you consider a separate Asbestos Inspection and Condition Audit, which can include the taking of samples for definitive confirmation of the presence of Asbestos.

In the interim, the client is advised to act with caution, especially when considering any damage to building materials general wear and tear renovations extensions demolition and general maintenance activities due to the suspected presence of Asbestos.

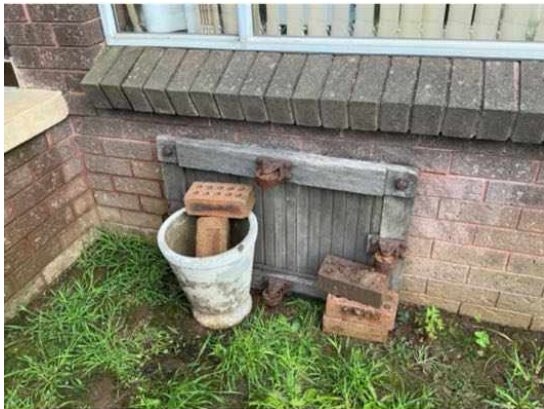
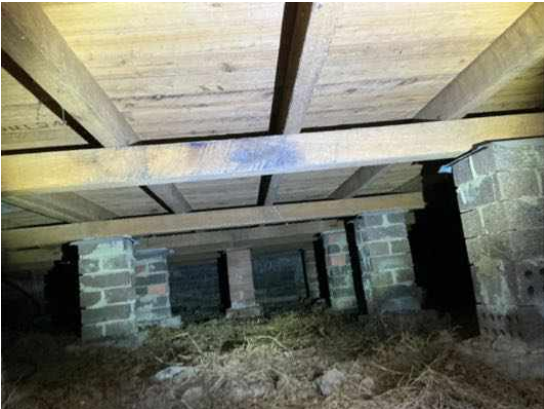
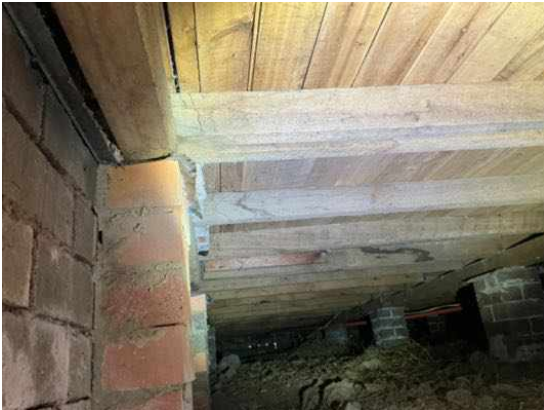
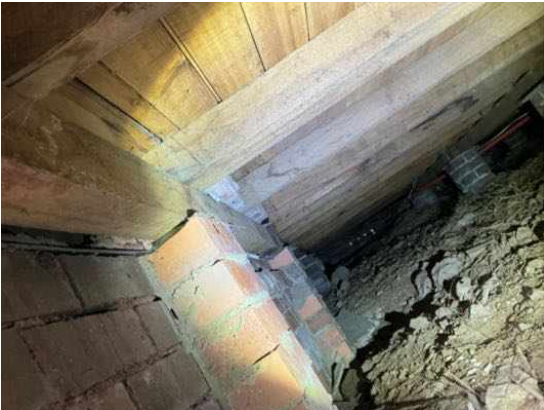
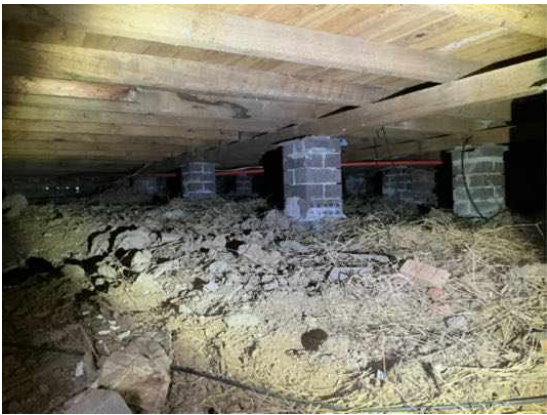
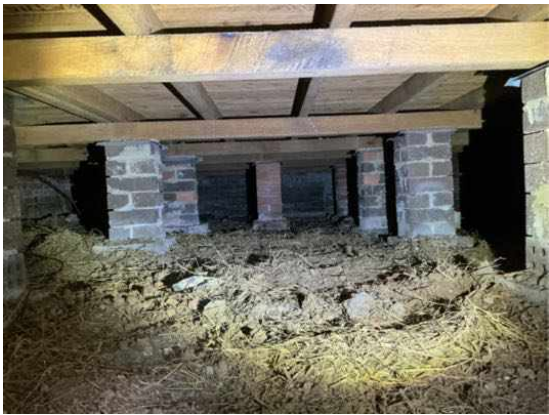
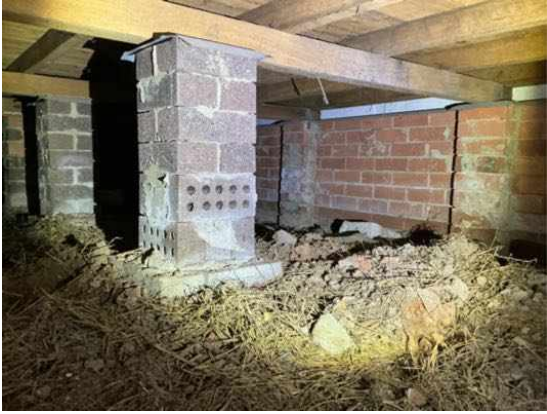
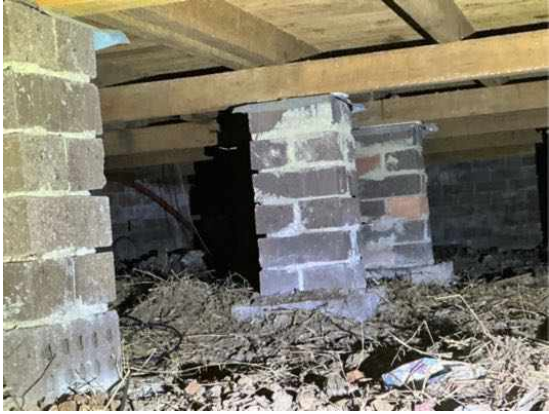
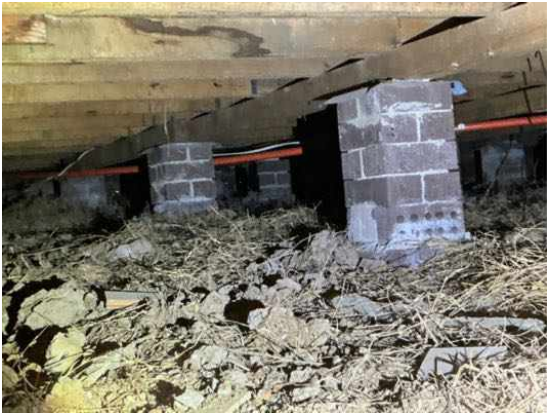
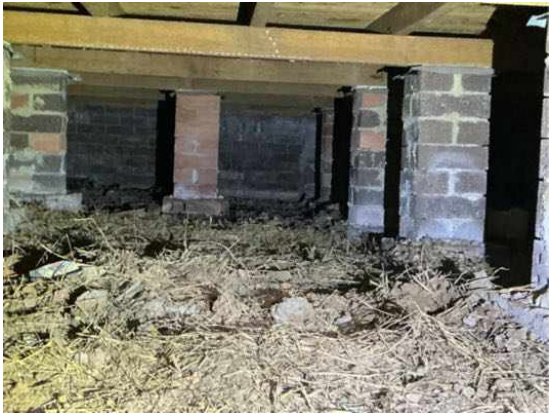
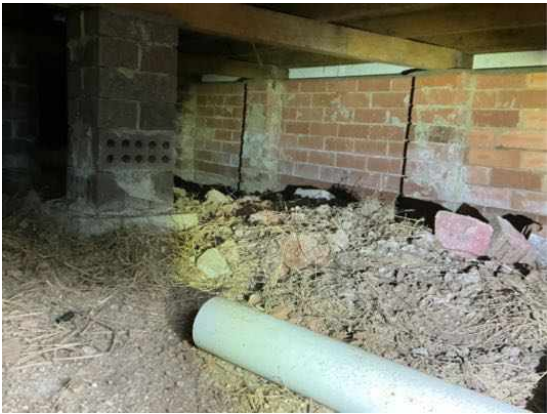
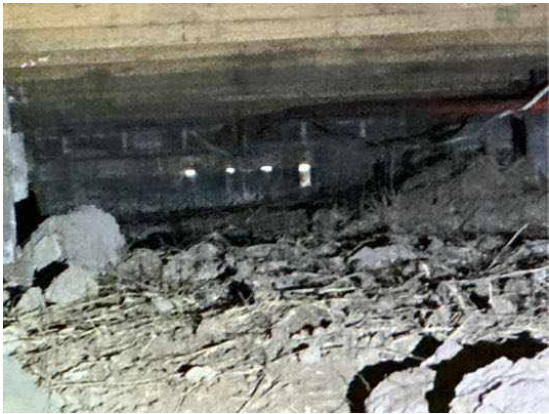
Building: Main Building
Location: Subfloor
Finding: Additional Photos - Subfloor
Information: Additional photos are provided for your general reference
