Building and Timber Pest Inspection Report

Inspection Date: Tue, 27 Jan 2026

Property Address: 5 Flemington Pkwy, Box Hill NSW 2765,
Australia

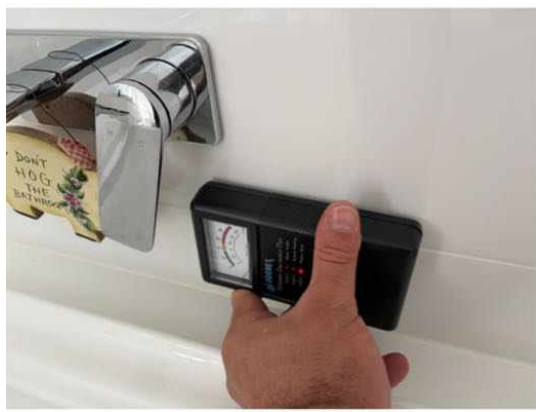
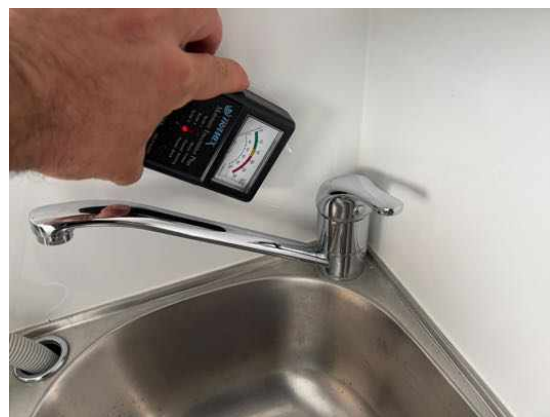
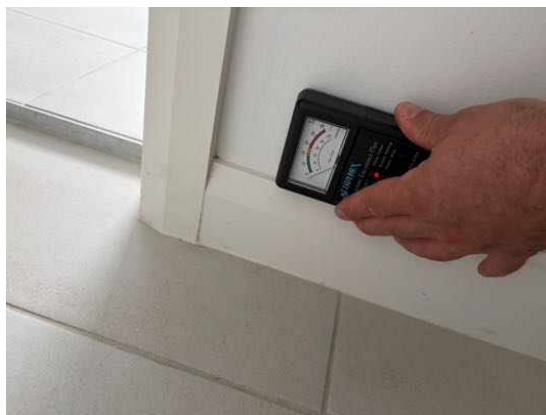
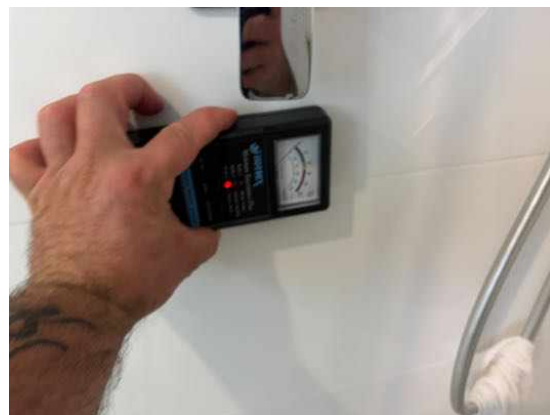
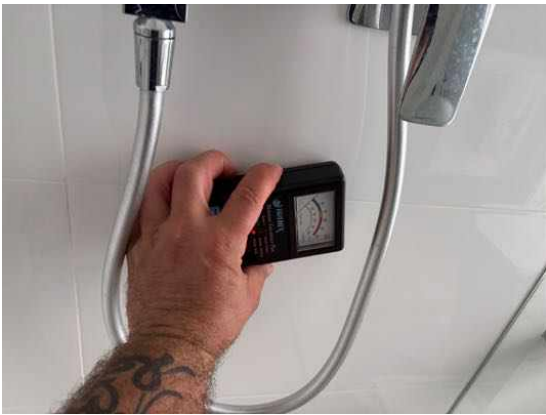
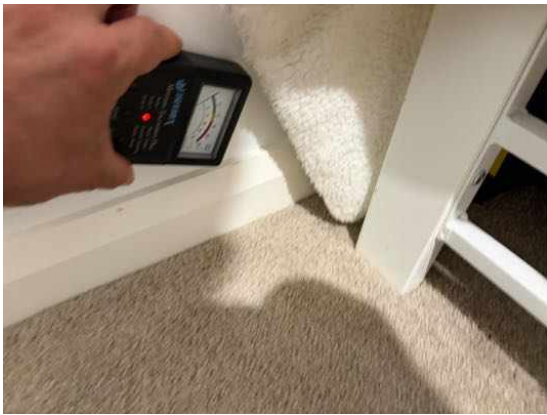
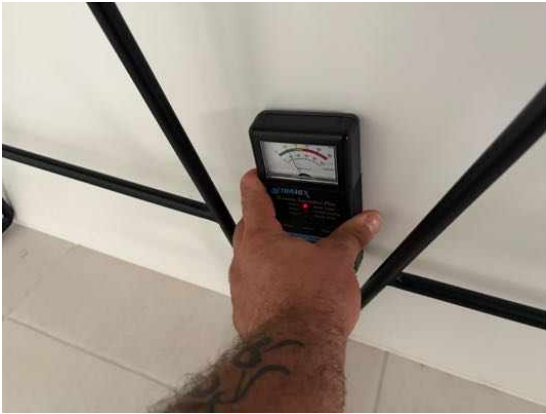
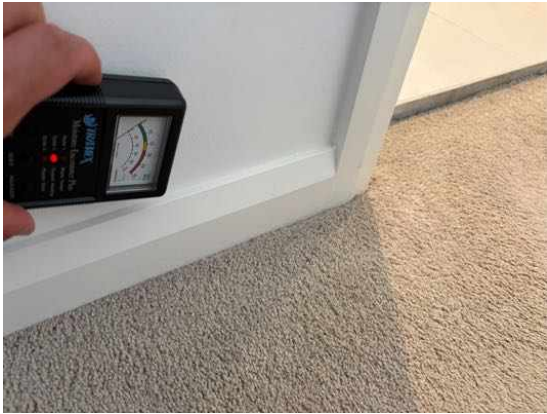
Building: Main Building
Location: All Areas
Finding: Moisture metre
Information: During the inspection the property was checked for moisture using a moisture metre.

This is for information only.

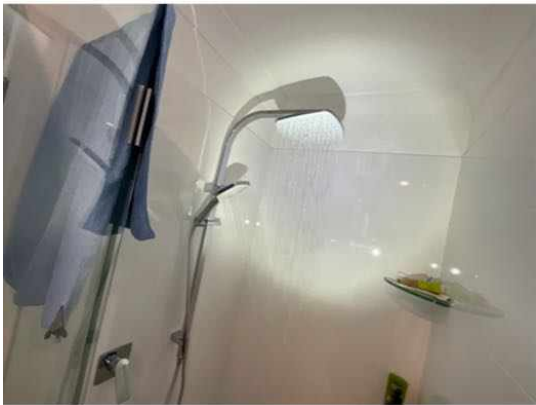
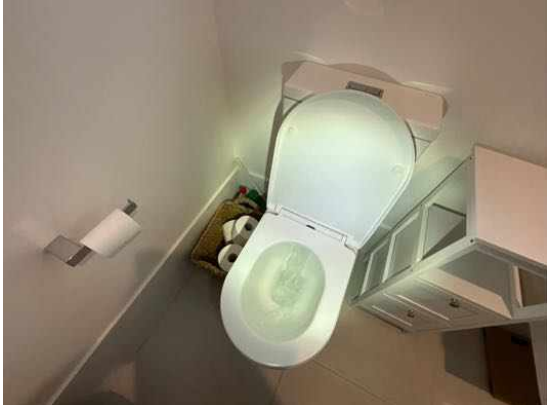
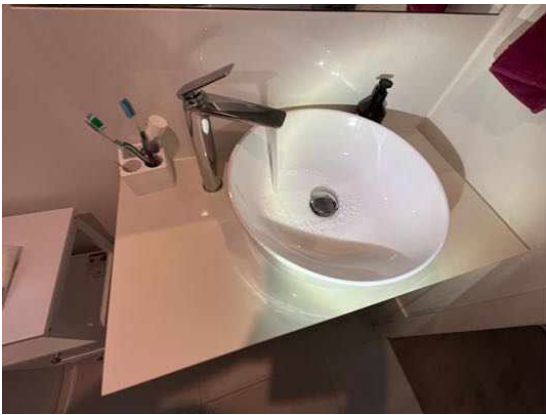
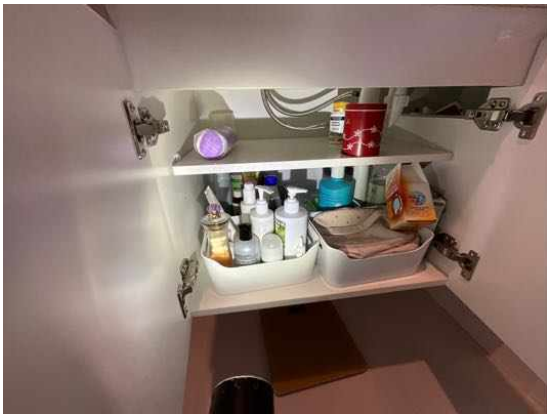
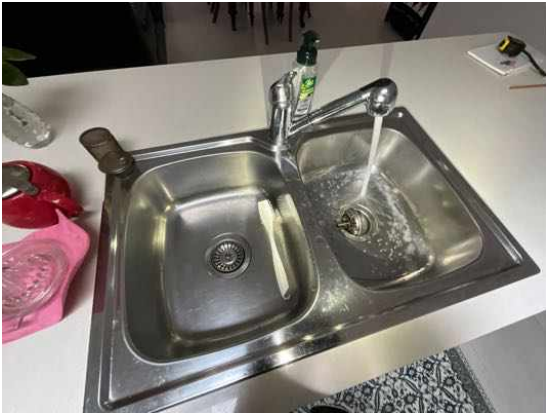
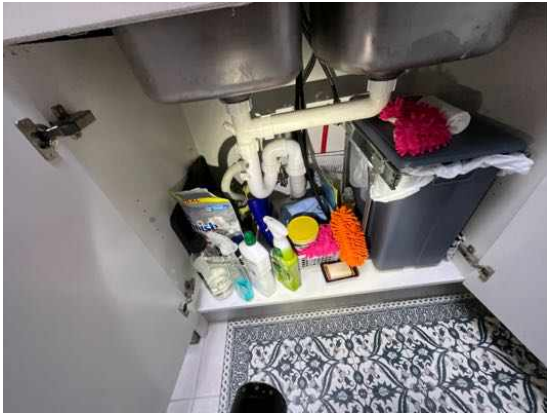
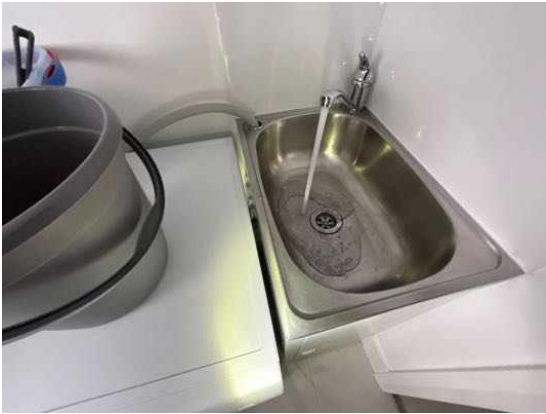
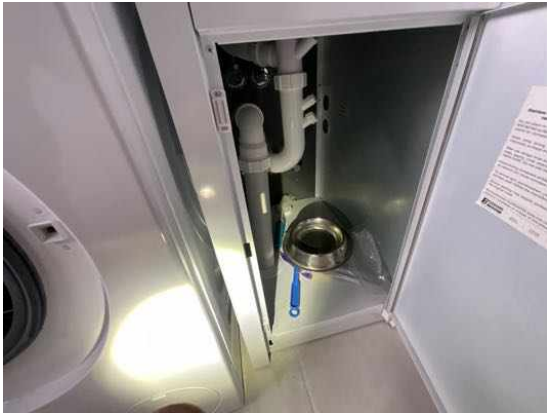
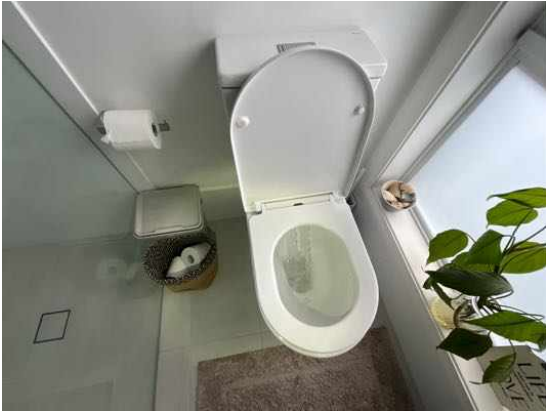
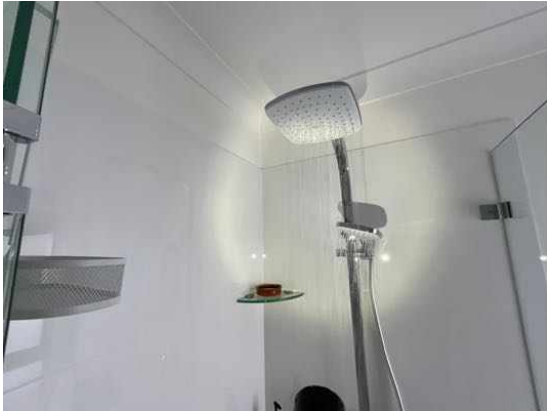
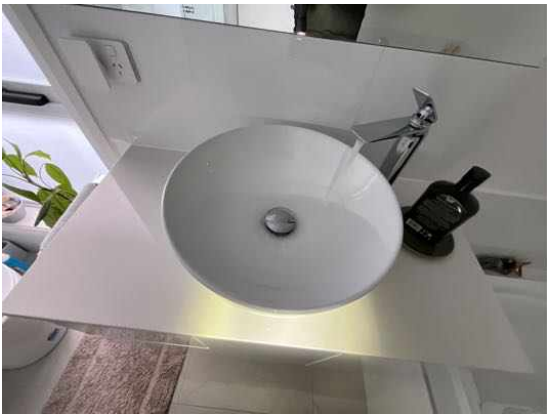
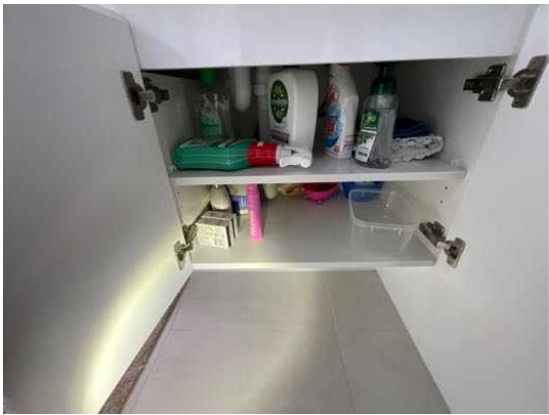
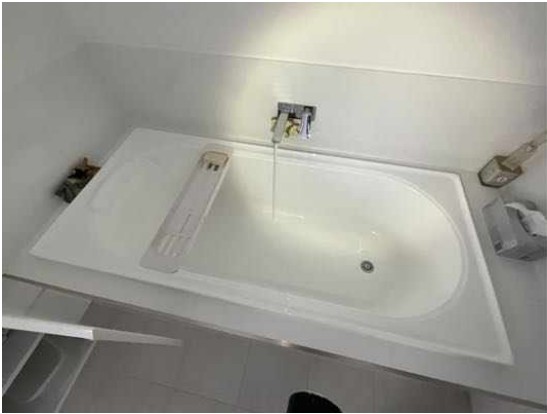
Building: Main Building
Location: All Wet Areas
Finding: Additional Photos
Information:

Additional photos are provided for your general reference.

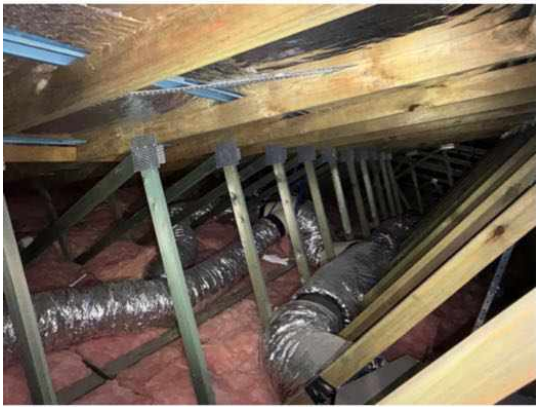
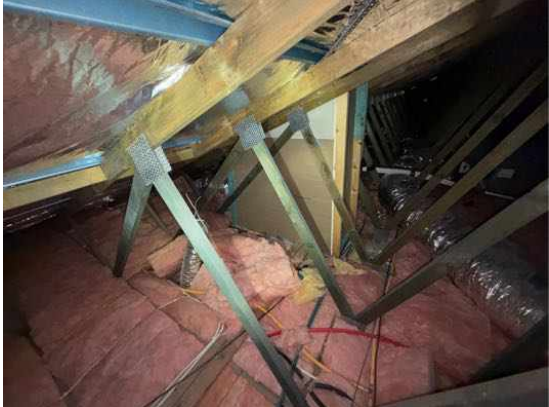
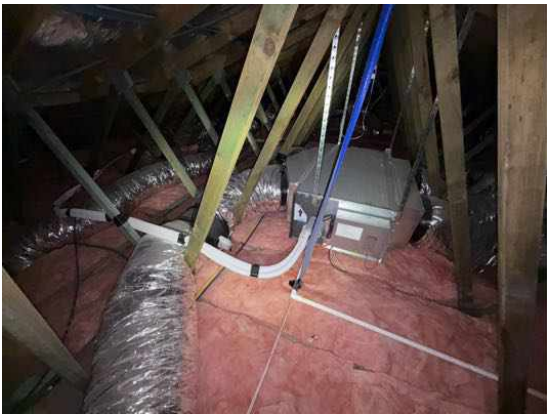
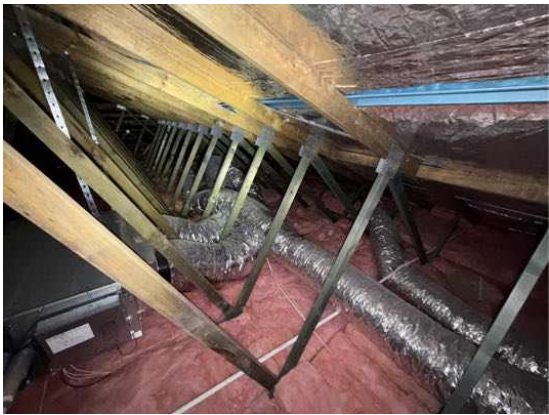
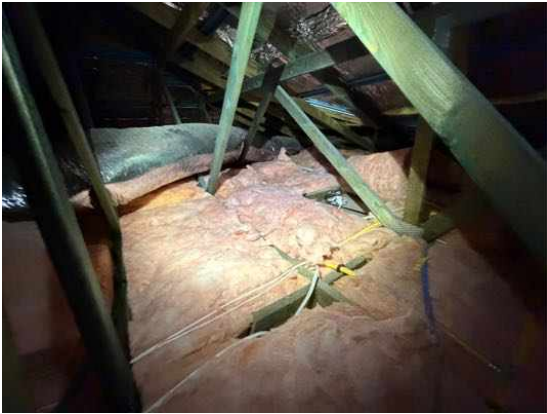
Building: Main Building
Location: Roof Void
Finding: Additional Photos
Information:

Additional photos are provided for your general reference.

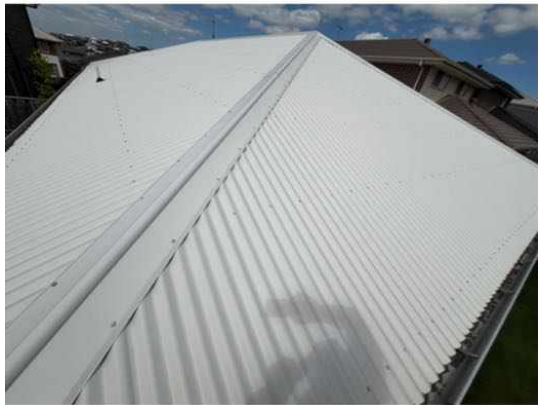
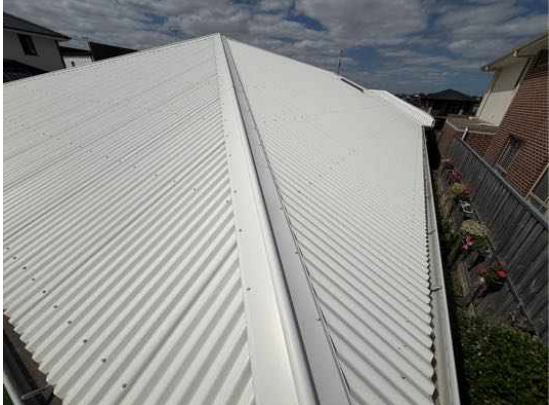
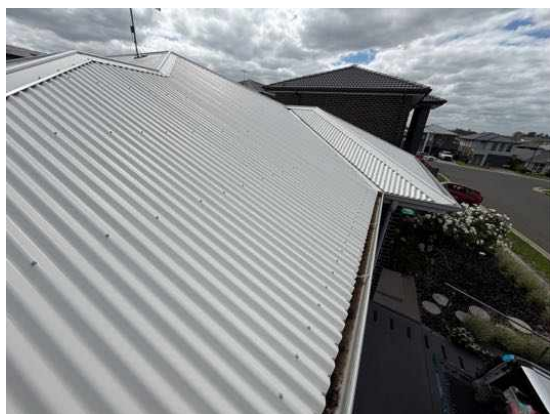
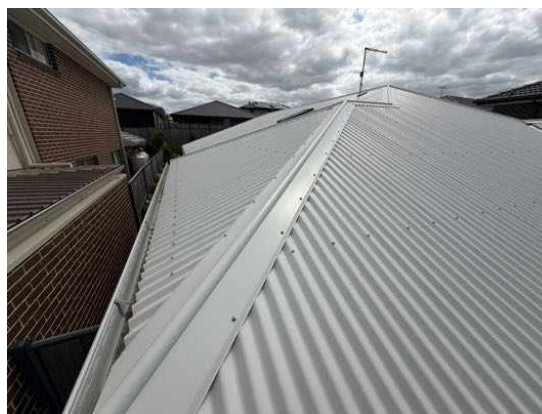
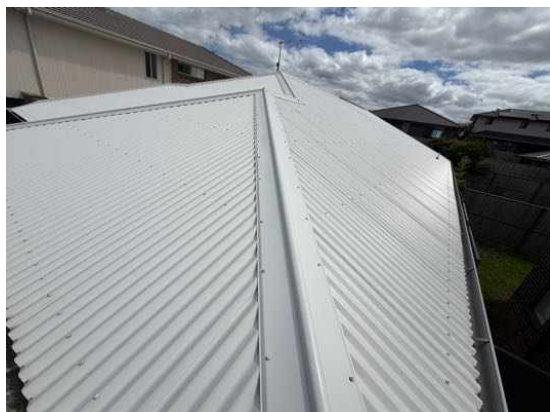
Building: Main Building
Location: Roof Exterior
Finding: Additional Photos
Information:

Additional photos are provided for your general reference.

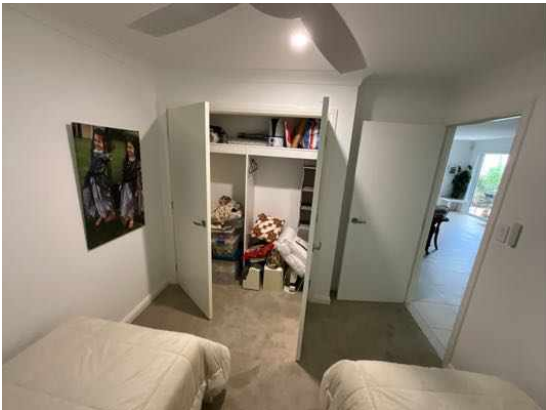
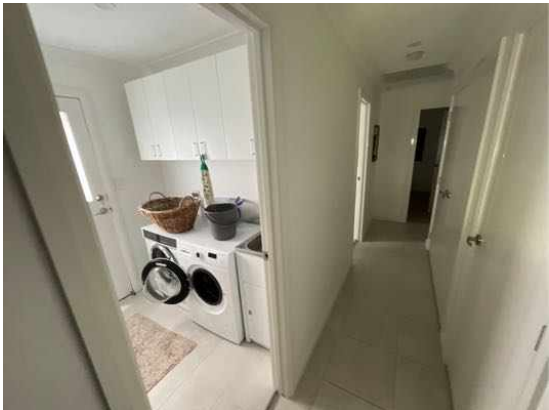
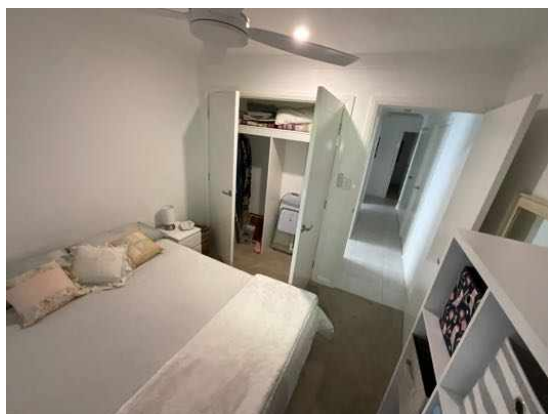
Building: Main Building
 Location: All Areas
 Finding: Additional Photos - Obstructions and Limitations
 Information:

These photographs are an indication of the obstructions and limitations which impeded full inspection of the property at the time of inspection. These obstructions can hide an array of defects and should be removed to allow full inspection to be carried out. A re-inspection is recommended once the areas are made accessible.
