Building Inspection Report

Inspection Date: Mon, 16 Mar 2026

Property Address: 7/267 Princes Hwy, Corrimal NSW 2518,
Australia

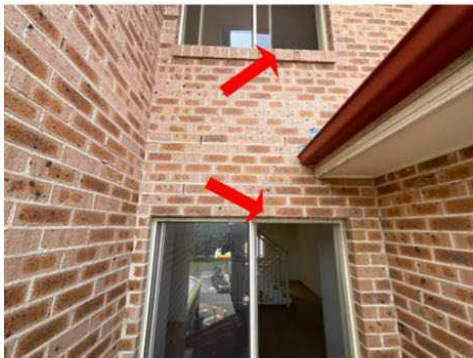
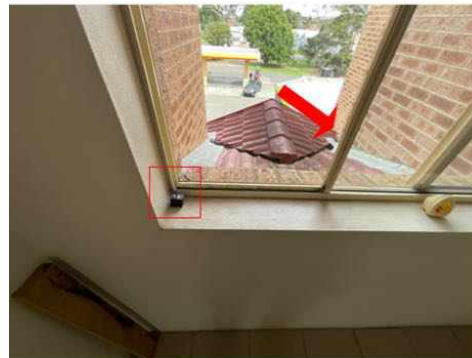
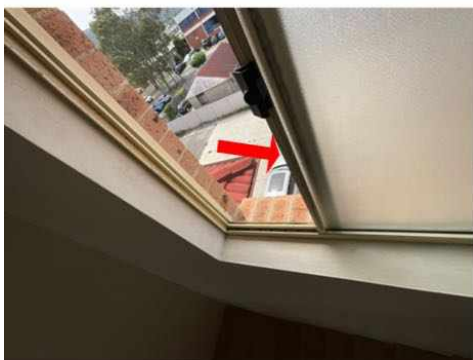
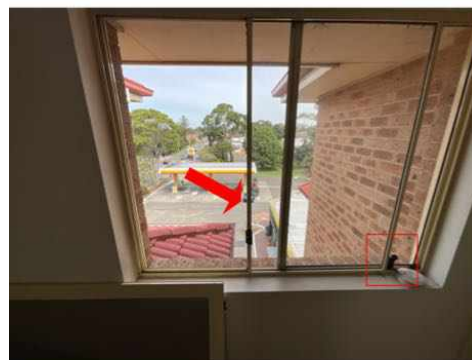
Defects 1.01

| Finding: | Window opening restrictors missing. |

Window restrictors are required where people who are vulnerable to the risk of falling have access to windows. This means all windows above ground level which do not have another fall prevention safety measure in place, such as a balcony or balustrade should have a restrictor.

These need to be added urgently for the safety of all persons.

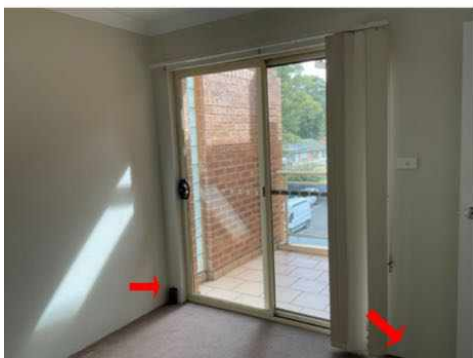
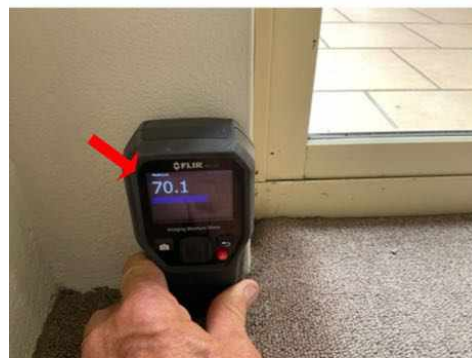
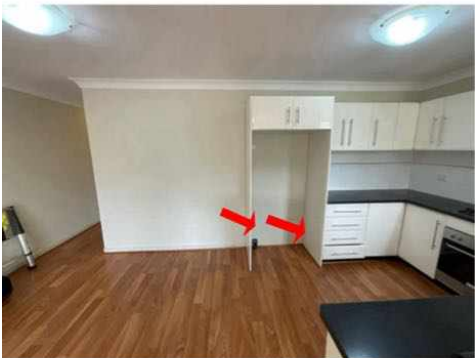
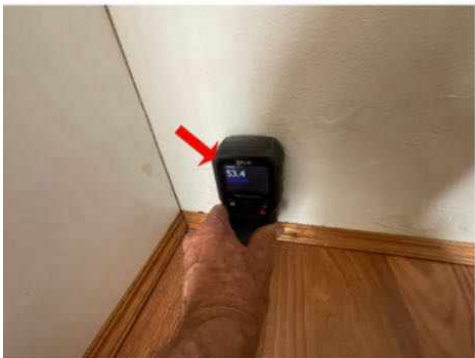
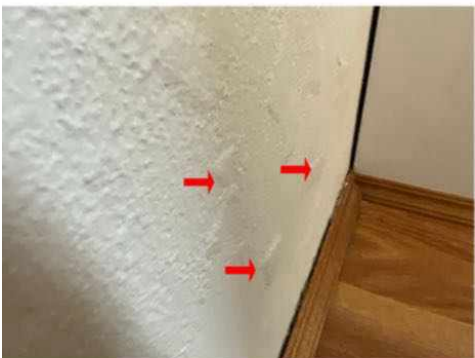
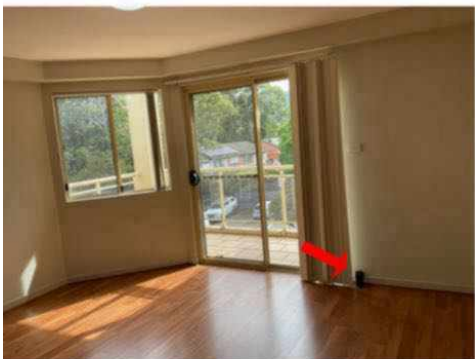
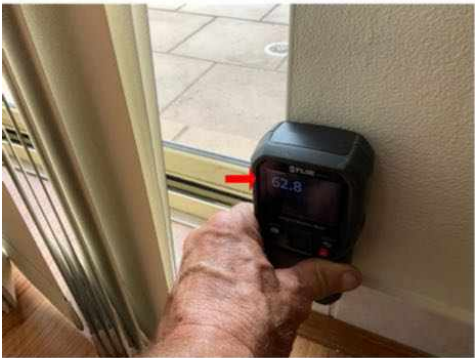
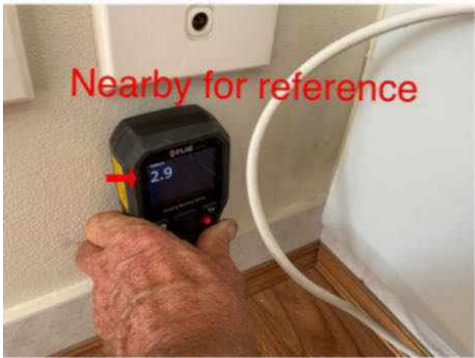
Defects 3.01

| Finding: | Evidence of excessive moisture was present at the time of inspection |
| Information: | Excessive moisture can attract termites and produce conditions that promote termite attack, fungal growth and wood decay. |

The kitchen fridge area is thought to be caused by a leak from the bathroom. In other areas the moisture ingress appears to be from the external wall areas.

Excessive moisture is generally caused by deteriorated, inadequate or missing roof drainage, leaking plumbing pipes or fixtures, poorly plumbed HWS overflows or condenser units and poor site drainage. It is highly recommended that all plumbing and drainage fixtures and fittings be maintained regularly in order to prevent excessive moisture being present in the internal property.

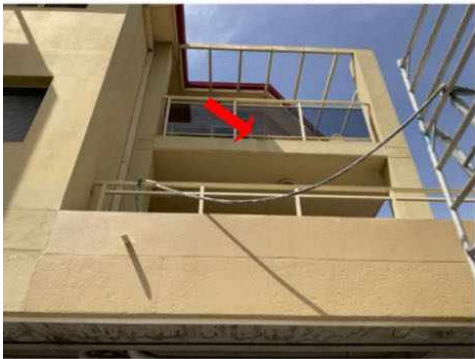
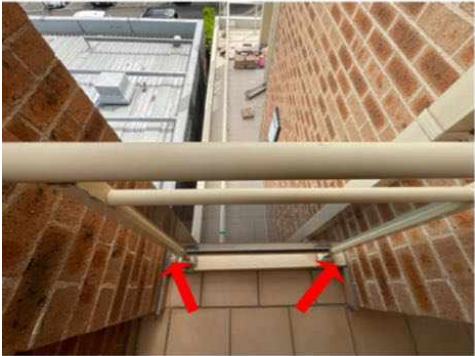
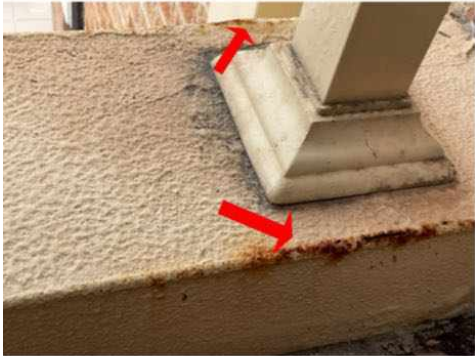
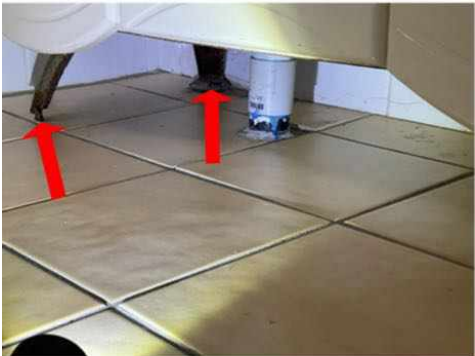
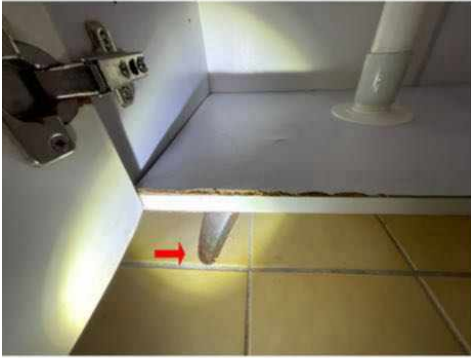
Defects 3.03

Building: Main Building
 Location: Exterior verandahs & vanity
 Finding: Areas rusted or corroded
 Information: These balconies and vanity area shows evidence of rusting and corrosion, which is likely to have developed as a result of excessive exposure to moisture and or inadequate coatings.

As surface rust provides no protection to the underlying iron, the deteriorating

condition is likely to worsen if not addressed in the short-term future.

Rusting and corrosion should be managed by ideally removing or limiting the affected surface from exposure to moisture. Many of these balcony areas will be, or may already be affected by concrete spalling like in unit 7 if these balcony areas are not sealed in the very near future.

Where possible, the use of galvanized (treated) metals or aluminium coated metals aid in rust prevention, as does regular general maintenance. Rust formation can be controlled with coatings, such as paint, that isolate the iron from the environment.

The rusted vanity legs will also require replacement .

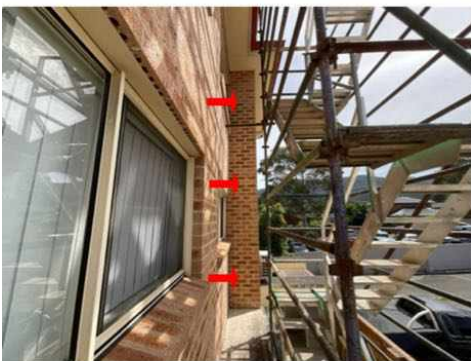
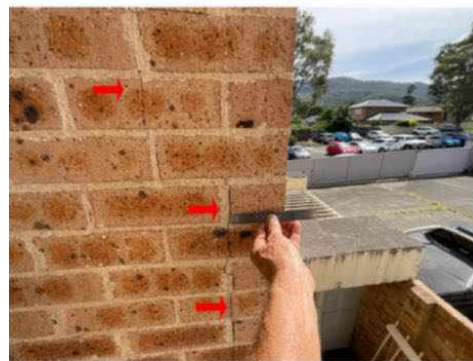
Defects 3.04

| Finding: | Brickwork - Step cracking (appears up to 3mm) |
| Information: | Step cracking of 2-3mm was identified to the brickwork 2 floors high in this northwest corner area at the time of inspection. Step cracking, which is similar to other forms of cracking, has a variety of possible causes. However, the most common is the subsidence of adjacent footings. |

Step cracking is a relatively common defect, and is most likely to occur adjacent to windows, doors and other openings. Mortar failure in the gaps between affected bricks indicates the stresses and tensions affecting the wall.

Where step cracking is extensive or severe, the client is advised to consult a structural engineer. This minor step cracking can be used as a warning sign to address factors causing stress to the wall, which can include the effect of surrounding trees, water leaks, soil erosion, or even the presence of reactive soils in the surrounding area.

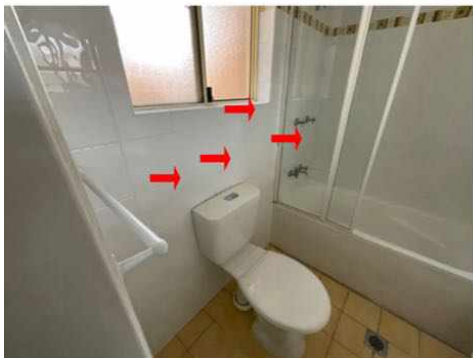
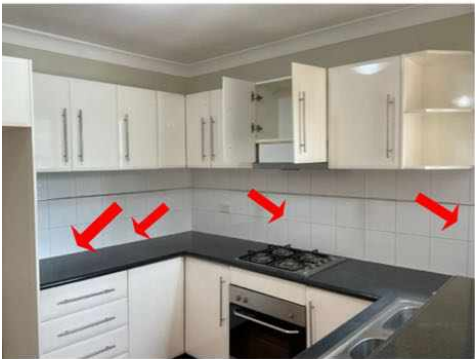
Defects 3.05

| Finding: | Cracked tiles |
| Information: | Cracking in many tiles was evident in these pictured unit and common areas at the time of inspection. It is suspected that this cracking has occurred as a result of settlement and impact damage. Cracked tiles throughout the household detract from the overall appearance of the affected areas however it is unlikely to create or lead to any secondary defects. |

Replacement of cracked floor tiles is recommended at the clients discretion. A tiling contractor may be appointed to perform these works.

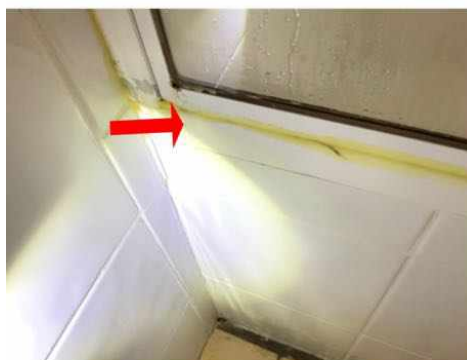
Defects 3.06

| Finding: | Shower screen - Leaking |
| Information: | Leaking was evident to the shower screening at the time of inspection. It is suspected that the leaking has occurred as a result missing sealant. Leaking from the shower , where left unattended, is likely to lead to water damage to adjoining flooring and walls. Such damage can lead to water damage and necessitate extensive remedial works being required. Active water leaks may also create an environment that is susceptible to the formation and development of mould. |

| | Appointment of a sealant expert is required to repair or replace this missing sealant. Such works should be performed as soon as possible to ensure that no further damage occurs. |

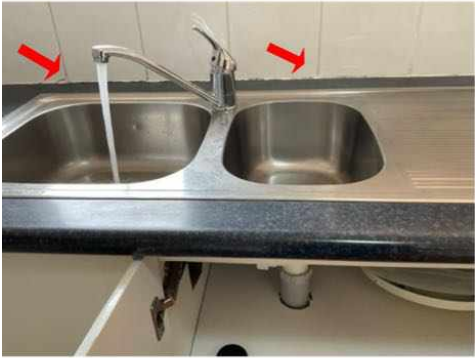
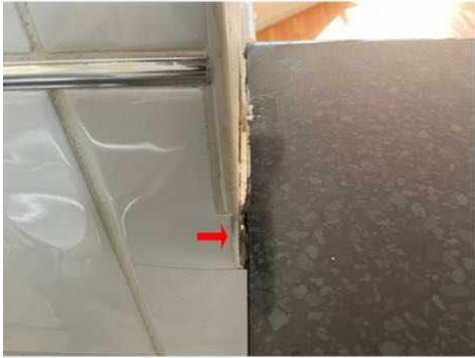
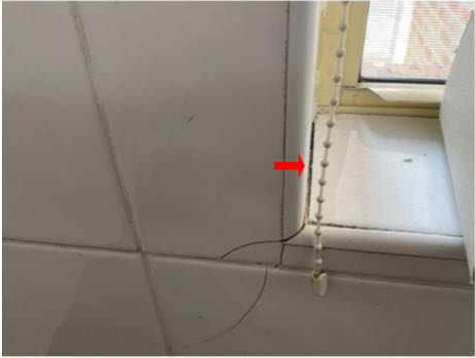
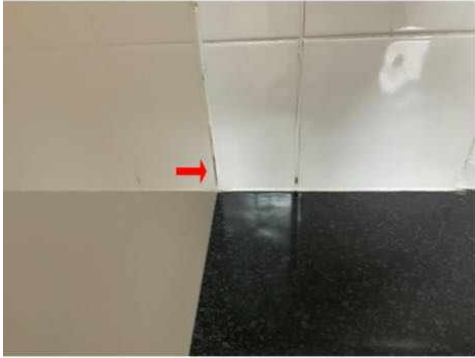
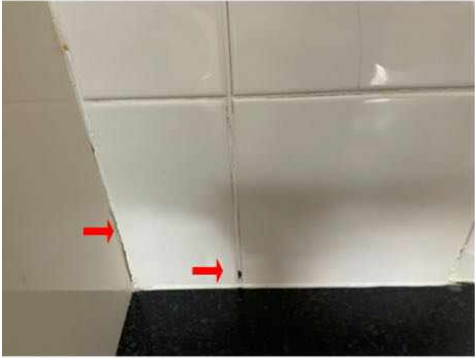
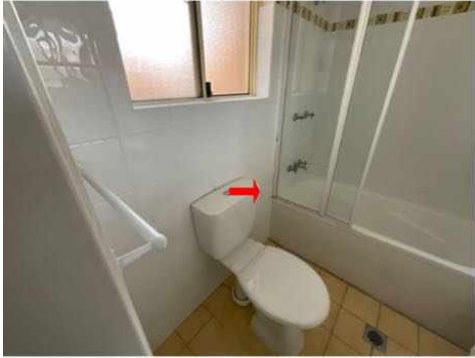
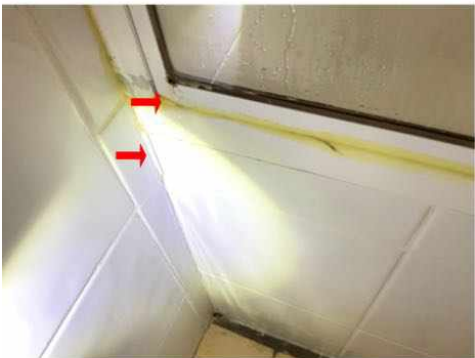
Defects 3.07

| Finding: | Sealant and grouting - Missing or damaged |
| Information: | It was noted on inspection that sealant or grout is degraded to the tiled shower alcove and or other areas of the bathroom. |

Different materials and floor areas move at different rates, generally causing cracking to grout or sealant at this point. A flexible sealant is required to allow for expected expansion and contraction, while keeping the joint water tight and protective of all associated building materials.

There appears to be excessive mould to the sealant and grout which will likely require scraping out and replacement.

Flexible and mould resistant materials should be applied to affected areas to prevent any subsequent water damage that is likely to occur. Regular maintenance and replacement of damage or missing or damaged sealant and grout is highly recommended to the wet areas, as this is a regular wear and tear defect. Sealant and

A sealant specialist or tiling contractor should be appointed to complete these works as soon as possible

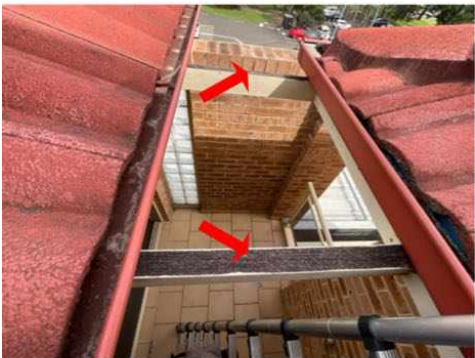
Defects 3.15

Building: Main Building
Location: Roof Exterior
Finding: Sealant (external) - Missing.
Information: It was noted on inspection that areas of external sealant was missing to small areas of the external roof areas.

A sealant specialist or skilled handy person should be appointed to complete these works as soon as possible

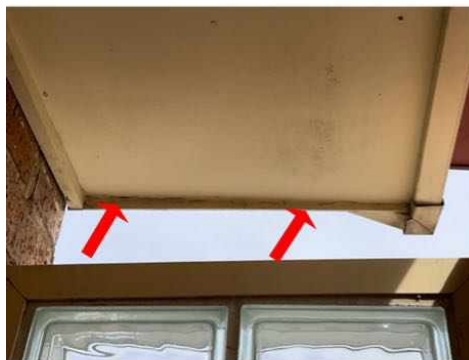
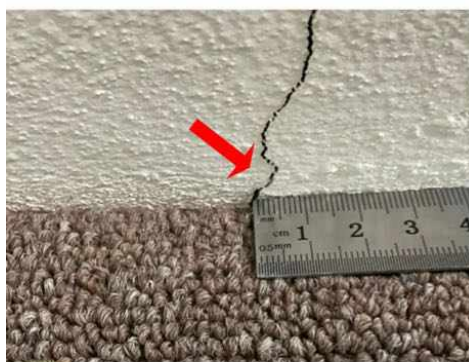
Defects 3.16

Category 2 damage is required to be monitored for a period of 12 months. After the monitoring period, a crack rated at Category 2 or above is considered a defect requiring rectification.

Always contact your building inspector should cracks widen, lengthen, or become more numerous.

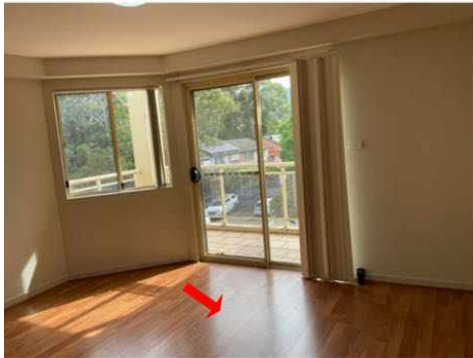
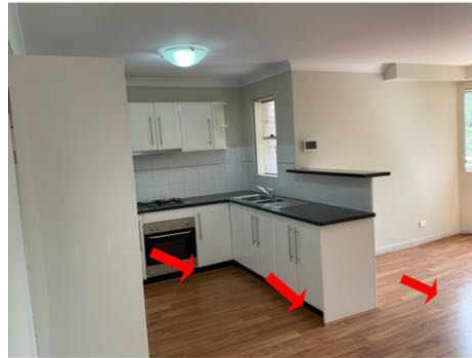
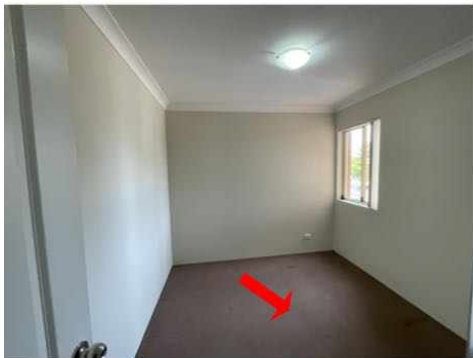
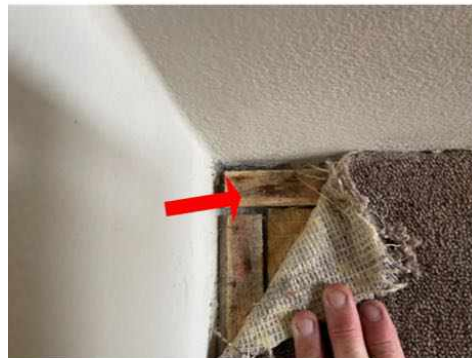
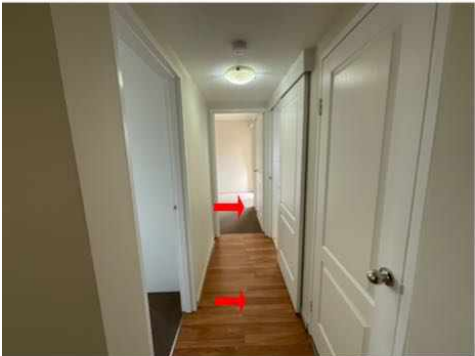
Noted Item

Building: Main Building
Location: All Internal Areas
Finding: Additional Photos - Obstructions and Limitations of Internal areas
Information: These photographs are an indication of the obstructions and limitations which impeded full inspection of Internal areas at the time of inspection. These obstructions can hide an array of defects and should be removed to allow full inspection to be carried out. A re-inspection is recommended once the areas are made accessible.

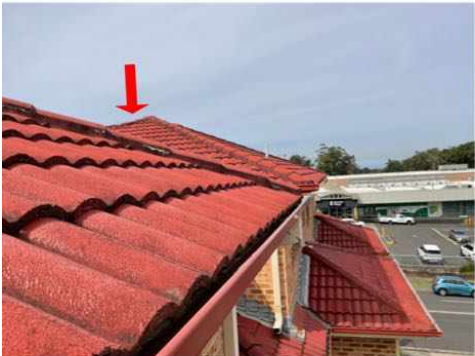
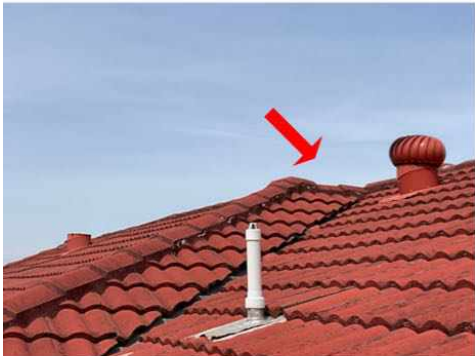
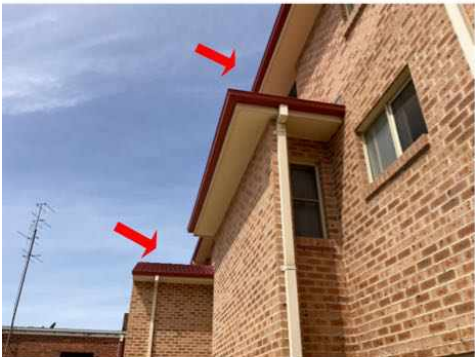
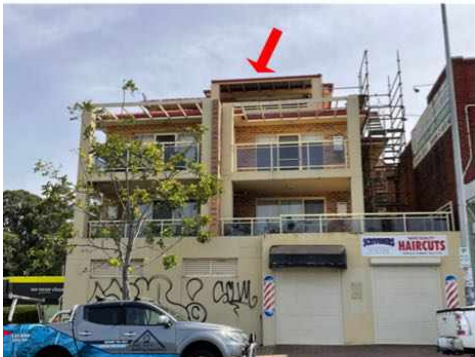
Building: Yard
Location: All External Areas
Finding: Additional Photos - Obstructions and Limitations of External areas
Information: These photographs are an indication of the obstructions and limitations which impeded full inspection of external areas at the time of inspection. These obstructions can hide an array of defects and should be removed to allow full inspection to be carried out. A re-inspection is recommended once the areas are made accessible.

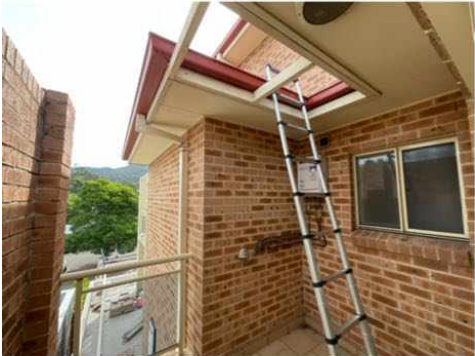
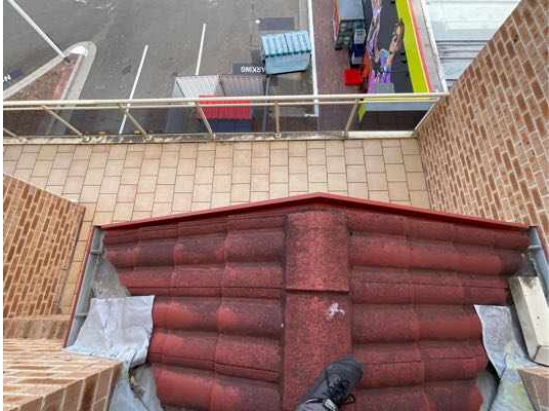
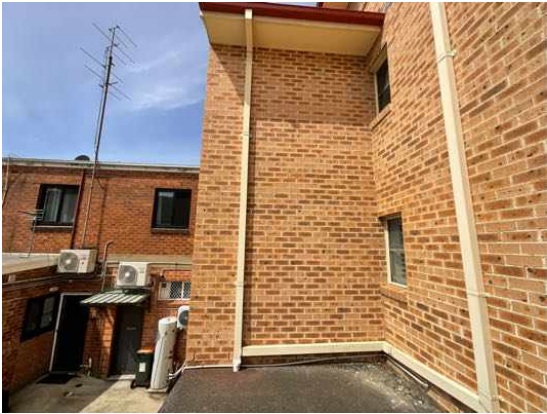
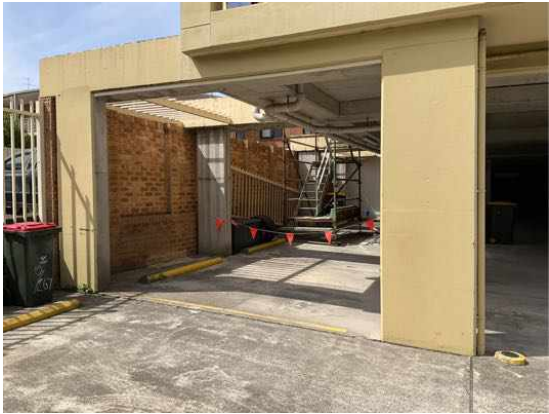
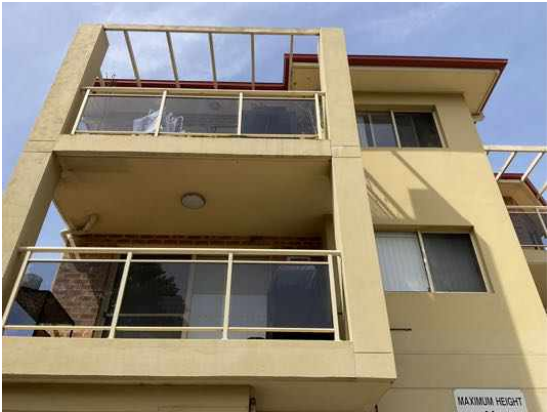
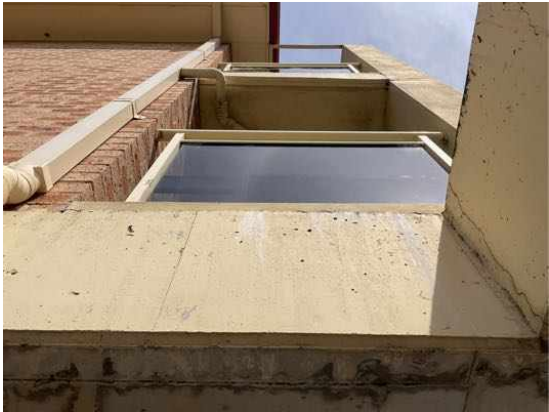
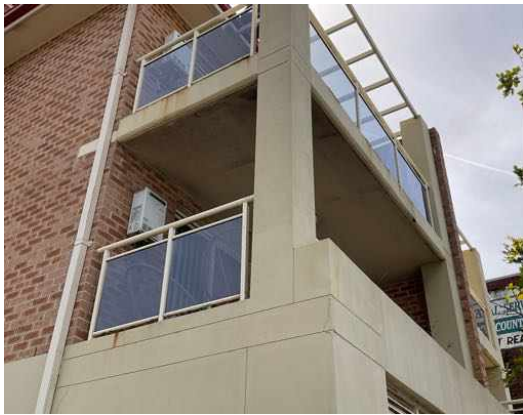
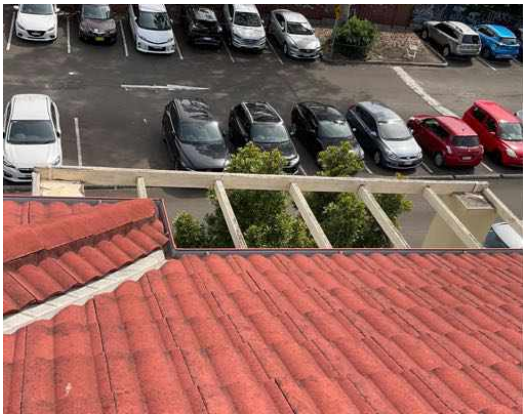
Building: Building 1
Location: All External Areas
Finding: Additional Photos
Information: Additional photos are provided for your general reference

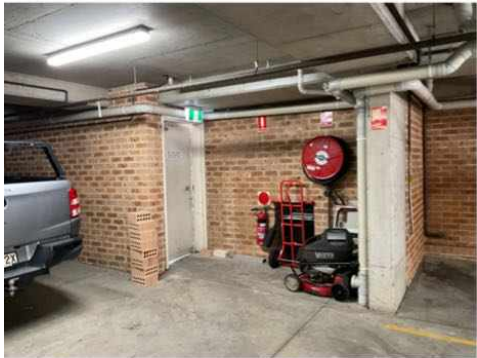
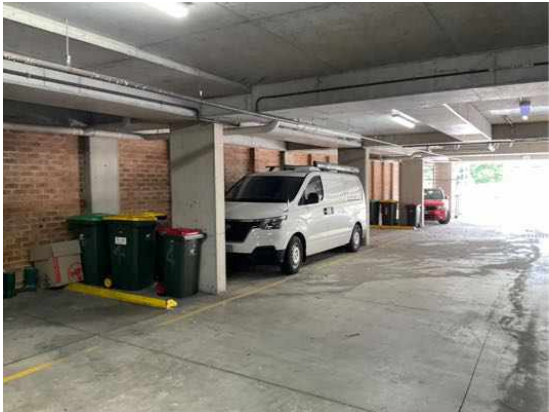
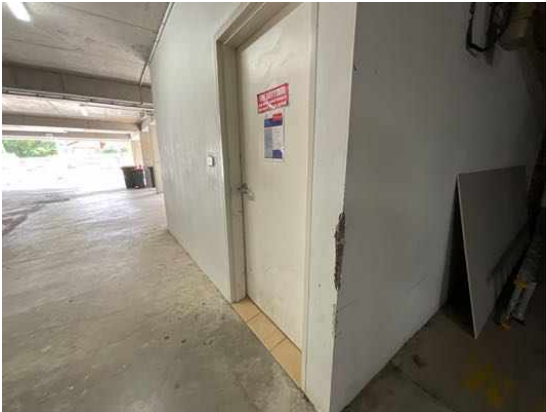
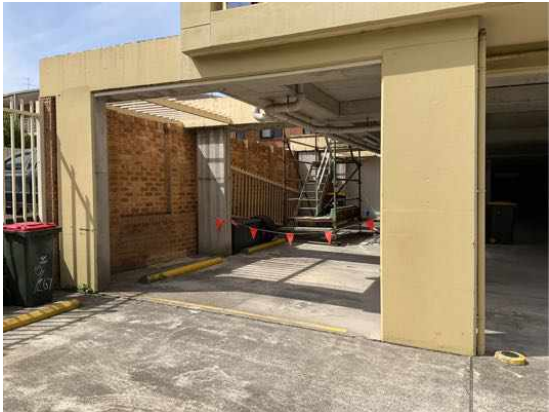
Building: Building 1
 Location: Garage
 Finding: Additional Photos
 Information: Additional photos are provided for your general reference

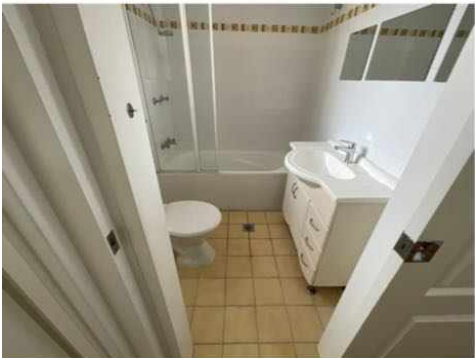
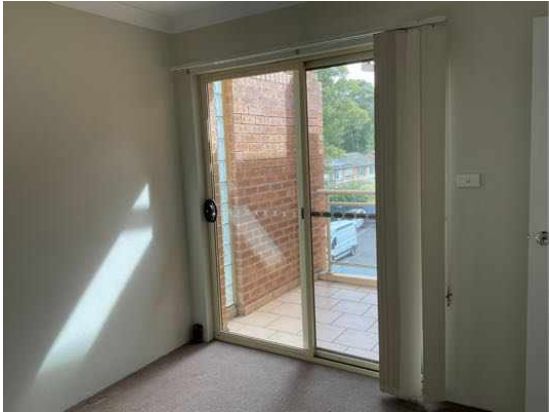
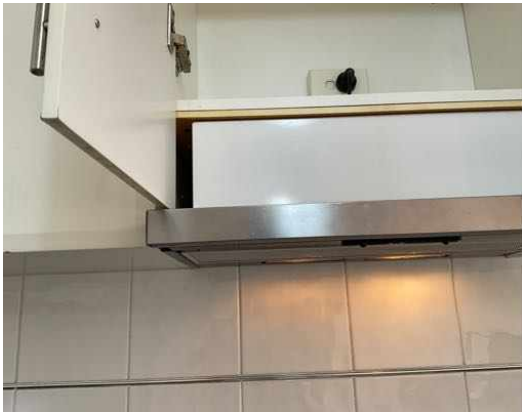
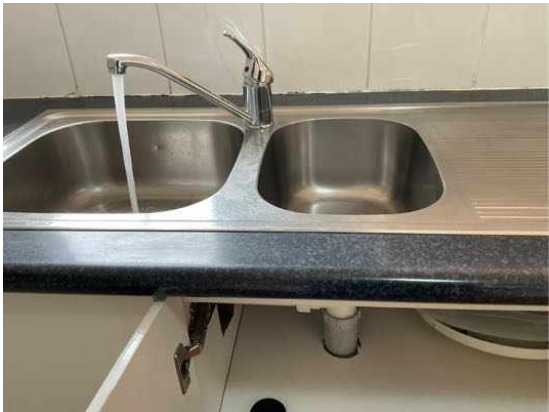
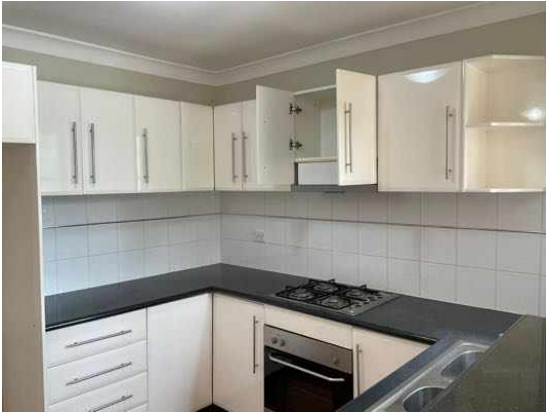
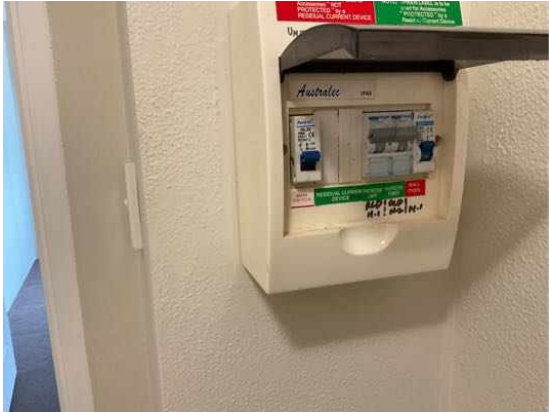
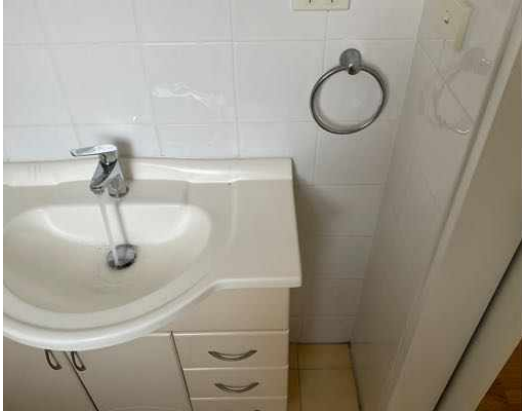
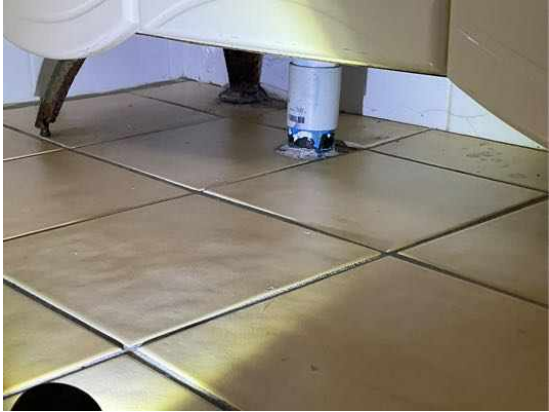
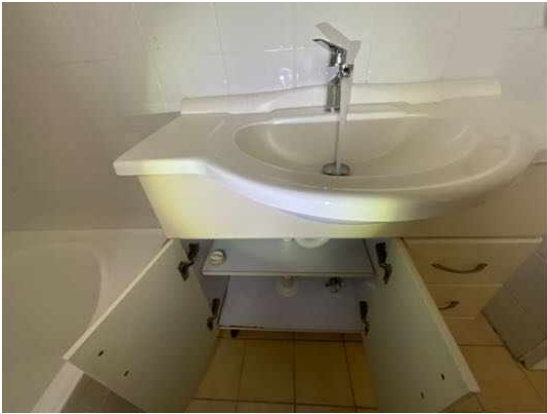
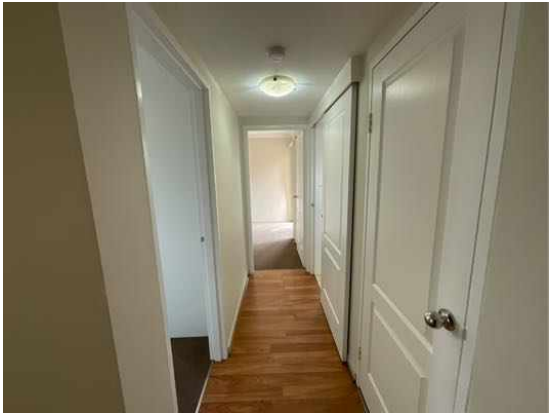
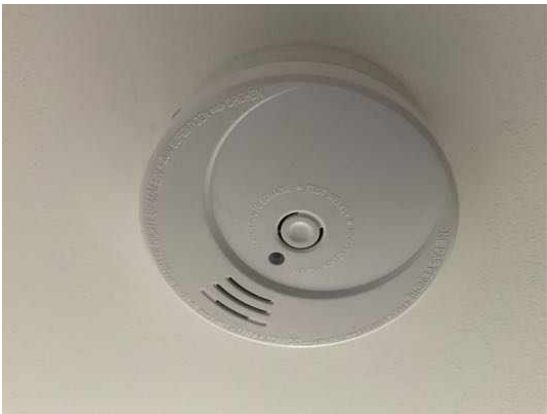
Building: Building 1
 Location: All Internal Areas
 Finding: Additional Photos

Information: Additional photos are provided for your general reference

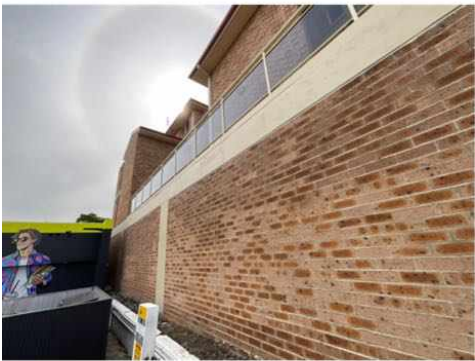
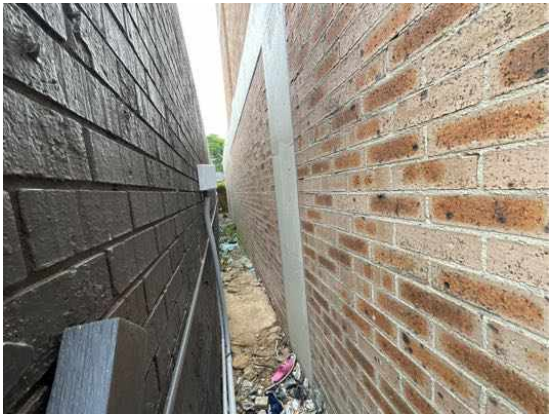
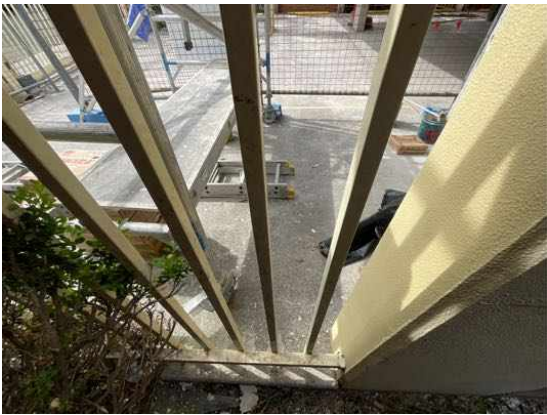
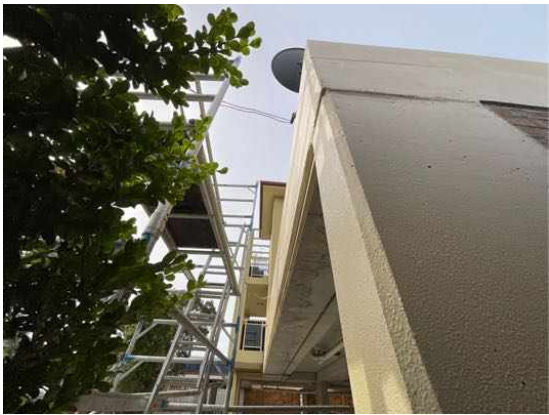
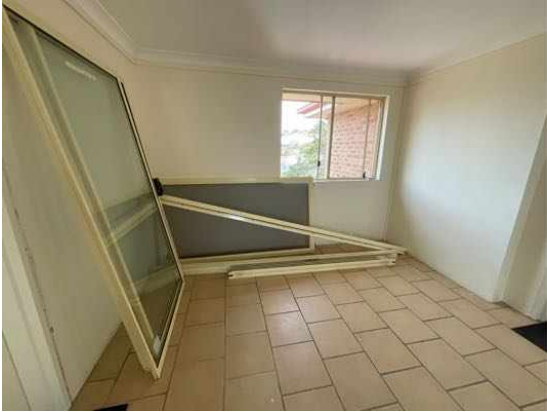
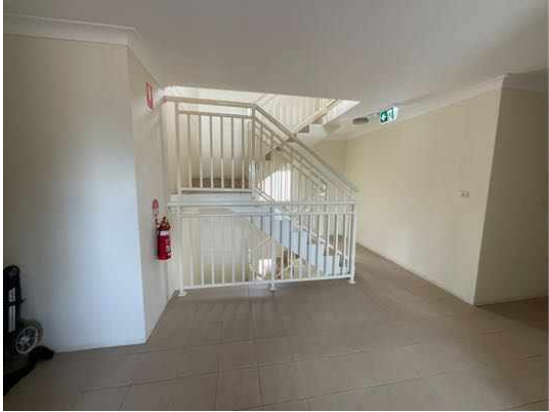
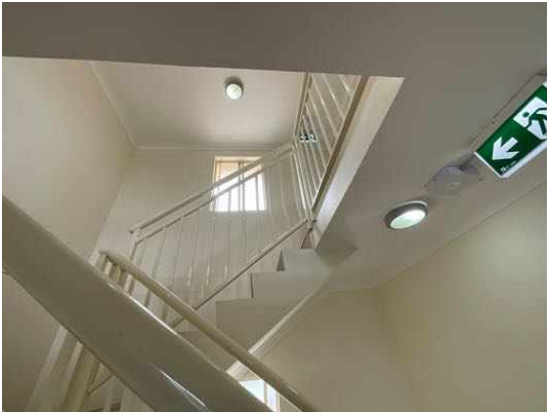
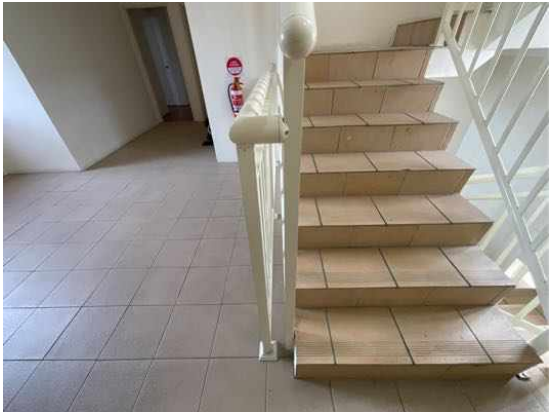
Building: Building 1
Location: Common areas
Finding: Additional Photos
Information: Additional photos are provided for your general reference
