# Building and Timber Pest Inspection Report

Inspection Date: Thu, 26 Mar 2026

Property Address: 31 Fairholm Grove, Camberwell VIC 3124,  
Australia

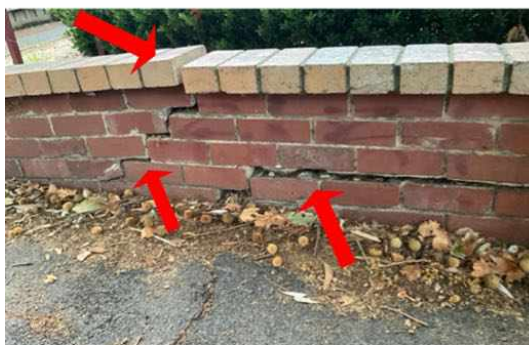
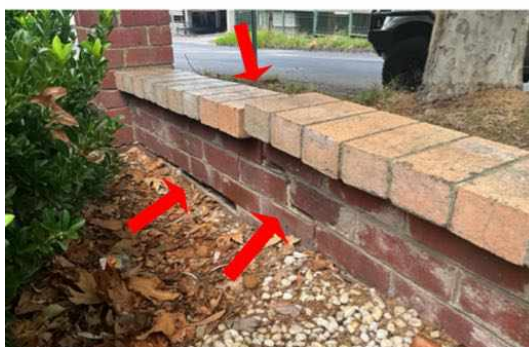
Finding: Brickwork - Step cracking noted within small brick retaining wall

Information: Extensive Step cracking was identified to the brick retaining wall at the time of inspection. This is classified as a major\* defect.

Step cracking, which is similar to other forms of cracking, has a variety of possible causes. However, the most common is the subsidence of adjacent footings, in this instance suspected to be caused by the presence of tree roots in the area.

Mortar failure in the gaps between affected bricks indicates the stresses and tensions affecting the wall.

Please note. As the defect is suspected to have been caused by the tree roots from the tree on council land immediately in front of this area, it is recommended that further enquiries be made to determine whether repairs to the brick wall may be covered by the council.

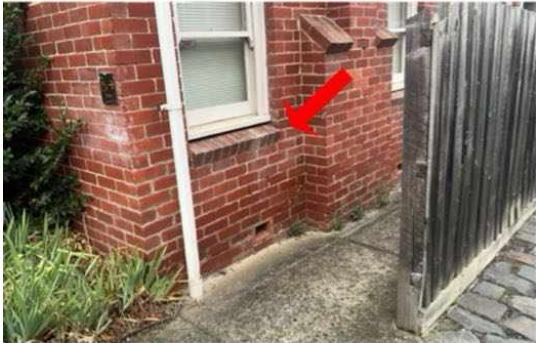
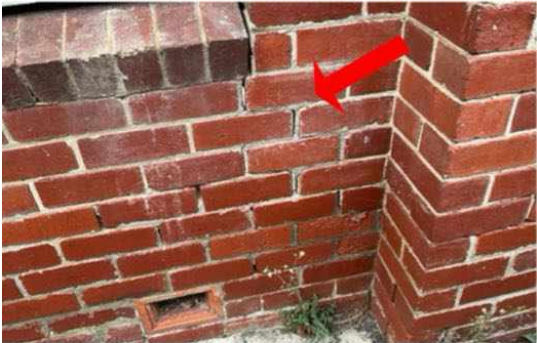
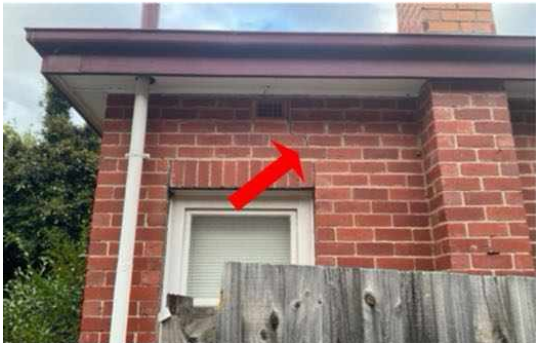
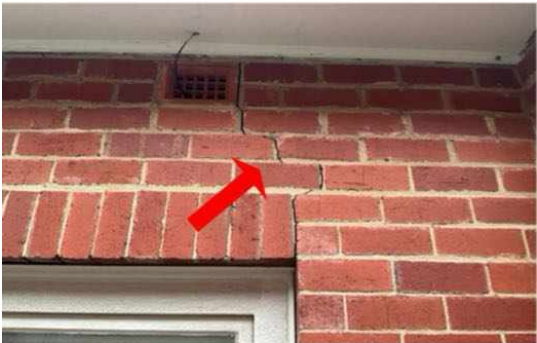
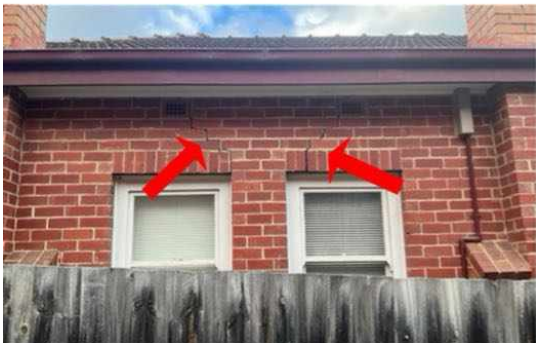
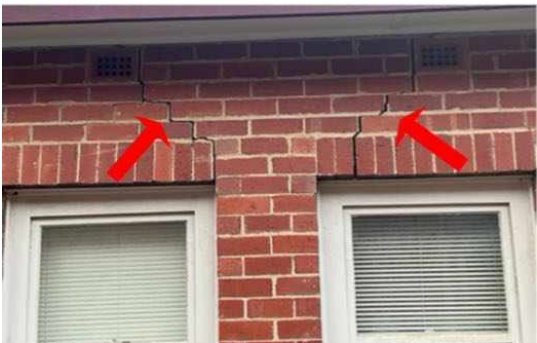
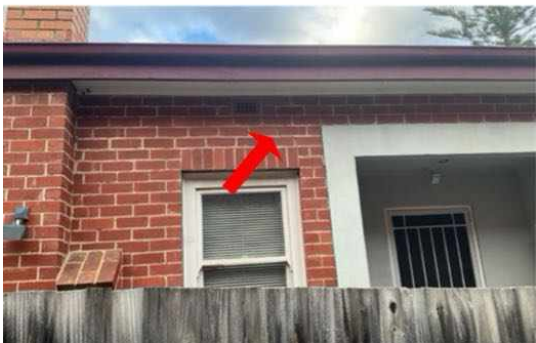
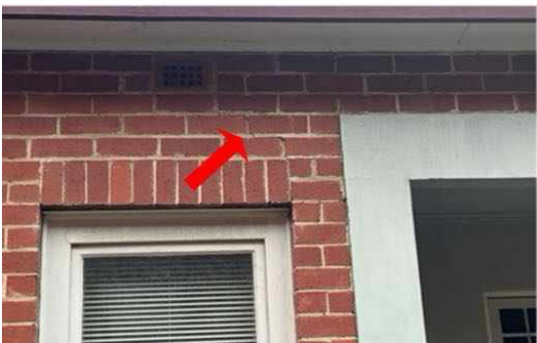
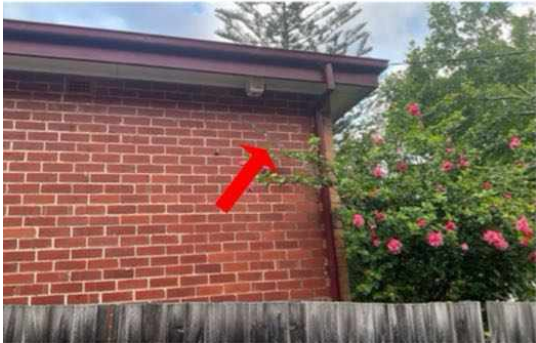
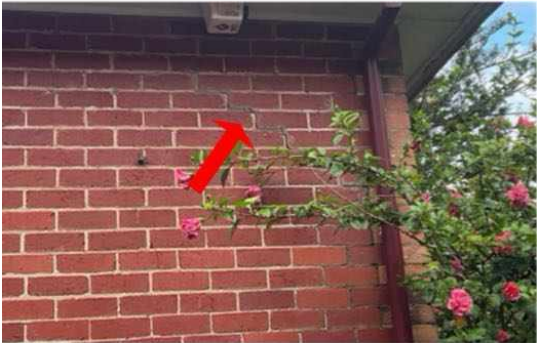
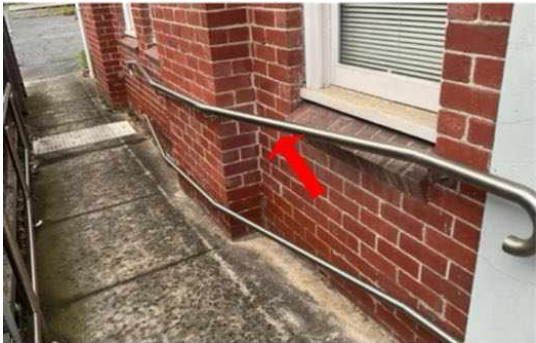
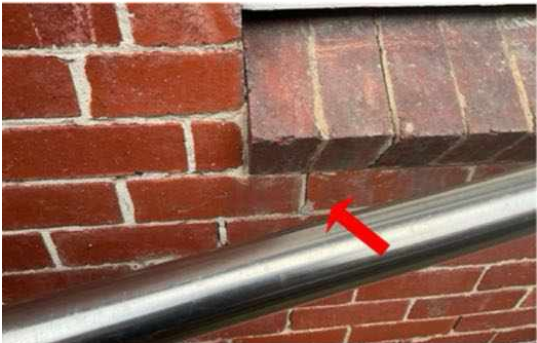
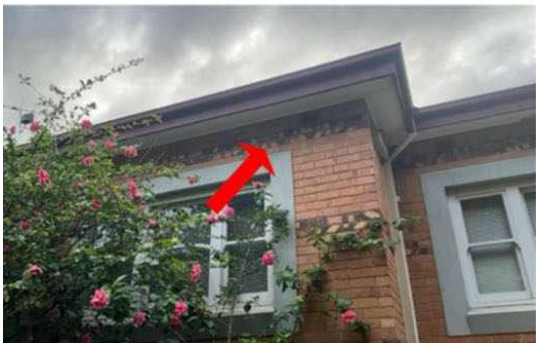
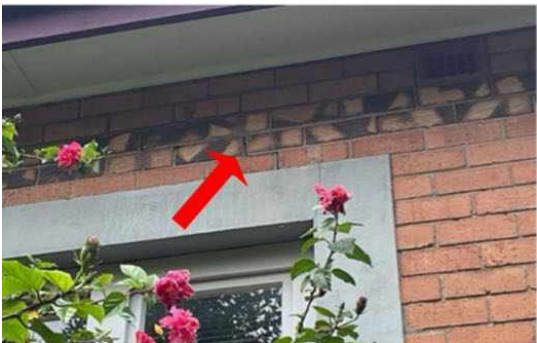
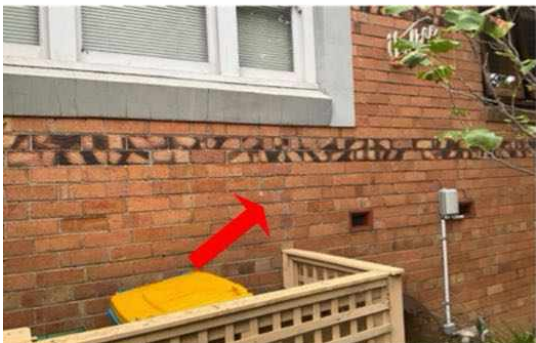
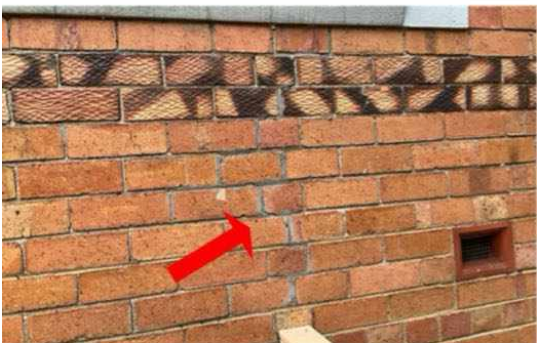
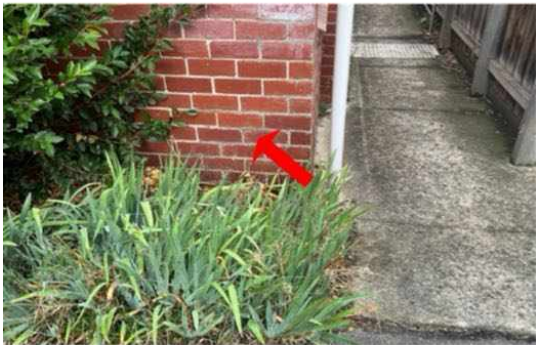
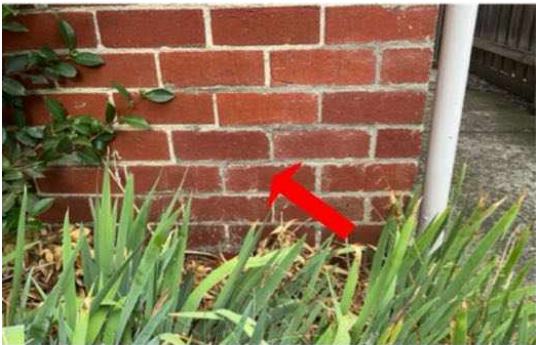
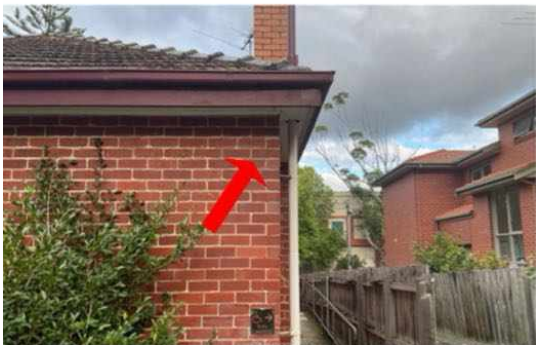
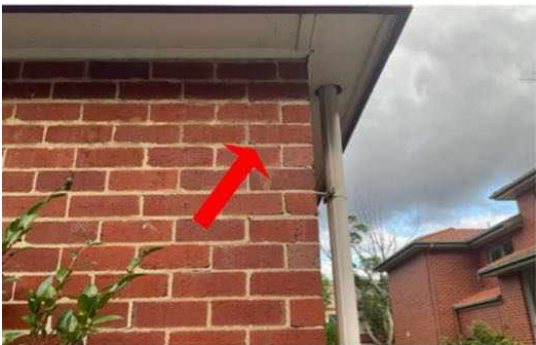
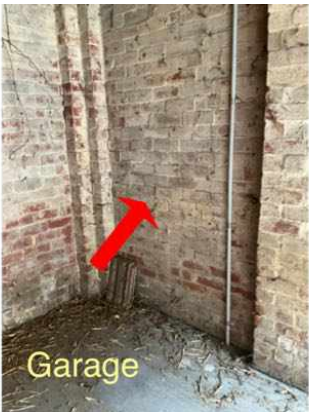
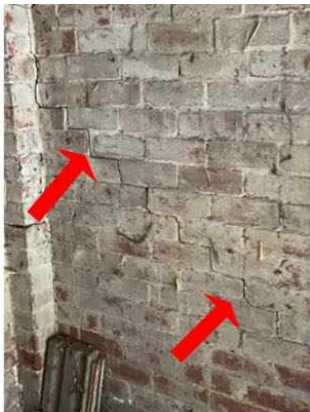
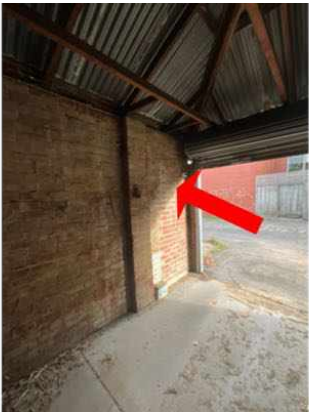
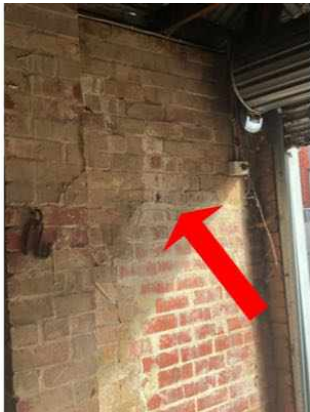
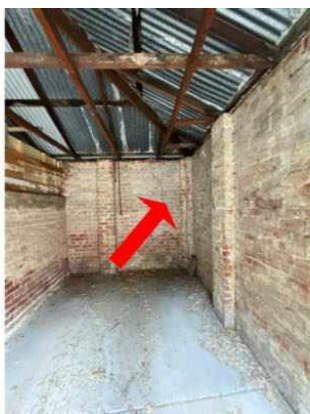
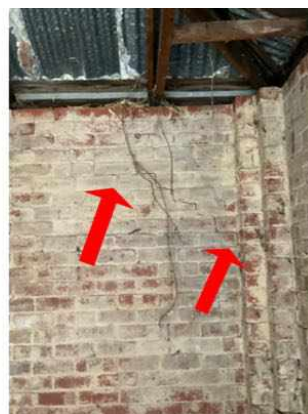
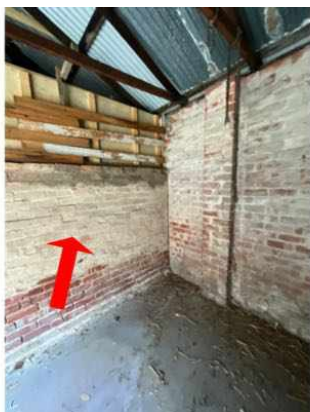
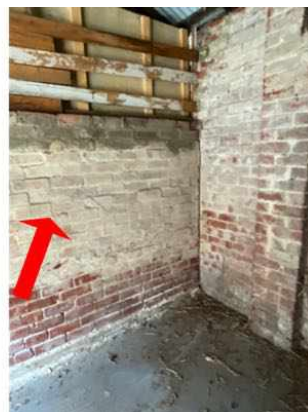
## Finding 2.02

Building:	
Location:	All External Areas
Finding:	Brickwork - Step cracking
Information:	Extensive Step cracking was identified to the brickwork in this area at the time of inspection. Due to the significant amount and the extensive nature of the cracking this is classified as a major defect*.

Step cracking, which is similar to other forms of cracking, has a variety of possible causes. However, the most common is the subsidence of adjacent footings.

Step cracking is a relatively common defect, and is most likely to occur adjacent to windows, doors and other openings. Mortar failure in the gaps between affected bricks indicates the stresses and tensions affecting the wall.

Where step cracking is extensive or severe or is coupled with other formed of cracking to the brickwork ( as noted here) , the client is advised to consult a structural engineer.

It is highly recommended that the cracking be monitored for a period of time e.g. six

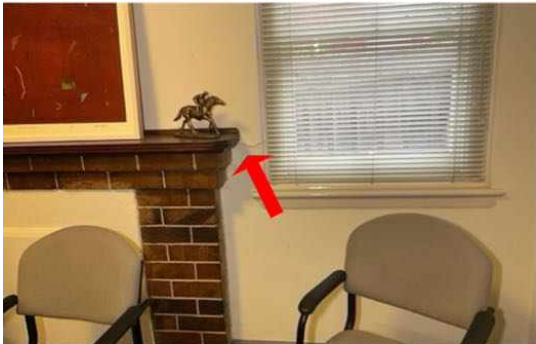
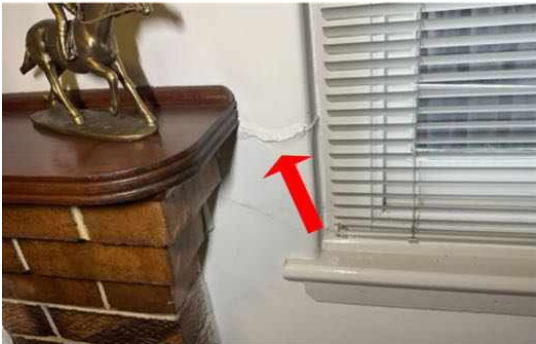
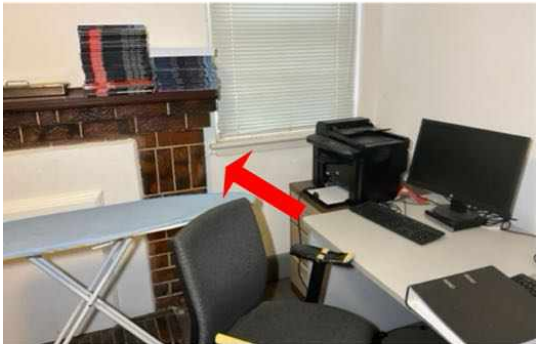
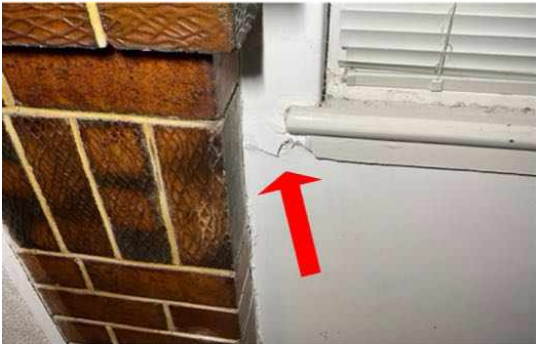
### Finding 2.03

Finding: Cracks to internal solid walls

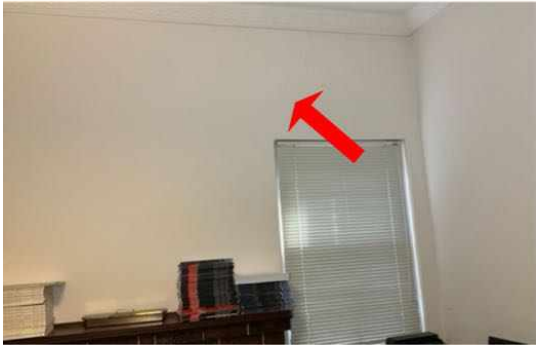
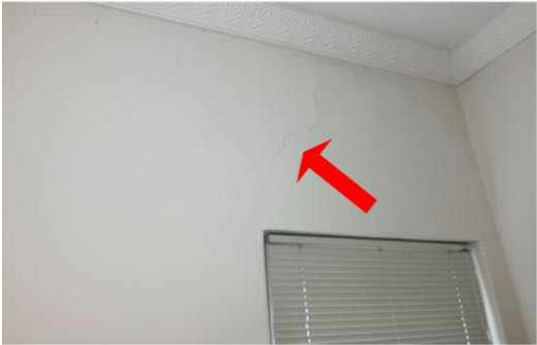
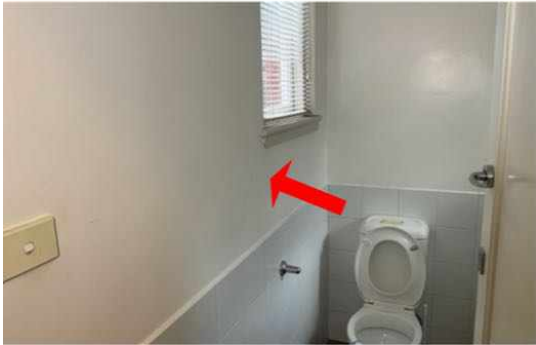
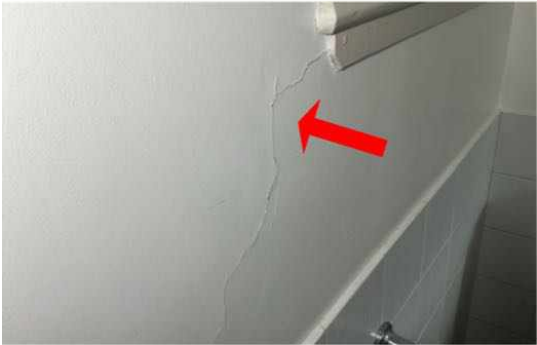
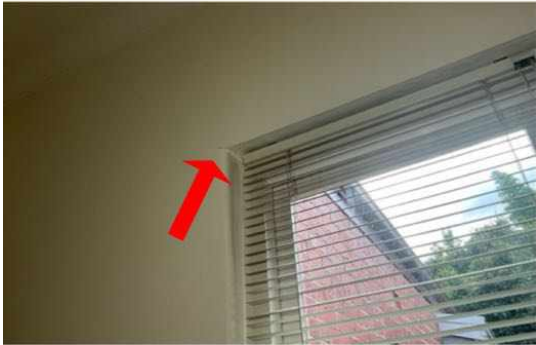
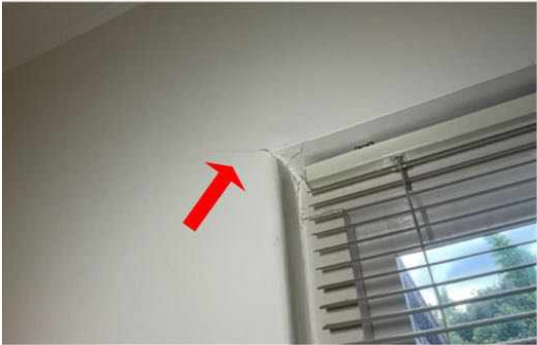
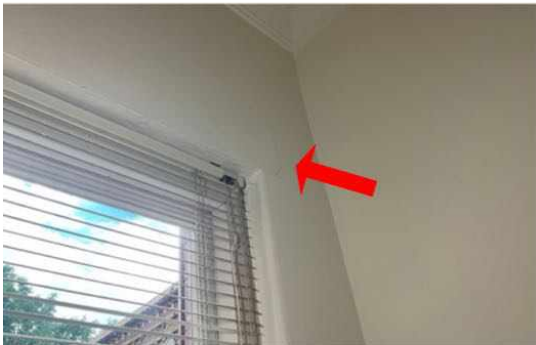
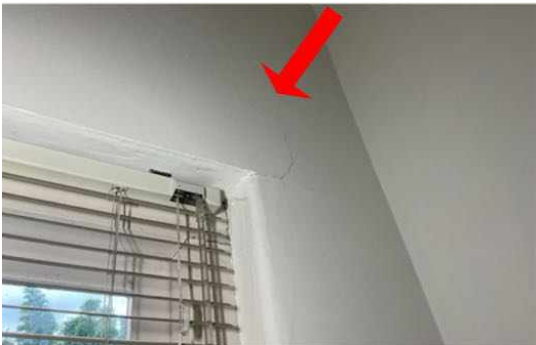
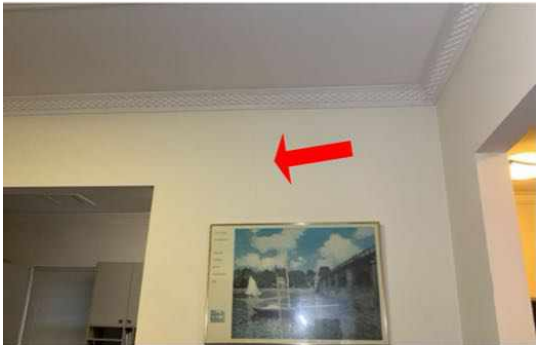
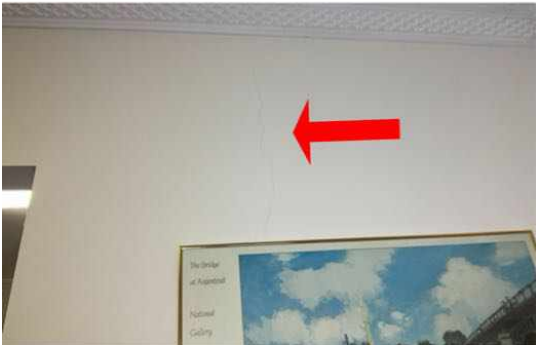
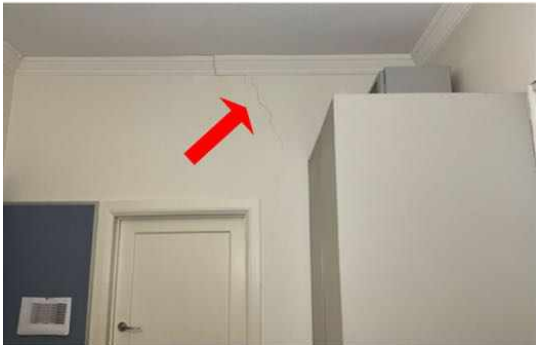
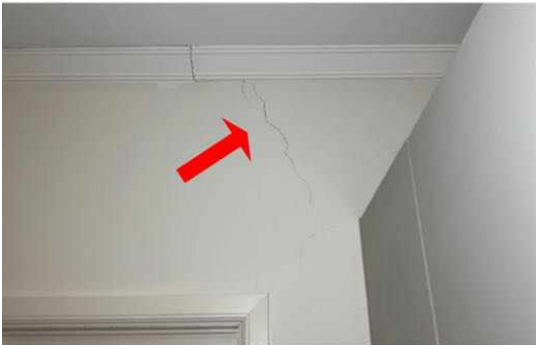
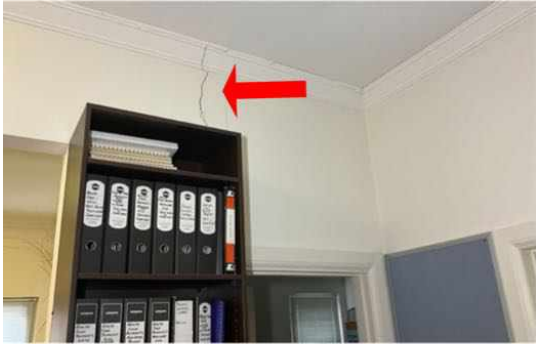
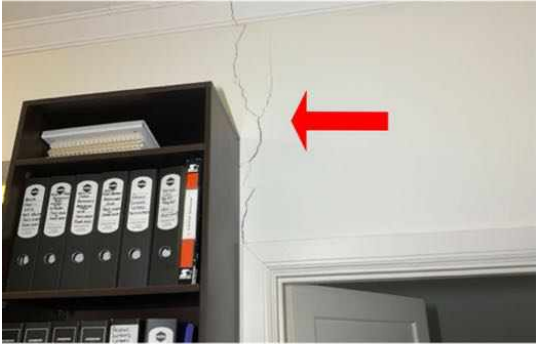
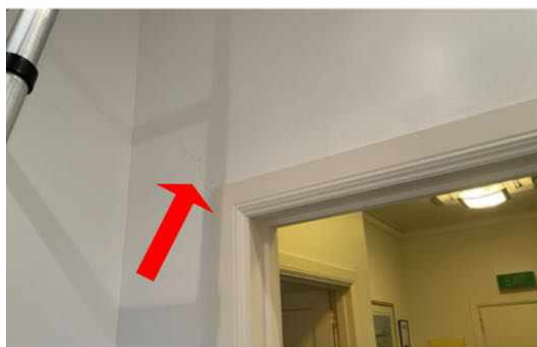
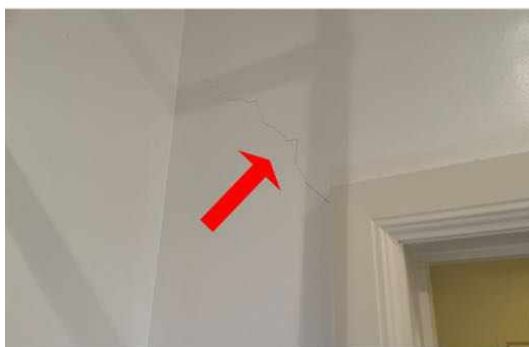
Information: It has been observed that cracking to some of the solid internal walls has occurred. Whilst some of the cracks may appear minor, a lot of them are extensive and in conjunction with the extensive step cracking to the external brickwork, is classified as a major defect.\*

Generally, the cause of cracking to solid surfaces is indicative of a slight movement of the building

Monitoring of all cracking should be conducted and should no further cracking occur, repairs should be undertaken. Cracking of this nature can generally be repaired with minor sanding, filling and/or repainting. Such works should be performed by a qualified painter or a general handyman.

Always contact a building inspector should cracks widen, lengthen, or become more numerous.

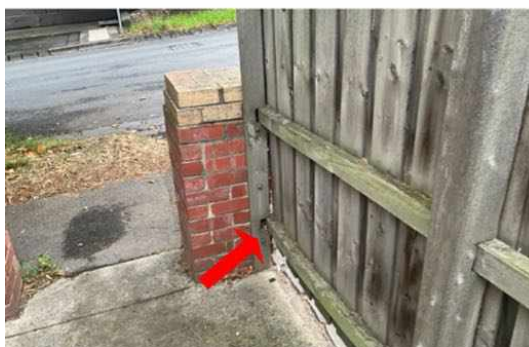
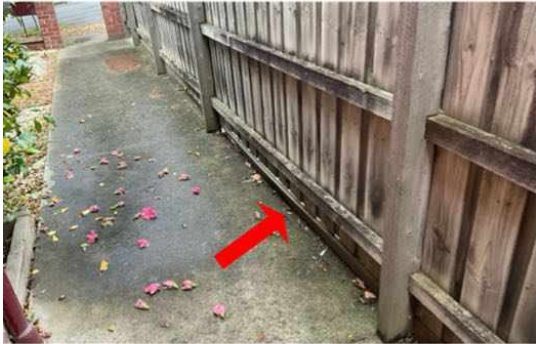
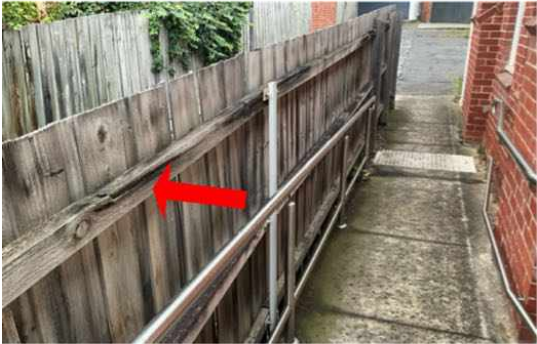
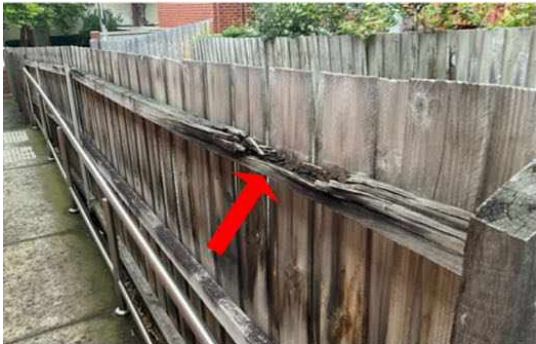
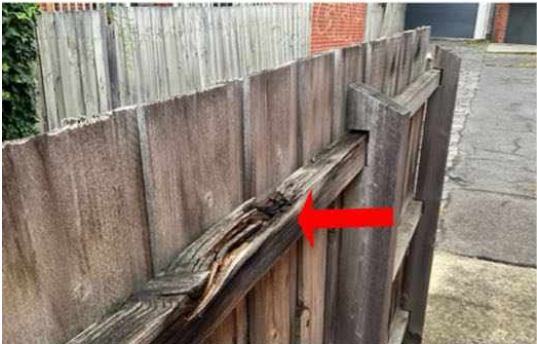
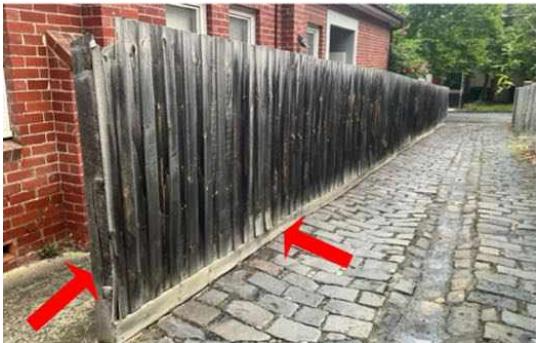
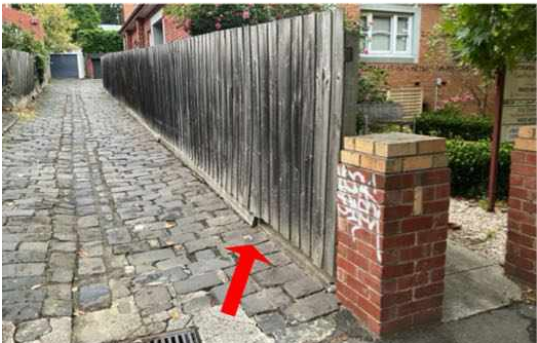
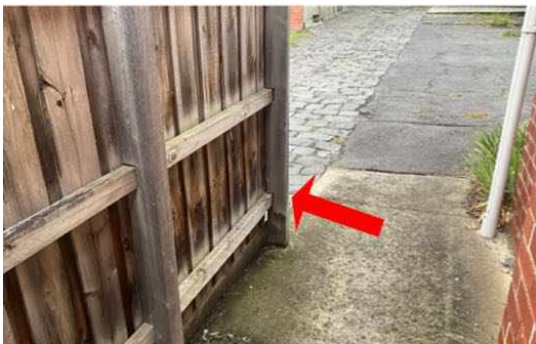
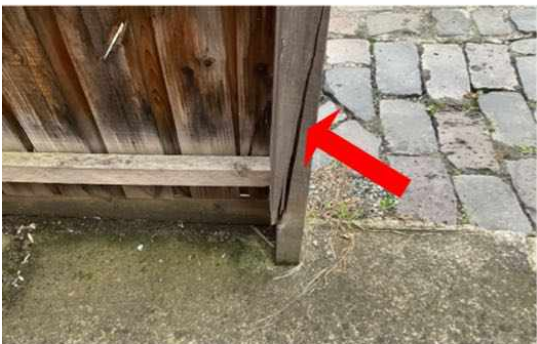
## Finding 2.04

Finding: Fencing - Deteriorated

Information: It was noted at the time of inspection that sections of the fencing throughout the property have deteriorated, with wood rot and splitting of timbers noted. Due to the amount of repairs required, this defect is listed as a major defect\* .

Typically fencing deteriorates due to age and or wear, rot and or rust which is generally expected for a structure of this age, due to prolonged exposure to weather conditions. Sometimes inadequate installation or maintenance can be to blame. Significant wood rot was noted in sections of the fencing.

If left unattended, it is likely that further damage will occur. It is suspected that repair and replacement of several elements of the fencing will be required.

A licensed fencing contractor should be appointed to provide further advice and perform rectification works as necessary.

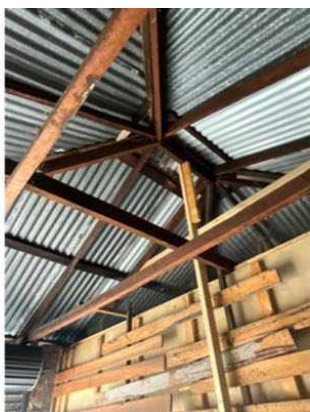
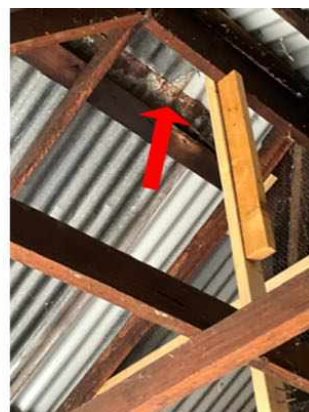
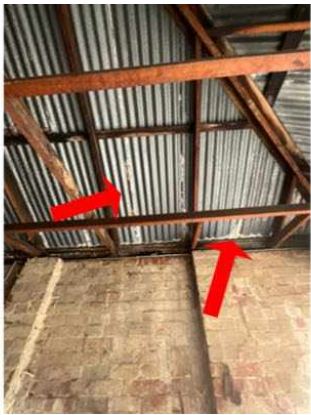
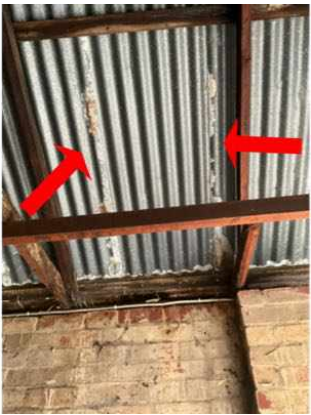
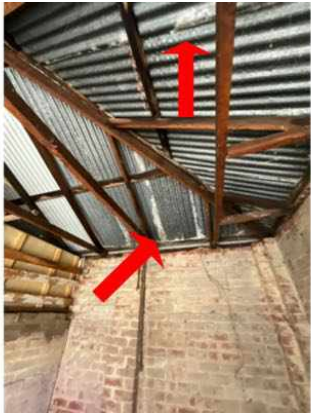
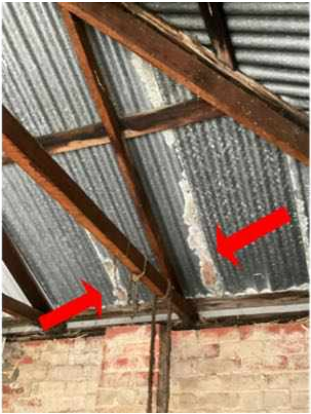
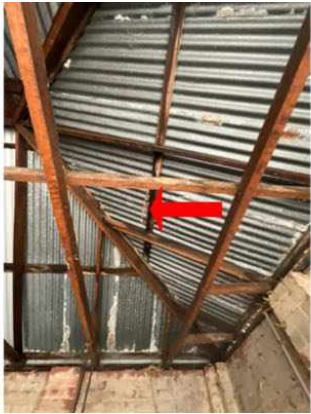
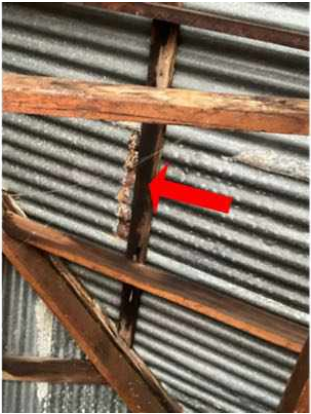
## Finding 2.05

Finding: Metal Roofing - Rusted

Information: Metal roofs generally comprise numerous individual sheets, which join and overlap. These are particularly prone to rusting and lifting at the edges.

Upon inspection of the exterior roofing structure of the garage, evidence of significant surface rust was identified. This is a major defect \*

If left unmanaged, this can develop further and allow water ingress to the internal roofing structures, potentially leading to secondary damage of building elements. Accelerated deterioration of the roofing sheets and any associated building elements is also likely to occur.

A roofing contractor should be appointed immediately to assess the condition of the roofing sheets and capping and to perform remedial works as necessary.

Works may include replacement of severely affected areas or minor works such as the application of rust-retardant surface protectors.

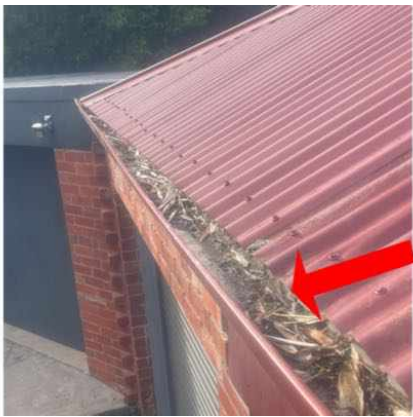
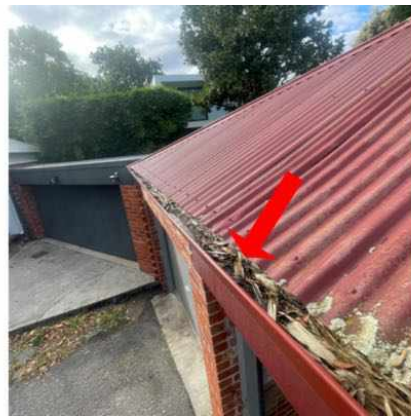
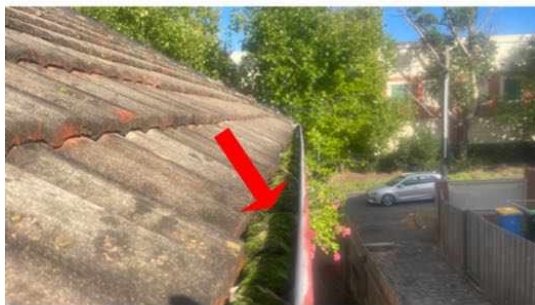
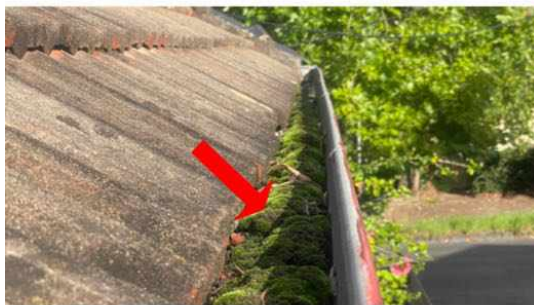
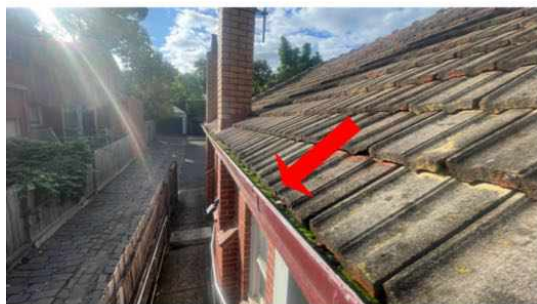
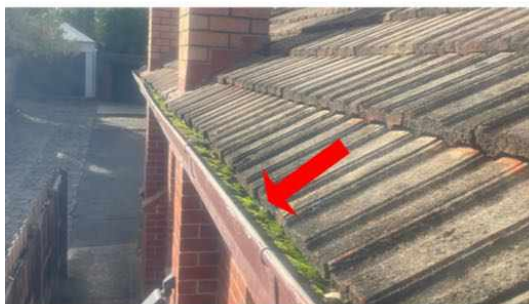
**Finding 2.06**

Information: At the time of inspection, it was noted that the gutters were blocked with leaves and other vegetation . As this has the potential to cause further deterioration to the property, it is classified as a major defect \*

Blocked gutters are likely to lead to high levels of moisture in the affected areas. Such moisture will not only cause rust and decay of the associated building materials, but can also provide conditions that are conducive to termite and timber pest activity. Blockages in gutters should therefore be removed immediately to ensure dry conditions are maintained.

Consult a Licensed Plumber for further specific advice on remedial works that may be required. In the interim, it is highly advised that blocked gutters be cleared by a general handyman or gutter cleaning specialist as a matter of urgency.

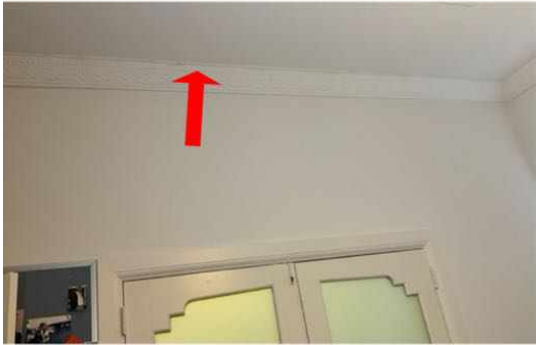
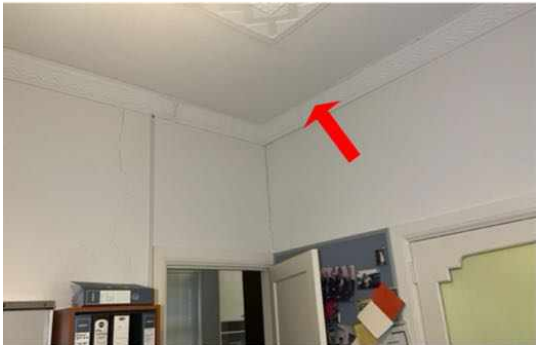
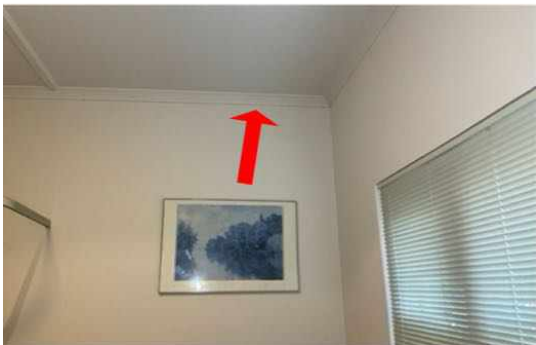
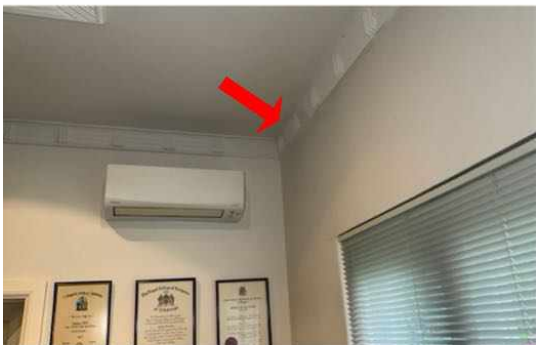
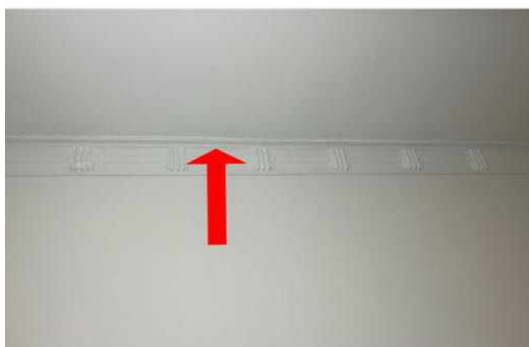
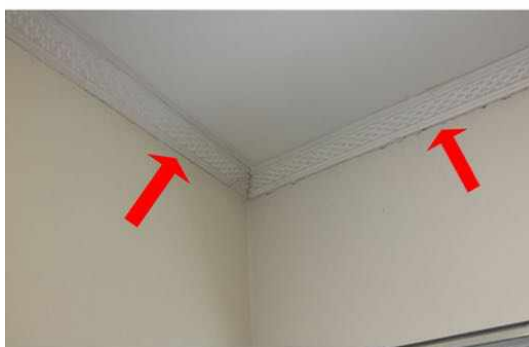
Finding: Cracking - fine

Information: Some fine cracking was noted throughout the property.

Although fine cracks are quite noticeable, they are often only considered to be an appearance defect, and usually do not indicate any structural damage. Generally, the cause of a fine crack is indicative of a separation between building materials and finishes (e.g. paint, plaster, etc.) along joints.

Note: photos included are indicative of fine cracking noted at the the time of inspection. Other fine cracks may be present but not recorded here.

Cracking of this nature can generally be repaired with minor sanding, filling and/or repainting. Such works should be performed by a qualified painter or a general handyman.

Monitoring of all cracking should be conducted frequently. Always contact a building inspector should cracks widen, lengthen, or become more numerous.

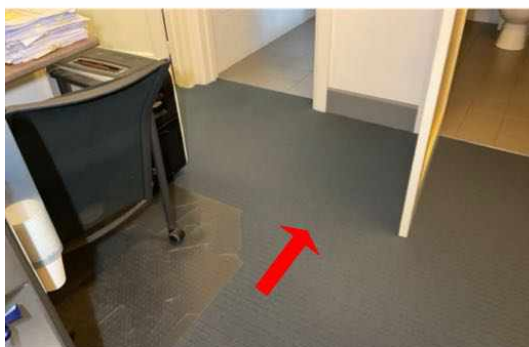
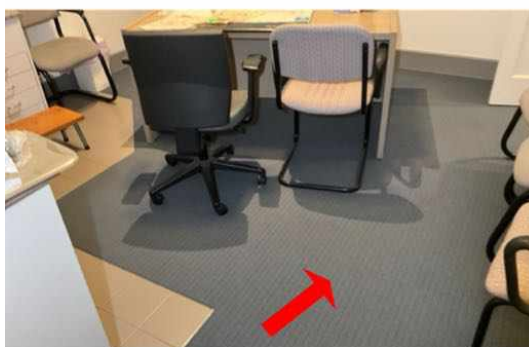
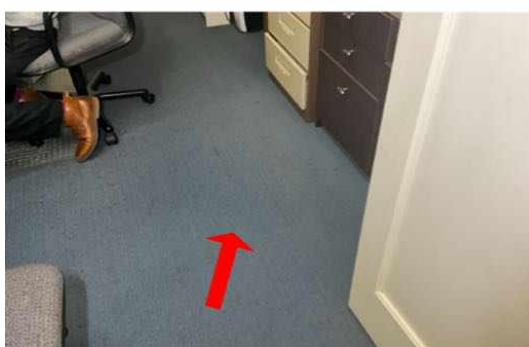
### Finding 3.02

Creaking floors generally indicate that the floorboards or the subfloor structures are coming loose from the supporting structure that they are installed on.

Please note: no access was available to inspect the subfloor. The purchaser should be aware that further defects may be present within the subfloor that cannot be inspected.

The areas should be monitored for any changes or unevenness. Should this occur, consultation with a registered builder should be undertaken to determine the cause. The potential resolution may involve regluing and screwing the floor down through to replacement of subfloor support structures.

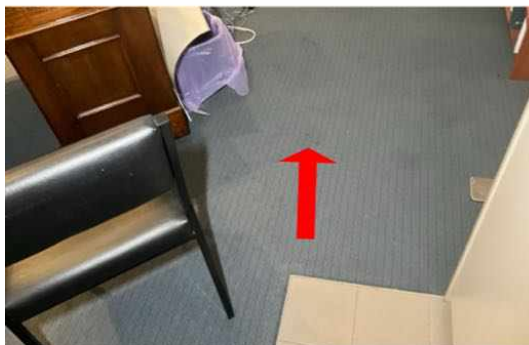
### Finding 3.03

Bouncy floors generally indicate that the floorboards or the subfloor structures are coming loose from the joists that they are installed on. Bouncy flooring may also be the result of gaps between flooring and stumps or joist structures, which require packing.

Please note: as no access was available to inspect the subfloor underneath this area the purchaser should be aware that more significant defects may be present that has caused this bouncing to the floor.

Where necessary, the client is advised to seek quotations for required repairs from a Registered Builder specialising in re-stumping. The potential resolution may range from packing gaps in subfloor structures through to replacement of subfloors stumps and refixing of flooring.

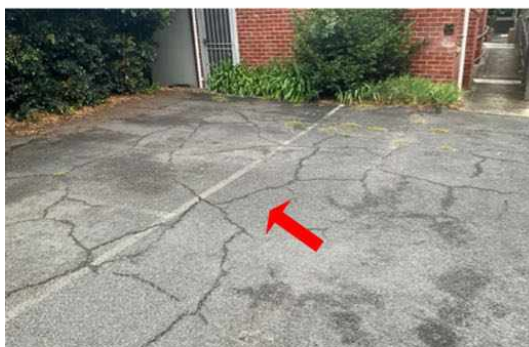
### Finding 3.04

Building: All External Areas  
 Location: All External Areas  
 Finding: Noticeable Cracking - External Concrete Paving  
 Information: Noticeable cracks were identified in the concrete paving at the rear of the property.

General age and expected deterioration of the paved areas is a common cause of this type of cracking. However, expansion and contraction of the concrete may also have occurred due to environmental factors. Such factors include variable moisture and weather conditions, the presence of trees and their roots having a settling or lifting affect on the soil, or the effect of load bearing over a sustained period of time.

Cracking to this degree may also be due to poor original installation of the concrete. Factors such as poor compaction of the sub surface and/or inadequate reinforcing of the slab may create cracking and other secondary defects. Noticeable cracks may also be due to subsidence of soils.

The area should be monitored for any changes that may occur and potentially cause tripping hazards. Should this occur, repair and likely replacement of the concrete paving may be necessary.

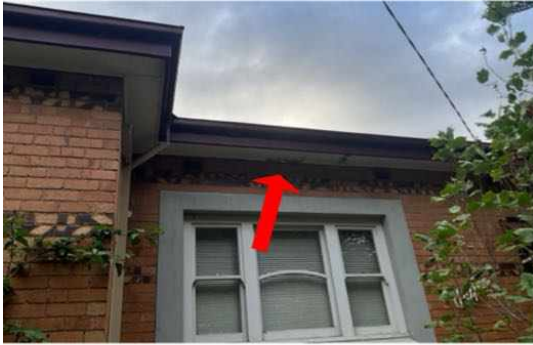
### Finding 3.05

Building:	
Location:	Eaves
Finding:	Eaves - Suspected previous moisture damage
Information:	At the time of inspection bubbling and peeling of the painted surface was noted to the eaves at the front of the property. It is suspected that this has been caused by a failure in the guttering system above creating excessive moisture within the area.

Please note: given the age of the property there is a high chance that the eave sheets may contain asbestos material. It is recommended that prior to any works being carried out on the eaves, an asbestos inspection and sampling be carried out to determine whether this is the case. Your Jim's building consultant can help you with this.

Where bubbling/ peeling is evident, the primary requirement is to identify and rectify the source of the leaking. Where the damage is still active a roofing plumber should be appointed immediately to identify the leak and perform rectification works as necessary, ensuring the moisture damage is restricted.

Once the leak is repaired, consultation with relevant tradespeople, including painters is advised. Rectification works may include replacement of eave lining or minor repainting, depending on the extent of the damage.

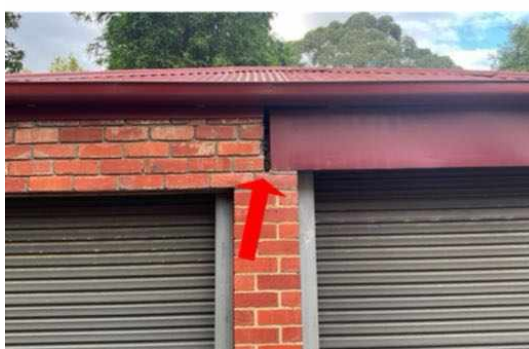
### Finding 3.06

Finding: Beads - Damaged

Information: Beading acts (like cornice or skirtings) to cover the intersection or joins of building materials. It was noted at the time of inspection that beading in this area has come loose. This deterioration is suspected to have been caused by general ageing and frequent exposure to weather, which is expected in a building of this age and condition.

Beading is important in weatherproofing the surrounding building elements and preventing termite or pest ingress. Furthermore, beading works to protect the joins of building materials, which are more susceptible to deterioration and decay.

Repair or replacement of the beading is advised to ensure the protection and longevity of any associated building elements. Such works may be performed by a general handyperson or qualified carpenter.

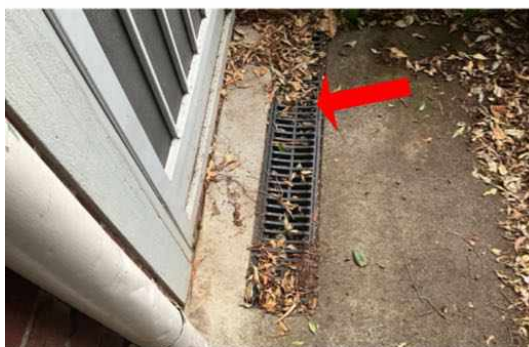
### Finding 3.08

Building: Exterior walls - rear  
 Location: Exterior walls - rear  
 Finding: Channel drain - blocked with leaves  
 Information: The channel drain in the path outside the rear door appeared blocked with leaves at the time of inspection. This has the potential to cause the drain to fail in its purpose of removing water from the area. The drains should be cleared as a matter of urgency to ensure water is channelled away correctly.

Failure to clear the drains of leaf litter may cause the drains to overflow and create moisture ingress issues within the property.

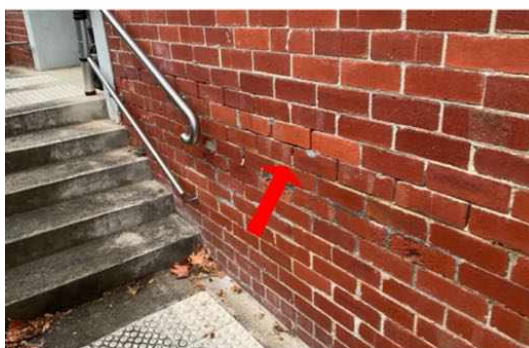
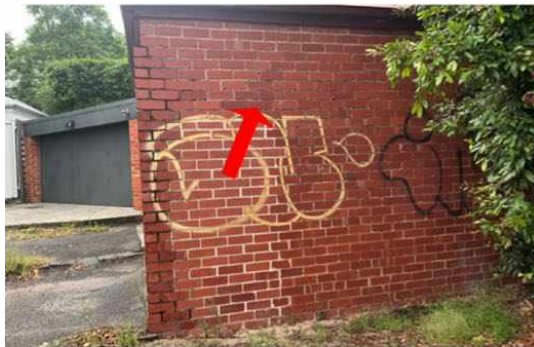
### Finding 3.09

Finding: Brickwork - Deteriorated mortar

Information: Deteriorated or missing mortar was noted around brickwork in this area.

Mortar, or 'bedding', is the material which fills joints and intersections between bricks in masonry walls and structures. Sections of mortar in this brickwork were identified as having deteriorated, which is generally expected for a property of this age and condition.

Mortar may deteriorate as a result of age of building materials, minor movement of bricks, or frequent exposure to weathering. Mortar should be replaced to ensure that bricks remain in their intended location and to prevent gaps, which would allow water or moisture ingress and secondary damage as a result.

Mortar deterioration can be addressed by a bricklayer where areas of deterioration are localised and easily accessible. Alternatively, appointment of a registered builder is advised, to repoint large areas of decaying mortar. Where secondary structural defects have become evident, consultation with a structural engineer may be required.

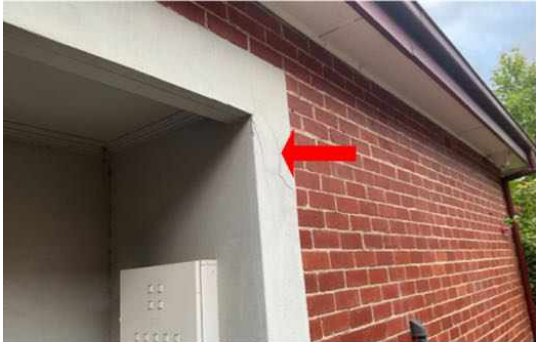
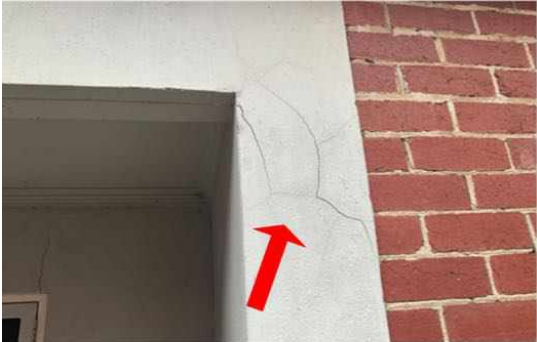
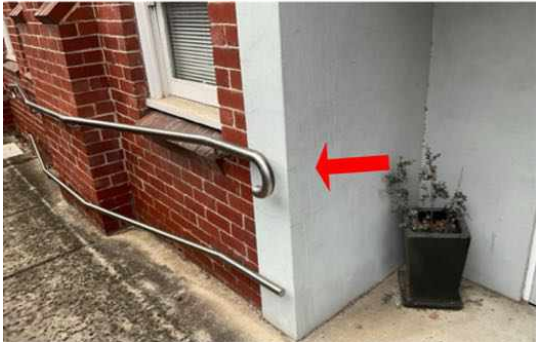
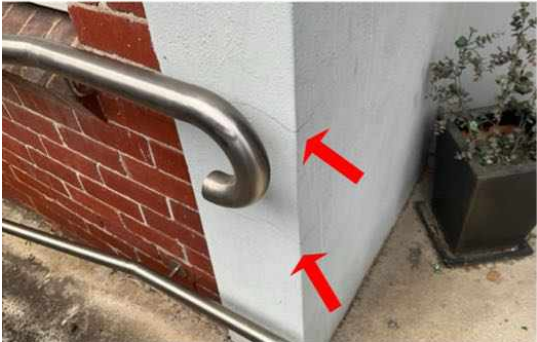
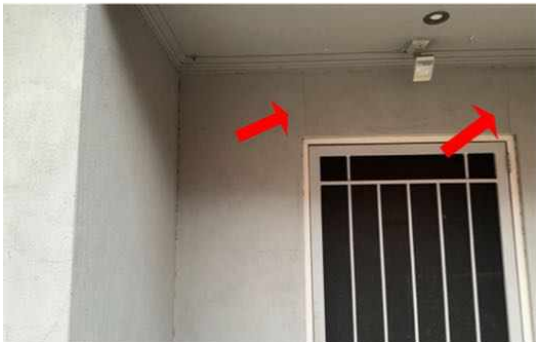
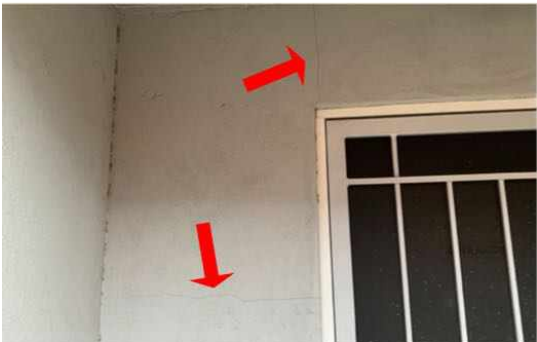
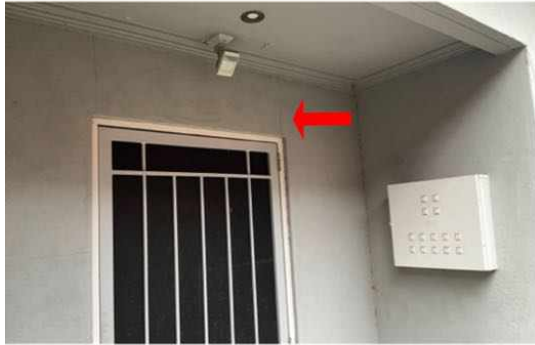
### Finding 3.10

Finding: Rendered exterior wall - minor cracking

Information: Minor cracking to the rendered wall was identified at the time of inspection.

This type of cracking is often consistent with general movement of the foundations of the property and is not considered a major structural defect.

Whilst it is more of an appearance issue, repairs may be required as failure to act may allow moisture to enter the crack and cause secondary damage to other building elements.

Consultation with a suitably qualified renderer should be sought to determine costs involved with any repairs necessary.

Should cracks increase in size or number, speak with your building inspector for further advice.
