# Building and Timber Pest Inspection Report

Inspection Date: Thu, 26 Mar 2026

Property Address: 31 Fairholm Grove, Camberwell VIC 3124,  
Australia

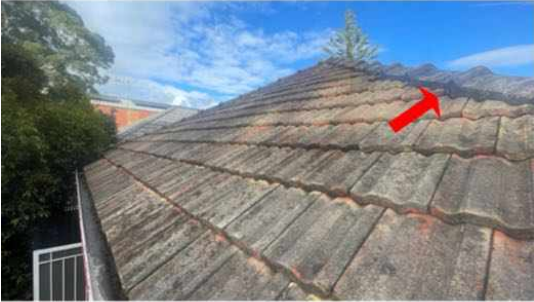
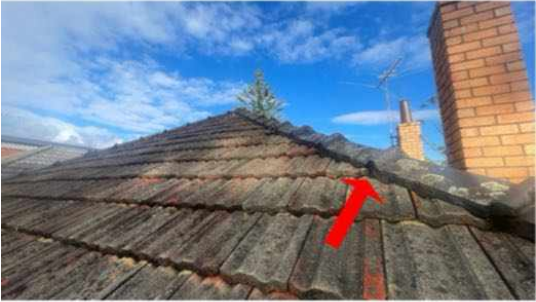
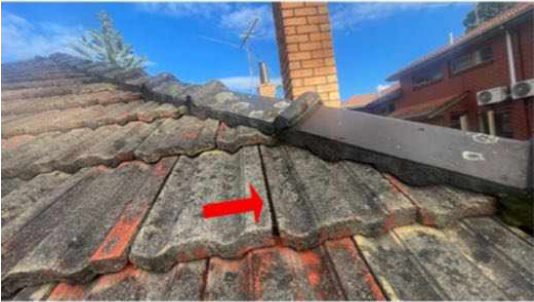
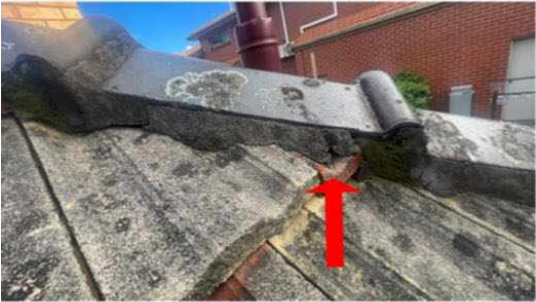
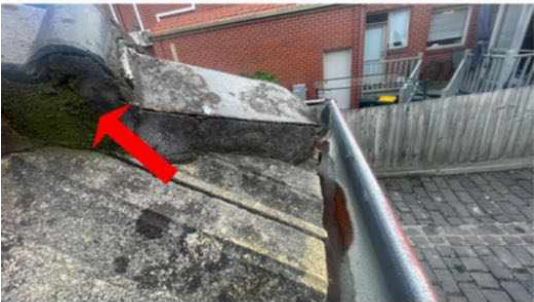
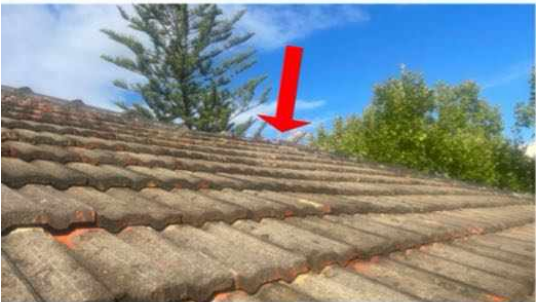
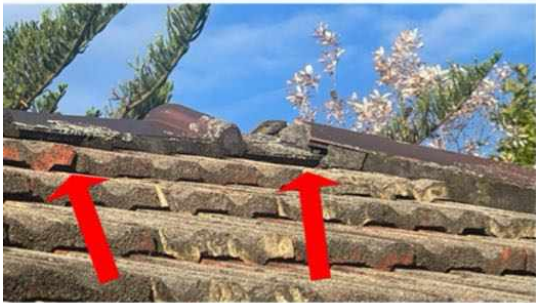
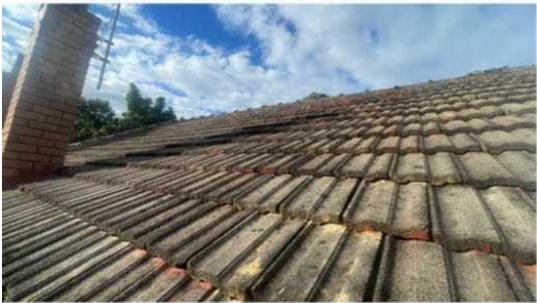
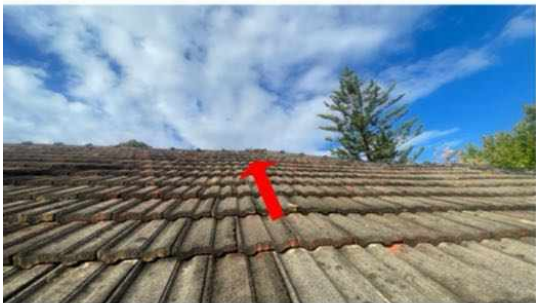
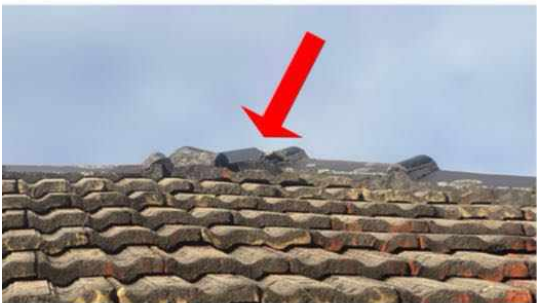
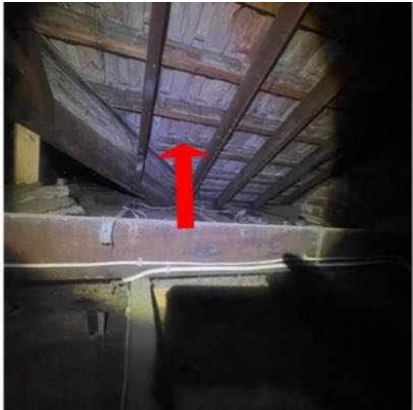
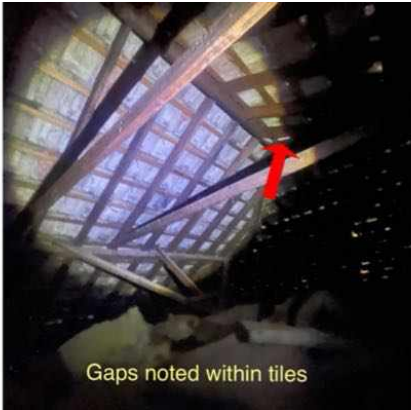
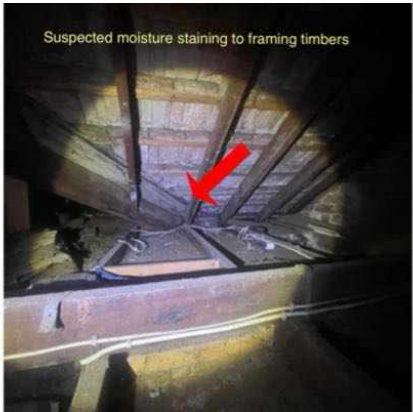
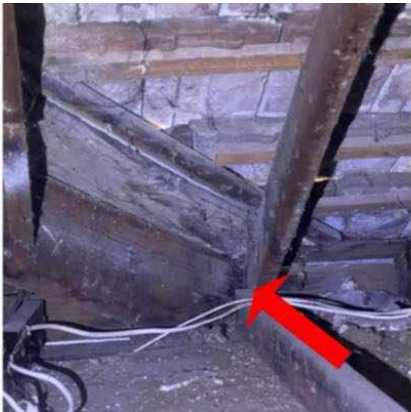
### Finding 3.11

Information: Upon inspection of the exterior roofing, the majority of roof tiles were considered to be in a fair condition. While weathering of the tiles is consistent with the age of the property, maintenance works are required.

Areas of minor chipping of tiles was noted. Some tiles had also moved slightly from their original placements which has resulted in gaps being evident between tiles that may allow moisture to enter the roof space. Cracking to the mortar around the ridge and hip capping was also observed. Suspected moisture staining to roof framing

timbers was noted within the roof void. Repairs are urgently required.

Consultation with a roofing contractor is highly advised to gain advice on remedial works that will be required . Where left unmanaged, damage is likely to lead to a number of secondary defects, including water leaks and weather exposure to internal roofing structures.

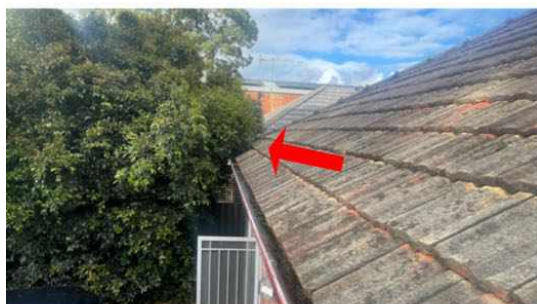
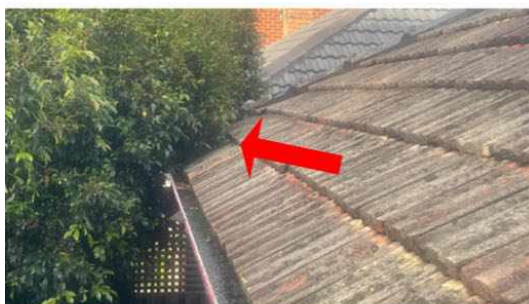
Finding 3.12

Building:  
 Location: Roof Exterior  
 Finding: Trees - Overhanging and filling gutters  
 Information: At the time of inspection, it was noted the trees were overhanging the roof exterior . Overhanging trees often result in excessive amounts of leaf debris accumulating in gutters.

Gutters are a critical part of the building's management of storm water and rain. It is therefore important that they be kept clear to prevent secondary damage to associated building elements, including exterior and interior walls, ceiling linings and any adjoining building elements. Where gutters are blocked, pooling of rainwater is likely to occur, fast-tracking rust and corrosion of the roof plumbing elements.

It is highly advised that all overhanging tree branches be removed as soon as possible to prevent any further damage. An arborist may be engaged to perform this task.

Gutters should then be cleaned out by a gutter cleaning specialist. Repair and/or replacement of sections of damaged guttering may also be required where the extent of the damage necessitates.. Consultation with a licensed roof plumber will be required where guttering has been damaged.

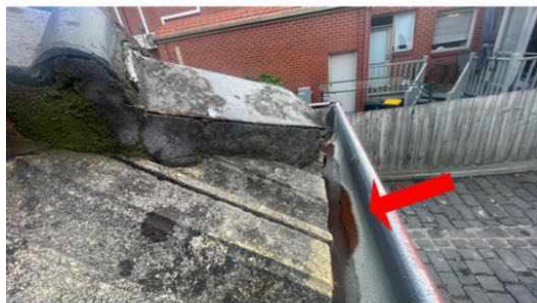
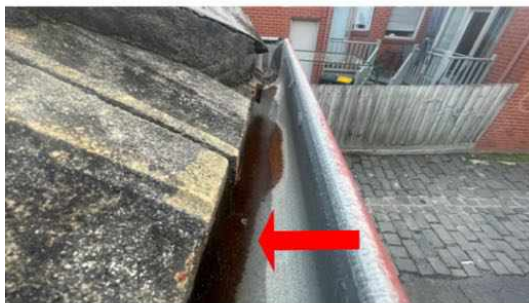
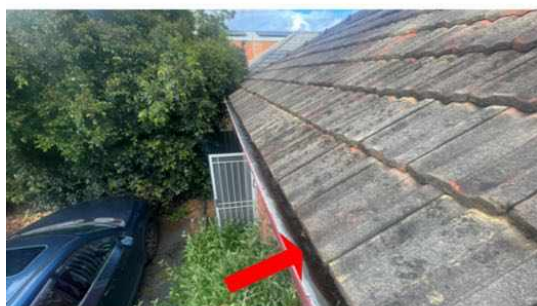
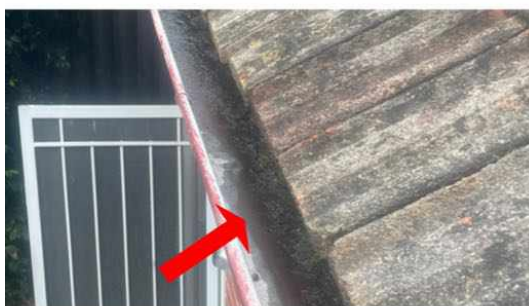
Building:  
 Location: Roof Exterior  
 Finding: Guttering - Deterioration and rusting  
 Information: Upon inspection of the exterior roofing, it was found that the guttering around the property shows signs of deterioration, with surface rust noted.

Rusted, deteriorated and damaged guttering is susceptible to water penetration, exposing the surrounding associated area to potential roof leaks and water damage.

- Rusting was noted to the guttering in some areas of the property.

A roofing contractor should be appointed immediately to assess the damage to the guttering and to perform remedial works as necessary. Works may include replacement of severely affected roofing or minor works such as the application of

rust-retardant surface protectors.

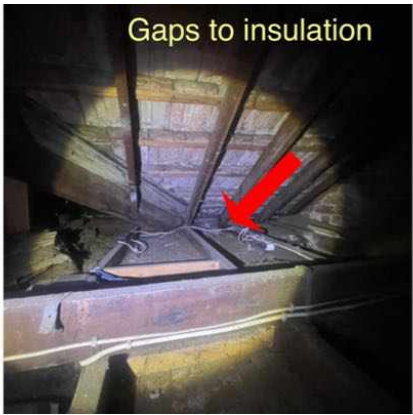
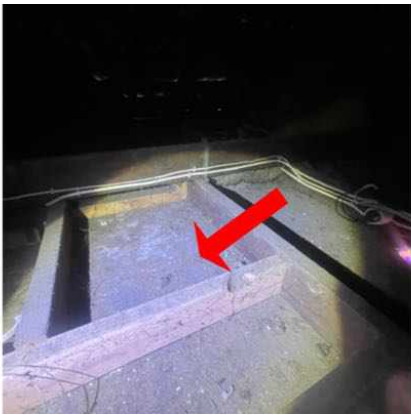
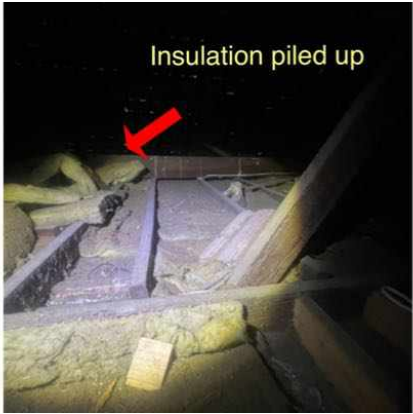
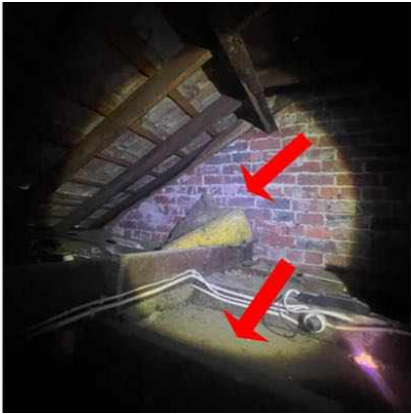
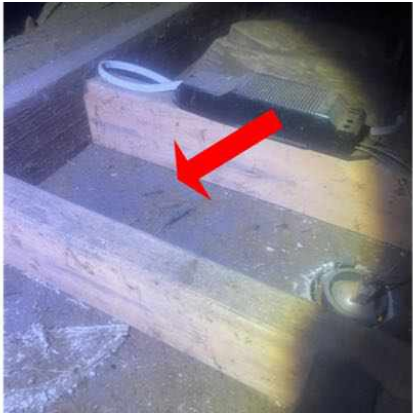
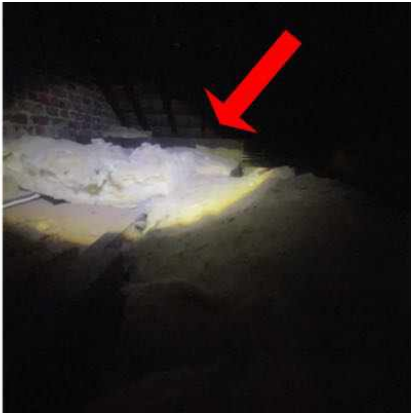
### Finding 3.14

Insulation - Missing or poor coverage

Upon inspection of the roof void it was noted that insulation was uneven and missing in some areas of the roof space. It appeared to be piled up in other areas but with a poor coverage.

Insufficient insulation will result in a comparatively higher cost to heat and cool a property as there is a lack of Insulation (or uneven coverage of insulation) which works as a barrier to heat transfer. This helps to keep out unwanted heat in summer and preserves warmth inside your home in winter. It can also help soundproof your home from unwanted airborne noise transfer.

Where insulation is not present or missing in large areas, this does not meet current Australian Standards. Installation of adequate insulation is required and should be conducted as soon as possible by an insulation specialist.

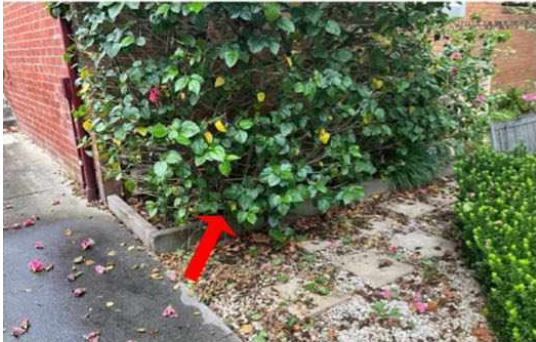
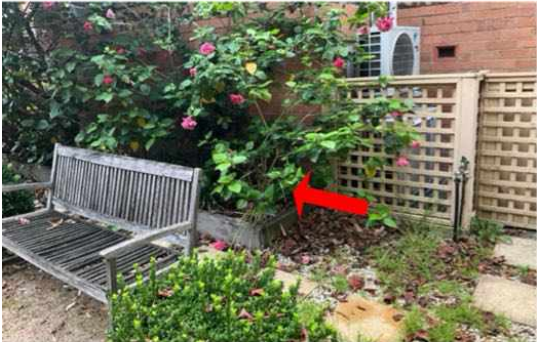
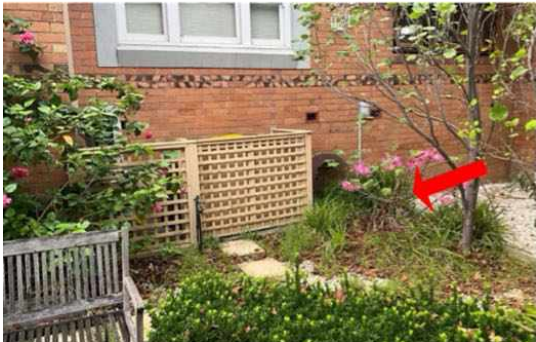
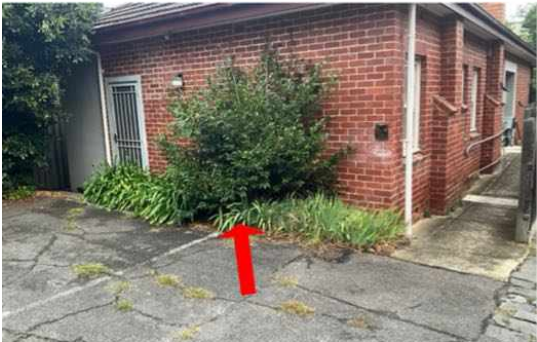
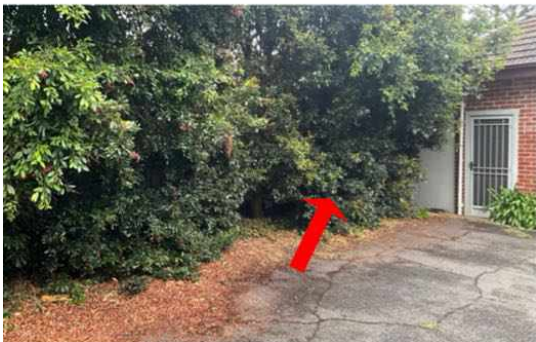
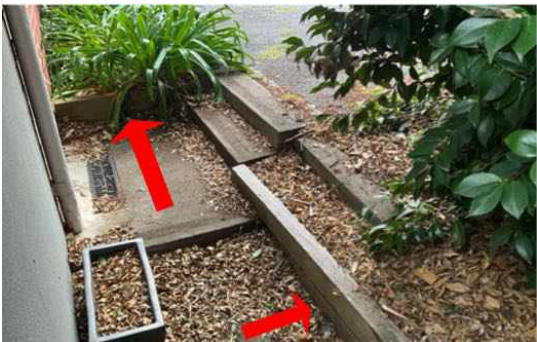
Finding: Garden Beds - Conditions Conducive to Termites

Information: Garden beds were found to be evident around and against the property. These garden beds can include untreated timber, and with a combination of moisture from rainfall and hosing, can make conditions conducive to termite activity and termite ingress.

The removal and replanting of species that do not provide "cover" or cutting back of existing vegetation will assist greatly in preventing this from occurring.

Where removal of any such materials that may be conducive to termite activity is not possible or practical regular monitoring of the areas should be carried out to minimize the risk of potential termite attack.

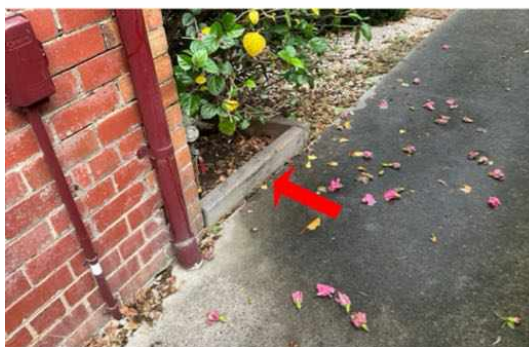
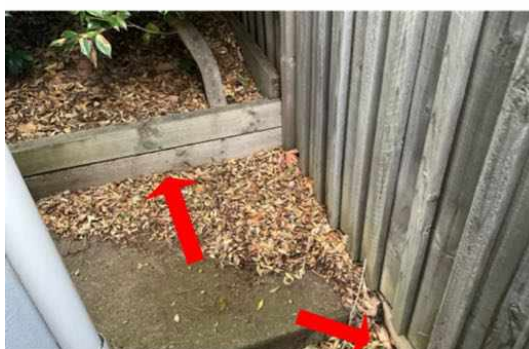
**Finding 6.02**

Building: All External Areas  
Location: Building materials in direct ground contact - conducive to termites  
Finding:

Where timber elements are in direct contact with the ground and consequently moisture or dampness, they become conducive to termite activity. Whether timber is used as a building element, part of a fencing structure or stored as an unused item, they can provide an environment that is attractive to termite infestation.

When met with excessive moisture, timber begins to decay and develop wood rot. Any timbers that are in direct contact with external grounds especially if left untreated or non-durable also provide ingress for subterranean termites into that particular element.

Where possible, the removal of any such materials that may be conducive to termite activity should be carried out as soon as possible to minimise the risk of termite attack. Where not possible or practical, regular monitoring of timber elements is recommended. Replacement of any damaged materials should be carried out where necessary.

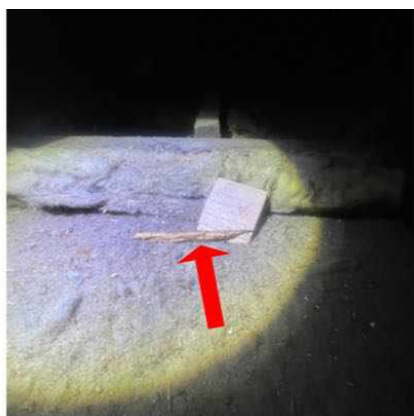
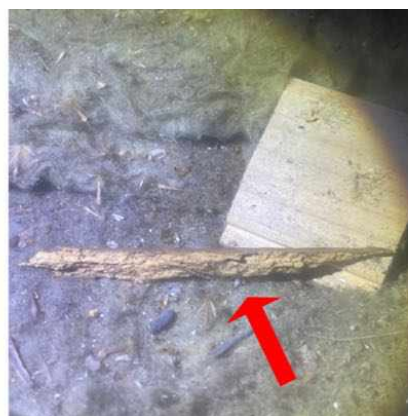
Building:	
Location:	Roof Void
Finding:	Evidence of wood borer damage identified
Information:	At the time of inspection, some previous wood borer damage was noted to some timbers in the roof void.

Wood borers are small beetles that colonise in exposed timber elements and are a common timber pest that are regularly mistaken for termites. Although wood borer activity is generally not detrimental to the affected timber they may lead to serious damage and necessitate replacement of certain building elements if in large numbers and left unattended.

Some suspected wood borer damage was noted to timber within the roof space.

As no live wood borer activity was identified treatment is not required at this time. Replacement of affected timbers may be considered by the client for superficial reasons.

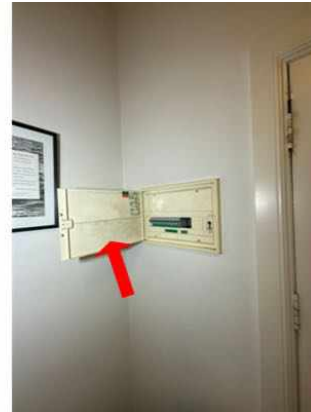
Building:  
 Location: Meter Box  
 Finding: Termite Management System - no evidence of a chemical installation  
 Information: The application of a post-construction chemical termite barrier is highly recommended for all properties, particularly if live termite activity has been found on the site previously. Such barriers are highly effective in preventing termite attack on any timber building elements throughout the property.

The client may consider gaining further advice from a pest controller as to the costs and procedures involved with this application. It is recommended that obtaining such

advice be a short-term priority.

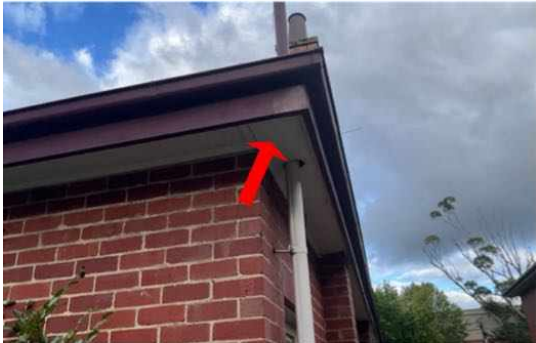
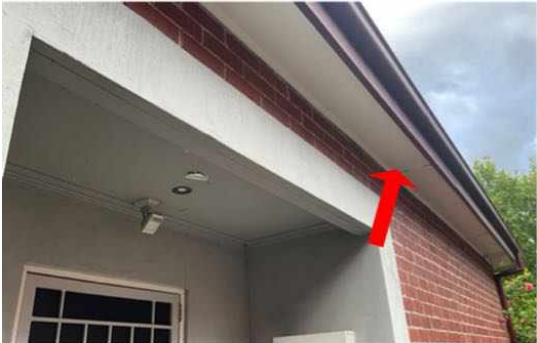
Building:	
Location:	All Areas
Finding:	Asbestos - Suspected ACM Identified on Site
Information:	Reporting on Asbestos is outside the Scope of this Report. This suspected defect is highlighted as a caution only. We suspect, based on our experience in the building industry, that there is a higher risk of the property containing asbestos.

As Asbestos Reporting is outside the scope of this report, we advise that you consider a separate Asbestos Inspection and Condition Audit, which can include the taking of samples for definitive confirmation of the presence of Asbestos.

In the interim, the client is advised to act with caution, especially when considering any damage to building materials general wear and tear renovations extensions demolition and general maintenance activities due to the suspected presence of Asbestos.

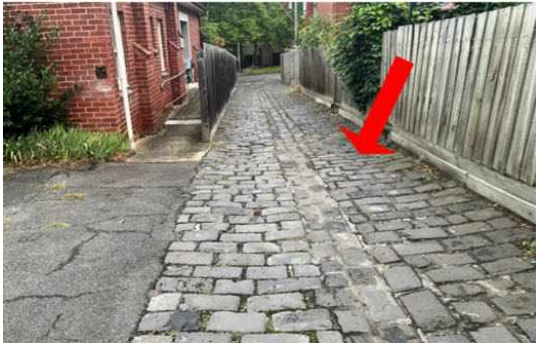
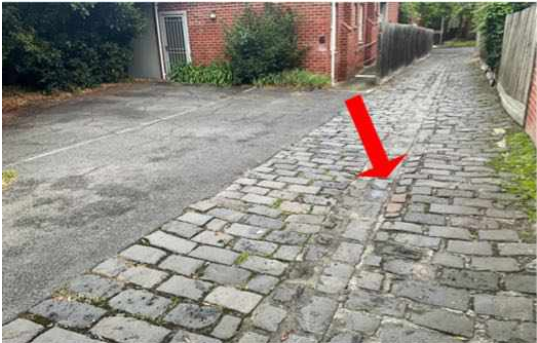
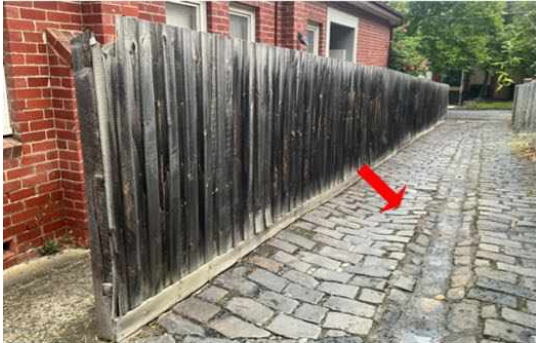
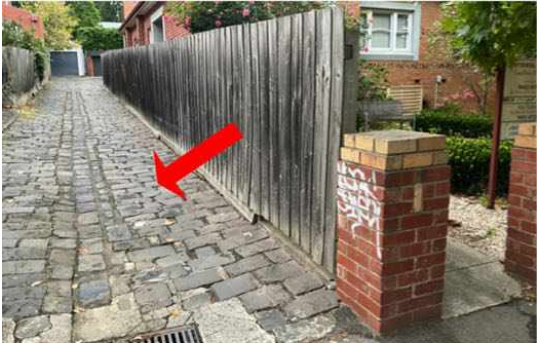
Information: Subsidence to the bluestone paved roadway along the side of the property was noted. This "road" appears to be a common access road for several properties. It is suspected this may be council owned land.

It is recommended further enquiries be made to determine whether this is the case.

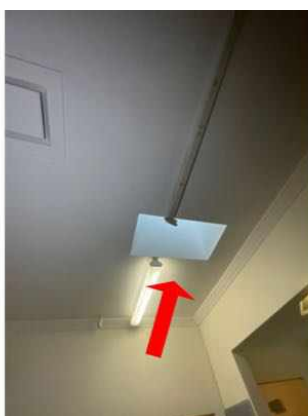
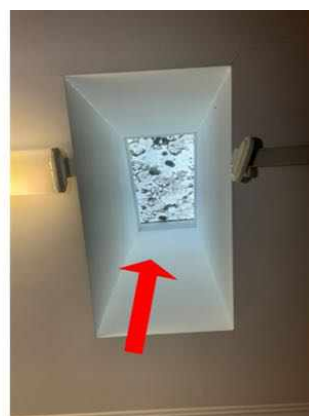
Building:  
Location: Office  
Finding: Skylight present within the property  
Information: It was noted the property has skylights present.

Whilst no evidence of any moisture leaking was noted during the inspection, skylights are notorious for leaking. The seals and/or flashing around the skylights can deteriorate allowing moisture to enter.

The ceilings around the skylights should be regularly monitored for any evidence of moisture leaking eg staining or bubbling of paint.

Where moisture damage becomes evident, a plumber should be appointed as soon as possible to identify the leak and perform rectification works as necessary, ensuring the moisture damage is restricted.

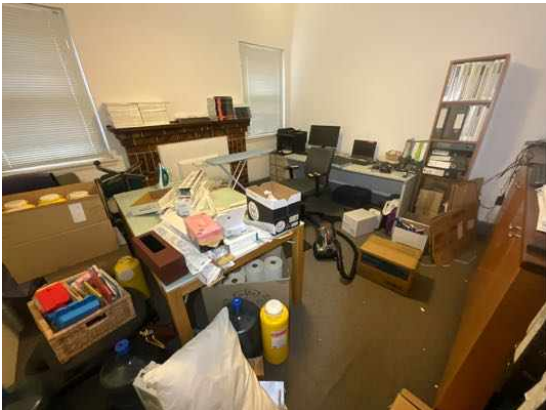
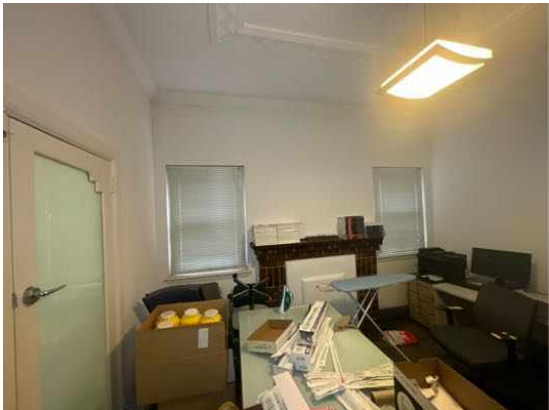
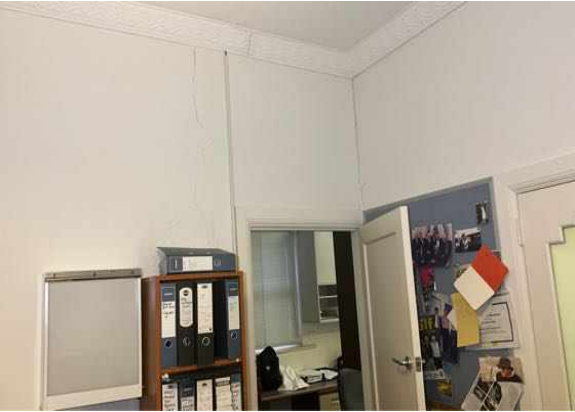
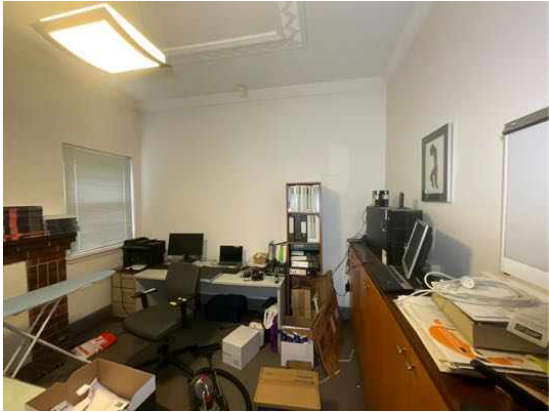
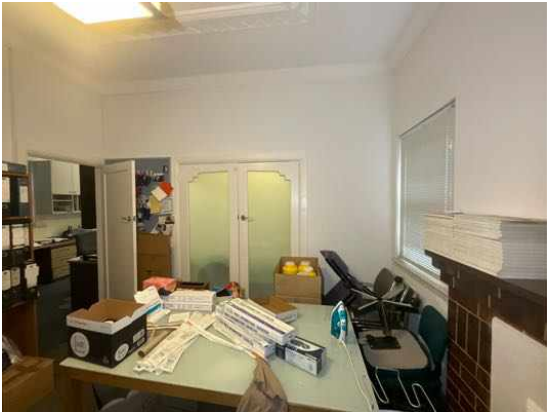
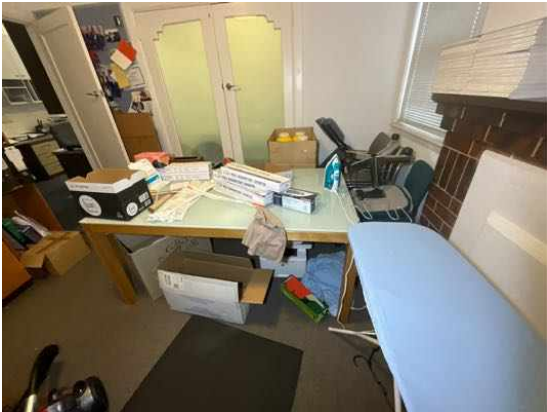
Building:  
Location: All Areas  
Finding: Additional Photos - Obstructions and Limitations  
Information: These photographs are an indication of the obstructions and limitations which impeded full inspection of the property at the time of inspection. These obstructions can hide an array of defects and should be removed to allow full inspection to be carried out. A re-inspection is recommended once the areas are made accessible.
