# Building and Timber Pest Inspection Report

Inspection Date: Thu, 5 Feb 2026

Property Address: 85/21 Leviathan Dr, Mudgeeraba QLD  
4213, Australia

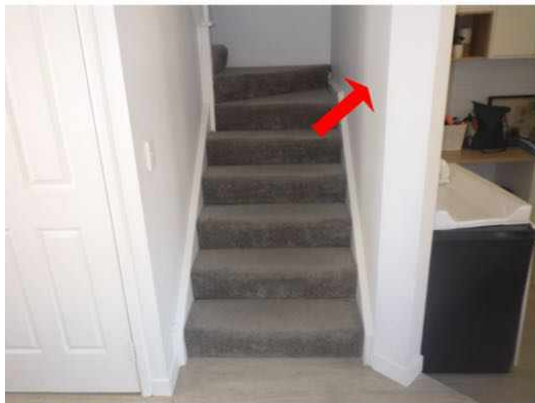
Building: Main Building  
Location: Stairs - Internal > Existing  
Finding: Stairs - Handrail  
Information: At the time of inspection it was noted there was no handrail in the internal stairway. The absence of a handrail in the stairway compromises the safety and accessibility of the stairs for all users.

This is noted as a safety concern and this regulation may not have been in place at the time of construction.

A licensed builder could be consulted for further information on stairway requirements.

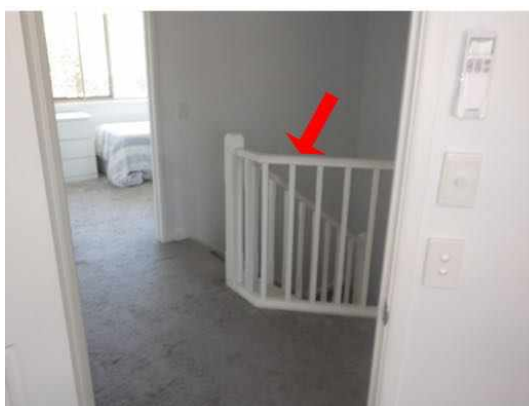
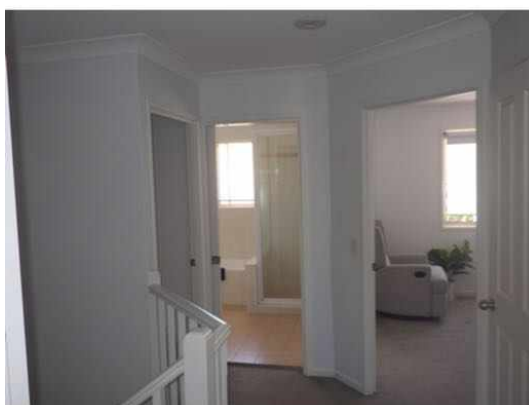
#### Finding 1.02

Building: Main Building  
 Location: Stair Landing > Existing  
 Finding: Balustrade - Suspected Non-Compliance  
 Information: The upper level stair landing area balustrade was measured and found to be (.980mm high) less than the present building regulation requirement of 1000mm high.

Some changes to the building regulations are made to ensure the safety of all inhabitants and balustrades are definitely one of those crucial regulations.

A registered builder could be contacted to discuss possible rectification solutions.

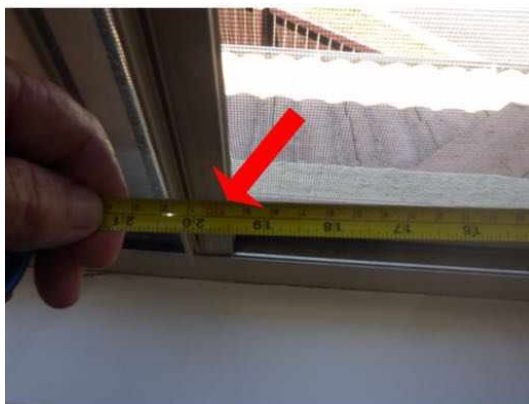
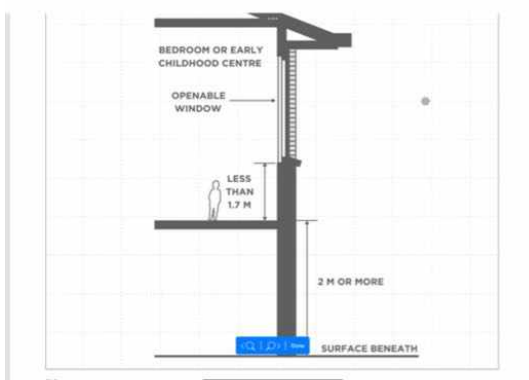
### Finding 1.03

Building: Main Building  
 Location: Main Bedroom > Centre Left  
 Finding: Window safety  
 Information: It was noted that the window of the upper level main bedroom is less than 1.7m from the floor and has a fall greater than 2m on the exterior from the sill and as such are required to only open upto 125mm or have security grills fitted.

This is noted as a safety concern and this regulation may not have been in place at the time of construction.

See NCC Vol2 Part 3.9.2.6 for further detail on this matter.

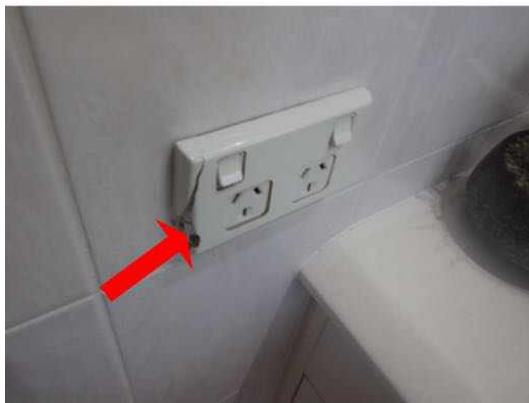
### Finding 1.04

Building: Main Building  
 Location: Bathroom > Rear Left  
 Finding: Electrical Switch  
 Information: At the time of inspection the general power outlet switch in the bathroom area showed signs of damage and/or cracking to the cover plate.

A licensed electrician should be engaged to repair or replace the electrical switch/fitting.

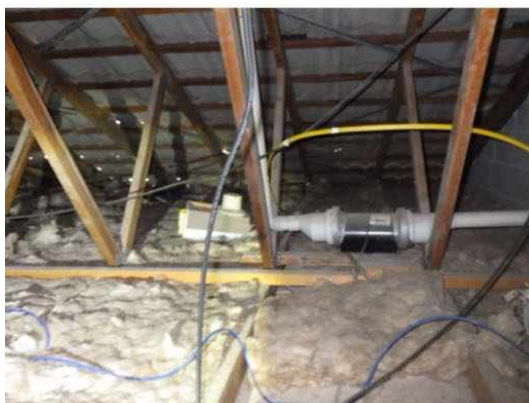
### Finding 1.05

Information: At the time of inspection it was suspected sections of insulation in the roof void may be covering down light fittings (as per example photos). While the down lights appear to be LED style lights the presence of this insulation can create a potential fire hazard.

Downlights with clear markings and supporting documentation showing the appropriate IC-F or IC ratings may be covered with insulation, but is still not recommended by the manufacturers.

The client is advised to engage a licensed electrician to check and/or confirm the IC-F or IC rating of the properties installed down lights.

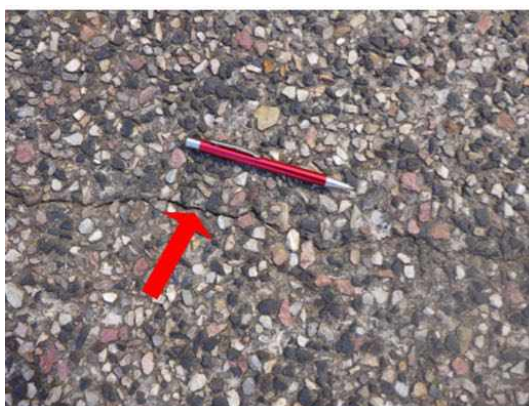
Building: Main Building  
 Location: Driveway > Ground Level  
 Finding: Cracking in concrete slab - Category 1  
 Information: Cracking coded as Category 1 was identified in the driveway and footpaths concrete slab. A Category 1 crack is described as a fine but noticeable crack, with the slab at an otherwise reasonable level.

To be considered Category 1, the approximate width of the crack is less than 1.0mm, or a less than 10mm change in offset when a 3m straight edge is placed over the defect.

Category 1 cracks should be monitored for a period of 12 months. At the end of the monitoring period, identified cracks that are rated greater than Category 2 are considered defects, and require rectification.

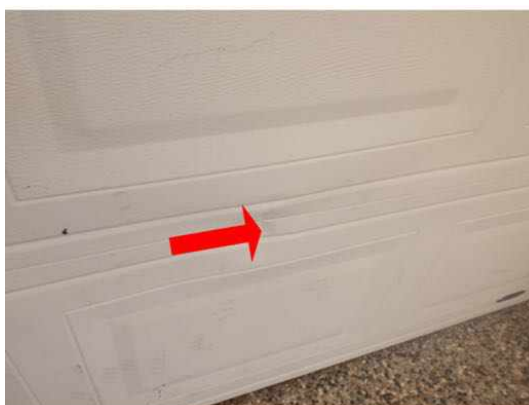
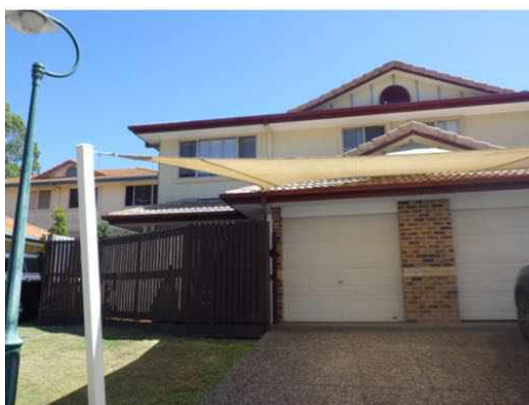
### Finding 3.02

Building:	Main Building
Location:	Garage > Front
Finding:	Garage door - dent
Information:	The garage door has a number of marks and dents likely to have resulted from impact damage be it accidental or deliberate impact at sometime.

Repair and/or replacement of the garage door would improve the condition of the garage but certainly not an urgent item

A qualified sectional door installer or supplier could be engaged to check out the operation and overall condition of the door to determine if repair is an option otherwise replacement may need to be considered.

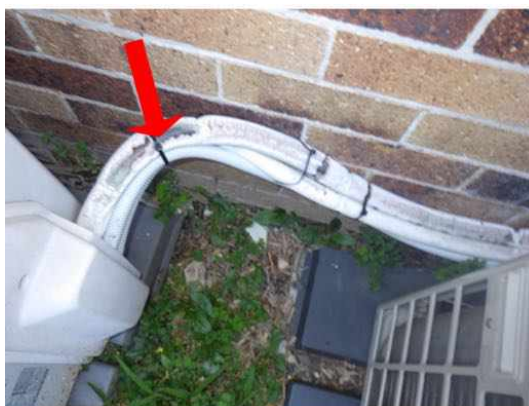
### Finding 3.03

Building:	Main Building
Location:	Exterior walls - left side > Centre Left
Finding:	Pipework - Insulation deteriorated

Information: At the time of inspection sections of the air conditioning unit pipe work insulation showed evidence of damage and deterioration. It is suspected that this deterioration has developed as a result of excessive exposure to weather, including UV exposure in daylight. Deteriorated insulation reduces the effectiveness of the material in helping to maintain the desired temperature and work most efficiently.

If left in an exposed position, it is likely that the deterioration will continue and worsen over time, potentially resulting in secondary building defects as well as a further loss in insulating properties.

Some areas of replacement of pipe insulation is likely to be required. Further preventative measures to remove or protect the material from future exposure are also advisable. Consultation with a licensed air conditioning installer is advised to gain quotes for the repair and/or replacement of deteriorated insulation.

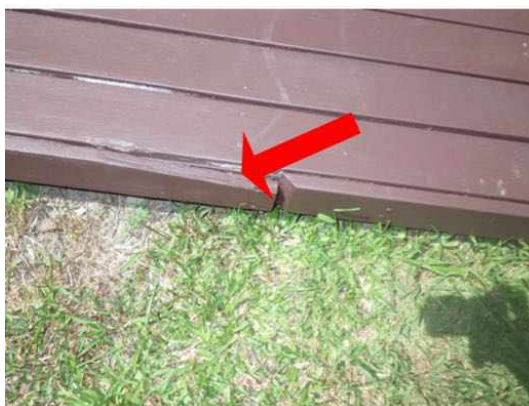
### Finding 3.04

Building: Main Building  
 Location: Deck > Rear Right  
 Finding: Decking Board  
 Information: At the time of inspection there was minor damage to a timber facing board on the front of the deck area at the rear of the property.

A qualified carpenter or general handyman could be engaged to undertake repair work to the affected decking board.

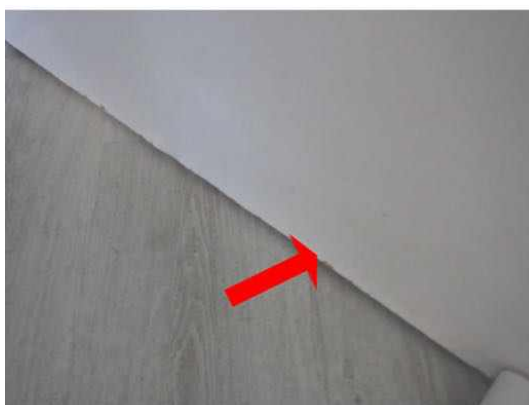
### Finding 3.05

Building: Main Building  
 Location: Entry > Front  
 Finding: Damaged Door  
 Information: It was observed at the time of inspection, the entry door has suffered damage to the bottom edge.

Damage occurs generally when the building materials have aged and decayed, but in this instance the damage appears to be the result of exposure to moisture, possibly from the bottom and/or top edges of the door not being sealed with a suitable paint or sealant at the time of construction.

A qualified carpenter or general handyman could be appointed to repair/replace the door at the clients discretion.

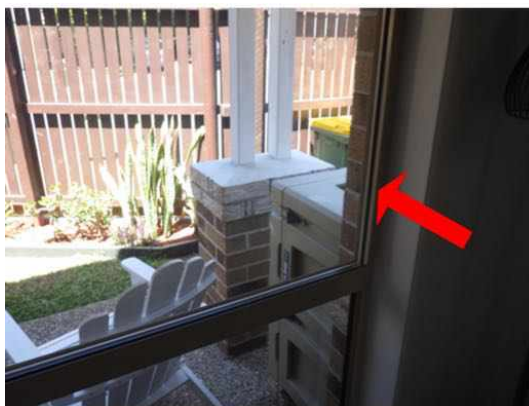
### Finding 3.06

Building: Main Building  
 Location: Living Room > Front  
 Finding: Window - missing latch  
 Information: The window latch to the living room area aluminium sliding window was found to be missing at the time of inspection. Breakage occurs generally when the building

materials have aged and decayed.

Replacement of the missing window catch is advised to improve the operational state of the associated window.

An aluminium window service agent or general handyman should be appointed to replace the window latch at the client's discretion.

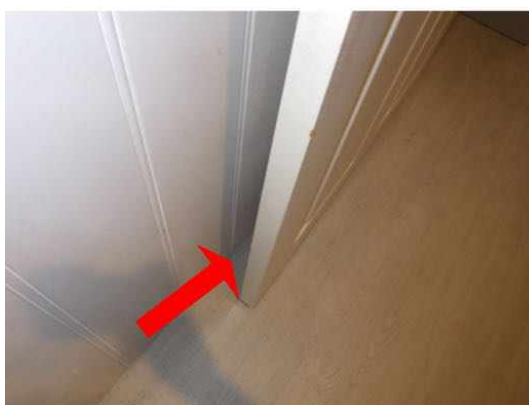
### Finding 3.07

Building: Main Building  
 Location: Utilities Room > Front  
 Finding: Door stop - Missing  
 Information: The utilities room door stop is missing or is inadequate to stop the door handle from damaging the wall.

Re-installation or replacement of the door stop is advised to prevent any subsequent damage to the wall linings or associated structures.

A general handyman may be appointed to perform these works at client discretion.

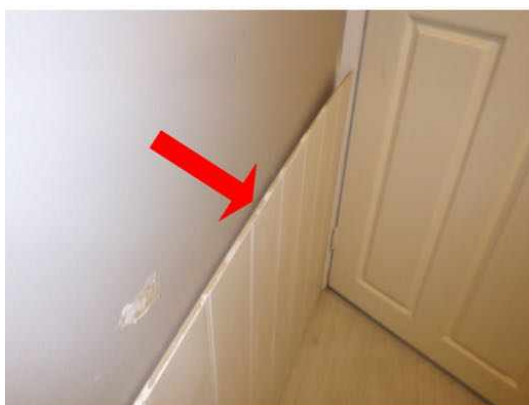
### Finding 3.08

Location: Utilities Room > Front Right  
 Finding: Wall Paneling - Deteriorated  
 Information: It was noted at the time of inspection that a section of the interior wall paneling to the utilities room area of the property have detached. Typically wall paneling deteriorates due to age and or wear which is generally expected for a structure of this age. Sometimes inadequate installation or maintenance can be to blame.

If left unattended, it is unlikely that further damage will occur. It is suspected that repair of several sections of the wall cladding may be required.

A licensed carpenter or general handyman could be engaged to undertake repair work.

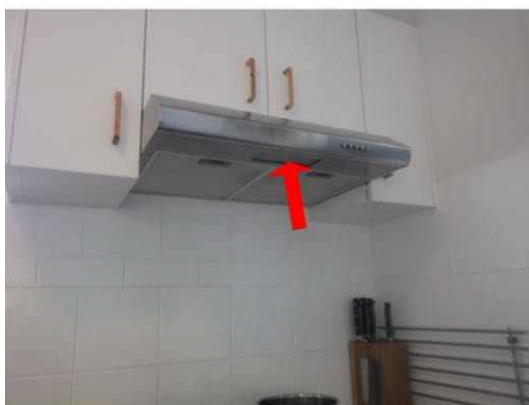
### Finding 3.09

Building: Main Building  
 Location: Kitchen > Rear Right  
 Finding: Rangehood - Light  
 Information: The kitchen range hood light was not working at the time of inspection. It is advised to replace the bulb first - if still not functioning, a licensed electrician could be appointed to repair or replace the range hood to restore it to a fully operational state.

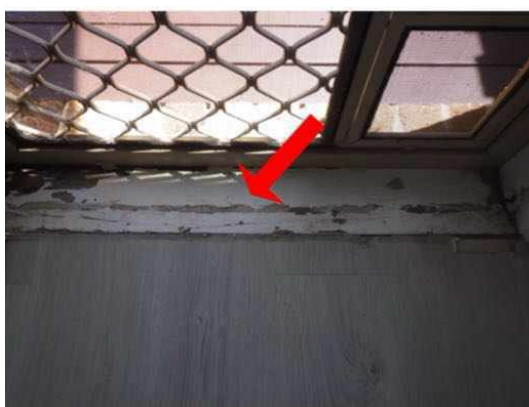
### Finding 3.10

Building: Main Building  
 Location: Laundry > Centre Left  
 Finding: Timber - exposed to weather  
 Information: At the time of inspection the laundry area exterior door timber sill showed evidence of weathering.

External timbers that are frequently exposed to harsh weather conditions require adequate protection in order to maintain their condition. Where timbers have not been painted or treated adequately, general deterioration is likely to occur at an accelerated rate.

Adequate treatment of the timber door sill is required as soon as possible by a painting contractor or general handyman.

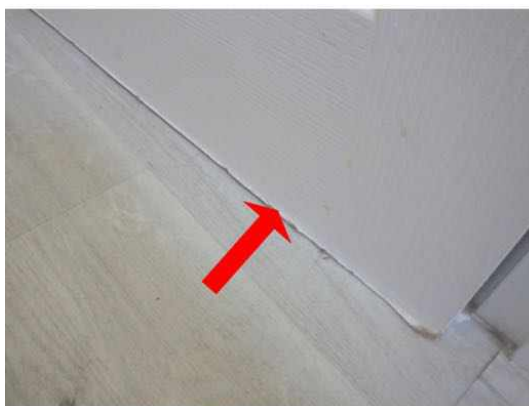
### Finding 3.11

Building: Main Building  
 Location: Toilet (WC) > Front  
 Finding: Damaged Door  
 Information: The doors leading into the ground floor WC and under stair storage area have suffered damage to the bottom edges.

Damage occurs generally when the building materials have aged and decayed, but in this instance the damage appears to be the result of exposure to moisture, possibly from the bottom edges of the doors not being sealed with a suitable paint or sealant at the time of construction.

A qualified carpenter or general handyman could be appointed to repair/replace the door at the clients discretion.

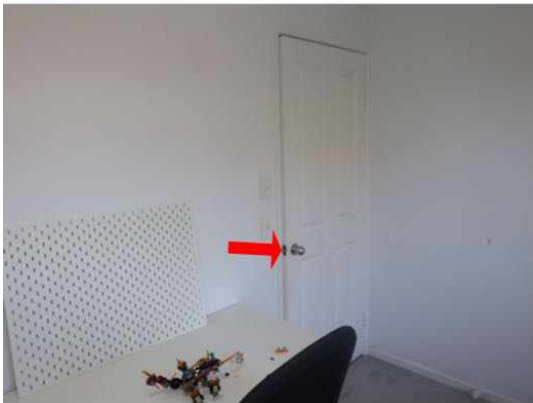
### Finding 3.14

Building: Main Building  
 Location: Bedroom 3 > Front Left  
 Finding: Internal walls - Hole  
 Information: A hole was identified in the bedroom 3 left hand side wall section. It is suspected the hole is caused from the door handle impact.

All excessive holes, gaps or cracks should be adequately filled by a suitable sealant to prevent any further damage. Such works may be conducted by a general handyperson or licensed painter.

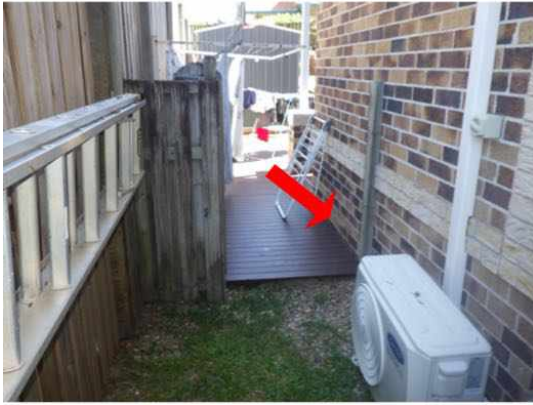
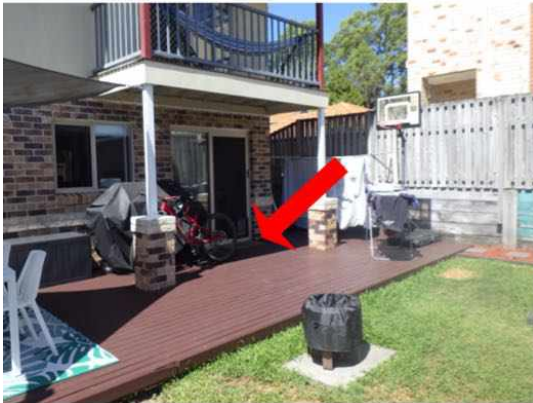
### Finding 6.05

Building: Main Building  
 Location: Deck > Rear  
 Finding: Deck - In ground contact  
 Information: At the time of inspection it was noted the timber deck area to the left side and rear of the property is in direct contact with the finished ground level.

Any timbers in direct ground contact provide opportunity for concealed termite entry and are likely to be subject to premature rot and decay as the soil retains moisture or damp conditions against the timbers.

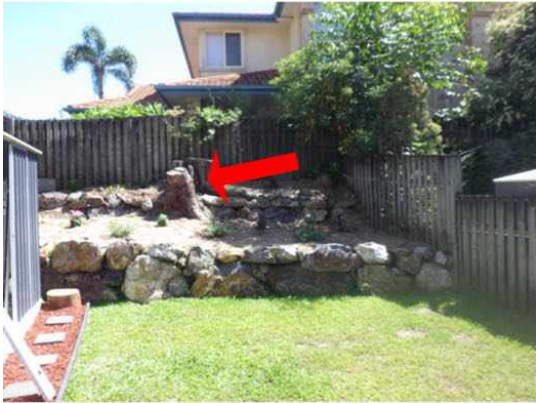
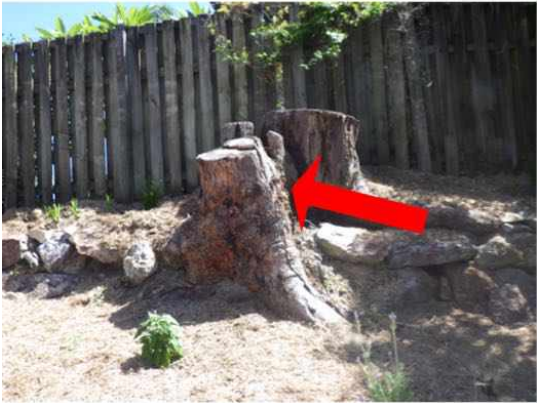
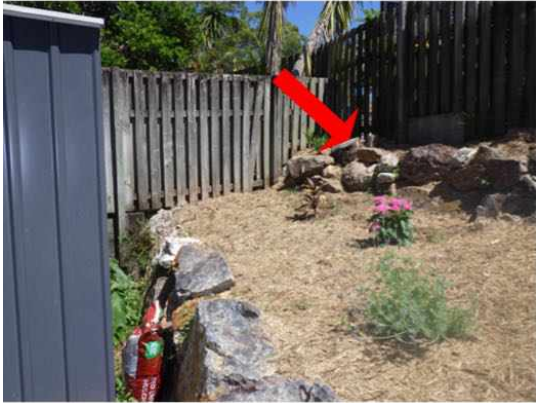
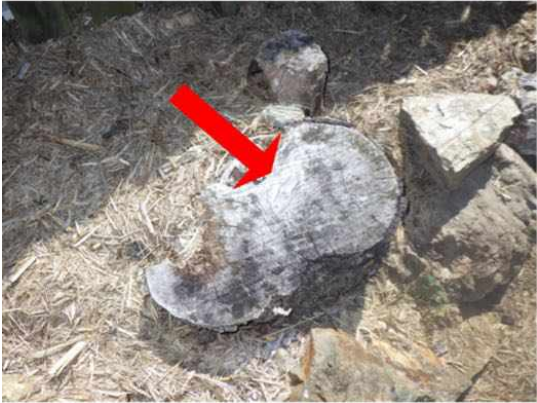
### Finding 6.06

Building: Main Building  
 Location: Yard - Back > Ground Level  
 Finding: In ground - Tree Stump  
 Information: At the time of inspection there was tree stumps on/in ground areas to the rear of the property.

Any timbers in direct ground contact provide opportunity for concealed termite activity and are likely to be subject to premature rot and decay as the soil retains moisture or damp conditions against the timbers.

Removal or chemical treatment of any untreated timber or tree stumps which are in direct contact with external ground is recommended. Frequent pest inspections are advised to readily identify any termite activity in these areas.

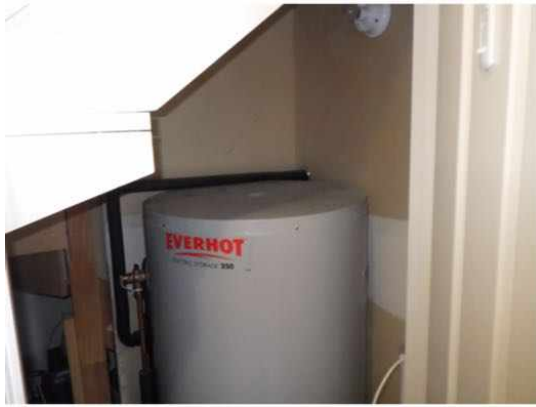
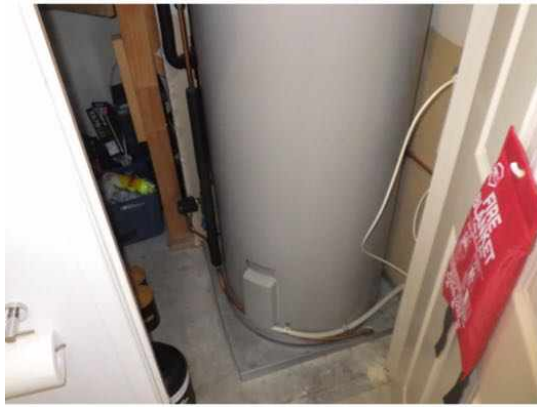
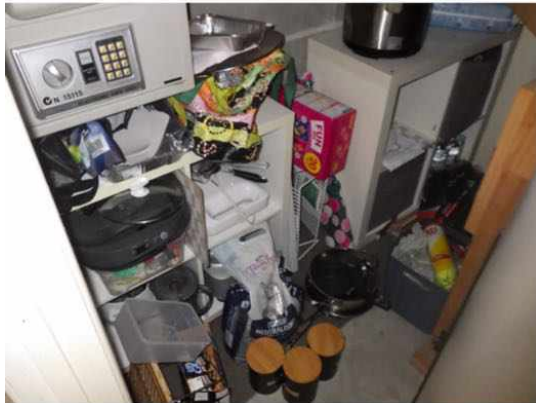
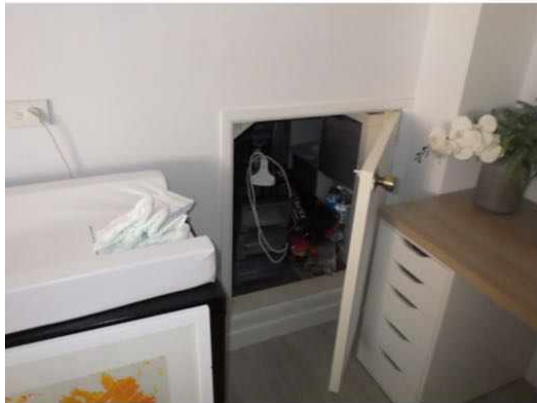
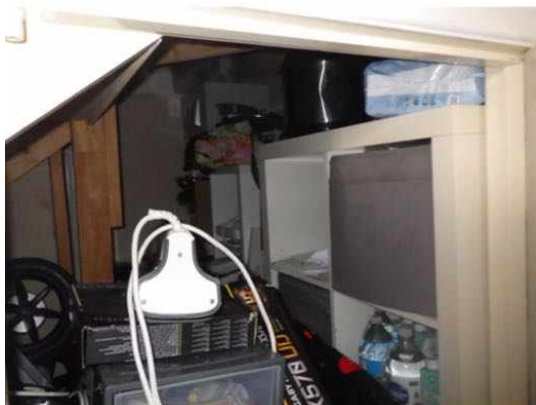
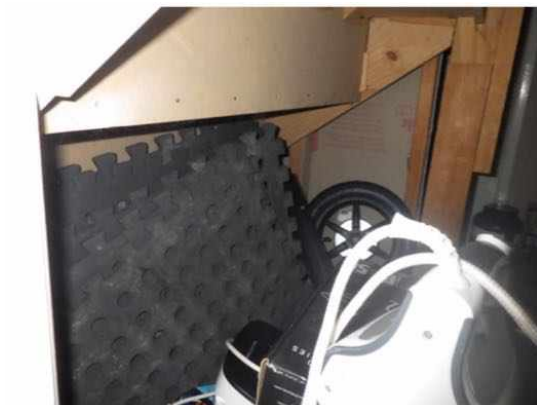
Building: Main Building  
 Location: Under Stair Void or Storeroom > Existing  
 Finding: Obstructions and Limitations Internal Areas  
 Information: These photographs are an indication of the obstructions and limitations which impeded full inspection of the under stair cupboard internal areas at the time of inspection. These obstructions can hide an array of defects and should be removed to allow full inspection to be carried out. A re-inspection is recommended once the areas are made accessible.

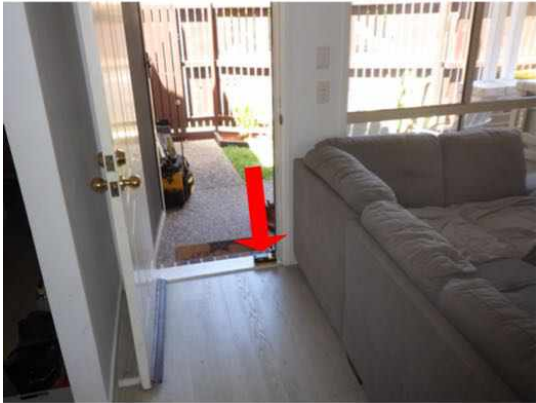
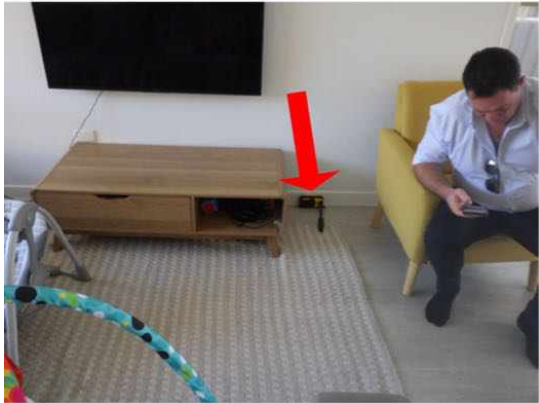
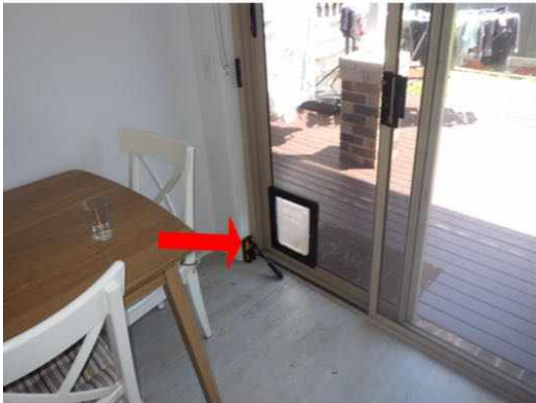
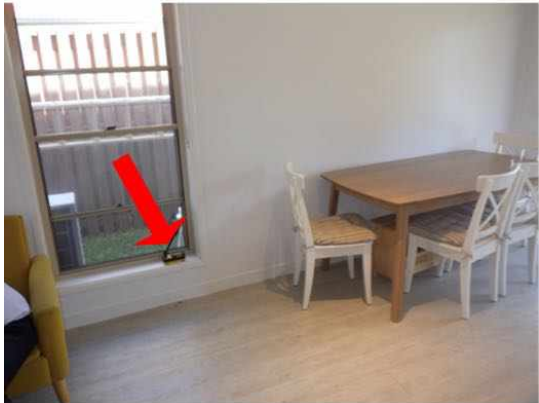
Building: Main Building  
Location: Internal Areas > Existing  
Finding: Termitracker  
Information: The termitracker was positioned randomly to the external timber deck area and to internal wall, timber skirting and window frame areas checking for signs of termite activity.

No activity was recorded at the time of inspection.

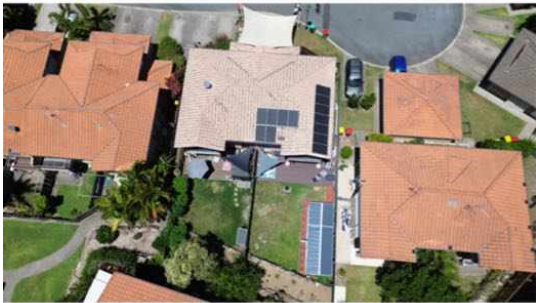
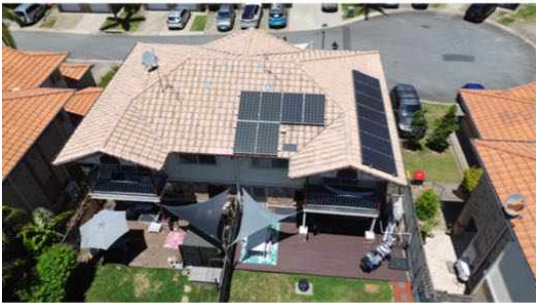
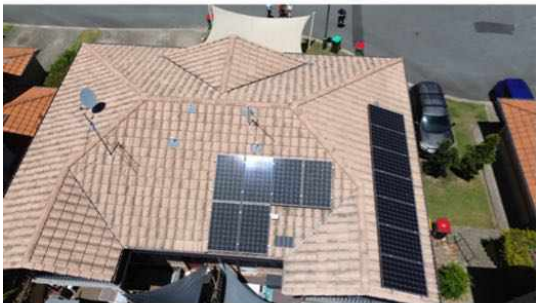
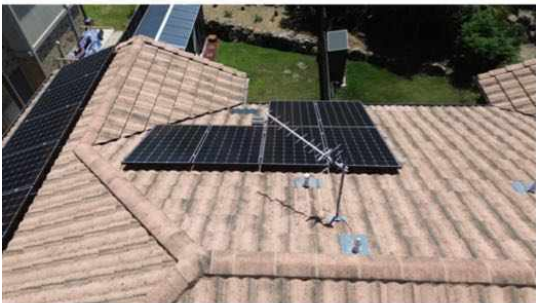
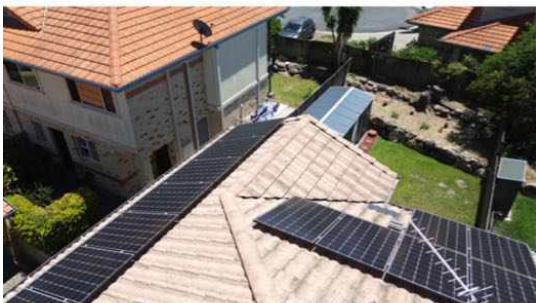
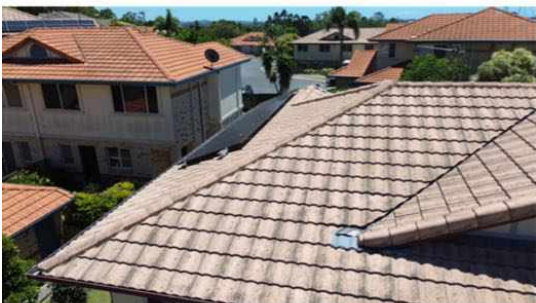
Building: Main Building  
 Location: Roof Exterior > Existing  
 Finding: Roof Photos  
 Information: Roof area photos were taken manually and with the DJI Mini 3 Drone flown over the roof at the time of inspection.

NOTE - External wall and roof exterior repairs or maintenance is generally the responsibility of the buildings body corporate managers.

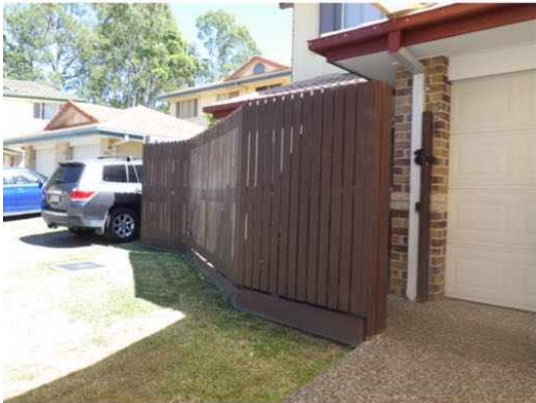
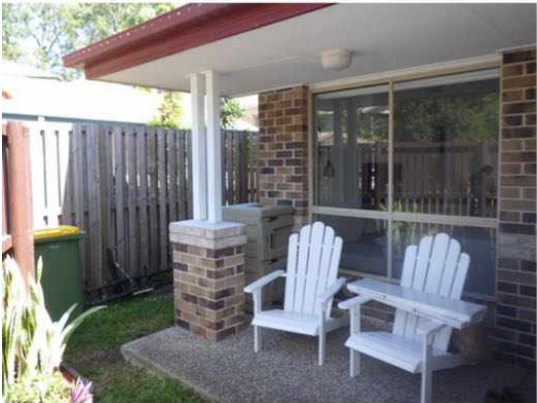
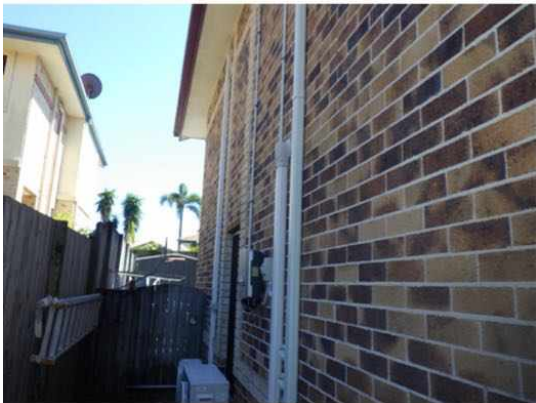
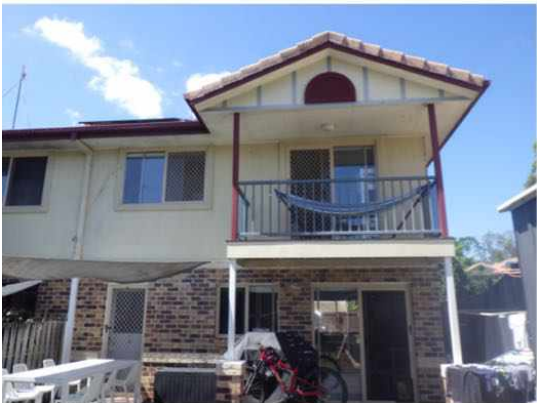
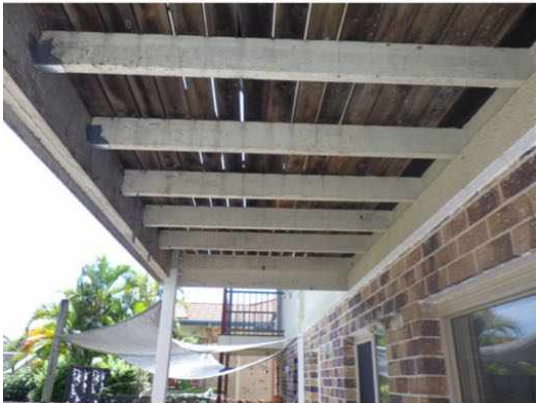
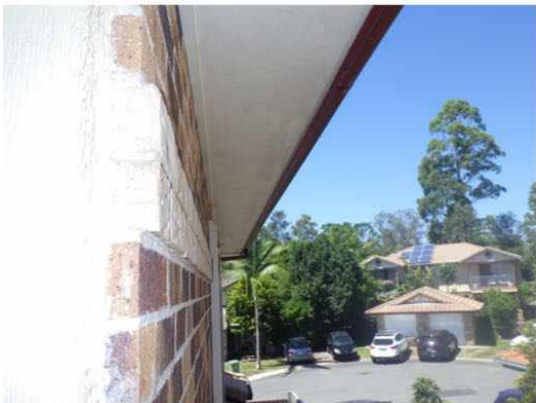
Building: Main Building  
Location: External Areas > Existing  
Finding: Additional Photos  
Information: Additional photos are provided for your general reference

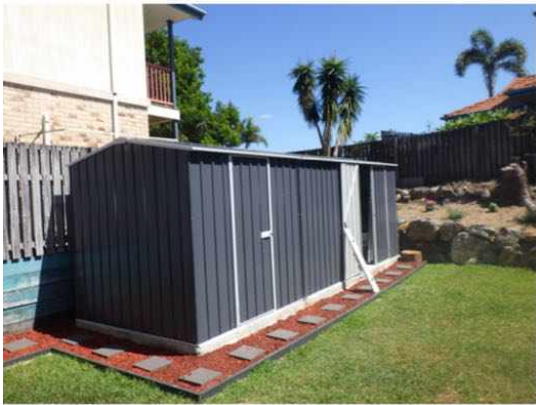
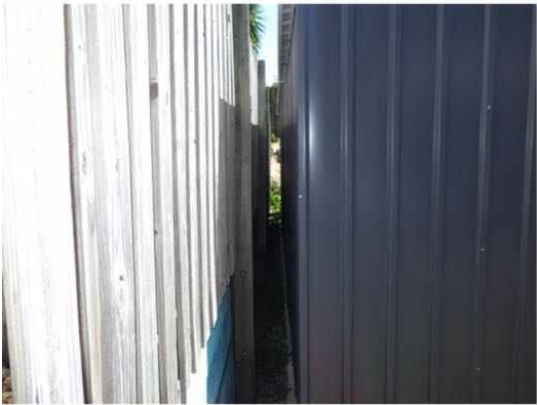
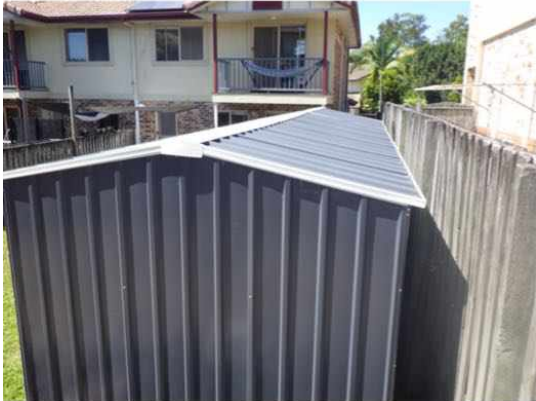
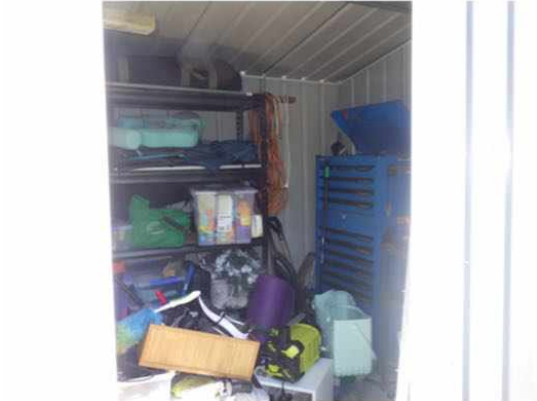
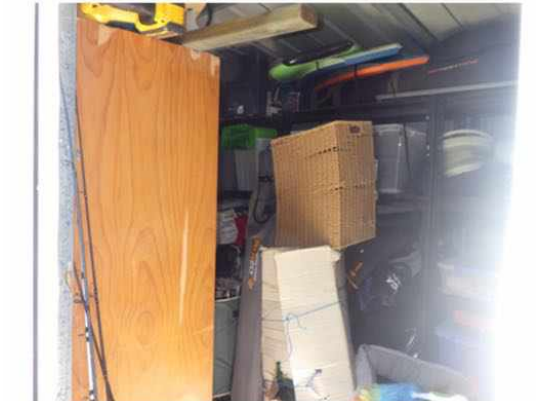
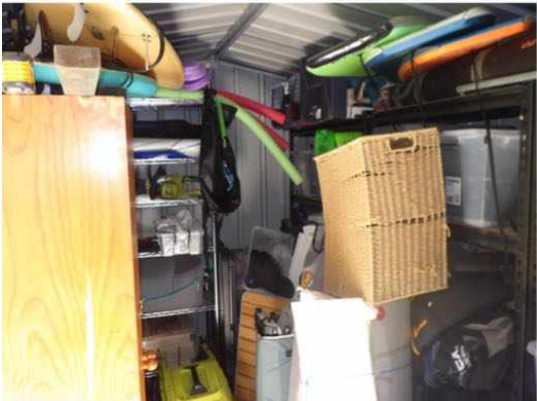
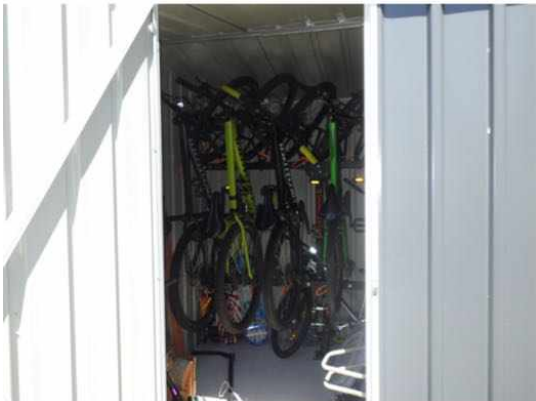
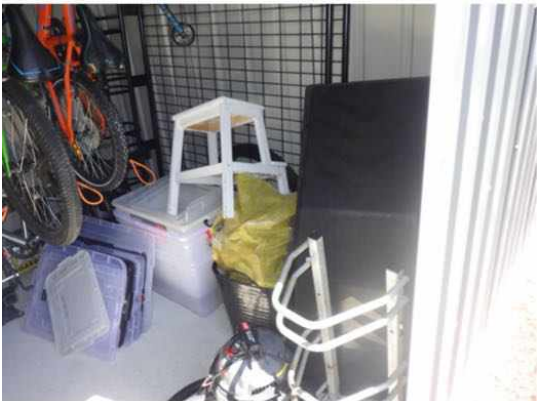
Building: Shed  
Location: Yard - Back > Existing  
Finding: Additional Photos  
Information: Additional photos are provided for your general reference

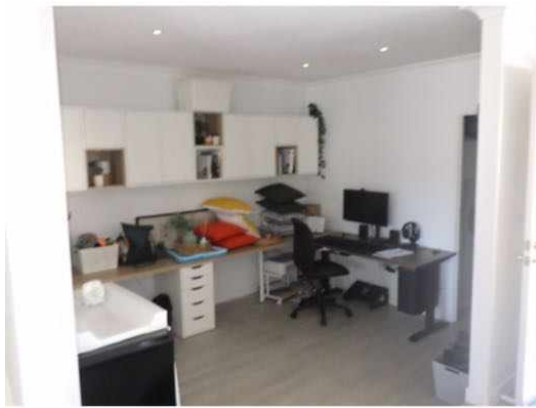
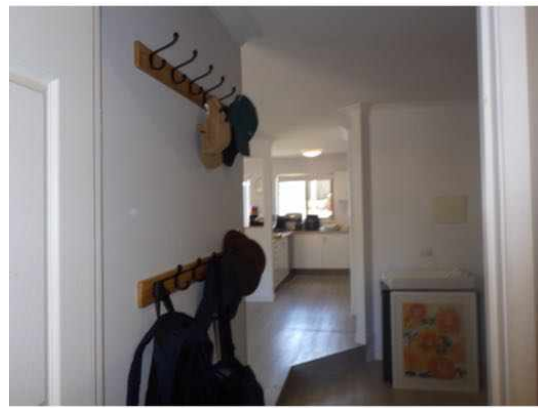
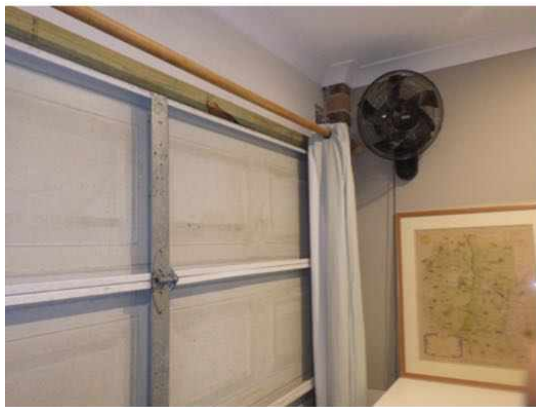
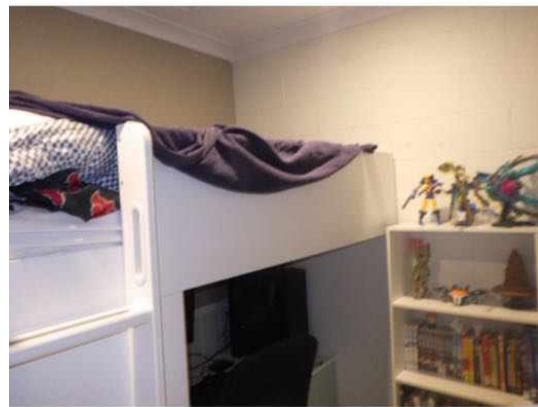
Building: Main Building  
 Location: Internal Areas > Existing  
 Finding: Building Compliance  
 Information: At the time of inspection it was noted there has been building renovation/alteration works to the dwelling.

It is highly recommended that the seller provides the relevant approval information, or a search of the Local Council and QBCC records be made to determine what approvals have been granted for the alterations and/or renovation works to the property.

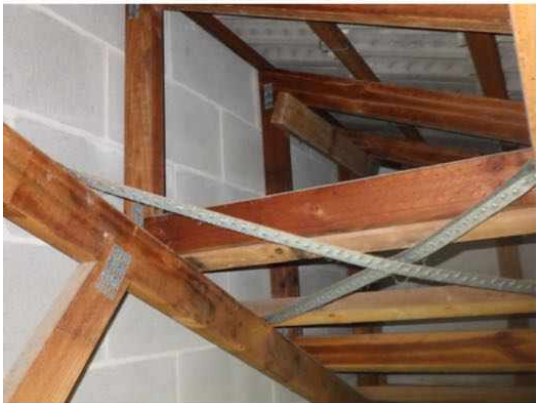
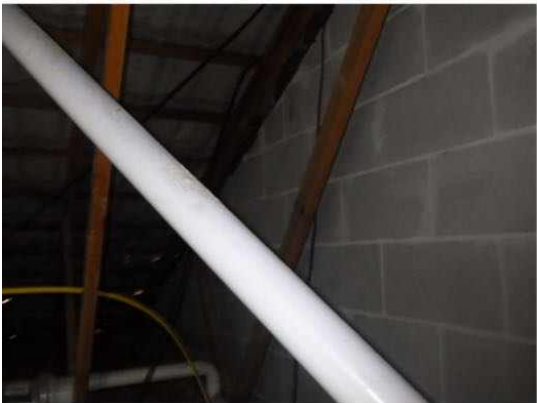
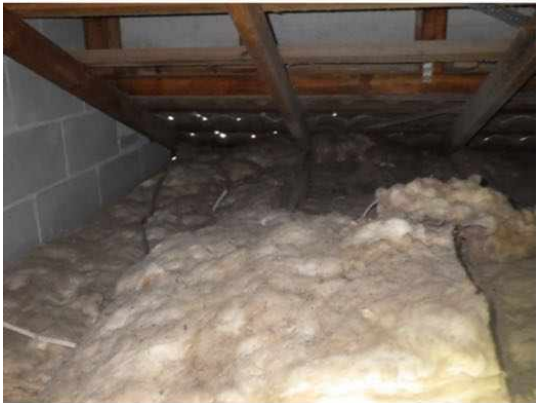
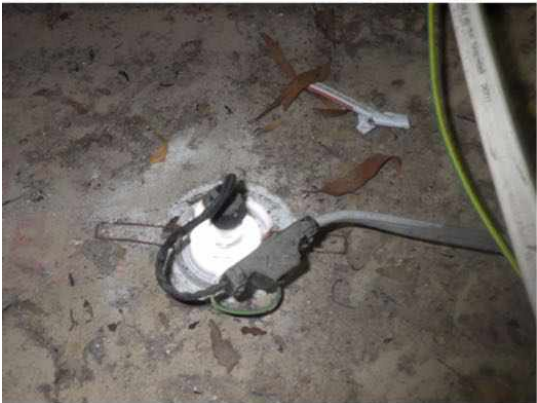
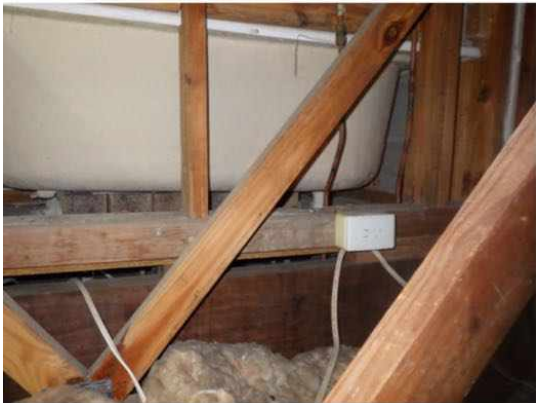
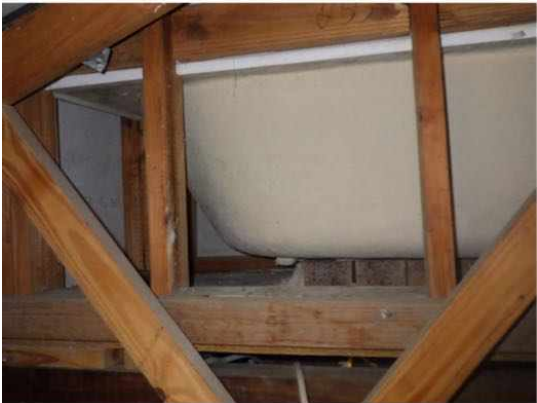
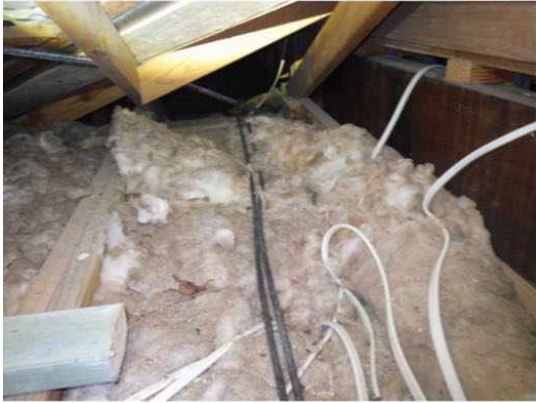
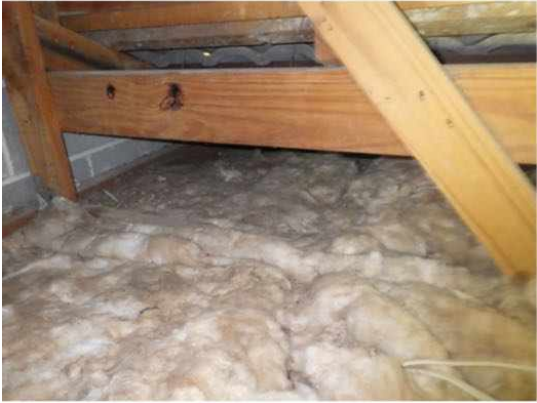
Building: Main Building  
 Location: Attic > Existing  
 Finding: Additional Photos  
 Information: Additional photos are provided for your general reference
