Building and Timber Pest Inspection Report

Inspection Date: Wed, 25 Mar 2026

Property Address: 34 Pauline Dr, Surrey Downs SA 5126,
Australia

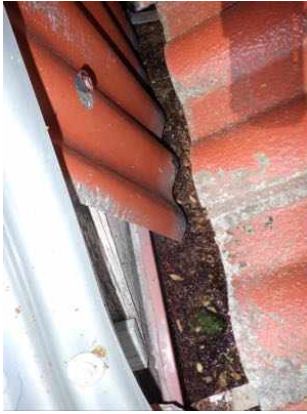
Blocked gutters are likely to lead to high levels of moisture in the affected areas. Such moisture will not only cause rust and decay of the associated building materials, but can also provide conditions that are conducive to termite and timber pest activity. Blockages in gutters should therefore be removed immediately to ensure dry conditions are maintained.

Removal of debris may expose currently concealed defects.

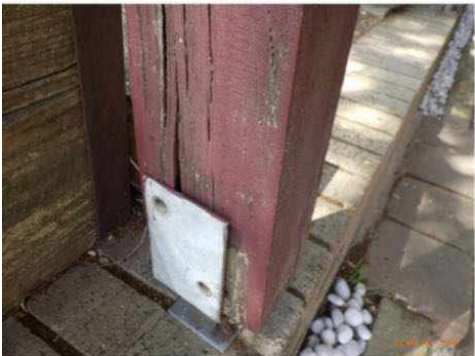
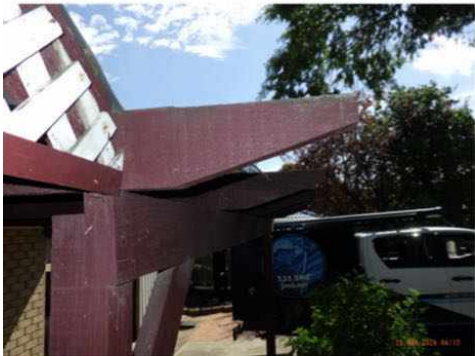
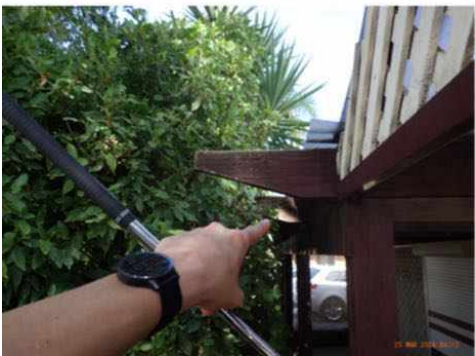
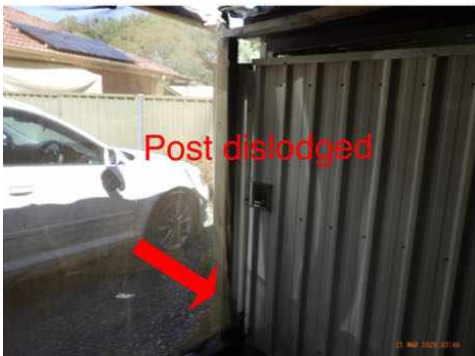
Finding 3.01

Building:	Building 1
Location:	Front Elevation
Finding:	Structure - Old and non-compliant
Information:	The pergola structure, whilst appearing to provide adequate structural support, does not comply with contemporary building practices and current Australian Standards. This is not a requirement in older homes and is merely noted for your information that there are several minor issues relating to this area.

This includes the lack of guttering to remove the stormwater from the area and the deterioration to the timber elements and a post has become dislodged from the sleeper beneath.

Without repair it is likely that the area could become further deteriorated and as such should be addressed in the short to mid term.

It is advised that this structure be inspected by a registered builder to ensure that the structure remains in a serviceable condition.

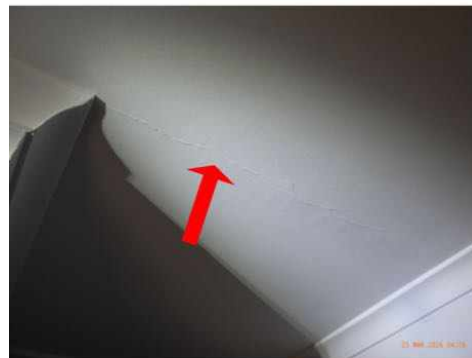
Building:	Building 1
Location:	All Internal Areas
Finding:	Cracking and repairs, Walls and ceilings (minor)
Information:	Several cracks and or crack repairs were evident throughout the internal walls and ceilings of the property.

Although fine cracks are quite noticeable, they are often only considered to be an appearance defect and usually do not indicate any structural damage. Generally, the cause of a fine crack is indicative of minor expected movement of a structure of this age however as repairs have been carried out, it is impossible to know the extent of any cracking.

Cracking of this nature can generally be repaired with minor filling and should be conducted by a qualified painting contractor

Always contact a building inspector should cracks widen lengthen or become more numerous.

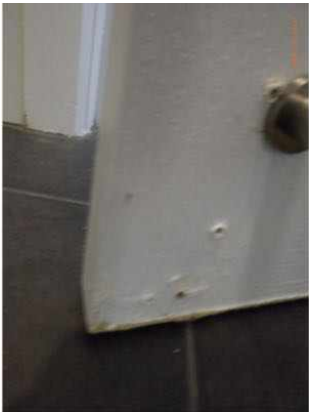
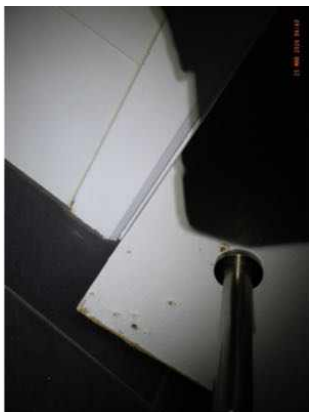
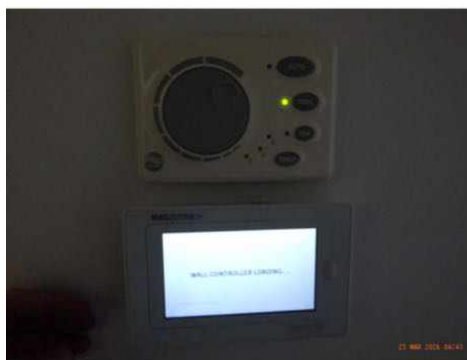
Building:	Building 1
Location:	All Areas
Finding:	Minor defects present
Information:	Minor defects were evident throughout the dwelling at the time of inspection, which are consistent with normal wear and tear and considered appropriate for a property of this age.

These defects are typical of ongoing material ageing, settlement, and general use over time, and include, but are not limited to:

- Minor cracking to bricks above rumpus door
- Minor deteriorated to concrete below rumpus door
- Rust to shed wall iron
- Swelling evident to kitchen kicker and bathroom door
- Heater not operating at the time of inspection

While these defects are not considered structurally significant at present, they should be addressed as part of routine and ongoing property maintenance to prevent further deterioration. Repairs and maintenance works should be carried out by appropriately licensed and qualified tradespeople to ensure the continued serviceability and longevity of the dwelling.

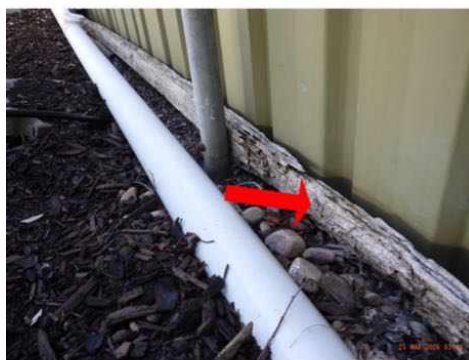
Untreated timbers in direct contact with the ground are likely to develop severe wood rot and/or fungal decay if left unattended creating attraction for subterranean termites to infest the timbers from surrounding areas.

If untreated or non-durable timbers are found to be in a hazardous environment it is highly advised that replacement of these building elements be performed as soon as possible to aid the protection of the property against termite / timber pest attack. Failing this close monitoring is recommended in an attempt to identify termite infestation at an early stage.

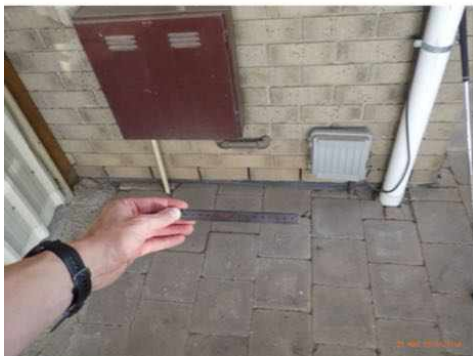
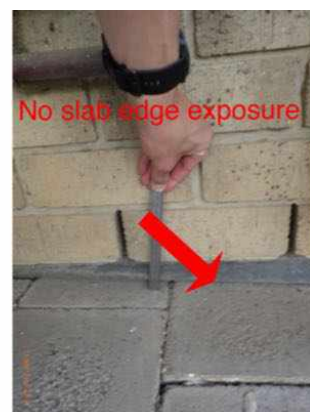
If the slab edge is not properly exposed there is a high risk of termite attack. Sometimes, in order to determine the type of slab, a suitably qualified person such as an architect or builder may be required to consult the construction plans.

Where the slab edge cannot be properly inspected, it is highly recommended that termite or timber pest inspections be carried out every 6-12 months to aid protection of the property against infestation.

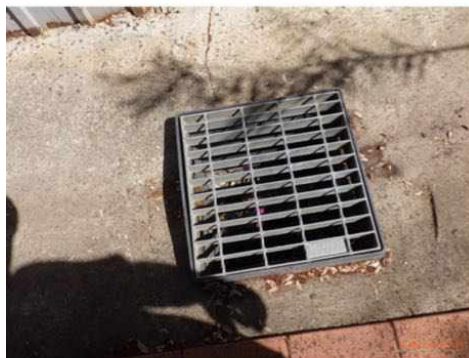
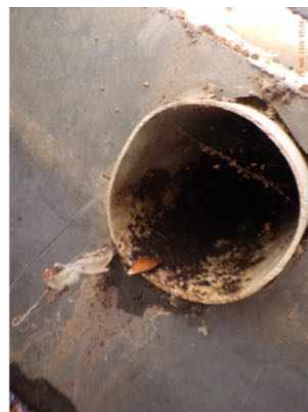
It is important that water does not lie against the base of walls; surrounding paths and ground levels should be sloped to drain water away from walls. Downpipes should not discharge stormwater onto lower walls or plinths. Stormwater should be carried away by large, regularly cleaned drains.

Where site drainage is inadequate, installation of additional drainage may be required. A qualified plumber should be appointed to further inspect the property to ensure the sump functionality and perform any remedial works as necessary. Water damage and secondary defects are likely to occur if left unmanaged.

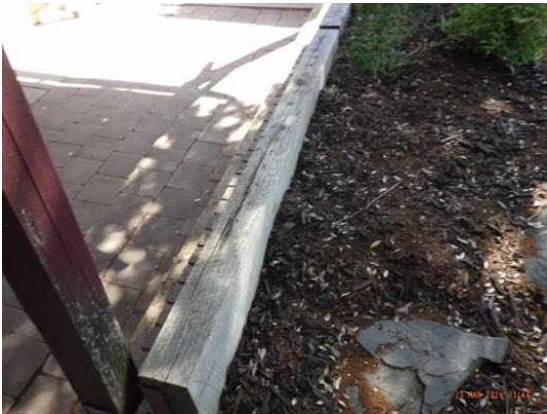
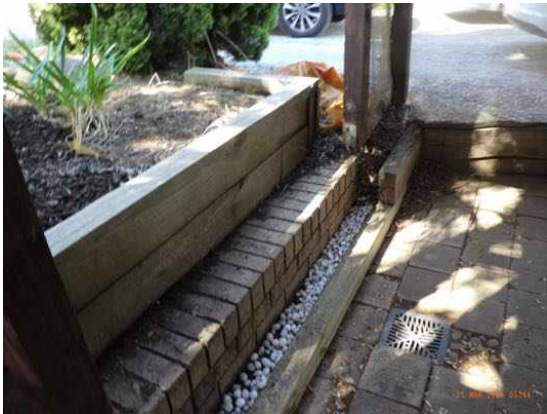
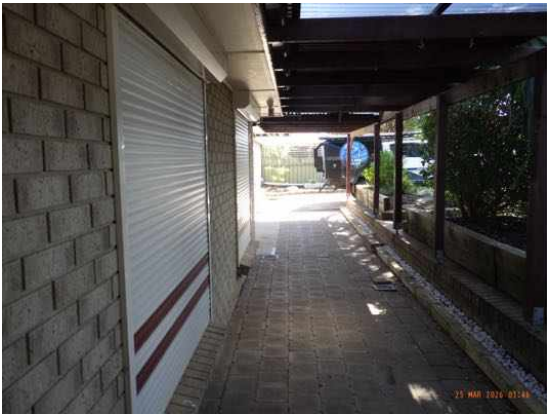
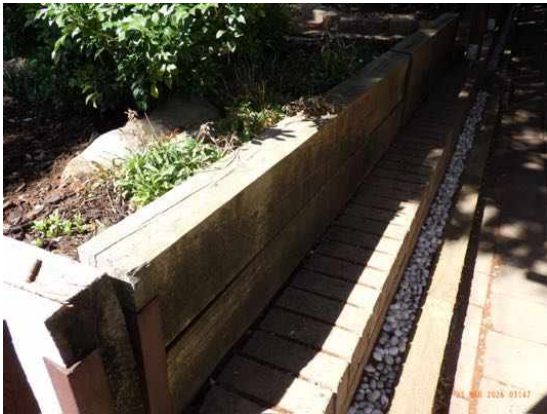
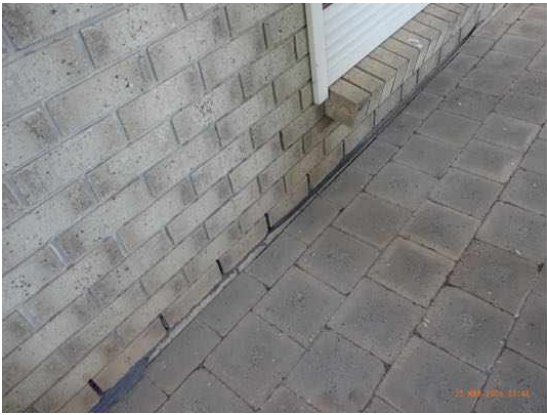
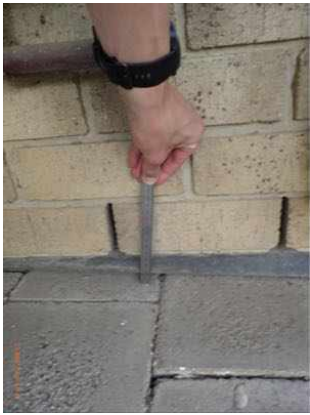
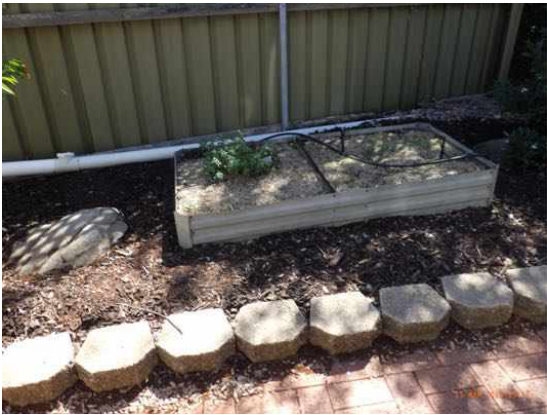
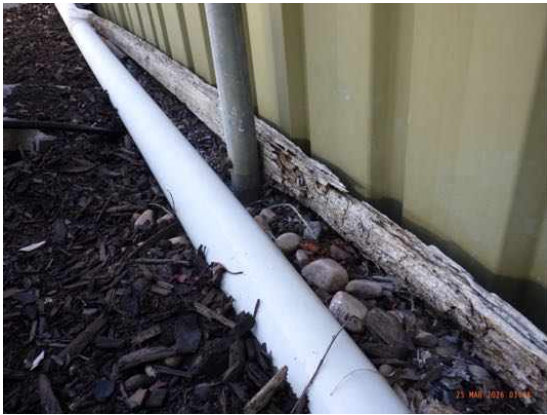
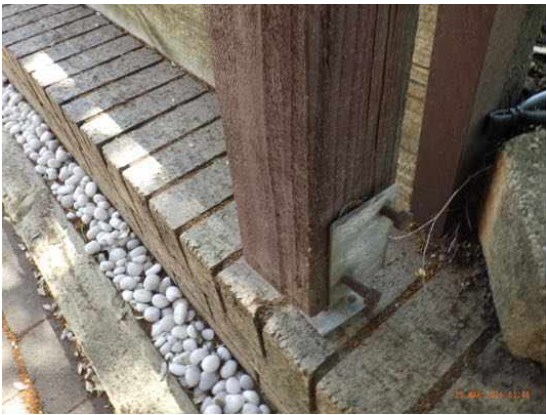
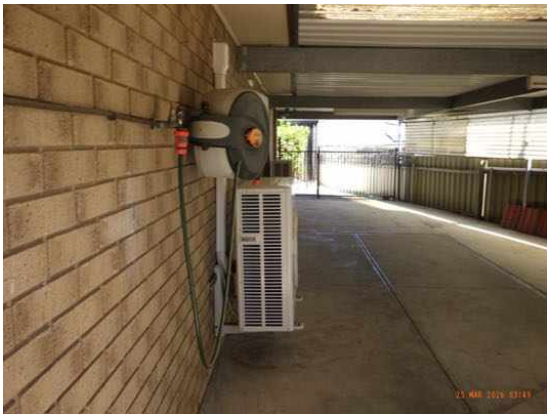
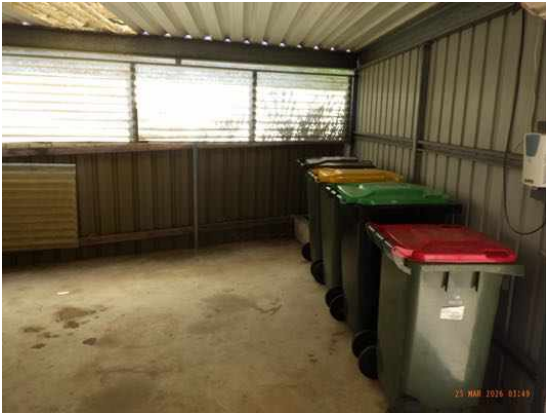
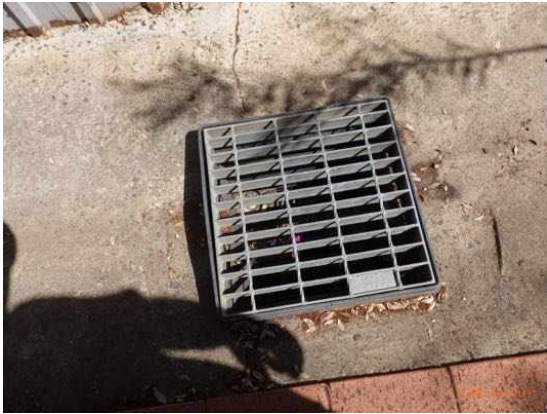
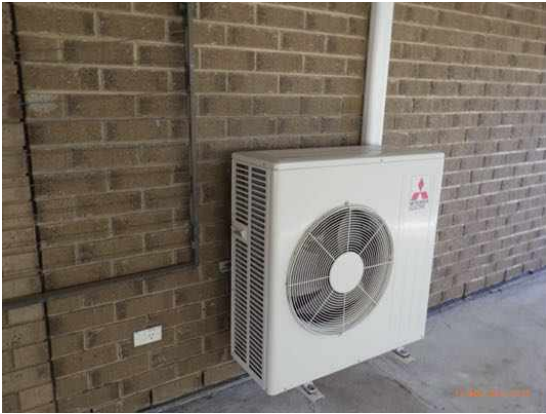
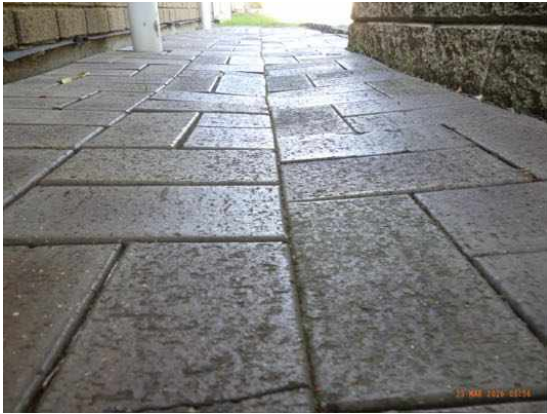
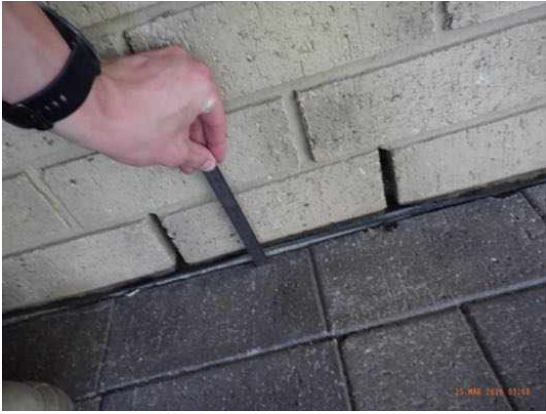
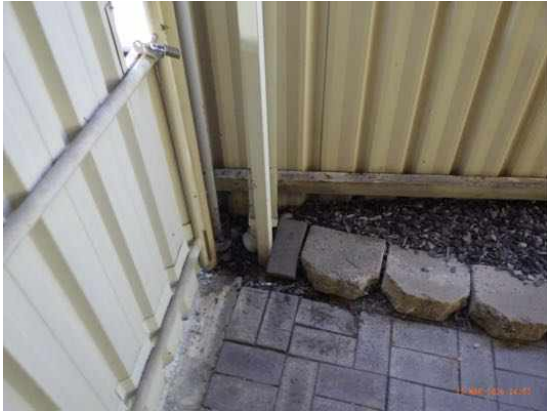
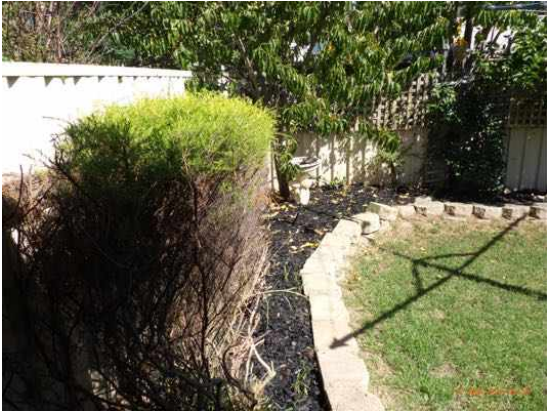
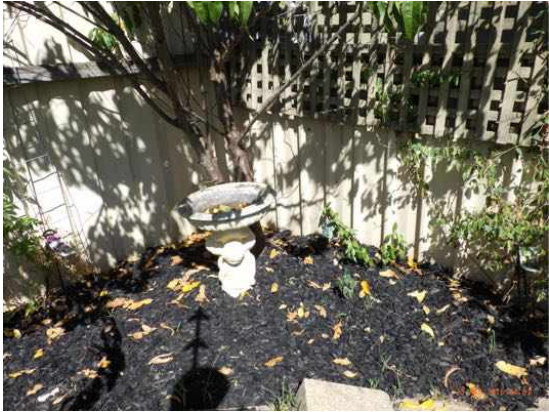
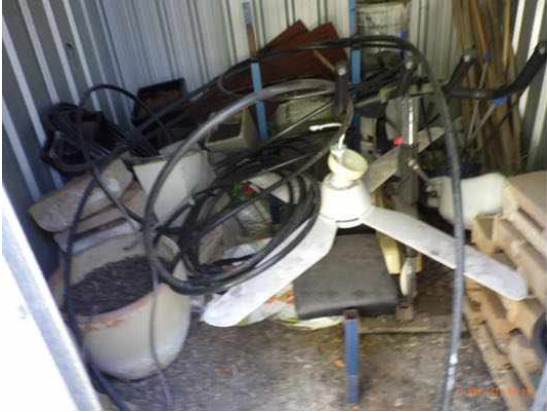
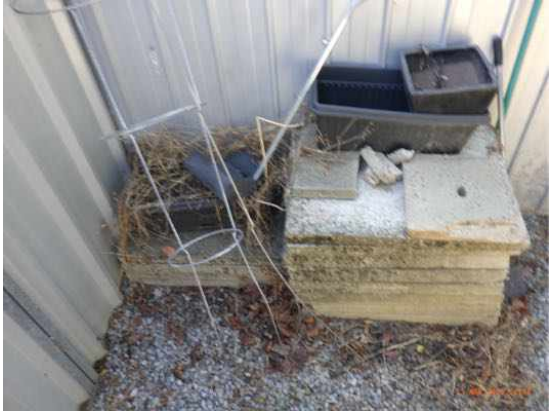
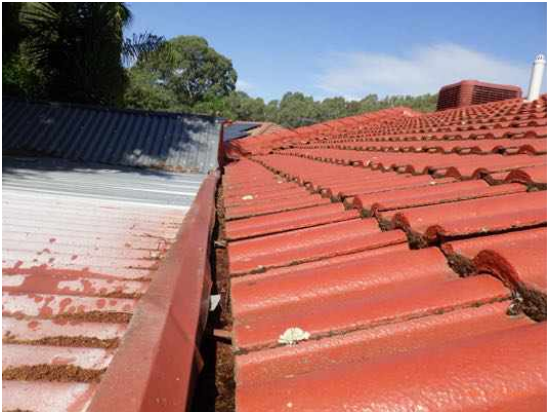
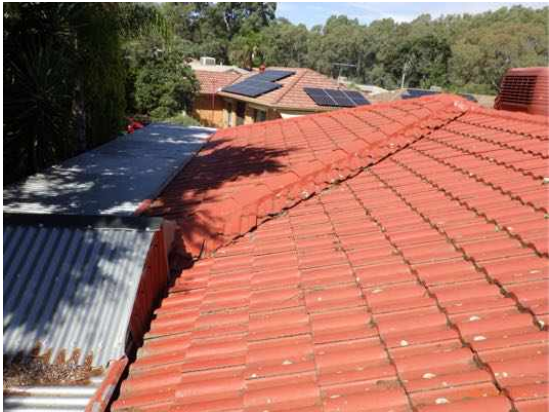
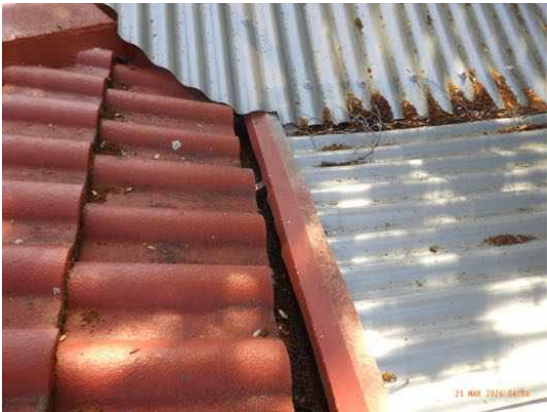
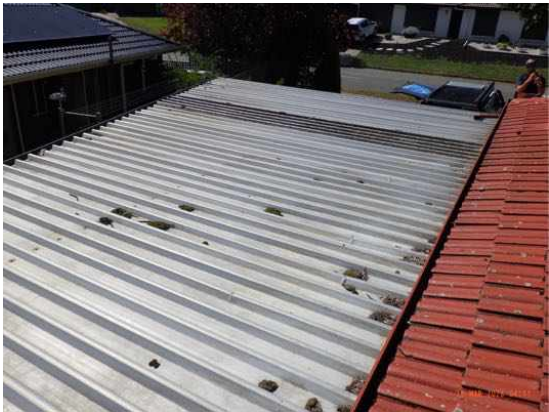
Noted Item

Building: Building 1
 Location: All Areas
 Finding: Additional Photos - Obstructions and Limitations
 Information: These photographs are an indication of the obstructions and limitations which impeded full inspection of the property at the time of inspection. These obstructions can hide an array of defects and should be removed to allow full inspection to be carried out. Reinspection is recommended once access is provided.

Please note access to the roof void was pretty much non-existent due to multiple ducts crossing over the manhole.
