Building Inspection Report

Inspection Date: Tue, 27 Jan 2026

Property Address: 410/7 Hinchcliffe Pl, Zetland NSW 2017,
Australia

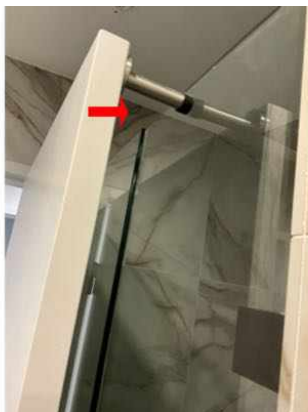
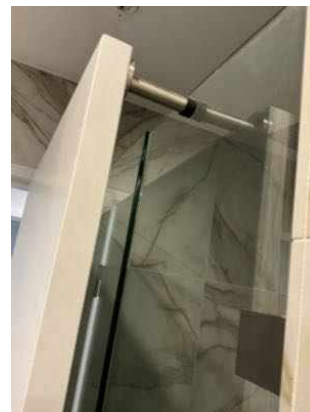
Defects 1.01

Information: The door stopper swings open and directly contacts the glass shower screen, which poses a risk of damage to the screen over time due to repeated impact. This may result in cracking, chipping, or shattering of the glass, creating a potential safety hazard for occupants.

A qualified handyman or carpenter should install a doorstop or restrictor to prevent the door stopper from swinging into the shower screen..

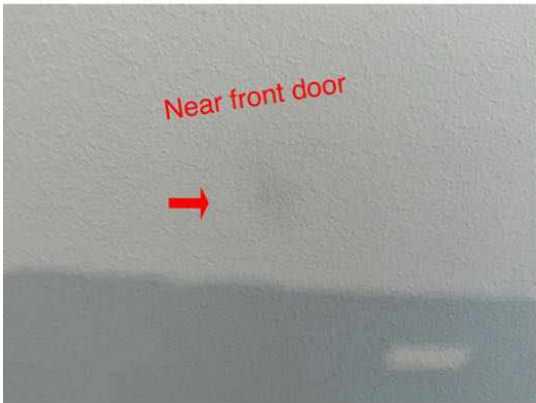
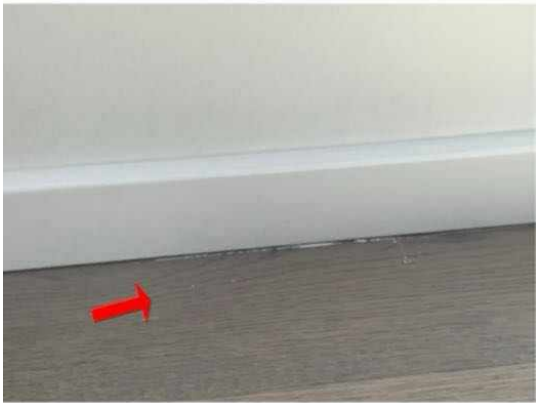
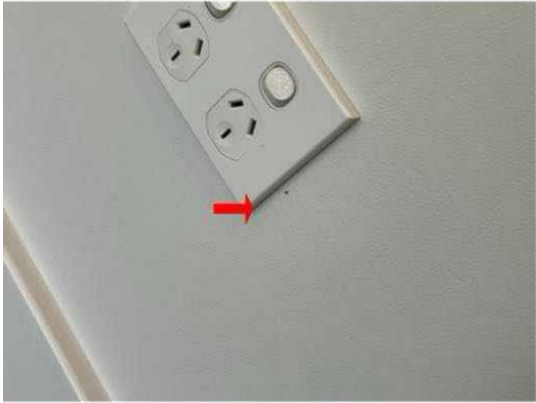
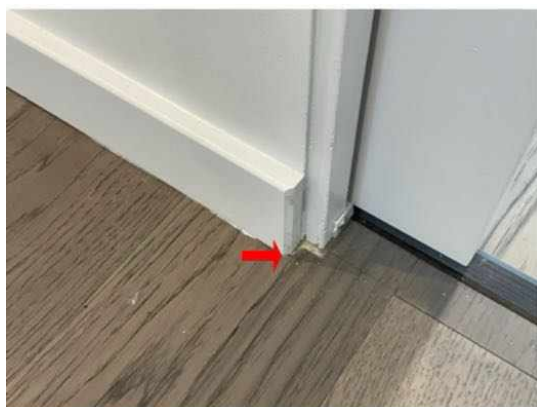
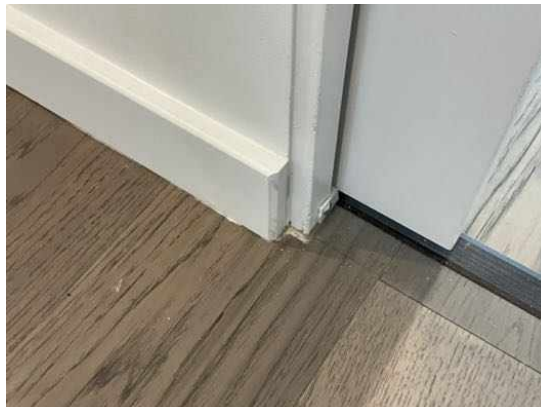
Defects 3.02

Building:	Main Building
Location:	All Areas
Finding:	Paint - Substandard
Information:	Areas were identified where the surface finish of the painting is substandard and this is considered a defect.

Any irregularity in the surface which is visible from a normal viewing position is considered a defect. Marks may also be a result of fault by other tradespeople throughout the construction process.

Defective surface finish of paintwork is marked with an arrow to the below photos in

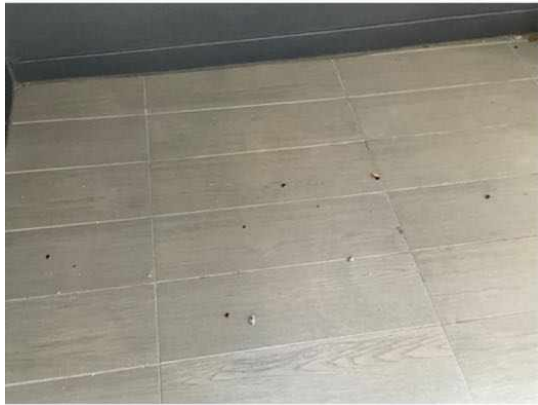
Defects 3.03

Building:	Main Building
Location:	All Areas
Finding:	Cleaning required
Information:	It was observed that the house requires cleaning.

Works are defective where windows are not clean, floors are not swept, mopped or vacuumed as appropriate, tiles, sinks, basins, baths, windows or any other area throughout the property are not cleaned, and shelving, drawers and cupboards are not ready for use not cleaned and ready for use at handover.

This is to be addressed prior to handover.

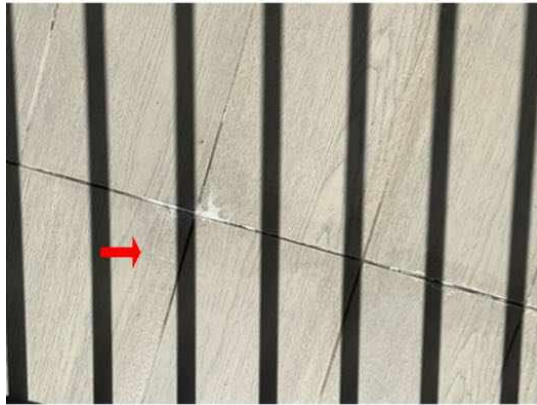
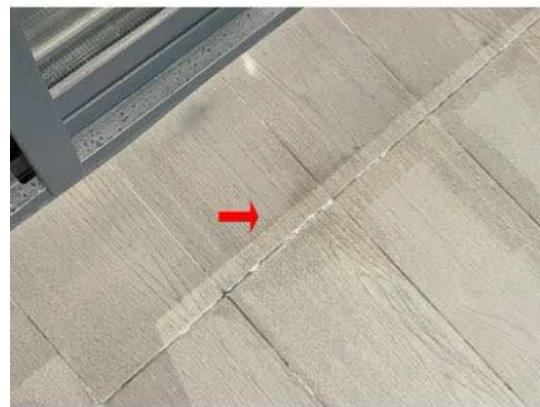
Defects 3.04

Building:	Main Building
Location:	All Areas
Finding:	Balcony - Efflorescence and Moisture Staining to External Tiled Floor
Information:	White crystalline deposits (efflorescence) and visible moisture staining were observed across grout lines and tile surfaces. This condition is commonly associated with the movement of moisture through the tile bed or substrate, which dissolves soluble salts and deposits them on the surface as water evaporates.

- Indicates potential waterproofing failure or inadequate drainage.
- May lead to tile delamination, deterioration of grout and adhesive, and long-term moisture damage to the substructure.
- In severe or persistent cases, dampness may migrate into internal areas, potentially leading to mould growth or structural deterioration.
- Surface may become slippery, increasing the risk of slips and falls.

- Engage a licensed waterproofing contractor to conduct moisture testing and assess

the integrity of the waterproofing membrane.

- If failure is confirmed, rectification may require tile removal and reapplication of a compliant waterproofing system, followed by re-tiling by a qualified tiler.
- If moisture ingress is suspected to affect internal structural components, an invasive inspection by a registered building consultant or structural engineer is recommended.

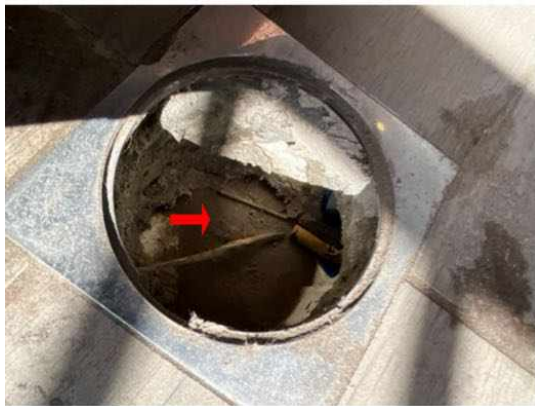
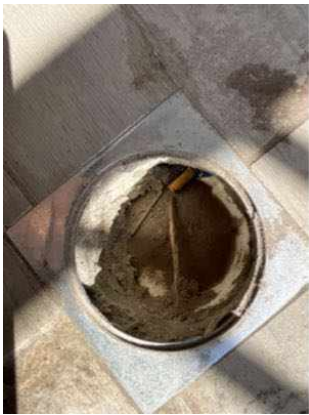
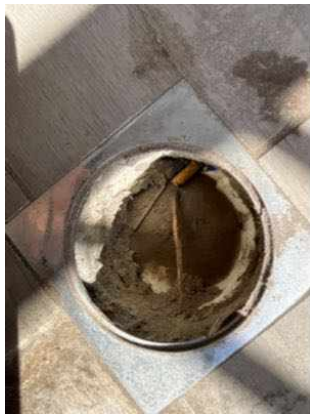
Defects 3.05

Building:	Main Building
Location:	All Areas
Finding:	Floor waste Debris
Information:	It was noted that there is builder debris in the floor waste drainage. Debris in the plumbing system may lead to blockages in the future.

This is referenced against the Australian Standards and Tolerances clause 19.8 Cleaning - Owners are entitled to expect that the building site and works are clean and tidy on completion.

Building sites are defective if they are not clear of building debris. All floor wastes need to be checked and cleared prior to handover.

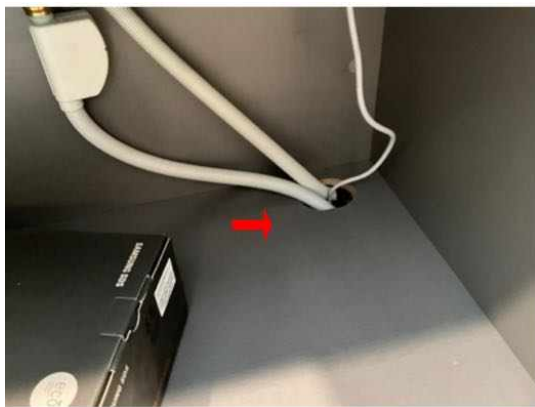
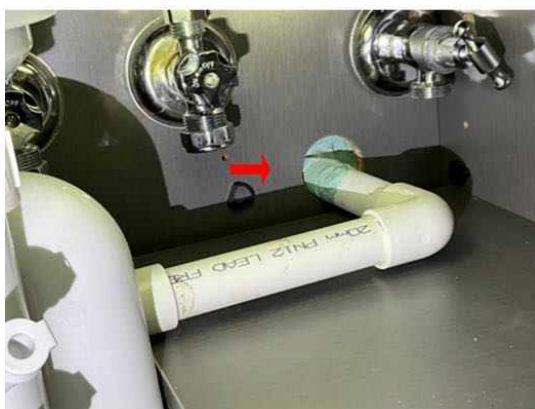
Defects 3.06

Building: Main Building
 Location: All Areas
 Finding: Pipe Penetrations - caps required
 Information: It was noted that at the time of the inspection the pipe penetrations were defective as stated in the Australian Standards and Tolerances 7.3.

Plumbing holes are defective if they are not:

- properly grouted as appropriate
- fitted through neat minimal size penetrations (in the case of cabinet network)
- fitted with tight fitting cover plates or collars with penetrations kept to the smallest size practicable.

This is to be rectified prior to handover.

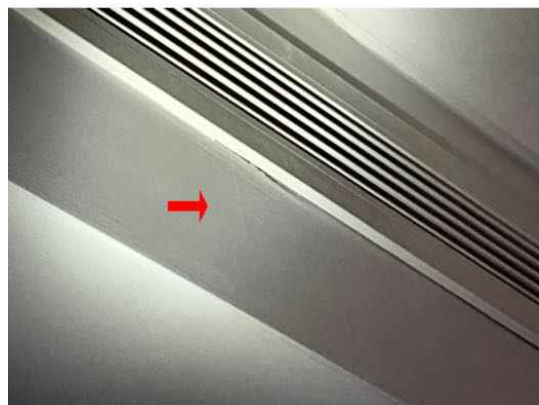
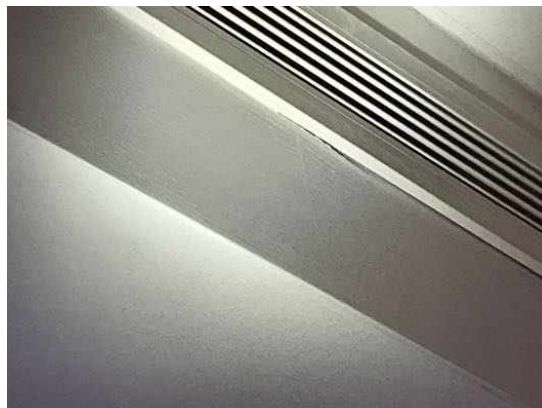
Defects 3.08

Building:	Main Building
Location:	Living Room
Finding:	Cracking - Damage Category 0 - Hairline (less than 1mm)
Information:	Hairline cracks are very minor in nature and generally are only ever an appearance defect. While such cracking may be noticeable in some cases, it is quite common and does not indicate any structural damage.

Cracking of this nature can generally be repaired with minor sanding, filling and/or repainting. Such works should be performed by a qualified painter or a general handyman.

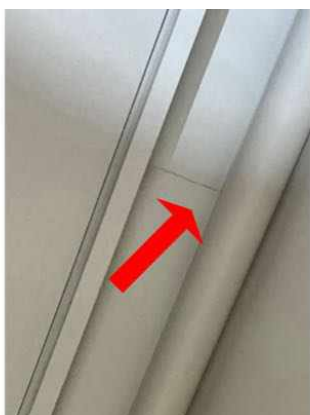
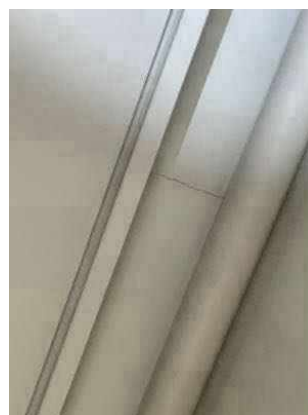
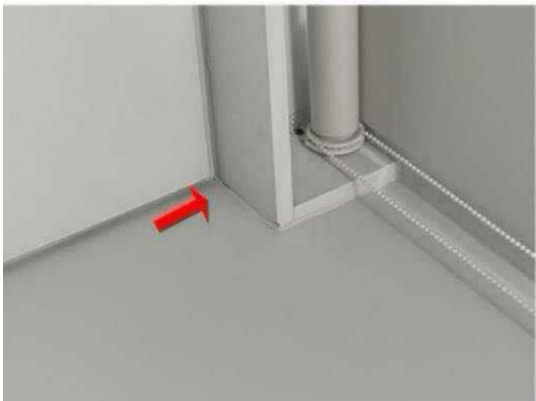
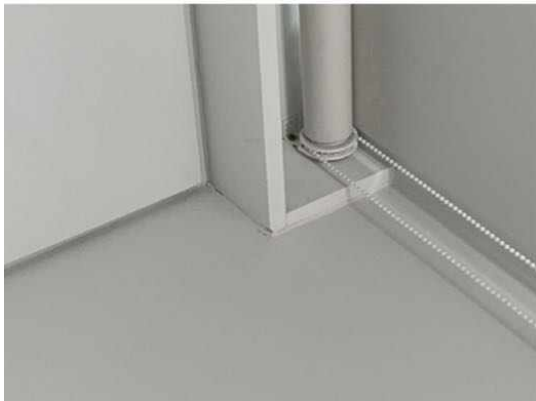
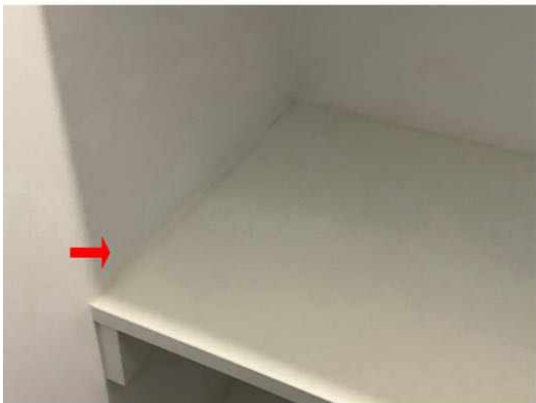
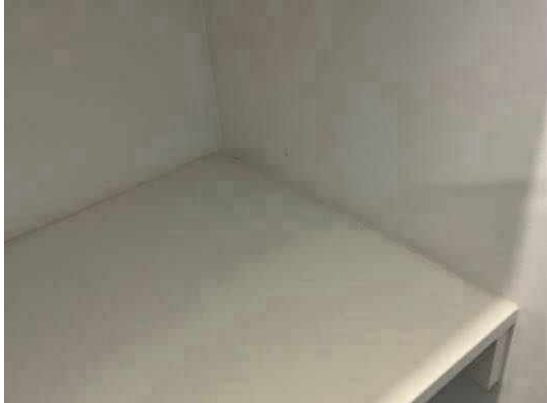
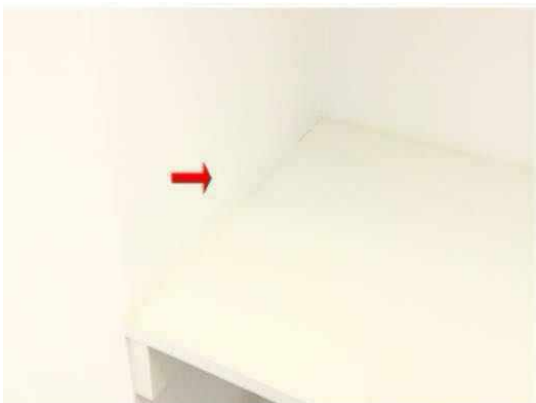
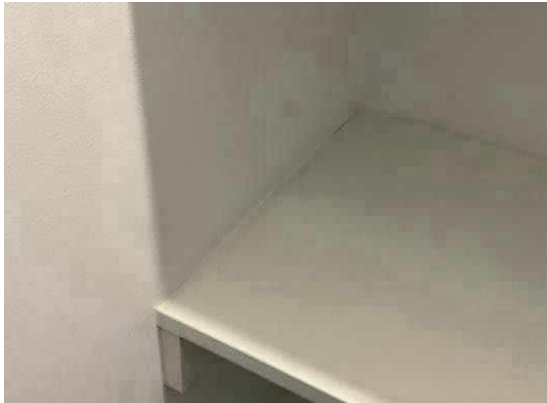
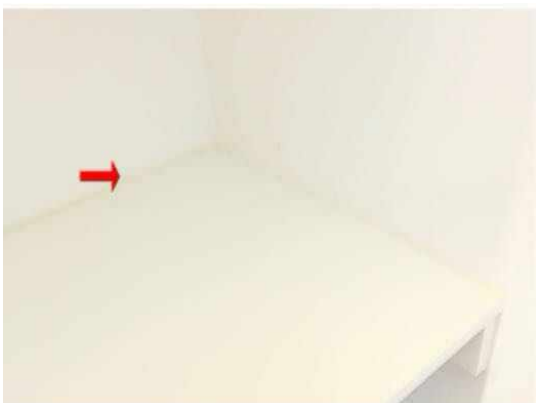
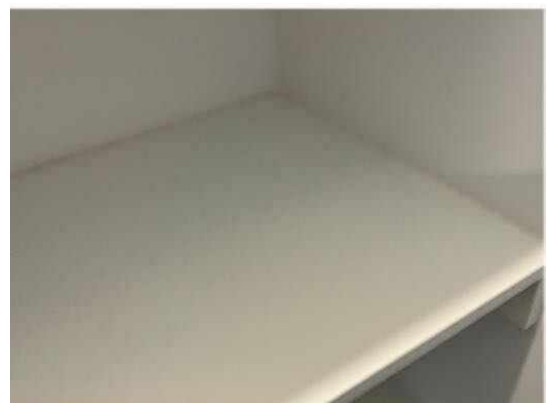
Defects 3.09

Building:	Main Building
Location:	All Areas
Finding:	Substandard Work- Various Areas of the Building
Information:	Substandard work has been identified in multiple areas throughout the building, failing to meet the requirements specified by Australian Guides and Tolerances.

- ****Paint Application:**** Inconsistent and incomplete paint coverage on walls, ceilings, and downpipes, with visible brush marks, drips, and streaks.
- ****Surface Preparation:**** Poor surface preparation resulting in inadequate paint adhesion.
- ****Flooring:**** Uneven flooring with dips and bumps exceeding allowable tolerances.

- **Plasterwork:** Cracks in plaster exceeding the acceptable width as specified in the Guide to Standards and Tolerances.

- **Fixtures and Fittings:** Misaligned or improperly installed fixtures and fittings, not meeting the standard requirements for level and alignment.

- Repainting surfaces with proper surface preparation and uniform application.
- Correcting uneven flooring to meet the specified tolerances.
- Repairing or replacing cracked plaster to ensure compliance with acceptable standards.
- Realigning and properly installing fixtures and fittings.

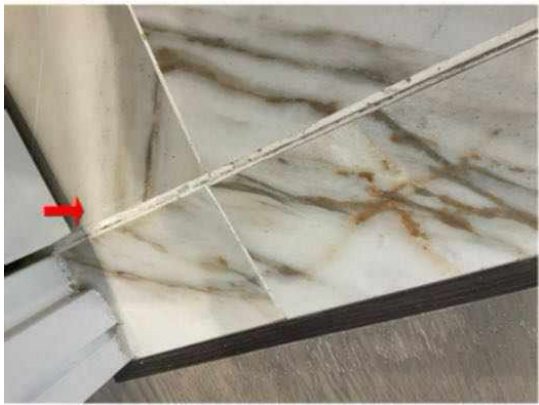
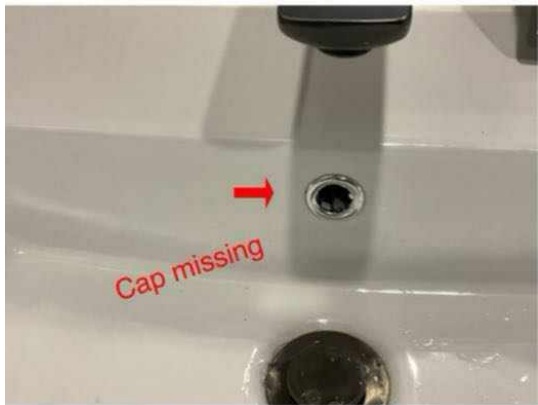
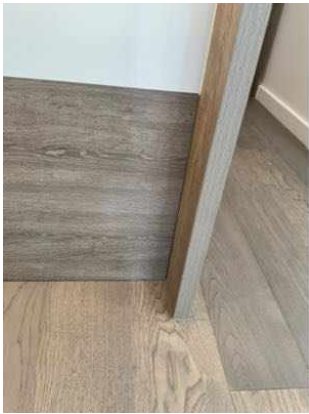
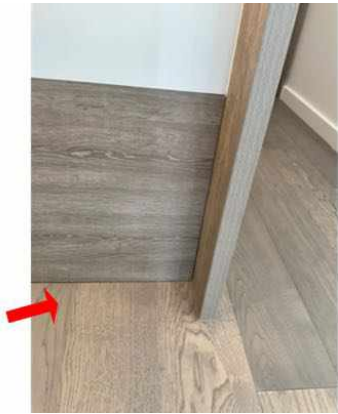
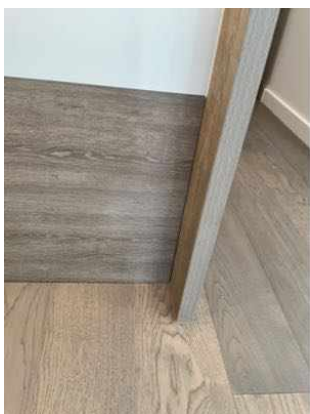
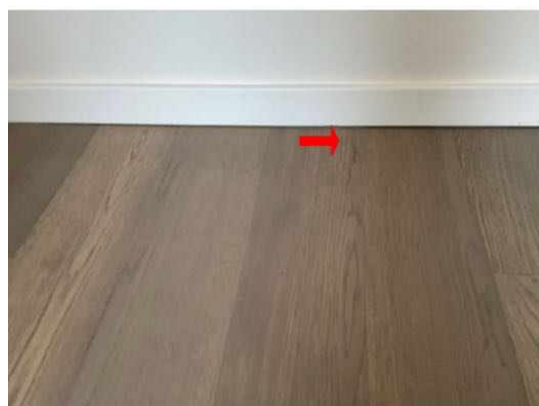
- Accelerated deterioration and reduced durability of the affected elements.
- Compromised aesthetic quality and overall value of the property.
- Potential safety hazards and increased maintenance costs.
- Negative impact on the building's functionality and usability.

A comprehensive inspection should be conducted post-repairs to ensure all rectifications comply with the required standards.

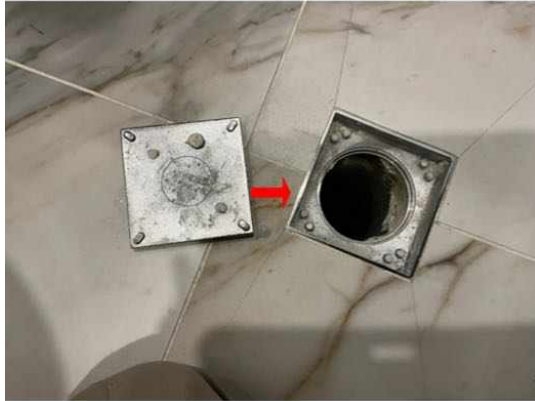
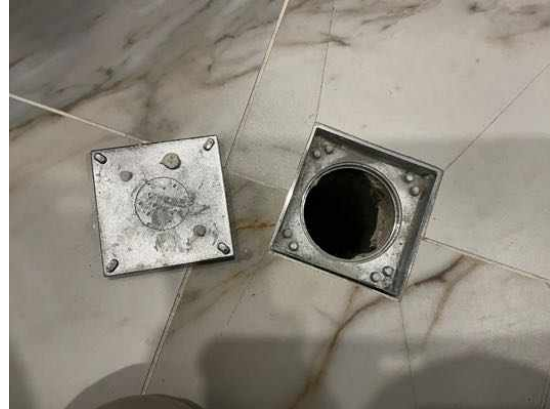
Defects 3.10

Building:	Main Building
Location:	Ensuite
Finding:	Floor waste- missing internal grill component (strainer or insert)
Information:	The drain cover in the tiled floor area is missing its internal grill component (strainer or insert), exposing a direct opening into the drain pipe. This is considered a non-compliant installation as the drain cover is incomplete.

prevents debris from entering the drainage system and ensures the safe operation of the drain.

- The Guide to Standards and Tolerances 2017, Section 13 (Plumbing and Drainage), notes that drainage systems should be installed in accordance with relevant standards, including correct fitting of drain covers and grates to ensure hygiene, safety, and protection from blockages.

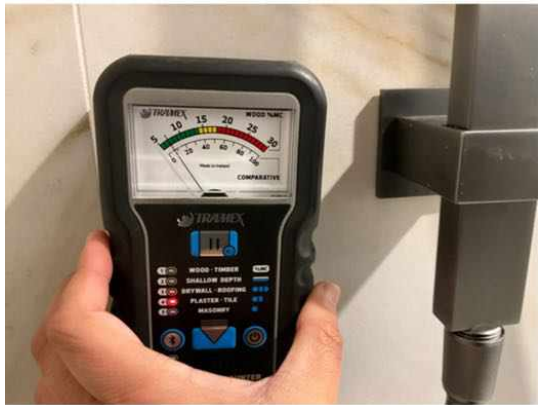
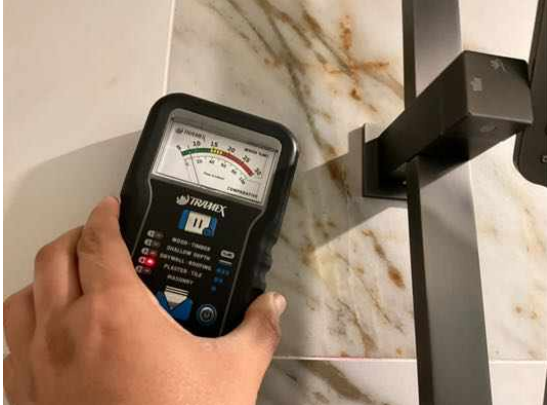
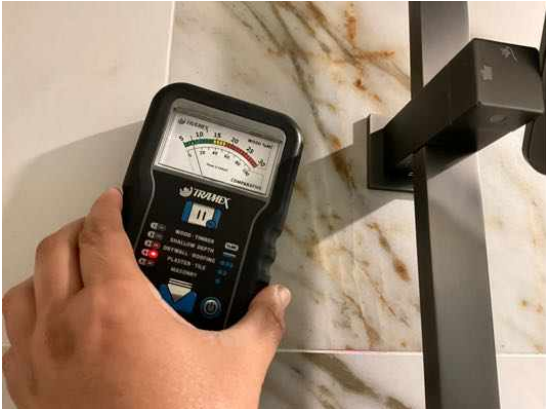
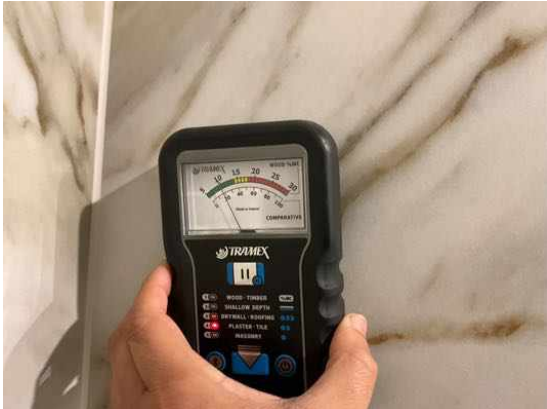
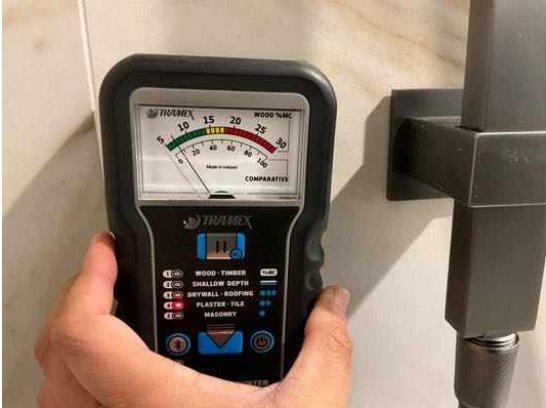
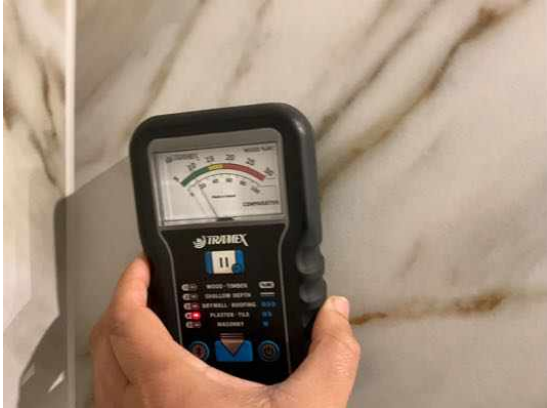
Noted Item

- Building: Main Building
- Location: All Areas
- Finding: Additional Photos
- Information: Additional photos are provided for your general reference

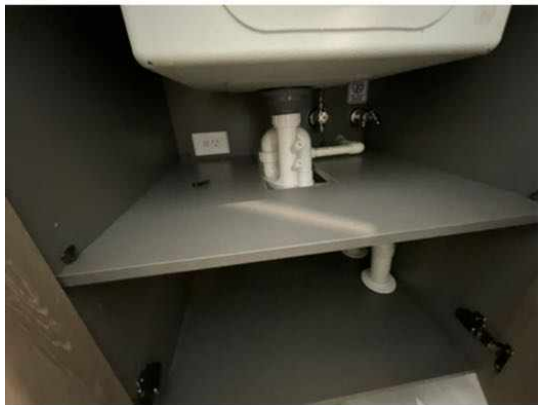
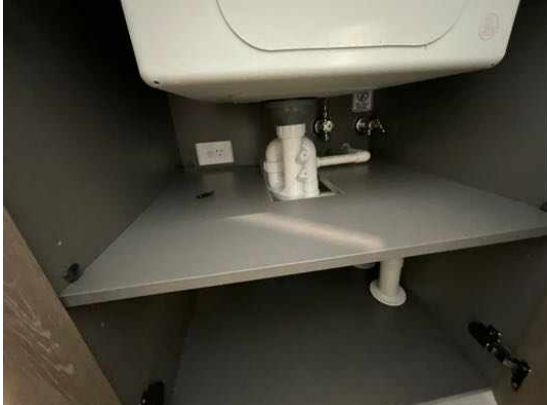
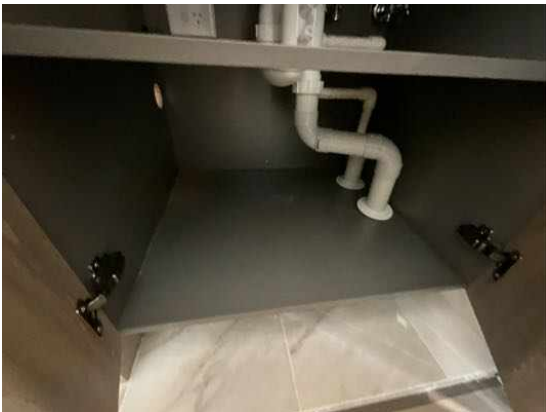
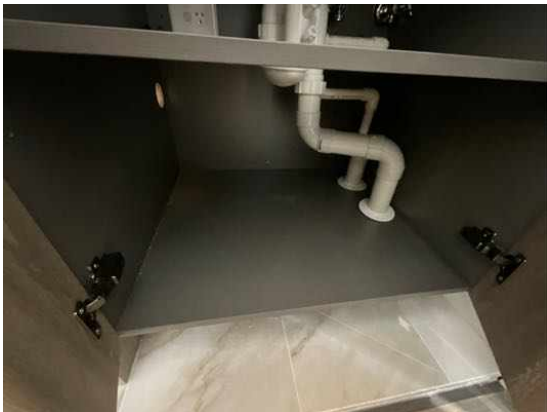
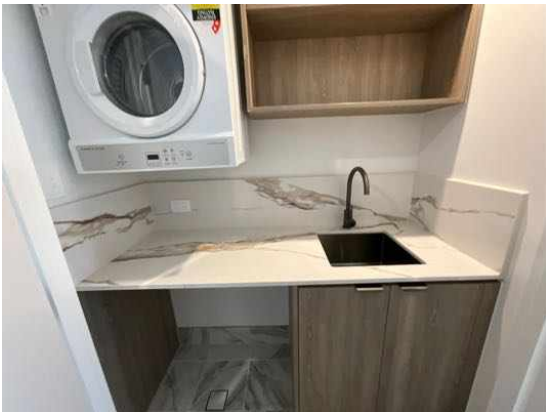
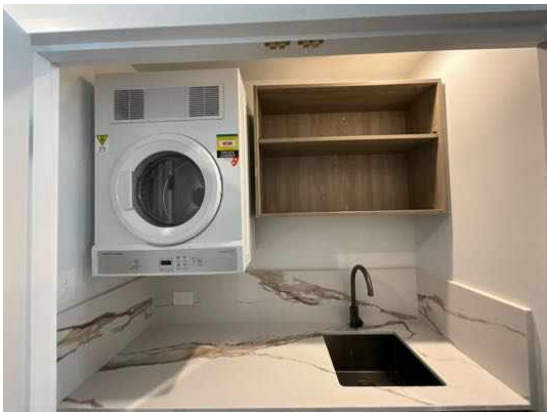
Noted Item

Building: Main Building
Location: All Areas
Finding: Additional Photos - Obstructions and Limitations
Information: These photographs are an indication of the obstructions and limitations which impeded full inspection of the property at the time of inspection. These obstructions can hide an array of defects and should be removed to allow full inspection to be carried out. A re-inspection is recommended once the areas are made accessible.
