Building and Timber Pest Inspection Report

Inspection Date: Fri, 6 Feb 2026

Property Address: 6/47 West St, Hurstville NSW 2220,
Australia

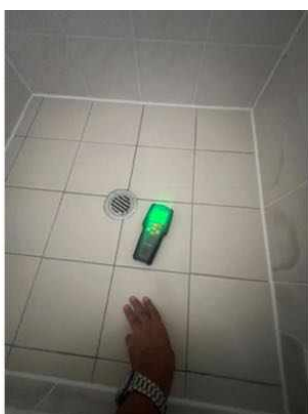
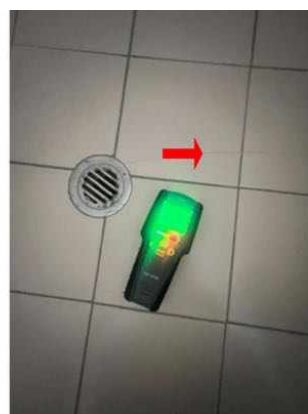
Building: Main Building
Location: Bathroom
Finding: Cracked Shower Tiles & Elevated Moisture – Bathroom (Also refer to defect 3.1)
Information: Cracked tiles were noted within the shower area, and moisture readings returned elevated levels above typical thresholds. This defect may be contributing to concealed water penetration due to cracked tiling on the floor and could lead to further damage if not remediated.

Recommend investigation by a licensed plumber and waterproofing contractor to access further followed by a licensed tiler.

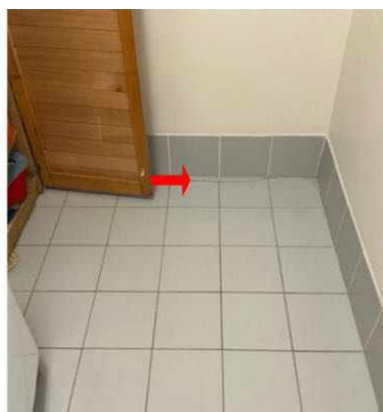
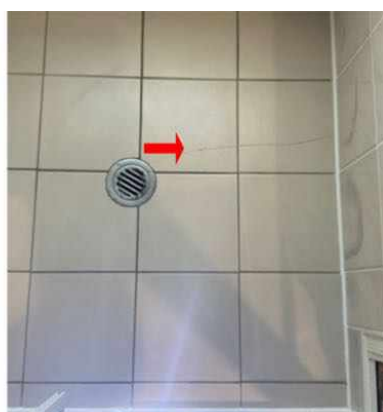
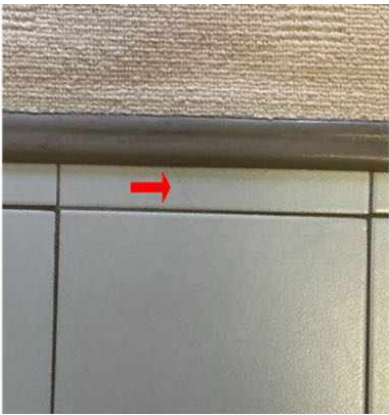
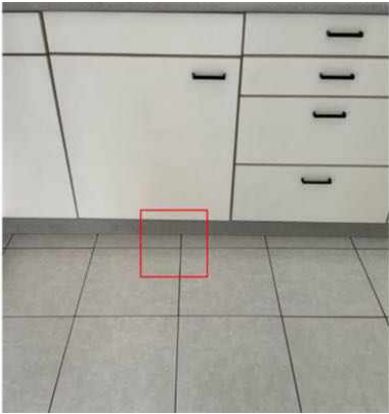
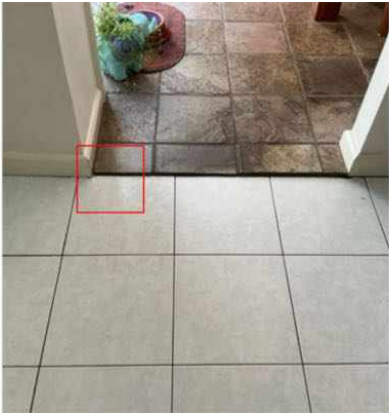
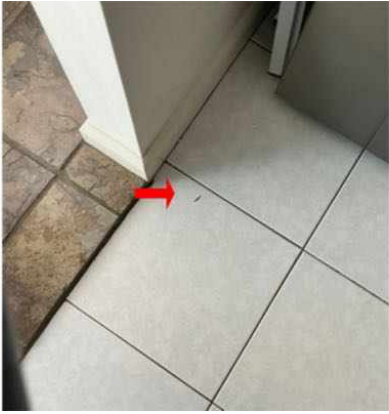
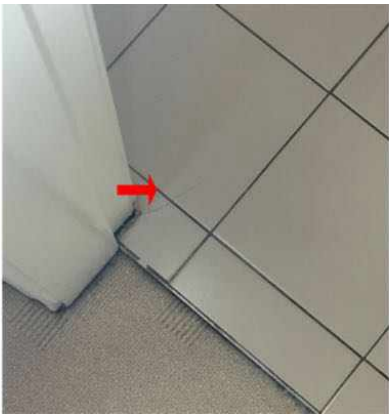
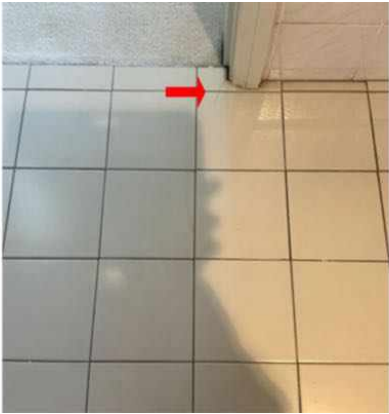
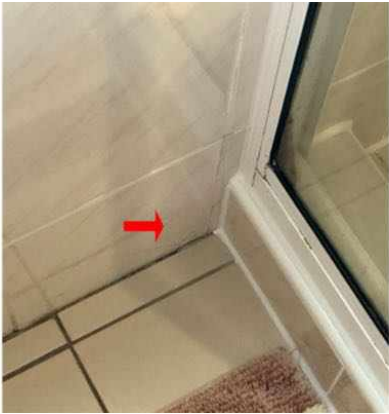
Finding 3.01

Building: Main Building
Location: All Internal Areas - Toilet, laundry, kitchen, main bathroom
Finding: Tiles - Cracked or damaged
Information: Cracking was evident to the tiling in this area at the time of inspection. While the cracking appears to be minor, this area is frequently exposed to water, allowing potential for water penetration into adjoining sections of walls or flooring. (shower area, laundry)

If left unmanaged, water penetration to these areas may lead to subsequent water damage, which is likely necessitate repair work to affected building elements.

A tiling contractor should be appointed to ensure that no further water damage occurs. The re-application of silicone and grouting throughout remaining tile work is also advised, to further protect the area against water penetration.

Where water penetration has led to water damage, appointment of a relevant tradesperson may be required to repair damaged building elements.

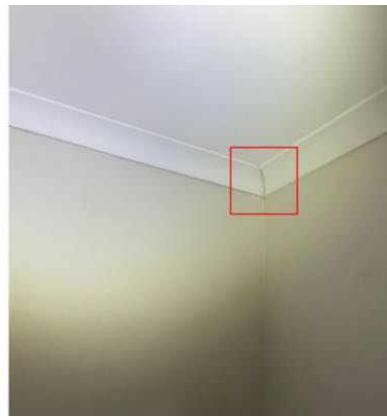
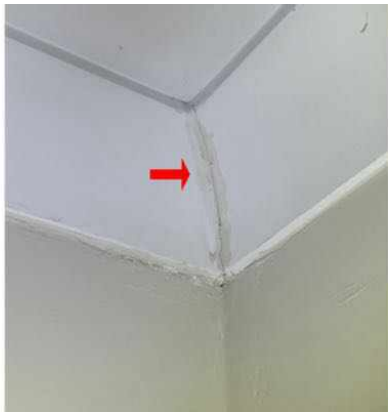
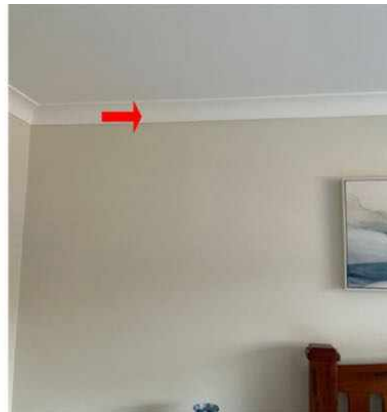
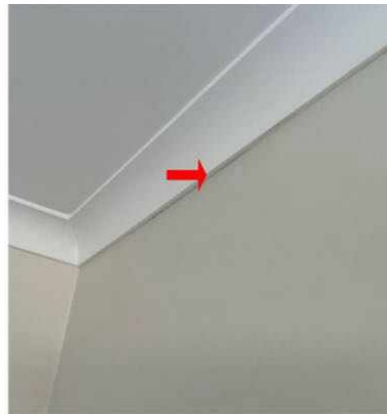
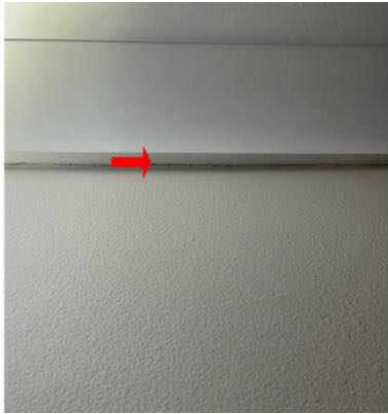
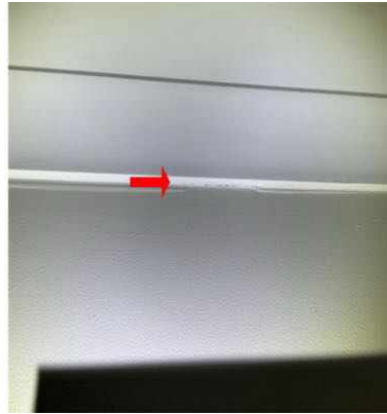
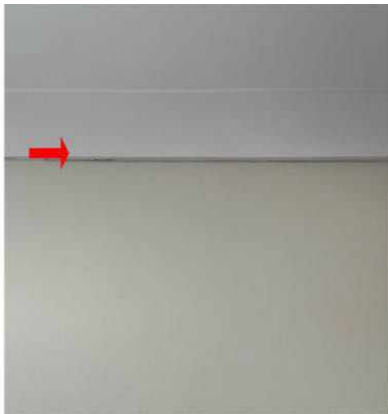
Finding 3.02

Building: Main Building
Location: Bedroom - Master
Finding: Moisture Damage and Minor Mould at Ceiling–Wall Junction
Information: Moisture staining, plaster deterioration and localised separation were observed at the ceiling–wall junction, with very minor possible mould present beneath the cornice. The condition is not consistent with normal settlement alone and indicates past or intermittent moisture ingress, potentially from roof leakage, flashing or gutter issues, or condensation within the ceiling space. While the visible mould is limited, the presence of staining and material breakdown suggests the area has been subjected to prolonged damp conditions. Further investigation is recommended to identify and rectify the moisture source before cosmetic repairs are undertaken, with ongoing monitoring to confirm no recurrence, in accordance with the intent of AS 4349.1.

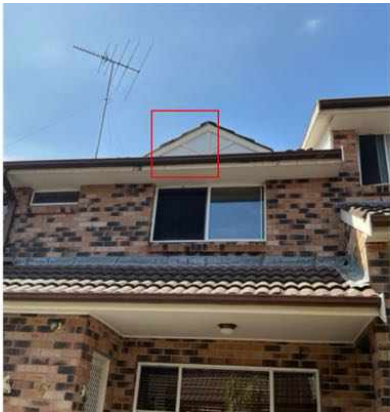
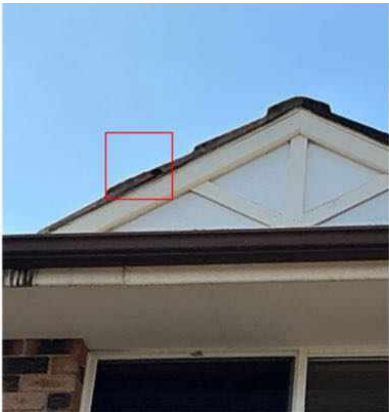
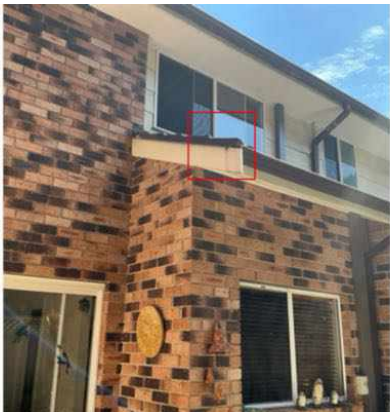
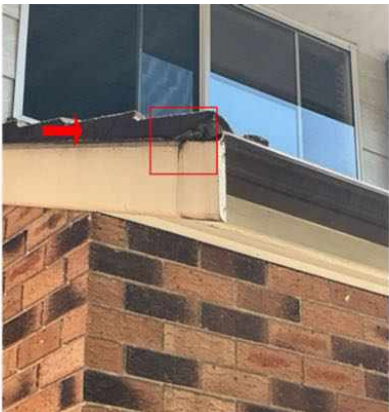
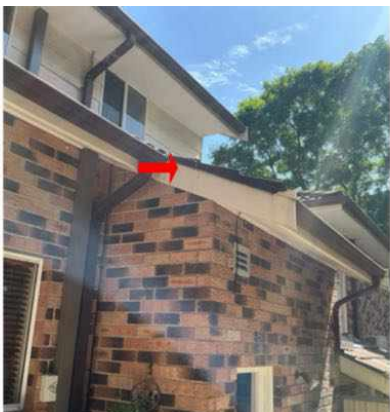
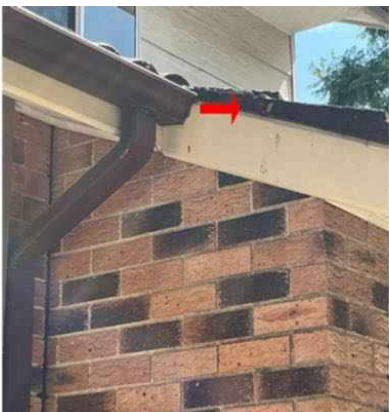
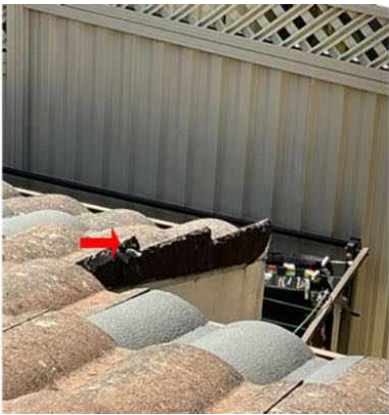
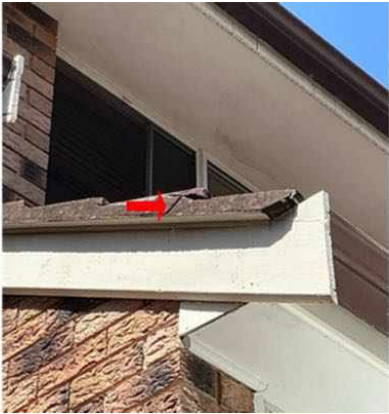
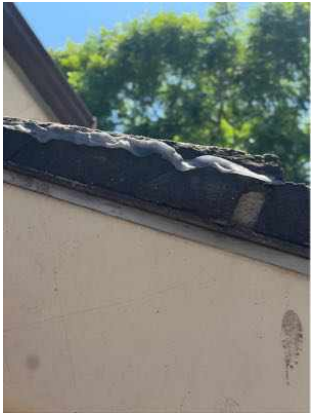
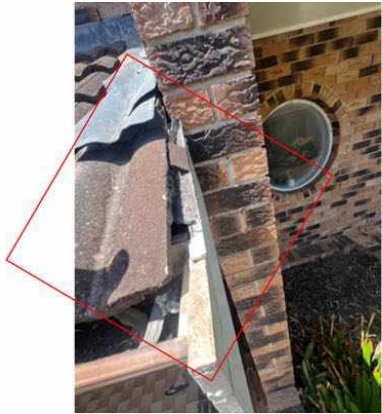
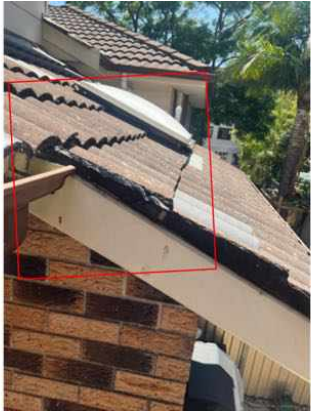
Finding 3.03

Finding: Mortar - Deterioration (Possible moisture ingress)

Information: Mortar, or 'bedding', is the material which fills joints and intersections between tiles and other building elements on the exterior roof covering, such as gable ends, hip capping and valleys. Upon inspection of the exterior roof, it was noted that sections of the mortar show varying levels of deterioration.

Mortar generally deteriorates as a result of frequent exposure to weather conditions over a prolonged period of time. Mortar that is deteriorating may allow water ingress into the roof void, putting associated building elements and roofing structures at risk of

water damage. Deteriorated mortar also detracts from the functionality of roof tiles and other roofing elements, potentially decreasing weather tightness and roof drainage.

Mortar deterioration can be attended to by a handy person where areas of deterioration are localised and easily accessible. Otherwise, consultation with a roofing contractor is advised where greater works are required.

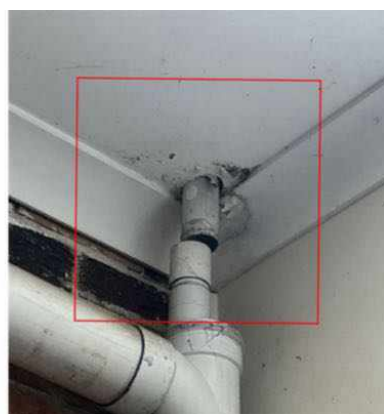
Finding 3.04

Building: Main Building
 Location: Garage
 Finding: Ceiling - Water damaged
 Information: Water damage to the ceiling lining is generally an indication of excessive moisture being present in the roof void, usually via a leak to the roof covering.

Where water damage is evident to the ceiling, the primary requirement is to identify and rectify the source of the leak. A roofing plumber should be appointed as soon as possible to identify the leak and perform rectification works as necessary, ensuring the water damage is restricted.

Once the leak is repaired, consultation with relevant tradespeople, including plasterers and painters, is advised. Rectification works may include replacement of ceiling lining or minor repainting, depending on the extent of the damage.

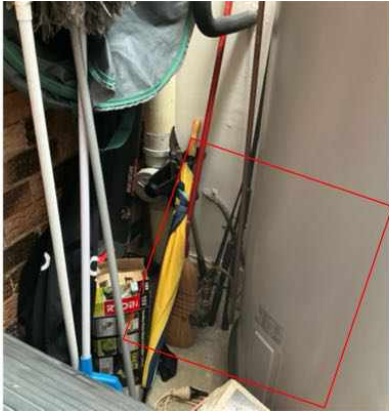
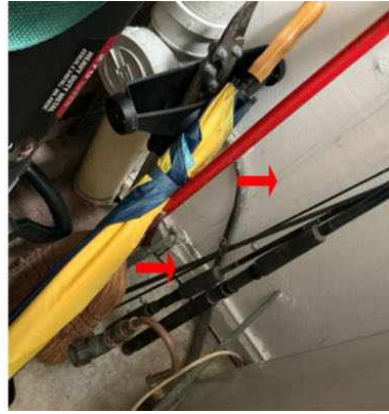
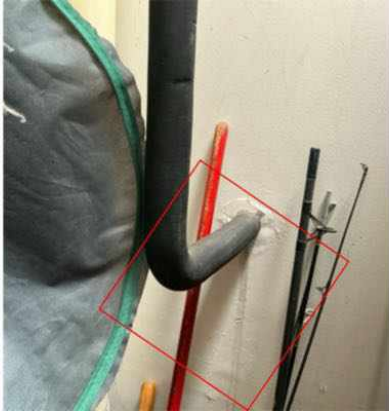
Finding 3.05

Building: Main Building
 Location: Garage
 Finding: Building element - Damaged (Moisture damage)
 Information: Breakage occurs generally when the building materials have either aged and decayed, or as a result of damage (accidental or deliberate).

Repair and/or replacement of broken elements is advised to ensure that additional secondary defects do not arise as a consequence. Such works are necessary, as all building elements play a key role in the operation and function of the overall structure and its performance.

A relevant tradesperson should be appointed to repair or replace the affected building element prior to any subsequent damage being caused.

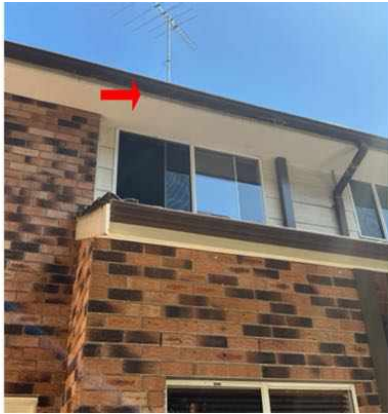
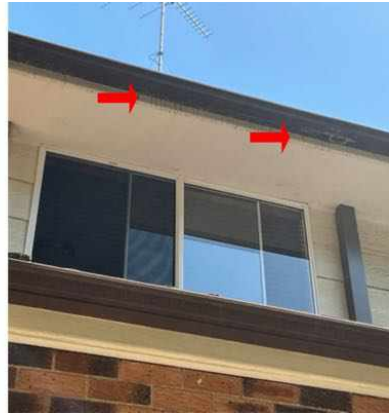
Finding 3.06

Building:	Main Building
Location:	All External Areas
Finding:	Moisture Staining to Eaves / Soffit /Fascia
Information:	Moisture staining was observed to the external eaves/soffit lining/Fascia consistent with past or ongoing water runoff from the gutter line above. This condition is commonly associated with overflowing or leaking gutters, inadequate falls, blocked downpipes, or deteriorated gutter joints, allowing water to track back onto the fascia and soffit. While no significant deformation is visible, continued moisture exposure can lead to deterioration/wood rot of the fascia, soffit lining, fixings, and concealed framing over time. Further inspection of the guttering system is recommended, with cleaning, repair or adjustment as required, and monitoring after rectification in accordance with the intent of AS 4349.1.

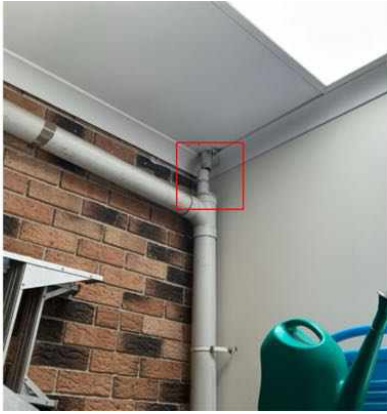
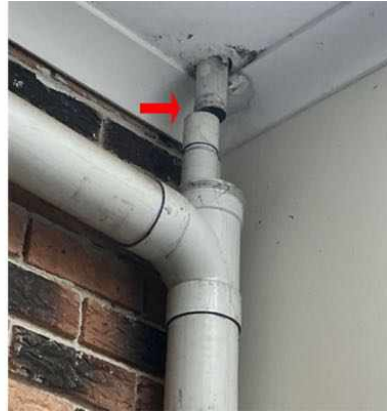
Finding 3.07

Building:	Main Building
Location:	Garage
Finding:	Incomplete or substandard works (Pipe not connected possible water ingress)
Information:	The works to this area appear to be incomplete or have been completed to a substandard level.

Works that have not been completed to a satisfactory level create potential for the development of building defects and may impede on the safety and integrity of the overall structure.

rectification by a licensed plumber is recommended to reduce the likelihood of ongoing moisture entry.

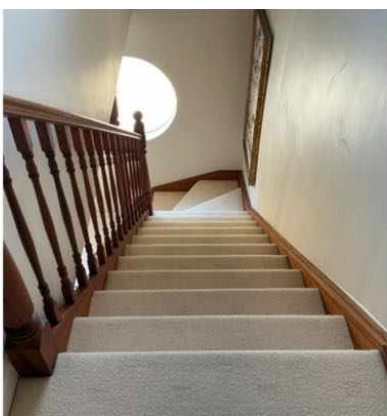
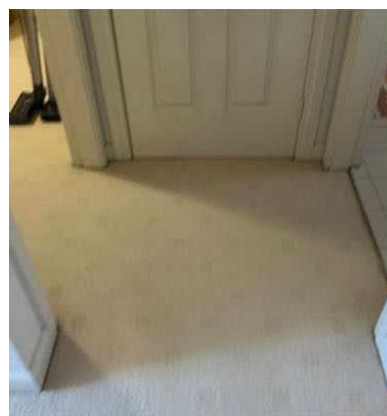
Bouncy floors generally indicate that the floorboards or the subfloor structures are coming loose from the joists that they are installed on. Bouncy flooring may also be the result of gaps between flooring and stumps or joist structures, which require packing.

The client is advised to seek quotations for required repairs from a Registered Builder specialising in re-stumping. The potential resolution may range from packing gaps in subfloor structures through to replacement of subfloors stumps and refixing of flooring.

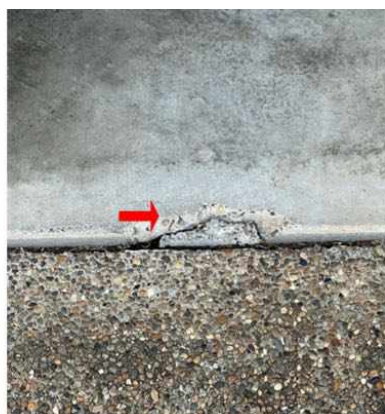
Finding 3.09

Building:	Main Building
Location:	All External Areas
Finding:	Building element - Damaged - Concrete damage
Information:	Breakage occurs generally when the building materials have either aged and decayed, or as a result of damage (accidental or deliberate).

Repair and/or replacement of broken elements is advised to ensure that additional secondary defects do not arise as a consequence. Such works are necessary, as all building elements play a key role in the operation and function of the overall structure and its performance.

A relevant tradesperson should be appointed to repair or replace the affected building element prior to any subsequent damage being caused.

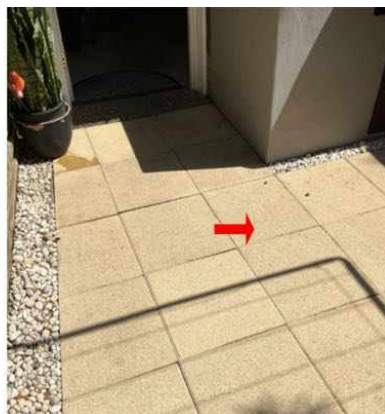
Finding 3.10

Building:	Main Building
Location:	All External Areas - Rear
Finding:	Paving - Uneven
Information:	Sections of the external paved area are uneven, creating a potential trip hazard. It appears as though the area has been subject to rough installation, or that paving

sections have lifted due to movements in the foundation of the property.

Where paving creates a trip hazard, personal injury may ensue if due caution is not taken by all persons within this area.

Re-paving of the area is required as soon as possible to remedy this situation. Further consultation with a specialist concreter is advised.

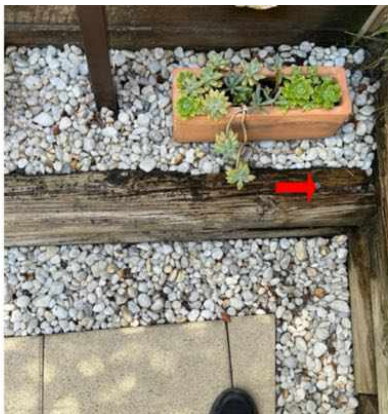
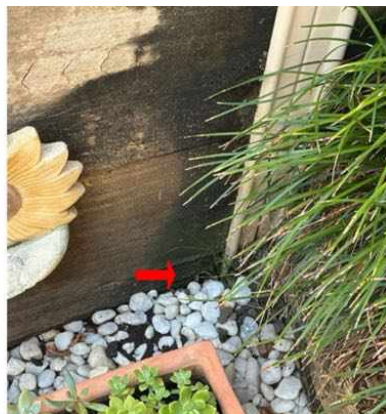
Finding 3.11

Building:	Main Building
Location:	All External Areas - Retaining wall
Finding:	Wood rot to some areas
Information:	This building element shows evidence of wood rot. Wood rot, also known as Fungal Decay, occurs when timbers and other cellulose building materials are exposed to damp conditions on an ongoing basis. This could be the result of exposure to weathering over a prolonged period of time, or the attraction of excessive moisture from other abutting building materials. Contributing factors also include poor air ventilation in the area.

Wood rot is often associated with general damp problems and is evidenced by a 'musty' smell or mould and mildew occurring on surfaces. If left unmanaged, damp conditions can lead to further health problems and the decay of timbers will continue.

Early intervention and regular maintenance, particularly of exterior timbers, will prolong the useful life of these building elements. Prior to any works being performed, the cause of the moisture that has created the visible wood rot should be identified and addressed in a suitable manner. Replacement of affected timbers may then be a necessary step in protecting surrounding building elements from such deterioration.

A qualified plumber may be appointed to assess the cause of excessive moisture and to provide advice on any remedial works as required. A qualified carpenter or registered builder may also be required to replace affected building materials.

Even though Liverpool termite activity was not visible. A further invasive inspection by a licensed termite technician its also highly recommended to eliminate possibility of potential termite activity.

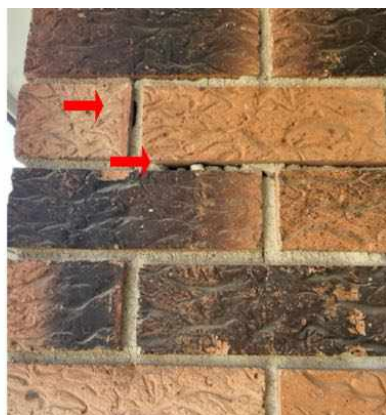
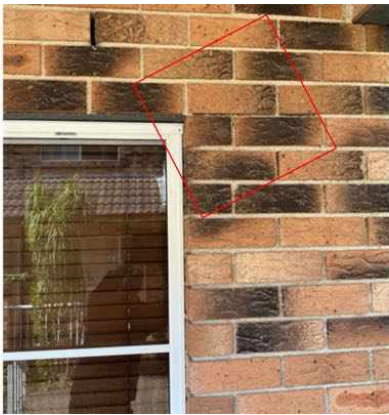
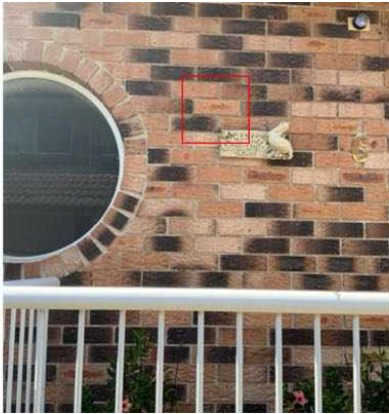
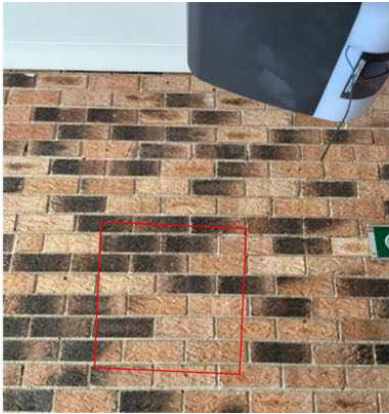
Finding 3.12

Building: Main Building
 Location: All External Areas
 Finding: Brickwork - Deteriorated mortar to some areas
 Information: Mortar, or 'bedding', is the material which fills joins and intersections between bricks in masonry walls and structures. Sections of mortar in this brickwork were identified as having deteriorated, which is generally expected for a property of this age and condition.

Mortar may deteriorate as a result of age of building materials, minor movement of bricks, or frequent exposure to weathering. Mortar should be replaced to ensure that bricks remain in their intended location and to prevent gaps, which would allow water or moisture ingress and secondary damage as a result.

Mortar deterioration can be addressed by a bricklayer where areas of deterioration are localised and easily accessible. Alternatively, appointment of a registered builder is advised, to repoint large areas of decaying mortar. Where secondary structural defects have become evident, consultation with a structural engineer may be required.

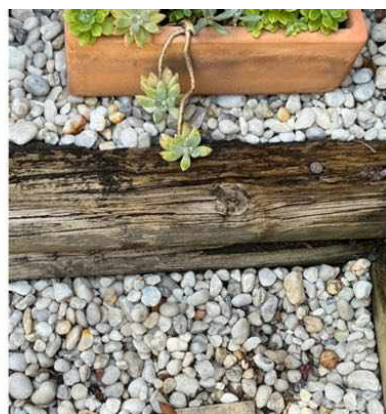
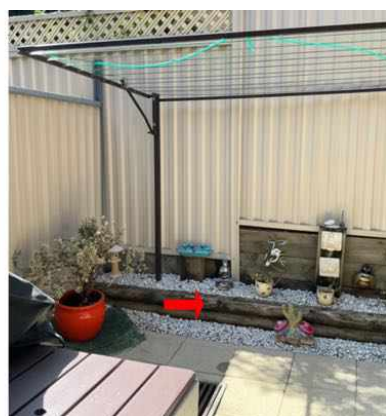
Finding 3.13

Building:	Main Building
Location:	All External Areas - Rear
Finding:	Retaining wall - Defective (Wood rot and splitting timber) to some areas
Information:	The retaining wall in this area was found to be defective at the time of inspection. Generally, defective retaining walls are caused by poor original design or material use. However, deteriorated retaining walls may also be a result of substandard construction, poor site drainage or unmanaged stormwater flows.

If left unmanaged, the retaining wall may become a safety hazard if it continues to destabilise. Where retaining walls further rot and decay, an environment is created that is conducive to termite and pest infestation.

Significant repair and replacement should be expected. Where retaining walls are considered structural walls, a structural engineer / surveyor should be consulted regarding required remedial works. Otherwise, a landscaper or retaining wall installer may be appointed to repair or replace the wall, at the discretion of the client.

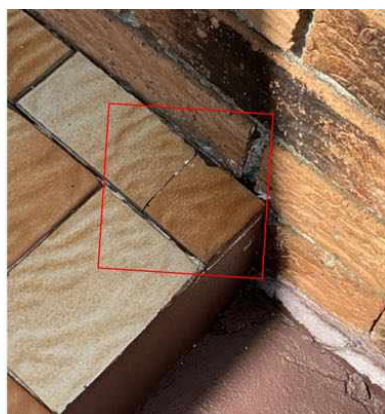
Finding 3.14

Building:	Main Building
Location:	All External Areas - Front
Finding:	Tiles - Cracked or damaged
Information:	Cracking was evident to the tiling in this area at the time of inspection. While the

cracking appears to be minor, this area is frequently exposed to water, allowing potential for water penetration into adjoining sections of walls or flooring.

If left unmanaged, water penetration to these areas may lead to subsequent water damage, which is likely necessitate repair work to affected building elements.

A tiling contractor should be appointed to ensure that no further water damage occurs. The re-application of silicone and grouting throughout remaining tile work is also advised, to further protect the area against water penetration.

Where water penetration has led to water damage, appointment of a relevant tradesperson may be required to repair damaged building elements.

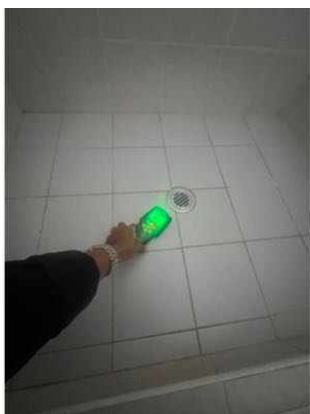
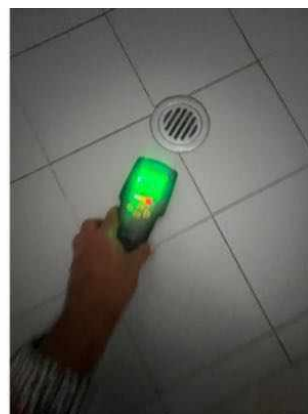
Finding 3.15

Building:	Main Building
Location:	Ensuite
Finding:	Elevated Moisture Bathroom (No visible deterioration noted)
Information:	Elevated moisture levels were detected to tiled surfaces in bathroom/shower areas. Persistent moisture ingress can lead to concealed damage, including timber rot and mould growth.

Elevated moisture readings in tiled wet areas can occur from normal shower use, age/deterioration of waterproofing membranes, plumbing leaks or moisture absorption through grout lines. While no damage was visible, elevated readings may indicate moisture retention behind tiles, which can be a conducive condition for future deterioration if not monitored.

No immediate action required. Monitor the area over time for signs of drumming, efflorescence, tile movement, or grout deterioration. If concerns arise, a licensed waterproofing specialist can perform further investigation (e.g., pressure testing, membrane assessment).

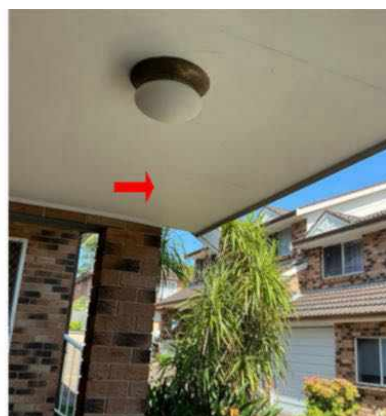
Finding 3.16

Building:	Main Building
Location:	All External Areas - Porch
Finding:	Ceiling - Sagging
Information:	Sections of the ceiling were found to be sagging at the time of inspection. Sagging to the fixed ceiling structure generally indicates that the building materials have swollen, due to contact with water, or that fixings (e.g. nails or glue) have become loose and require reattachment.

In some cases, sagging ceiling linings may also indicate that there are structural issues, causing surfaces to warp, twist or sag. Where sagging appears to be major, appointment of a structural engineer is advised to further inspect the property and identify the source and rectification works required.

Where minor sagging is evident, comparatively minor works, such as re-gluing of ceiling sheets, may be required. Such works may be performed by relevant tradespeople, such as plasterers and painters. Where excessive moisture has caused the roofing structure to swell and sag, the source of the water leak should primarily be identified prior to any remedial works being performed.

The appropriate action should be taken by the client as soon as possible to ensure that any potential further damage is limited.

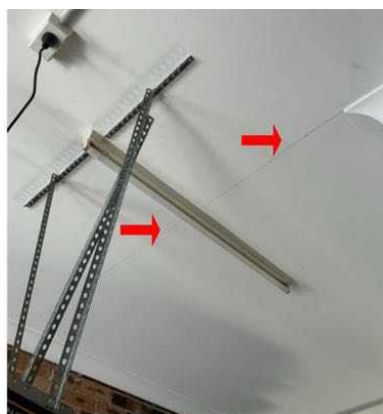
Finding 3.17

Building:	Main Building
Location:	All External Areas
Finding:	Cracking - Damage Category 1 - Fine (up to 1mm)
Information:	Although fine cracks are quite noticeable, they are often only considered to be an appearance defect, and usually do not indicate any structural damage. Generally, the cause of a fine crack is indicative of a separation between building materials and finishes (e.g. paint, plaster, etc.) along joins.

Cracking of this nature can generally be repaired with minor sanding, filling and/or repainting. Such works should be performed by a qualified painter or a general handyman.

Monitoring of all cracking should be conducted frequently. Always contact a building inspector should cracks widen, lengthen, or become more numerous.

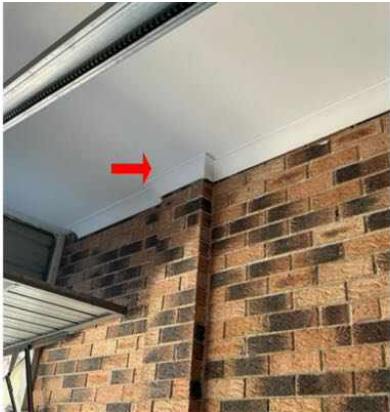
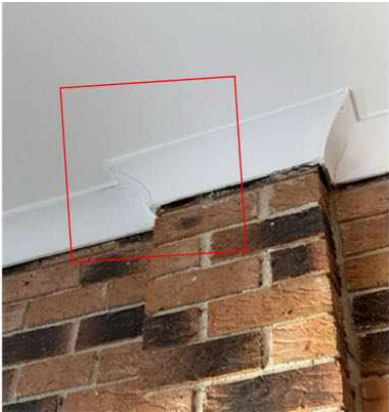
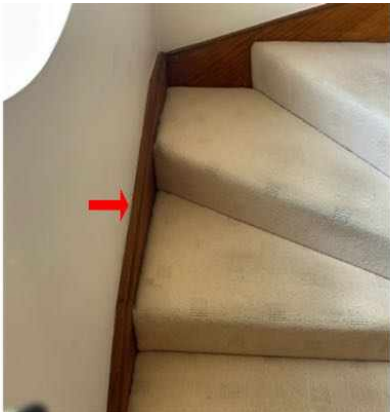
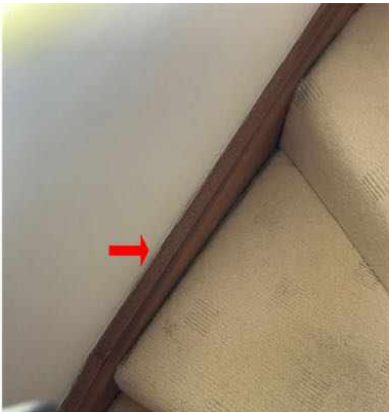
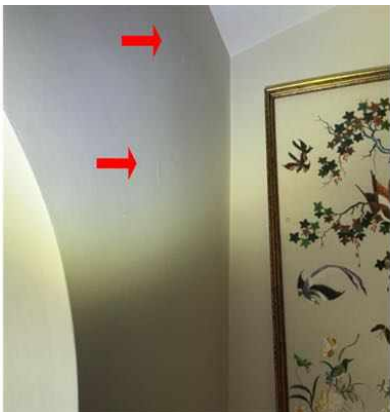
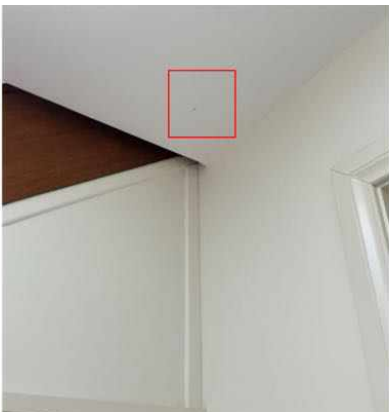
Finding 3.18

Building:	Main Building
Location:	All Internal Areas
Finding:	Paint Finish & Hairline Cracking - To some areas
Information:	The paint finish in this area was identified as being incomplete or substandard at the time of inspection including some hairline minor cracking/separation. Monitoring is recommended where cracking and separation is evident.

Whilst incomplete or missing paint finish is generally an appearance defect, it can also lead to the development of secondary building defects over time. Incomplete areas of paint finish expose the area to moisture, potentially accelerating the deterioration of underlying building materials.

Incomplete paint finishes should be sanded back, filled, leveled and painted, as applicable. Where inadequate or missing paint protection has led to the deterioration of the associated building element, repair and/or replacement of this building element

may be required.

A painting contractor should be appointed as soon as possible to perform necessary works to aid the appearance of the affected area and to ensure the area is protected against further deterioration. Alternatively, the homeowner following manufacturer instructions may perform these works.

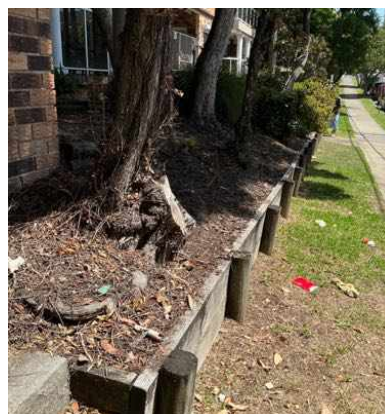
Finding 6.03

Building:	Main Building
Location:	All External Areas
Finding:	In ground contact - Timber - to some areas
Information:	Any timbers in direct ground contact provide opportunity for concealed termite entry and are likely to be subject to premature rot and decay as the soil retains moisture or damp conditions against the timbers.

Remove untreated timber that is in direct contact with external grounds. Consider replacement with more durable materials i.e. treated timber or non timber elements. Frequent pest inspections are advised to readily identify any termite activity in these areas.

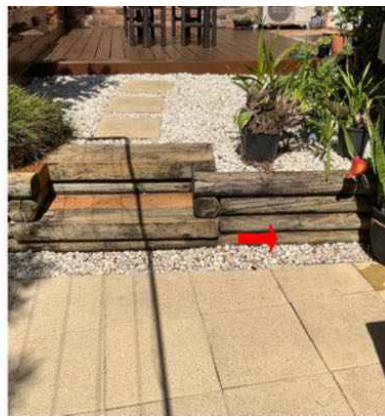
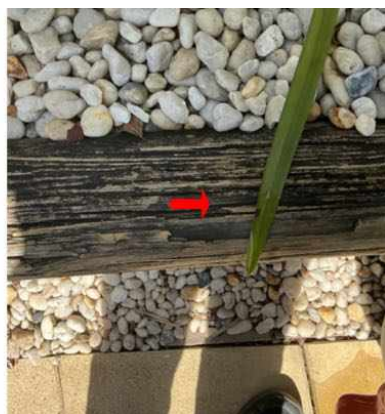
Finding 7.01

Building:	Main Building
Location:	All External Areas
Finding:	Fungal decay - present
Information:	Fungal decay also known as wood decay or wood rot generally refers to the deterioration of timber elements when in contact with excessive levels of moisture for a prolonged period of time.

The development of fungal decay is accelerated by temperatures in the range of 5degreeC to 40degreeC as well as the presence of oxygen. Generally fungal decay develops on timber elements that are in use in an external environment which are exposed to rain penetration.

In this case although the affected timber element is in a decaying state the extent of any visible damage appears to be localised to a specific area and is yet to spread to other parts of the building element or affect adjoining structures. The fungal decay is therefore likely to be of a relatively superficial nature with minimal impact on the structural integrity or tensile strength of the timber element.

- Treat, repair, or replace any wood rot found on the property.
- Clean and flush out blocked guttering regularly.
- Connect the HWS & A/C overflows to storm water or away from the edge of the building (minimum 1m).

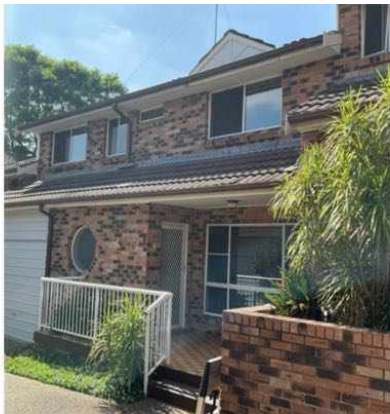
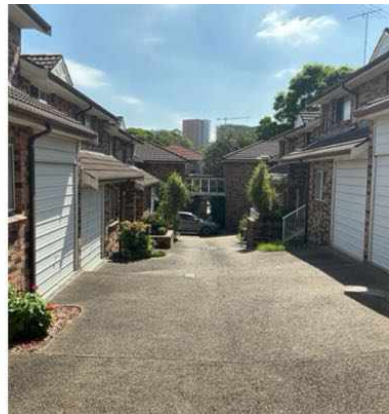
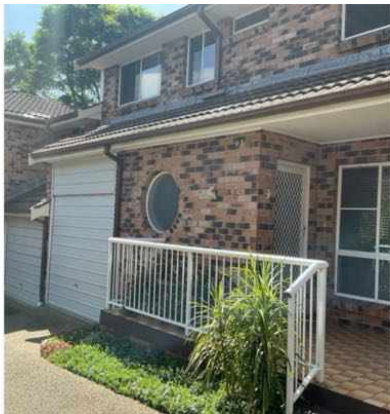
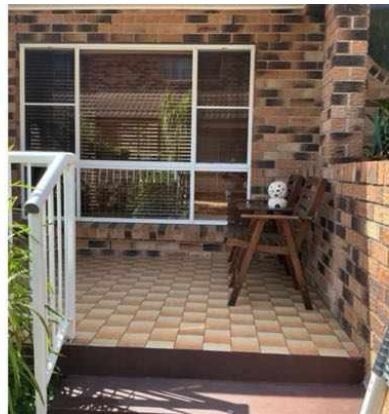
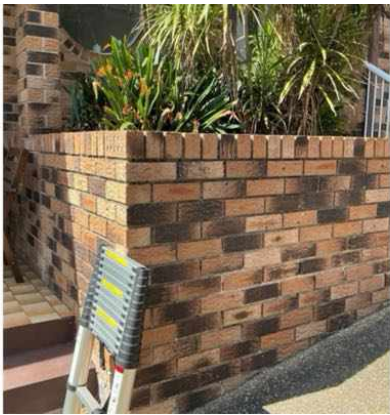
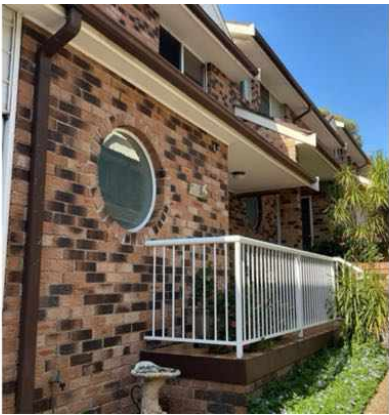
Noted Item

Building: Main Building
Location: All External Areas
Finding: Additional Photos - Obstructions and Limitations
Information: These photographs are an indication of the obstructions and limitations which impeded full inspection of the property at the time of inspection. These obstructions can hide an array of defects and should be removed to allow full inspection to be carried out. A re-inspection is recommended once the areas are made accessible.

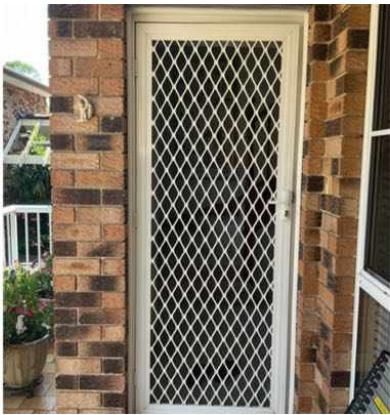
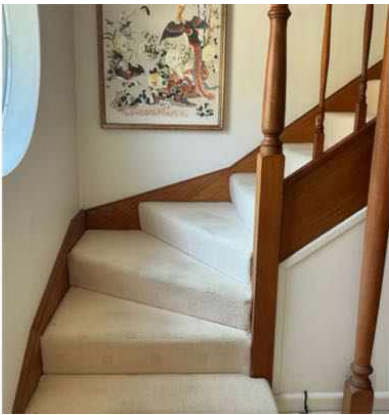
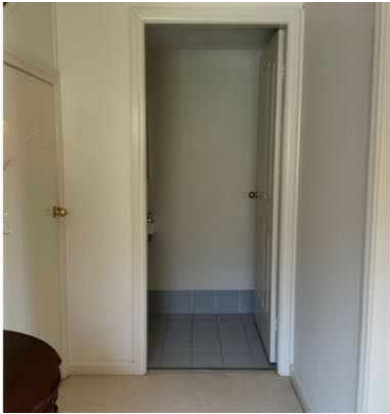
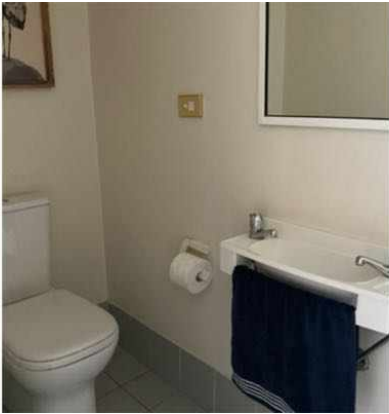
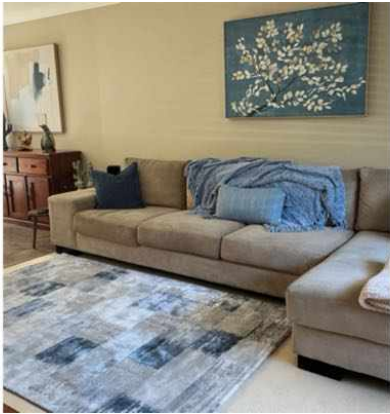
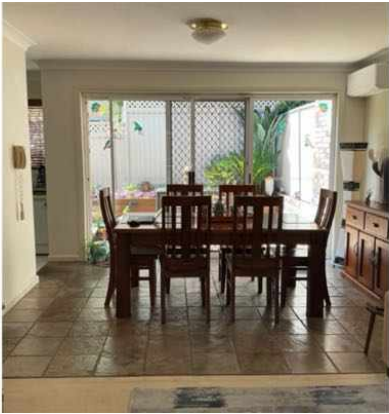
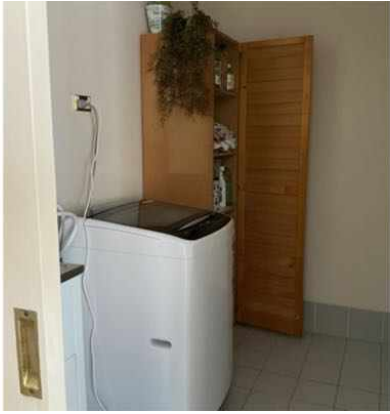
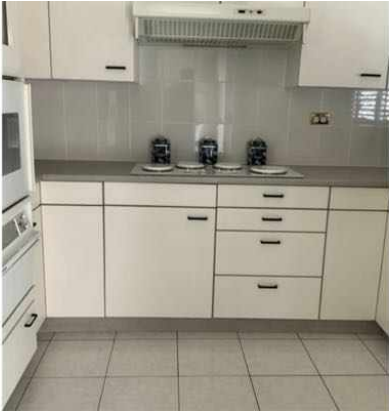
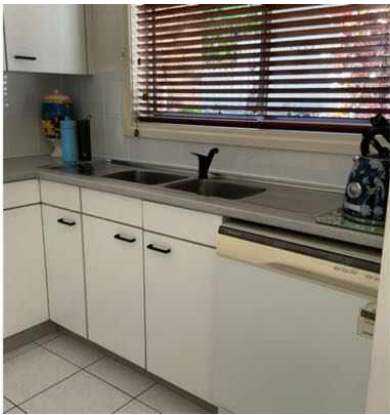
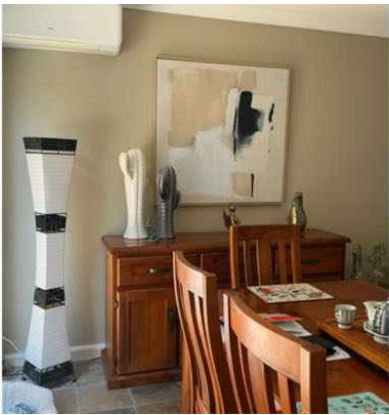
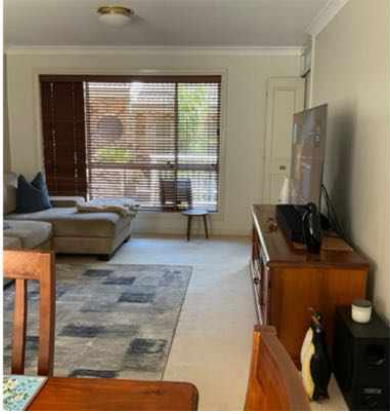
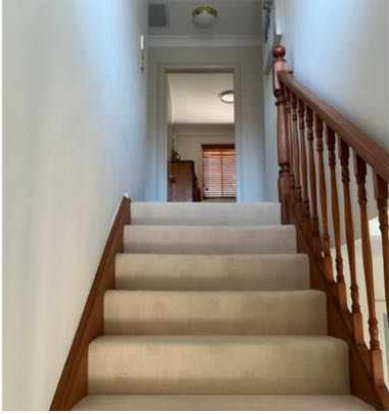
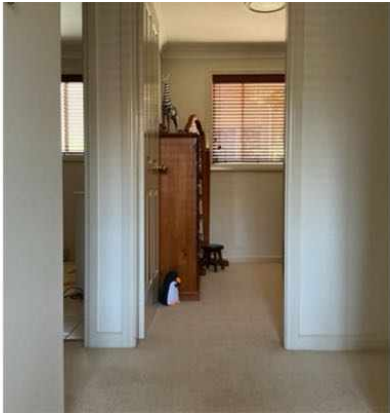
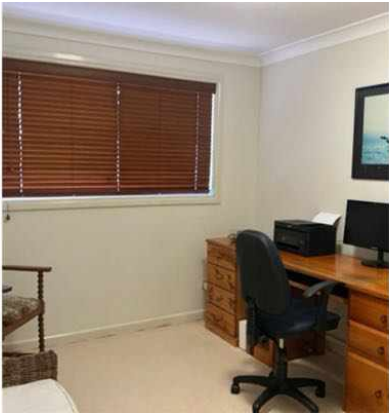
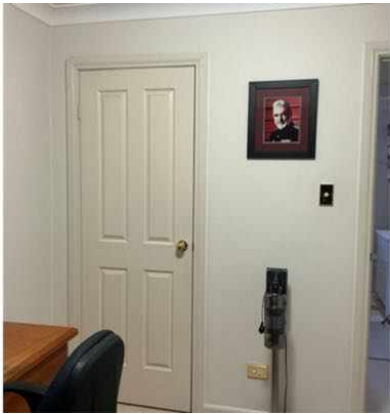
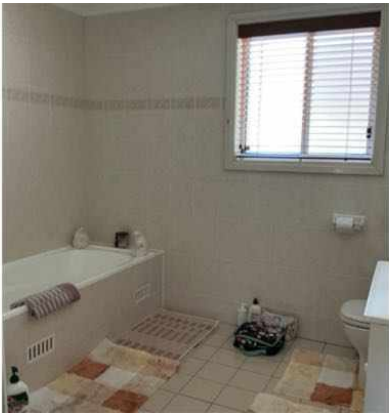
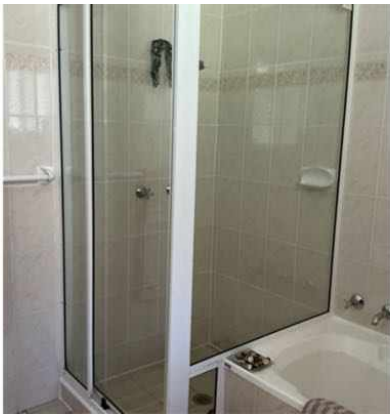
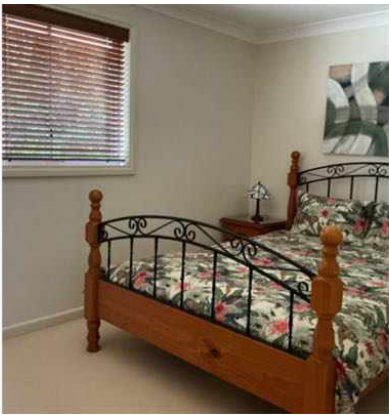
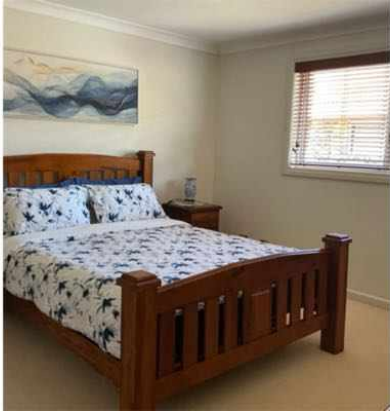
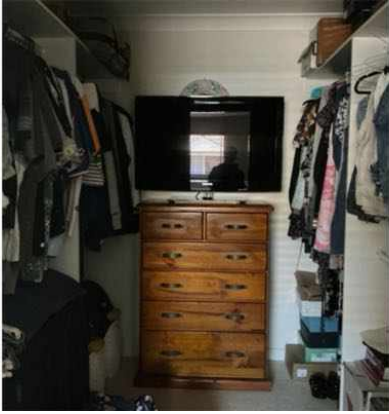
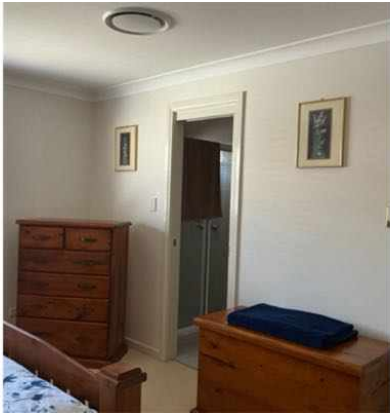
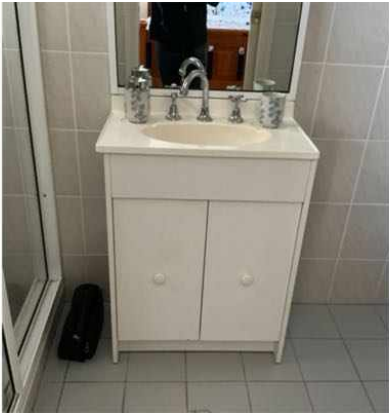
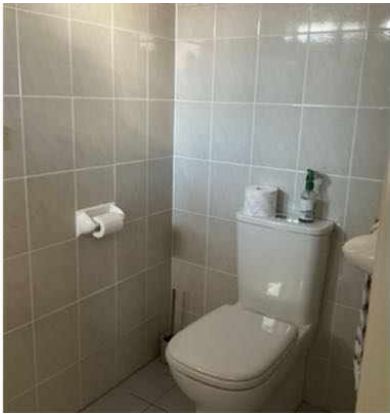
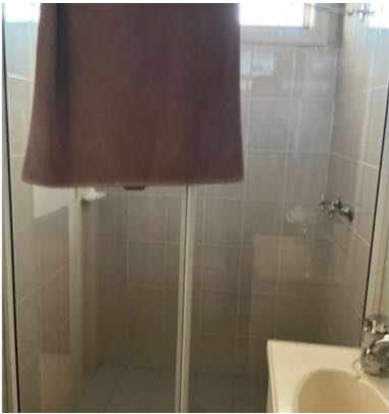
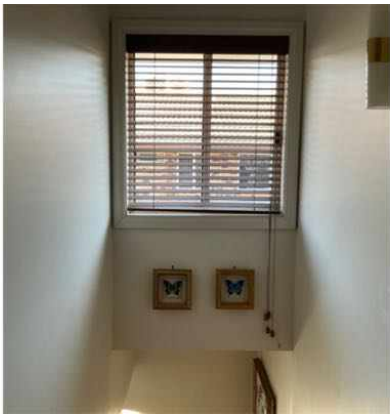
Noted Item

Building:	Main Building
Location:	All Internal Areas
Finding:	Additional Photos - Obstructions and Limitations
Information:	These photographs are an indication of the obstructions and limitations which impeded full inspection of the property at the time of inspection. These obstructions can hide an array of defects and should be removed to allow full inspection to be carried out. A re-inspection is recommended once the areas are made accessible.

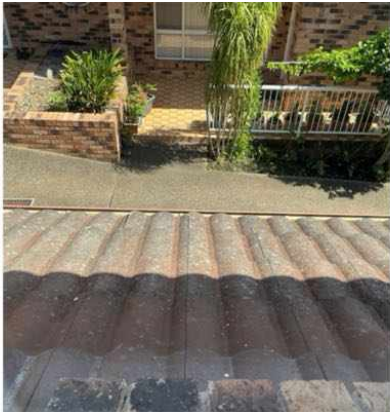
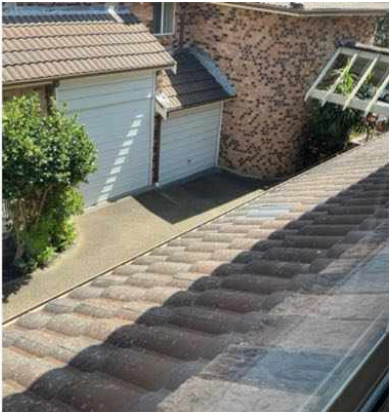
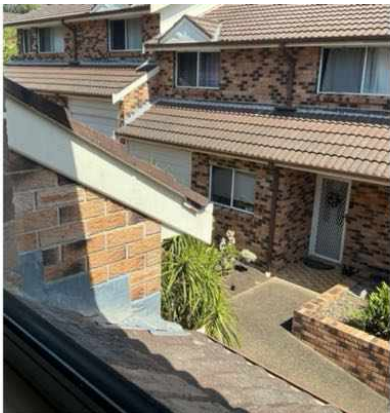
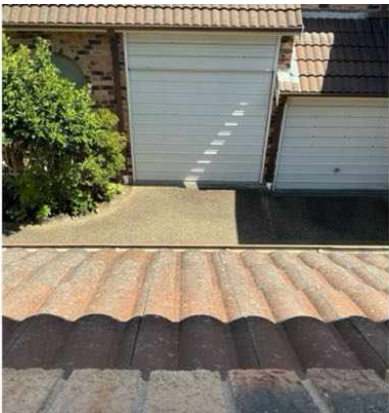
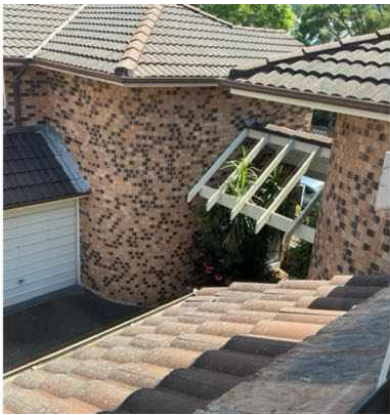
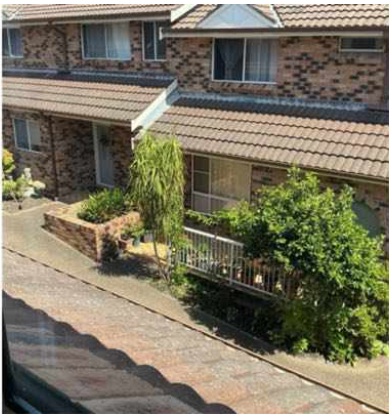
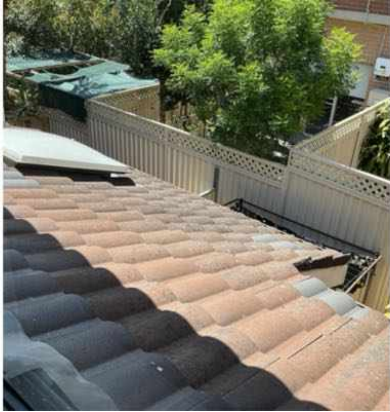
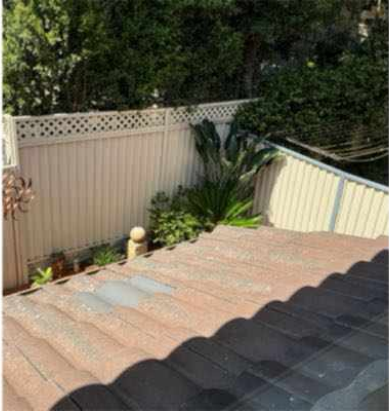
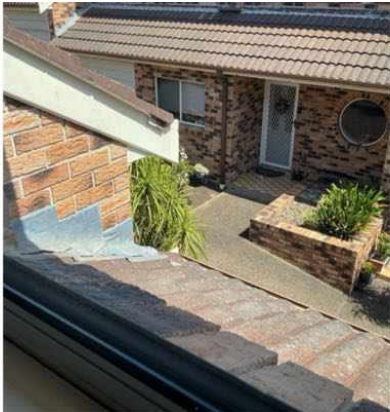
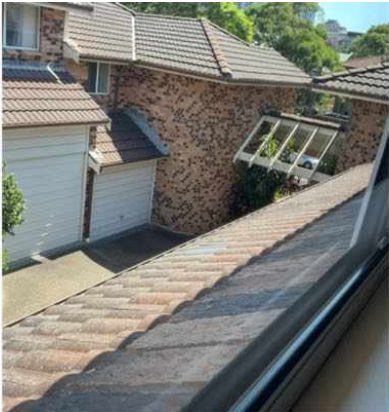
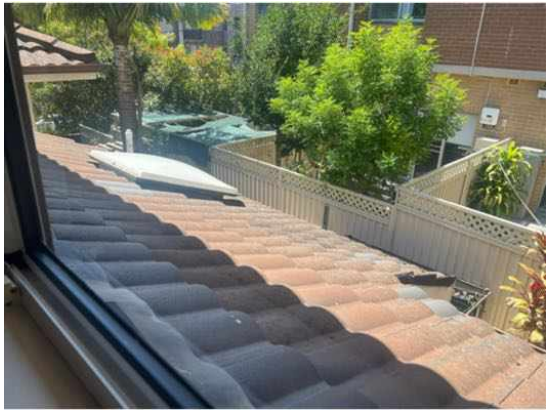
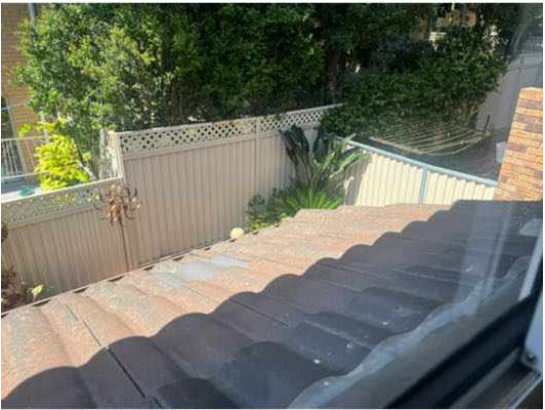
Noted Item

Building: Main Building
Location: Roof Exterior
Finding: Additional Photos - Obstructions and Limitations
Information: These photographs are an indication of the obstructions and limitations which impeded full inspection of the property at the time of inspection. These obstructions can hide an array of defects and should be removed to allow full inspection to be carried out. A re-inspection is recommended once the areas are made accessible.
