Building and Timber Pest Inspection Report

Inspection Date: Fri, 6 Feb 2026

Property Address: 6/47 West St, Hurstville NSW 2220,
Australia

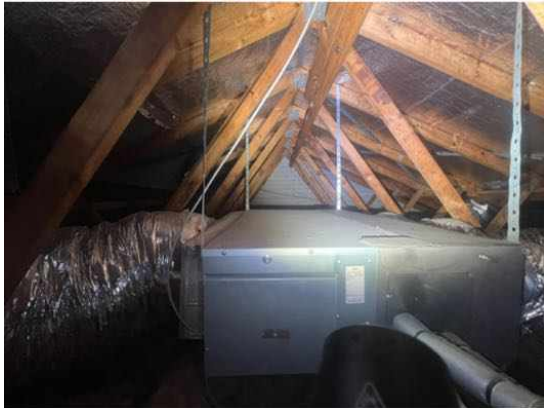
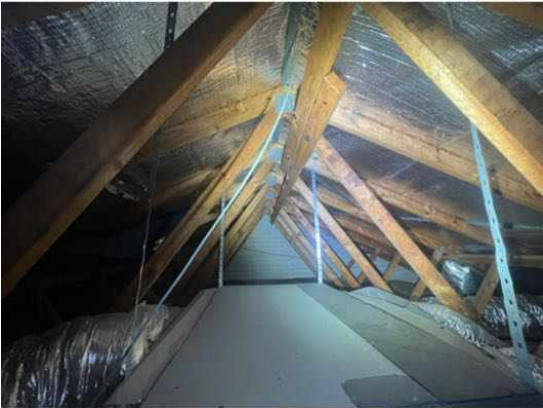
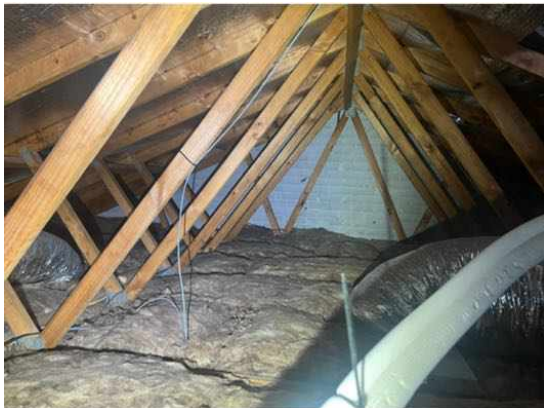
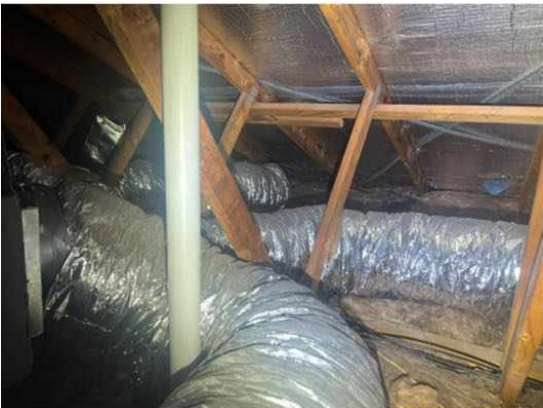
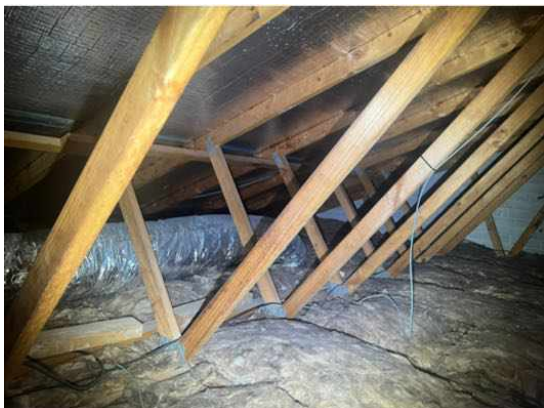
Building: Main Building
Location: Roof Void
Finding: Additional Photos - Obstructions and Limitations
Information: These photographs are an indication of the obstructions and limitations which impeded full inspection of the property at the time of inspection. These obstructions can hide an array of defects and should be removed to allow full inspection to be carried out. A re-inspection is recommended once the areas are made accessible.
