Building and Timber Pest Inspection Report

Inspection Date: Wed, 18 Feb 2026

Property Address: 7/547 Chapel Rd, Bankstown NSW 2200,
Australia

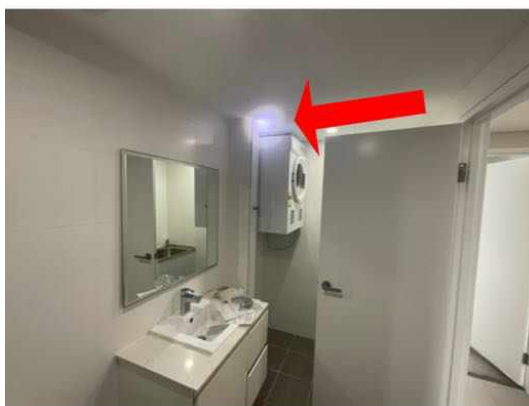
Building: Main Building
Location: Bathroom > Level 1
Finding: Ceiling - Water damaged
Information: Water damage to the ceiling lining is generally an indication of excessive moisture being present in the roof void, usually via a leak to the roof covering.

Where water damage is evident to the ceiling, the primary requirement is to identify and rectify the source of the leak. A roofing plumber should be appointed as soon as possible to identify the leak and perform rectification works as necessary, ensuring the water damage is restricted.

Once the leak is repaired, consultation with relevant tradespeople, including plasterers and painters, is advised. Rectification works may include replacement of ceiling lining or minor repainting, depending on the extent of the damage.

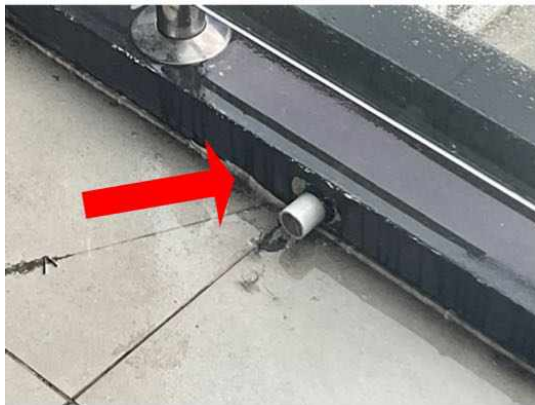
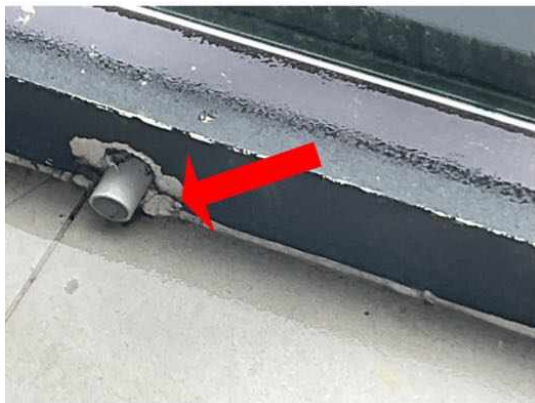
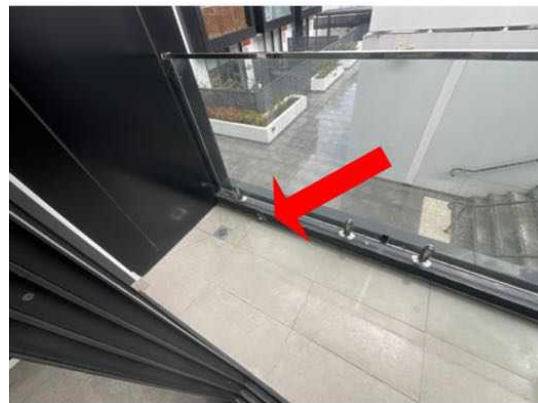
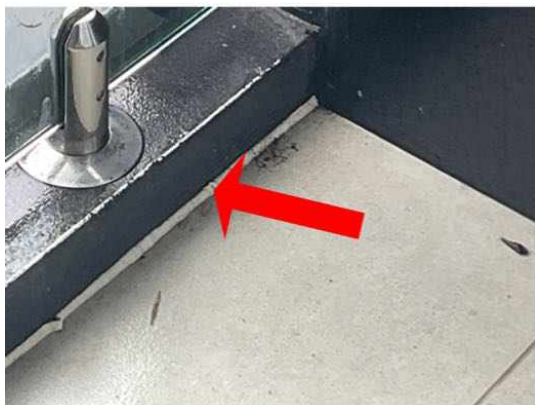
Finding 2.02

Building: Main Building
 Location: Balcony
 Finding: Poor Quality Sealant Application
 Information: Sealant around internal wall and junctions has been applied in a poor and inconsistent manner. The finish is uneven, with gaps, rough edges, and visible defects. The sealant does not provide a neat or durable finish.

- NCC 2022 – Volume Two, Part 2.1.2 (Amenity and Durability): Internal finishes must be installed to ensure adequate performance and durability.
- AS 3740:2021 – Waterproofing of domestic wet areas: Sealant must be applied correctly at junctions in wet areas to ensure waterproofing integrity.
- Guide to Standards and Tolerances 2017 (Section 12.10 – Sealant Finish): Sealant is defective if it is not applied in a neat, consistent manner or if it does not provide a watertight seal.

Recommendation:

The builder is to remove the defective sealant and reapply in a professional and

consistent manner, ensuring compliance with AS 3740 and manufacturer's installation instructions. Sealant must be tooled smooth, continuous, and provide an effective watertight joint.

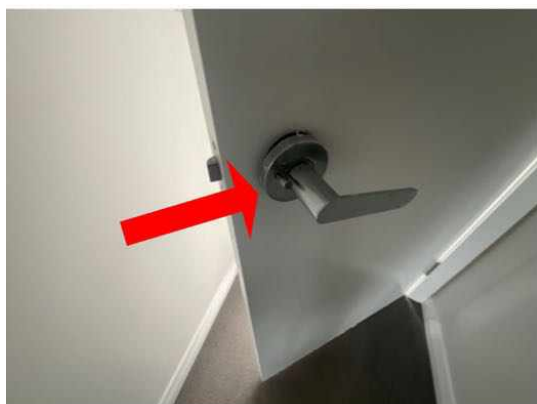
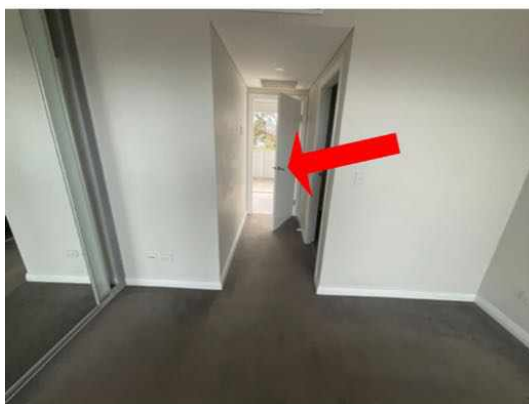
Finding 2.03

Building: Main Building
 Location: Bedroom - Master > Level 2
 Finding: Fitting (door handle) - Loose
 Information: The fitting in this area is loose and requires adjustment to tighten.

If left unmanaged, the fitting may further deteriorate, causing potential for the

development of other minor secondary defects.

A relevant tradesperson should be appointed to perform these rectification works at discretion of the client.

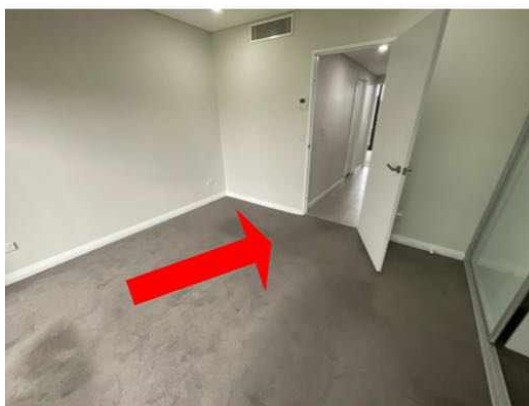
Building:	Main Building
Location:	All Internal Areas
Finding:	Carpet - damaged / deteriorated
Information:	Static Damage

Static is created through friction and as a result, the carpet snaps, crackles and pop as you walk across. Due to the dry weather and low humidity, static charges are formed within the carpet thus resulting to static damage. Although new types of carpets have anti-static agents like conductive agents and fine metal wires that protects the carpet.

The color differences between carpet areas caused by every day deterioration through physical contact and resulting random differences in pile lay direction; usually referred as shading.

Shading is a characteristic especially for all cut-pile carpets and others refer to this as a manufacturing defect but it's not. It is caused by the physical difference between cut end lustre and side lustre of the fiber. The side of the fibers reflects more light and will appear brighter and lighter in color while the end will absorb more light and darker in color.

Given the situation, lighter colored carpet fades faster than darker colored carpets because of it contains smaller amounts of dye used in the carpet. The best way to prevent sunlight damage is keeping the windows covered with draperies and protective coating, filtering UV rays that damages the carpet.

Replacement of the affected carpet is required as a matter of urgency to ensure the safety of the area. Where required, remedial works should be undertaken to any associated walls and flooring showing evidence of mould.

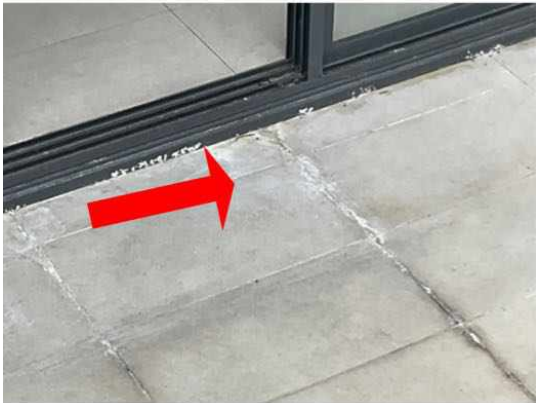
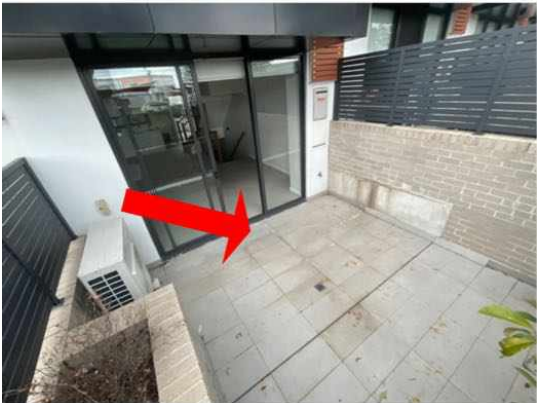
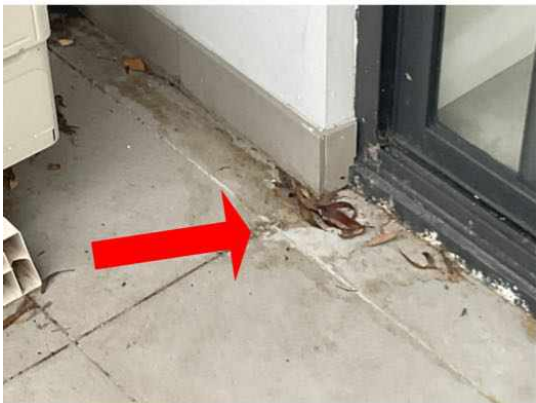
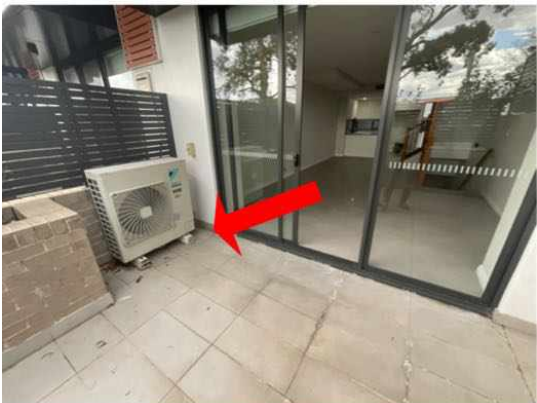
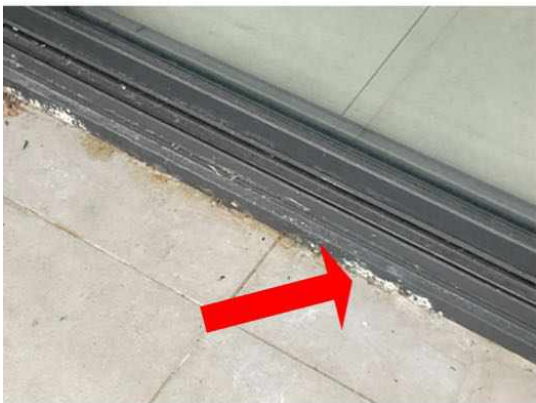
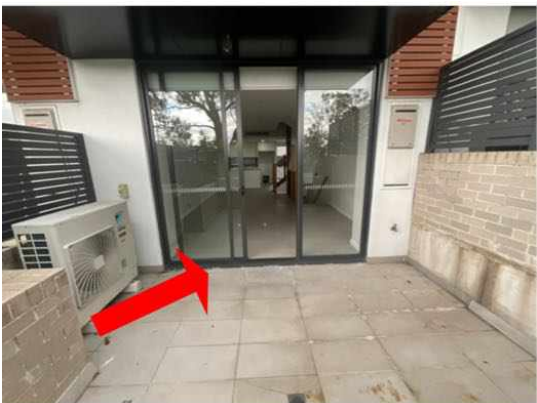
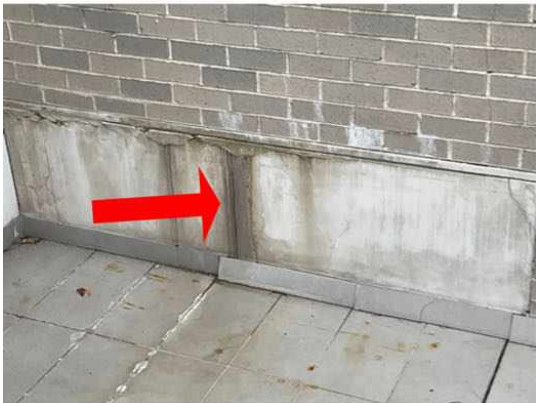
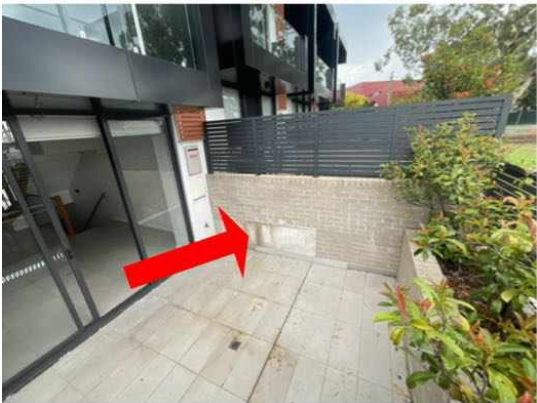
Finding 3.03

Building:	Main Building
Location:	Yard - Back
Finding:	Courtyard– Tiling & Wall (Evidence of Moisture Ingress)
Information:	Evidence of moisture-related deterioration was observed to the courtyard area. Tile adhesive is lifting through grout joints, tiles show signs of debonding, and cracking is visible to the adjoining concrete wall. Water staining and efflorescence were noted to the base of the external brick wall.

- Lift tiles as required
- Assess condition of waterproof membrane and substrate
- Check falls toward drainage point
- Rectify waterproofing and drainage defects as necessary

Monitoring is recommended to determine whether moisture intrusion is active.

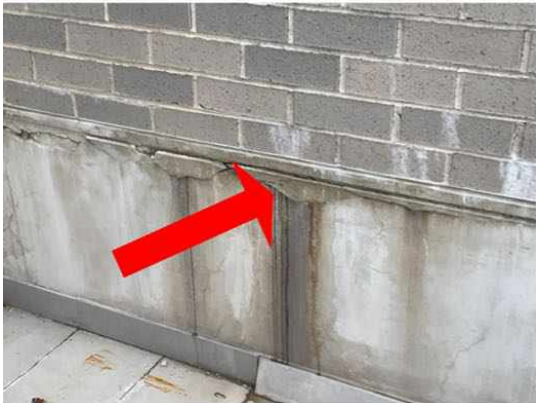
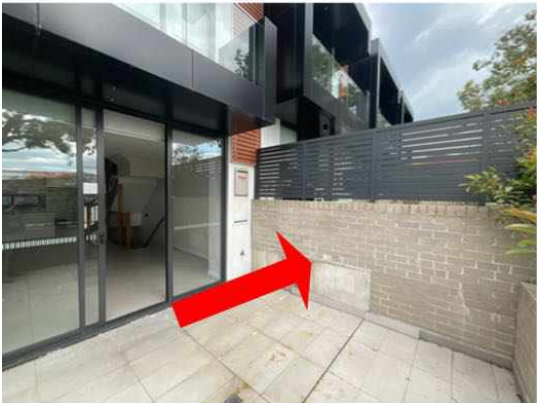
Finding 3.04

Building: Main Building
Location: Yard - Back
Finding: Brickwork / Concrete - damaged
Information: At the time of inspection, damaged bricks / concrete were identified. Significant deterioration is apparent in both the brick and concrete surfaces, with areas showing signs of erosion, crumbling, and loss of material, likely due to environmental exposure or aging or building structure moving.

Evidence of structural instability is present in both the brickwork and concrete, with sections showing signs of leaning, bulging, or displacement, posing safety hazards and requiring immediate attention

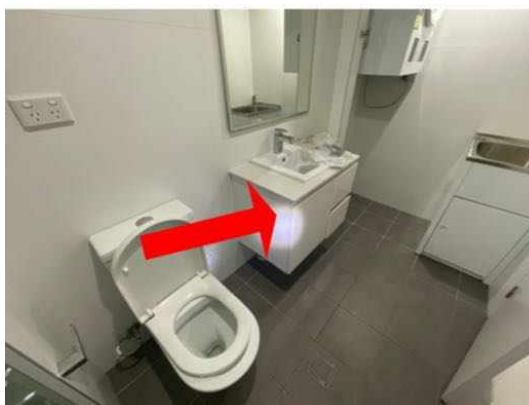
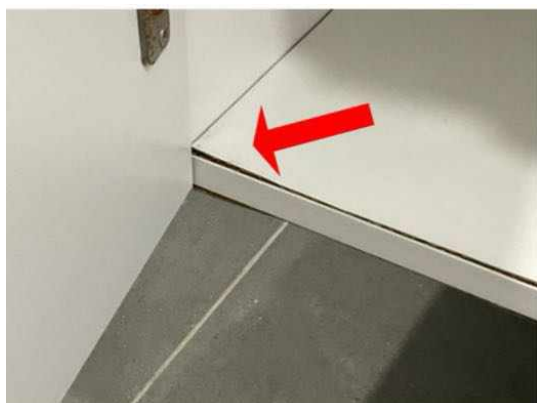
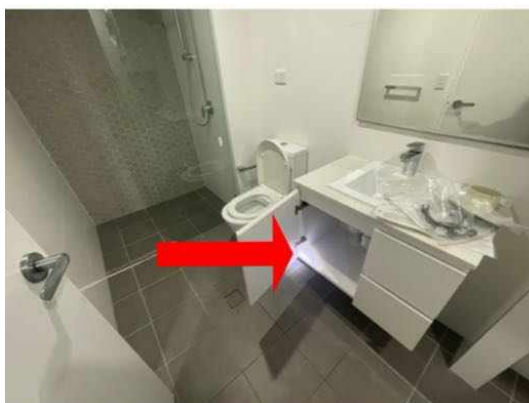
Finding 3.05

Building:	Main Building
Location:	Bathroom
Finding:	Delamination of timbers
Information:	Delamination is one means by which composite materials (e.g. layered timber composites) may fail over time. In laminated materials, repeated cyclic stresses may lead to the formation of mini-structures of separate layers, with significant loss of mechanical toughness. Water penetration or the presence of excessive moisture also generally contributes to delamination.

Delamination of timbers may be repaired where the area affected is minor and/or easily accessible, by gluing and screwing layers back together. However, this is an interim repair, and where delamination has occurred, the client should plan for the replacement of affected timbers sooner than would otherwise be expected.

All timber structures affected by delamination should be replaced as soon as possible to avoid any further damage. Repair and replacement estimates should be sought from a registered builder or qualified carpenter.

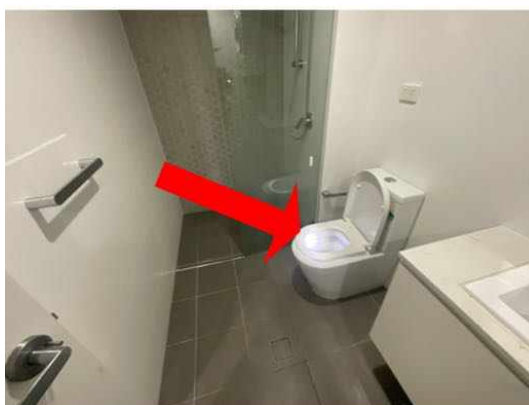
Finding 3.06

If left unmanaged, the toilet pan could deteriorate further, leading to greater destabilisation and the potential for water leaks to surrounding building elements.

It is recommended that the pan be refixed to the floor with concrete or silicone by a licensed plumbing contractor.

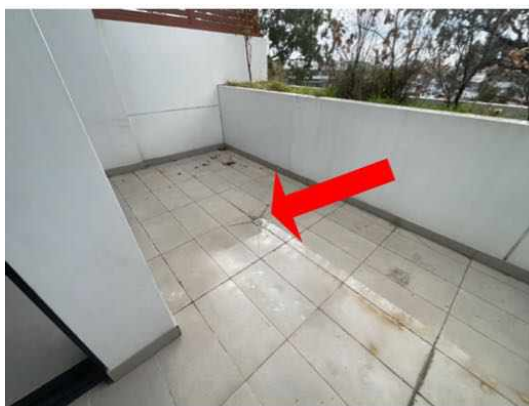
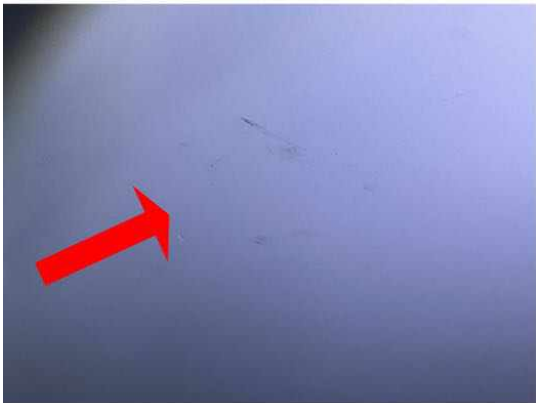
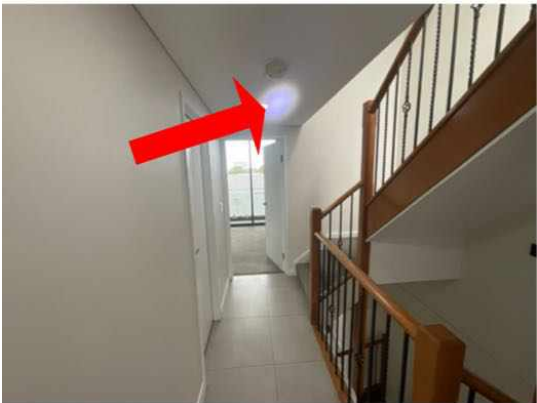
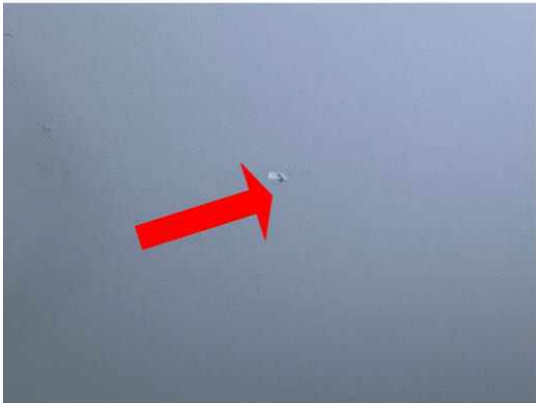
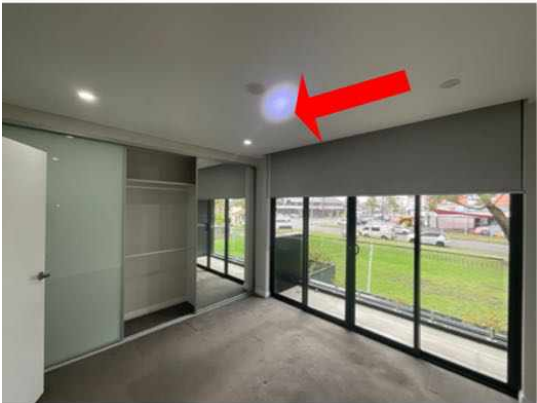
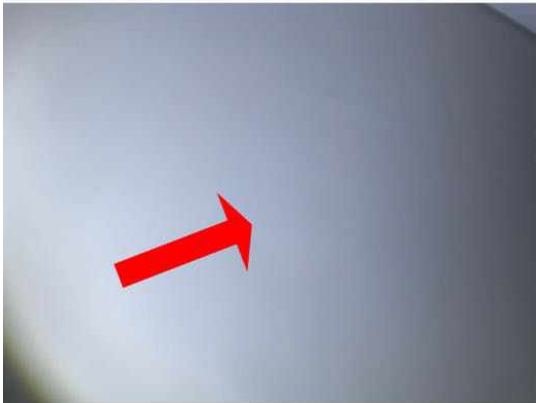
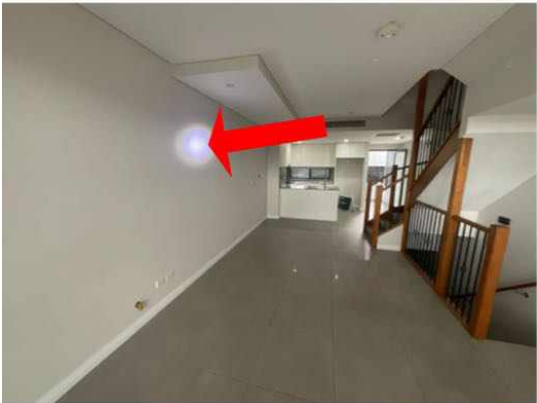
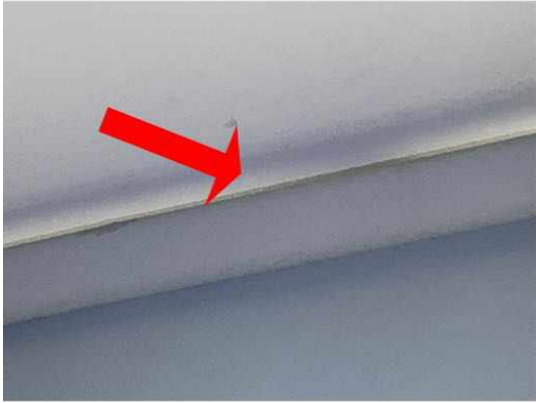
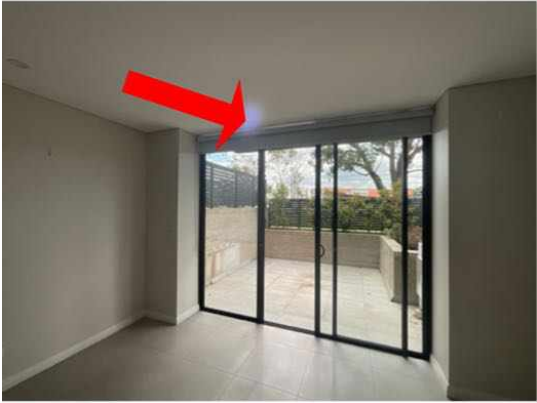
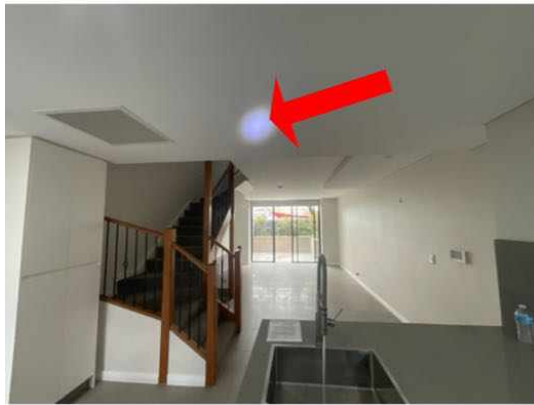
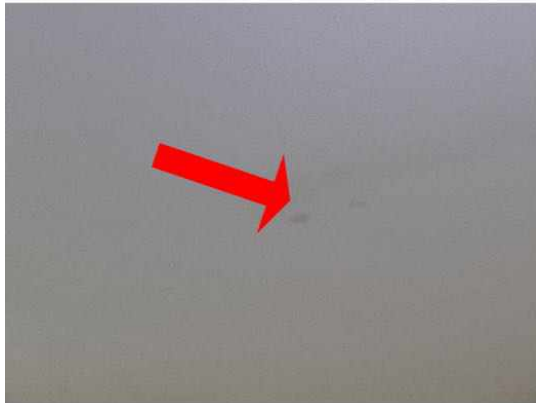
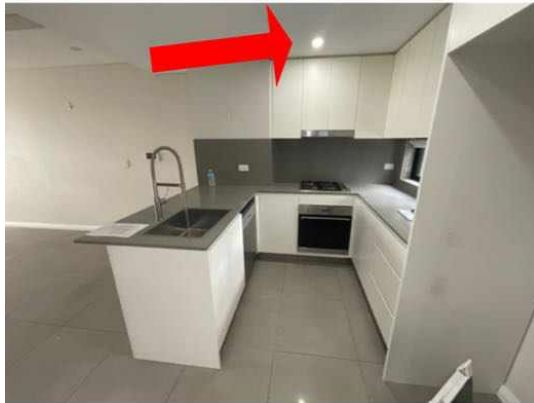
Finding 3.08

Building:	Main Building
Location:	All Internal Areas
Finding:	Paint finish - Substandard, Wear and Tear
Information:	The paint finish in this area was found to have been completed to a substandard level or wear and tear as the normal deterioration of a property from ordinary, everyday use. Exposure to the elements, time, as well as day to day living can cause fair wear and tear.

Substandard, wear and tear paint finishes should be sanded back, filled, leveled and repainted, as applicable. Where inadequate paint protection has led to the deterioration of the associated building element, repair and/or replacement of this building element may be required.

A painting contractor should be appointed as soon as possible to perform necessary works to aid the appearance of the affected area and to ensure that the area is protected against further deterioration. Alternatively, the homeowner following manufacturer instructions may be able to provide this service.

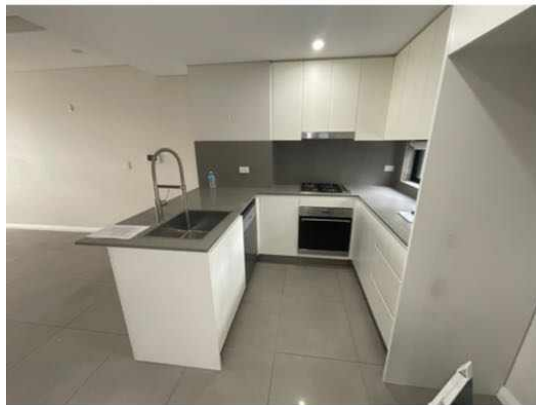
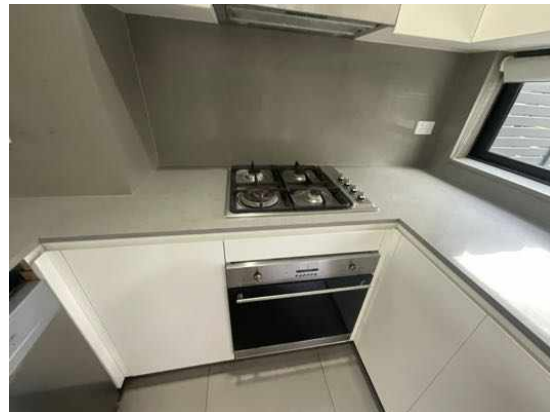
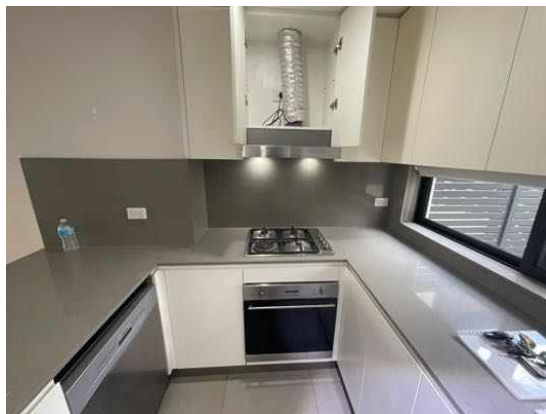
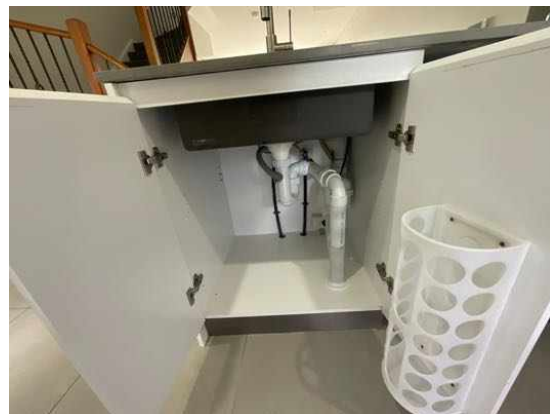
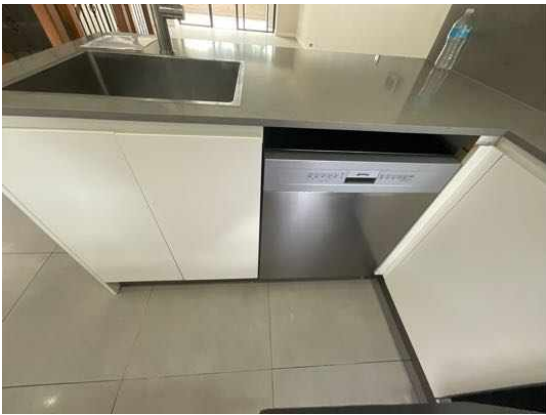
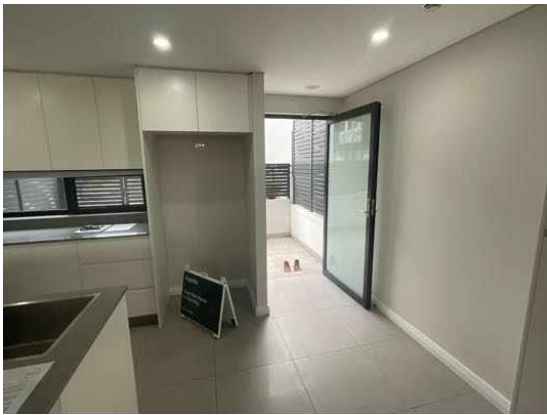
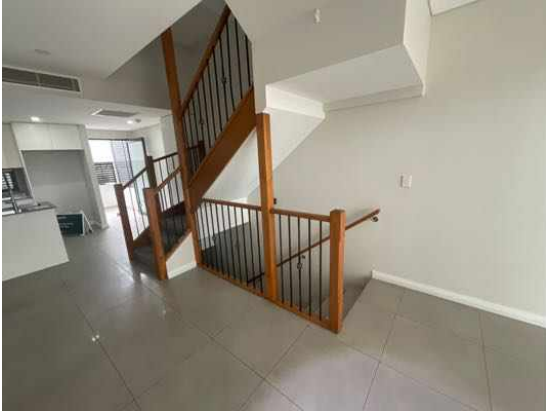
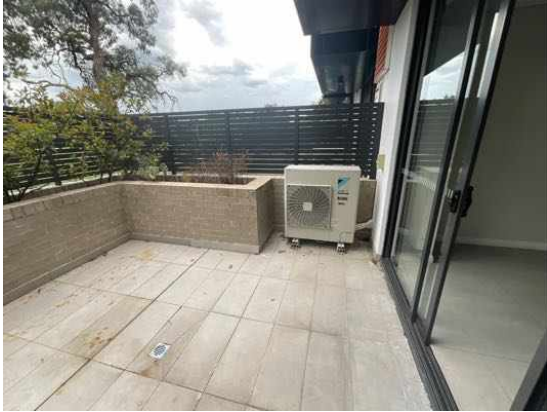
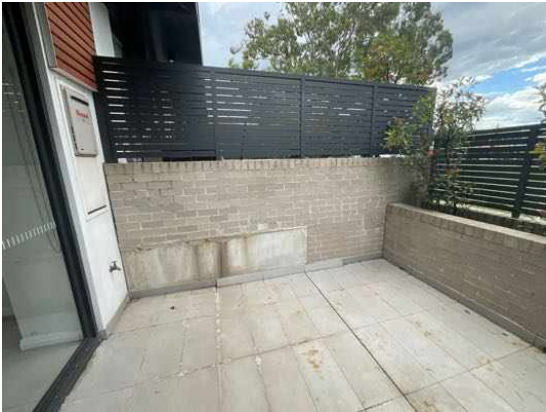
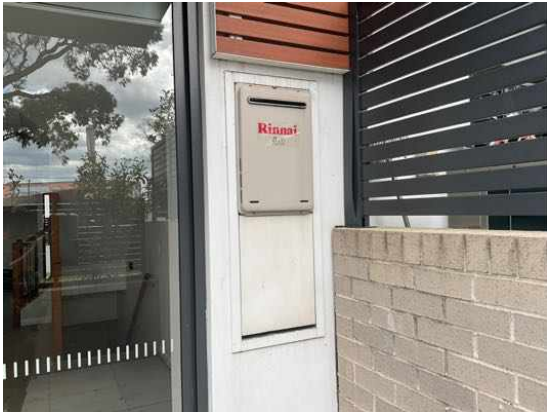
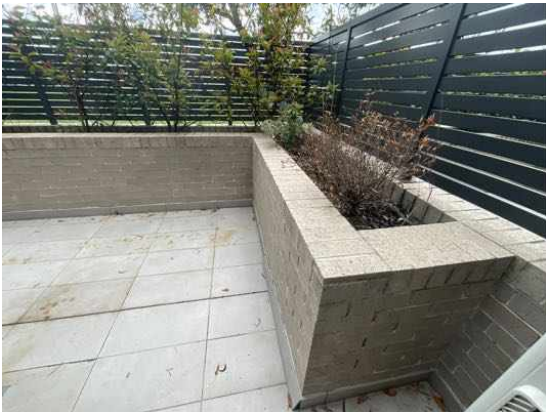
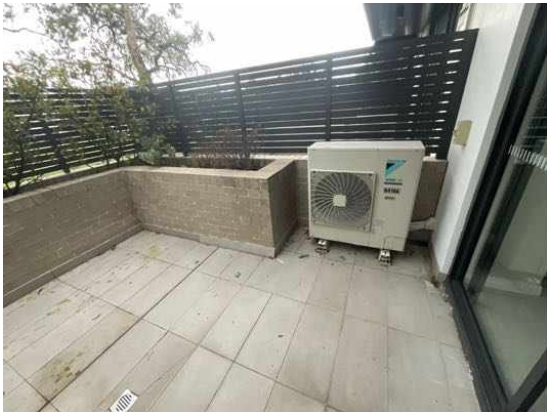
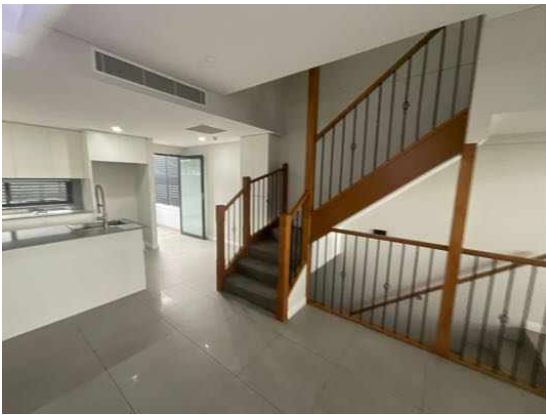
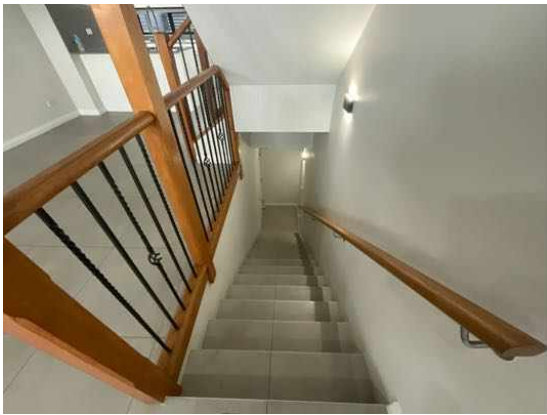
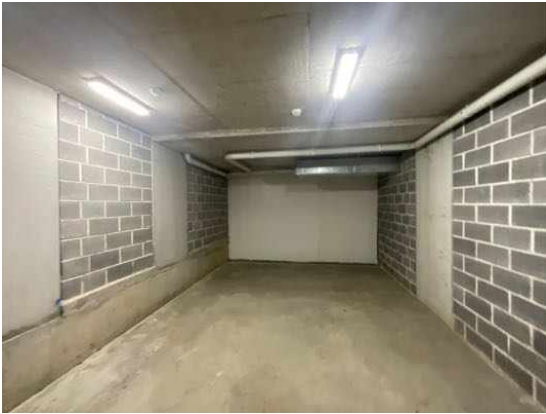
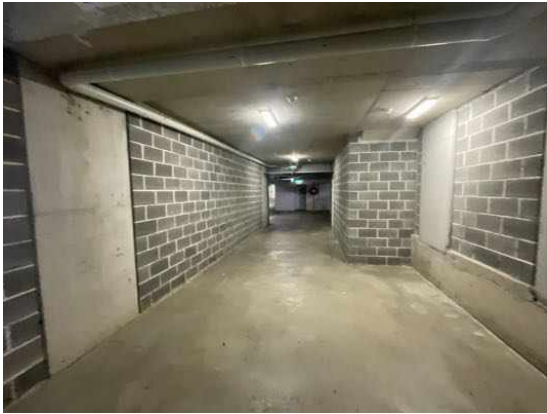
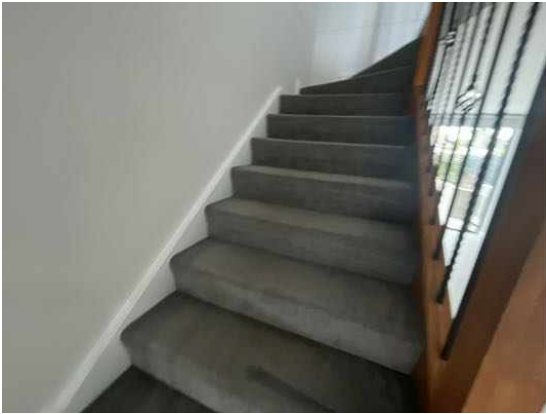
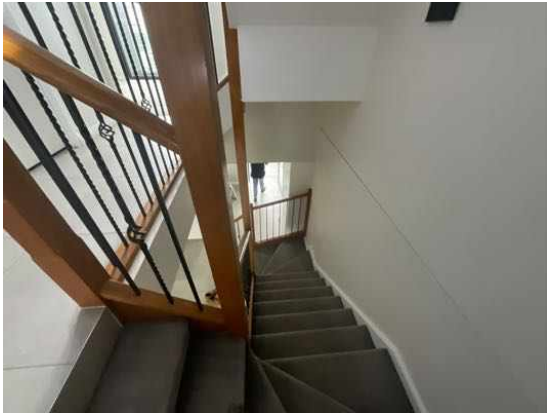
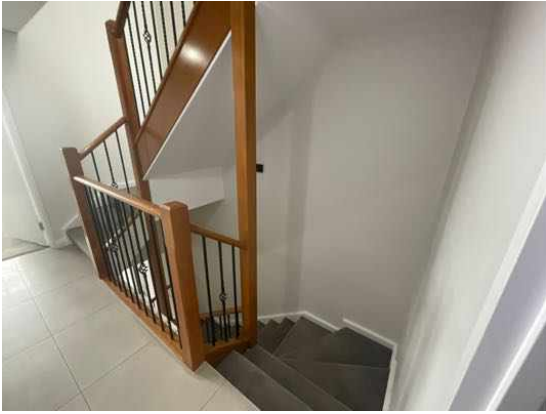
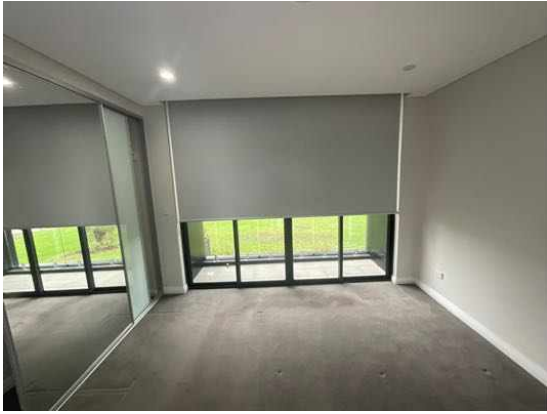
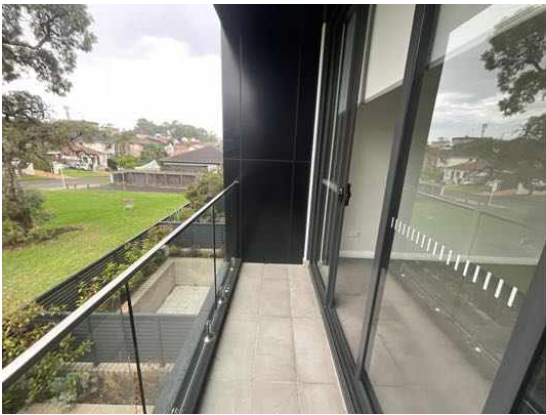
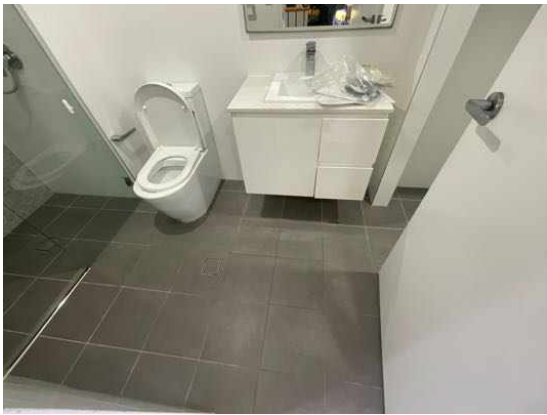
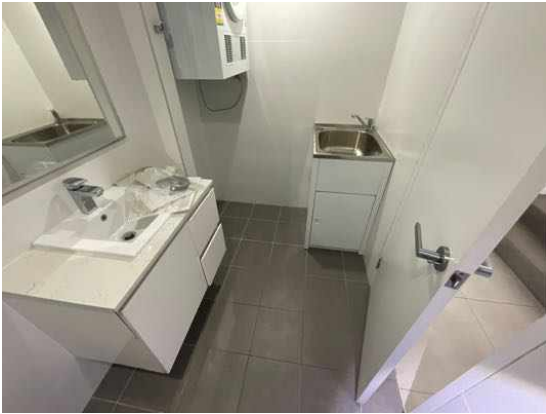
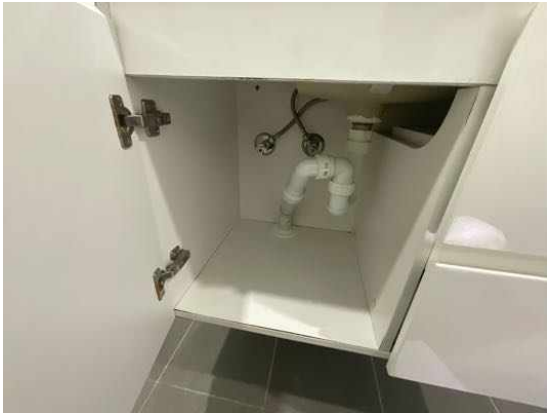
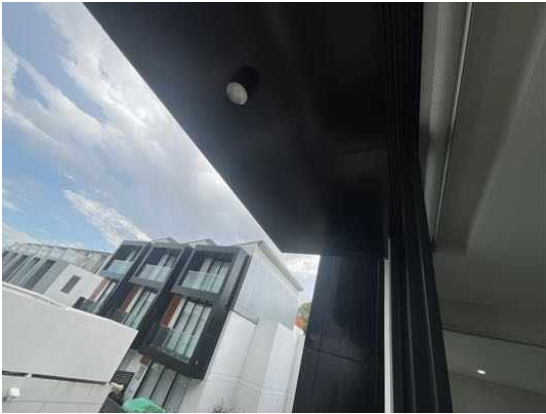
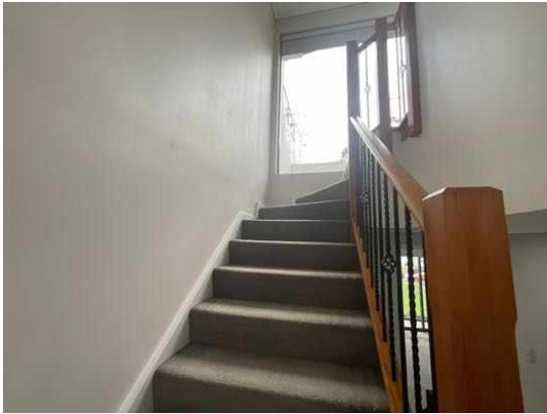
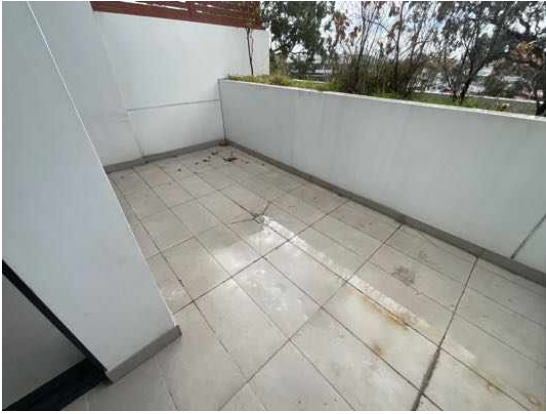
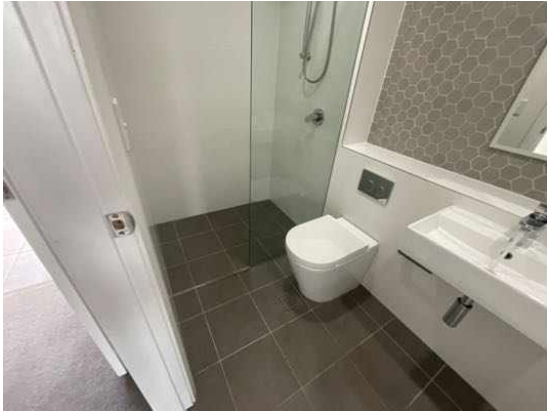
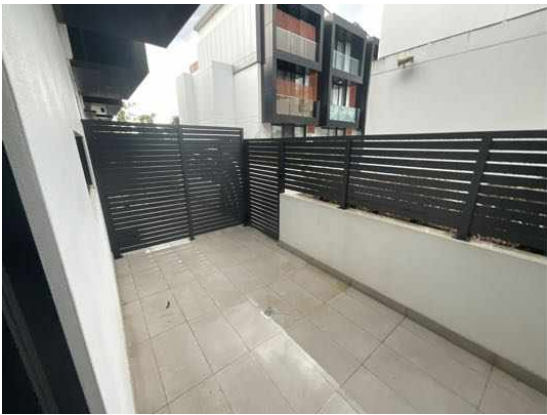
Building: Main Building
Location: All Areas
Finding: Additional Photos - Obstructions and Limitations
Information: These photographs are an indication of the obstructions and limitations which impeded full inspection of the property at the time of inspection. These obstructions can hide an array of defects and should be removed to allow full inspection to be carried out. A re-inspection is recommended once the areas are made accessible.

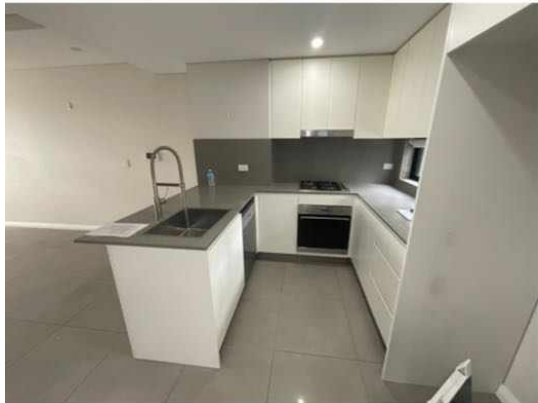
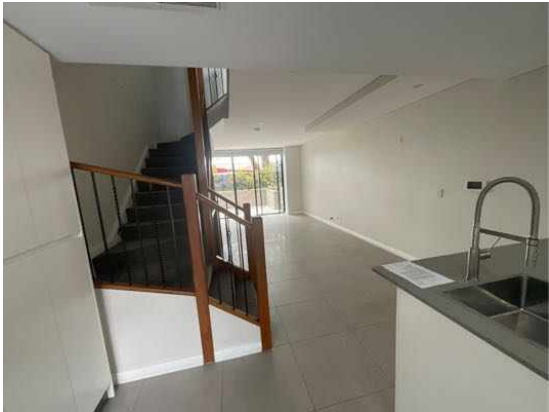
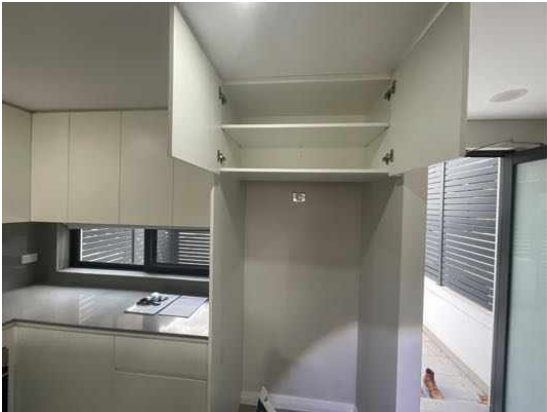
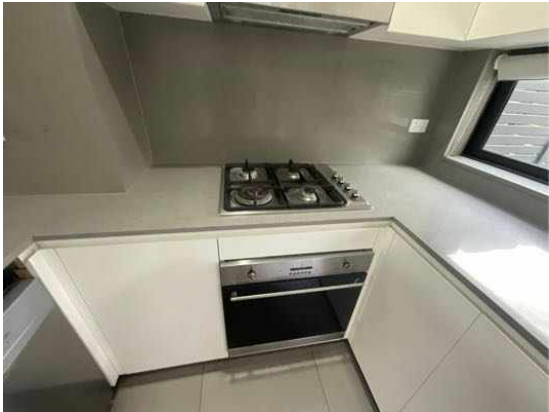
Building: Main Building
Location: All Areas
Finding: Additional Photos
Information: Additional photos are provided for your general reference
