Building and Timber Pest Inspection Report

Inspection Date: Wed, 18 Feb 2026

Property Address: 7/547 Chapel Rd, Bankstown NSW 2200,
Australia

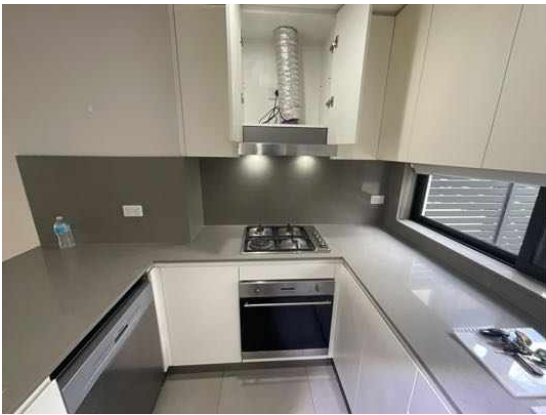
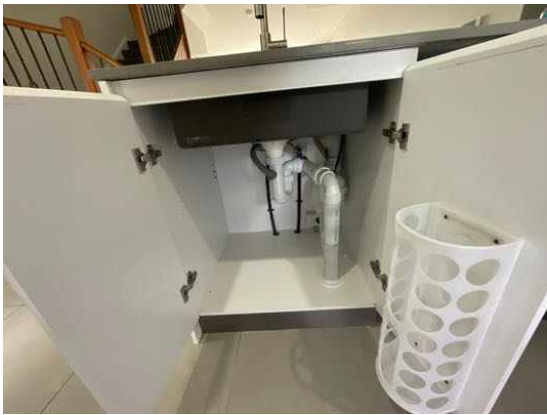
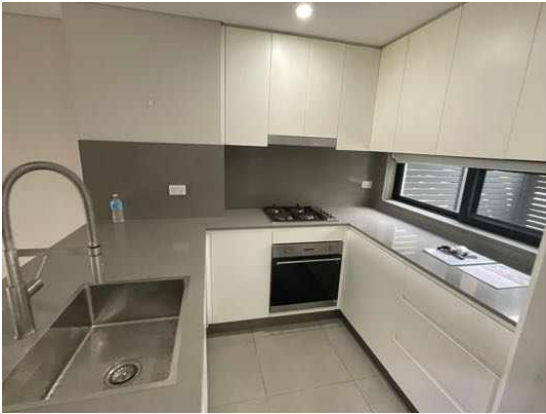
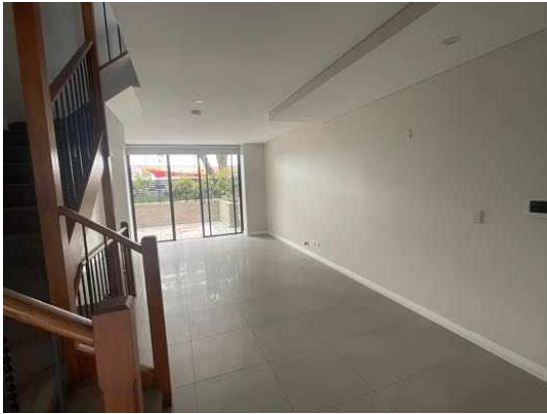
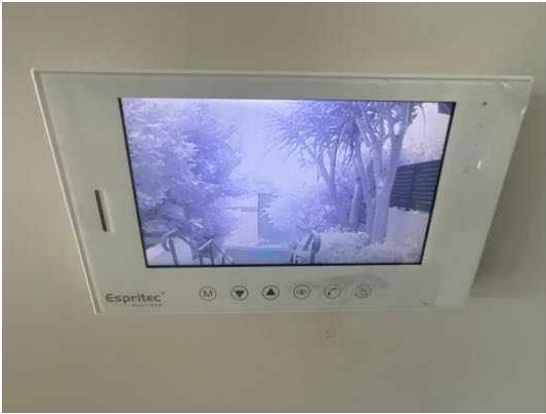
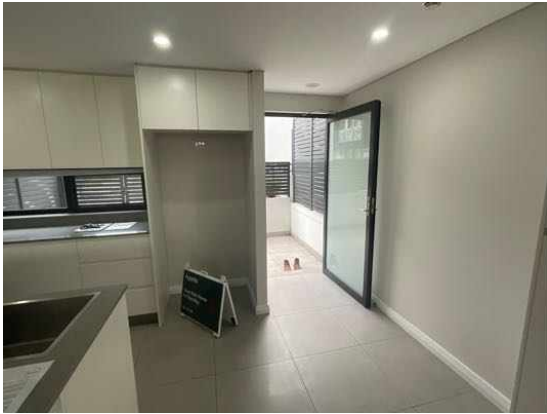
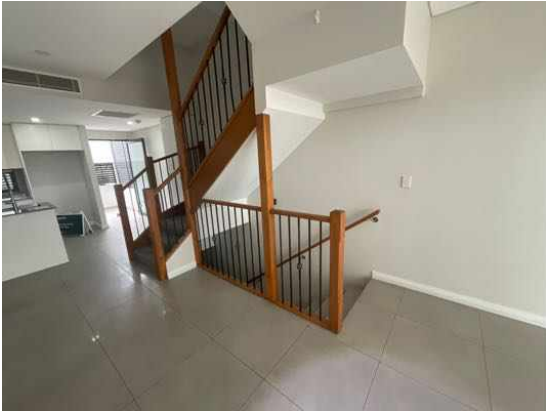
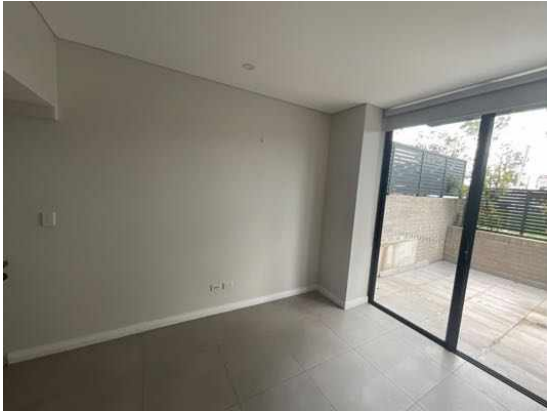
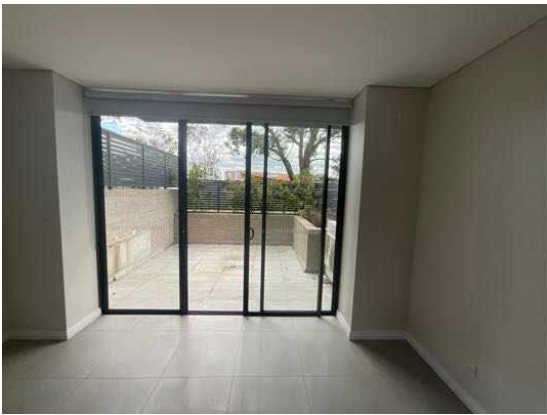
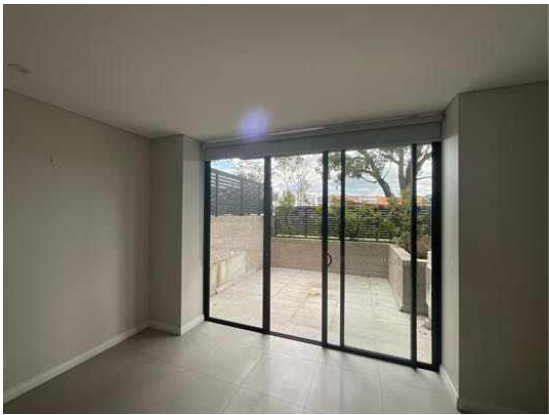
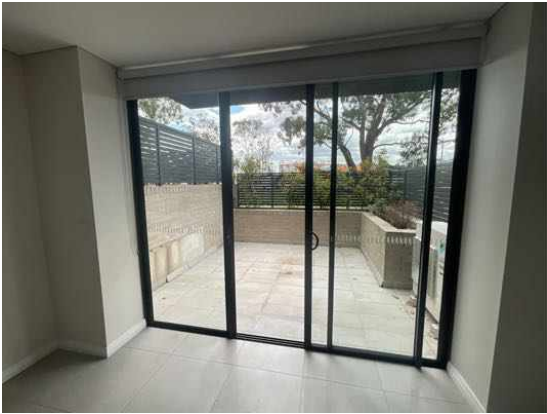
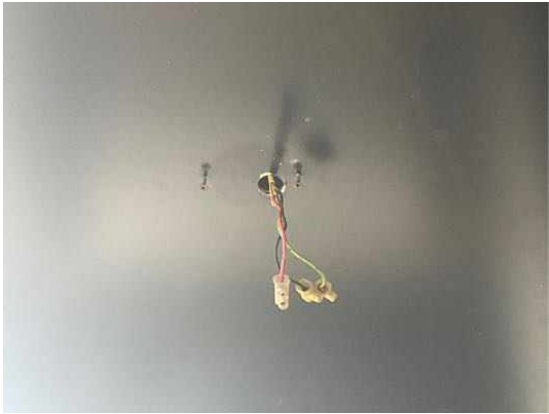
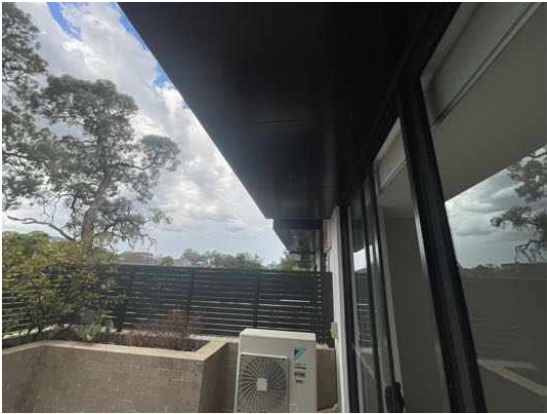
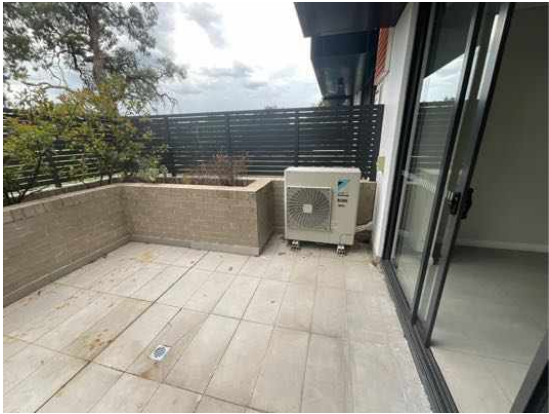
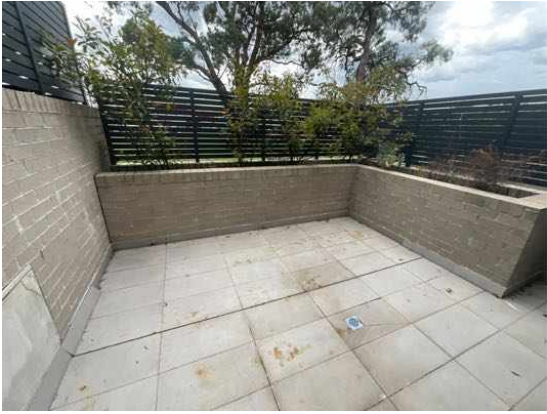
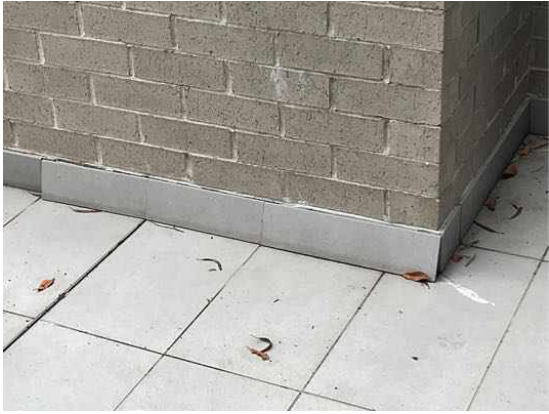
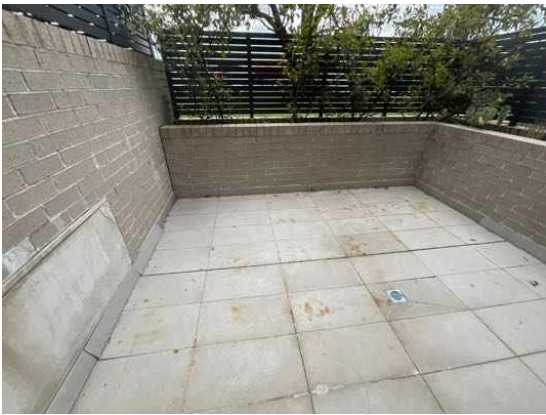
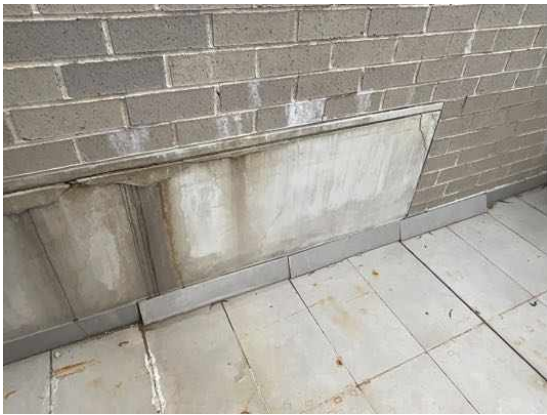
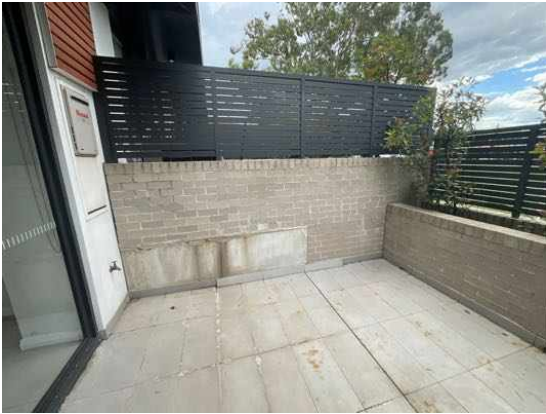
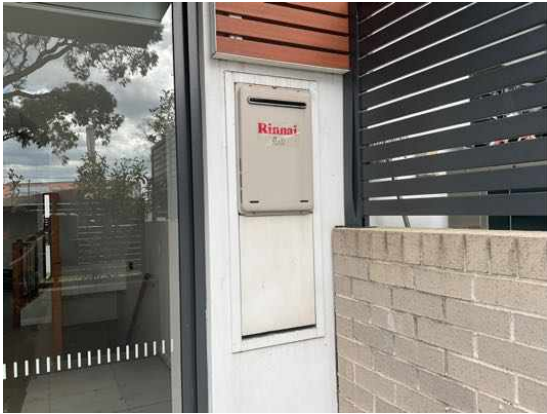
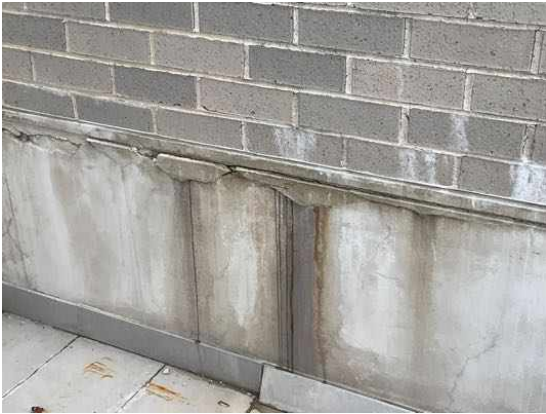
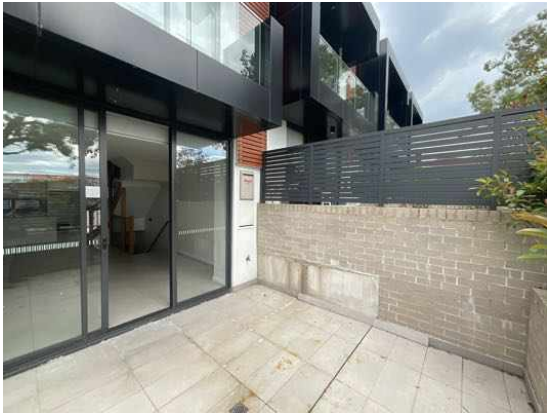
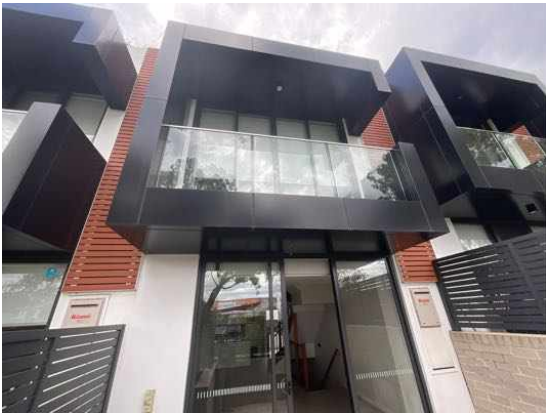
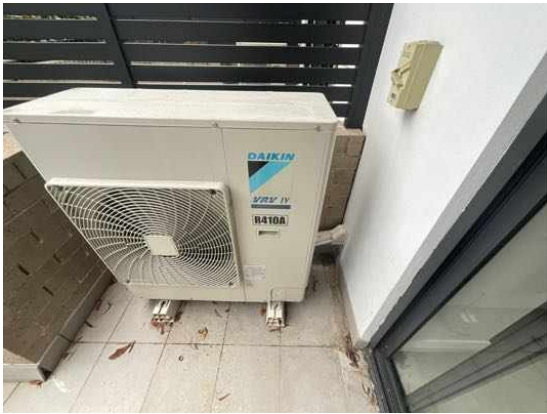
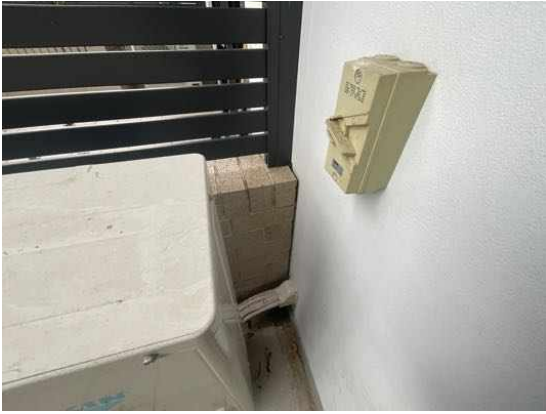
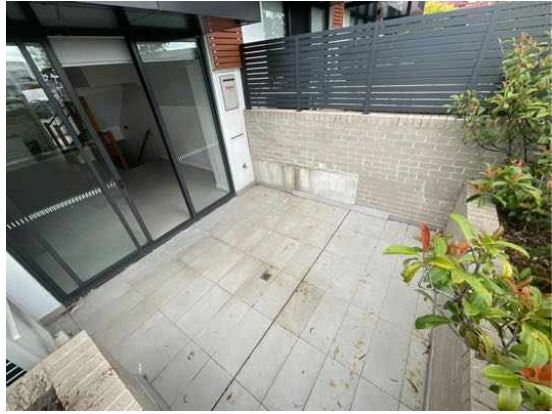
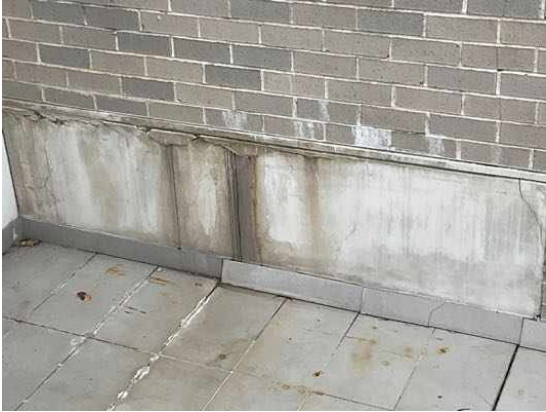
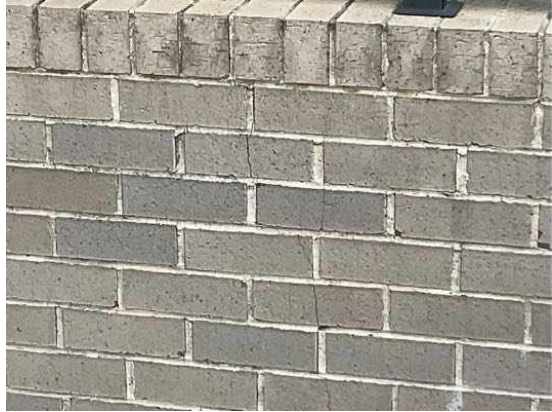
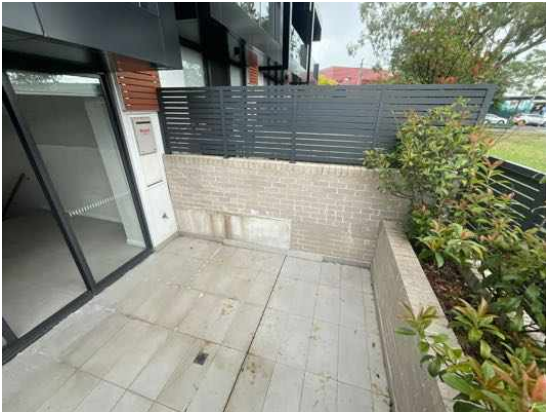
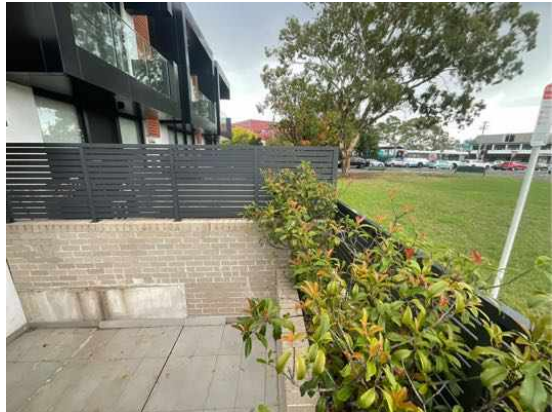
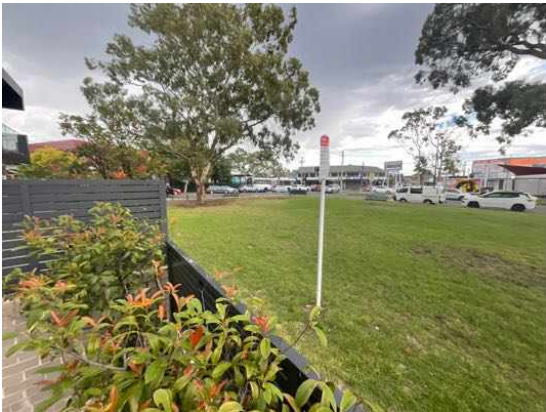
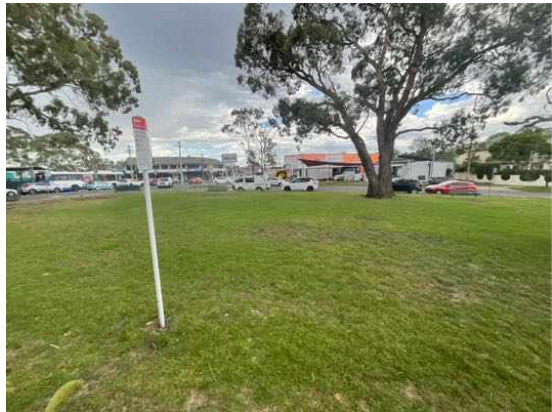
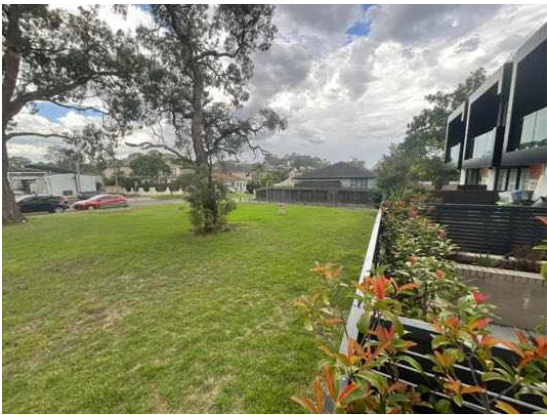
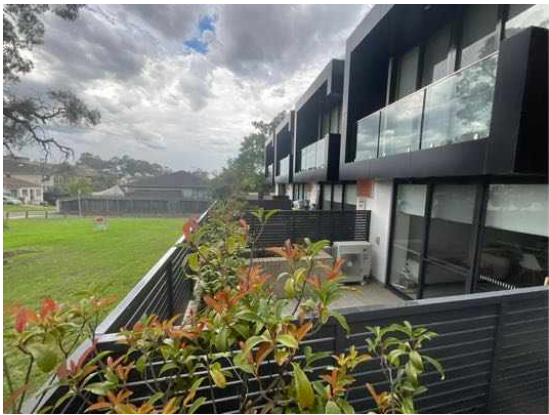
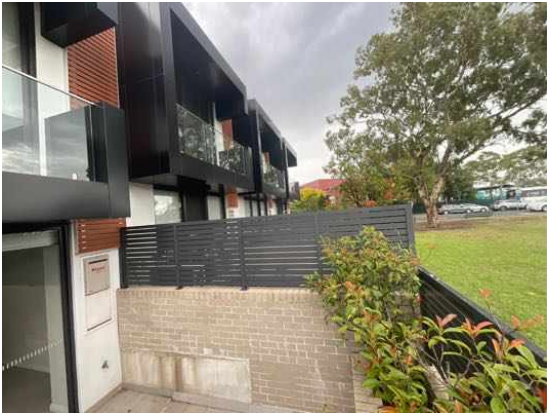
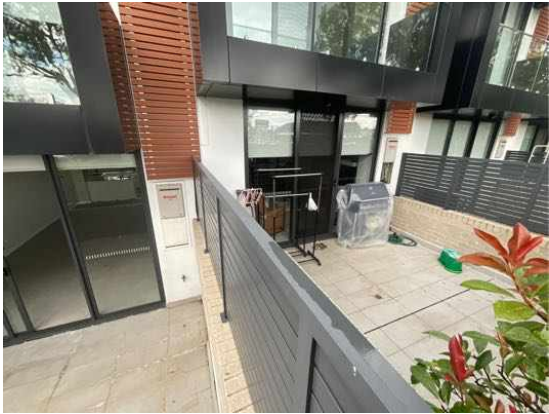
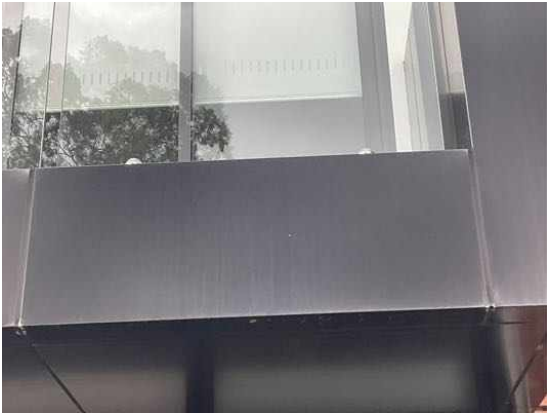
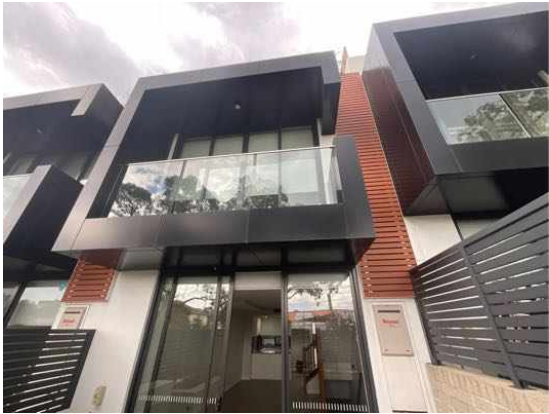
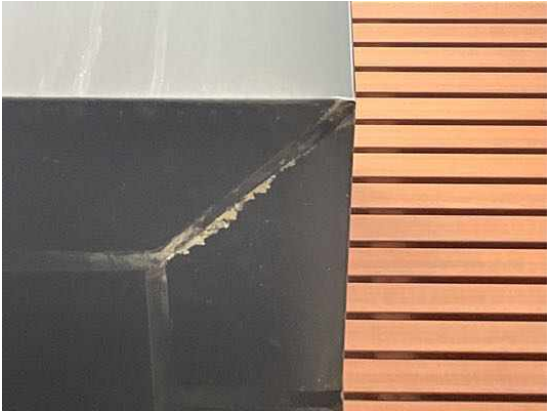
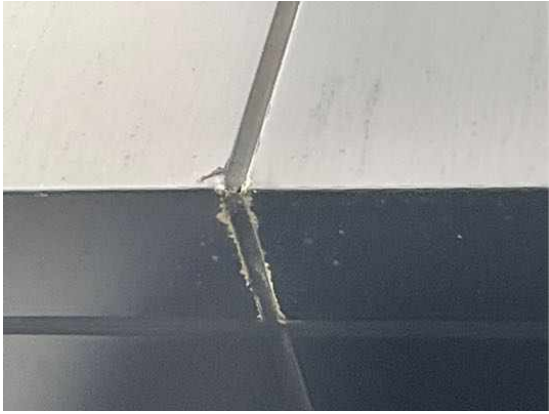
Building: Main Building
Location: All Areas
Finding: Additional Photos
Information: Additional photos are provided for your general reference

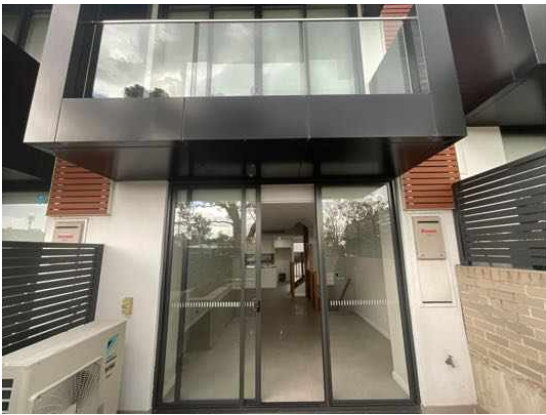
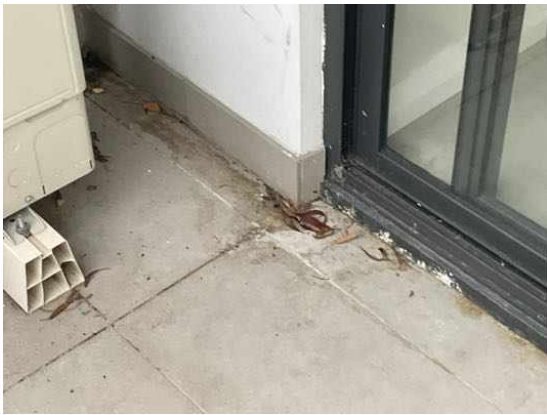
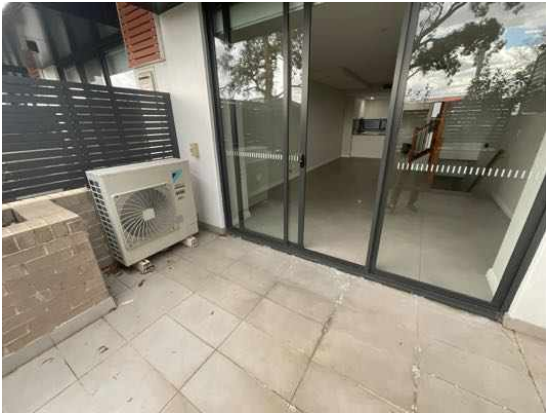
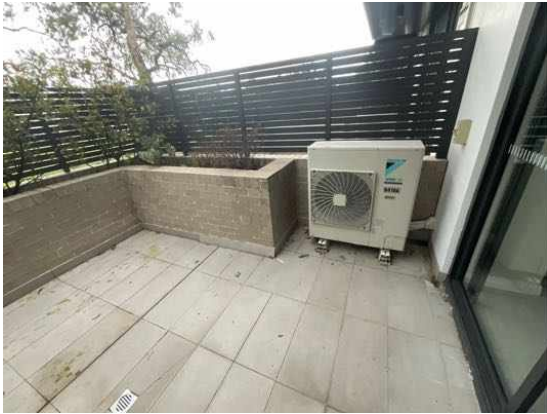
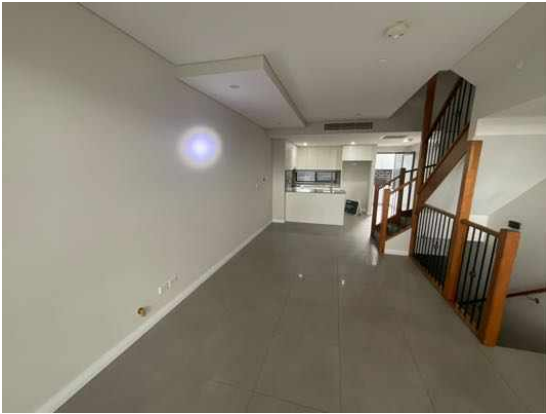
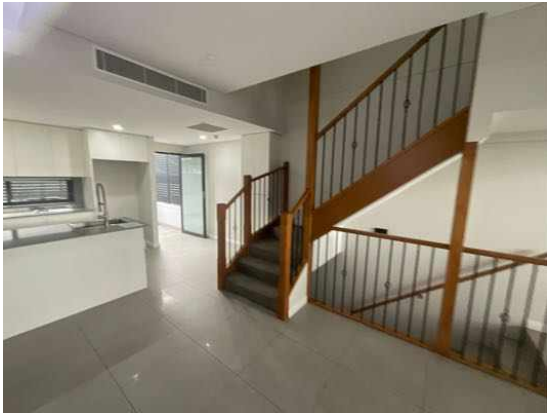
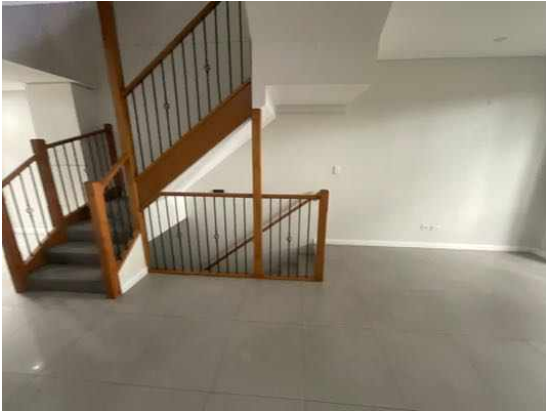
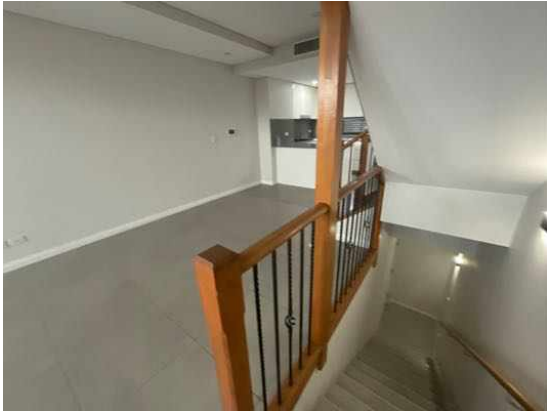
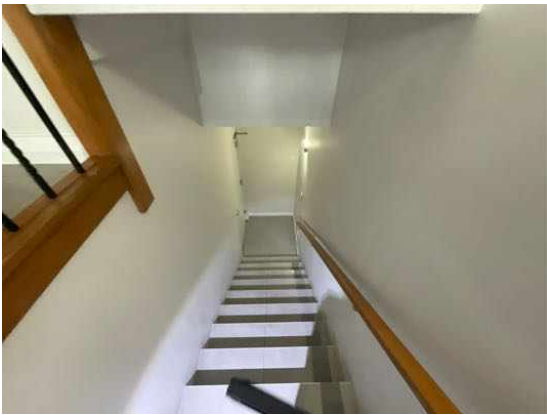
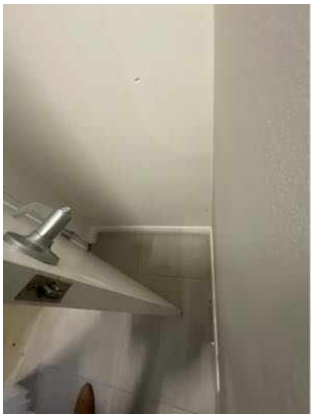
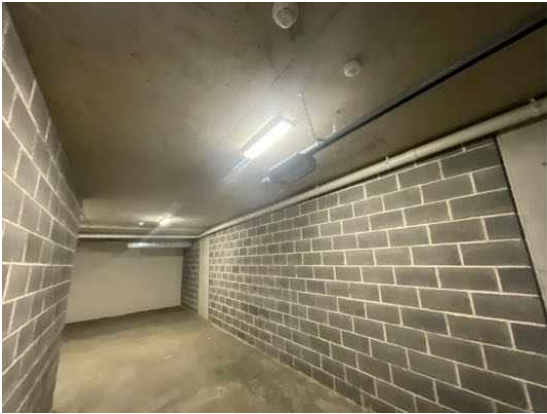
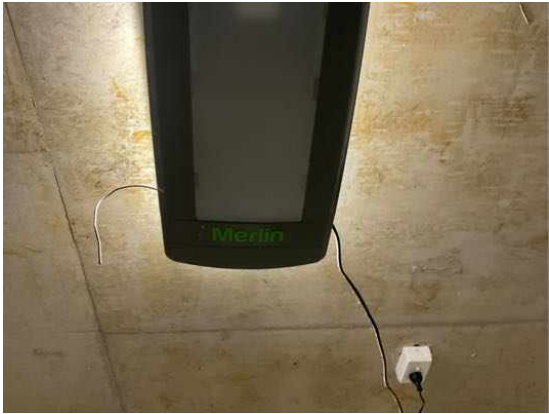
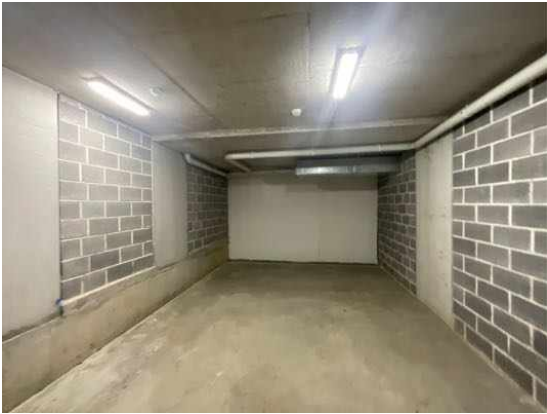
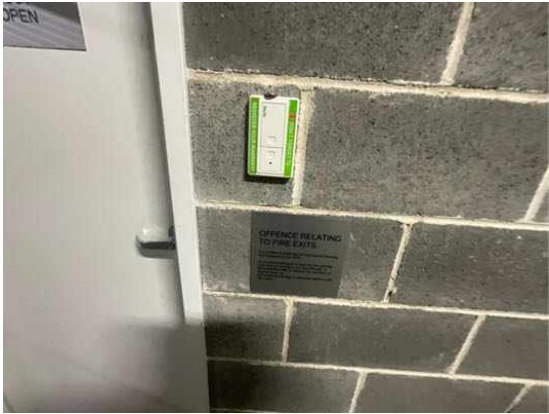
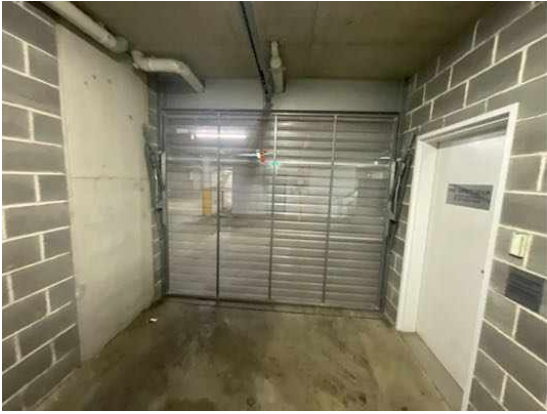
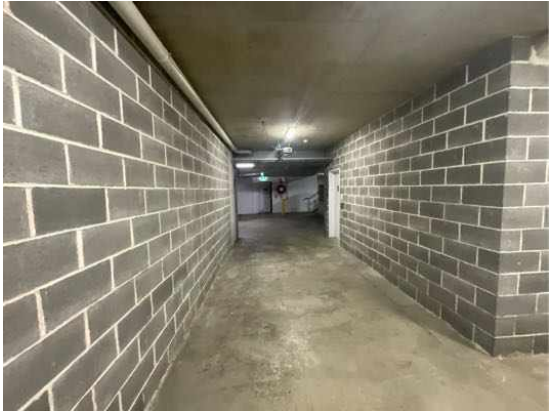
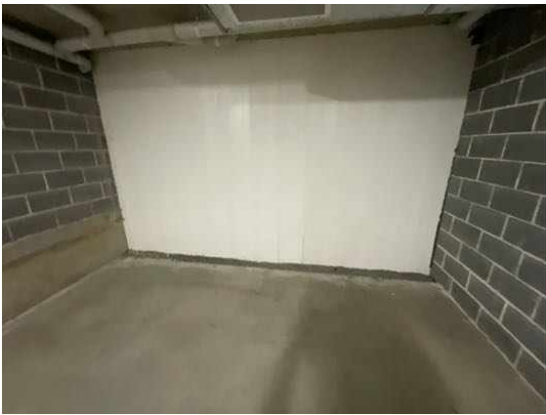
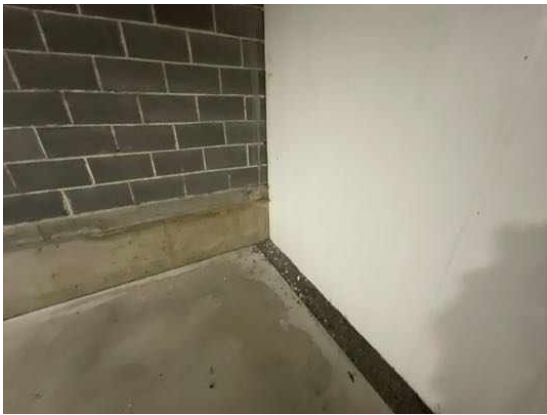
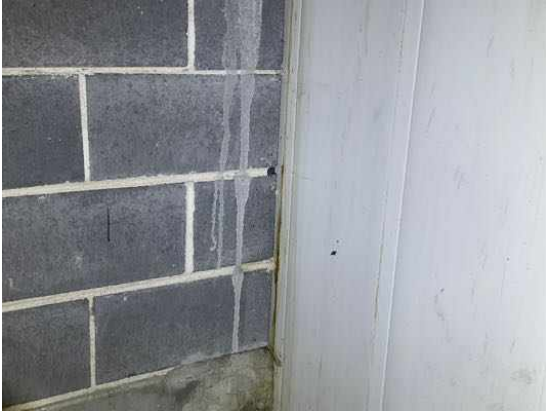
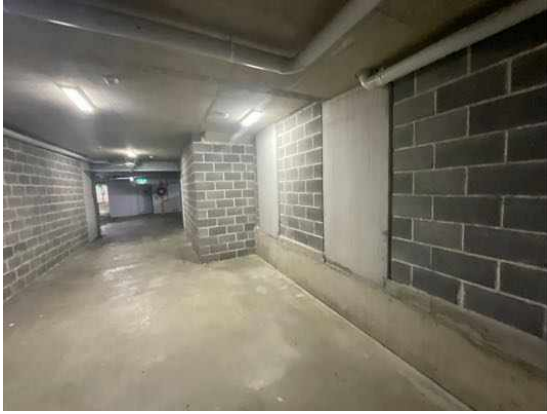
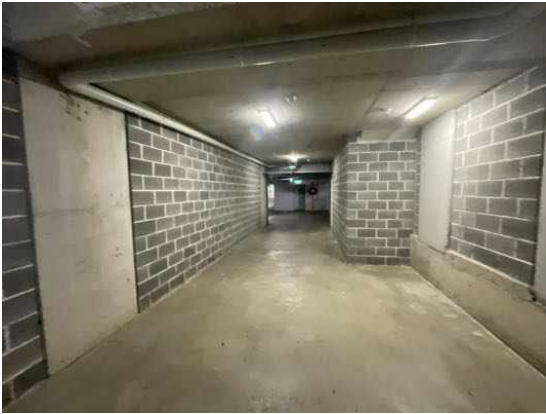
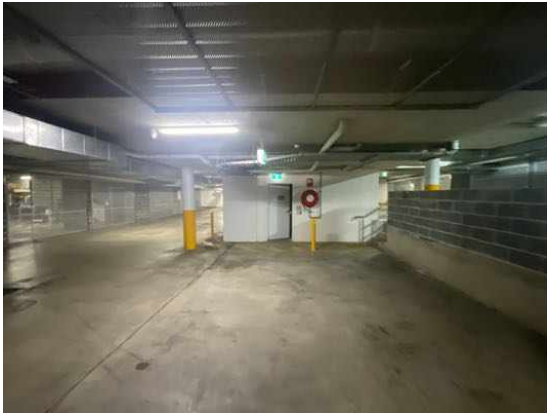
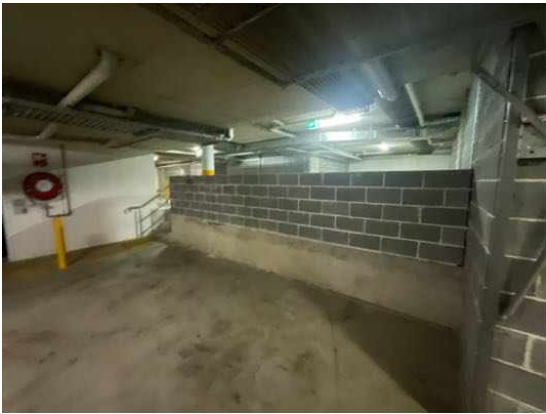
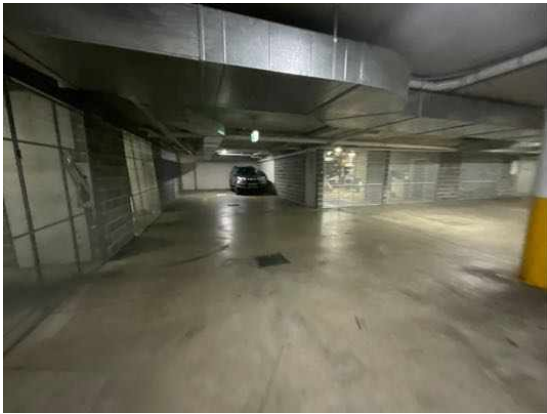
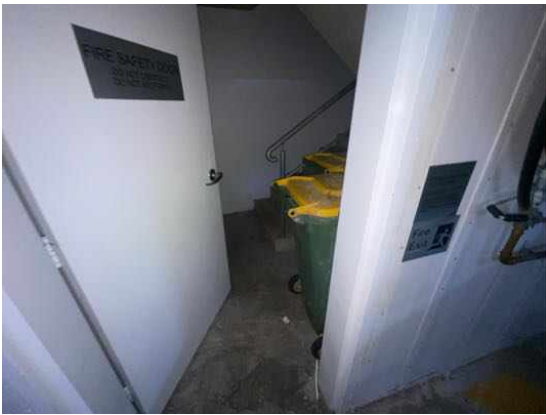
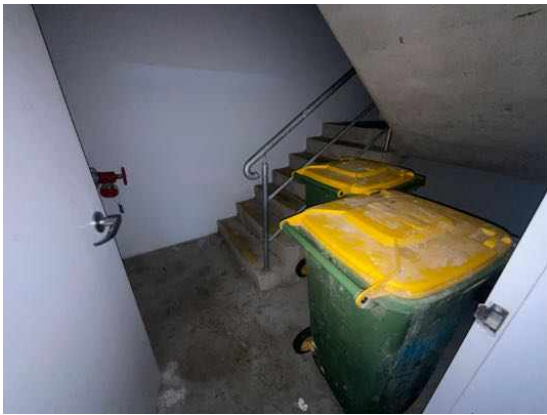
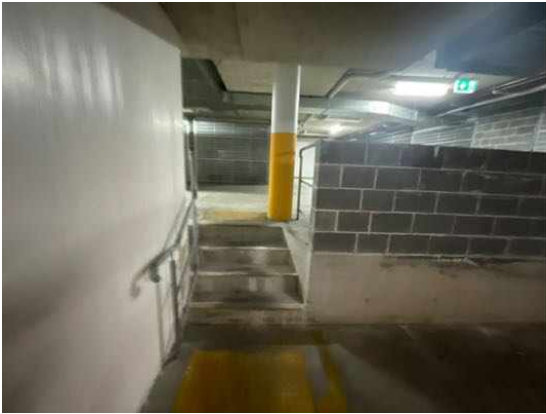
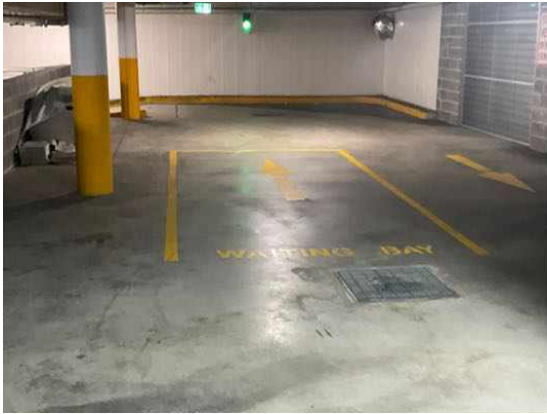
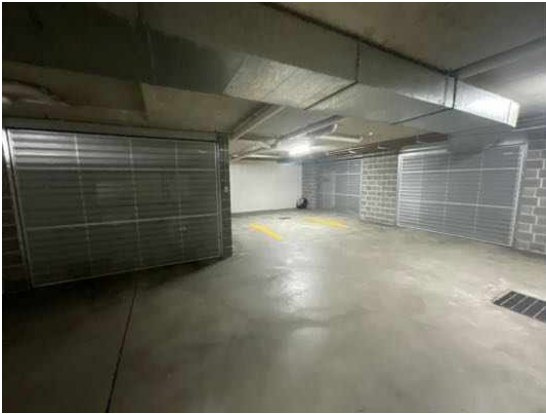
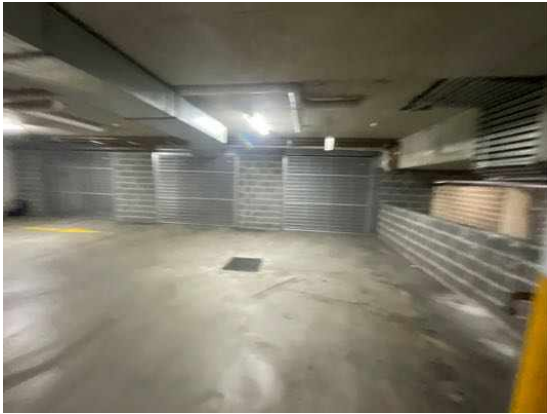
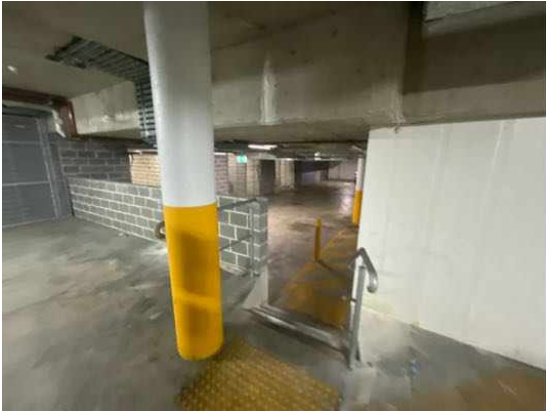
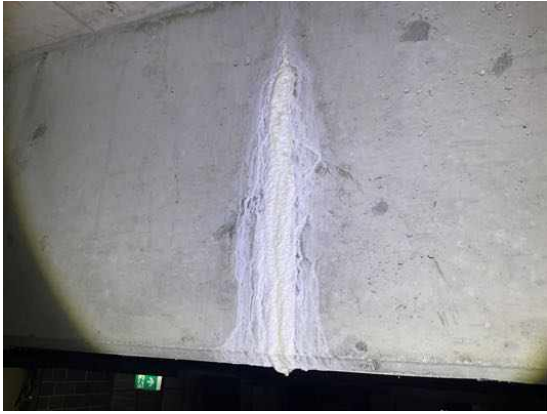
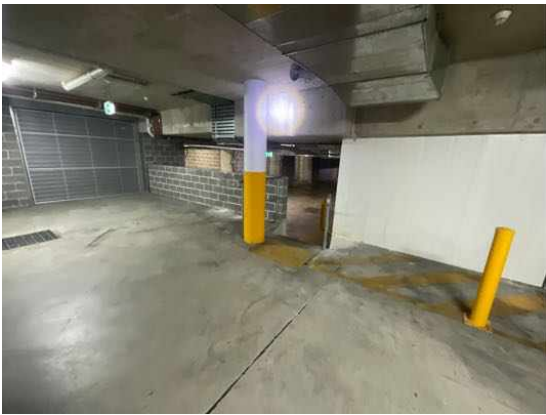
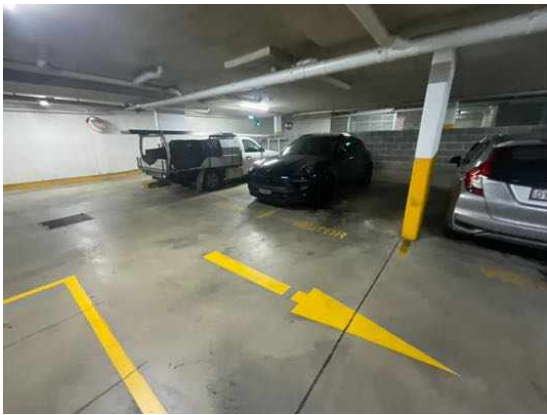
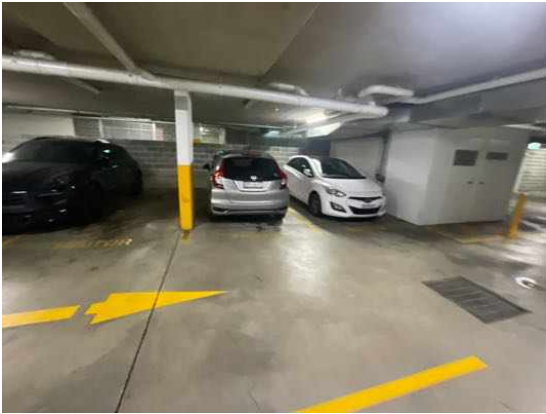
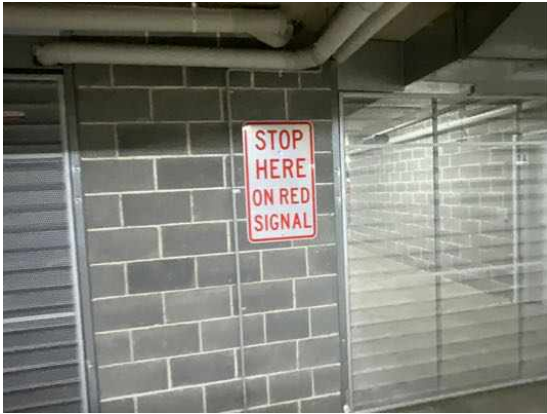
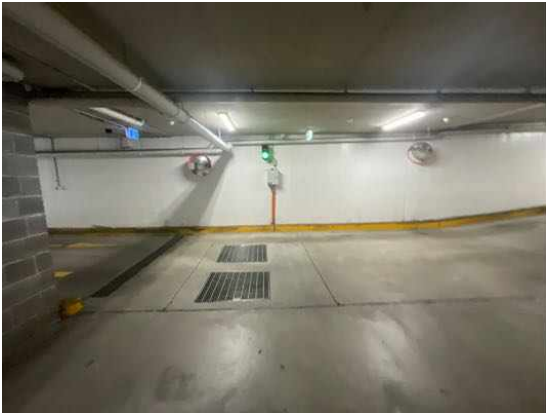
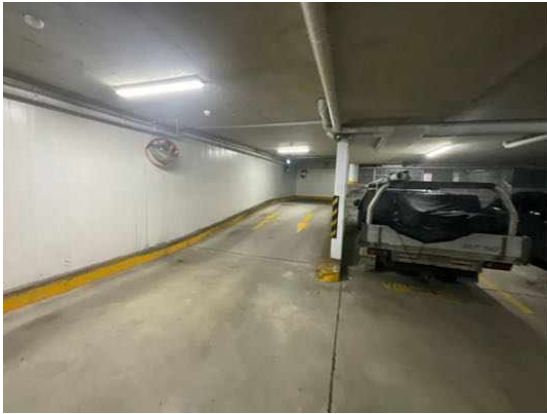
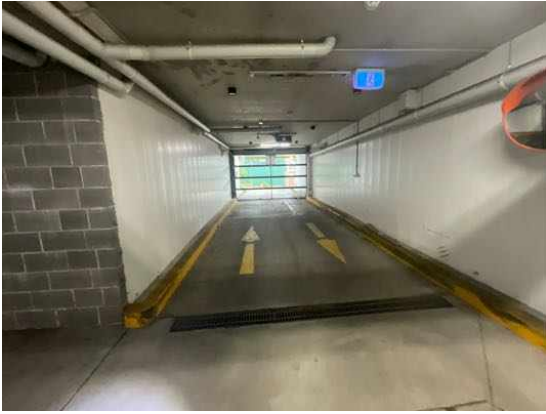
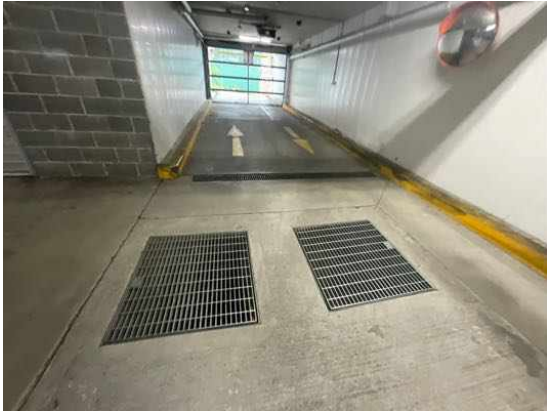
Building: Main Building
Location: All Areas
Finding: Additional Photos - Obstructions and Limitations
Information: These photographs are an indication of the obstructions and limitations which impeded full inspection of the property at the time of inspection. These obstructions can hide an array of defects and should be removed to allow full inspection to be carried out. A re-inspection is recommended once the areas are made accessible.
