Building and Timber Pest Inspection Report

Inspection Date: Wed, 18 Feb 2026

Property Address: 7/547 Chapel Rd, Bankstown NSW 2200,
Australia

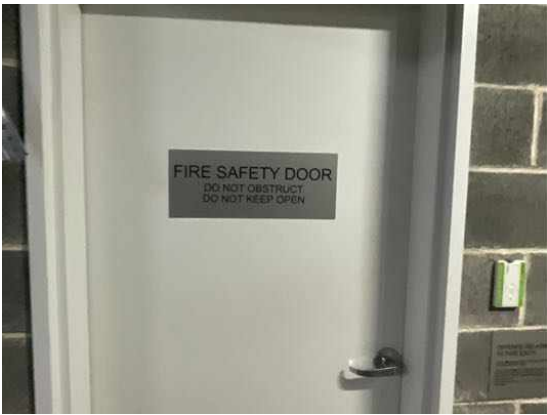
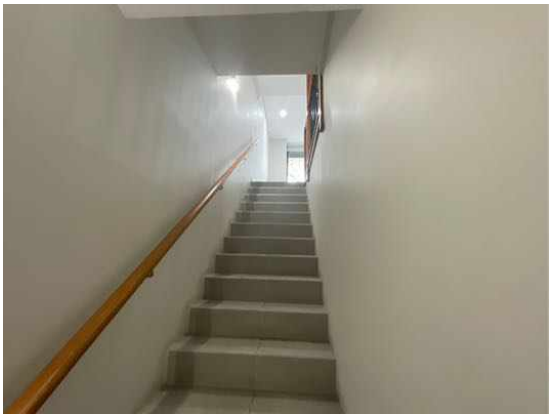
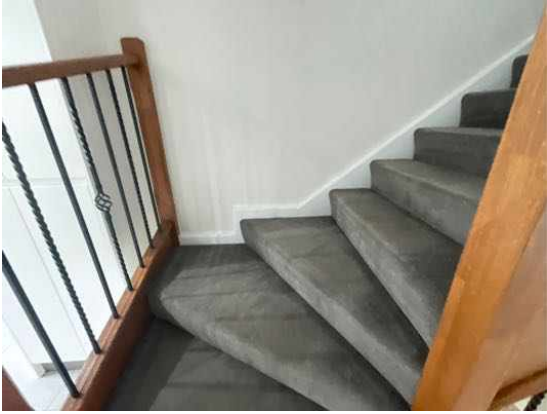
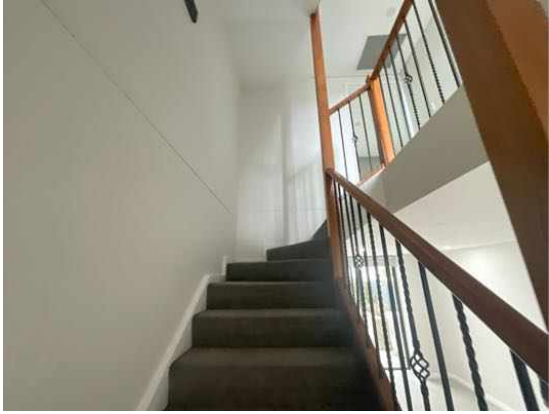
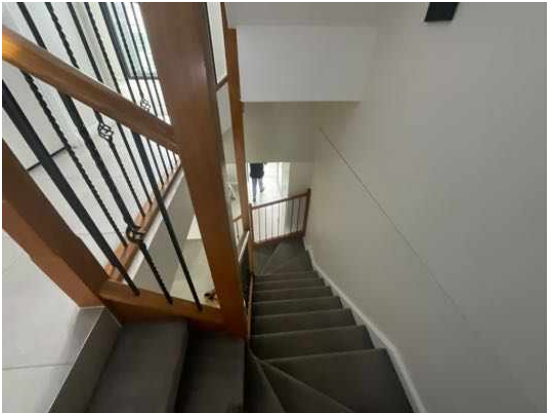
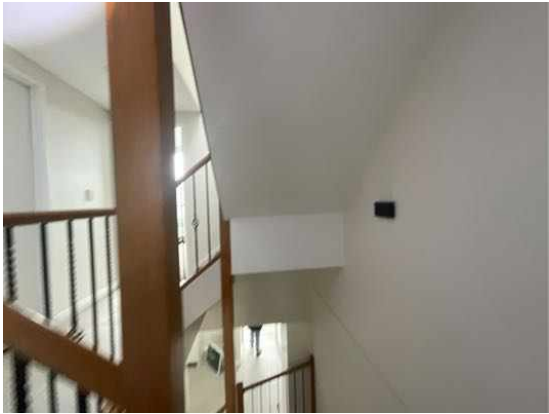
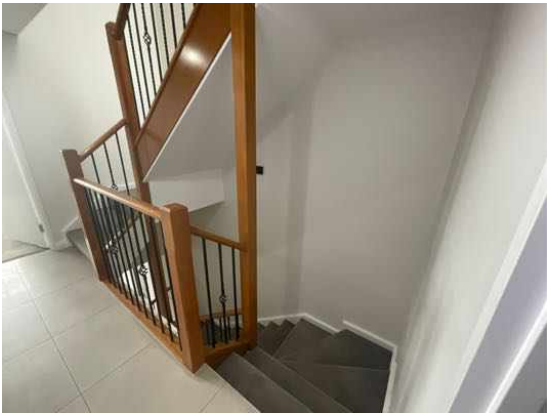
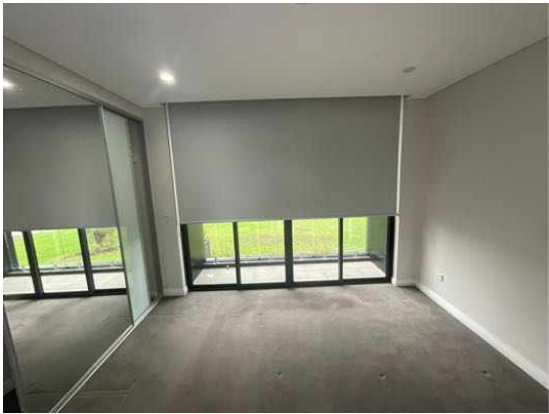
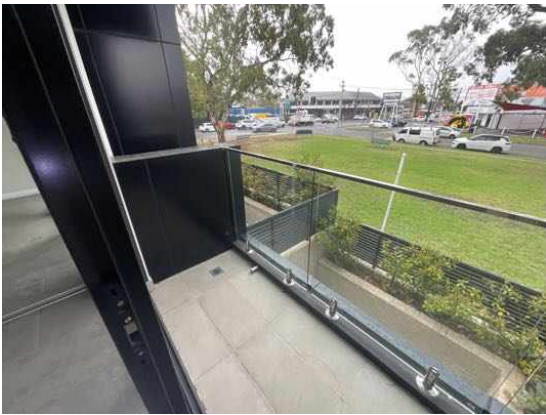
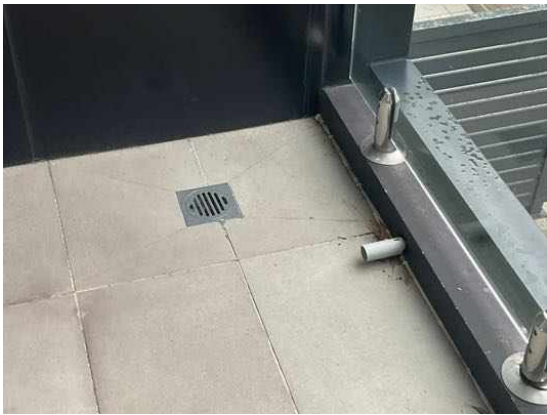
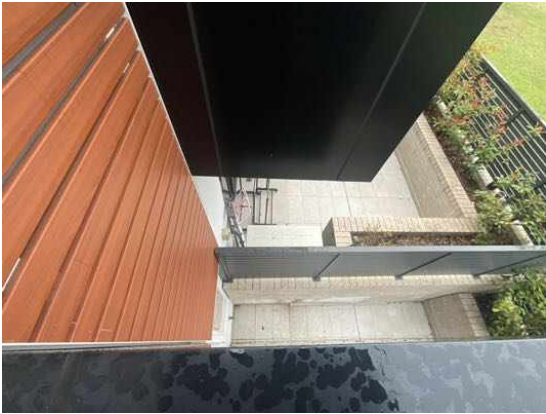
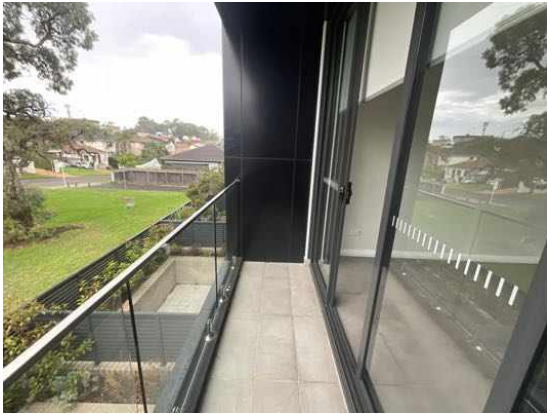
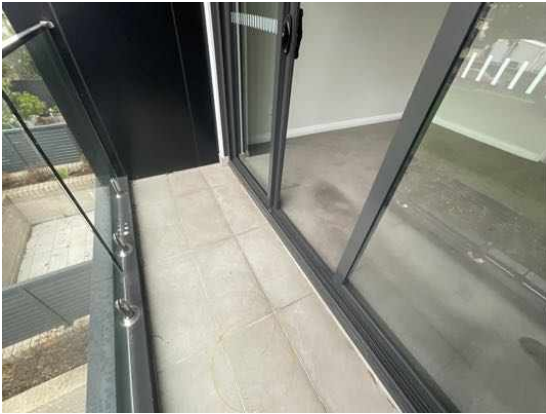
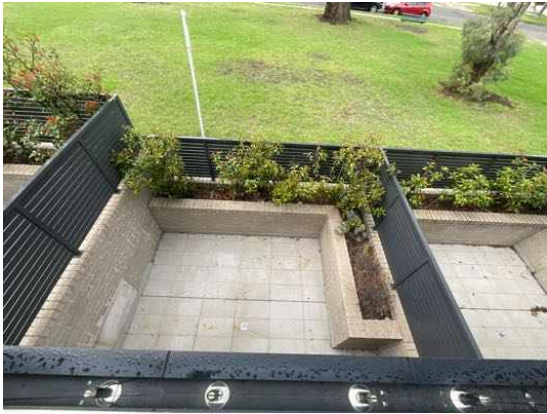
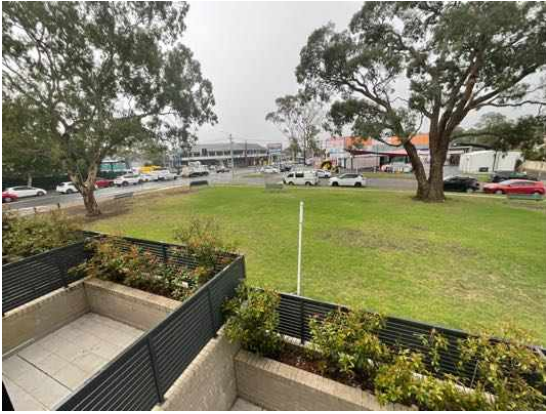
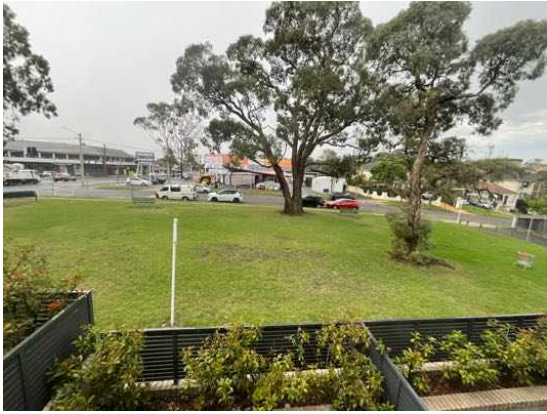
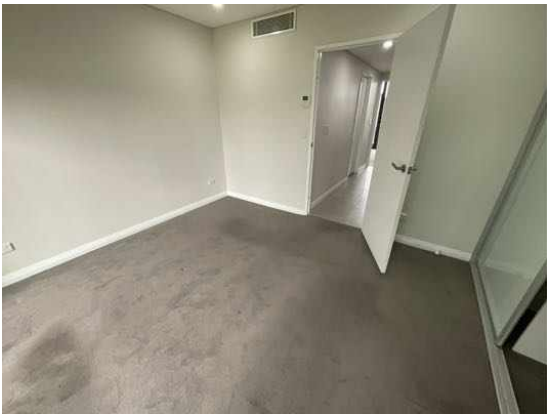
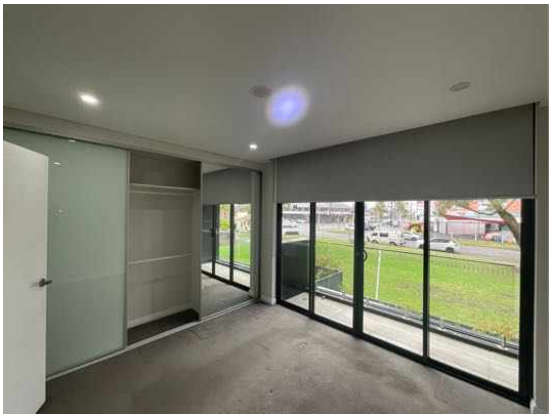
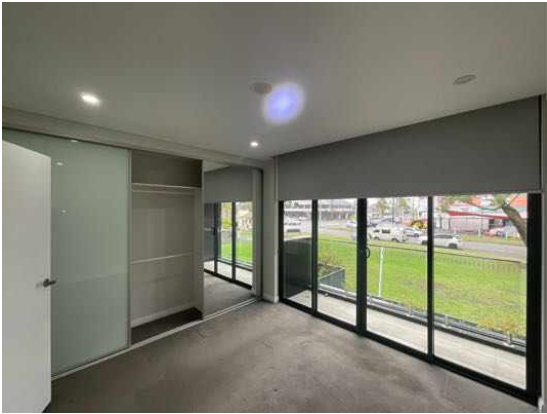
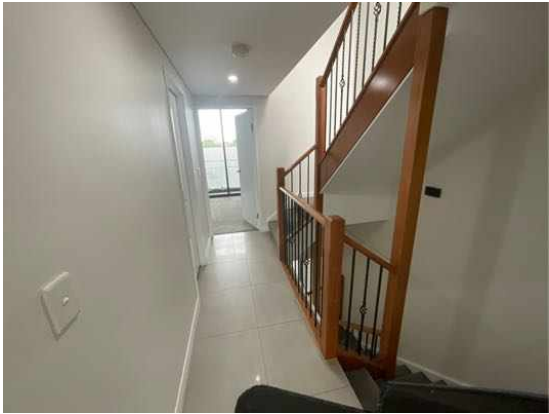
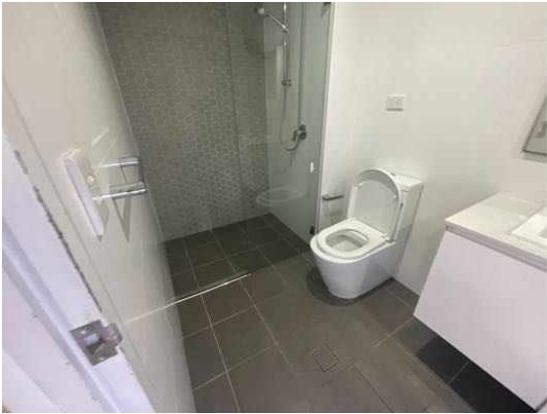
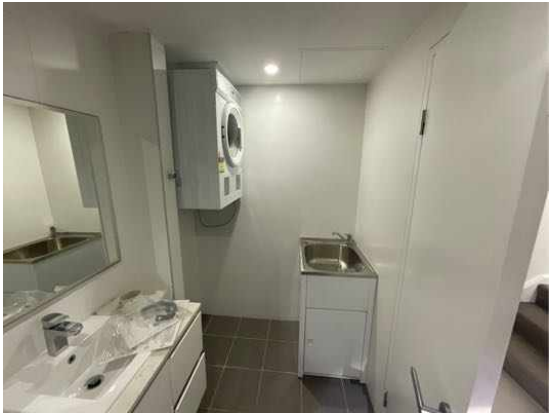
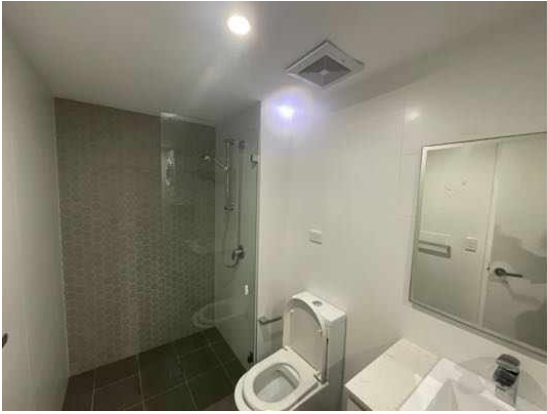
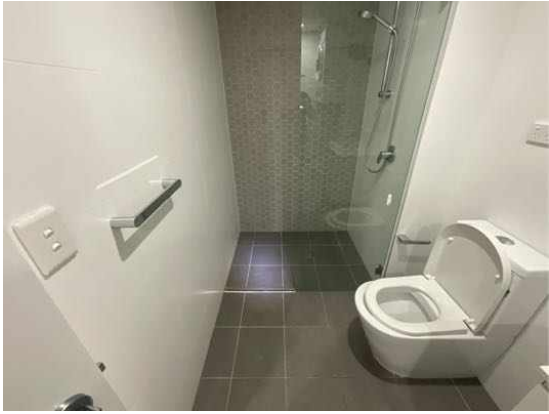
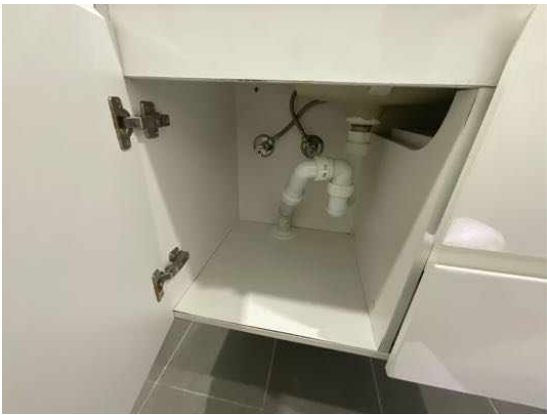
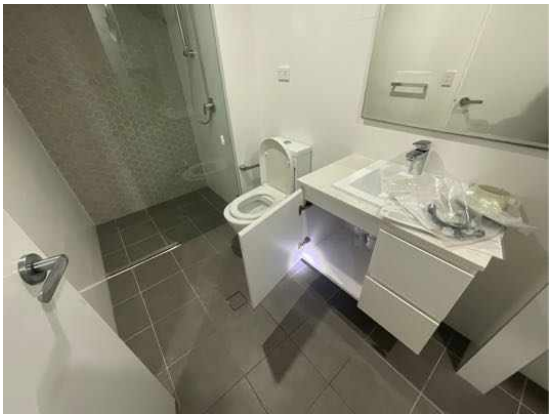
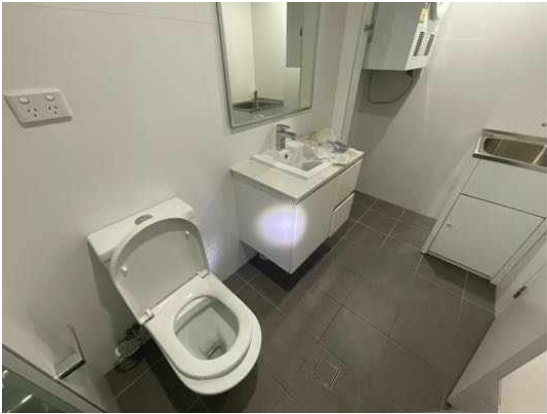
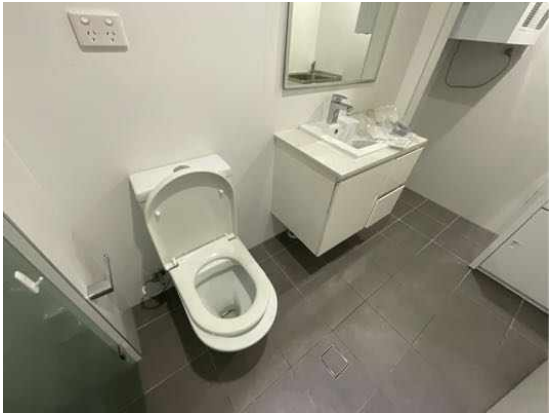
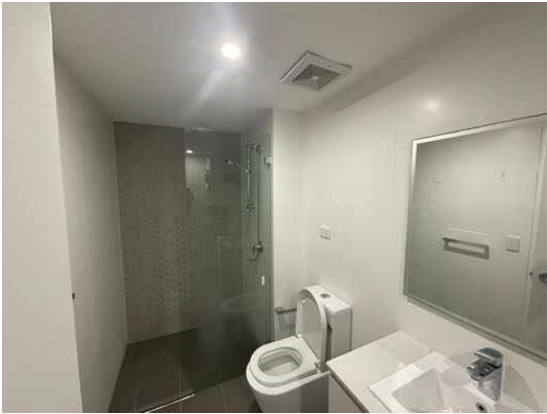
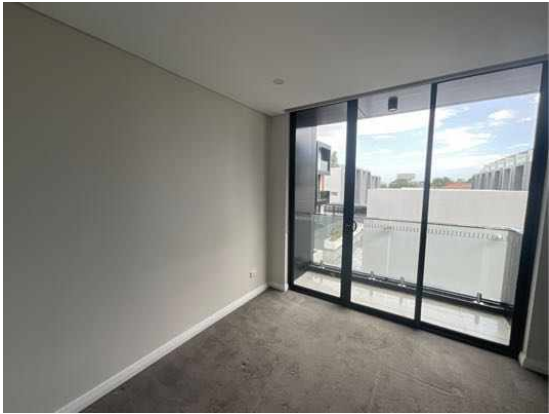
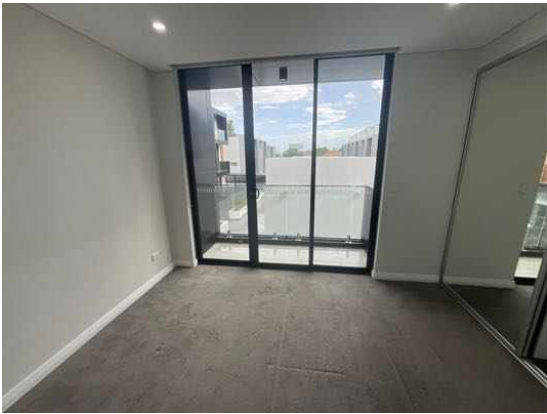
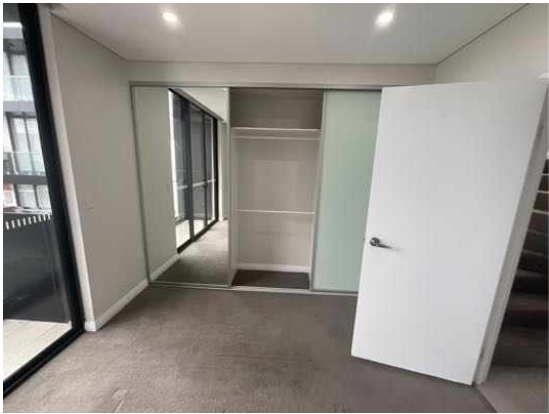
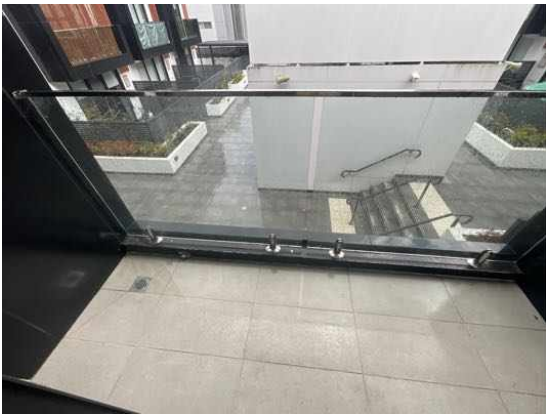
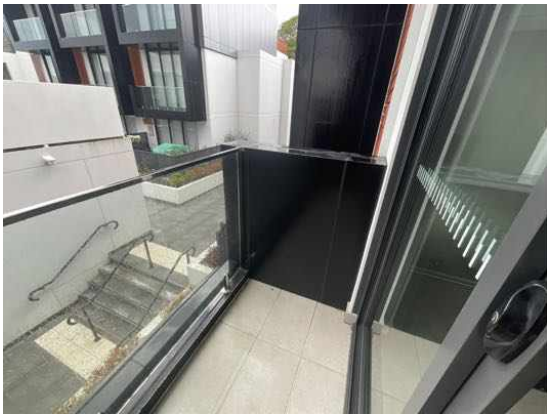
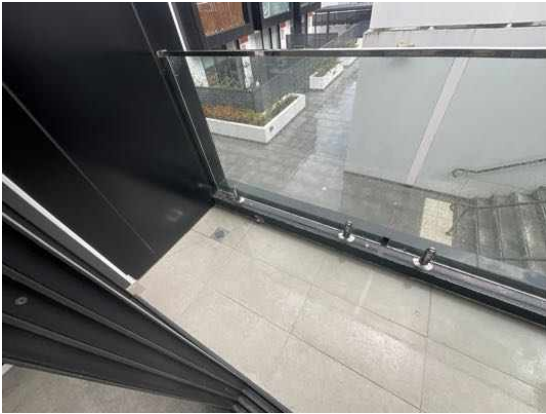
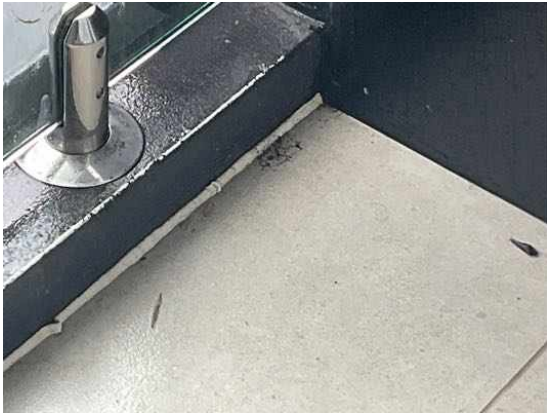
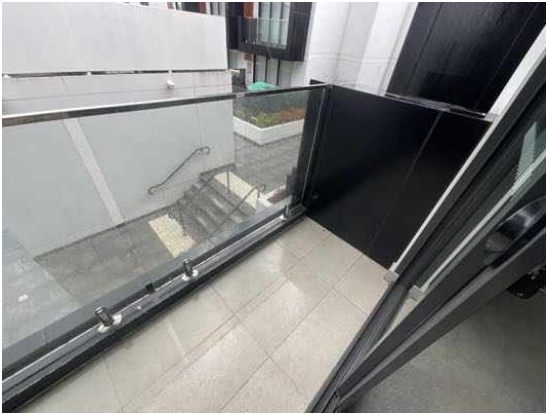
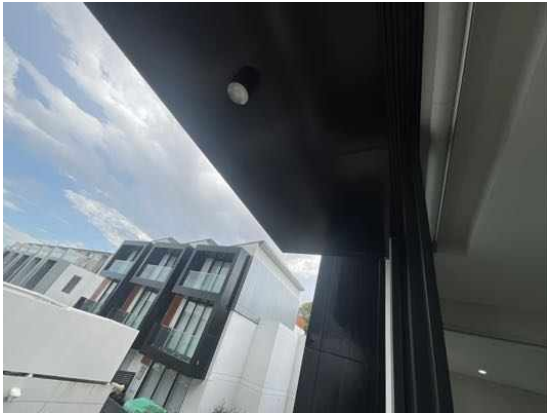
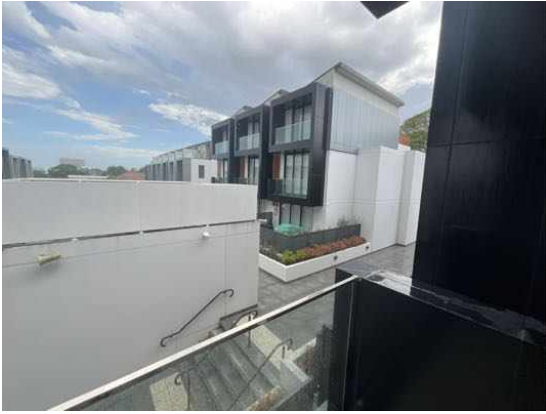
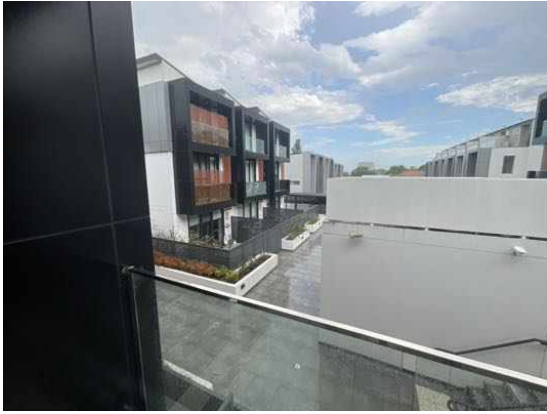
Building: Main Building
Location: All Areas
Finding: Additional Photos - Obstructions and Limitations
Information: These photographs are an indication of the obstructions and limitations which impeded full inspection of the property at the time of inspection. These obstructions can hide an array of defects and should be removed to allow full inspection to be carried out. A re-inspection is recommended once the areas are made accessible.
