# Building and Timber Pest Inspection Report

Inspection Date: Thu, 6 Nov 2025

Property Address: 29 Cambridge Ave, Vaucluse NSW 2030, Australia

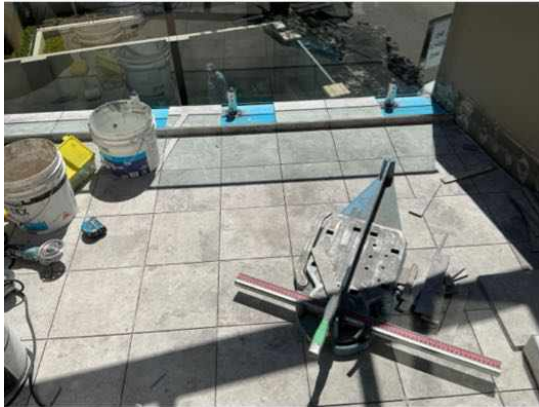
#### Finding 3.02

Works that have not been completed to a satisfactory level create potential for the development of building defects and may impede on the safety and integrity of the overall structure.

It is highly recommended that the relevant trades be appointed to complete these works and ensure the safety of the area and the longevity of all associated building elements.

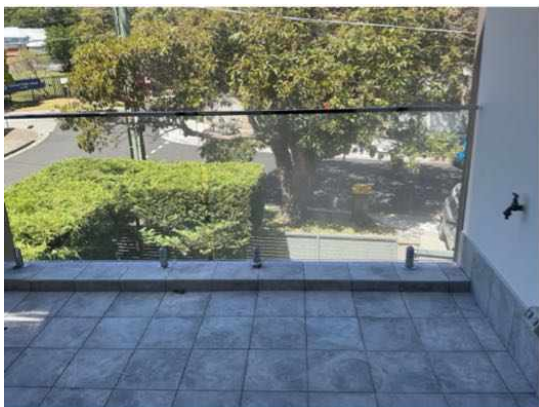
### Finding 3.03

| Finding: | Grout - Missing |
| Information: | Grout is missing in this area. Grout is used to protect gaps and crevices in building materials to ensure that they are water-tight and prevent water penetration to the associated structures. |

Where grout is missing, a tiling contractor should be appointed immediately to apply grout and re-apply any silicone where necessary. Failure to do so is likely to lead to water damage to the surrounding area.

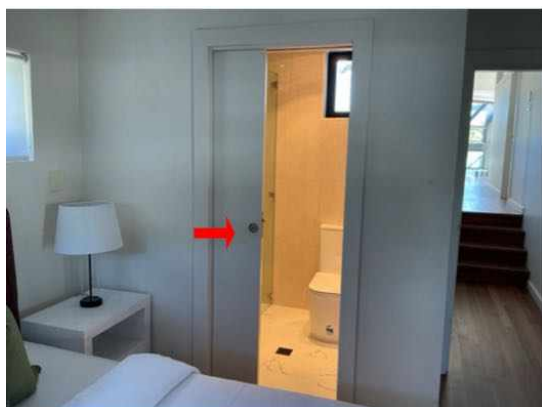
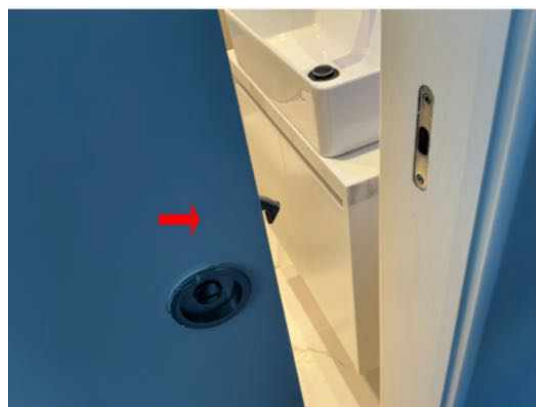
### Finding 3.04

| Information: | It was noted that the door in this area was not latching during operation at the time of inspection. Whilst detracting from the functionality of this building element, this minor defect may also be a security risk, and may therefore have serious implications if left unattended. |

It is suspected that this defect has occurred due to minor issues with the associated hinges. Such damage is identified as general wear and tear, which is expected for building elements of this age.

A qualified carpenter or general handyperson may be appointed to perform rectification works as necessary, at client discretion. If left unattended, further functional impairment is likely to occur.

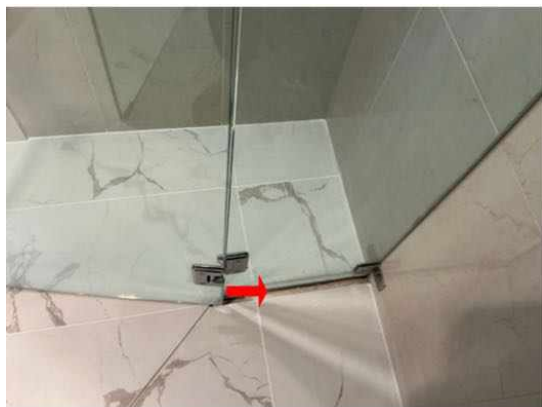
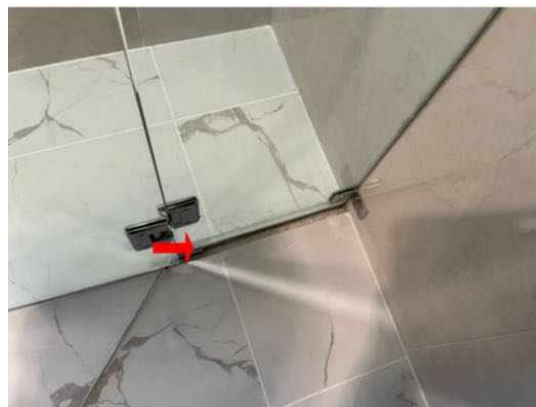
### Finding 3.05

Works that have not been completed to a satisfactory level create potential for the development of building defects and may impede on the safety and integrity of the overall structure.

It is highly recommended that the relevant trades be appointed to complete these works and ensure the safety of the area and the longevity of all associated building elements.

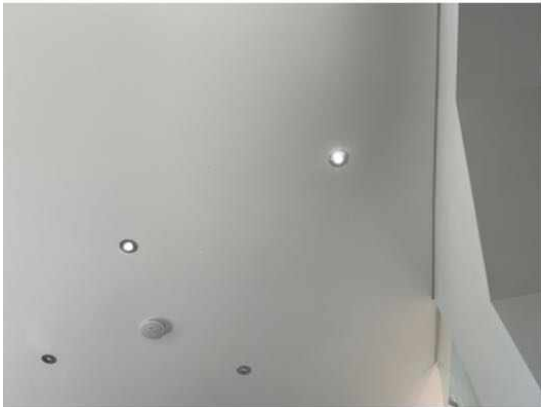
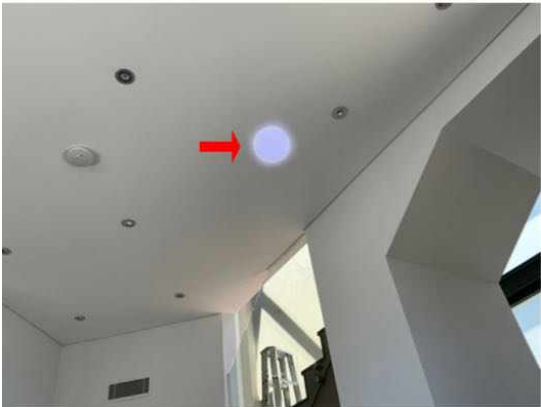
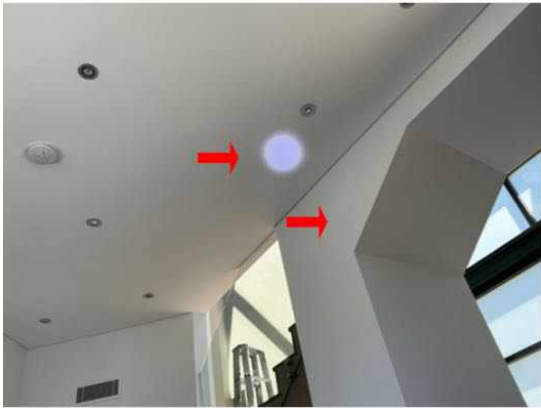
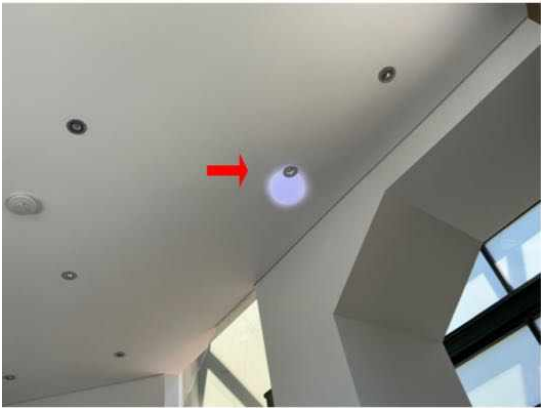
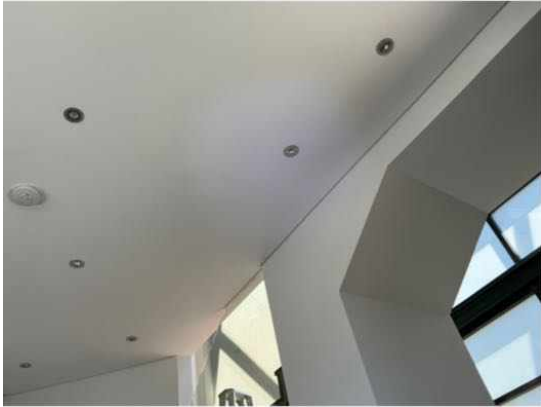
### Finding 3.06

Information: The paint finish in this area was found to have been completed to a substandard level. Substandard painting is generally classified as an appearance defect. However, the substandard appearance may also be indicative of poor surface preparation and substandard workmanship.

If this applies, further areas of poor and incomplete finishes could develop over time. Furthermore, substandard paint finishes in areas exposed to moisture, e.g. external areas or wet areas, could lead to deterioration of underlying building materials.

Substandard paint finishes should be sanded back, filled, leveled and repainted, as applicable. Where inadequate paint protection has led to the deterioration of the associated building element, repair and/or replacement of this building element may be required.

A painting contractor should be appointed as soon as possible to perform necessary works to aid the appearance of the affected area and to ensure that the area is protected against further deterioration. Alternatively, the homeowner following manufacturer instructions may be able to provide this service.

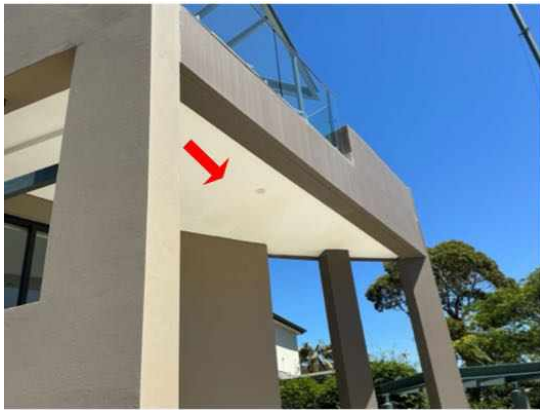
**Finding 3.07**

Building: Main Building  
Location: Entry  
Finding: Paint finish - Substandard  
Information: The paint finish in this area was found to have been completed to a substandard level. Substandard painting is generally classified as an appearance defect. However, the substandard appearance may also be indicative of poor surface preparation and substandard workmanship.

If this applies, further areas of poor and incomplete finishes could develop over time. Furthermore, substandard paint finishes in areas exposed to moisture, e.g. external

areas or wet areas, could lead to deterioration of underlying building materials.

Substandard paint finishes should be sanded back, filled, leveled and repainted, as applicable. Where inadequate paint protection has led to the deterioration of the associated building element, repair and/or replacement of this building element may be required.

A painting contractor should be appointed as soon as possible to perform necessary works to aid the appearance of the affected area and to ensure that the area is protected against further deterioration. Alternatively, the homeowner following manufacturer instructions may be able to provide this service.

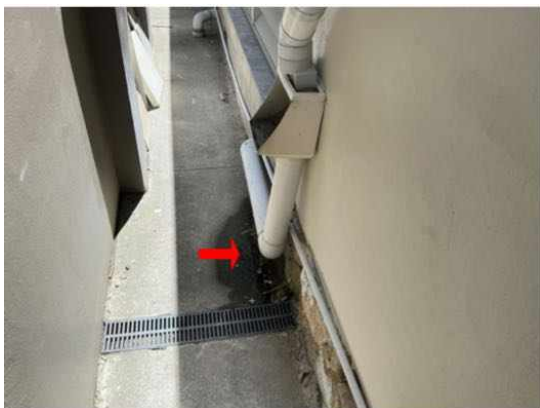
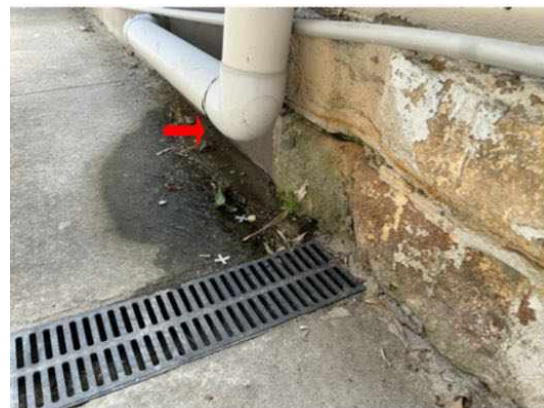
### Finding 3.08

| Finding: | Pipe leak - Active |
| Information: | The minor water pipe leakage observed during the home inspection can lead to potential water damage. It is advisable to enlist the services of a licensed plumber to promptly identify and fix the leak, preventing further issues and ensuring the integrity of the plumbing system. |

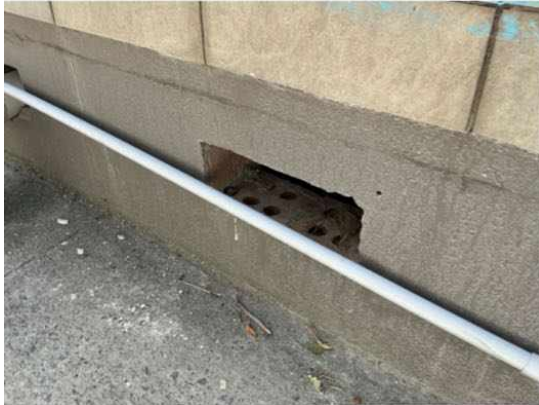
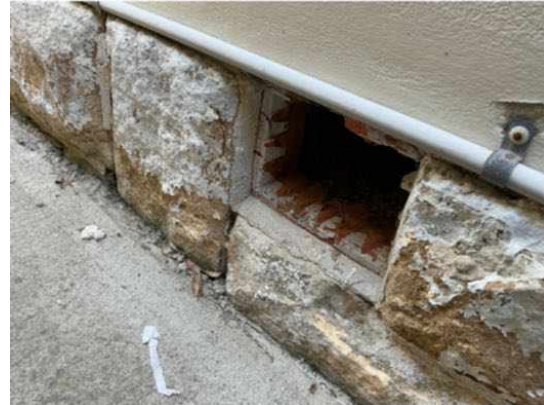
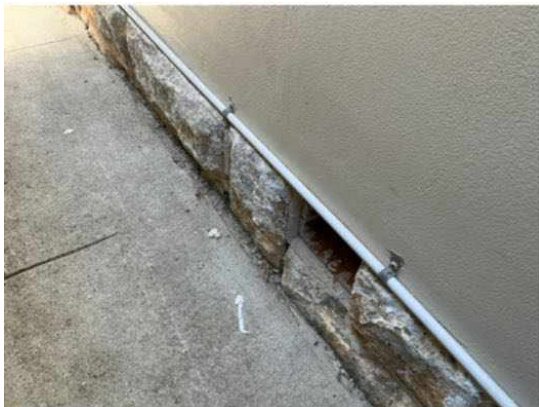
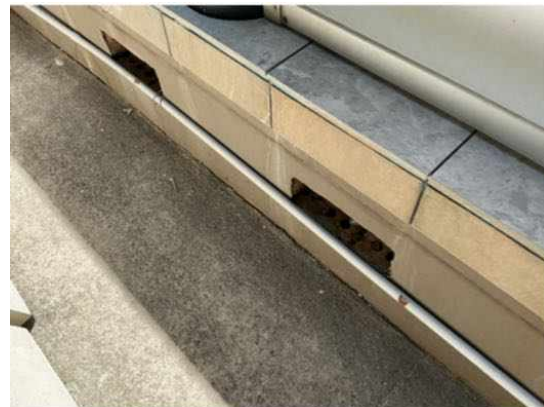
### Finding 3.09

| Finding: | Missing Air Vent Covers Around Subfloor Area |
| Information: | During the inspection, it was observed that all air vent openings around the subfloor area are missing their protective covers. These uncovered openings are quite large and may allow insects, rodents, or other pests to enter the subfloor space. It is recommended to install appropriate vent covers to prevent pest intrusion and to maintain proper ventilation while ensuring the subfloor area remains protected. |

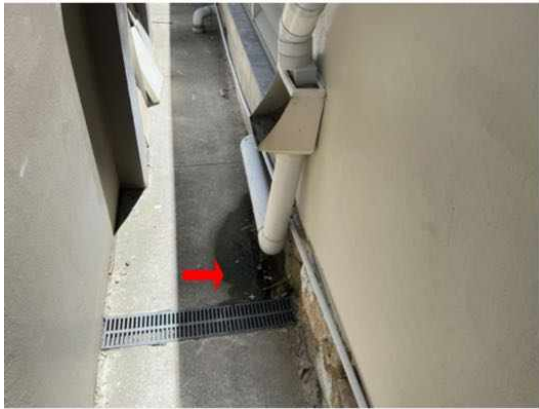
Building: Main Building  
 Location: Exterior walls - left side  
 Finding: Excessive moisture - identified  
 Information: Excessive moisture can attract termites and produce conditions that promote fungal growth and wood decay.

Excessive moisture is generally caused by deteriorated, inadequate or missing roof drainage, leaking plumbing pipes or fixtures, poorly plumbed HWS overflows or condenser units and poor site drainage.

Prior to any remedial works being performed a qualified plumber should be appointed to further inspect the property and to identify the cause of the excessive moisture. Works to remove affected building elements may then be necessary and should be

performed by an appropriate tradesperson.

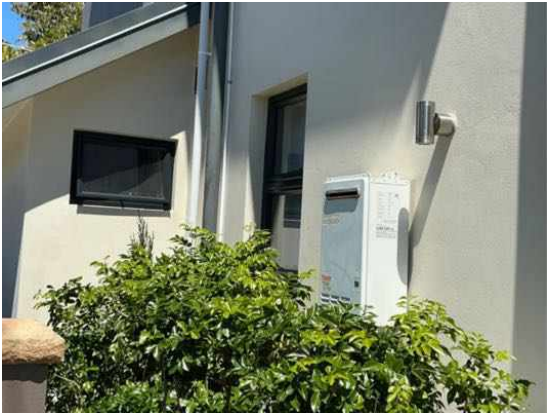
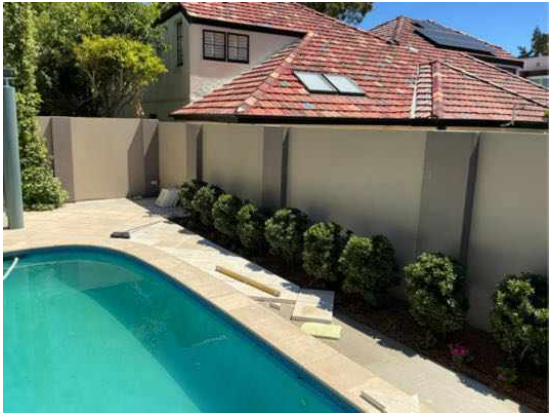
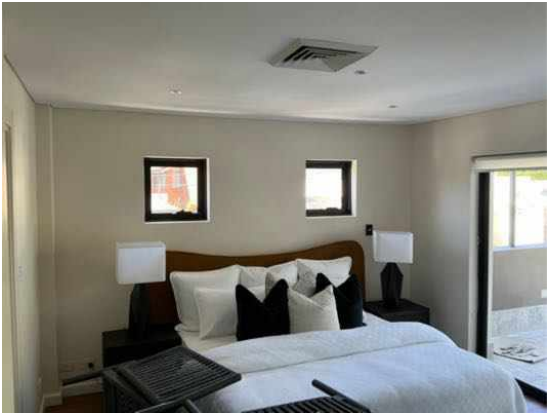
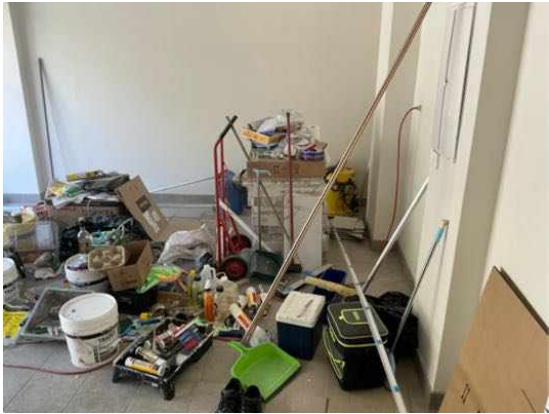
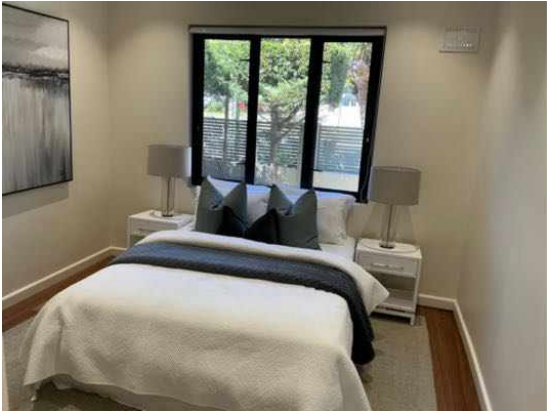
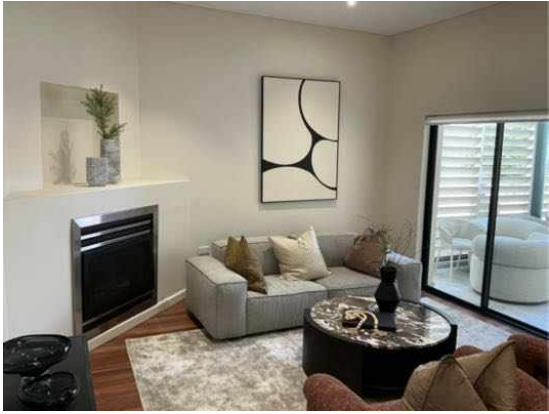
Information: These photographs are an indication of the obstructions and limitations which impeded full inspection of the property at the time of inspection. These obstructions can hide an array of defects and should be removed to allow full inspection to be carried out. A re-inspection is recommended once the areas are made accessible.

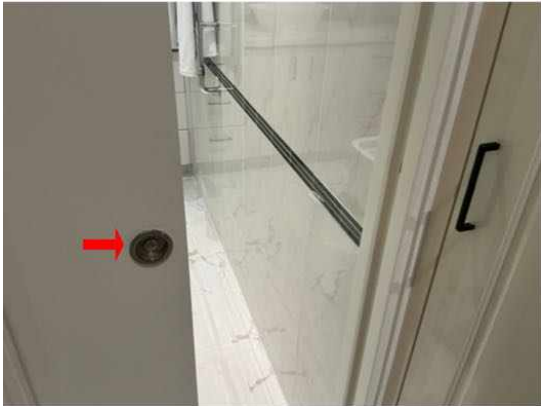
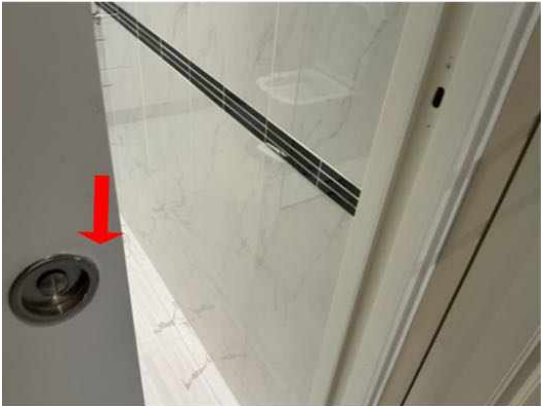
Building: Main Building  
Location: Bathroom  
Finding: Door handle - Not latching  
Information: It was noted that the door in this area was not latching during operation at the time of inspection. Whilst detracting from the functionality of this building element, this minor defect may also be a security risk, and may therefore have serious implications if left unattended.

It is suspected that this defect has occurred due to minor issues with the associated hinges. Such damage is identified as general wear and tear, which is expected for building elements of this age.

A qualified carpenter or general handyperson may be appointed to perform rectification works as necessary, at client discretion. If left unattended, further

functional impairment is likely to occur.

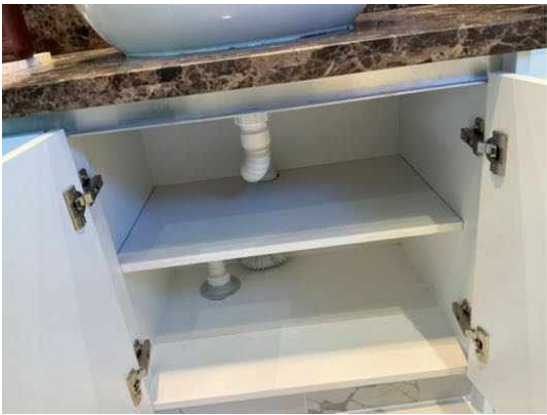
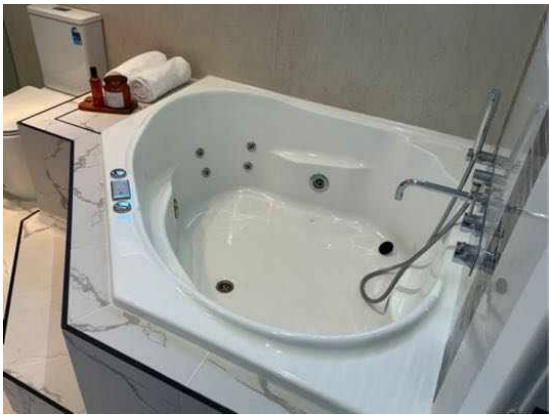
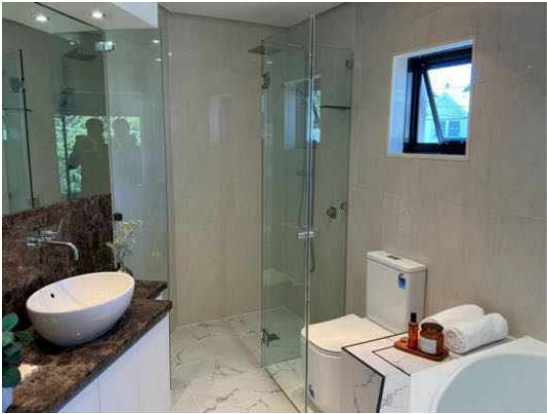
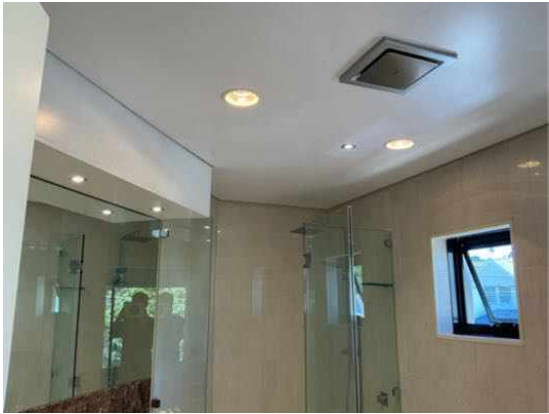
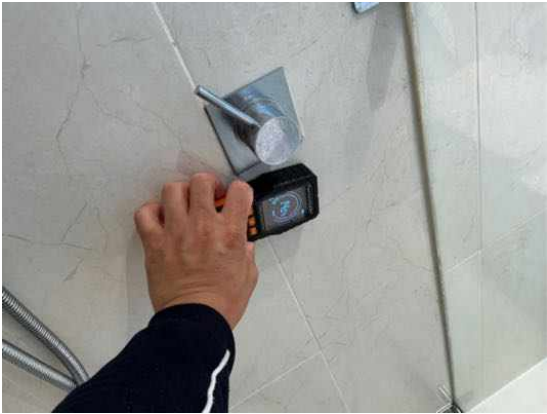
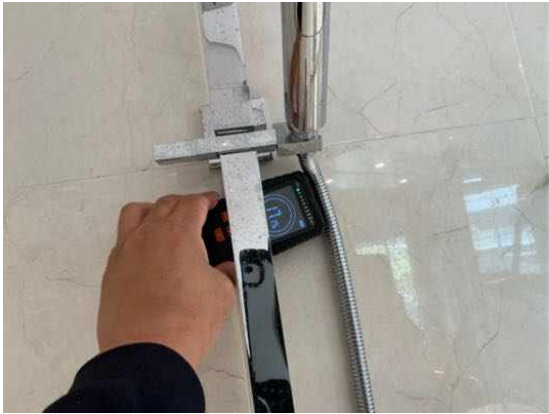
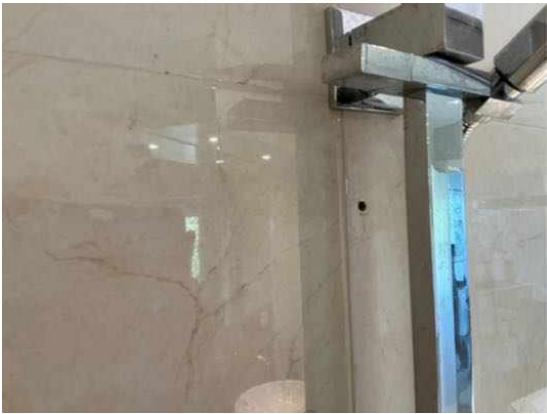
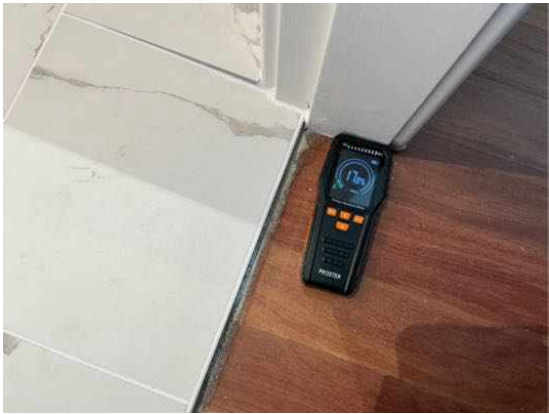
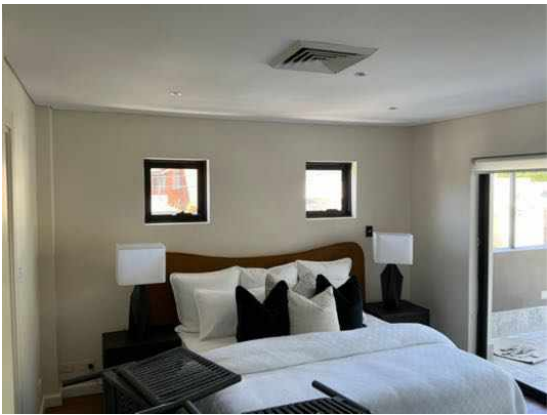
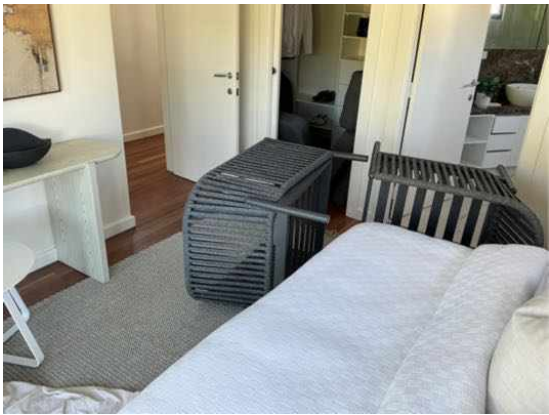
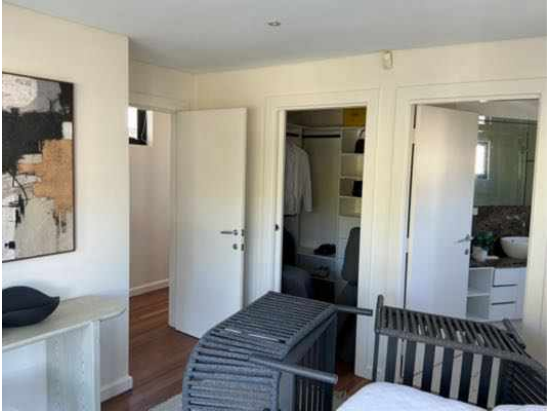
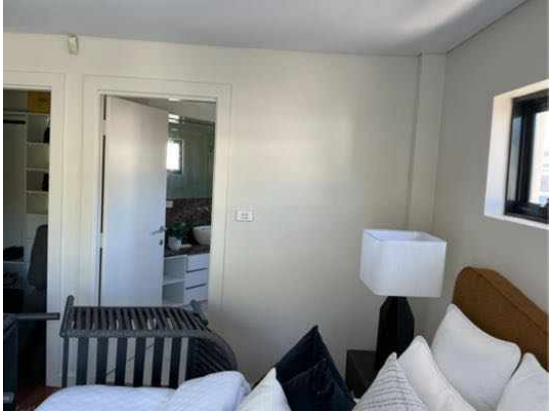
Building: Main Building  
Location: Bedroom - Master  
Finding: No Visible Defects  
Information: Additional photos are provided for your general reference

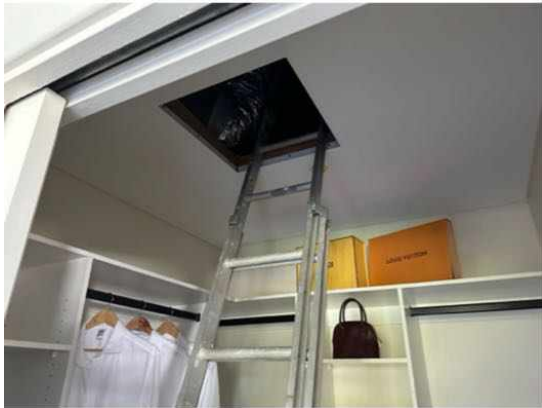
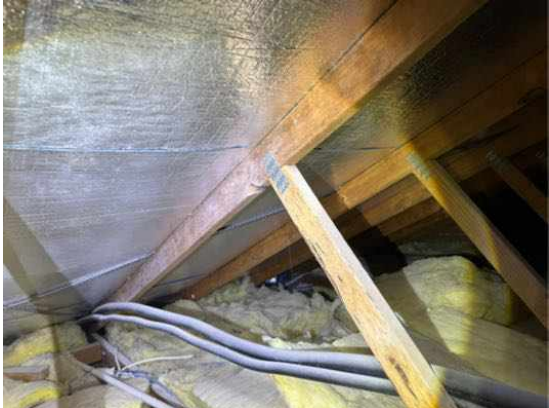
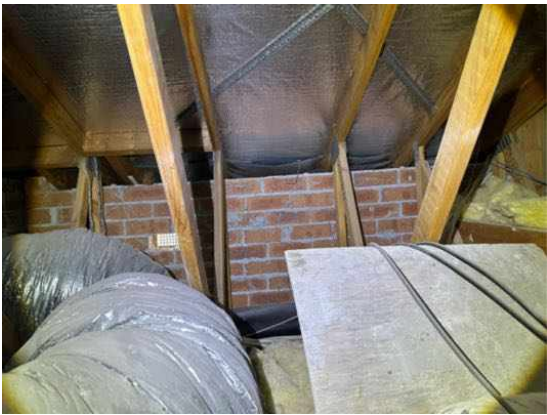
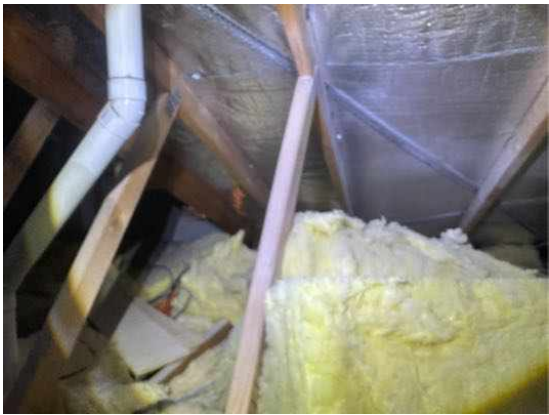
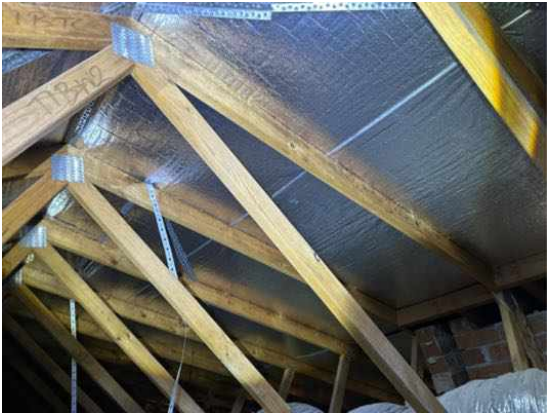
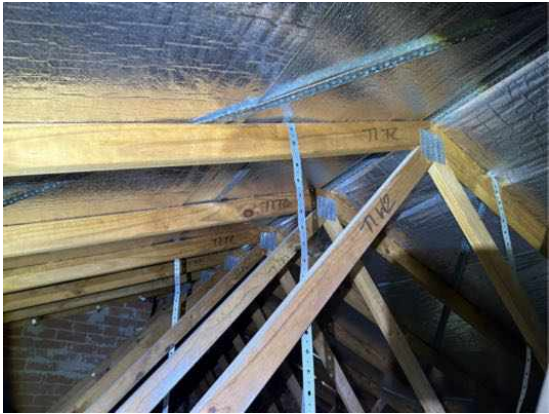
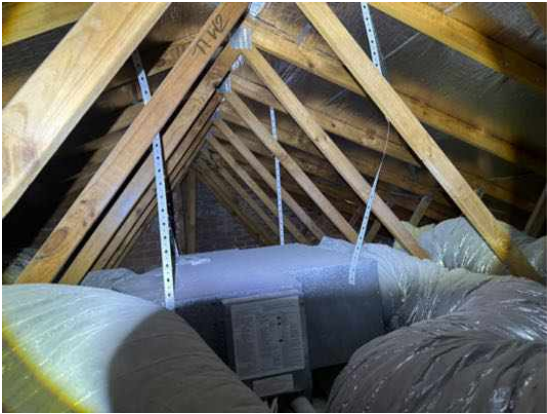
Building: Main Building  
Location: Roof Void  
Finding: Additional Photos  
Information: Additional photos are provided for your general reference
