Building and Timber Pest Inspection Report

Inspection Date: Mon, 9 Mar 2026

Property Address: 28 Rose Ave, Albion Park Rail NSW 2527, Australia

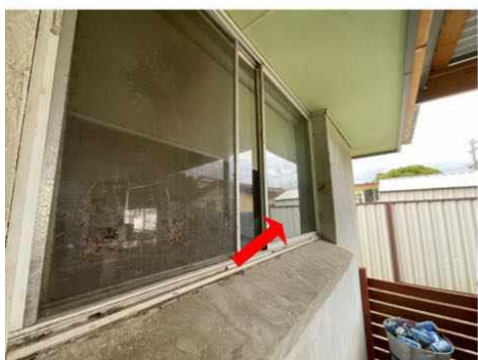
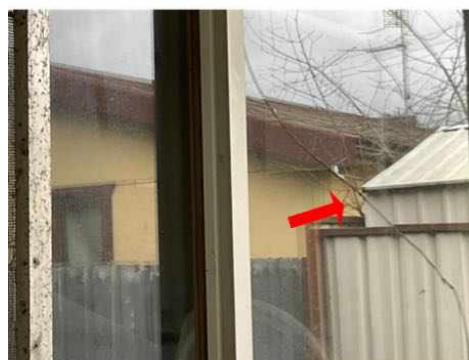
Building:	Building 1
Location:	Exterior walls - rear
Finding:	Window - Cracked
Information:	Cracks were identified in the window in this area. Cracking in windows is generally the result of impact damage, and is likely to develop further when left unmanaged.

The likelihood of this windowpane further cracking and shattering is increased exponentially, providing a safety hazard in the area. The cracked window also impairs the weather tightness of the building, creating potential for minor water leaks.

A qualified glazier is required to repair the window as soon as possible. Depending on the extent of the cracking, replacement of the window may be required. Please be advised that any persons coming into contact with the cracked window should do so with due caution to avoid any personal injury that may ensue.

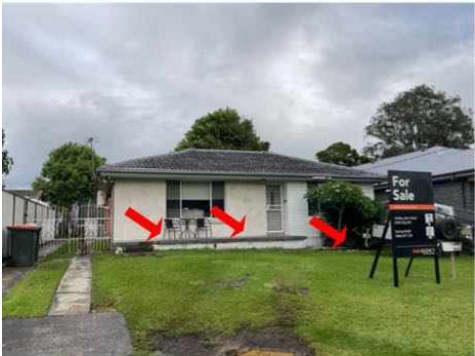
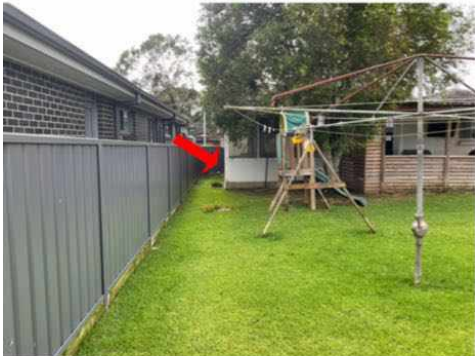
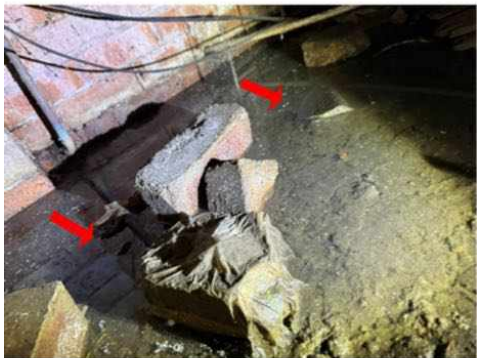
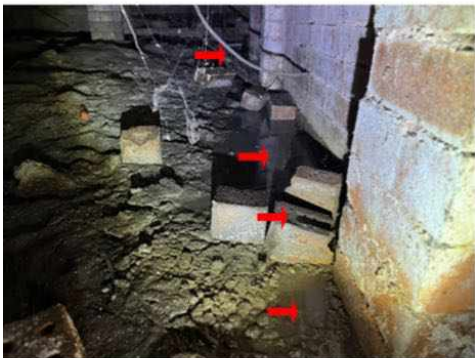
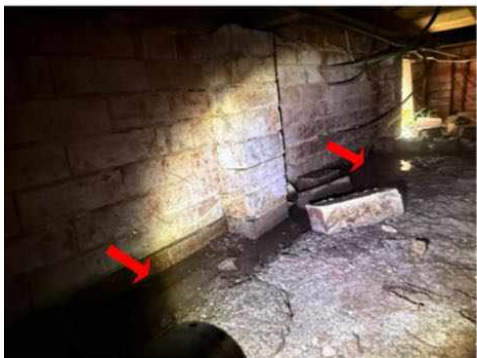
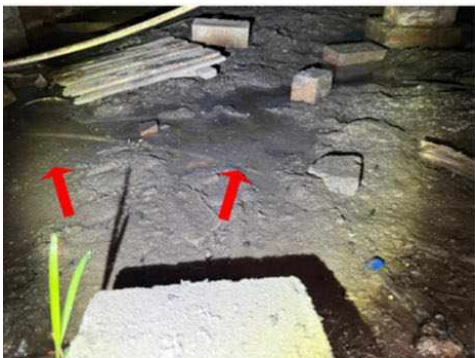
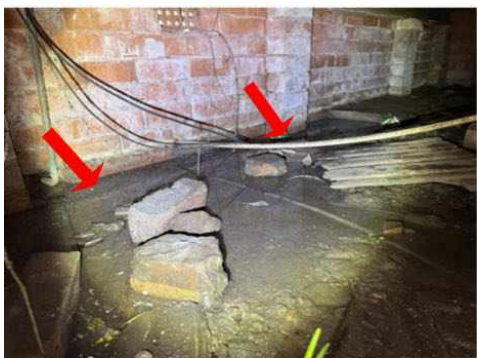
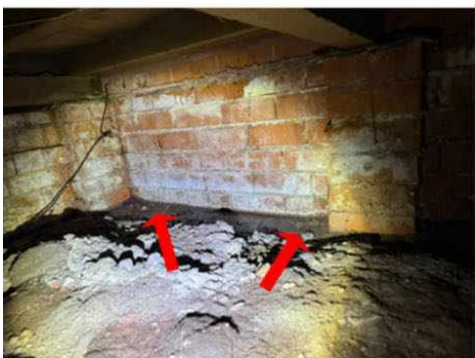
Building: Building 1
Location: Subfloor
Finding: Foundations - adjacent water pooling
Information: Water was found to be pooling near foundations across most of the front walls, the front half of the right wall and other areas. This is a serious concern with the potential to adversely impact on the longevity of the dwelling. The Building Code of Australia (BCA) outlines that the soil must be graded away from the dwelling at a minimum of 50mm over 1m (1:50 fall).

Repairs are required. Licensed plumbers are required to give quotes for repair before purchase.

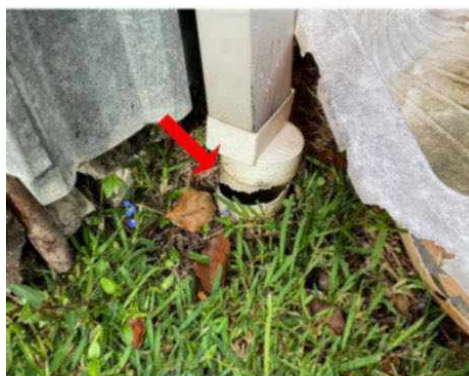
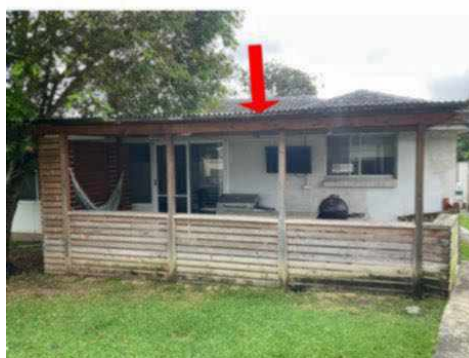
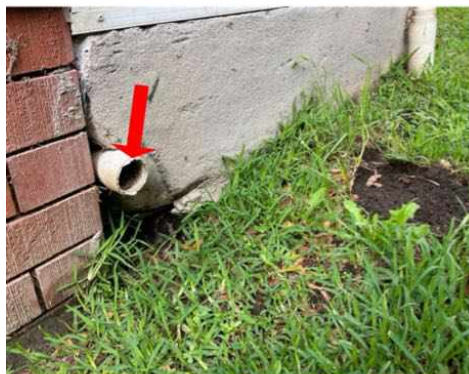
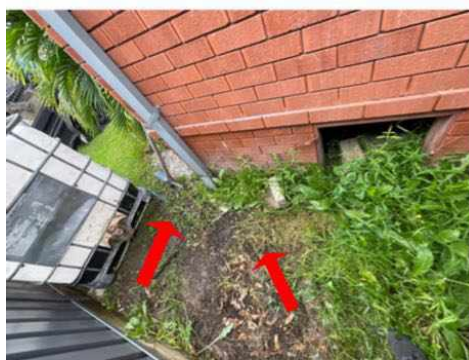
Finding 3.01

Building: Building 1
Location: Walls
Finding: Site drainage - Inadequate
Information: The site drainage in these areas was found to be inadequate at the time of inspection, creating potential for subsequent water damage to associated building elements.

2. The garage gutters are sagging and most downpipe boots on the property have cracked.
3. The pergola has no gutters.
4. Two areas of the right rear gutter are leaking.
5. One overflow pipe runs onto the right rear wall.

It is important that water does not lie against the base of walls; surrounding paths and ground levels should be sloped to drain water away from walls. Downpipes should not discharge stormwater onto lower walls or plinths. Stormwater should be carried away by large, regularly cleaned drains. Ground levels may need to be lowered to expose a buried DPC.

Where site drainage is inadequate, installation of an Agricultural (Aggie) Drain may be required. A qualified plumber should be appointed before purchase to further inspect the property and perform any remedial works as necessary. Secondary defects are likely to occur if left unmanaged.

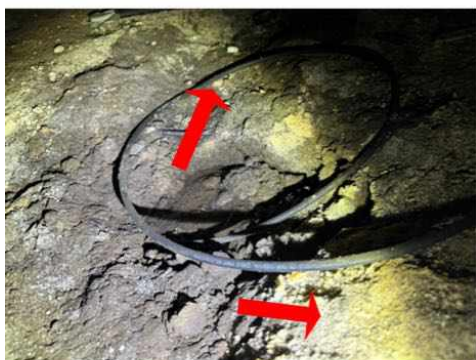
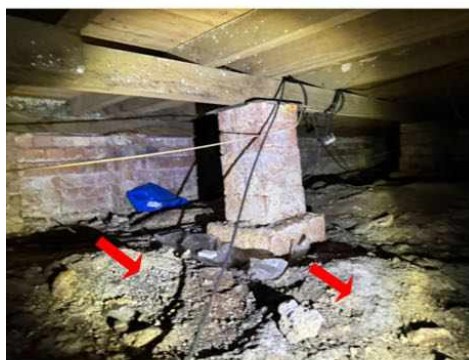
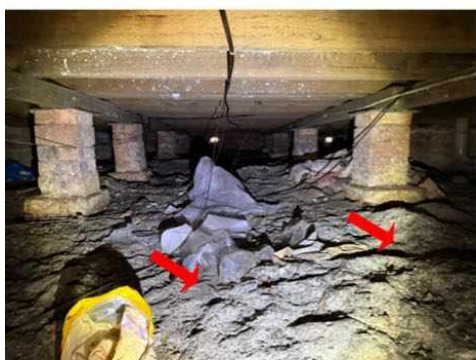
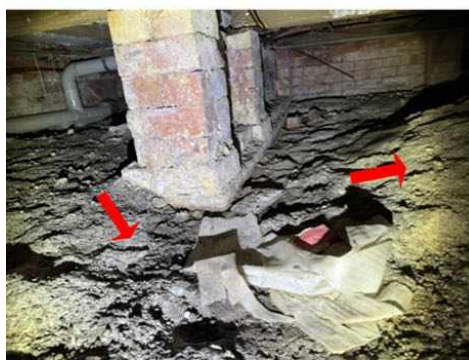
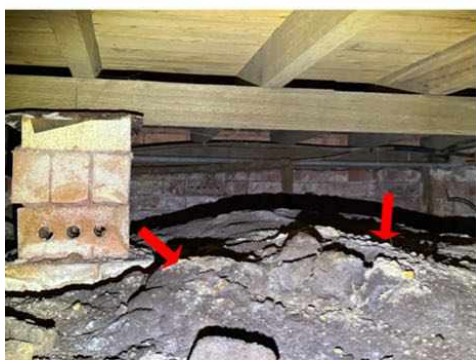
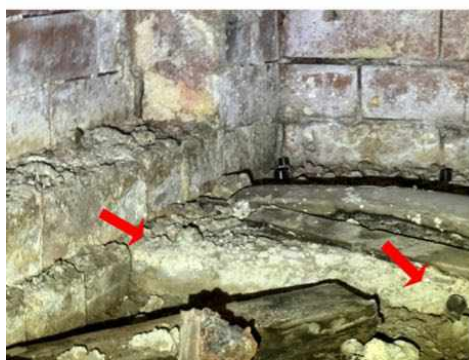
Finding 3.02

Building:	Building 1
Location:	Subfloor
Finding:	Mould - Present in subfloor
Information:	Where evidence of mould growth was noted, there may be environmental, biological or health issues associated with the report. A specialist inspection by a suitably qualified environmental health inspector is warranted, where mould is extensive or where any queries regarding air quality spores or other related issues apply.

Subfloor mould is generally caused by moisture ingress, lack of external drainage, lack of adequate ventilation and subfloor debris present. These issues need rectification

to stop mould development. Any mould found during the inspection should be cleaned immediately by a cleaning contractor or the homeowner as applicable.

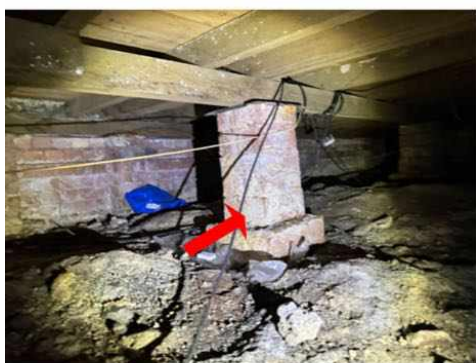
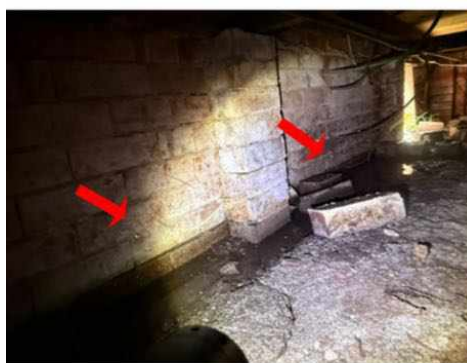
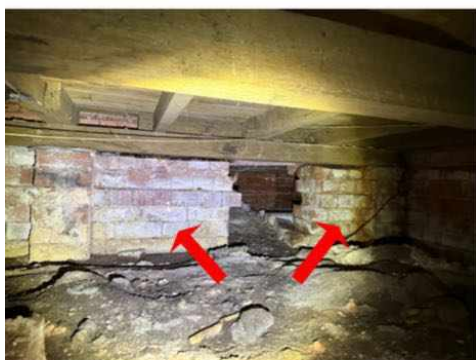
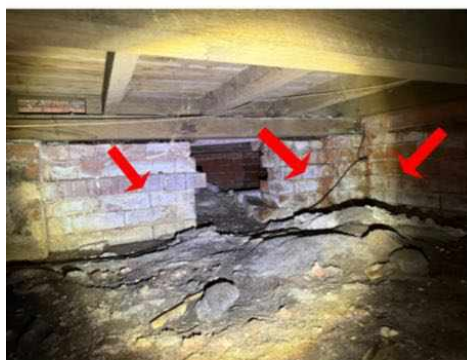
Finding 3.03

Building:	Building 1
Location:	Subfloor
Finding:	Damp - Rising
Information:	Rising damp describes the upward movement of water in low sections of building elements (e.g. walls) by capillary action - the movement of water through porous materials such as bricks, sandstone or mortar.

consequence of poor workmanship, or it may have been bridged where materials built up against the side of the house allow moisture ingress above the DPC level.

The first step in addressing rising damp is to diagnose the cause. The identified cause should be addressed first before addressing the appearance and other defects which have resulted from the rising damp. If the original cause is not resolved, further cases of damp are likely to ensue, resulting in secondary defects.

Consultation with a qualified plumber is advised immediately to identify the cause of the damp and perform remedial works as required.

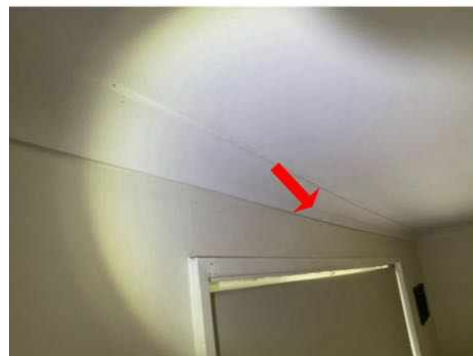
Finding 3.04

Building:	Building 1
Location:	Pictured lounge/kitchen areas
Finding:	Ceilings - Sagging/deflection evident and wall bowed
Information:	The ceiling cornice in the lounge/dining areas were found to have a minor deflection at the time of inspection. Deflection to the fixed ceiling structure may indicate that the building materials have swollen, due to contact with water, or that fixings (e.g. nails or

glue) have become loose and require reattachment. However it may also be just minor sagging of timbers over time.

Where minor sagging is evident, comparatively minor works, such as re-gluing of ceiling sheets, may be required. Such works may be performed by relevant tradespeople, such as plasterers and painters. Where excessive moisture has caused the roofing structure to swell and sag, the source of the water leak should primarily be identified prior to any remedial works being performed.

An invasive inspection is required to remove roof tiles or plaster to check this area for the cause.

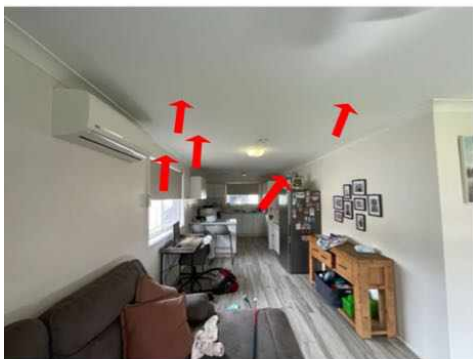
Finding 3.05

Building:	Building 1
Location:	Loungeroom/kitchen
Finding:	Cracking - Damage Category 1 - Fine (up to 1mm)
Information:	Although these numerous cracks are quite noticeable, they are usually only considered to be an appearance defect, and usually do not indicate any structural damage. Generally, the cause of a fine crack is indicative of a separation between building materials and finishes (e.g. paint, plaster, etc.) along joins.

Monitoring of all cracking should be conducted frequently. It is not clear if these cracks are related to the very high moisture in the subfloor areas.

Cracking of this nature can generally be repaired with minor sanding, filling and/or repainting. Such works should be performed by a qualified painter or a general handyman.

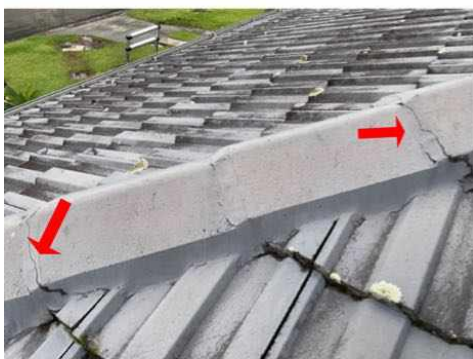
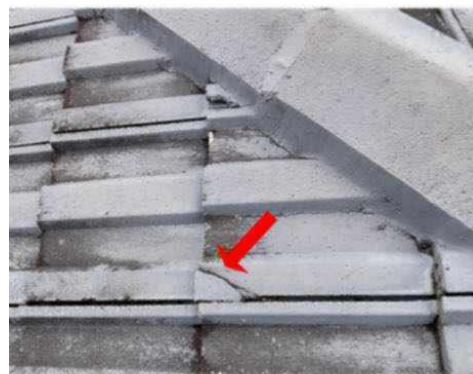
Finding 3.06

Building:	Building 1
Location:	All External Areas
Finding:	Roofing areas - Weathered
Information:	Upon inspection of the exterior roofing, the majority of the tiled roof areas were considered to be in a good condition. The garage roof is in poor condition. Many areas of the garage and pergola roof could not be seen due to overhanging trees and accumulated leaf debris. While weathering of these pictured areas is consistent with the age of the property, maintenance works are required.

Re-sealing and replacing small areas of gaps, damage or rust the may be considered as an interim solution by the client to help preserve and extend the life span of these roofing areas. Where left unmanaged, deteriorating roofing materials are likely to lead to a number of secondary defects, including minor water leaks and weather exposure to internal roofing structures.

Consultation with a roofing contractor is highly advised to gain advice on cost of remedial works that may be required in the short to medium term.

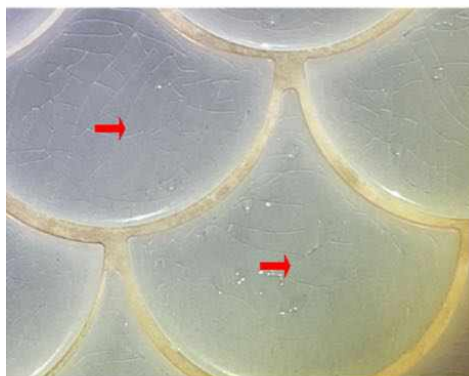
Information: Most fish scale tiles in the bathroom have suffered crazing. Crazing is internal fracturing without a change of the surface texture. It might be seen when light transmits through transparent or translucent material and it can also exist in opaque plastics. Crazing can be a precursor to cracking if it extends to the surface, but even if it stops short of the surface, crazing still decreases the strength of the material.

These tiles may need replacement in the future and can be undertaken by a tiling contractor.

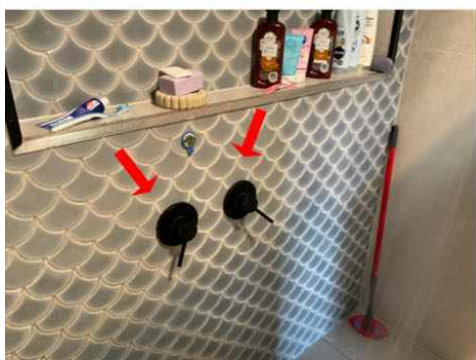
Finding 3.09

Information: These taps shows evidence of water hammer being present. Water hammer, a pressure surge resulting when a fluid is forced to suddenly change direction, is a common defect in plumbing fittings, particularly those that are aged and not frequently maintained. Water hammer is generally caused by factors that create high water

Although water hammer is generally considered to be a minor defect, subsequent damage such as erosion of tap hardware and/or water damage to associated building elements is likely to occur if left unmanaged.

A licensed plumber should be appointed as soon as possible to replace any affected tap hardware and perform any remedial works as necessary. Please be advised that the appointment of a cabinet maker or qualified carpenter may be necessary if water damage to associated building elements has occurred.

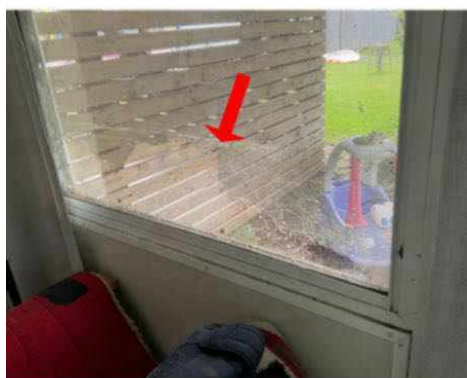
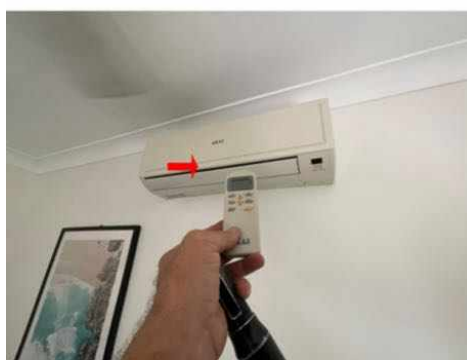
Building: Building 1
 Location: Pictured external areas
 Finding: Building elements - Damaged
 Information: Evidence of minor missing or damaged areas was identified at the time of the inspection. These include -

2. Many flyscreens are dog damaged.
3. The laundry wall has a large hole requiring repair and possibly made of asbestos .
4. The master bedroom ceiling fan would not work - possibly flat remote battery,

A carpenter and electrician would be the trades responsible for rectification of these areas when convenient.

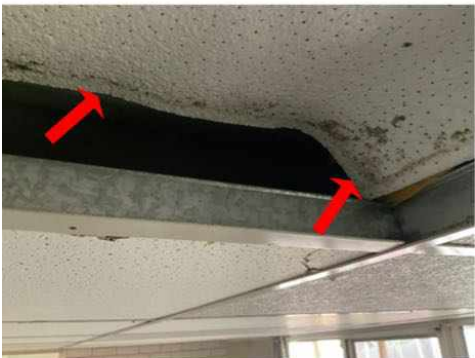
Finding 3.13

Building:	Building 1
Location:	Rear sunroom ceiling tiles
Finding:	Ceiling - Water stained, loose, minor mould
Information:	Water staining and minor mould in ceiling linings in this area was evident at the time of inspection. Water staining indicates that surfaces have been exposed to excessive moisture over time. The minerals and other elements in the water lead to staining, which may graduate to corrosion and deterioration if left unmanaged.

While mostly an appearance defect, water staining can be indicative of more serious defects, which may be currently concealed by interior ceilings.

Where water staining is active, a licensed plumber must be consulted to identify the cause of the staining and to provide advice on any reparation works that may be

required. Replacement of any damaged structures is advised.

Conversely, where water staining is old and inactive, affected building materials may be repaired or replaced at client discretion.

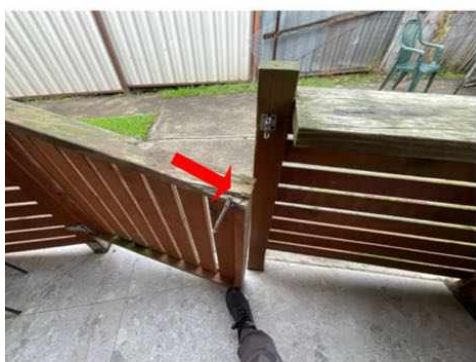
Building:	Building 1
Location:	Rear gate
Finding:	Gate - Binding/jamming
Information:	Binding of this gate was evident during standard operation. This defect inhibits the functionality of the affected gate making it hard to operate.

A gate that binds to the post or adjoining fence usually occurs as a result of minor movement of the post/fence or deteriorated hinges.

A qualified carpenter or general handyperson should be appointed to perform minor rectification works at client discretion.

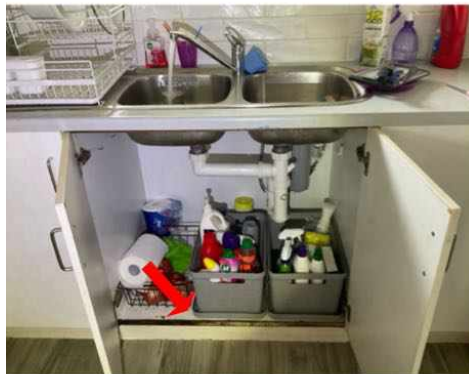
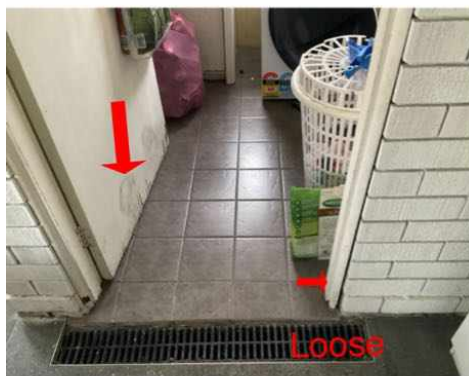
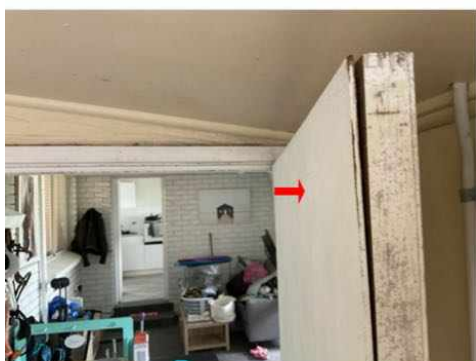
Finding 3.17

Building:	Building 1
Location:	Many doors and other small areas
Finding:	Swollen or damaged building materials
Information:	Swollen building materials generally indicate that the building materials have been affected by excessive moisture over a prolonged period of time, and have swollen as a result. The structural integrity of swollen building elements cannot be guaranteed, and further damage is likely to develop if left unmanaged. Excessive moisture is likely to

lead to the development of secondary damage to any associated building elements, which may necessitate major reparation works if prolonged.

Repair and/or replacement of swollen building elements should be conducted as a matter of urgency by a registered builder or qualified carpenter.

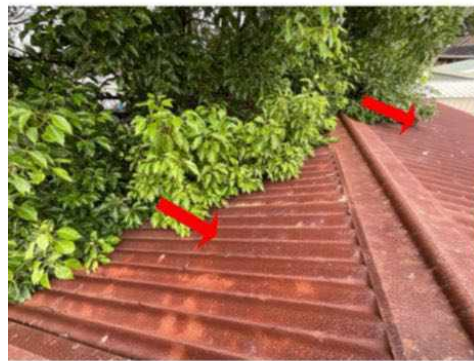
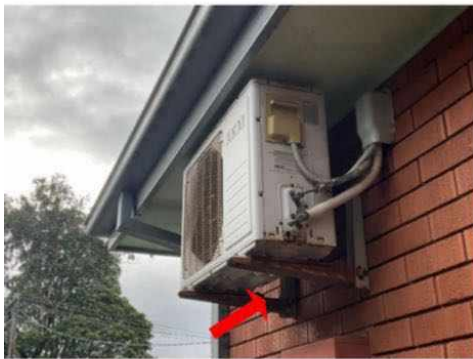
Building:	Building 1
Location:	External garage and other areas
Finding:	Building element - Rusted or corroded
Information:	These areas show evidence of rusting and corrosion, which is likely to have developed

as a result of excessive exposure to moisture and or inadequate coatings.

As surface rust provides no protection to the underlying iron, the deteriorating condition is likely to worsen if not addressed in the short-term future.

Where possible, the use of galvanized (treated) metals or aluminium coated metals aid in rust prevention, as does regular general maintenance. Rust formation can be controlled with coatings, such as paint, that isolate the iron from the environment.

Rusting and corrosion should be managed by ideally removing or limiting the affected surface from exposure to moisture. A registered builder may be appointed to replace any building elements that have been severely affected by rust or water damage.

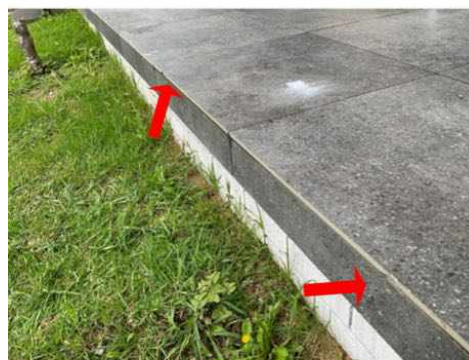
Finding 3.19

Building:	Building 1
Location:	Verandah
Finding:	Tiles loose/ chipped/ cracked or loose
Information:	Damaged and missing tiles were evident in these pictured verandah areas at the time of inspection. It is suspected that this cracking has occurred as a result of impact damage. Missing tiles throughout the household detract from the overall appearance of the affected areas.

Replacement of cracked tiles is recommended as soon as possible. A tiling contractor may be appointed to perform these works. Where cracks become more numerous, contact a licensed building inspector for further investigation.

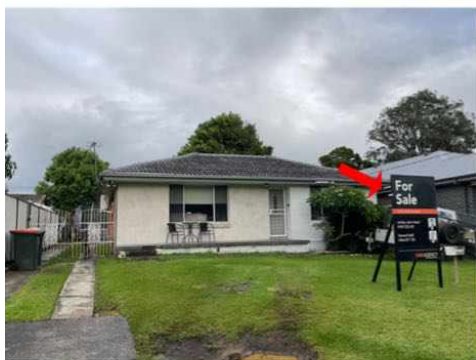
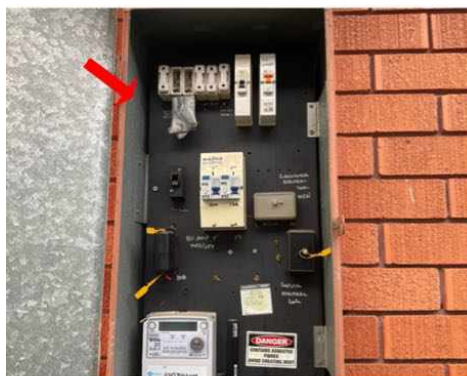
Building:	Building 1
Location:	Meter Box
Finding:	Termite Management System - no evidence of a chemical installation
Information:	The application of a post-construction chemical termite barrier is highly recommended for all properties. Such barriers are highly effective in preventing termite attack on any timber building elements throughout the property.

A durable notice should be placed in the switchboard unit to indicate current termite barriers. At the time of inspection, no durable notice was evident and it appeared as though no chemical termite management system has been installed, with no evidence to suggest preventative works taking place since the property was built.

The client may consider gaining further advice from a pest controller as to the costs and procedures involved with a 'chemical' application. It is recommended that obtaining such advice be a short-term priority.

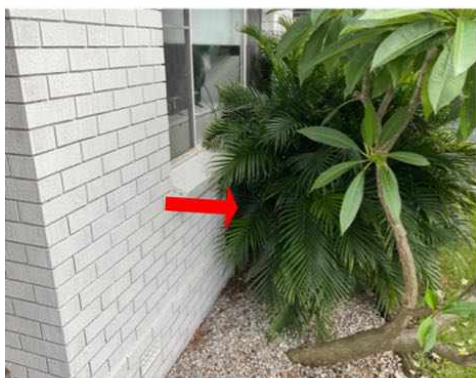
Finding 6.02

Building:	Building 1
Location:	Yard - front
Finding:	Bridging - Vegetation and decking
Information:	Where vegetation and decking obstructs inspection of building elements, also known as bridging as it provides a bridging point for the access of termites, full inspection can not be achieved. Consequently moisture or dampness may be present and the areas becomes conducive to termite activity. Plants and decks against or very close to buildings provide cover, shade and can provide an environment that is attractive to termite infestation.

The removal and replanting of plant species that do not provide "cover" or cutting back of existing vegetation and leaving a small gap between decking and the building walls will assist greatly in preventing Bridging from occurring.

The removal of any such stored building or plant materials that may be conducive to termite activity should be carried out as soon as possible and arrange re inspection to minimize the risk of termite attack.

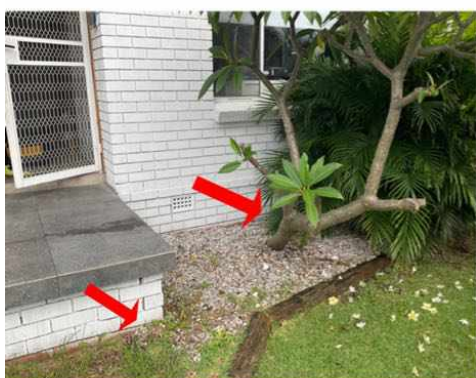
Finding 6.03

Building:	Building 1
Location:	Exterior walls
Finding:	Slab Edge - Exposure
Information:	An inspection zone of at least 75mm in relation to the exposed slab edge, between the bottom brick and the perimeter pavement, is required. This inspection zone should be maintained in order to force termites into the open where they can be detected more readily during regular inspections. The slab edge should not be concealed by anything that may prevent inspection of the area, including render, landscaping, soil, turf, paving, concrete cladding or other structures.

If the slab edge is not properly exposed there is a high risk of termite attack. Sometimes, in order to determine the type of slab, a suitably qualified person such as an architect or builder may be required to consult the construction plans.

Where the slab edge cannot be properly inspected, it is highly recommended that termite or timber pest inspections be carried out every 6-12 months to aid protection of the property against infestation.

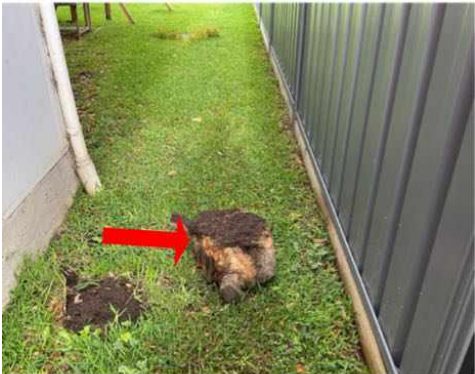
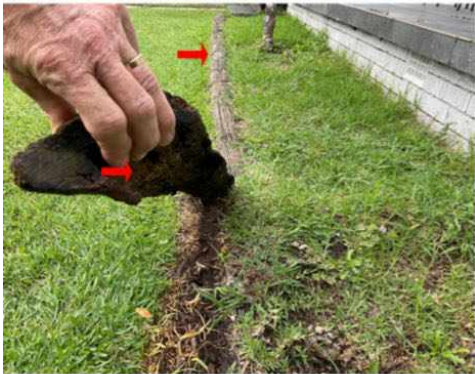
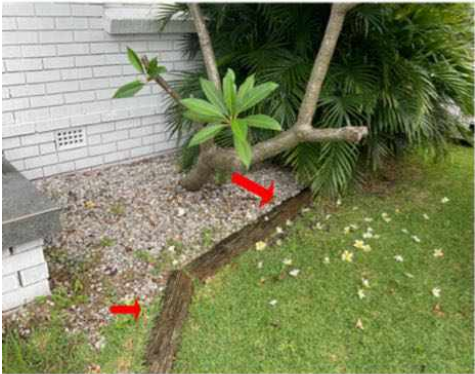
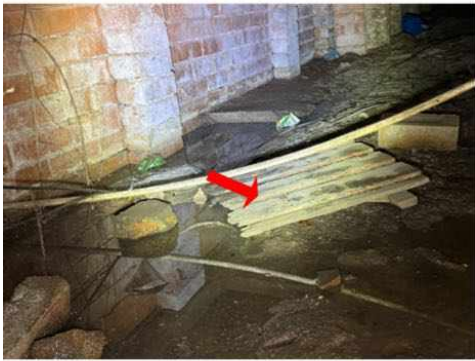
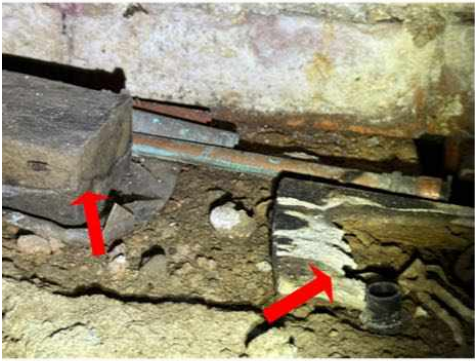
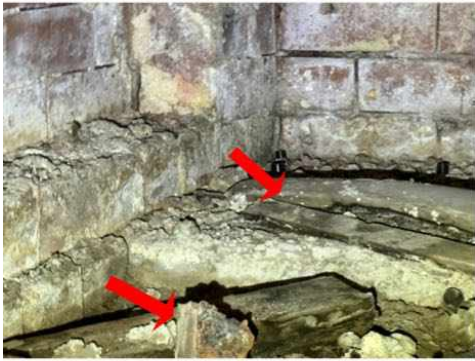
Finding 6.04

Building:	Building 1
Location:	Subfloor and rear yard

Finding: Timber in contact with the ground
Information: Any timbers in direct ground contact provide opportunity for concealed termite entry and are likely to be subject to premature rot and decay as the soil retains moisture or damp conditions against the timbers.

Removal of all waste timber that is in direct contact with ground is highly advised. This timber is promoting mould and wood rot and is very attractive to termites.

Frequent pest inspections are advised to readily identify any termite activity in these areas.

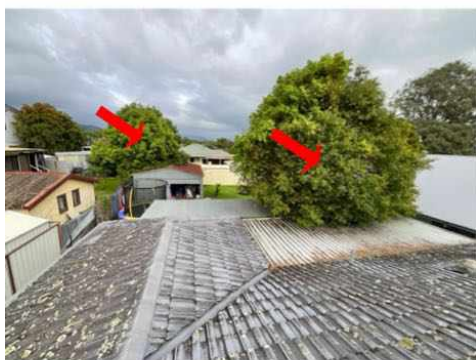
Finding 6.05

Building:	Building 1
Location:	Roof areas
Finding:	Trees - Overhanging and filling gutters
Information:	Overhanging trees often result in excessive amounts of leaf debris accumulating in gutters.

Gutters are a critical part of the building's management of storm water and rain. It is therefore important that they be kept clear to prevent secondary damage to associated building elements, including exterior and interior walls, ceiling linings and any adjoining building elements. Where gutters are blocked, pooling of rainwater is likely to occur, fast-tracking rust and corrosion of the roof plumbing elements.

It is highly advised that all overhanging tree branches be removed as soon as possible to prevent any further damage. Such works should be performed by the homeowner; however, appointment of a landscape contractor or an arborist may be required.

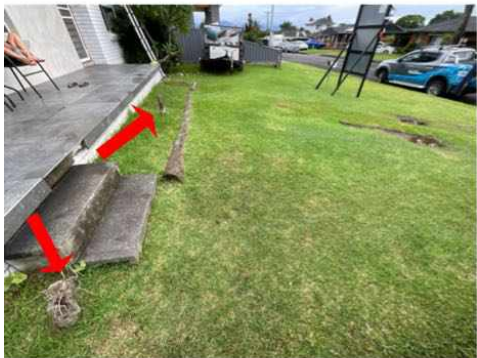
Finding 6.06

Building:	Building 1
Location:	Pictured yard area
Finding:	Tree stumps - left in ground
Information:	Tree stumps left in ground provide opportunity for termite attack as they are likely to be subject to rot and decay providing an attractive food source. Treatment and/or Removal of the stump is highly recommended. A pest controller and tree removalist should be engaged to perform such works.

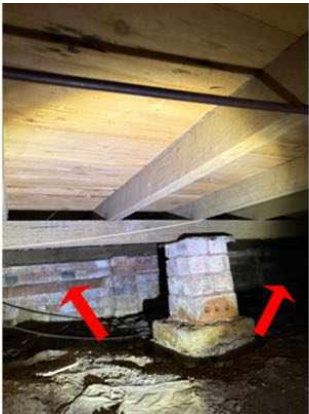
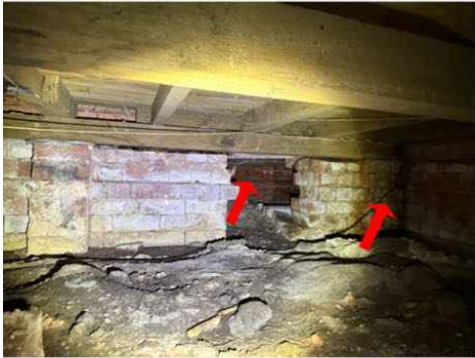
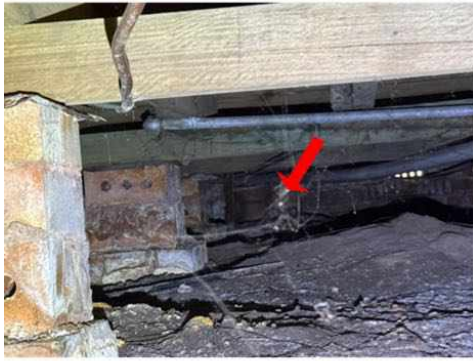
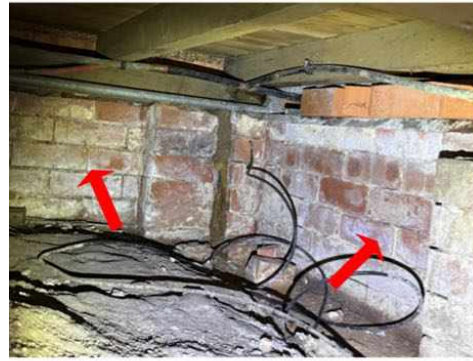
Finding 6.07

Building: Building 1
Location: Subfloor
Finding: Subfloor ventilation - Inadequate
Information: Adequate subfloor ventilation aids in preventing excessive moisture wood rot and termite activity by ensuring a dry subfloor environment.

Where ventilation is substandard or blocked, it is usually caused by factors such as failure to install adequate vents during construction or earth and vegetation covering vents. Low subfloor clearance and stored items or debris in the subfloor also restricting airflow.

Subfloor ventilation can be improved in most cases by addressing the causes such as exposing subfloor vents, installing additional vents, installing mechanical ventilation and removing debris from the subfloor.

A registered builder should be appointed as soon as possible to perform these works as necessary.

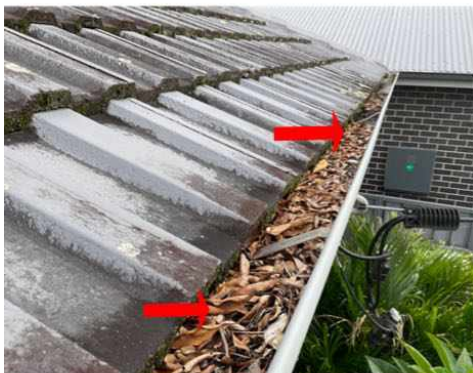
Finding 6.08

Building:	Building 1
Location:	Roof exterior
Finding:	Gutters - Full and blocked
Information:	The guttering on around the roof was found to be blocked at the time of the inspection. Roof plumbing structures, such as guttering and downpipes, should be free of all debris to prevent blockages. Blockages of the guttering and downpipes will lead to pooling and accumulated water overflows, which is likely to subsequently flood eaves and exterior walls.

Blocked gutters are likely to lead to high levels of moisture in the affected areas. Such moisture will not only cause rust and decay of the associated building materials, but can also provide conditions that are conducive to termite and timber pest activity. Blockages in gutters should therefore be removed immediately to ensure dry conditions are maintained.

It is highly advised that gutters be cleaned by the homeowner or a general handyperson as a matter of urgency.

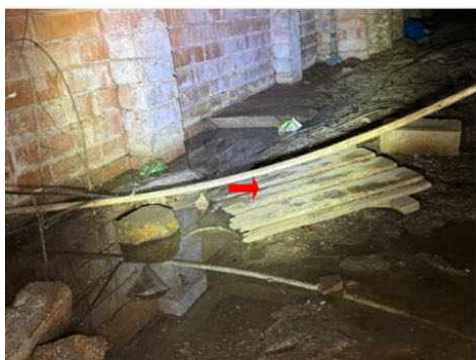
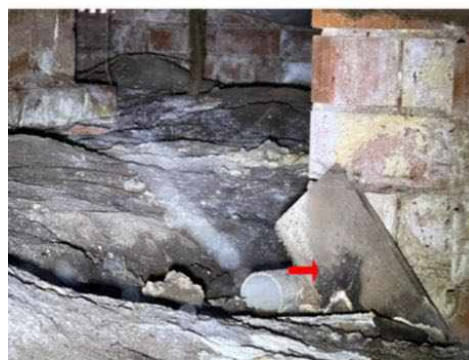
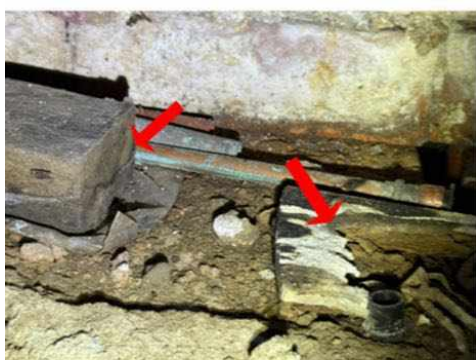
Finding 7.01

Building:	Building 1
Location:	Subfloor
Finding:	Fungal decay - present (localised)
Information:	Fungal decay also known as wood decay or wood rot generally refers to the deterioration of timber elements when in contact with excessive levels of moisture for a prolonged period of time.

The development of fungal decay is accelerated by temperatures from 5degreeC to 40degreeC as well as the presence of oxygen. Generally fungal decay develops on timber elements that are in use in an external environment which are exposed to rain penetration.

Note - See ALL wood rot photos, all these show fungal decay.

In this case, the affected timber element is in a decaying state and will need replacement by a carpenter or licensed builder.

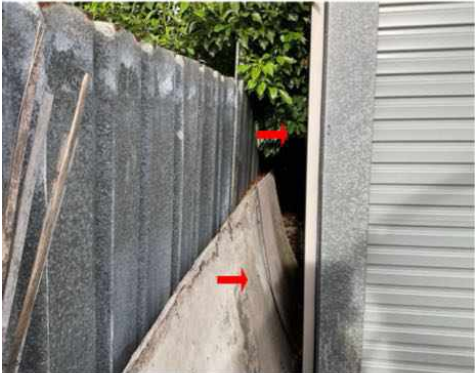
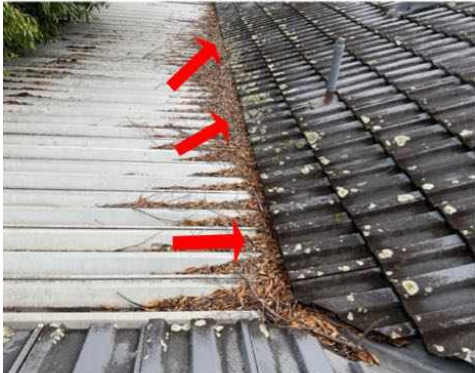
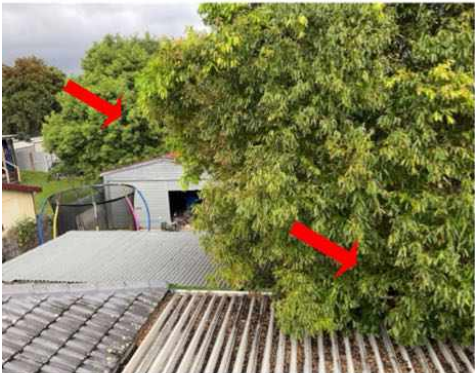
Building: Building 1
 Location: All External Areas
 Finding: Additional Photos - Obstructions and Limitations of EXTERNAL AREAS
 Information: These photographs are an indication of the obstructions and limitations which impeded full inspection of external areas at the time of inspection. These obstructions can hide an array of defects and should be removed to allow full inspection to be carried out. A re-inspection is recommended once the areas are made accessible.

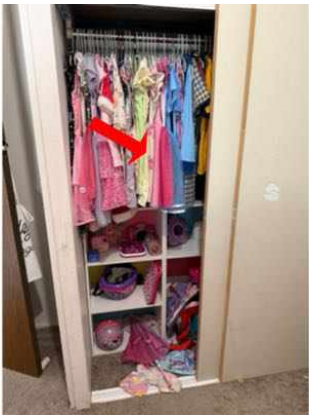
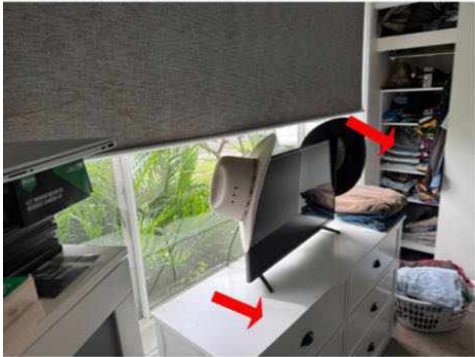
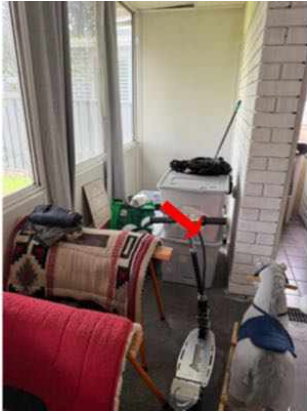
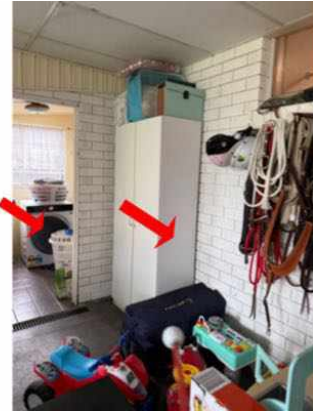
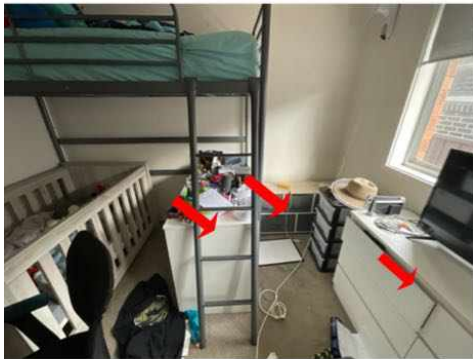
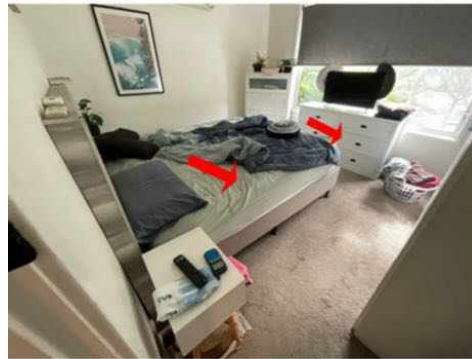
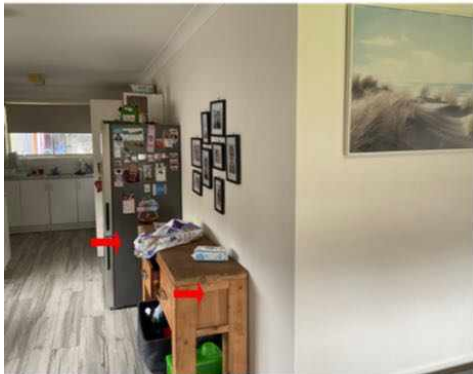
Building: Building 1
Location: All Internal Areas
Finding: Additional Photos - Obstructions and Limitations of INTERNAL AREAS
Information: These photographs are an indication of the obstructions and limitations which impeded full inspection of Internal areas at the time of inspection. These obstructions can hide an array of defects and should be removed to allow full inspection to be carried out. A re-inspection is recommended once the areas are made accessible.

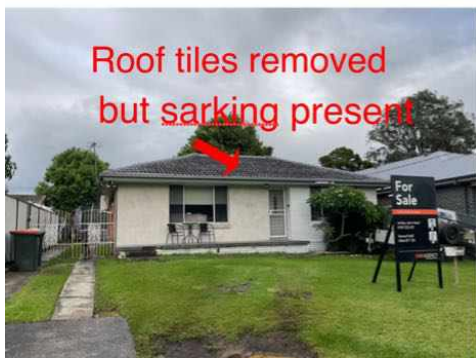
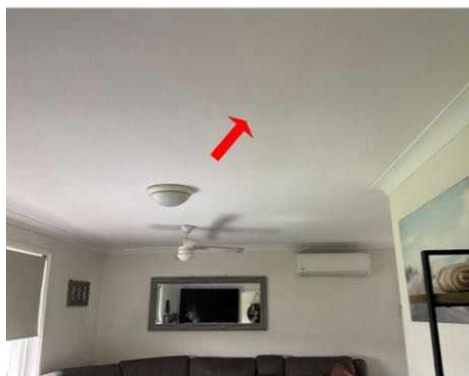
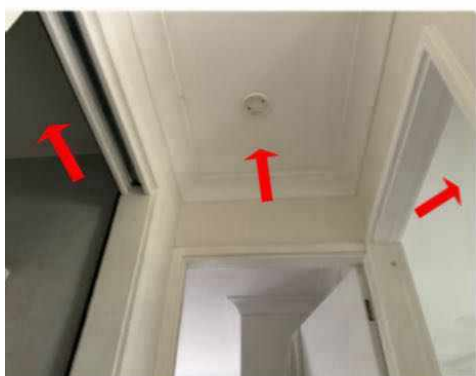
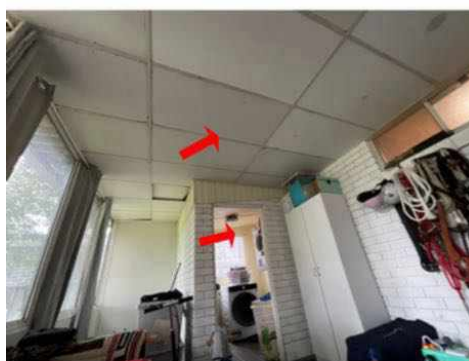
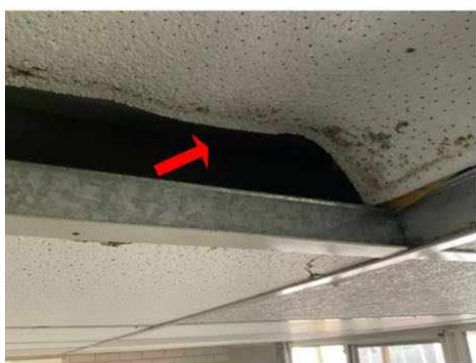
Building: Building 1
 Location: All Roof cavity areas
 Finding: Additional Photos - Obstructions and Limitations of the ROOF CAVITY
 Information: These photographs are an indication of the obstructions and limitations which impeded full inspection of roof cavity areas at the time of inspection. These obstructions can hide an array of defects and should be removed to allow full inspection to be carried out if applicable. A re-inspection is recommended once the areas are made accessible.

The inspection was also limited to areas with an allowable crawl space of 600mm x 600mm, in particular towards the external walls where the roof line diminishes, these

areas were not accessible.

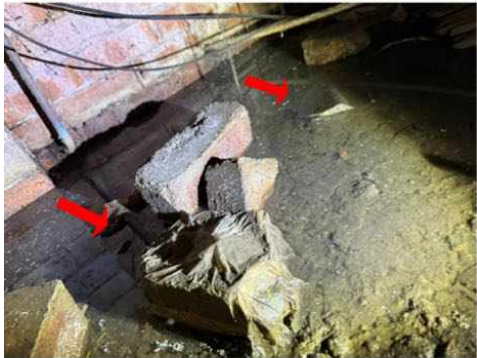
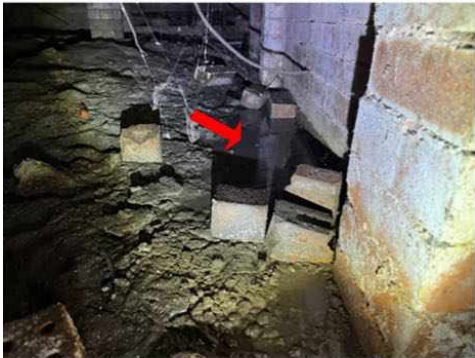
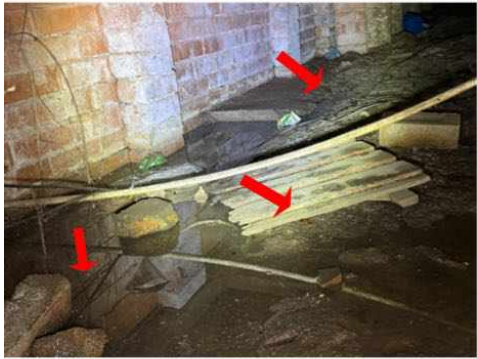
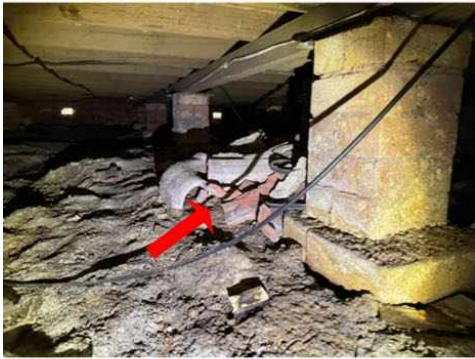
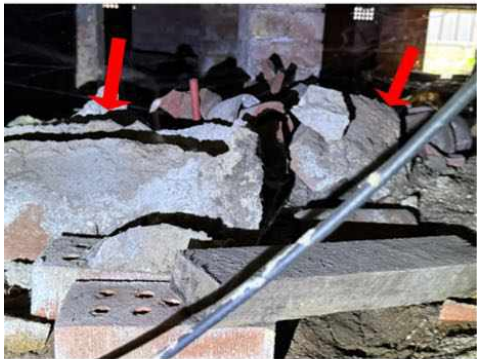
Building: Building 1
 Location: All Subfloor Areas
 Finding: Additional Photos - Obstructions and Limitations of SUBFLOOR AREAS
 Information: These photographs are an indication of the obstructions and limitations which impeded full inspection of subfloor areas at the time of inspection. These obstructions can hide an array of defects and should be removed to allow full inspection to be carried out. A re-inspection is recommended once the areas are made accessible.

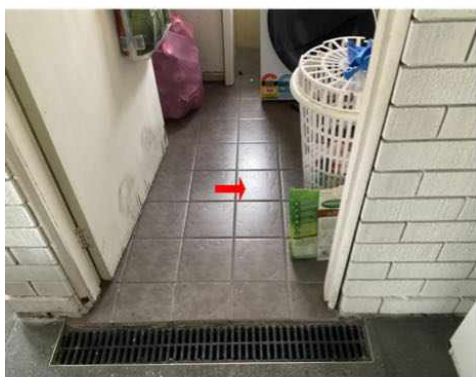
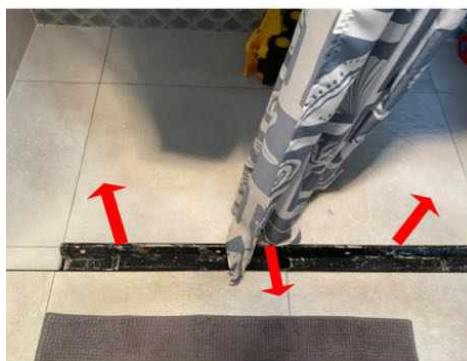
With older property's where this information is unavailable all wet areas should be monitored. If any leaks, water staining, peeling or bubbling of the paint become evident to any adjacent walls or ceilings below a licensed builder or waterproofing specialist is recommended to investigate further.

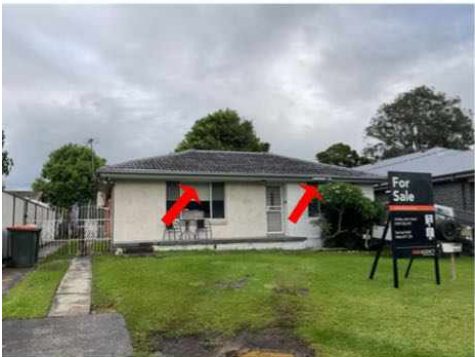
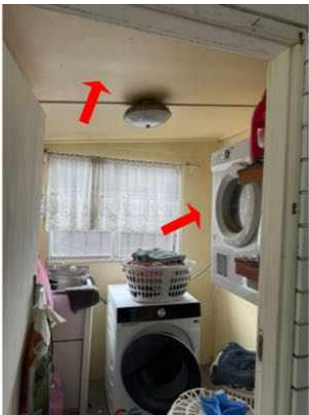
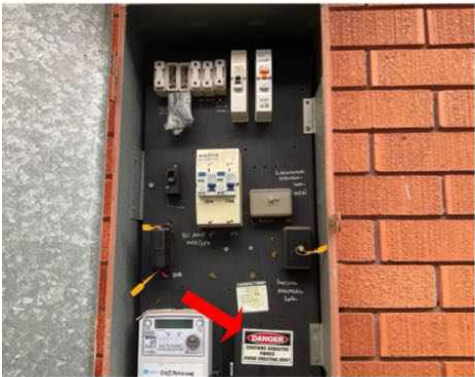
Building: Building 1
 Location: Meter Box, laundry, eaves

Information: Reporting on Asbestos is outside the Scope of this Report. This suspected defect is highlighted as a caution only. We suspect, based on our experience in the building industry, that there is a higher risk of the identified building element containing asbestos.

As Asbestos Reporting is outside the scope of this report, we advise that you consider a separate Asbestos Inspection and Condition Audit, which can include the taking of samples for definitive confirmation of the presence of Asbestos.

In the interim, the client is advised to act with caution, especially when considering any damage to building materials general wear and tear renovations extensions demolition and general maintenance activities due to the suspected presence of Asbestos.
