Building and Timber Pest Inspection Report

Inspection Date: Wed, 18 Mar 2026

Property Address: 229 Goomalibee Rd, Benalla VIC 3672,
Australia

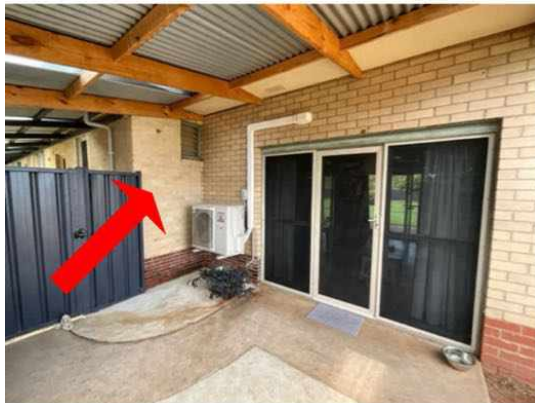
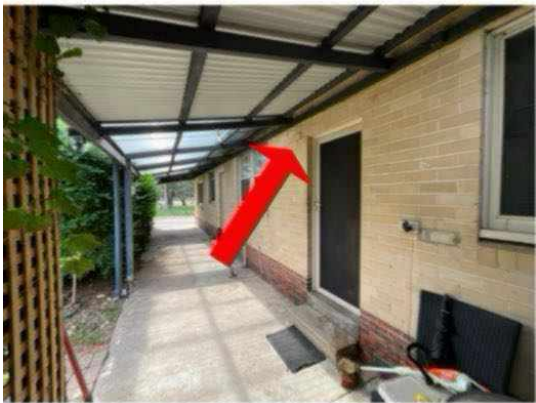
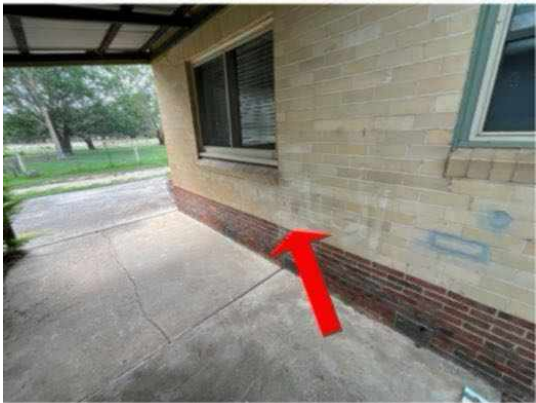
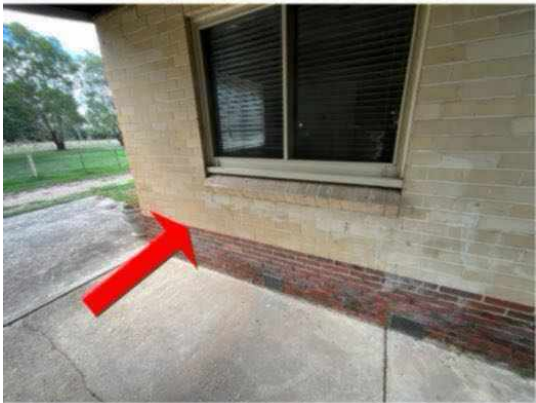
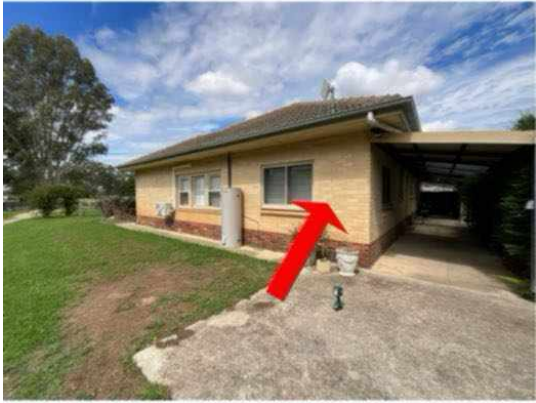
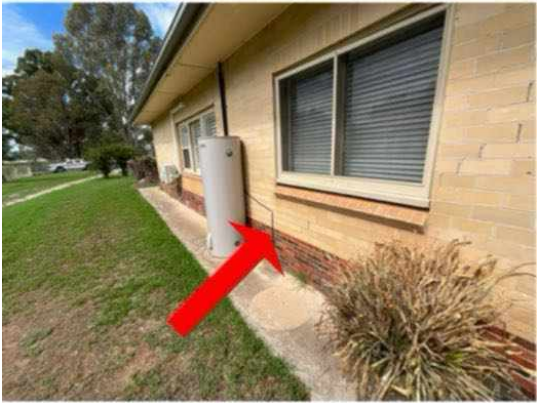
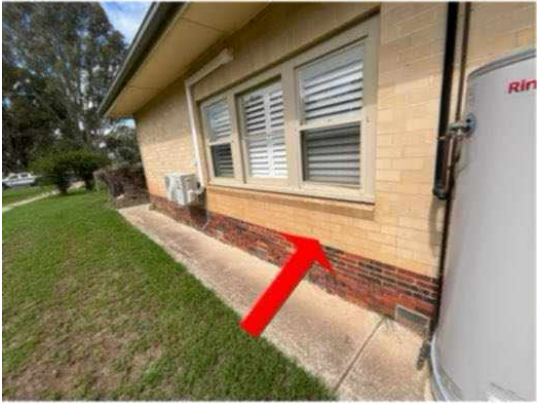
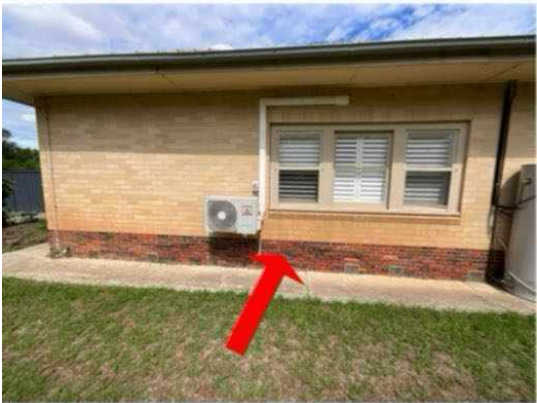
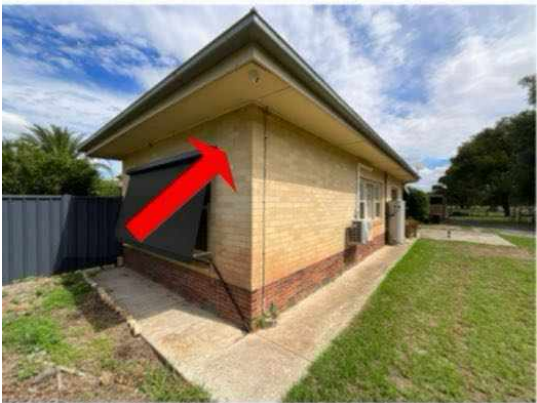
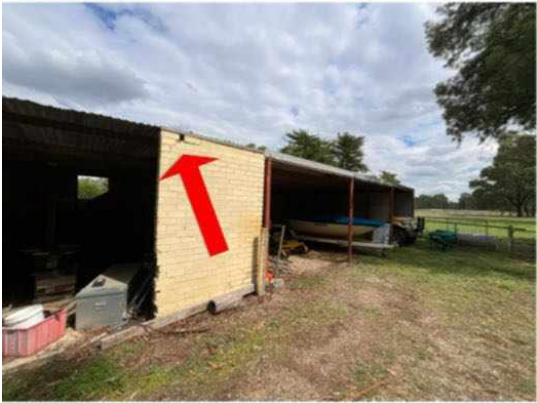
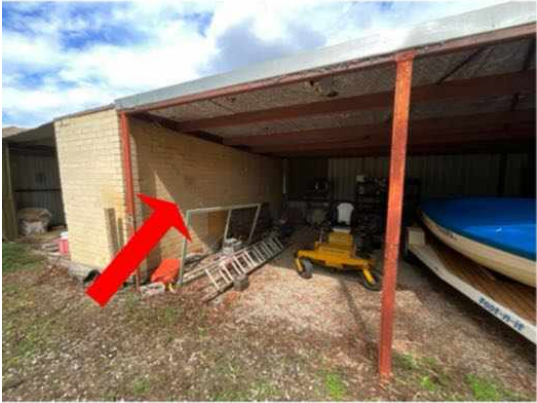
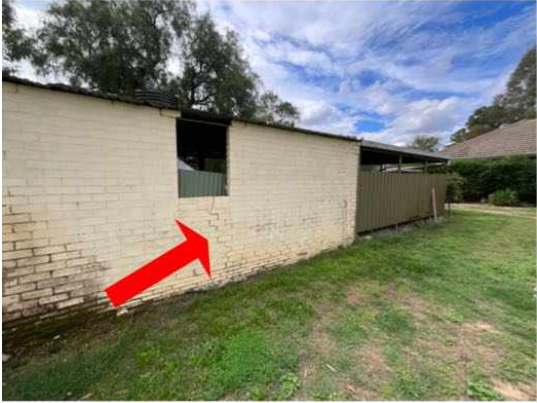
Building: Building 1
Location: Alfresco, laundry area, back verandah area, equipment shed
Finding: Brickwork - Step cracking
Information: Step cracking was identified to the brickwork in this area at the time of inspection. Step cracking, which is similar to other forms of cracking, has a variety of possible causes. However, the most common is the subsidence of adjacent footings.

Step cracking is a relatively common defect, and is most likely to occur adjacent to windows, doors and other openings. Mortar failure in the gaps between affected bricks indicates the stresses and tensions affecting the wall.

Where step cracking is extensive or severe, the client is advised to consult a structural engineer. Minor step cracking can be used as a warning sign to address factors causing stress to the wall, which can include the effect of surrounding trees, water leaks, soil erosion, or even the presence of reactive soils in the surrounding area.

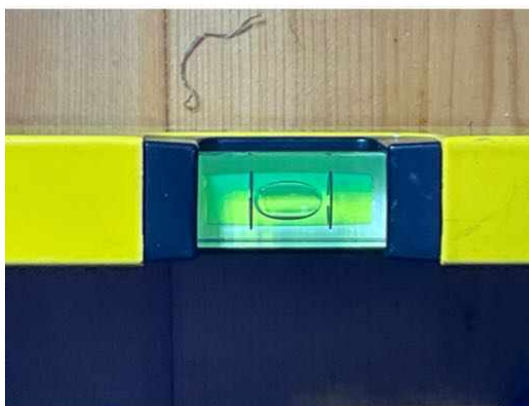
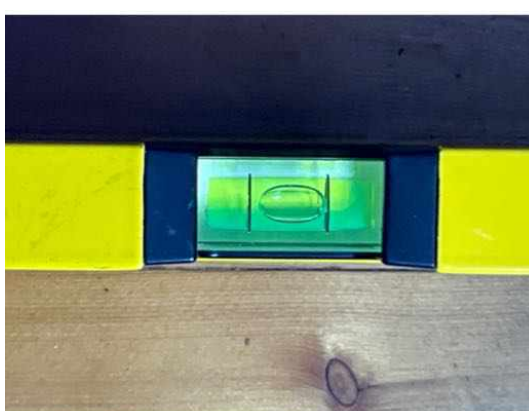
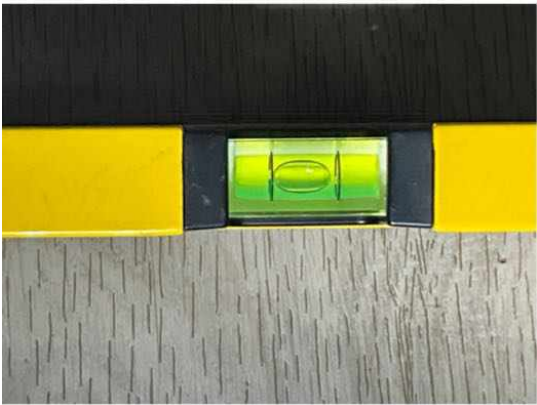
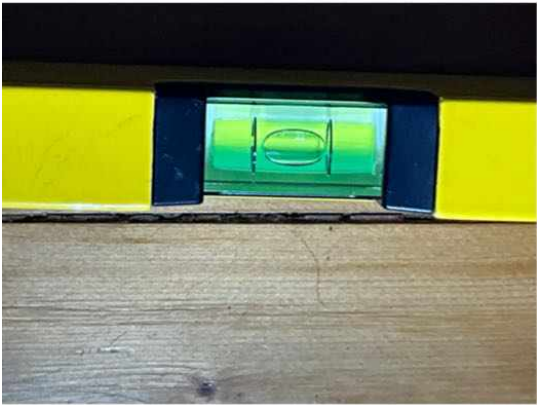
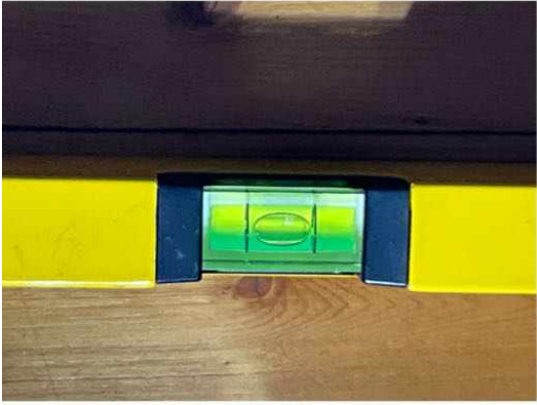
Finding 3.01

Building:	Building 1
Location:	All Internal Areas in original house
Finding:	Flooring - Uneven
Information:	The internal flooring in this area is out of level and uneven. Uneven flooring is likely to indicate minor defects such as expected movement of the foundations of the property, but may also indicate subsidence of the associated subfloor stumps.

It is advised that the flooring be closely monitored to identify any further movement. Where flooring remains relatively unchanged for an extended period of time (i.e. several months), it is likely that this defect has been caused by expected movement of the foundations of the property.

However, where flooring is uneven further, potentially invasive inspection of the subfloor structures and stumps in this area is required. In this case, works to repair are likely to be required, and would be carried out by a registered builder specialising in re-stumping.

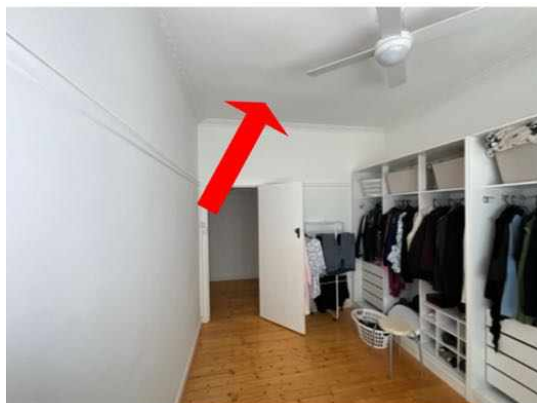
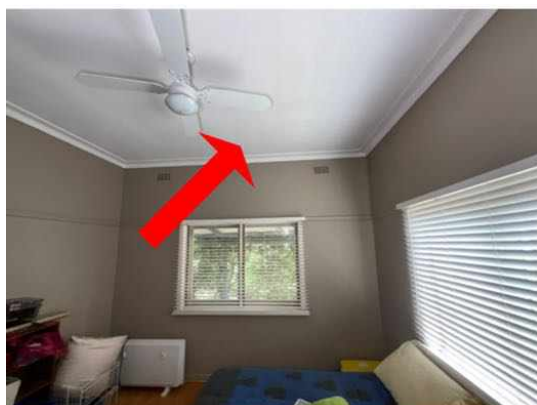
Building:	Building 1
Location:	Bedroom 2,3
Finding:	Paint- Flaking
Information:	Sections of paint in this area was found to have deteriorated. Paint flaking is generally an indication of excessive moisture in the area, that is currently hidden by the painted surface.

The presence of excessive moisture can have major implications on associated building elements if left unattended. While only seemingly minor at this stage, the damage cannot be determined due to the paint obstructing any further inspection of the damage.

A qualified Painter should be contacted at the Owner's discretion to re-paint the area.

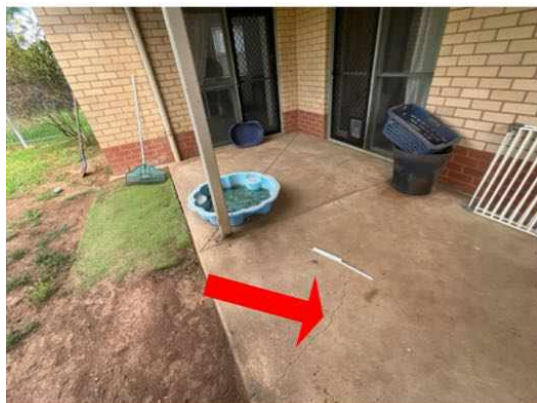
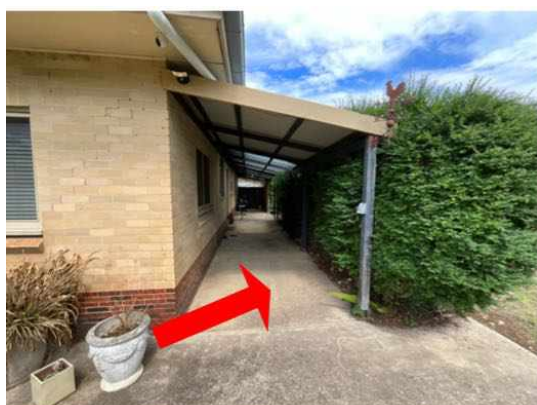
Finding 3.05

Building:	Building 1
Location:	Verandah, back and front
Finding:	Cracking - External Concrete Paving Damage Category 3 - Wide Cracks (2mm - 4mm)
Information:	Wide cracks were identified in external concrete paving. Wide cracks are significant and are likely to lead to the development of safety hazards and secondary defects if left unmanaged.

General age and expected deterioration of the paved areas is a common cause of this type of cracking. However, expansion and contraction of the slab may also have occurred due to environmental factors. Such factors include variable moisture and weather conditions, the presence of trees and their roots having a settling or lifting affect on the soil, or the effect of load bearing, e.g. heavy vehicles over a sustained period of time.

Cracking to this degree may also be due to poor original installation of the concrete. Factors such as poor compaction of the sub surface and/or inadequate reinforcing of the slab may create cracking and other secondary defects. Wide cracks may also have a more significant structural cause, such as subsidence of soils.

Where the crack is located adjacent to structural elements of the building, the advice

of a Structural Engineer is advisable before undertaking repairs. Significant repair and likely replacement of the concrete paving is probable.

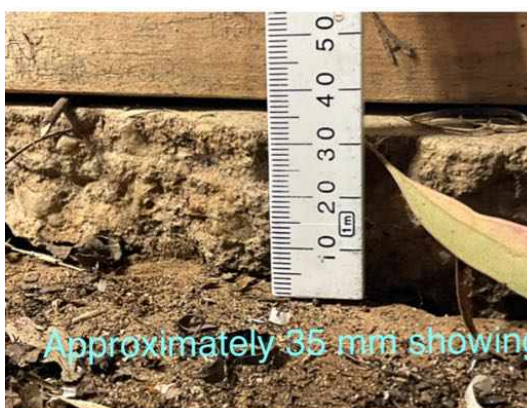
Finding 3.06

Building:	Building 1
Location:	Equipment shed
Finding:	Cracking - External Concrete Paving Damage Category 4 - Gaps in Slab (4mm - 10mm +)
Information:	Gaps in the slab were identified in external concrete paving. Gaps in the slab are significant and are likely to lead to the development of safety hazards and secondary defects if left unmanaged, such as the creation of a trip hazard.

General age and expected deterioration of the paved areas is a common cause of this type of cracking. However, expansion and contraction of the slab may also have occurred due to environmental factors. Such factors include variable moisture and weather conditions, the presence of trees and their roots having a settling or lifting affect on the soil, or the effect of load bearing, e.g. heavy vehicles over a sustained period of time.

Cracking to this degree may also be due to poor original installation of the concrete. Factors such as poor compaction of the sub surface and/or inadequate reinforcing of the slab may create cracking and other secondary defects. Gaps in the concrete paving may also have a more significant structural cause, such as subsidence of soils.

Where gaps in the concrete paving are adjacent to structural elements of the building, the advice of a Structural Engineer is advisable before undertaking repairs. Significant repair and likely replacement of the concrete paving is probable.

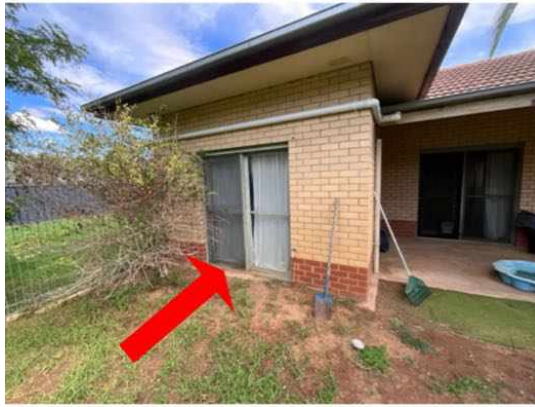
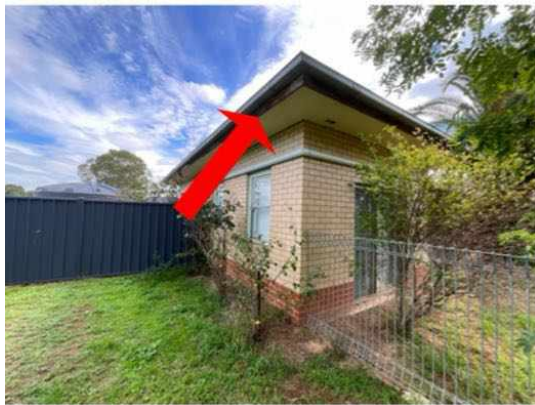
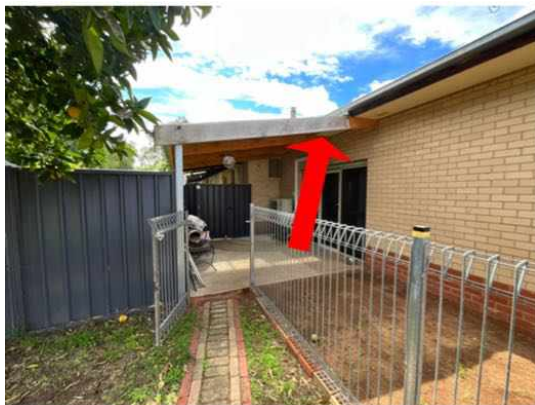
Building:	Building 1
Location:	External timber
Finding:	External painting deteriorated
Information:	Much of the external paintwork including but not limited to windows, fascias, guttering, veranda and other external fitments have been neglected and require attention to prepare and re-paint.

Whilst incomplete or missing paint finish is generally an appearance defect, it can also lead to the development of secondary building defects over time. Incomplete areas of paint finish expose the area to moisture, potentially accelerating the deterioration of underlying building materials.

Degraded paint finishes should be sanded back, filled, leveled and painted, as applicable. Where inadequate or missing paint protection has led to the deterioration of the associated building element, repair and/or replacement of this building element may be required.

A painting contractor should be appointed as soon as possible to perform necessary works to aid the appearance of the affected area and to ensure the area is protected against further deterioration. Alternatively, the homeowner following manufacturer instructions may perform these works.

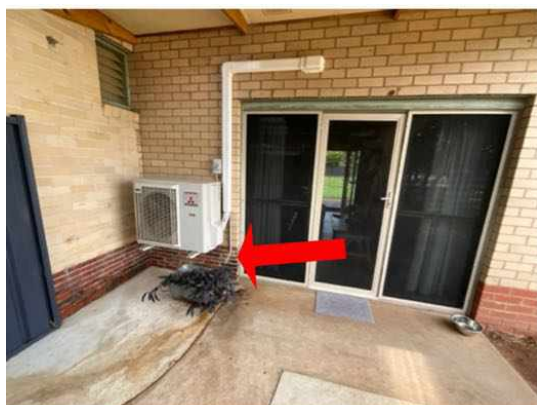
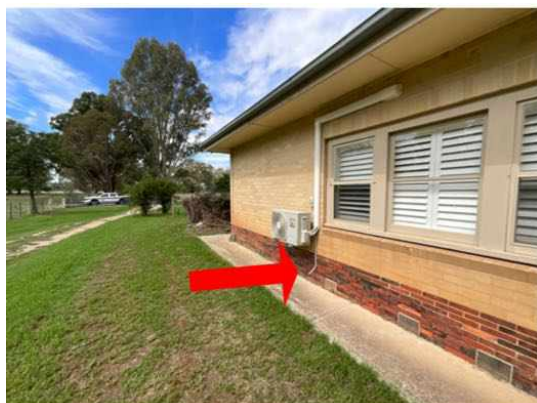
Finding 6.02

Building: Building 1
 Location: Yard - Side, driveway
 Finding: Air conditioner - Disconnected overflow
 Information: The Air Conditioner (A/C) overflow was found to be disconnected from storm water drainage and is creating excessive moisture in the surrounding area.

Such leaking creates an environment which is conducive to an array of defects, including water damage to associated building elements and the attraction of termite or timber pest infestation.

It is highly recommended that a licensed plumber be appointed to connect the A/C overflow in order to prevent such an environment from being created. These minor works should be carried out as soon as possible.

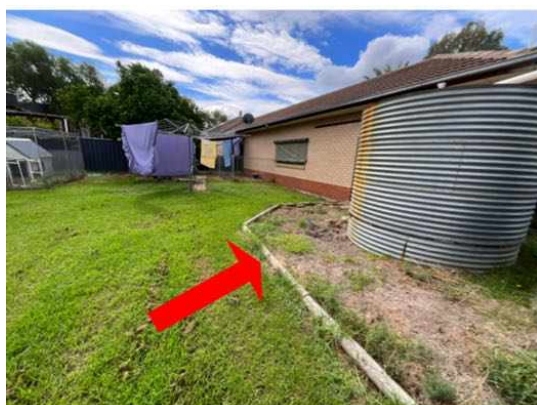
Building:	Building 1
Location:	Yard - Side
Finding:	Untreated or non-durable timbers in a hazardous environment
Information:	To reduce the risk of timber pest attack it is essential that timber used in a hazardous environment (e.g. in direct contact with the ground or frequently exposed to damp conditions) is of sufficient durability and/or is adequately preservative treated.

Untreated timbers in direct contact with the ground are likely to develop severe wood rot and/or fungal decay if left unattended creating attraction for subterranean termites to infest the timbers from surrounding areas.

If untreated or non-durable timbers are found to be in a hazardous environment it is highly advised that replacement of these building elements be performed as soon as possible to aid the protection of the property against termite / timber pest attack.

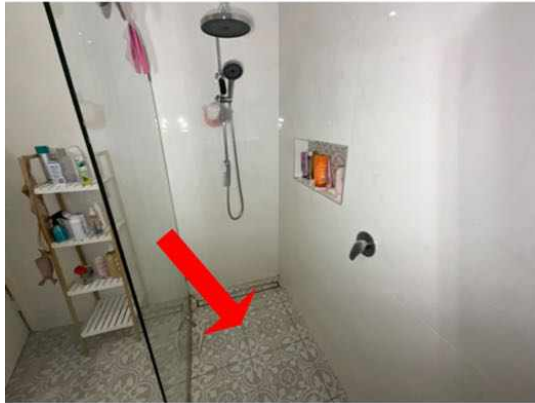
Finding 6.05

Building:	Building 1
Location:	Bathroom
Finding:	Inadequate sealant or Grout
Information:	This area has a lack of effective Sealant or Grout. This is allowing the ingress of water

The presence of water encourages Termite attack, Mould and Fungal Decay.

A Tiler or General Handy person must be contacted as soon as possible to effect repairs and prevent further deterioration.

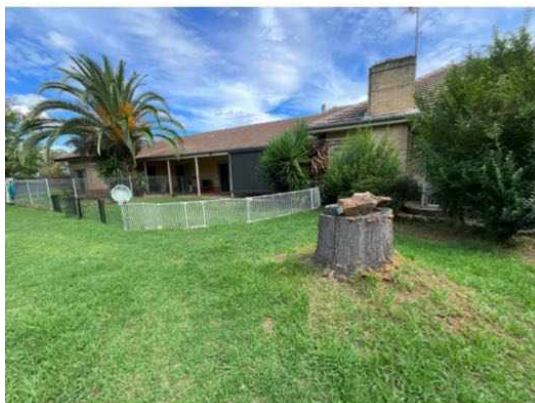
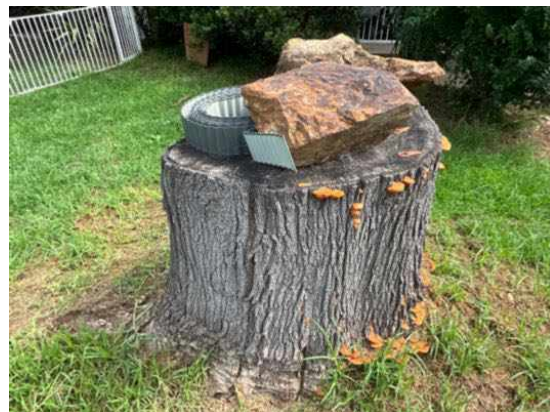
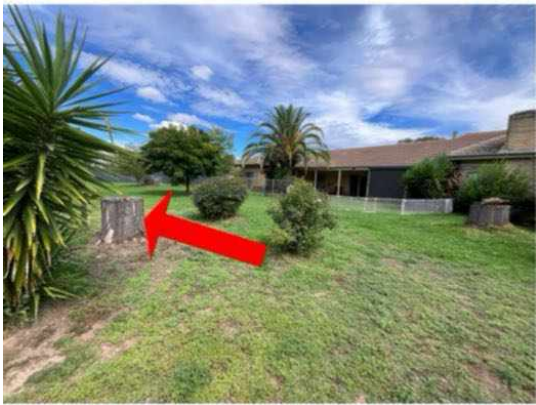
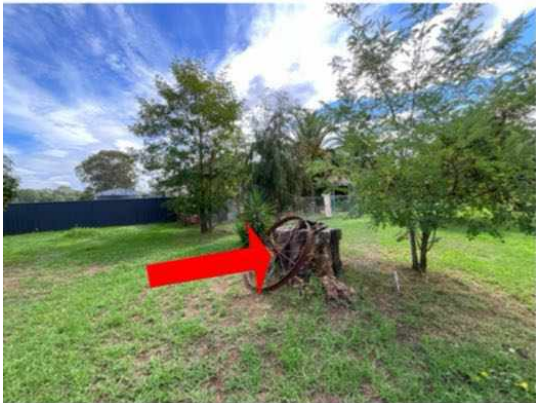
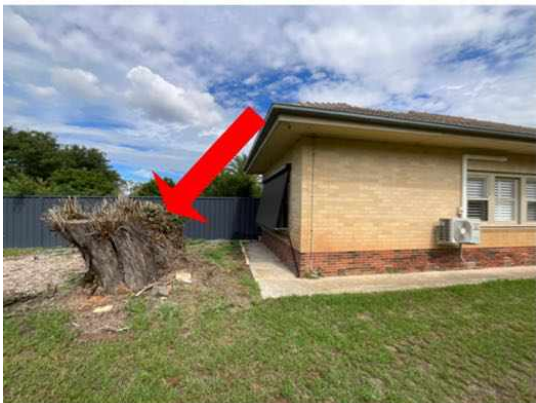
Finding 6.06

Building:	Building 1
Location:	Yard - Back, driveway
Finding:	Tree Stump in Ground
Information:	Any tree stumps in the yard not removed during the tree removal process provides the opportunity for Termite infestation and is likely to be subject to decay from damp conditions against the stump.

All tree stumps should be removed by professional tree removal services where possible. Meanwhile regular inspections are advised to identify any termite activity in the areas identified.

Services for tree stump removal should be contacted as soon as possible to reduce the risk of timber pest attack.

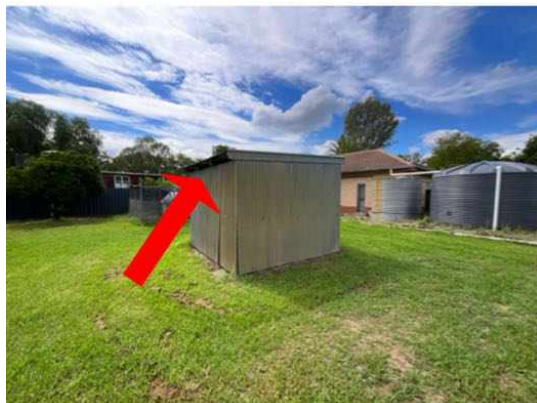
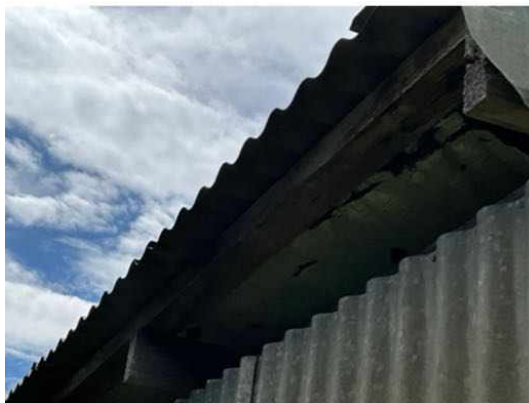
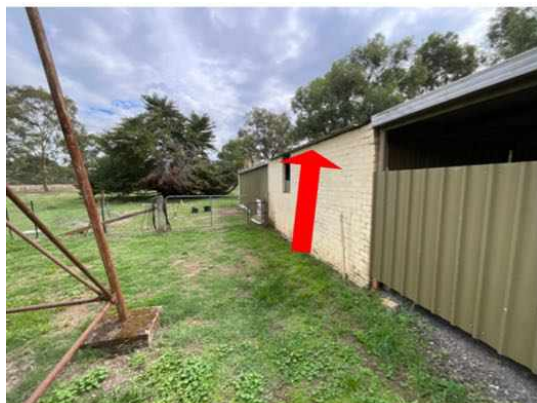
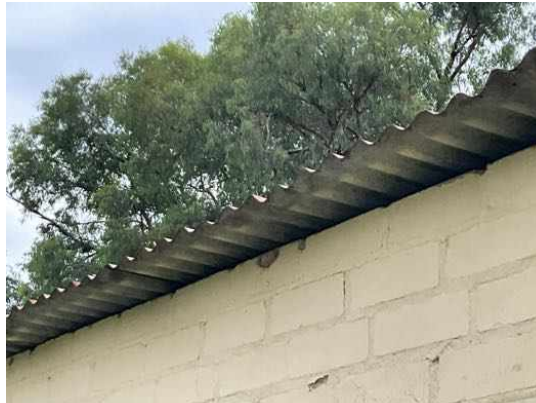
Finding 6.07

Building: Building 1
 Location: Shed, equipment shed
 Finding: Guttering Missing
 Information: The Guttering in this area was missing at the time of inspection. Guttering, Downpipes and Stormwater drainage are vital to protect the integrity of the structure and to prevent an environment conducive to Timber Pest attack.

A Plumber should be contacted as soon as possible to replace and connect to drainage the missing Guttering.

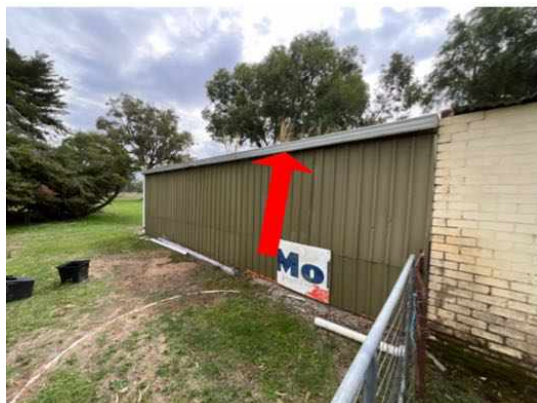
Where roof plumbing doesn't drain adequately, the area at the base perimeter can become excessively damp, potentially creating an environment that is susceptible to rust and corrosion of surrounding building elements, as well as attracting termites and other pests.

It is highly recommended that a plumber be appointed to further inspect the area and to install adequate drainage equipment where necessary.

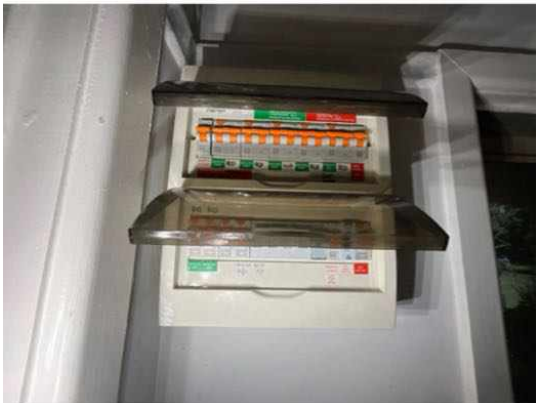
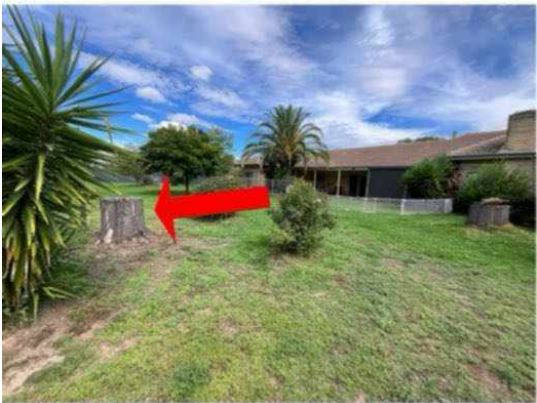
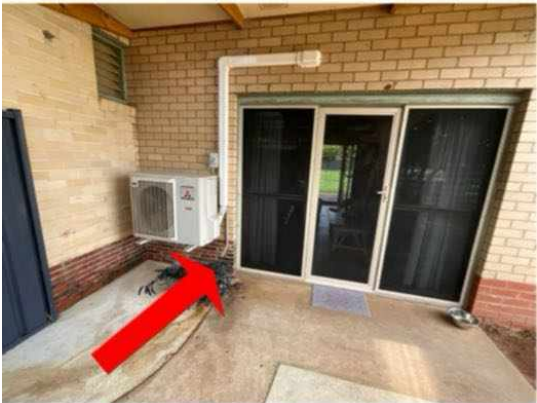
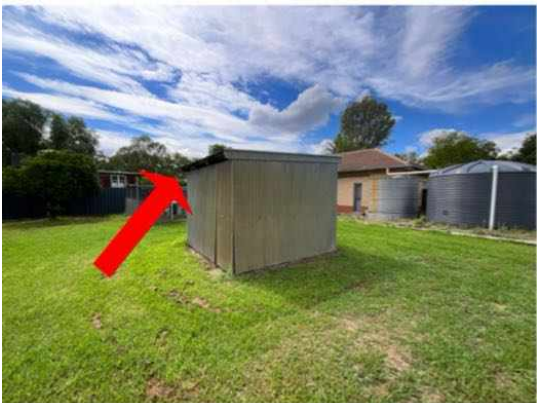
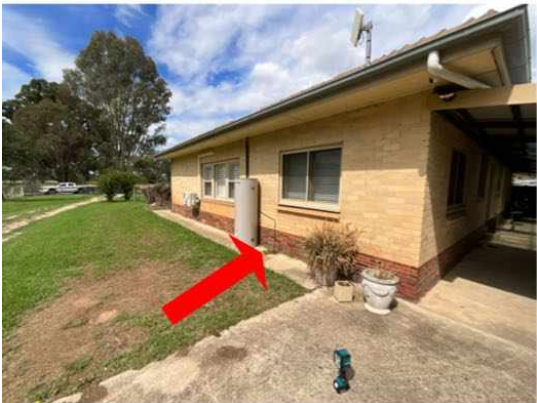
Finding 6.09

Building:	Building 1
Location:	All External Areas
Finding:	Termite Management System - no evidence of a chemical installation
Information:	The application of a post-construction chemical termite barrier is highly recommended for all properties, particularly if live termite activity has been found on the site previously. Such barriers are highly effective in preventing termite attack on any timber building elements throughout the property.

A durable notice should be placed in the switchboard unit to indicate current termite barriers. At the time of inspection, it appeared as though no termite management system has been installed, with no evidence to suggest preventative works taking place.

The client may consider gaining further advice from a pest controller as to the costs and procedures involved with this application. It is recommended that obtaining such advice be a short-term priority.

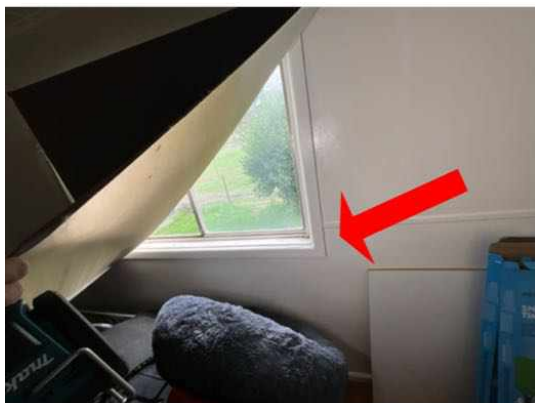
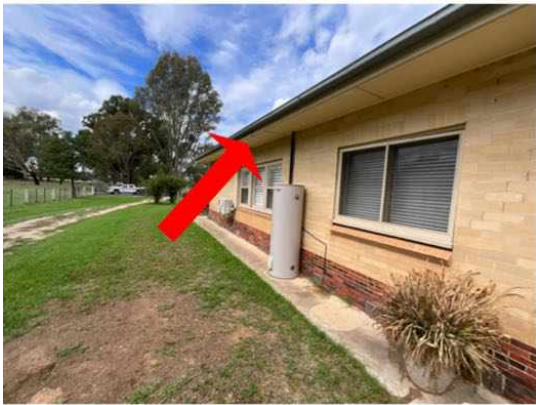
Building:	Building 1
Location:	Studio, eaves
Finding:	Fungal decay - present (localised)
Information:	Fungal decay also known as wood decay or wood rot generally refers to the deterioration of timber elements when in contact with excessive levels of moisture for a prolonged period of time.

In this case although the affected timber element is in a decaying state the extent of any visible damage appears to be localised to a specific area and is yet to spread to other parts of the building element or affect adjoining structures. The fungal decay is therefore likely to be of a relatively superficial nature with minimal impact on the structural integrity or tensile strength of the timber element.

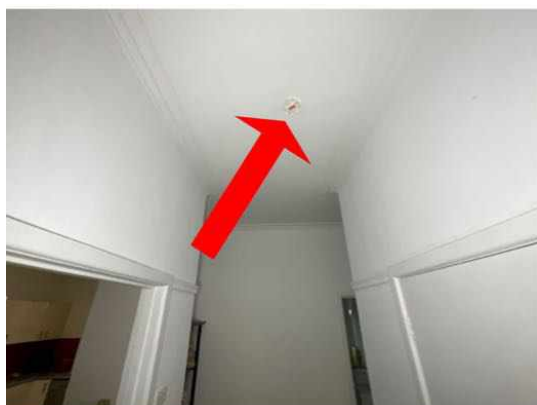
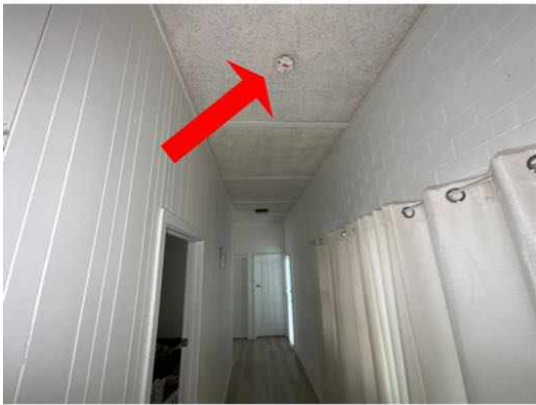
Please note that this defect is highlighted as a caution only. We suspect, based on our experience in the building industry, that the absence of smoke detectors, or their poor condition, should be addressed as a matter of urgency to improve occupant safety.

Always ensure sufficient working and suitable smoke detectors are installed prior to occupying any building. Additionally, it is advised that all smoke detectors be tested by the homeowner on a monthly basis.

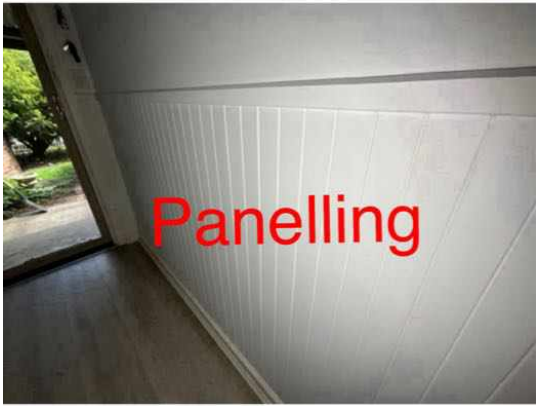
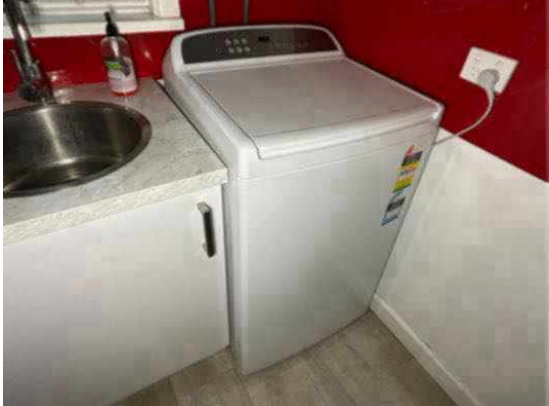
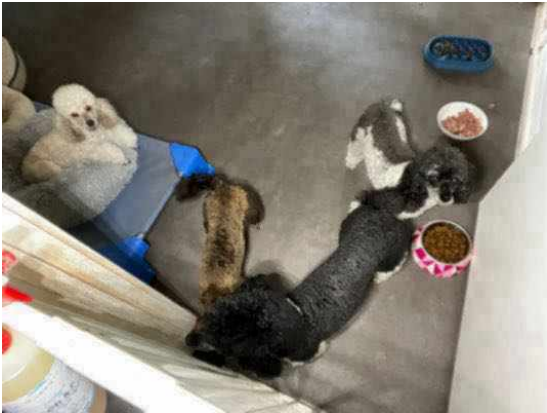
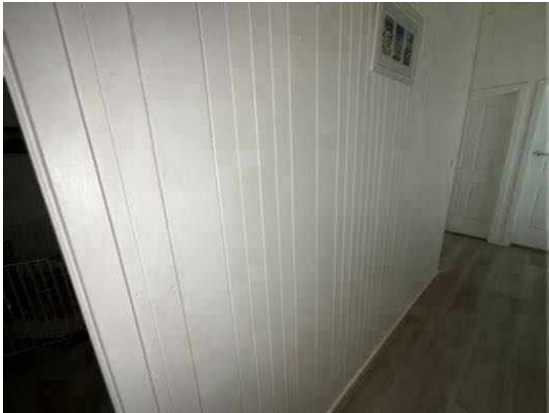
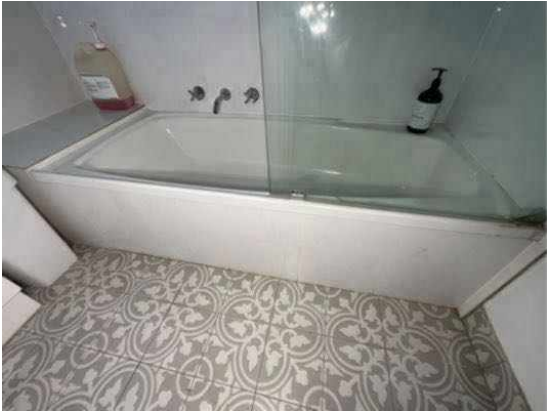
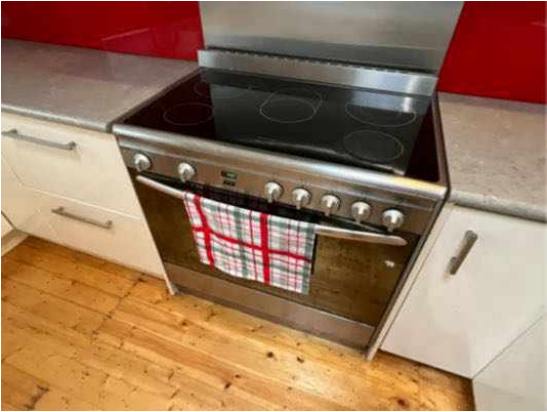
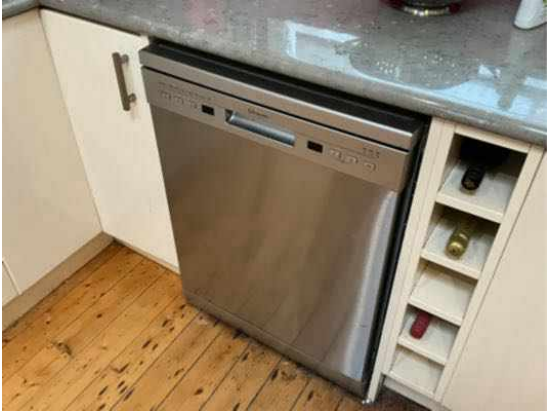
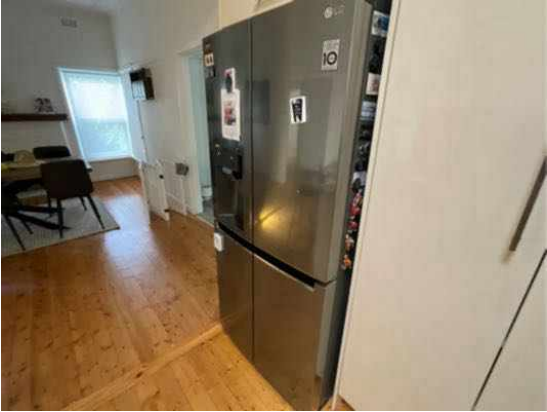
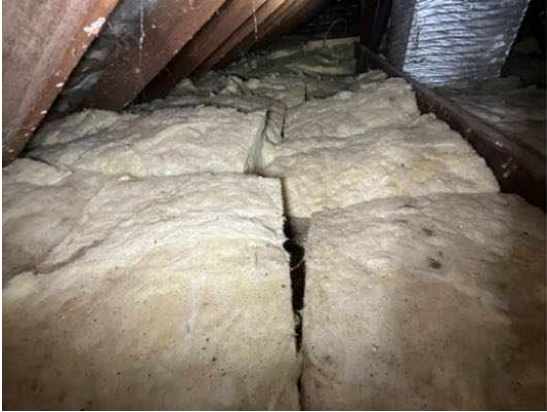
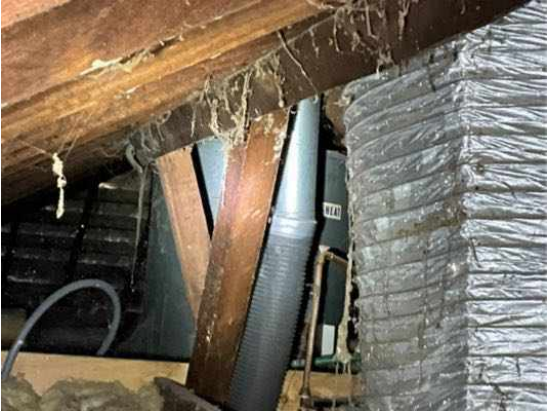
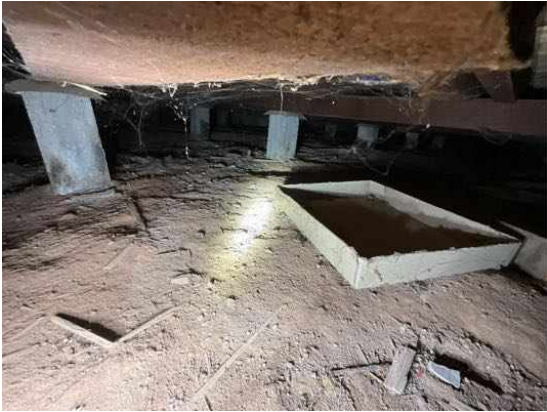
Building: Building 1
Location: All Areas
Finding: Additional Photos - Obstructions and Limitations
Information: These photographs are an indication of the obstructions and limitations which impeded full inspection of the property at the time of inspection. These obstructions can hide an array of defects and should be removed to allow full inspection to be carried out. A re-inspection is recommended once the areas are made accessible.
